The South Terrace, Cliveden

Archaeological Investigations 2013-17

May 2018

Client Name: The National Trust
Client Ref No.: n/a
Document Title: The South Terrace, Cliveden
Document Type: Report on Archaeological Investigations 2013-17

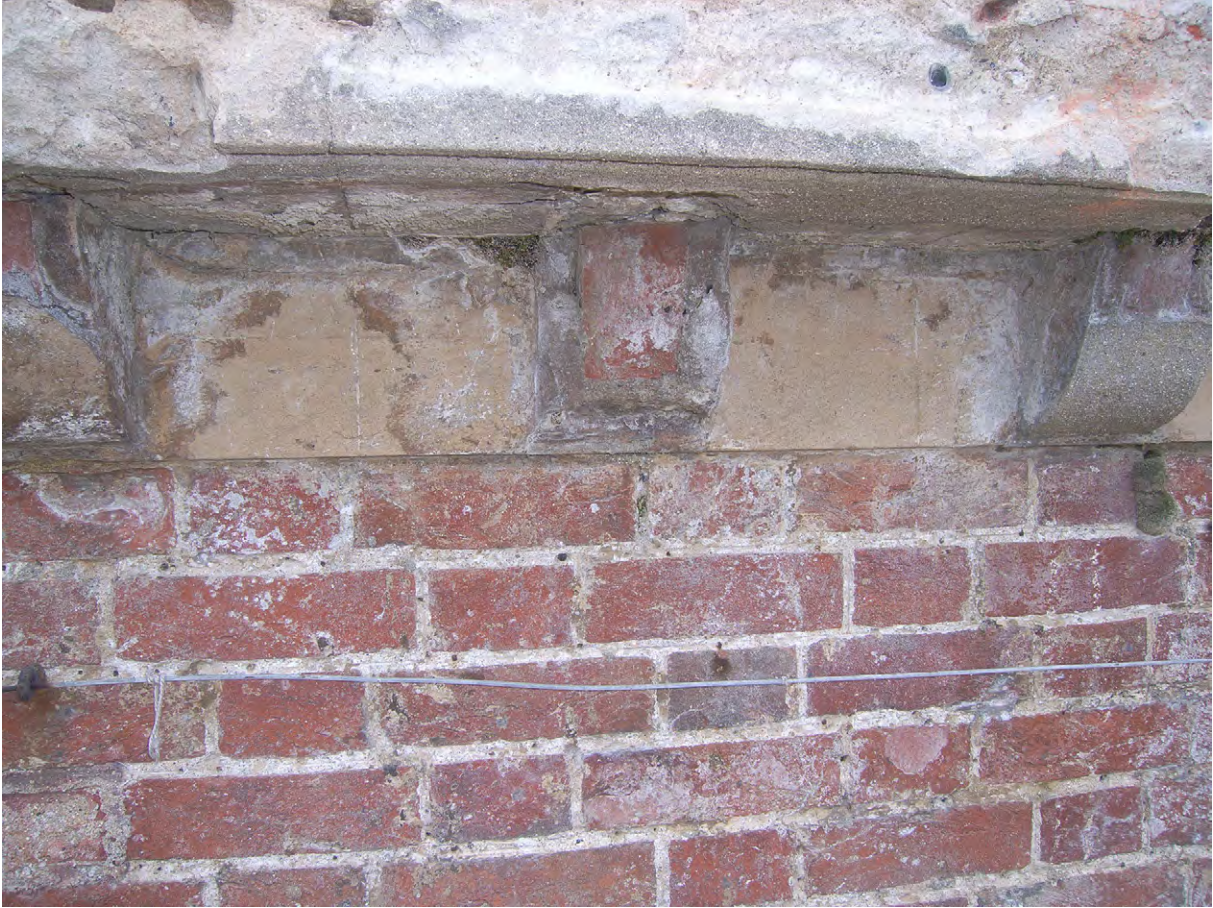
Plate B.19: Detail of exposed rendered brick bracket in cornice

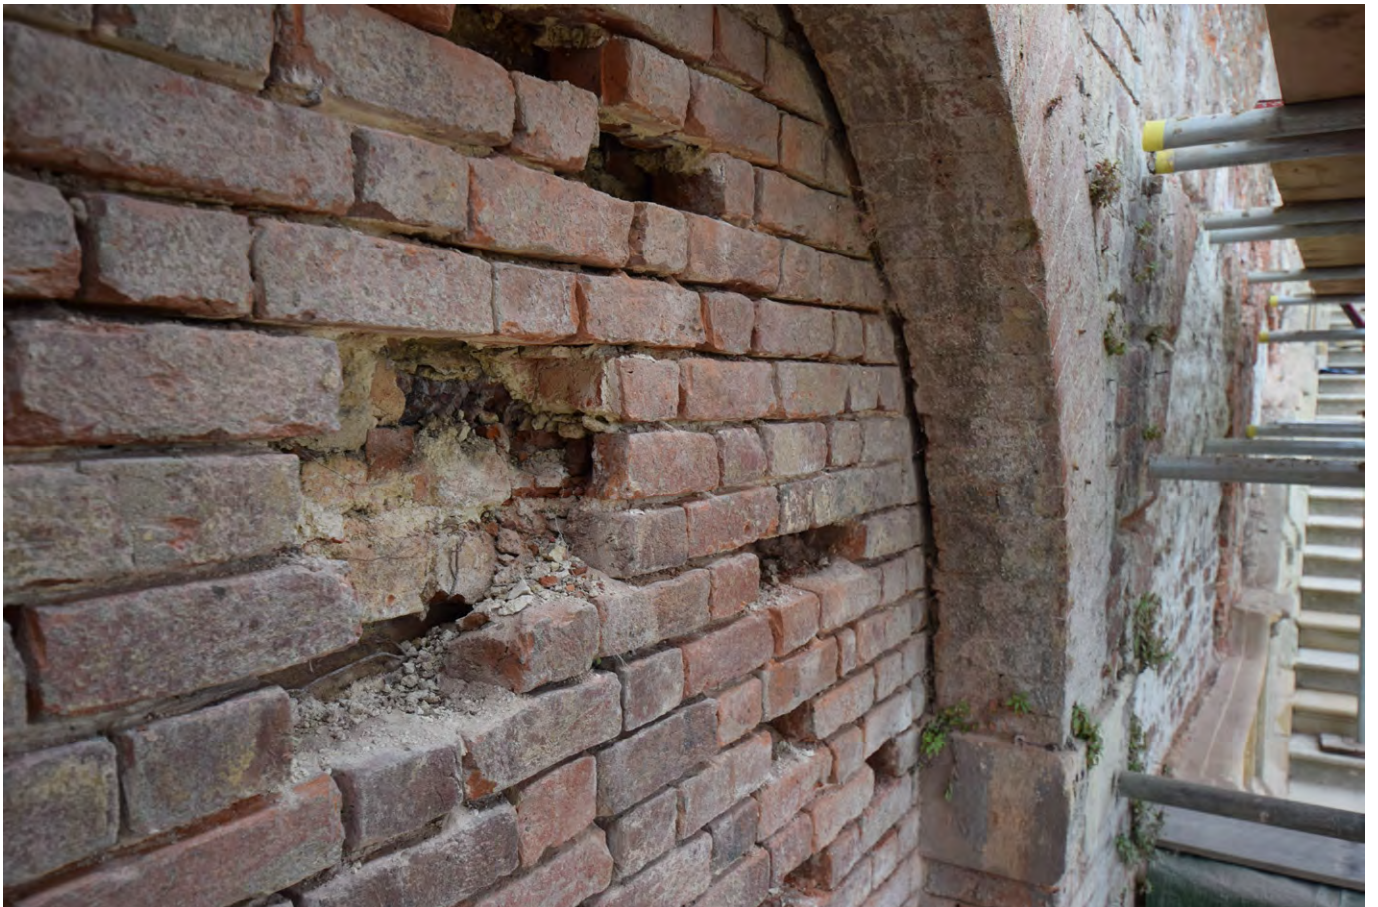
Plate B.20: Isolated bricks removed from blind arcade (Arch 9)

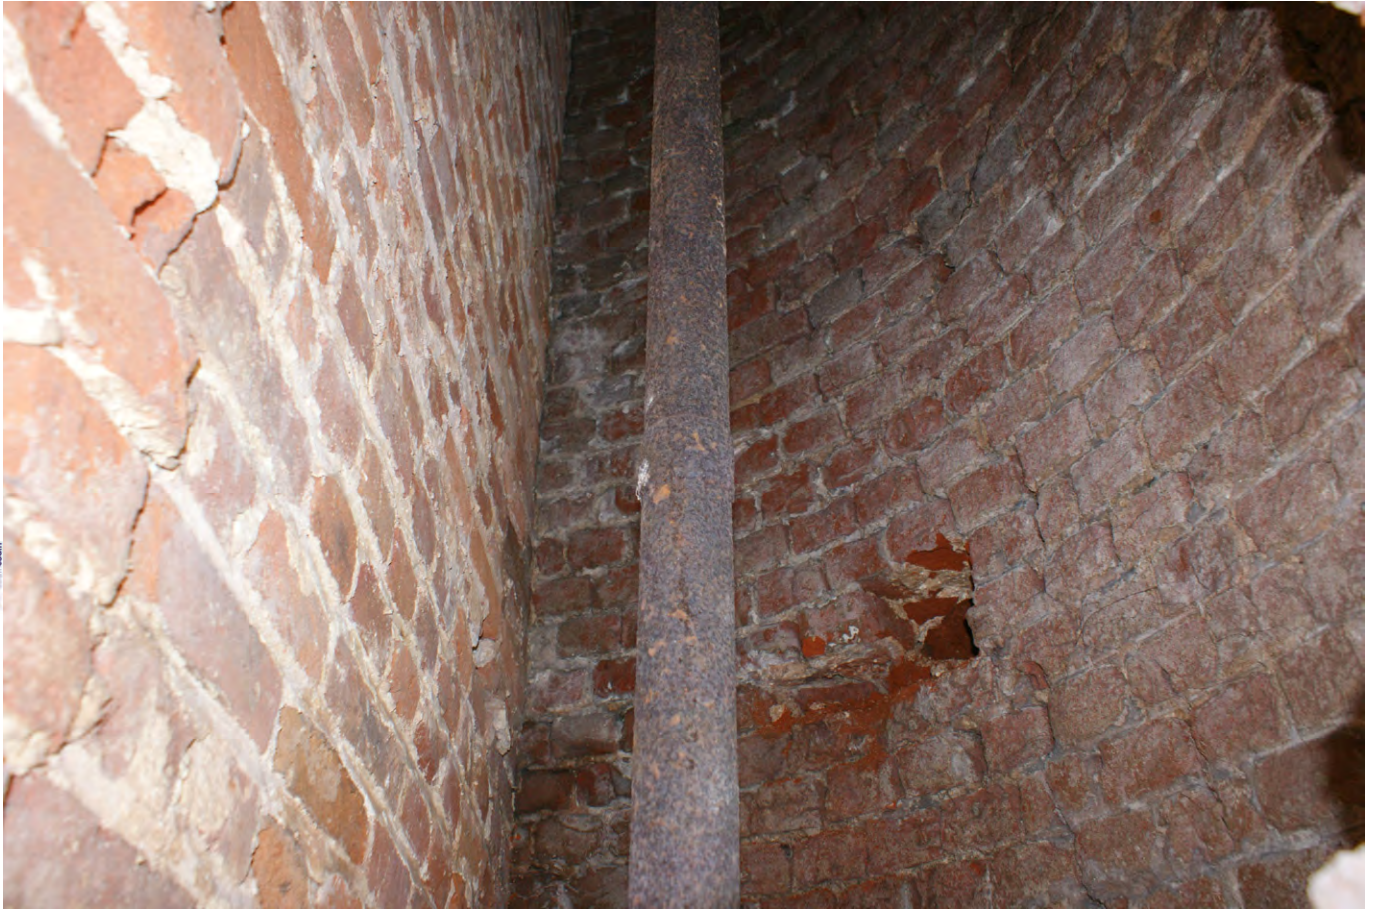
Plate B.21: Hidden brickwork from former niche behind later blind arcade exposed by NT in 2012

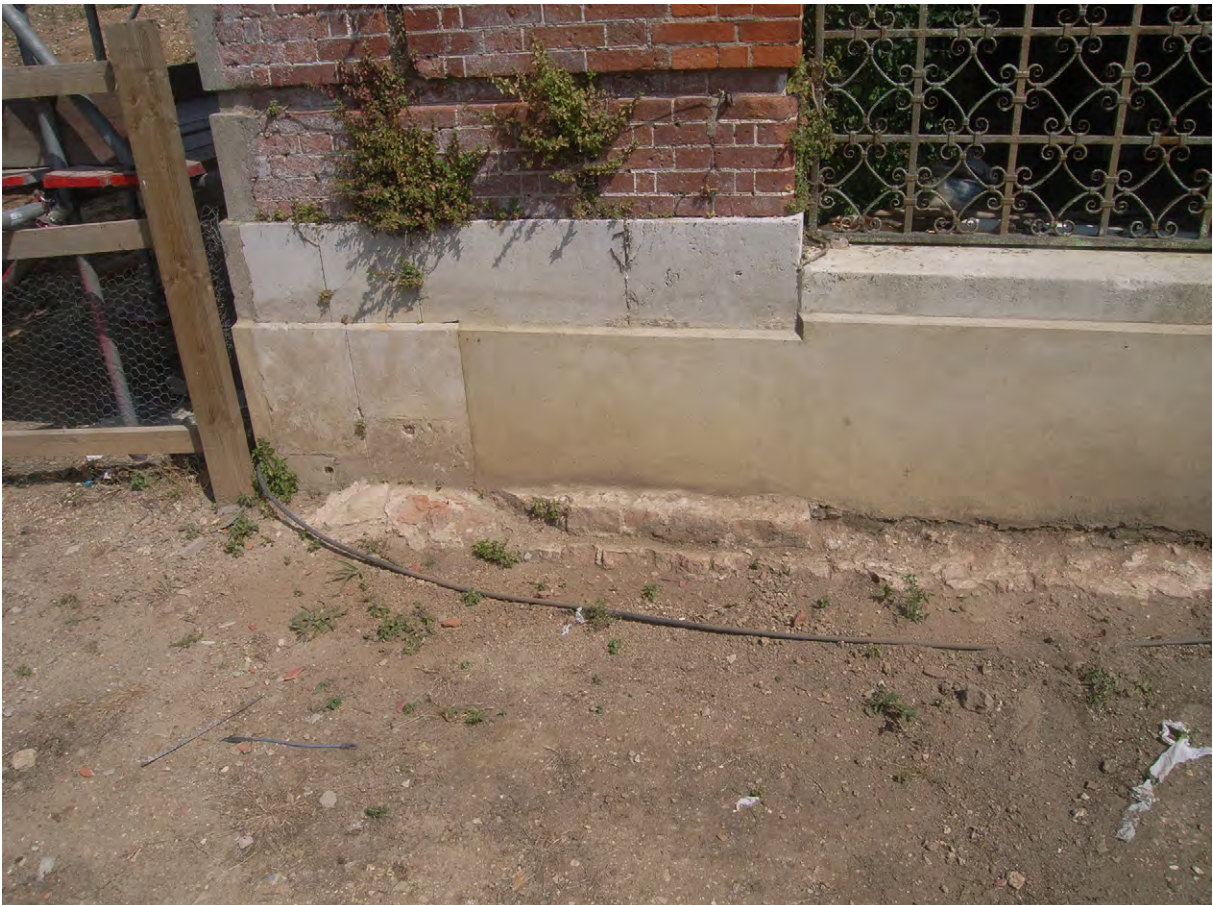
Plate C.4: Footings visible beneath front wall of West Fernery, looking north

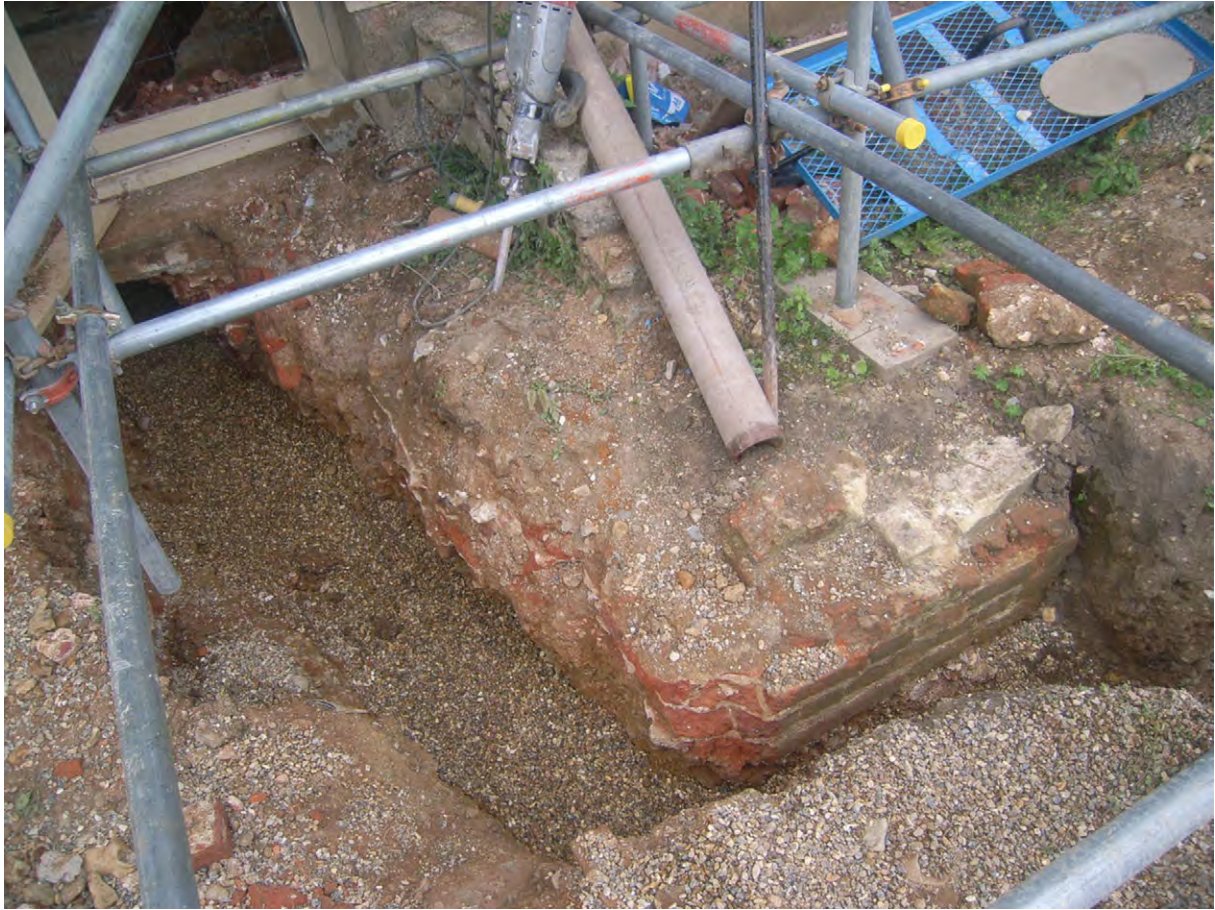
Plate C.5: Exposed footings in front of West Fernery [G.117.1], looking north-east

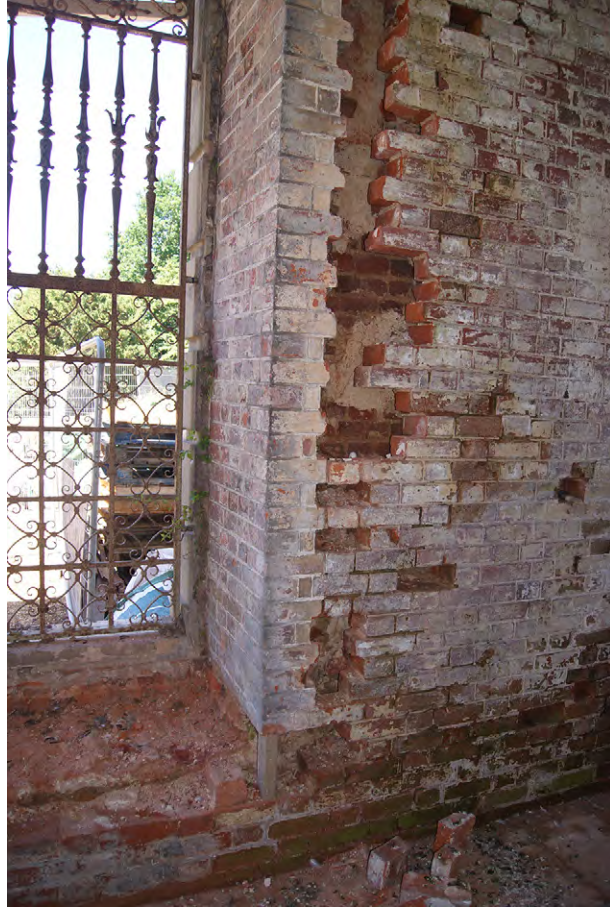
Plate C.16: Bricks removed from internal face of west wall in West Fernery, looking west

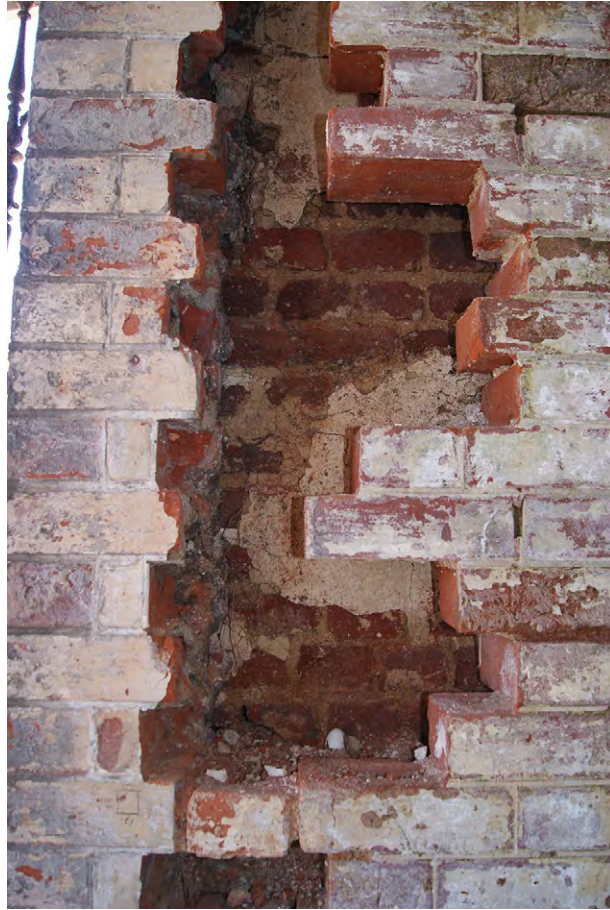
- 6.3.31 As referred to above a number of isolated bricks have recently been removed from the inner wall lining to enable repairs and this has allowed some examination of the previously hidden structure behind. The main bricks removed have been from the west wall and north wall. This has confirmed that the visible brick face is not bonded to the older structure behind and the later face of the west wall is c.19 cm in front of the older face (ie apparently with a void of c.7-8 cm). Fragments from the probably original lime plaster surface survived to the face of the earlier wall behind the later 19th century lining. The earlier plaster was particularly clear in an area immediately north from the inserted opening in the west wall (*Pl. C18*).

Plate C.18: Area of removed bricks with older plastered face behind west wall of West Fernery

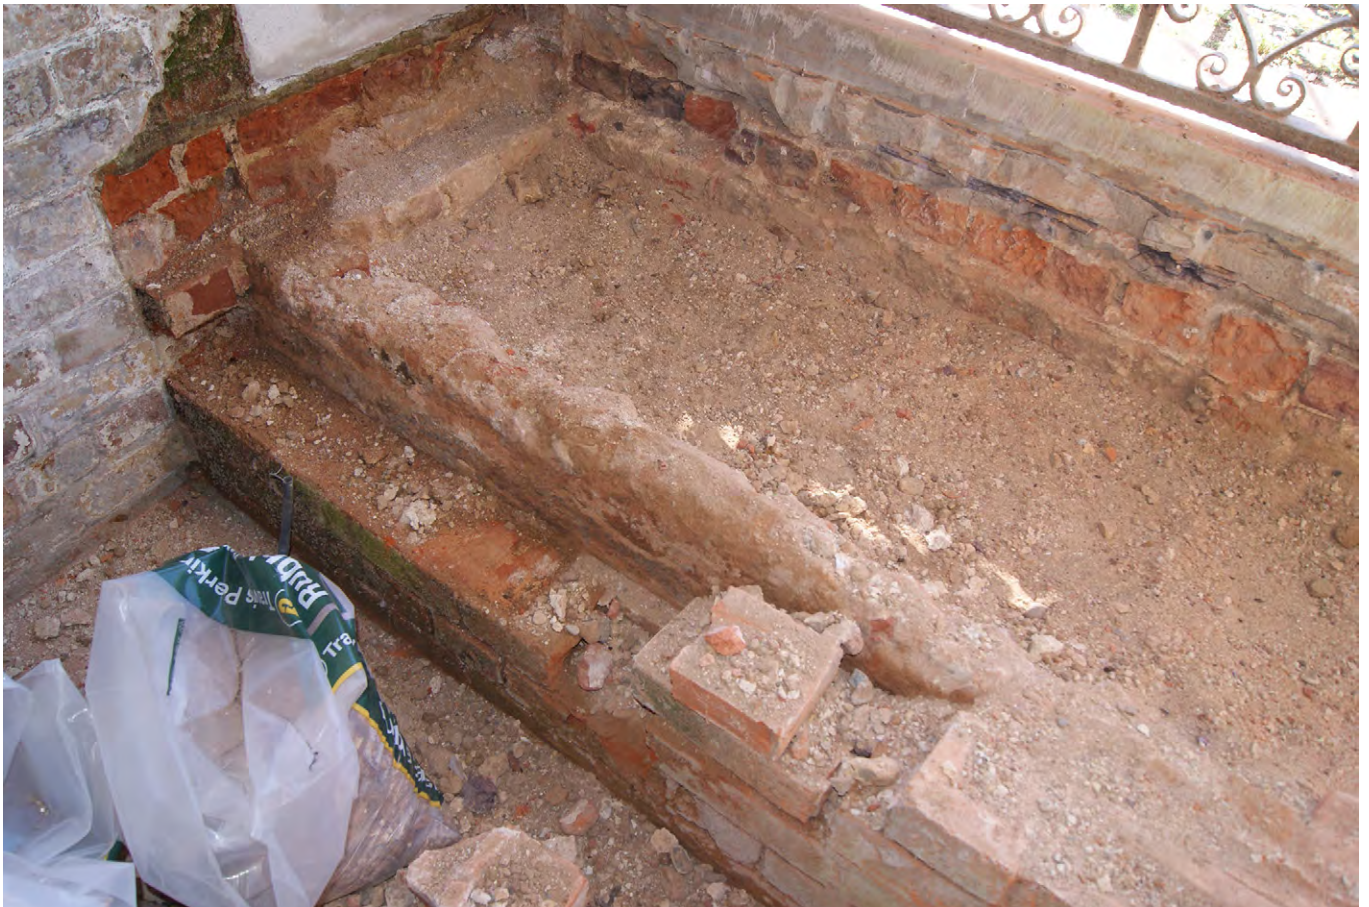
- 6.3.29 There is an opening with a fixed iron grille in the west wall of the West Fernery and it appears from the brickwork surrounding it that this opening is a secondary insertion (ie later than the c.1840 lining to the walls). The character of this brickwork around the opening is distinct from the main brickwork that lines the walls of the West Fernery and the suggestion that the opening was a secondary insertion is also supported by evidence recently revealed by repair works within the chamber. The iron grille was removed for conservation and the exposed part of the sill strongly appeared to have been formed by truncating bricks. This sill also appeared quite different to the sills of the two windows in the south wall of the fernery. These two windows in the south wall had something of a void within the brickwork at their sills which have a loose fill (*Pl. C19*) whereas the sill of the window in the west wall is solid (truncated

Plate C.19: Exposed base of wall beneath window in West Fernery, looking south

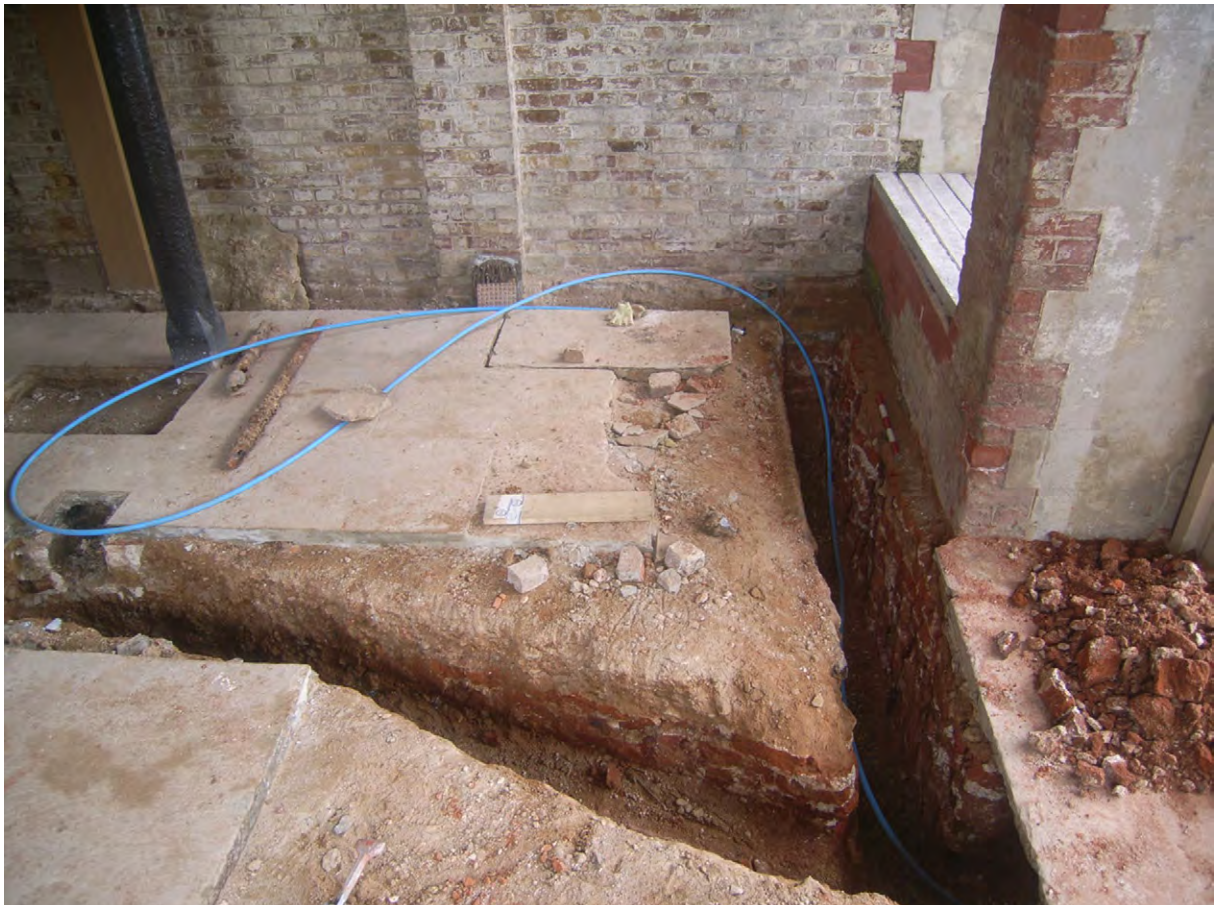
6.3.38 The current project has included some excavation works in the floor of the West Fernery which have exposed evidence of the previous form of the structure. The main excavations were immediately inside the front wall of the Fernery and they extended across the eastern half of the room but there was a branch trench which extended from this in a north-easterly direction (*Pl. C20-22*). The works exposed a very substantial brick footing [*Feature C.100.1*] and it appeared to continue through from the brick base found immediately to the south of the fernery [*Feature C.1.1*] which is believed to have formed part of the set of steps shown on various 18th century views (discussed more in Section 9 on Area F. The brickwork in the main foundation [*Feature C.100.1*] along the front of the room was seen to be 8 courses deep (extending to 80 cm below surface) and formed from soft, red brick with soft white mortar laid in thick joints.

Plate C.21: Excavations in West Fernery with exposed wall [C.1.8], looking east

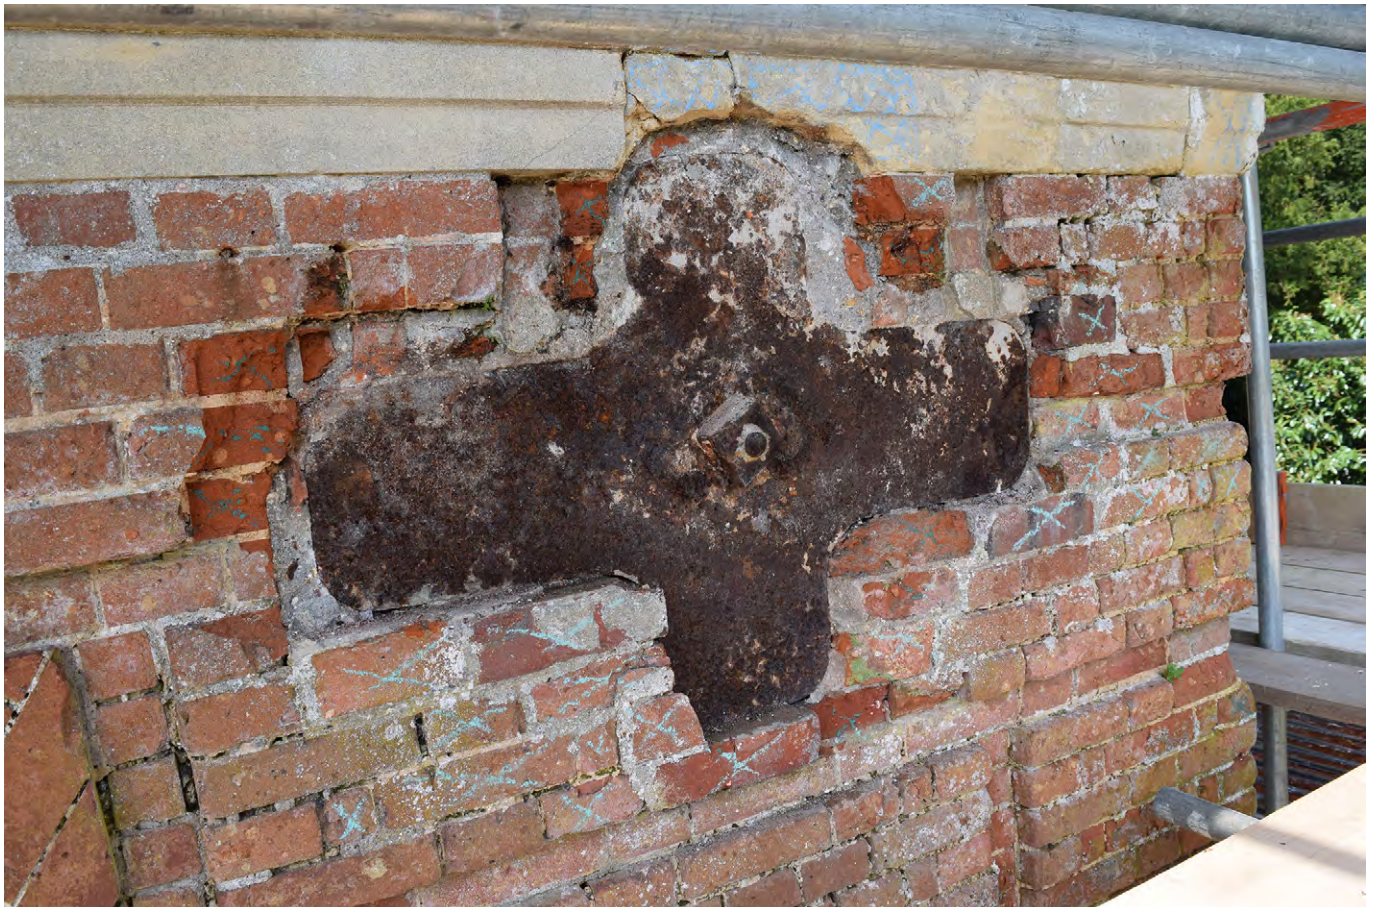
- 6.3.13 Towards the outer ends of the south facing walls of each fernery there was an anchor plate from a north-to-south tie bar (*Pl. C25*) just below the entablature, and these had been crudely hidden by a covering of render [*Feature C.1.2*]. These were partly exposed during the recent repair works.

Plate C.25: Large iron tie-bar in south wall of East Fenery, looking north

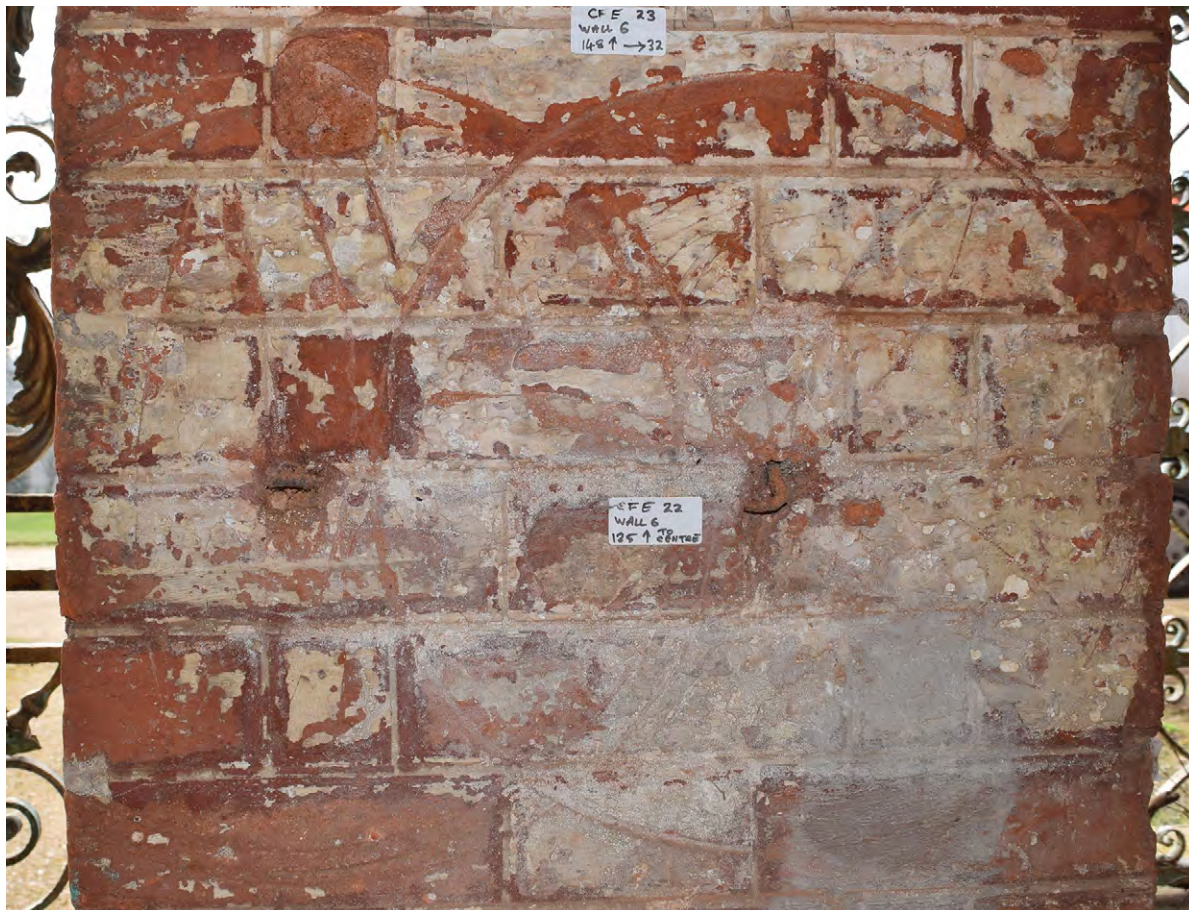
Plate C.30: Circular marks on south wall inside East Fernery [C.2.1], looking south to east of doorway

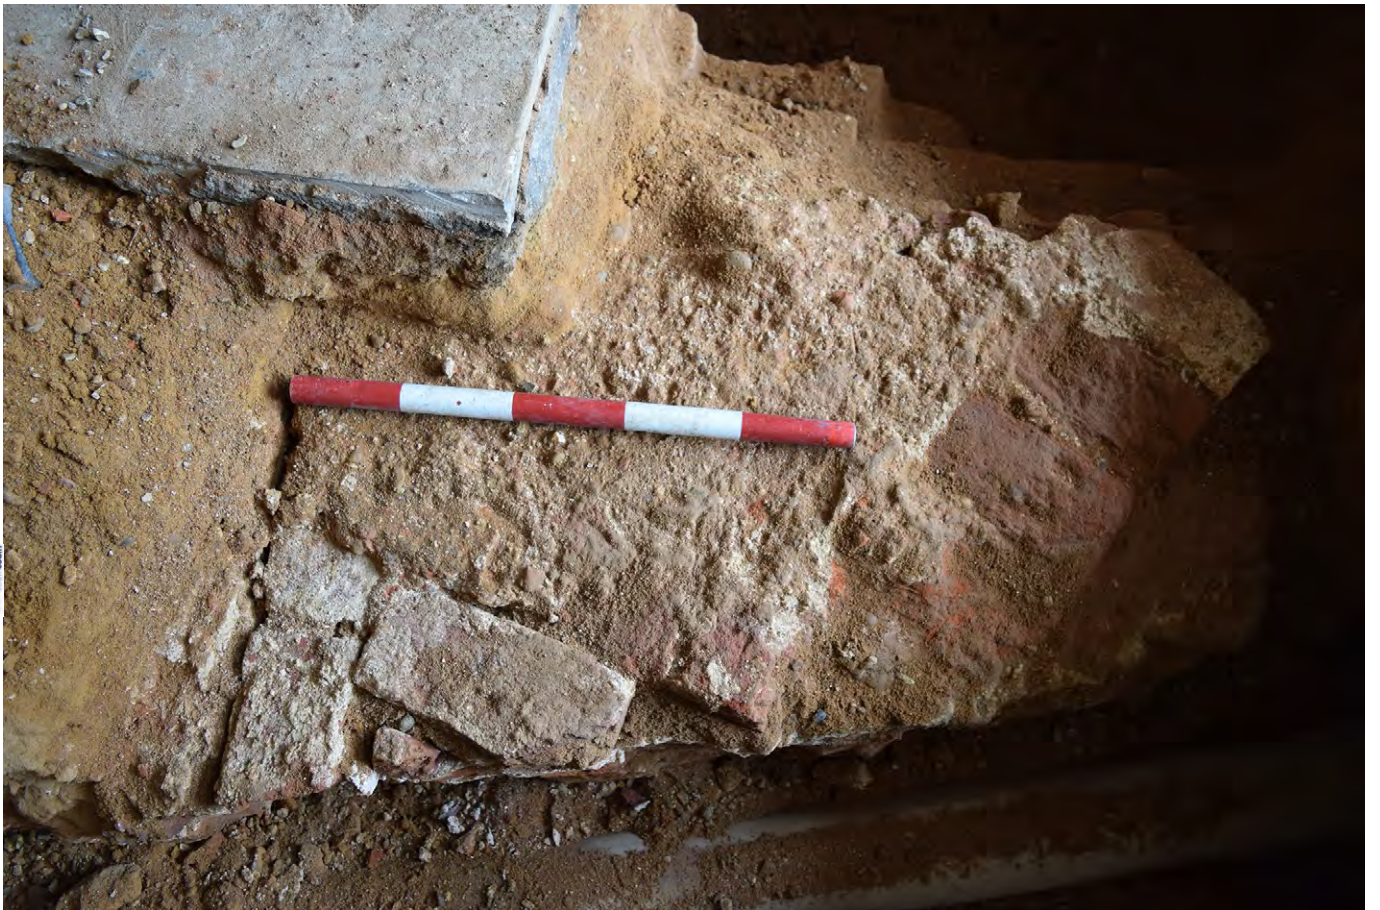
Plate C.32: Trace of foundations from former curved feature exposed in floor [C.2.5]

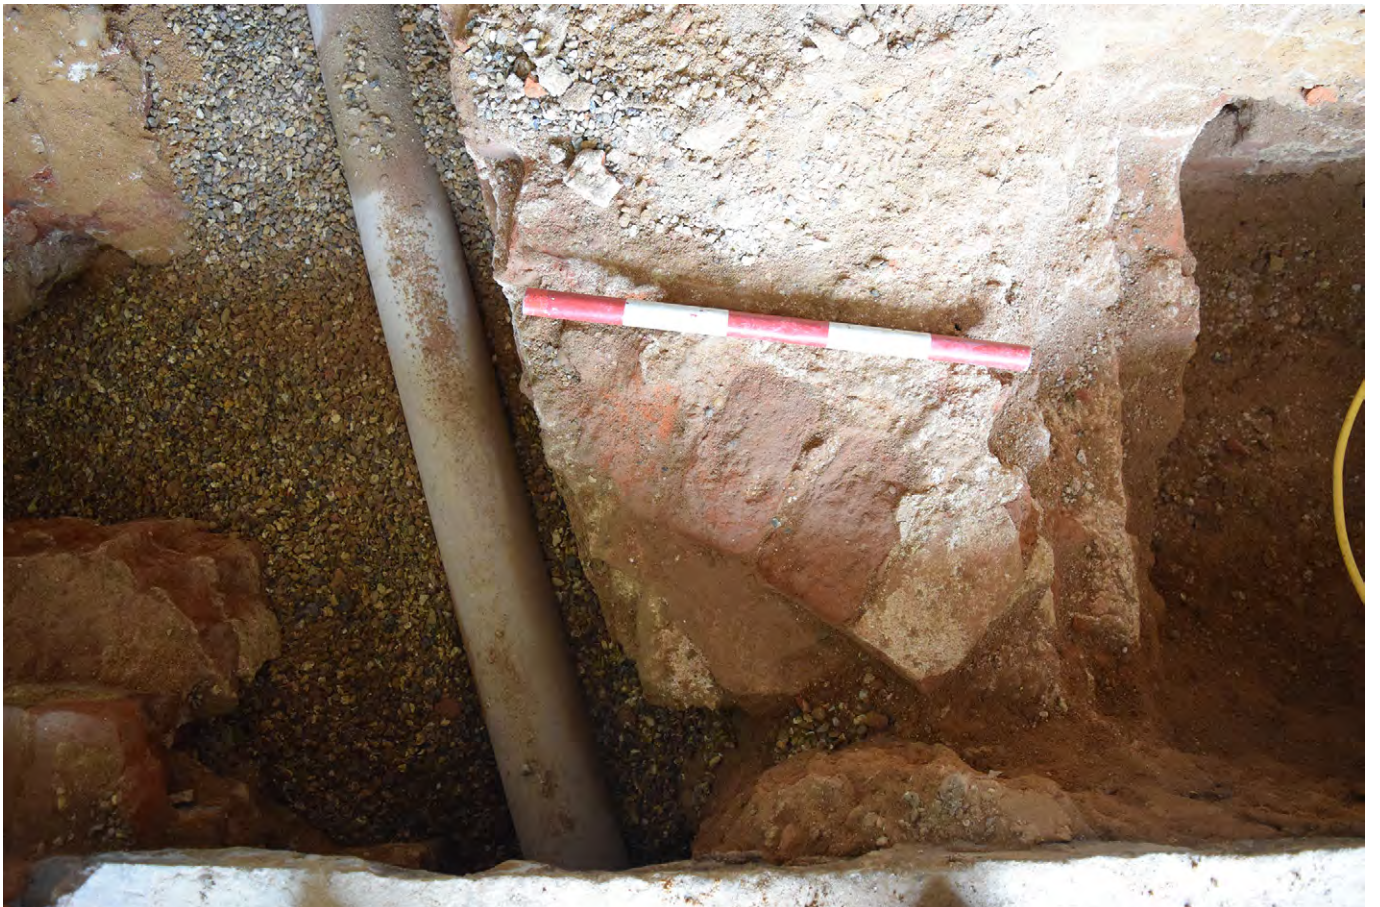
Plate C.33: Trace of foundations from former curved feature exposed in floor [C.2.5]

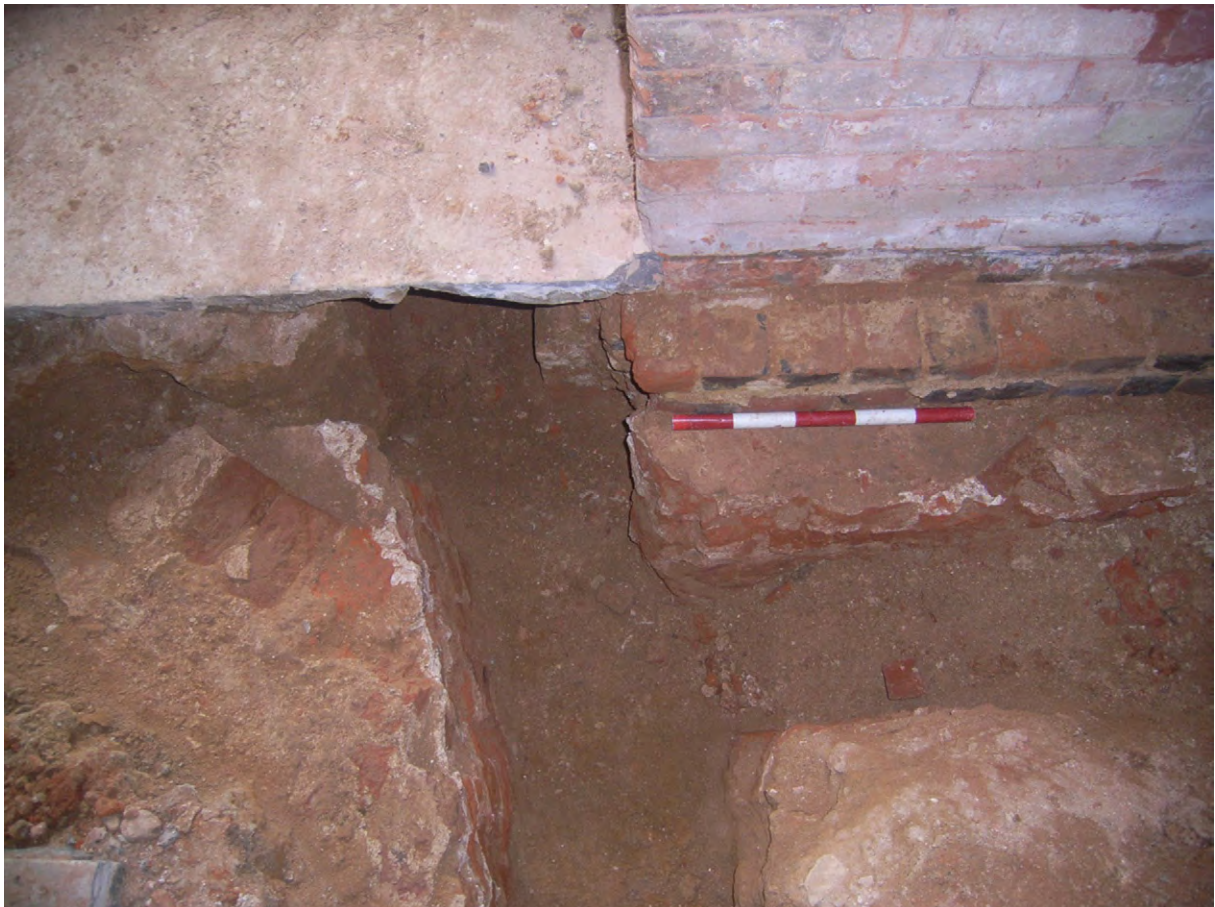
Plate C.35: Trace of foundations from former curved feature exposed in floor [C.2.5], looking south

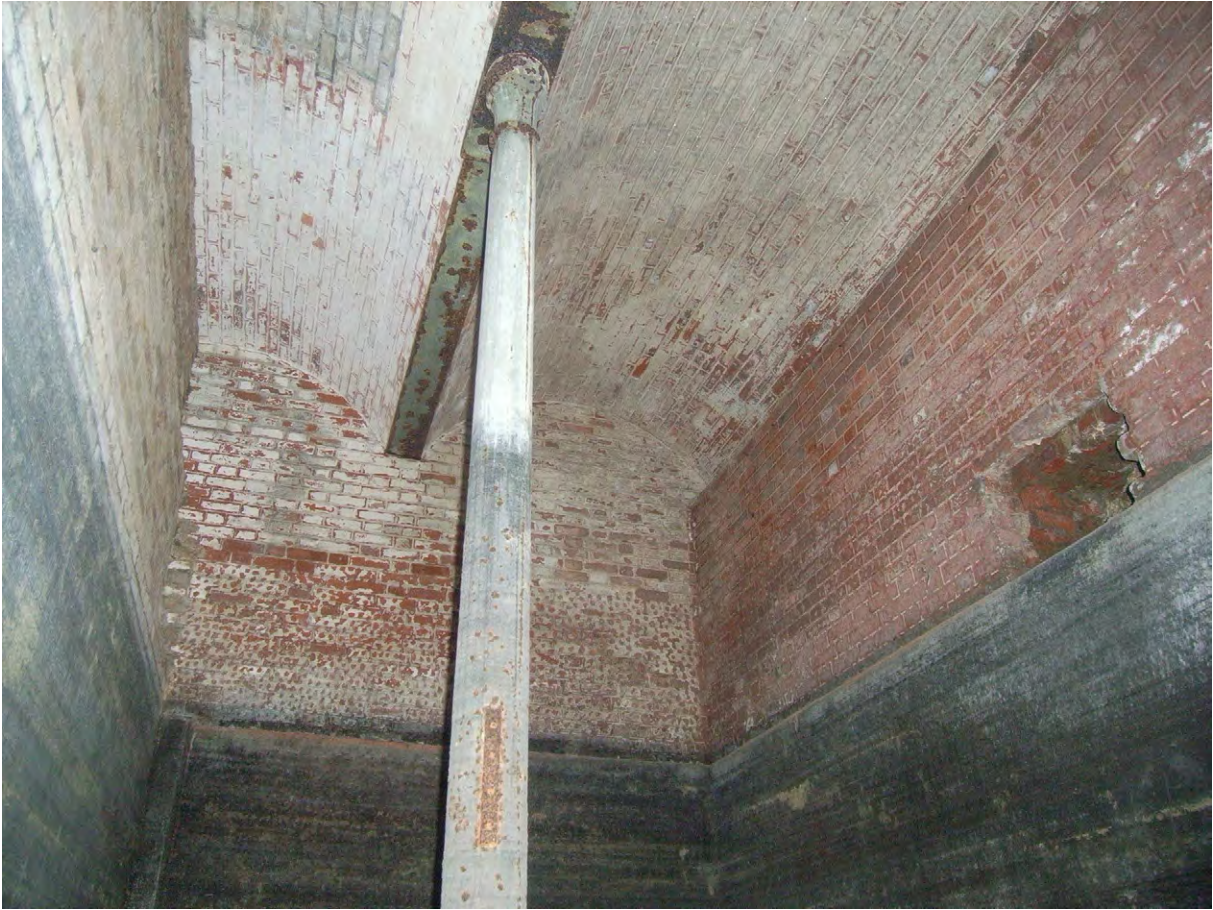
Plate C.36: West Fernery Water Tank (looking north)

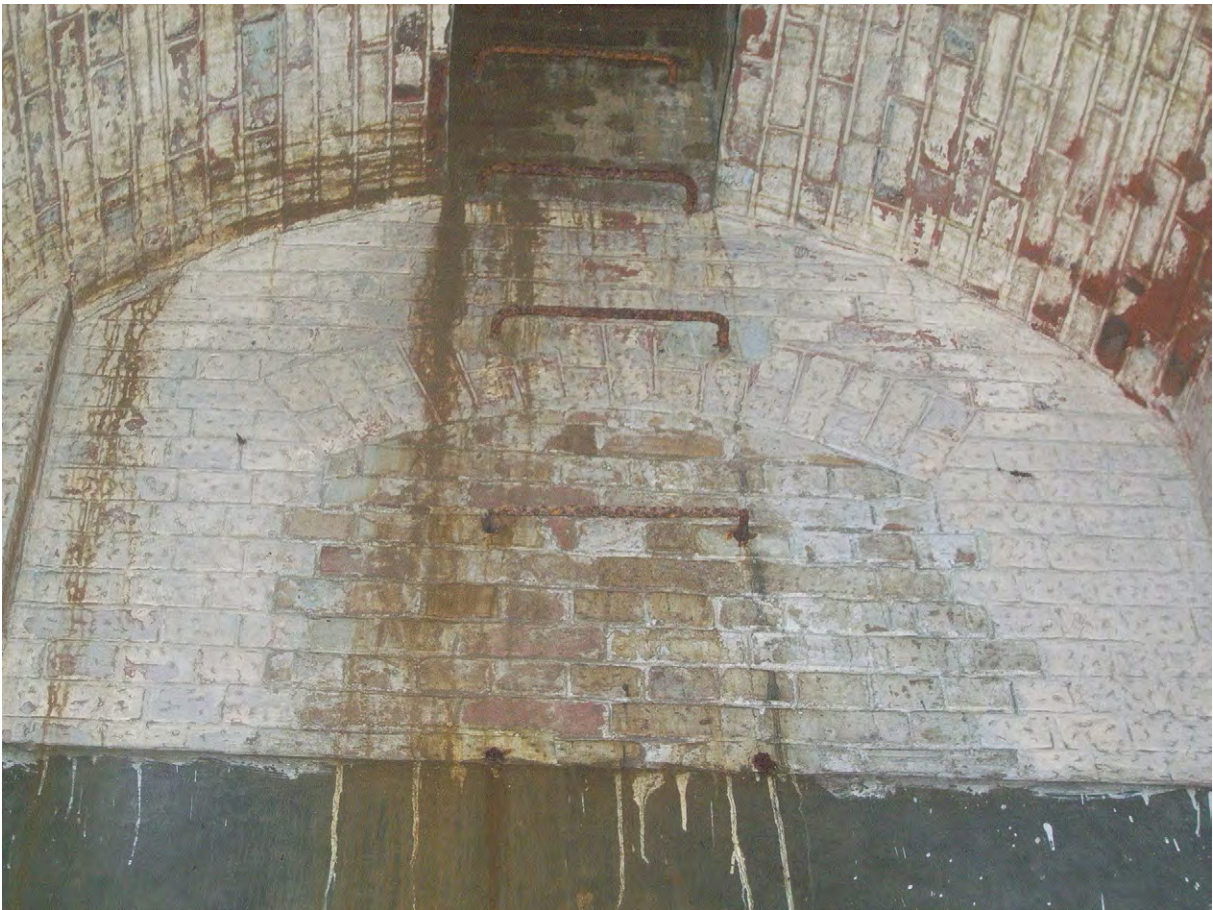
Plate C.37: Ladder and blocked arch in north wall of West Fernery Water Tank, looking north

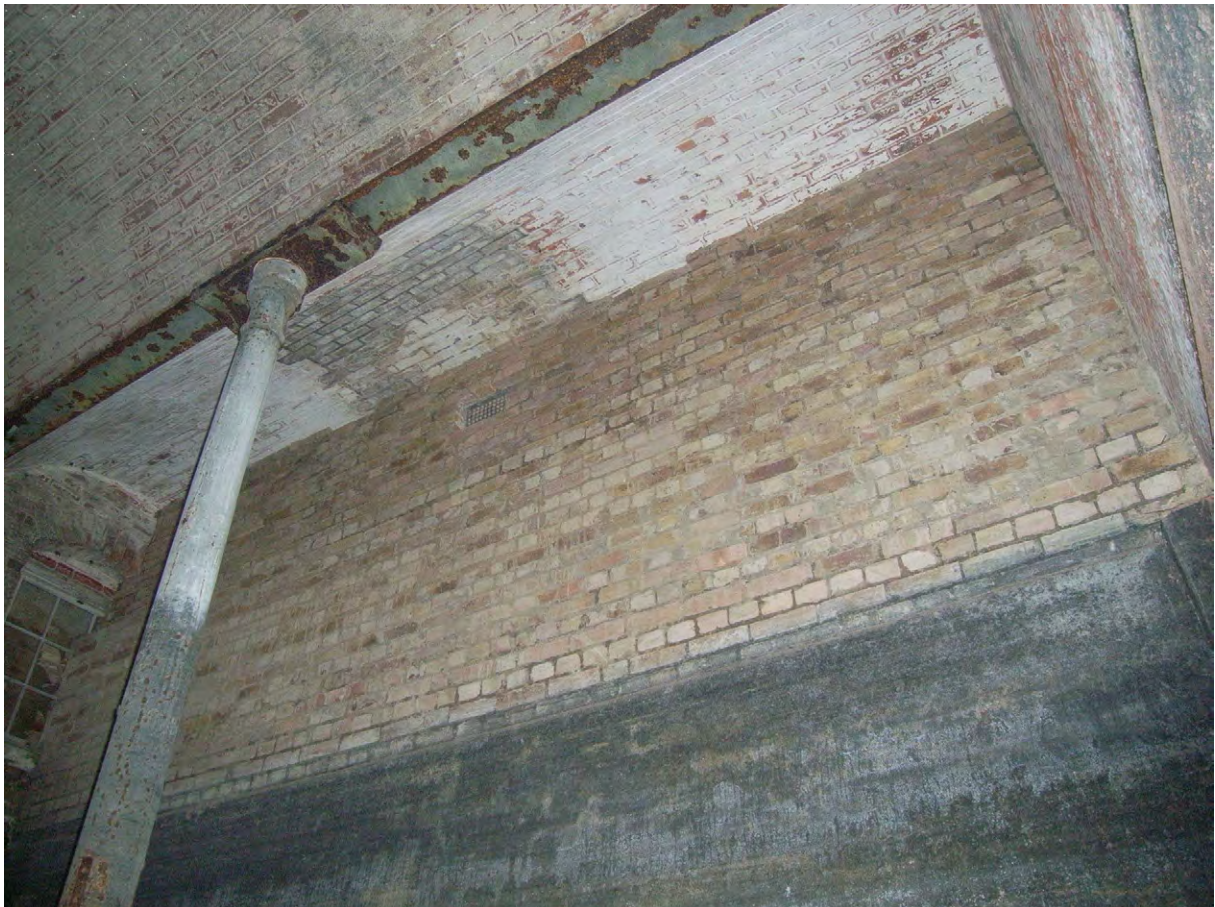
Plate C.41: East Fernery Water Tank (note brick infill in vault [C.4.3], looking north-east

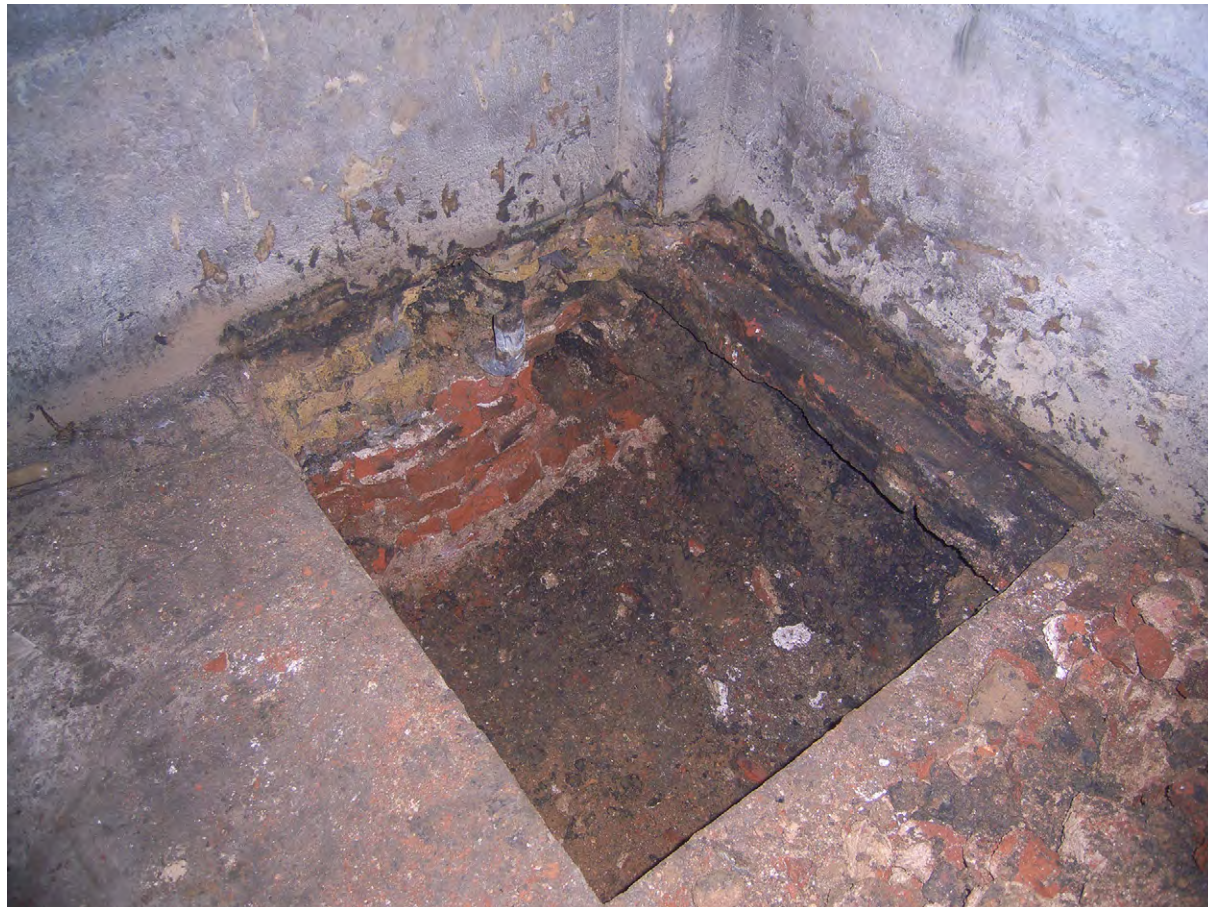
Plate C.43: Pit dug in floor of East Fernery Water Tank , looking south-east

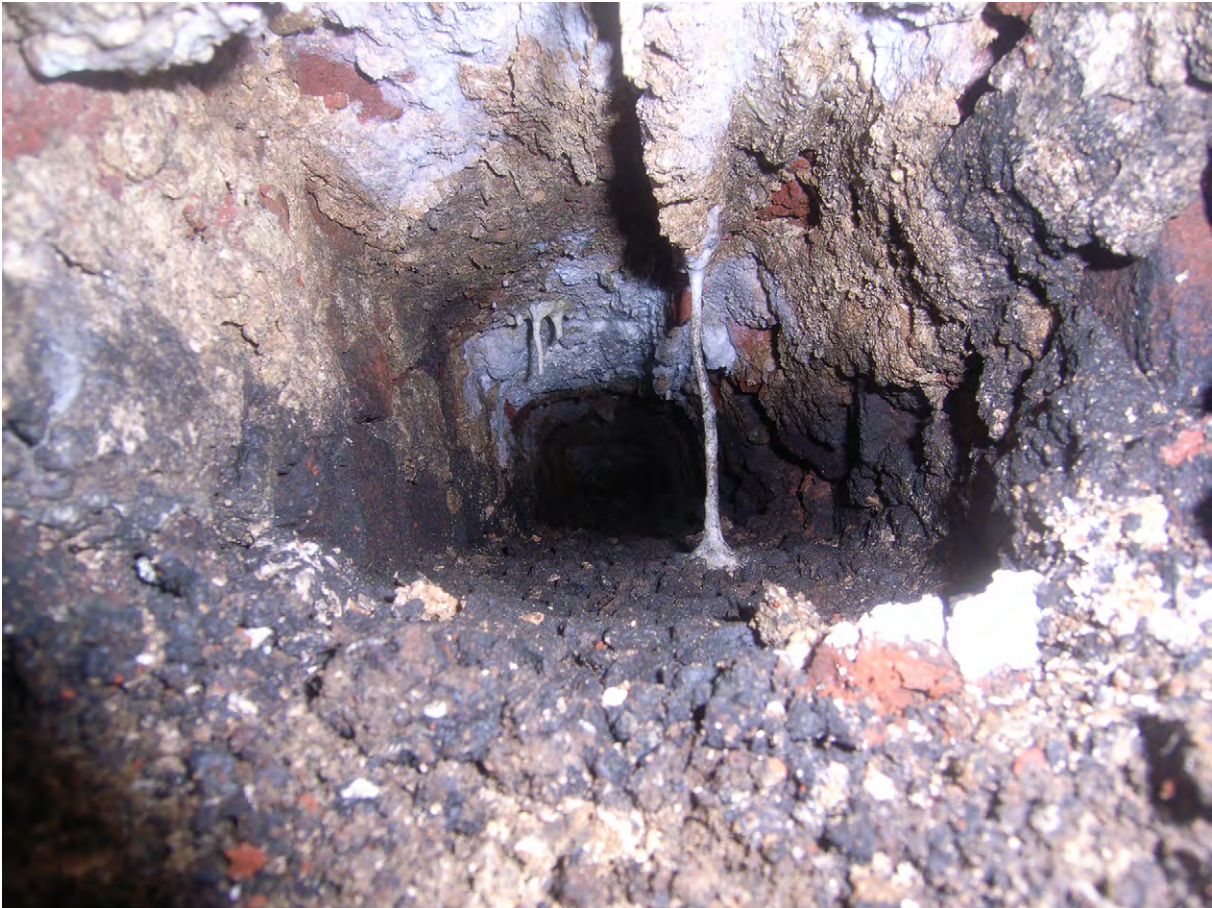
Plate C.45: E-W drainage duct exposed in excavations in East Fernery Water Tank [C.4.2], looking west

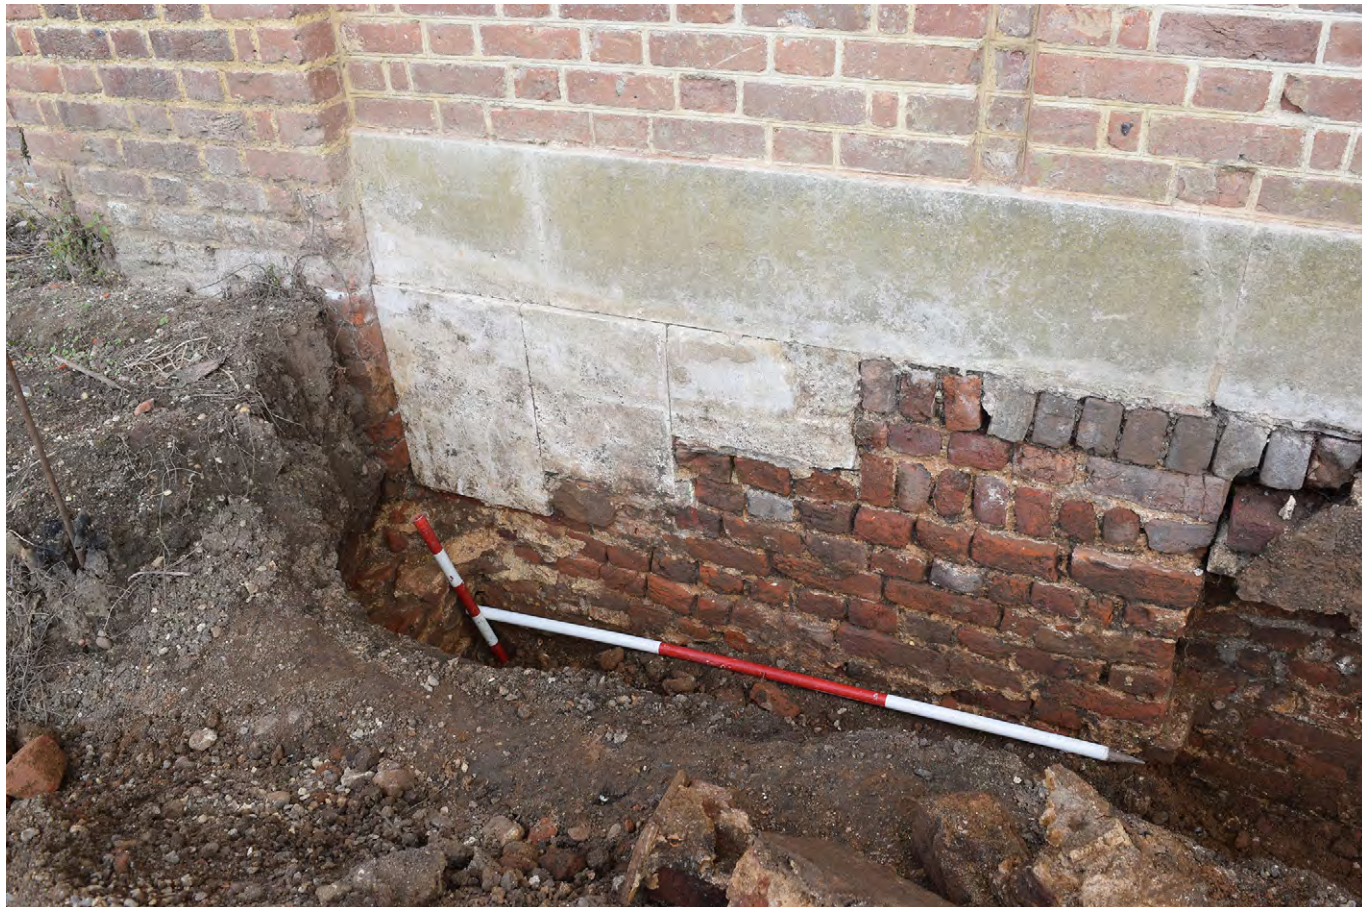
Plate C.47: Evidence of former steps in south face of East Fernery, looking north
