The South Terrace, Cliveden

Archaeological Investigations 2013-17

May 2018

Client Name: The National Trust
Client Ref No.: n/a
Document Title: The South Terrace, Cliveden
Document Type: Report on Archaeological Investigations 2013-17

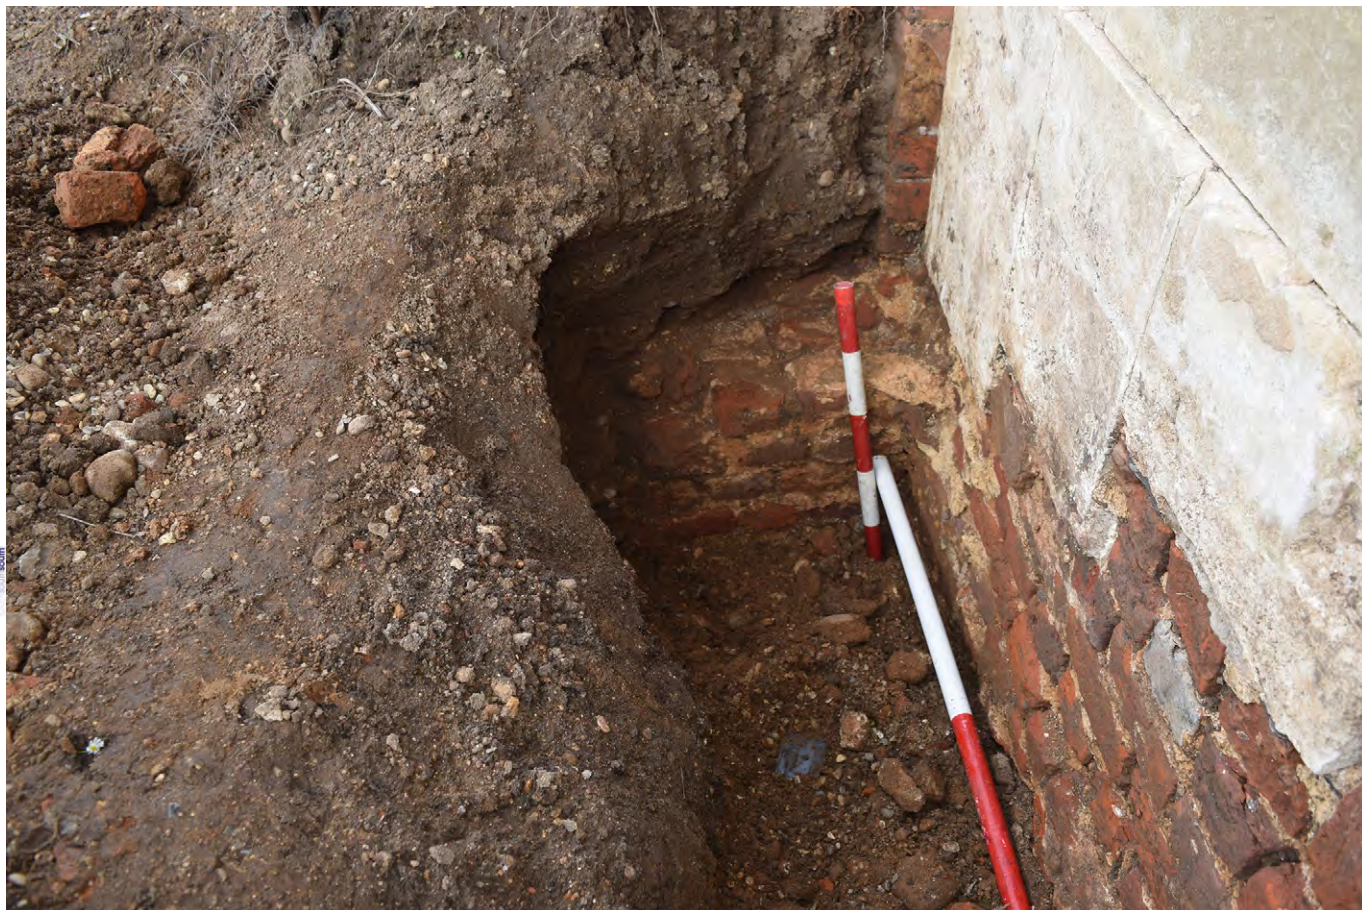
Plate C.48: Brick footing looking west exposed by East Fernery. Possibly supported lower step

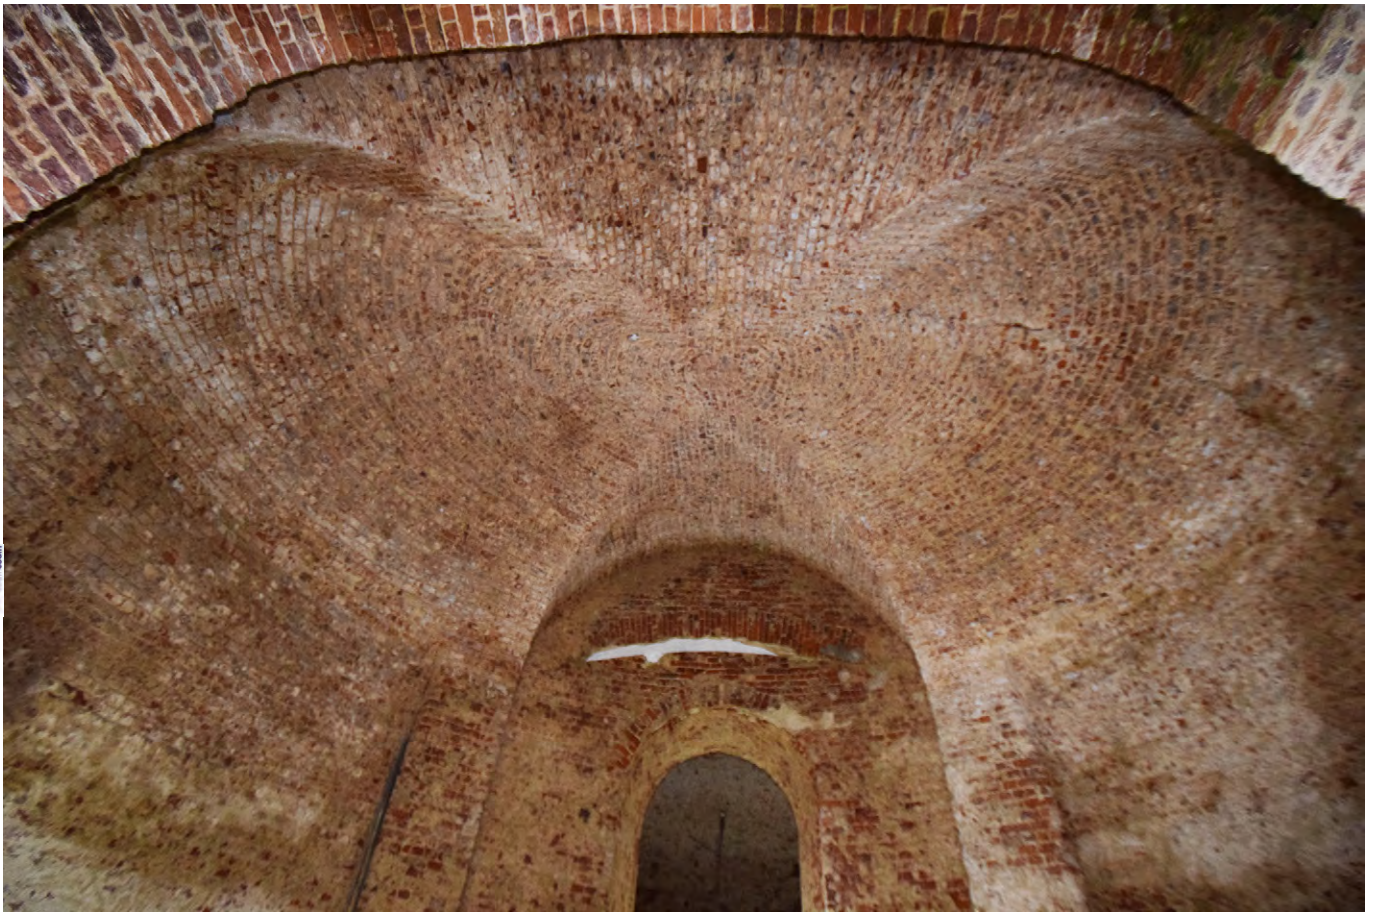
- 7.5.4 The removal of plaster has revealed significant vertical structural cracks towards the centre of the east and west walls following a similar line down from a point just to the south of the crest of the dome towards the ground. The cracks slope gently towards the south and they support other evidence in the terrace which suggests that the structure experienced structural problems such as the front façade starting to come away. The eastern crack is particularly pronounced (up to c.3 cm wide in parts) and this has been partially infilled with a very hard fine grey mortar (Roman cement?) which appears to be the same as that used to repair parts of the fine brickwork to the front of the terrace staircase. This type of mortar was noted behind some of the pilaster brickwork on the west side of the terrace stairs, apparently used to re-apply a facing brick which was not bonded to the main wall behind.

Plate D.3: Vault of central chamber [D.2] after plaster removal, looking north

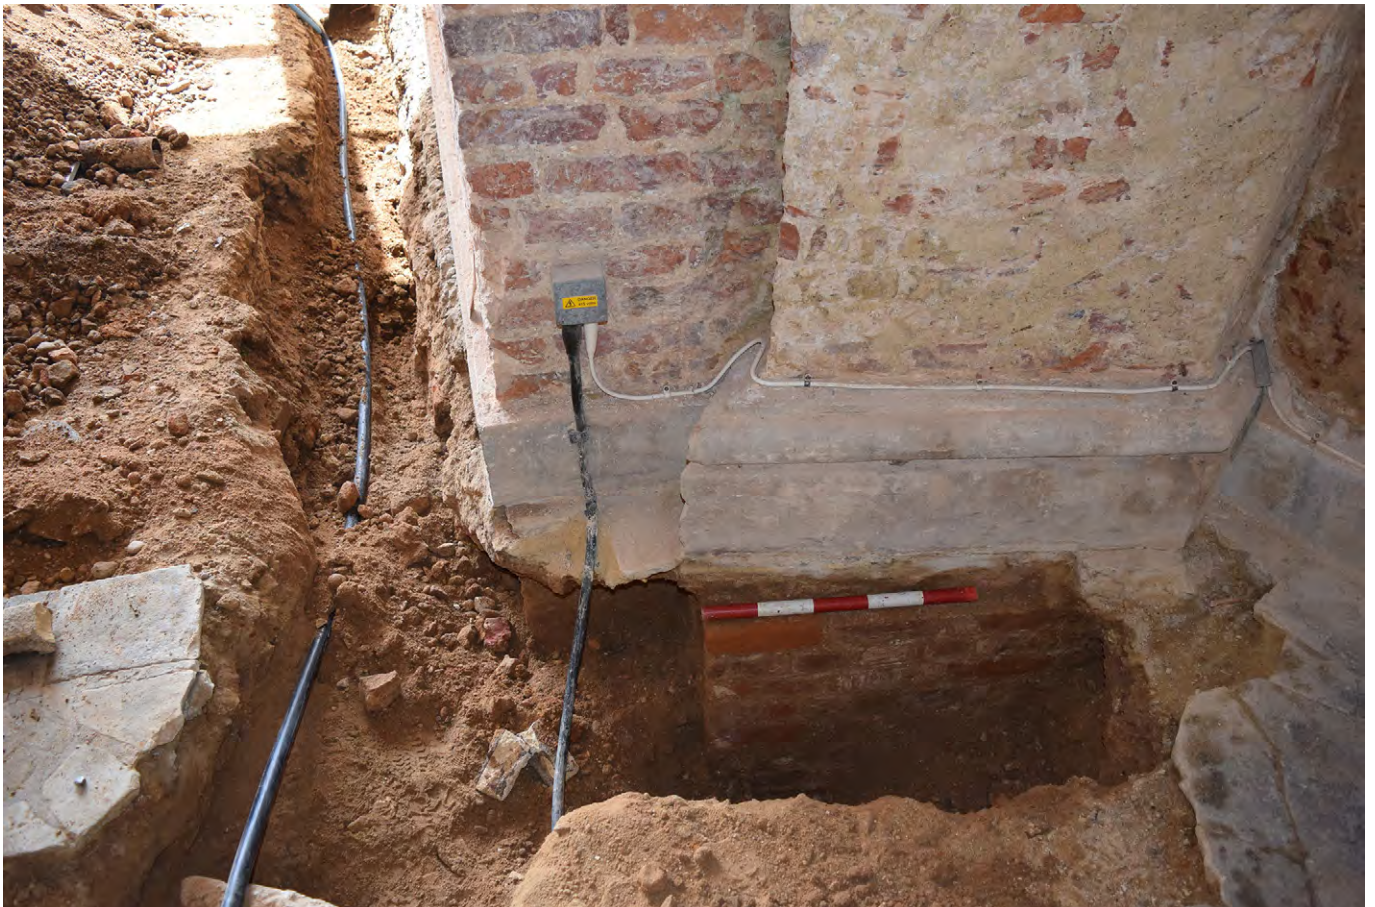
7.6.7 During the current project a trench was dug [*Pit D.100*] along the west side of the entrance passage, extending around the south-western corner of the central chamber, and this revealed part of the footings in this area (*Pl. D6-D7*). Beneath the pilaster at the south-western corner of the central chamber there was found to be a regular flat-faced brick foundation, 56 cm tall (7 courses) and set on a pebbly layer [*Feature D.100.1*]. The bottom of the brickwork was definitely reached in this pit. The angle of this foundation was not quite the same as that of the pilaster above but they appeared to be contemporary with each other.

7.6.8 The foundation of the wall on the west side of the entrance corridor was slightly different to that beneath the pilaster at the south-west corner of the central chamber although they seem contemporaneous with each other. The main foundation at the northern end of the wall [*Feature D.100.2*] had two steps and this returned west to adjoin the flat-faced foundation beneath the pilaster referred to above.

7.6.9 At the southern end of the stepped foundation there was a c.15 cm slot or recess [*Feature D.100.3*] in the foundation of the west wall, c.50 cm to the south of the return at the north end of the passage and c.20 cm below the ground surface. This appeared to be primary and it may relate to a beam across the floor (possibly a sill stone or threshold beam). This southern edge of this slot (*Feature D.100.3*) appeared to line up with the straight joint which continues up the west wall of the passage suggesting that it would have been just inside the original entrance prior to the addition of the staircase.

7.6.10 To the south of the slot the foundation was more obscured by a layer of very hard mortar [*Feature D.100.4*] but there seemed to be a single skin of brickwork apparently in front of the main foundation behind.

Plate D.6: Pit at SW corner of central chamber, looking south [Pit D.100]

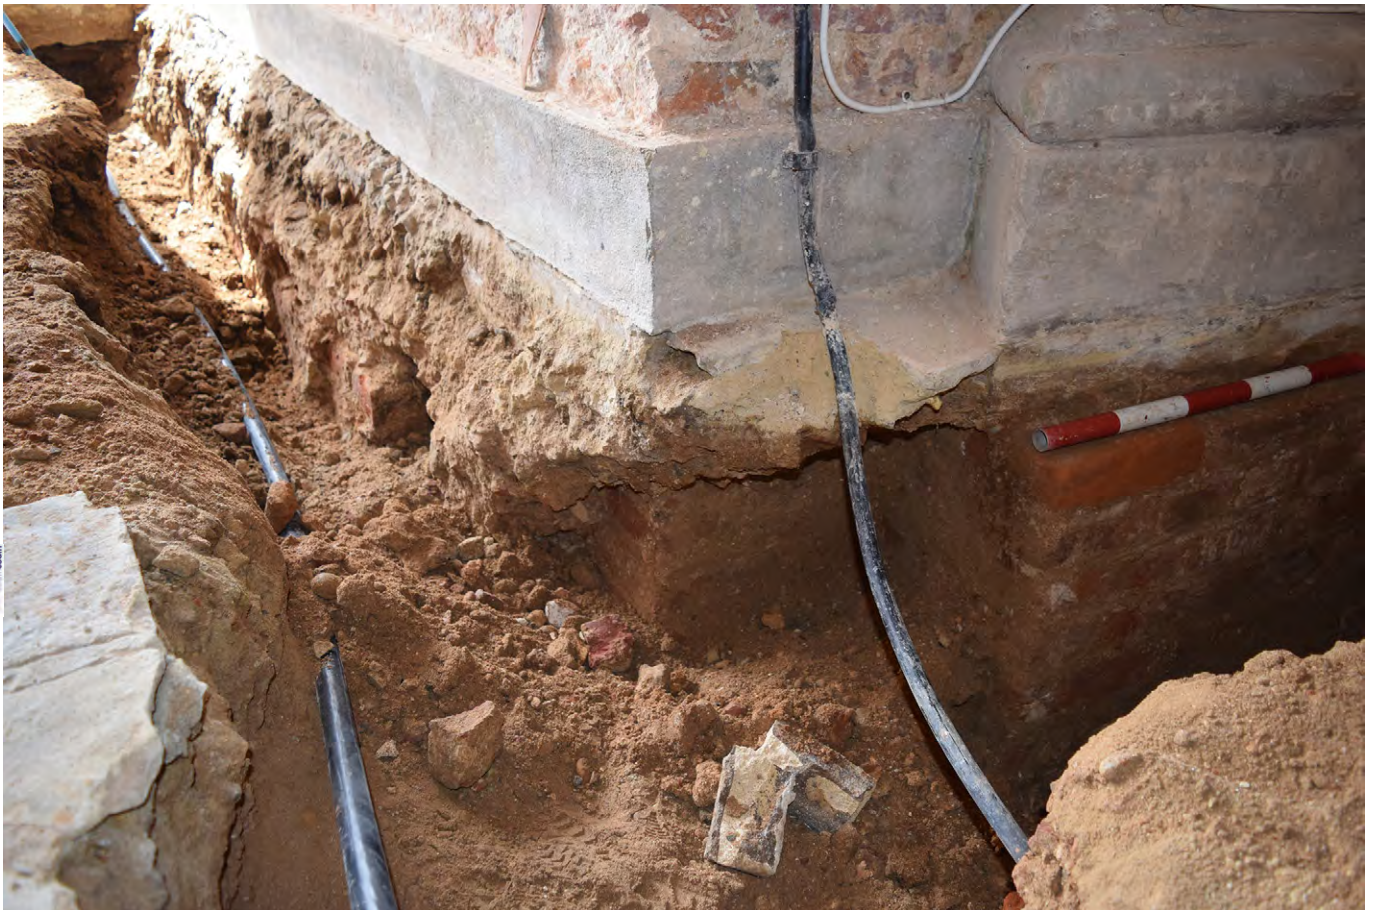
Plate D.7: Pit at SW corner of central chamber, looking south-west [Pit D.100]

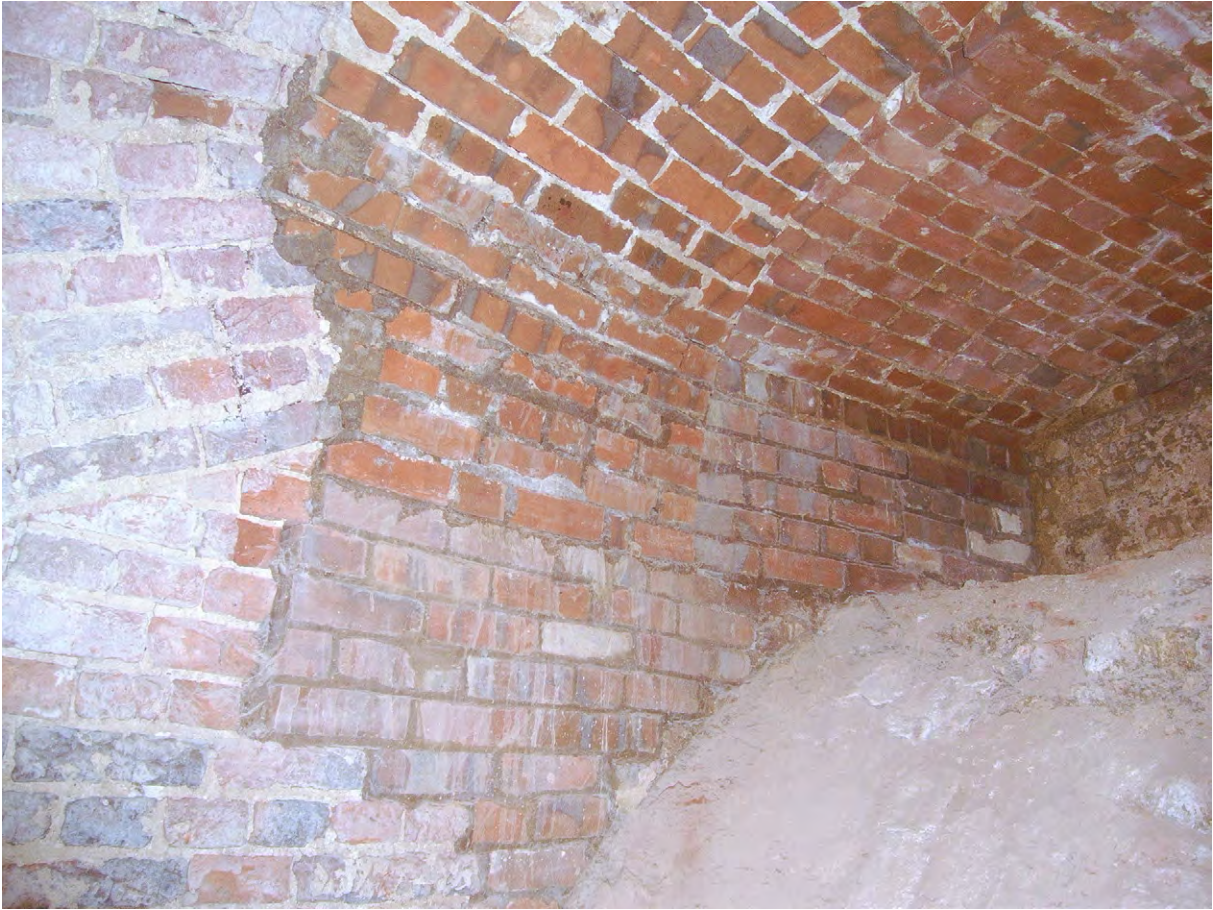
Plate D.11: Rebuilt brickwork towards top of eastern light well, looking south-east

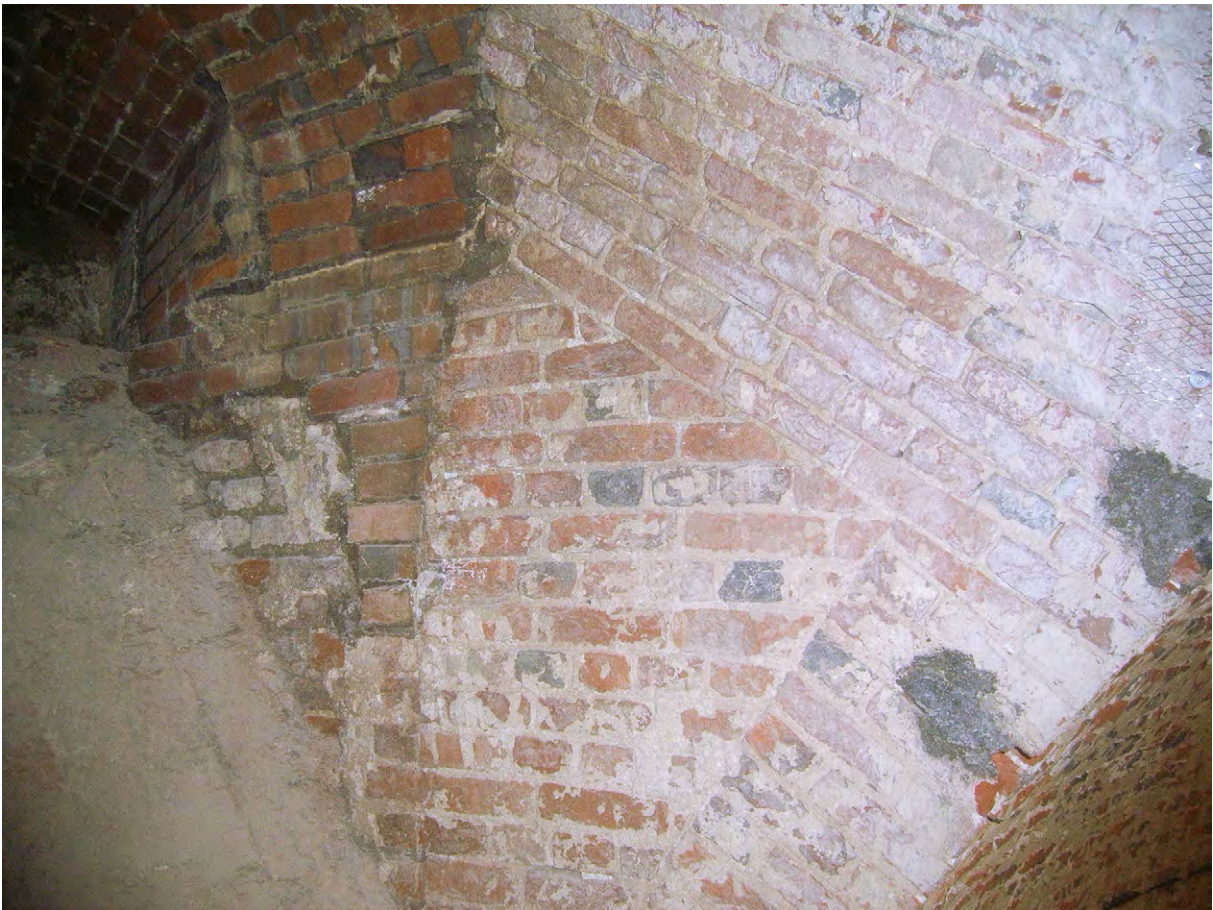
Plate D.12: Rebuilt brickwork towards top of eastern light well, looking west

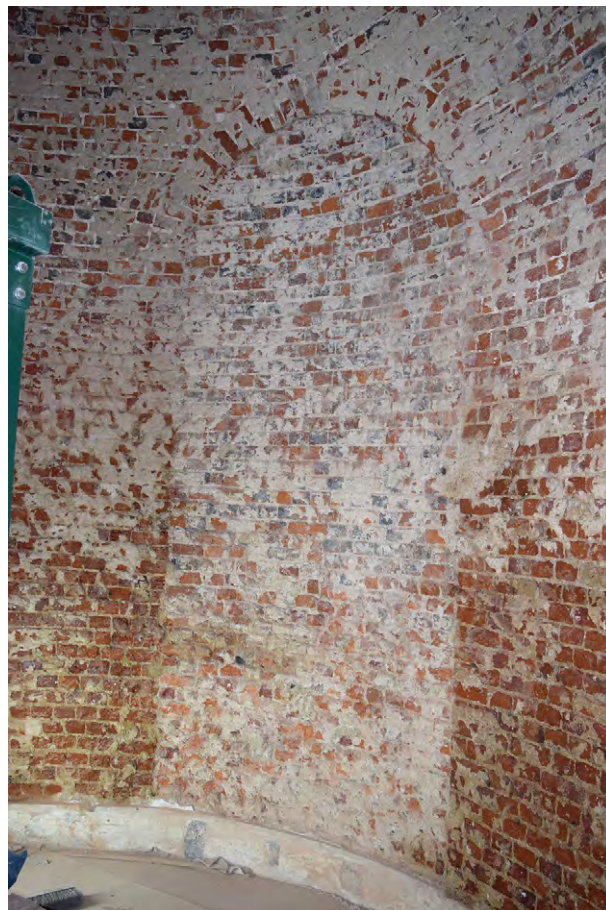
- 7.6.15 The plaster removal has also revealed a blocked opening in the east wall which it appears formed an opening to a chamber immediately east of the Sounding Chamber. A painting from c.1798 appears to show evidence of a chamber here and it may be that this was the location of an internal staircase which is mentioned in 1724 connecting the chamber to the mansion above.

Plate D.14: Blocked archway [D.1.8] in east wall of Inner Sounding Chamber

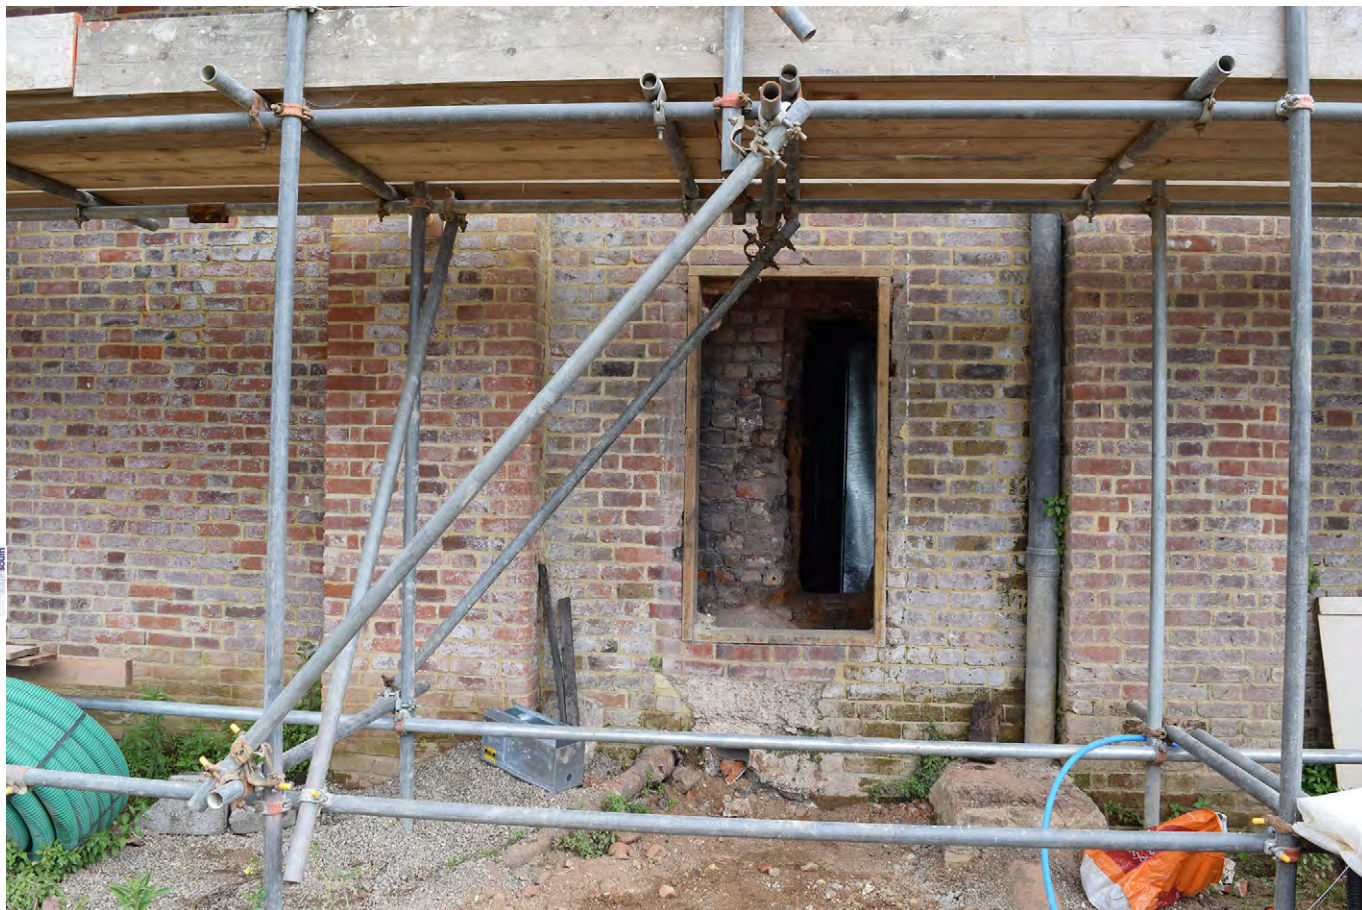
Plate E.1: Entrance formed in blind arcade to West Barrel Vaulted Chamber

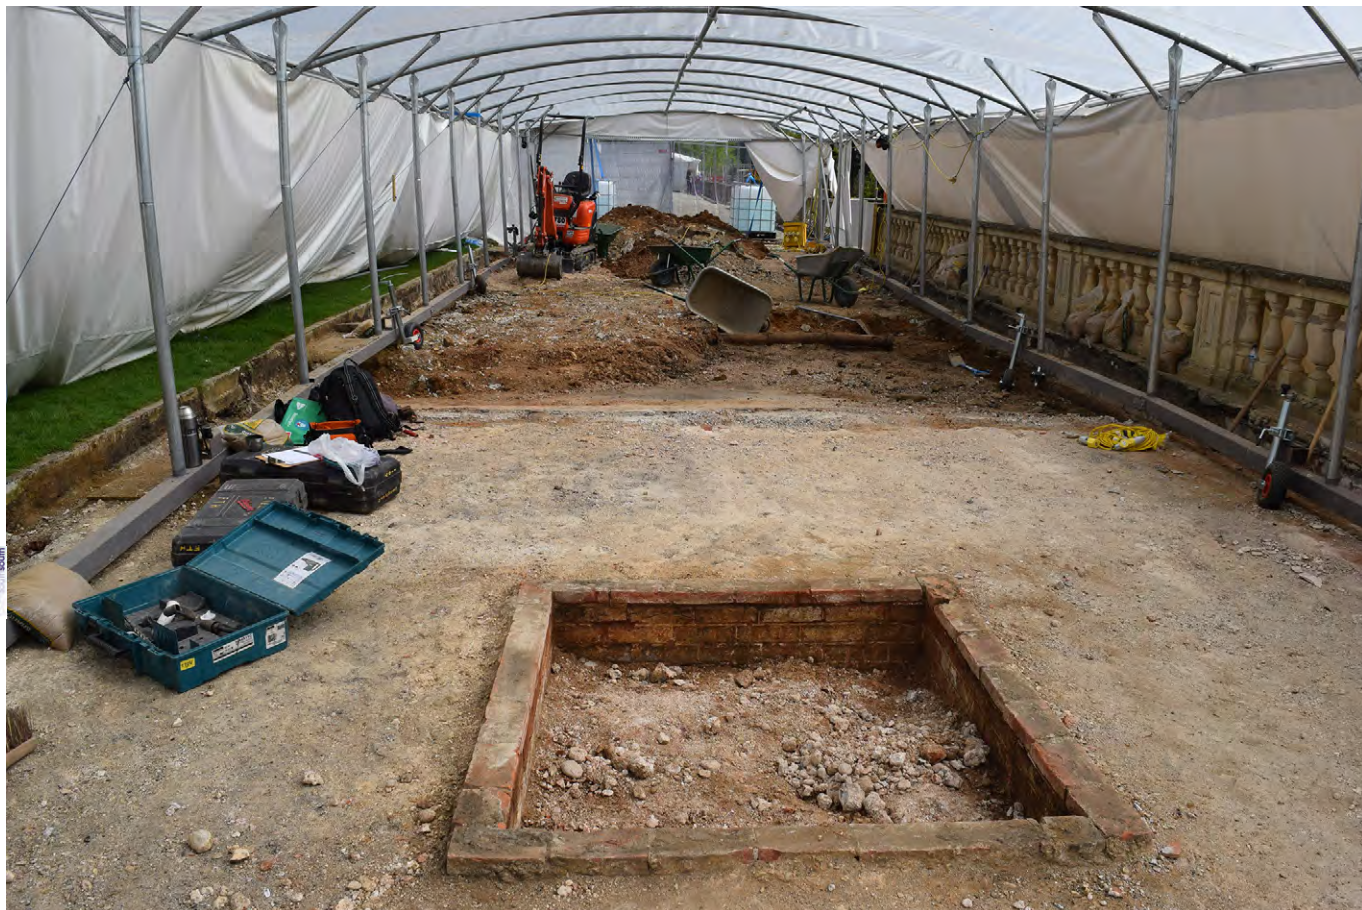
- 9.3.14 To the east of the brick arches above the West Fernery and associated fernery water tank the terrace substructure was quite different being comprised of several layers of loose gravelly fill with various drainage channels and pipes (*Pl. F1*).

Plate F.1: Western third of terrace looking east. Remains of lightwell [F.1.2] in foreground

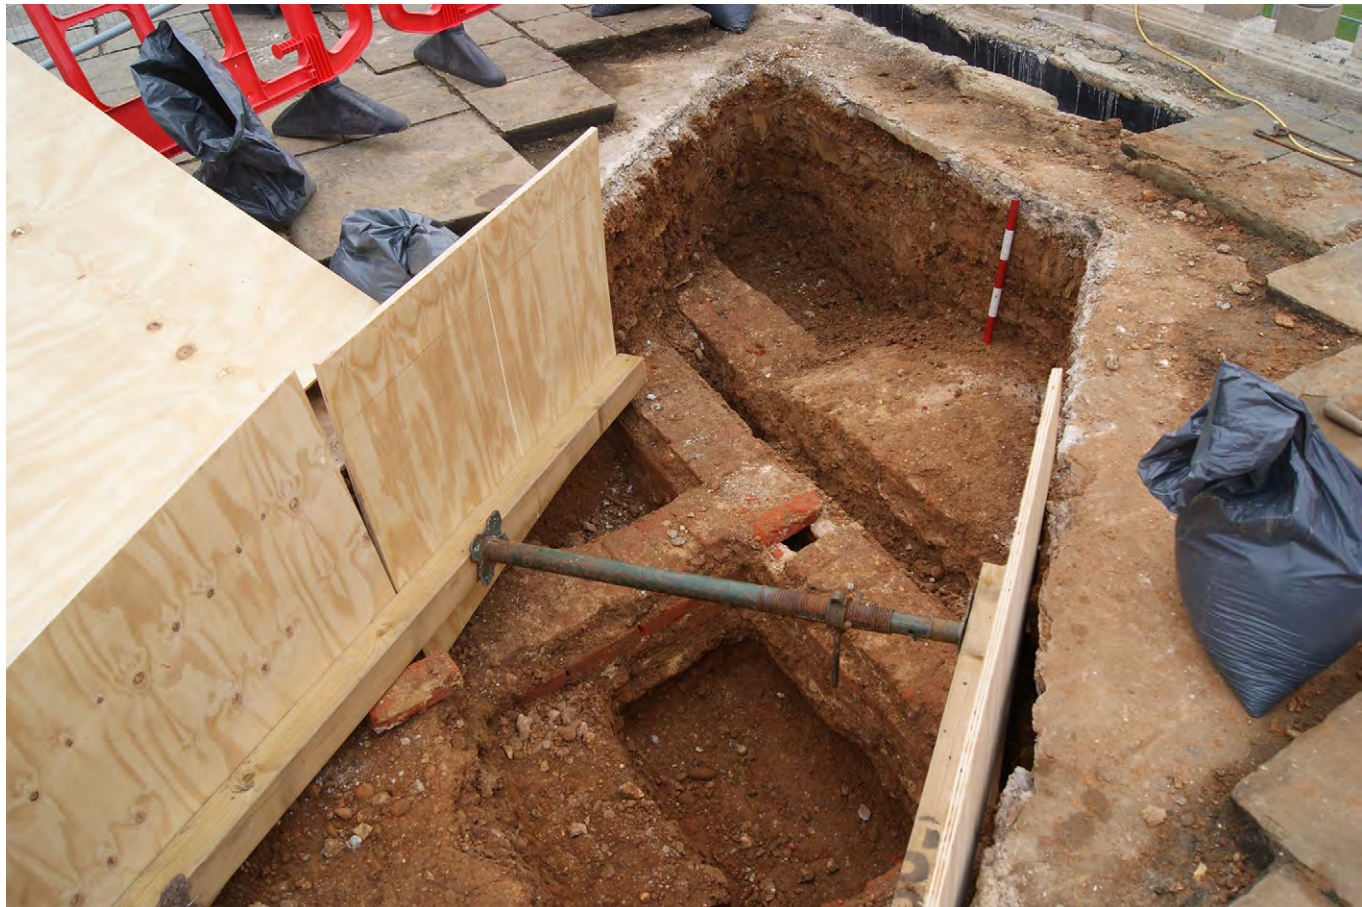
- 9.4.8 As outlined above part of one vault and a short section of the associated wall were also exposed in the trial trench opened on top of the terrace to the west of the mansion (Area F1. See Pl. F2-F3 & Fig F7). This was adjacent to the 7th arch in the blind arcade to the west side. The arch here had a substantial structural crack which it has been suggested could relate to the need to rebuild the front wall of the terrace in the second half of the 18th century. There was no sign of similar structural issues in the other vaults exposed in Area F2 although this may be because these vaults were not fully exposed. The main excavation works in this area to the western third of the terrace (F1) did not expose any more of these vaults but that is assumed to be because the excavation was not deep enough. Similarly the excavations in the eastern third of the terrace also did not reveal the vaults but this is assumed to be because the excavations were not sufficiently deep.

Plate F.2: Features revealed in Pit F.101 towards front of terrace, looking south-east

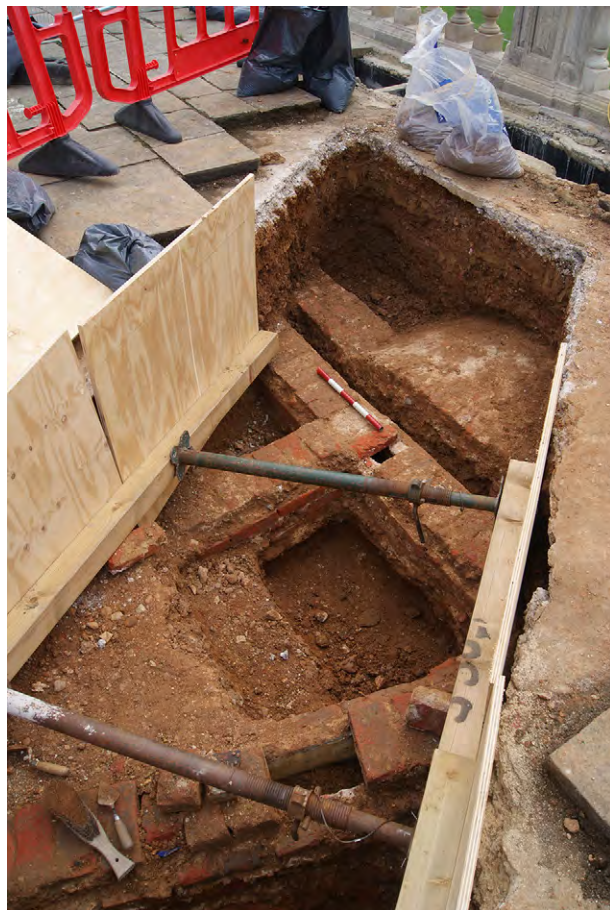
Plate F.3: Features revealed in Pit F.101 towards front of terrace, looking south-east

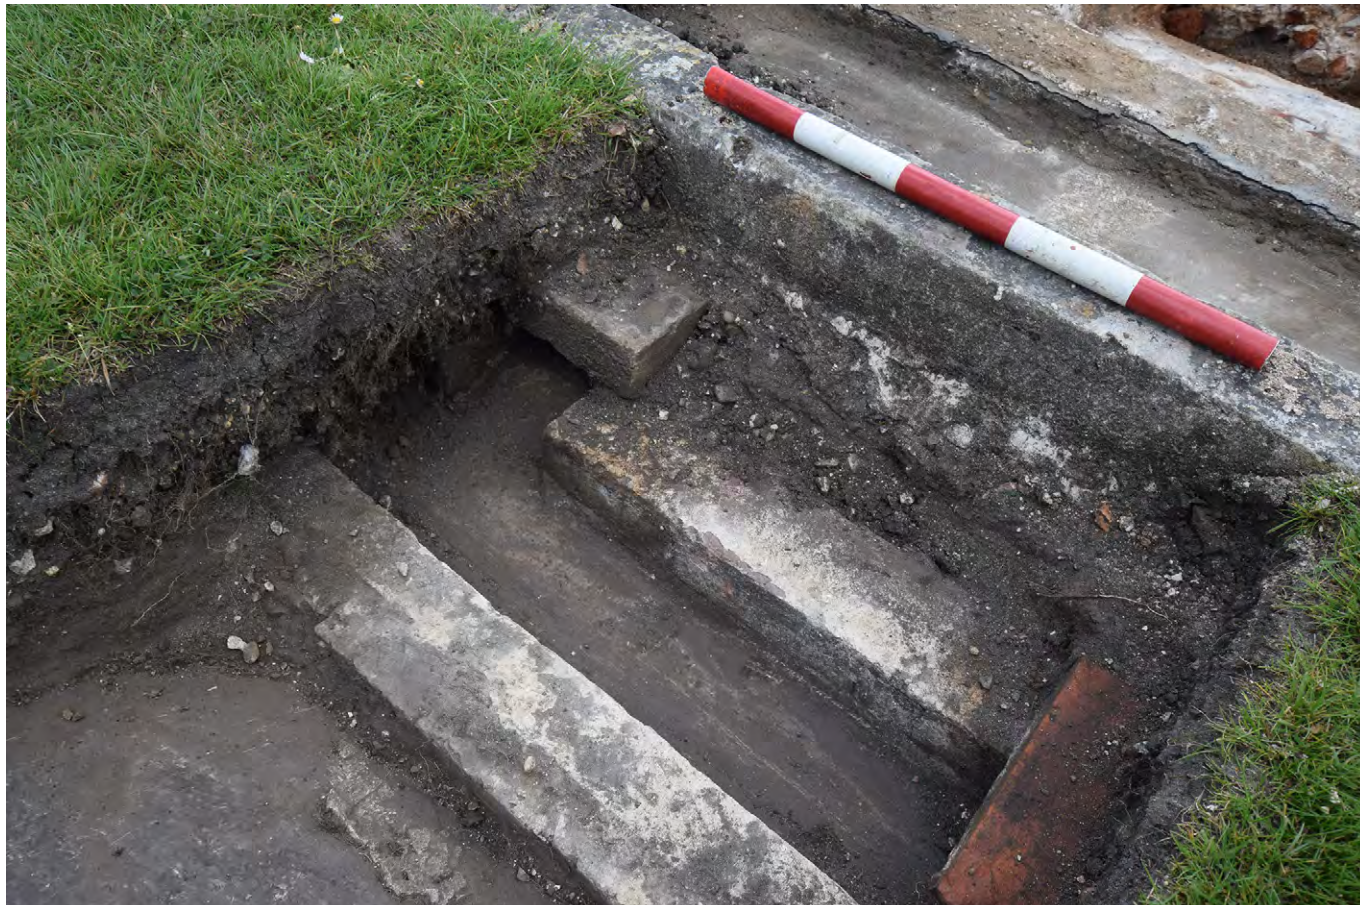
Plate F.4: Features revealed in Pit F.100 at junction with West Lawn, looking south-east

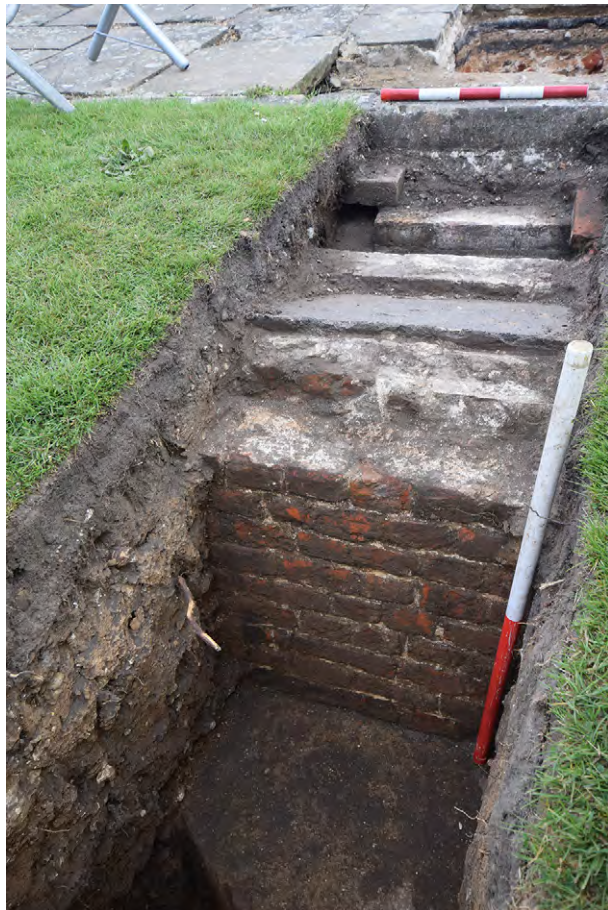
Plate F.5: Former north wall of terrace [F.1.8] exposed in Pit F.100, looking south

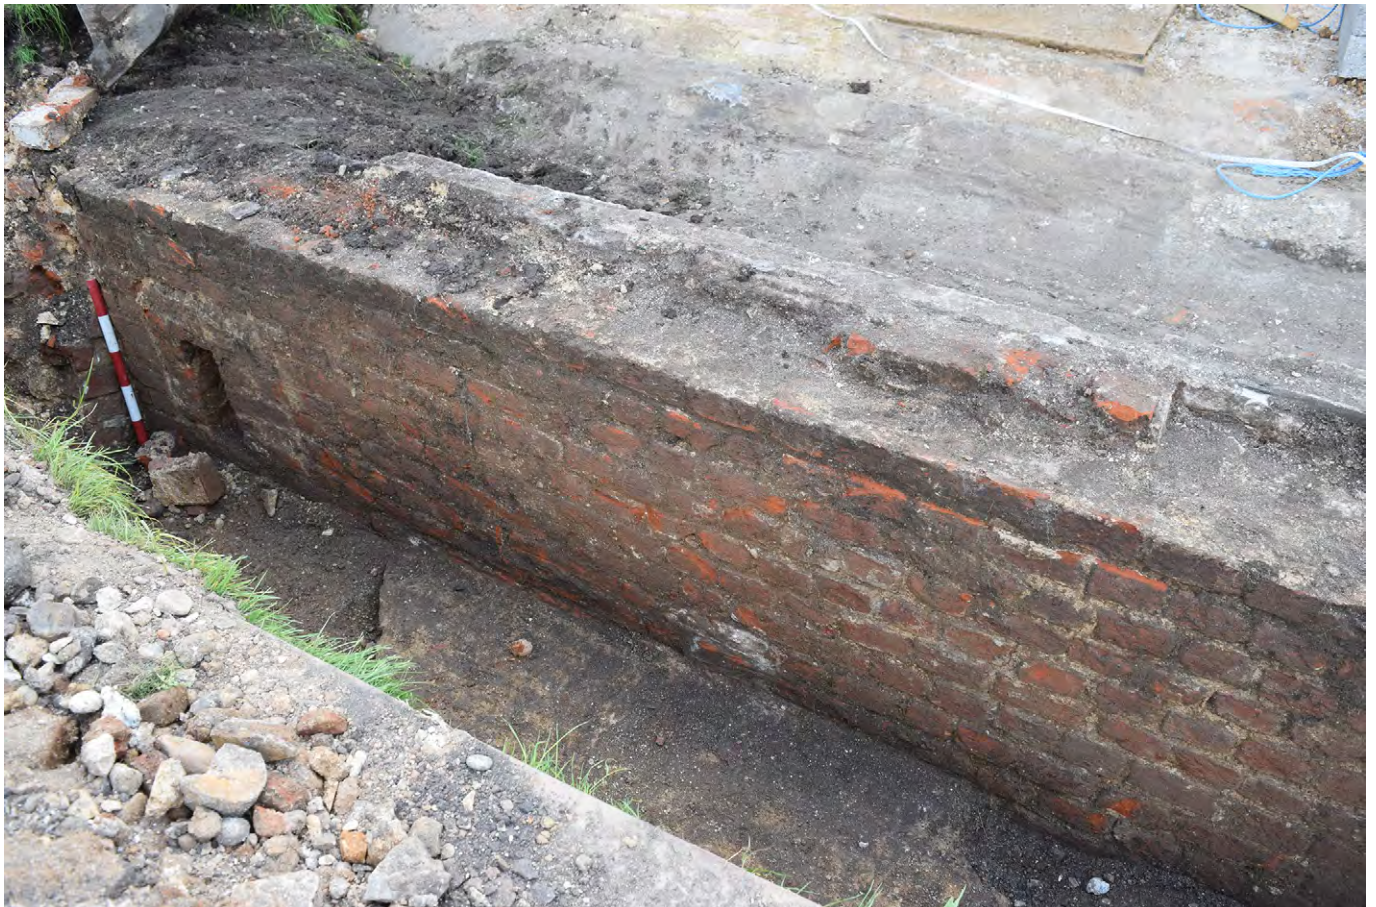
Plate F.6: Former north wall of terrace [F.1.8] as well as features F.1.10 & F.1.12, looking south

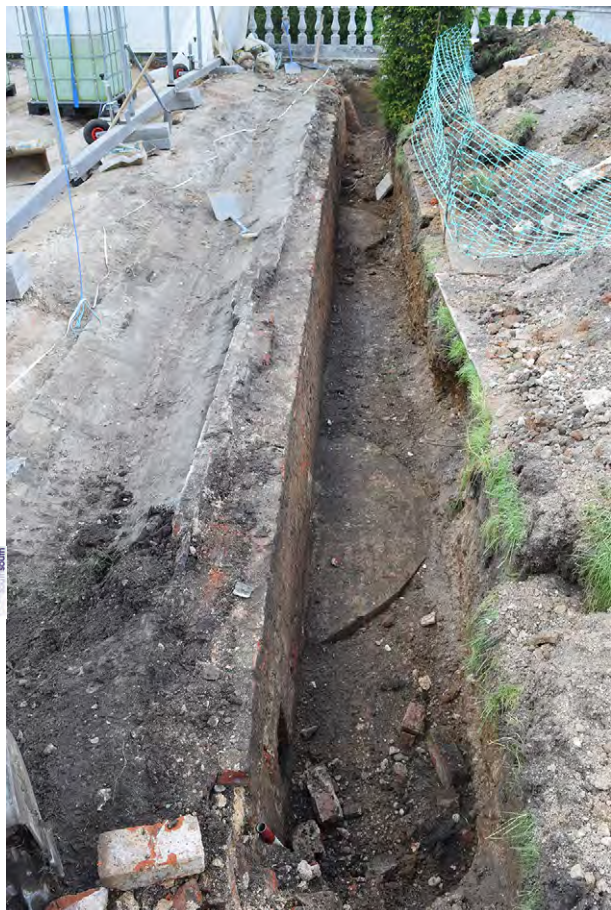
Plate F.7: Trench immediately north of west part of Terrace (note F.1.10), looking west

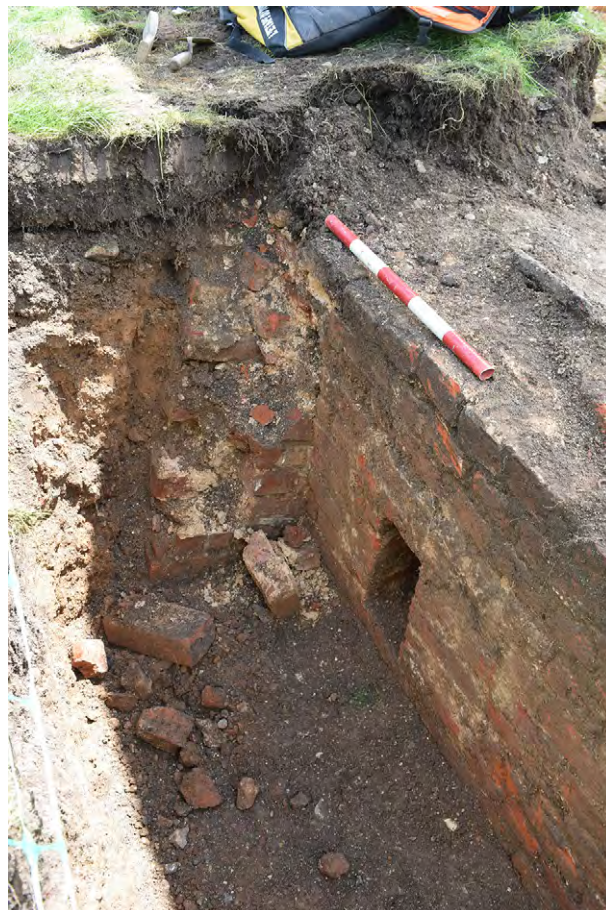
9.3.24 Various features of interest were noted in the northern face of the wall including three simple sloped brick buttresses c.90 cm wide (F.1.9). The best preserved of these buttresses was previously found in one of the trial trenches opened in September 2014 (Trench F.101. See Fig F1) and this buttress was located c.19.5 m to the east of the western balustrade (*Pl. F10*). The top of this buttress had been truncated along with the top of the adjacent wall but from the angle of the slope it probably continued up for a further 3 courses (c.22 cm). The base of the buttresses was not reached in the excavation. During the main terrace works in May-June 2016 a further similar buttress was exposed (*Pl. F8*) at 12.55 m to the east of the west balustrade although this had been damaged during the excavation works and another similar feature was found at the western end (*Pl. F11*) almost immediately adjacent to the west balustrade. These buttresses were keyed into the main wall and they all appeared to be of the same phase. It is interesting to note that the spacing of the three buttresses would suggest that there may have been formerly been a further buttress approximately six metres to the east of the west balustrade. There was no clear evidence of a former buttress here although this was the location of a semi-circular structure (F.1.10. *Pl. F7, F9, F12*) within the trench (relating to the windows inside the Fernery) and therefore it is possible that the buttress here was removed.

Plate F.8: Former north wall of terrace. Truncated buttress [F.1.9] to left and [F.1.12] to centre, looking east

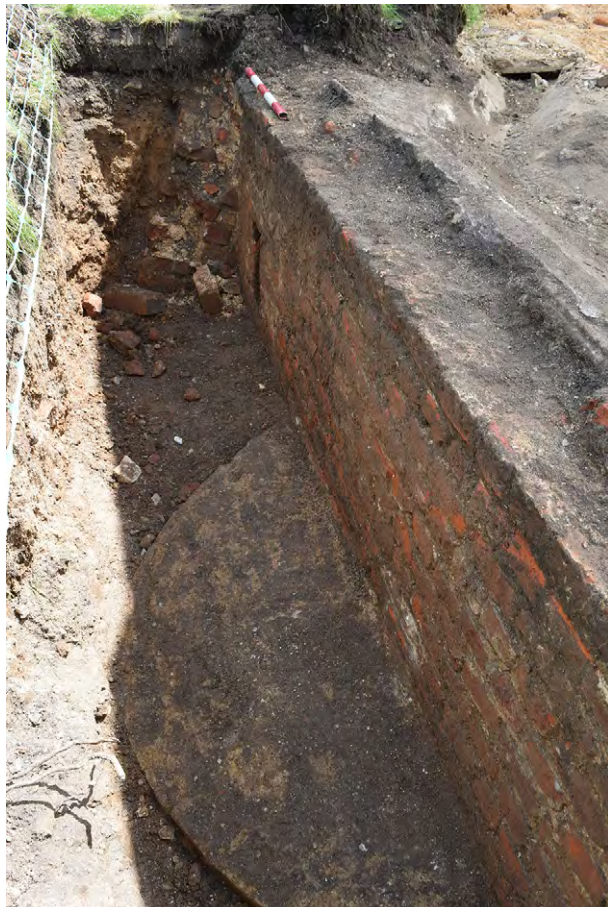
Plate F.9: Former north wall of terrace. Truncated buttress [F.1.9] to left and [F.1.10] to centre, looking west

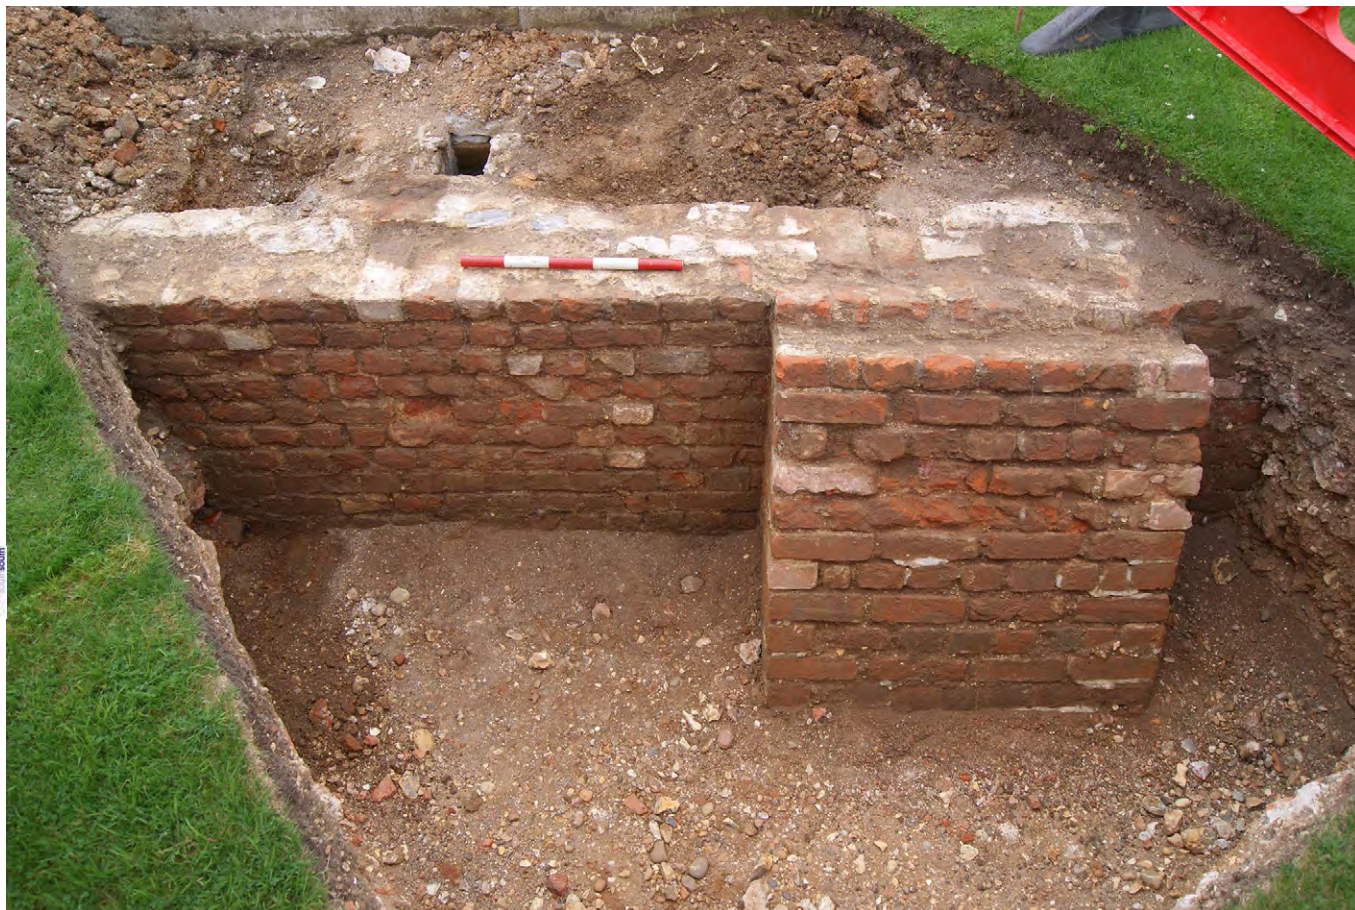
Plate F.10: Former north wall of terrace exposed in Pit F.101, looking south

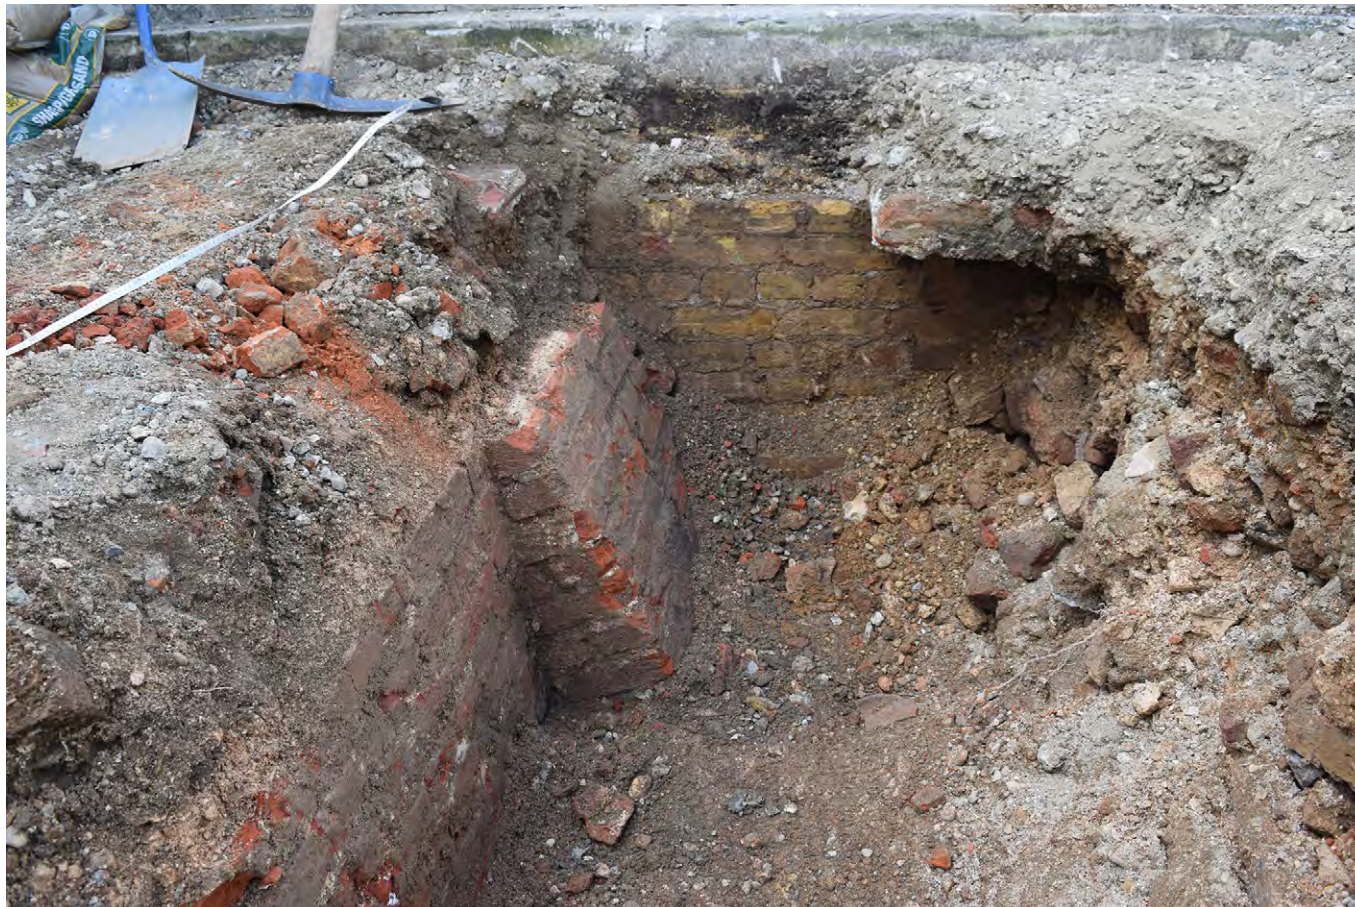
Plate F.11: Western end of former north wall of terrace. Buttress [F.1.9] exposed and later yellow brick-work forming retaining wall between terrace and pavilion, looking west

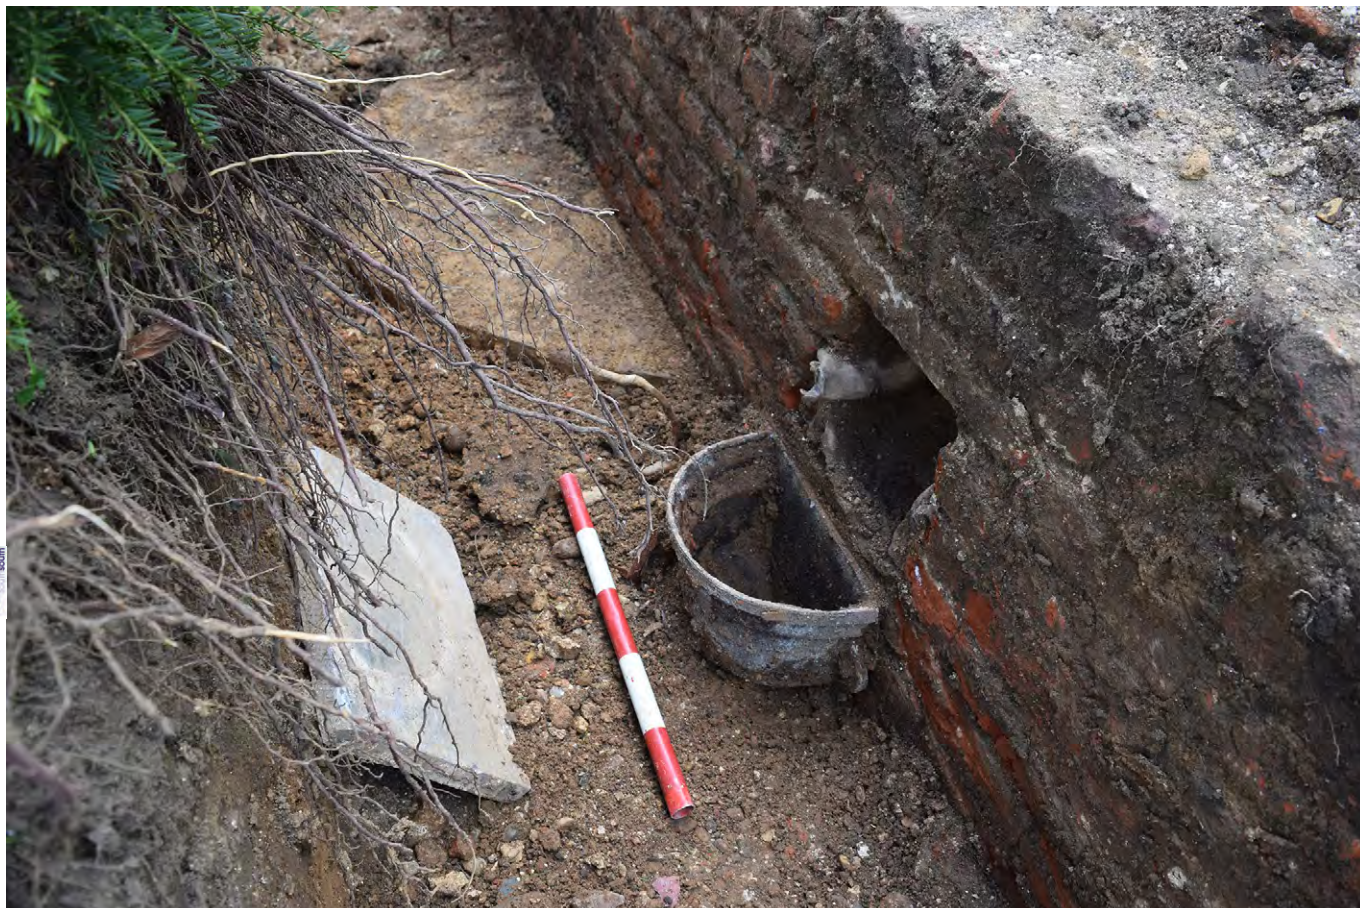
Plate F.12: Drainage hopper [F.1.11] in former north wall of terrace, looking south-east
