The South Terrace, Cliveden

Archaeological Investigations 2013-17

May 2018

Client Name: The National Trust
Client Ref No.: n/a
Document Title: The South Terrace, Cliveden
Document Type: Report on Archaeological Investigations 2013-17

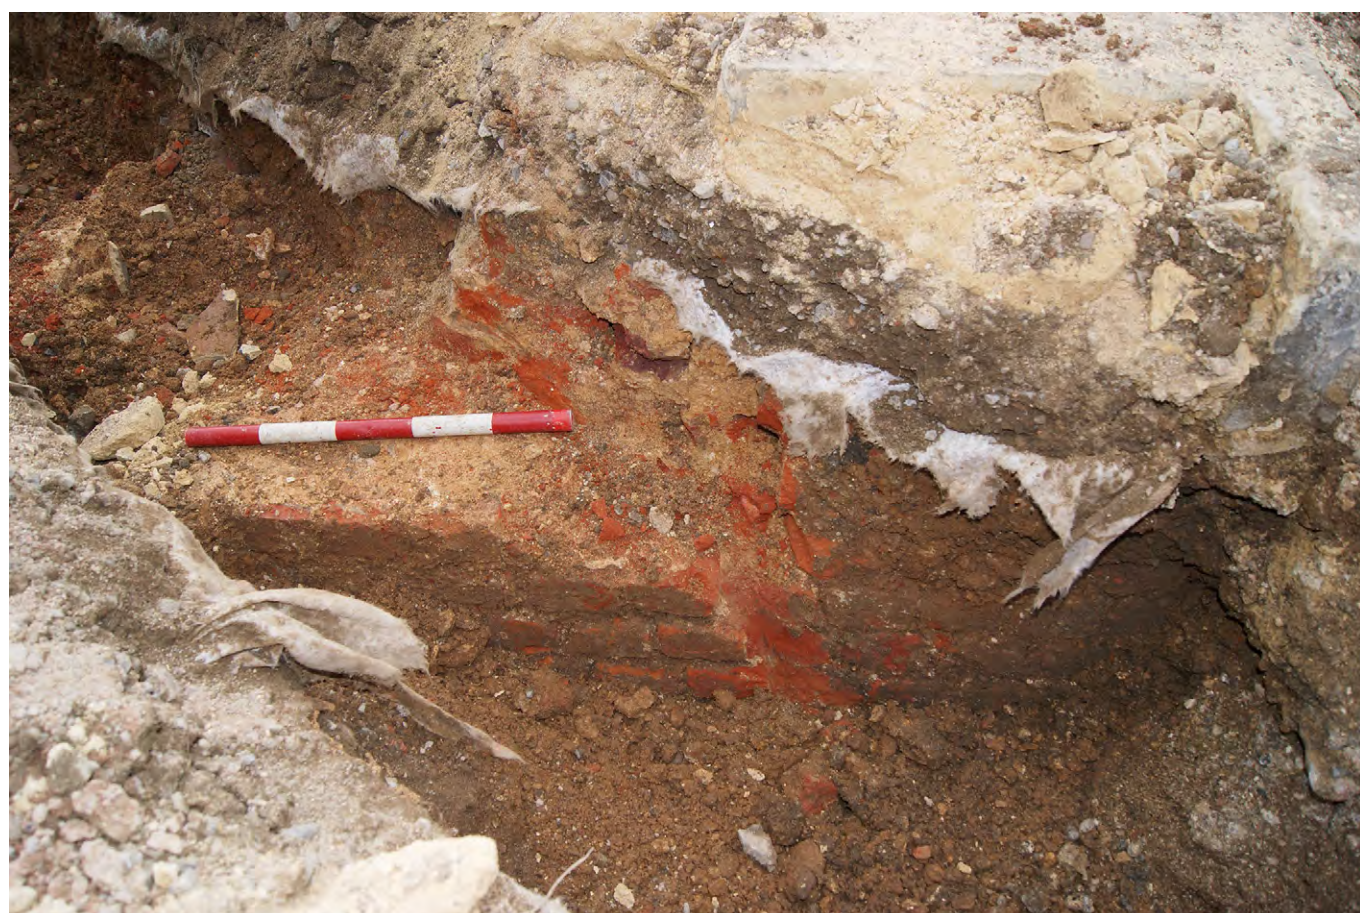
Plate F.13: Truncated wall to west of south wall of mansion [F.1.18], looking south

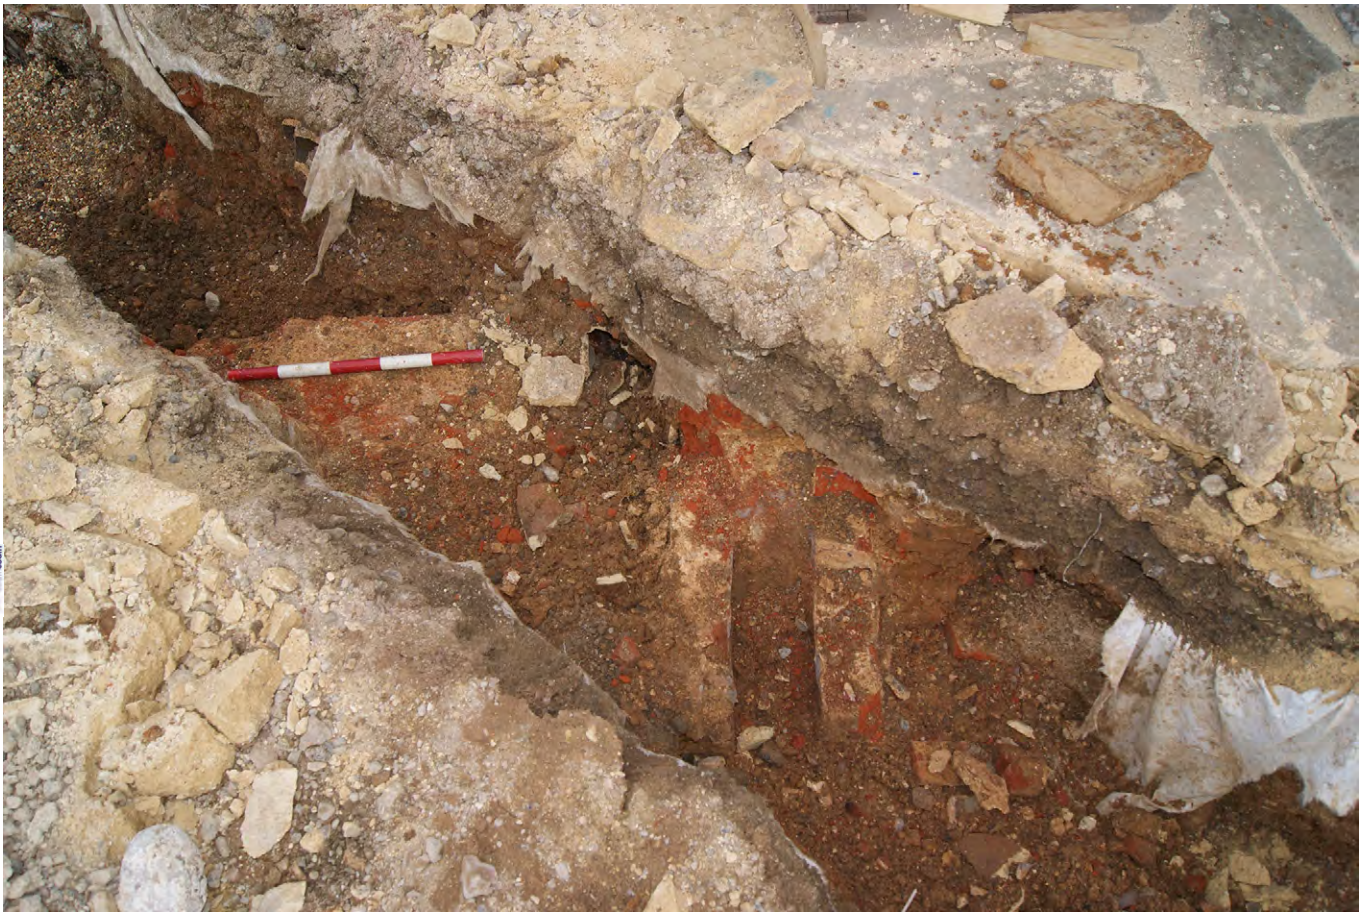
Plate F.14: Truncated wall looking north to west of south wall of mansion [F.1.18]

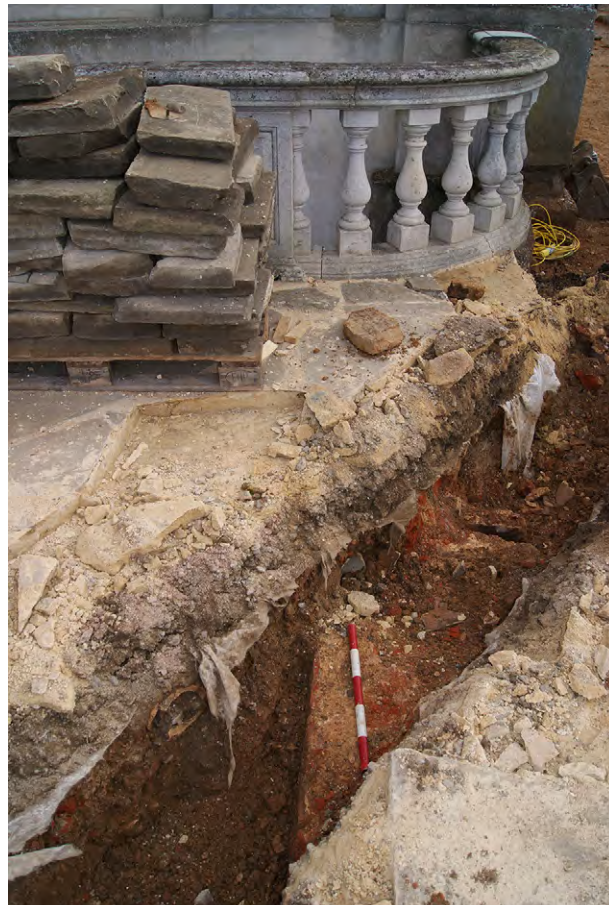
Plate F.15: Truncated wall to ewest of south front of mansion [F.1.18], looking east

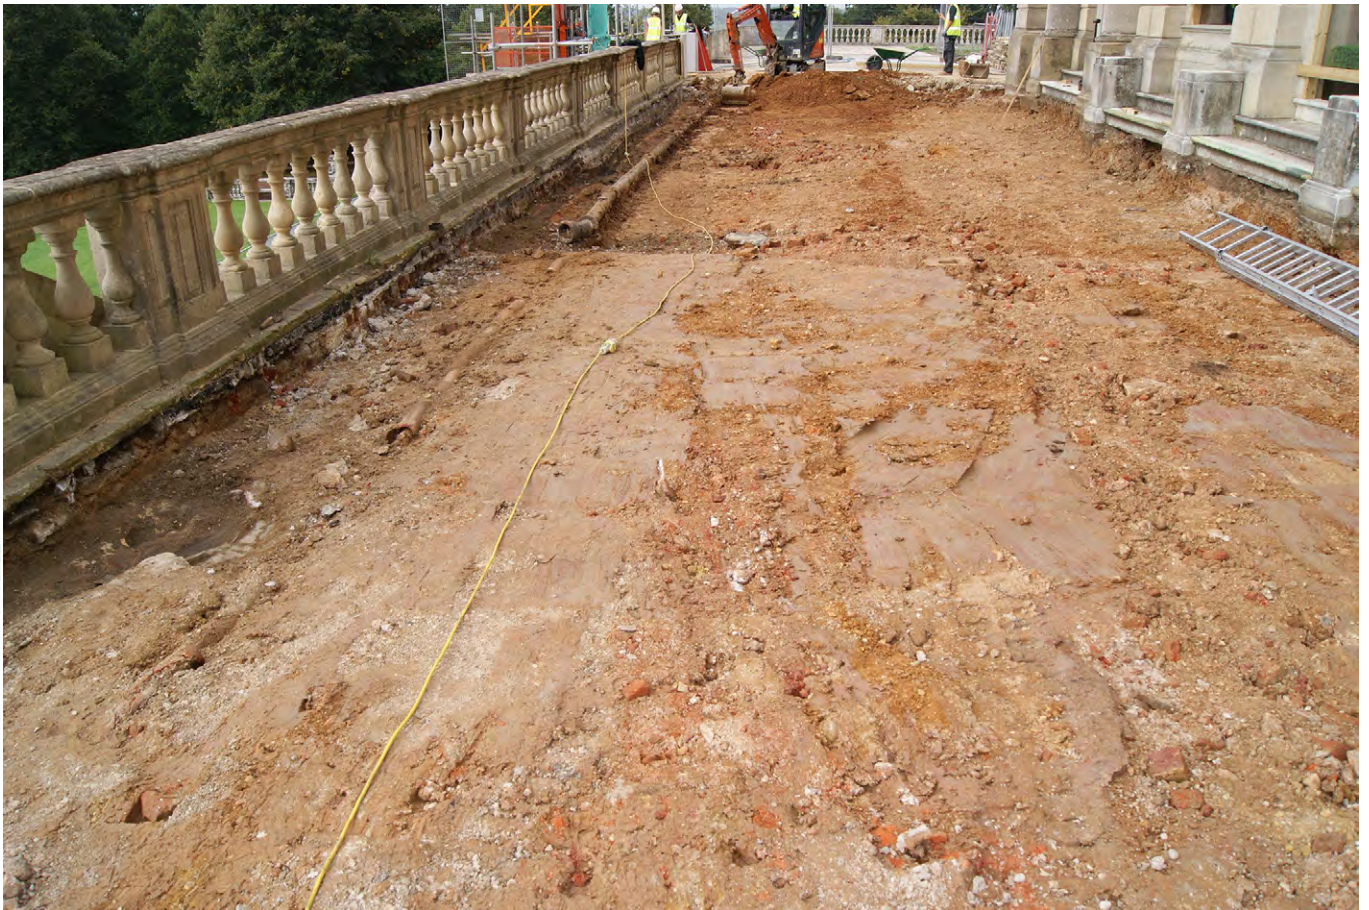
Plate F.16: Central part of terrace looking west after removal of paving and upper loose fill. (note clay pudding)

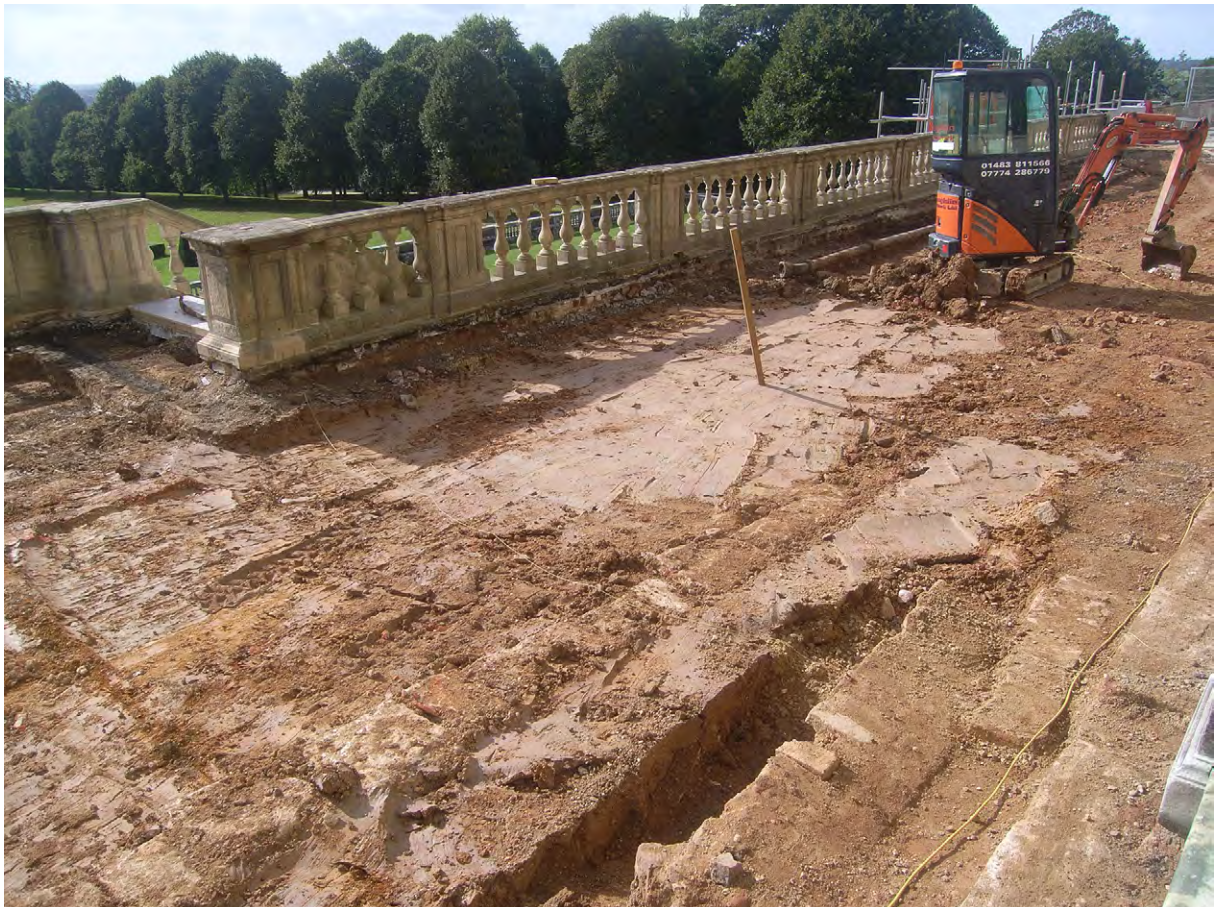
Plate F.17: Central part of terrace looking south-west after removal of paving and upper loose fill. (note clay pudding)

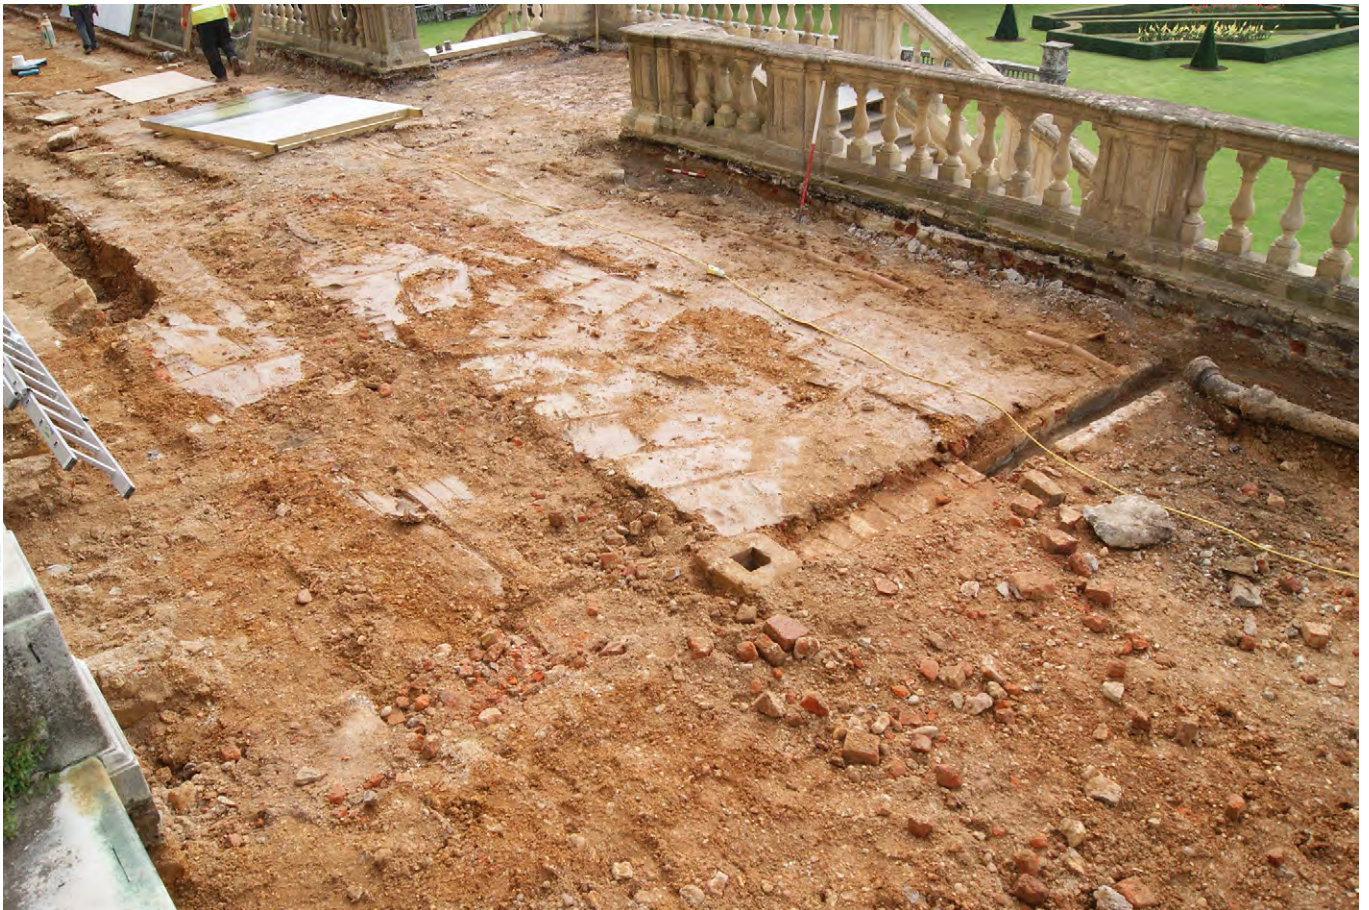
Plate F.18: Central part of terrace looking south-east. Note puddling clay and drain 1 [F.2.6]

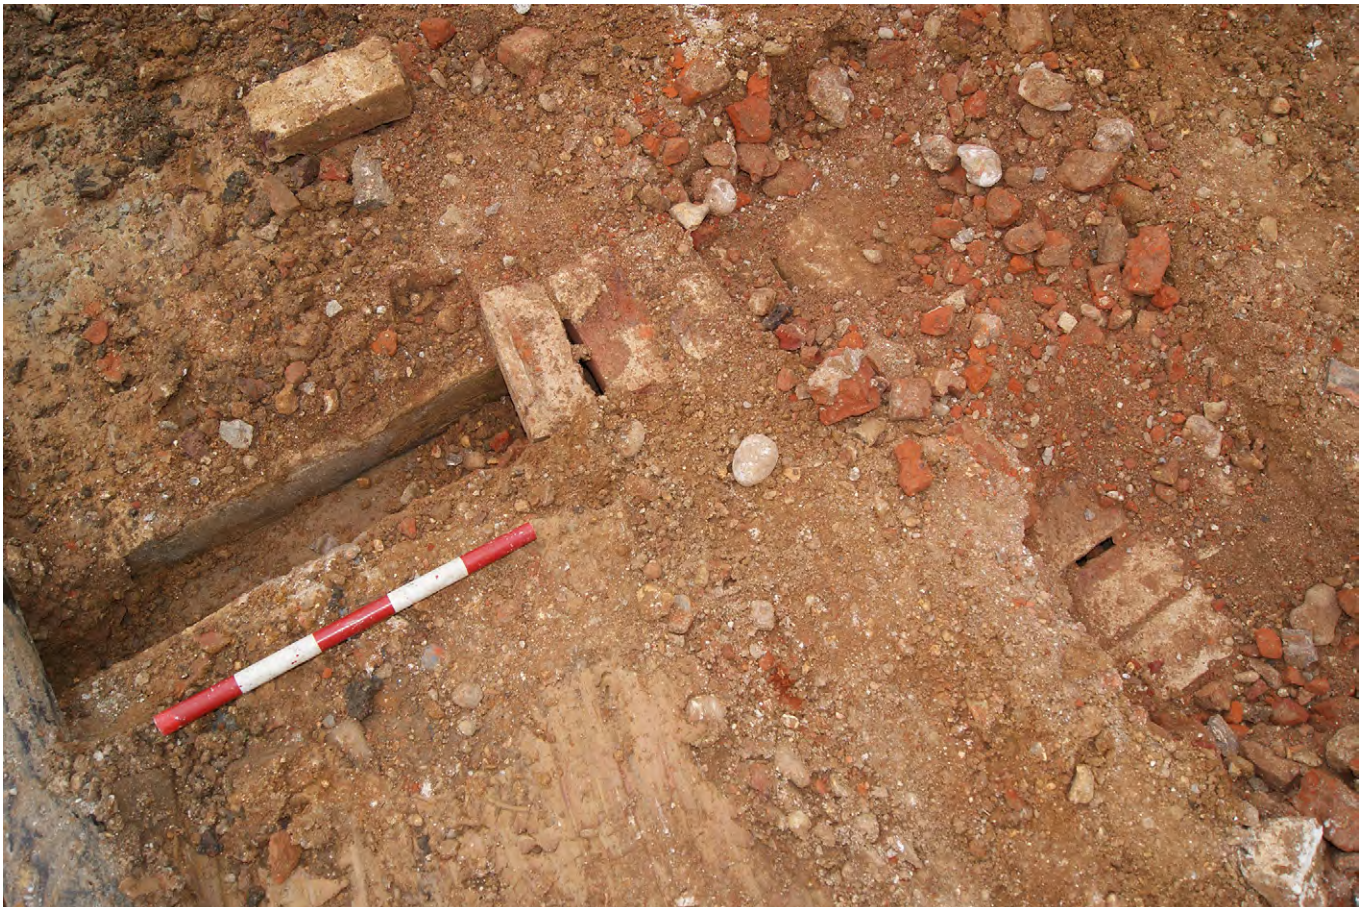
Plate F.19: Drain 3 [F.2.8] and Drain 4 [F.2.9]. (North is to right of image)

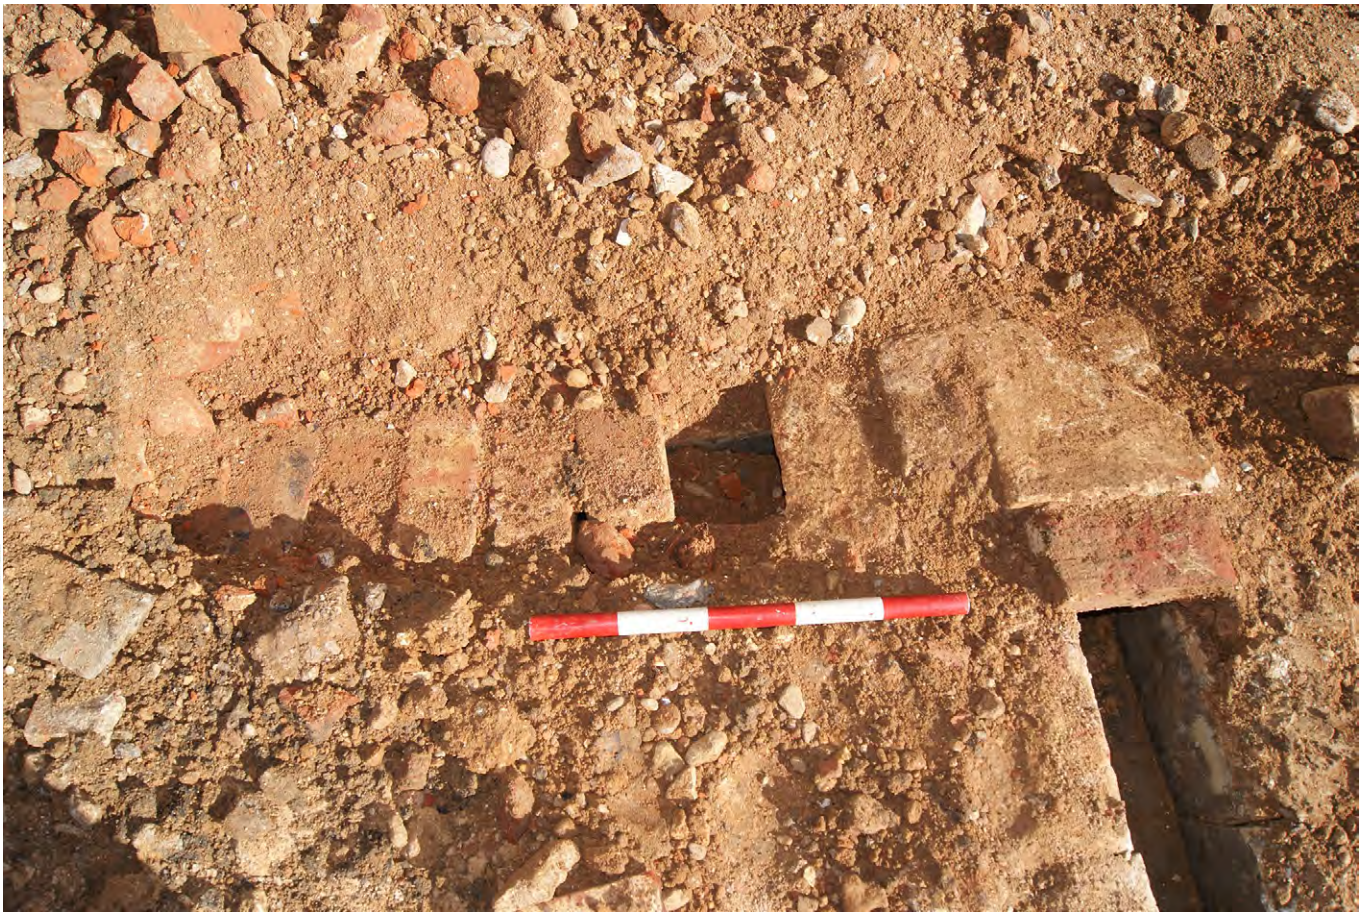
Plate F.20: Drain 2 [F.2.7] and Drain 4 [F.2.9] looking north

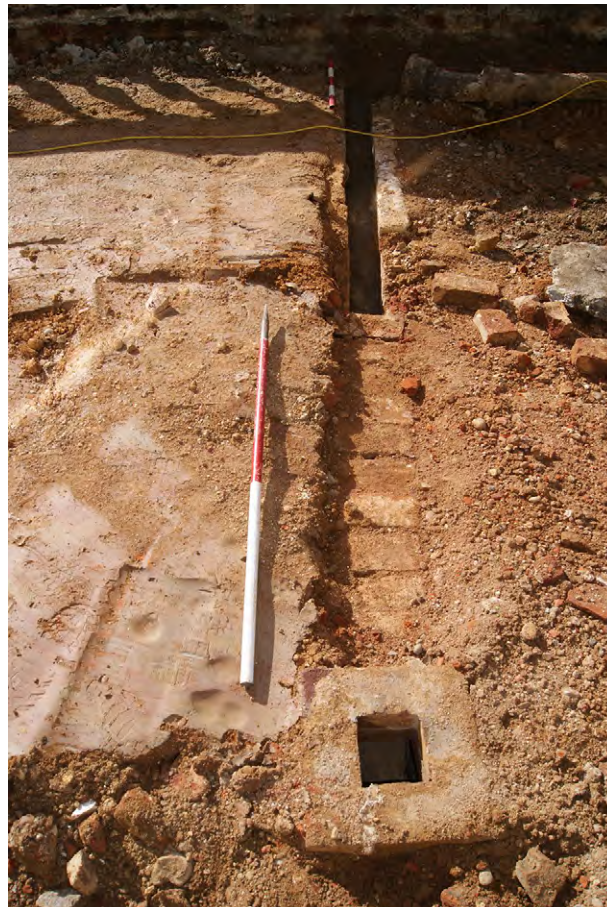
Plate F.21: Drain 1 [F.2.6] looking south toward balustrade

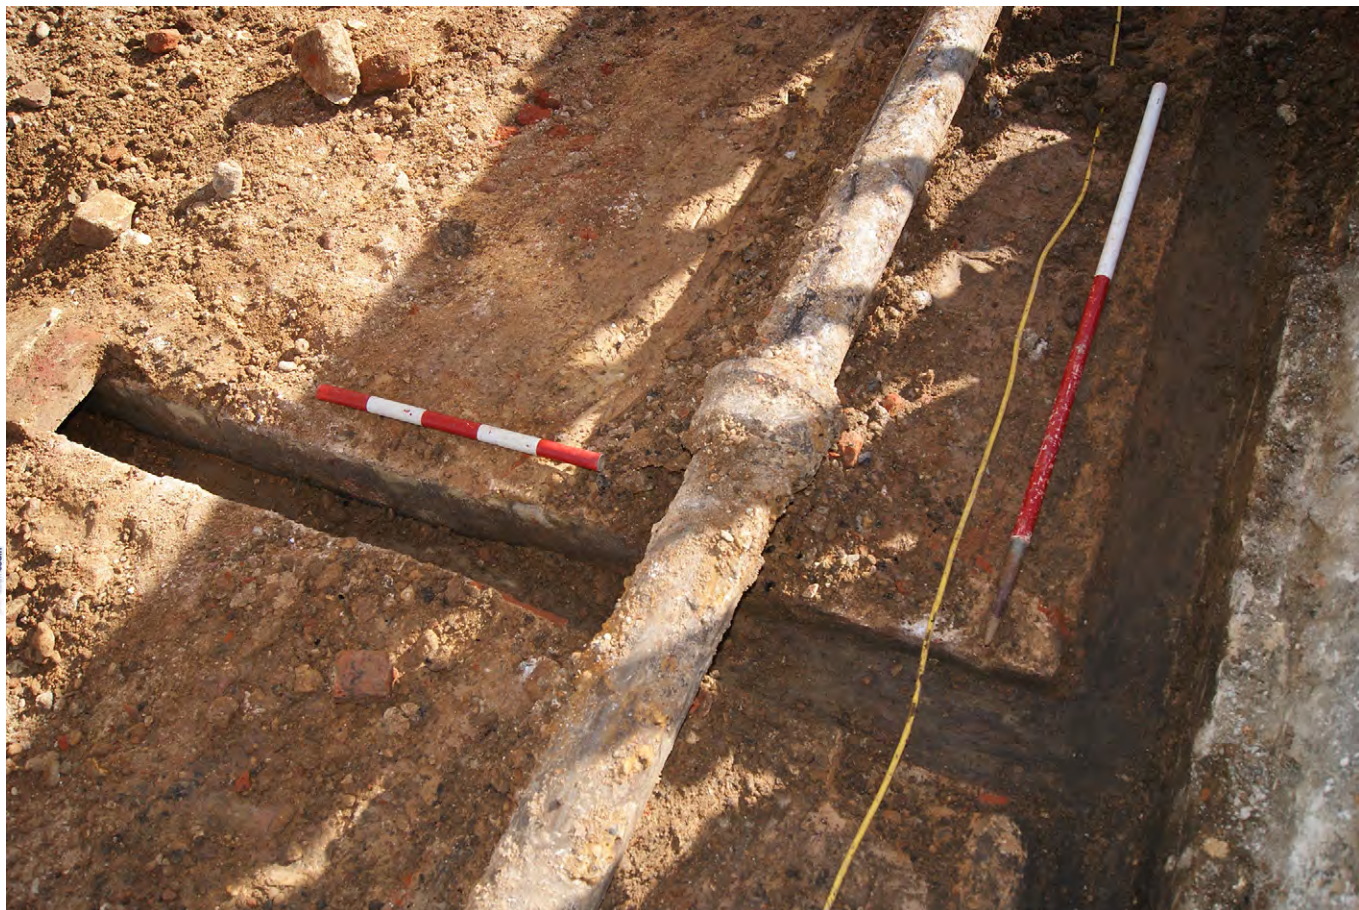
Plate F.22: Drain 5 [F.2.10] , Drain 2 [F.2.7] and cast-iron pipe, looking east

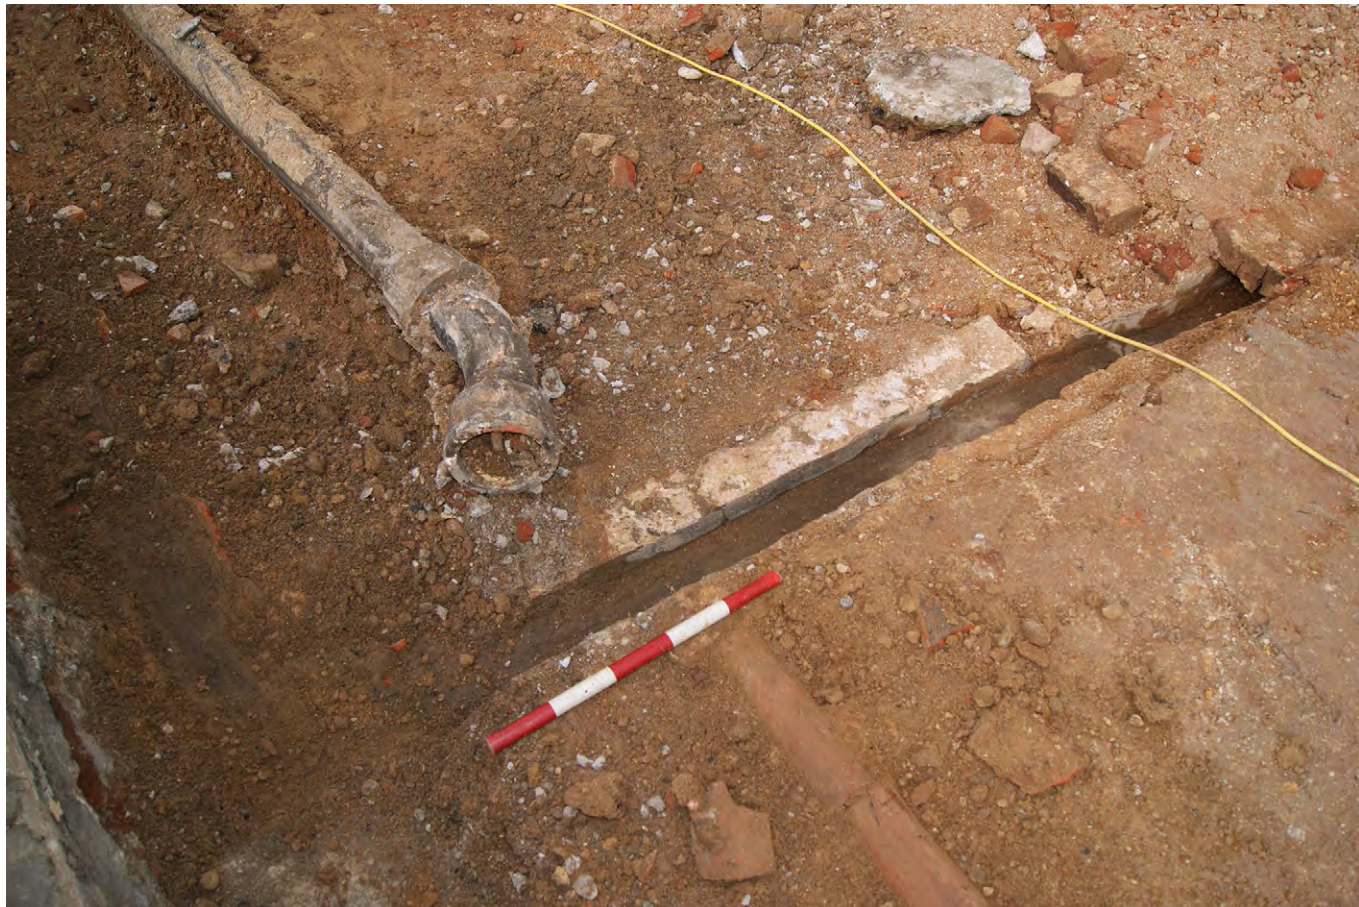
Plate F.23: Drain 1 [F.2.6] extending left to right. Terrace balustrade is to left of image

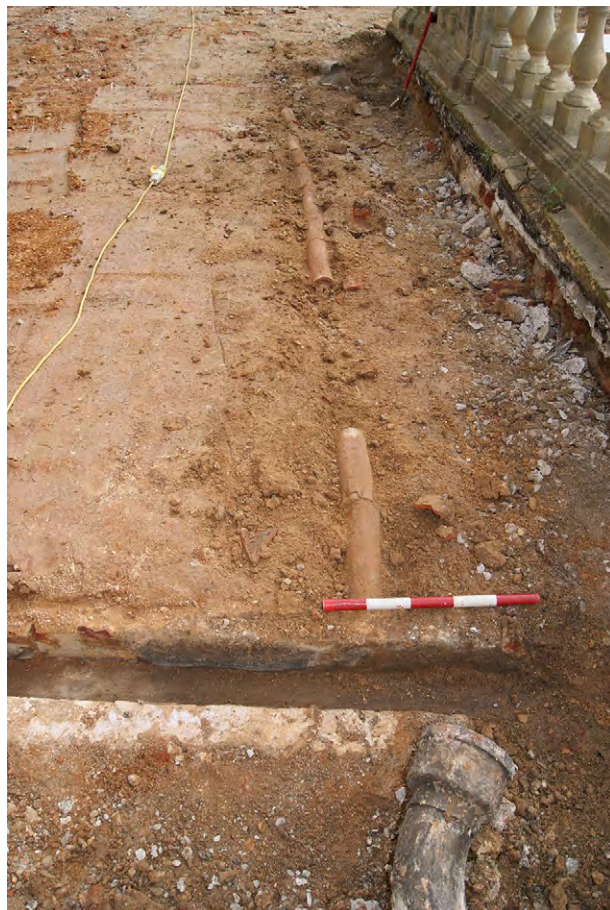
Plate F.24: Horseshoe pipe extending eastwards from Drain 1 [F.2.6], looking east

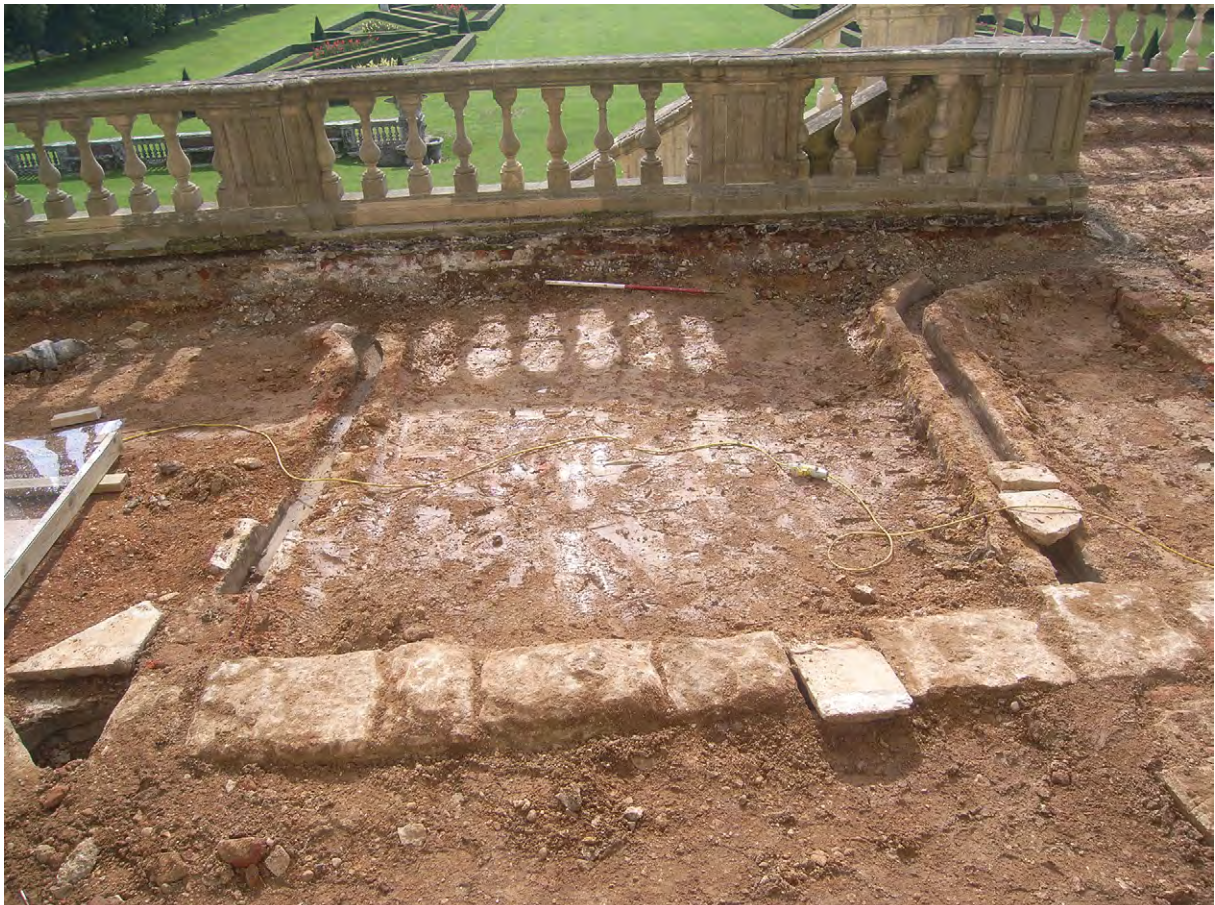
Plate F.29: Area of terrace just to east of centre showing Drain 8 [F.2.13], Drain 9 [F.2.14] and Drain 10 [F.2.15], looking south

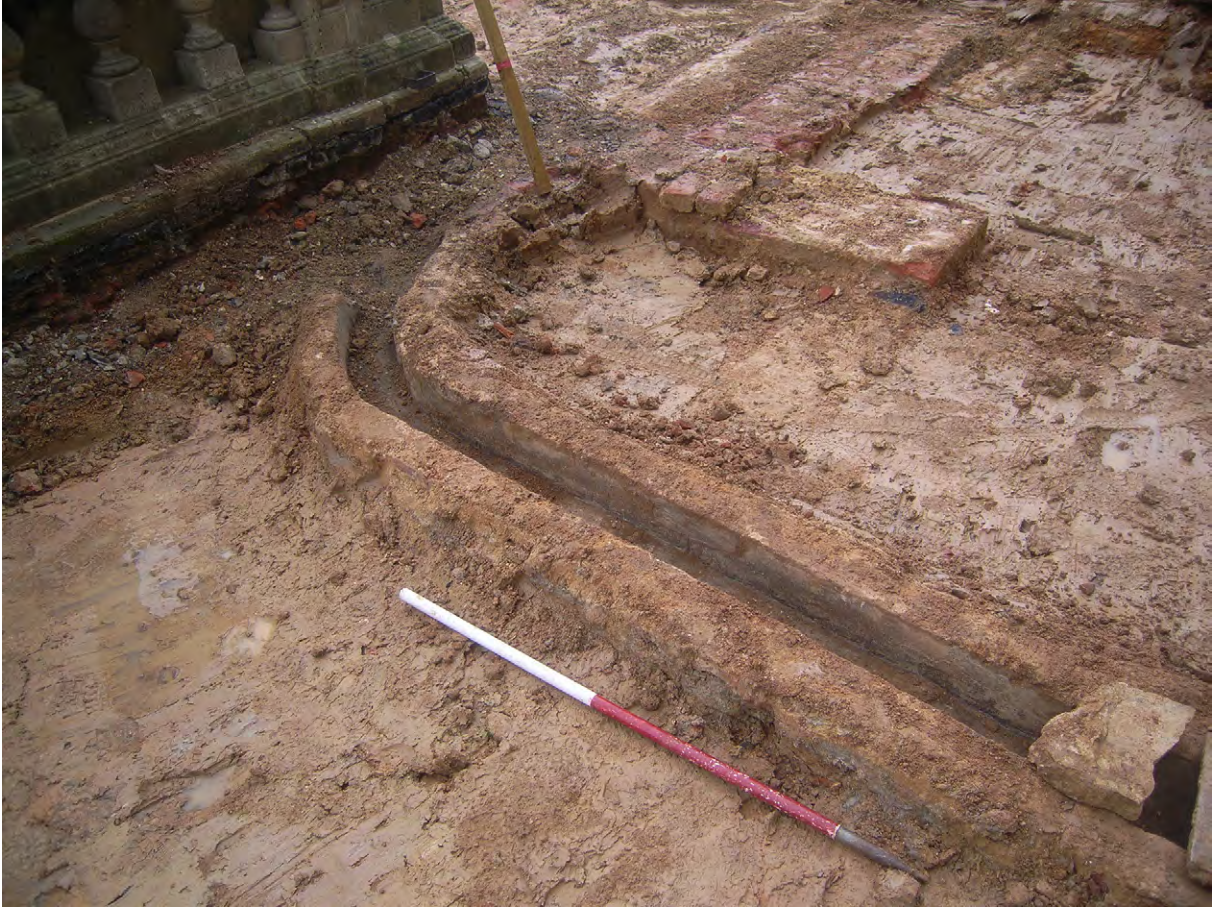
Plate F.30: Drain 8 [F.2.13] exposed during works, looking south-west toward top of stairs

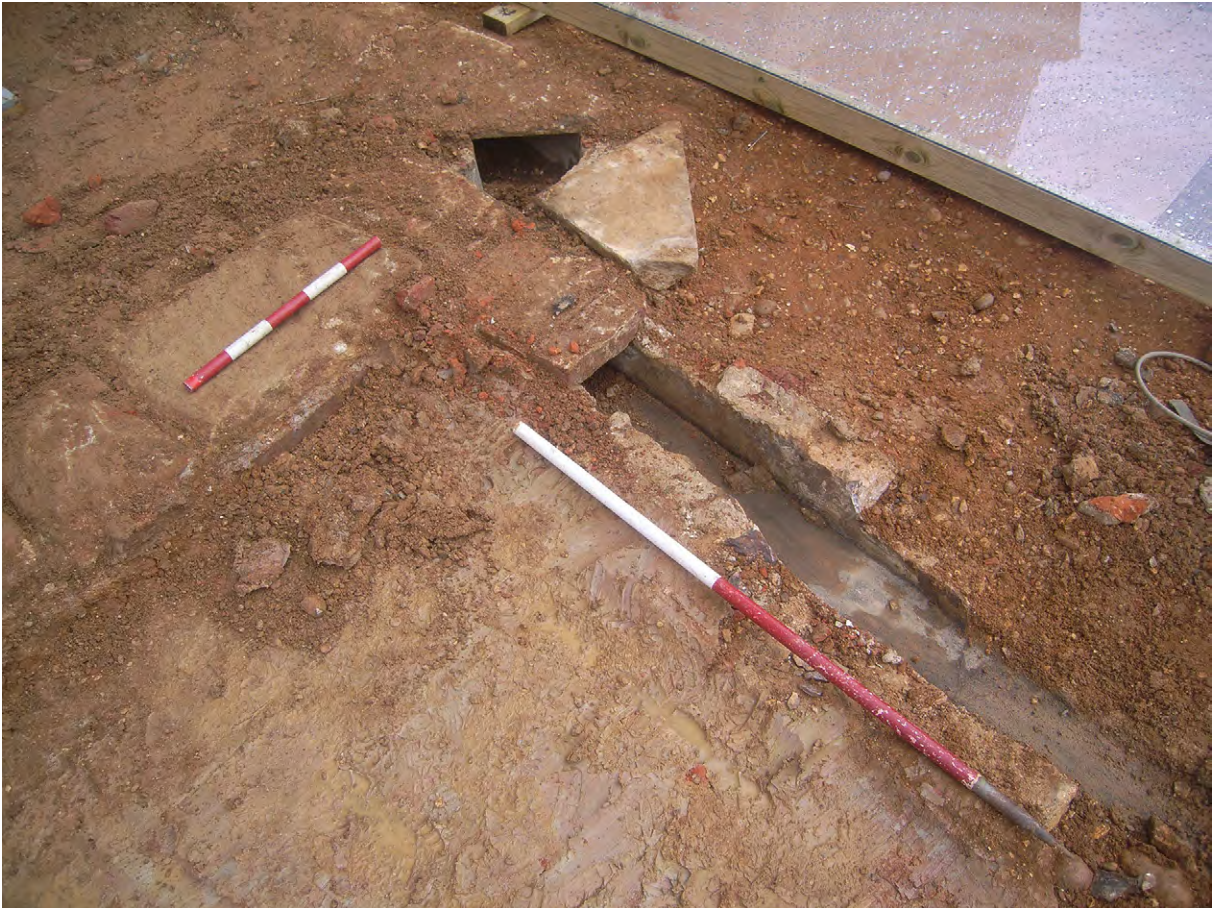
Plate F.31: Drain 9 [F.2.14], Drain 10 [F.2.15] and Drain 12 [F.2.17] looking north-east

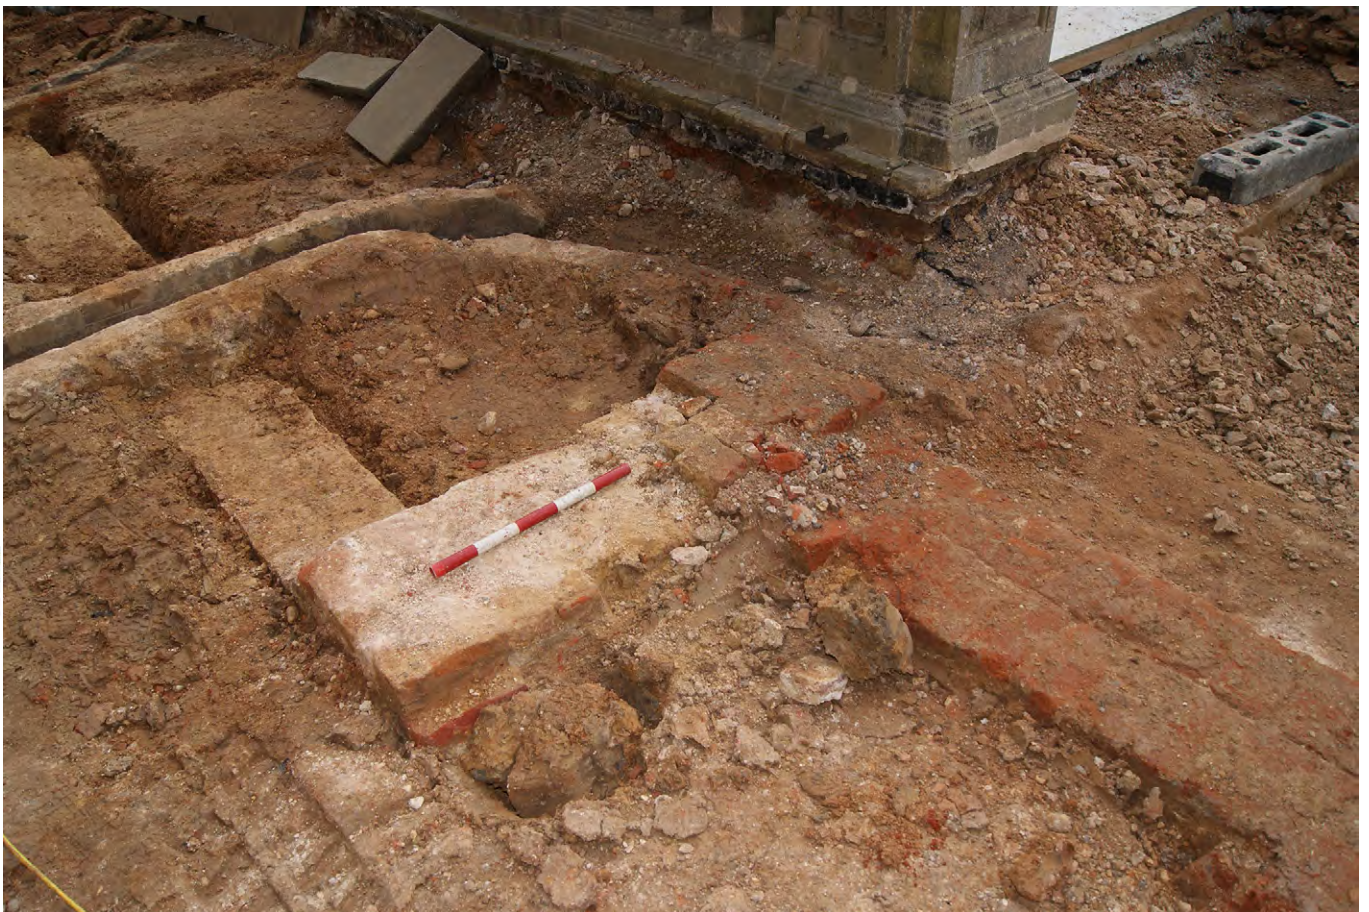
Plate F.32: Point where wall [F.2.2] steps forward in front of mansion, looking SE

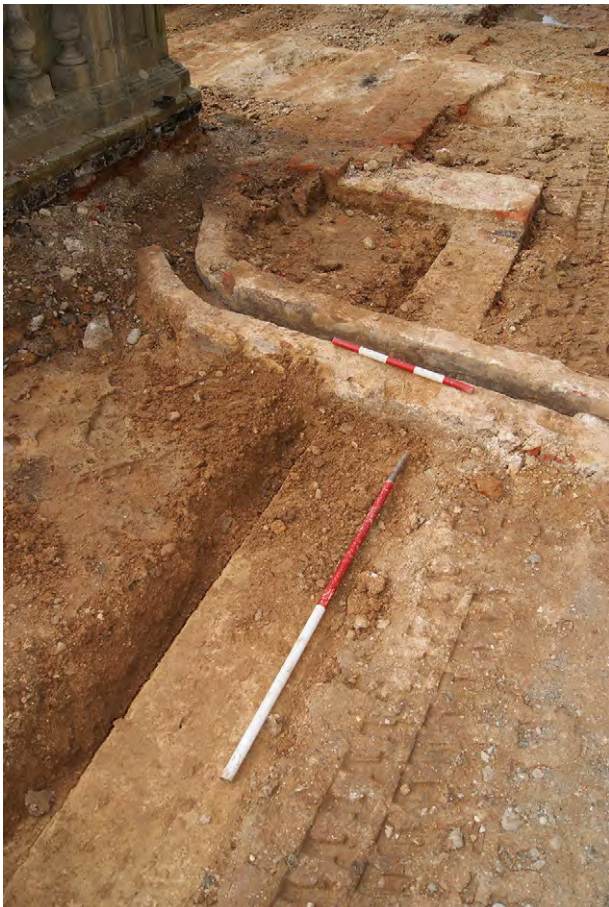
Plate F.33: East-to-west wall [F.2.1] towards front of terrace with drain [F.2.13] overlying it, looking west

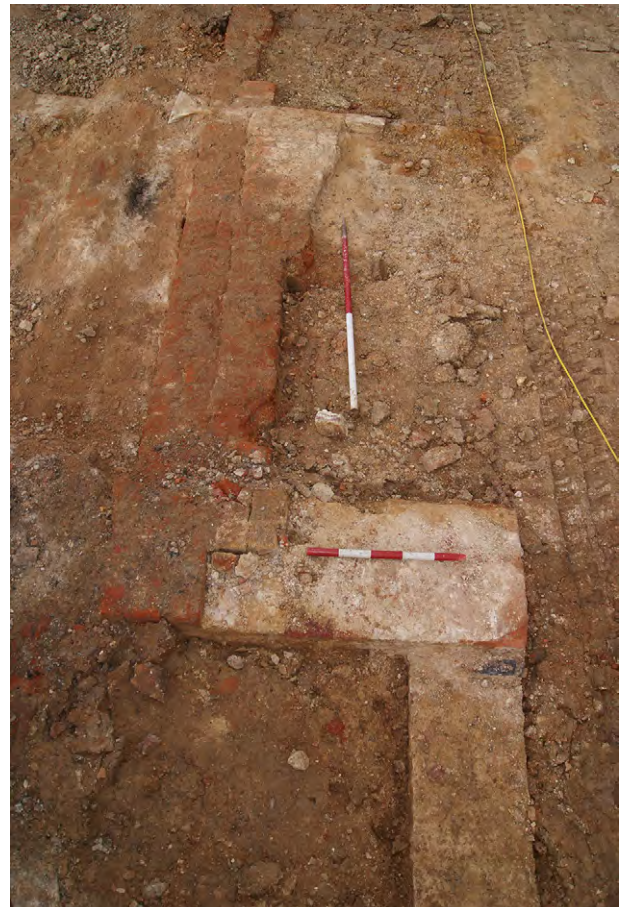
Plate F.34: Walls [F.2.1 & F.2.2] in front of mansion looking west

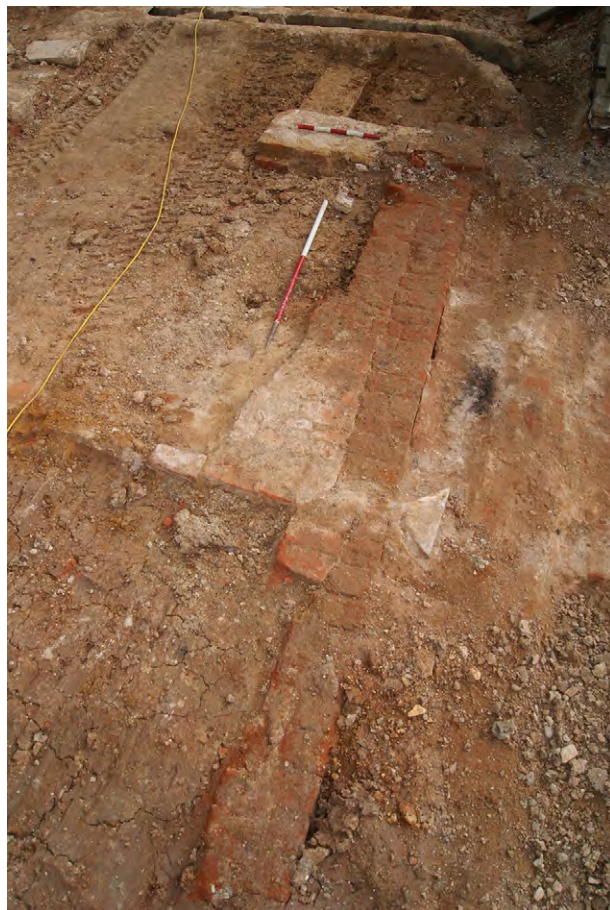
Plate F.35: Wall [F.2.2] in front of mansion, looking east. Top of staircase is immediately to right

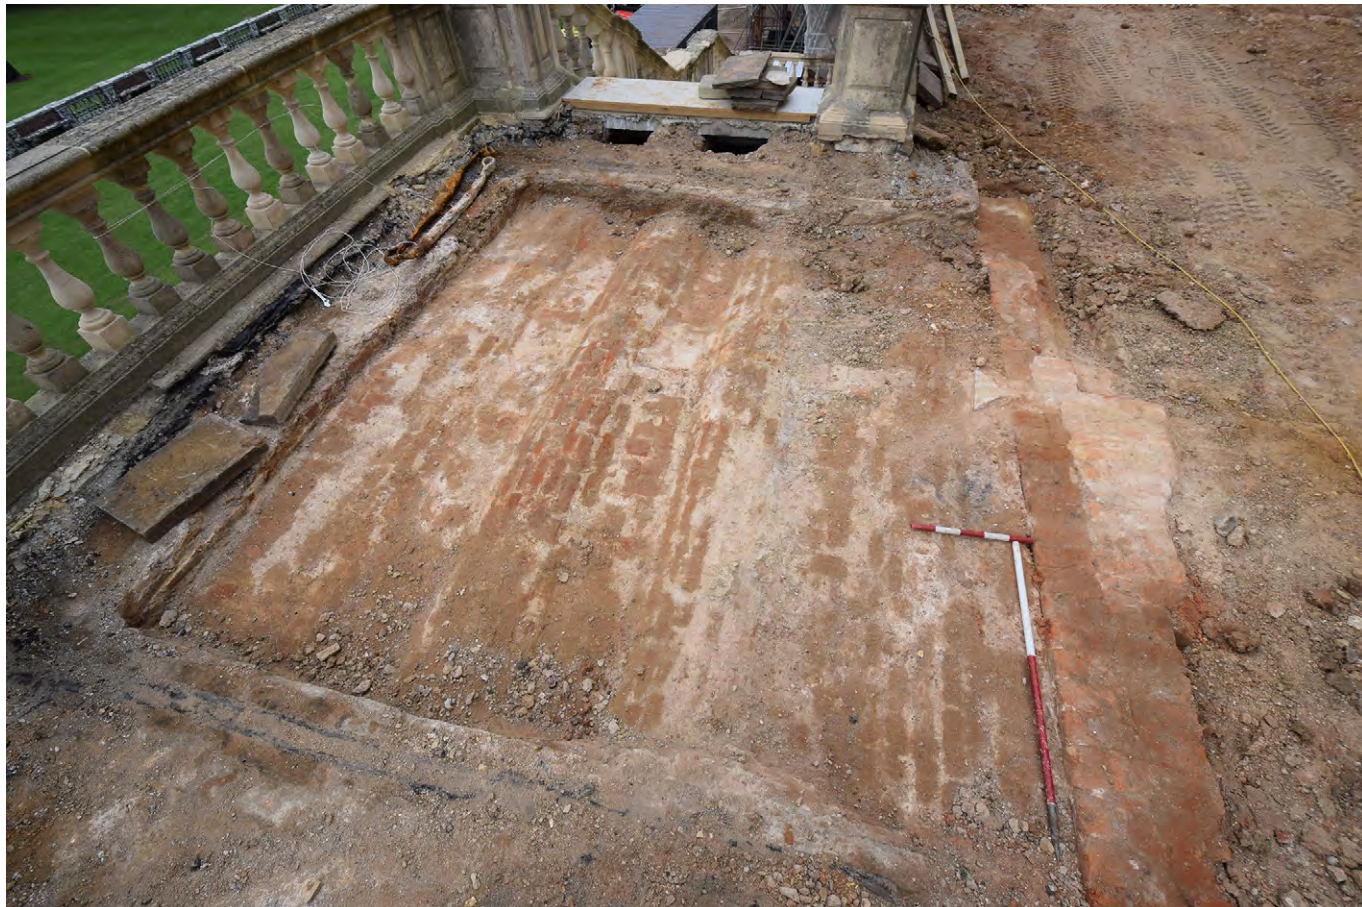
Plate F.36: Vaults over landing at top of staircase, looking west

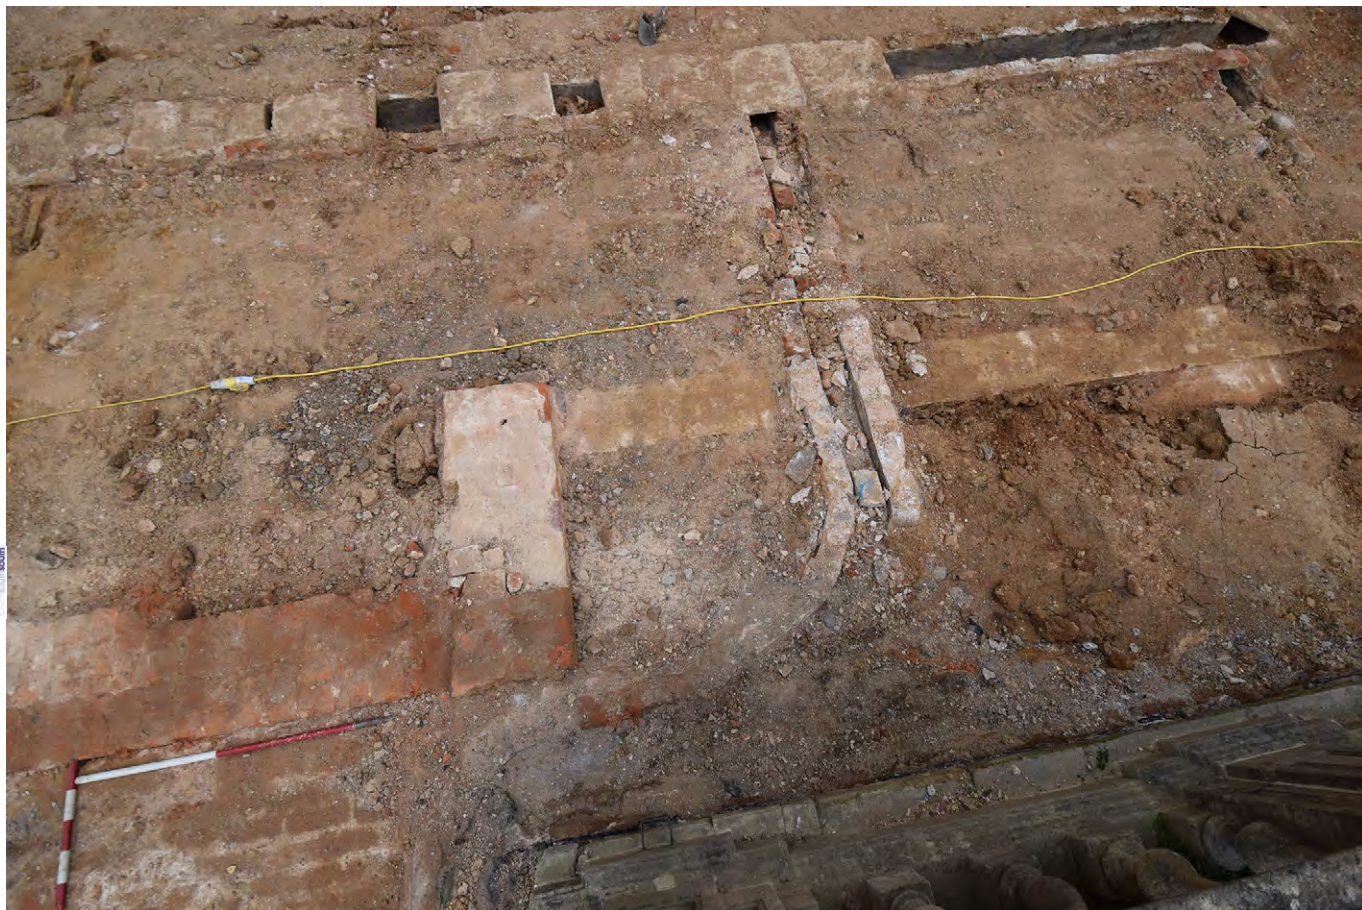
Plate F.37: General view of drains in central part of terrace, looking north towards mansion

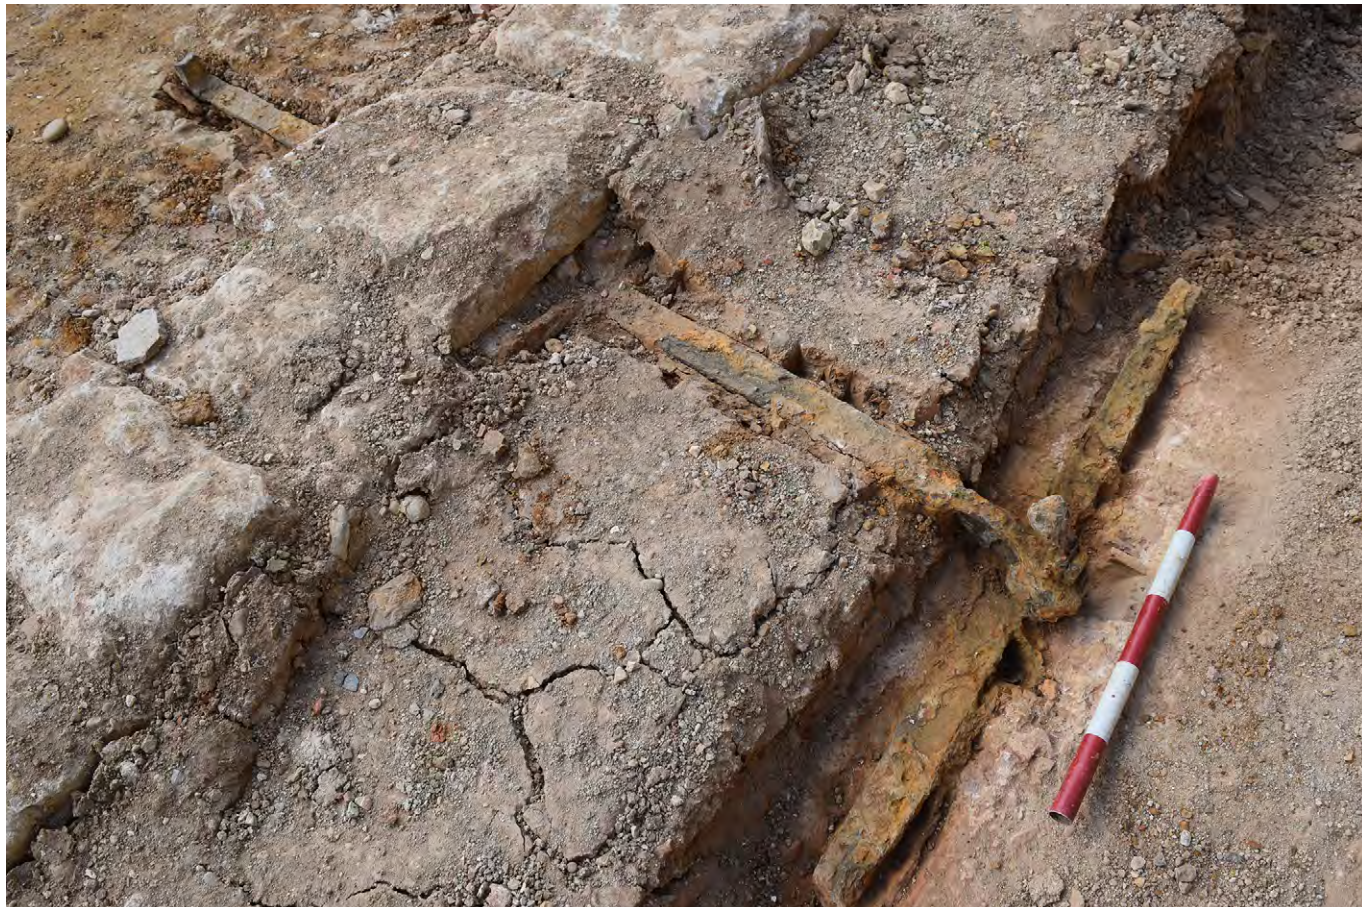
Plate F.38: Iron fixings along central line of terrace (above Sounding Chambers), looking west
