The South Terrace, Cliveden

Archaeological Investigations 2013-17

May 2018

Client Name: The National Trust
Client Ref No.: n/a
Document Title: The South Terrace, Cliveden
Document Type: Report on Archaeological Investigations 2013-17

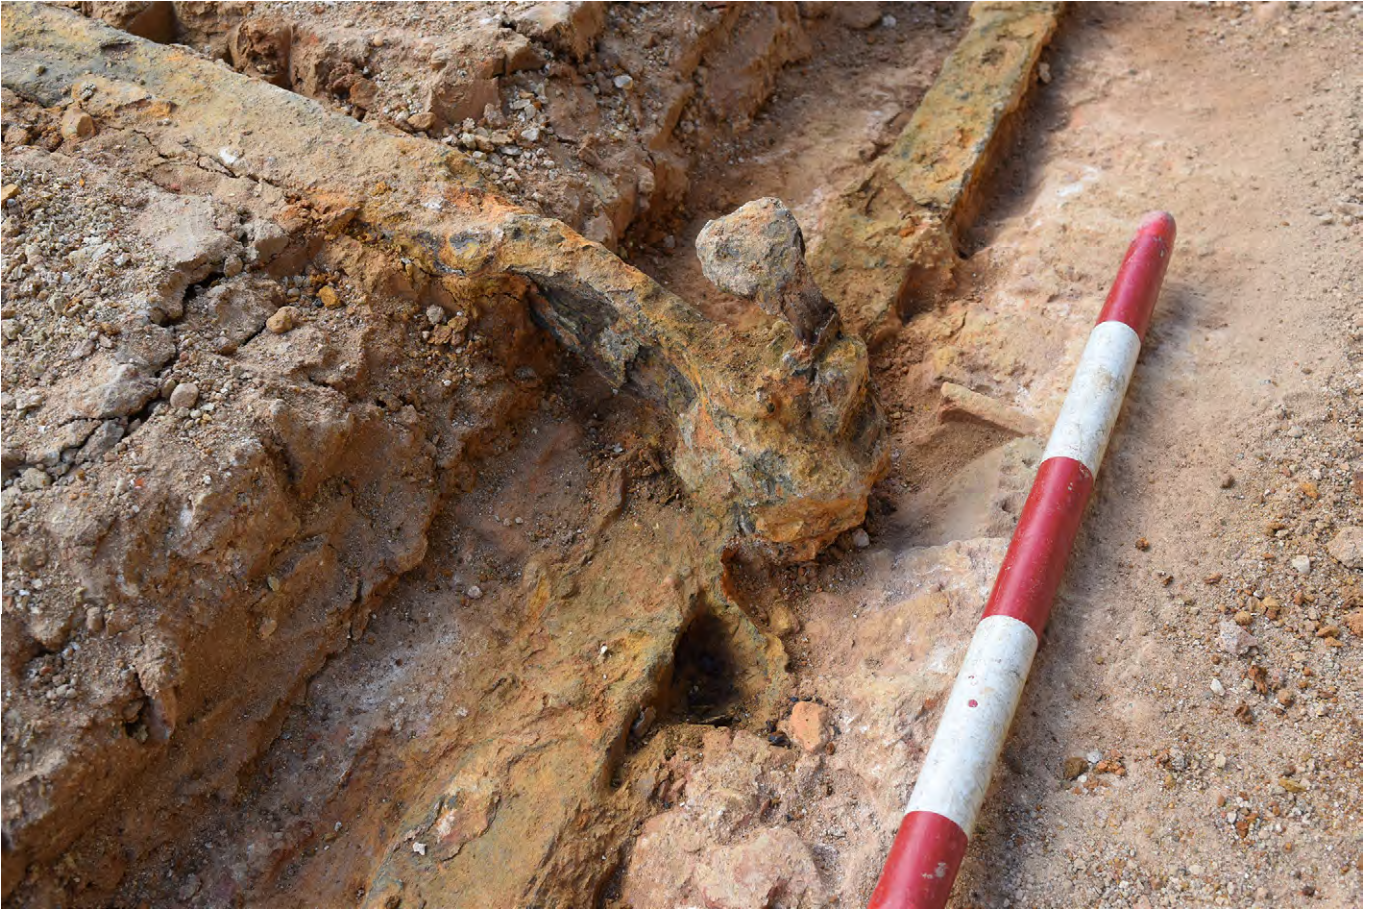
Plate F.39: Detail of iron tie fixing at central point of terrace, looking west

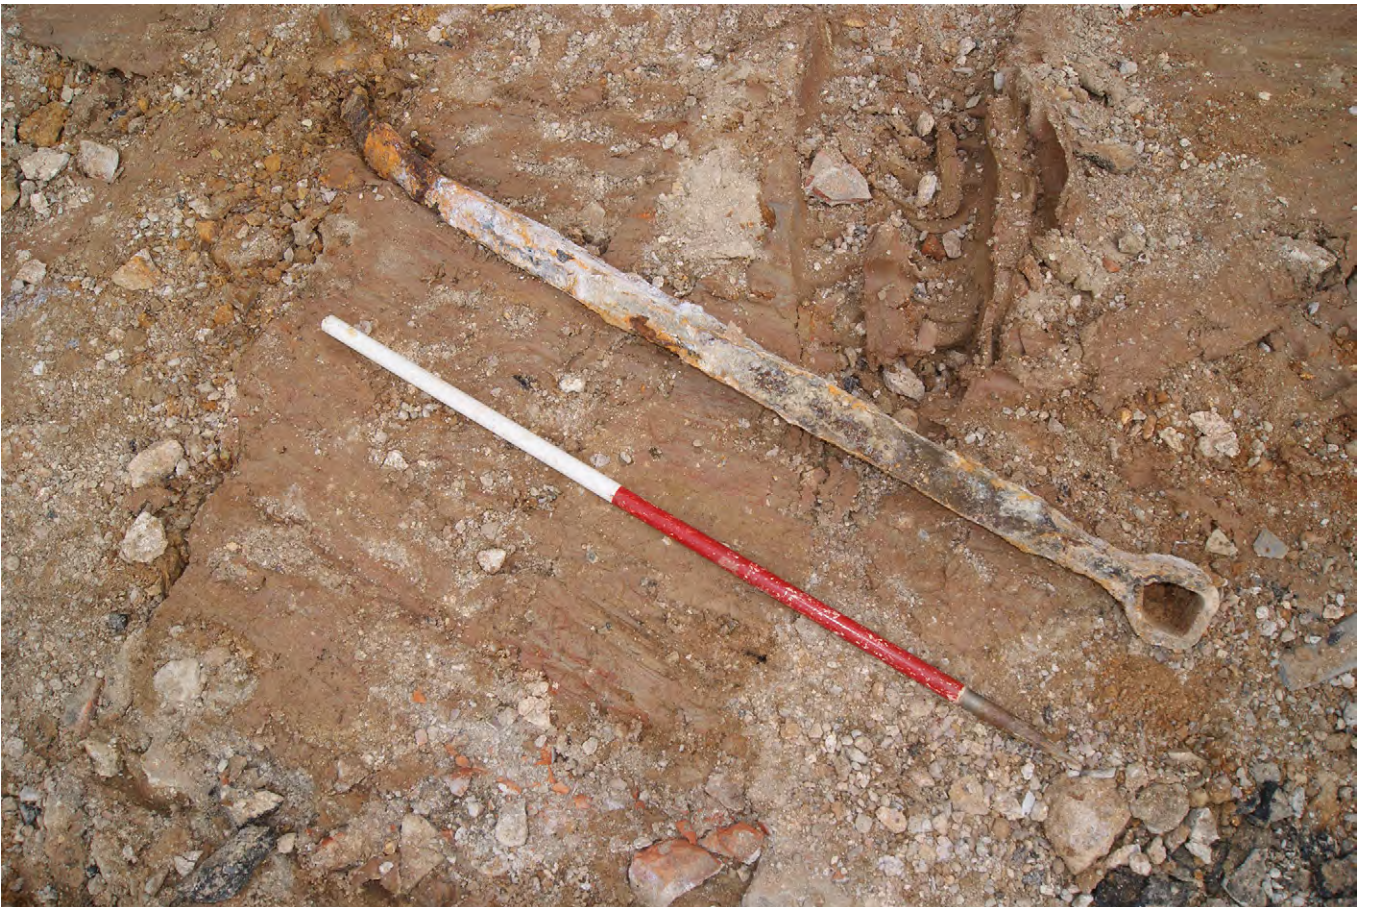
Plate F.40: Iron tie-bar bent away from original line

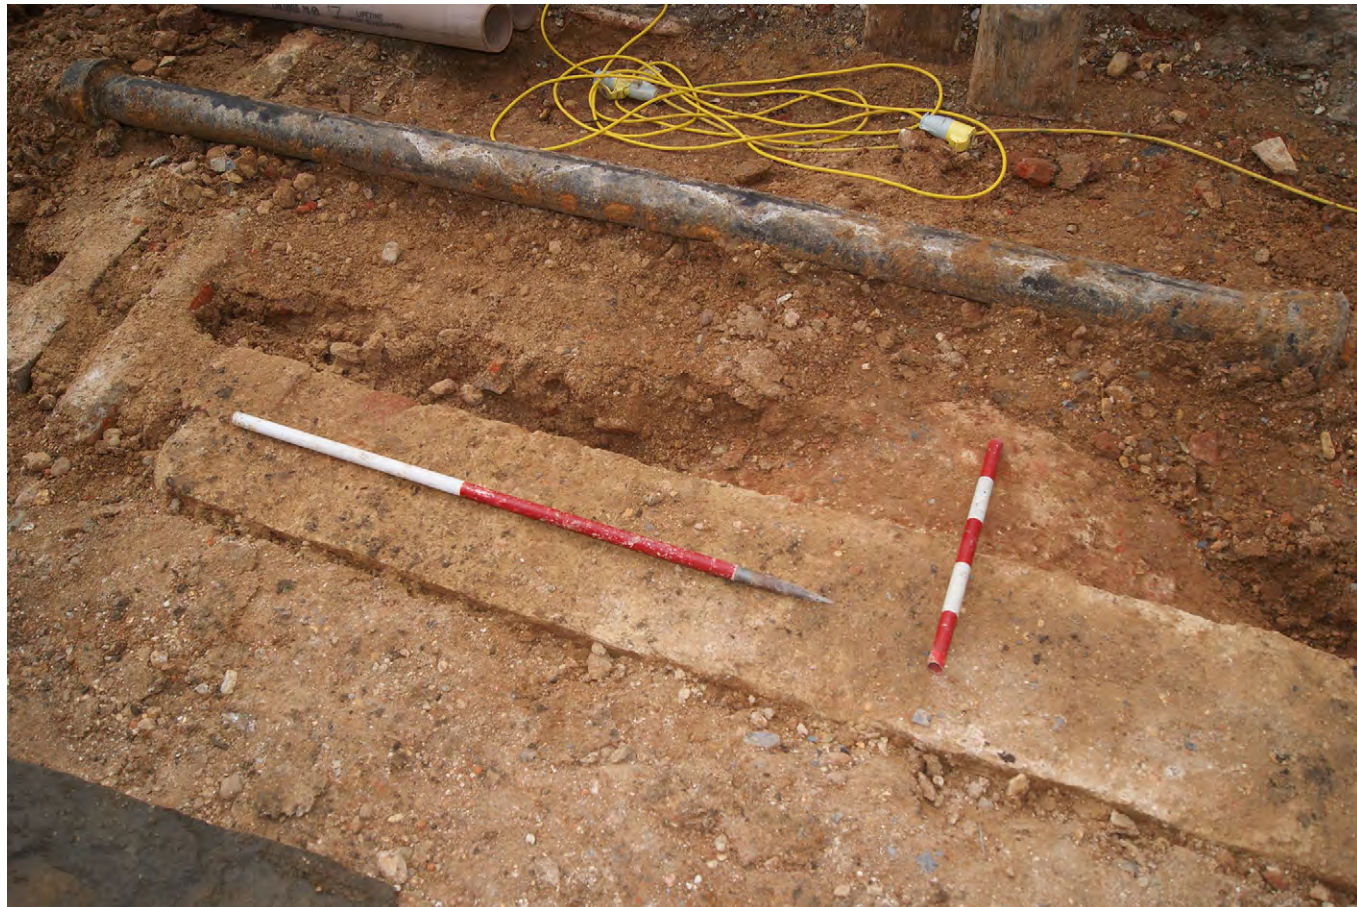
Plate F.42: East-to-west wall [F.2.1] towards front of terrace, looking north

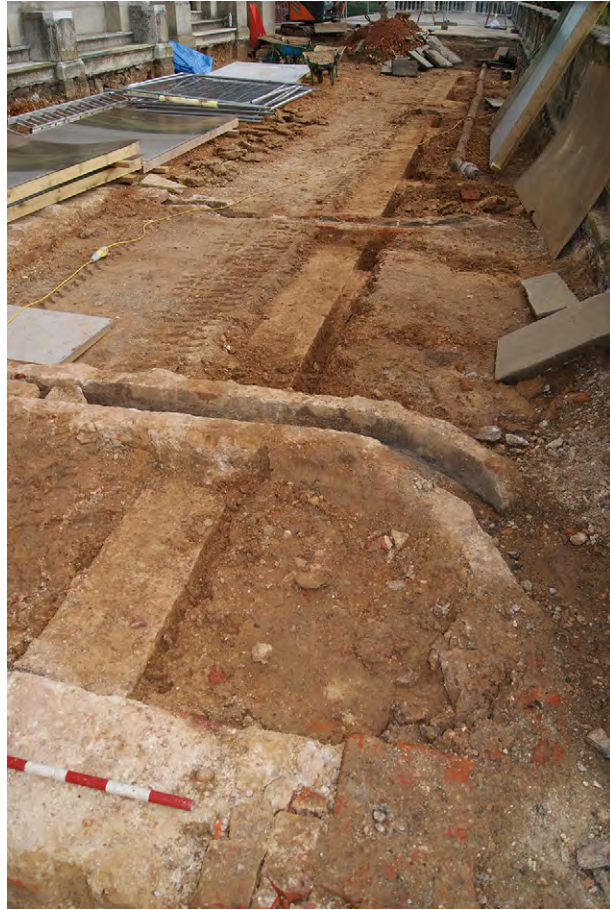
Plate F.43: East-to-west wall [F.2.1] towards front of terrace and overlying drains, looking east

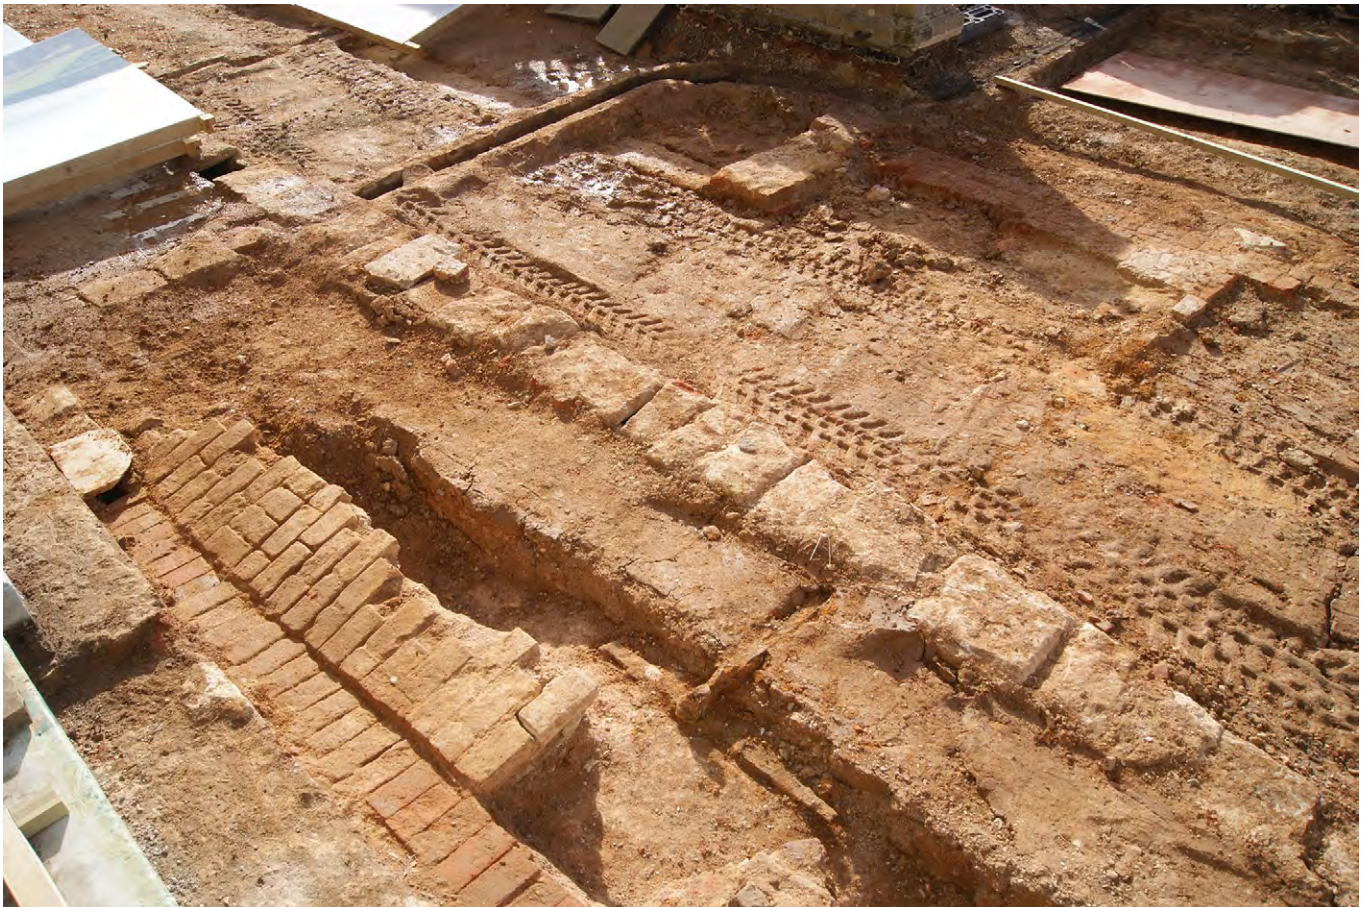
Plate F.44: Drains and features immediately in front of centre of mansion, looking south-east

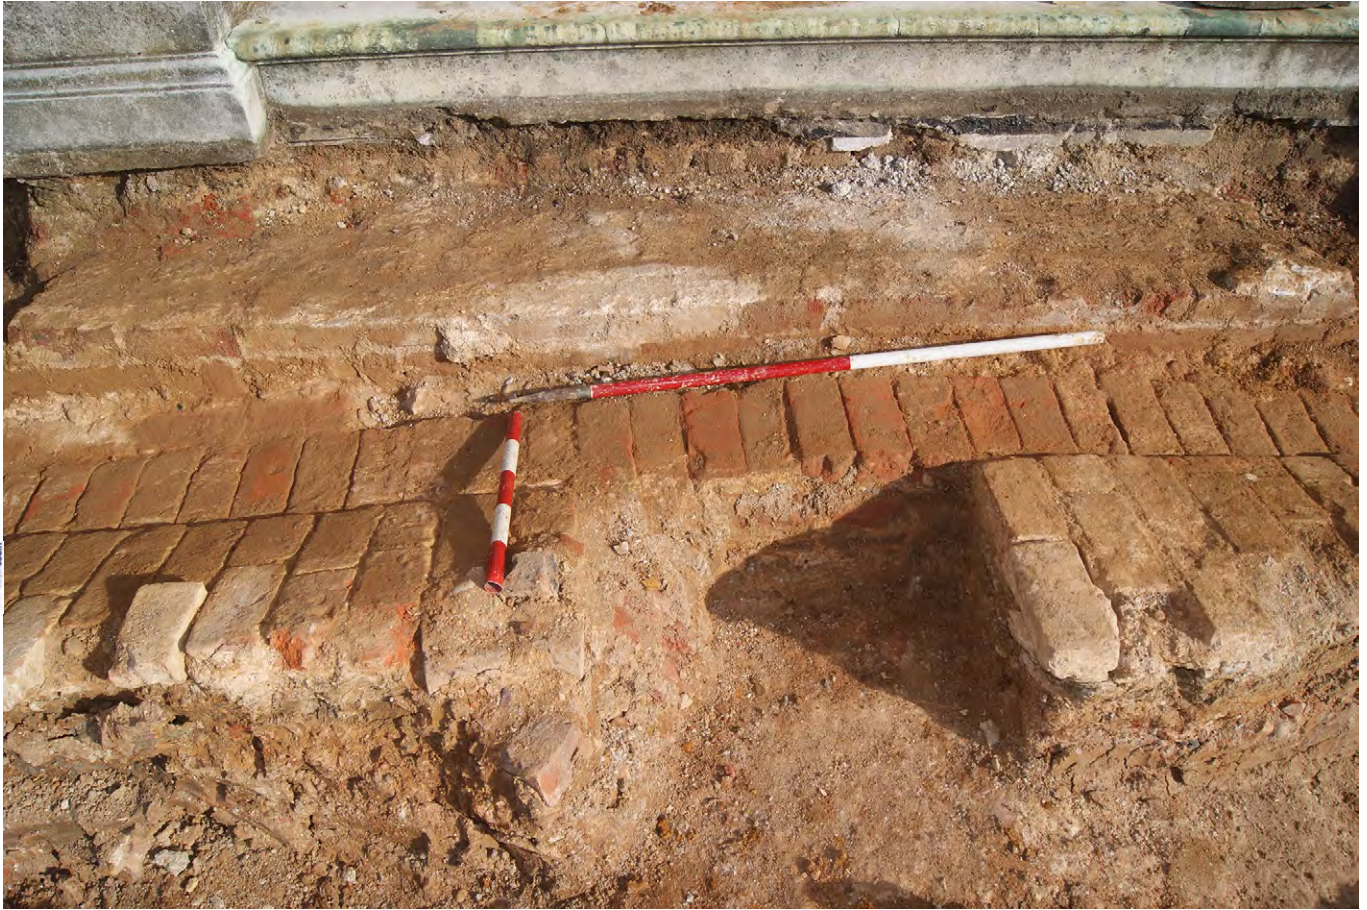
Plate F.48: Brick drains in front of mansion, looking north

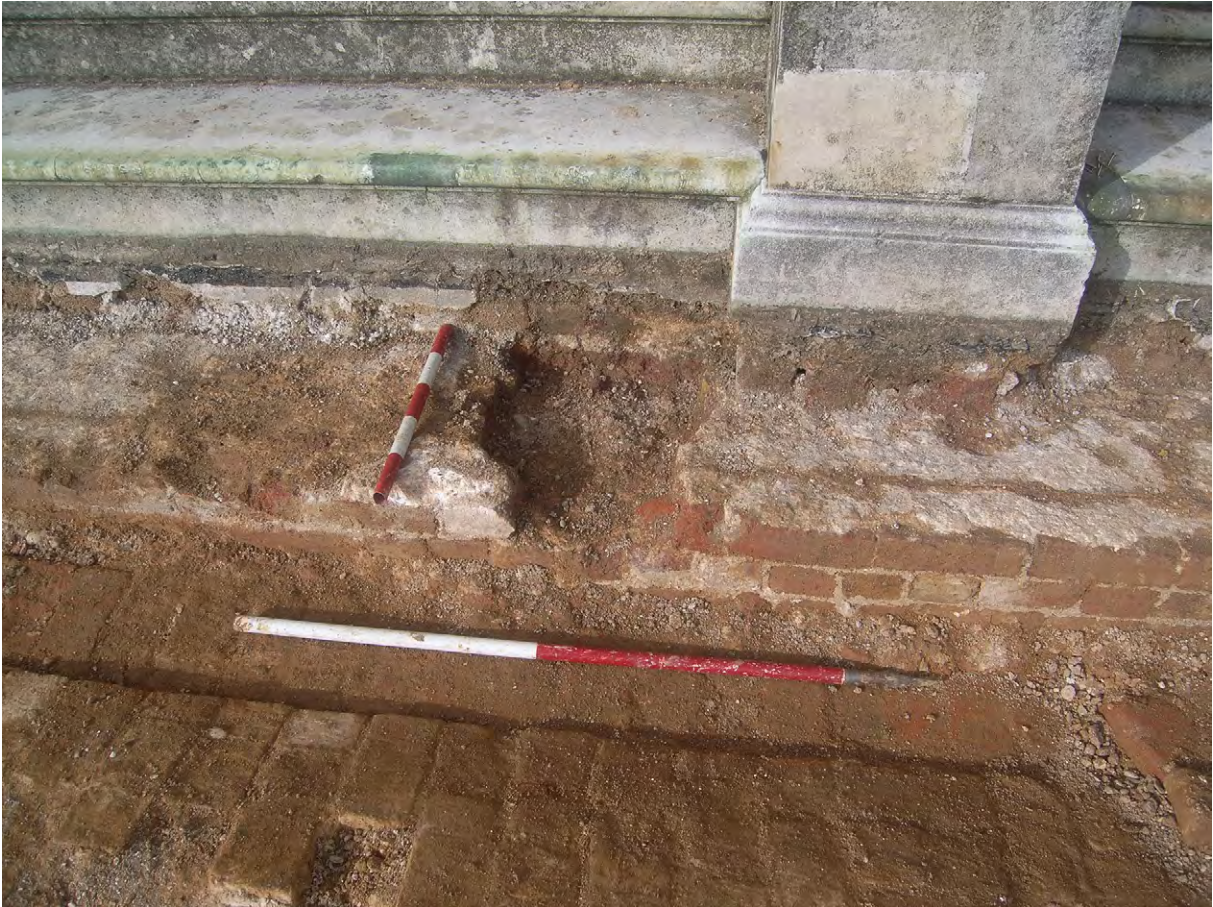
Plate F.50: Feature in stepped 'shelf' [F.2.5] surface in front of mansion, looking north

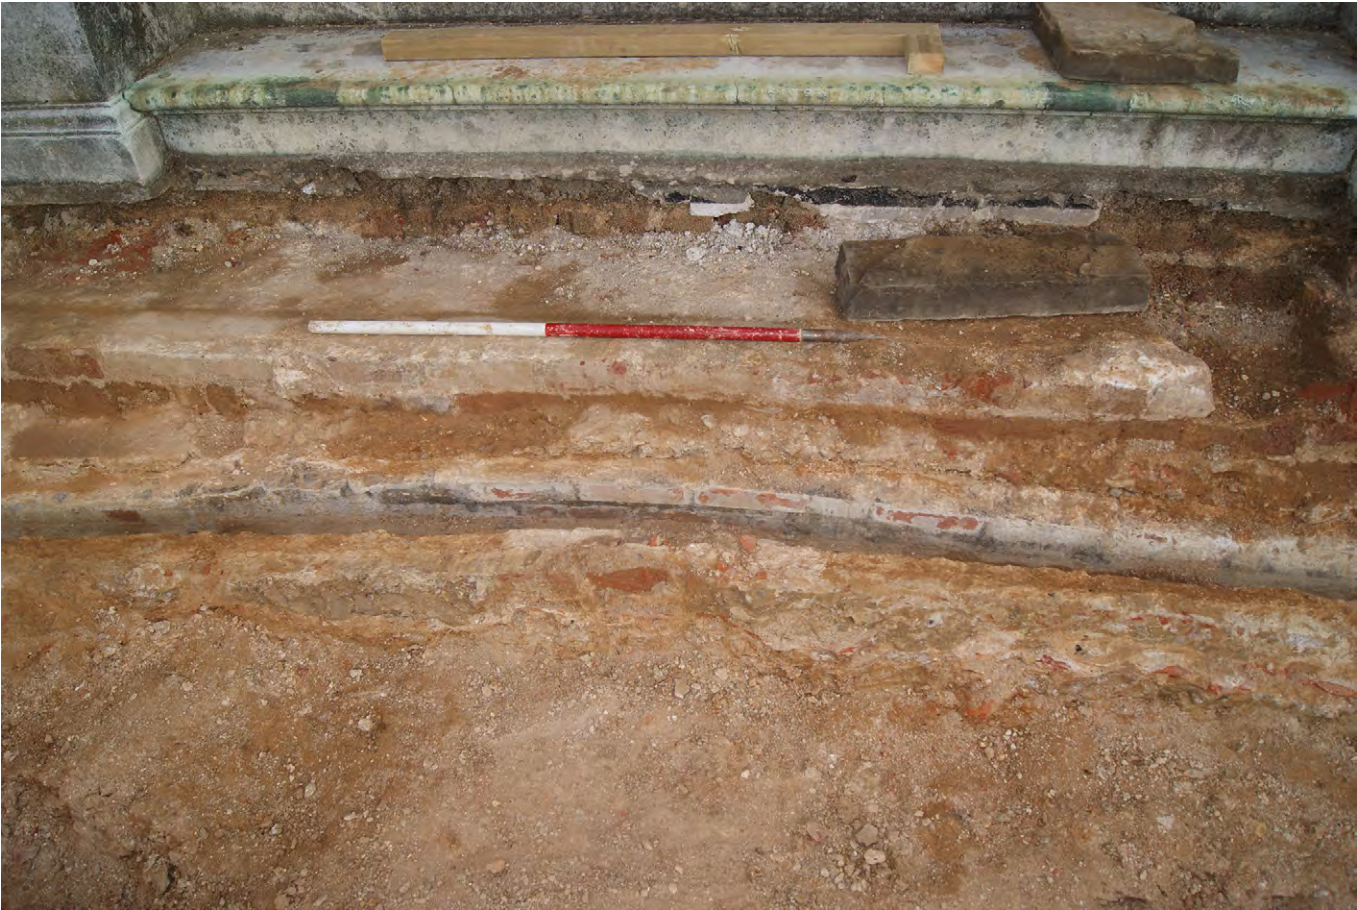
Plate F.51: Drains in front of mansion after removal of brick capping, looking north

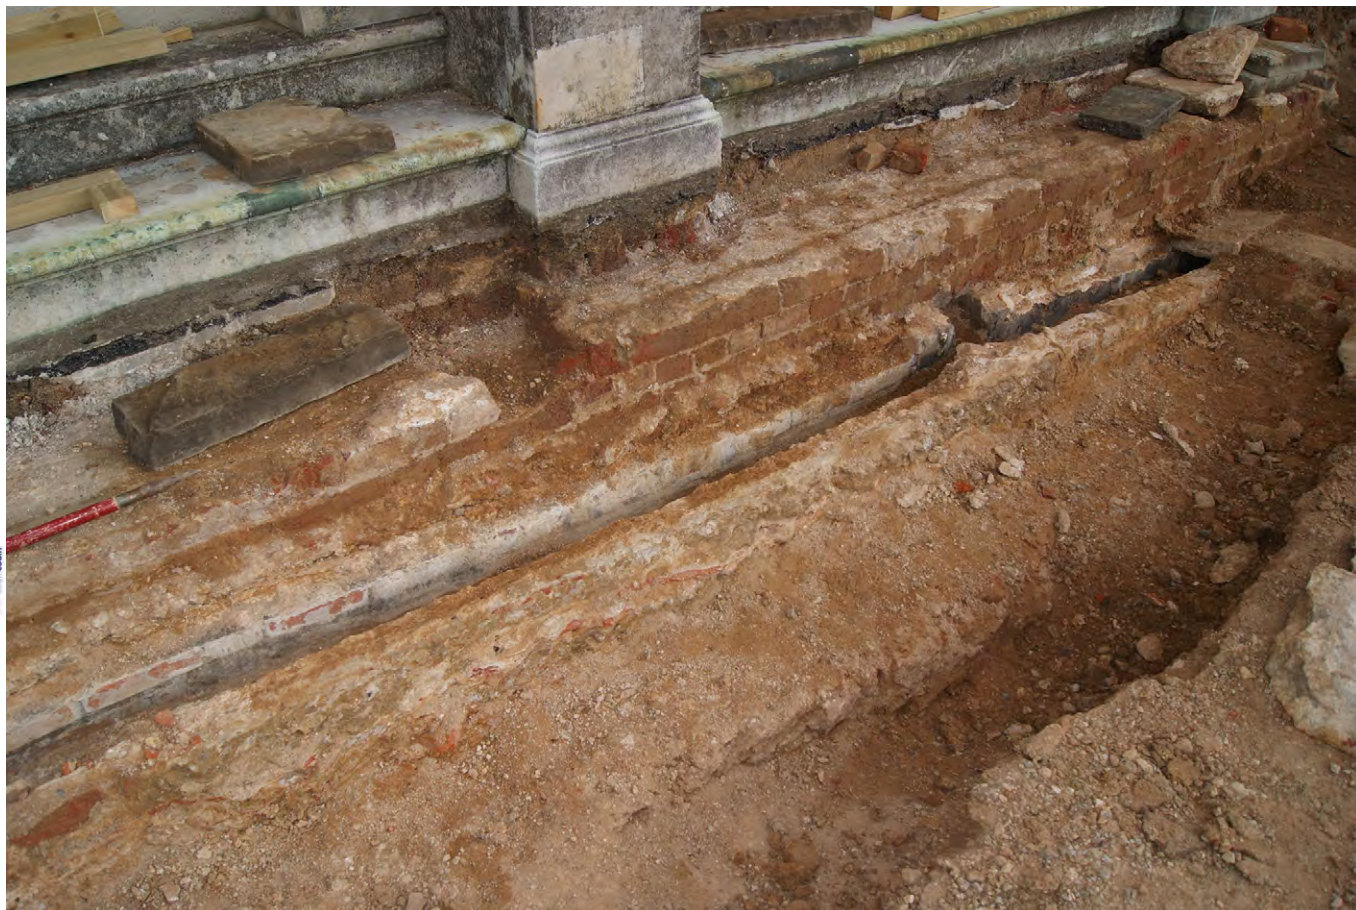
Plate F.52: Drains in front of mansion after removal of brick capping, looking north-east

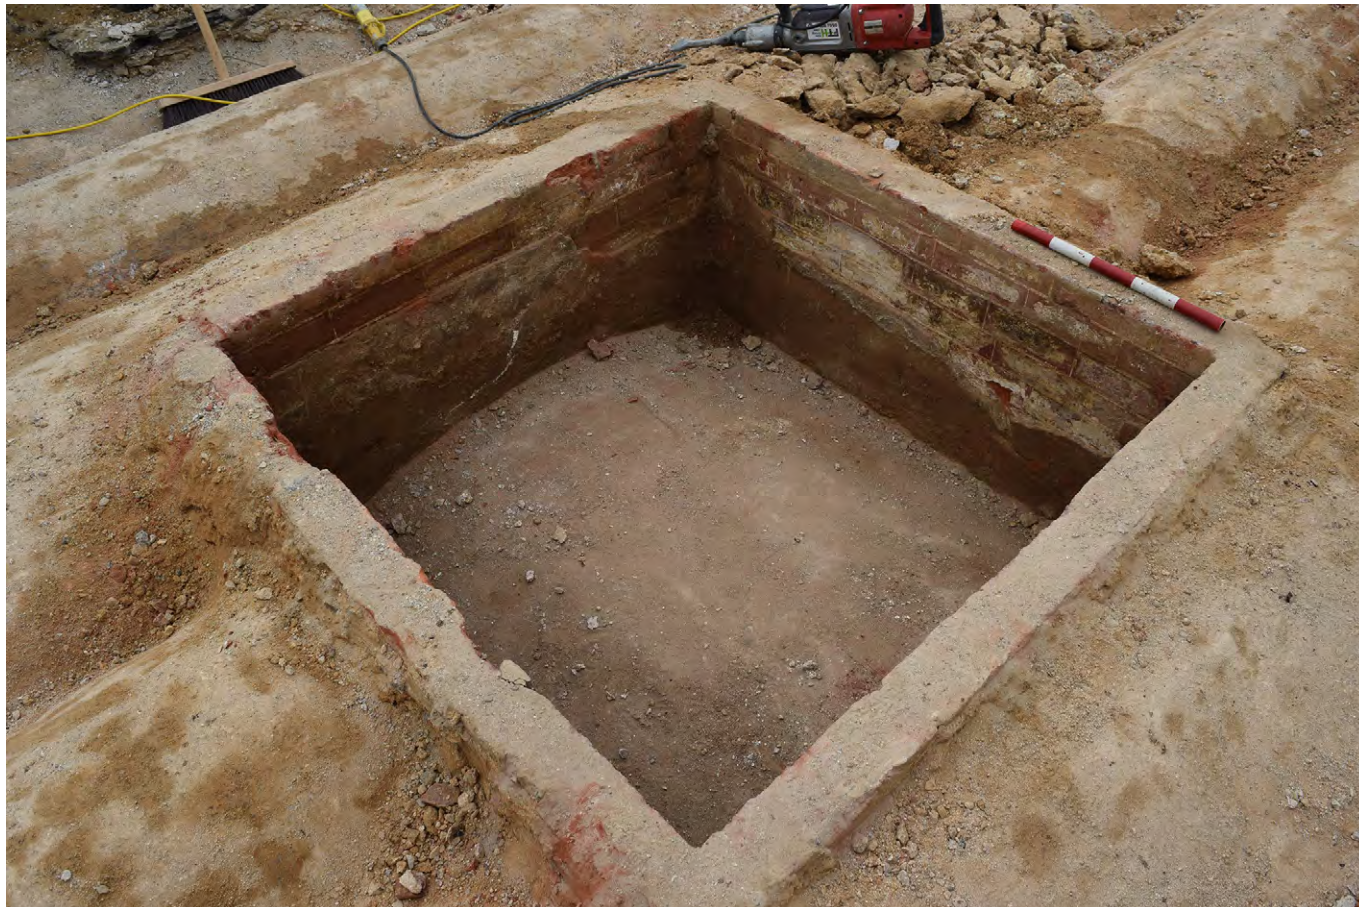
Plate F.53: Base of light well exposed in eastern third of terrace, looking north-east

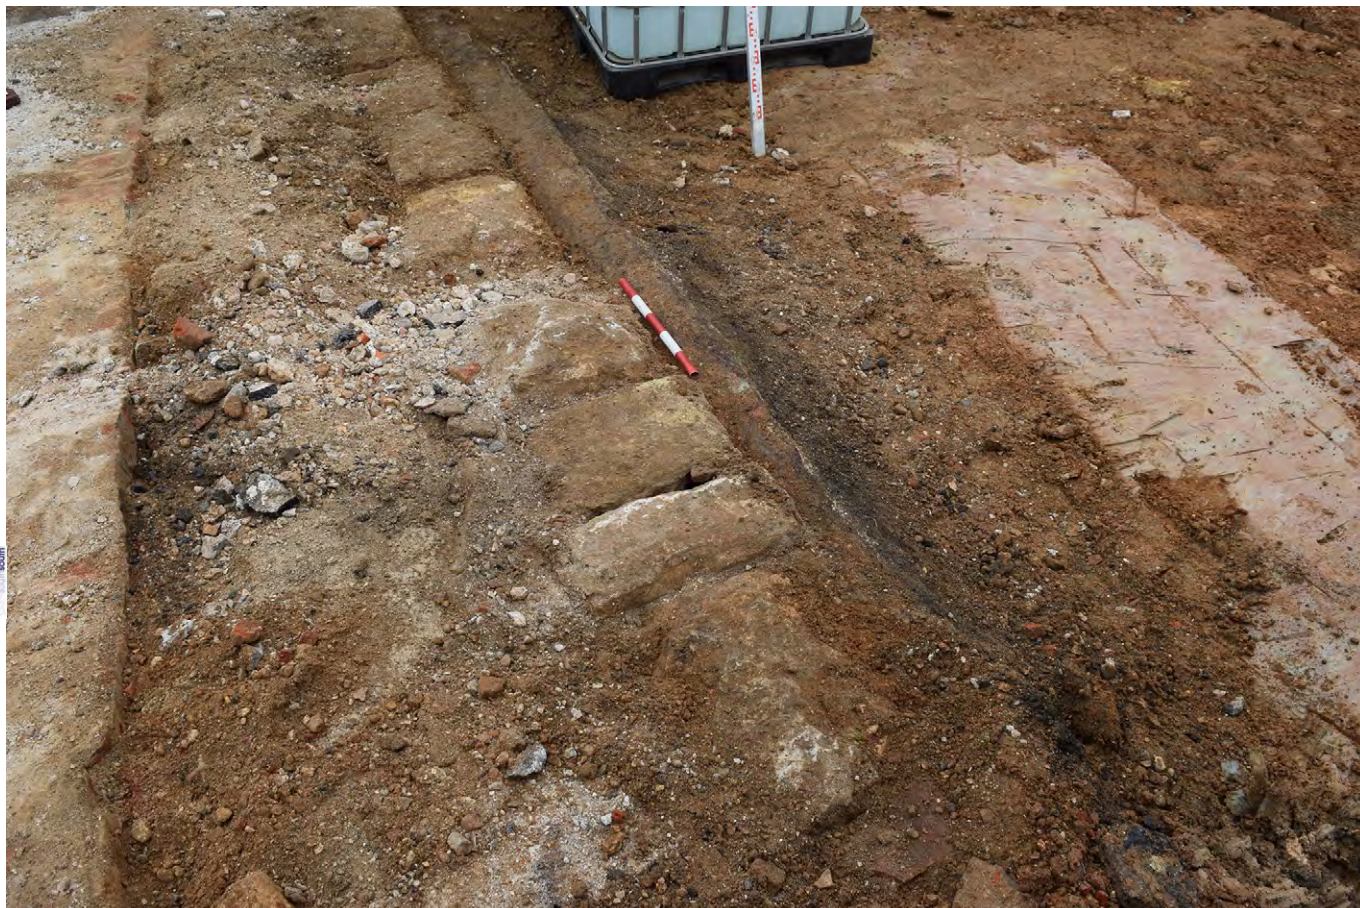
Plate F.56: Features exposed in eastern third of terrace, looking south, showing drain [F.3.4]

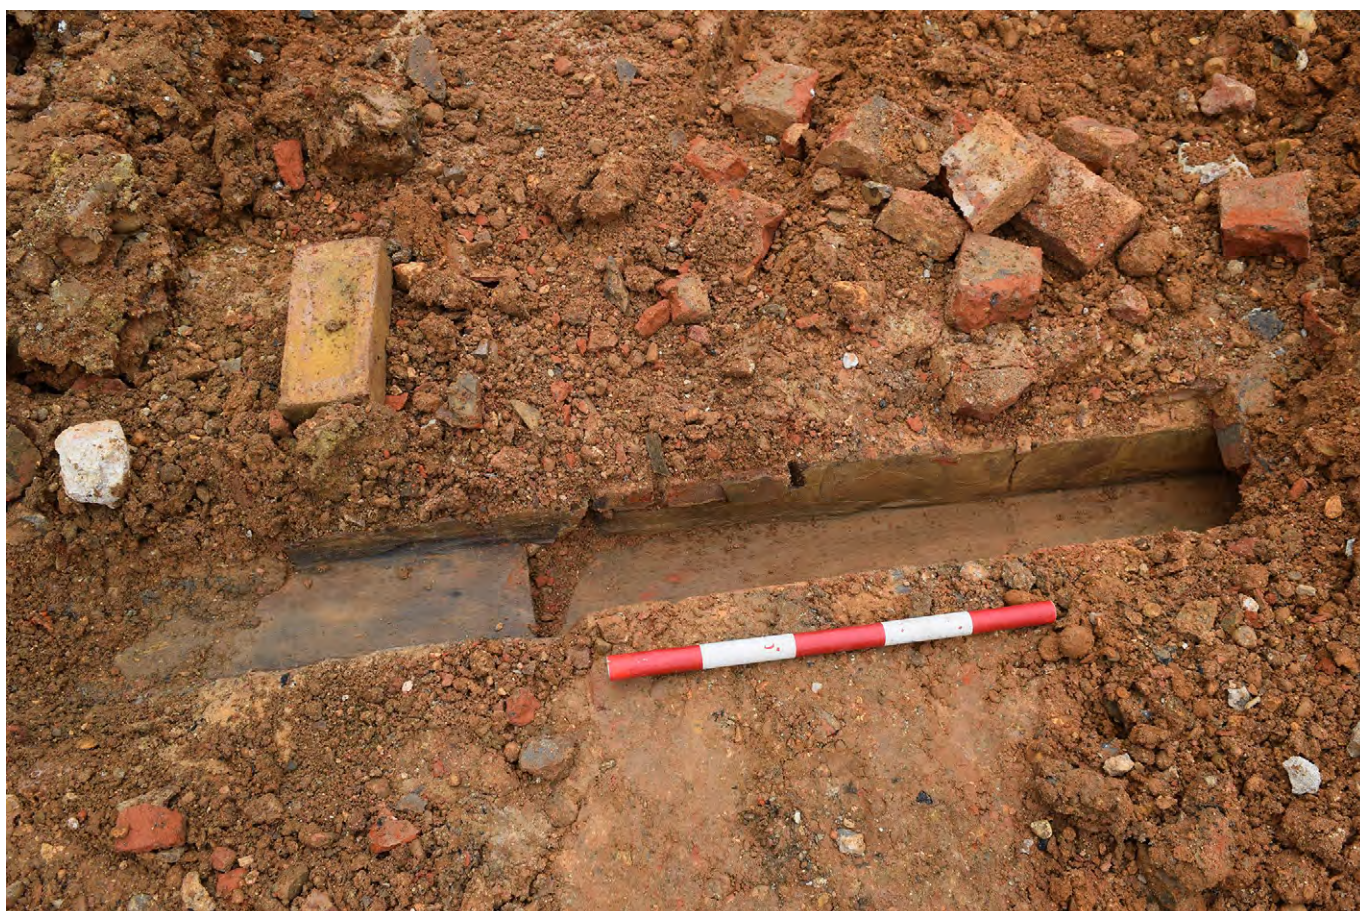
Plate F.57: Simple drainage trench in eastern third of terrace, looking west, showing drain [F.3.7]

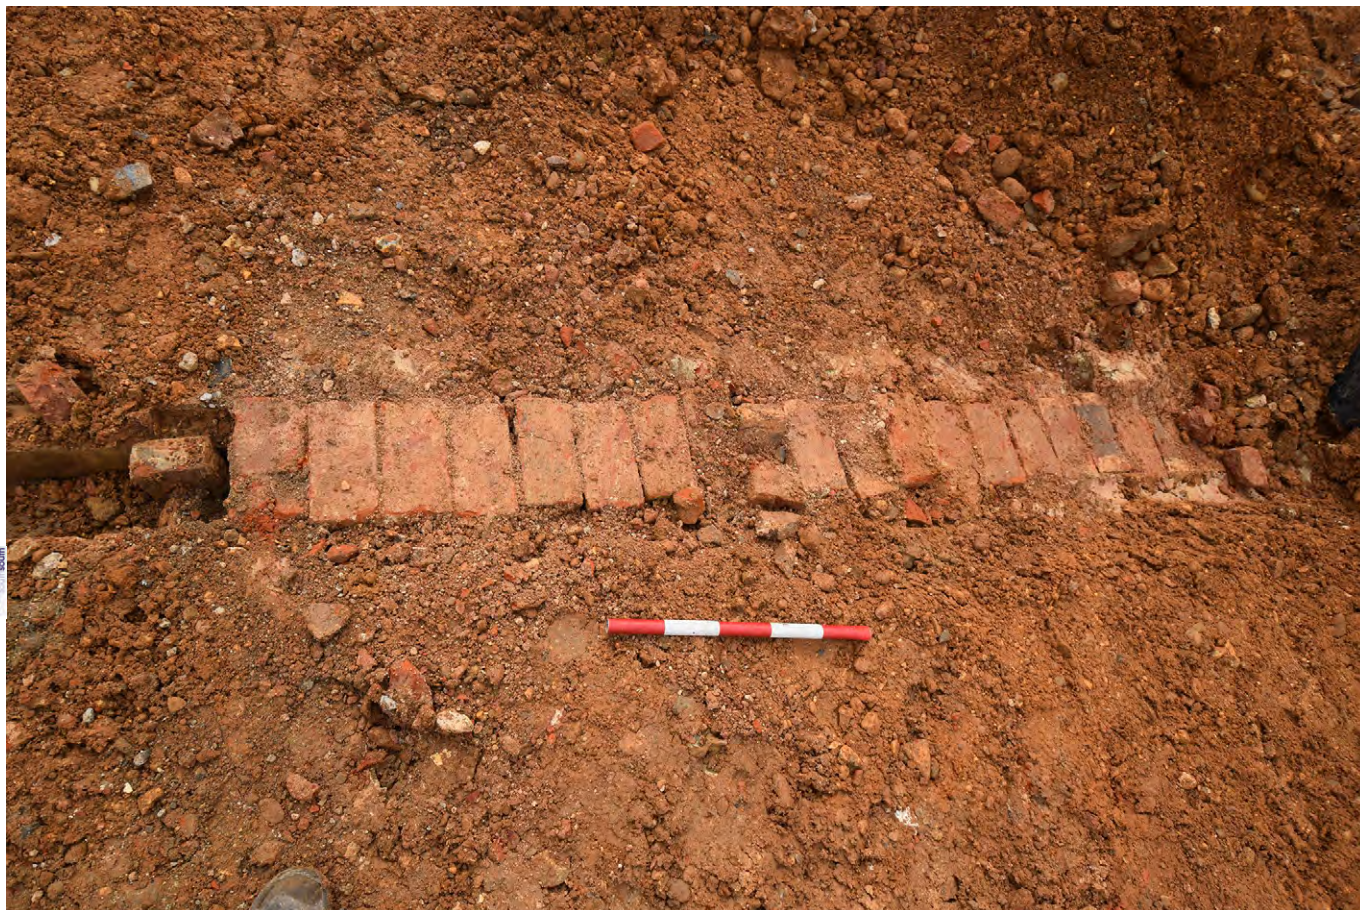
Plate F.58: Simple drainage trench in eastern third of terrace, looking west, showing drain [F3.7]

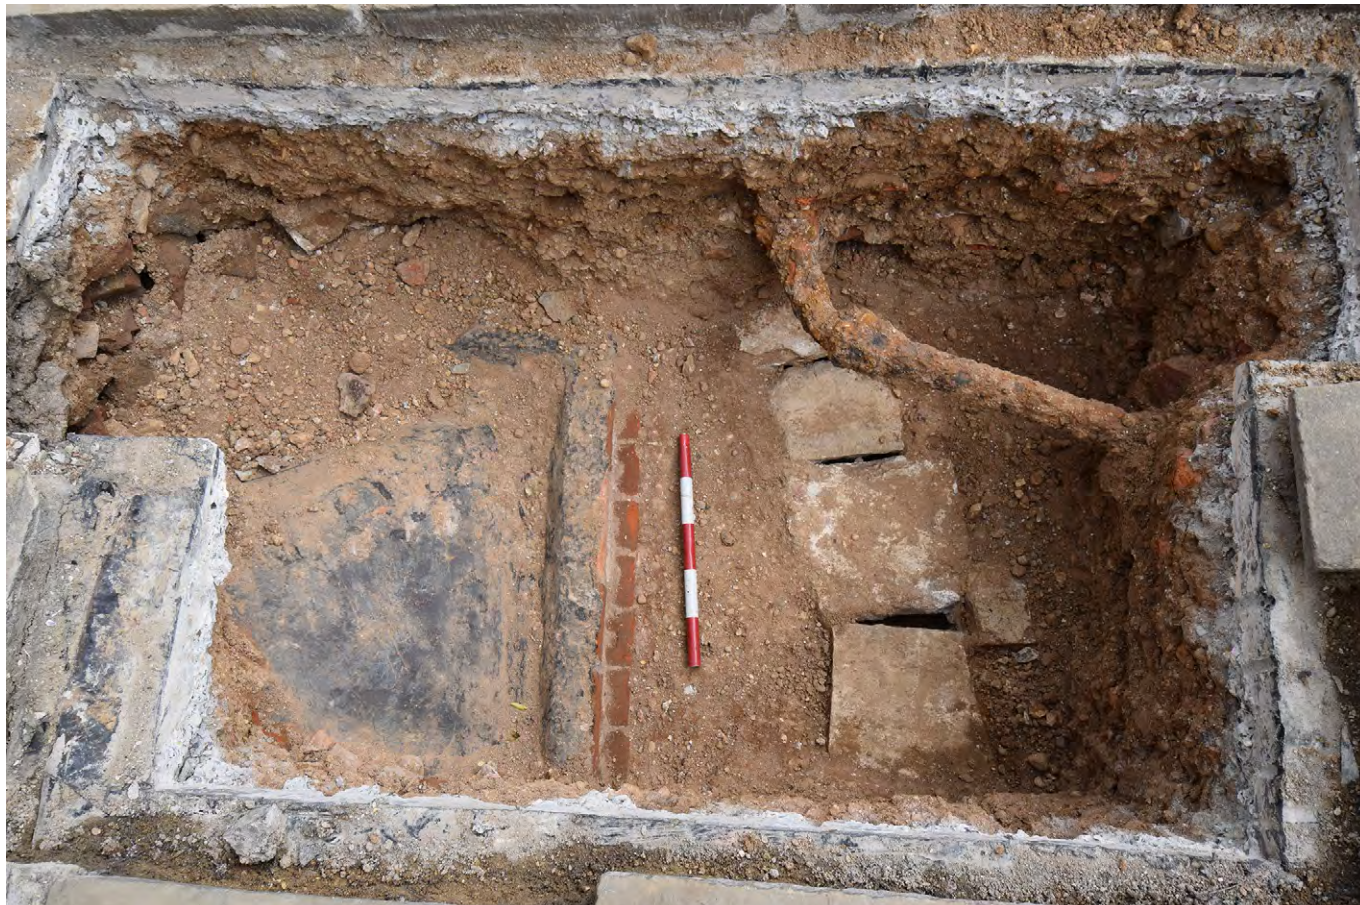
Plate F.59: Features exposed in Pit F.103 by SE corner of mansion, looking west, showing drain [F2.25]

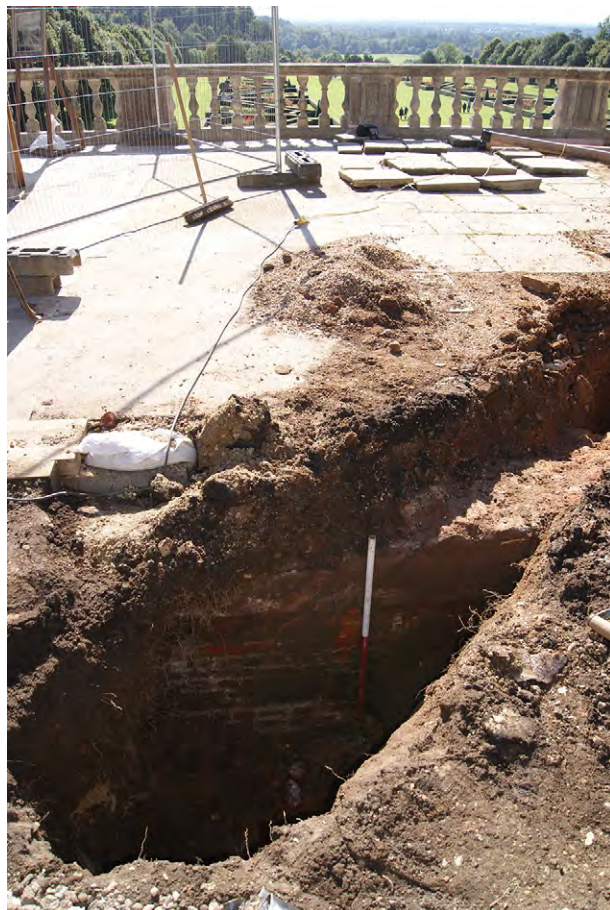
Plate F.62: Former north wall of terrace [F.106.1] exposed in pit just to SE of mansion, looking south

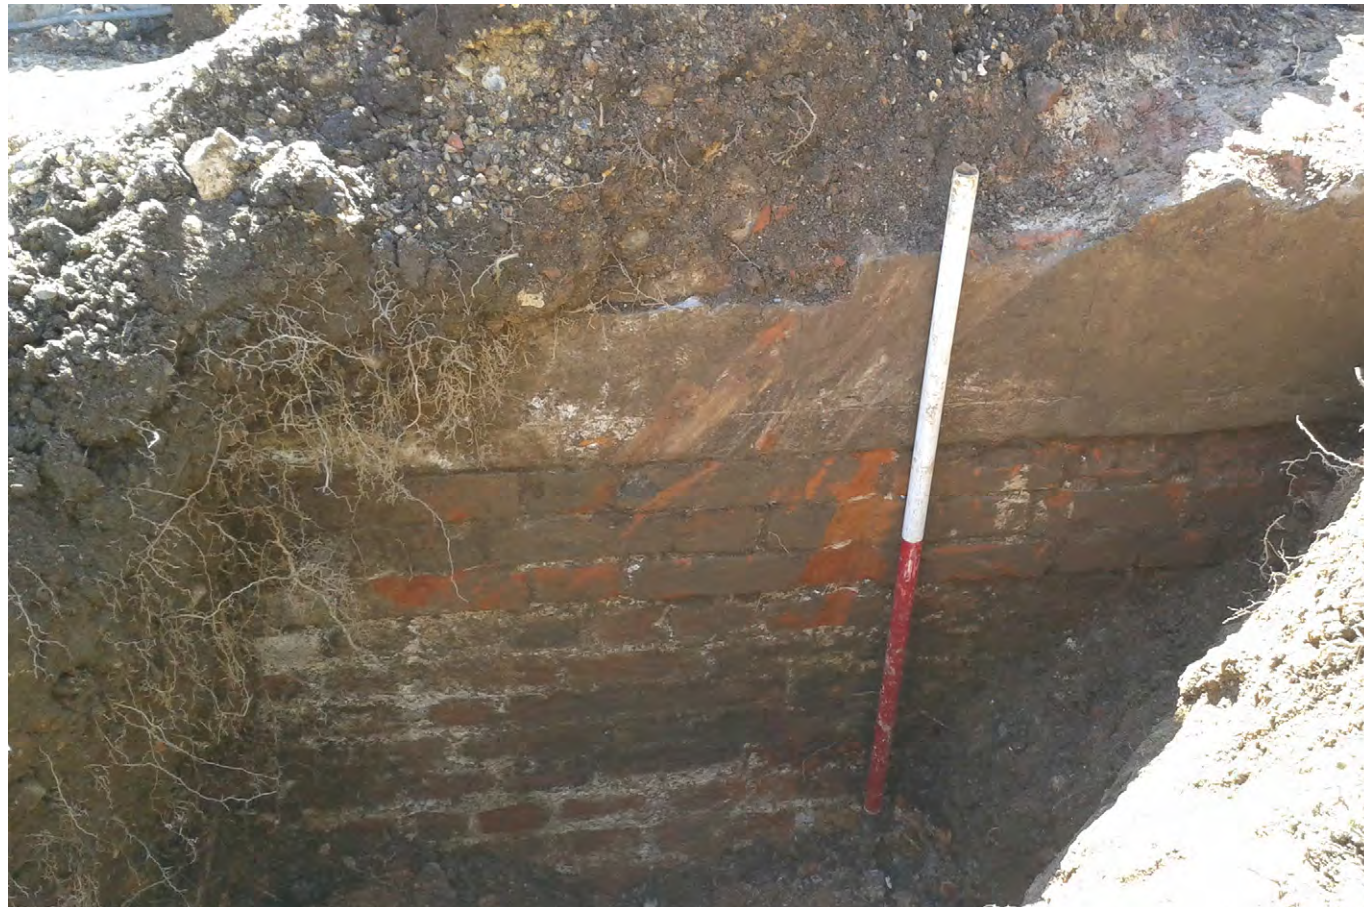
Plate F.63: North wall of terrace [F.106.1] exposed in pit just to SE of mansion, looking south

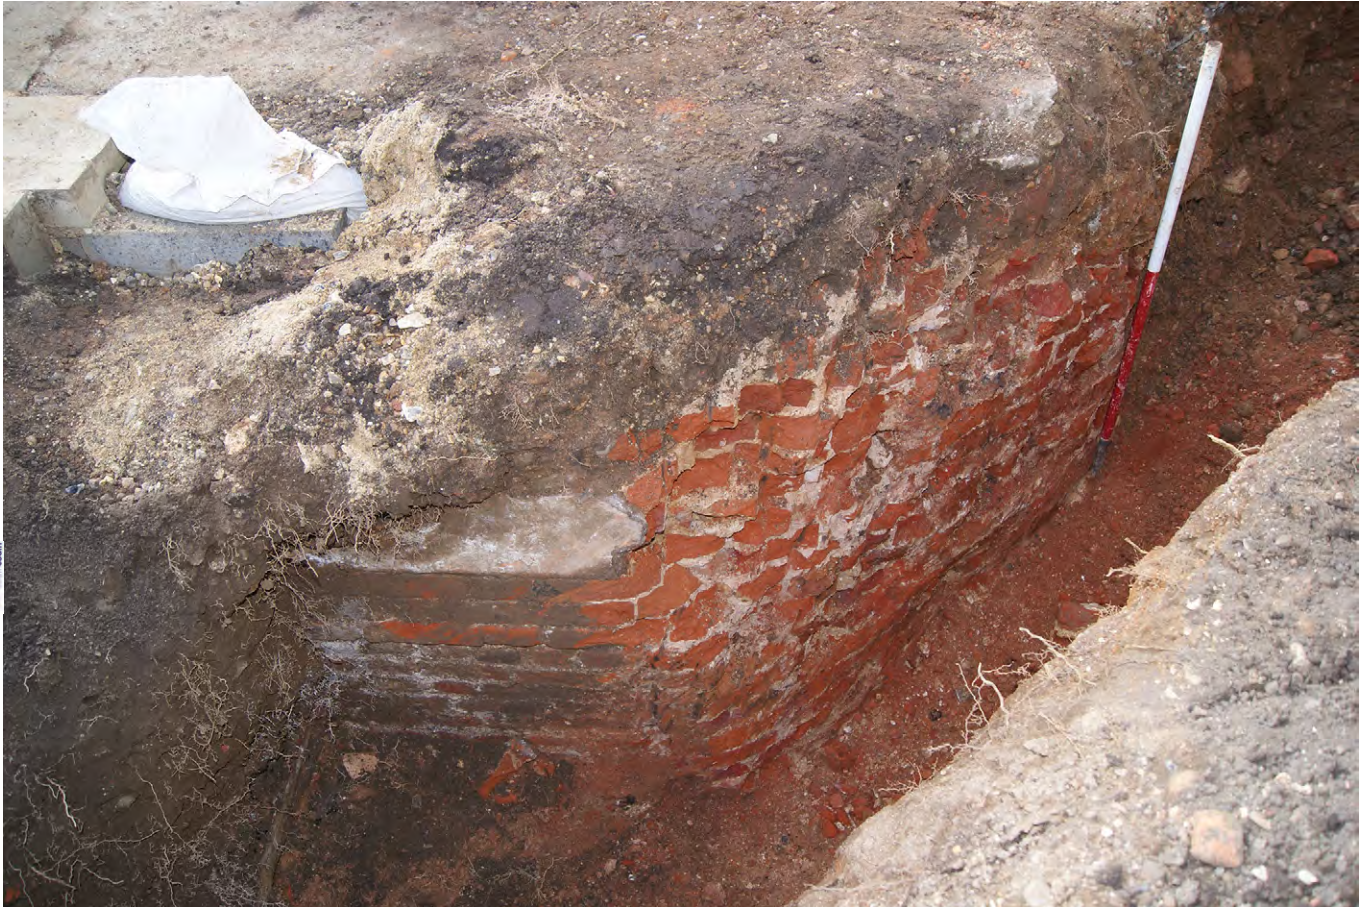
Plate F.64: North wall of terrace [F.106.1] exposed in pit to SE of mansion, looking south

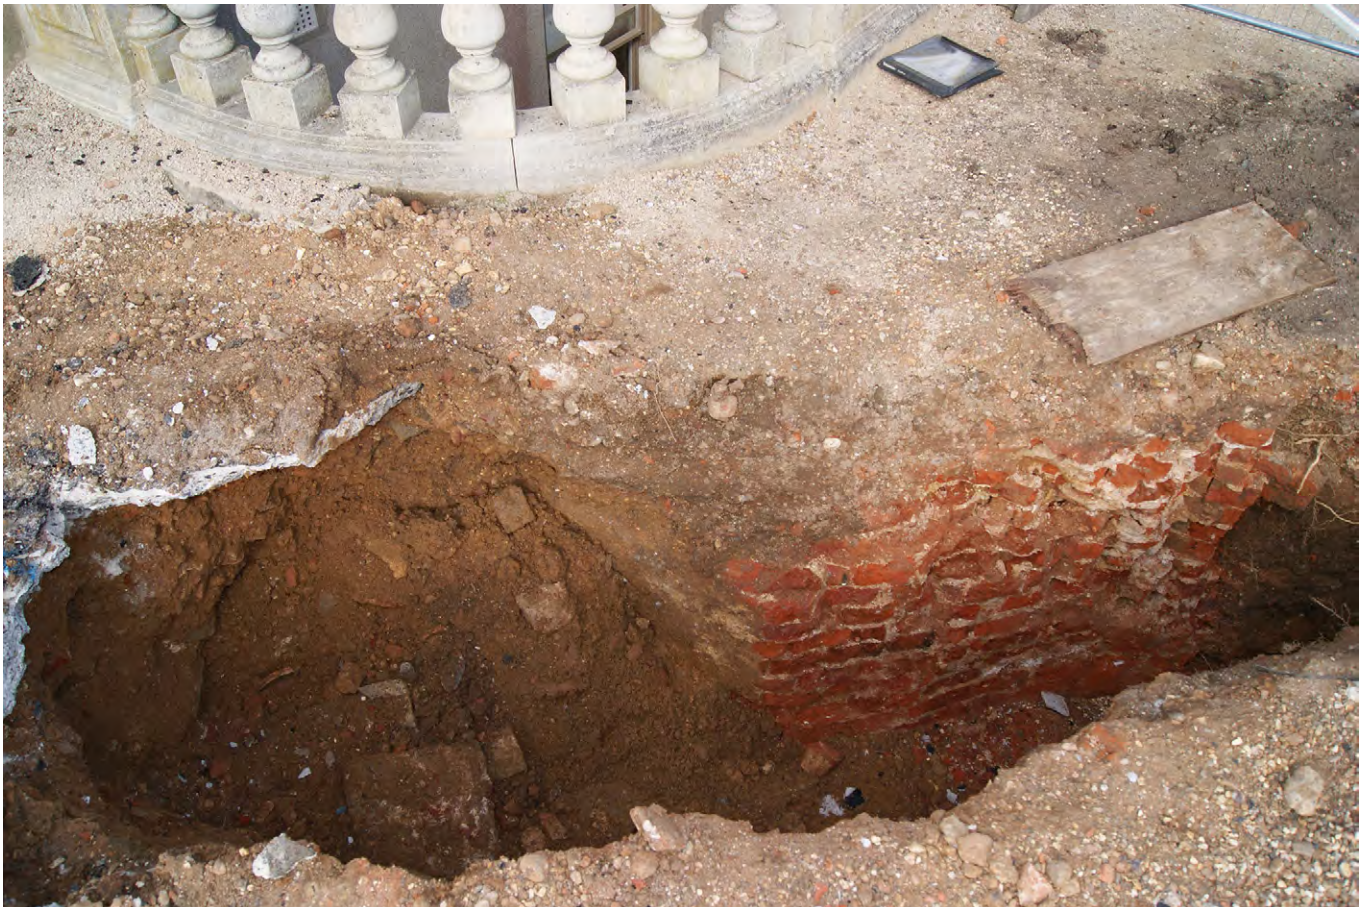
Plate F.65: Former north wall of terrace [F.106.1] to SE of mansion looking NW

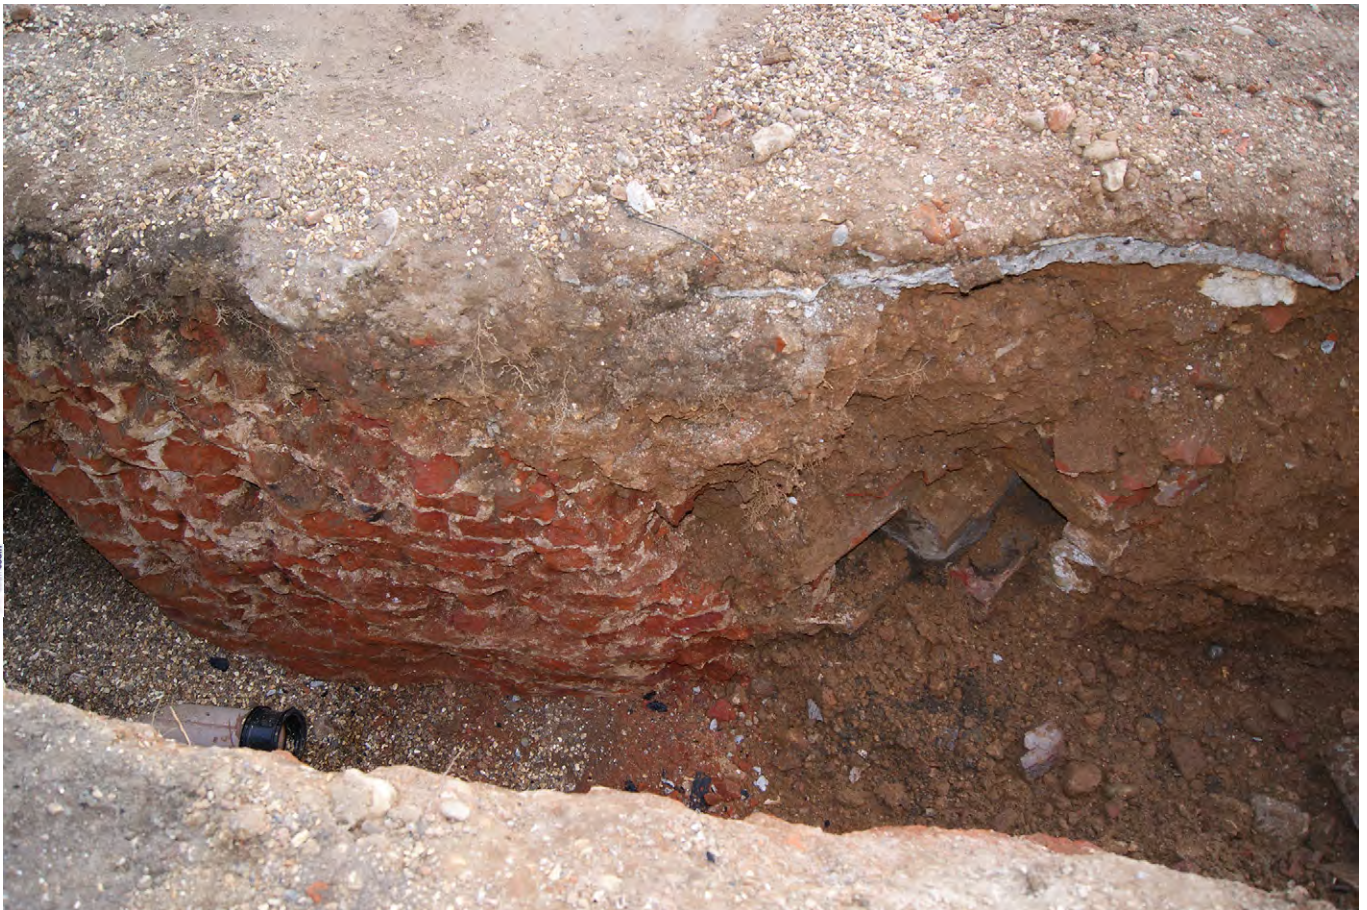
Plate F.66: Former north wall of terrace [F.106.1] and drainage channels, looking SE
