The South Terrace, Cliveden

Archaeological Investigations 2013-17

May 2018

Client Name: The National Trust
Client Ref No.: n/a
Document Title: The South Terrace, Cliveden
Document Type: Report on Archaeological Investigations 2013-17

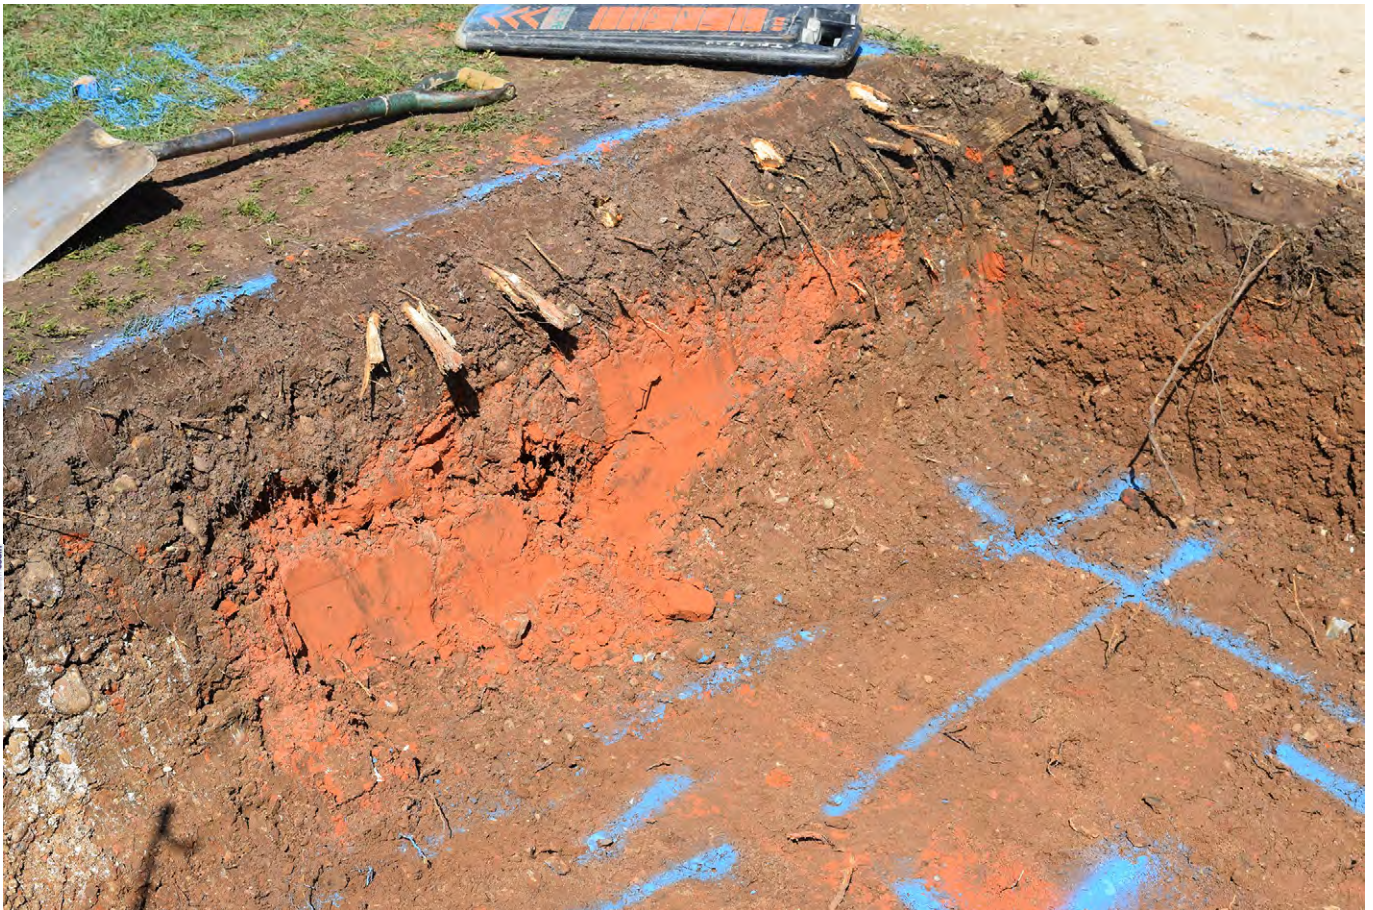
Plate G.1: Patch of brick dust [G.100.2] found at west end of main trunk drainage trench [G.100], looking north-west

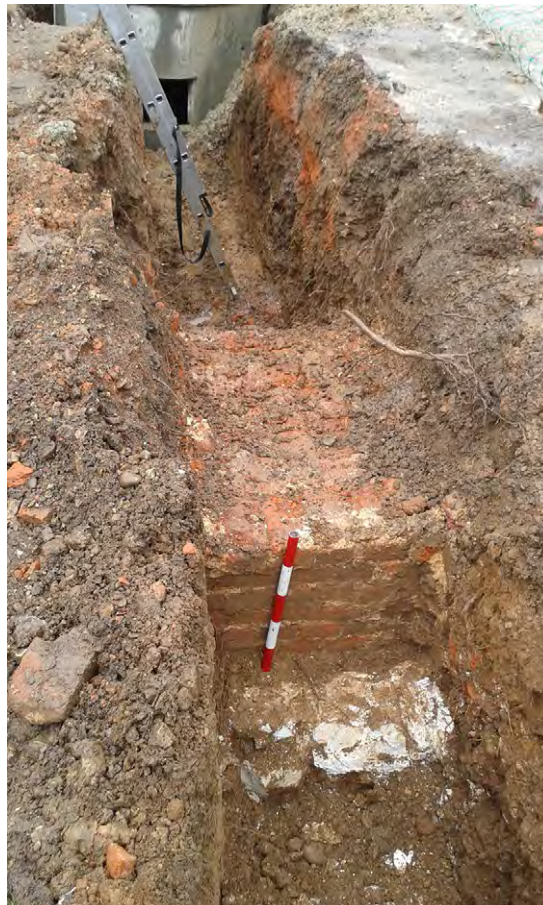
Plate G.2: Wall [G.100.5] found towards west end of main trunk drainage trench [G.100], looking west

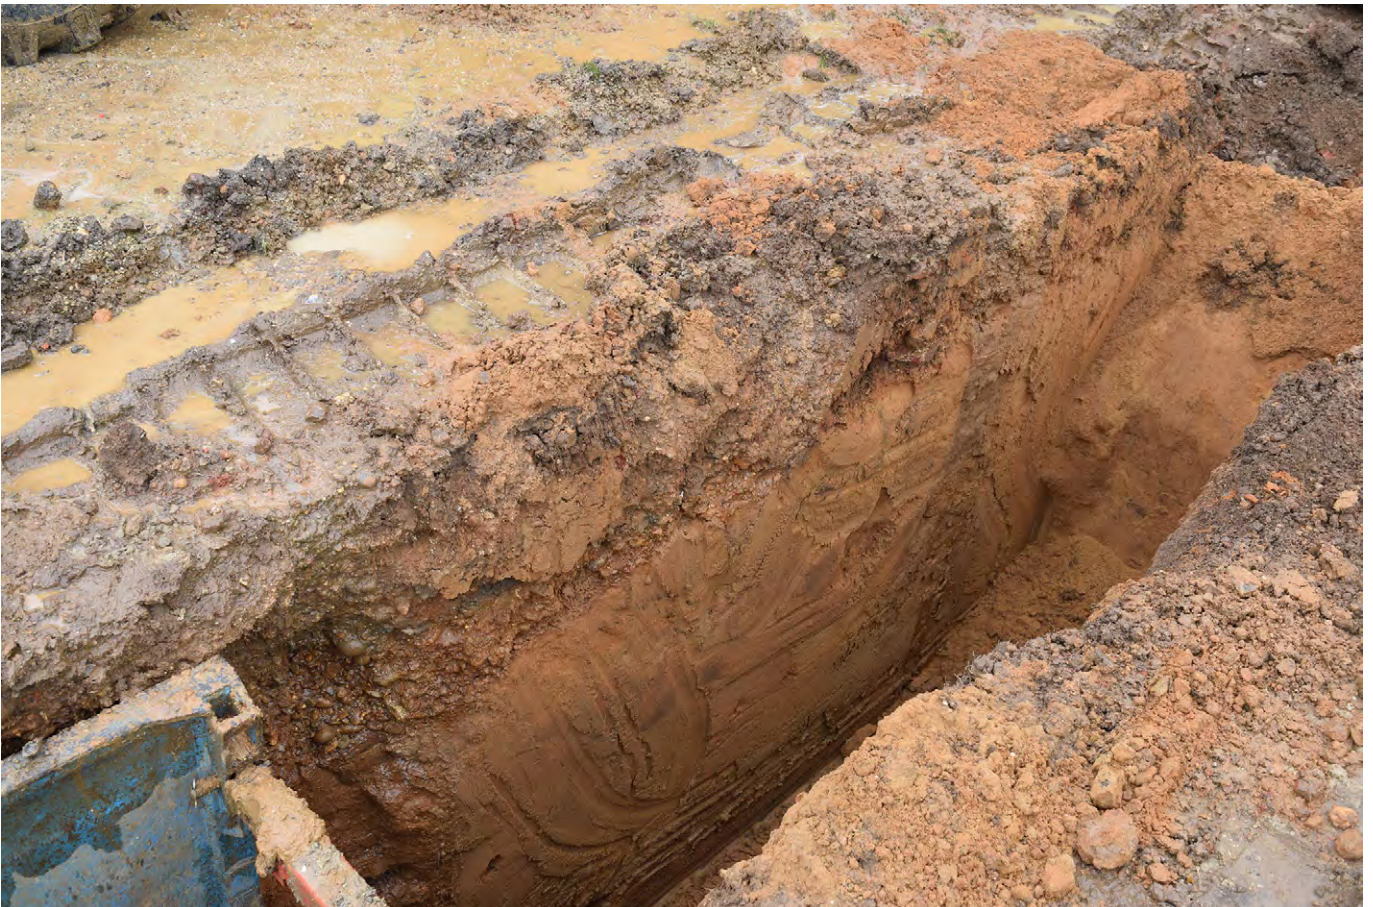
Plate G.4: Large area of pure sand in main trench [G.100] in front of East Fernery Water Tank, looking north-east

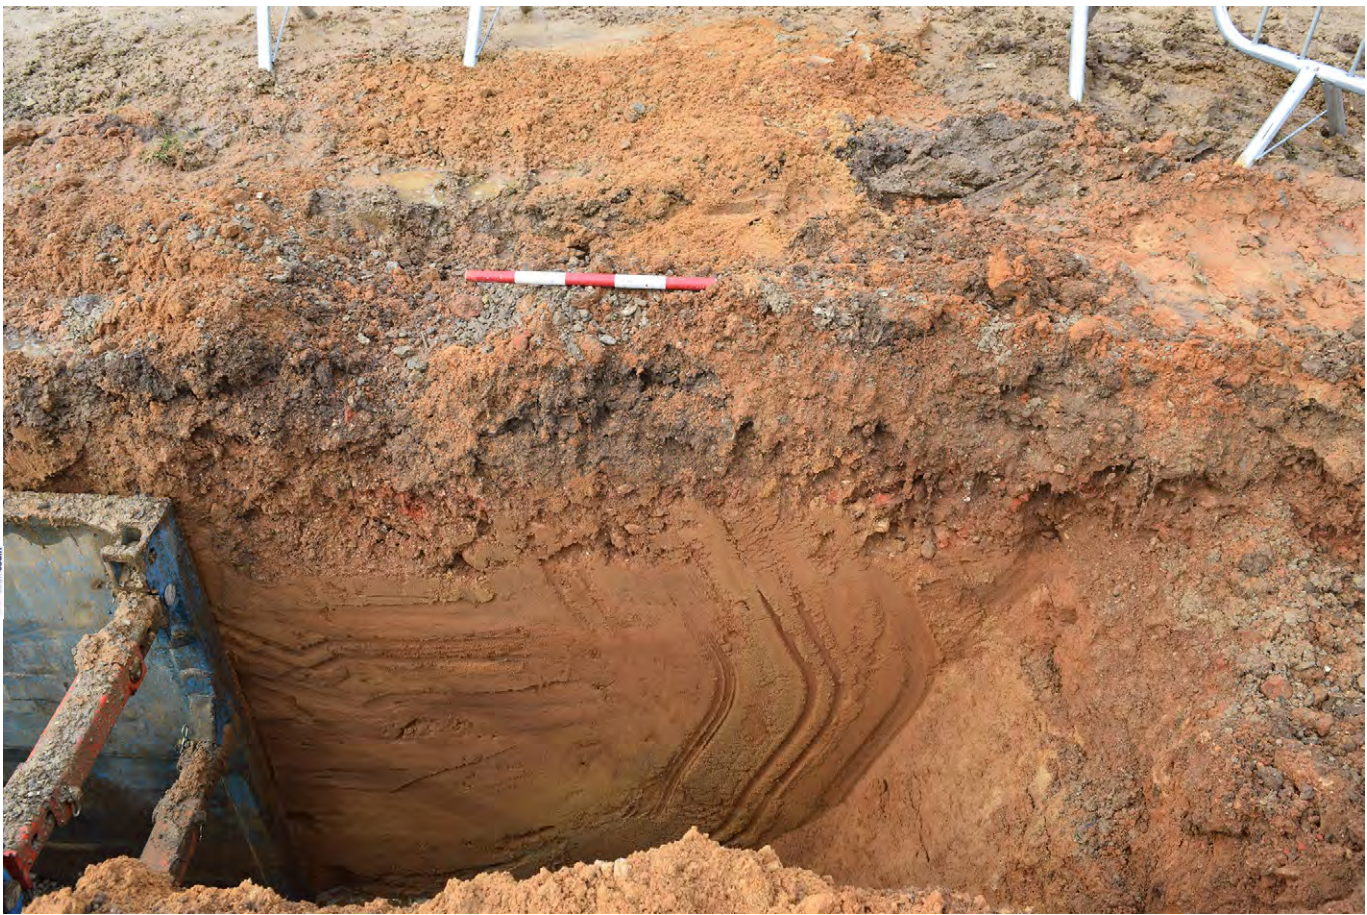
Plate G.5: Large area of pure sand in main trench [G.100] in front of East Fernery Water Tank, looking north
