# Temple Room, Dining Room and West Corridor Stowe House, Buckinghamshire.

## Historic Building Recording

September 2022

**Client: Stowe House Preservation Trust**

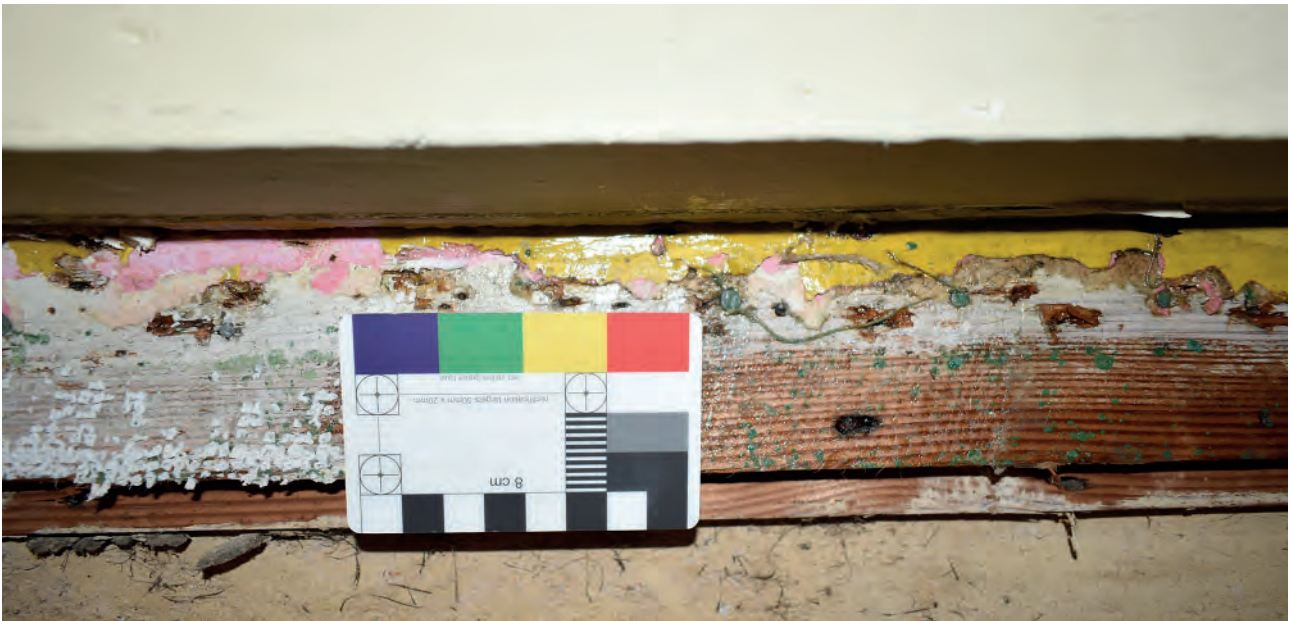
Plate 6: Temple Room, partial sequence of decorative finishes

- 3.2.2 A sequence of wall coverings more extensive than found elsewhere in the room was uncovered to the underside of the cornice above the fireplace during the work (Plate 6). The lack of context of the finishes did not allow for dating or firmly tying into the schemes uncovered by Patrick Baty or during the project. This full sequence of wall coverings comprised: timber boards over the frame attached to the brickwork, off-white paint, pink wallpaper or pink-painted wallpaper, yellow paint, [likely hessian scrim with orange damask over], dark green paint, mid-green paint, hardboard, layers of modern off-white paint.
- 3.2.3 It was judged that to replicate the orange damask was not hardy enough for the modern function of the room as a dining and function room, and so the pattern was recreated in a durable wallpaper (Plates 7-9).

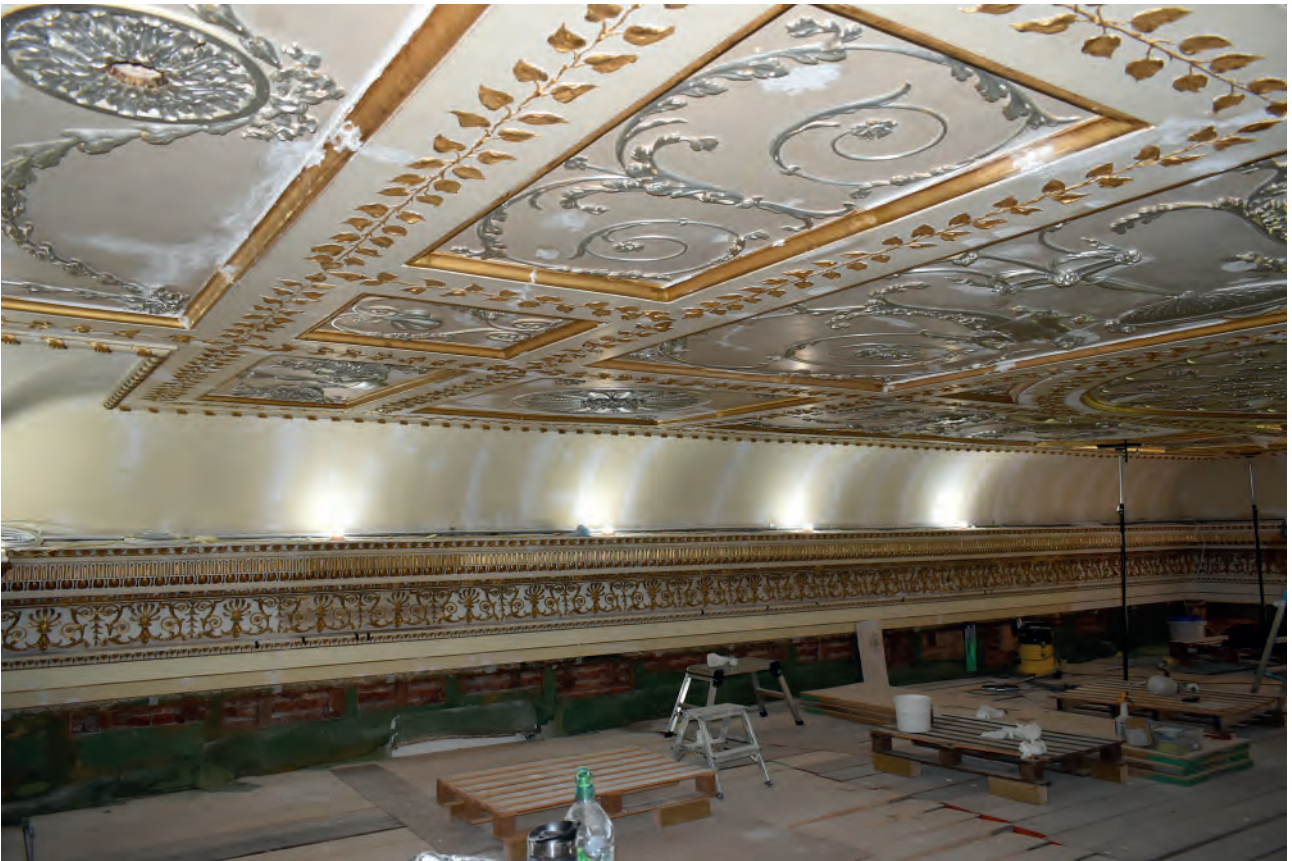
Plate 10: Temple Room, ceiling, during conservation work

- 3.3.1 The cracks above the cornice to the east were c450 - 470mm apart, corresponding with the joists above, these are less severe to the west side, although still evident (Plate 10).

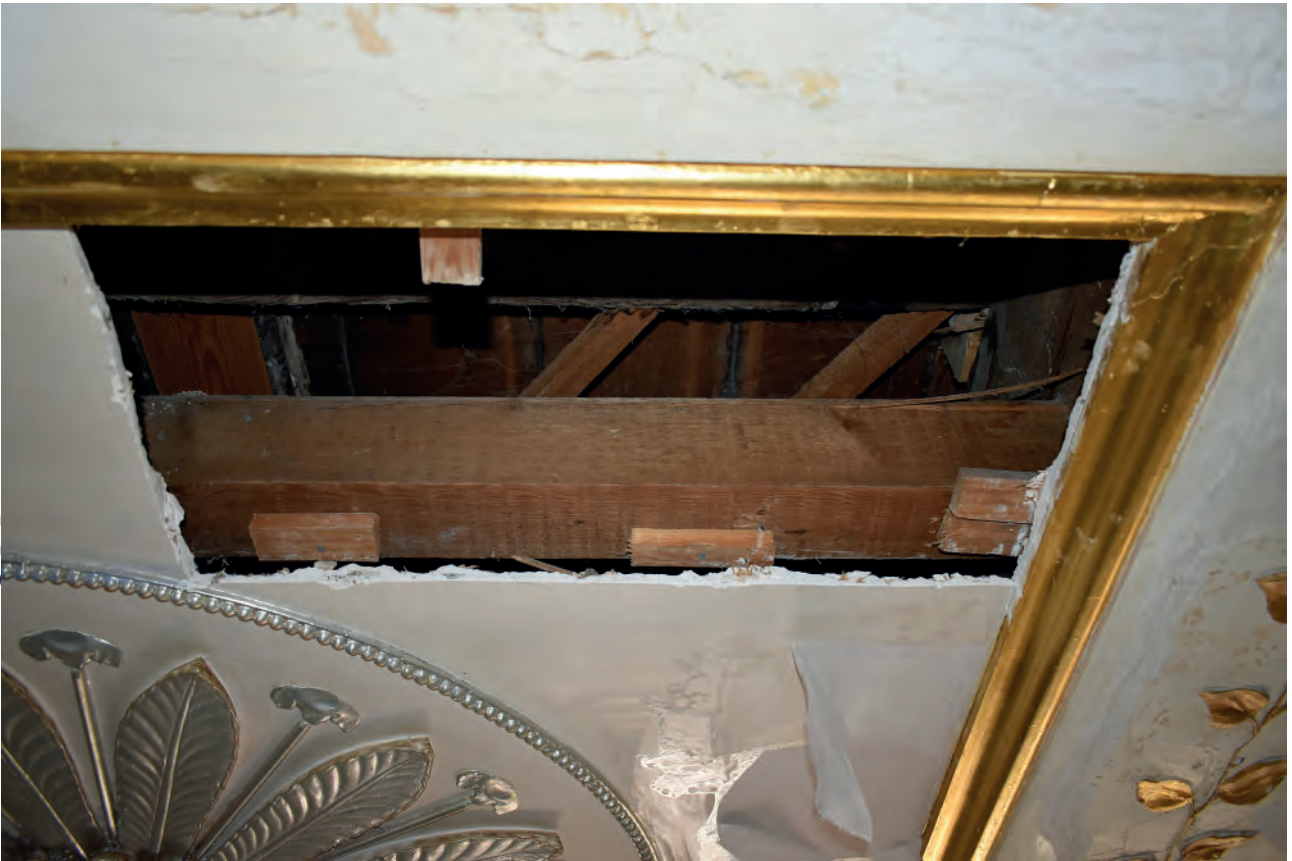
Plate 11: Temple Room, ceiling, 1965 panel towards the south east

- 3.3.3 A hole measuring 290 x 600mm, was cut into the decorated panel at the east of the ceiling which dates to 1965 and was replaced due to water damage from the bathrooms above, presumably prompting the 1965 phase of work (Plate 11). This replacement panel was mounted on modern battens of 34 x 14mm in section and made from very fine gypsum plaster on hessian on modern laths. The panel is approximately 10mm thick and pre-formed before installation. Visible above the hole are two ceiling joists which are 103 x 76mm in section, and a joist for the floor above, which is staggered from the ceiling joists below (Plate 12). A beam, presumably a secondary beam judging by the size (300mm deep, no other dimensions were visible), runs north to south, in line with the applied decorative beam. Also visible is reed pugging on diagonal braces (26 x 30mm but variable), for the floor above, as per that of the floor of the Temple Room.

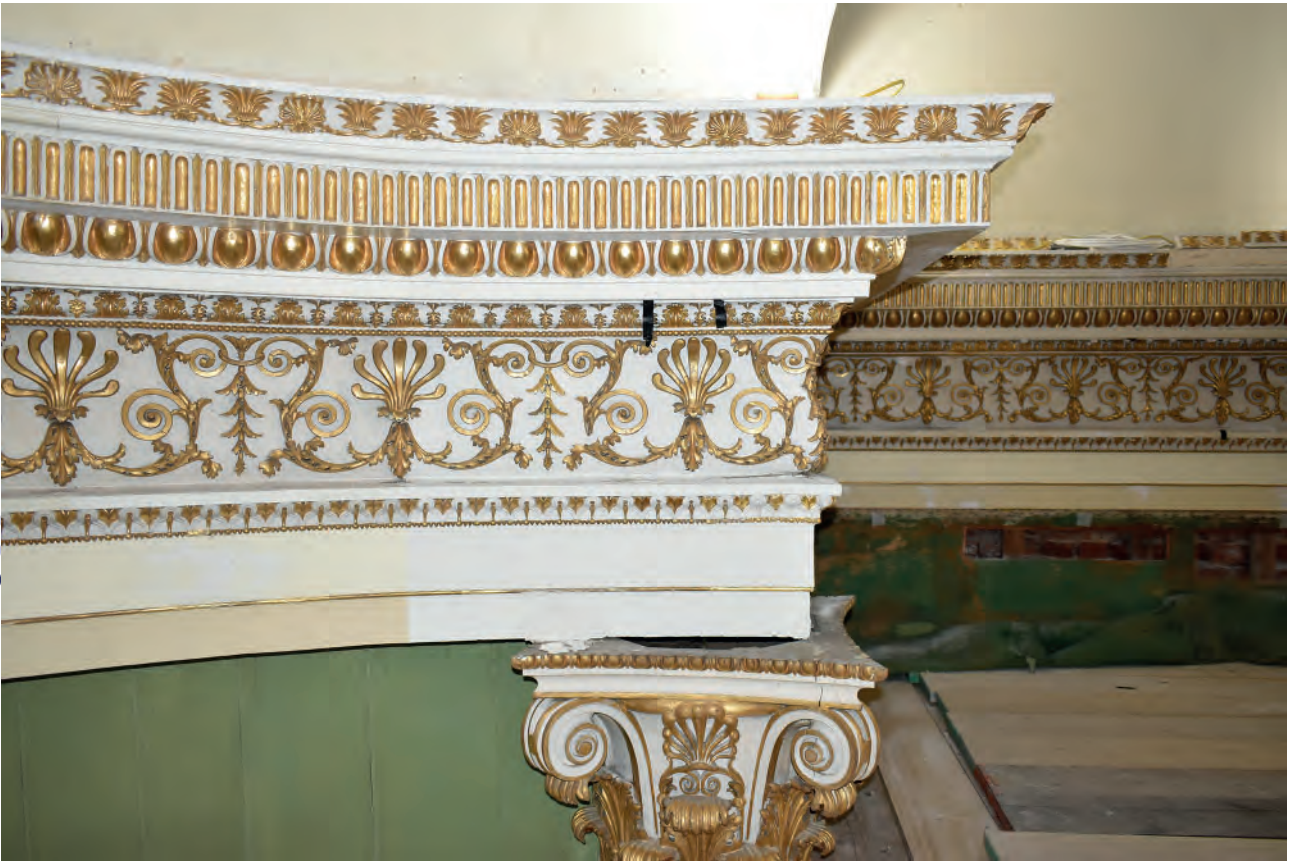
Plate 15: Temple Room, cornice, example of cleaning

- 3.3.4 Cracks and flaking of finishes were observed generally due to movement of the building, humidity and water ingress from the bathrooms above (Plates 13 & 14). General cleaning of surfaces was also required where repairs were not necessary (Plate 15).

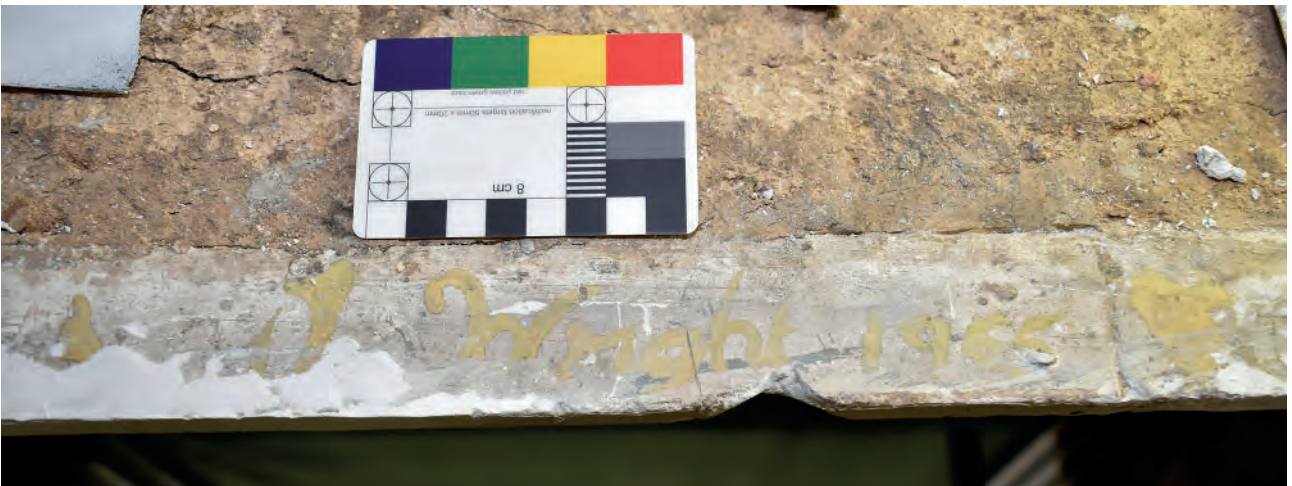
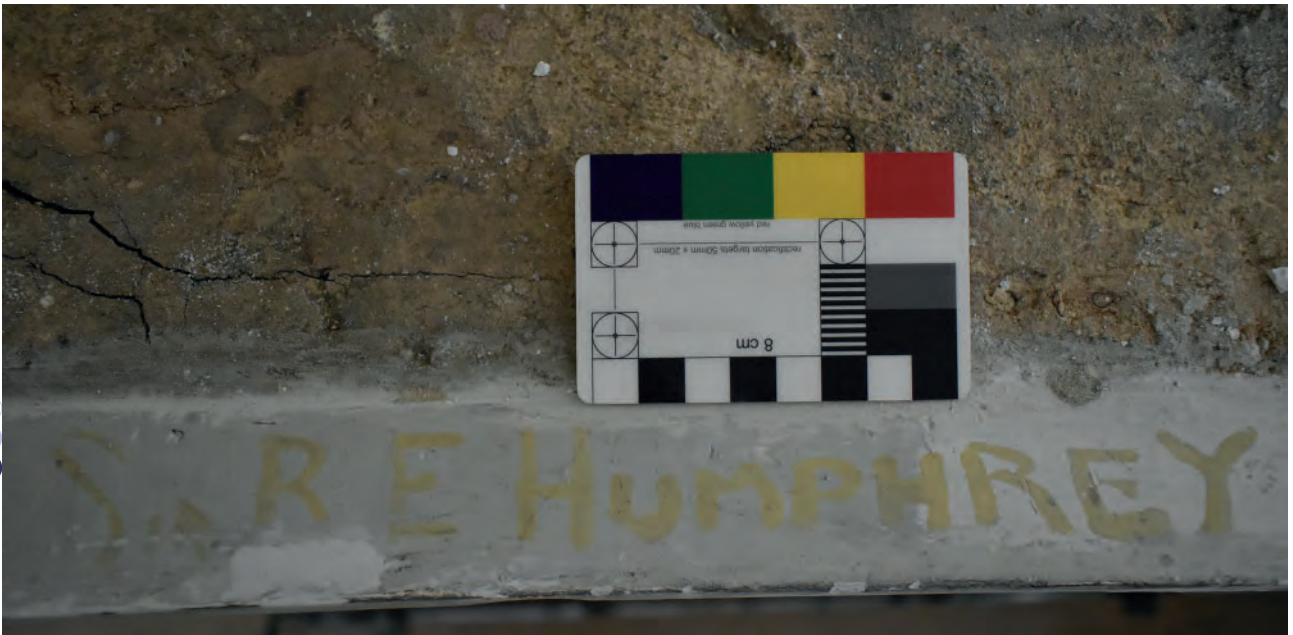
- 3.3.5 Graffiti was found to the cornice to the east of the alcove, dated to the 1965 phase. Scored in plaster were the names: [?] McCann 1965, J. Wright and what appears to be G Cameron. J. Wright had also signed his name in the gold paint used instead of gilding in 1965, as had someone signing their name as Sir R. E. Humphrey (Plates 16 & 17).

Plate 16: Temple Room, cornice, example of graffiti

Plate 17: Temple Room, cornice, example of graffiti

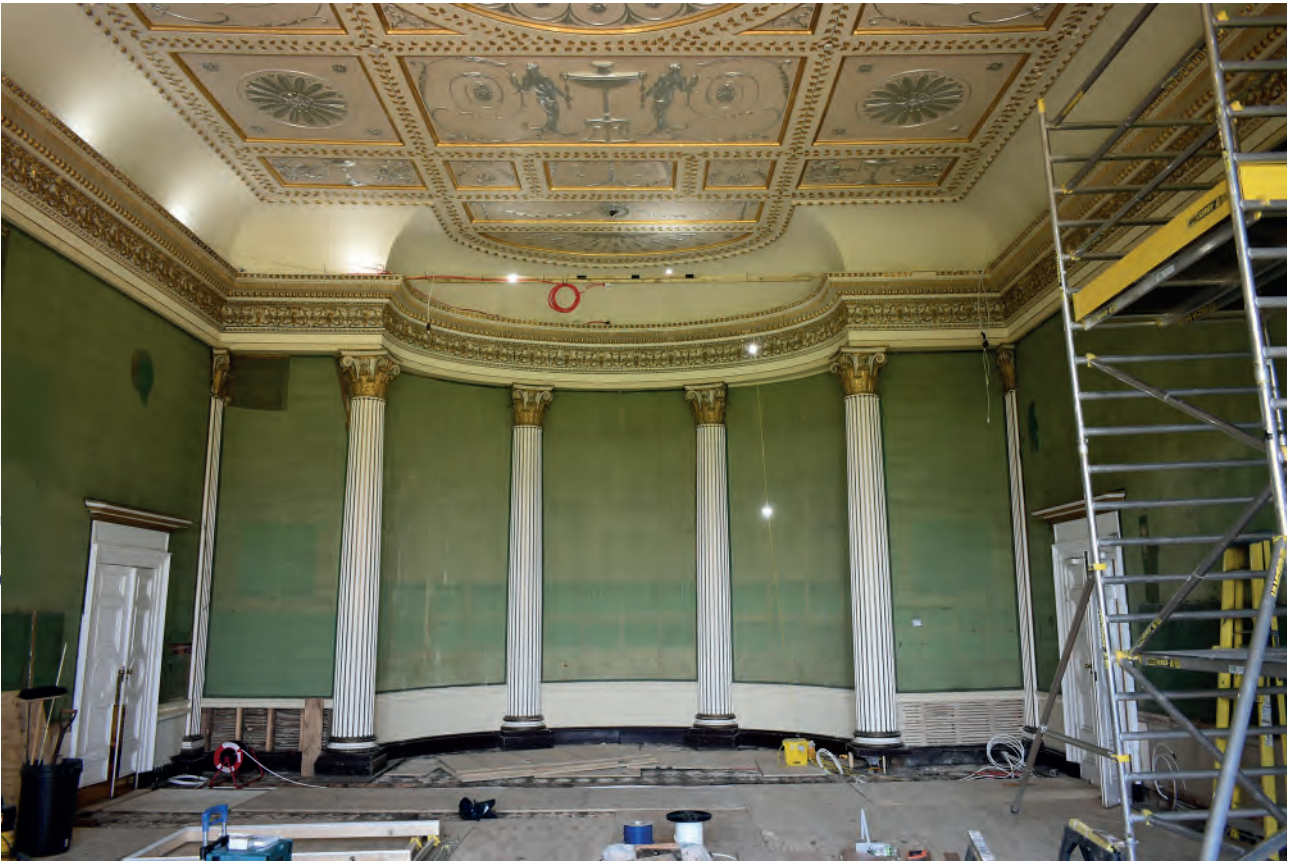
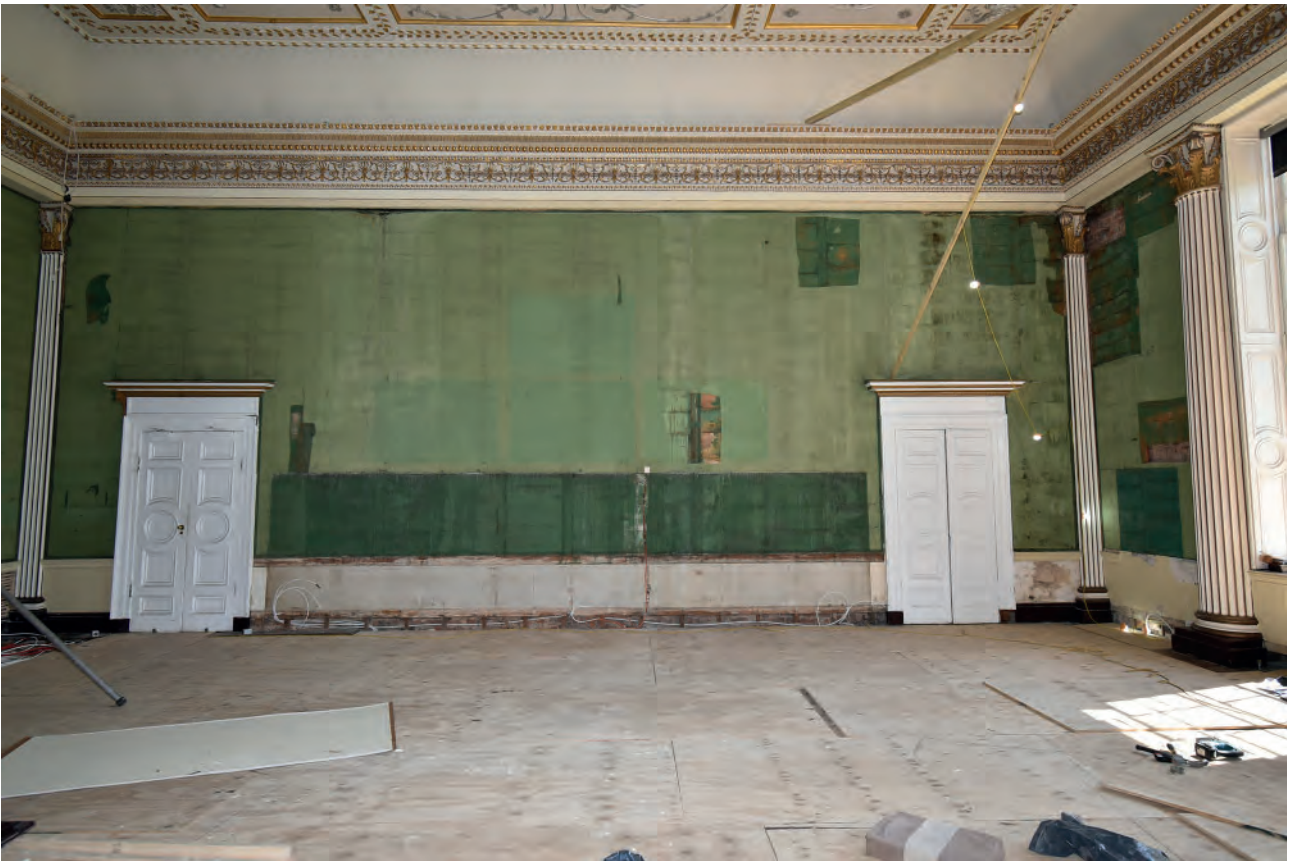
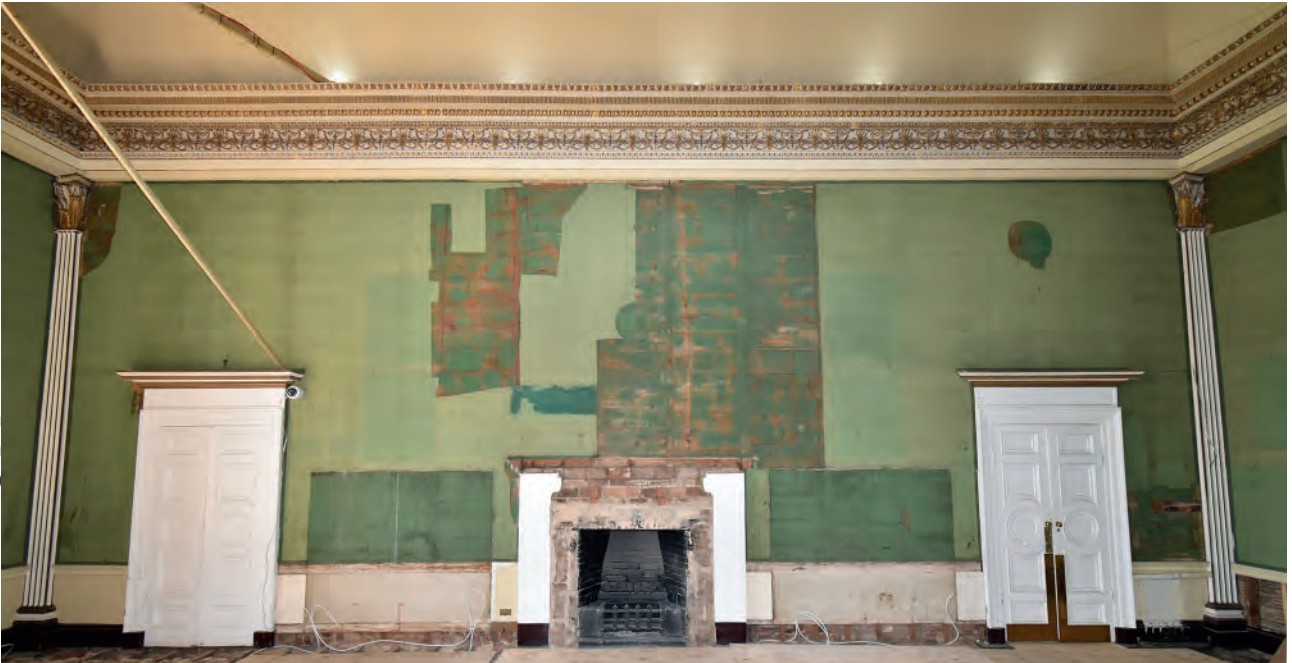
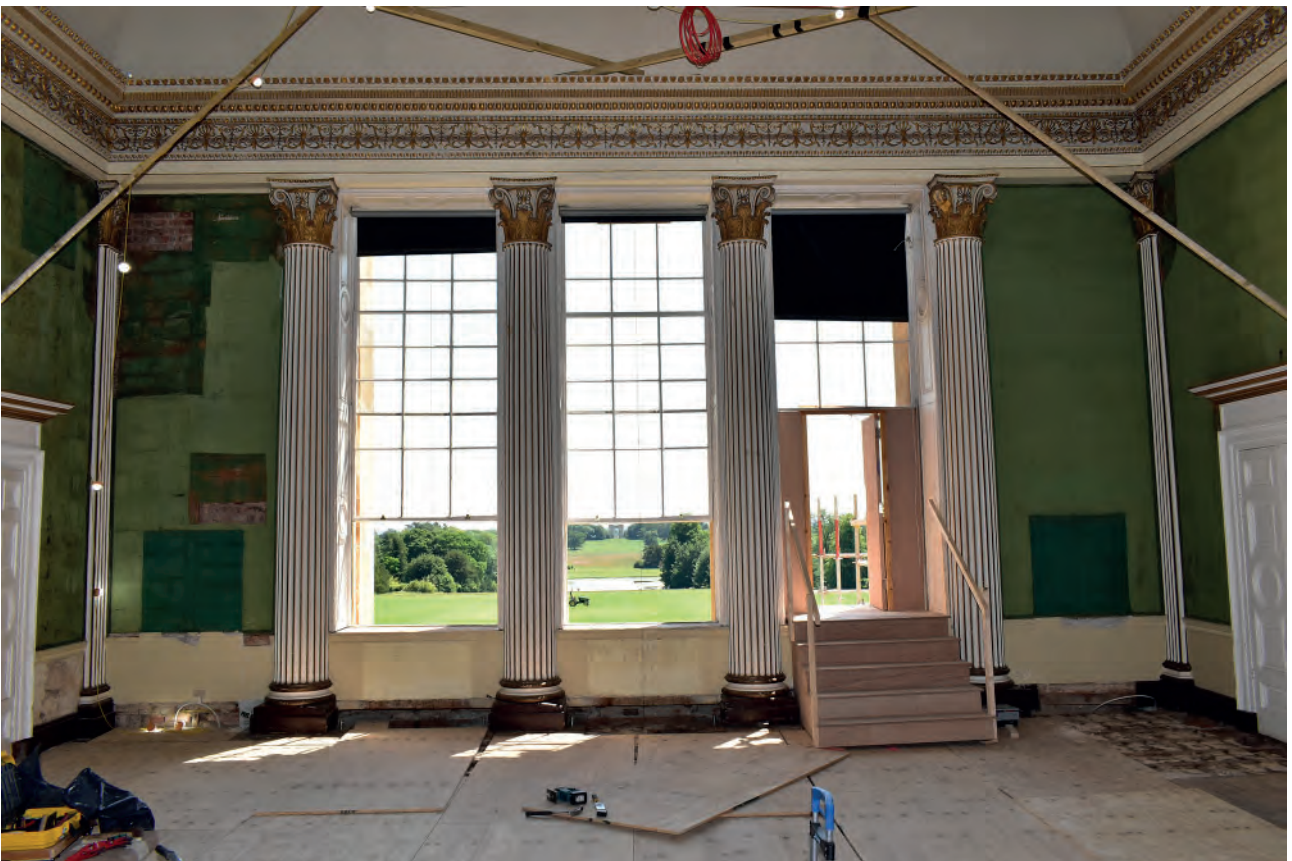
- 3.4.1 The hardboard was stripped from the walls, revealing that it had been fixed over green-painted hessian scrim over wooden boards (Plates 19-22). The timber boards were tongue and groove, 15mm thick with variable widths up to 336mm as observed (Plate 23).
- 3.4.2 The brickwork was exposed in places, particularly to the top of the walls beneath the level of the cornice to assess the suitability for fixing the new picture rail. In the apse, an iron hook remained beneath the cornice which had been used to hang paintings; no other early fittings were noted (Plate 24).

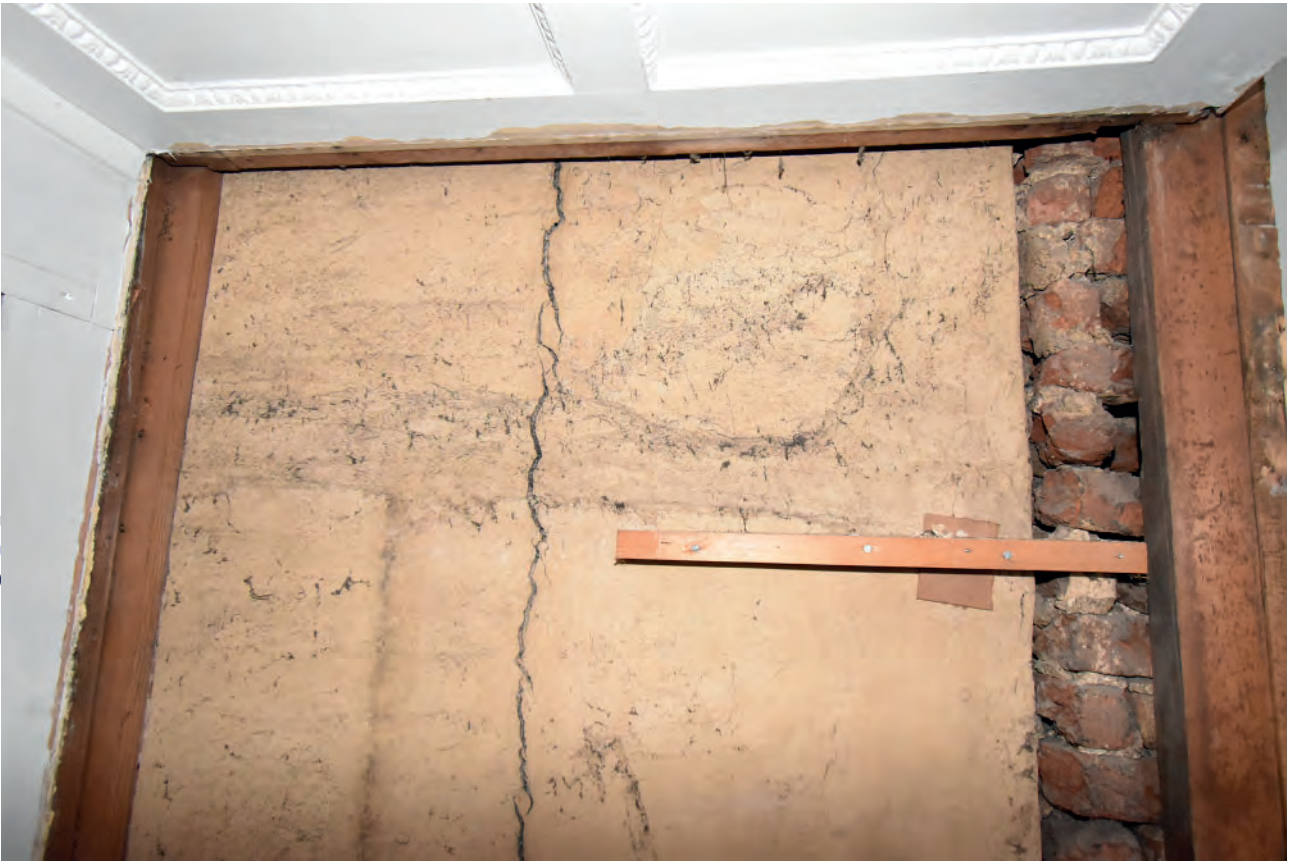
- 3.5.2 The doorway between the Temple Room and the Dining Room required repair comprising the replacement of several modern panels and the recreation of the original moulding. The panelling from the north side of the doorway included two phases of modern panels to the centre and bottom of the panelling, comprising hardboard and plywood, and had lost much of the moulding surrounding those replacements. The replacements had been carried out while the panelling was in situ (Plate 40). The panelling to the south of the doorway retained the original panels, although this had undergone repairs to splits consisting of linen strips glued to the rear of the panels (Plate 41). The walls behind the panelling are shown in plates 30 & 31.

Plate 30: Temple Room, doorway to Dining Room, south return and later brickwork

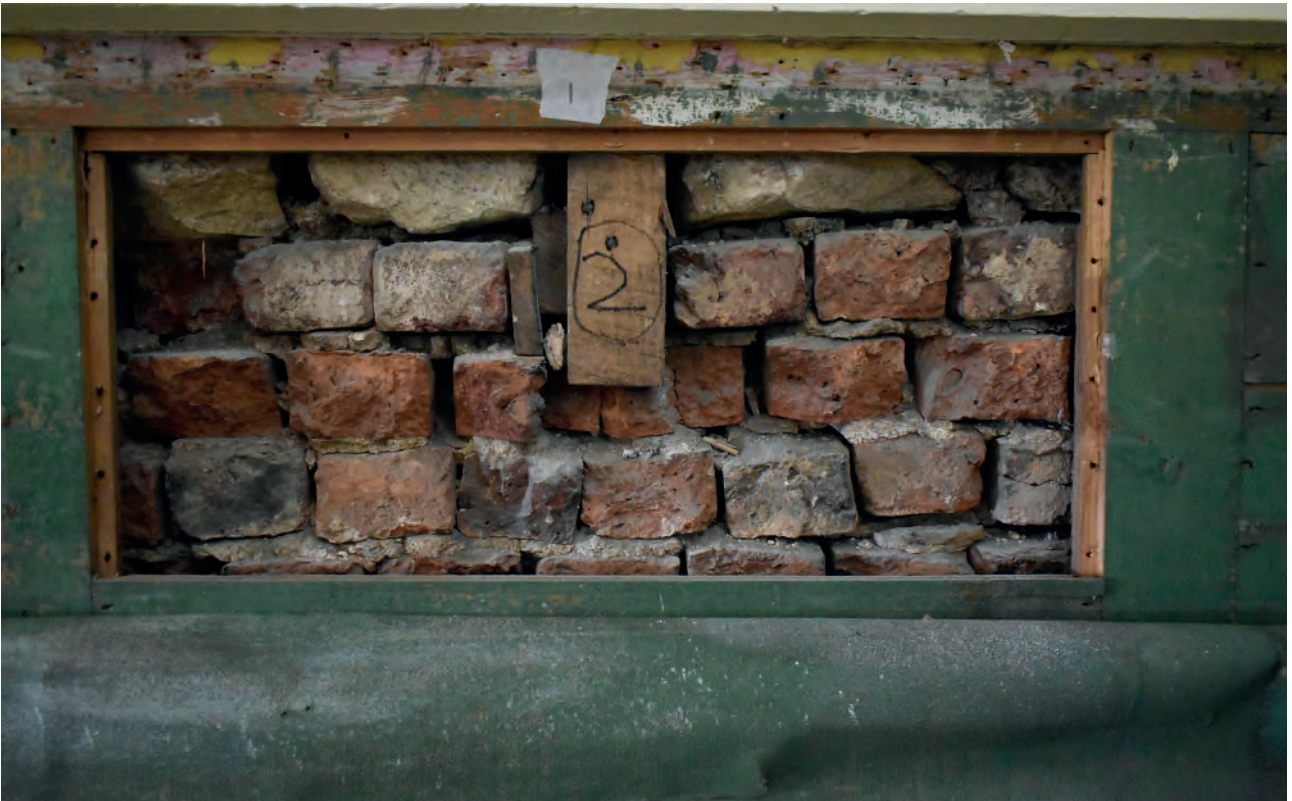
Plate 31: Temple Room, doorway to Dining Room, north return and later brickwork

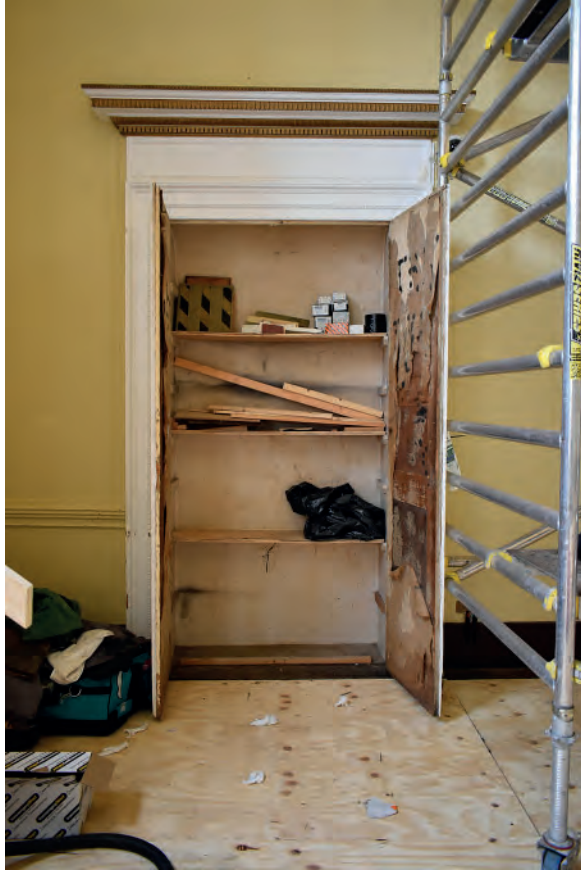
- 3.5.1 Cupboards were behind the false doorways to the south end of the west and east walls (Plates 37 & 38). They originally had hessian scrim lining over unpainted inner faces of the doors, although the scrim of the east cupboard had been removed and that in the west was in poor condition (Plate 39). The shelves of the west cupboard are modern plywood, the shelf brackets are simple and earlier but probably not original; the shelves of the east cupboard are later replacements but not as modern as the west cupboard. The interiors are finished with fine white lime plaster. All ironmongery is 20th-century and the hinges also have been rehung with later screws.

Plate 37: Temple Room, east wall, cupboard

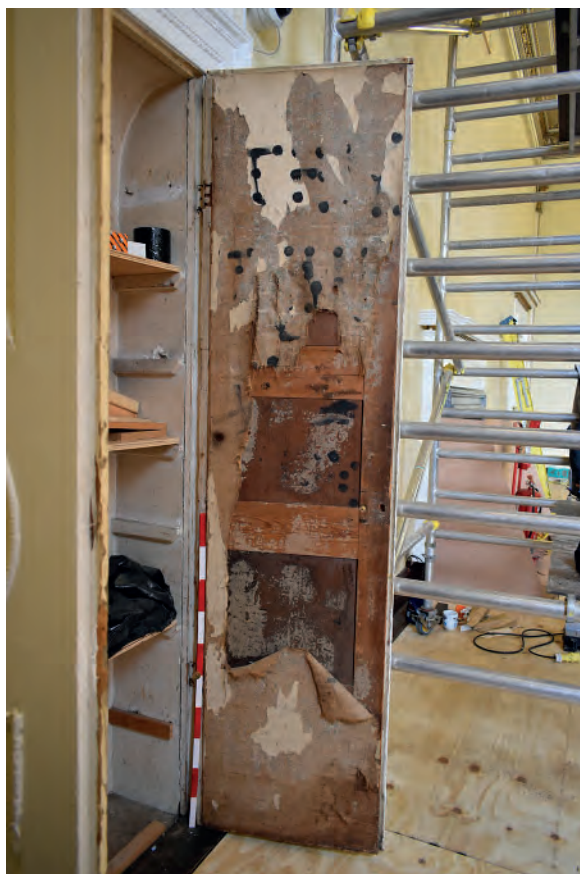
Plate 38: Temple Room, west wall, cupboard

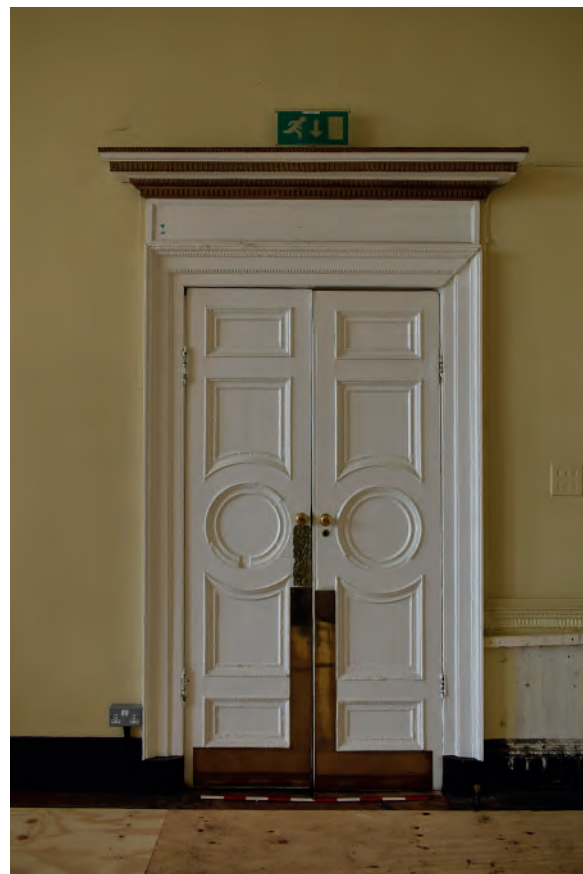
Plate 41: Temple Room, doorway to Dining Room, south panel

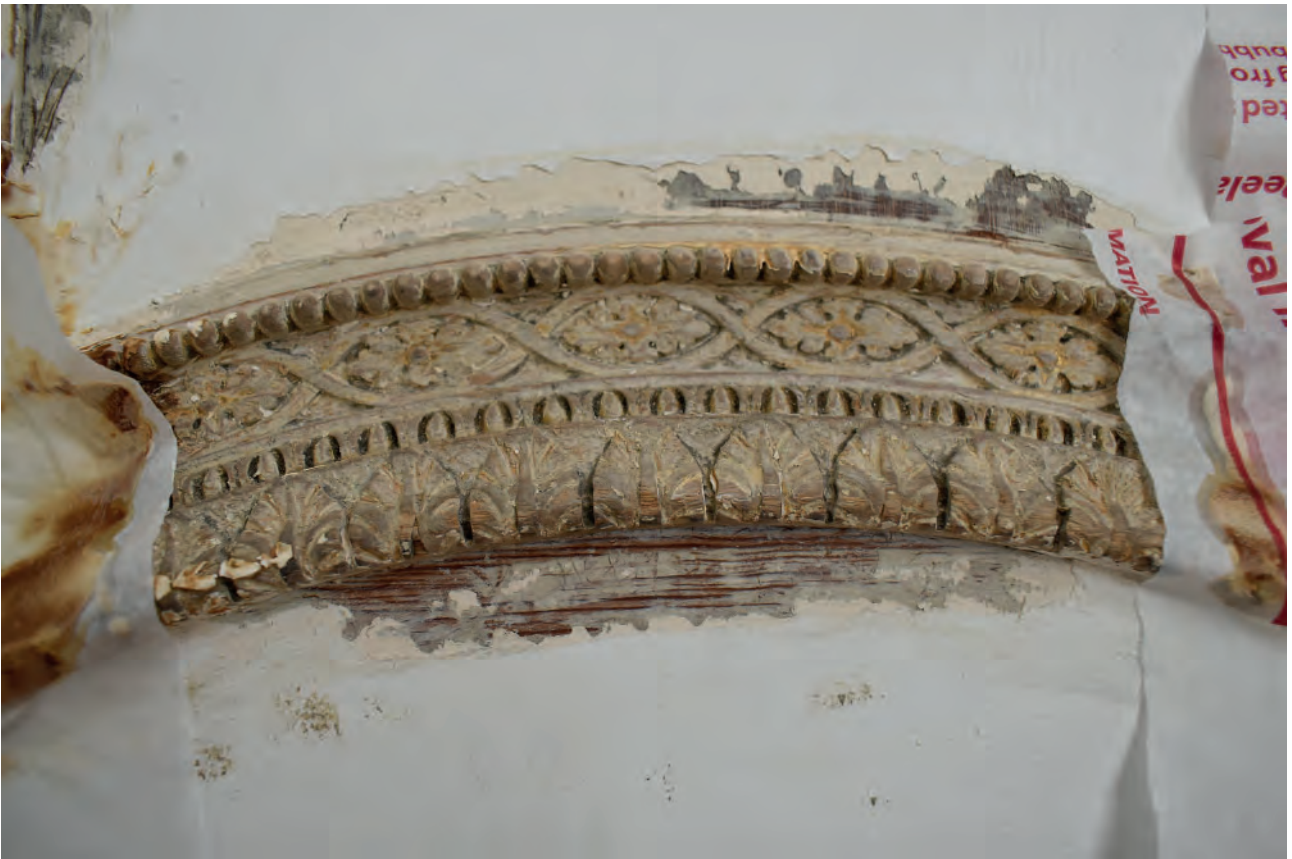
Plate 45: Temple Room, door to Dining Room, damage to moulding

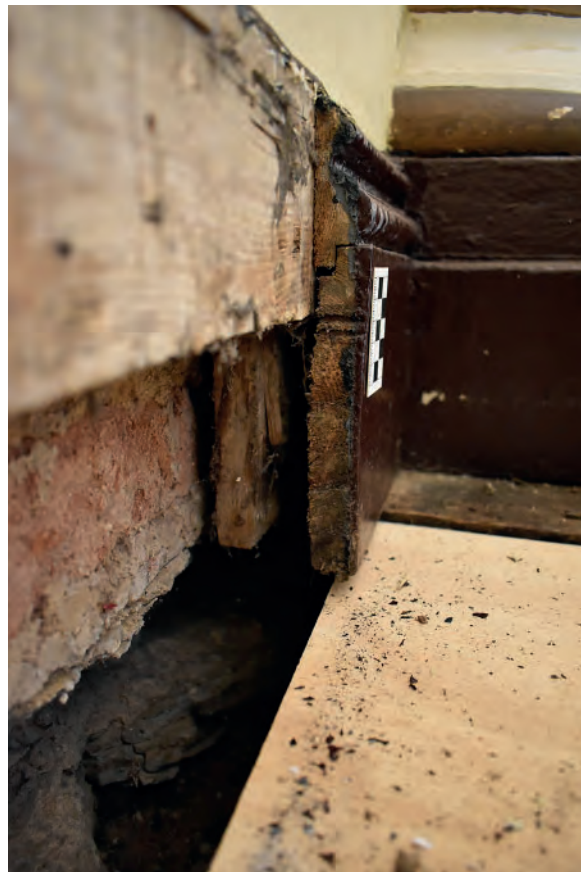
- 3.5.4 The skirting boards were formed from a plain board with a rebate to the back upon which a strip of moulded timber was added (Figure 7, section 2) (Plates 49 & 50). The chair rail had also been overpainted with modern paint and showed damage (PI 51).

Plate 49: Temple Room, example of skirting

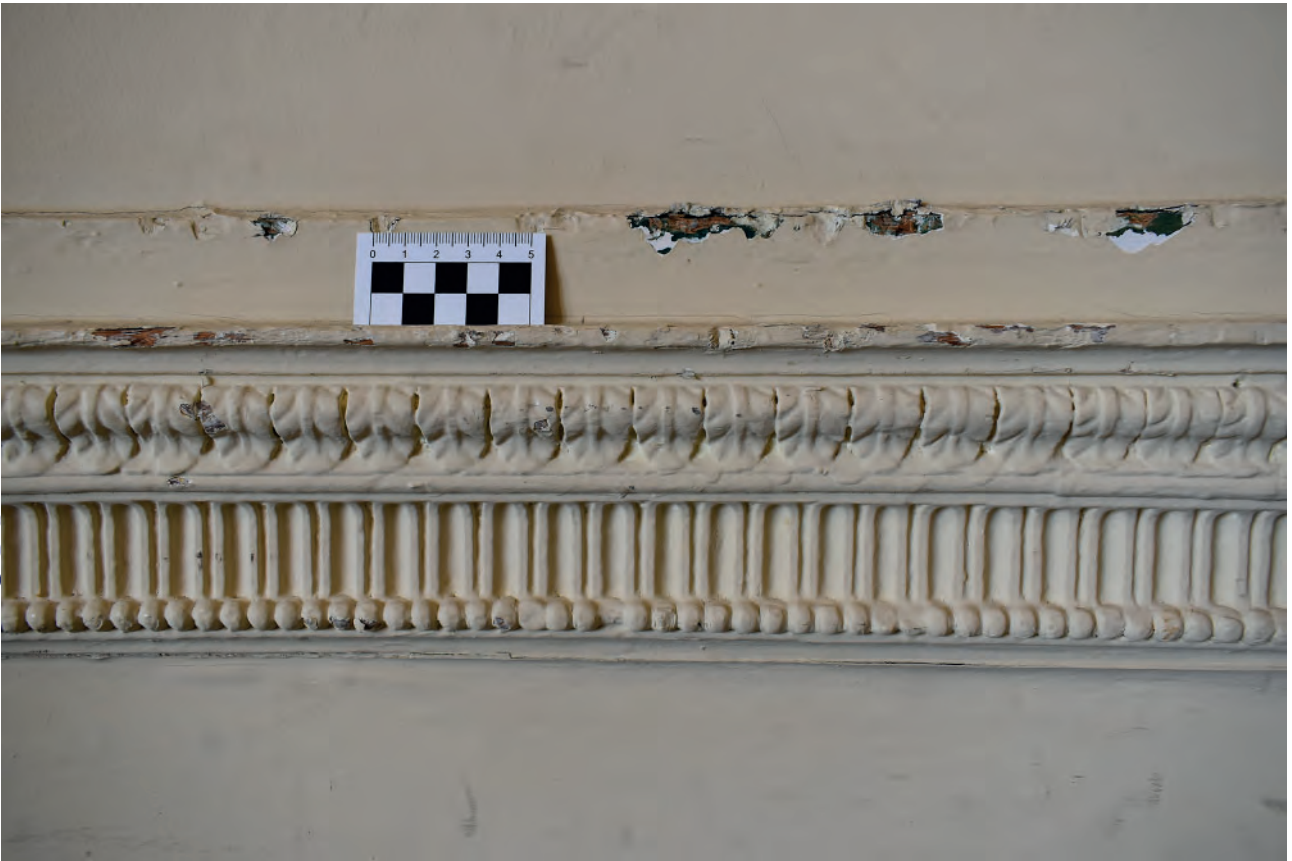
Plate 50: Temple Room, example of skirting

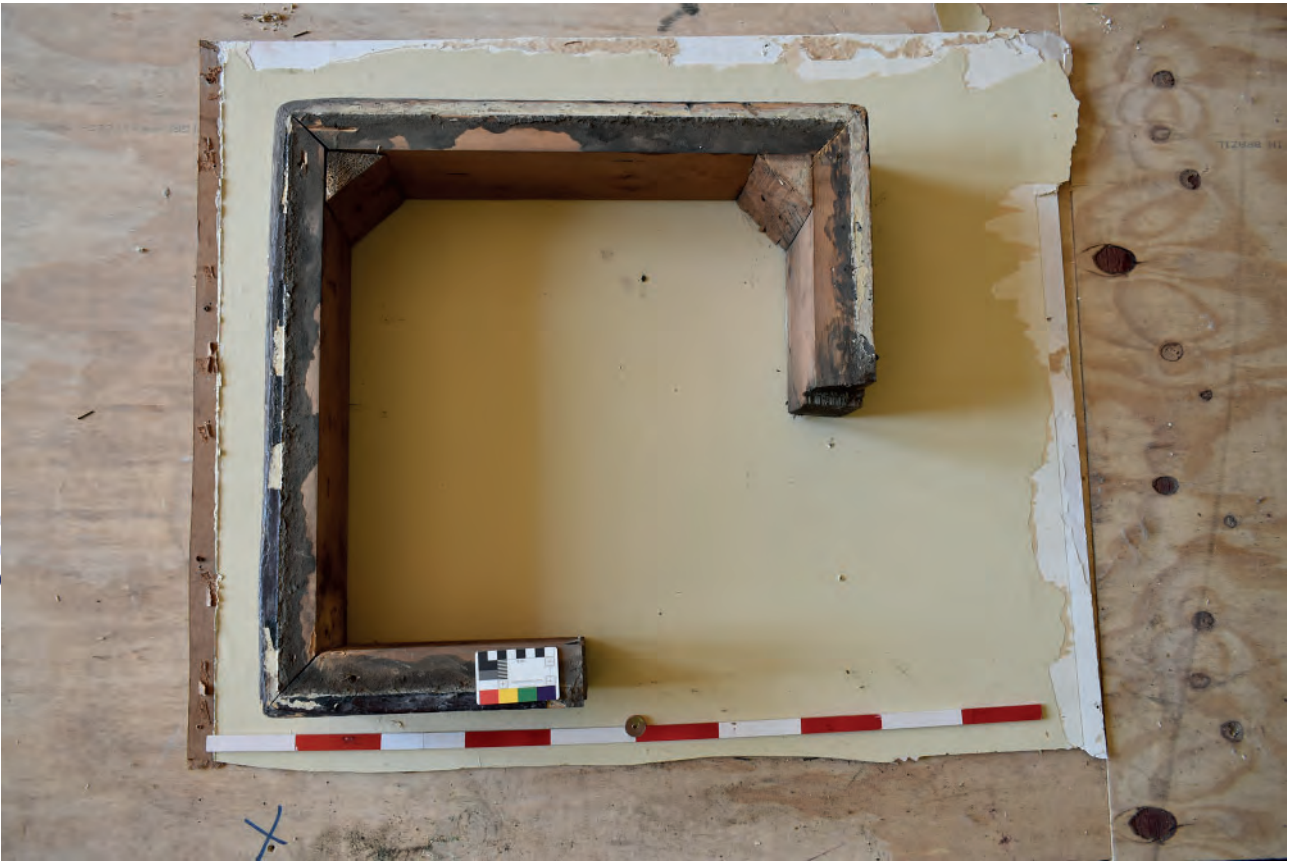
- 3.5.5 Three of the four pilasters along the south wall were marked with Roman numerals to the upper surface: the westernmost lacked a number, that between the west and central window was marked 'VIII', that between the central and east windows 'IX' and the easternmost 'X' (Plate 52). The pilaster bases were made of plain timber (Plate 53).

Plate 52: Temple Room, south wall, example of numbered pilaster

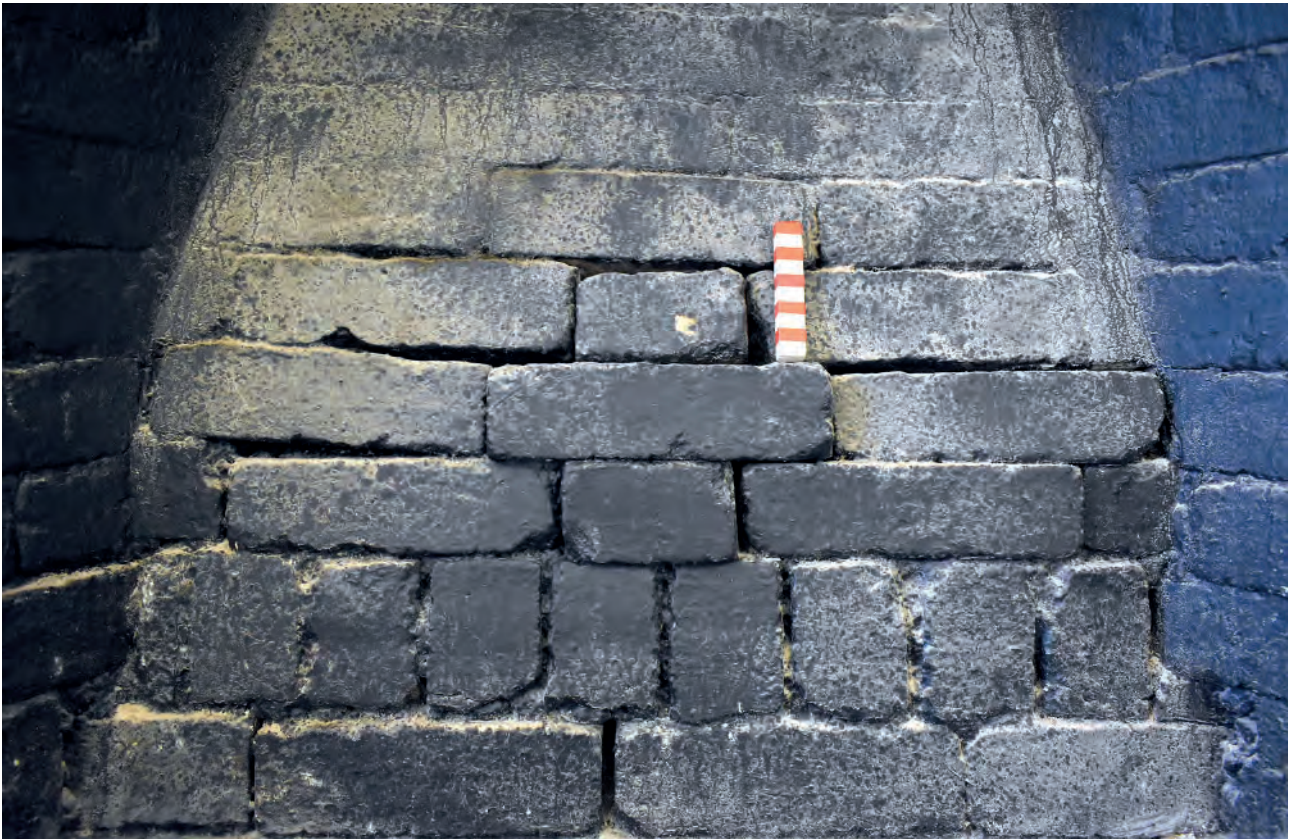
- 3.6.3 There are three instances of pencil setting out marks plus four lines in the brickwork, probably associated with the fitting of the c 1922 fireplace. The southernmost pencil mark is in line with the plaster edge of the c 1922 fireplace, the following is in line with the opening, the next is in line with the canted edge. The central mark is an arrow incised into the brick to the south of the voussoir, plus a pencil line, so probably the centre of the c 1922 fireplace (Plate 58). The next two pencil lines are level with the canted edge and opening, as per those at the southern end. The northernmost mark depicts a diagonal detail; it is not evident what this detail relates to, but the vertical lines are aligned with the edge of the plaster (Plate 59).

Plate 59: Temple Room, 1922 fireplace construction marks

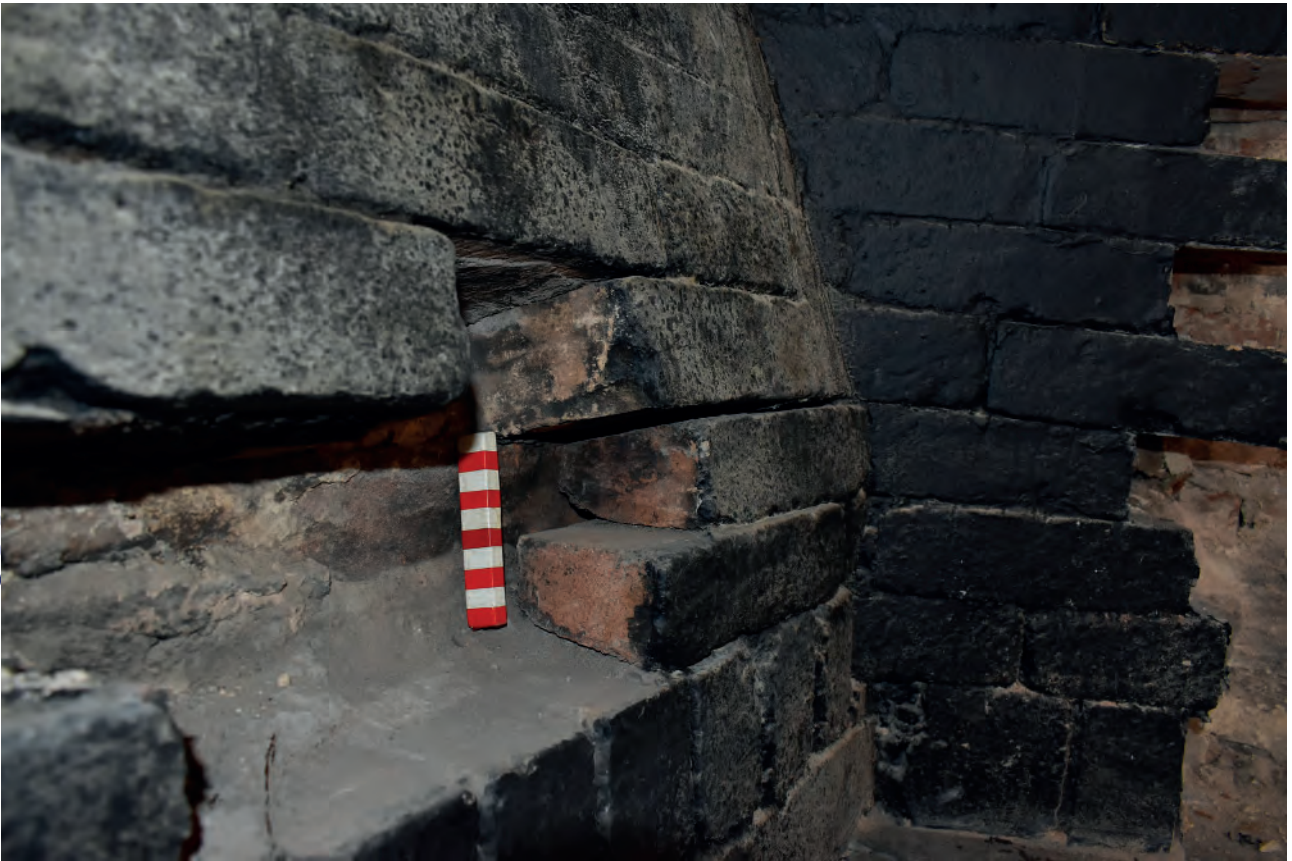
- 3.6.5 The chimney has a blocked circular flue, and all of the flue and c1922 fireplace back had been painted black. The rear of the fireplace had a simple cross pattern formed of a stretcher and two headers projecting slightly from the brickwork (Plate 60). Several bricks to the curved back of the fireplace, including the upper stretcher of the cross patten, were wedge-shaped, possibly voussoirs (Plate 61). Some were cut standard bricks but all were early 20th-century which confirmed the back of the fireplace was altered in c1922. The wedge-shaped bricks had stamps and were manufactured by Hall of Stourbridge (Plate 62), a fire brick manufacturer (Grace's Guide, 2018). The cut bricks and the full bricks did not have stamps.

Plate 60: Temple Room, 1922 fireplace back

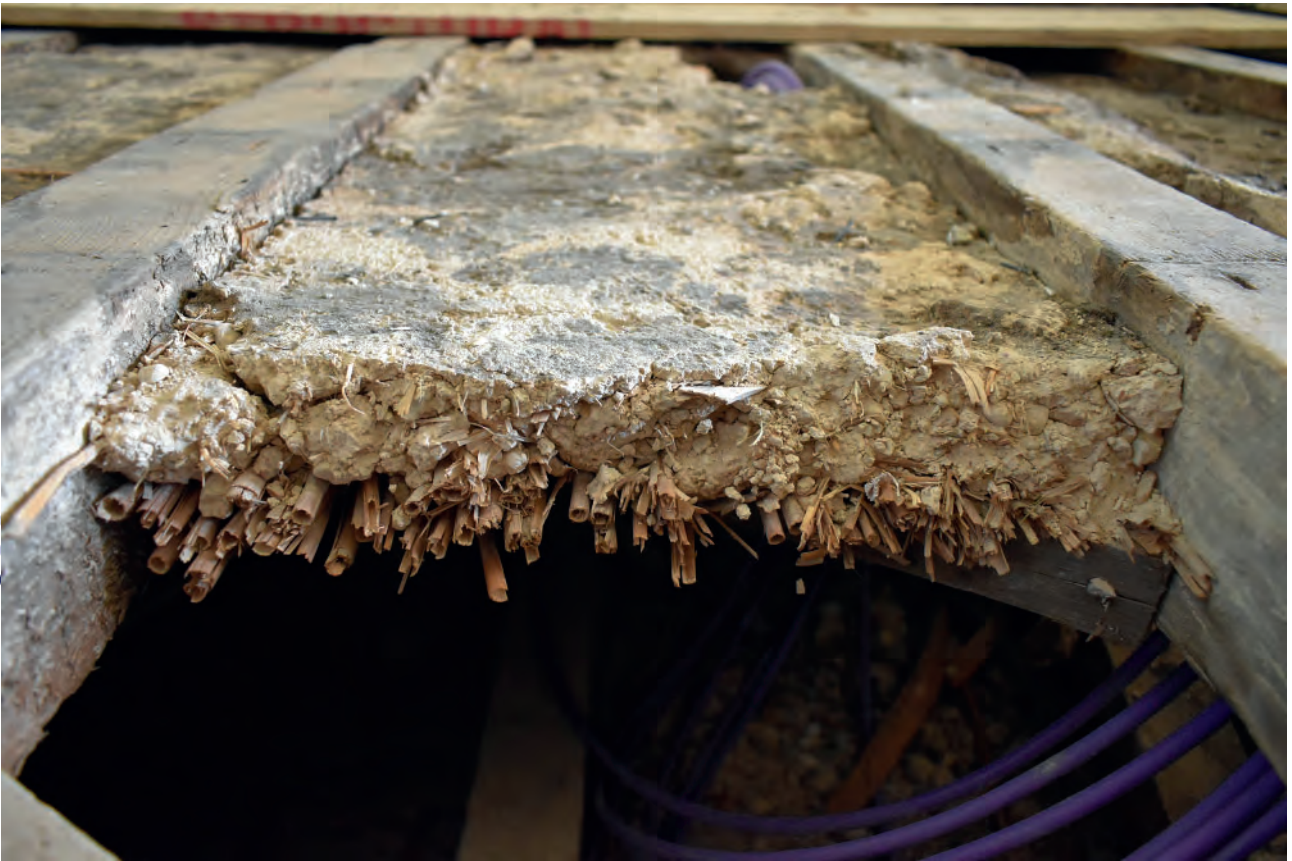
- 3.7.5 The pugging between the joists is supported on crossed pieces of timber. It consists of reeds with a layer of lime (Plates 80-82). It is feasible that these water reeds were sourced from the grounds, being a free and useful material and still observed in the current landscape of the National Trust land surrounding the school. Although reeds are usually associated with thatching of roofs, generally harvested in Norfolk, they grow alongside ditches and rivers in many parts of the country in insufficient quantities for thatching but would have been used for other uses such as providing a key for plastering (English Heritage, 2013, p. 336).
- 3.7.6 New oak boards were laid and the use of the mechanical polisher is to be limited (Plate 83).

Plate 81: Temple Room, floor, section through pugging
