# Temple Room, Dining Room and West Corridor Stowe House, Buckinghamshire.

## Historic Building Recording

September 2022

**Client: Stowe House Preservation Trust**

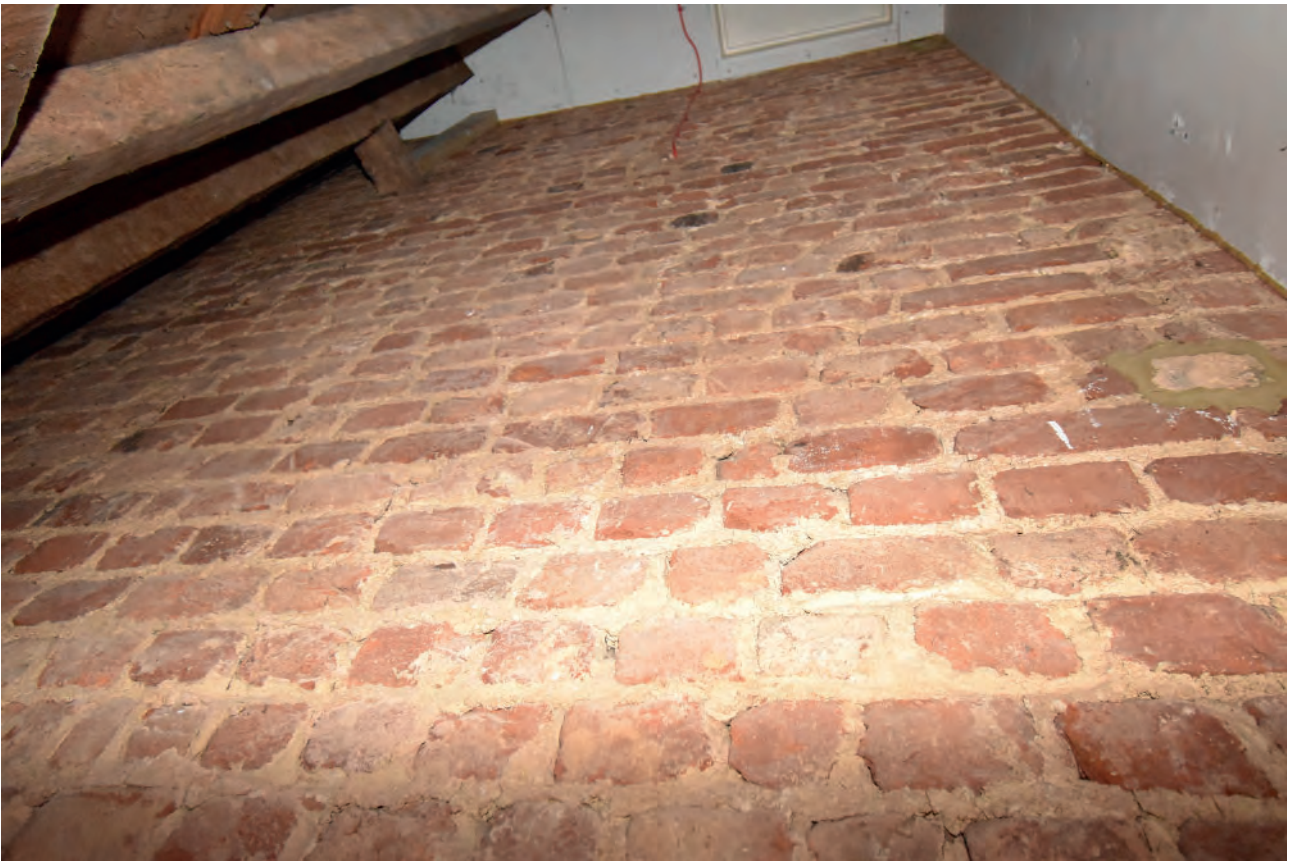
- 3.8.1 To the north of the room is an east-west wall concealed by the apsidal wall, forming two voids either side of the apse. The easternmost void is accessed from the cleaners' cupboard. The westernmost void is concealed behind the lift and could not be inspected. The bricks of this wall measured 210-220mm x 110-125mm x 62-65mm, and bonded very unevenly with a rough, unfinished lime mortar (Plate 84). The north face of the wall is roughly plastered to approximately 5ft. The rear of the apse is visible, confirming its construction of lath and plaster over timber studs below the dado level and boards above (Plates 85 & 86).

Plate 84: Void behind Temple Room apse, wall to the north of the void

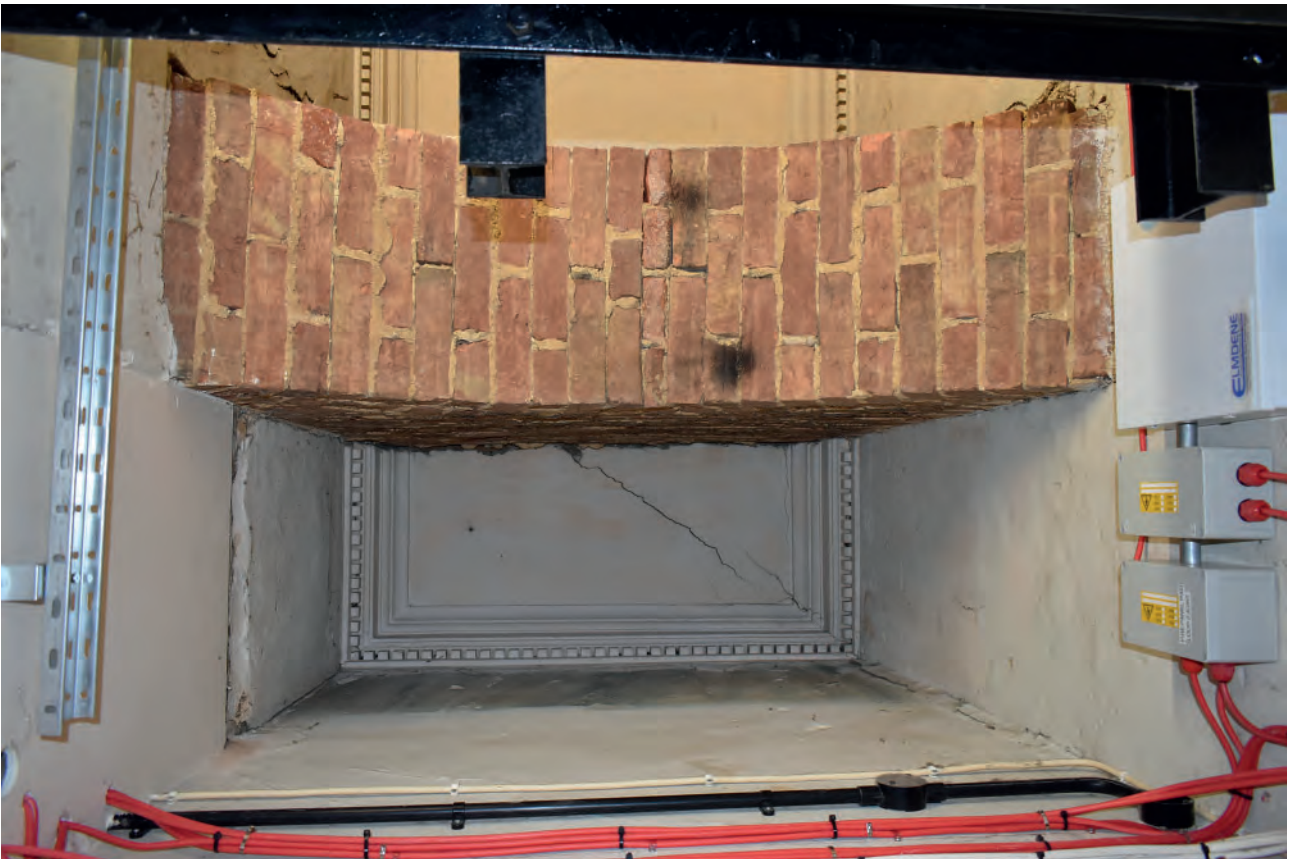
- 3.8.2 The corridor wall to the north of the voids forms a further space used for electrical distribution (Plate 87). In the cleaner's cupboard, a brick arch associated with later structural repairs cuts across a ceiling with a dentilled cornice, likely that of the dressing room which was reconfigured during the formation of the State Drawing Room (Plate 88).

Plate 88: Void behind Temple Room apse, reinforcing brickwork in cleaners' cupboard

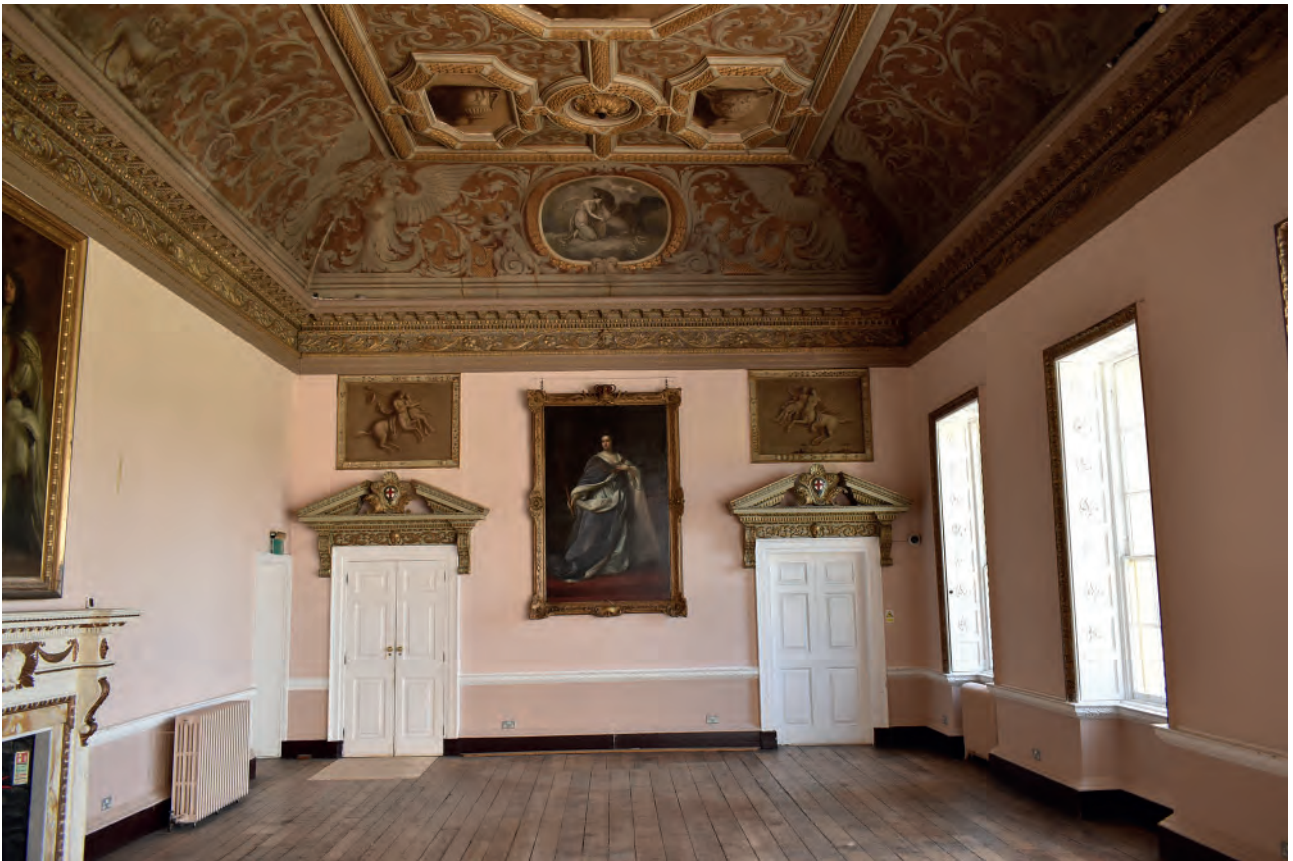
- 4.1.2 The Dining Room is to the west of the former Drawing Room, accessed via a doorway from the Drawing Room and three doorways to the corridor to the north, all formed during the use as a school (Plate 93). A doorway to the Servery is at the west end of the room. The pairs of doors at either end of the room are formed of the aforementioned doors to the Servery and Dining Room plus false doors to provide symmetry (Plates 94 & 95). No cupboards are behind the false doors, unlike the pairs of doors to the east and west walls of the Drawing Room.

Plate 94: Dining Room, east wall, at the start of the project

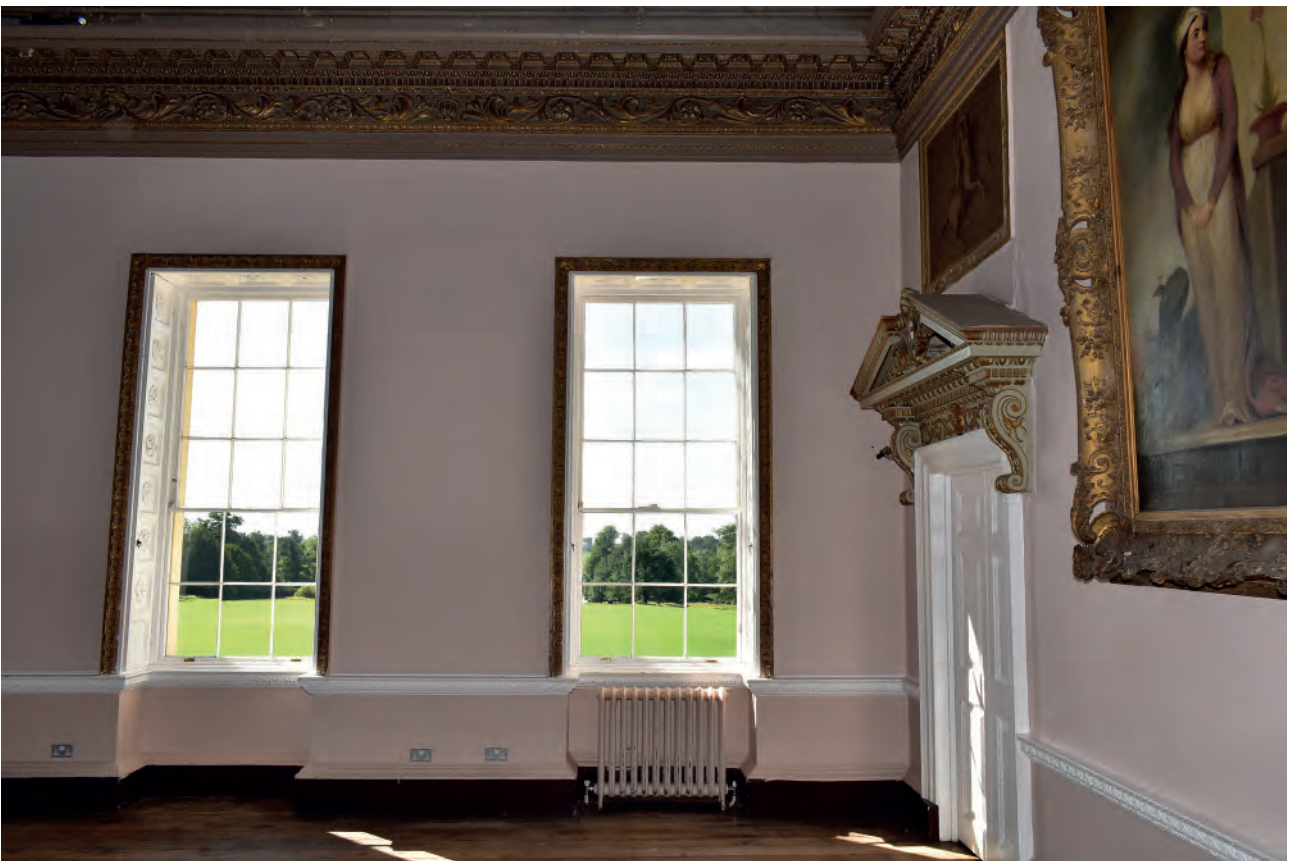
- 4.1.3 Seven sash windows are to the south wall with surviving shutters (Plate 96). Radiators dating to around the time of the foundation of the school are to alternate recesses beneath the windows (Plate 97) and three slightly later radiators are to the north wall (Plate 98). Until the sale of 1922, the north, east and west walls were hung with tapestries; the fireplaces were sold at the same date and the current fireplaces date to around the opening of the school (Plates 99 & 100).

Plate 96: Dining Room, south wall, example of windows at the start of the project

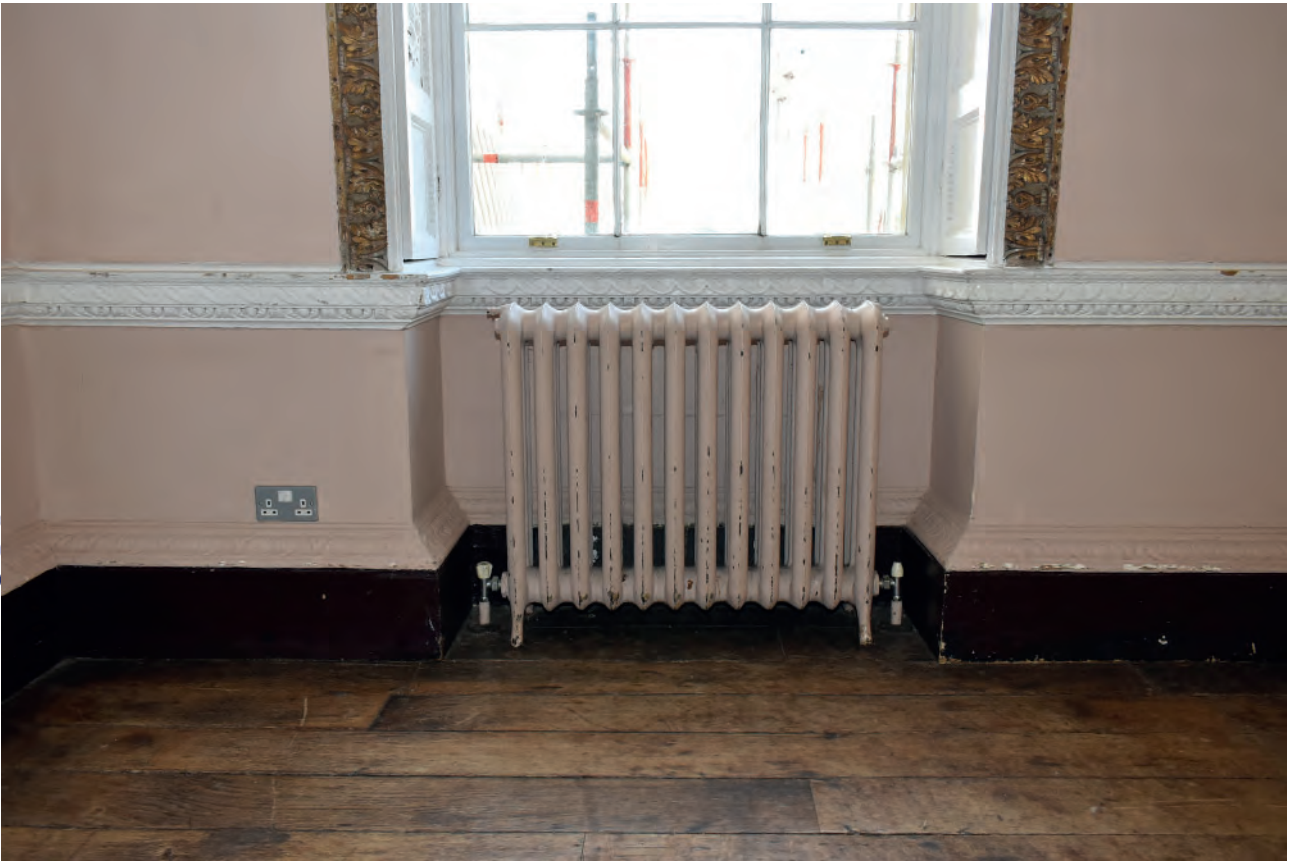
Plate 97: Dining Room, example of a radiator to the south wall

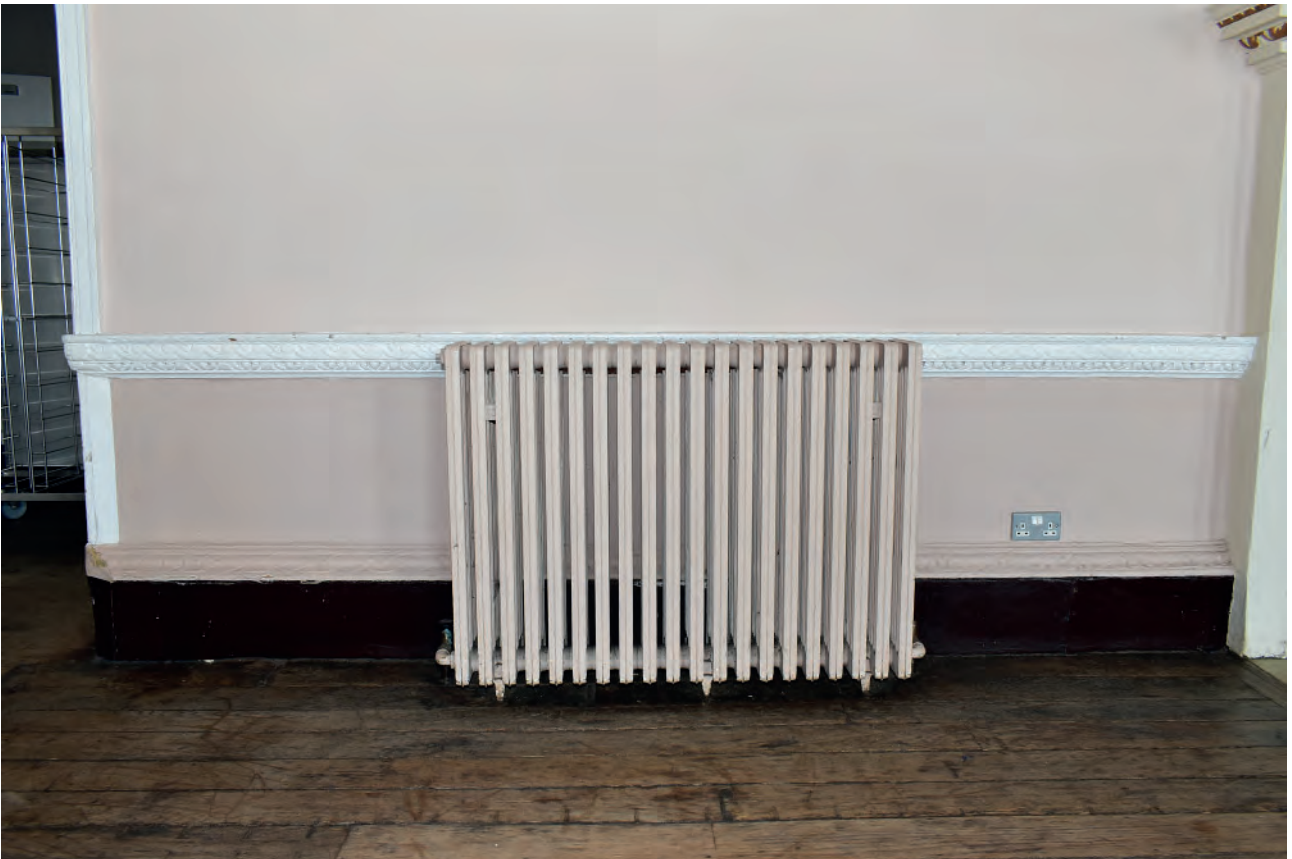
Plate 98: Dining Room, example of a radiator to the north wall

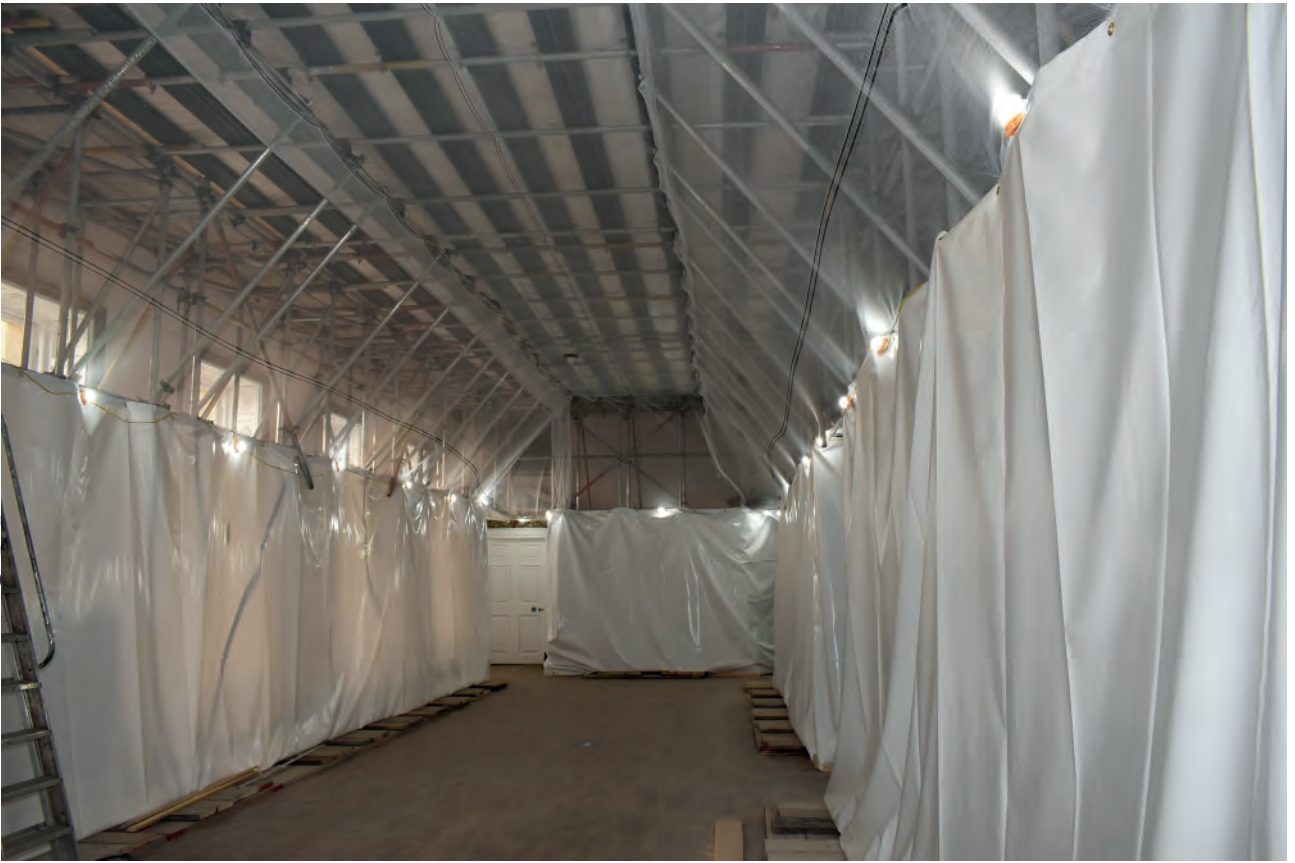
- 4.3.1 An internal scaffold was constructed and protected sheeting was installed to enable the conservation work (Plates 103 & 104).

Plate 103: Dining Room, preparation for conservation work

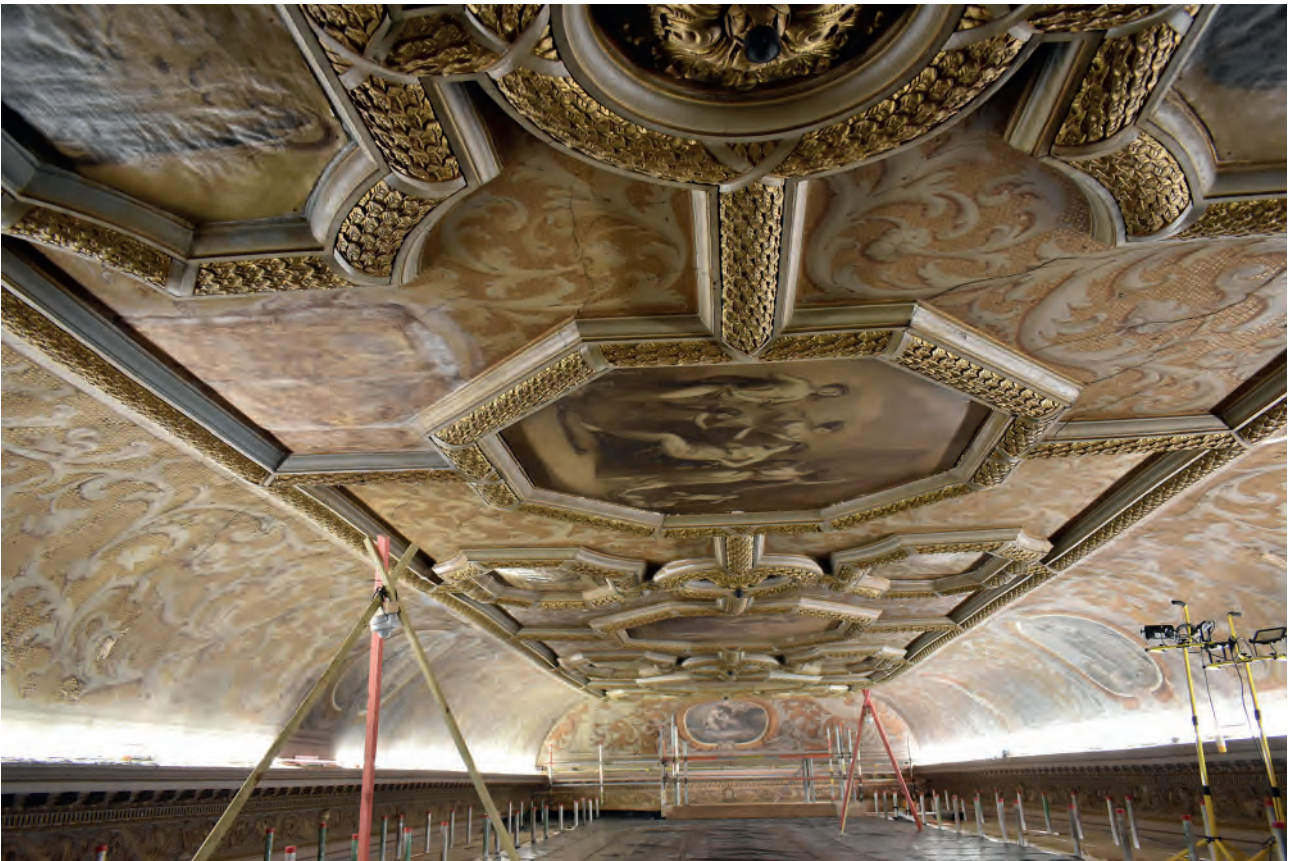
Plate 104: Dining Room, ceiling, at the beginning of conservation work

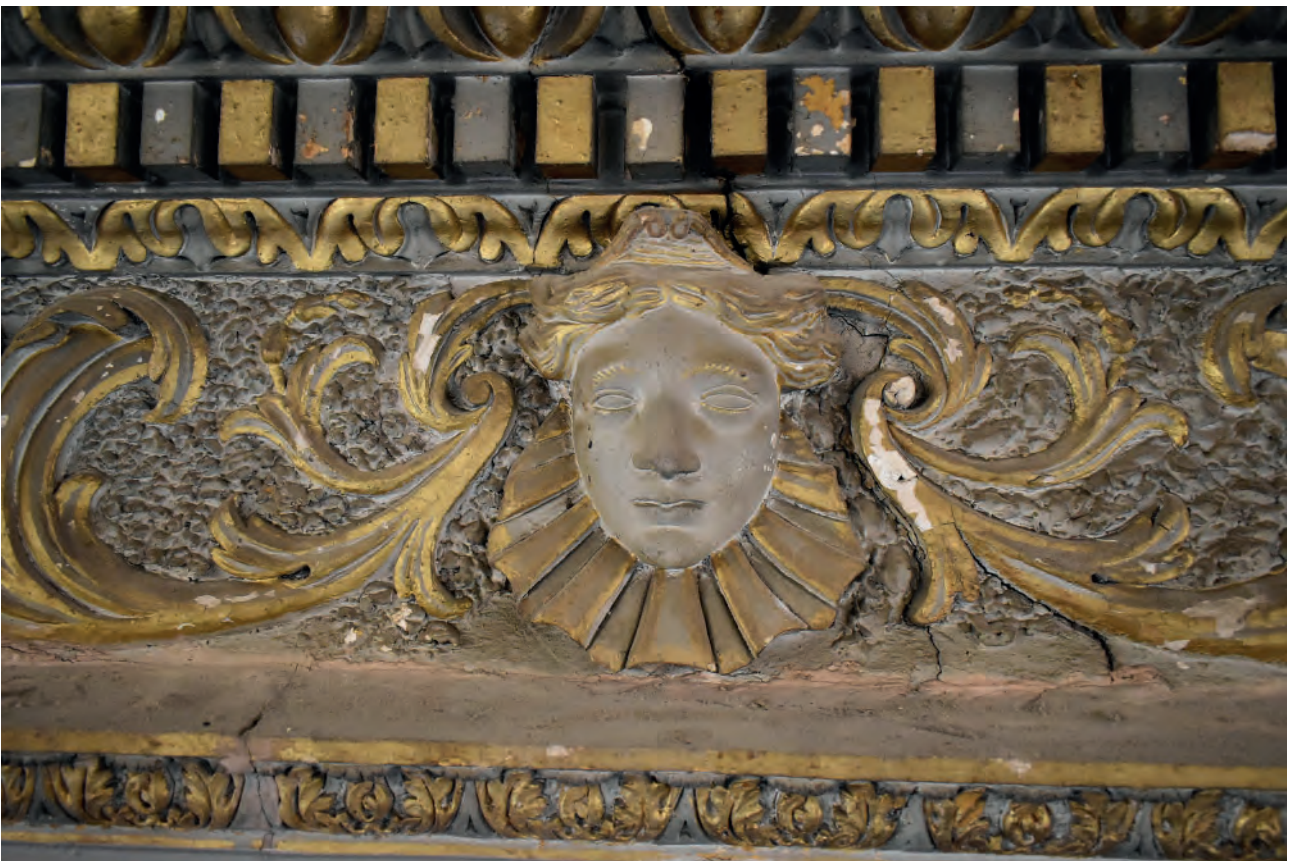
Plate 112: Dining Room, ceiling, example of dirt to decoration

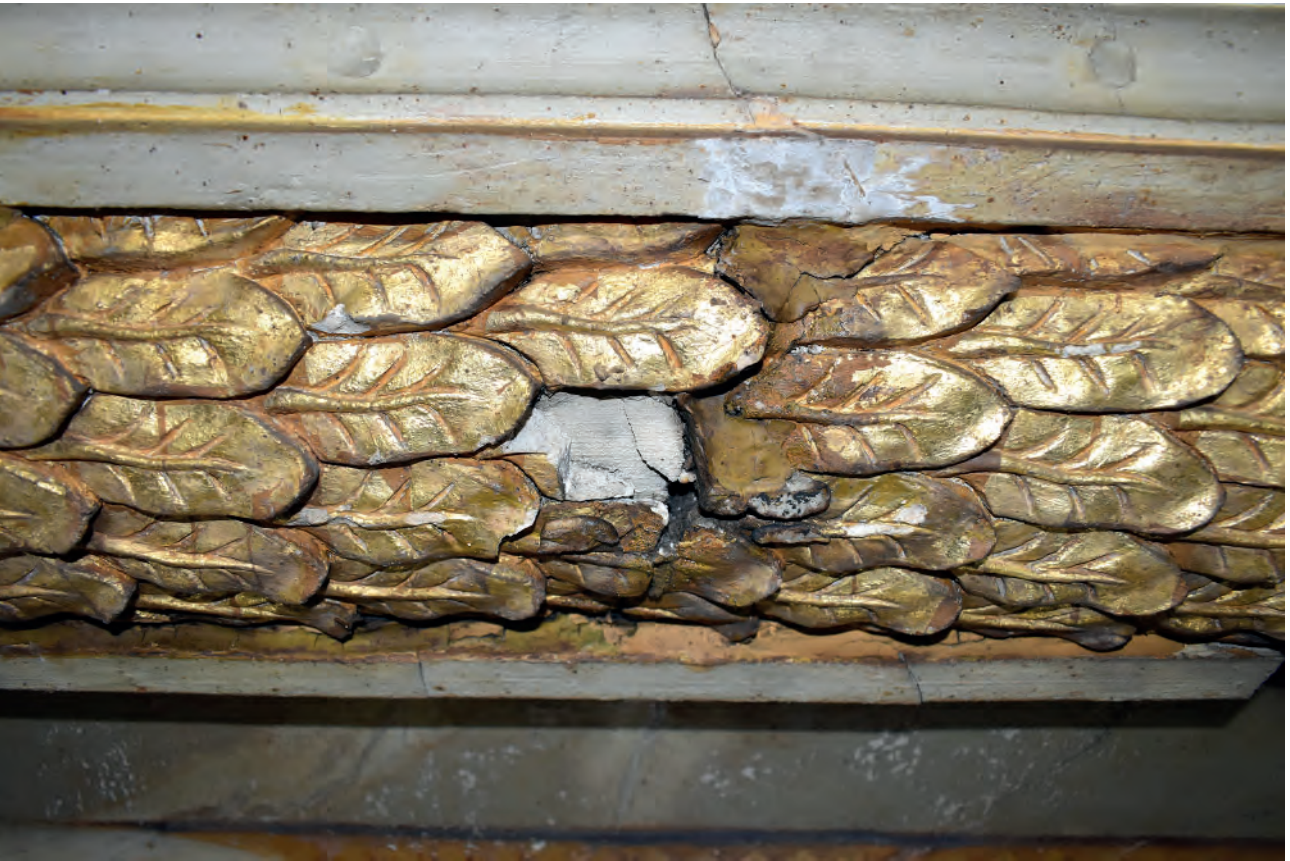
- 4.3.5 The moulded applied beams of the ceiling are approximately 100mm deep and decorated with gilded Plaster of Paris laurel-style leaves which appear to be individually applied to split laths (Plates 116 & 117). The moulding along these beams was originally run in *in situ*. That moulding at the west end of the room had been extensively repaired, although to a poor standard (Plate 118). Areas of moulding which were loose were reattached, using a resin for the smaller pieces of loose material which would adhere it to the secure areas, and the larger loose pieces were reattached to the laths or battens with screws.

Plate 117: Dining Room, ceiling, detail of applied decoration

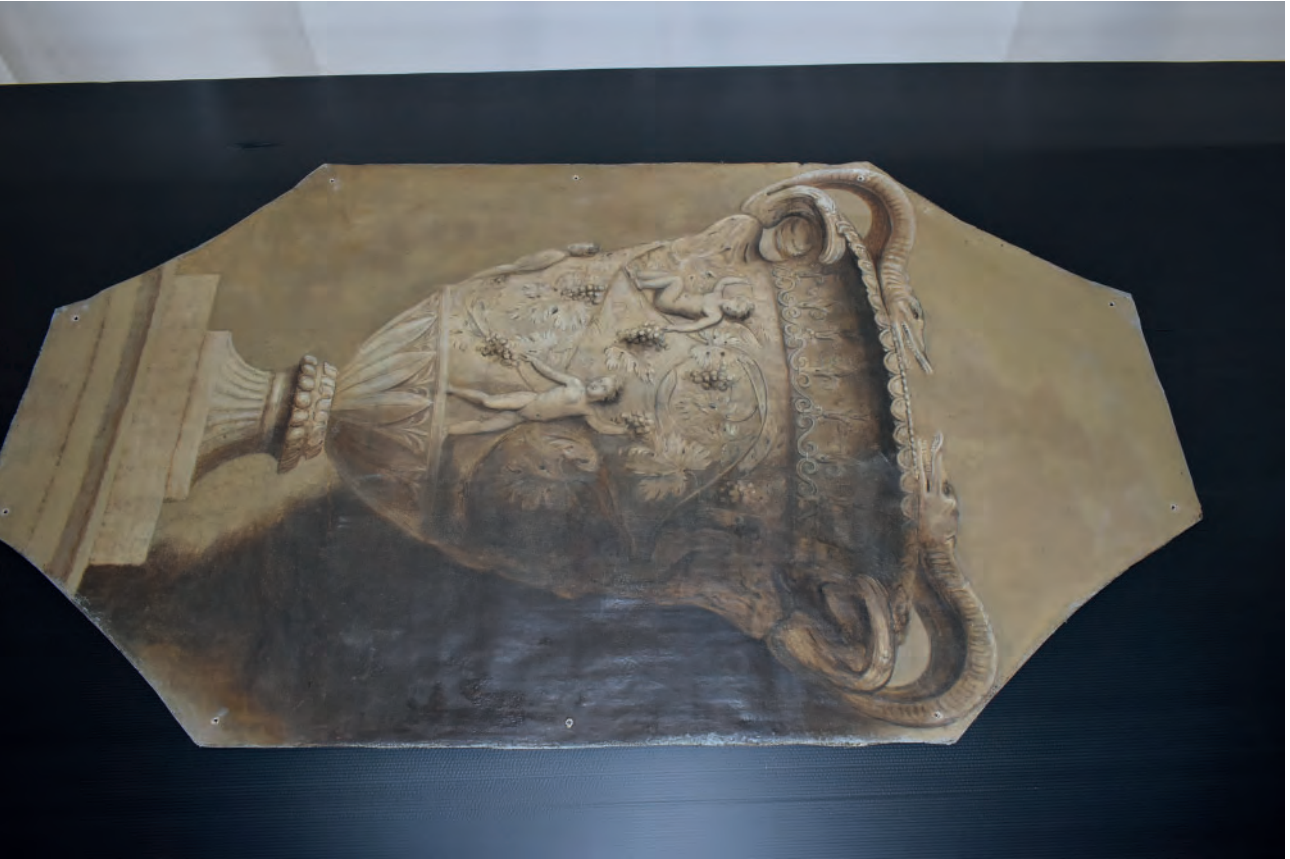
Plate 123: Dining Room, ceiling, example of a smaller painting

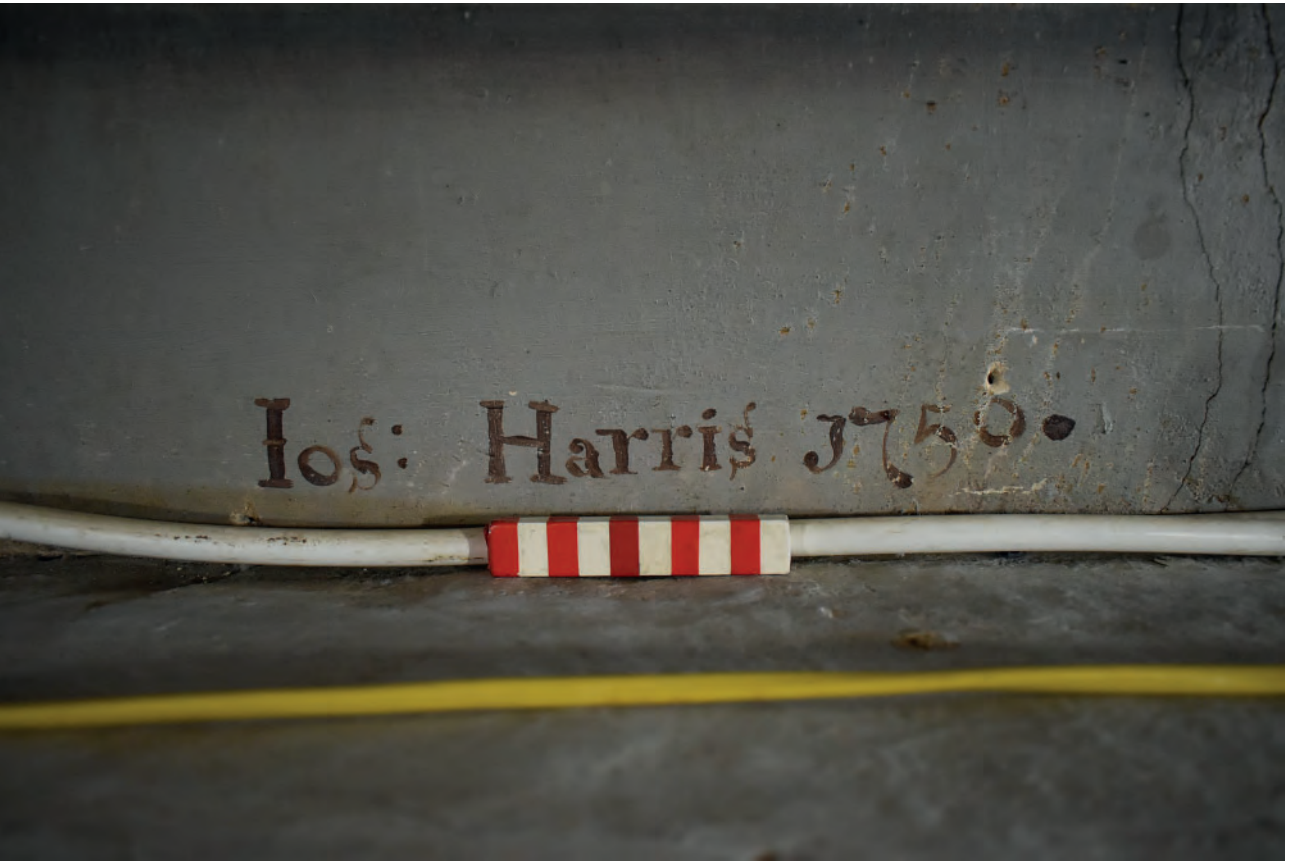
- 4.3.8 The signature of Joshua Harris 'Ios: Harris 1750' was noted on the cove to the south wall, 7305mm from the east end of the room (Plates 126 & 127). To the east end of the room, three signatures and items of graffiti were noted to the cornice: to the urn above the doorway, the signature of J. Phillip and the date 1776 was noted (Plate 128),

Plate 127: Dining Room, ceiling, signature of the artist

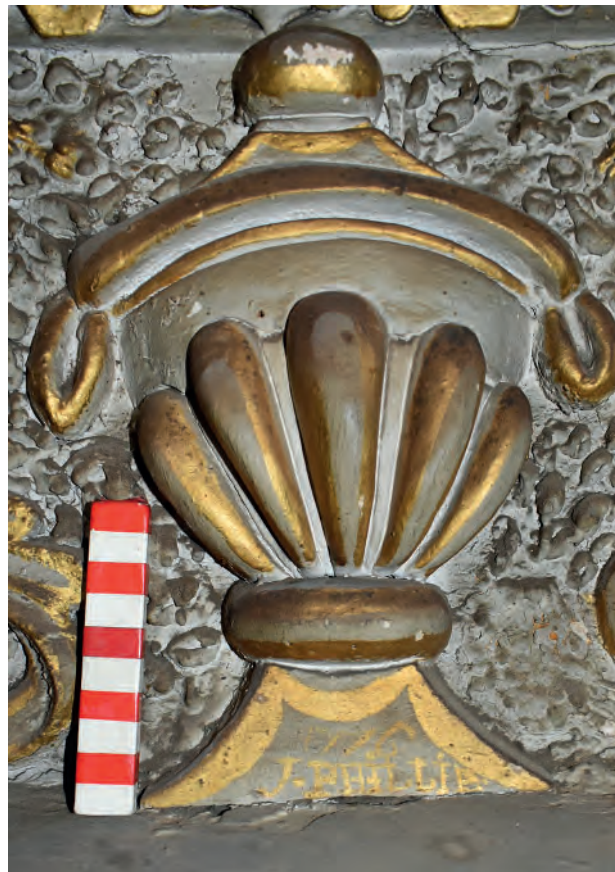
Plate 128: Dining Room, ceiling, example of graffiti

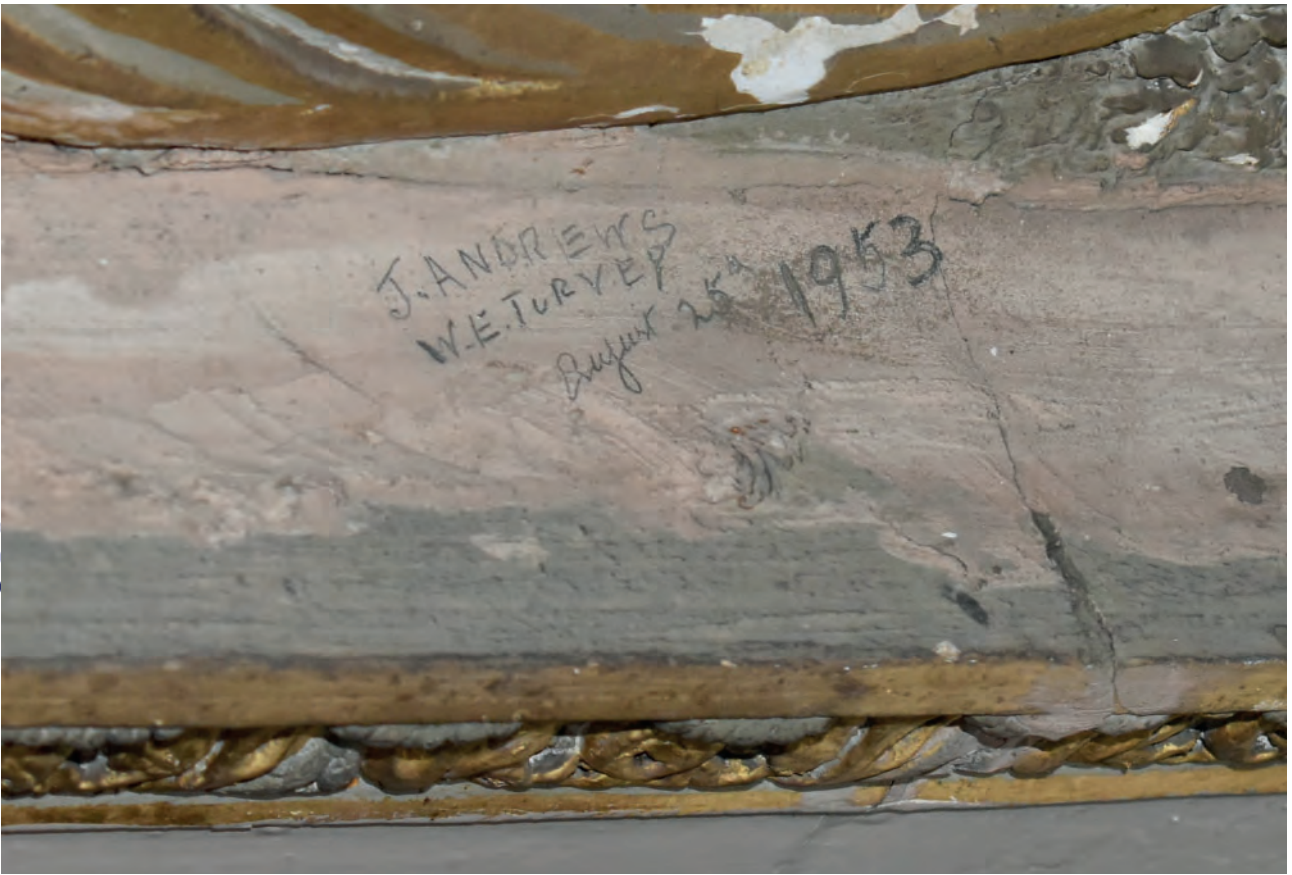
to the approximate centre of the room, the signatures of J. Andrews and W. E. Turvey and the date of August 25th 1953 was seen (Plate 129), and above the false door, the signatures of D. Dunkley and G Blacknell and the date of 27/03/[19]73 (Plate 130). The signature of c. Shellnack [?] and the date of 1990 was noted approximately 3495mm from the east end of the room (Plate 131). Pencil-drawn arrows at intervals to the top of the cornice throughout were observed, although no corresponding features indicated their meaning (Plate 132).

Plate 129: Dining Room, ceiling, example of graffiti

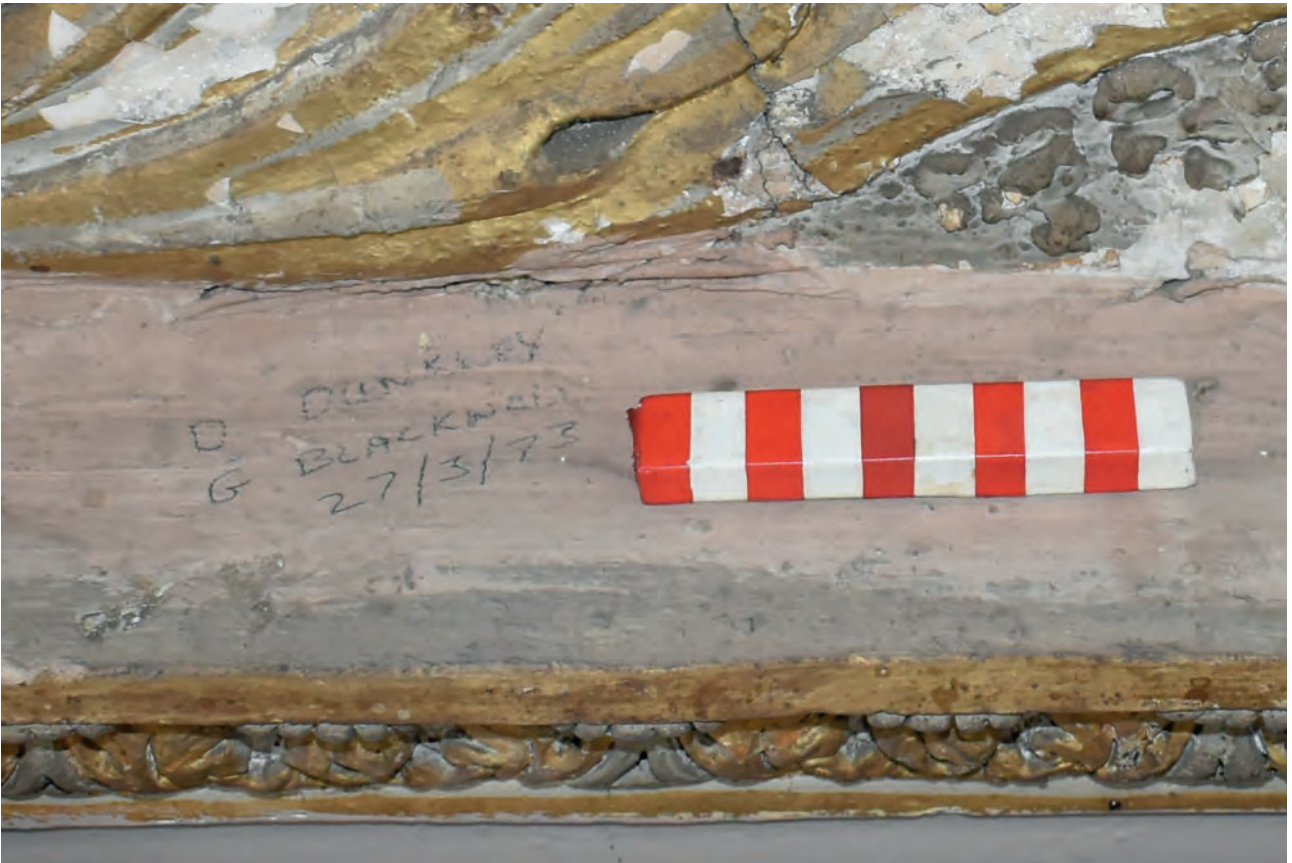
Plate 130: Dining Room, ceiling, example of graffiti

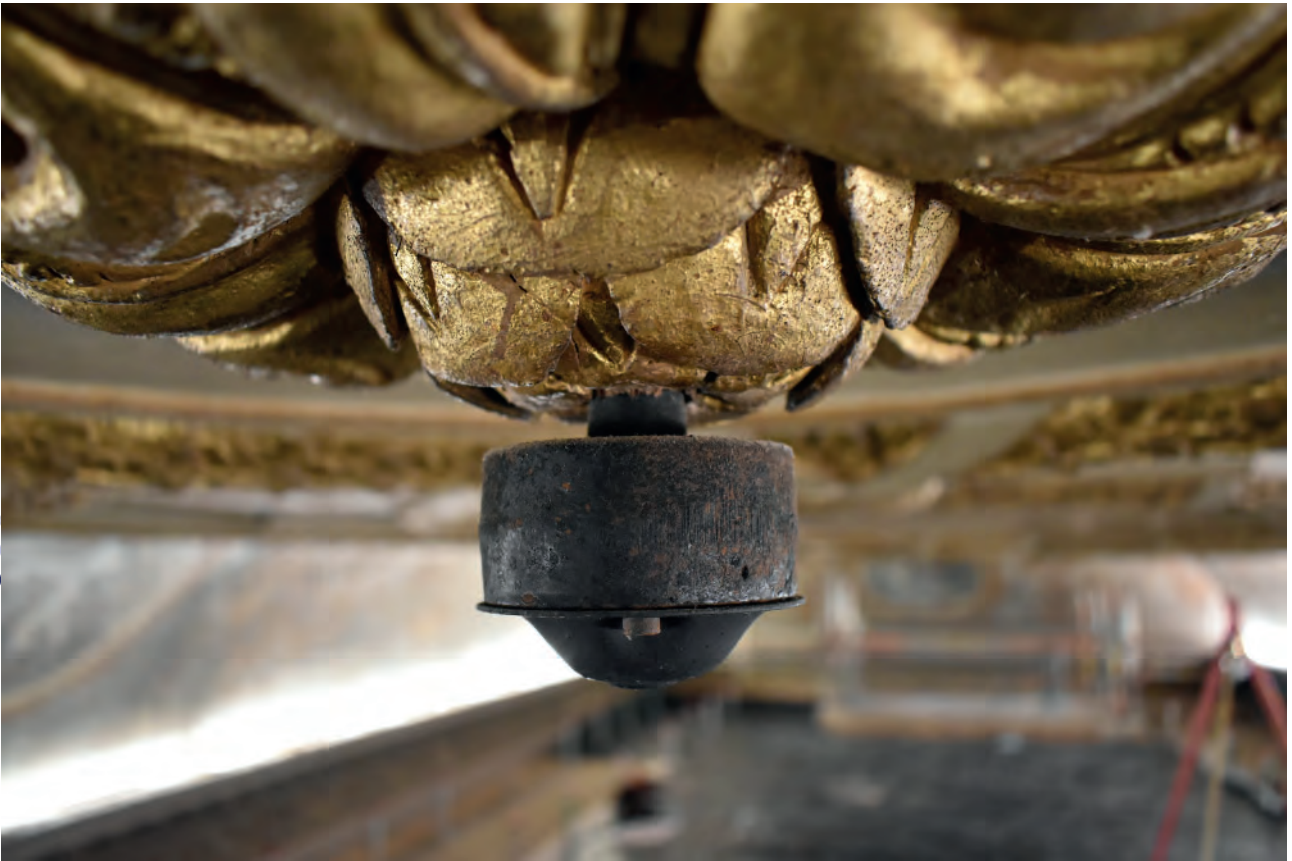
- 4.3.9 The redundant fittings in the ceiling are likely to have been gas light fittings (Plate 133).
- 4.3.10 Following the extensive conservation work, the ceiling was re-lit with new fitting above the cornice (Plates 134 & 135).

Plate 133: Dining Room, ceiling, redundant gas light fitting

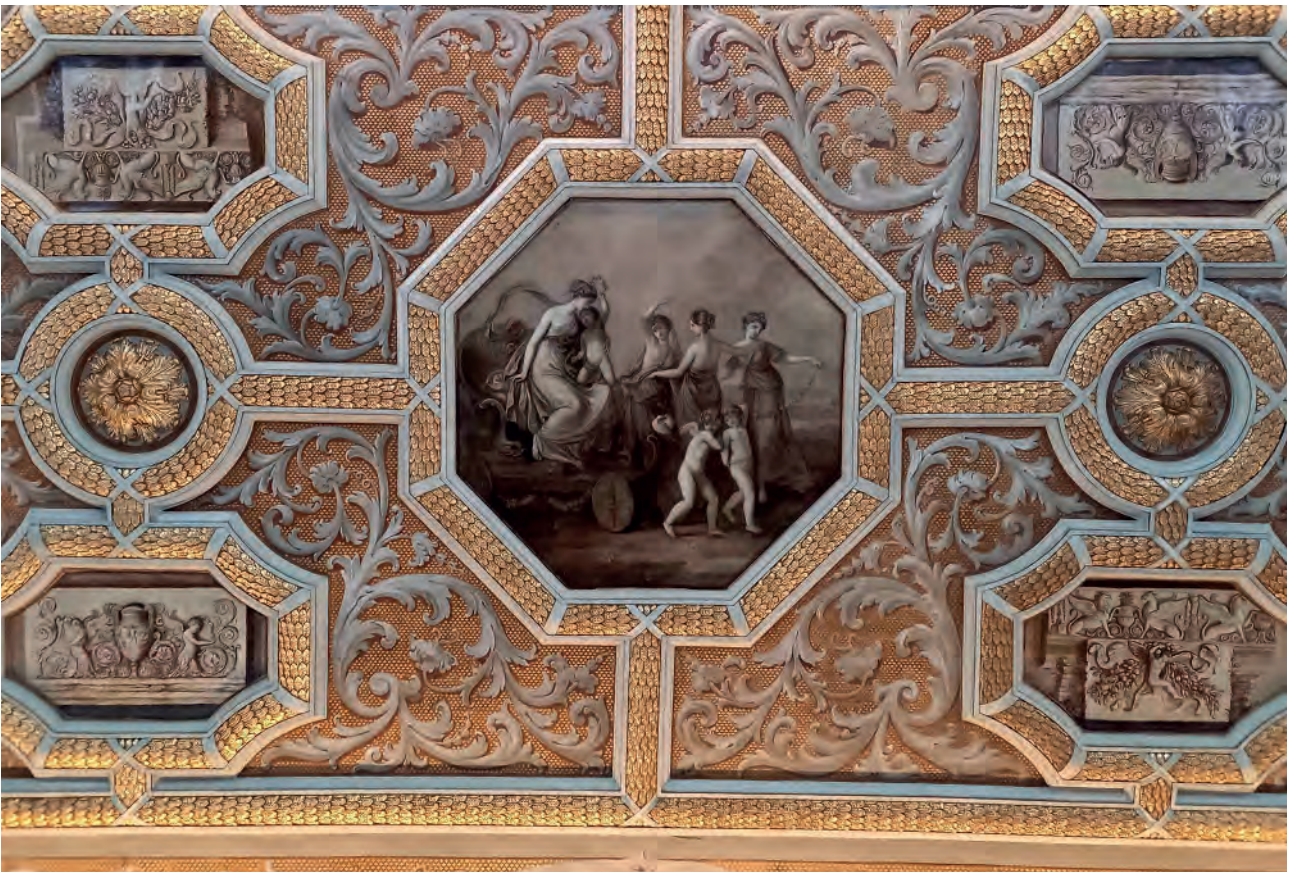
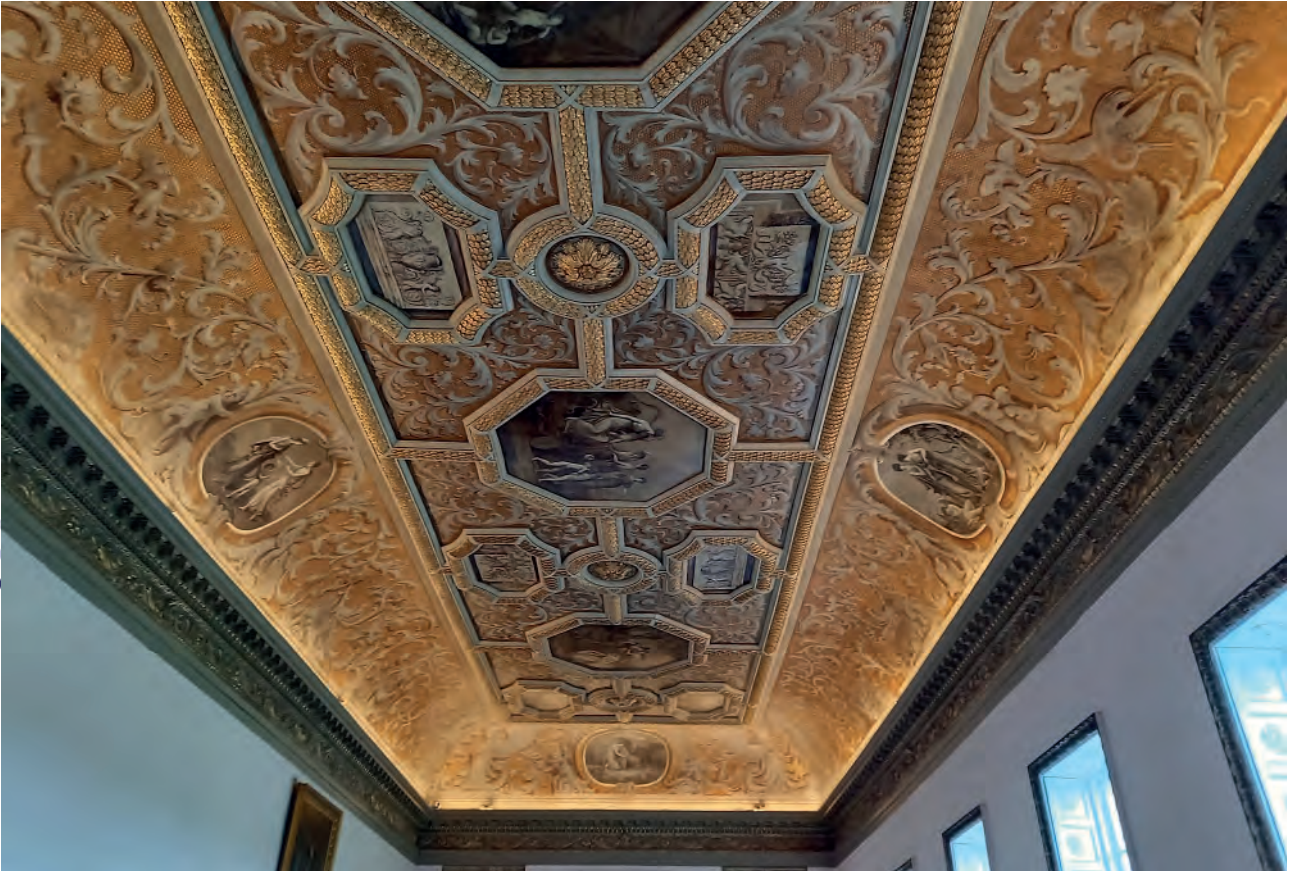
Plate 134: Dining Room, ceiling, detail following conservation

Plate 135: Dining Room, ceiling, following conservation, looking east

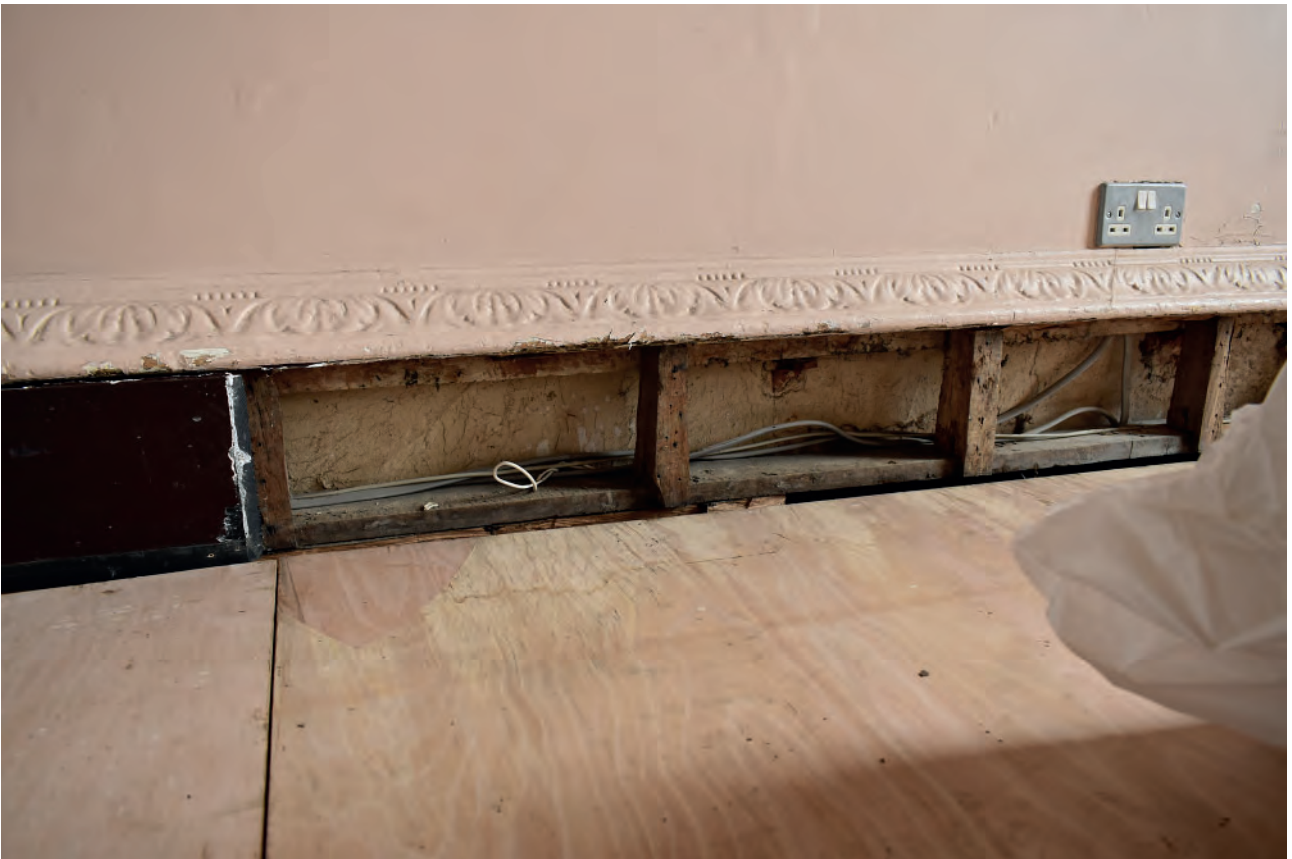
- 4.4.2 The walls behind the skirting were exposed in places (Plate 136). It was roughly plastered and the skirting and moulded timber above the plain boards was shown to be mounted on a frame. The walls between the windows were shown to be proud of the brickwork behind (Plate 137). The lower part of the south wall was exposed by the removal of the floorboards. Relieving arches of modern bricks were visible beneath the windows (Plate 138). Modern brickwork was exposed beneath the false door at the east end of the room, indicating the location of modern structural work (Plate 139).

Plate 136: Dining Room, wall, example of rough plaster behind wall surface
