# Temple Room, Dining Room and West Corridor Stowe House, Buckinghamshire.

## Historic Building Recording

September 2022

**Client: Stowe House Preservation Trust**

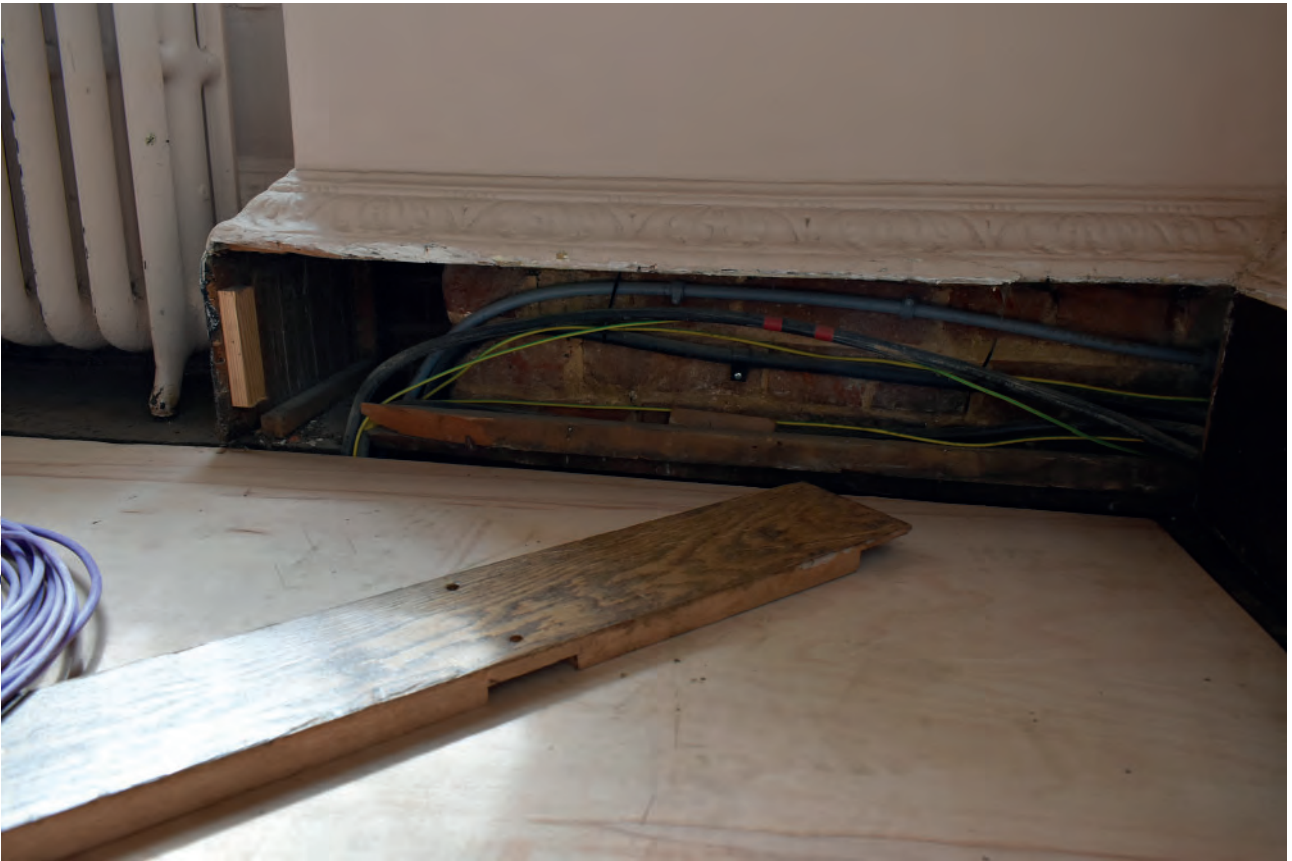
- 4.4.2 The walls behind the skirting were exposed in places (Plate 136). It was roughly plastered and the skirting and moulded timber above the plain boards was shown to be mounted on a frame. The walls between the windows were shown to be proud of the brickwork behind (Plate 137). The lower part of the south wall was exposed by the removal of the floorboards. Relieving arches of modern bricks were visible beneath the windows (Plate 138). Modern brickwork was exposed beneath the false door at the east end of the room, indicating the location of modern structural work (Plate 139).

Plate 137: Dining Room, wall, example of brickwork set behind wall surface

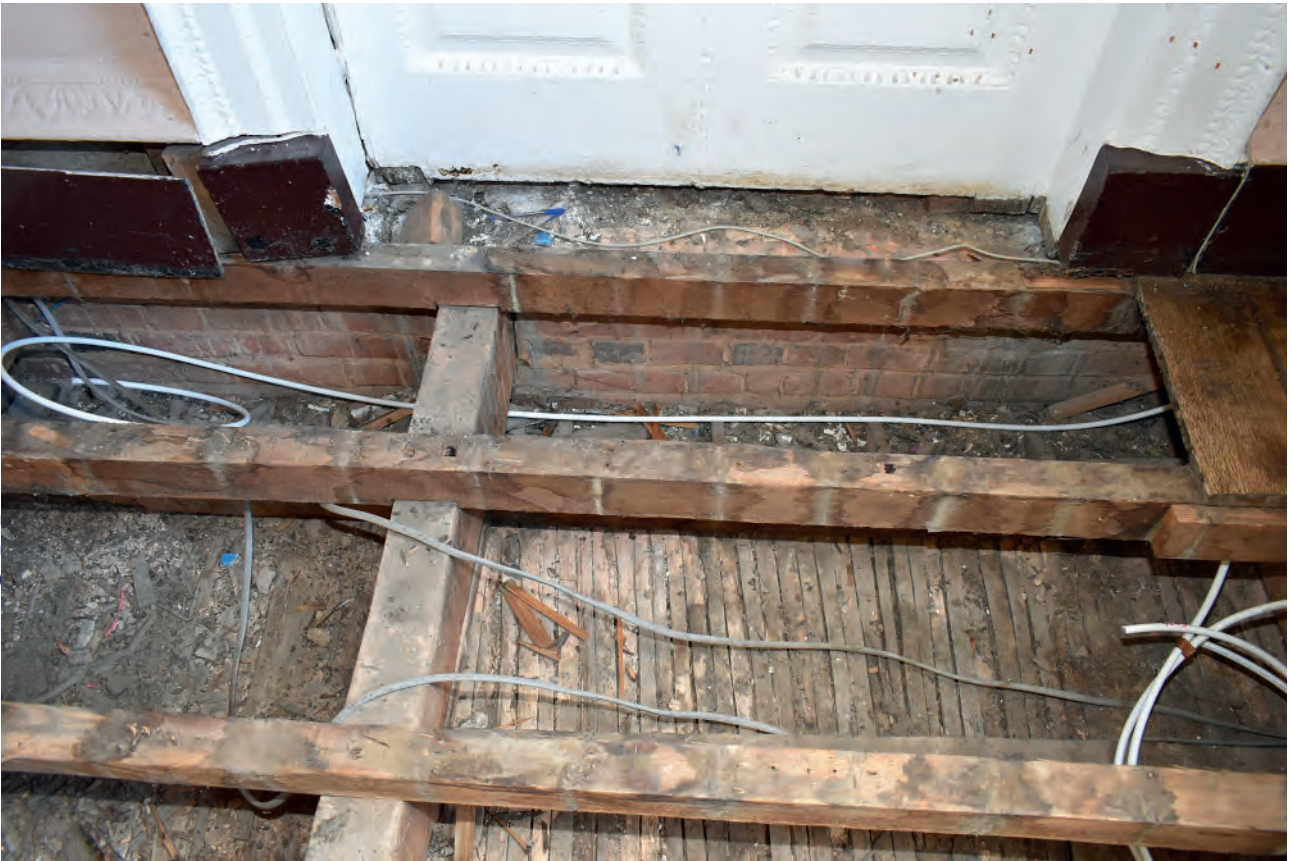
Plate 139: Dining Room, wall, modern brickwork beneath false door to the east wall

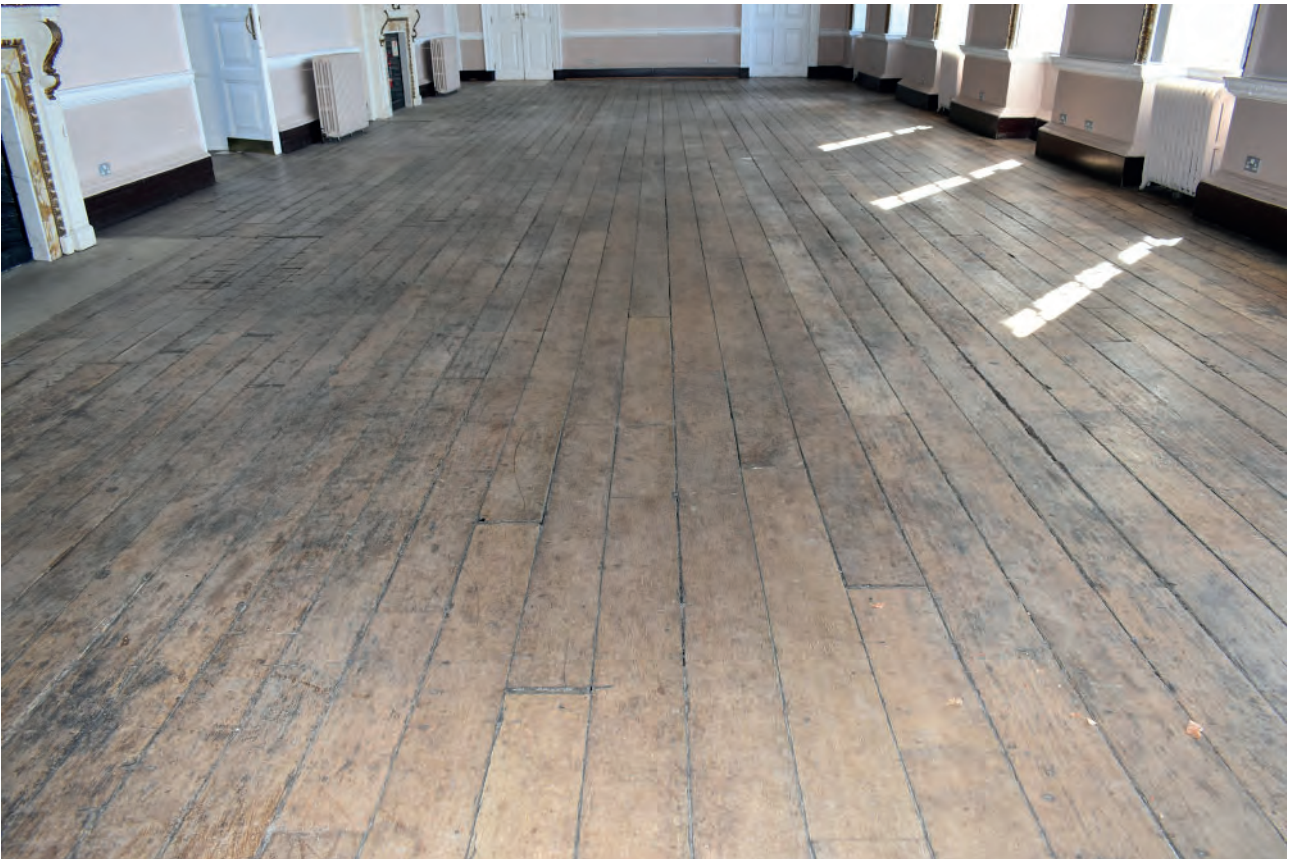
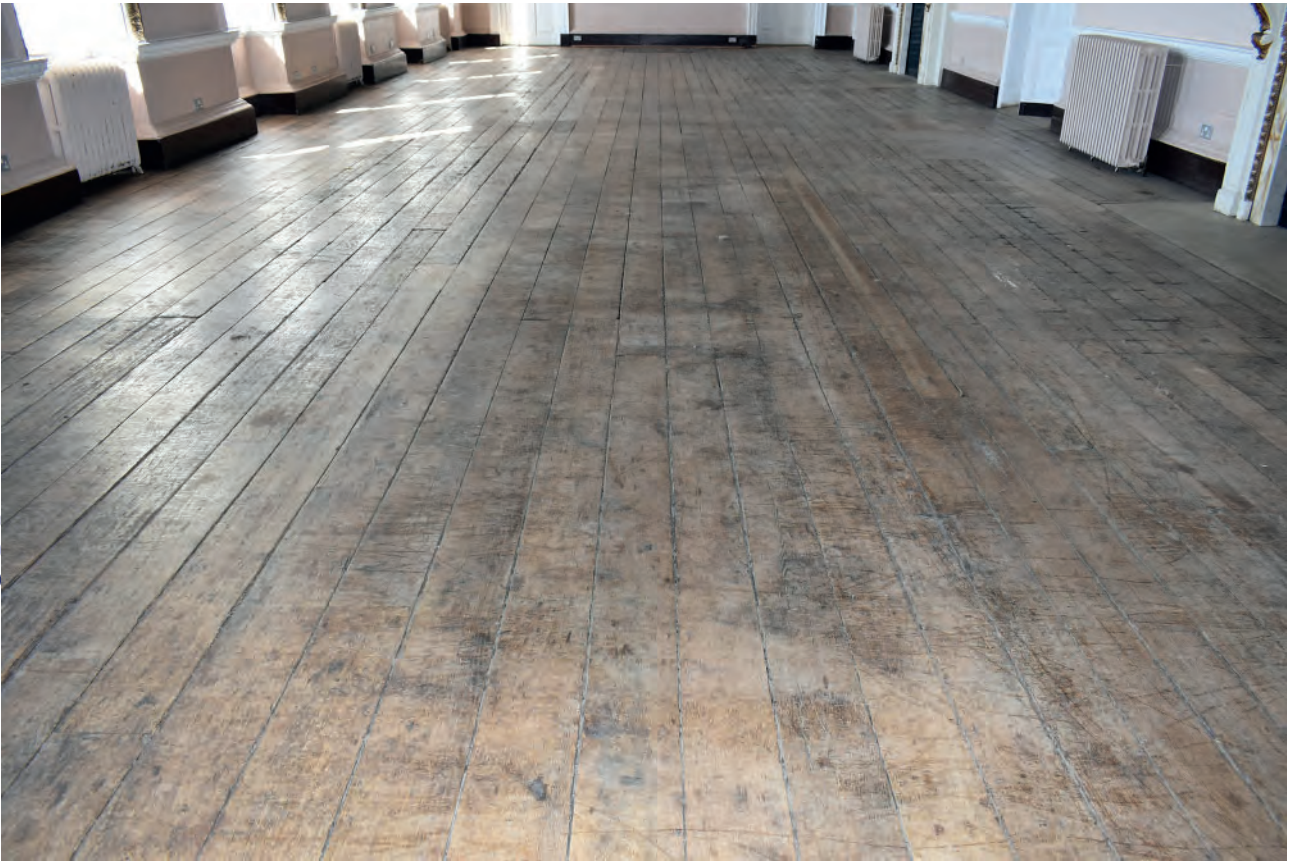
- 4.6.1 The floor prior to the project was oak floorboards (Plates 142 & 143), although the boards differed to those in the adjacent Temple Room. The widths of the boards, which ran east-west, were of variable widths between 122-215mm (Figure 10). The boards

Plate 142: Dining Room, floor, at the start of the project, looking east

Plate 143: Dining Room, floor, at the start of the project, looking west

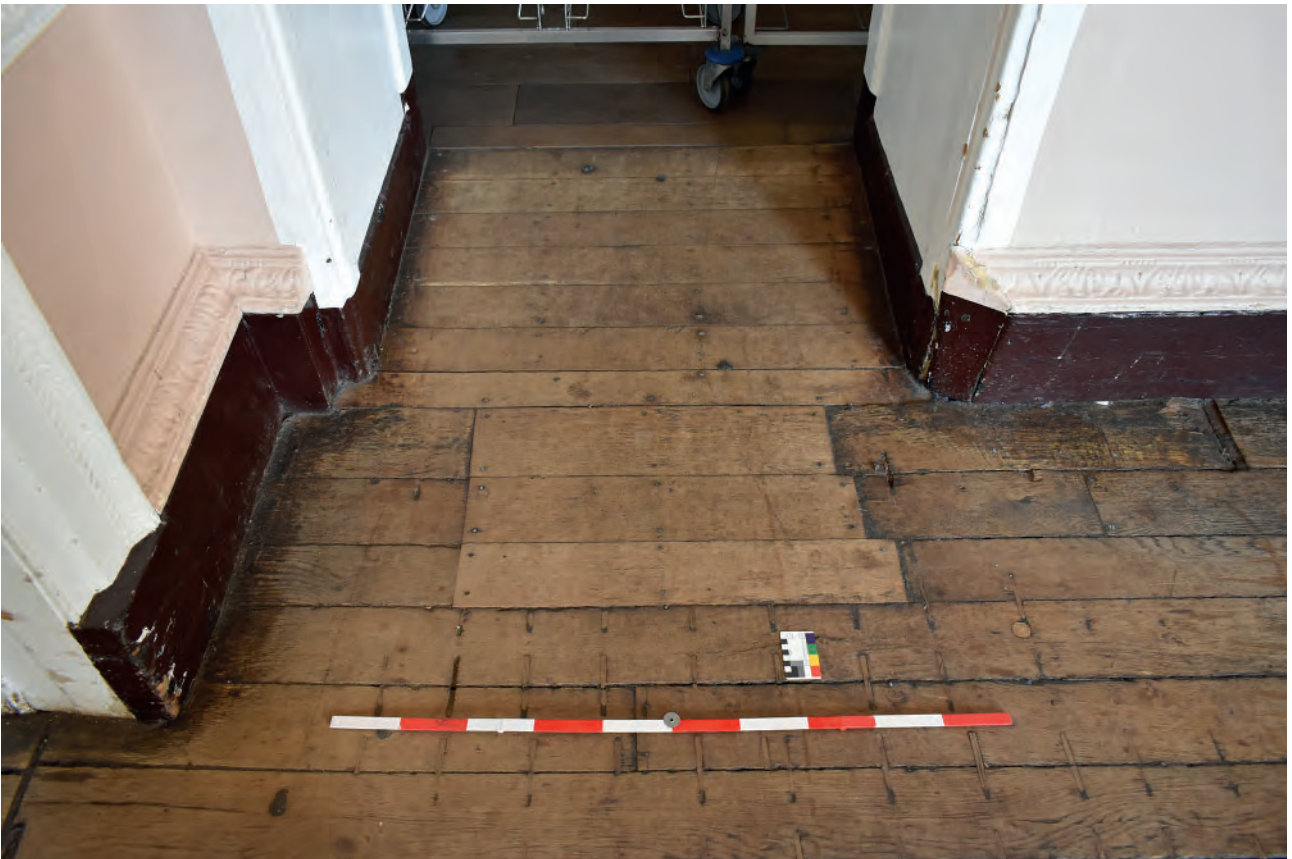
were heavily patched with assorted materials (Plate 144); the most recent to the east of the central doorway was plywood with a pattern of floorboards marked in permanent marker pen and fitted following a failure of the floorboards (Plate 145). Several patches were made from old school furniture including desk lids and drawer fronts (Plates 146-149).

Plate 144: Dining Room, floor, example of patching of the floorboards

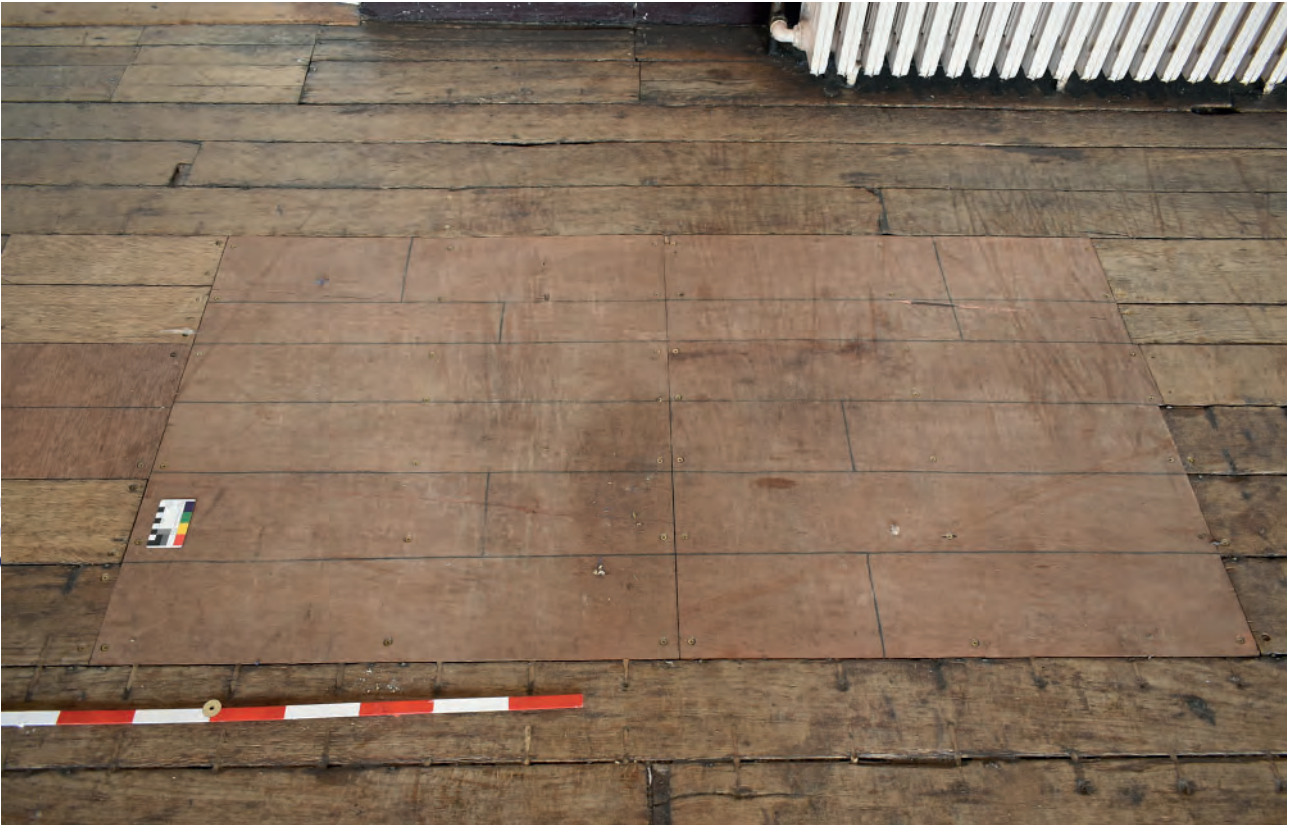
Plate 145: Dining Room, floor, example of patching of the floorboards

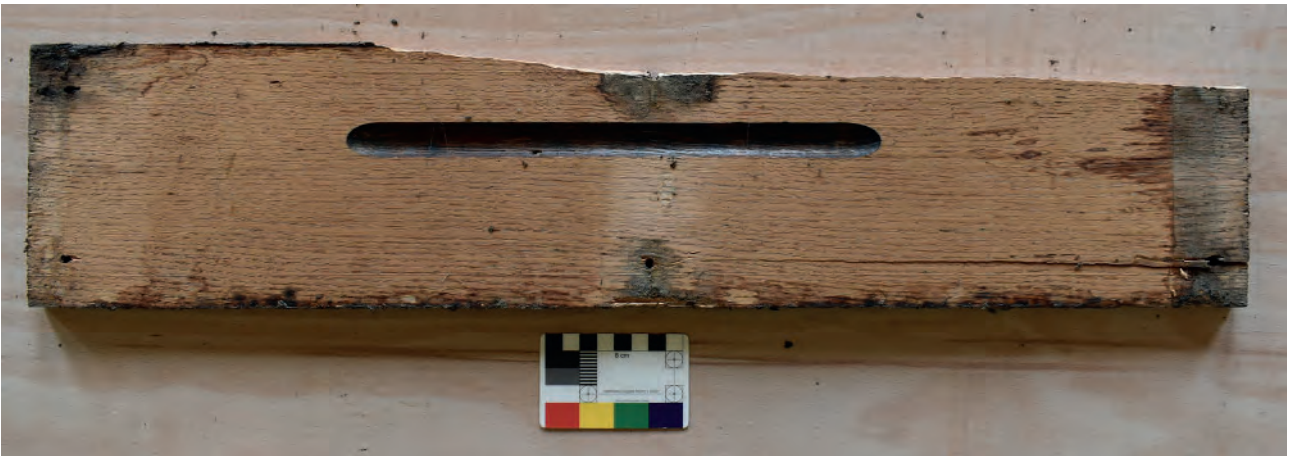
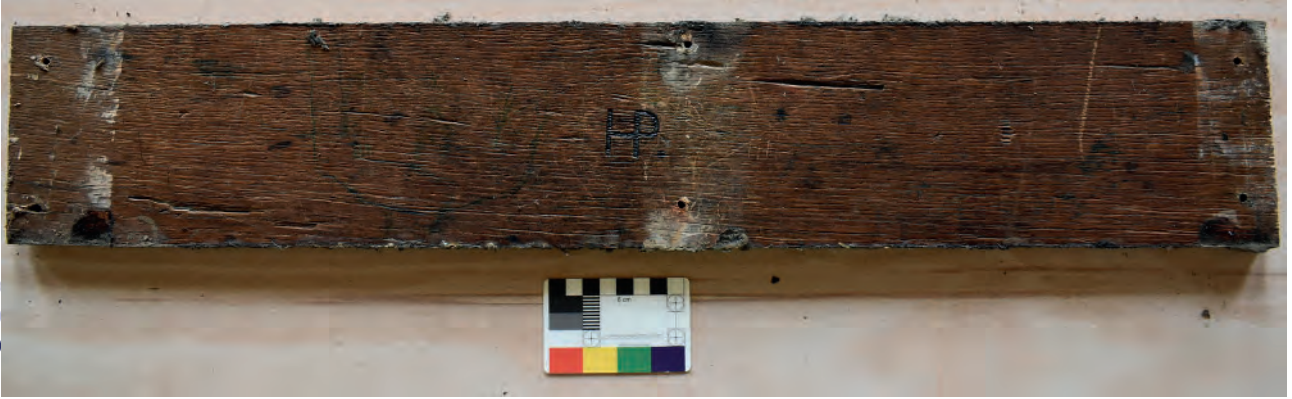
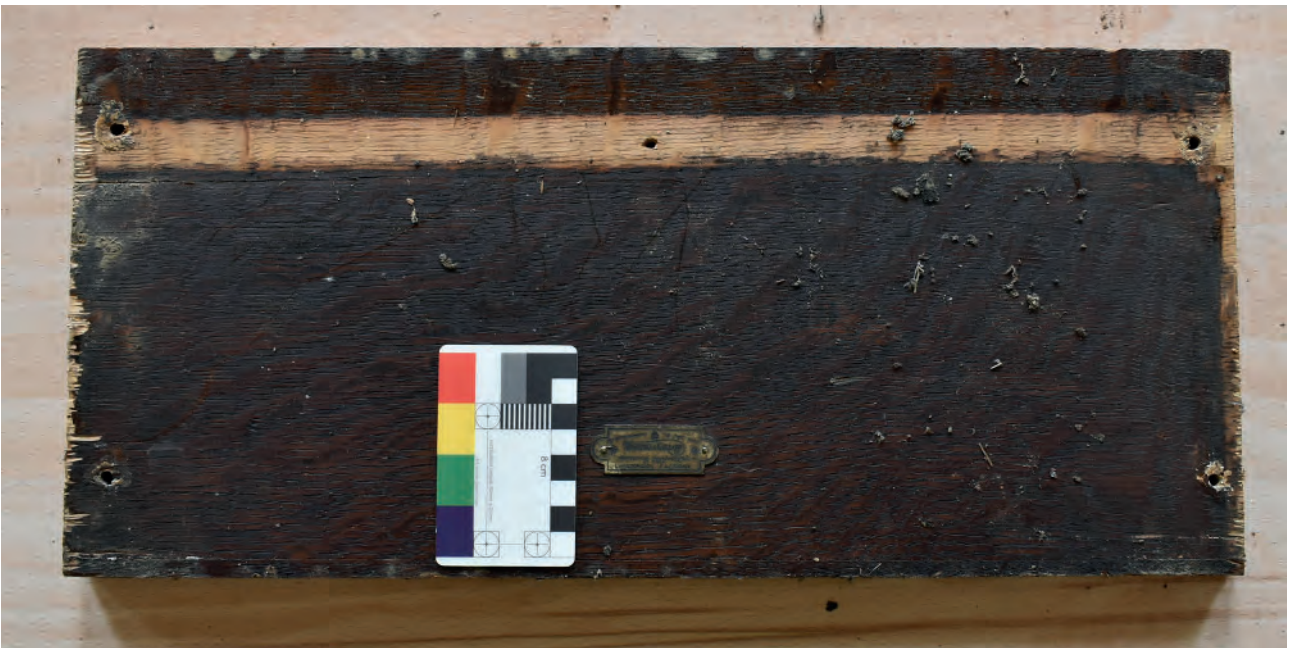
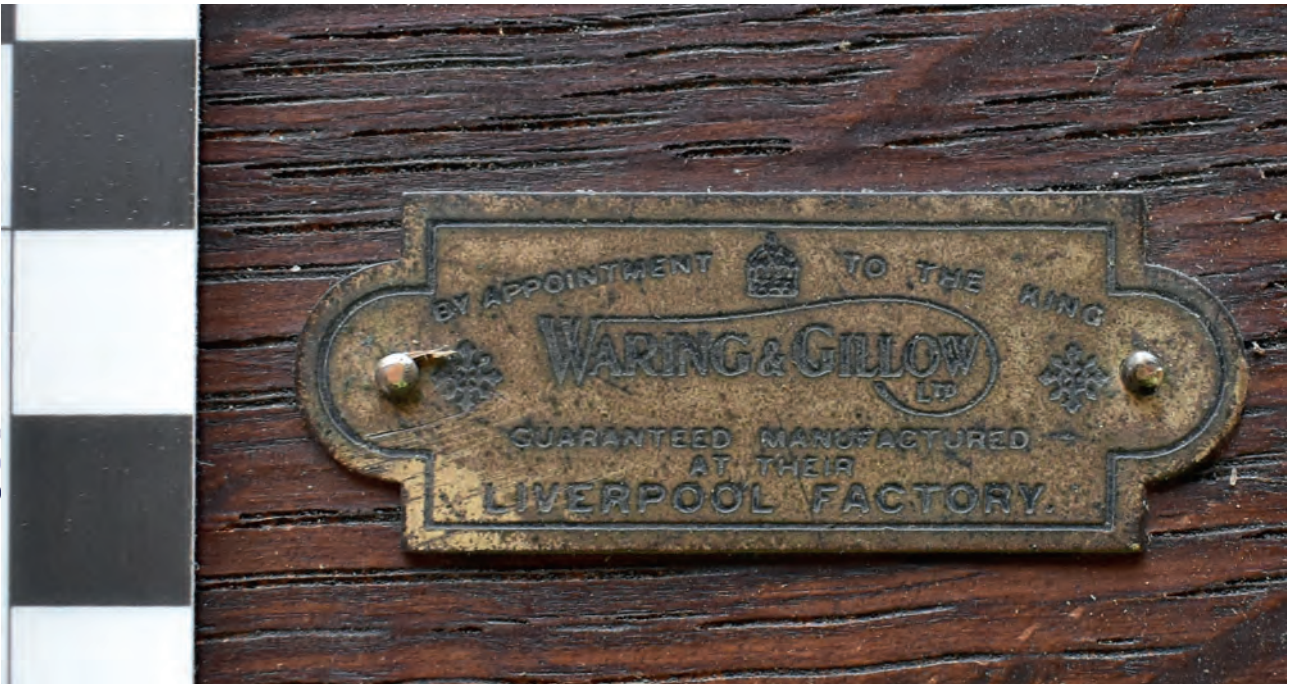
Plate 146: Dining Room, floor, example of furniture used to patch the floorboards

Plate 147: Dining Room, floor, example of furniture used to patch the floorboards

Plate 148: Dining Room, floor, example of furniture used to patch the floorboards

Plate 149: Dining Room, floor, example of furniture used to patch the floorboards

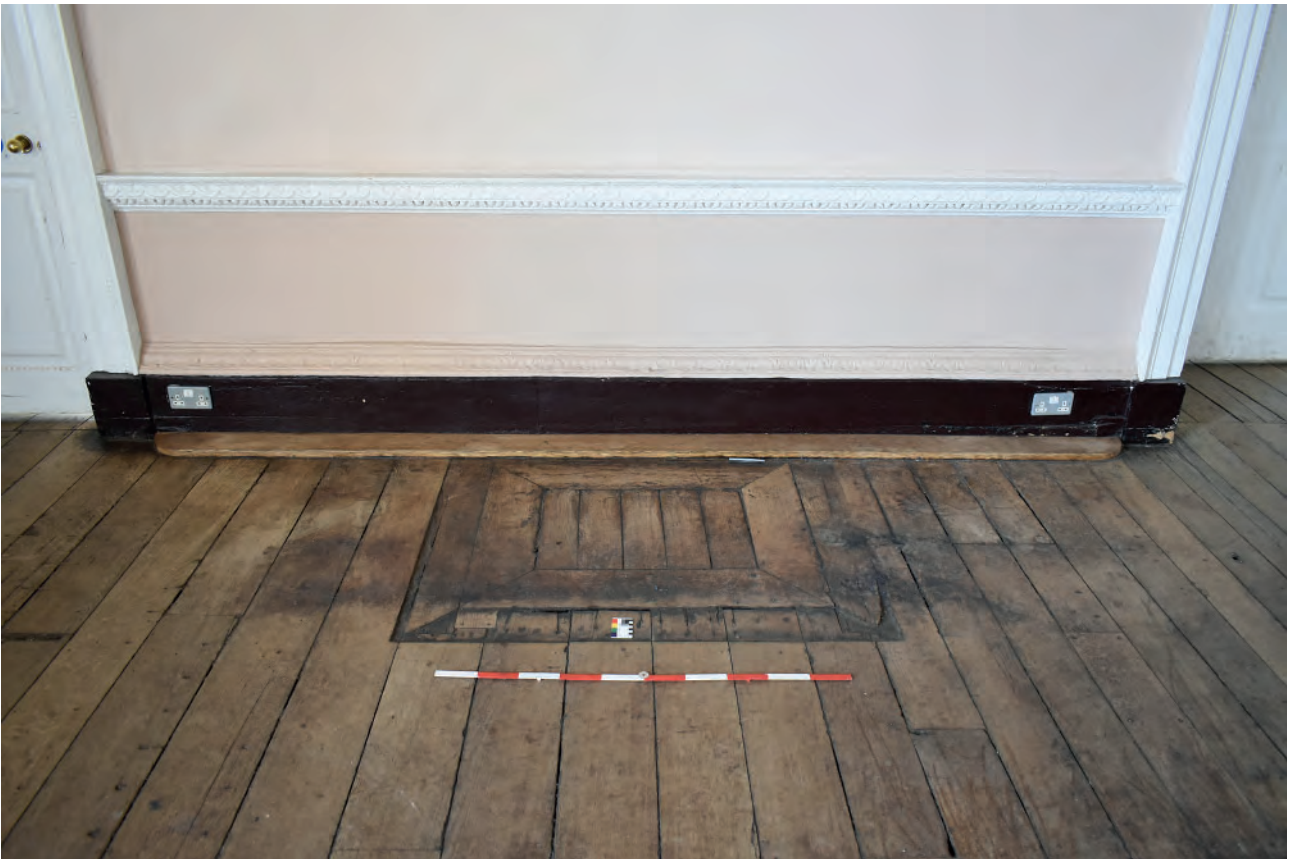
- 4.6.2 The dowelling was exposed in several areas where the boards were worn to almost half of their thickness (Plate 150). One instance of a repair, towards the west of the room, carried out far more carefully than the later patches, was noted (Plate 151). Features almost hearth-like in appearance were to the east and west ends of the room (Plate 152) which will be discussed below.

Plate 152: Dining Room, floor, the strengthened feature at the west end of the room

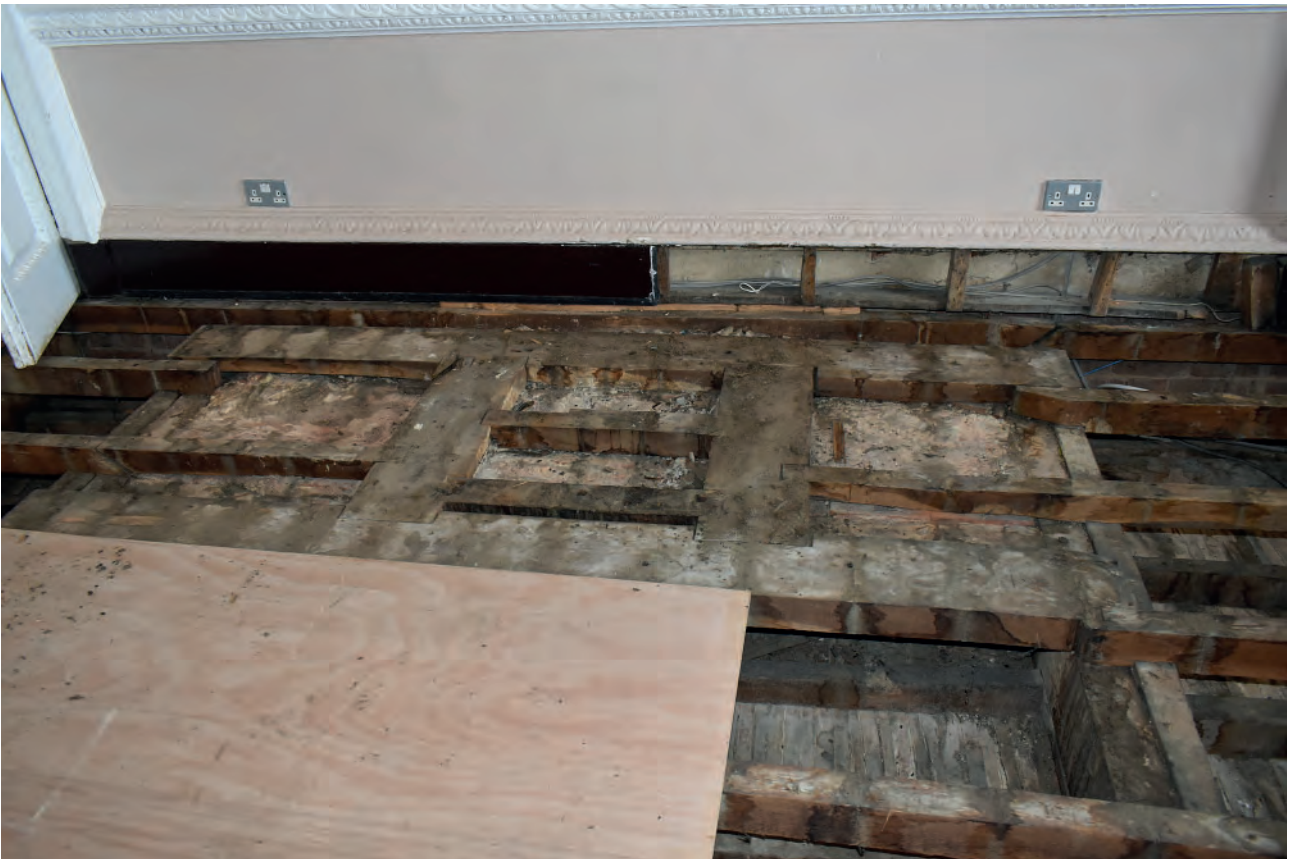
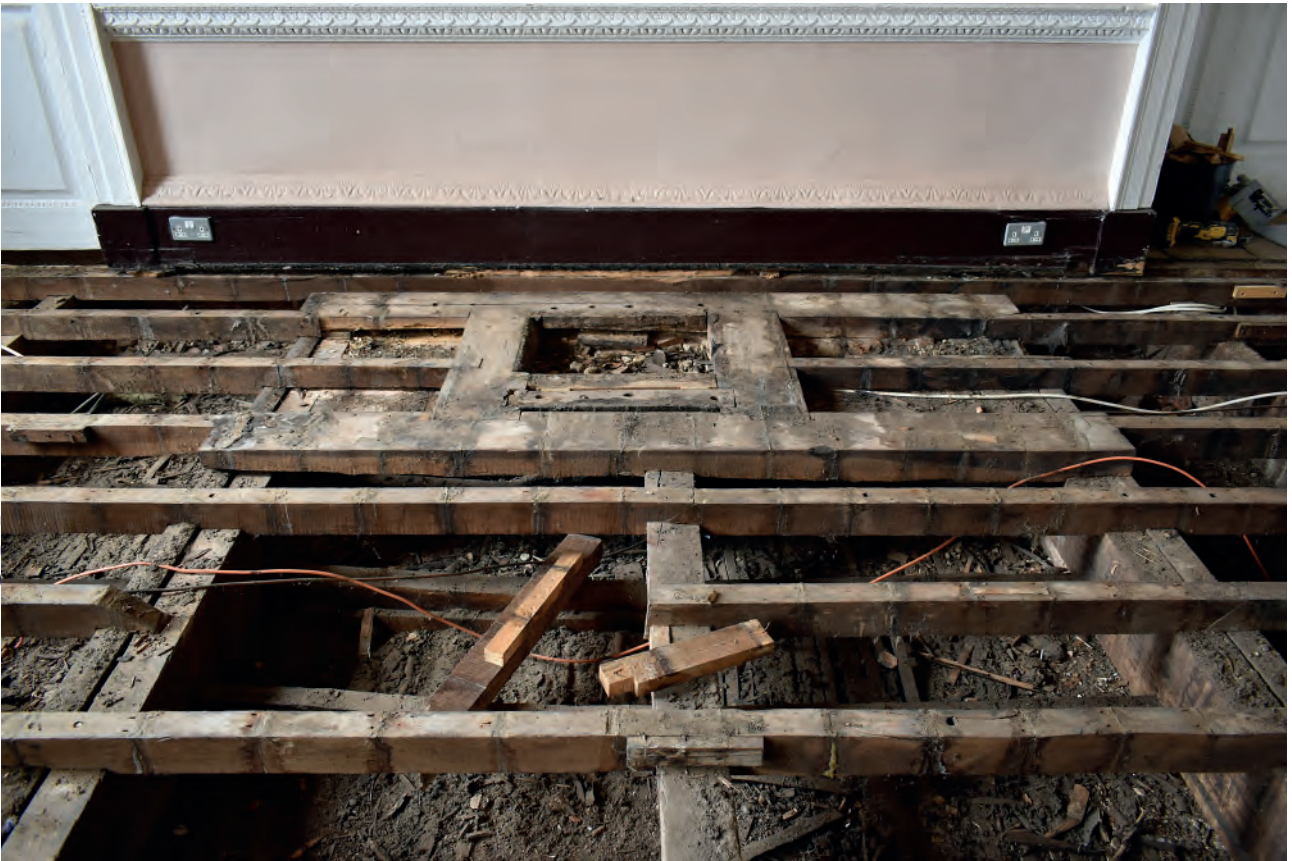
- 4.6.6 At either end of the room, two reinforced structures were uncovered which are similar in appearance to that of a hearth (Plates 166 & 167). Although there is a fireplace in this location in the room beneath the west end and a fireplace to the opposite side of the wall at the east end, there is no evidence of former fireplaces in this room or its past configurations. More evidence may be uncovered in the future phase of repair to the walls. It is more likely that they relate to structural strengthening for statues or heavy furniture. There was less wear to the floorboards above the features which supports this interpretation.

Plate 166: Dining Room, floor, strengthened feature at the east end of the room

Plate 167: Dining Room, floor, strengthened feature at the west end of the room

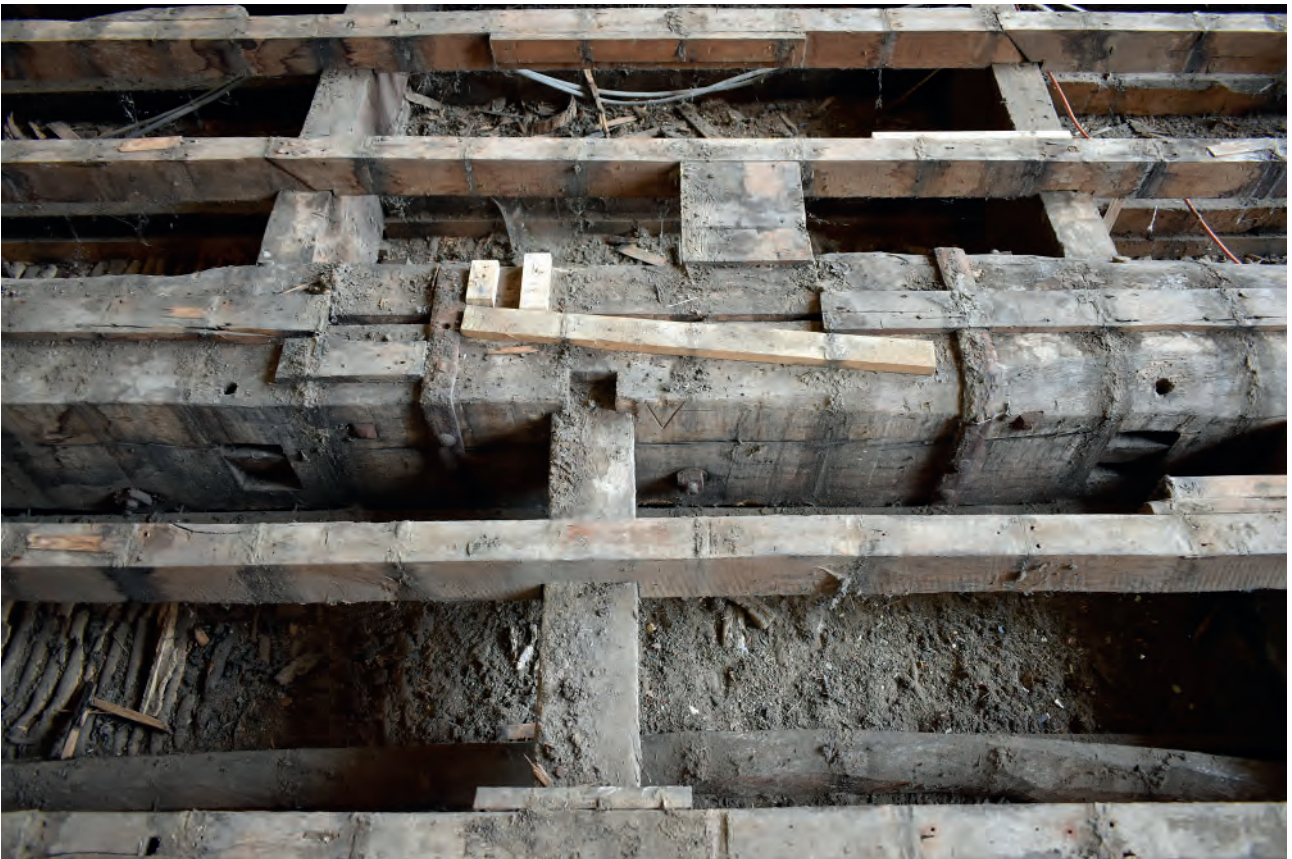
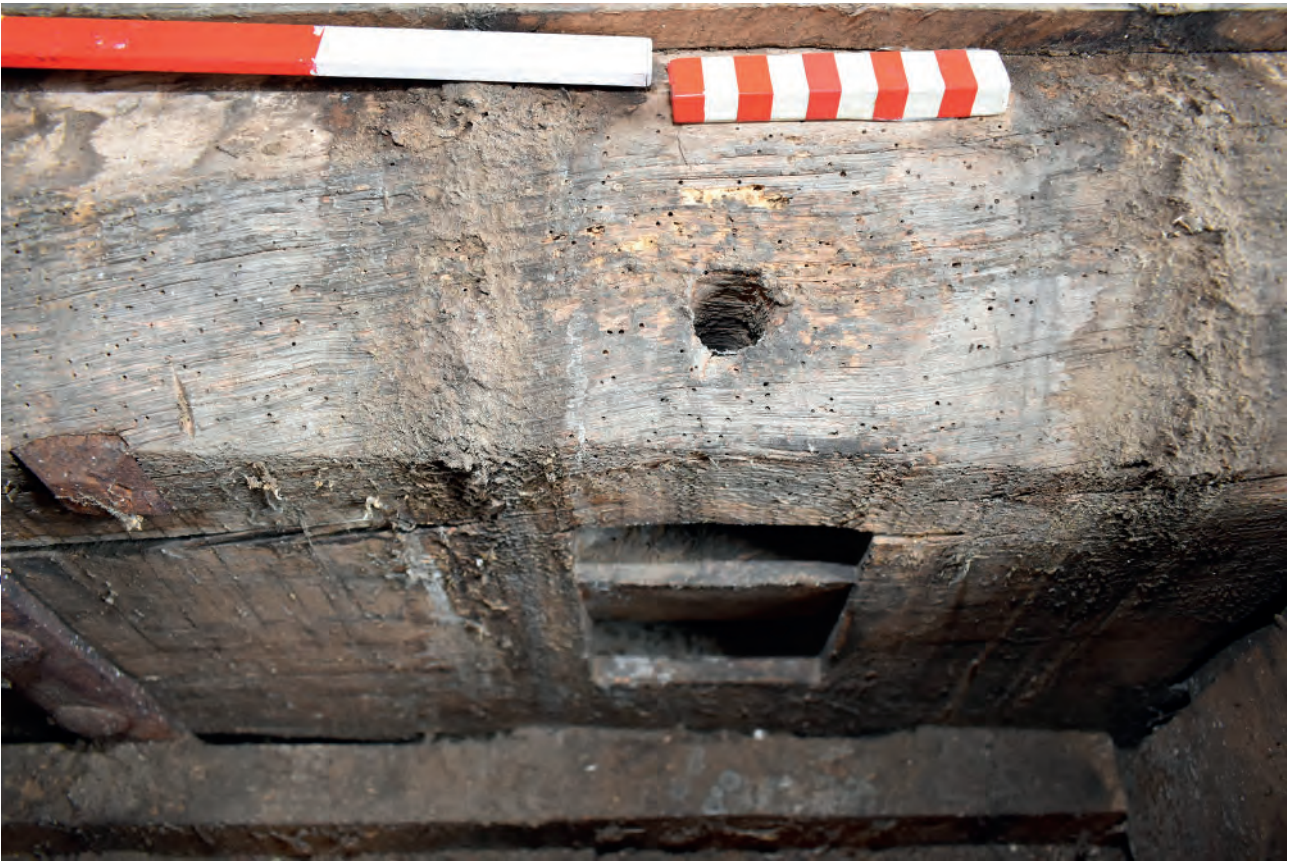
- 4.6.7 There are few signs of alterations, although two redundant mortices to the west end of the room in the primary beam close to the reinforced area indicate that the feature may be a later addition in a contemporary floor (Plates 168 & 169). Carpenter's marks are inconsistently incised into the beams and joists which do not suggest a construction pattern to the floor, however, neither is there sufficient evidence of reuse

Plate 168: Dining Room, floor, evidence of reconfiguration at the west end of the room

Plate 169: Dining Room, floor, redundant mortice at the west end of the room

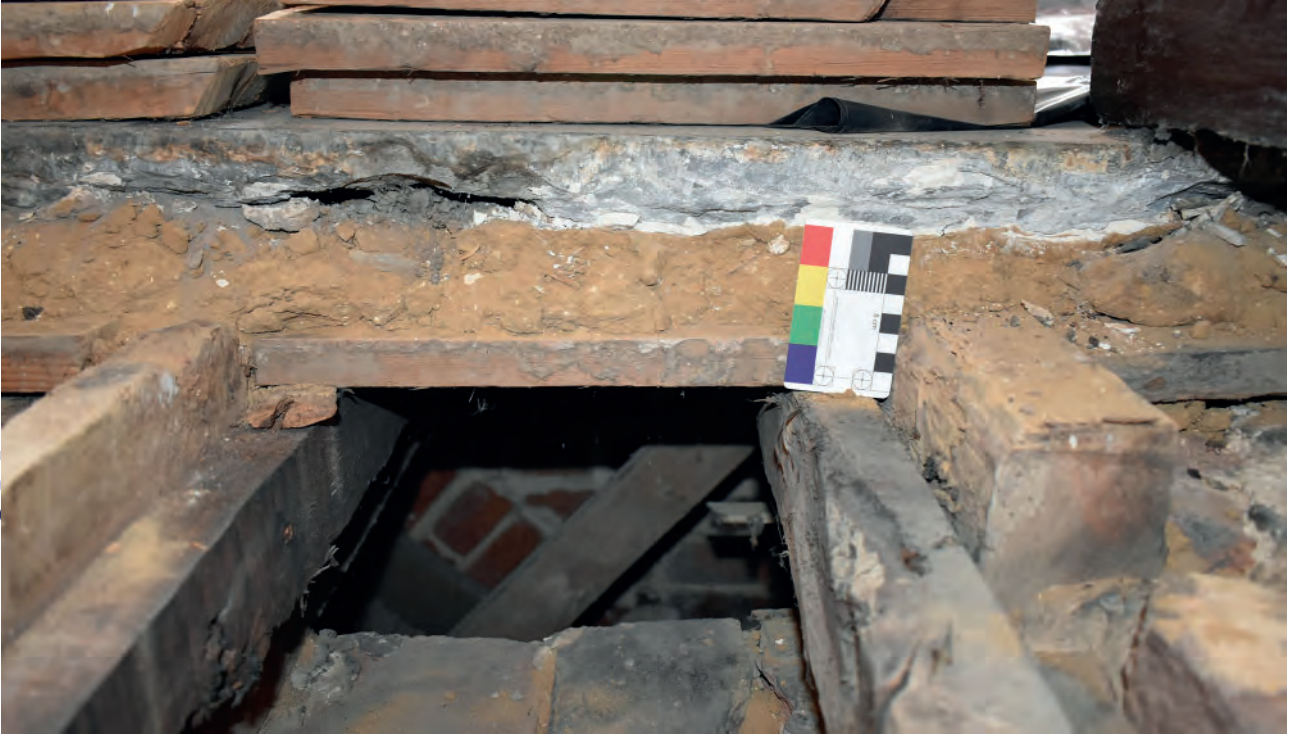
5.3.1 Beneath the stone floor was a packed sandy layer laid over the pugging boards (Plates 184 & 185). This had partially fallen between the boards and onto the ceiling below, causing the stones to shift and break.

Plate 184: West Corridor, floor, sandy levelling layer (provided by Nick Jones of Messenger)

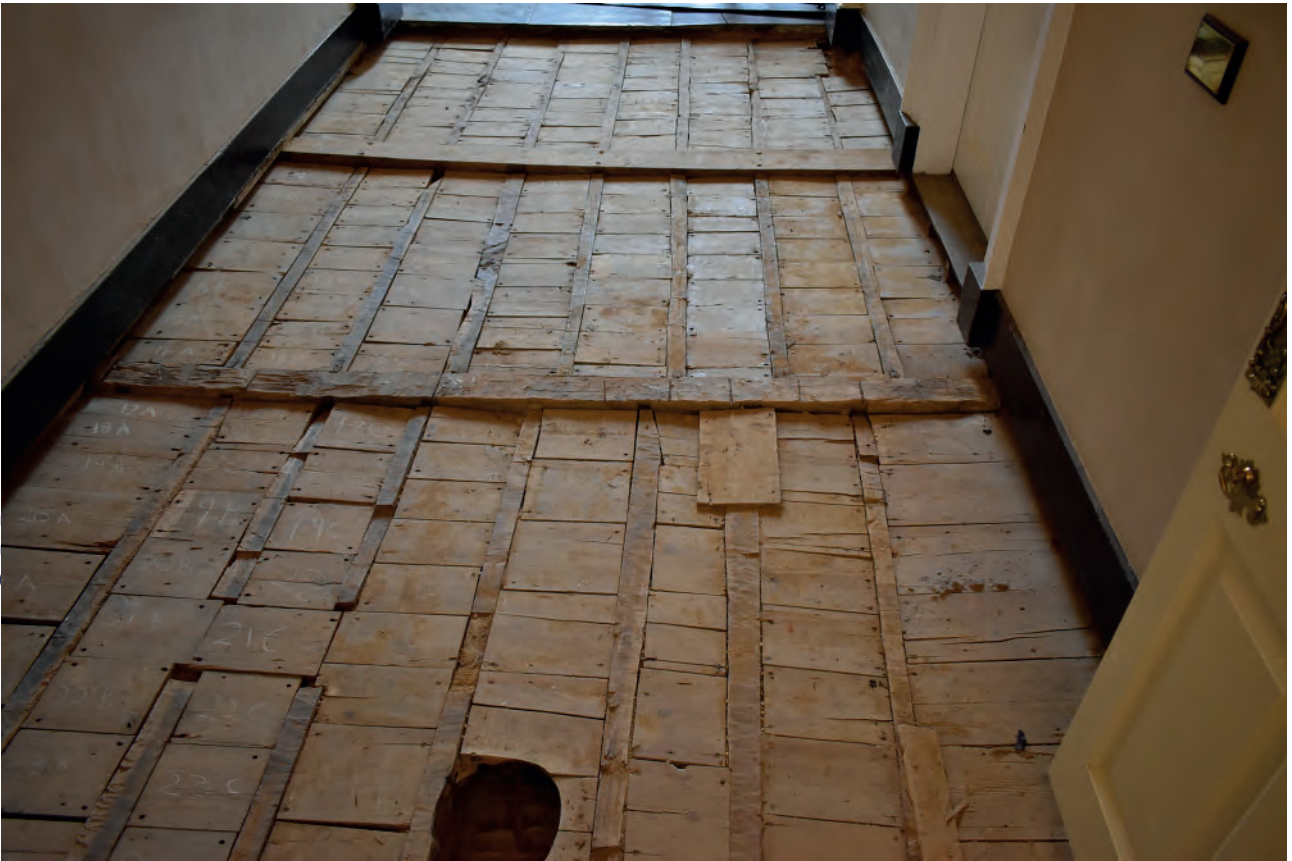
5.3.2 The pugging boards are 1" (25mm) thick, all cut to fit and are unfinished to the underside. They are all of different widths, with the widest noted at 280mm (Plates 186 & 187). A circular hole was in the pugging boards towards the east end of the floor which also cut into the joist and the pugging supports, which indicates that either the hole was cut *in situ* and post-dates the flooring, or it may represent a former structure which was worked around while constructing the floor (Plate 188). There was no reflection of any such feature in the floor covering and the lath and plaster of the floor below indicates any evidence beneath which may support that interpretation no longer exists.

Plate 186: West Corridor, floor, exposed pugging boards, looking east

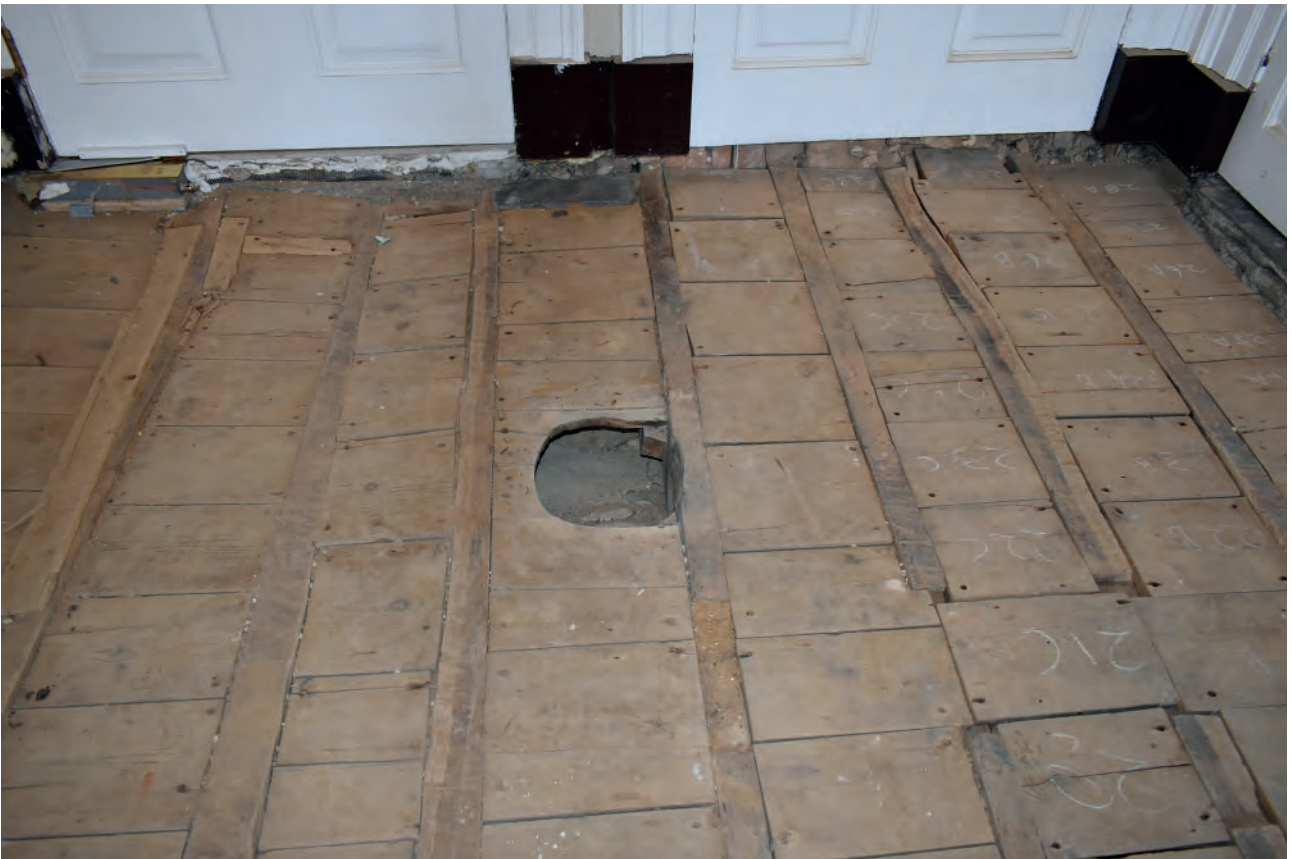
Plate 187: West Corridor, floor, exposed pugging boards, looking west

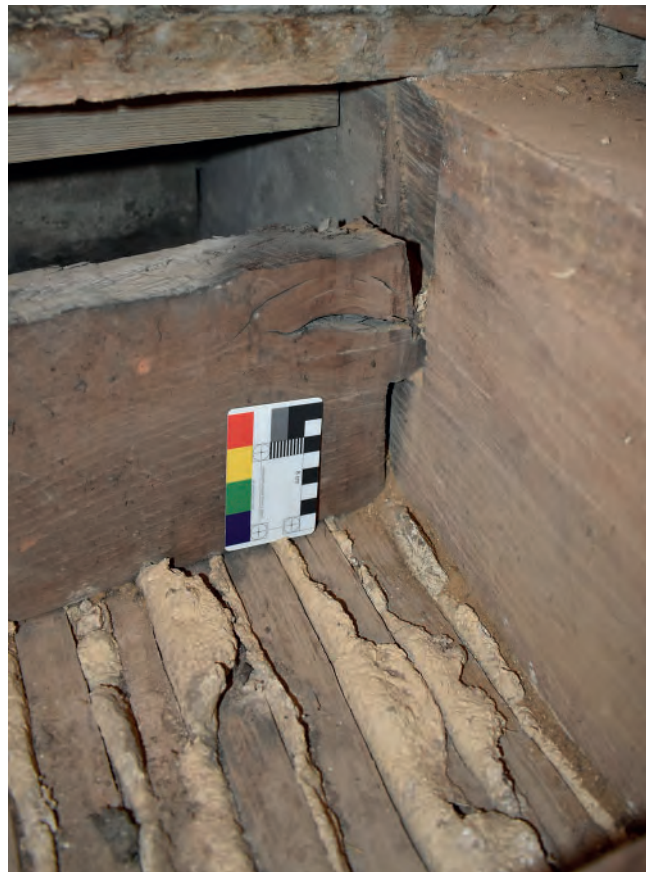
5.3.4 The easternmost of the beams appears to be surviving from the 1680s original phase of the building, having been fairly roughly hewn with an adze to the upper face to reduce it to the required height for the current floor surface and configuration (Plate 189). The original 1680s joists are mortice and tenoned into the east face of this eastern beam with no reinforcement; the upper edge of the mortices have been exposed by the hewing. The two sets of joists either side are staggered.

Plate 189: West Corridor, floor, detail of the altered easternmost beam

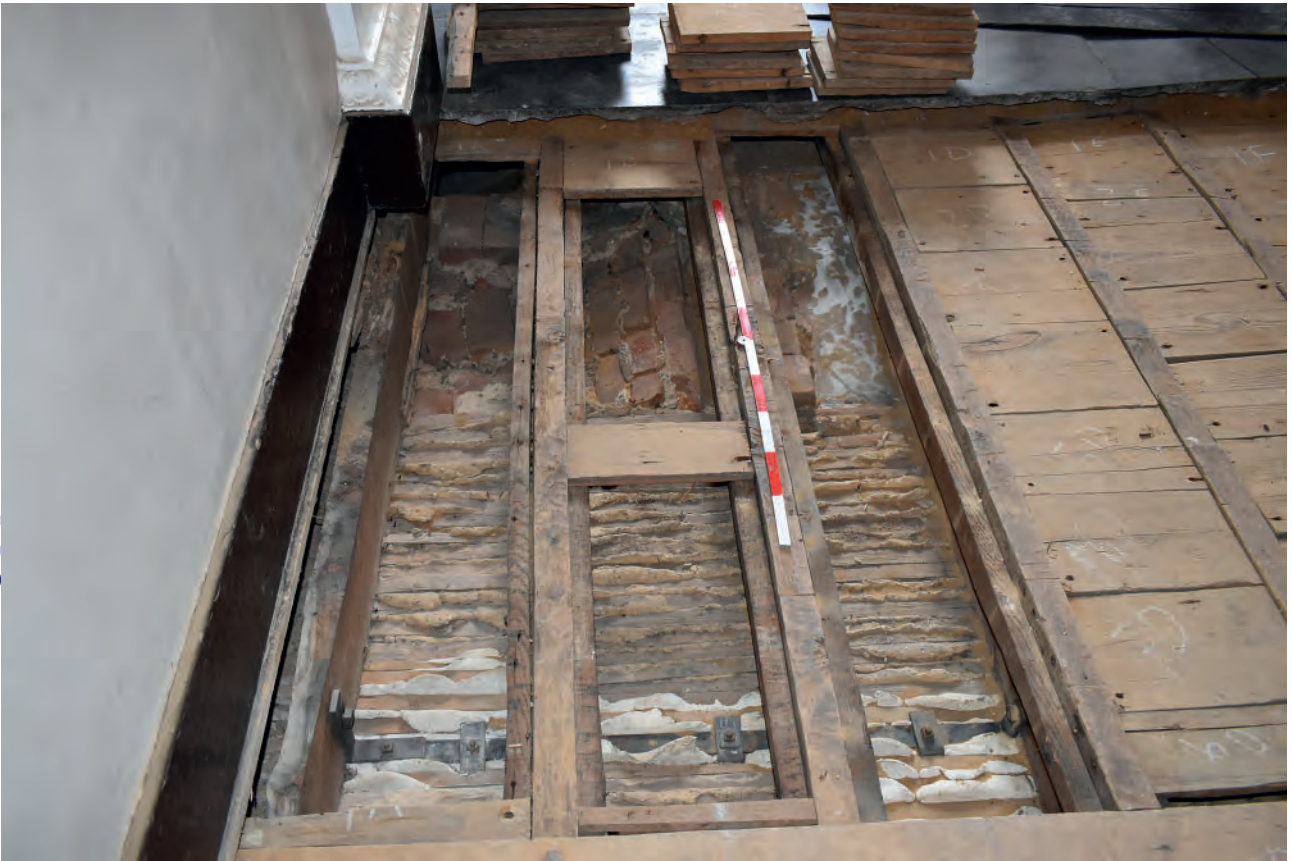
- 5.3.7 A large piece of timber runs east-west from the central bay to the west bay in the third space from the north (Plate 192). It may represent an earlier phase or function as it does not align with the surrounding timbers or perform a function in the current structure, other than the later ceiling attached to the underside. It has been cut to let in the westernmost beam and ends short of the easternmost beam.

Plate 192: West Corridor, floor, additional timber, looking east

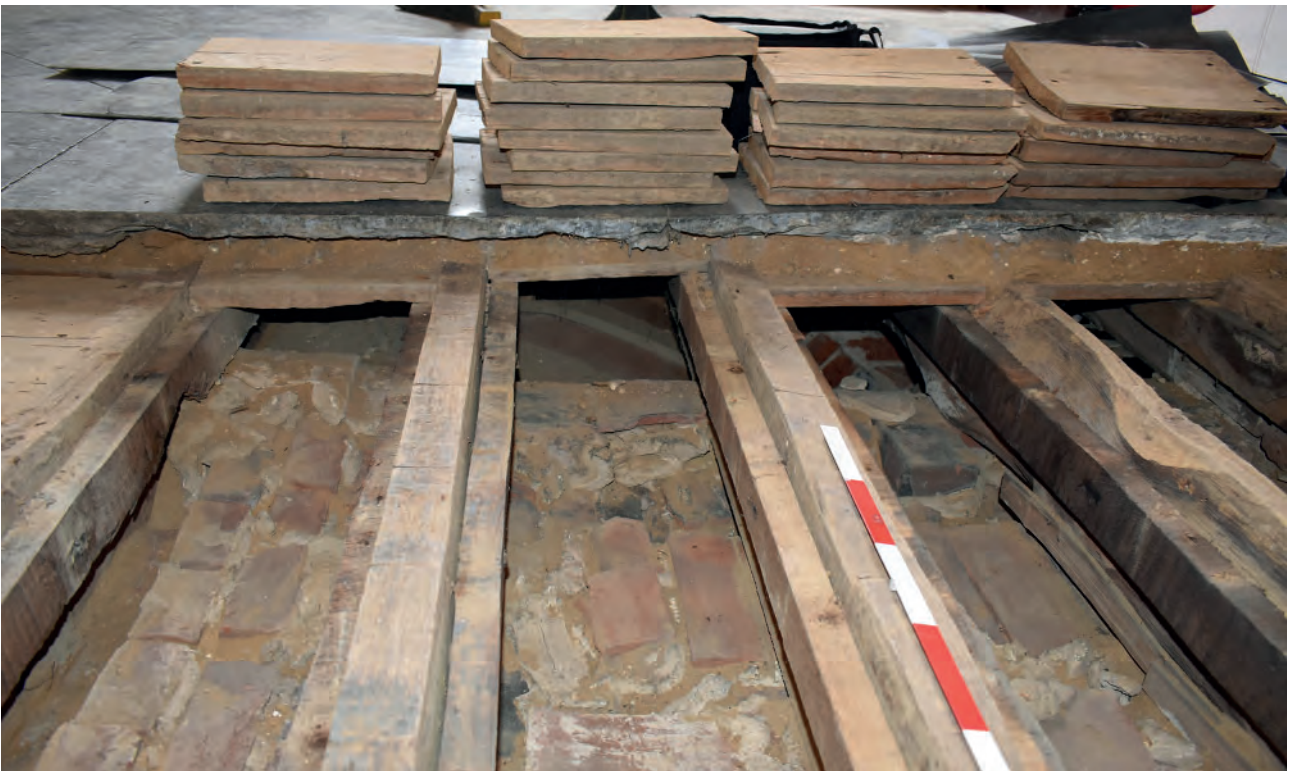
- 5.3.8 Sawn battens have been fixed to the side of all joists to support the pugging boards, these are likely to date from the c1730s phase.
- 5.3.9 A brick vault is to the west end with what appears to be a further vault beyond under the grey flooring to the west, which was not lifted (Plates 193 & 194). The vault incorporated some reused roof tiles, measuring 240 x 150 x 9mm. No bricks of the vault are fully visible but the composite measurement of a brick would be 225 x 107 x 66mm.

Plate 193: West Corridor, floor, brick vault beneath floor, looking west
