# Temple Room, Dining Room and West Corridor Stowe House, Buckinghamshire.

## Historic Building Recording

September 2022

**Client: Stowe House Preservation Trust**

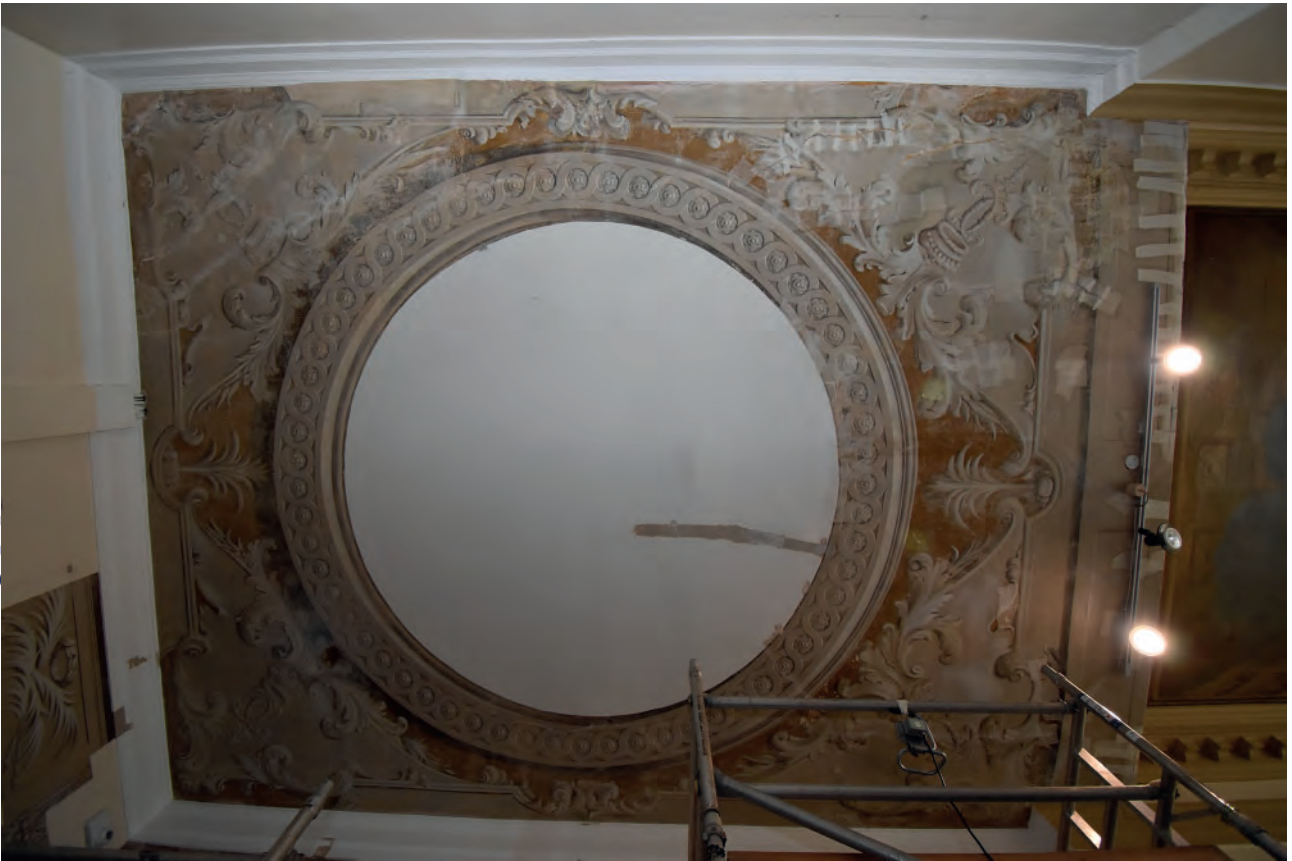
- 6.1.2 In summary, as detailed in Clarricoates' chapter, the c1740 painted ceiling 'Fame and Victory' by Francesco Sleter above the staircase and decorated ceiling above the landing were until recently the only prominent decoration of the east staircase (Plates 196 & 197). Clarricoates describes the inclusion of the 'Grand Staircase' paintings in 18th-century guidebooks, however, it appears that two of the paintings named alongside 'Fame and Victory' were lost, likely during the 1770s remodelling. The decoration to the walls had been described as 'warlike pieces' in the same guidebooks. The 'warlike pieces' have now been uncovered sufficiently to be shown to include a figure of Minerva or Athena carrying a shield in a trompe-l'oeil niche on the landing (Plates 198 & 199). Further figures and emblems are being revealed (Plates 200 – 202).

Plate 196: East Corridor Wall Paintings, ceiling above stairs

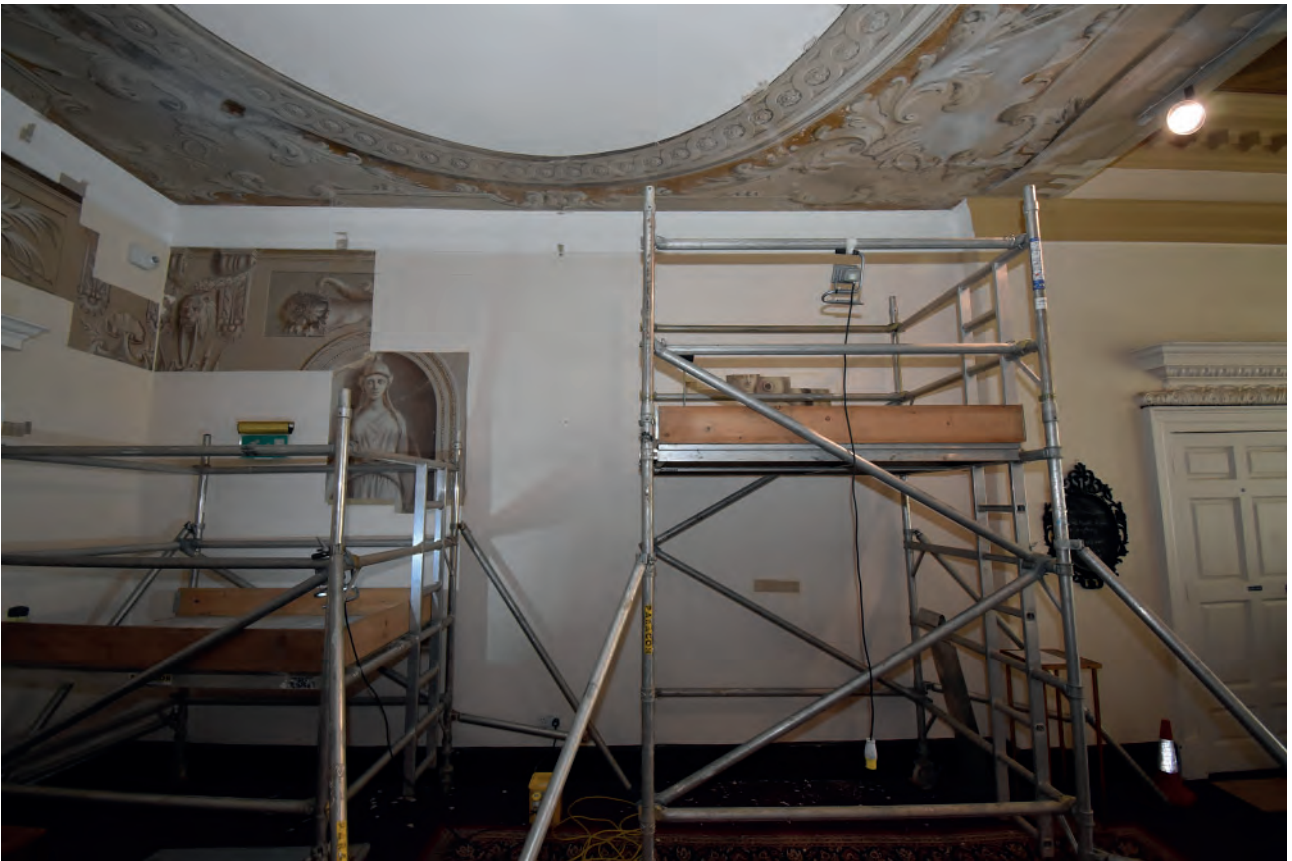
Plate 197: East Corridor Wall Paintings, ceiling above landing

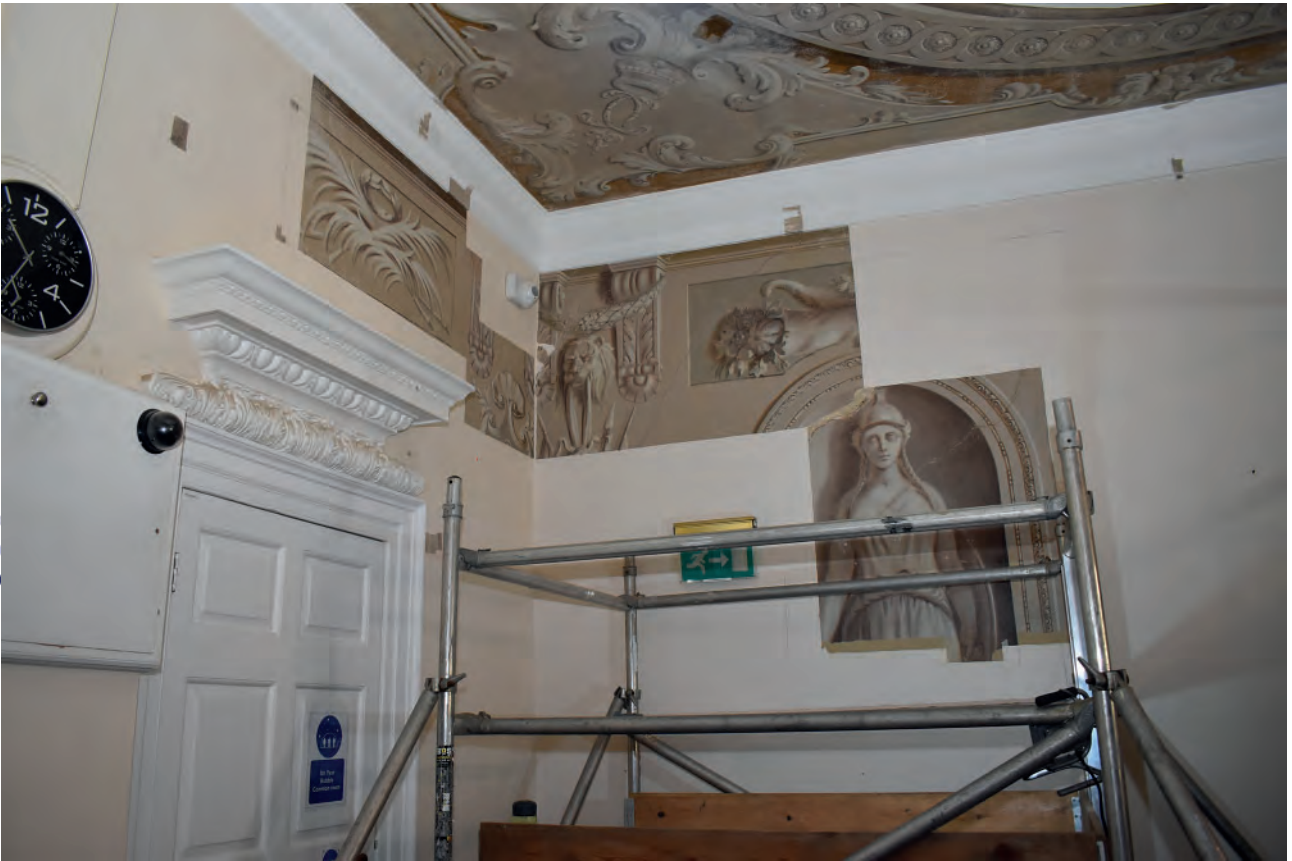
Plate 198: East Corridor Wall Paintings, north wall

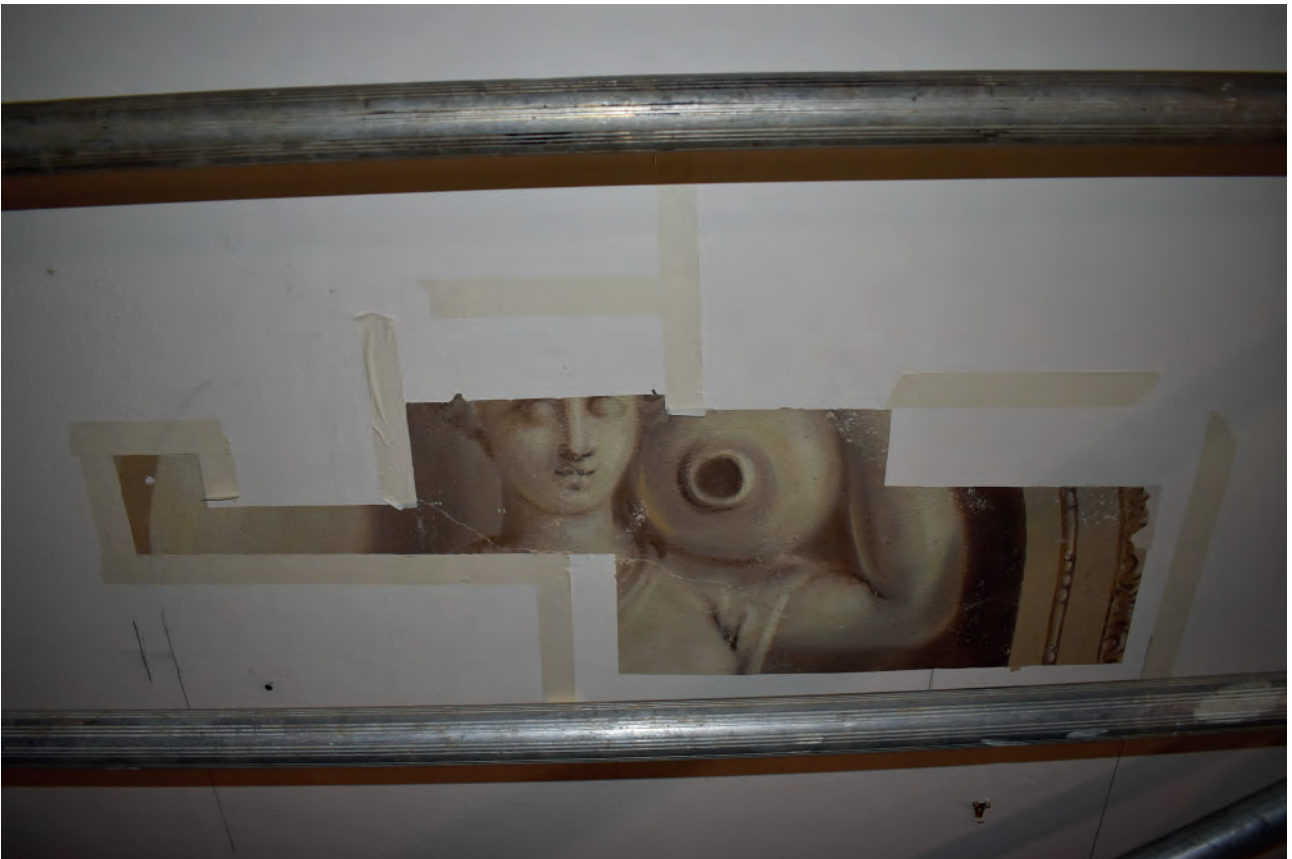
Plate 199: East Corridor Wall Paintings, north west corner

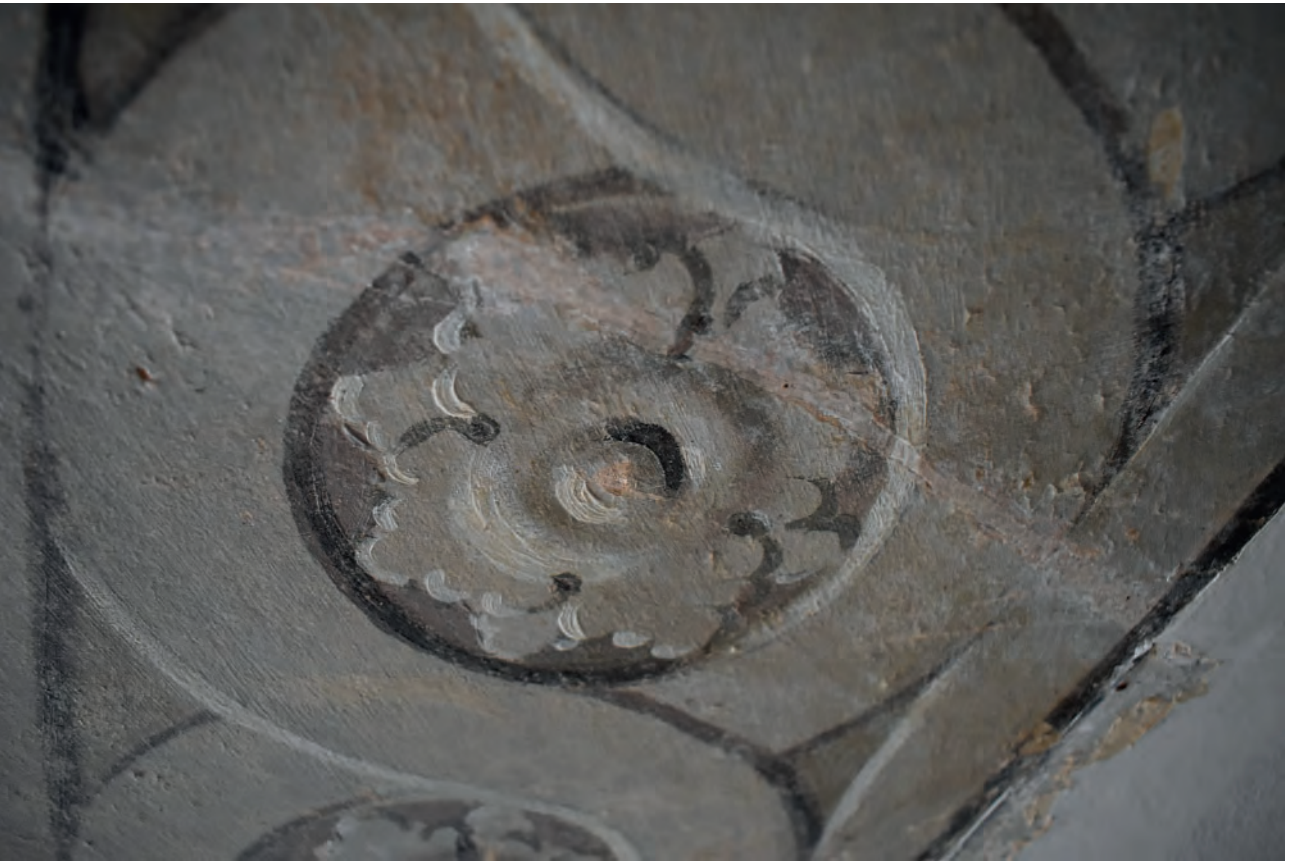
Plate 200: East Corridor Wall Paintings, example of emerging detail

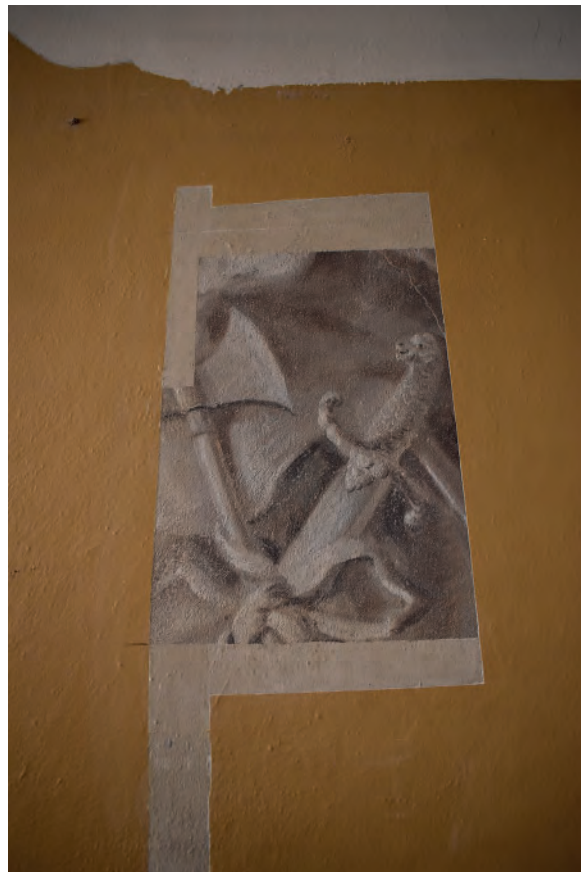
Plate 201: East Corridor Wall Paintings, example of emerging detail

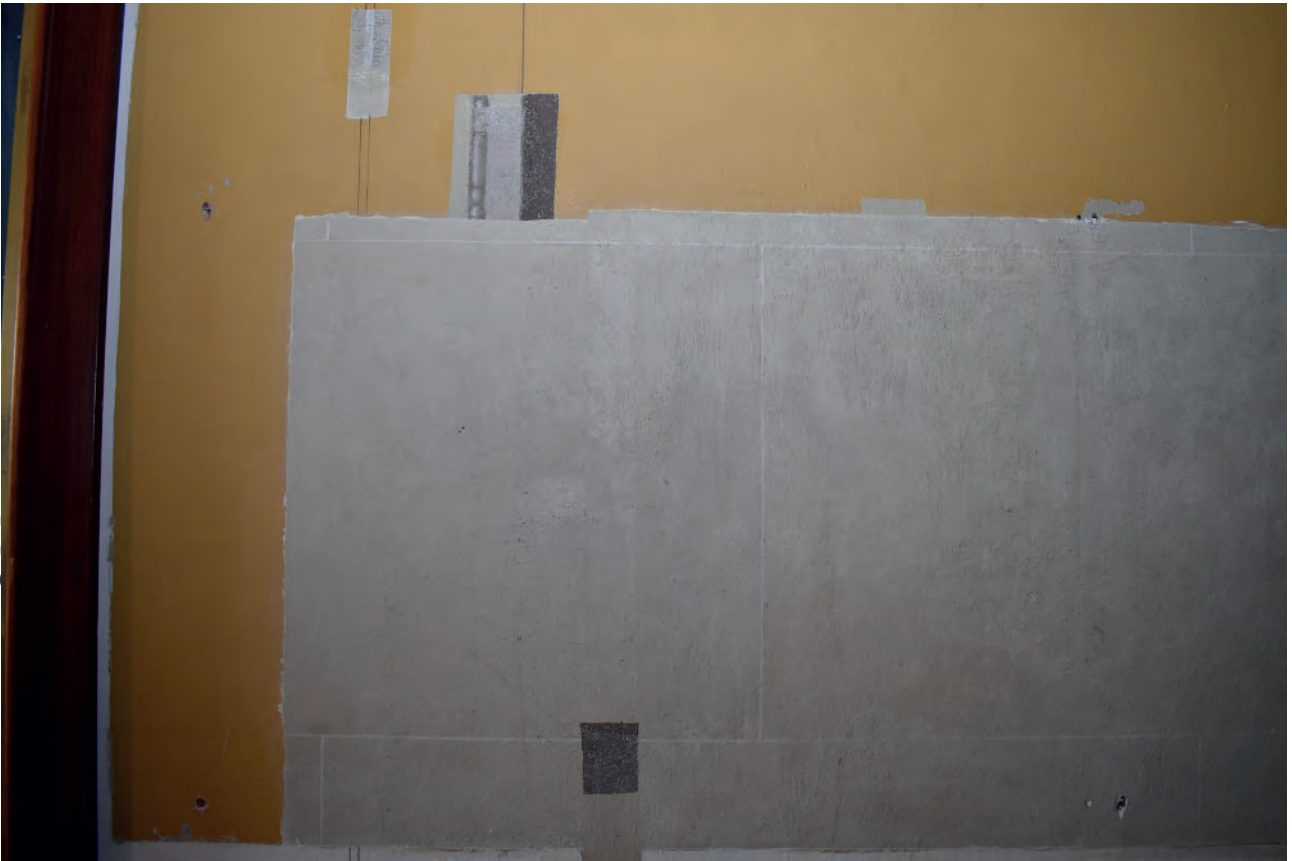
Plate 202: East Corridor Wall Paintings, example of emerging detail

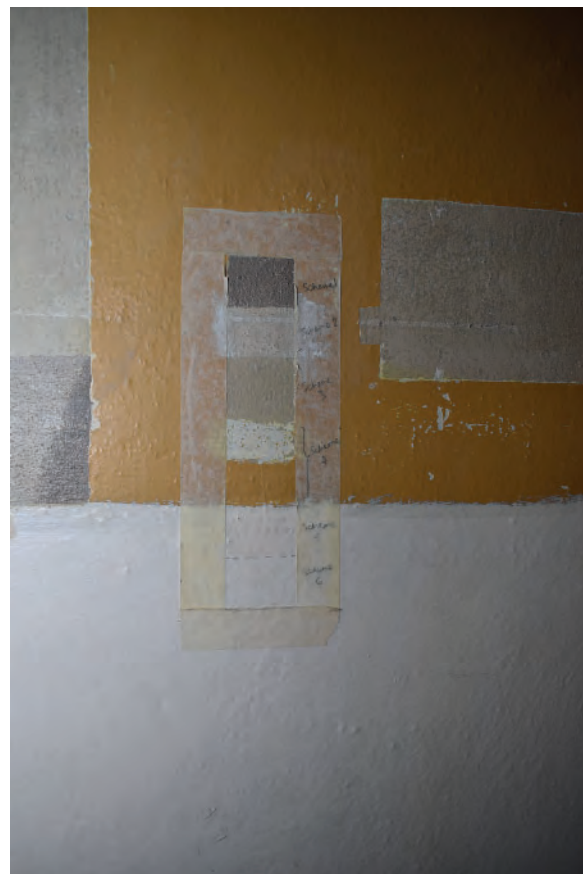
- 6.1.4 The layers of paint over the wall paintings were plain with the exception of the second scheme which comprised a pale stone colour paint with thin, white painted lines to imitate ashlar blockwork (Plates 203 & 204).

Plate 203: East Corridor Wall Paintings, example of second phase of decoration
