# State Dining Room Stowe House Buckinghamshire

## Historic Building Investigation and Recording

July 2023

Document Type: Historic Building Investigation and Recording

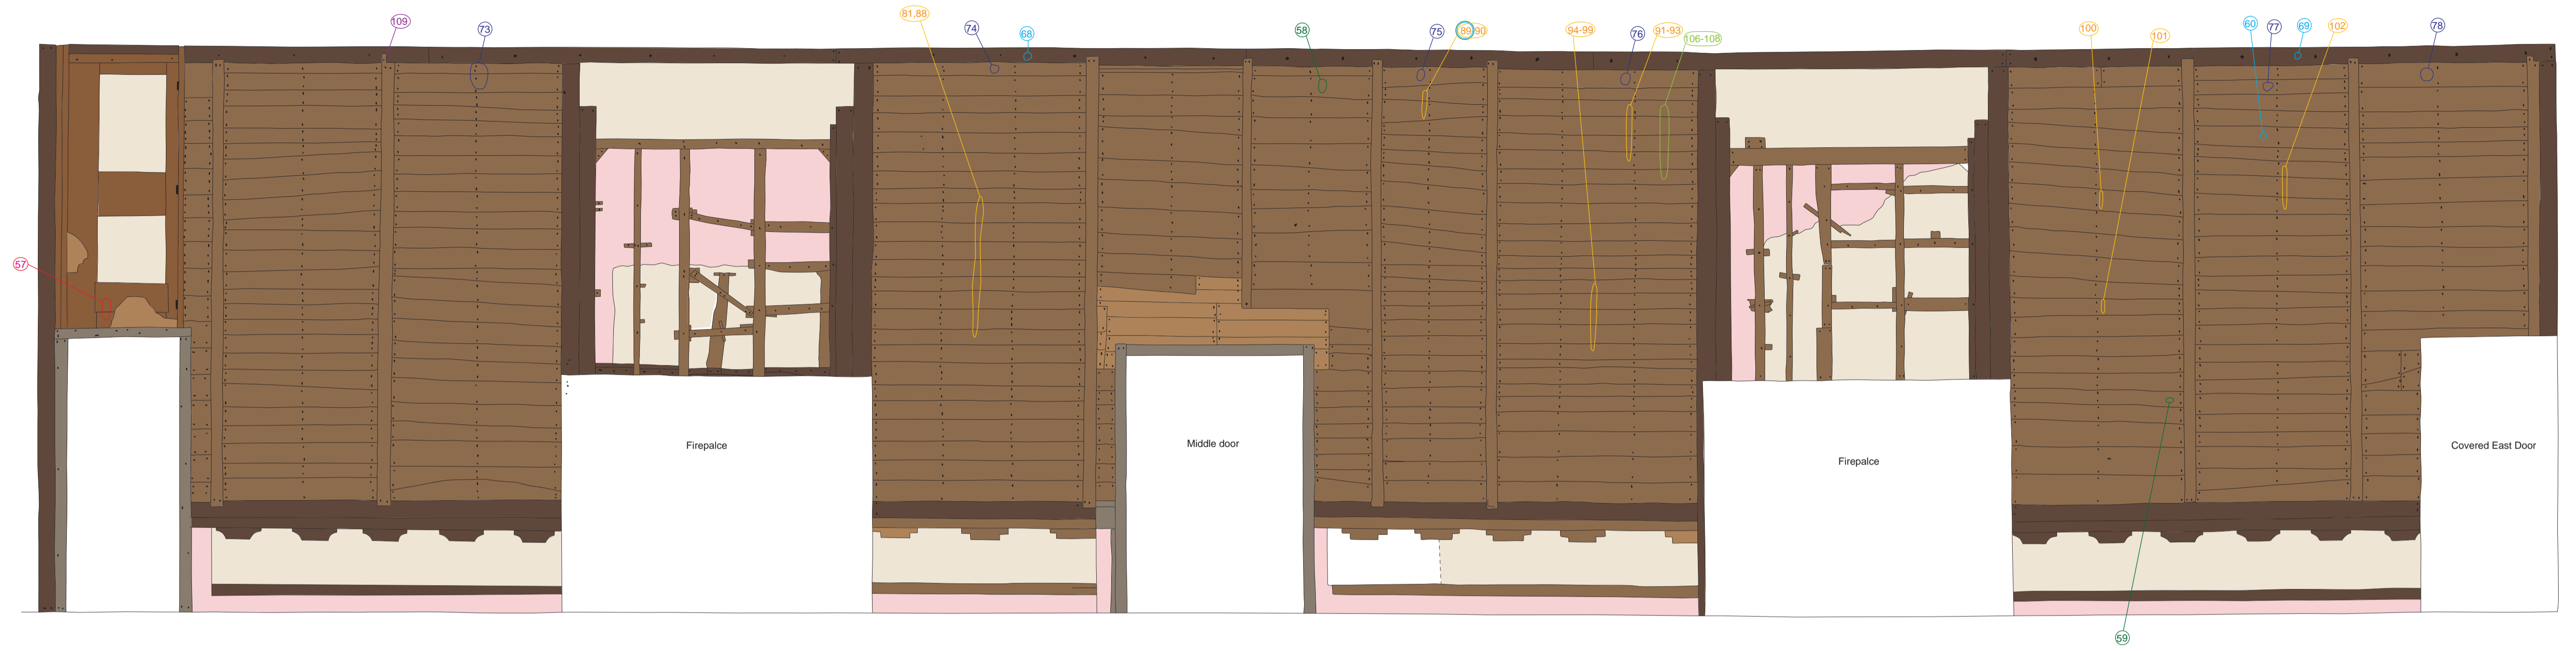
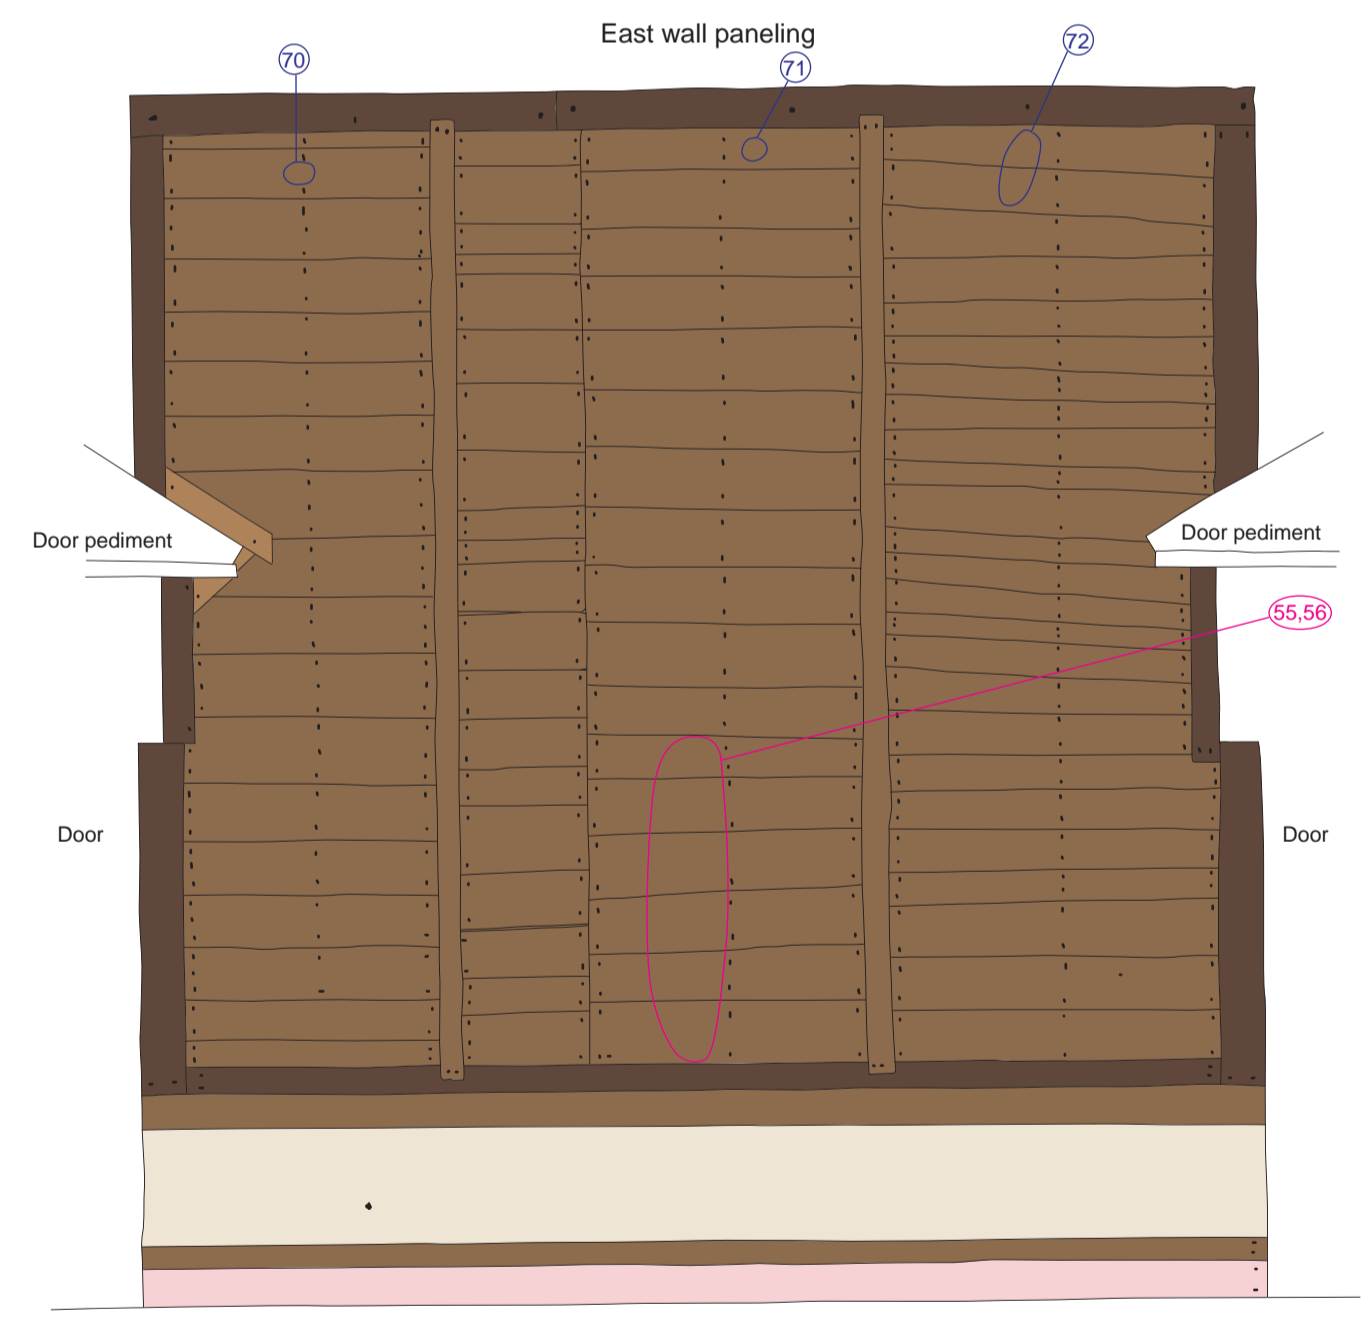
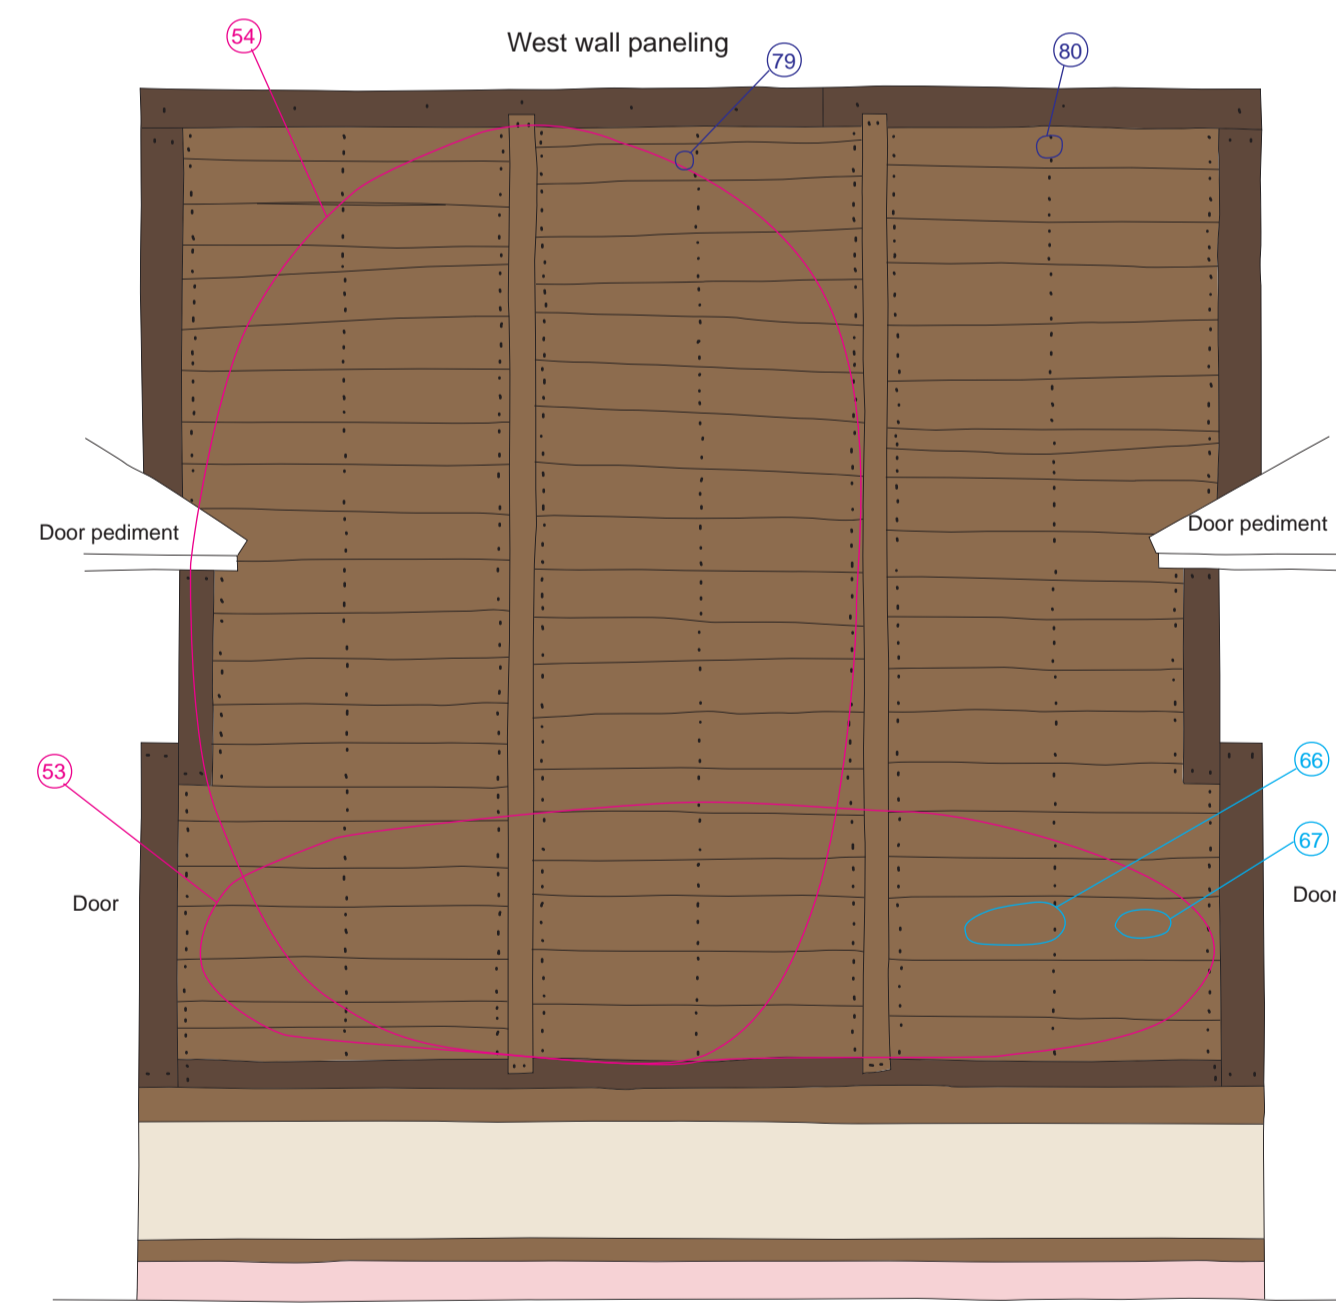
Figure 5: Wooden paneling on west, north and east walls of State Dining Room

- 3.2.20 Various pieces of graffiti have been noted on the sarking boards but perhaps the most interesting and impressive is the drawing of the outline of a sofa extending across the timber boards of the lower part of the west wall (Figure 5, Plate 53). The drawing is in pencil and it measures 300 x 95 cm. It is drawn directly on sarking boards and therefore under the wallpaper. Although the drawing is only in outline it has a Rococco design with a richly decorated upper frame, incorporating scroll shaped armrests, and slightly S-shaped legs. In addition, on the first two sections of boarding (counted from the south) there are two large X signs drawn along the entire length of the paneling (Plate 54). Unfortunately, the context of sofa graffiti is unknown, and it is unrelated to any known scheme in the room. Perhaps it was an idea for decorations of the room referring to the style of the 18<sup>th</sup> or 19<sup>th</sup> century. It should be noted that the graffiti is part way up the wall rather than being at floor level.

- 3.2.21 On the opposite wall, on the second panel counting from the north, a vertical line was drawn in pencil, which goes from the twelfth board down to the dado rail. On each board through which the line passes, what may have been stems of leaves are schematically drawn, or it is possible that these are the letter V (Figure 5, Plates 55 and 56).

- 3.2.22 On the hinged frame, above the west door of the north wall, to the west of the trace of the bell, there is a scratched graffiti depicting the profile of the unknown element (Figure 5, Plate 57).

- 3.2.34 Only some boards are numbered in this style, but a certain relationship has been noticed: All boards with this numbering are only on the uppermost part of the paneling, usually the first or second board from the top (Figure 5). On the eastern wall there are boards with the letter *B* (Plates 70- 72), on the northern wall there are boards with the letter *A* (Plates 73- 78), and on the western wall there are boards with the letter *C* (Plates 79 and 80).

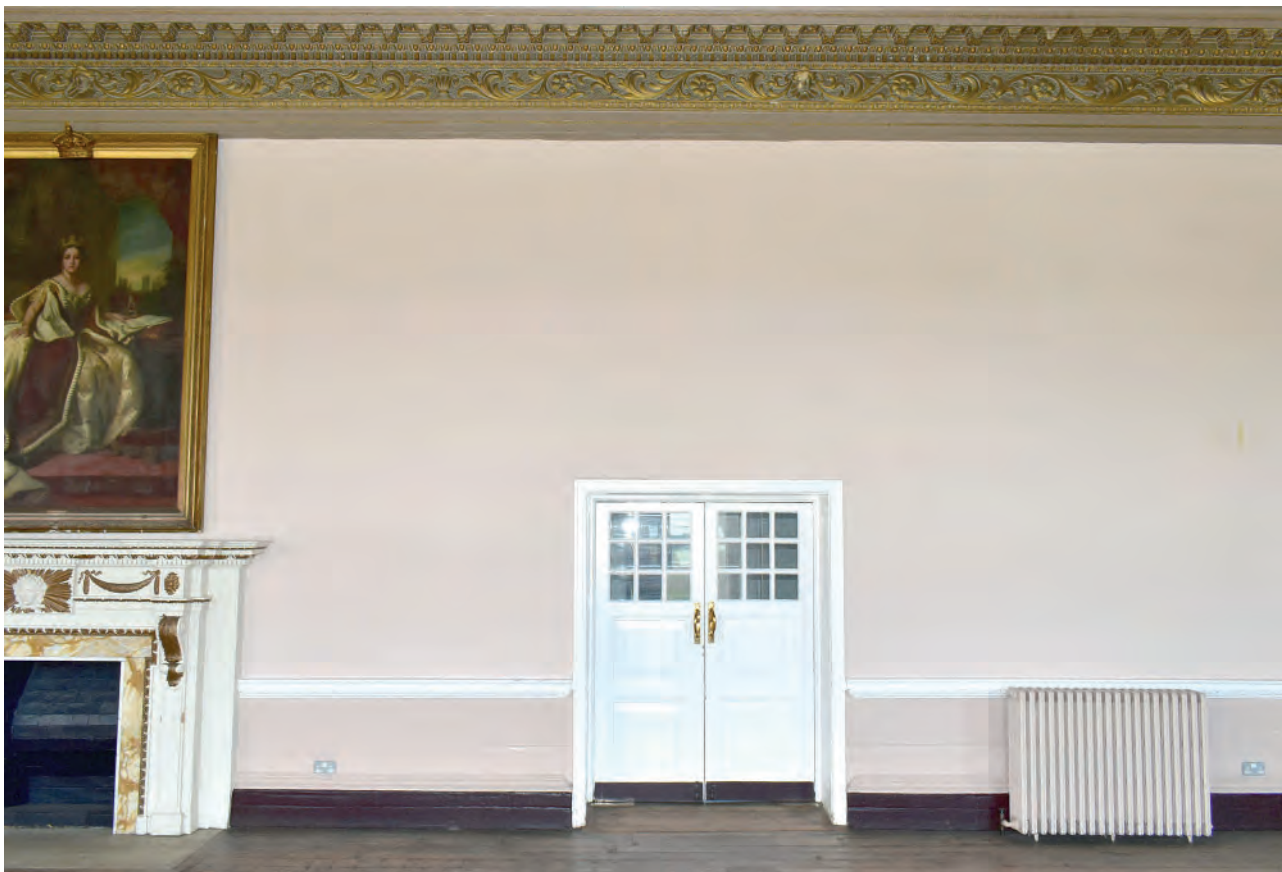
Plate 1: North wall, example of an early 20th-century doorway

- 3.1.2 The Dining Room is accessed via a doorway from the former Drawing Room to the west, as well as via three doorways from the corridor to the north, each of which were formed during the building's use as a school (Plate 1).

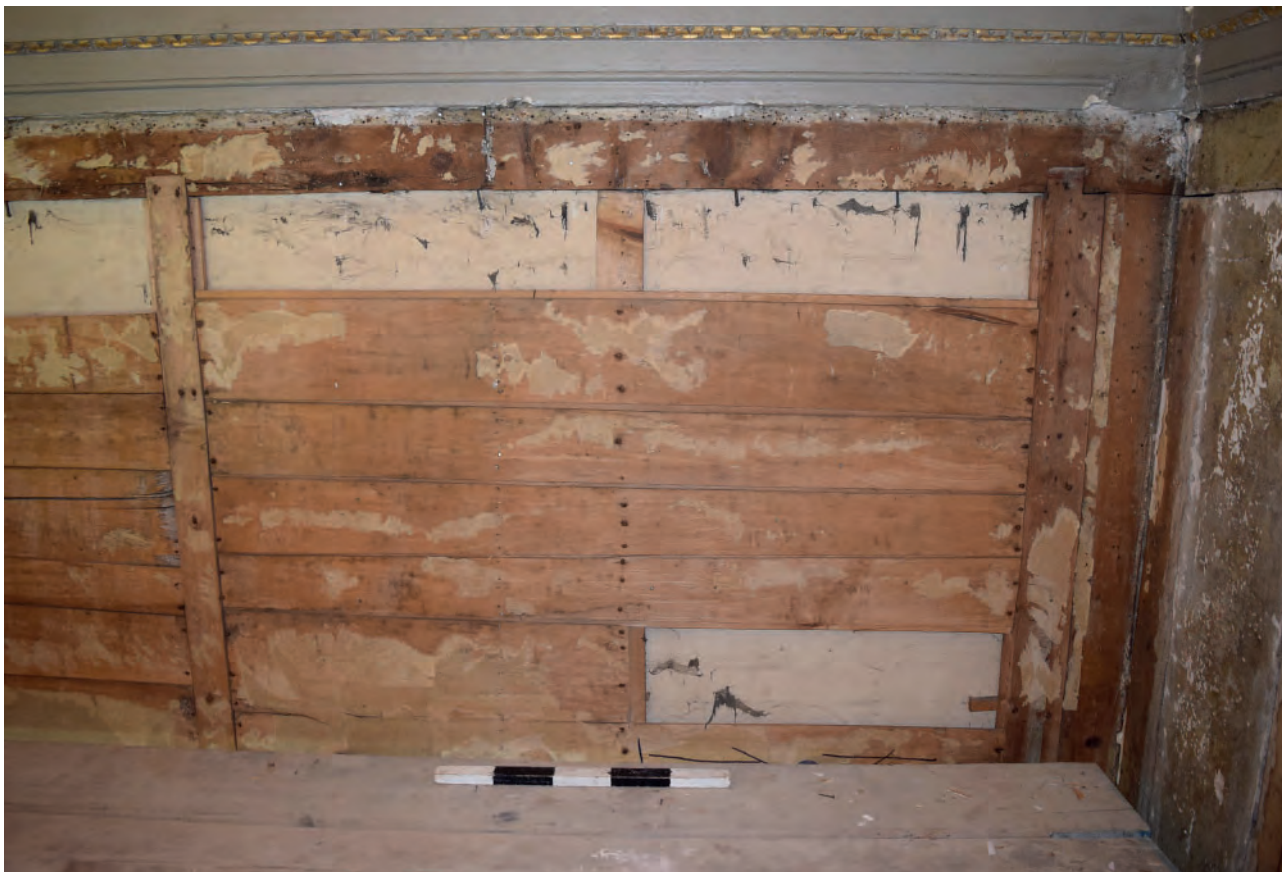
Plate 13: North wall, lime plaster behind sarking boards

- 3.2.14 The original timber frame shows traces of dark brown paint and is chipped with nail holes in many places from where hessian would have been hung. After removing the upper sarking boards, the original nails were visible, driven from the bottom into the boards of the timber frame (Plates 13, 14 and 50).

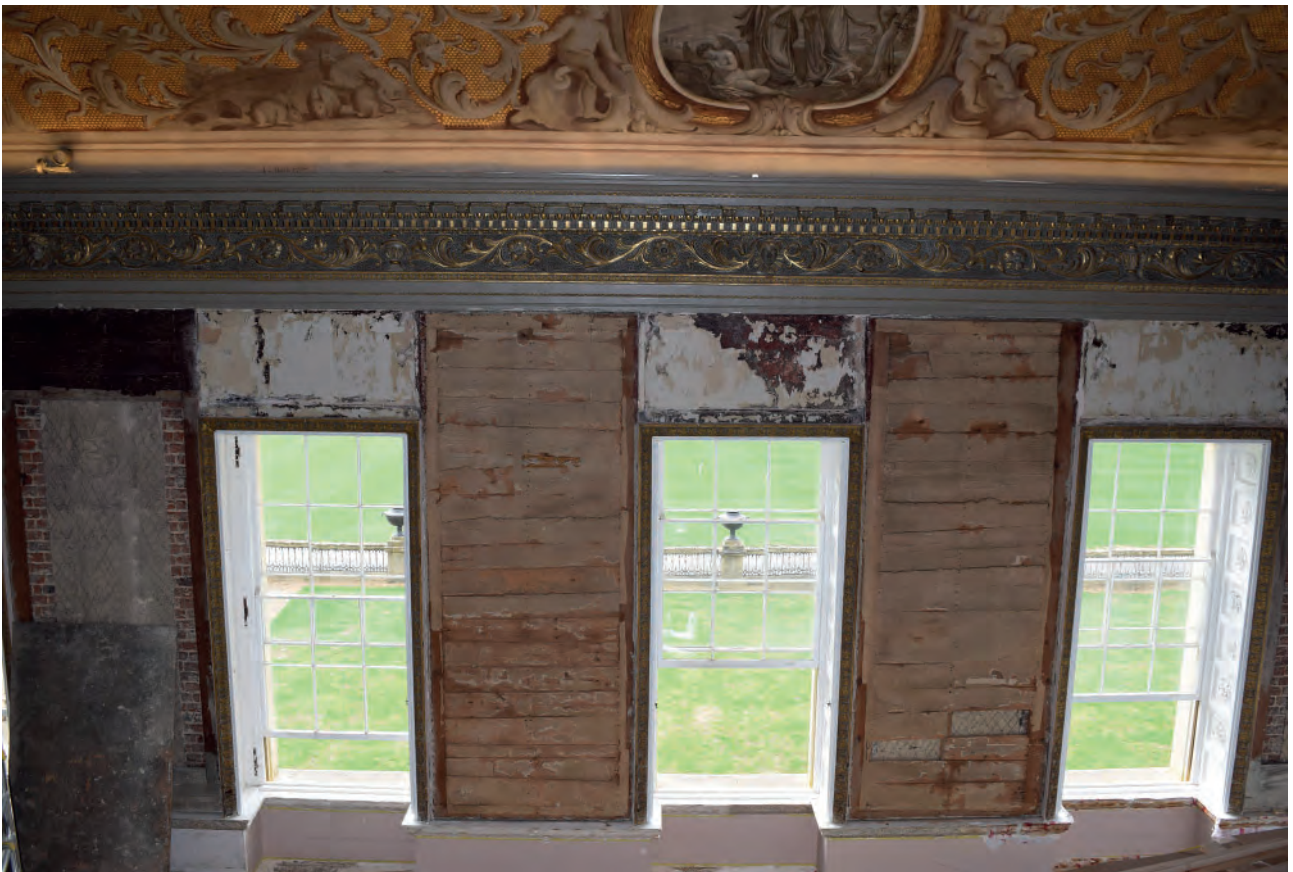
Plate 35: South wall, original plaster over windows

3.2.7 The southern wall has seven large windows. The surfaces above them are covered with lime plaster, which was first painted in light beige and then repainted in dark brown (Plates 35 and 36), whereas on all panels between windows a modern cement plaster has been applied (Plate 37). The plaster on the panel between the fifth and sixth windows (counting from the east) was covered with hardboard, rather than sarking boards as in the other cases (Plate 38).

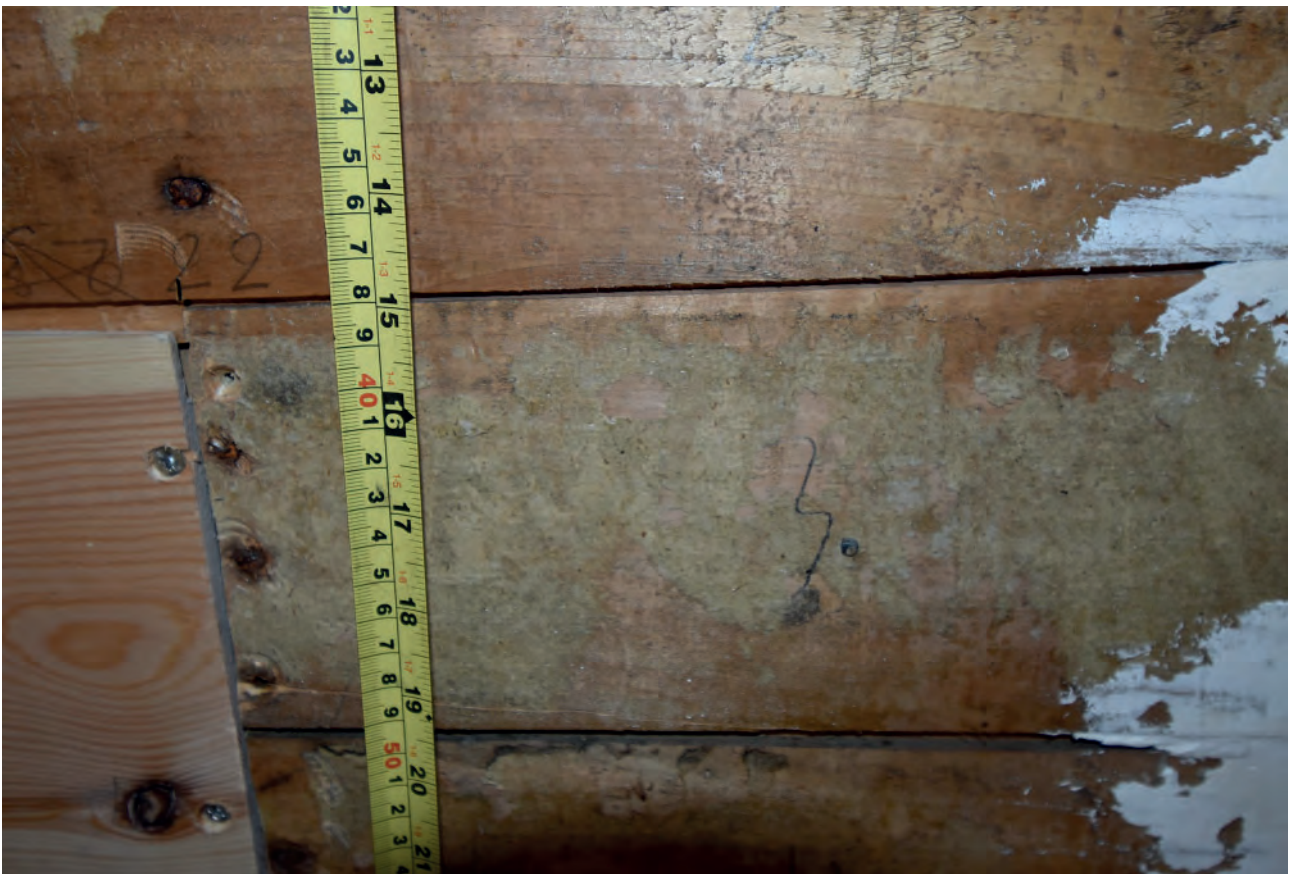
3.2.36 The third type of numbering is represented by the same numbers 3 cm high, located on several boards to the right of the central tiny numbers of the second type. These are the numbers 1, 2, 3, 4 and 5 (Plates 89, 106- 108).

Plate 89: North wall, panel 8, example of second and third type of numbering

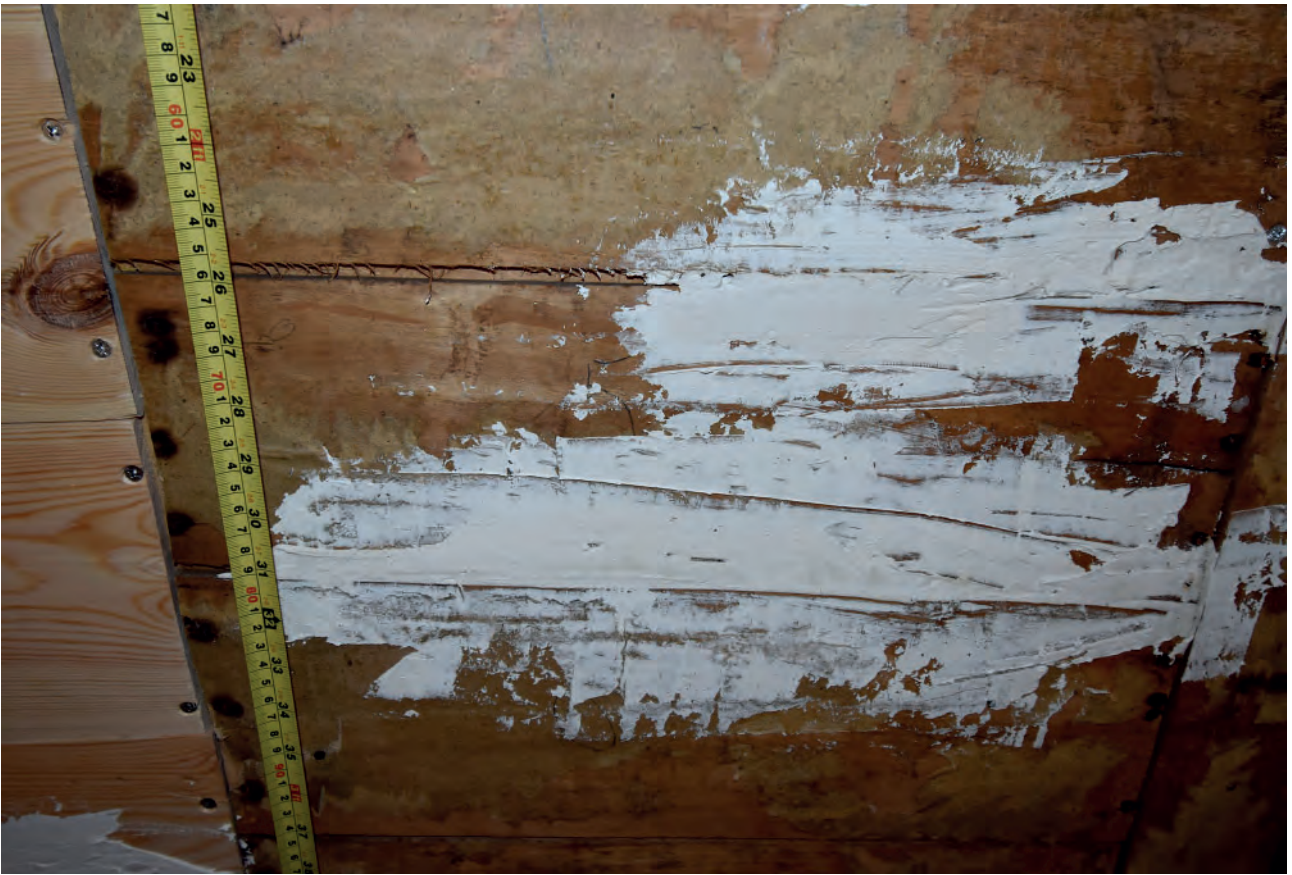
Plate 107: North wall, panel 8, example of third type of numbering

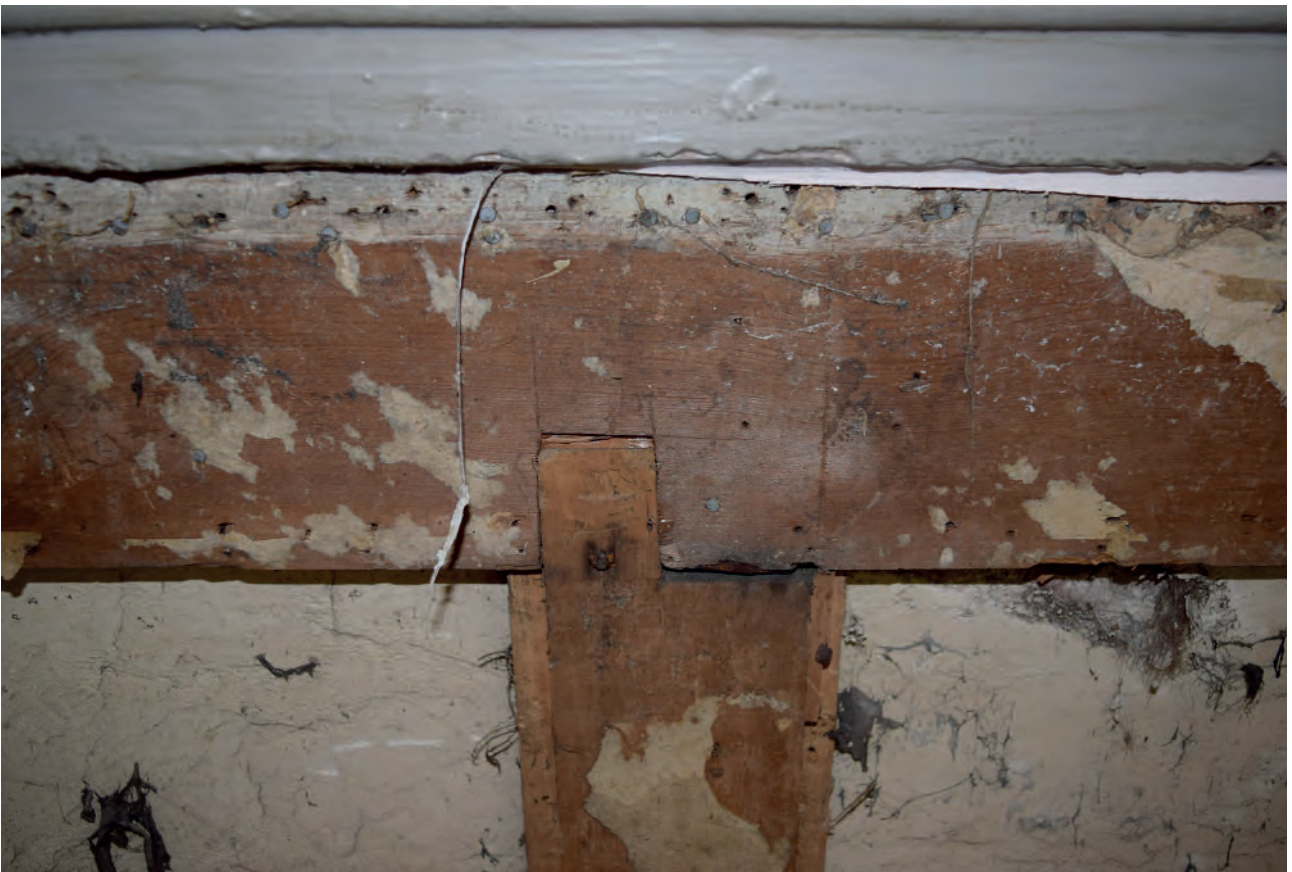
Plate 108: North wall, panel 8, example of third type of numbering

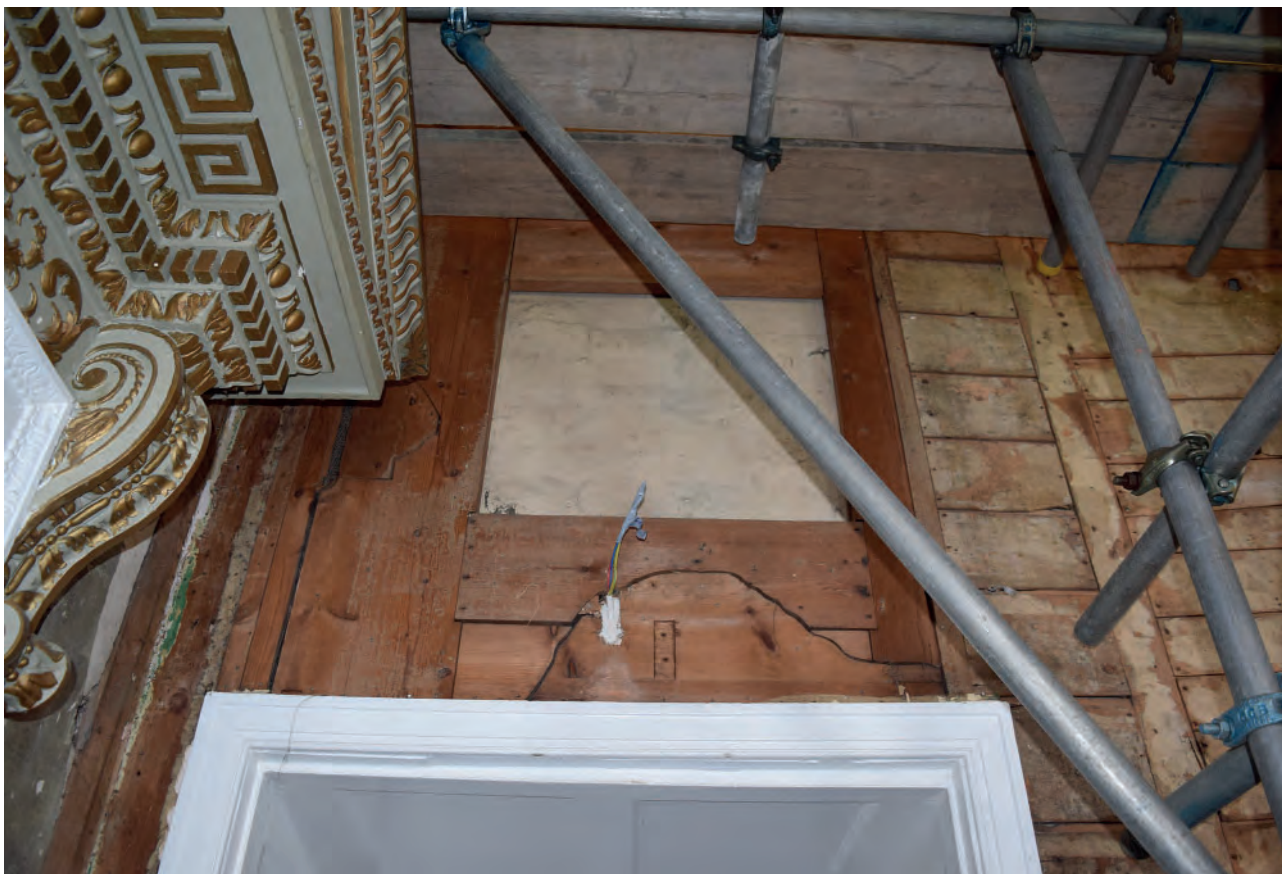
- 3.2.41 There are many small nail holes on the frame suggesting that the frame must have been upholstered with fabric (Plates 110- 113).
- 3.2.42 The hinged frame is hung on a wall covered with lime plaster painted in a light beige colour. Remnants of a green jute cloth protrude from between the reused door and the west door of the northern wall (Plate 115).

Plate 110: North wall, upper part of reused door

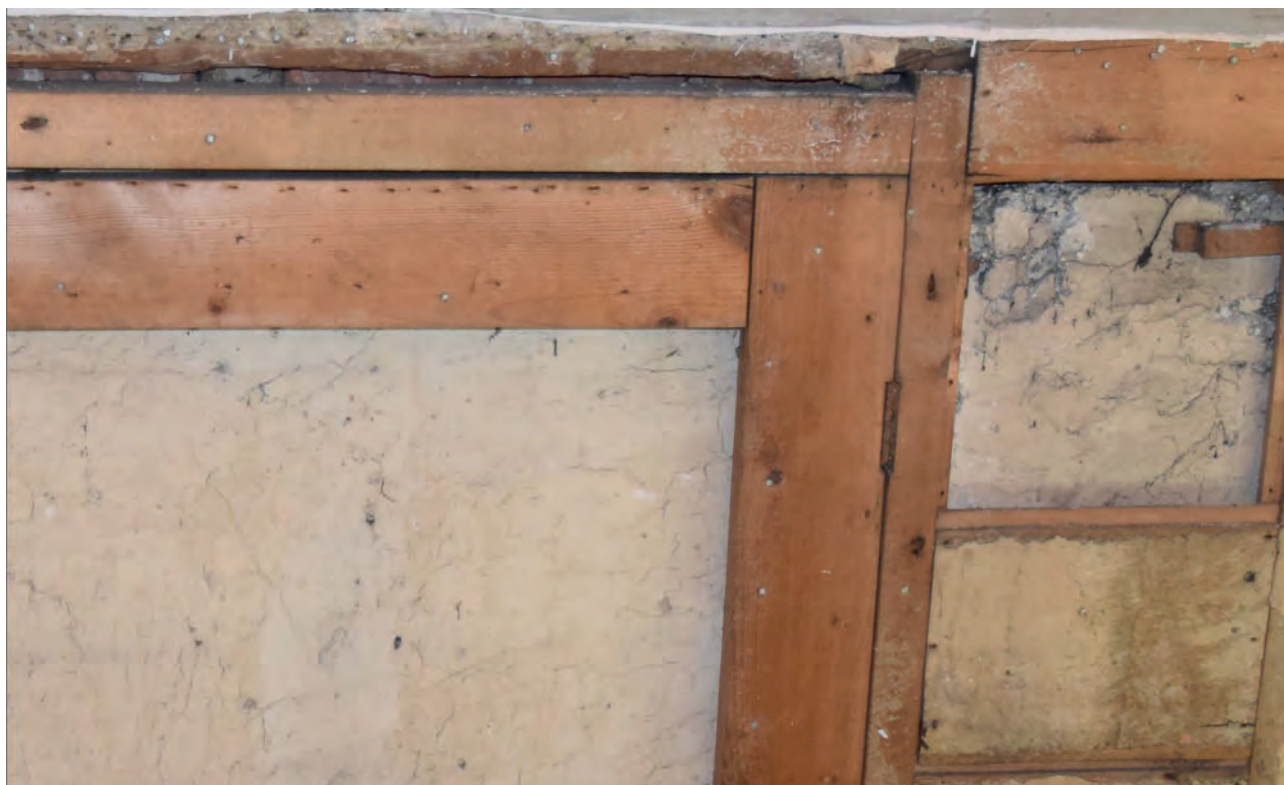
Plate 111: North wall, lower part of reused door

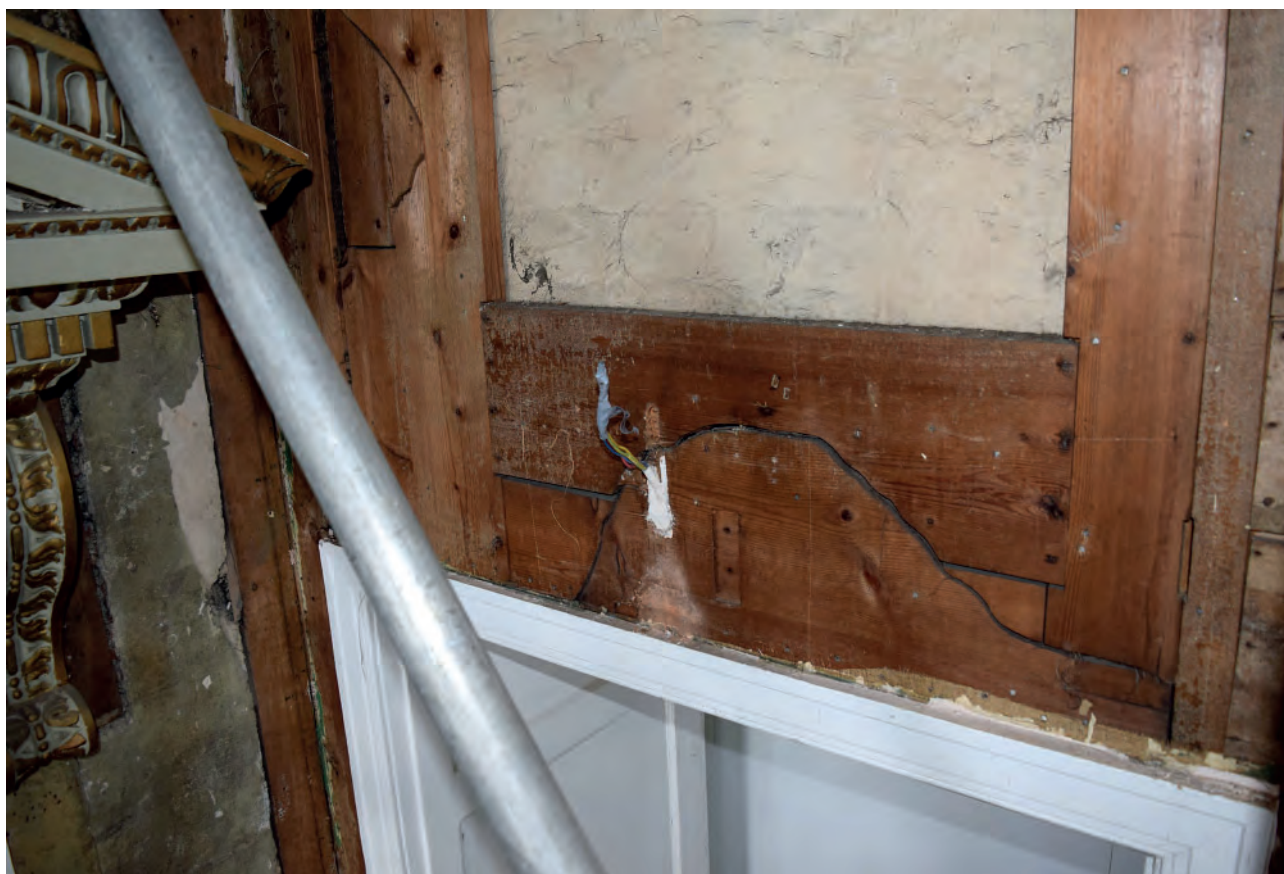
Plate 112: North wall, upper part of reused door, masked place of removal of upper hinge

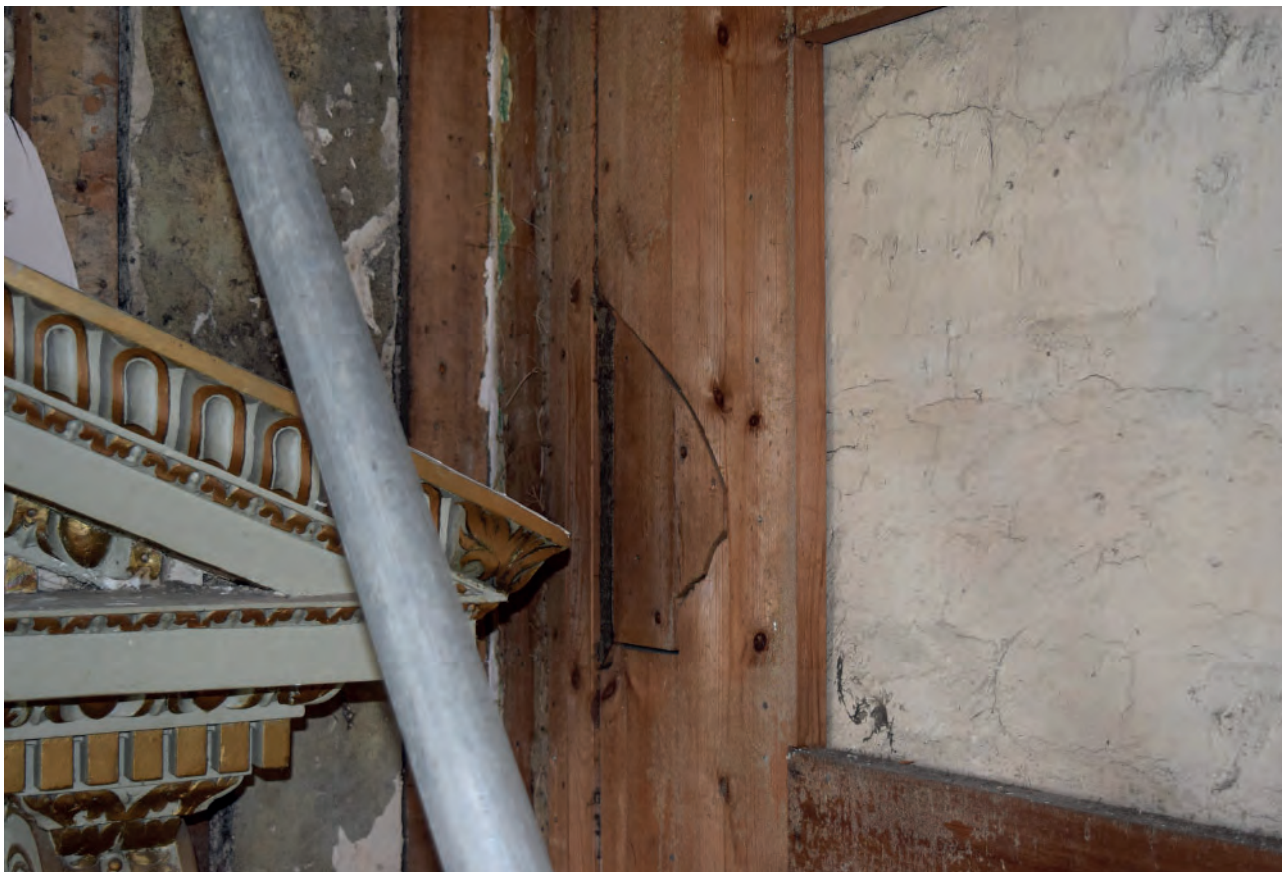
- 3.2.39 The western jamb of the frame is three times wider than the eastern one and in its lower part is cut out in the irregular shape of the pediment above the adjacent door (the northern door of the western wall; Plate 113 and 114). This has evidently been shaped to avoid it hitting the head of the pediment when opening the hinged frame. In the base rail of the frame there is another irregular shape cut out suggesting there must have been another irregularly shaped object there, blocking the frame. In both places the cuts in the reused door are masked with boards cut in the shape of the resulting holes (Plates 111 and 113). All this indicates that the hinged frame found here was once opened but its purpose is unclear.

Plate 113: North wall, lower part of reused door, masked place of removal of lower hinge and irregular shape cut

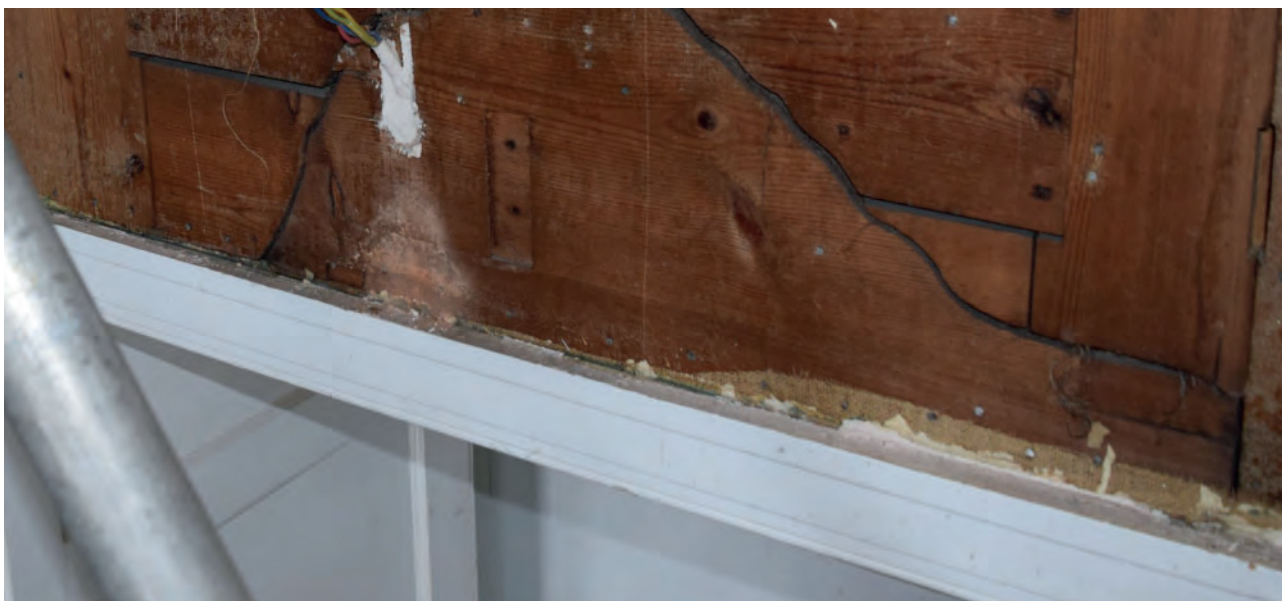
Plate 114: North wall, lower part of reused door, irregular shape cut

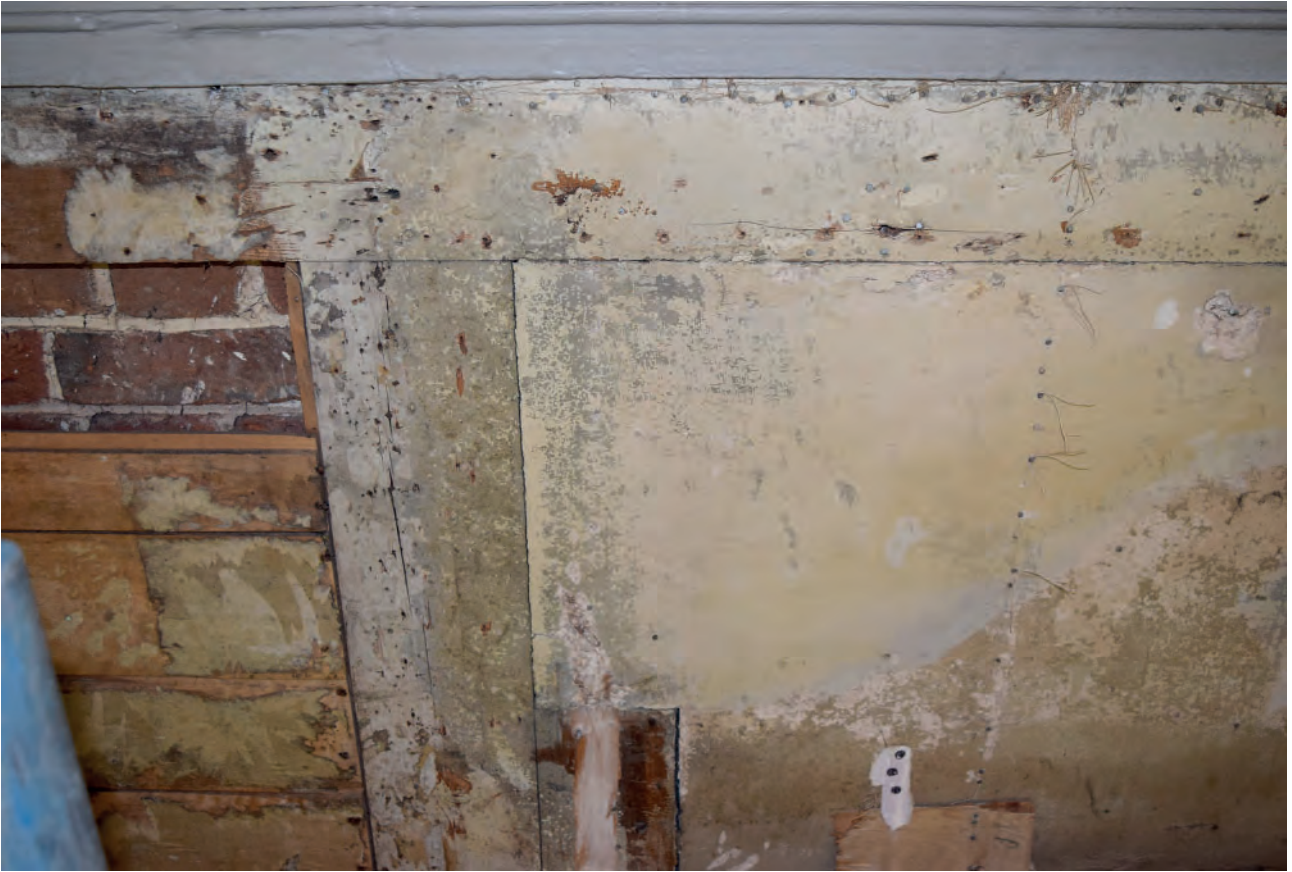
Plate 115: North wall, lower part of reused door, remnants of a green jute cloth

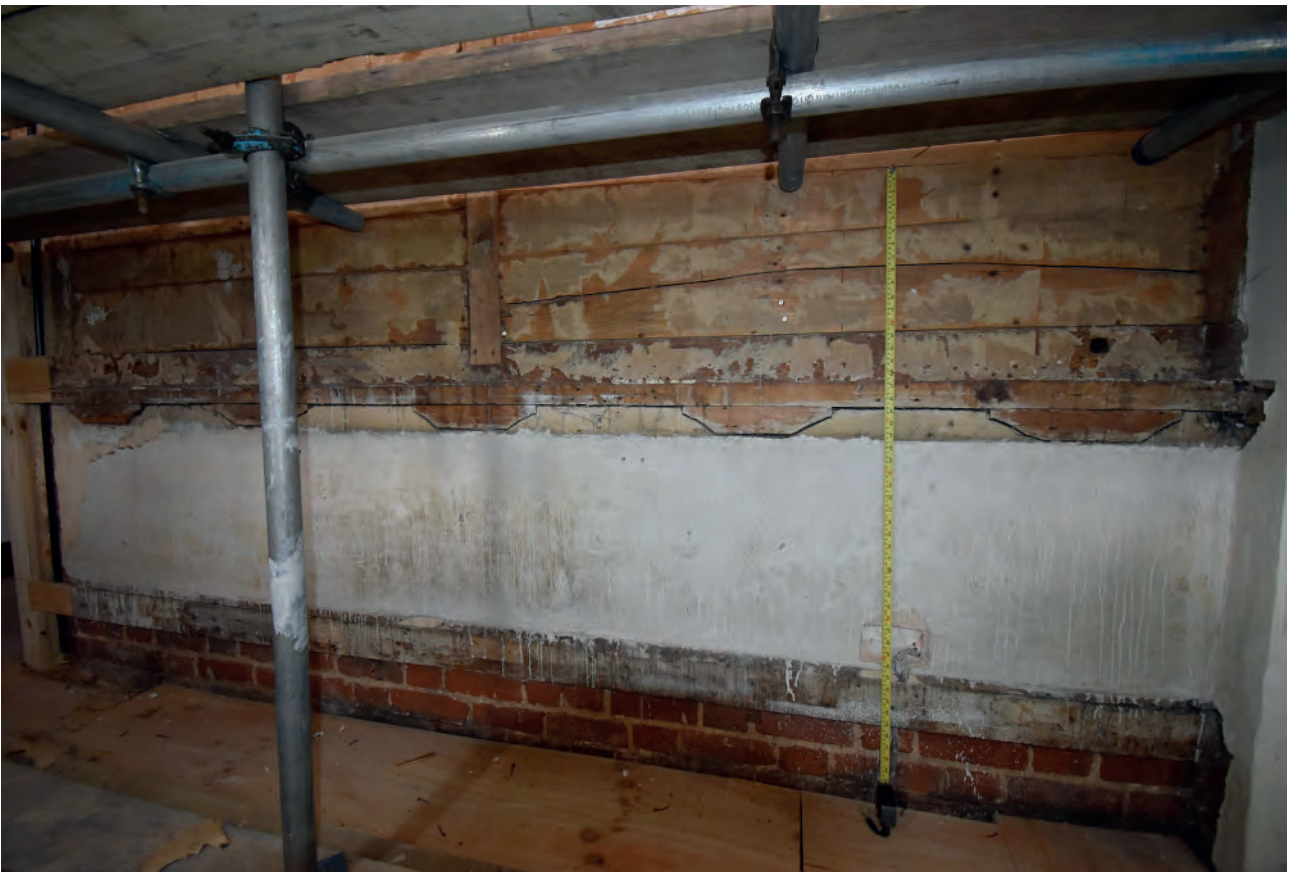
- 3.2.44 The upper parts of the frames are filled with light beige lime plaster, on which crowns of overmantels have been imprinted. They are marked by a line of green paint - a remnant of green hessian (Plates 29, 30). On the plaster of the eastern frame, in the areas where the nails were driven, there are left over fibres of jute, which had been applied here earlier (Plate 116). On both plasters of the eastern and western structures there are hessian texture marks.

Plate 116: North wall, east upper part of overmantel, example of hessian threads

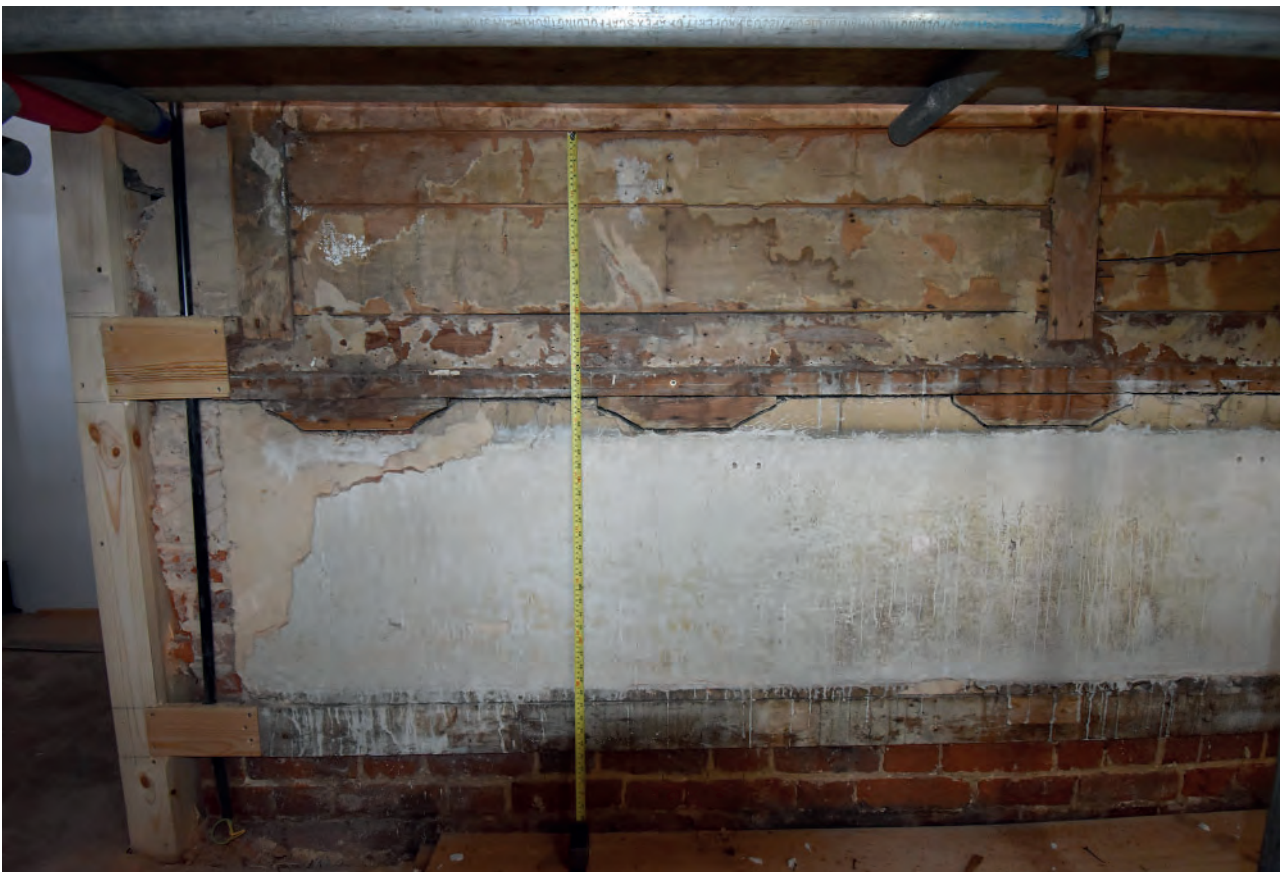
- 3.2.49 In the western part of the north wall, between the modern western door and the western fireplace, as well as in the eastern part, between the eastern fireplace and the modern eastern door, the upper timber rails are supported on timber bases, each in the shape of an inverted isosceles trapezoid, with slightly concave sides. These bases are arranged along the entire length of both rails. There are five of them in the western part and six in the eastern part (Plates 117). It seems that the wooden dado structure in these places is original.

- 3.2.51 In both of these dado areas, there are electrical sockets above the lower dado rail, from the sides of the fireplaces (Plate 117, 119). On both dados from the sides of the doors there are visible damages to the walls and dados related to the punching out of doors openings (east and west) in these places (Plate 118).

Plate 117: North wall, dado between west door and west fireplace
