# State Dining Room Stowe House Buckinghamshire

## Historic Building Investigation and Recording

July 2023

Document Type: Historic Building Investigation and Recording

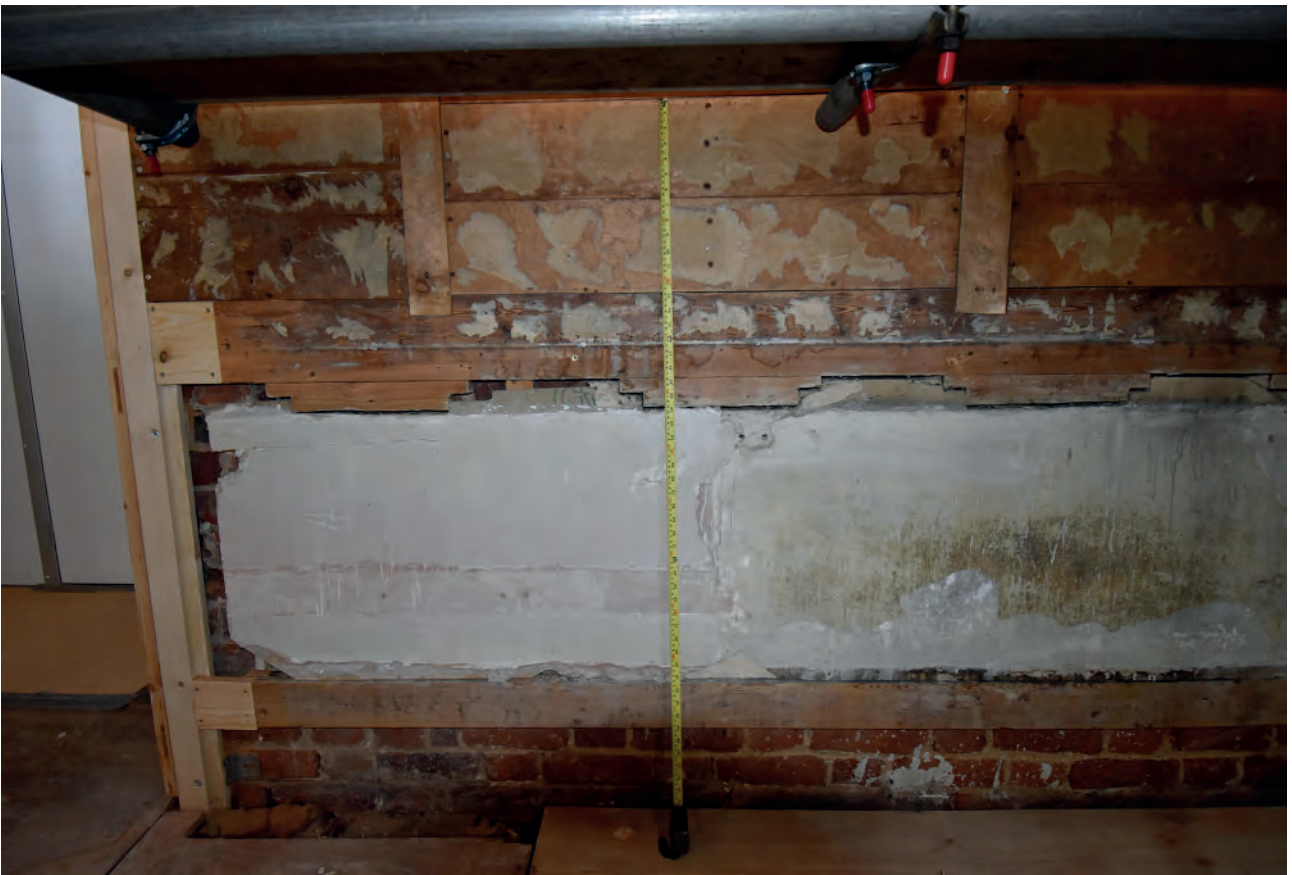
- 3.2.53 The dado between the middle door and the west fireplace shows traces of remodeling. In connection with the rebuilding of the fireplace, a new base (from the west) was placed under the upper rail. On the east side, at the middle door frame, there is an elongated base in a slightly different shape. Modern grey cement plaster was applied between the upper and lower rail (Plate 120).

Plate 120: North wall, dado between west fireplace and middle door

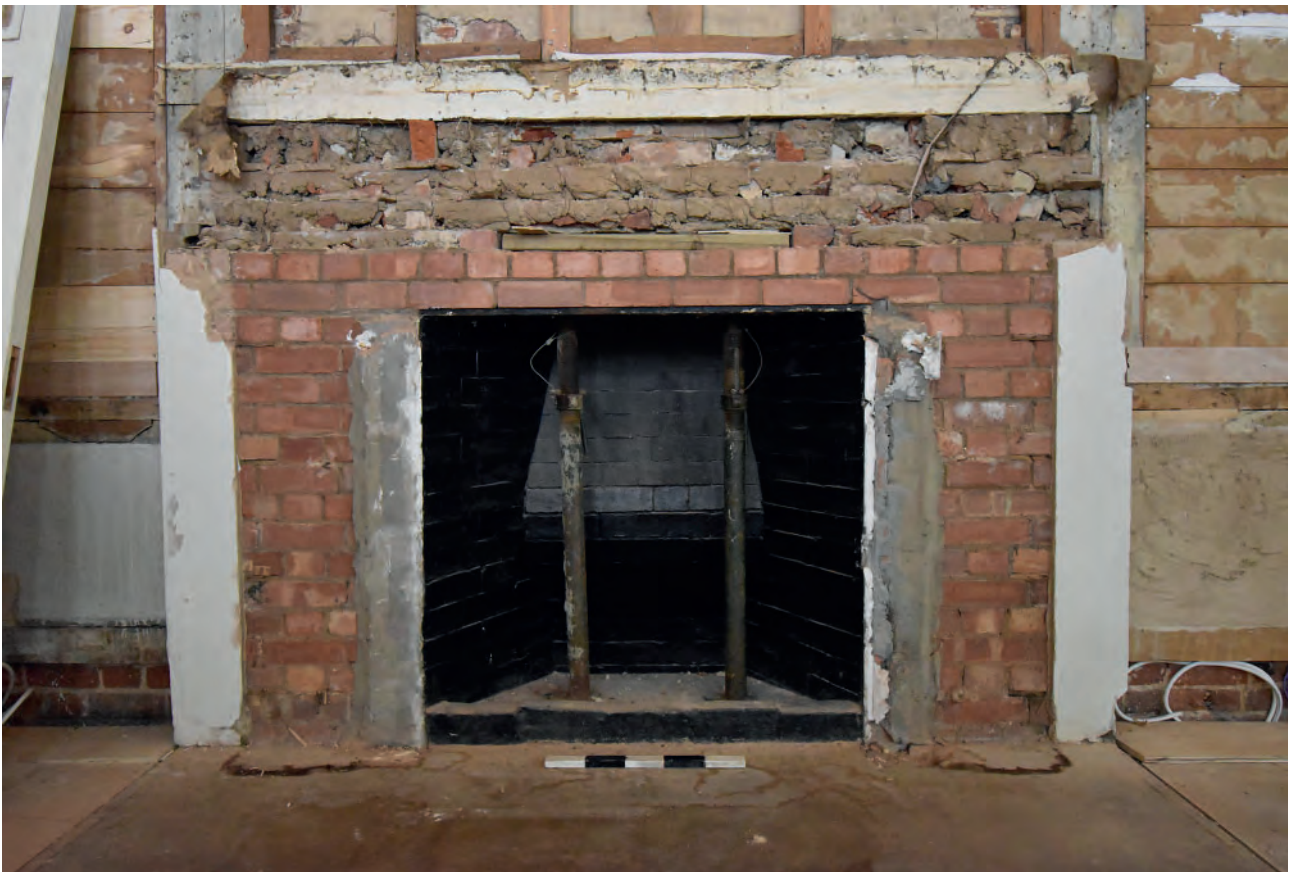
- 3.2.52 The bases for the dado rail between the middle door and the west and east fireplaces are slightly different from those described above. Each base here is in the shape of an inverted isosceles trapezoid, with stepped sides (Plates 120- 122). There are three such bases in the western part and five in the eastern part. The structures of these dados appear to be later and date to the same period as the sarking boards.

- 3.2.54 The dado on the west side of the middle door has also been remodeled. To the east of the doorway, between the wooden rails, plasterboard was placed on the wall, which was covered with cement and painted white. The plasterboard occupies space up to the middle of the second base under the top rail (Plate 121). On the eastern side of this dado there is visible damage related to the installation of the eastern fireplace and electric cables. For this reason, the last base from the east under the dado rail was damaged. The base was removed (also with lime plaster) from its original place and half of this base was fixed from the west of the eastern fireplace (Plate 122). The space between the rails in this place was additionally plastered and painted white, and in its lower part, below the damaged base for the wooden rail, a hole was cut in the wall for an electrical socket. A horizontal strip was attached to the plaster above the electrical socket (Plate 122).

Plate 122: North wall, east part of dado between middle door and east fireplace

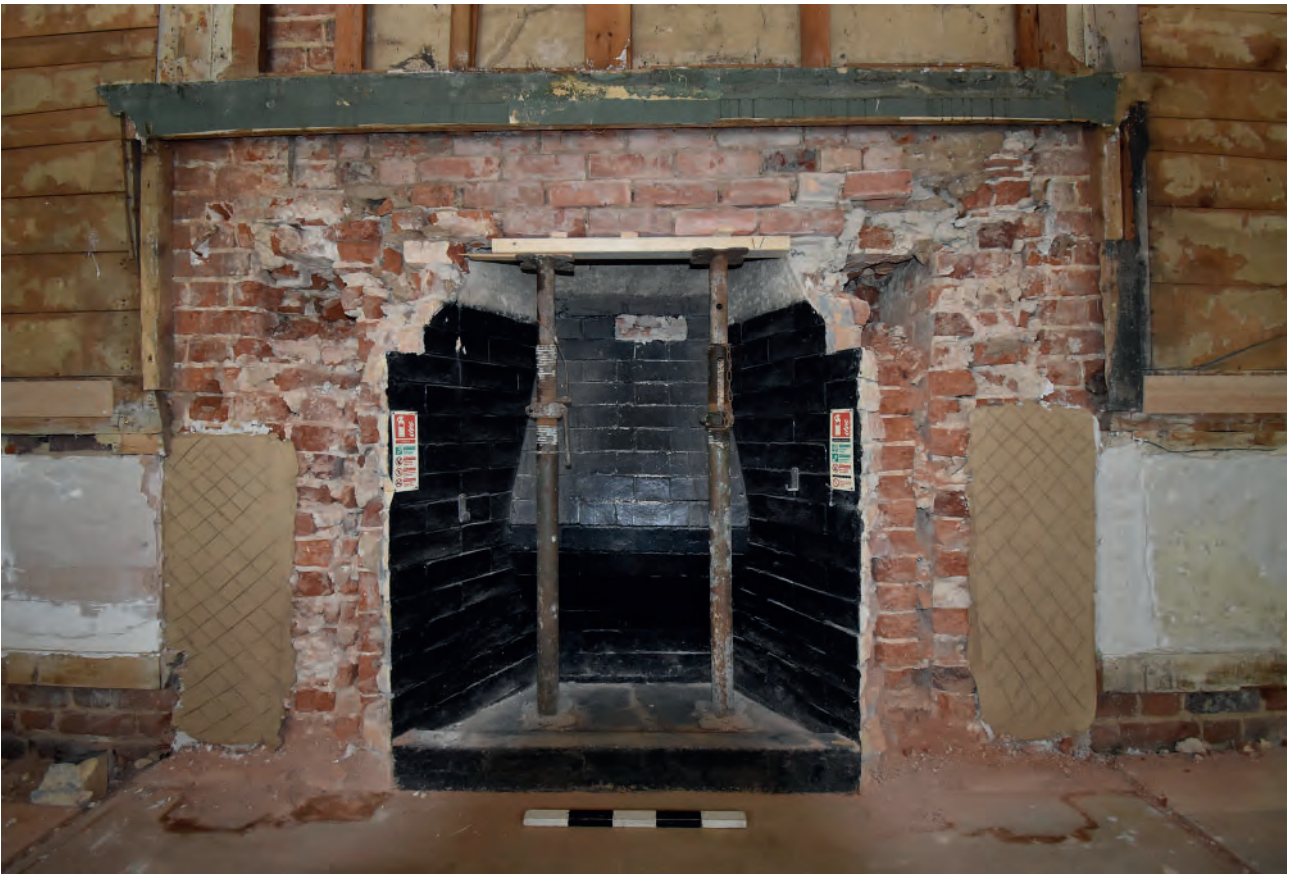
- 3.3.2 Once the 1920s fire surrounds were removed it could be seen that the face of the fireplaces are constructed with English bond using modern pinkish red brick with frogs, dimensions 220 x 110 x 65 mm (Plates 123- 125). The cement mortar is dark grey, 10 mm thick. On the faces of the fireplace's walls, on both sides of the openings, there are iron hooks for mounting the wooden fireplace casings.

- 3.3.3 The face of each hearth is formed from modern bricks painted black but older, 18<sup>th</sup>-century bricks have been exposed behind them (Plates 123- 124 and 126). The brick in the hearths (with Flemish bond) is light pinkish yellow and measures 230 x 110 x 73 mm. The mortar used is dark gray with a thickness of 5 mm (Plates 127- 129). The sides of the hearths are splayed, and the back has a bulge at a height of 46 cm. The fireplace opening is 115.5 cm long and 121.5 cm high (Plate 123 and 124).

Plate 123: North wall, west fireplace

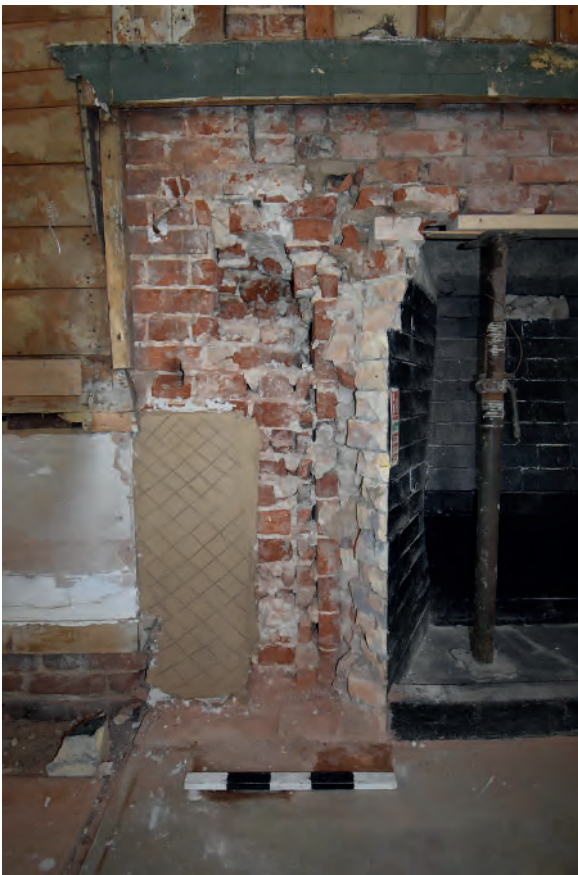
- 3.3.5 The original fireplace openings were slightly larger than the original hearths installed in them. A layer of bricks in the corners and sides of the fireplaces fills the gap between the original fireplace opening and the original hearth (Plates 130 and 131). The filler

Plate 130: North wall, west part of east fireplace

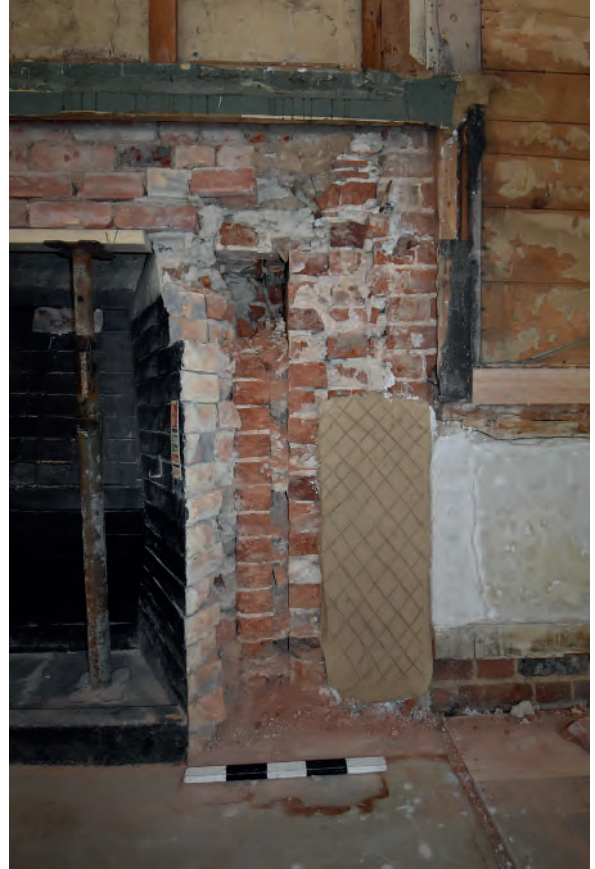
Plate 131: North wall, east part of east fireplace

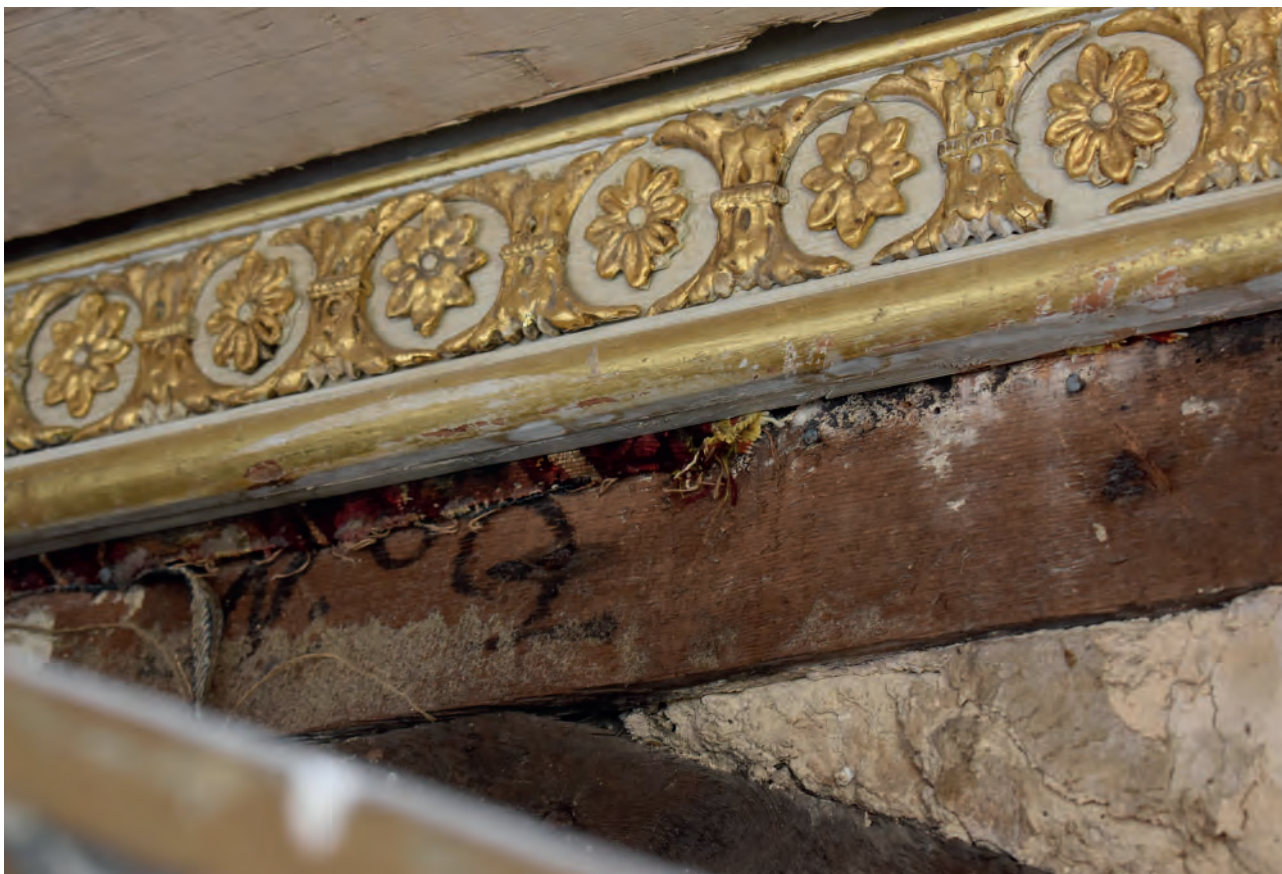
- 3.4.1 All four doors in the west and east walls in the Dining Room have open, richly decorated pediments and above each is a painting of a Centaur (Plates 44-45 and 137-140). During the conservation works to the southern pediment on the eastern wall, a fragment of red tapestry protruding from behind the Centaur painting was discovered (Plate 141). No similar or any other fabric has been found in the areas of other Centaur paintings.

Plate 141: East wall, south door pediment, remnants of red tapestry

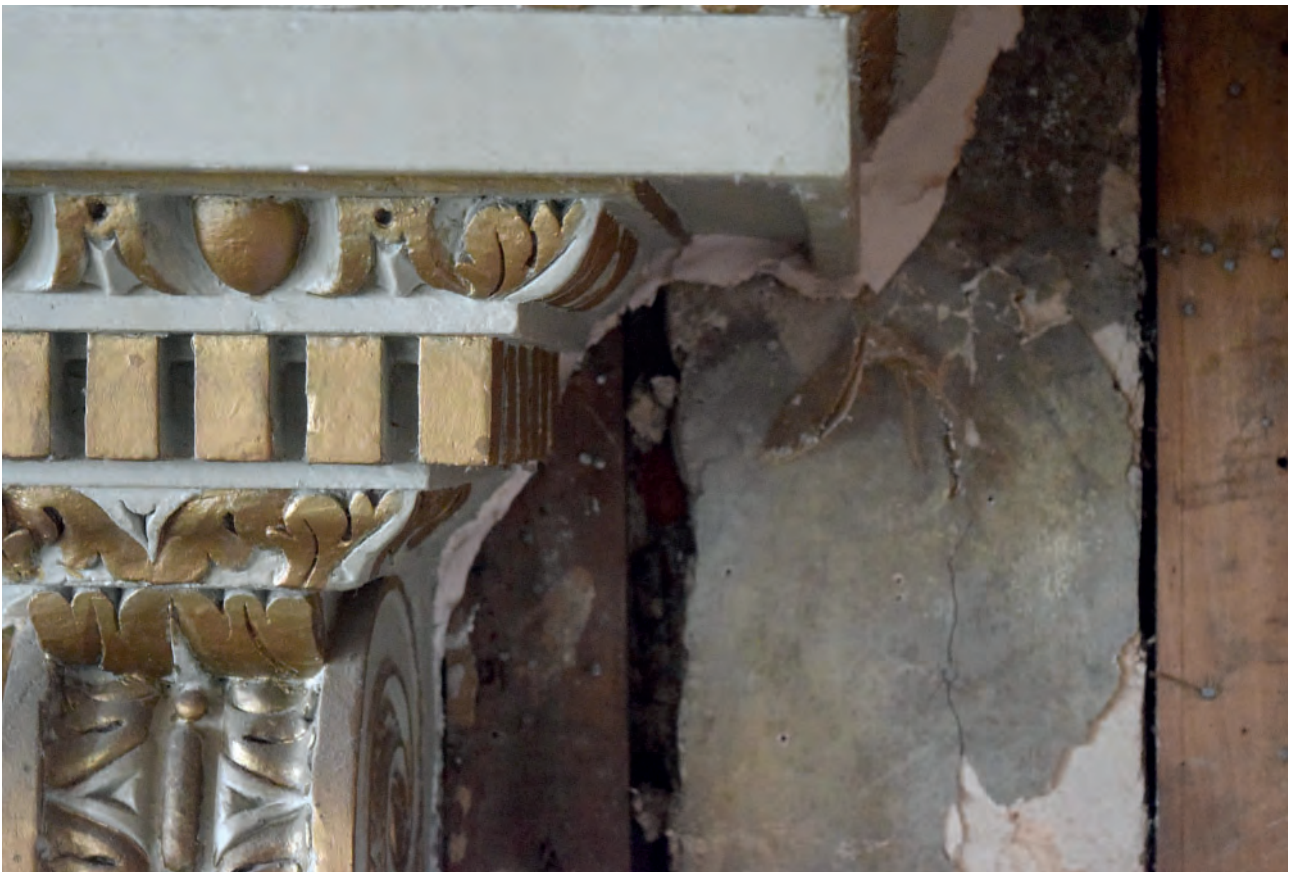
- 3.4.3 The bases of the pediments also have carved dentil ornament (Plate 143) again coloured in grey and gold. The curved, uppermost elements of the open pediment are also similarly coloured but rather than being carved they have a painted 'trompe l'oeil' impression of carved detailing. These elements are modern replacements created after 1920 (Plates 144 and 145).

Plate 143: East wall, north door pediment, exemplar of dentil decoration

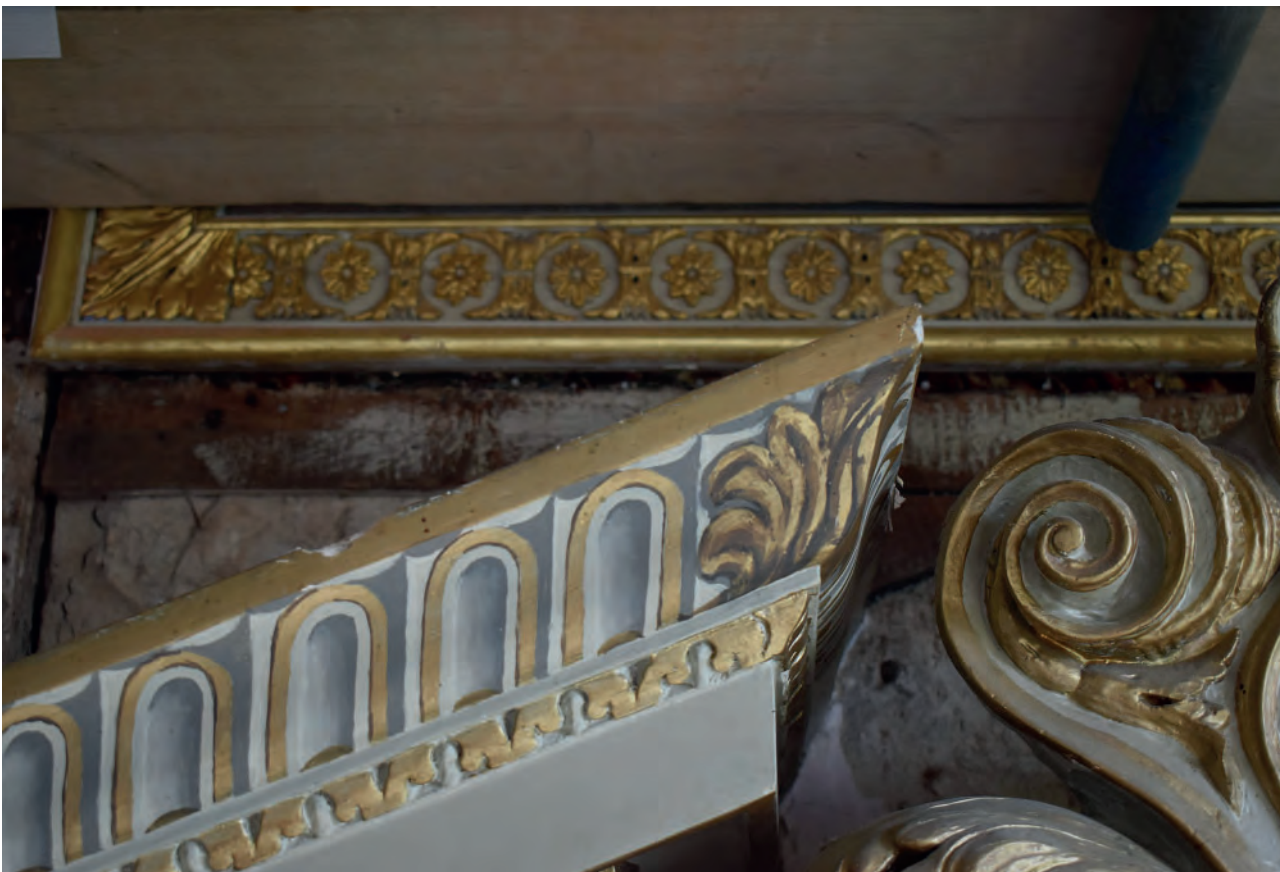
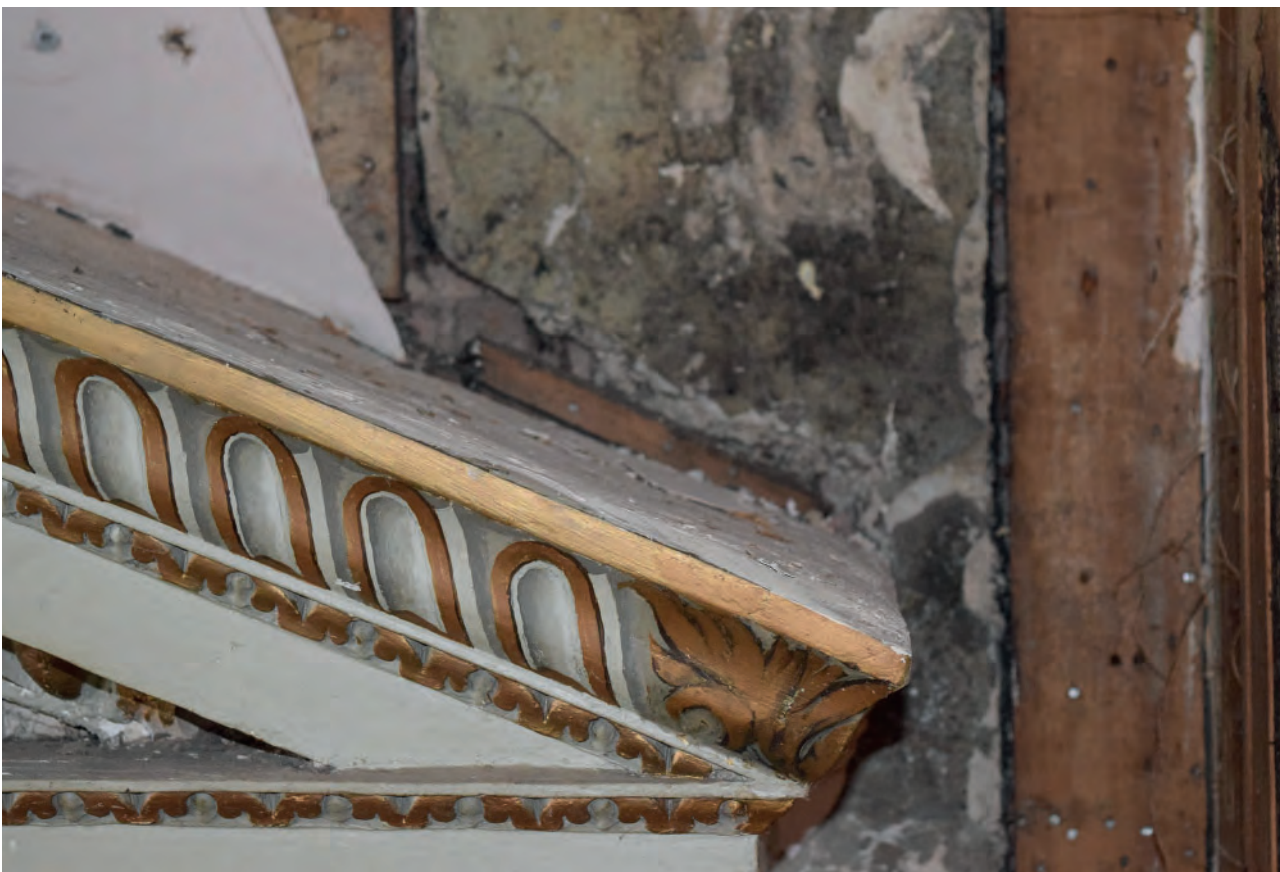
Plate 144: East wall, south door pediment, exemplar of painted gable

Plate 145: East wall, south door pediment, exemplar of painted gable

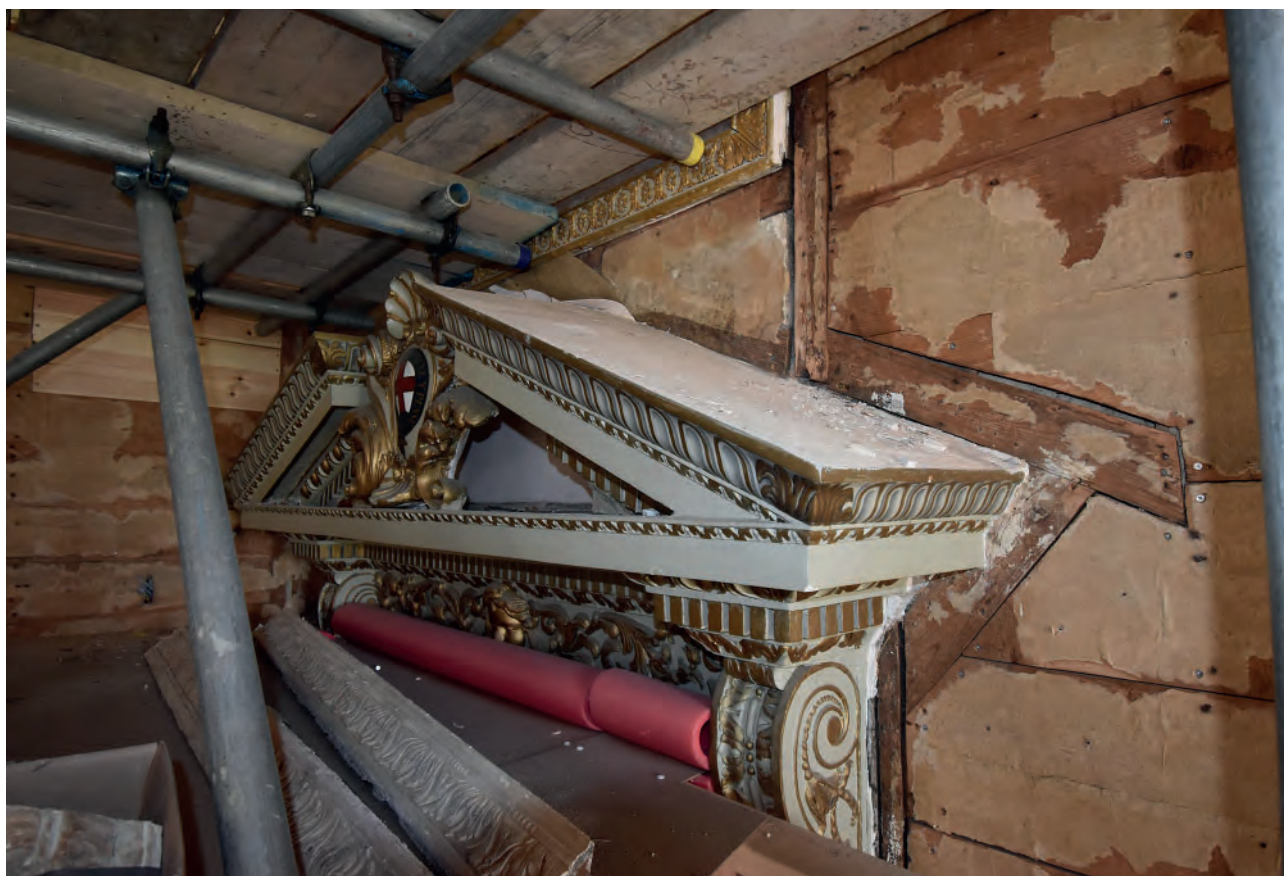
- 3.4.5 On the eastern wall in the northern corner, on the south side of the door pediment, sarking boards were cut to the shape of the pediment and pediment was glued to them (Plate 147). This shows that the pediment is later than the sarking boards.

Plate 147: East wall, north door pediment, remodeled sarking boards

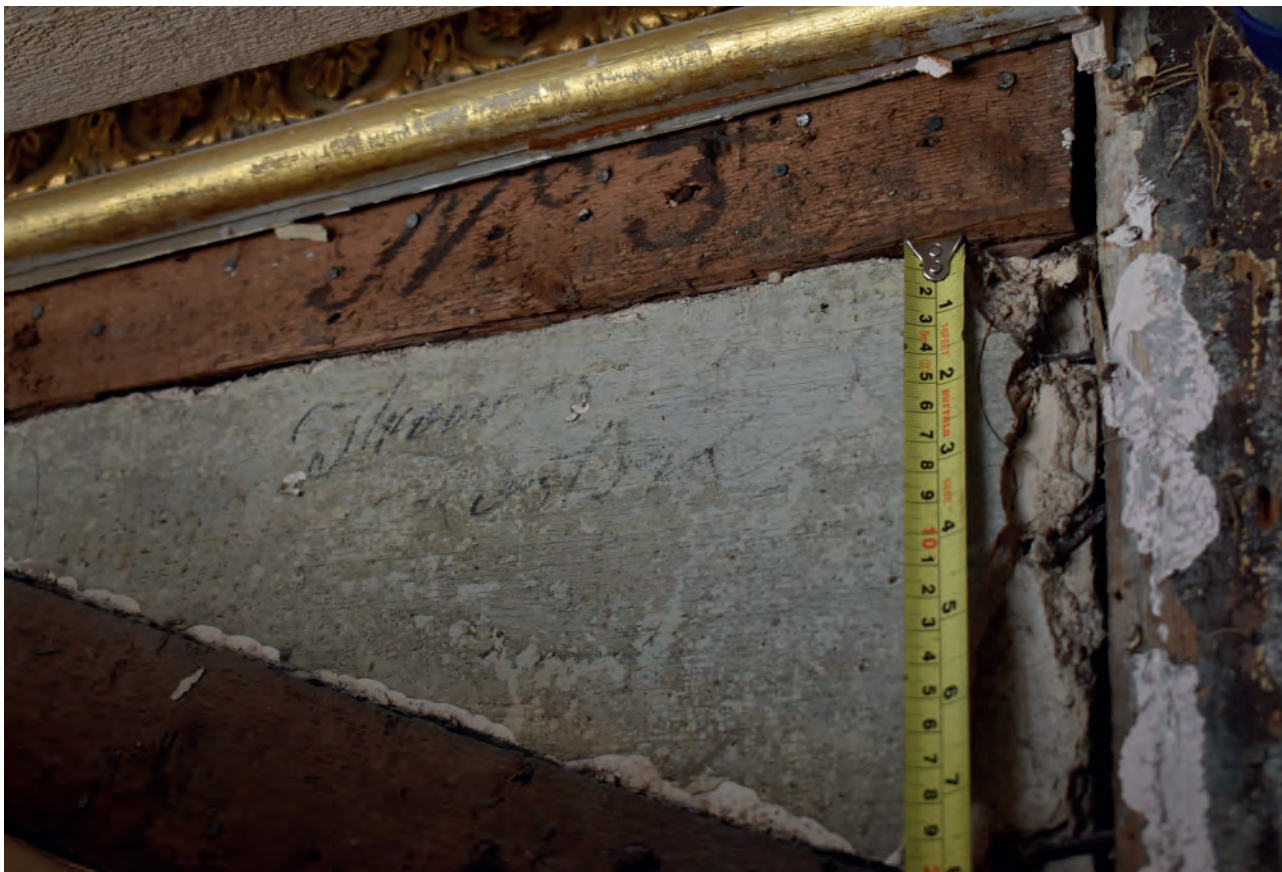
- 3.4.6 On the western wall, above the southern door pediment, on its northern side there is a signature of an unknown author. It is written in pencil on lime plaster but is illegible. The first and last name are written in two rows. The length of the inscription is 15 cm, and the height is 6 cm (Plate 148).

3.4.8 These are the stylized inscriptions: *N:°3* (on the southern door of the western wall, Plates 148), *N:°4* (on the northern door of the western wall, Plate 149), and *N:°2* on the southern door of the eastern wall (Plate 150). Following this numbering, the number 1 should be on the garter behind the northern pediment of the eastern wall, but it is missing.

Plate 148: West wall, south door pediment, exemplars of graffiti

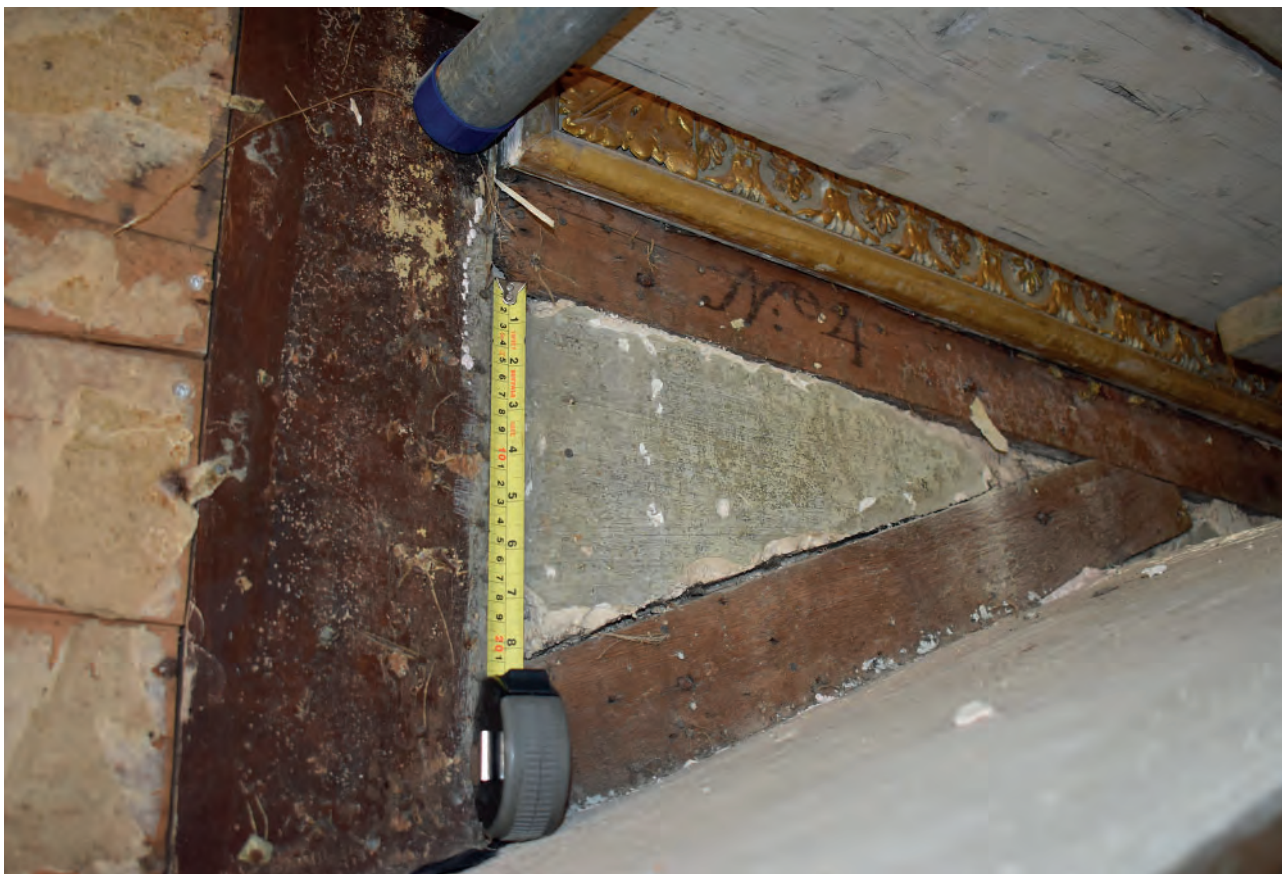
Plate 149: West wall, north door pediment, exemplar of graffiti

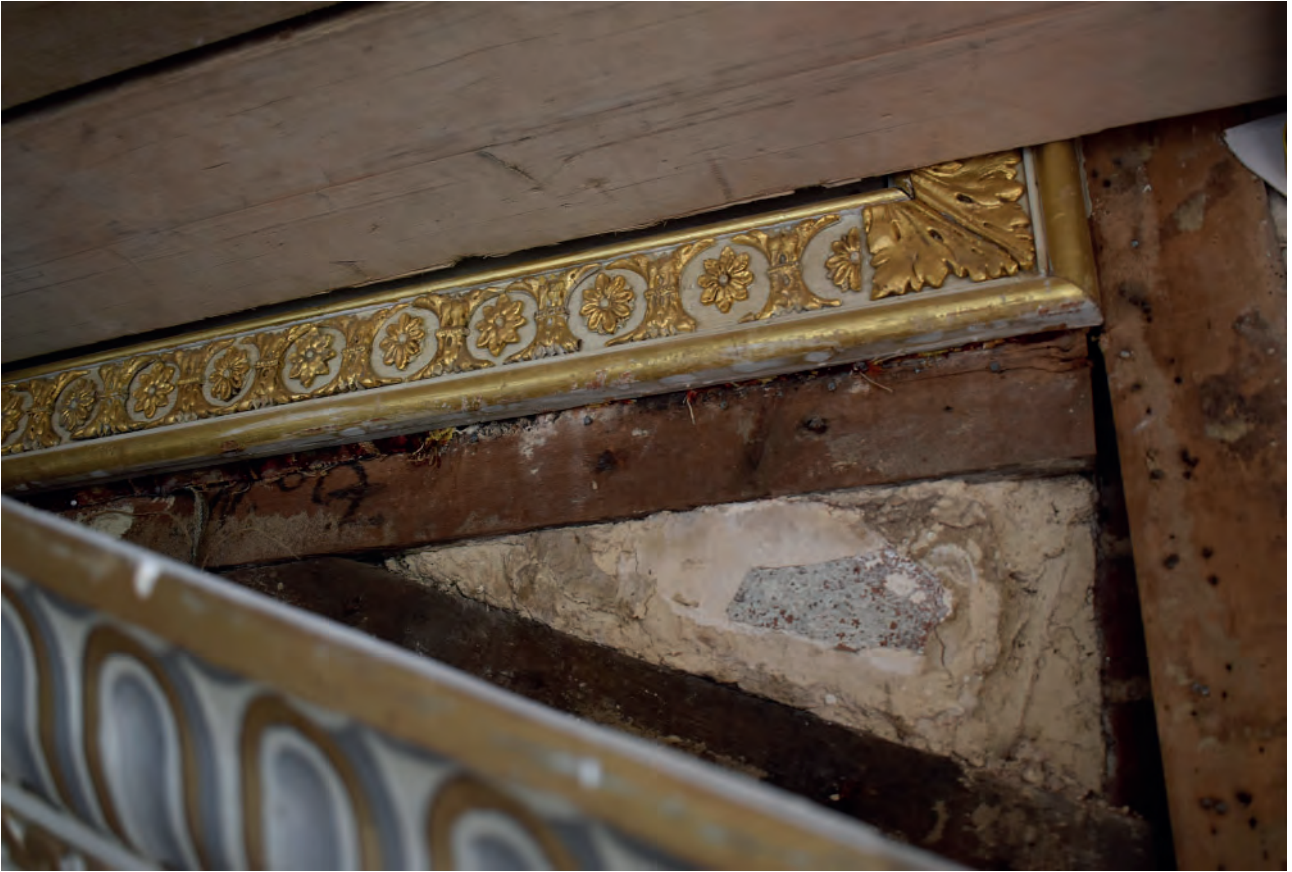
Plate 150: East wall, south door pediment, exemplar of graffiti

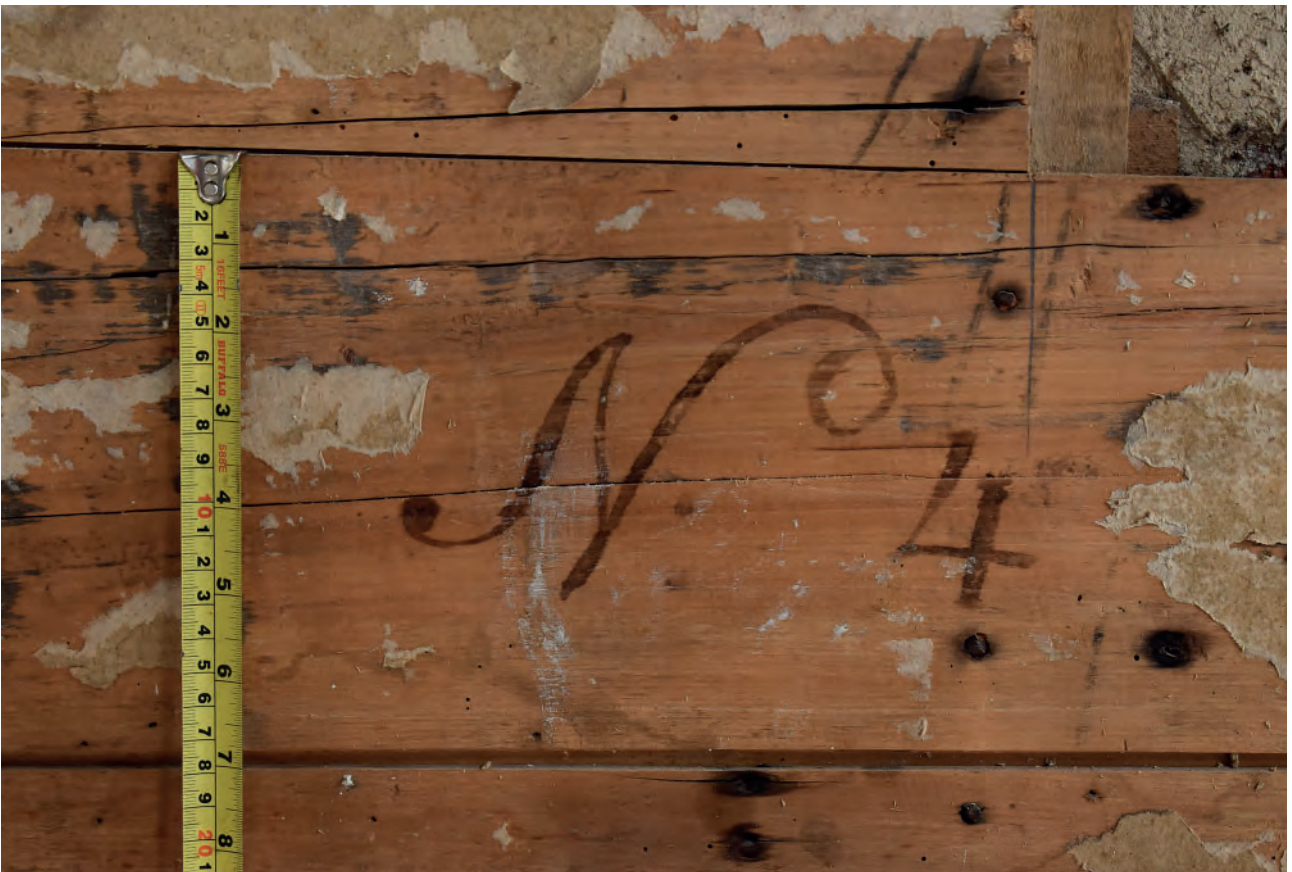
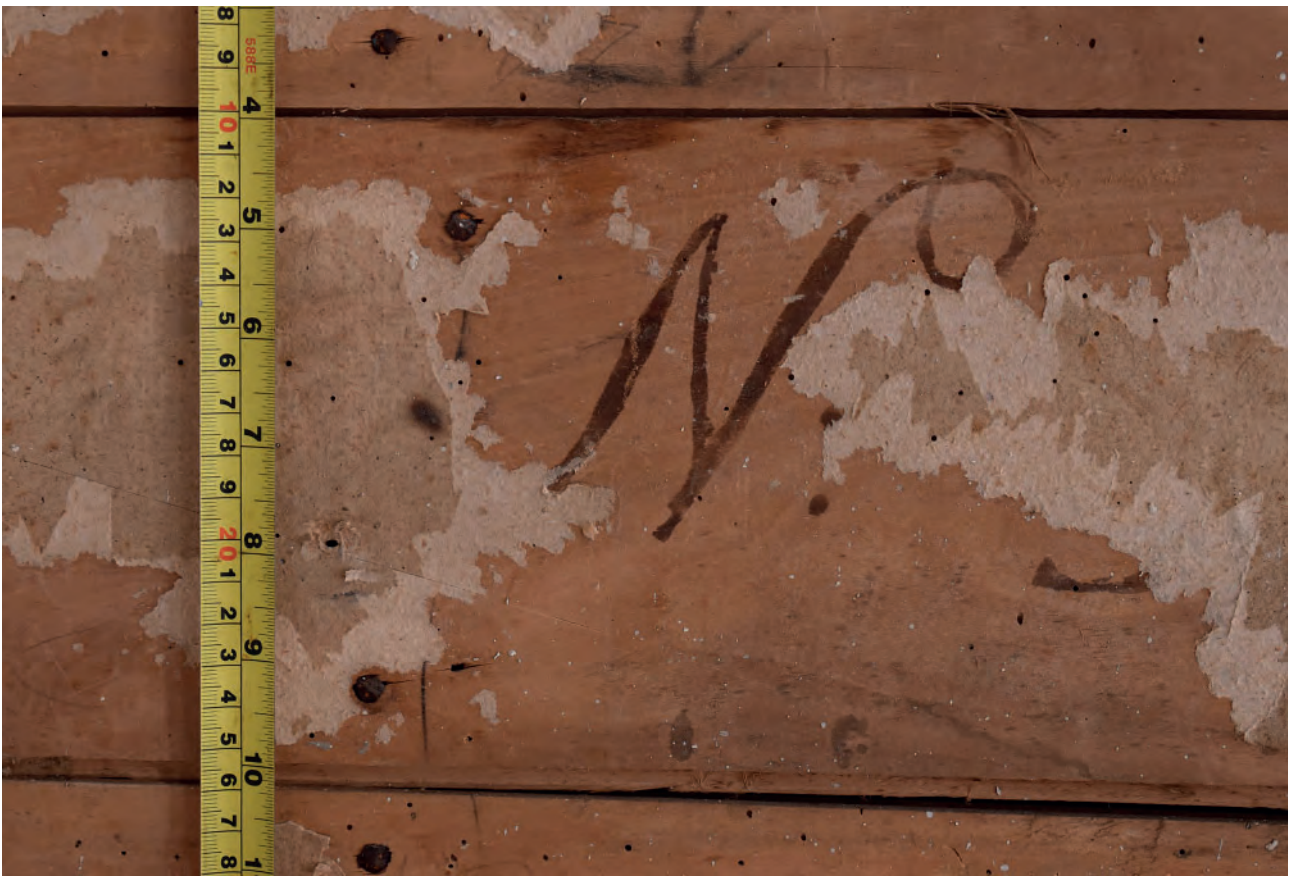
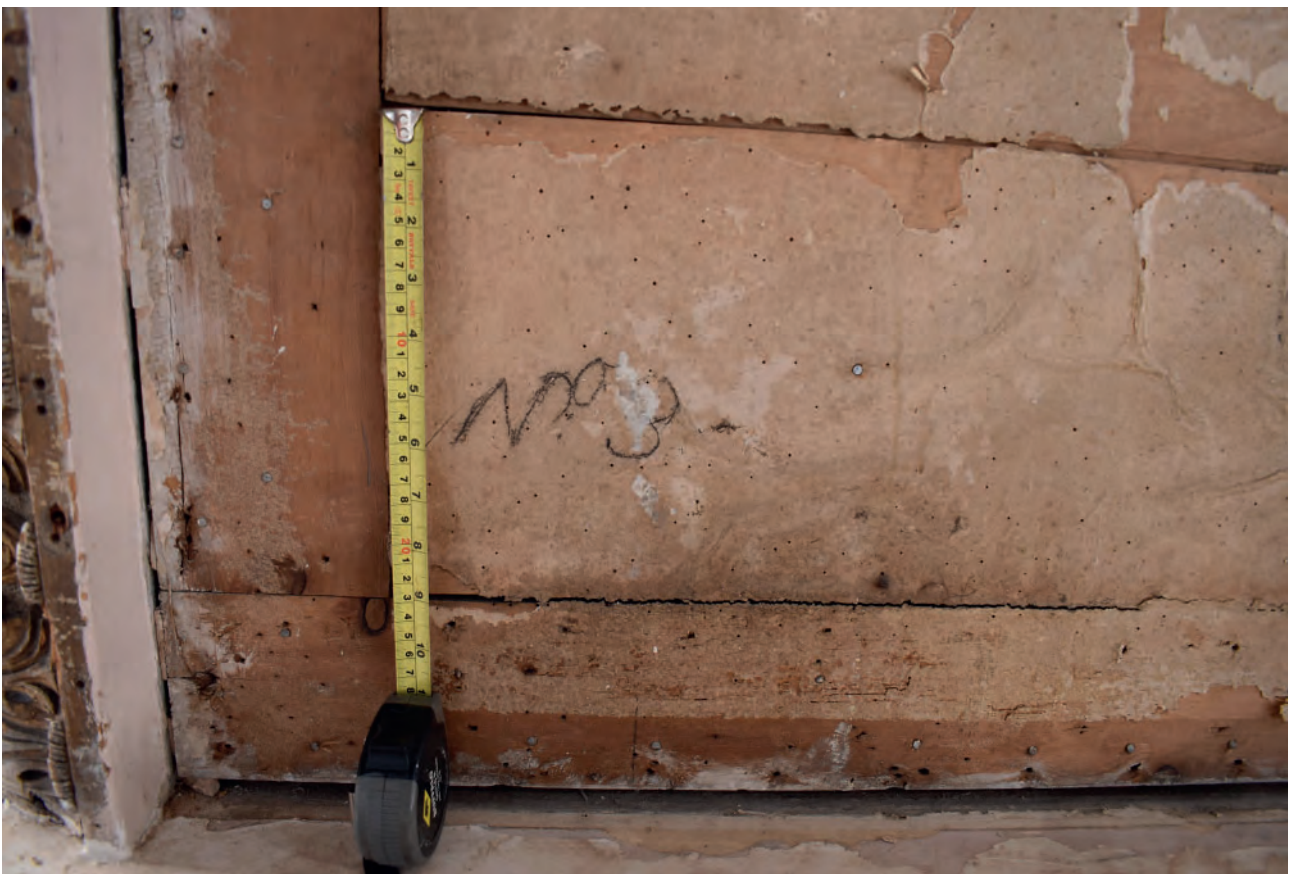
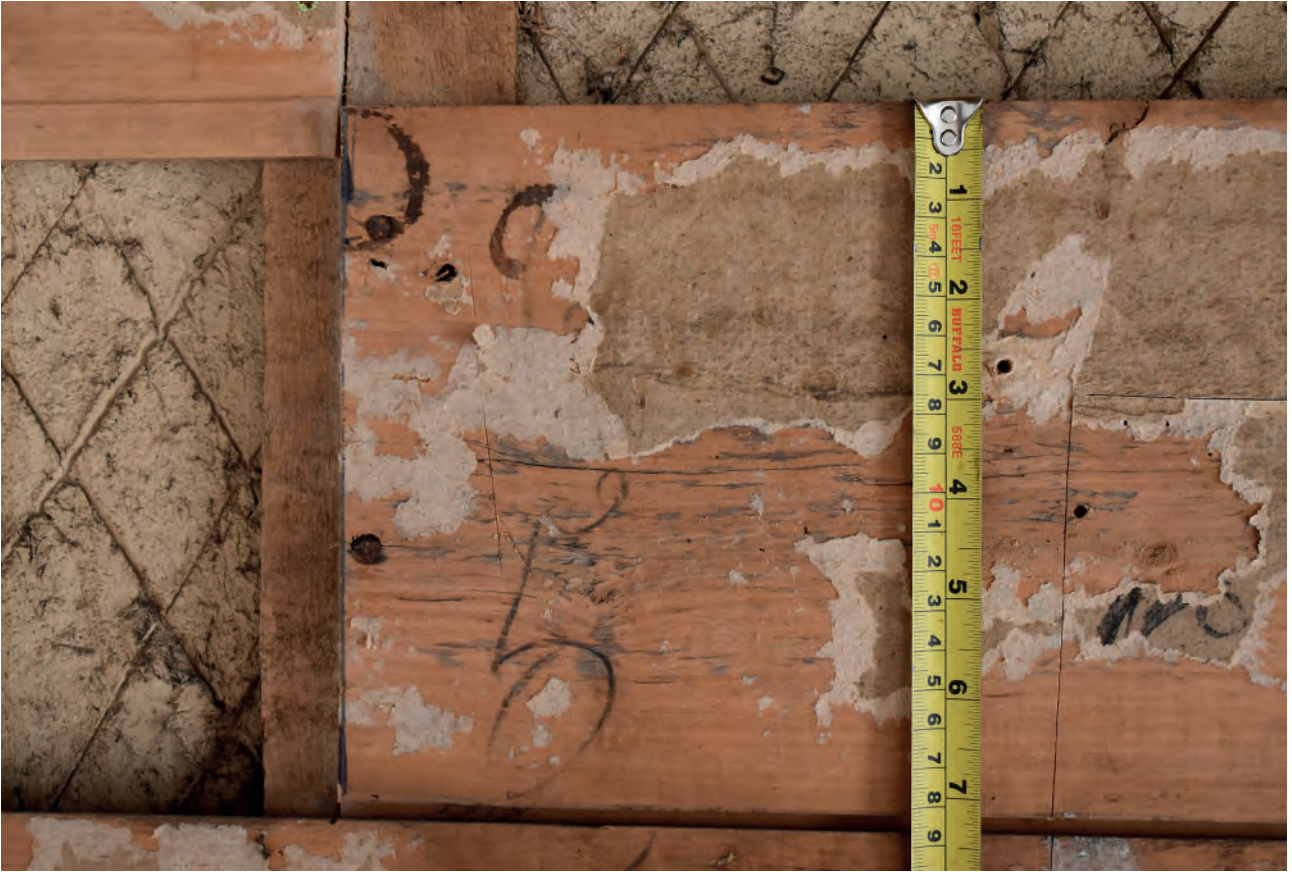
3.4.9 Numbering in this style is also visible on the southern wall on some panels between the windows. On the second panel, looking from the east, on the second board from the bottom, there is an inscription *N:°4* (Plate 151), and on the fourth panel, also on the second board from the bottom, there is an inscription *N:°3*, although the number 3 is significantly obscured by the remnants of wallpaper (Plate 152). An inscription in a similar style was written in pencil in the lower left corner of the panel (Plate 153). On fifth panel, on the third board from the bottom, there are remains of the inscription *N:°2* (Plate 154).

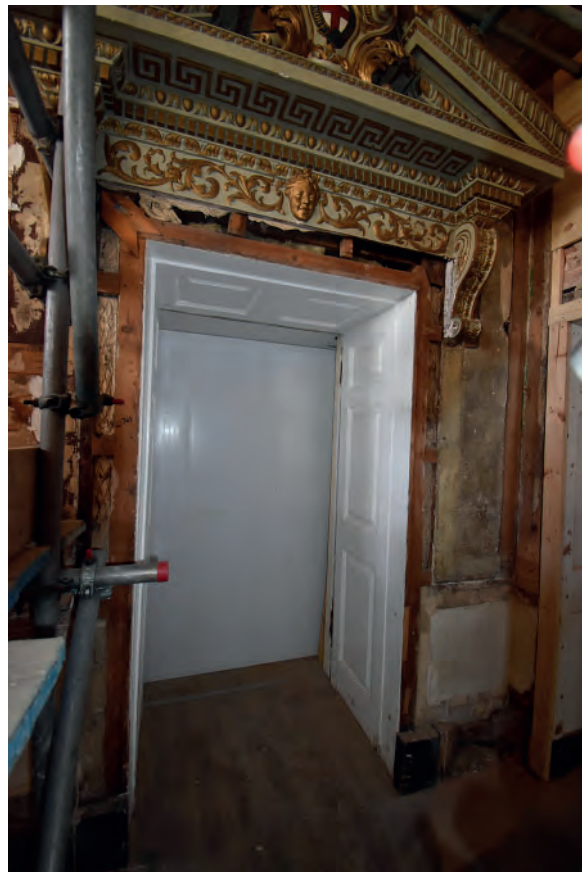
3.4.10 As a result of the conservation works, the frame of the northern door of the western wall was also exposed (Plate 155). The frame is wooden. There are a few centimeters of space between the frame lintel and the door opening, where are 2 timber studs. Such studs are also found on the sides of jambs. Empty spaces between the door opening and the jambs were bricked up and plastered. Additionally, in its southern upper corner there is a wooden strut in the shape of an arrow (Plate 156).

Plate 155: West wall, north door frame

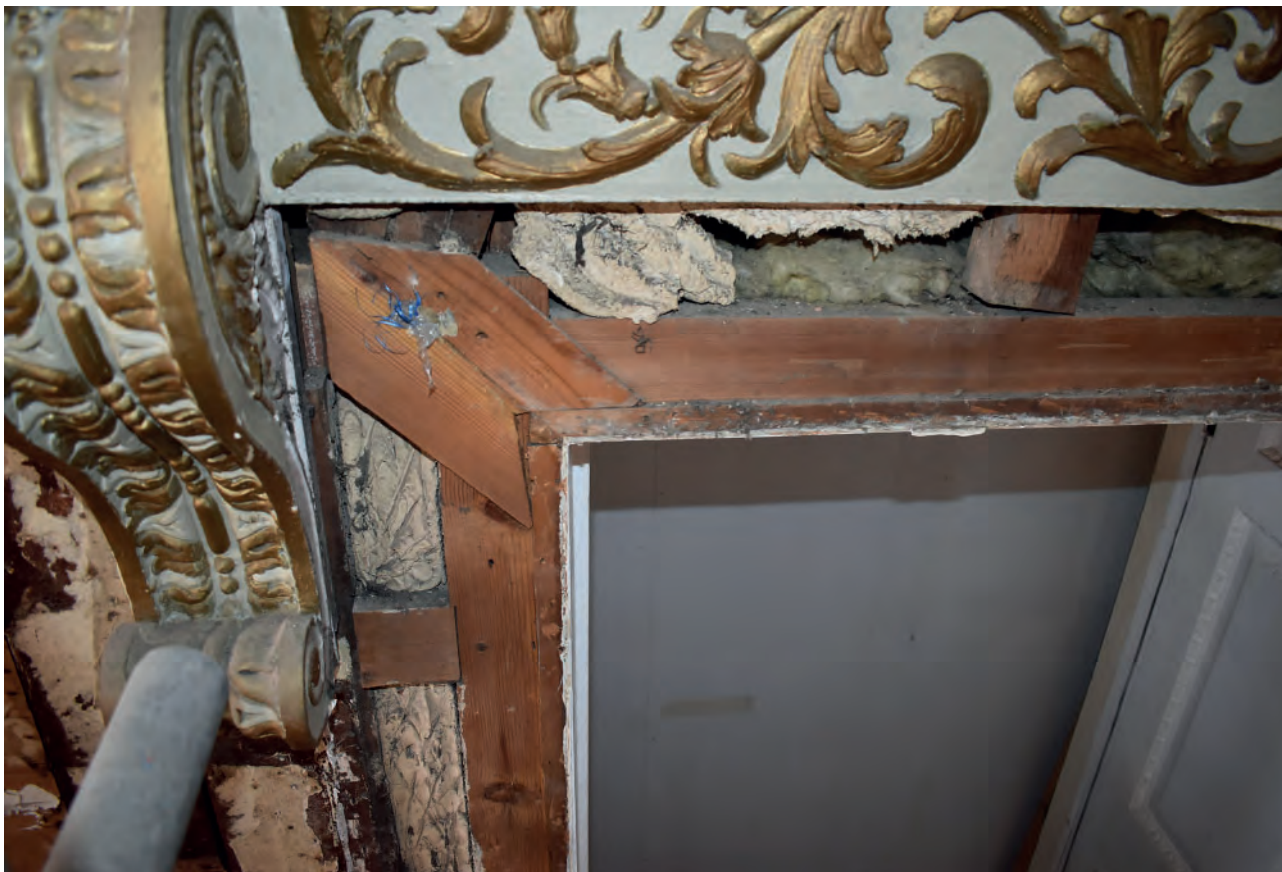
Plate 156: West wall, north door frame
