# State Dining Room Stowe House Buckinghamshire

## Historic Building Investigation and Recording

July 2023

Document Type: Historic Building Investigation and Recording

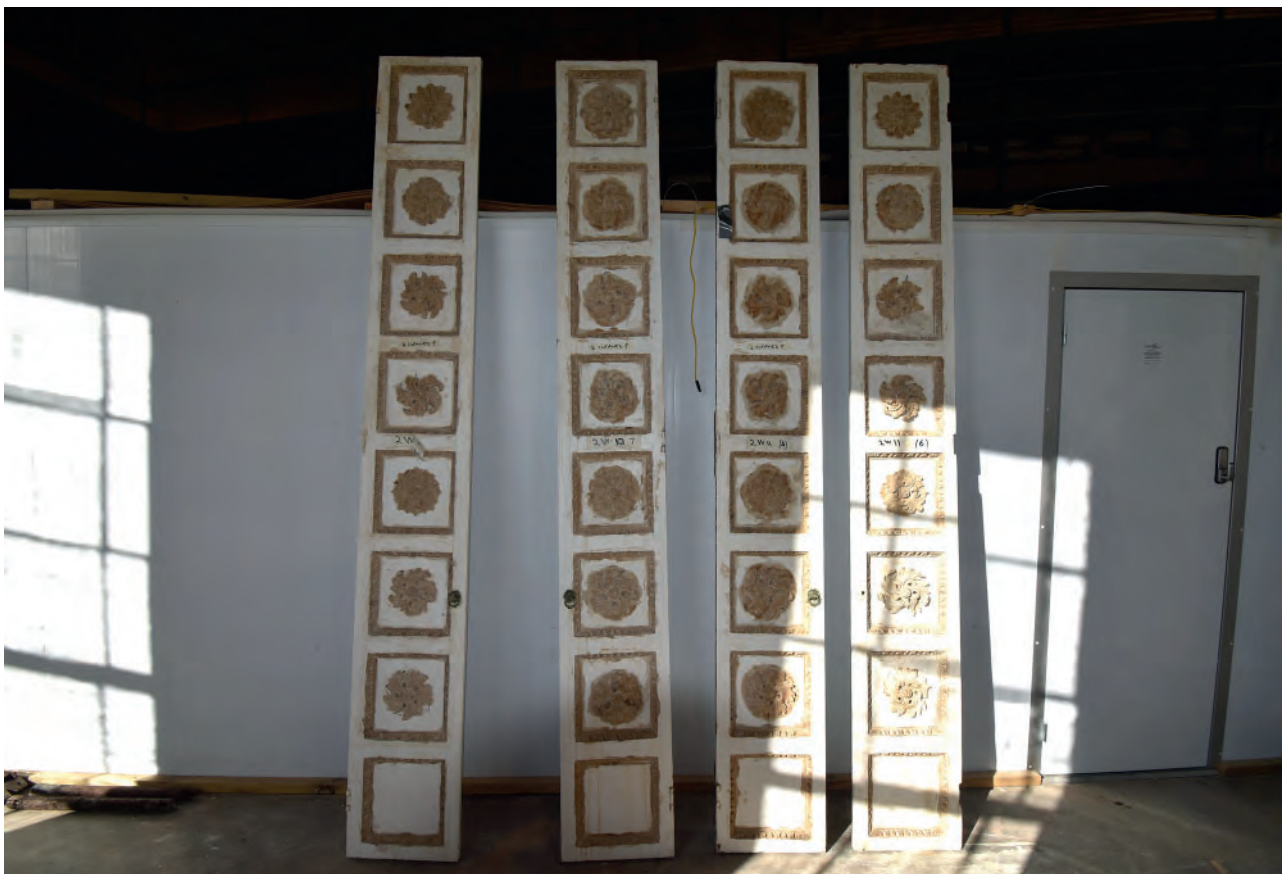
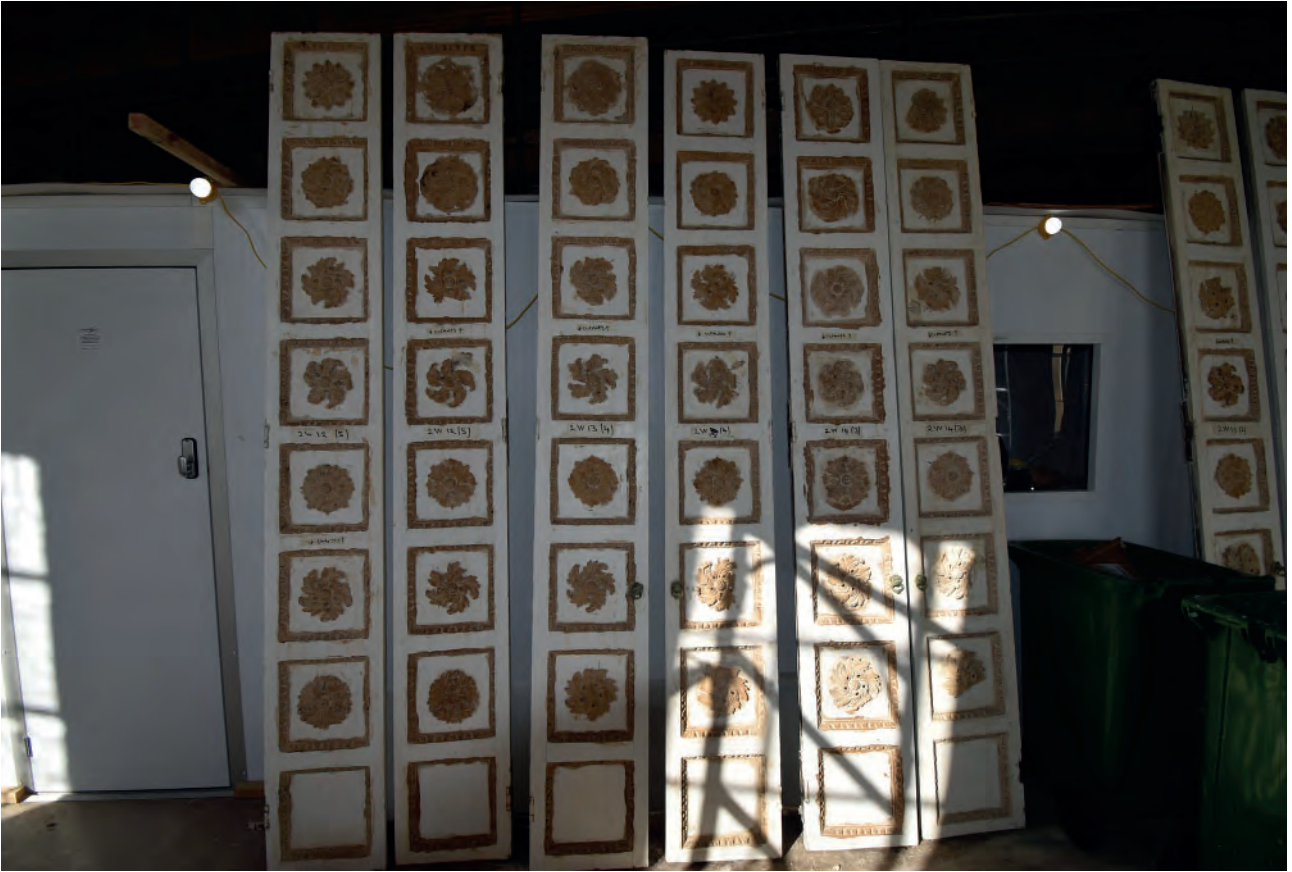
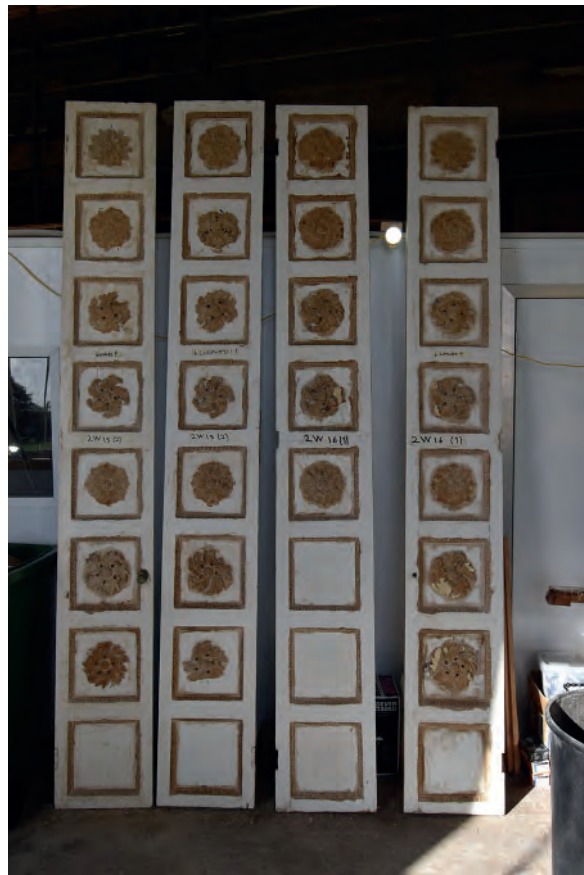
3.4.11 During the conservation work related to the shutters, it turned out that the rosettes in the shutters differ. On each shutter there are eight different rosettes arranged vertically. Each shutter lacks the lowest rosette, and one of them lacks as many as three (Plates 157- 159). They are visible in the old photos, so they must have been removed.
