# Stonor Park, Oxfordshire.

Watching Brief during Construction Work  
October - November 1994

Oxford Archaeological Unit  
December 1994

(NGR: SU 7425 8923)

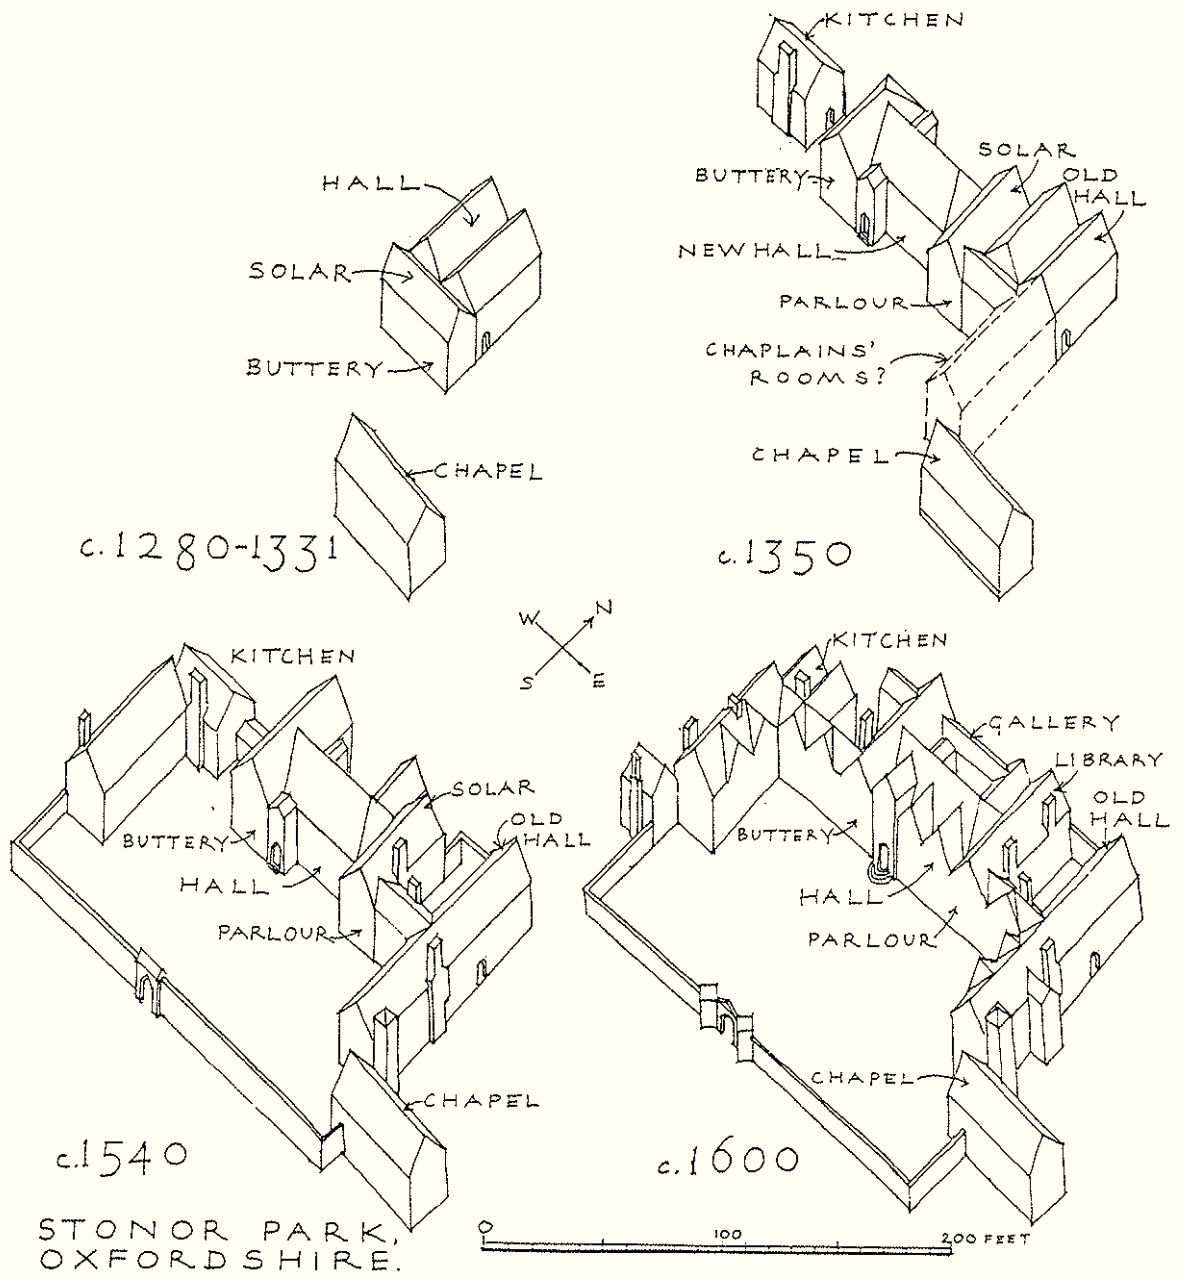
Figure 7: Conjectural development phases (WA Pantin). Copyright VCH.

- 2.3 An illustrated account of the building was prepared by WA Pantin for the VCH (Oxon.) viii, p.145-147 (Pantins illustration of the conjectural phases of development is included here as figure 7).
