Battles Hall Barns Maggots End Manuden Essex

Historic Building Survey

May2012

Historic Building Survey and Archaeological Monitoring

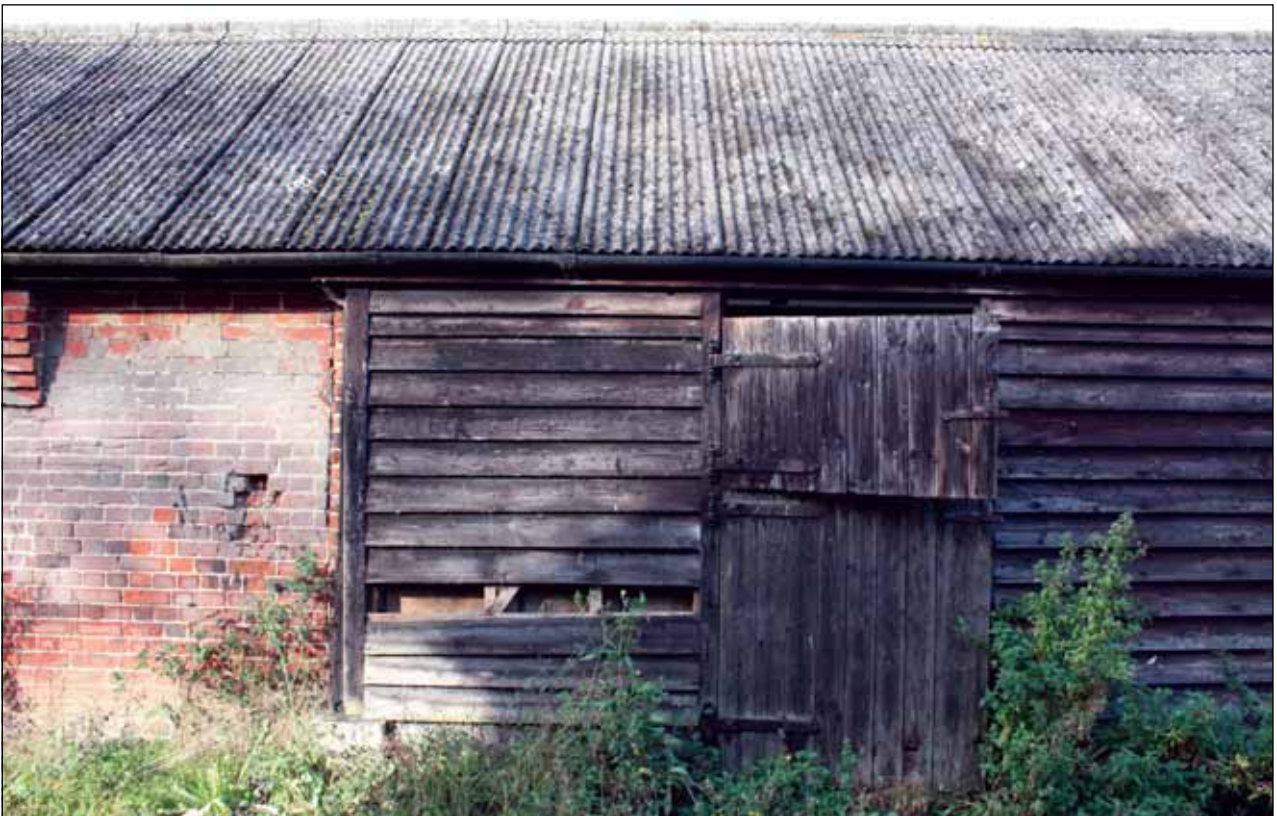
Plate 41: Detail of weatherboard and door on Building 8

- 4.9.2 The building is only accessed from the east-facing elevation via four two-part stable doors and a wider opening at the northern end (Figure 11, Elevation 8 and Plate 40.). On the far southern end is a later brick-built building which is not accessible from Building 8 and is not part of the current development area. The two-part stable doors on this elevation are the same as those recorded on Buildings 1 and 3 with the same heavy hinges and latches (Plate 41). This elevation is mostly covered with horizontally laid weather-boards with a small concrete plinth measuring 0.40m in height at the base. The large opening at the northern end (Plate 42) has an exposed curved brace and iron hooks indicating it once had a door, or set of double doors, to enclose it.

Plate 40: East-facing elevation, Building 8

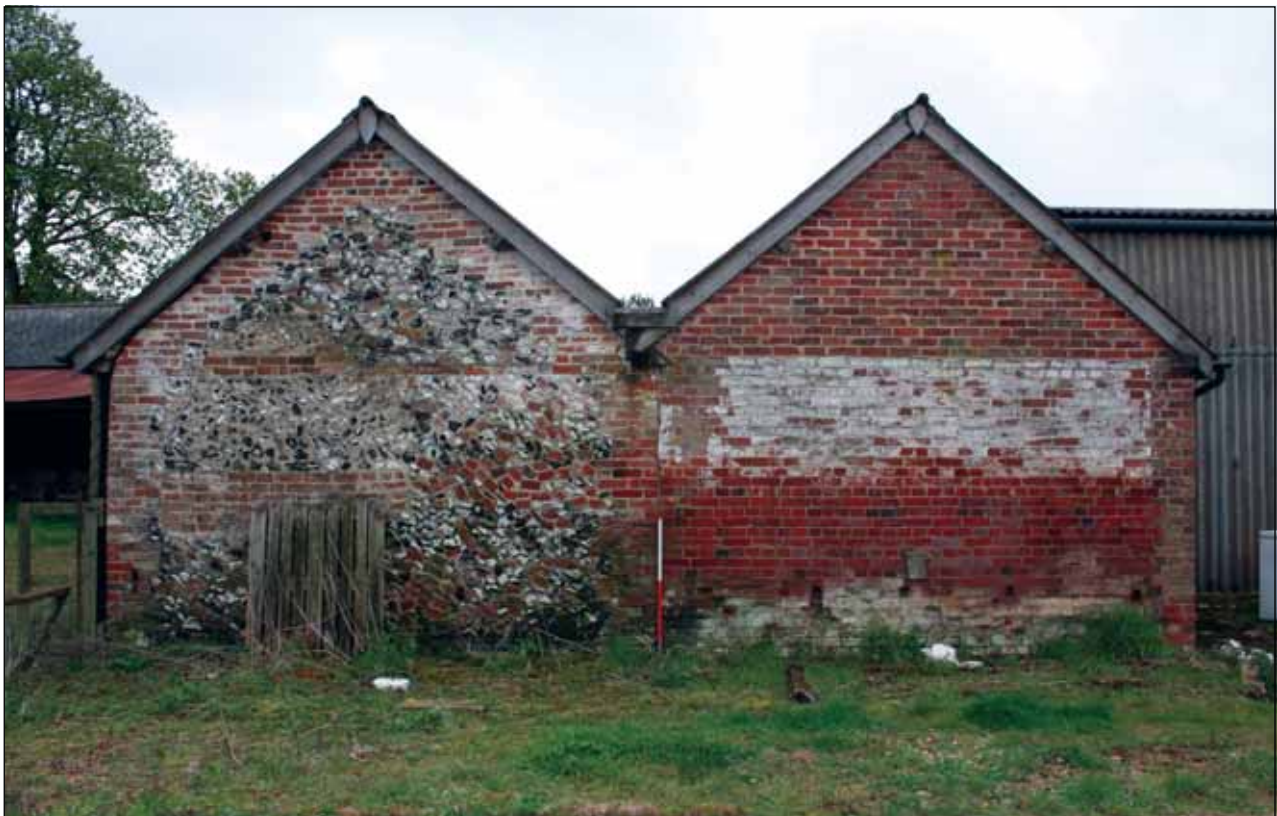
- 4.9.3 The north-facing gable end (Figure 11, Elevation 9; Plate 43) shows the proximity to Building 9 on the western side. This end is constructed using flint and brick with wooden barge-boards and a diamond-shaped wooden finial. Close inspection of the brickwork indicates that Building 9 was constructed against Building 8.

- 4.10.2 The north-facing elevation (Figure 11, Elevation 9; Plate 43) is constructed entirely from brick with a wooden barge-board and finial. The roof has a moderate pitch and is covered with corrugated asbestos.

Plate 43: North-facing gable-ends, Buildings 8 and 9

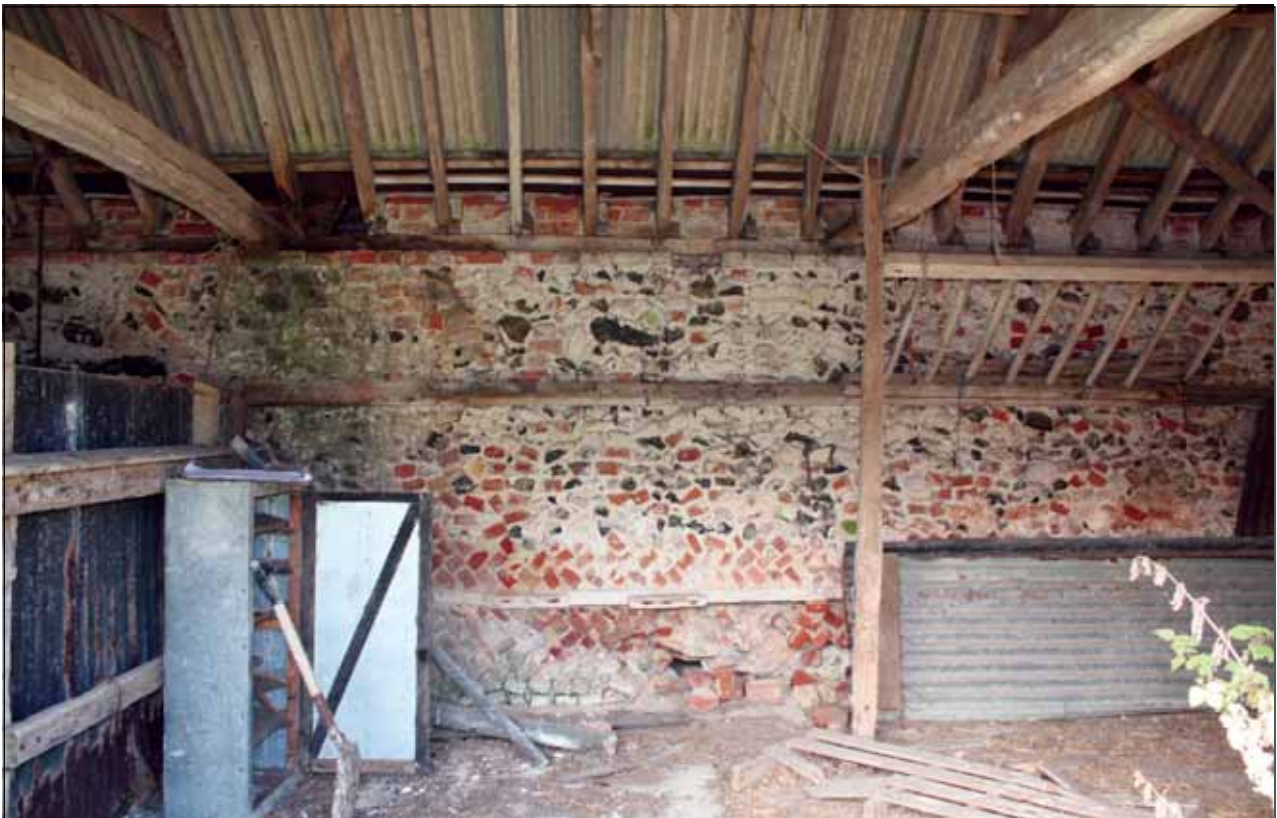
- 4.9.6 There are a number of fixtures which indicate that this building was used for sheltering animals. These include a wall-mounted iron manger (Plate 46), a wooden trough with iron tethering hoop (Plate 47) and a wooden stall (Plate 48). Although the stall was only present in the northern end of Building 8, the wooden wall mount to which it was secured spans the length of most of the building.

Plate 47: Wooden trough, Building 8

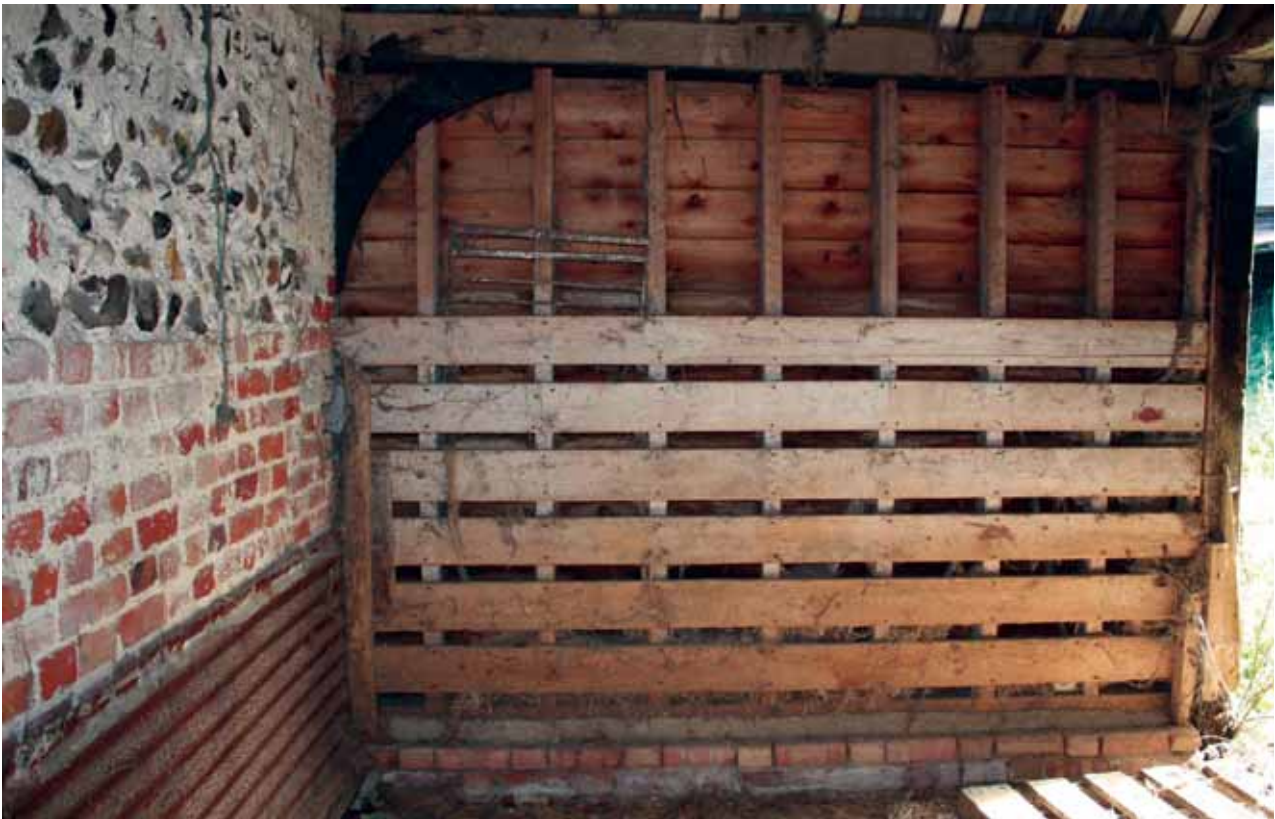
Plate 48: Detail of brick and flint wall and wooden stall, Building 8
