St Giles Church Imber Wiltshire

Phase One Repairs

**Historic Building Investigation
and Recording**

August 2006

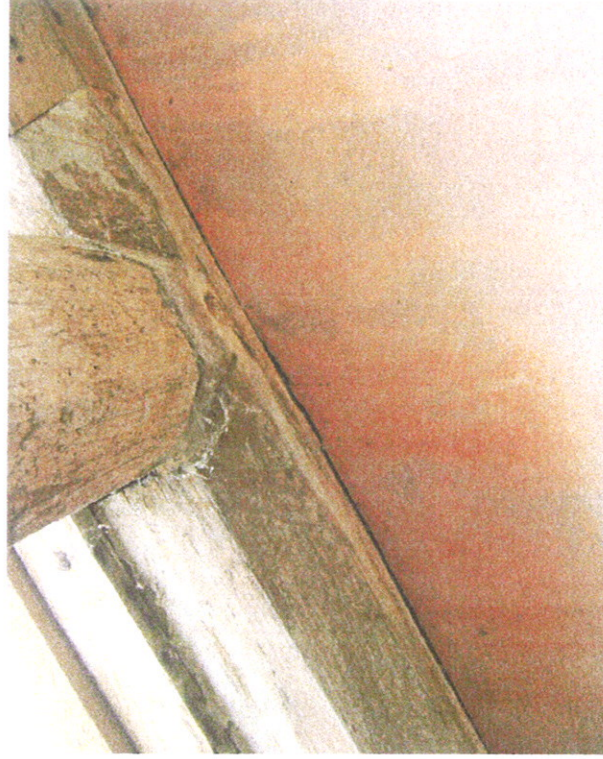
Plate 4: Detail of main rafter and purlin

- 4.3.4 The roof is all of one build and in detail and construction it appears to be late medieval and is presumably the aisles original 15th century roof. The roof is divided into five bays by large moulded principal rafters all joined by a moulded purlin (Fig. 2, Plates 3 & 4). Above this lie the common rafters. It is clear that there was once a ceiling nailed to the common rafters with the moulded timbers projecting downwards from its surface. Above the rafters was a planking roof made of stained pine (1950s?). The planking was clad in lead sheeting and this was in turn covered in clay peg tiles fixed on battens.
