18th Century Stables
of the Former
Debden Hall
Debden
Essex

Historic Building Survey

July 2011

OA East Report No: 1282
OASIS No: oxfordar3-102361
NGR: TL 5495 3334

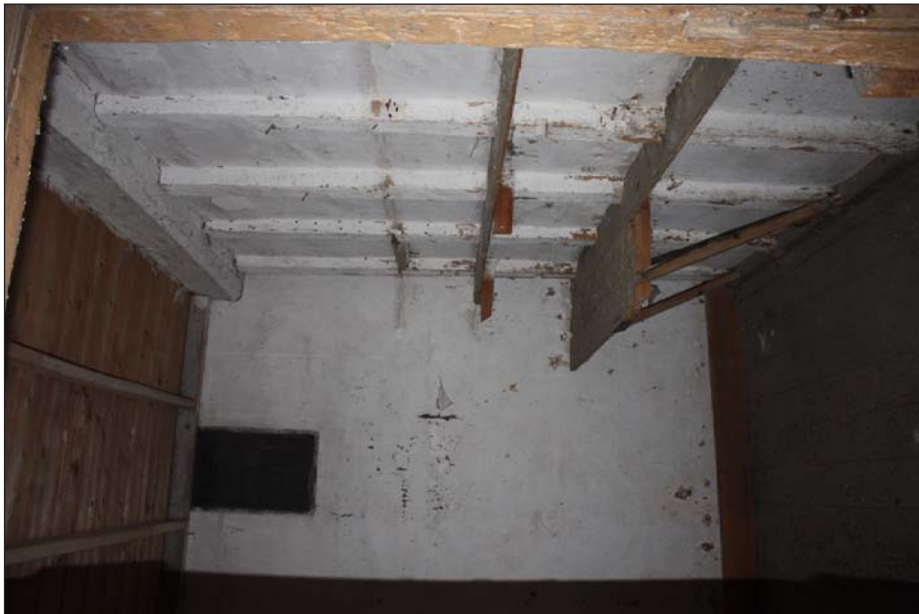
Plate 52: General view, F7

- 4.3.52 On the other side of the partition which creates F2, F6 and F9 is a long narrow room measuring 7.42m by 1.24m. This room is accessed via a door from F2 (plate 50) and was most recently used as a toilet (plate 52). Along with a sign for “LADIES” and notes about potato storage, this door also has “POST OFFICE” written in red chalk. This may be further evidence of the buildings wartime function.

4.3.53 When created in the 19th century this area, like the space behind F3, had been left open to provide access to the hay feeding hatches which span the length of G1 (these can be seen in plate 52). It appears that later, during the 20th century, this area was enclosed and a toilet added.

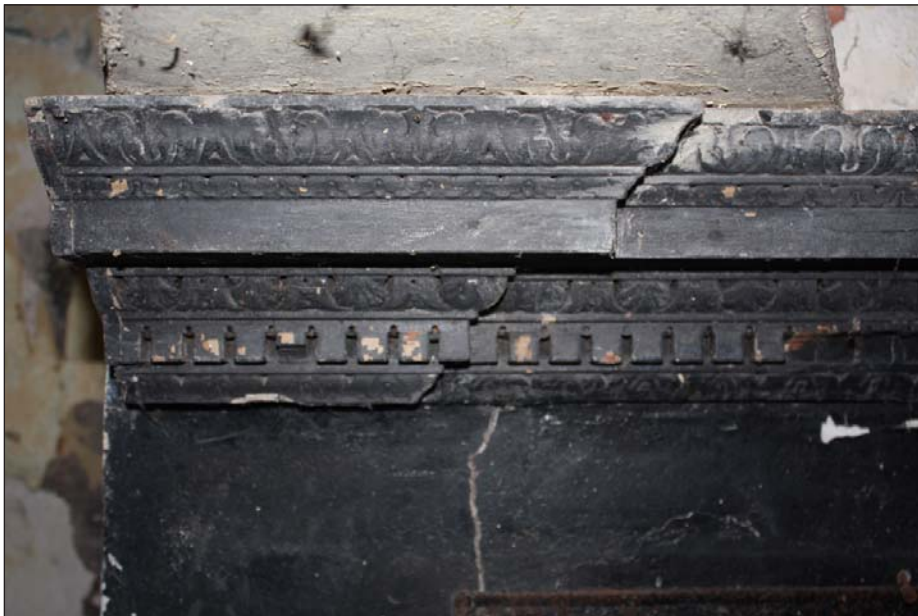
Plate 53: Fireplace, cupboard, chair rail and skirting board, F8

4.3.55 The fireplace and built-in cupboard are located in one corner of this room (plate 53). This fireplace is served by the same chimney as that in G4 directly below. It is more elaborate and decorative than those recorded in G5 and F4, and although there is evidence that it is not original to the construction of the stables, it pre-dates the other fireplaces recorded. The fire surround is made from cast iron and has wide, plain side surrounds, however, the upper surround and mantle are far more elaborate with carved dentils and foliage design which may indicate an Early Georgian date (plate 54). As the fireplace is not original to the construction of the stables, it is likely that it has been re-used from another building of higher status, perhaps Debden Hall itself, after the re-modelling in the 1790s.

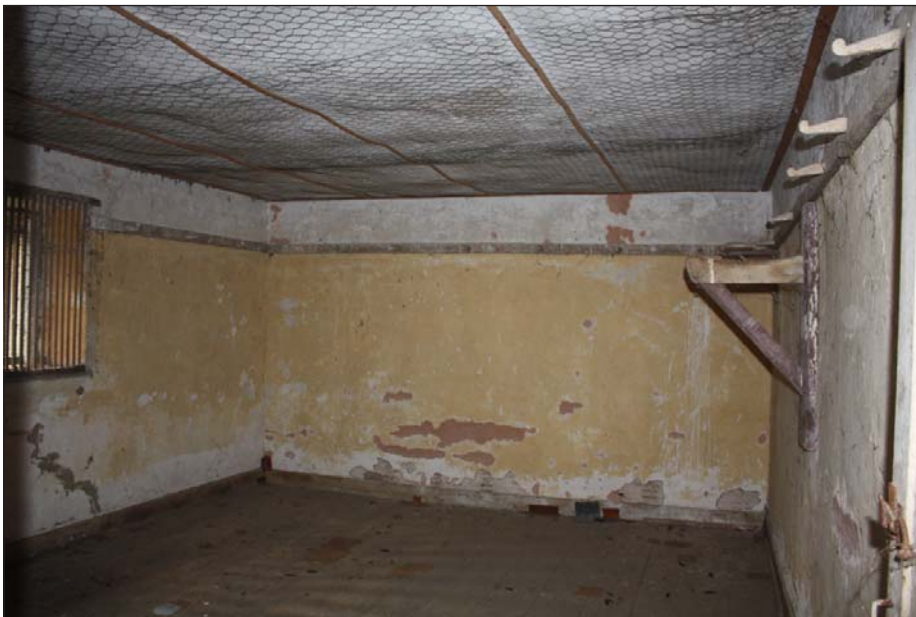
Plate 55: Internal door connecting F8 and F9 (from F8)

4.3.56 The door between F8 and F9 (plate 55) is likely to be original to the building and is different to the plain wooden panel doors recorded elsewhere on this floor. This room is most likely to have been used as accommodation. Although it is difficult to tell if it was originally designed as such when the stable was built, it certainly has a separate function to storage.
