Chapel Court
North Facing Elevation
Hampton Court
P a l a c e

Historic Building Recording

May 2007

Client: Historic Royal Palaces

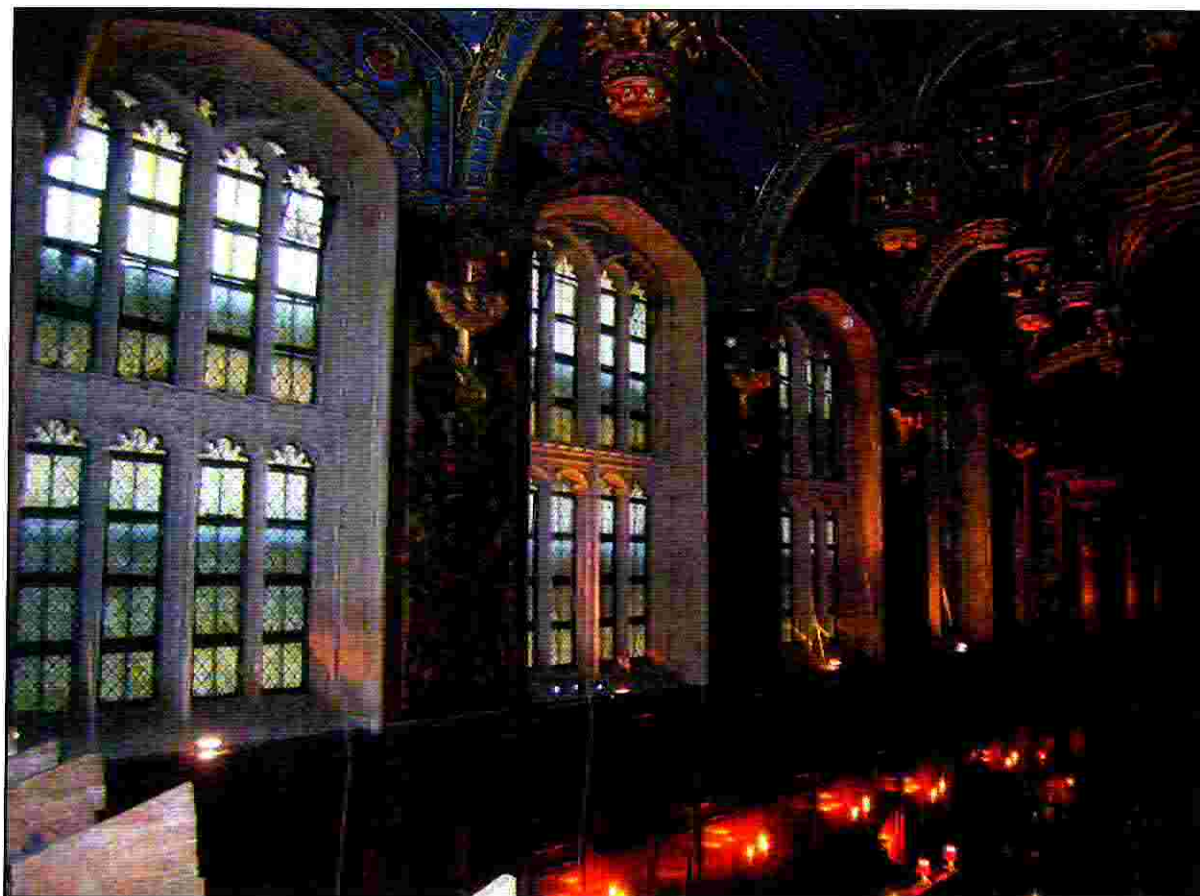
- 2.1.3 The main changes that affected the north facing elevation of chapel court are the replacement of the chapel windows in the 18th and 19th centuries. The original Tudor windows were replaced with casement windows during refurbishment of the chapel in 1710/1711. After a proposal in 1847 to refenestrate the chapel was rejected, the windows were finally replaced in 1894 (plate 1), in a style based upon a design of existing 16th century windows located in the organ loft. After a request from SPAB (Society for Protection of Ancient Buildings) the trompe l'oeil windows within the chapel that show the 18th century window design were retained (plate 2). Many of these changes have been outlined within the 'Royal Pew, Chapel: Summary Statement of Significance' which is included in Appendix III.

Plate 1: Chapel Court, North Facing Elevation - The 1894 chapel windows

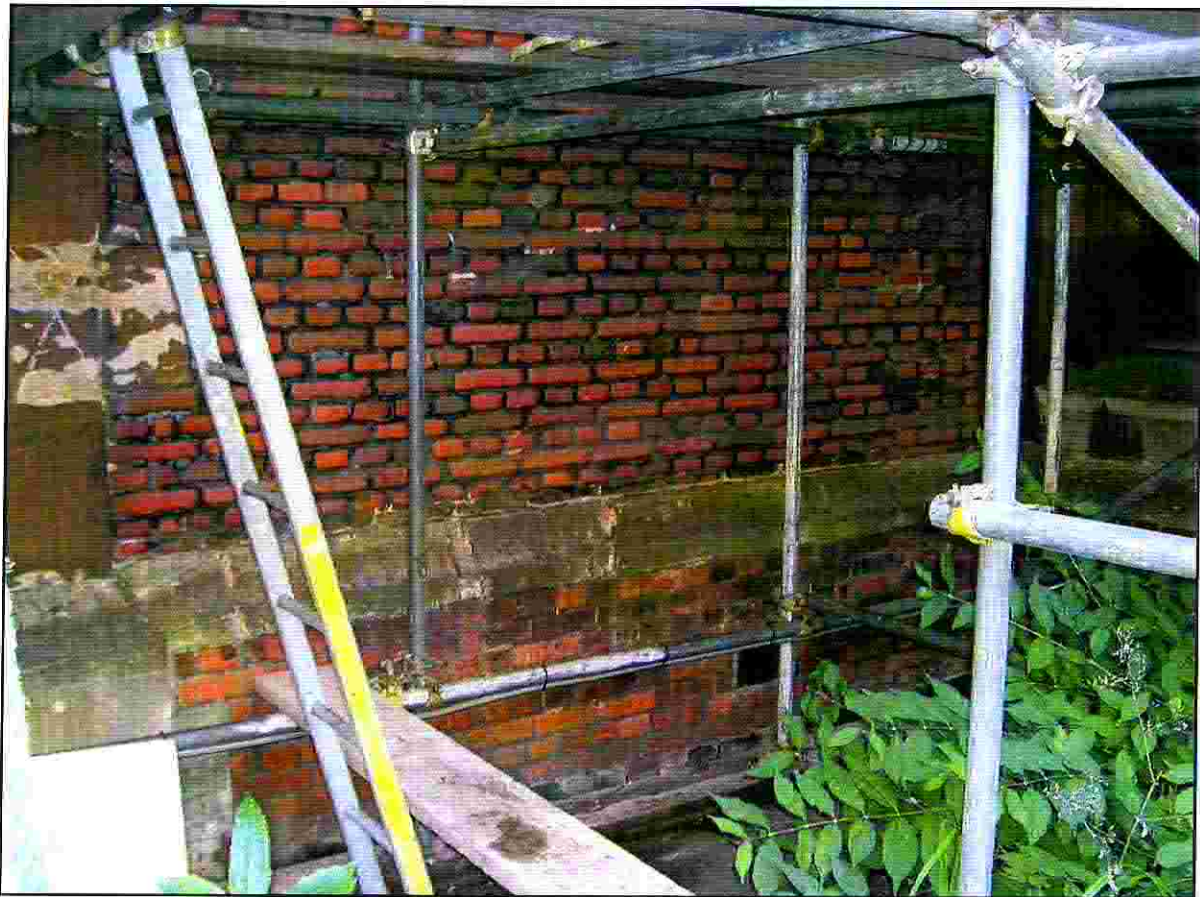
- 3.2.4 There is a brickwork plinth at the base of the elevation that is topped by a stone weathering course (plate 7). There is calcification upon the brickwork and mortar. The bricks are 19th century Type T stock bricks in various shades of orangey-red, the mortar is flat and a light grey in colour. There are patches of friable soft bricks, probably due to weathering. There is a large quantity of organic growth on the brickwork, mostly a mossy substance.

Plate 7: Chapel Court, North Facing Elevation - The plinth

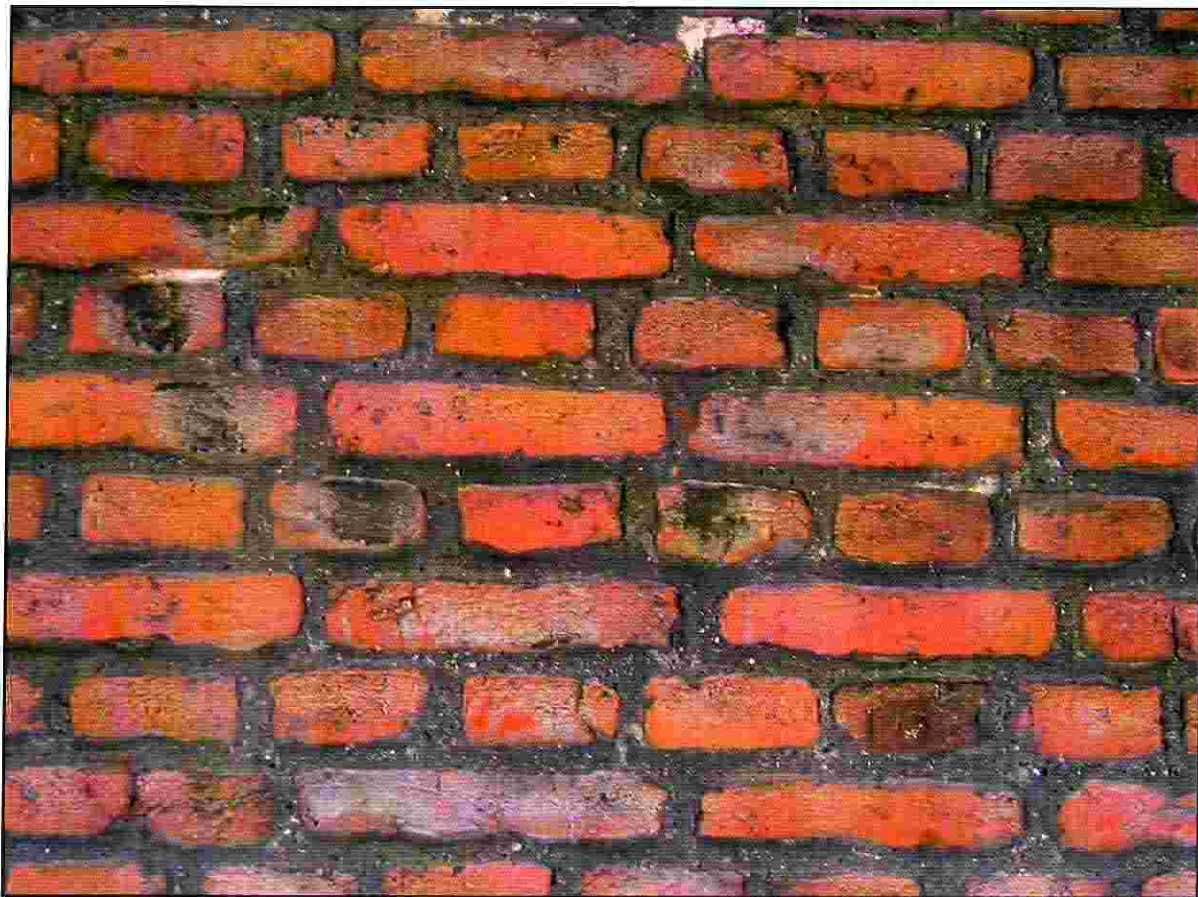
3.2.7 There are patches of replacement brickwork within the elevation which have used using Type T 19th century stock bricks. In many cases care has been taken to match the bond and coursing of the existing brickwork with the use of tiles and stretchers which have been cut to look like two headers (plate 8).

Plate 8: Chapel Court, North Facing Elevation - 19th century repair with stretcher cut to look like headers

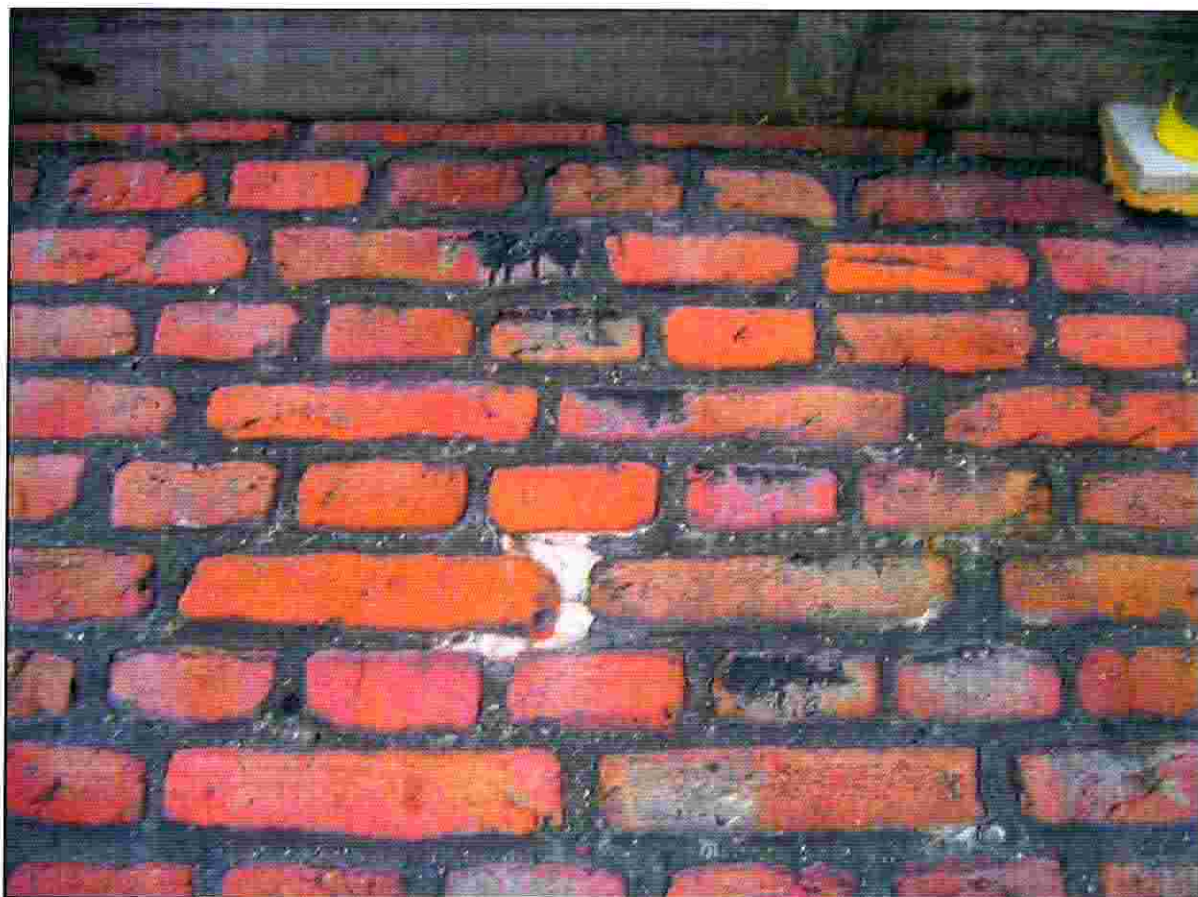
Plate 9: Chapel Court, North Facing Elevation - Diaperwork

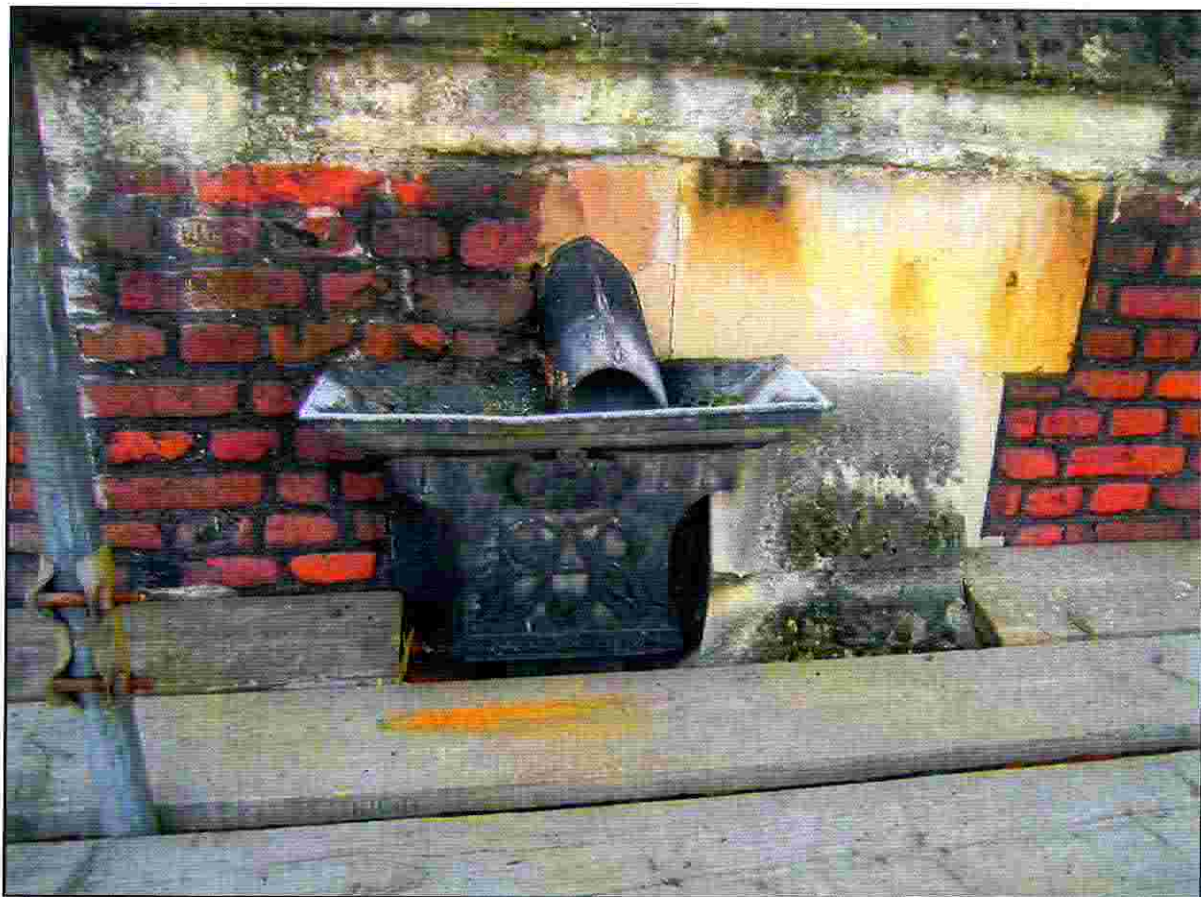
4.4.1 There are two main downpipes to this elevation, located beside the two outer pilasters. The hoppers of these have the insignia of Queen Anne and a date of 1711 and were possibly added to the elevation at the same time as the casement windows (plate 12).

Plate 12: Chapel Court, North Facing Elevation - 1711 hopper

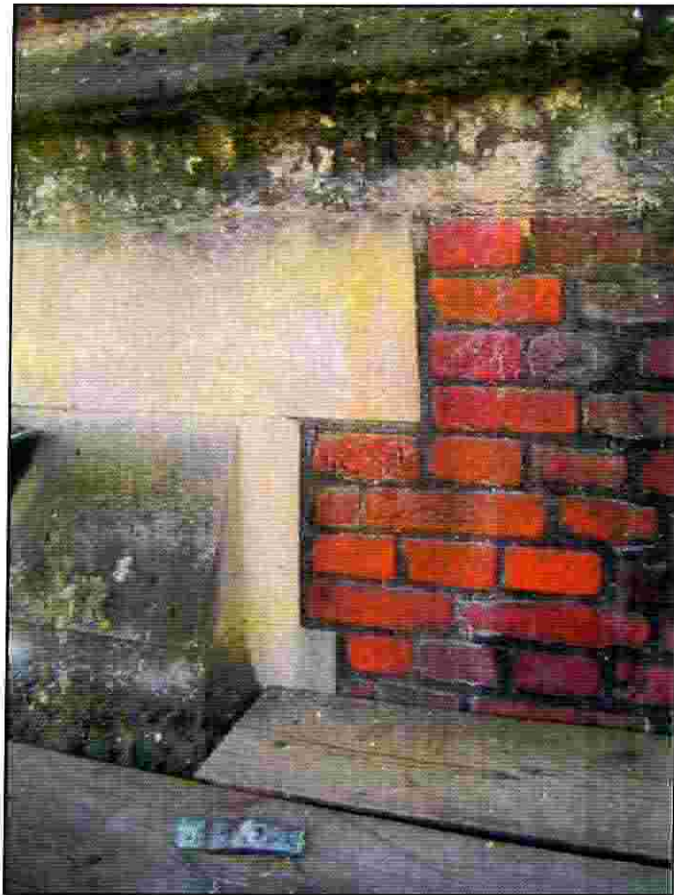
Plate 14: Chapel Court, North Facing Elevation - Inscribed graffiti upon 19th century stock brick

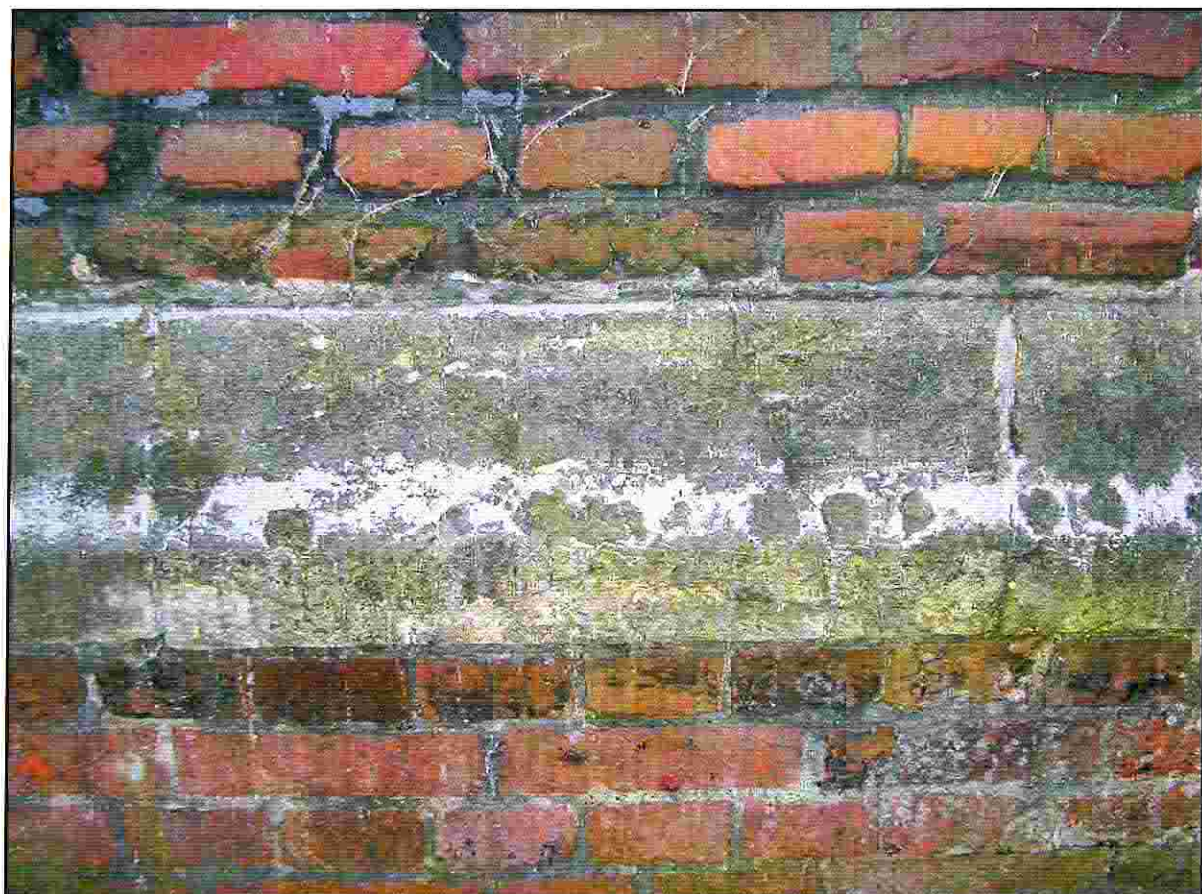
Plate 18: Chapel Court, North Facing Elevation - Blistering on lower pilaster stonework

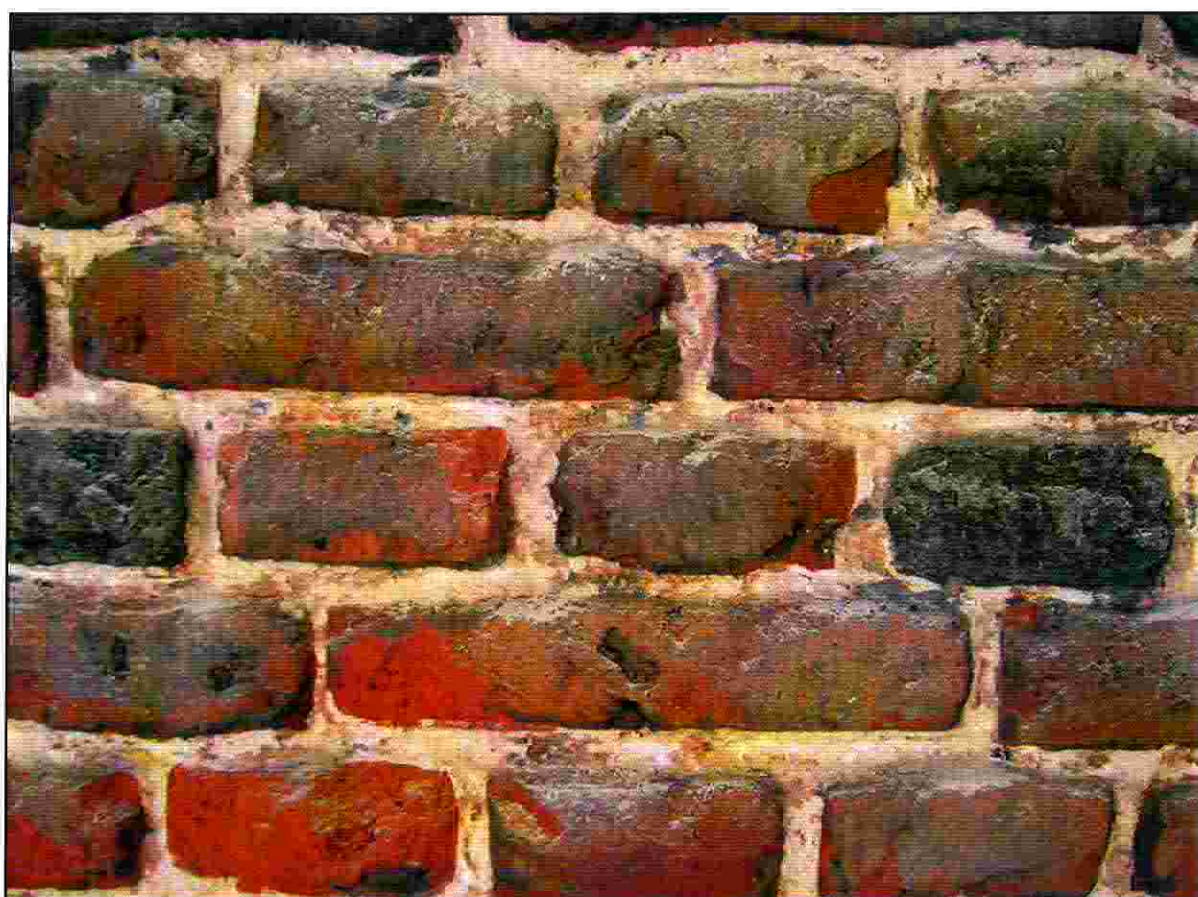
Plate 19: Chapel Court, North Facing Elevation - Plinth stonework

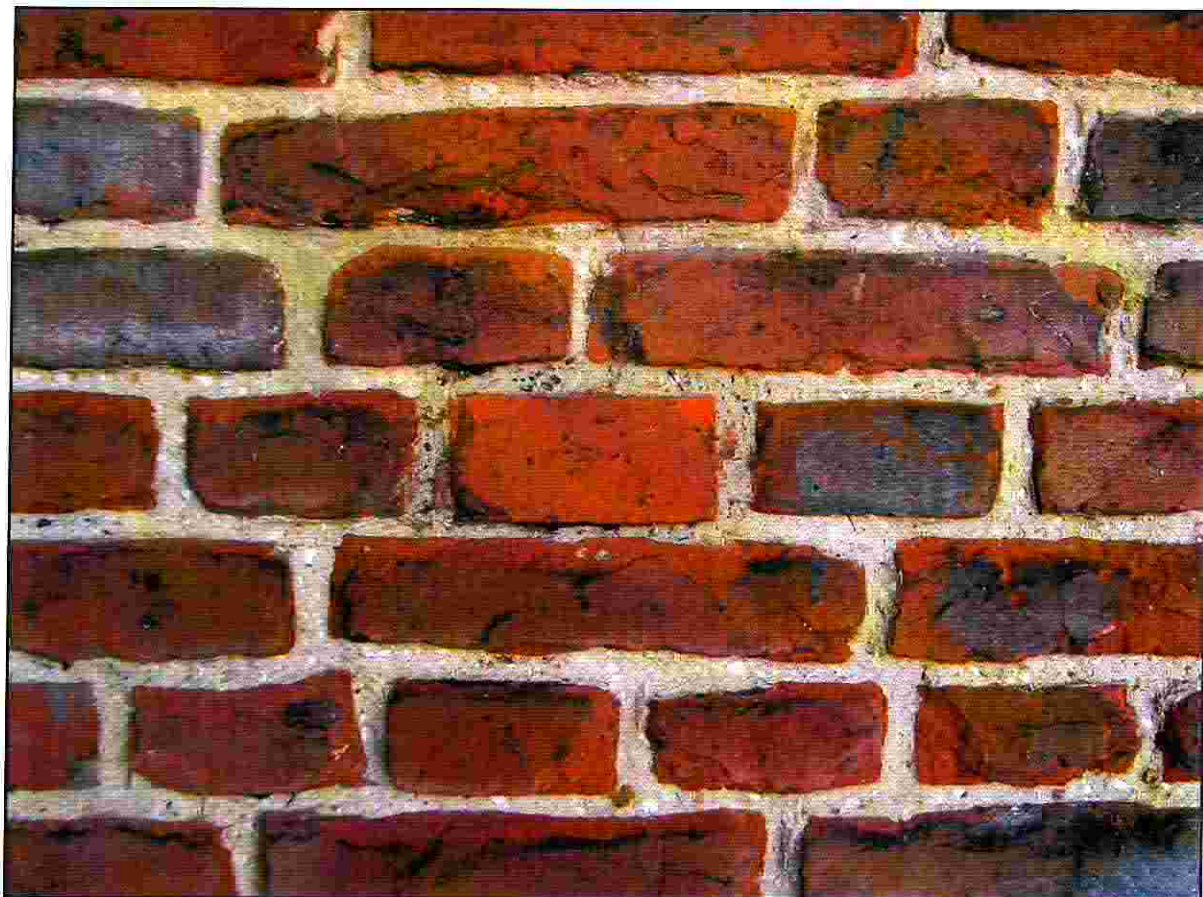
Plate 20: Chapel Court, North Facing Elevation - Red paint on original bedding mortar

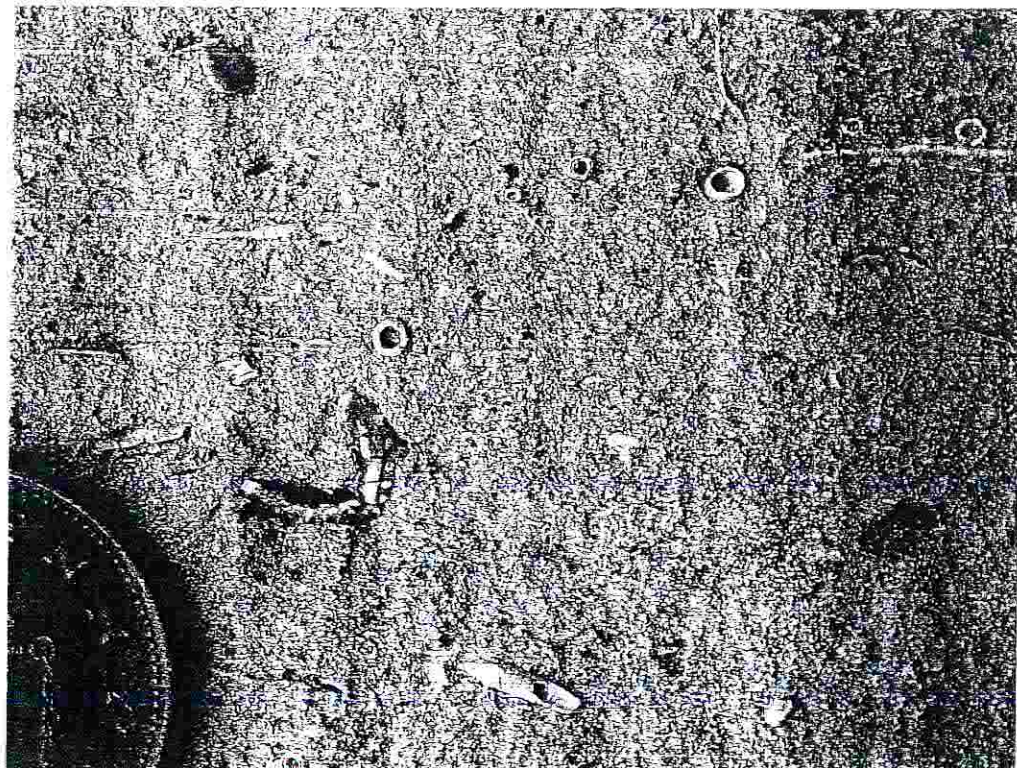
Fig. 2. Buttress of 1533 Close Tennis Play showing original weathering stones embedded in south wall of Prince Edward's Lodging (to left). Elevation SF5.

Fig. 2. Calcaire grossier weatherings to Tudor period buttress.

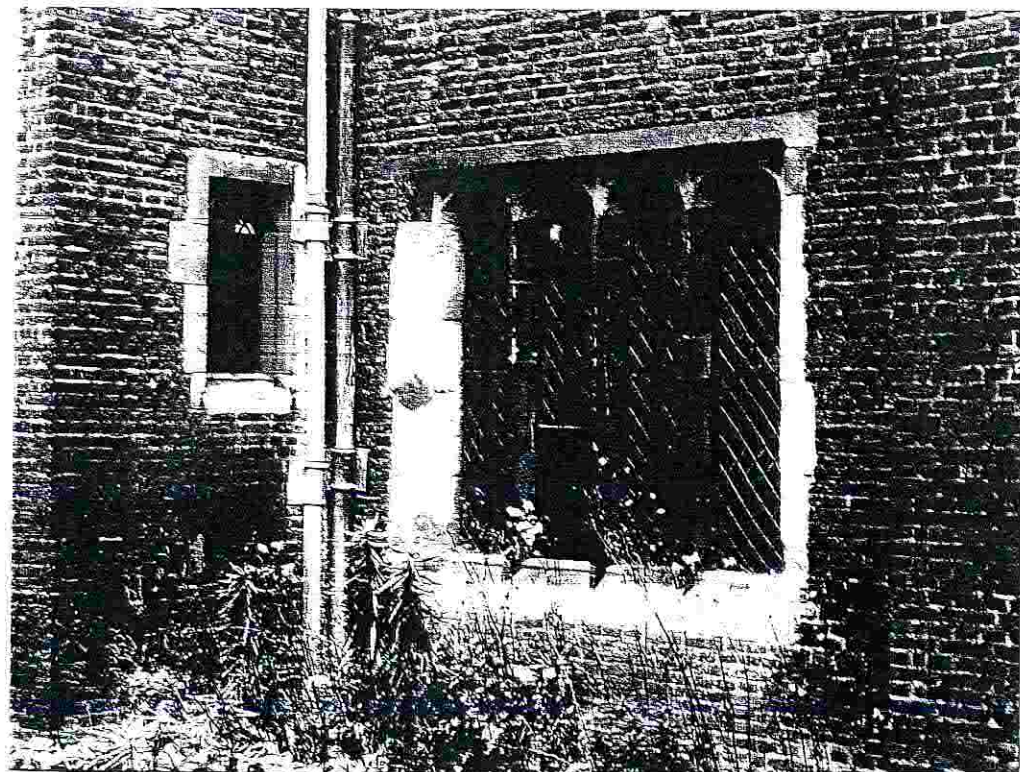
Fig. 4. Bath Stone window, 3rd floor of Elevation SF4. Note accelerated decay of the sill.

Fig. 4. Bath Stone window. 3rd floor Elevation SF4.

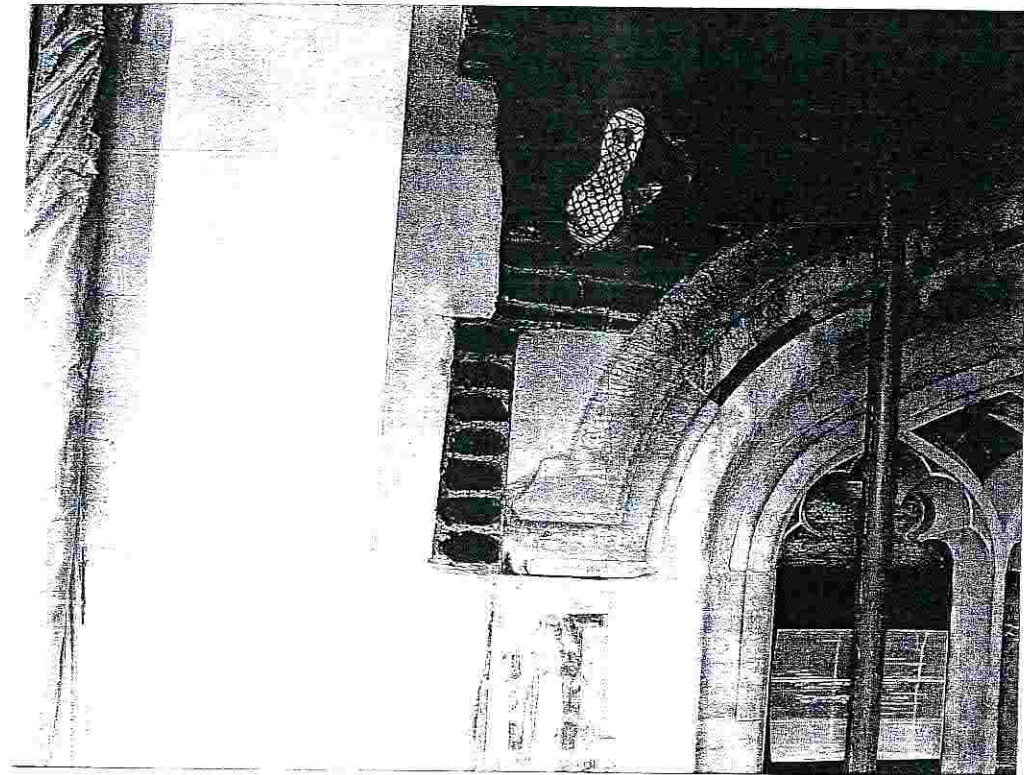
Fig. 5. Prince Edward's Lodging. Ground floor Tudor window.

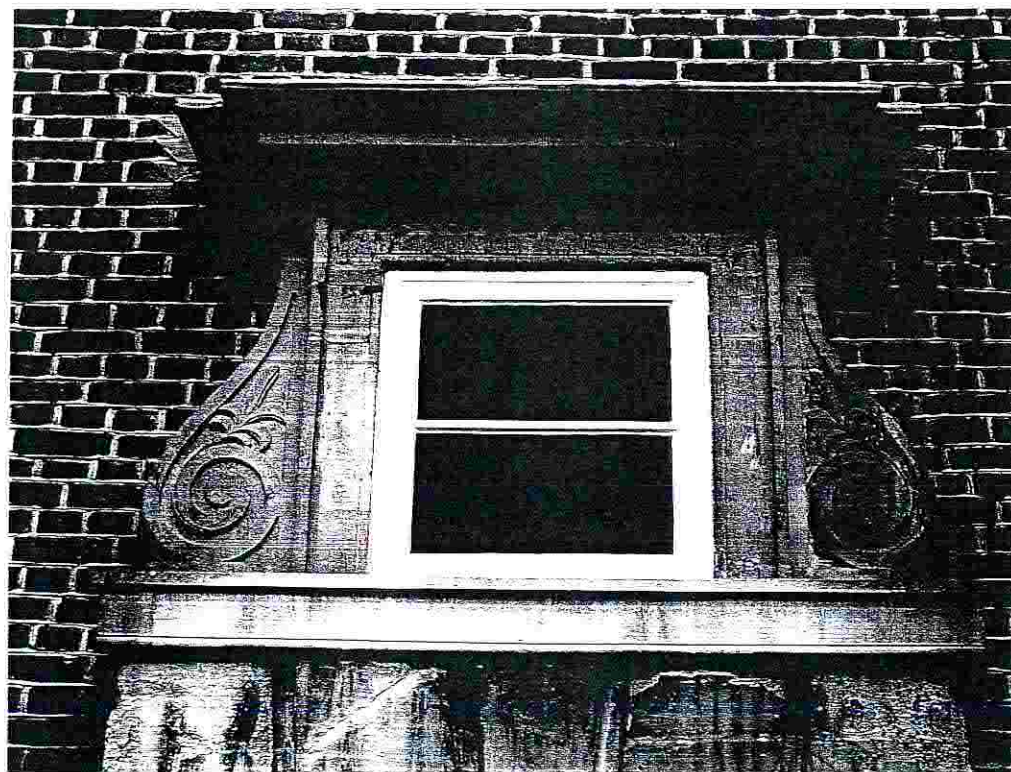
Fig. 10. Ditto. Detail of repairs.

Fig. 10. Duke of York's Lodging doorway. Patching & replacement of Taynton stone with Bath stone.

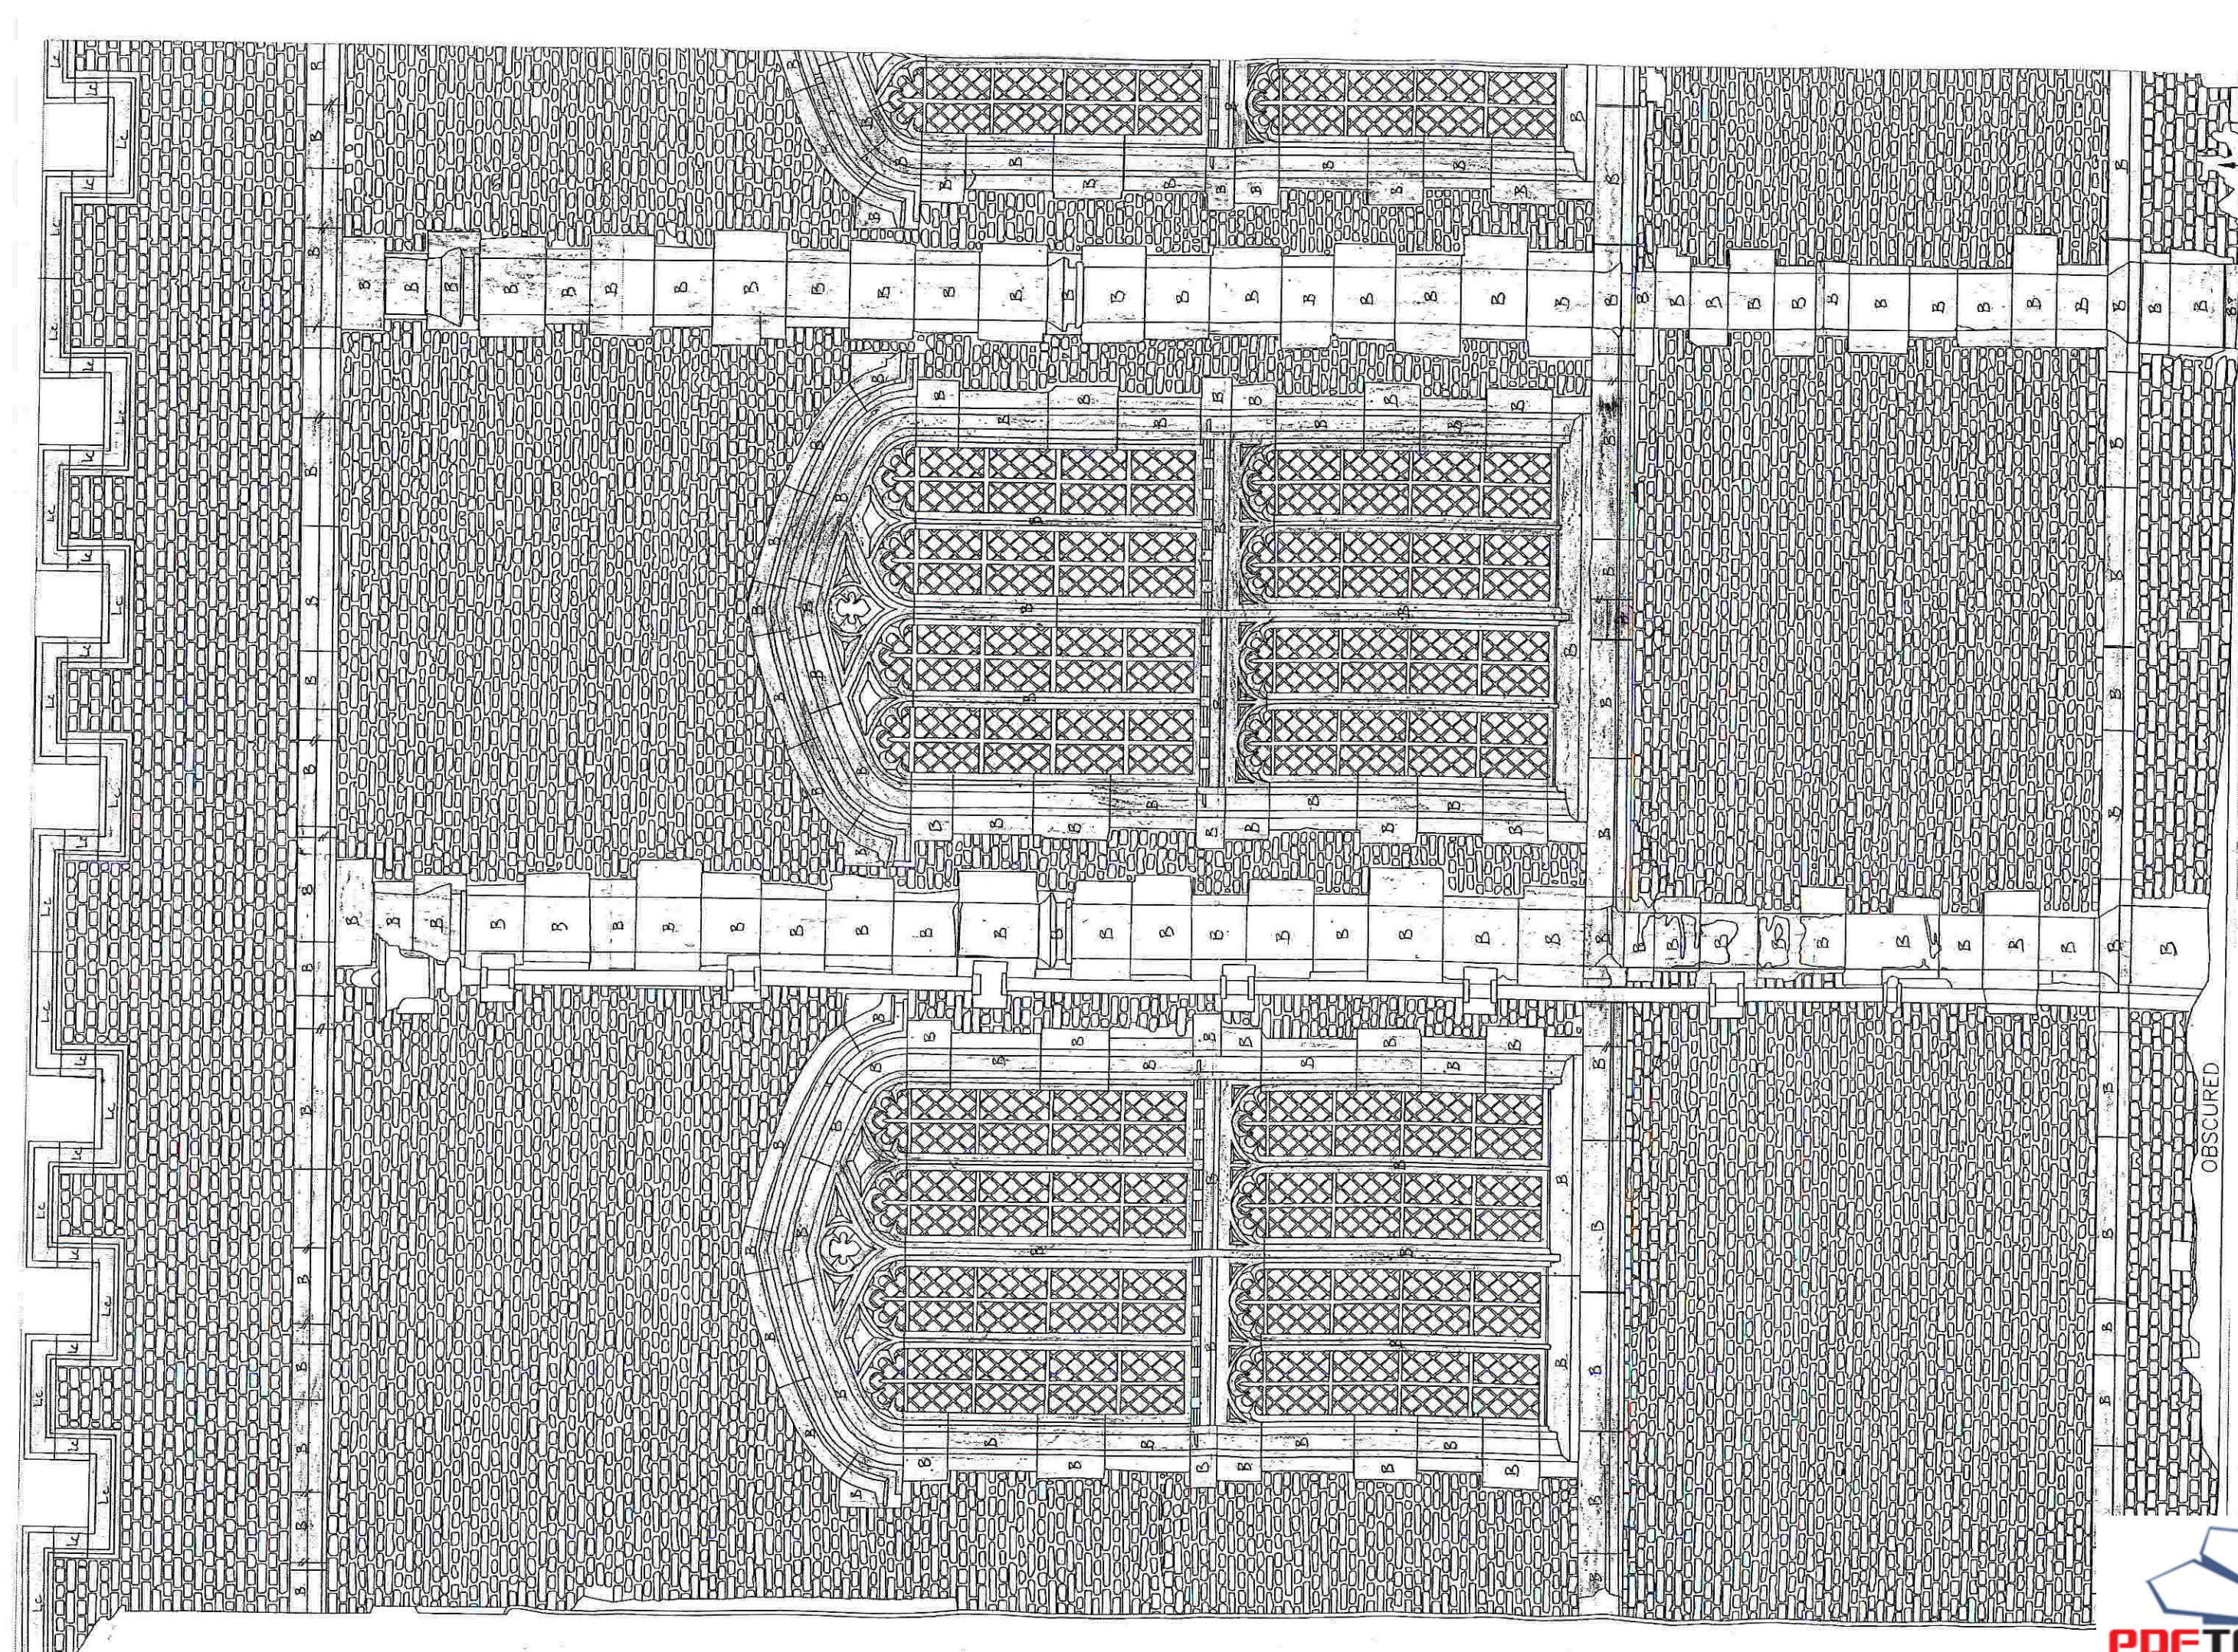
Fig. 11. Ditto. Renewed pediment.

Fig. 11. Duke of York's Lodging door pediment. Mostly 'new' Bath stone.
