Apprentice Store De Montalt Mill Combe Down Bath

**Historic Building Investigation
and Recording**

May 2006

Document Title: Historic Building Recording and Investigation

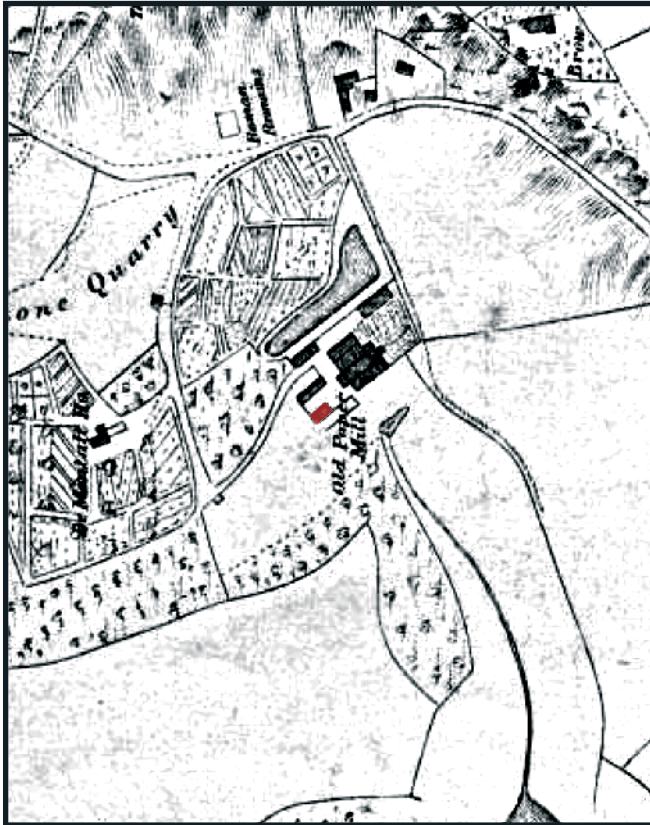
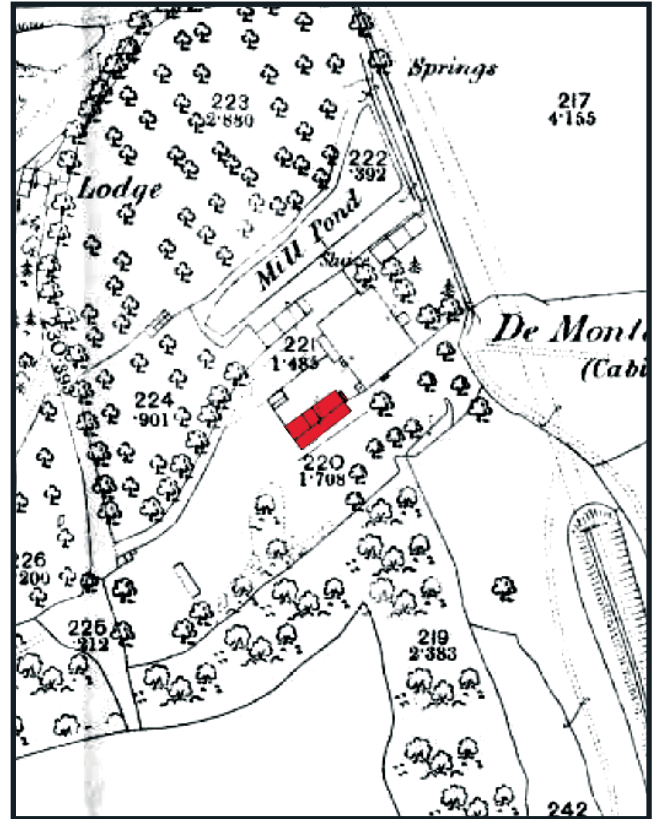
Figure 3: Historical maps.

- 2.1.8 Cotterell and Spackmans map of 1852 (fig. 3) shows the earliest part of the Apprentice Store range (Phase 1 and probably phase 2) in existence.

- 2.1.13 The first edition Ordnance Survey map of 1886 (fig. 3) shows the fully developed Apprentice Store range with eastern extension, southern lean-to and external stair at east end.
