**BELMONT
BLEACH WORKS,
EGERTON ROAD,
BELMONT,
BLACKBURN WITH
DARWEN**

**Historic Building
Investigation**

October 2015

Millson Associates
Planning Application 10/12/0590

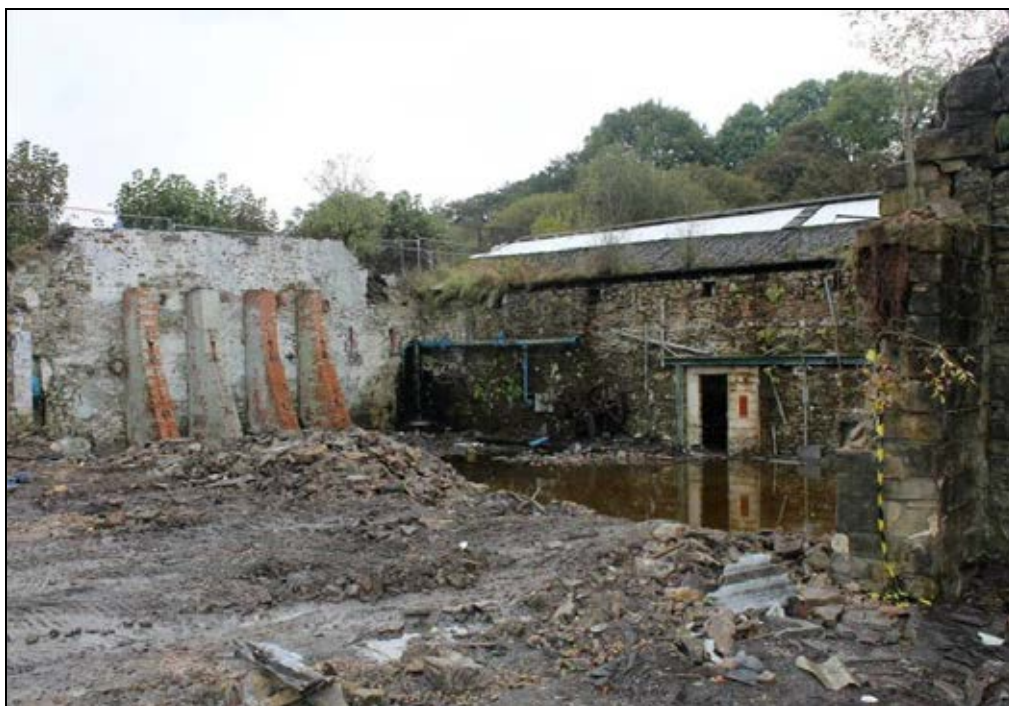
- 3.2.1 Building A was a large rectangular structure, aligned north/south, and constructed of light yellow sandstone (Plate 11). The building had been partially demolished, and only the northern and eastern walls remained to their approximate full height, with the northern end of the western wall and the southern wall surviving only as fragmentary remains. The roof had apparently collapsed, and had been removed to make the site safe.

Plate 11: Building A looking north into the interior after demolition of the western wall

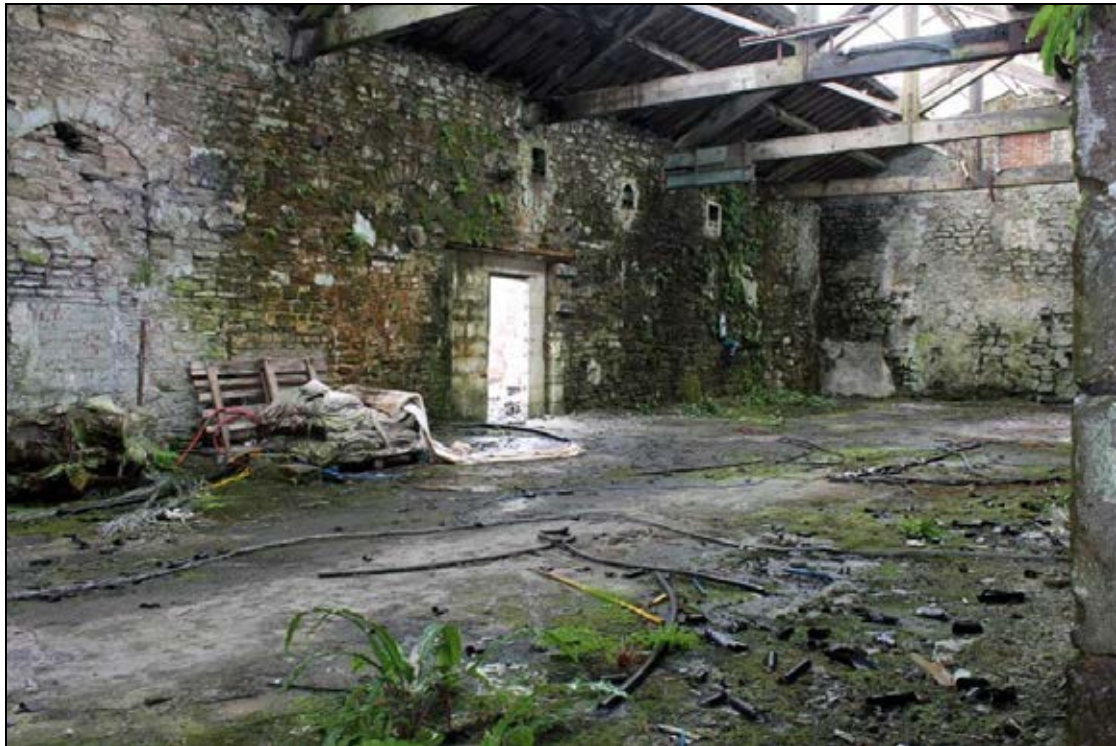
- 3.2.6 **Eastern Wall:** the eastern elevation of Building A had been incorporated into the later Building B, and therefore formed an internal wall dividing the two structures (Plate 14). Its relationship with the remaining fragment of Building A's southern wall clearly indicated that originally this had been an external wall.

Plate 14: Original external elevation of Building A, facing north-west

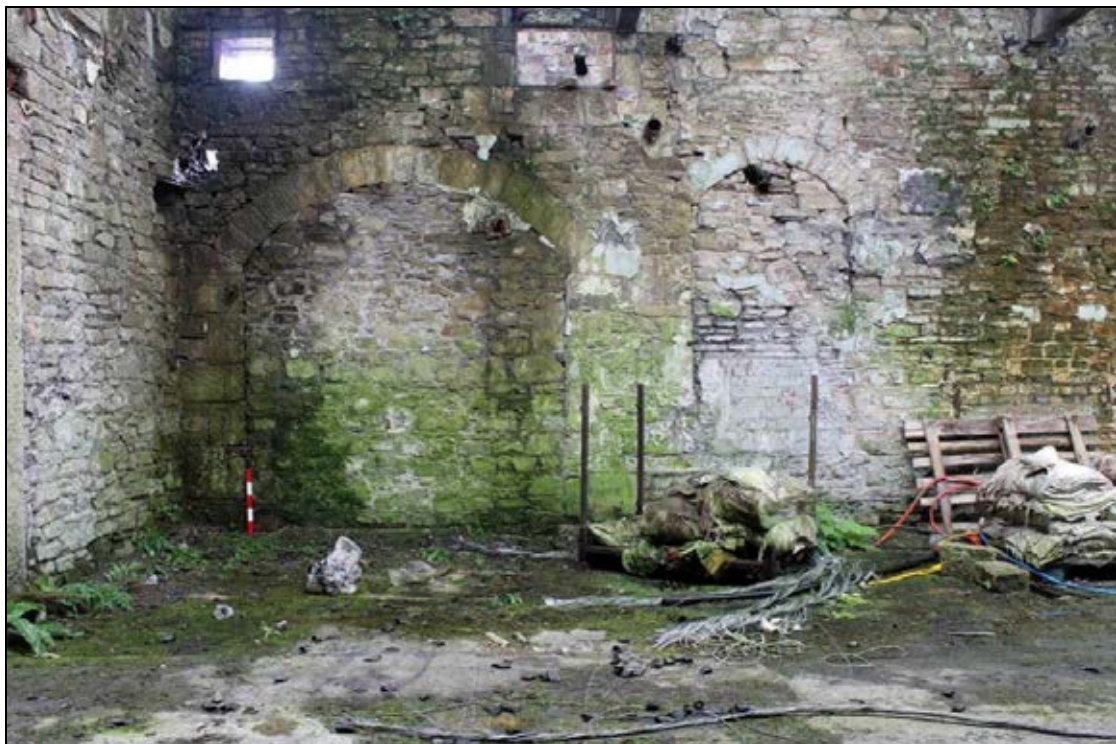
- 3.2.7 The wall contained just a single extant rectangular, square-headed, opening at the centre of the elevation, which once served as a large through doorway but had been converted to a pedestrian doorway subsequently by being partially in-filled with concrete blocks. A second large opening with an arched head formed in regular voussoirs and formal quoins lay at the southern end of the wall, but it had been in-filled by rubble stone work (Plate 15). A pintel hinge survived towards the top of its southern jamb, suggesting the doors were hung externally.

Plate 15: Large opening at southern end of western wall, facing west. 0.5m Scale

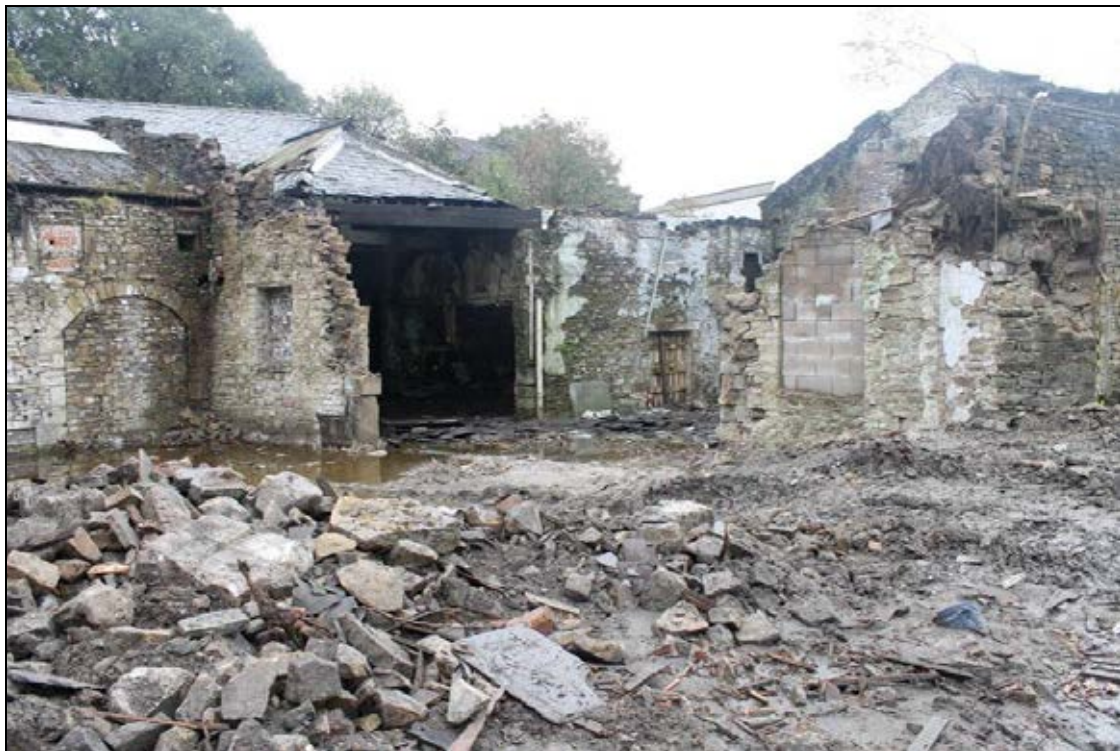
- 3.2.9 **Southern Wall:** the southern elevation of the southern gable had been reduced to first-floor height, and the central portion removed to leave a fragment of walling on either side (Plate 17). That they belonged to the same wall was established by their use of water-shot coursing laid in regular sandstone blocks, and this was confirmed by the photographic evidence prior to the walls removal (Plates 18 and 19). A single vertically arranged rectangular window with a tapered single-piece sandstone lintel and projecting stone sill survived at the eastern and western ends (Plate 20). Both had been in-filled with a hard red brick.

Plate 17: Remains of southern gable wall, facing south-east

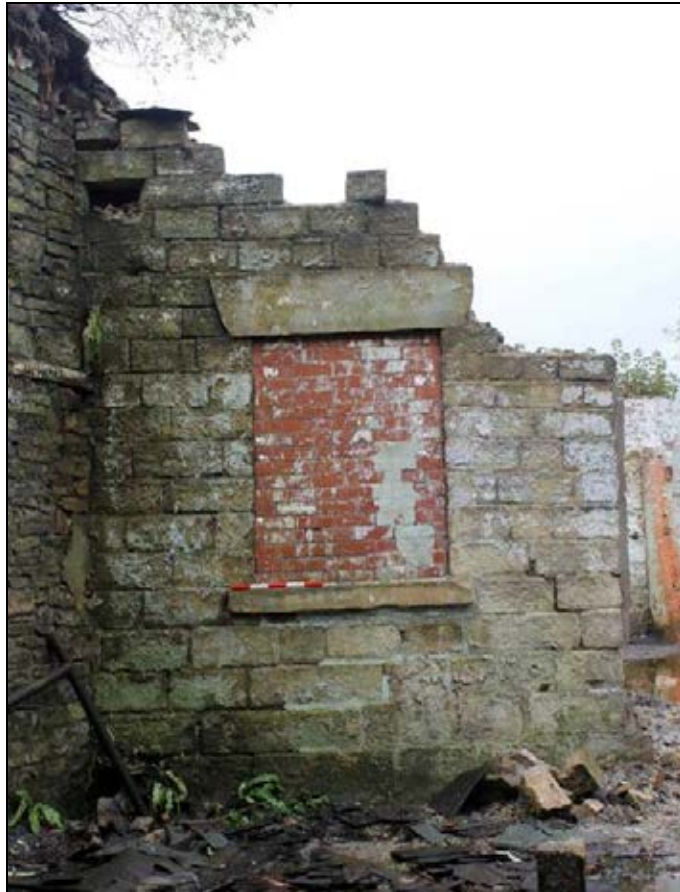
Plate 18: Remains of western end of southern gable wall, facing north. 0.5m scale

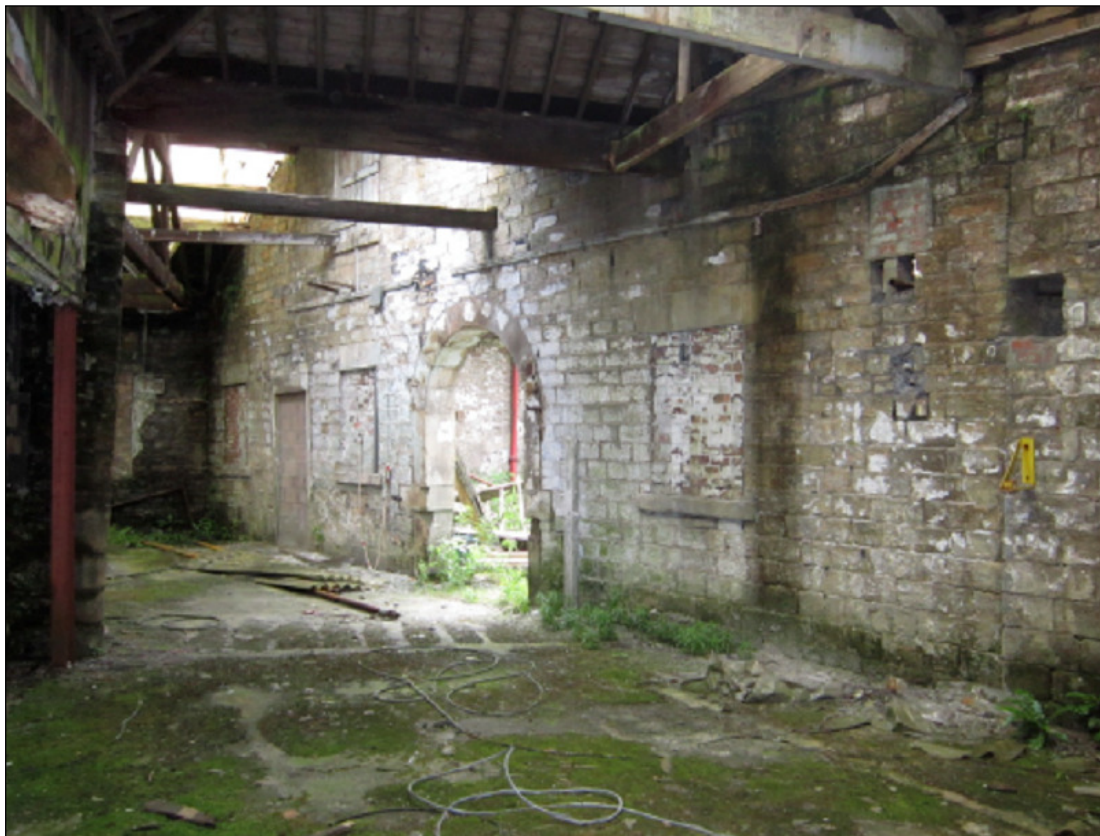
- 3.2.10 Prior to demolition, a large arch-headed doorway lay to the east of centre with a window identical to those just described immediately to the west and a pedestrian doorway beyond this (Plate 19). At least one first-floor window was also present, directly above the ground-floor window. Only the lower eastern jamb of the large opening to the east and the western jamb of the pedestrian doorway to the west remained at the time of the present survey.

Plate 19: Southern elevation prior to partial demolition (Griffiths, 2014)

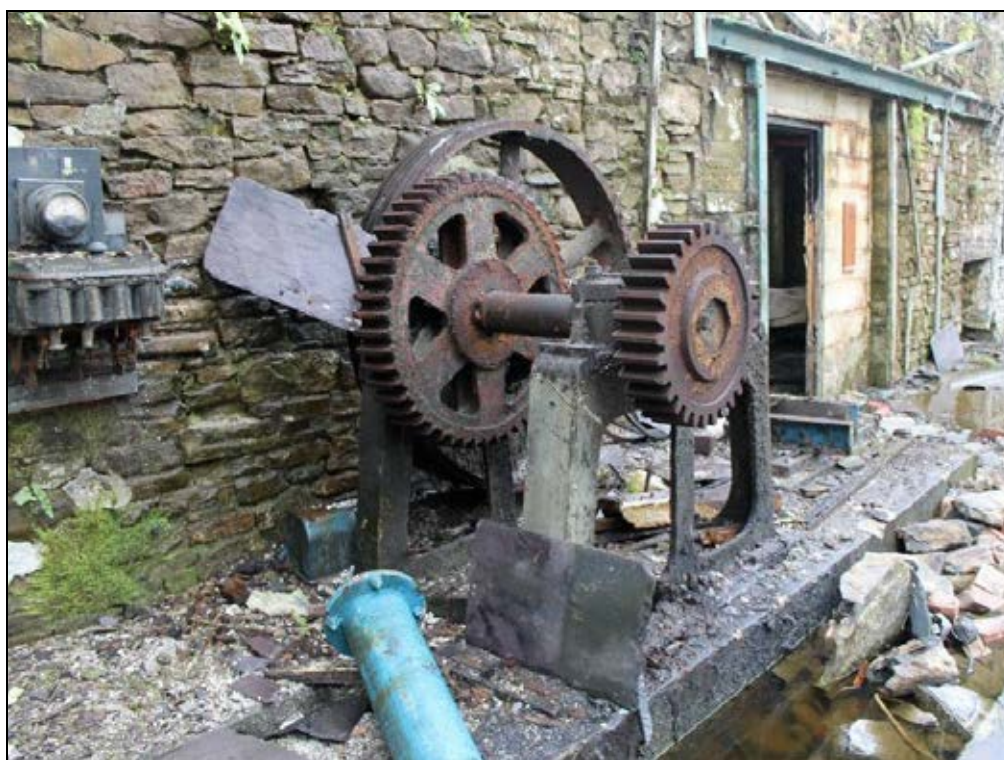
- 3.2.14 The remnants of a mechanical press mounted upon a concrete platform stood against the eastern wall just to the north of the extant doorway (Plate 21). Two steel gears and a drive wheel remained in place, but the rest of the press had been removed prior to demolition. The owner of the complex commented that this press had been in operation up until the closure of the bleach works in 2006.

Plate 21: Remains of mechanical press, facing south

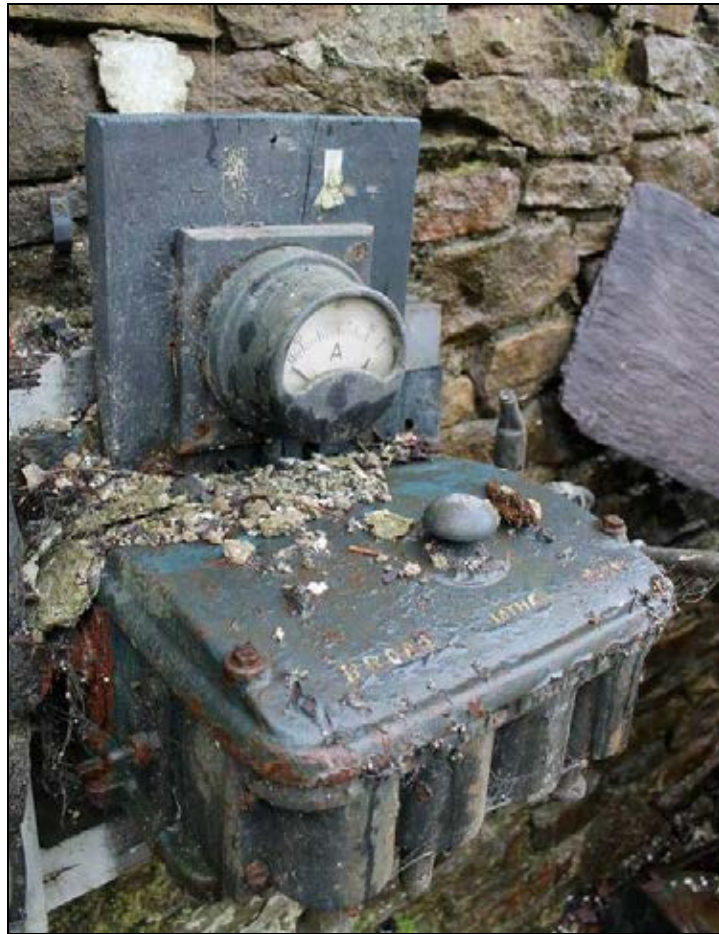
- 3.2.15 An ammeter and two electrical operating switches were mounted upon the eastern wall immediately to the north of the remains of the press (Plate 22). The ammeter recorded the names Broad, Mather, Platt across its top. A large diameter metal water pipe projected from the eastern end of the northern gable wall, running south above head height along the internal elevation of the eastern wall (Plates 11 and 12). A second concrete mounting platform situated in the north-western corner of the building denoted the former location of a second item of now scrapped mechanical equipment (Plate 23).

Plate 22: Wall-mounted ammeter on eastern wall of Building A

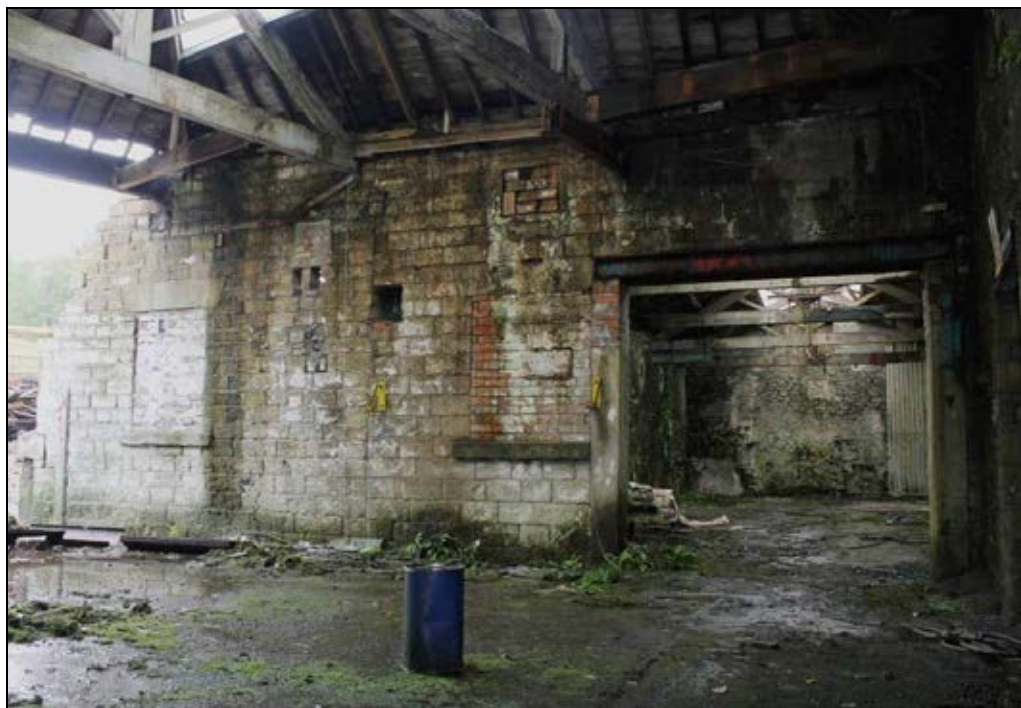
- 3.3.2 **Southern Wall:** the original external elevation of the southern wall was constructed of sandstone, laid in coursed rectangular blocks in water-shot fashion (Plate 24). A butt joint at the western end of the wall clearly established the building's relationship with Building A (Plate 25). The eastern end of the wall continued up to a height that could comfortably have accommodated a first floor (Plate 26).

- 3.3.3 A rectangular, vertically set window with a single-piece tapered stone lintel and projecting stone sill was recorded at the western end of the wall (Plate 25). It was similar in form to those described on the southern elevation of building A, and had also been blocked, perhaps at the same time, using identical red brick. Its eastern jamb was formed of the western jamb of a large double doorway, and their uncomfortable proximity might indicate the doorway to be a later insertion. The doorway was surmounted by a metal H-section lintel, but the upper jambs were constructed in red brick in contrast with the single-piece sandstone lower jambs, suggesting the height of the opening had been raised (Plate 24).

Plate 24: Southern wall of Building B, facing north

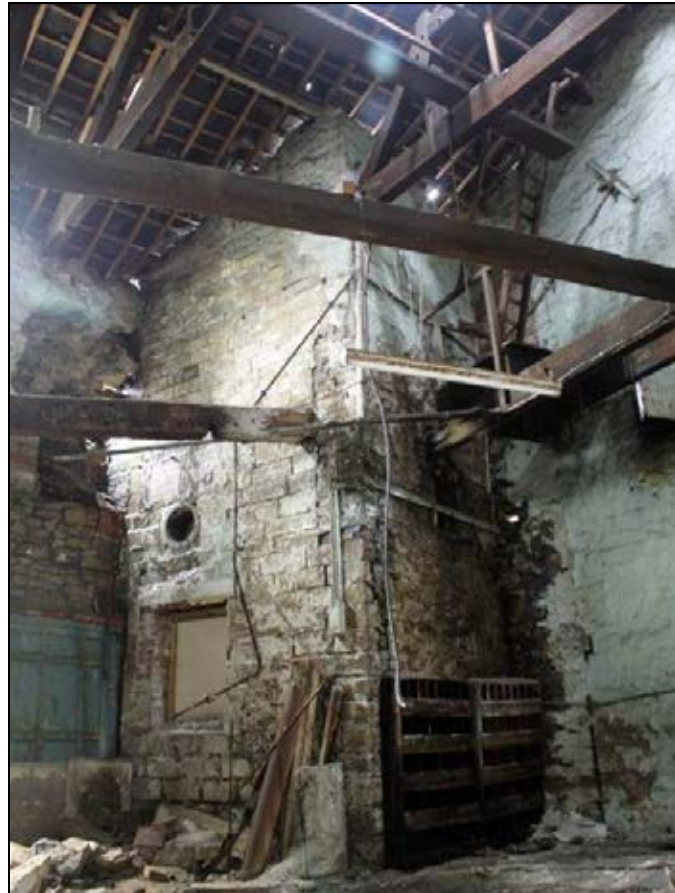
- 3.3.5 At the eastern end of the elevation there was a second and much altered window of approximately the same dimensions as the first. Its lintel had been replaced with a later concrete one, and its width narrowed by partial in-filling in brick to the west (Plate 26).

Plate 26: South-eastern corner of Building B, looking north-west, with blocked window to left and pipe and square aperture above

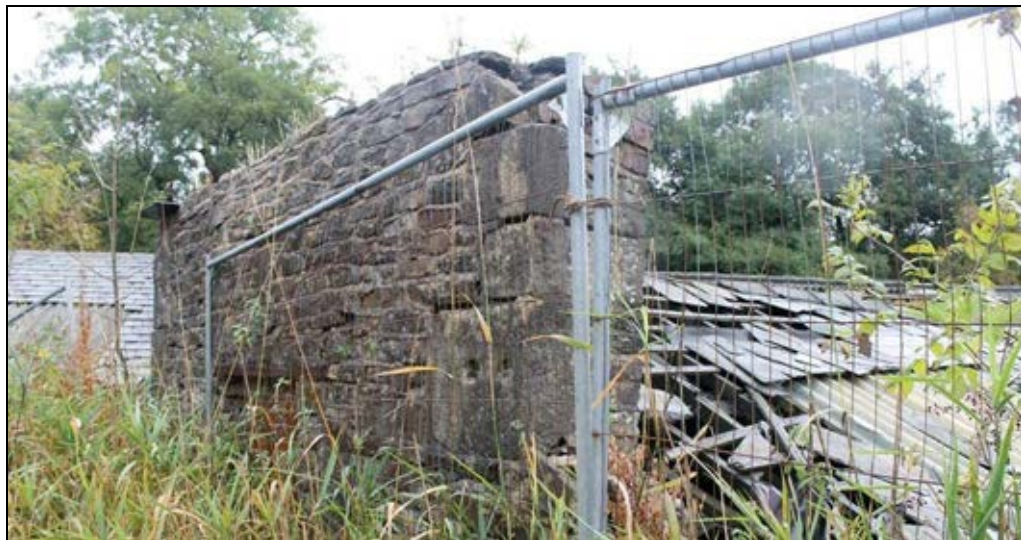
- 3.3.8 **Northern Wall:** the northern wall formed part of the northern retaining wall, with most of its northern elevation hidden from view. However, a small portion of upper gable was noted from the north, projecting above the bank (Plate 28). The internal elevation was rubble built, with a centrally placed square window topped by a metal lintel and in-filled with red brick (Plate 29). There was a small, square, stone-lined opening beneath this window with a cast-iron bearing box to the east and another small square opening to the west. The bearing box remained open, but the other two openings had been blocked with red brick.

Plate 28: External elevation of Building B's northern wall, facing south-east

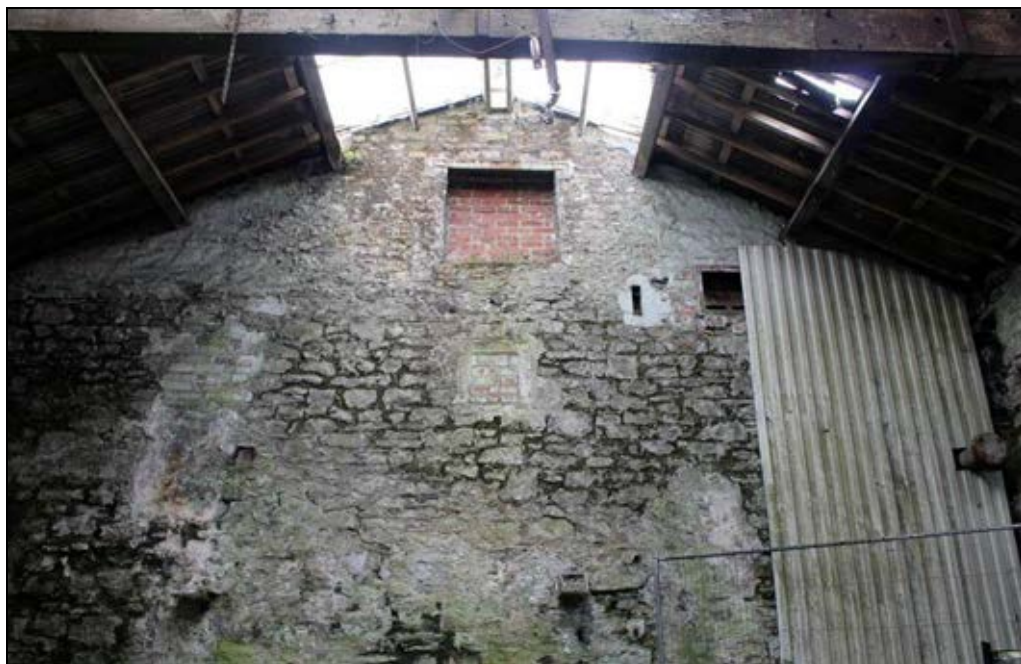
Plate 29: Internal elevation of Building B's northern wall, facing north

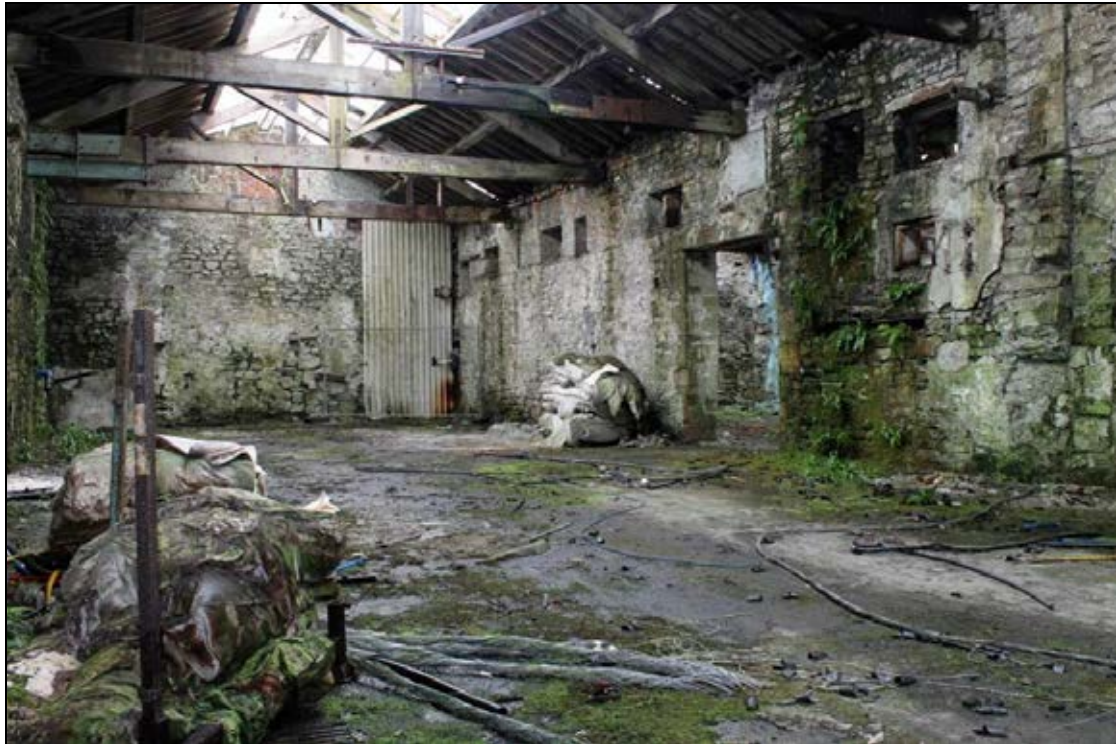
- 3.3.10 **Eastern Wall:** the eastern wall divided Building B from Building E to the east, and at least three phases of construction could be identified (Plate 30). A butt joint towards the eastern end of the wall and a slight change in the walls width denoted an apparent change in construction (Plate 31). To the south of the joint there was a large double doorway with a semi-circular headed arch of very similar character to that described on the opposing western wall. It had been blocked with rubble, and a later square aperture punched through at about head height, which had itself been blocked subsequently with brick.

- 3.3.12 Beyond the butt joint to the north, and at the approximate centre of the eastern wall, there was a second large double doorway, with a metal lintel and tooled stone jambs, which led into Building E (Plate 30). There were three square openings to the south of this doorway, one at head height with a timber frame and two more above (Plate 31). Beneath the lower opening a horizontal iron beam with a recessed channel in its centre was embedded in the wall. Above the double doorway there was a cast-iron power transfer bracket incorporated into a large blocked square bearing housing (Plate 32). From here power could have been transmitted via a bevel gear along the length of the building.

Plate 30: Internal elevation of Building B's eastern wall, facing north-east

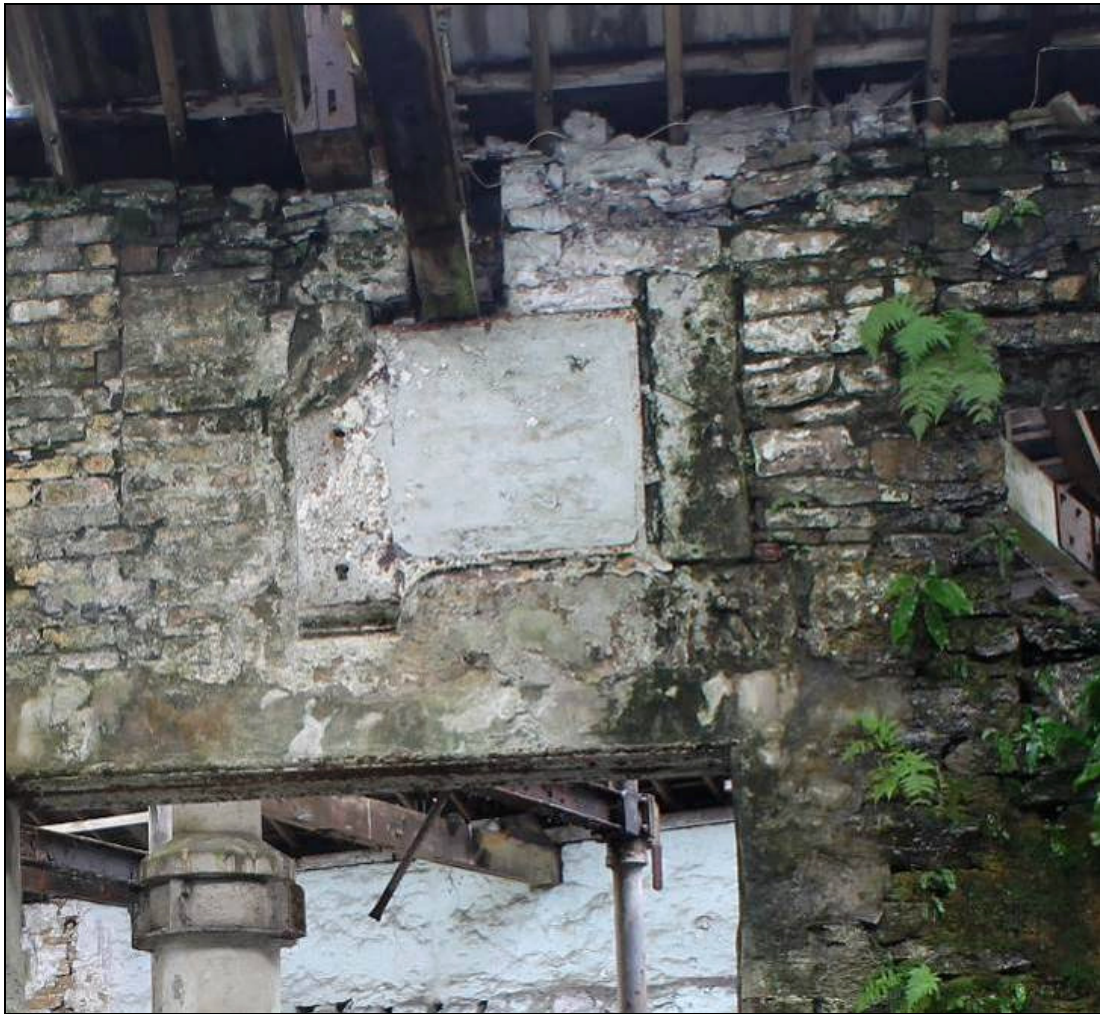
Plate 32: Drive transfer bearing box above doorway between Buildings B and E

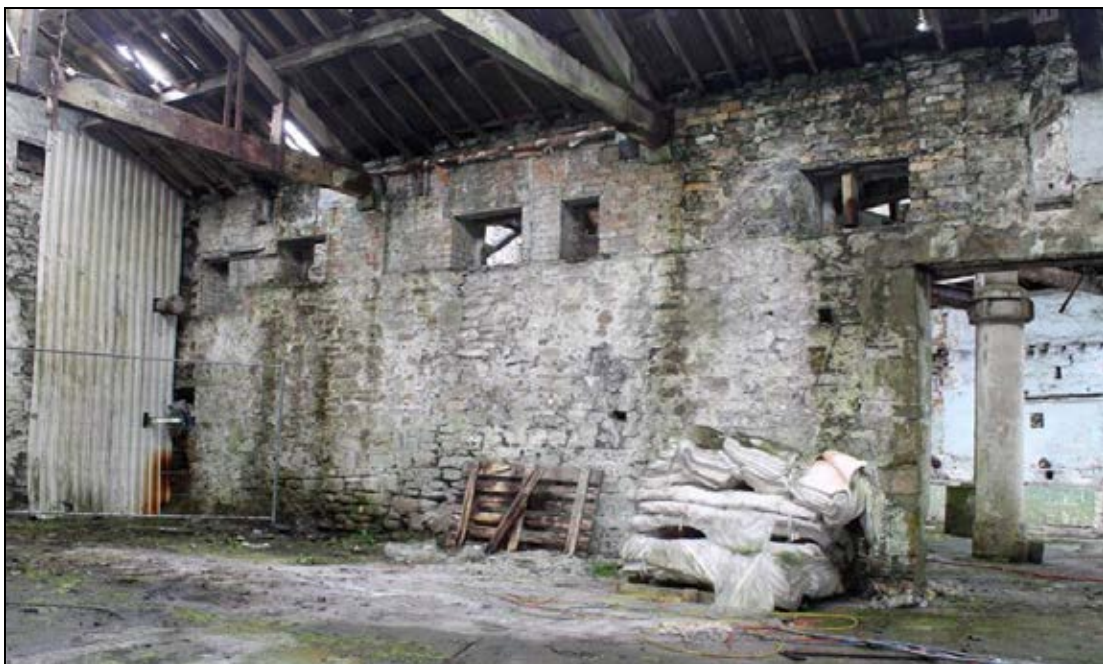
Plate 33: Northern end of the eastern wall facing north-east. Note the rectangular apertures towards the head of the wall

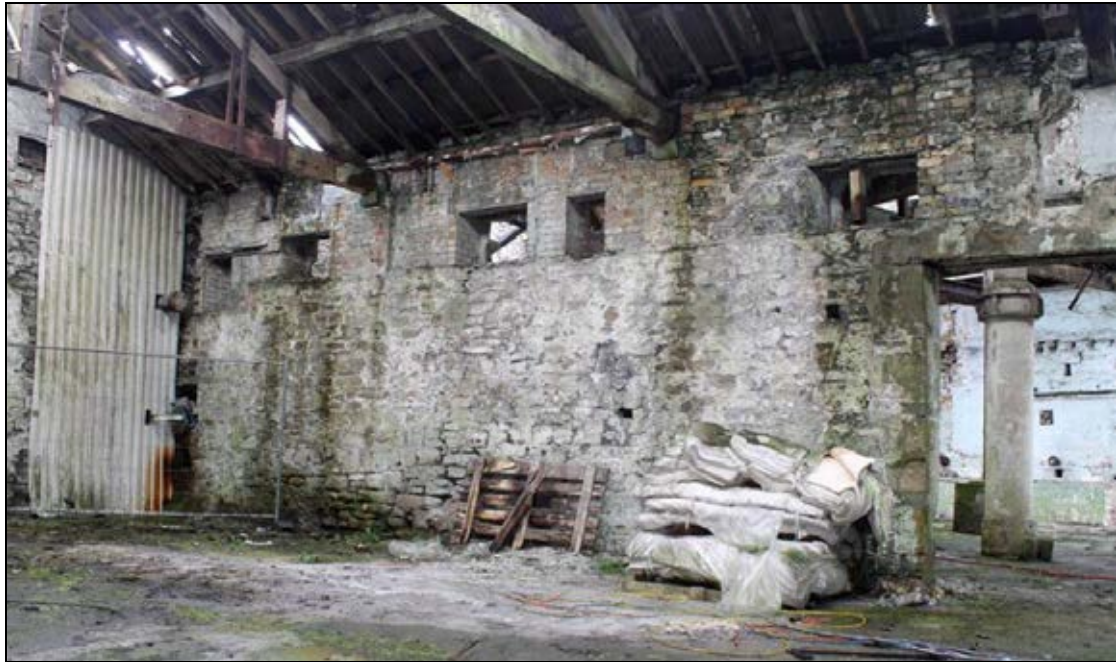
- 3.3.13 To the north of this bearing housing, the upper third of the wall had clearly been rebuilt or raised in brick and there was evidence for five more square or rectangular openings along its length. The first of these lay just to the north of the central doorway, with a pair at the far northern end and a second pair mid-way between these and the double doorway (Plate 33). The function of these openings was not immediately obvious until an inspection of the eastern elevation revealed the remnants of timber boards lying across at least three of the apertures. From what survived, it appeared that each of the boards had at least one small circular hole cut through them, which had probably held an eyelet (Plate 34).

Plate 34: Western elevation of the eastern wall facing north-west. The remains of a circular eyelet can be seen in the closest rectangular aperture towards the head of the wall

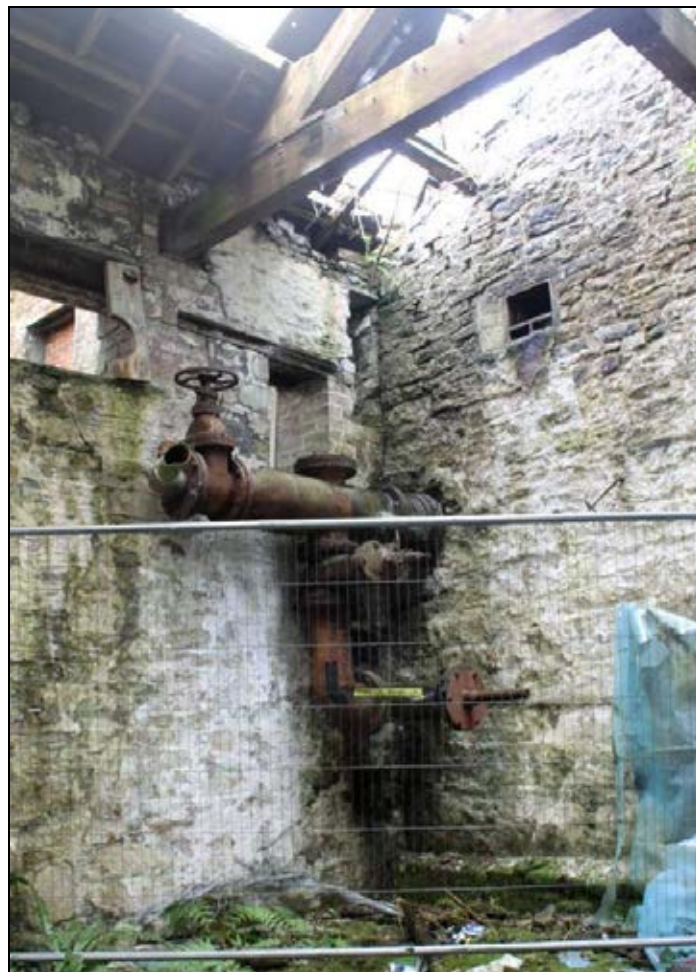
- 3.3.14 The eastern elevation was also rubble built and included a narrow opening, high up the wall, at the extreme northern end which was not visible on the opposing elevation (Plate 35). The presence of asbestos again prevented close inspection.

Plate 35: Northern end of the eastern wall of Building B facing north-west. The high narrow opening to the left of the corner was not visible on the opposing elevation

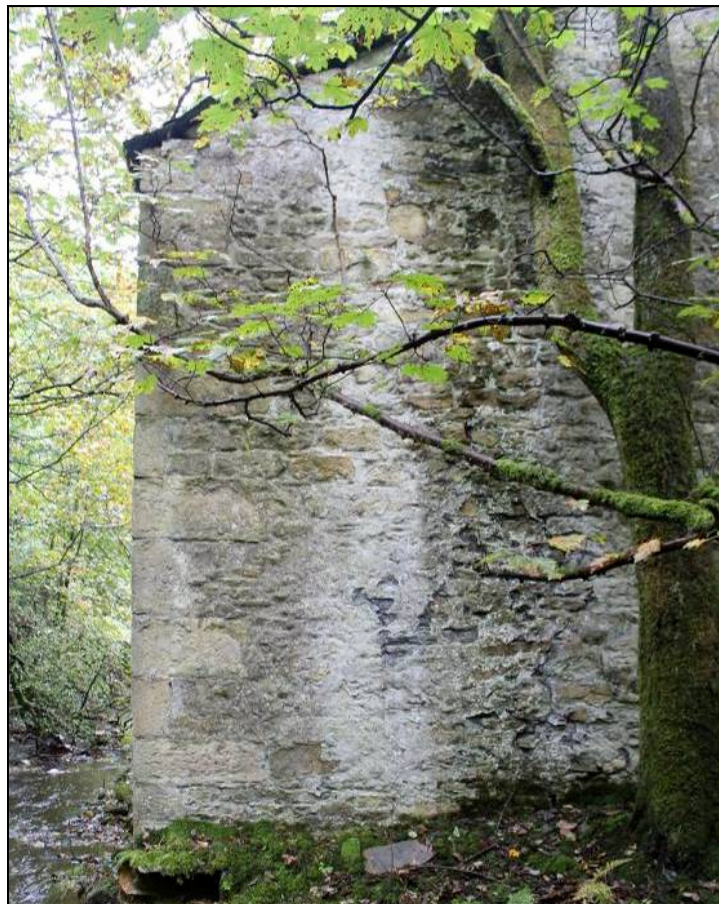
- 3.4.2 **Northern Wall:** the northern gable wall was partly obscured by vegetation and the lower portion of its western end was terraced into the bank of the brook. It was constructed in uncoursed rubble with roughly dressed alternating quoins at the eastern corner, and included a raised central parapet to provide room for a clerestory along each side of the roof (Plates 36 and 37). No extant or in-filled openings were noted.

Plate 36: External elevation of Building C's northern gable wall, facing south

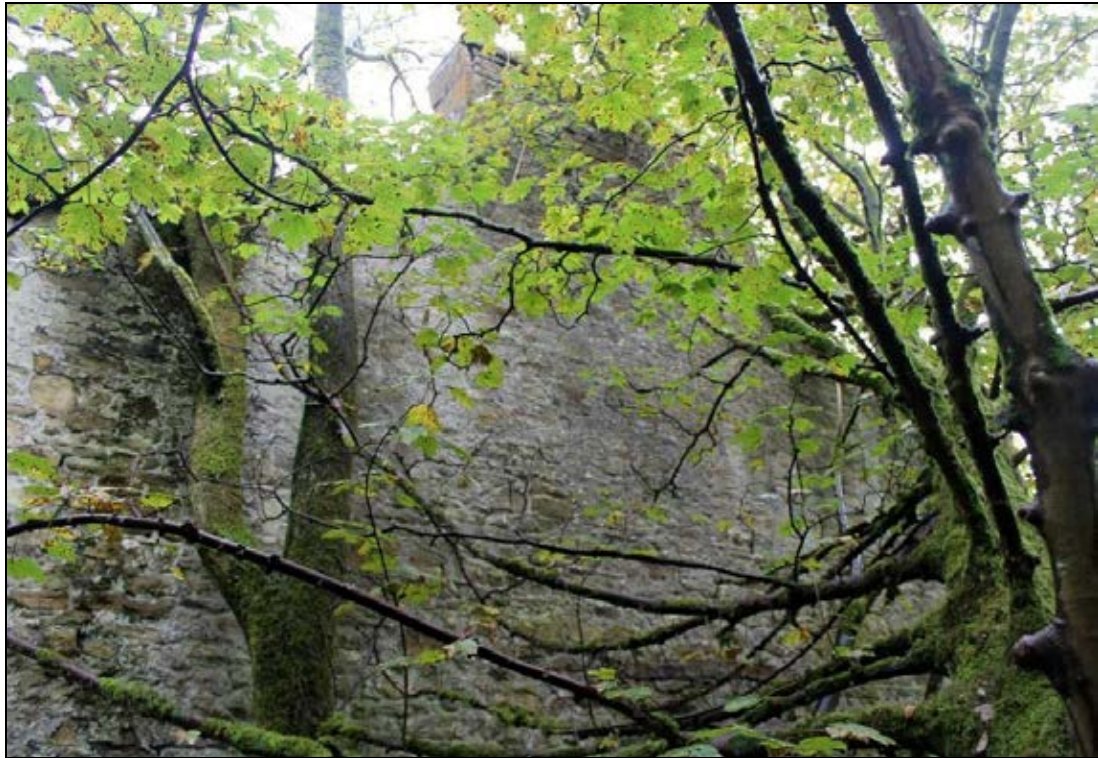
Plate 37: Northern gable wall, facing south. The raised central parapet can just be seen behind the foliage

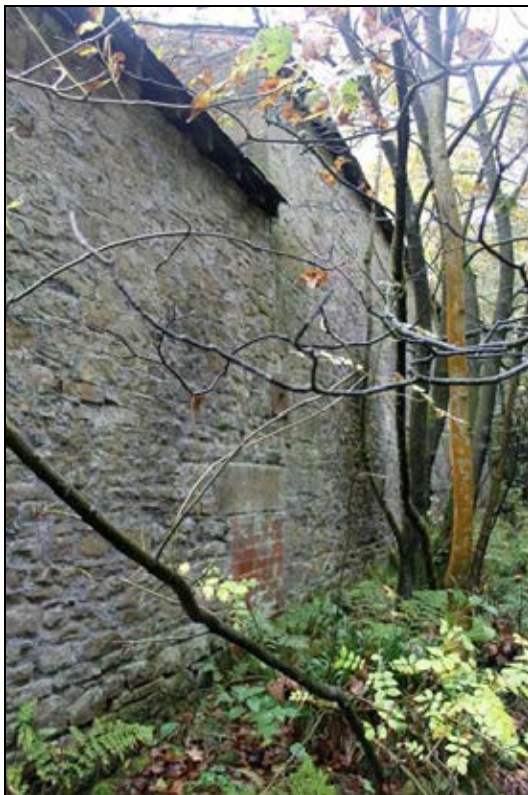
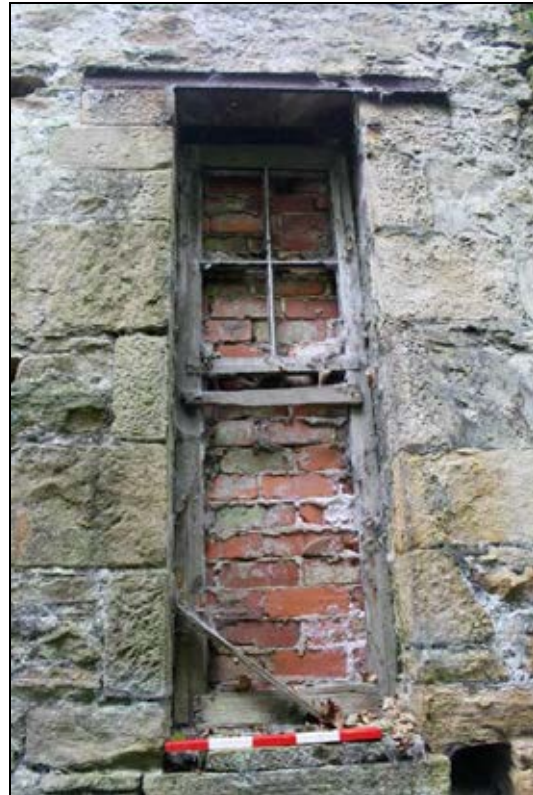
- 3.4.3 **Eastern Wall:** the eastern wall was also of uncoursed rubble construction and its southern limit was indicated by a butt joint and the presence of alternating quoins where it joined Building D (Plate 38). A single tall narrow window, also with alternating quoins at the jambs, lay at the centre of the elevation. The window's timber frame survived, and although the glazing was lost the upper portion retained its two-over-two lights (Plate 39). Immediately above the window there was small square opening fitted with a cast-iron bearing box, and a just to the north a similar stone-lined opening had been blocked up. The proximity of the river prevented a more detailed inspection of the elevation.

Plates 38 and 39: Eastern wall of Building's C and D with butt joint to centre and blocked window immediately to left. The narrow window to the right is located within the centre of Building C's eastern elevation

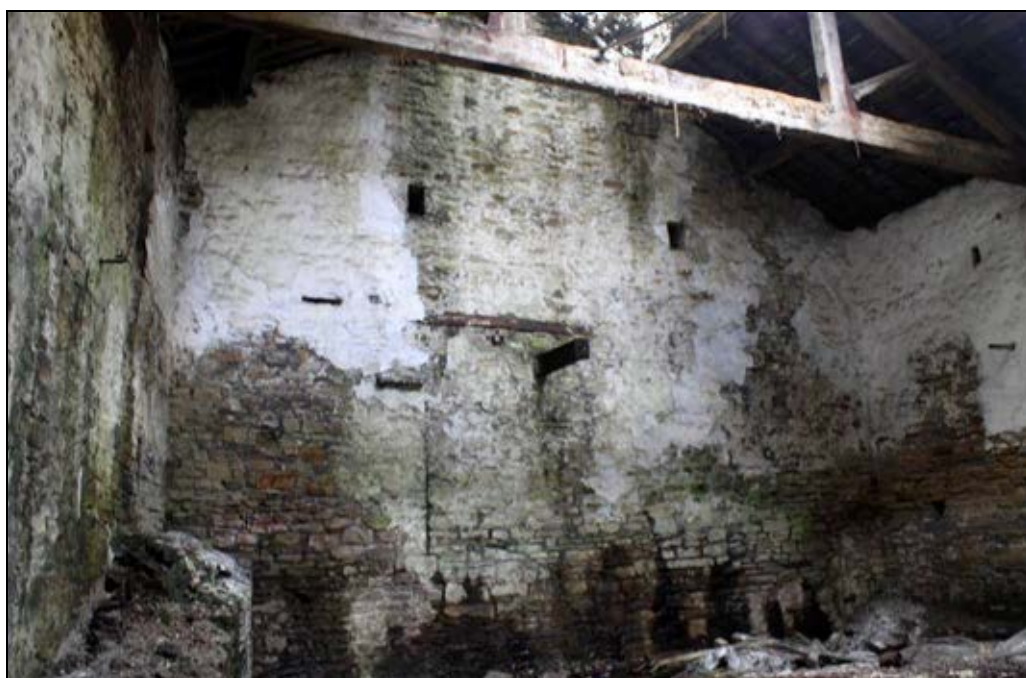
- 3.4.5 **Northern Wall:** the northern gable wall was constructed of rubble and had been given a coating of white paint, which survived in places (Plate 40). An iron beam projected southwards from the centre of the wall, presumably once forming some structural function, perhaps relating to a low mezzanine or platform. Two small rectangular sockets located at eaves height and at thirds across the length of the wall might have related to an earlier roof structure. In the western corner of the wall the ghost of a small gabled structure, perhaps similar in height and width to a garden shed, were recorded where the paint had been omitted from this portion of the wall.

Plate 40: Northern gable wall of Building C facing north. Note the empty beam sockets just below eaves height and the roof line of the gable structure to the left

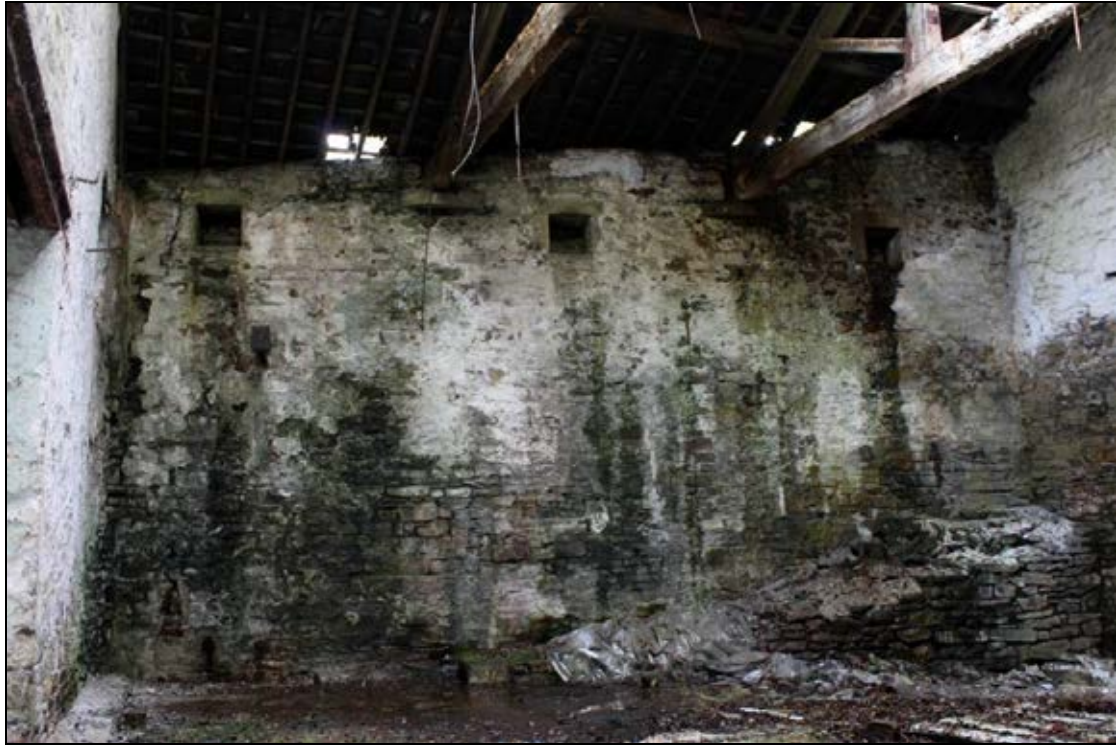
Plate 41: Northern end of the western wall of Building C, facing west

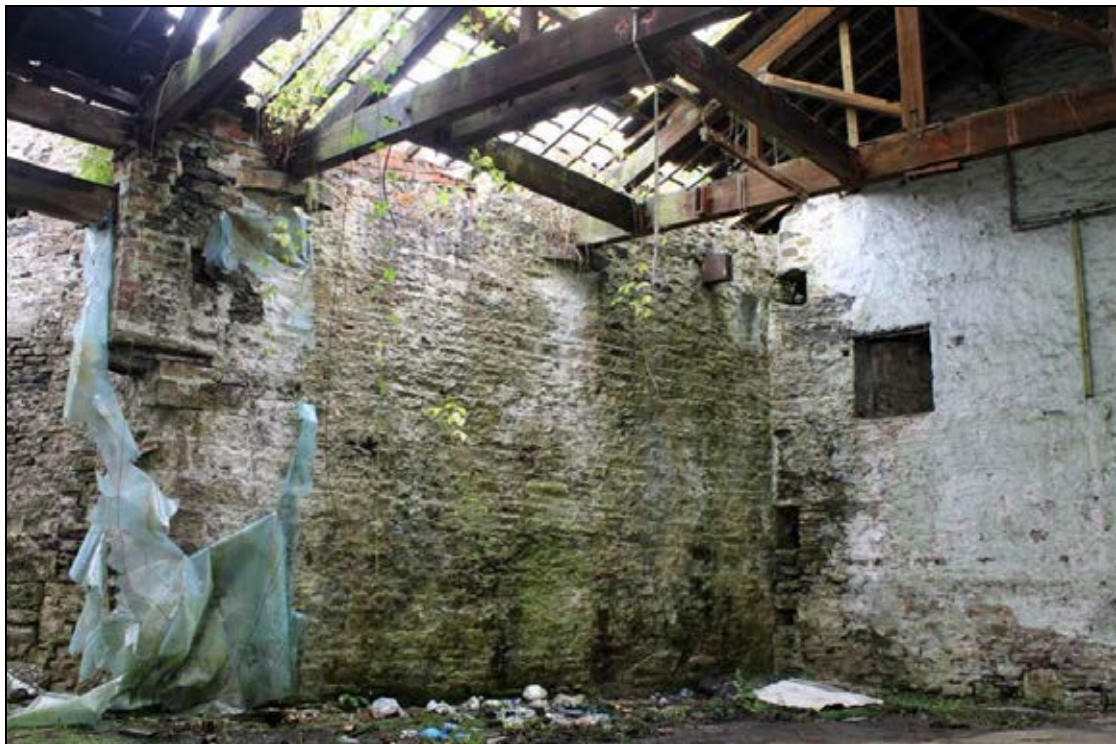
- 3.4.7 At the southern end of the wall, a joint had been formed with the northern wall of Building E, leaving an awkwardly formed obtuse corner constructed of stone quoins in its lower (Plate 42). The upper half was brick built, and over-sailed the lower half, being supported upon a projecting stone corbel.

Plate 42: Southern end of the western wall of Building C, facing north-west. An awkward corner joint to the left of frame connects Buildings C and E

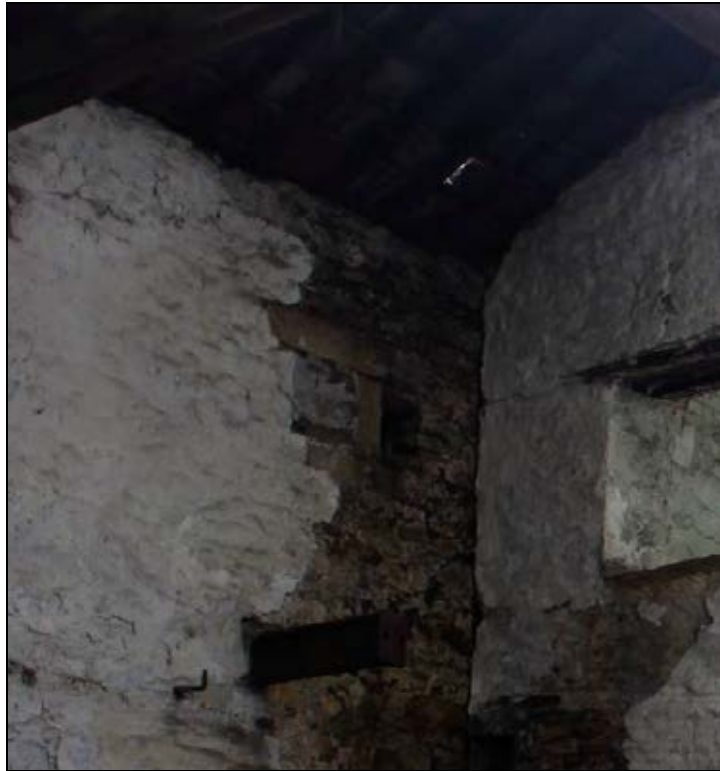
Plate 44 Blocked square aperture just to the north of the partition wall in Building C

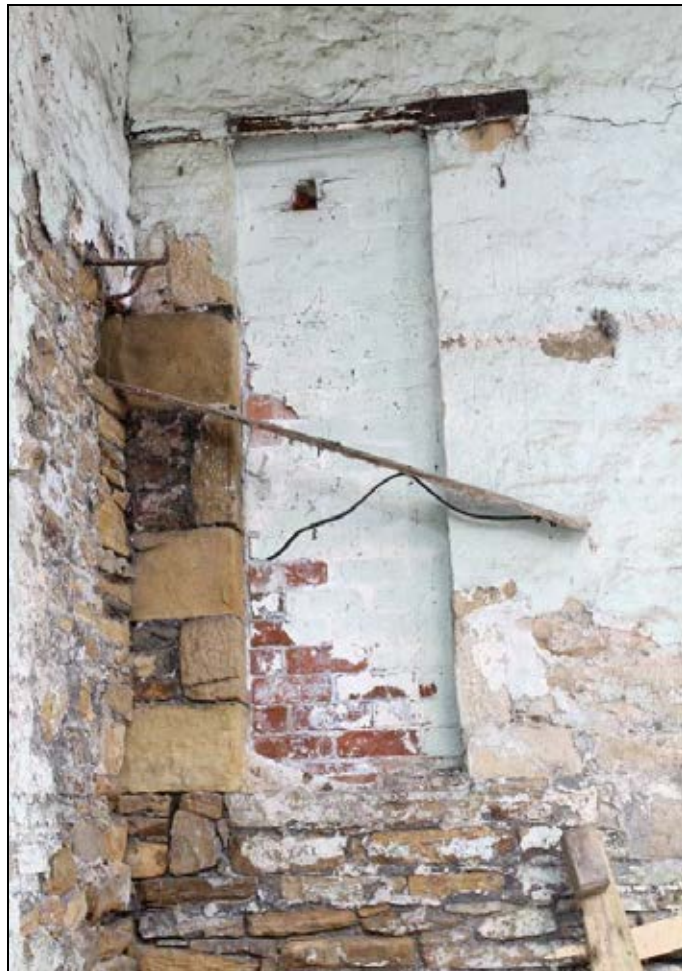
- 3.4.9 The narrow window noted externally was located just to the south of the partition wall. It had an iron lintel, alternating quoins and had been blocked with a hard red brick (Plate 45). There were several addition rough sockets towards the base of the northern half of the wall, but much of its surface retained a thick coating of white paint, potentially obscuring all other details. The joint between Buildings C and D recorded externally was not visible from the interior but, in plan, it coincided with the northern wall of the internal leat partition.

Plate 45: Internal view of blocked narrow window at centre of eastern wall
