**BELMONT
BLEACH WORKS,
EGERTON ROAD,
BELMONT,
BLACKBURN WITH
DARWEN**

**Historic Building
Investigation**

October 2015

Millson Associates
Planning Application 10/12/0590

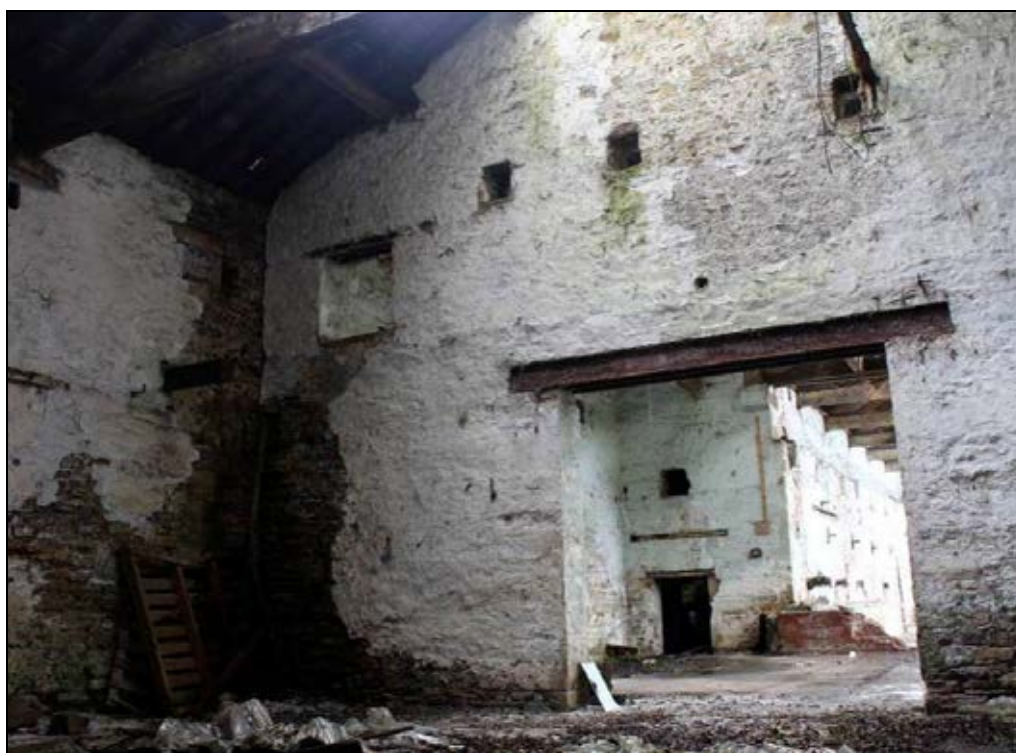
- 3.4.10 **Northern Partition Wall:** the northern partition wall was rubble built and appeared to be a later insertion, based upon the absence of substantial through bonding at the junction between its eastern end and the eastern wall of Building C. The relationship at the western junction was more difficult to determine, but may also have been only partly bonded. The wall included a large centrally placed rectangular doorway with an iron lintel above, and although the jambs were hidden by thick white paint they appeared to include at least some dressed quoins (Plate 46).

- 3.4.11 To the east and west of the doorway and above lintel height there was a single large square window-like opening, although neither aperture retained any type of frame. Three empty sockets were noted at eaves height towards the centre of the wall, one offset slightly to the east (Plate 46). The two central sockets appeared to align with those previously described on the northern elevation.

Plate 46: Partition wall in Building C, looking south-east

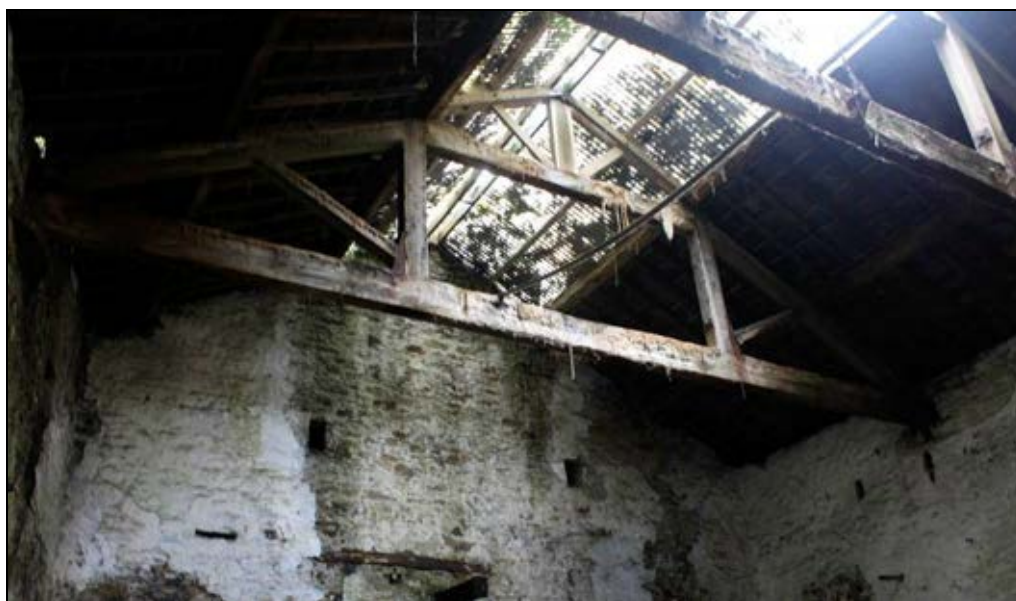
- 3.4.12 **Roof:** the roof over the northern cell was composed of two identical queen post trusses (Plate 47), bolted together with wrought-iron straps and bolts, while the two trusses to the south of the partition wall were of king post design. The faces of the two southern trusses tie beams were tied together by a series of short longitudinal beams resting within iron sockets. Each end of the four tie beams rested upon a projecting curved stone corbel. The remaining roof construction details were identical to those described in Building B, with a continuous covering of corrugated plastic sheeting forming a roof light across the upper third of both pitches.

Plate 47: Queen post truss in northern cell of Building C

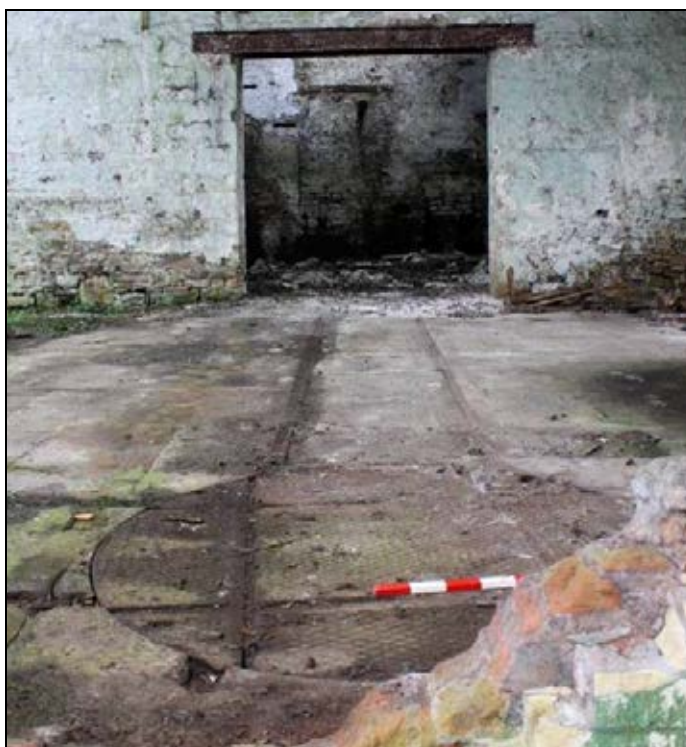
3.4.13 **Fixtures and Fittings:** Building C had a flagstone floor with a thick coating of paint applied to each wall except the western one. A two-way pivoting iron turntable was set into the floor towards the centre of the room's southern end, with tracks leading north and west into Building D (Plate 48). At several points the flagstone floor had been lifted to reveal a culverted drain, which entered the building from below the arch in the north-western corner of the northern cell. It continued east parallel with the northern gable wall before turning south at the eastern corner and following the line of the eastern wall (Plate 49). The drain passed beneath the east/west-aligned partition wall and continued south to enter the covered leat within Building D (Plate 50).

Plate 48: Turntable at southern end of Building C, facing north. 0.5m scale

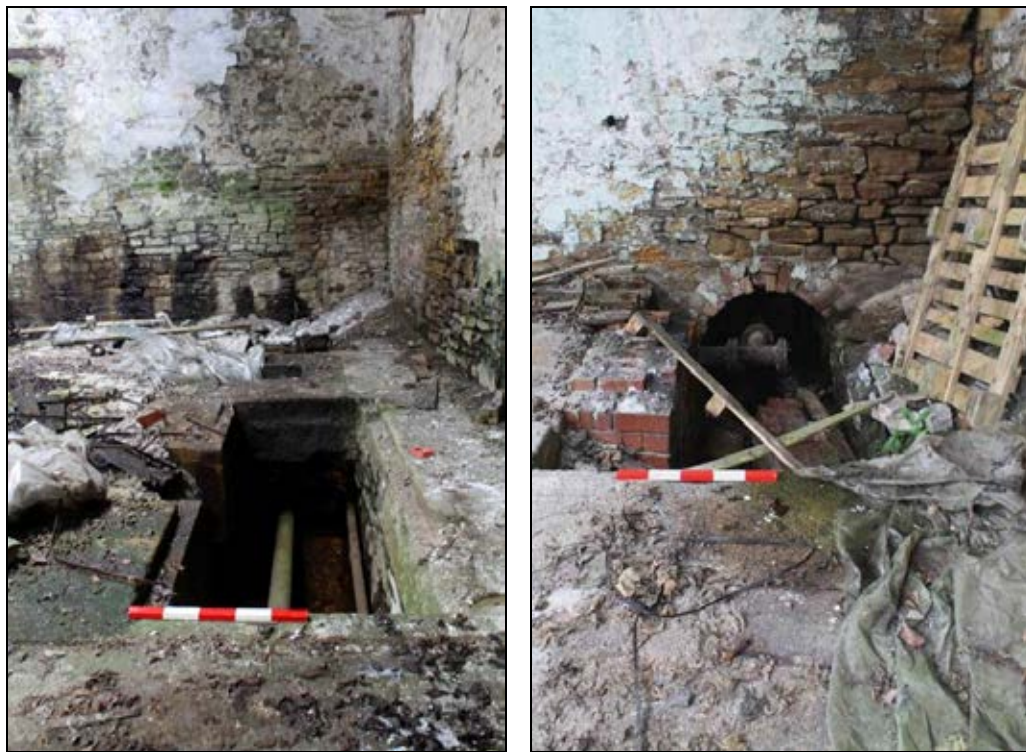
Plate 49 and 50: Culverted drain running alongside the eastern wall of Building C, looking north. Drain passing beneath the partition wall to right. 0.5m scale in both

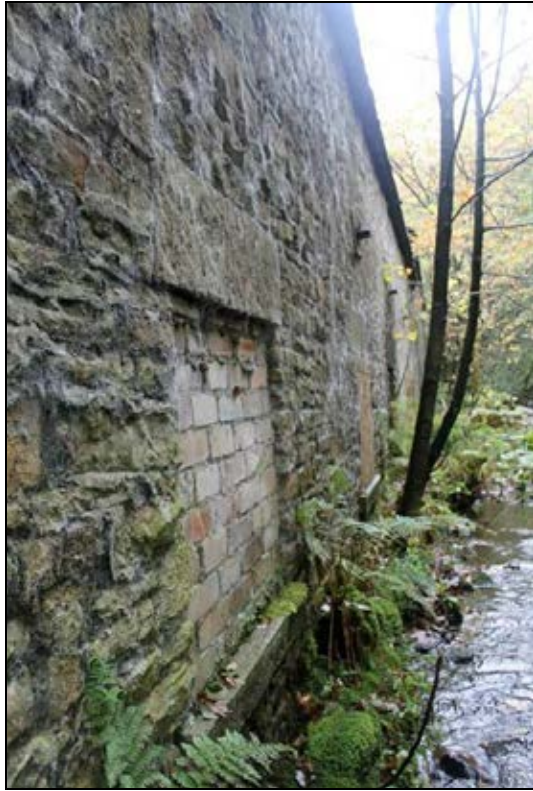
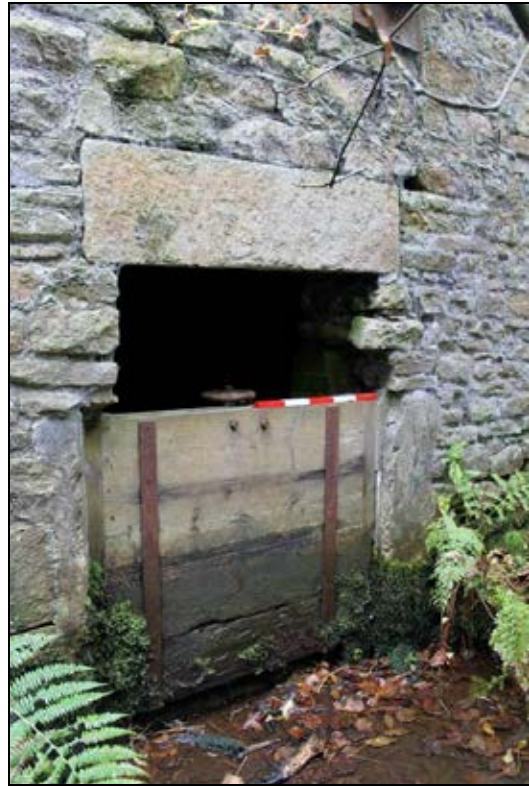
- 3.5.2 **Eastern wall:** the eastern wall was rubble built and included six low and equally spaced rectangular openings, each topped by a heavy stone lintel (Plate 51). The northernmost opening abutted the quoins at the southern end of Building C and, together with the three southern openings, had been bricked up (Plate 38). A timber sluice gate with a top-mounted cast-iron operating wheel survived in the second-most northerly opening, from which it was possible to inspect the enclosed leat (Plate 41). The remaining opening retained its four-by-five light cast-iron framed window (Plate 53).

Plate 51 and 52: Eastern wall of Building D, looking north with blocked window to left. Sluice gate to right with 0.5m scale

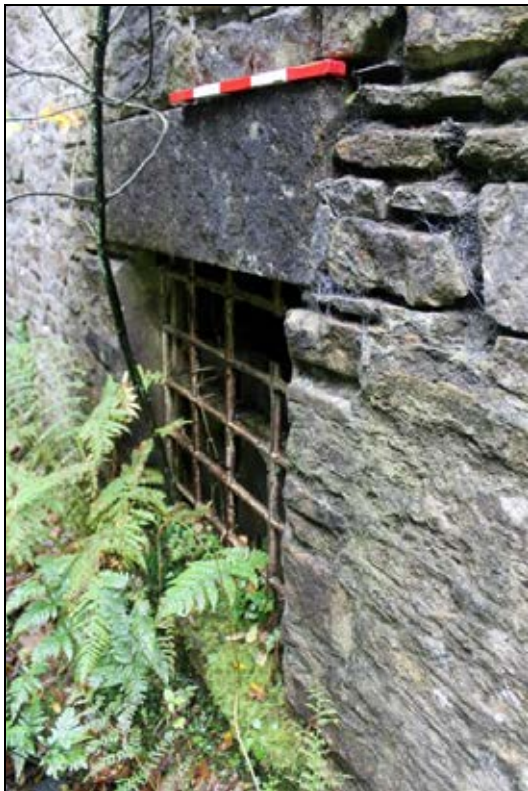
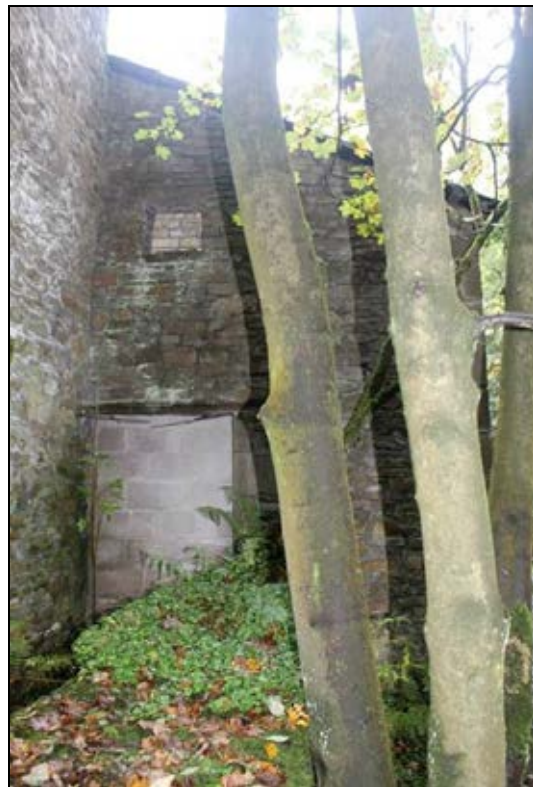
- 3.5.3 **Southern Wall:** only the extreme eastern end of the southern wall could be seen from the exterior, but it included a rectangular opening at its western end with an iron lintel at its head and tooled alternating quoins on its eastern jamb (Plate 54). It had been in-filled with concrete block work and above it there was a small square stone-lined aperture blocked in brick.

Plate 53 and 54: Cast-iron window frame on eastern wall of Building D, looking south. 0.5m scale.
External elevation of southern wall of Building D to right

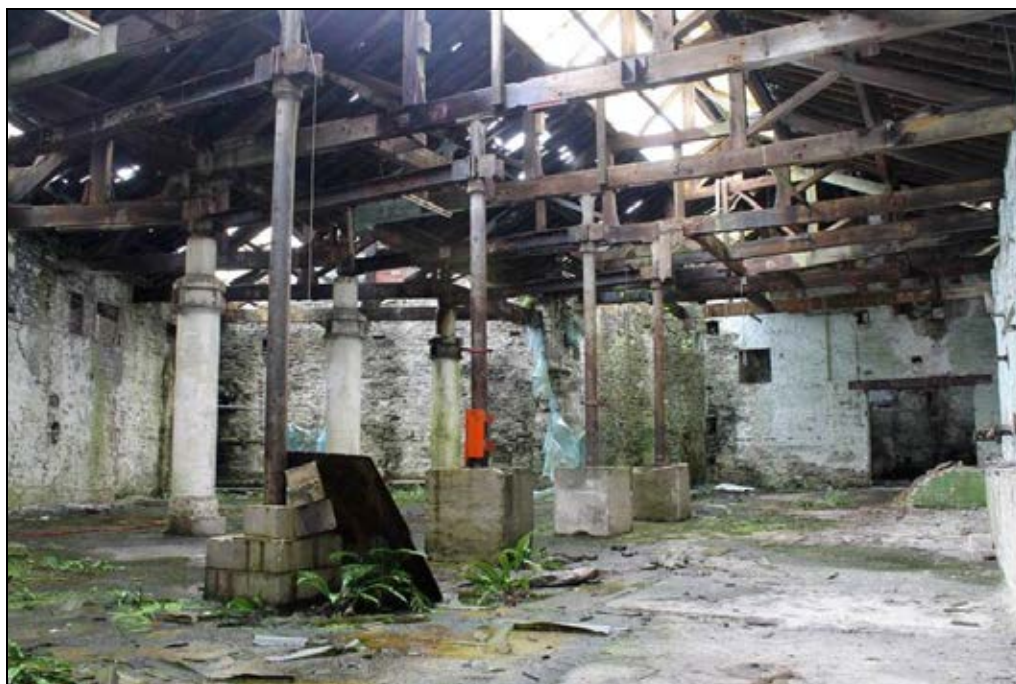
- 3.5.4 **Interior:** internally, Building D had a row of five, north/south-aligned, cast-iron columns along the centre of floor (Plate 55). The northern four columns had been mounted upon concrete bases, but the southern example was not, perhaps suggesting the remainder had been modified. The columns were 6" in diameter, with splayed flanges rising from their heads to intersect the underside of the head plate. The surfaces of each column were heavily corroded. Five more columns, each encased in concrete, lay upon the dividing line between Buildings D and E, and the roof tie beams rested upon both rows (Plate 55). The wall surfaces were coated in thick paint and the floor was laid in concrete.

Plate 55: Interior of Building D, looking north with cast-iron columns to centre of picture and concrete columns to left

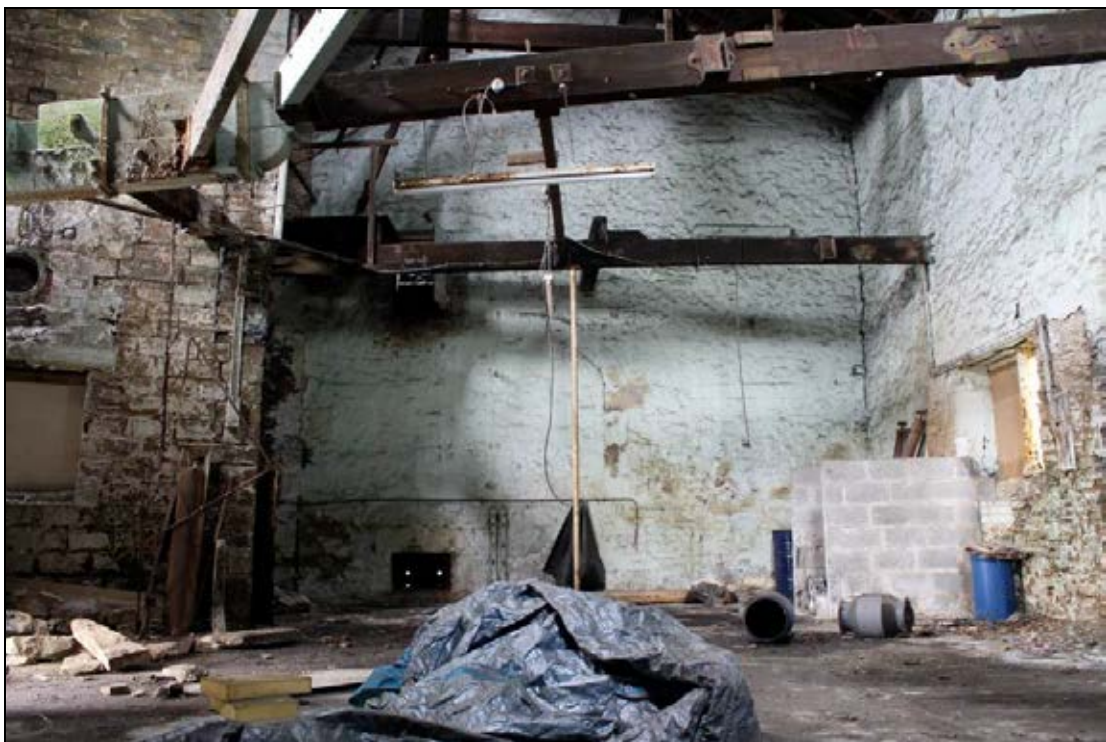
- 3.5.7 The southern elevation of the south wall was visible from the interior of Building F, and confirmed the presence of a blocked window on the opposing face of the recess (Plate 59). Although again heavily obscured by paint, the projecting sill of a second window at first-floor height was noted (Plate 60).
- 3.5.8 The large central doorway could also be seen on this elevation, but here it had a projecting keystone and prominent imposts suggesting this elevation had begun as an external wall (Plate 61). The western end of the wall had been slightly disturbed where Buildings B, D and F met, but there were slight traces of a lintel indicating the position of a second ground-floor window. The large bearing box noted on the northern elevation was also visible to the south, but had a small timber doorway in front of it.

Plate 59: Southern elevation of Building D's southern wall

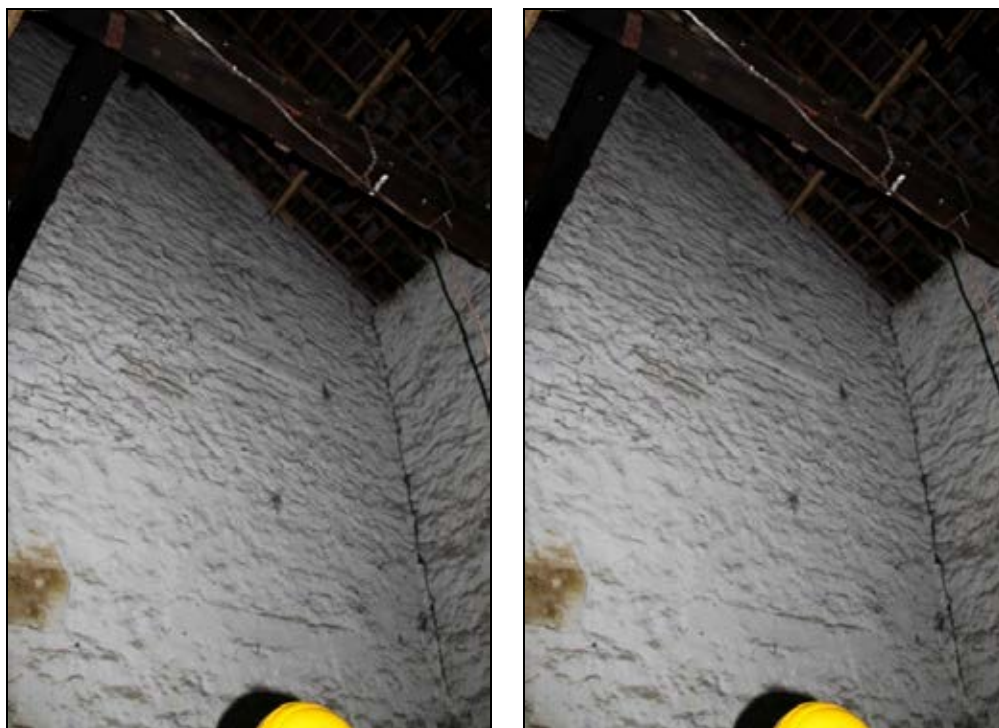
Plate 602 and 61: Projecting sill at first-floor level of southern elevation indicating former position of a window. Blocked doorway at centre of southern wall of Building D to right. The projecting keystone is visible at the centre of the arch, suggesting an external elevation

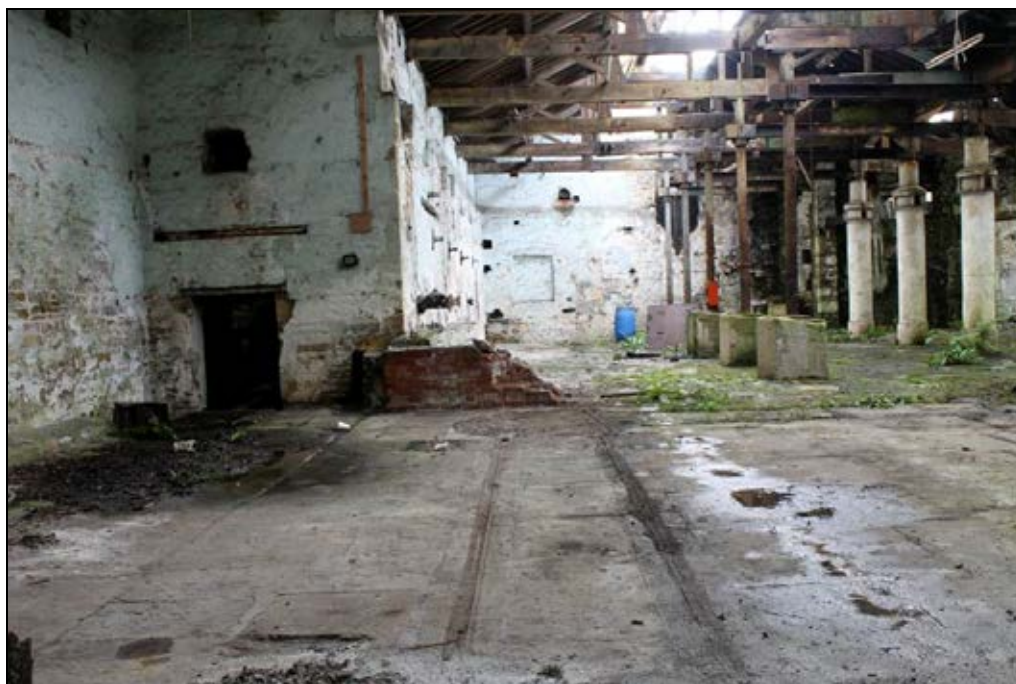
- 3.5.9 **Covered Leat:** the covered leat was composed of a north/south-aligned wall running along the eastern side of the room, which turned east at its northern end to join the external wall (Plate 62). There was a low rectangular opening at the centre of the northern wall topped by an iron lintel, and a small square aperture above, approximately mid-way up the wall.

Plate 62: Interior of Building D with covered leat to left of frame

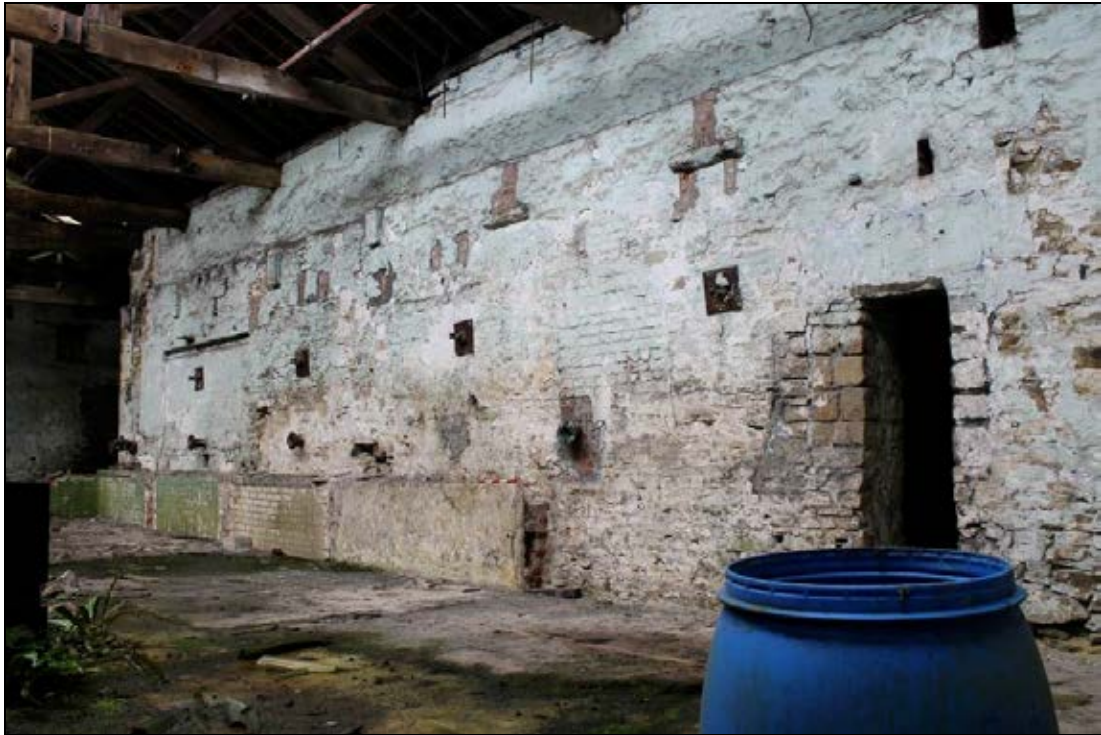
- 3.5.10 The western wall of the leat was covered in thick paint, but appeared to be of rubble construction, although it showed signs of patching and numerous alterations in brick (Plate 63). A series of redundant stone corbels approximately three quarters of the way up the wall showed it had certainly been raised in height.

Plate 63: Western wall of leat with redundant corbels towards the head of the wall

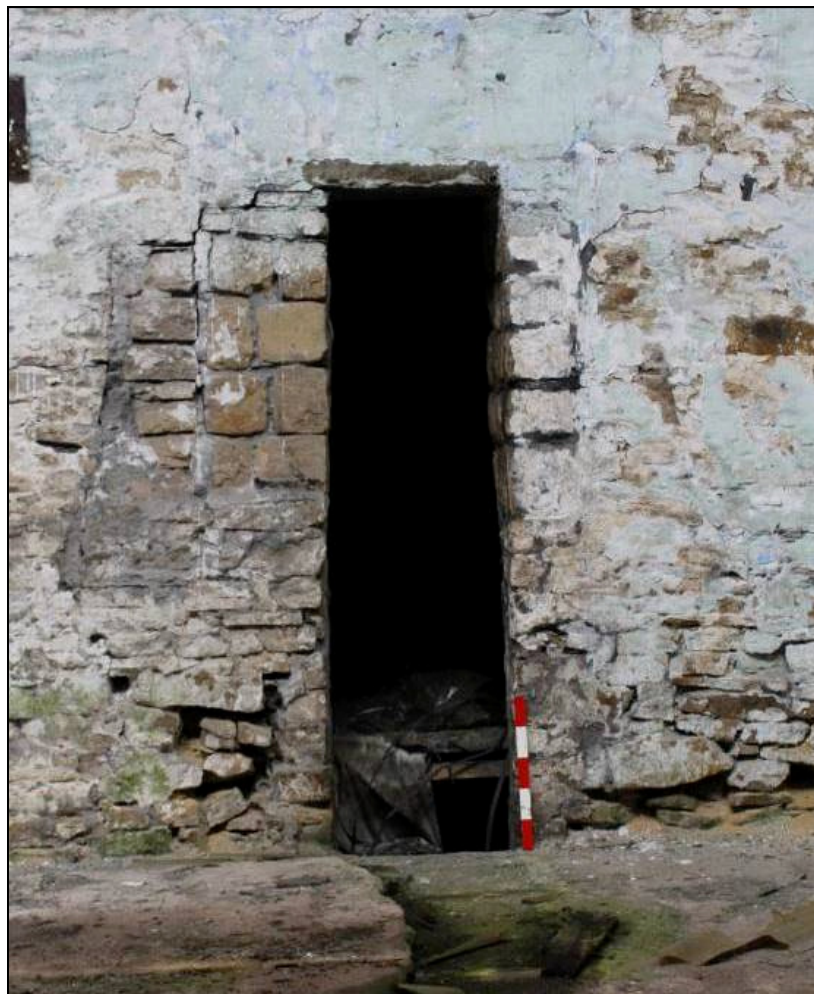
- 3.5.11 A series of five square iron wall ties were recorded upon the western elevation of the leat partition, presumably tying the wall to the exterior face of the eastern wall of Building D. At the southern end of the leat wall there was a very narrow doorway with stone surrounds from which it was possible to inspect the interior of the covered leat (Plate 64).

Plate 64: Narrow opening at the southern end of the western wall of the leat. 0.5m scale

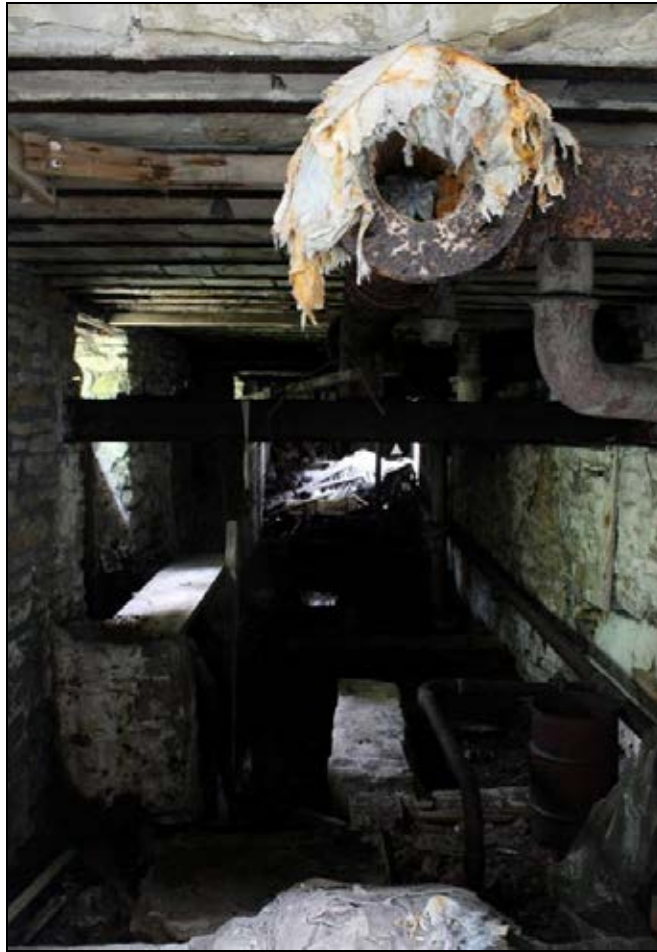
- 3.5.12 The area enclosing the leat was a long narrow space with a low ceiling supported on timber joist (Plate 65). Its limited access prevented a detailed record, but from what was observed it appeared that much of the pipe work and plumbing relating to the bleach works survived. The water was channelled along a stone-lined drain along the western side of the space, where it continued, to exit the building at its southern end (Plate 66). The floor above supported at least one stone tank.

Plate 65: View into covered leat, looking south from the northern opening

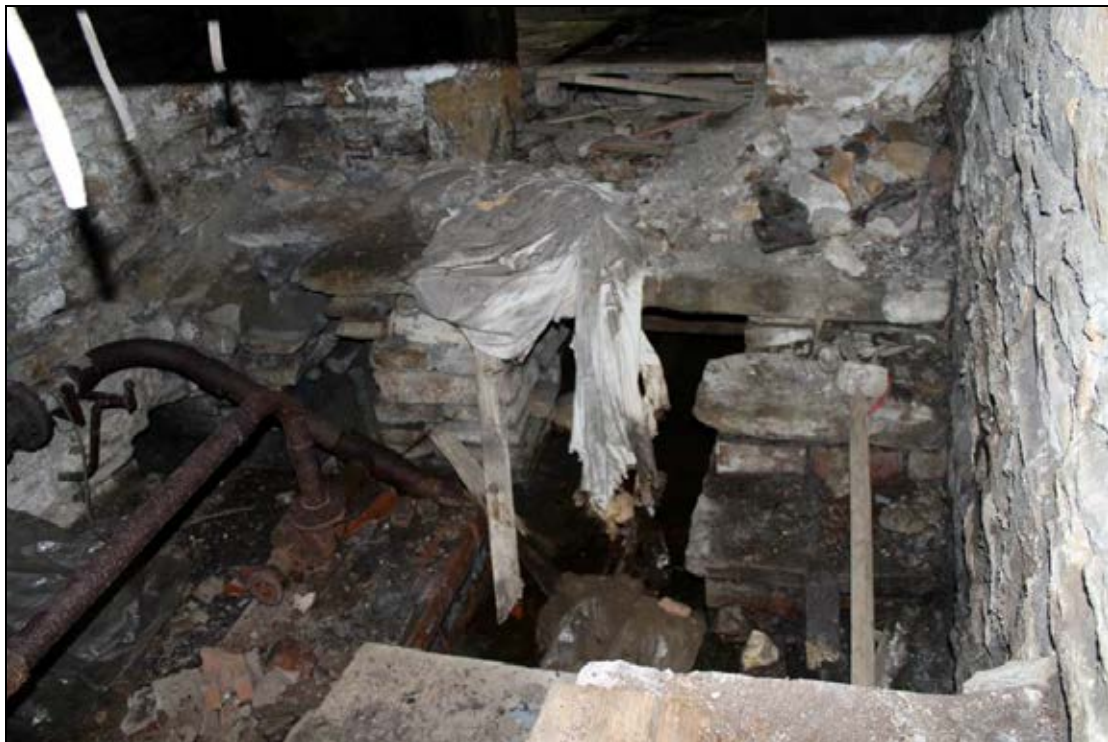
Plate 66: View into covered leat, looking north from the external sluice gate

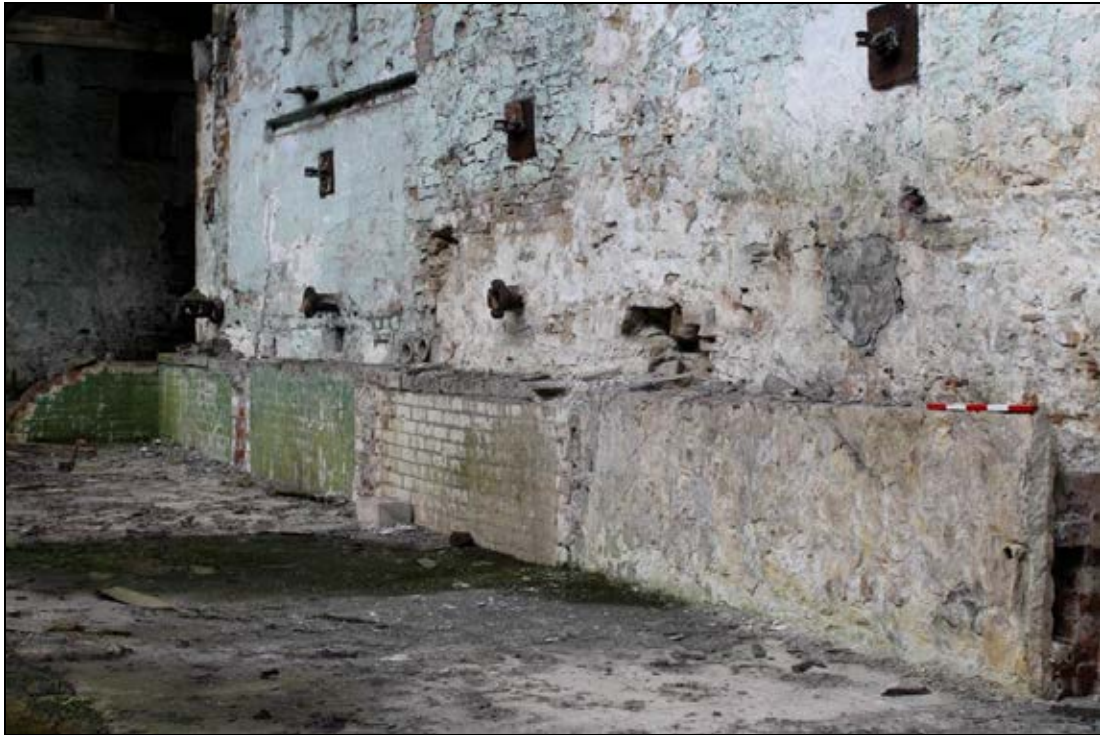
- 3.5.13 ***Fixtures and Fittings:*** immediately in front of, and running parallel to, the western wall of the leat there was a low brick wall with an east/west-aligned return at the northern end (Plate 67). The western elevation of this wall contained evidence for a series of demolished partition walls projecting westwards to from what must have been four large rectangular tanks. Surviving white glazed bricks on the face of the surviving section of the tanks indicated that the northern three tanks had been lined with these, while the southern tank appeared to have been lined with sandstone slabs (Plate 67). The only remaining slab was heavily eroded, perhaps suggesting continued exposure to corrosive chemicals. Each tank coincided with the flanged fitting of an iron pipe, which projected from approximately one quarter of the way up the face of the leat partition wall (Plate 68).

Plate 67: Low brick wall in front of western wall of leat. The partition walls have been removed, but their locations can still be identified

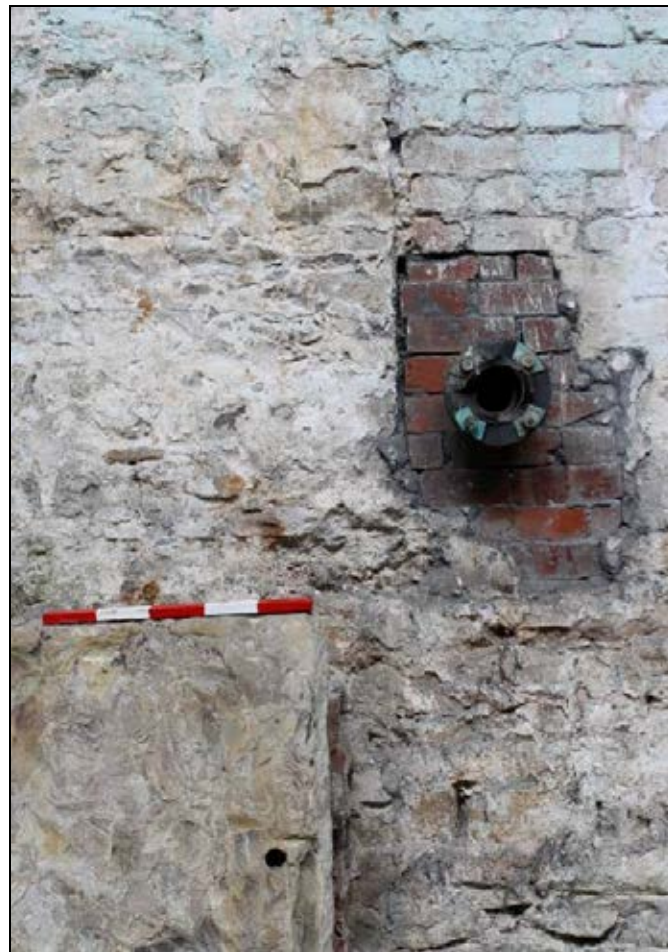
Plate 68: Flanged pipe projecting from western wall of leat. 0.5m scale resting upon the top of the remnants of the heavily eroded stone-lined tank

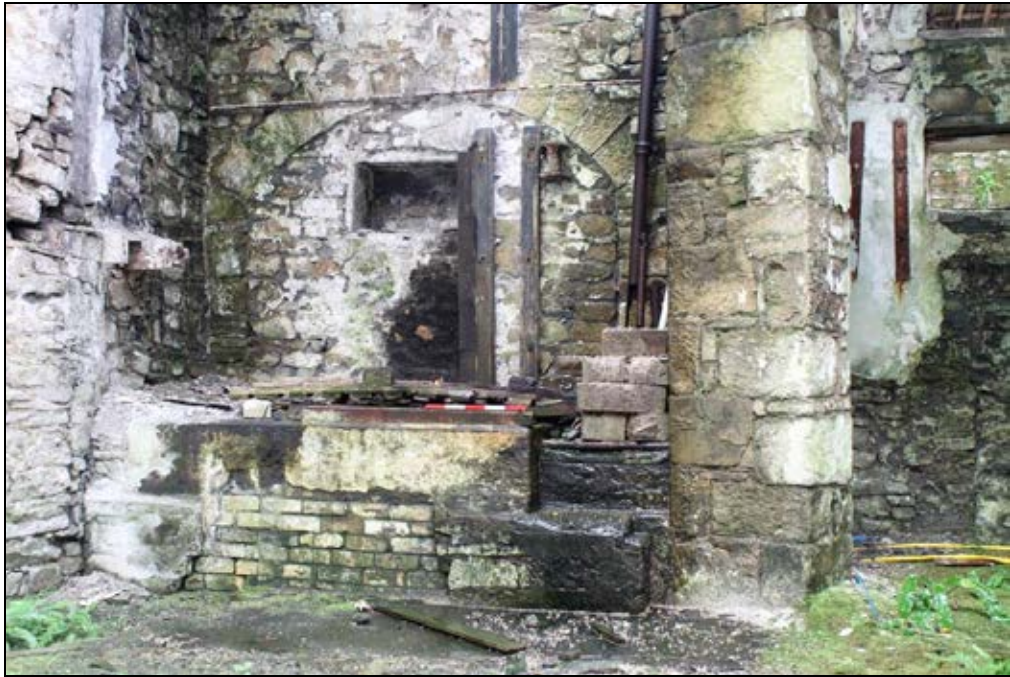
- 3.5.14 In the south-western corner of Building D, at the intersection with Buildings B, E and F, there was a shallow east-facing bay containing a raised brick and stone platform (Plate 69). An iron mounting bracket was bolted to the upper surface of the platform, suggesting the former presence of an engine or some other piece of mechanical equipment. At the rear of the bay a large semi-circular headed arch was visible, the reverse side of the blocked arch described in Building B. The platform obscured the lower half of the archway, and its insertion may have prompted the blocking of the arch. A rectangular cast-iron housing had been inserted into the blocked archway subsequently, visible from Building B as bricked-up aperture.

*Plate 69: Shallow east-facing bay with raised platform inserted and blocked archway behind.
0.5m scale*

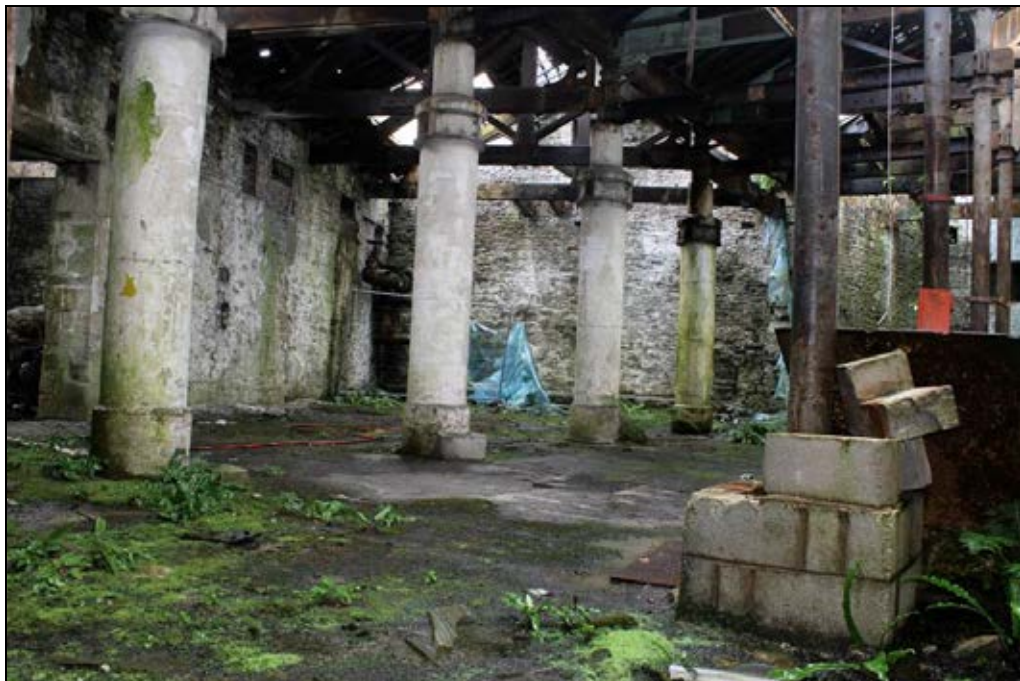
- 3.6.1 Building E lay to the east of Building B, with which it shared its western wall, and was divided from Building D by a series of four substantial concrete pillars (Plate 70). It constituted just a single wall at its northern end, the remainder having been described above within Sections B and D.

Plate 70: Looking north from Building D, with Building E beyond the concrete pillars

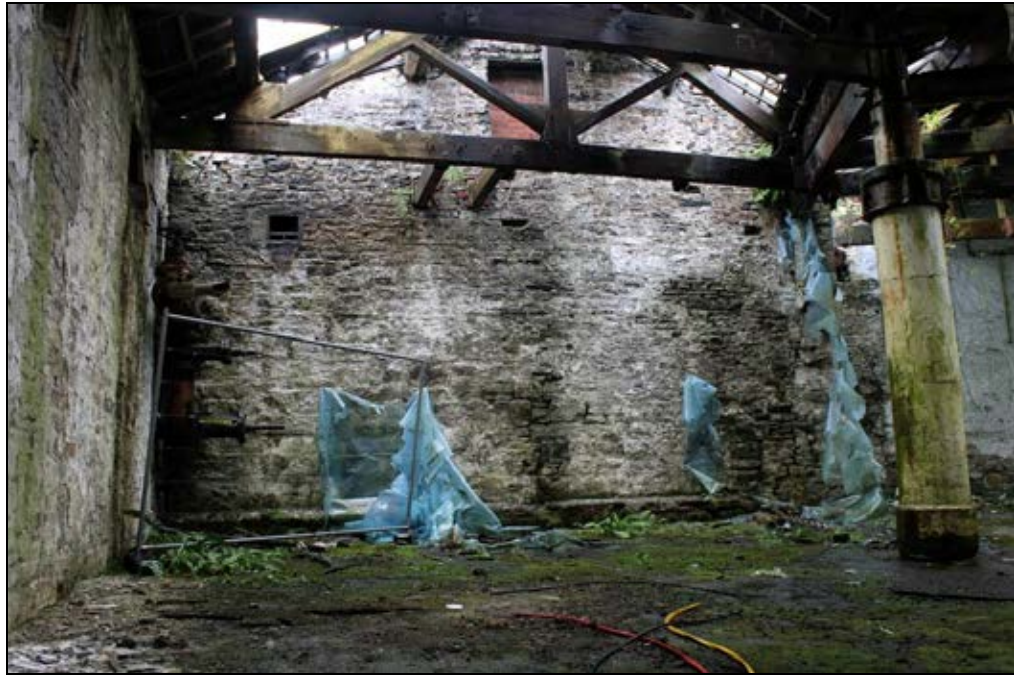
- 3.6.3 **Interior:** internally, the wall was of rubble and retained traces of white paint across its surface (Plate 72). The window recorded externally was also visible internally, where it was revealed as a rectangular opening rather than a square one. There was a small, square, cast-iron bearing box towards the western end of the wall and a short distance below eaves height, while a rough low plinth extended from the base of the elevation.

Plate 72: Internal elevation of northern wall in Building E

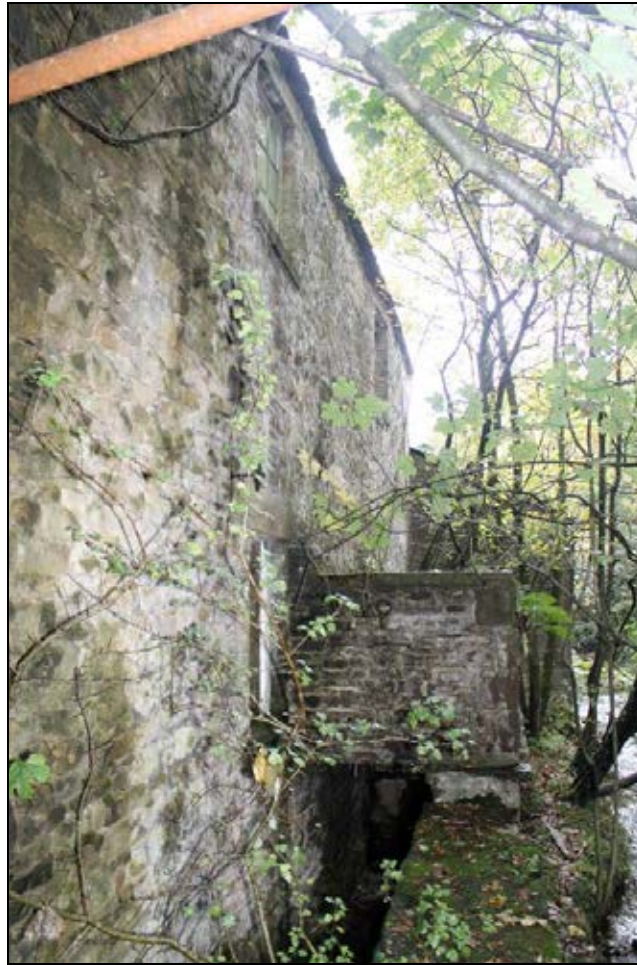
- 3.7.2 **Eastern Wall:** the only fully external elevation lay to the east, and was built of stone rubble to first floor ceiling height (Plate 73). It included two rectangular ground-floor windows separated by a stone tank affixed to the face of the wall and raised above the height of the leat.

- 3.7.5 Both windows had a corresponding rectangular first-floor window above with a projecting stone sill and single-piece stone lintel. The northern window opening had been bricked up but the southern window retained its three-by-three light frame complete with glazing (Plate 73).

Plate 73: Eastern wall of Building F, looking north

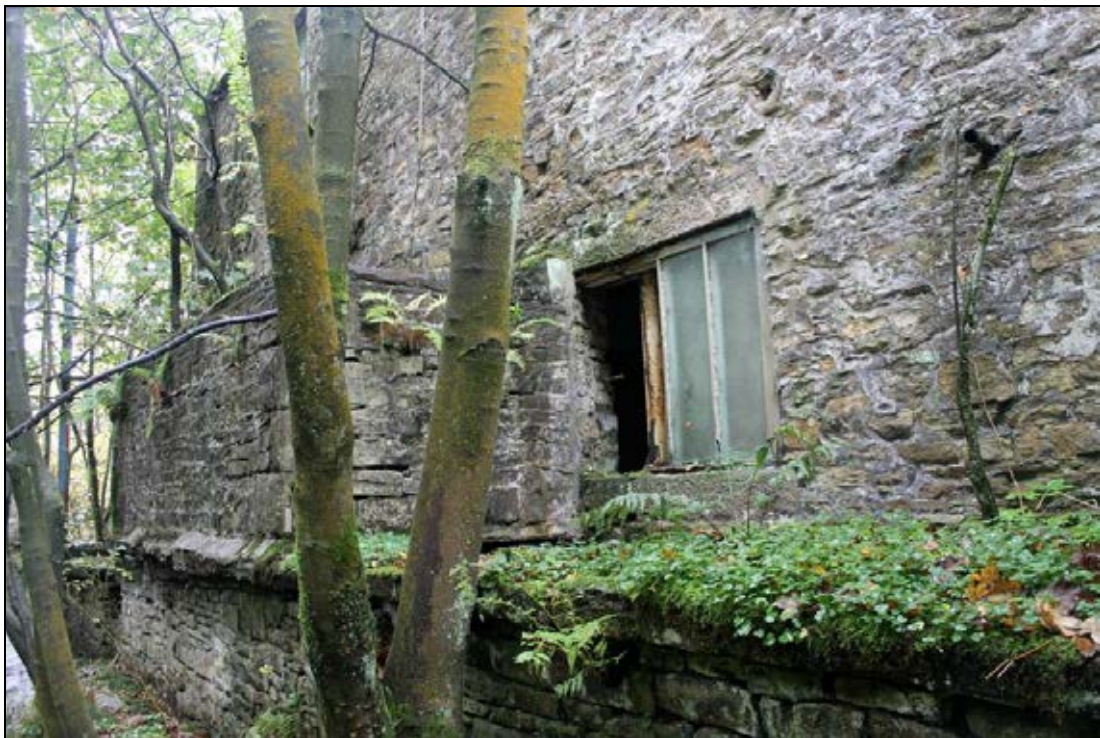
- 3.7.3 The northern window had a single-piece stone lintel and flush sill, both tooled to a picked finish (Plate 74). Two of its original four vertical, elongated rectangular lights survived in place, while a short cast-iron post had been inserted into the southern half of the opening.

Plate 74: Four-light window on eastern wall of Building F, with inserted cast-iron column replacing the two southern lights. Note the stone tank to the left of the window suspended above the leat

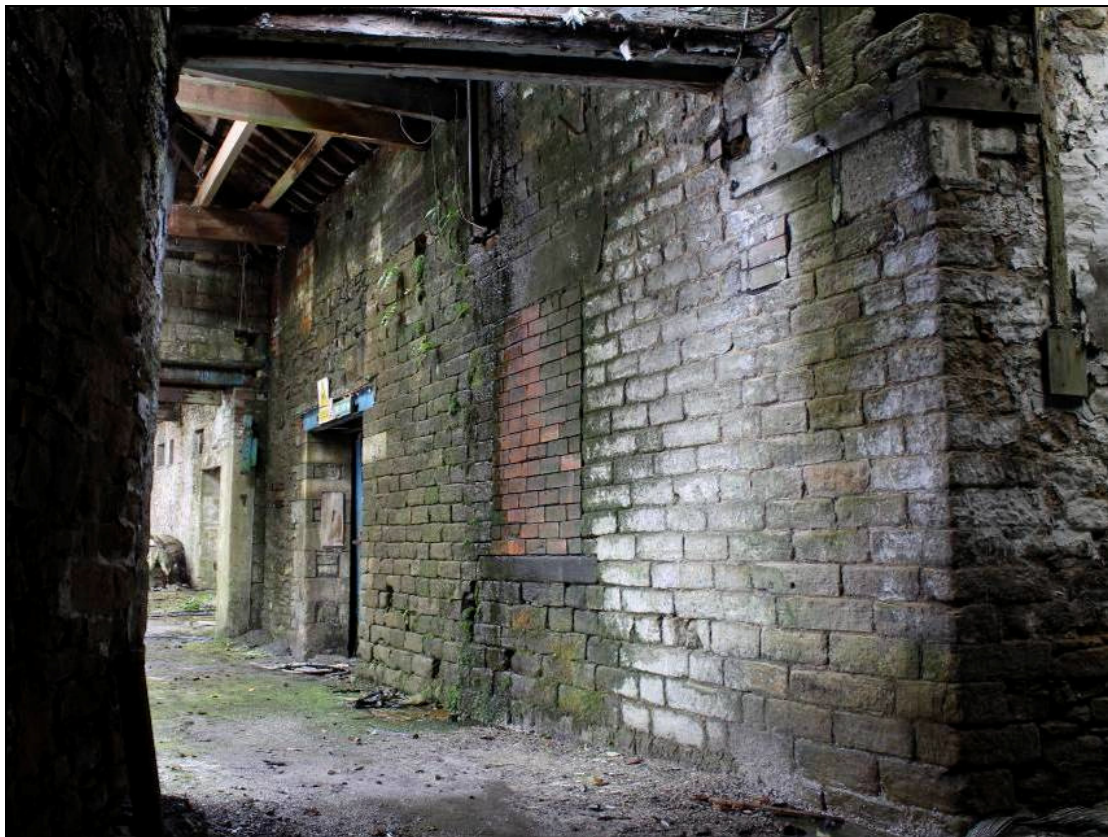
- 3.7.7 The western wall was constructed of coursed sandstone blocks laid in water-shot fashion, reflecting its original external character (Plate 77). Only the ground floor had been enclosed, and it had a large ground-floor doorway at the northern end with a flat H-section iron lintel. The southern jamb had no formal quoins, but the northern jamb was constructed using alternating quoins and, in fact, the entire northern end of the ground floor beyond the southern jamb had been rebuilt in rubble. At the southern end of the elevation there was a large vertically set rectangular window with a single-piece tapered stone lintel and a plain stone sill beneath (Plate 77). The opening had been in-filled with hard red brick. A shorter window with a projecting stone sill and tapered stone lintel was recorded at first-floor level directly above the ground-floor window, with a second of identical character to the north (Plate 78). A circular iron clamp was bolted to the first-floor exterior face at the southern end of the wall.

Plate 77: Western elevation of western wall of Building F, facing north-east

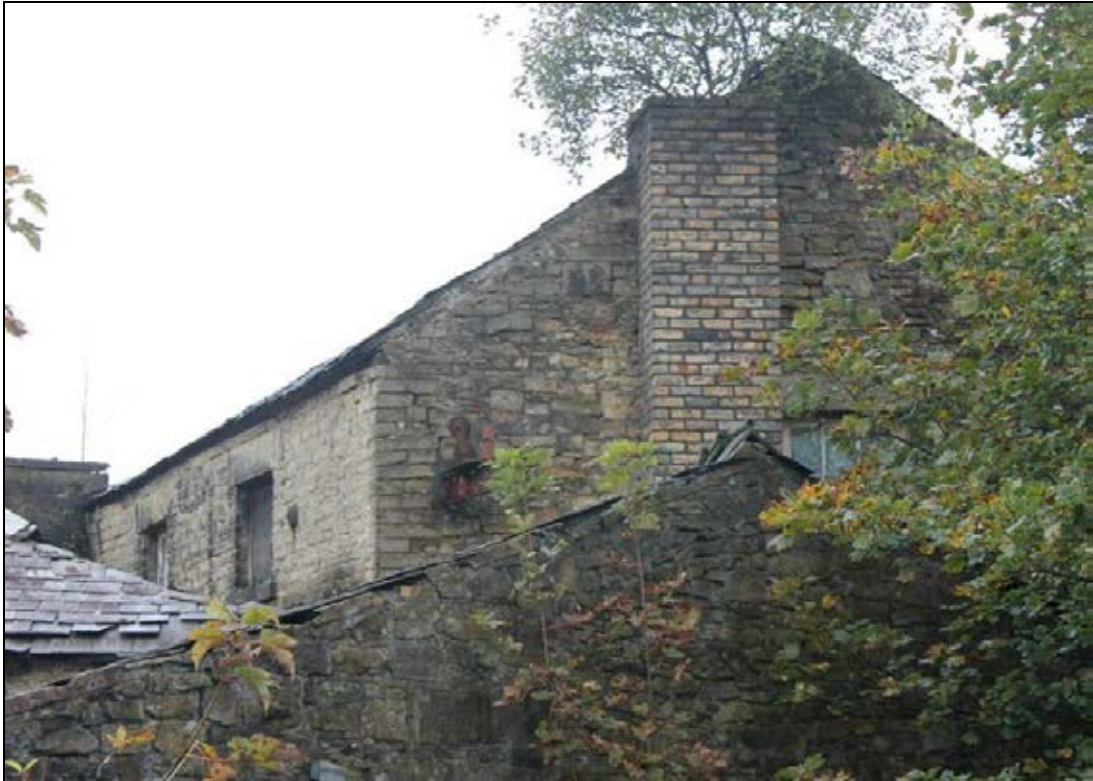
Plate 78: Building F, with western elevation to left and southern gable elevation to right, facing north. The first-floor window of the southern elevation is just visible to the right of the chimney stack

- 3.7.10 Above the roof line of Building G there was a second window at first-floor height, and directly above the ground-floor window to which it was identical in form (Plate 78). At the western end of the elevation an iron pulley hoist, clearly predating the erection of Building G, was bolted to the wall (Plate 78).

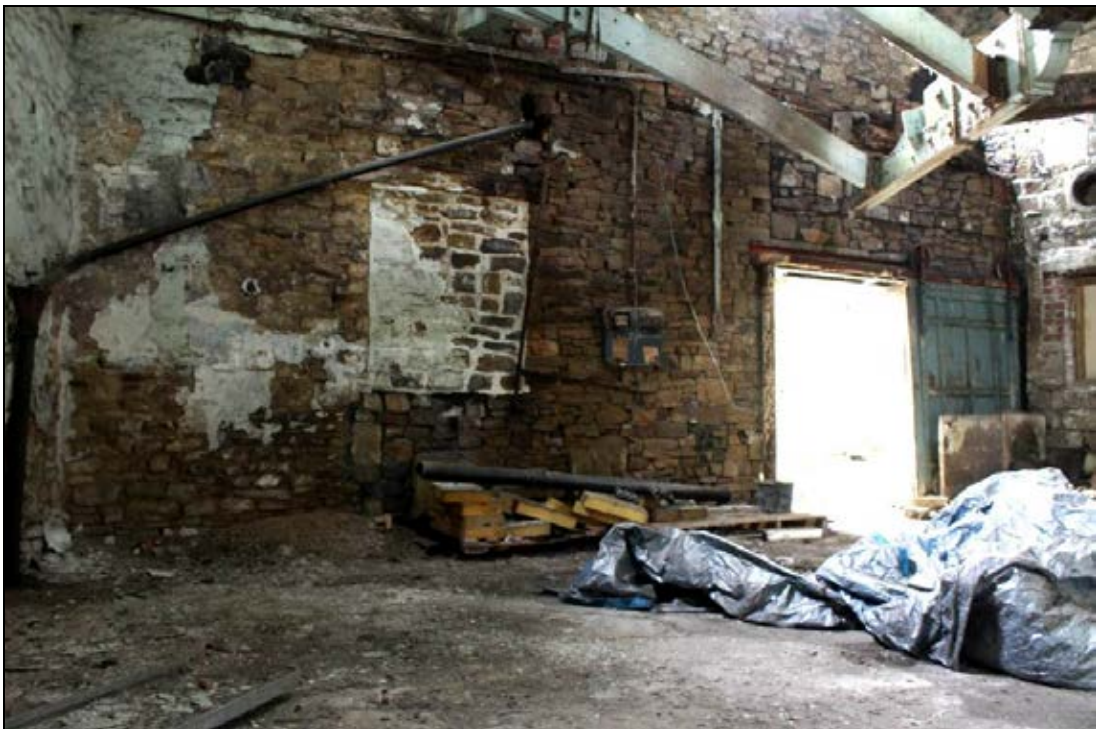
- 3.7.8 Internally, the western wall was constructed of uncoursed rubble, and it appeared that the rebuilding at the northern end may have related to the partial in-filling of a larger doorway (Plate 79). The present doorway had a top rail mounted sliding timber door. Above the doorway, a cast-iron joist bracket had been bolted to the face of the wall, but the end of the joist had sheared off leaving the first-floor structure in a precarious state. Internally, it was evident that the southern first-floor window retained its three-over-three light timber frame, but that the northern window had not.

Plate 79: Building F, internal elevation of western wall, facing west

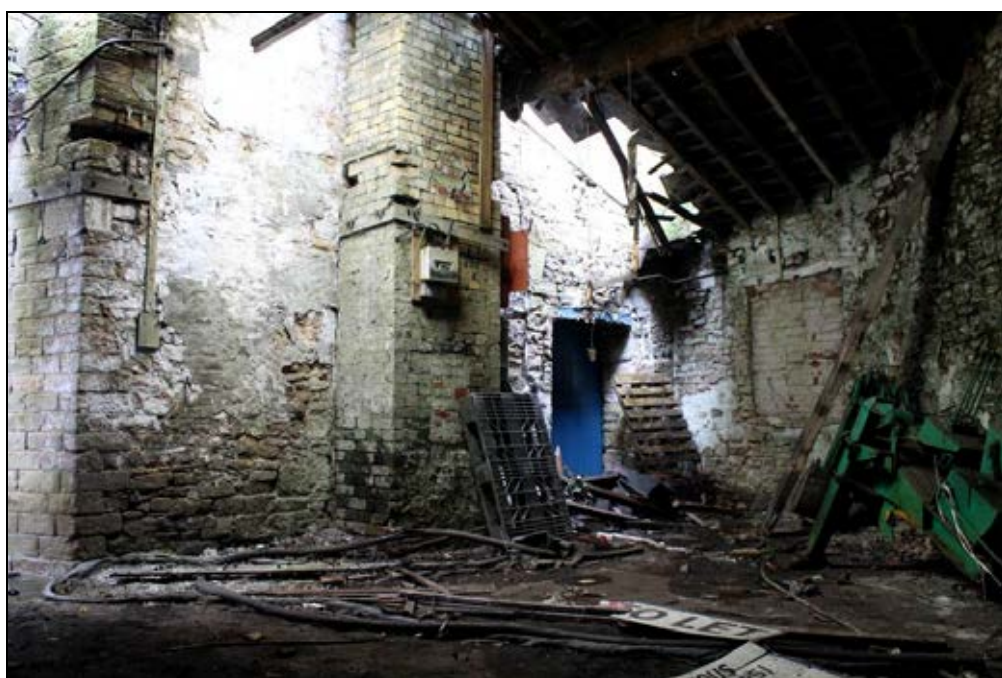
- 3.7.9 The southern wall was constructed of uncoursed sandstone, but a vertically set rectangular ground-floor window with a tapered stone lintel and single-piece stone sill at the centre of the elevation demonstrated it had been built as an external elevation (Plate 80 and 81). The window had been blocked, and a small rectangular brick chimney constructed immediately to its west, projecting from the centre of the elevation and obscuring the western jamb of the blocked window. A doorway with rubble jambs and a timber lintel lying to the east of the window may have been a later insertion, judging by its proximity to the window and slightly awkward surrounds.

Plate 80: Building F, southern elevation, facing north-east
