**BELMONT
BLEACH WORKS,
EGERTON ROAD,
BELMONT,
BLACKBURN WITH
DARWEN**

**Historic Building
Investigation**

October 2015

Millson Associates
Planning Application 10/12/0590

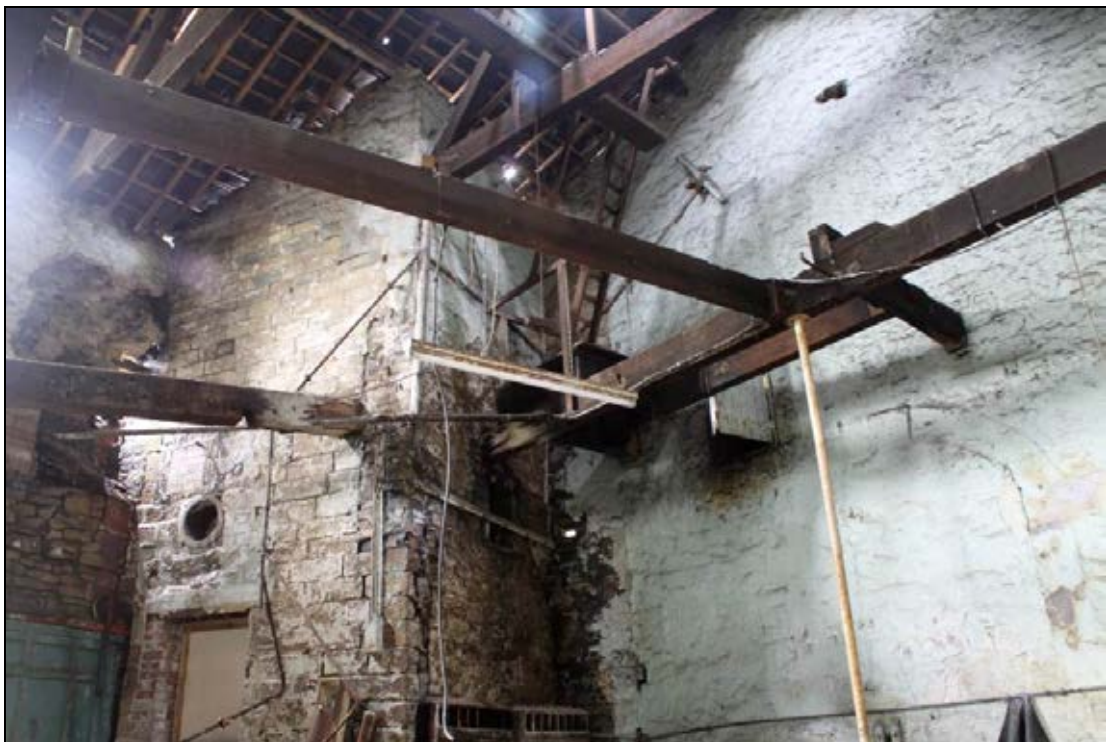
Plate 82: First-floor platform with timber ladder, in north-western corner of Building F

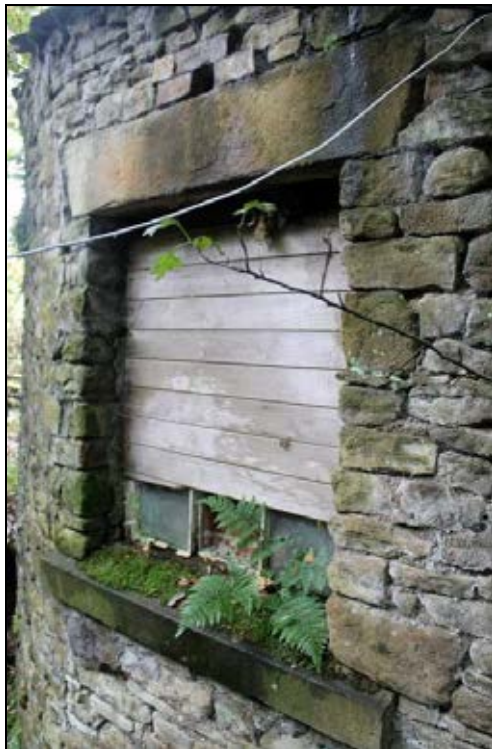
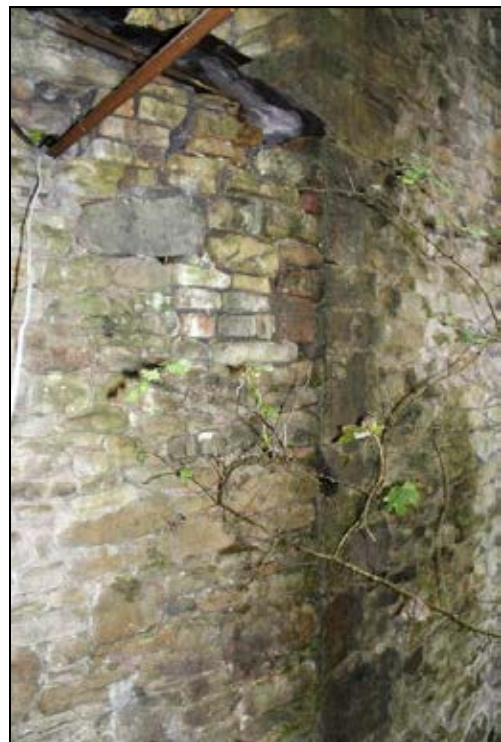
- 3.8.2 **Exterior:** the only external wall lay to the south-east, where it followed the alignment of the brook as it curved round to the south-west. This wall was constructed of sandstone rubble and had a vertically set rectangular window at the northern and southern ends, both with a tapered stone lintel and projecting stone sill. Although boarded-up, the northern window retained its three-by-three light timber frame with at least some of its original glazing intact (Plate 83). The southern window had been bricked-up. The butt joint between Building G and F was clearly visible at the northern end of this wall, with the alternating quoins of Building F extending to the north (Plate 84).

Plates 83 and 84: Northernmost window on eastern elevation of Building G, with butt joint between Buildings G and F to right

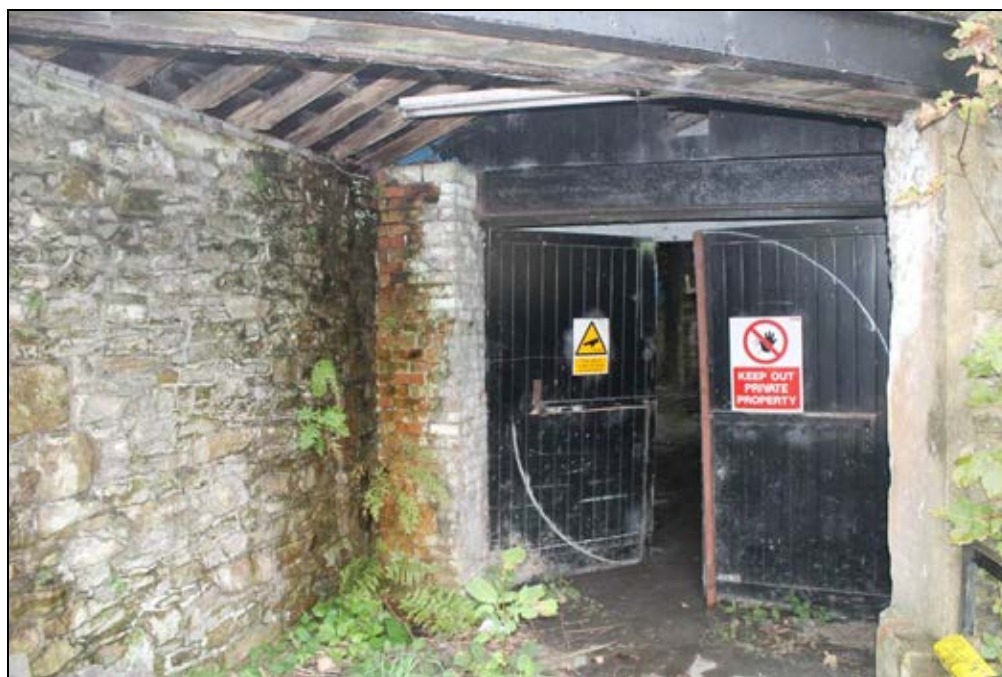
- 3.8.3 At the southern end of the wall, a large doorway with a steel H-section lintel provided access to the covered southern cell of Building G via a footbridge over the brook from the road. The entrance contained no doorway, but led onto a second doorway with a set of modern double doors from which the northern cell of the building could be accessed (Plate 85).

Plate 85: Southern entrance into Building G from the footbridge

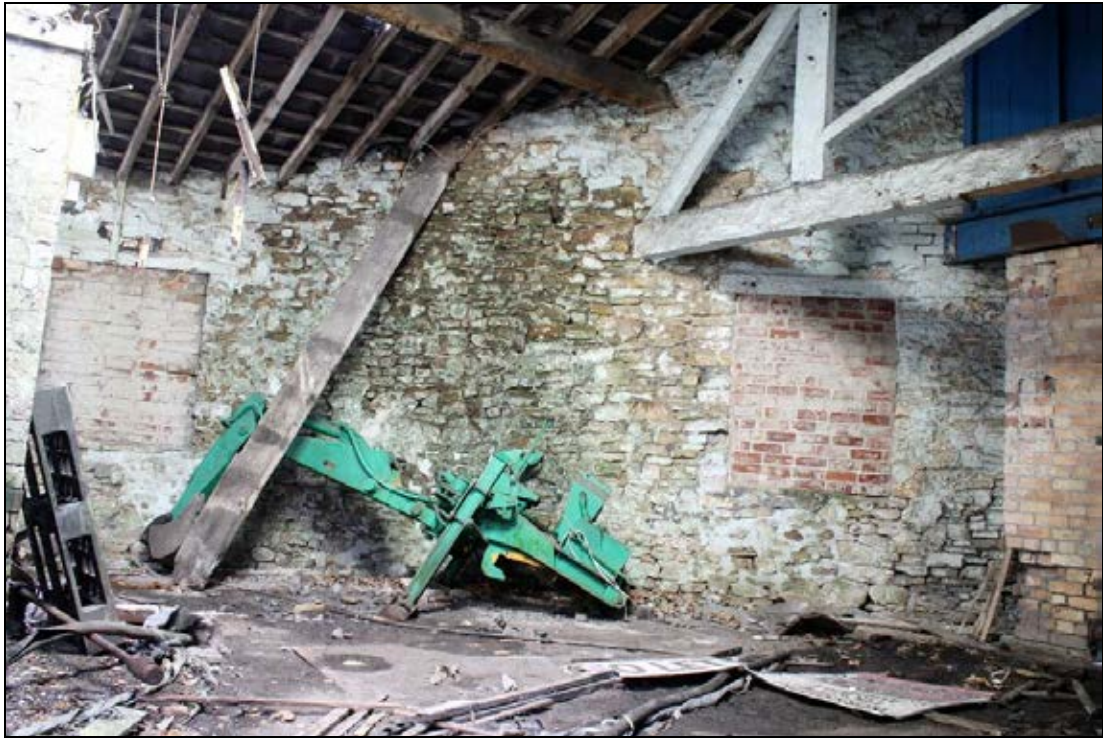
- 3.8.5 Internally, the eastern wall had been coated in white paint but, apart from the two windows described externally, displayed no other features of historical note (Plate 86).
- 3.8.6 The western wall was constructed of sandstone rubble and retained traces of an internal plaster finish. The only features of interest were a small, square, stone-lined aperture near the base of the centre of the wall, which had been infilled with brick and a small circular iron tie clamp at the base of the southern end of the wall (Plate 87).
- 3.8.7 **Roof:** the roof was composed of a single off-centre king post truss at the southern end of the northern cell (Plate 88). Purlins, extending from the southern elevation of the northern wall, were carried upon the back of the trusses principal rafters. The roof was covered with slates, although a number of these had been lost.

Plate 86: Internal elevation of the eastern wall, showing blocked windows at either end

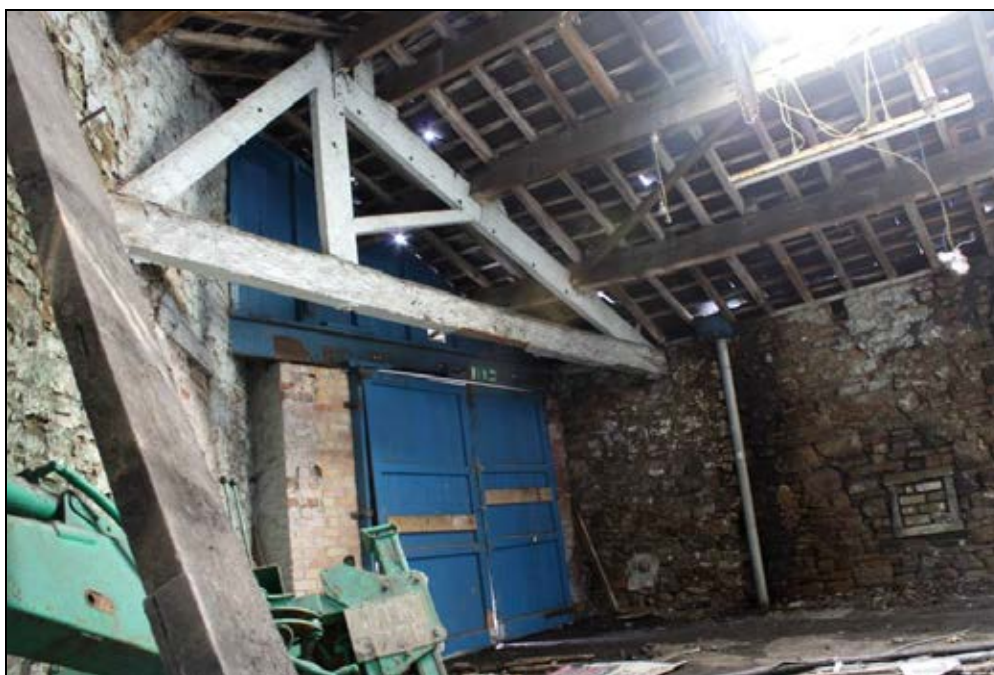
Plate 88: King post truss at the southern end of Building G, facing south-west

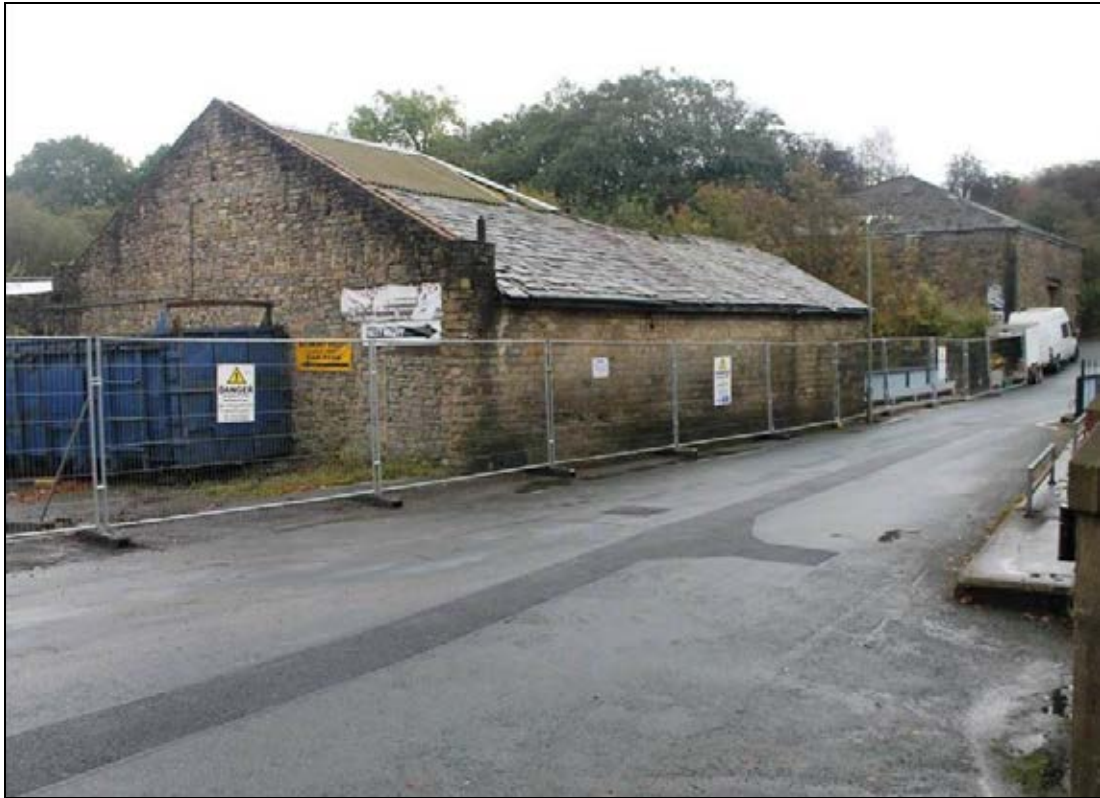
- 3.9.1 Building H was a single-storey rectangular building, aligned east/west, and lying at the southern end of the complex where it bordered the main road (Plate 89). It was abutted to the north by Building I and to the east by Building J, with its western gable wall facing the open yard at the entrance to the site.

Plate 89: Building H, facing east along Egerton Road

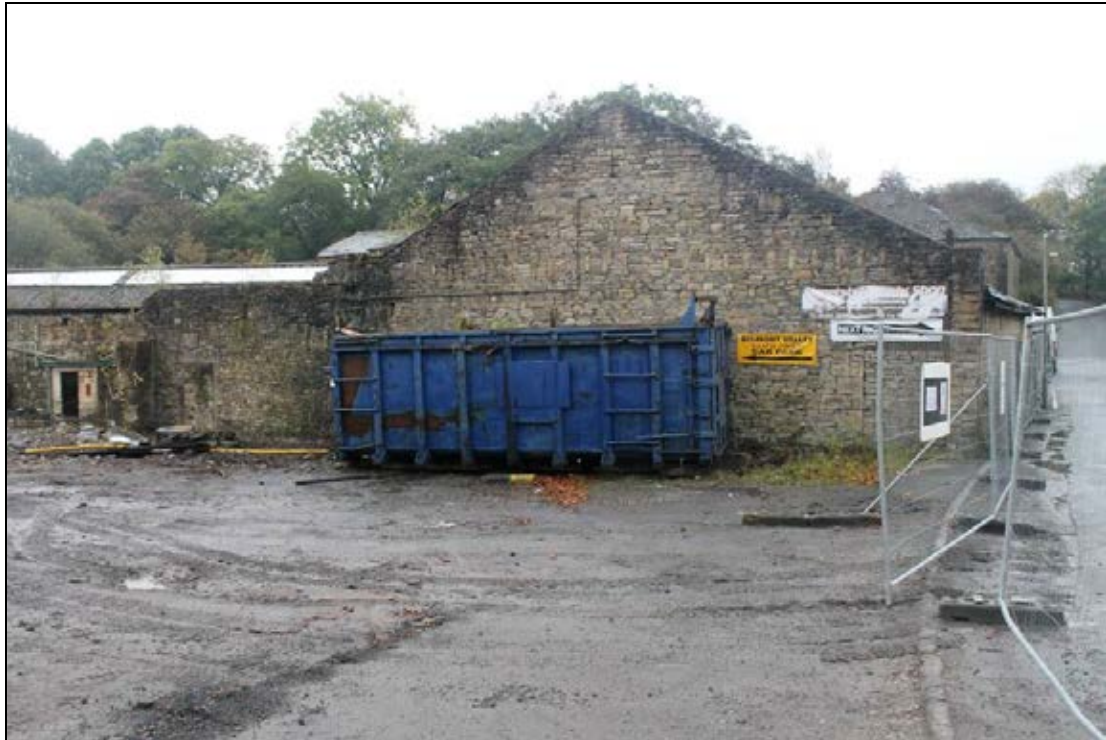
- 3.9.4 The western gable wall was built in uncoursed sandstone rubble, and included a raised parapet at its head (Plate 91). At the southern end of the wall there was a blocked pedestrian doorway, abutting the projecting southern wall to the south, but with quoins on its northern jamb (Plate 92). The character of the quoins suggested these may have been reused from elsewhere. A series of blocked joist sockets were noted across the length of the wall at eaves height, indicating the former presence of a first floor or attic space, but the remainder of the wall was obscured at the time of survey by a large skip (Plate 93). At its northern end, the wall could be seen to abut its northern elevation rather than forming a corner, and although truncated and refaced subsequently, it appeared that the northern wall had continued west beyond the limit of the western wall (Plate 94).

Plate 91: Building H, western external elevation, partially obscured by skip

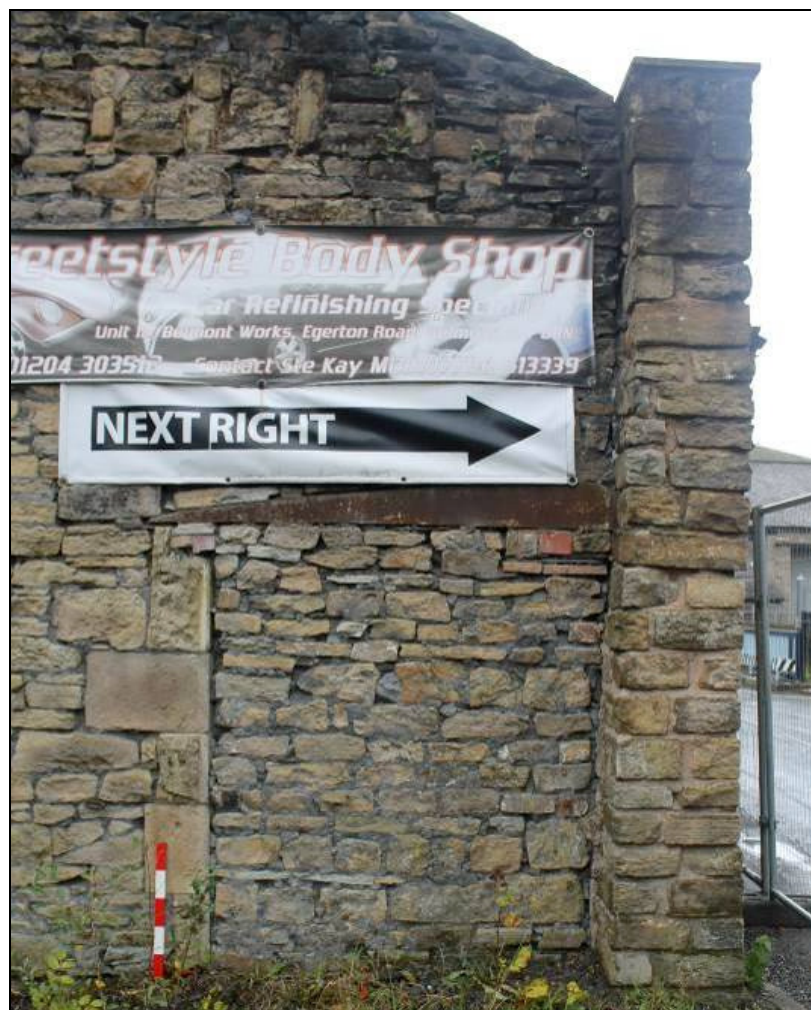
Plate 92: Blocked doorway at southern end of western gable wall. 0.5m scale

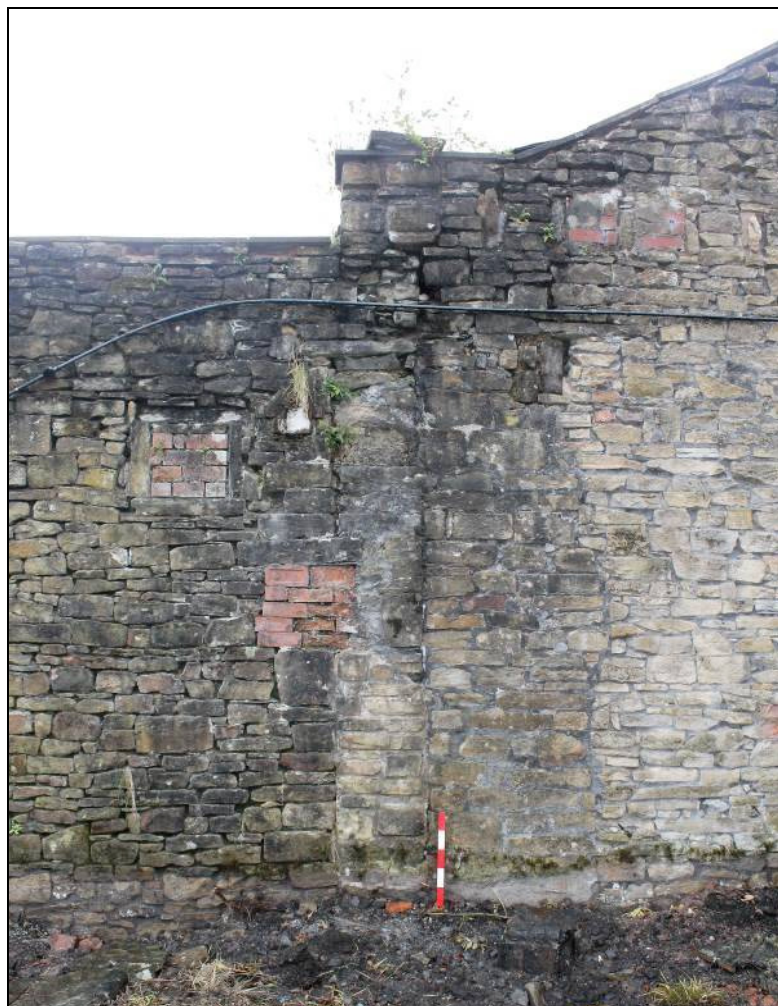
Plate 94: Butt joint at northern end of western gable wall with 0.5m scale

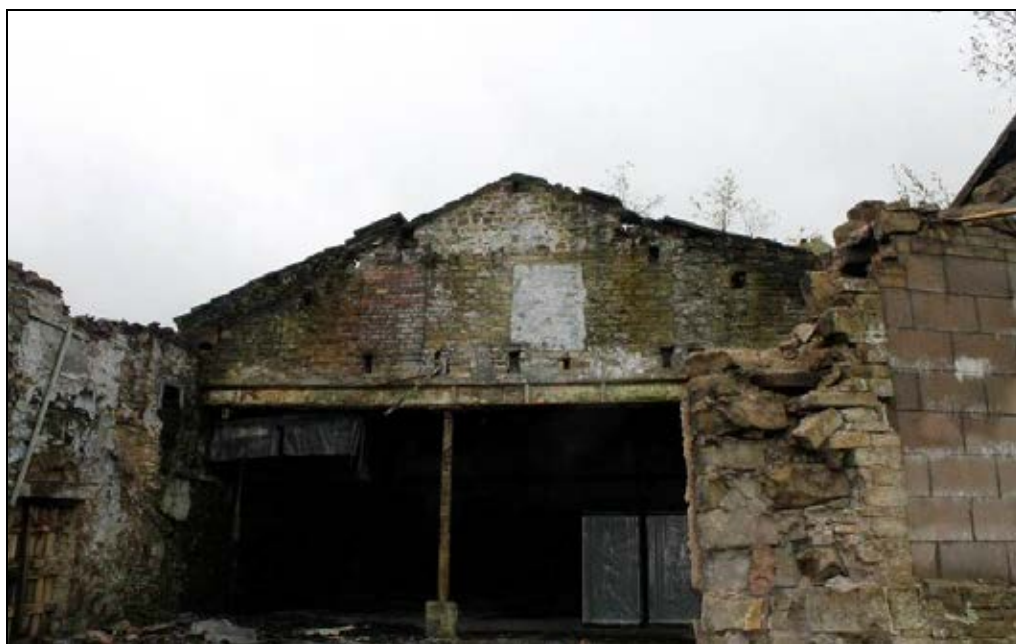
- 3.9.5 Only the upper gable of the northern wall of Building H remained, with the surviving masonry resting upon an iron lintel supported at its centre by a cast-iron column set upon a concrete pad (Plate 95). Although enclosed subsequently, the coursed sandstone blocks suggested that this had originally been an external elevation, and this was confirmed by the presence of four equally spaced rectangular windows along the length of the wall.

- 3.9.6 The upper portions of the eastern and westernmost windows had been truncated during works to remodel the wall to accommodate a gable roof, but the single-piece lintels survived in the two central examples. All of the windows had been blocked-up and a series of joists, and purlin sockets had been cut into the face of the wall.

Plate 95: Remaining section of northern elevation of Building H

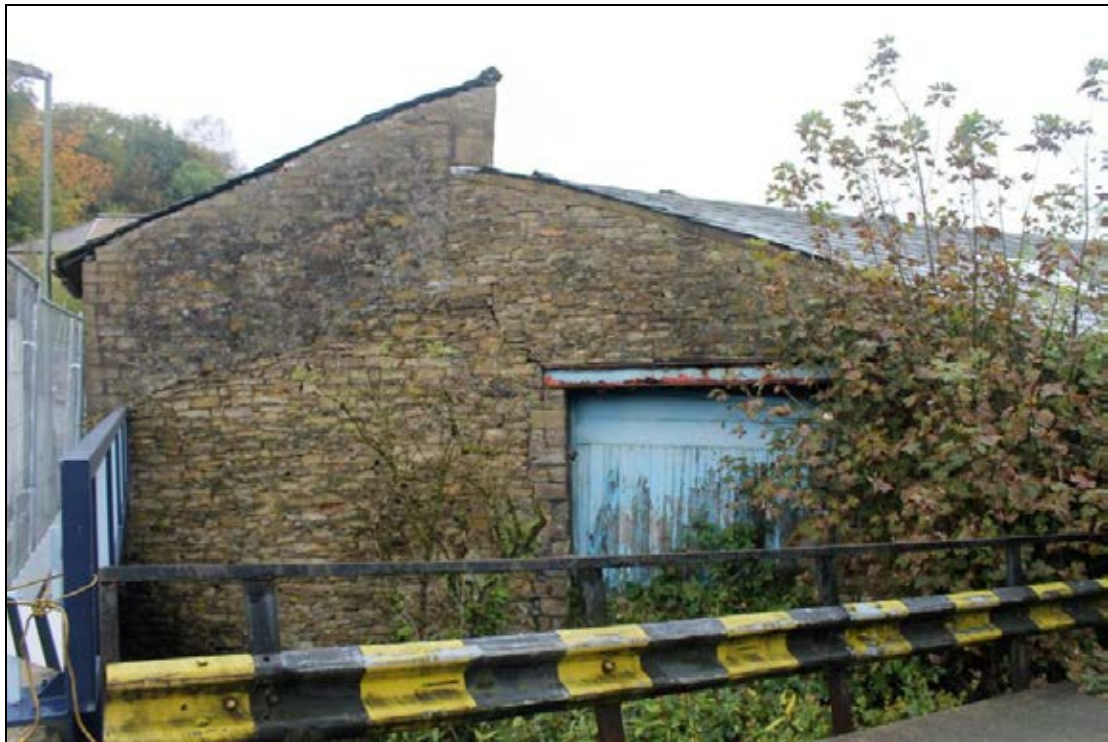
- 3.9.7 The eastern wall of Building H was shared with the later Building J, but is discussed here in relation to Building H. Externally, the wall was constructed in rough sandstone rubble upon a north-north-eastern alignment (Plate 96). From the centre of the elevation, the wall altered its alignment slightly to the north-east, adjoining the south-eastern wall of Building G at its north-eastern end. A large loading doorway within the north-eastern half of the elevation had rough stone quoins, and was topped by an iron lintel. It was fitted with a timber door constructed in narrow vertical planks.

Plate 96: Eastern elevation of Building H, with loading doorway to right

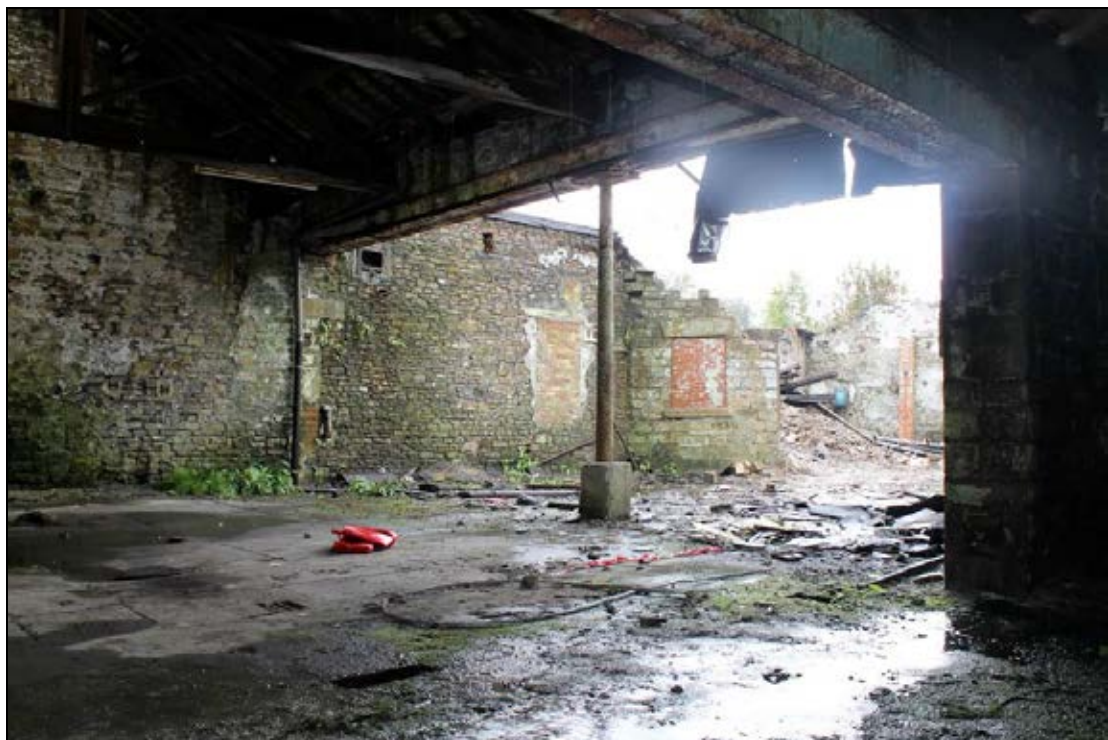
- 3.9.8 **Interior:** the partial removal of partition walls between Building I to the north and Building J to the east had resulted in a single continuous floor space, divided by a masonry pier to the east and a cast-iron column to the north (Plate 97).
- 3.9.9 The internal elevation of the southern wall contained no visible openings, but its upper half was coated in white paint, which may have obscured some detail. The lower half of the wall was clearly suffering from damp ingress, reflecting its use as a retaining wall against the road surface to the south.

Plate 97: Looking north-west across Building H, with Building I beyond

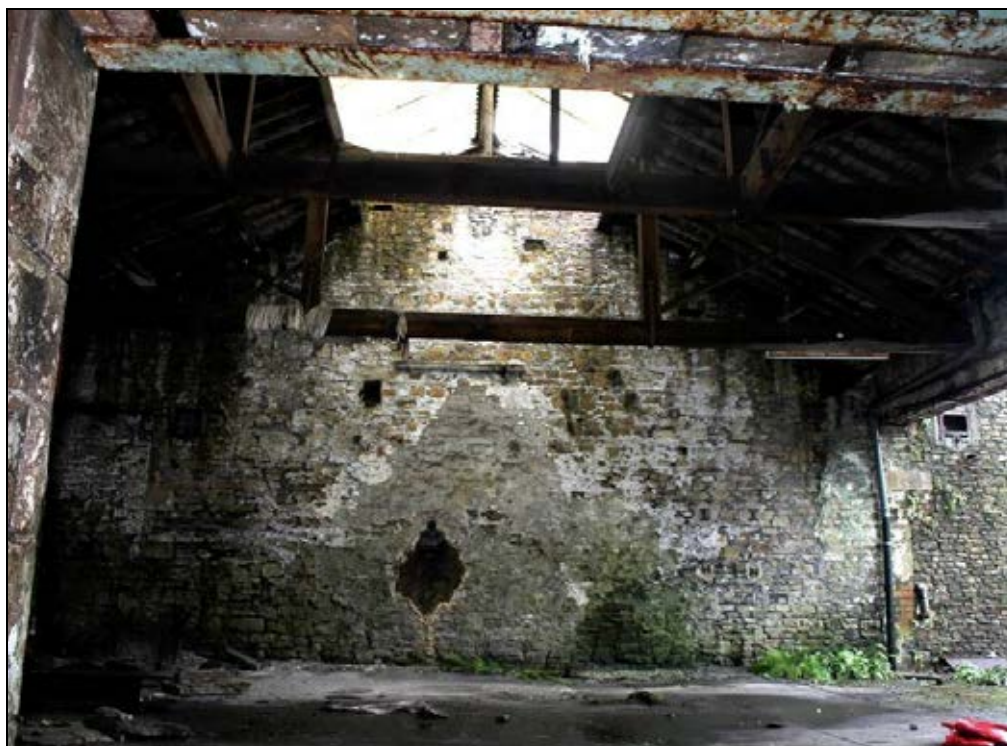
- 3.9.10 The blocked doorway at the southern end of the western wall recorded externally was also visible internally, but appeared to be a taller doorway. This perhaps suggests that the ground surface to the west of the building has been raised since its construction (Plate 98). Just to the north of the doorway and at lintel height there was a cast-iron bearing box set into the wall, with another near the centre of the elevation at approximately 1.5m from the ground.

Plate 98: Western wall of Building H, facing west. The blocked doorway can be seen to the left of the frame with the bearing box in the centre

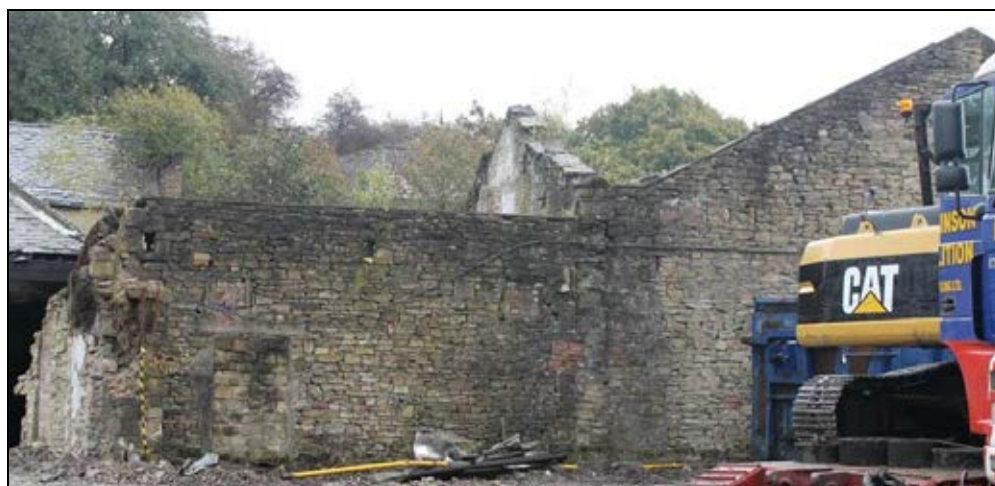
3.10.2 **Exterior:** the western wall was the only external wall, and comprised roughly squared sandstone blocks brought to very rough courses. It abutted the northern wall of Building H at its southern end, and the southern wall of Building A to its north (Plate 99). A pedestrian doorway with a concrete lintel and jambs roughly rendered in concrete was located at the northern end of the wall (Plate 100). It had been blocked-up with rough sandstone blocks. Immediately above the doorway there was a small square opening with stone surrounds, and a second at the southern end of the wall (Plate 101). Both had been blocked-up with red brick. Near the head of the wall at the centre and northern end of the elevation were two smaller stone-lined openings.

Plate 99: Western wall of Building I, facing east.

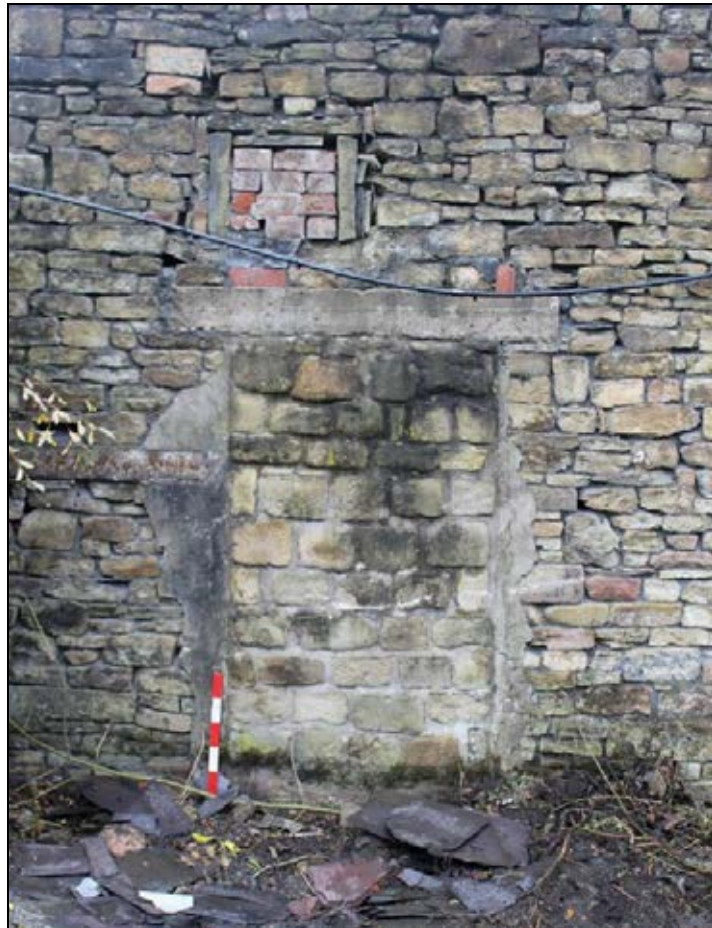
Plate 100: Blocked doorway at northern end of western wall, facing east. Stone-lined aperture above. 0.5m scale

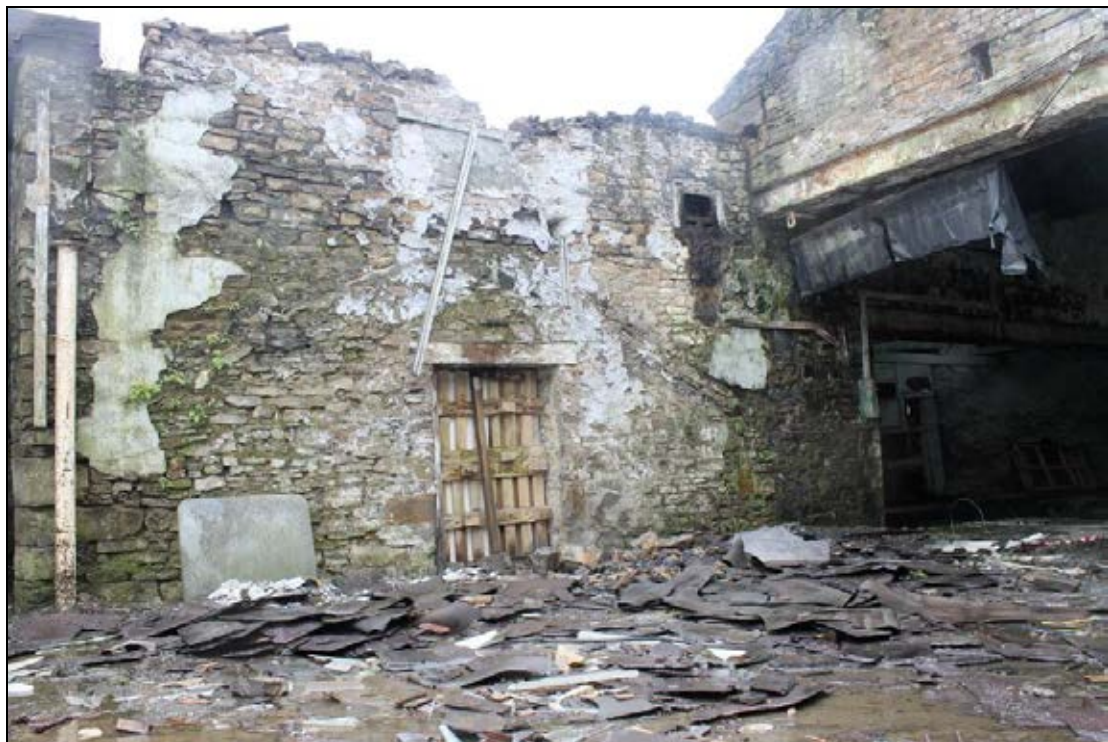
3.10.3 **Interior:** internally, the western wall was as described externally, but the southernmost square opening retained a cast-iron bearing box. The eastern wall was constructed in sandstone rubble and retained traces of its internal plaster finish (Plate 101). It contained a single cast-iron bearing box near the head of the wall at the southern end, corresponding to the bearing box noted on the opposite wall. At the centre of the elevation there was a low pedestrian doorway with a timber lintel and rough stone jambs. The wall was of patched and repaired appearance, and the loss of the plaster finish had revealed the only surviving wall of a low gabled structure (Plate 101). The outline of this building's gabled roof could be identified on both elevations, indicating that the entire wall had been fossilised within the later wall above. Given its position and height, it is probable that the doorway described above belonged to this original building rather than to Building I. The eastern elevation appeared much the same as the western elevation but a small, square, stone-lined aperture at the base of the wall's western end was noted and the lintel over the central door was a single piece of sandstone. The roof had been taken down prior to the present survey, and all fixtures and fittings removed from the interior. The floor had been laid in concrete.

Plate 101: Internal elevation of eastern wall of Building I. The outline of an earlier single-storey gabled building can be seen

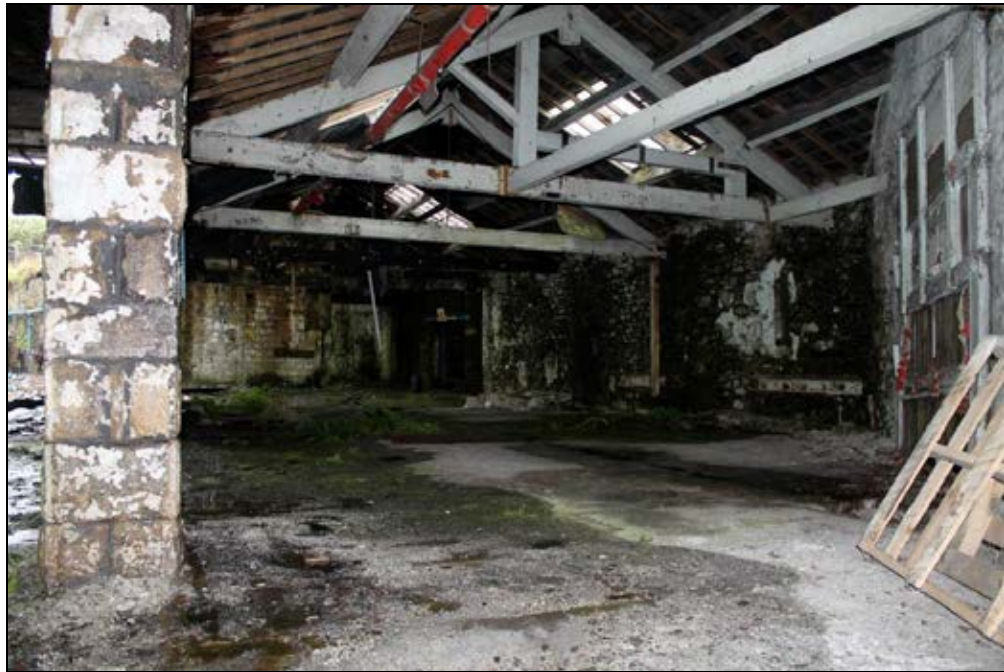
- 3.11.3 **Roof:** the roof structure was formed of four trusses, the two to the north being of king post design and the two to the south employing king rods. The southernmost example had been altered, with additional posts and a collar taking the place of the king rod, presumably to provide additional strength to support equipment (Plate 103).

Plate 103: Interior of Building J, looking northwards. Modified southern truss in foreground

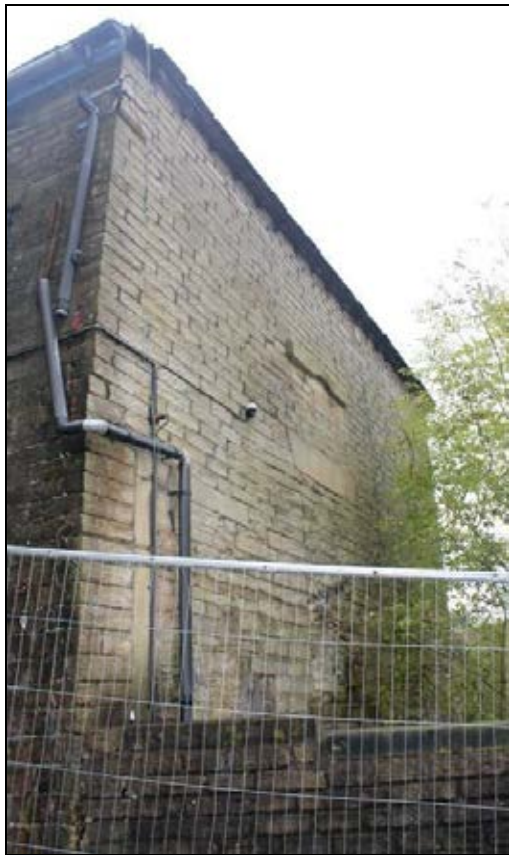
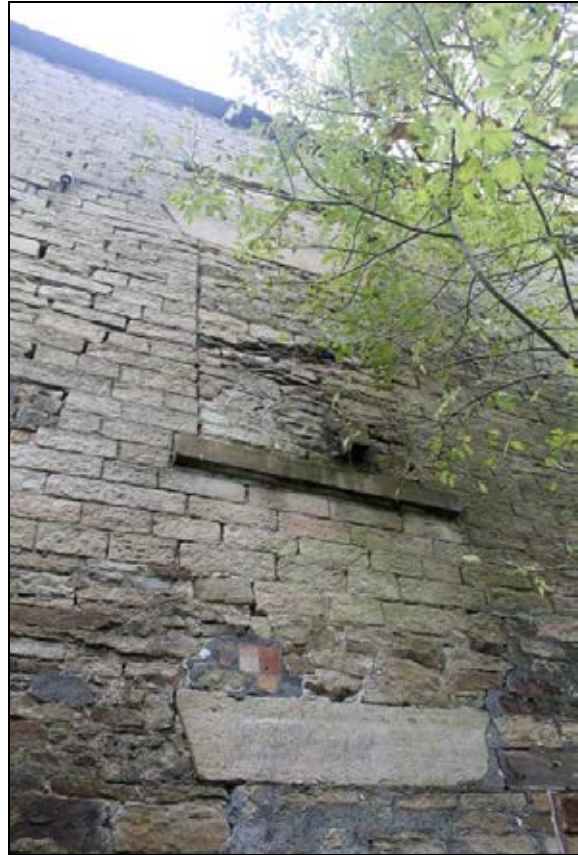
- 3.12.3 At the centre of the eastern end of the elevation there was a vertically set rectangular window with a tapered stone lintel and single-piece projecting stone sill (Plate 106). An identical first-floor window lay immediately above, but the upper third of the opening had been cut away when the building was reduced in height. To the east of the large opening a small section of low stone wall projected south for a distance of approximately 1m, and was topped by a flat coping stone. Scarring on the face of the main wall behind suggested this wall may once have been taller.

- 3.12.4 The coursed masonry blocks continued round onto the upper half of the eastern wall, suggesting it had been constructed as an external elevation, although the lower half was constructed of un-coursed rubble masonry (Plate 106). There was a centrally placed window at road level with a single-piece splayed stone lintel and projecting stone sill (Plate 107). This window had been blocked, and the diagonal scar of a roof pitch ran across its middle. A second window opening directly above had been truncated and was missing its lintel, demonstrating again that the building had been reduced in height. At the southern end of the elevation, there was the southern jamb and lintel of what appeared to have once been a road-level doorway (Plate 106). The northern jamb had been removed and the opening blocked.

Plate 106 and 107: Upper half of south-eastern elevation from Egerton Road to left. Looking up to ground-floor window from level of open yard to right

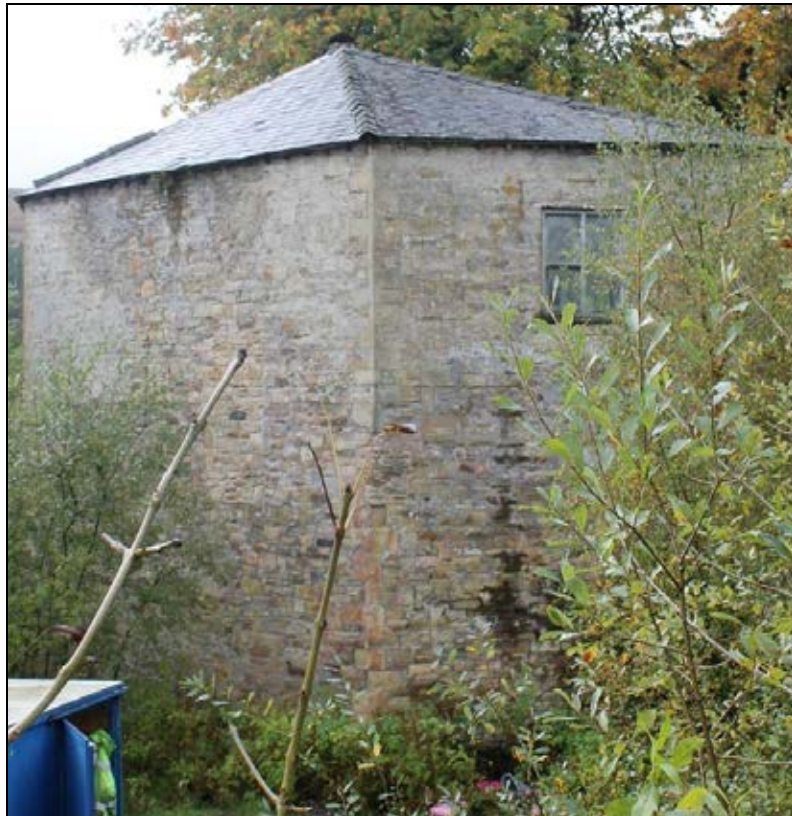
- 3.12.6 The eastern wall was of rubble construction, and had a road-level doorway towards the north-western end of the elevation (Plate 110). It had been blocked and its surrounds removed making it more difficult to identify externally. At the opposing end there was a large cast-iron bearing box housing projecting from the face of the wall, but this had also been blocked-up (Plate 111).

Plate 110: South-western elevation of Building K to left with eastern elevation to right. The blocked doorway can just be seen to the left of centre

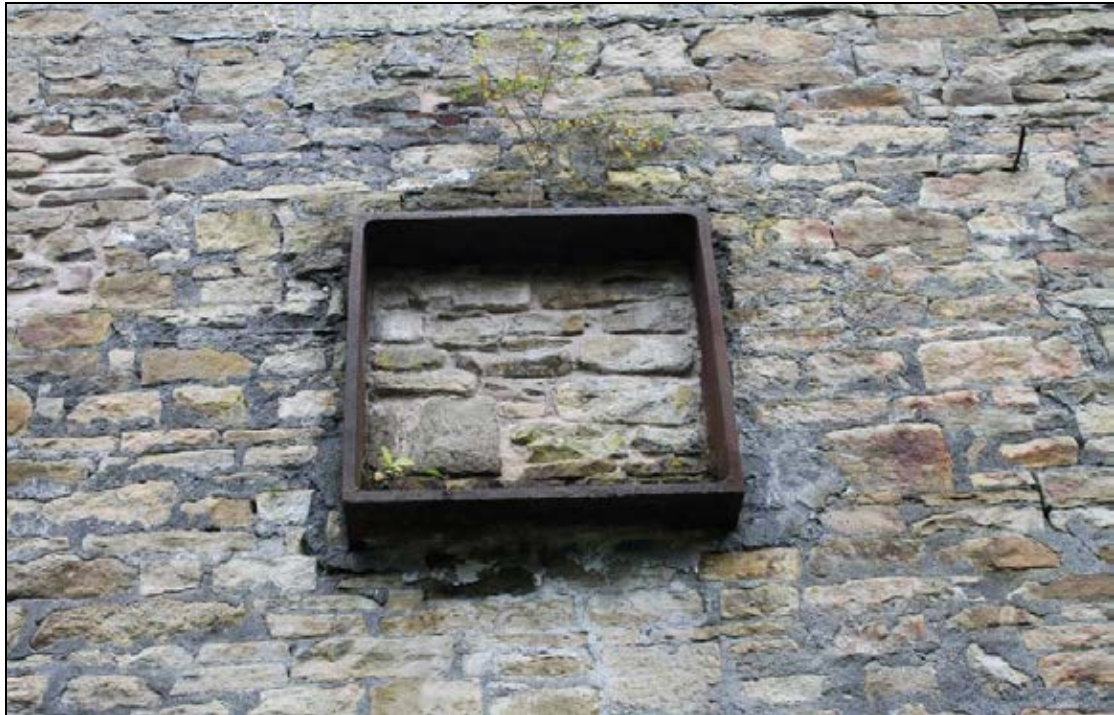
Plate 111: Blocked cast-iron bearing housing on south-eastern elevation

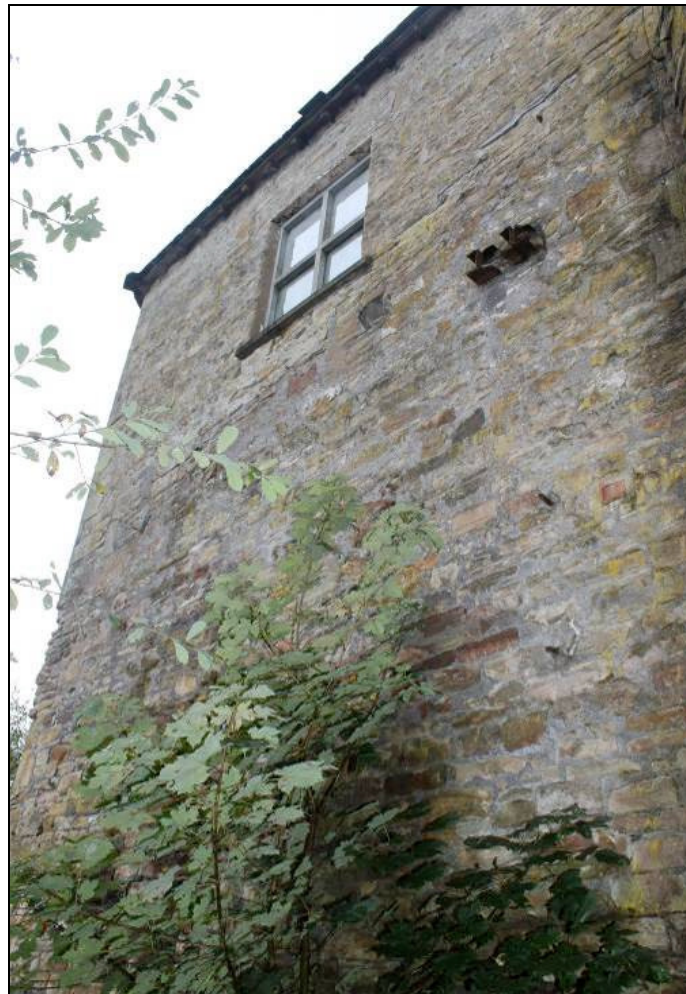
- 3.12.7 The northern wall was of uncoursed rubble and contained a single road-level window at the centre of the elevation (Plate 112). It retained its fixed two-over-two light glazed timber frame and had a narrow projecting stone sill. The lead flashing of a removed roof ran across the elevation, just beneath the window, rising to an apex at the western end before continuing across the north-eastern elevation of Building L (Plate 112).

Plate 112: North-eastern elevation with two-over-two window and diagonal line of lead flashing running beneath it from left to right

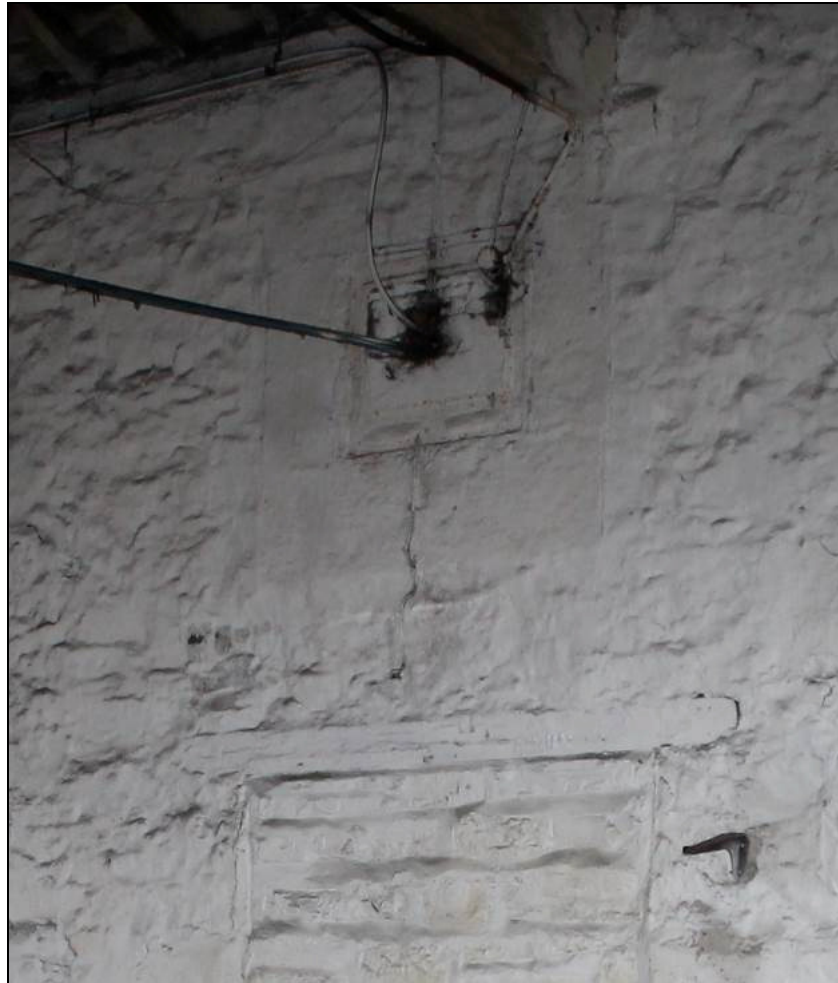
Plate 118: Central bearing box with substantial single-piece stone surrounds, looking west

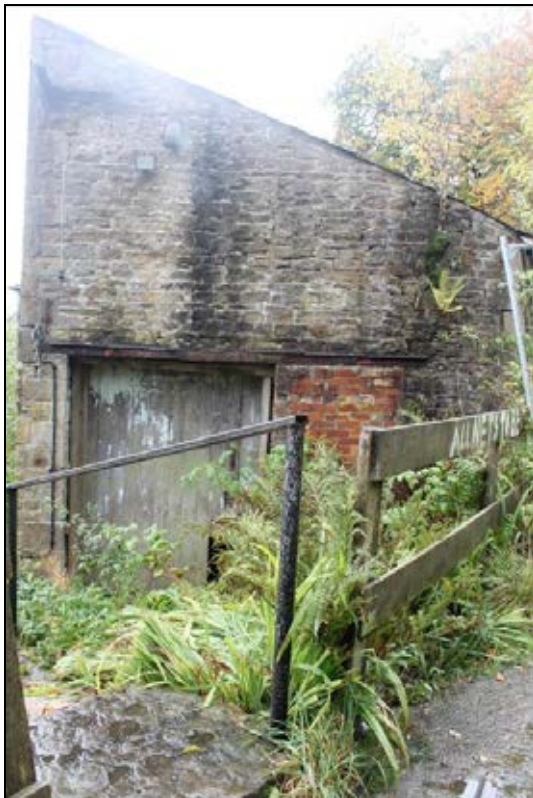
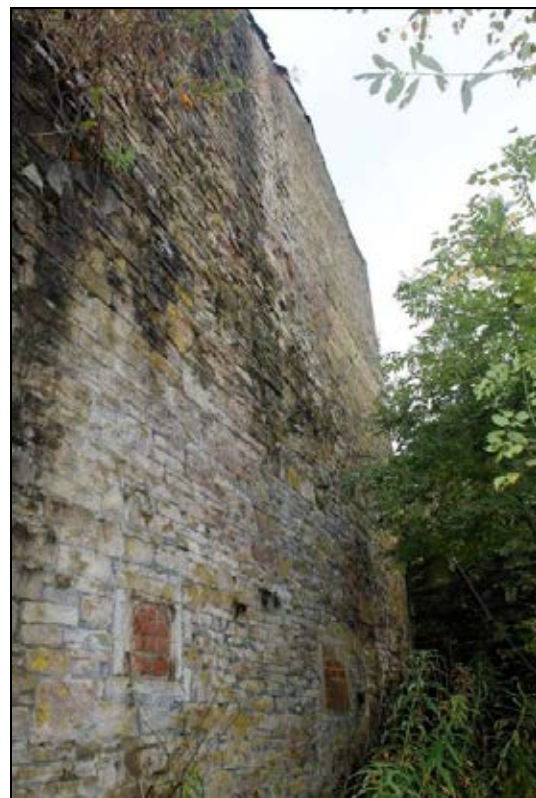
- 3.13.4 The northern wall was also partly obscured by vegetation, but had a mid-sized loading doorway at its eastern end with a narrow gauge iron lintel and alternating quoins to the east (Plate 123). The western jamb had been much altered, and its original form was not determined, although a large vertically set rectangular window lay immediately to the west of the doorway. The window had been blocked with red brick. The doorway was fitted with an internally opening timber door, hinged to the east.

- 3.13.5 The north-eastern wall had no windows or doorways, but at the base of the wall there were at least two square stone-lined apertures, one to the south-east and another near the centre of the elevation (Plate 124). Both were blocked with brick, but presumably once served as end bearing boxes for a now demolished structure to the east. Additional evidence of this structure survived in the horizontal scar of its former roof-line, approximately two thirds of the way up the elevation and extending across the full length of the wall (Plate 125).

Plate 123 and 124: Northern elevation of Building L, looking south. Note the blocked window to the right of the doorway. Frame to the right shows two blocked bearing boxes at the base of the north eastern wall

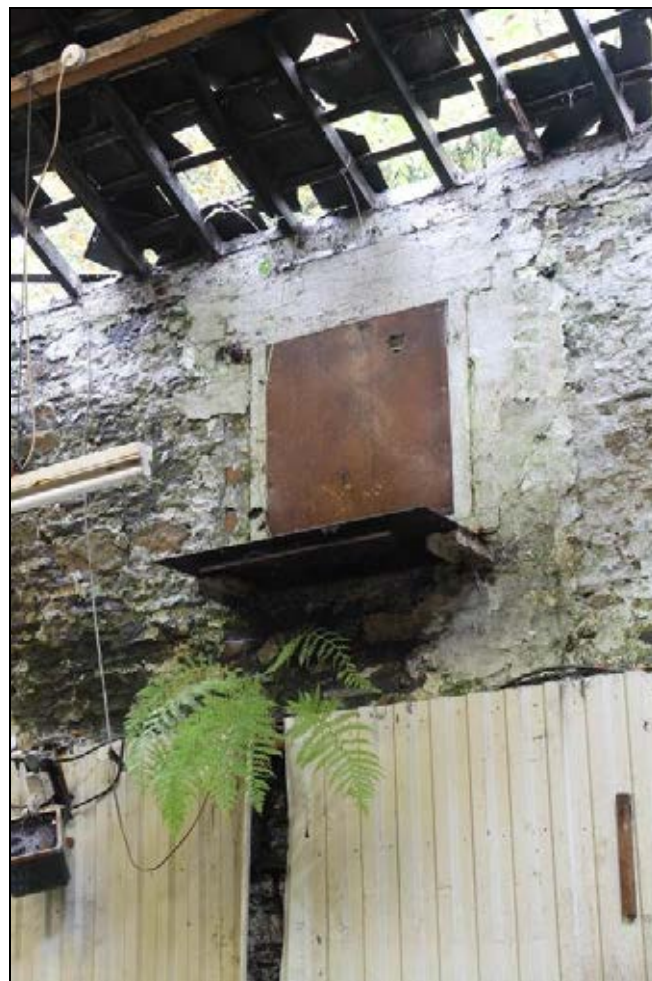
- 3.13.7 On the internal elevation, the central vent recorded externally was fitted with a timber surround and boarded up with a sheet of hardboard (Plate 127). Directly beneath it there was a steel shelf resting upon projecting steel beams which may have supported an air conditioning unit. The lower half of the wall was obscured by modern corrugated metal sheeting.

Plate 127: Blocked vent at centre of north-western wall
