**BELMONT
BLEACH WORKS,
EGERTON ROAD,
BELMONT,
BLACKBURN WITH
DARWEN**

**Historic Building
Investigation**

October 2015

Millson Associates
Planning Application 10/12/0590

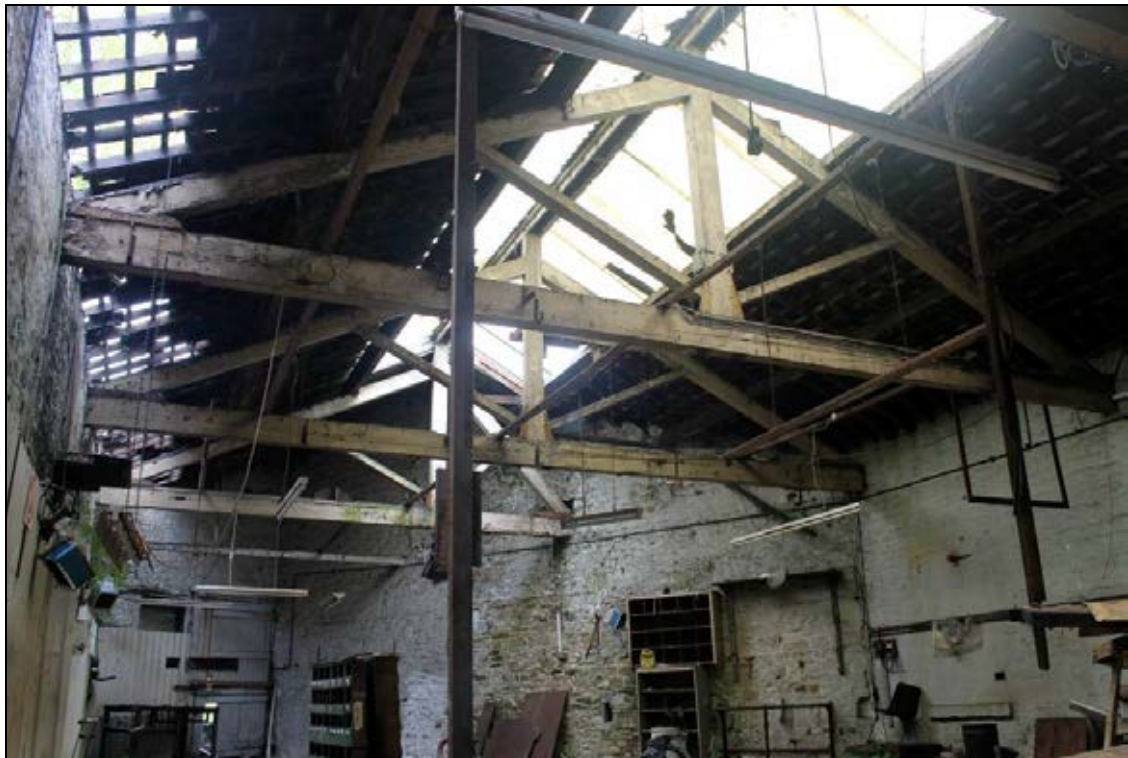
- 3.13.8 **Roof:** the slate roof was supported on four king post trusses similar in form to those used in Building K (Plate 128). At the hipped south-western end a series of three half trusses projected from the southern most king post truss to rest upon the south-western wall plate. The roof was in a poor condition with numerous slates missing, and a bank of central roof lights either side of the ridge-line had been provided by replacing the slates with corrugated plastic sheeting.
- 3.13.9 **Fixtures and Fittings:** although no original fixtures and fittings remained within the building, a low concrete platform was noted at the northern end of the south-eastern wall which may have formed a plinth for machine (Plate 129). A second plinth, probably performing the same function, lay to the west of the centre of the floor (Plate 130).

Plate 128: King post roof trusses supporting roof of Building L, facing north
