CLAIFE STATION AND COTTAGE, FERRY KNAB,

WINDERMERE

Archaeological Building Survey Report

National Trust

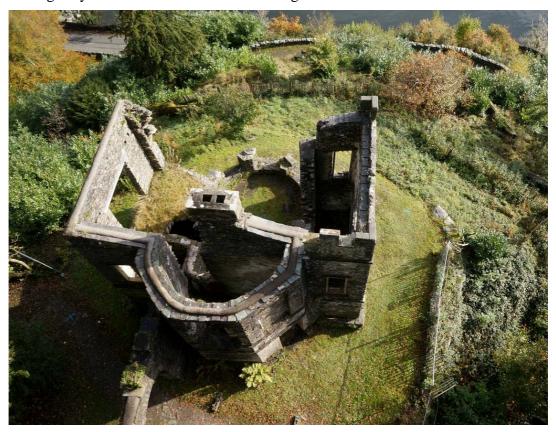
4.1.1 Claife Station is a small stone-built, structure with three-sided canted bays to the east and west and small projecting rectangular wings to the north and south (Plate 25; Fig 3). The building was in a partially ruinous condition at the time of the survey, lacking its roof or first floor, and its eastern bay window had collapsed, leaving only the lower metre of wall standing.

Plate 25: Aerial view of the Station from the west

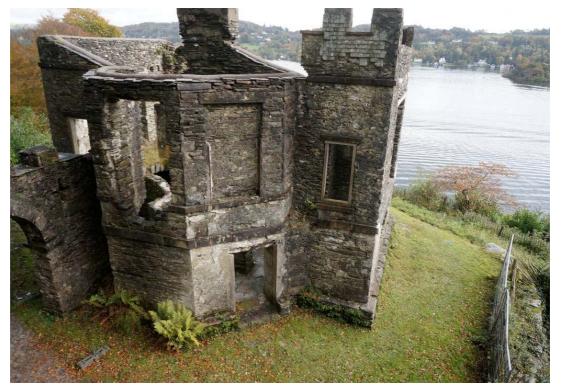
- 4.1.3 **Western Elevation** (Elevation 1): typically, Claife Station was approached from the west, revealing a central three-sided canted bay flanked to the north and south by the narrow end walls of the two side wings (Plate 26). The western elevation of

Plate 26: The western-facing elevation of the Station (Elevation 1)

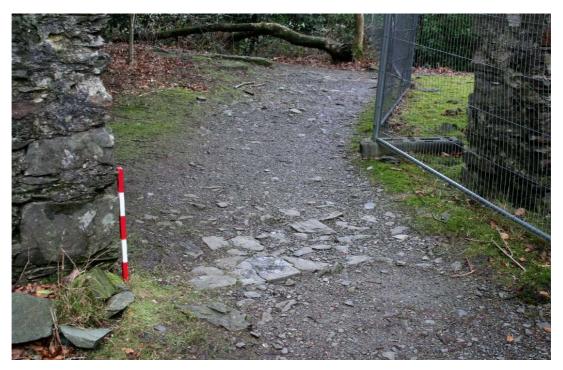
Plate 36: The stone threshold between jambs of the Station flanking wall arch

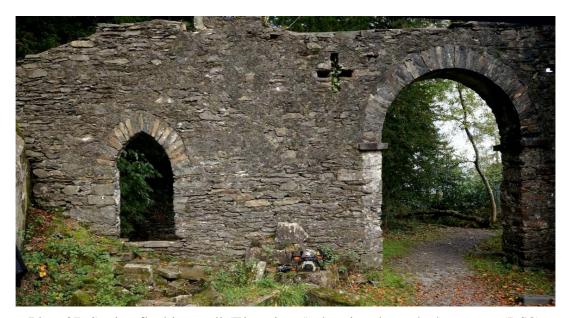
Plate 37: Station flanking wall (Elevation 5) showing the arched entrance (DS8) and gothic window (WS15)

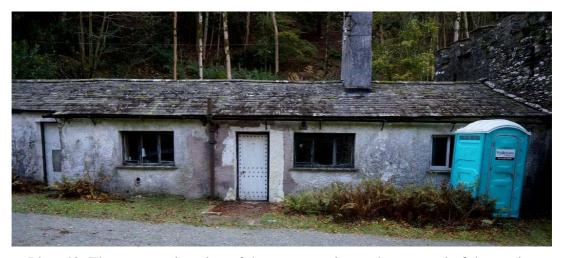
- 4.5.2 *East Elevation* (Fig 7, Elevation C5): the eastern wall was the primary elevation, with an iron-studded plank doorway (DC1) positioned to the south of centre, flanked by a three light casement window with a slate sill (WC1) to the north (Plate 40). Two further casements, one at the northern end (WC2) and one to the south (WC3), were also of three light casements with slate sills. Prior to the removal of the render in the course of the present works the walls and surrounds of each opening were roughly harled in concrete and painted white, largely masking the walls construction; however, where visible, the walls were of a local grey igneous slate stone. Around the doorway, the contrasting colour of the paint and modern render surface repairs revealed the former location of a now demolished porch, and this was also visible in plan as a concrete slab in front of the doorway.

Plate 40: The eastern elevation of the cottage prior to the removal of the render

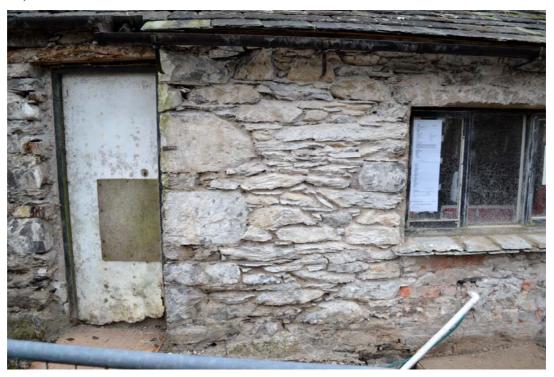
4.5.7 The removal of the render also revealed interesting constructional details at the north-eastern and south-eastern corners of the main building. At the south-eastern corner large alternating vertically set stone quoins had been used to strengthen the external angle, while at the opposing northern end these quoins were absent and instead the wall was well bonded into the east/west flanking wall (Plates 42 and 43).

Plate 42: Quoins at the south-eastern corner of the cottage

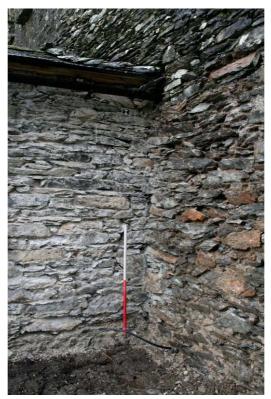
Plate 43: Well bonded junction between cottage and flanking wall

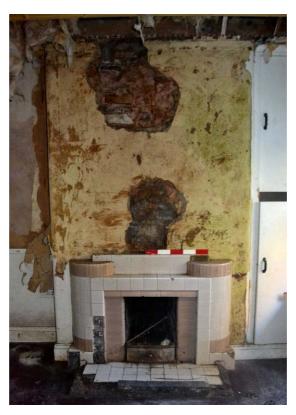
- 4.6.3 There was a tiled *c* 1950s fireplace at the centre of the northern cross-wall with a narrow cupboard set into the recess to the east of the chimney breast (Plate 44). At the western end of the wall a doorway (DC3) led into the northern room, while the southern wall had doorways at the eastern and western ends, opening into the kitchen (DC4) and narrow corridor (DC5) respectively. Along the eastern wall there was a three-light, modern casement window (WC1) with a wooden-topped window seat beneath.

Plate 44: The fireplace in the front room of the cottage

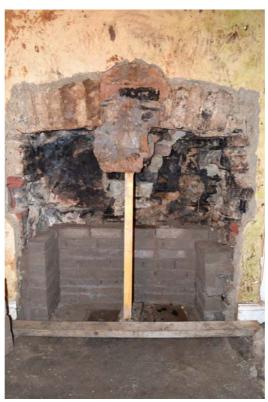
4.6.4 The removal of the 1950's fireplace during the present conservation works revealed the remnants of an earlier fireplace with a red brick cambered arch at the head (Plate 45). Although partially obscured by mortar the bricks appeared to be of nineteenth century date.

Plate 45: Brick arched fireplace after the removal of the 1950's surround

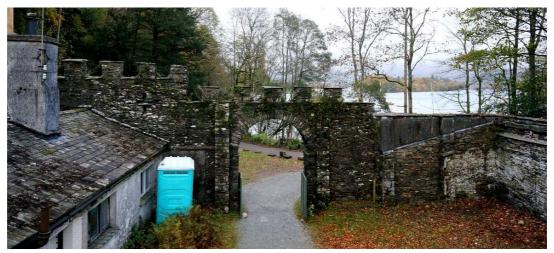
Plate 46: The southern elevation (Elevation C4) of the Cottage flanking wall

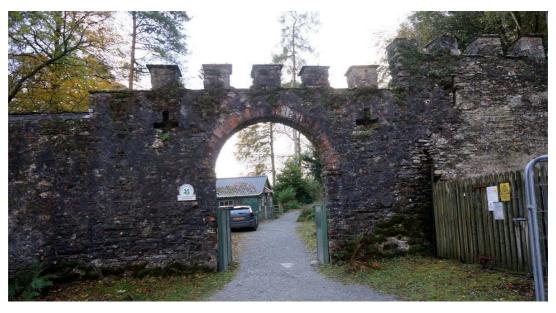
Plate 47: The northern elevation (Elevation C1) of the Cottage flanking wall

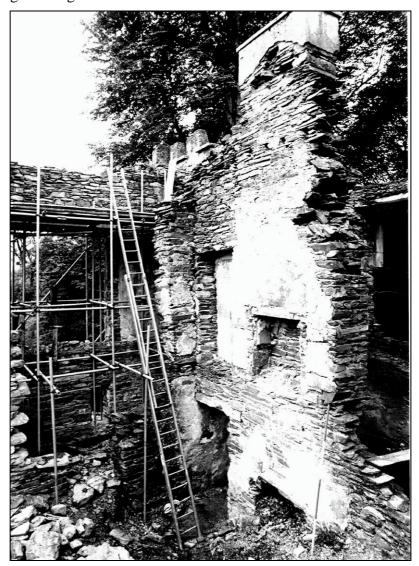
- 5.2.11 *The Roof:* although nothing survives of the roof itself there is enough evidence to draw reasonable conclusions as to its form during this phase. The empty timber sockets along the eastern-facing elevation (Elevation 8) of the building's north/south cross wall, and the surviving fragments of render upon the upper portions of the chimney stack, clearly demonstrate the use of a pitched roof (Fig 4). Although less apparent today, one of the photographs taken in the mid 1980s shows a triangle of three empty sockets on the face of the chimney stack (Plate 50). These would have held the ridge plate which must have extended to the centre of the now collapsed eastern wall, and two additional purlins to the north and south of the apex.

The row of five empty timber sockets a little lower down on the western face of the cross-wall are all that remain of the ceiling beams which also extended east to the eastern wall (Fig 4). From these it is possible to extrapolate the height of the first floor ceiling as being about 3.7m from the floor.

Plate 50 The eastern-facing internal elevation (Elevation 8) taken in 1986 showing the triangular arrangement of timber sockets on the face of the chimney stack

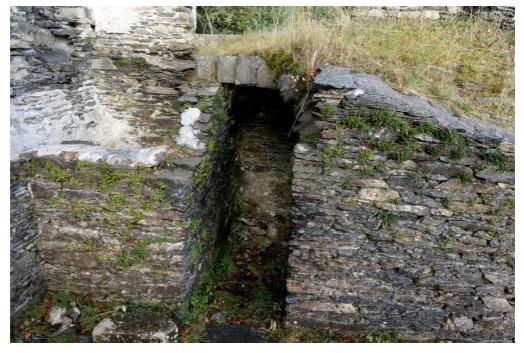
5.3.1 There was potentially an additional phase of construction when the barrel-vaulted wine cellar was constructed, creating the tiny room in the north-west corner, necessitating the partial blocking of the ground-floor window of the northern wing (WS12) (Plate 51; Fig 8). The implication then would be that it post-dates the construction of the northern wing; however the issue is complicated by the presence of blind windows on other parts of the building and the wine cellar might, therefore, belong to Phase 2. Unfortunately, the window on the southern wall was entirely reconstructed during the 1980s, using the northern one as a guide and so must be discounted as supporting evidence. Nevertheless, the size of the room to the northwest suggests it was more likely to be the result of alterations rather than designed as such.

Plate 51: The entrance to the barrel-vaulted wine cellar looking north, which was added as part of Phase 3
