# Manor Farm Courtyard Gazeley

## Level 2 Historic Building Survey

December 2016

**Client: Dalham Estate**

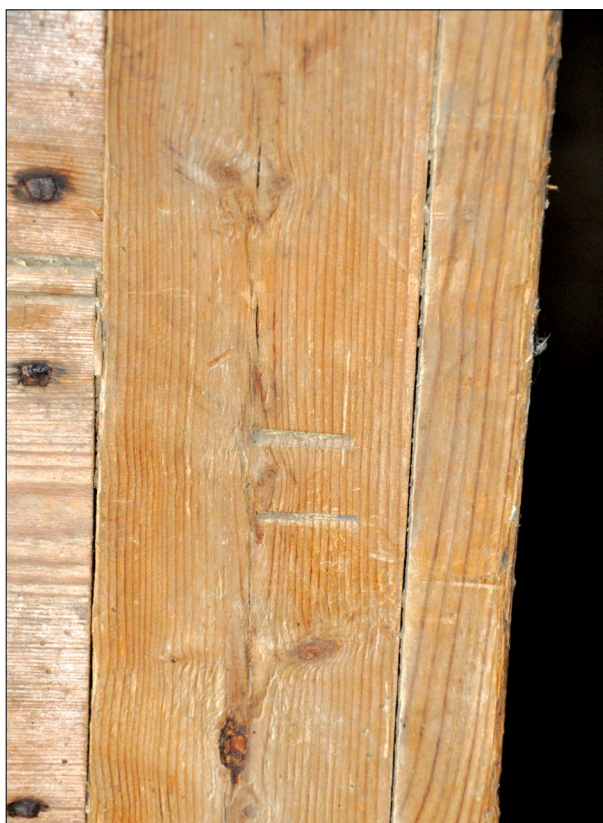
Plate 92: Detail of stalls and northern wall of Building E

- 3.7.5 The stalls (Plate 89) measure 3.48m x 2.99m and are separated by graduated close board divisions (Plate 92). Carpenter's marks were noted on the uprights of the stall closest to the entrance (Plates 93-95). None were visible on any other timbers. Stalls are accessed by open doorways measuring 0.92m. Timbers extend to ceiling height.

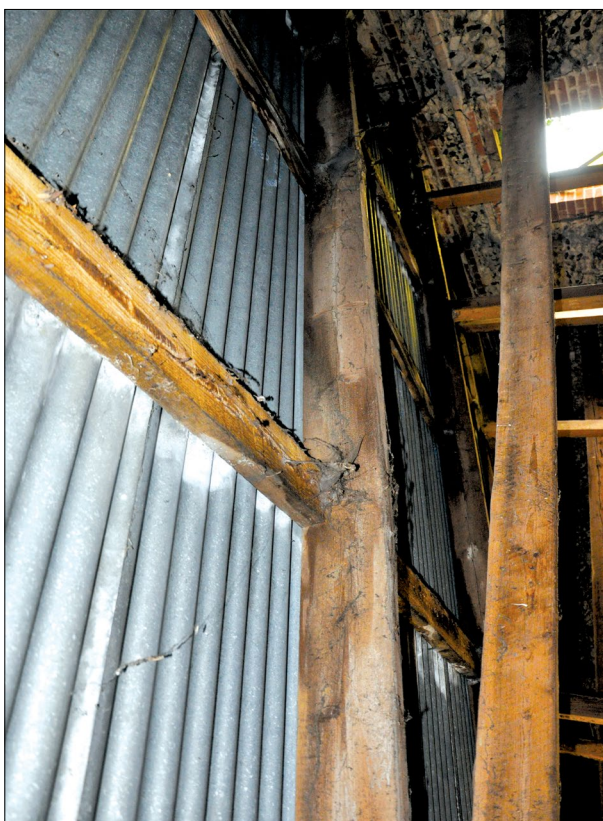
Plate 98: Detail of wooden flooring in Building E

- 3.7.7 A single window (Plate 88) is located on the rear wall, this measures 0.86m x 0.90m and has lost its glazing. The floor of the stable is wooden tongue and groove and is boarded throughout (Plate 98).
