# Croome Park Worcestershire

## Building Assessment Report

April 2002

**Document Title:** Croome Park, Worcestershire: Building Assessment Report

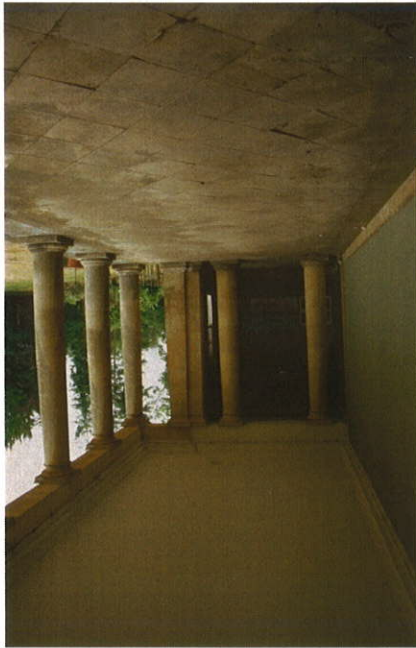
Plate 7: Interior of greenhouse

3.3.1.4. **Interior:** The interior of the lean-to is divided into two areas: a three and a half bay wide area to the west, open to the roof, in which the large greenhouse sashes were stored during summer (along with other garden paraphernalia) and a one and a half bay wide storied area to the east which provided accommodation for the greenhouse keeper (Plate 7).

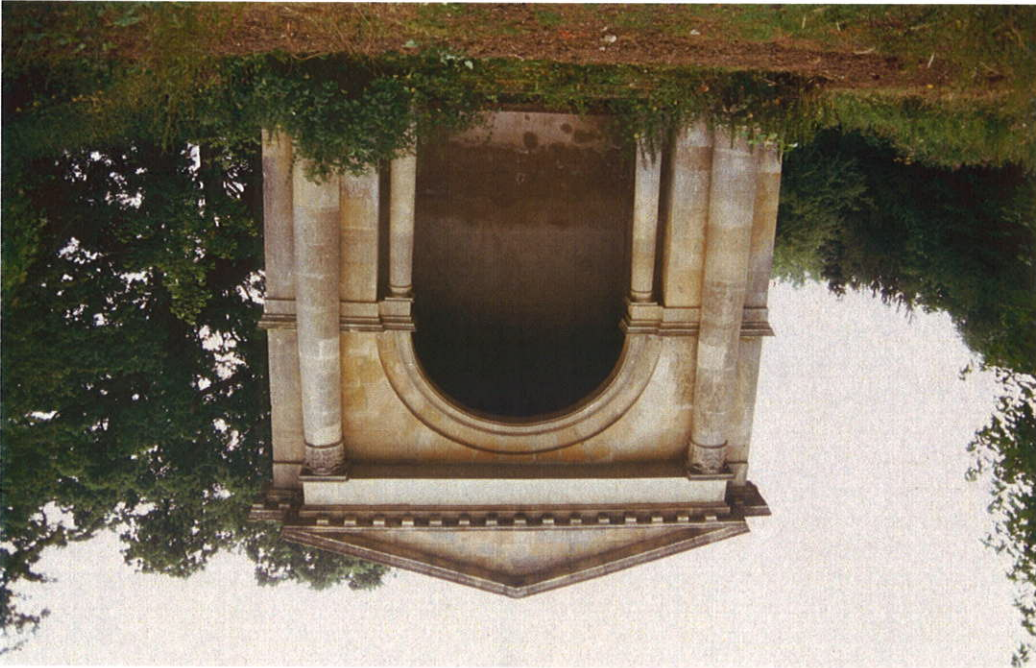
Plate 11: Primary front of Park Seat

5.3.1.5. One of the few pieces of evidence identified by the building assessment suggesting the structure's previous form are the holes in the floor at the front of the building indicating former gate posts. However as the holes strongly appeared to be secondary insertions restoring the gates would not appear to be desirable.

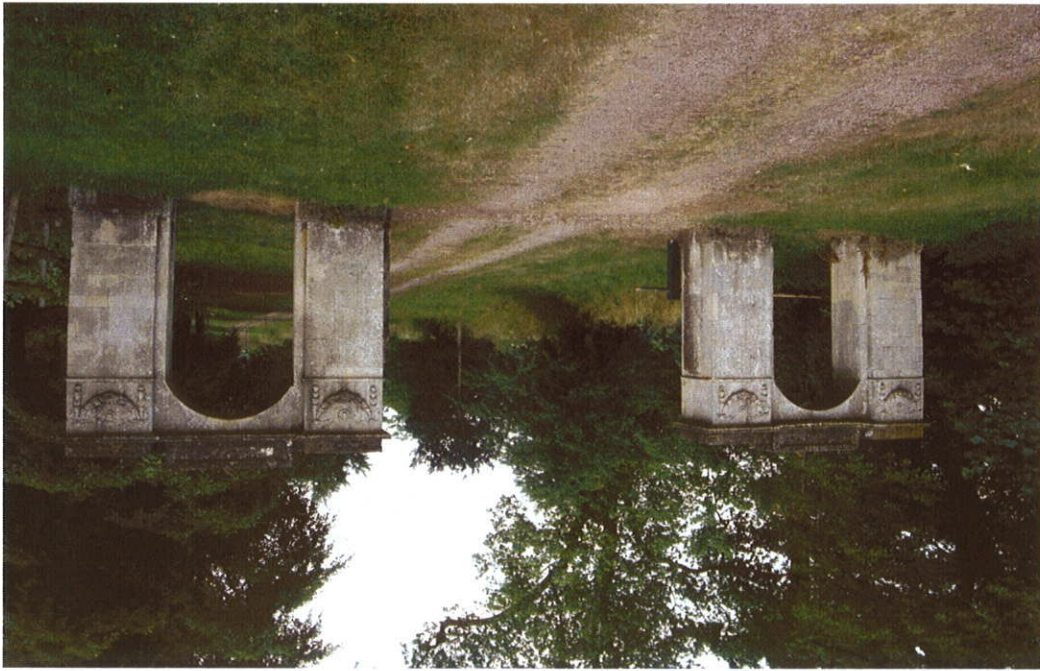
Plate 16: Punch Bowl Gates

1. The form of the gates or doors. The piers remain substantially intact and the Coade stone punch bowls are in store awaiting conservation and reinstatement but there appears to be no conclusive evidence of the form of the gates although their location has been confirmed by the trenching. It is not known when the gates were removed but it is likely to have been in the mid 20<sup>th</sup>-century (possibly when the RAF was at Croome) and it is likely that photographs survive either in a public archive or private collection showing the gates. If it proves impossible to determine the form of the gates there would be some justification in reproducing new gates using Robert Adam's 1791 proposal as a model.

2. The location of the original gates. As referred to above this is still open to debate with some documentary evidence suggesting that the gates may have been moved some distance from the east. However the evidence is tentative and no archaeological evidence has been identified in the current survey to support this. There would currently be no historical justification in moving the gates and even if conclusive archaeological evidence for a previous location were located this would still be debatable. For a greater understanding of the development of the park however determining the previous location of the gates (if they have been moved) would be of value and when resources allow should be undertaken. A programme of geophysics and/or archaeological trenching in the area to the east of the gates could determine this.
