BOLTON GILL AND HEBDEN GILL LEAD WORKINGS, HEBDEN

Archaeological Survey Report

Oxford Archaeology North

May 2015

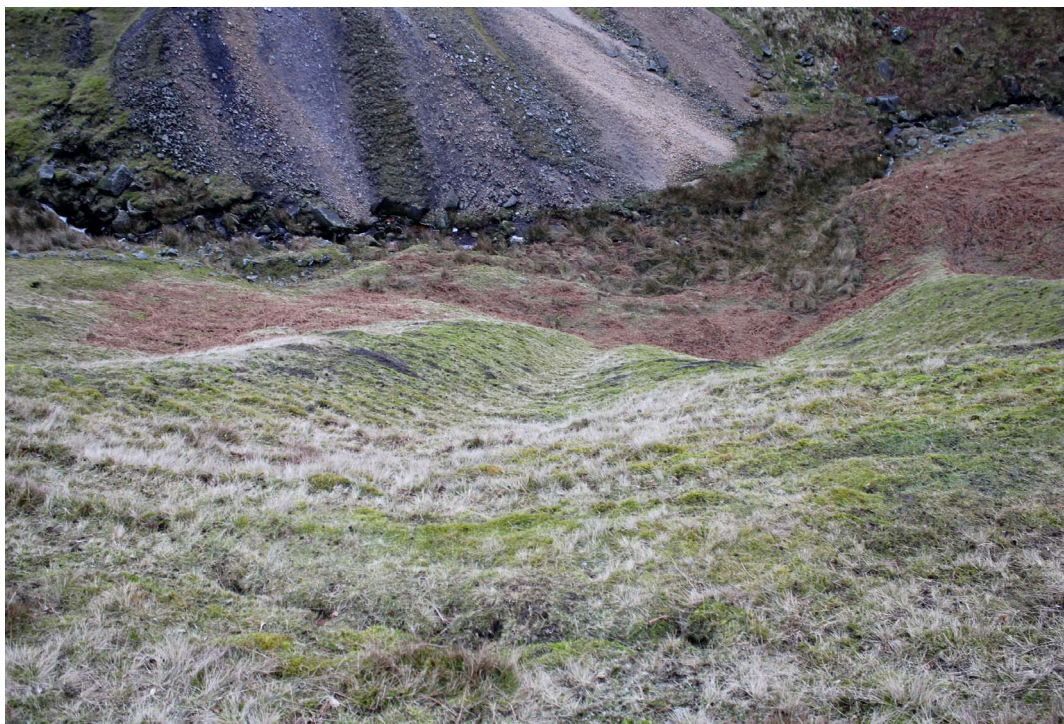
- 4.2.2 **Hushes:** the earliest episode of activity on the site was seemingly a series of six hushes (Sites **11.1-4** and **13.1-2**; Figs 19 and 20. The easternmost of these (Sites **11.2** and **11.3**) extend approximately north-east/south-west and cut across the line of Cockbur Vein. They are uniformly straight, contain no present day streams and terminate at Bolton Gill; they have exposed large boulders and lines of crag which are extant at the bottom of gullies. Site **13.2** extends above the present edge of the

valley side, and is crossed by a later enclosure boundary (which was first shown on the OS first edition 25" map (1892)). They are up to 17m wide, and over 80m long and reflect the loss of considerable volumes of soil. Hush **11.4**, seems to start just below the line of Cockbur Vein as represented by a line of five mine shafts (Site **12**) and towards the bottom of the hush it approximately coincides with Chance Vein, where it changes direction, then taking a more direct line to Bolton Gill. At the south-western part of the mining landscape were two very straight, parallel, and narrow hushes (Sites **13.1-2**; Plate 5) which extend down the steepest part of the valley side. These approximately coincide with the line of Providence Vein (Gill 1994, 113). Given that the hushes only coincide approximately with the lines of veins documented by later extraction, there exists the possibility that they were as much intended to investigate and identify the veins, as to provide a means of extracting the ore.

Plate 5: Looking down the two straight hushes (**13.1** and **13.2**) at the south-western part of Bolton Gill North

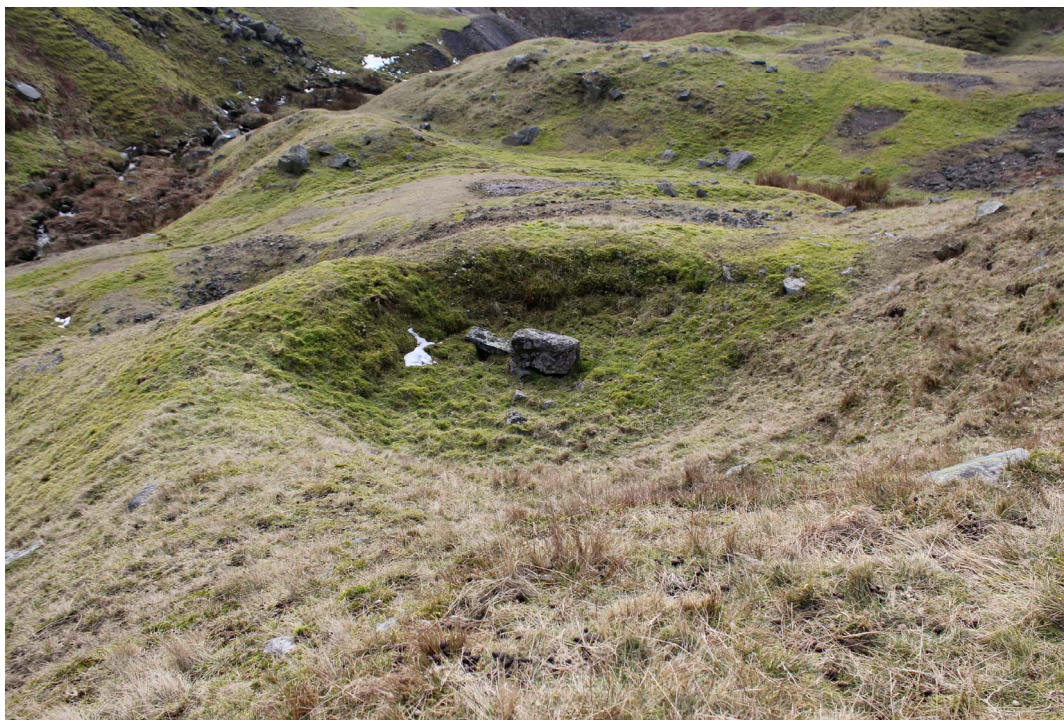
- 4.2.4 **Mine Shafts:** a line of five mine shafts (Sites **12.1-5**) at the north-eastern edge of the Bolton Gill valley is aligned with Cockbur Vein (Gill 1994) (Fig 19). They comprise narrow depressions with sub-circular spoil mounds around the outside, and are between 3.5m and 6.5m in diameter. The largest of these (Site **12.1**; Plate 6) also has a separate finger spoil mound extending downslope from the shaft; however, for the most part, the amount of spoil reflects that the shafts were sunk to relatively shallow depths.

Plate 6: Mine shaft **12.1** looking west

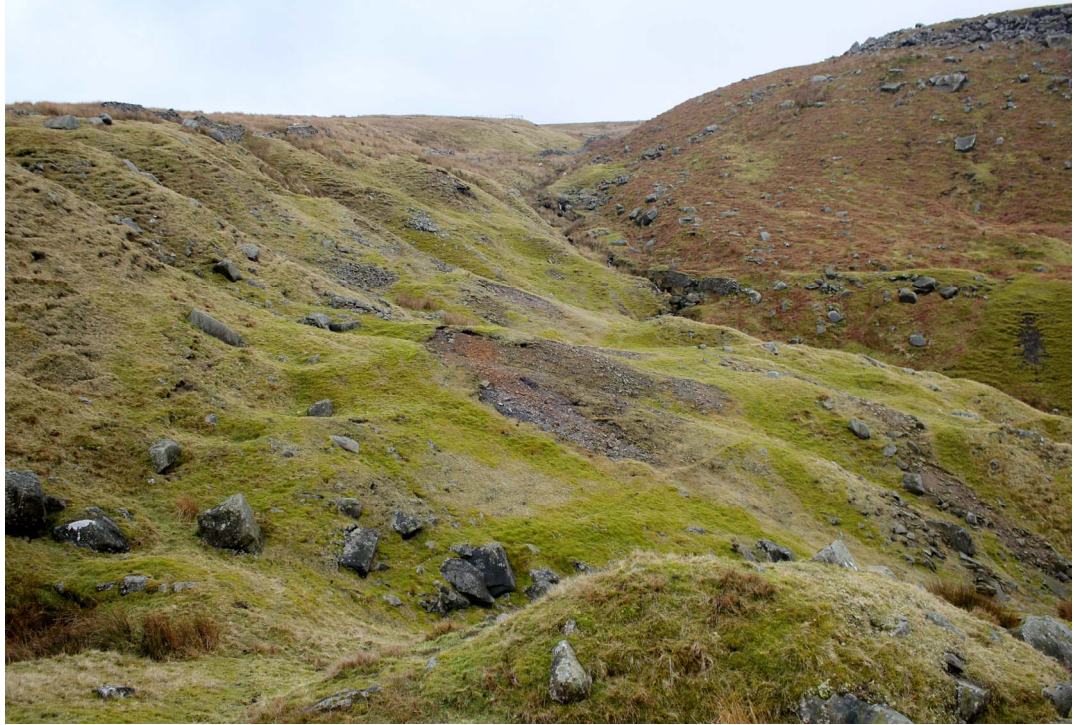
- 4.2.6 **Dressing Floors:** the lines of shafts are either at the top or at the immediate bottom of the steep valley sides, but at the base of the steepest slopes is an area of undulating gentle to moderate sloping land which forms a raised terrace set above the valley floor (Plate 7; Fig 19). Within this largely natural terrain, and located below the lines of mine shafts, are multiple exposures of dressing waste (Site **14.2**), indicative of extensive dressing floors. For the most part, this comprises medium to fine gravel-sized fragments of crushed stone, which would have been

Plate 7: The area of the Site **14** dressing floors looking east

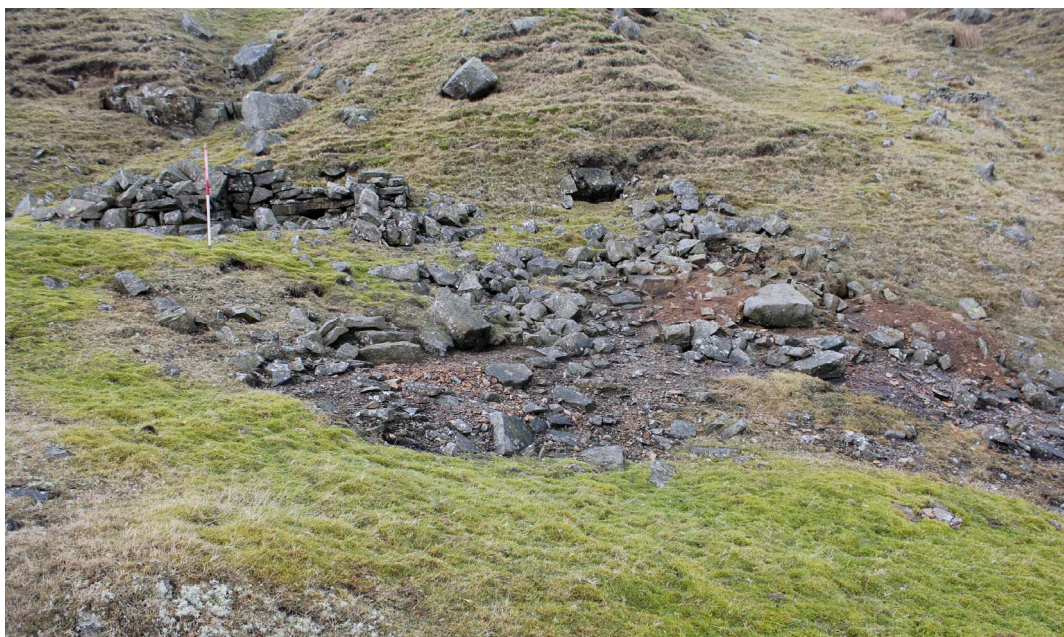
- 4.2.7 In the middle of the area of dressing floor waste is a single, small, dry-stone structure (Site **14.1**; 3.5m x 2.48m; Plate 8) which is open to the front, and has a low aperture, capped by a lintel, leading to the rear of the building where there is a small artificial hollow. Immediately to the south-east of the structure is a deposit of fine, red-soil dominant, dressing waste. This deposit is distinct in character from the other areas of dressing floor waste, being significantly finer and having the red colour soil. This reflects that the waste is a product of a different ore refinement process and it is probable that the structure accommodated a buddle for the water washing, settling and refinement of the ore. It is possible that the rear aperture allowed a water supply into the putative buddle, necessary for the washing and setting of the ores. There is, however, no indication of a tail race or gully below the structure to reflect the discharge of the water, but it is possible that the process did not use sufficient water to have created a pronounced erosion scar.

Plate 8: The dressing floor (Site **14.1**), with the fine red deposits in front of the putative buddle housing

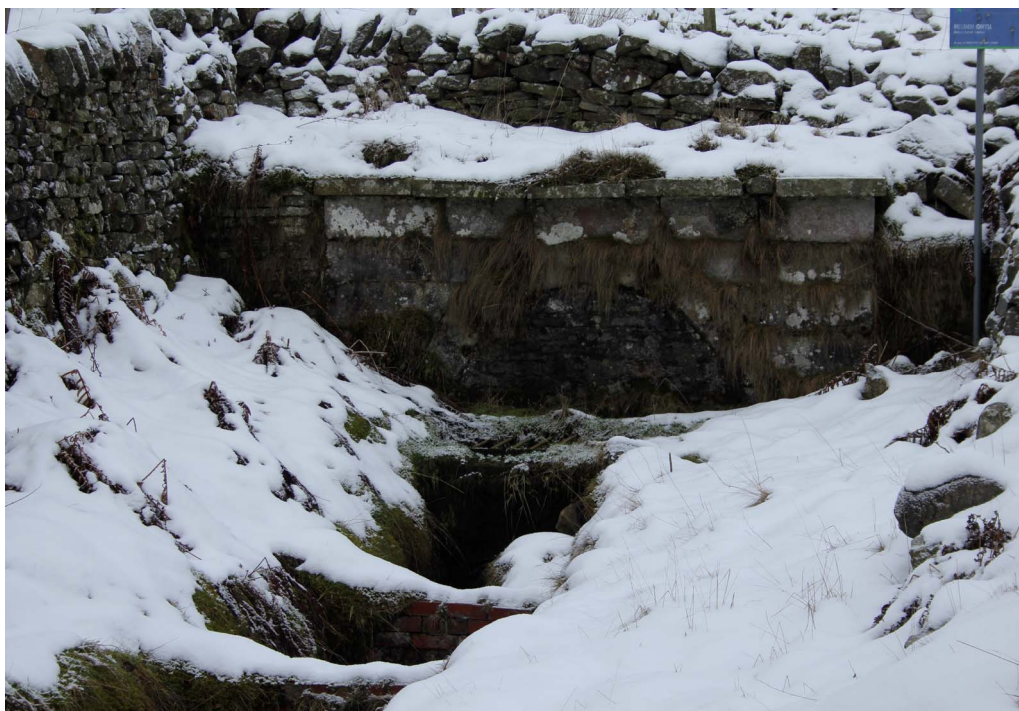
- 4.3.2 **Adit Entrance:** the adit entrance (Site **1.1**; Plate 9) comprised a stone revetted channel (17.5m long and 1.5m wide) extending out from a partially-blocked, arched aperture, which is within a small, dry-stone walled, enclosure (Plate 11). To the east it becomes a subterranean culvert leading a short distance to an outfall where it drains into Hebden Beck (Site **1.3**). Two brick arched walls extend across the open channel and their purpose is unknown, but given the use of brick, which contrasts with the use of stone elsewhere, it is possible that they were not contemporary with the construction of Duke's level entrance, possibly when the level was subsequently used as a water supply (R White pers comm).

Plate 9: Duke's Level Entrance

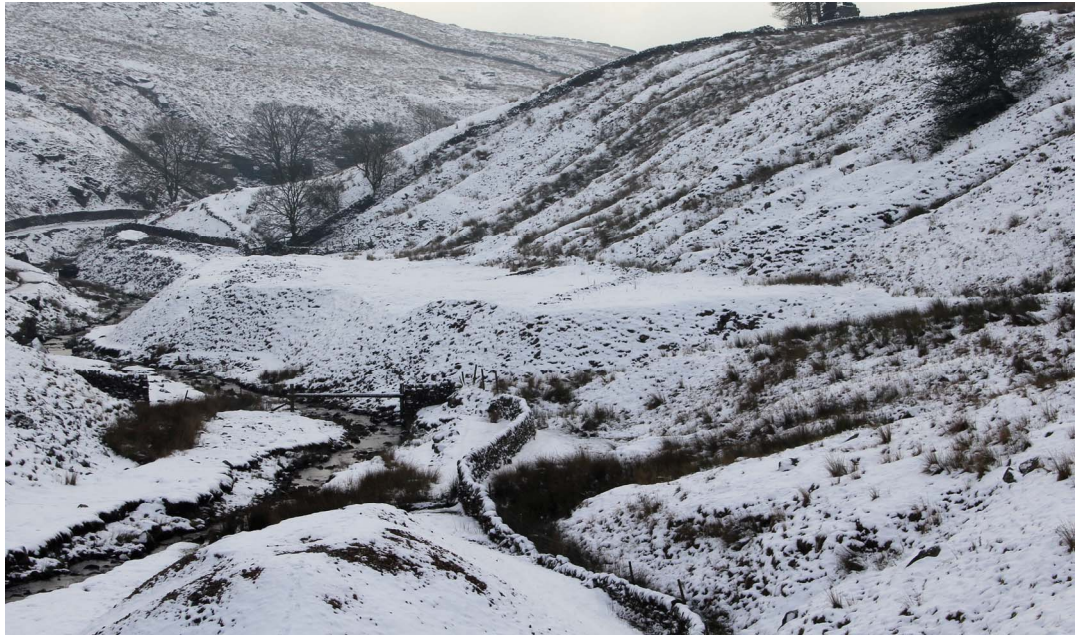
- 4.3.3 **Spoil Mound:** the large spoil mound is 210m long by 32m wide at its greatest extent and was up to 5m high above Hebden Beck to the east; it potentially comprises very approximately 14,500m³ of spoil (Plate 10; Figs 8-9). The top surface of the spoil mound slopes gently uphill towards the north, with a uniform gradient and there is a 3.0m height difference between the upper surface at the northern end of the spoil mound by comparison with that at the southern end. In part this reflects that the valley floor is rising slightly to the north, but also that the spoil mound is up to 1.4m higher than the valley floor to the north than it is to the south. This in part reflects the amount of spoil extending from the adit, and that there was a need to build up the spoil mound to the north to accommodate the output of the cutting of the adit. While this would evidently have entailed the transport of soil upslope to the far end of the spoil heap, there is no evidence of any extant lifting infrastructure to move the spoil.

Plate 10: The spoil mound of Duke's Level viewed from the north

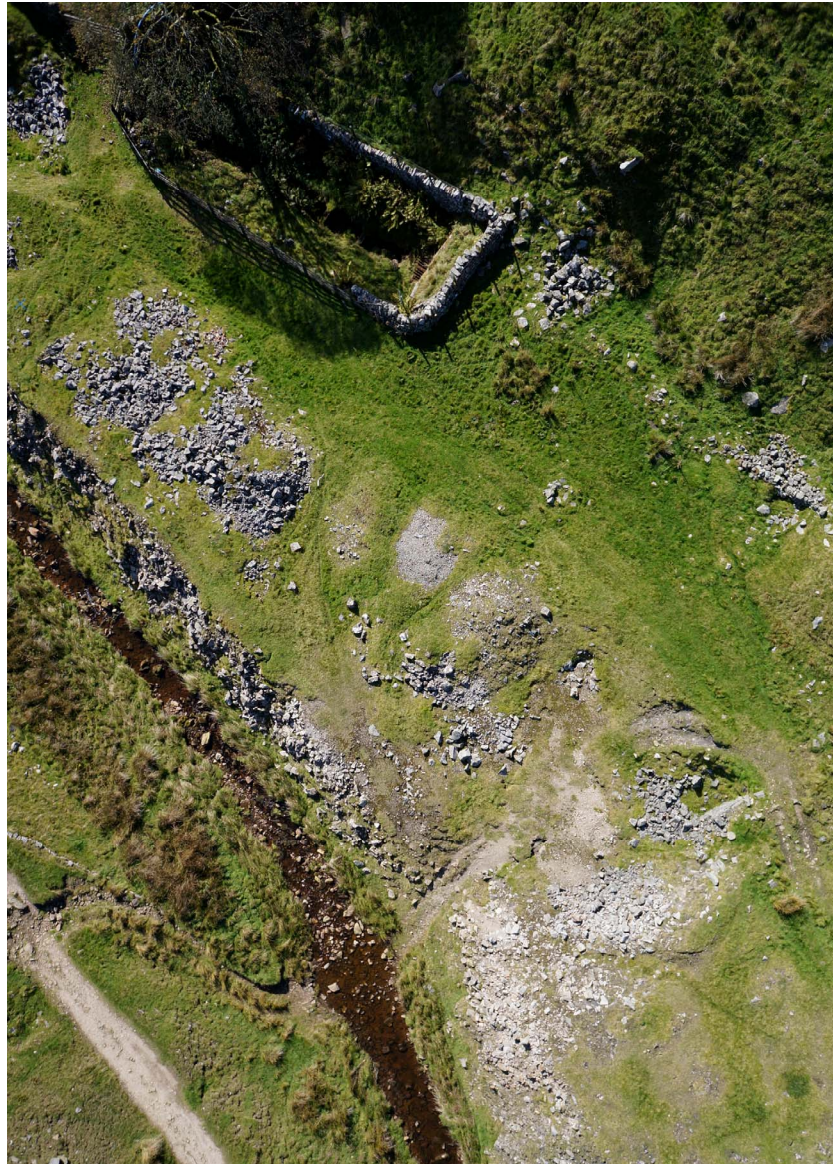
- 4.3.6 **Dressing Floors:** located on the larger spoil heap, and to the north-east of the adit entrance, are a pair of low mounds (4m and 5m across) (Site 1.4) that comprise non-earthfast deposits of small, fragmented, stone (typically 20mm across) (Plate 11; Fig 8). This material markedly contrasts with the rest of the spoil mound which comprises mainly large blocks. These small localised mounds would appear to be the product of crushing the ore before being further refined, and are an indication of localised dressing.

Plate 11: Aerial view of the adit entrance (Site **1.1**) and the dressing floor (Site **1.4**)

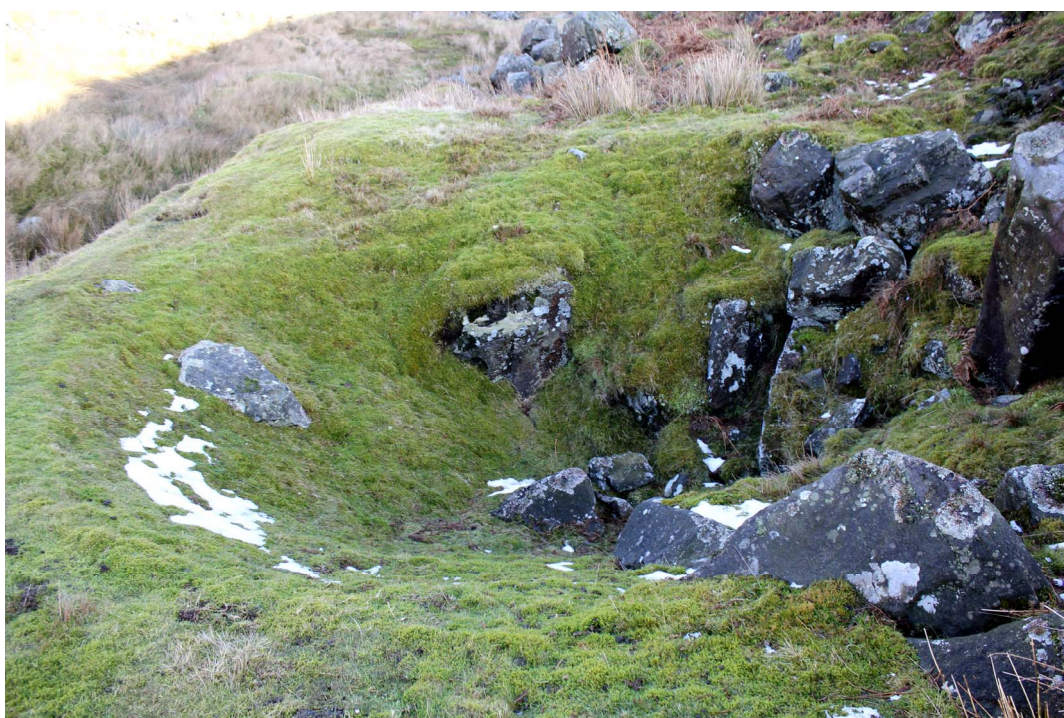
- 4.4.1 **Cockbur Vein:** a small group of shafts is located on the south side of Bolton Gill, just above the beck and set into the slope, approximately on the line of Cockbur Vein. The largest of the shafts is to the west (Site **10.2**; Plate 12; Fig 20), having a spoil mound that is 13m in diameter and has a 3m deep, central hollow into the shaft (Plate 13). Extending east from this is a line of three further shafts which is parallel to the line of the beck, and is approximately east/west (Sites **10.3-5**). The shafts are relatively small and irregular, and, in the case of Site **10.3**, comprises an irregular hollow set back into the slope rather than a conventional shaft. None of these three shafts has a substantial spoil heap and so contrast with the westernmost one (Site **10.2**) which does. The orientation of this line of shafts is approximately in line with Cockbur Vein, and the implication is that the smaller shafts were trial pits searching for the main lead bearing ore deposit, and that the larger one (Site **10.2**) was the one that managed to locate and exploit it.

Plate 12: Mine shaft **10.2** looking north

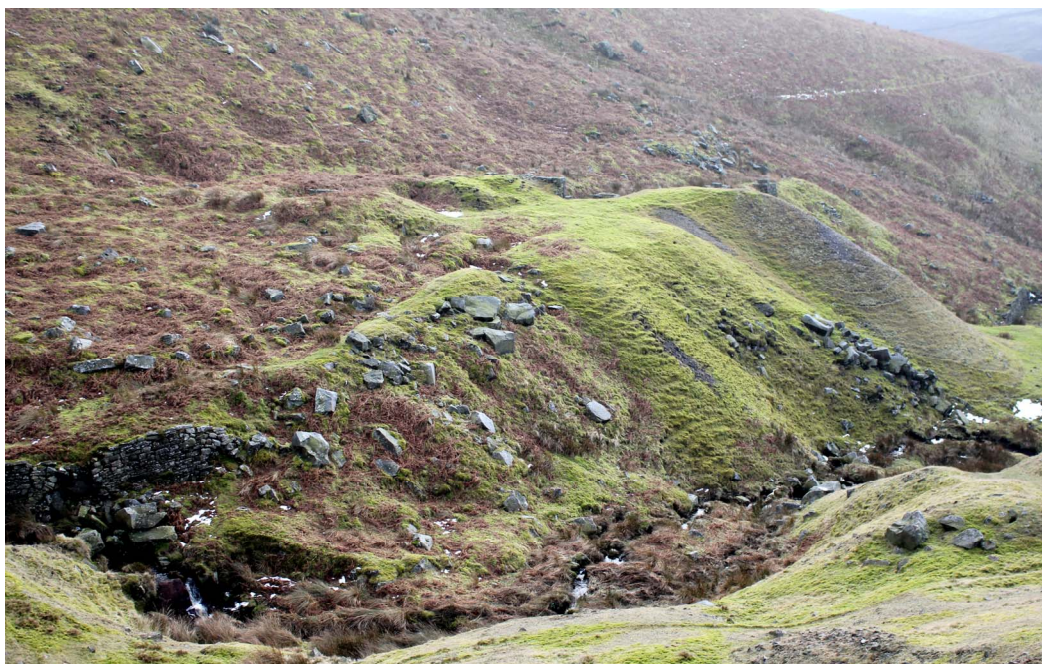
- 4.4.5 **Shaft Site 8.1:** the large shaft **8.1** has a large spoil mound around it (9m diameter), a dressing floor in front of it and a very large finger spoil mound extending out from the floor (Plate 13). It is a well constructed shaft with internally revetted sides to the internal hollow, and an extremely large, partially dressed, stone (size 2.48m x 0.65m) extending over the top of, the now filled, former shaft aperture. The stone was probably the anchor mount for a hoist extending up from the shaft. The shaft has an aperture opening out to the south-west and leading firstly onto a large flat area, with fine dressed material on top and from here to a large finger spoil mound (Site **8.2**). The spoil mound has little turf on it, indicative of a high lead content, and is largely made up of small fragments of crushed ore, and it is evident that the levelled area in front of the shaft has been used as a dressing floor. Just upslope from the shaft are two much smaller excavation hollows (Sites **8.3** and **8.4**) set into the slope; there is little spoil associated with either of these and it is probable that they were trial pits.

Plate 13: The spoil mound (8.2) and shaft (8.1) of Engine Shaft, with the track and spoil mound (10.1) of the Cockbur Vein workings in the foreground

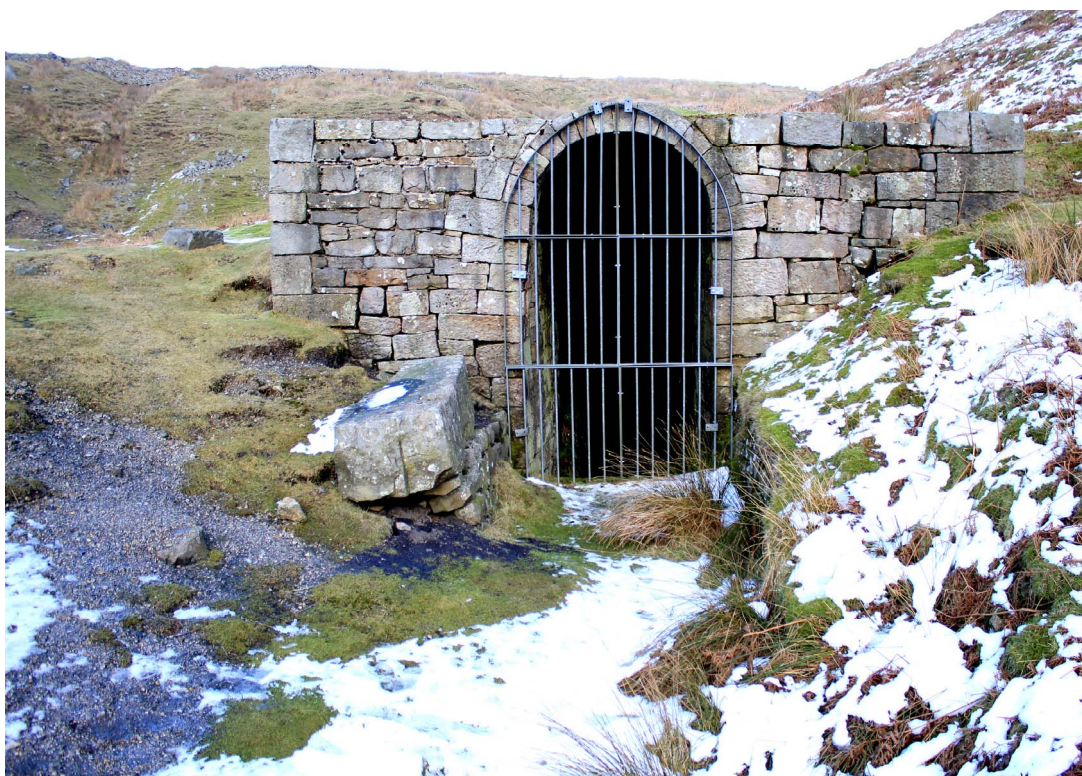
- 4.4.8 The portal (Site 7.2) is well constructed, comprising a tall barrel-vaulted chamber, which is 7.5m long, 2m wide and 4.49m high from the base (Plate 14). It is of dry-stone construction using partially dressed blocks, with dressed stones for the voussoirs of the vault. The internal walls are constructed on a bedrock bench on both sides and part of the chamber is rock cut (Plate 15). Three steps descend from the entrance to the floor of the chamber and at the western end is a rectangular

Plate 14: Entrance to the Engine Shaft portal (Site **7.2**)

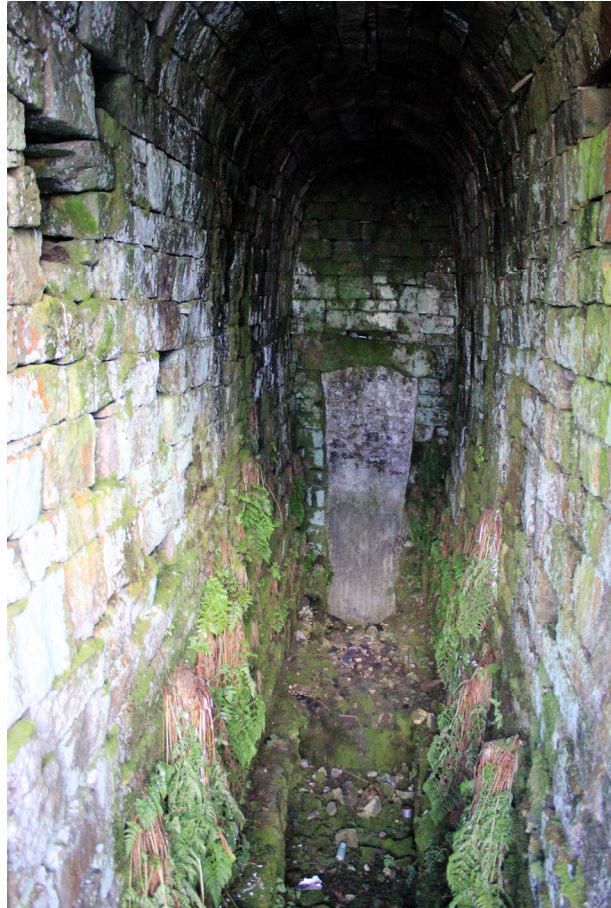
depression, possibly a wheel pit, which was 3.5m x 1m in size. Half way up the chamber, and above the wheel pit were a pair of axle mounting holes, presumably to support a wheel. A further pair of axle mount holes were set into the sides of the walled chamber, just below the springers of the barrel, and no more than a metre below the crown of the vault. These are located about a metre to the west of the actual shaft entrance at the eastern end of the chamber; the top of the now capped shaft is square in shape and 1m x 1m in size. There are axle supports directly above the shaft, which almost certainly supported axle mounts for a balance bob, and its distance from the shaft provides some indication of the length of the horizontal arms of the balance bob (Plate 16 for an example of a balance bob). Directly above the mounts for the balance bob is a deliberately-constructed aperture (now blocked) in the crown of the barrel vault; while the purpose for this is not known, it can be conjectured that it was intended to enable the extraction of power from the pump rods to a point outside the portal, possibly to drive a hoist over Shaft **8.1**.

Plate 15: The tall barrel-vaulted interior of the portal with a wheel pit in the base

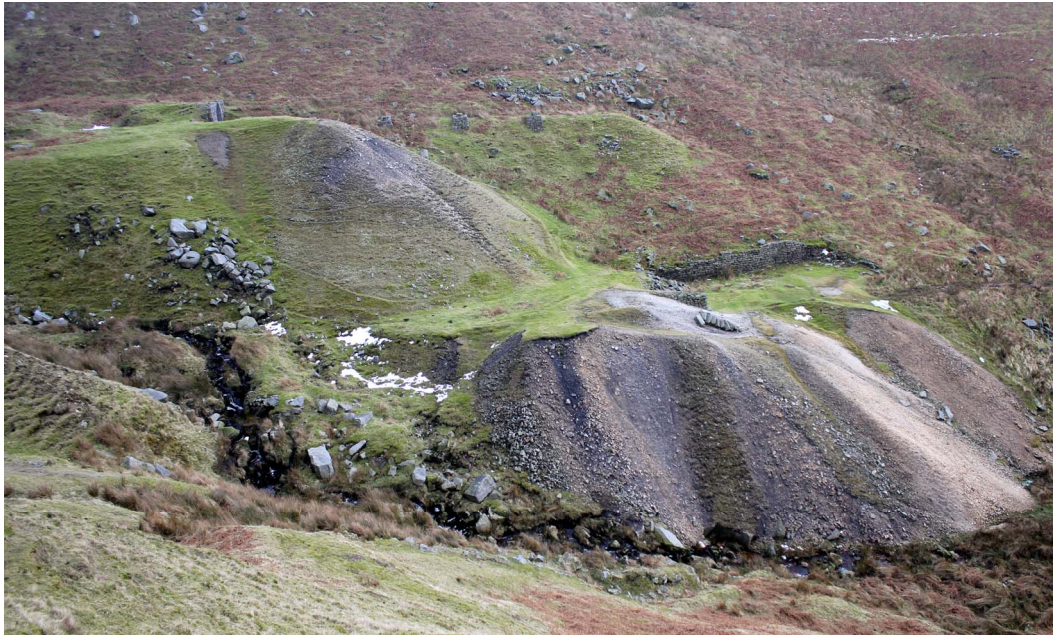
- 4.4.13 ***Bolton Gill Dressing Floor (Site 9; Fig 17):*** below the enormous spoil mounds that extend out from the area of Engine Shaft is a dressing floor where the lead ore was processed (Site 9.2; Plate 18). This floor initially serviced ore produced from the Top Level adit, which is believed to be under the 8.2 spoil heap, but the adit was closed and efforts were thereafter concentrated on the Engine Shaft, which then supplied the ore for the floor. There are two areas of dressing floor, an upper floor (Site 9.4) on a flat level terrace on top of spoil mounds and a lower dressing floor (Site 9.1) defined by large retaining walls, with a bouse team for washing ore (Site 9.2) and driven by a water wheel (Site 9.3).

Plate 18: General view of the dressing floor (Site 9) with the spoil heaps of Engine Shaft (Sites 8.2 and 7.1) above looking south-east

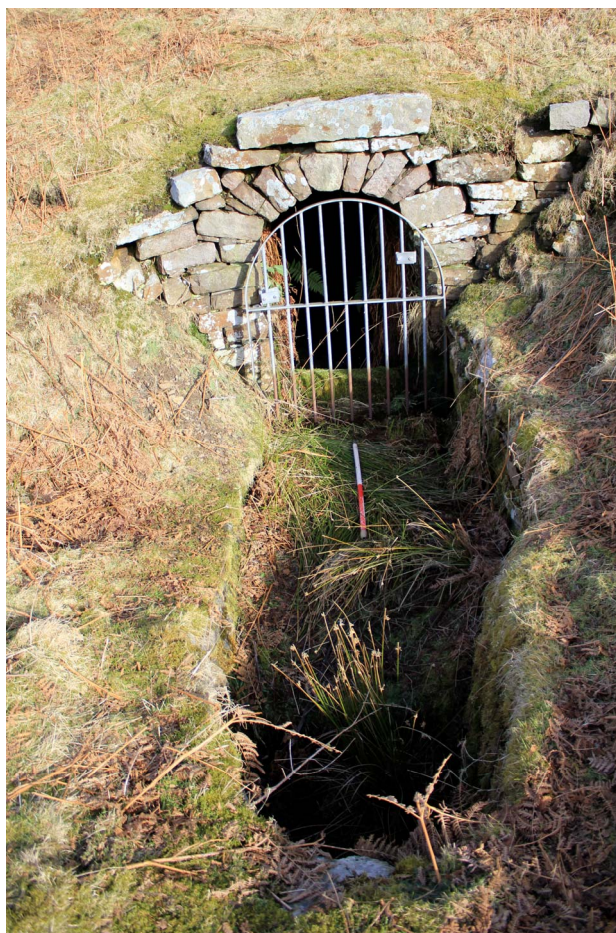
- 4.5.6 In front of the tunnel entrance is a revetted walled channel leading to a plastic pipe, that takes run-off water under the adjacent track (Site **22**). This was evidently modified as part of the drainage works in 2003; the NAA survey, undertaken prior to the works, shows the southernmost wall of this channel, but not the northern wall, which was evidently constructed at this stage. The survey does, however, show a north/south orientated wall extending out from this area, forming the western side of a leat that extends north, following the line of the contours (Section 4.6.3). It would appear that in the original design the run off from the adit was diverted north into the leat, rather than to the west and under the track as it is at present.

Plate 20: Entrance to the tunnel / tail race (Site **18.1**)

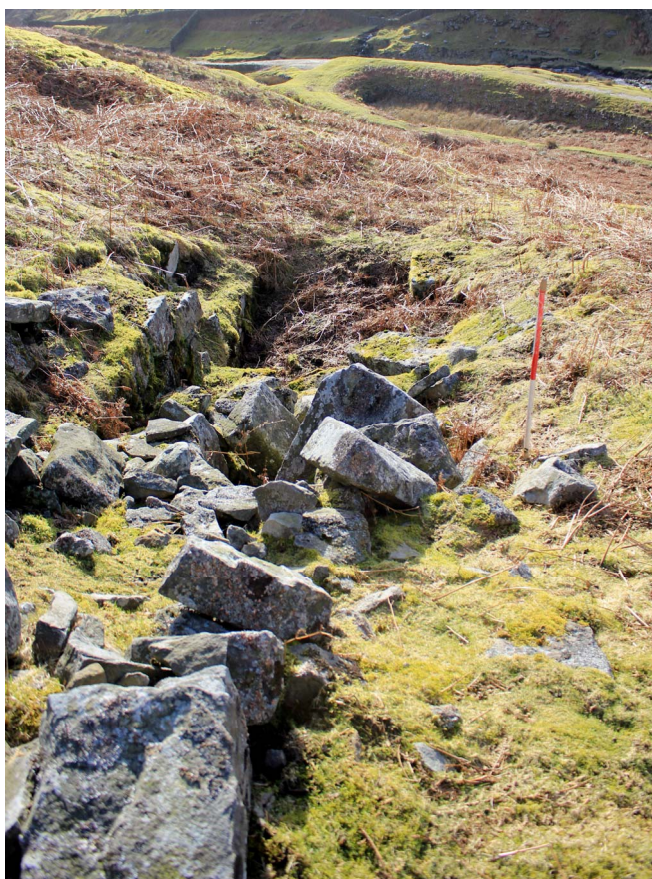
Plate 21: The Power Transfer House wheel pit

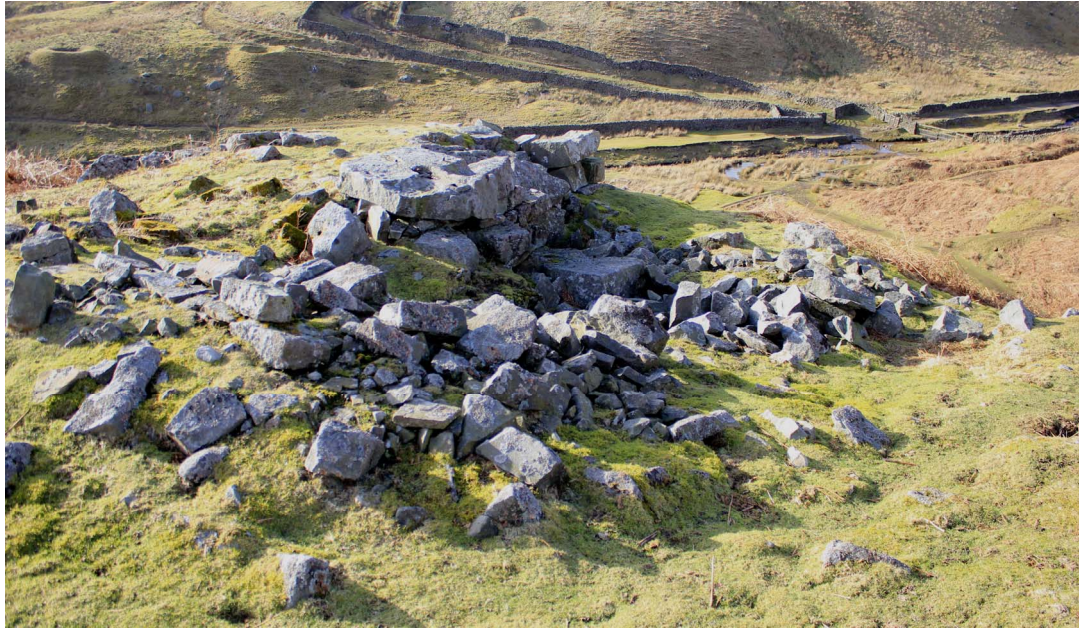
- 4.5.14 To the south-east of the wheel pit are further structural remains of the Power Transfer House (Plate 23), and associated with it is a substantial stone with three threaded mounting bolts for a bearing housing (Plate 24). Extending from the bearing housing is a line of kerb stones and thereafter the line of a gully, with banks on either side, that is orientated south-east towards northern end of wheel pit **18.2**. Hodge (1997, 150) reports a second bearing mount along this line, but one was not

Plate 23: The Power Transfer House (Site **17.1**) viewed from the north-east

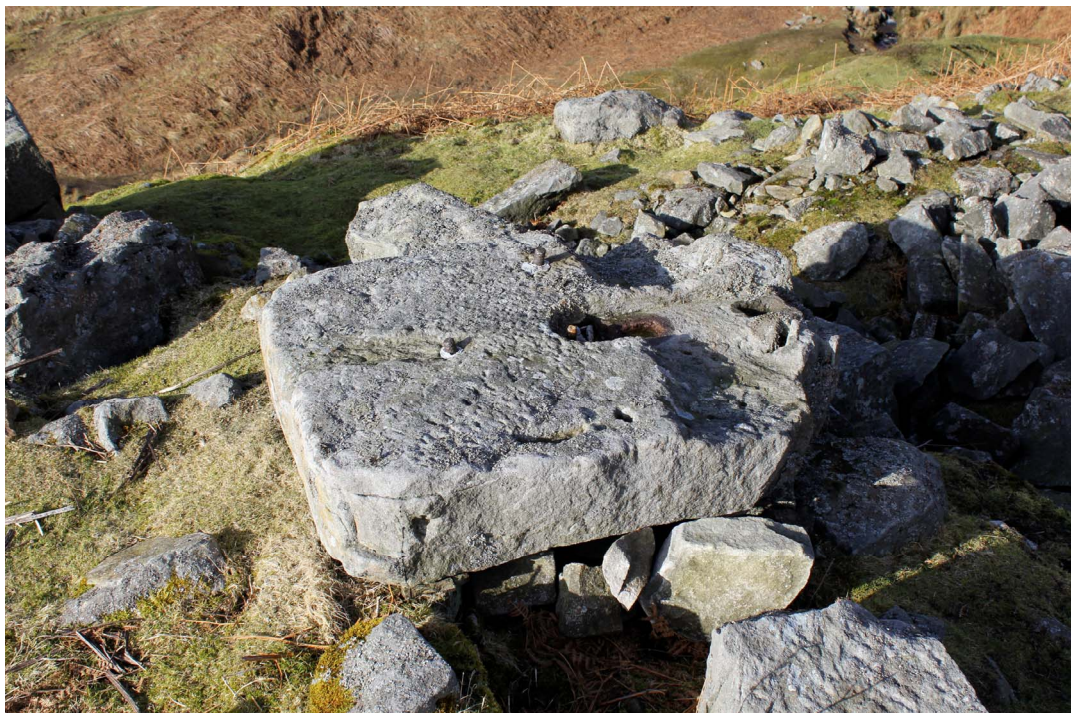
observed during the present survey and may be obscured by turf. This power train was either a rotating drive shaft or another line of push/pull pump rods, and would appear to be the power take-off from the 40 foot wheel into the Power Transfer House, which would have had two alternative power supplies; one from the adjacent wheel pit (**18.2**) and the other from the powered ropeway that would have carried power from a wheel at the Hebden Smelt Mill (*Section 4.5.11*).

Plate 24: Bearing mount for a drive train leading to the Site **18.2** pit

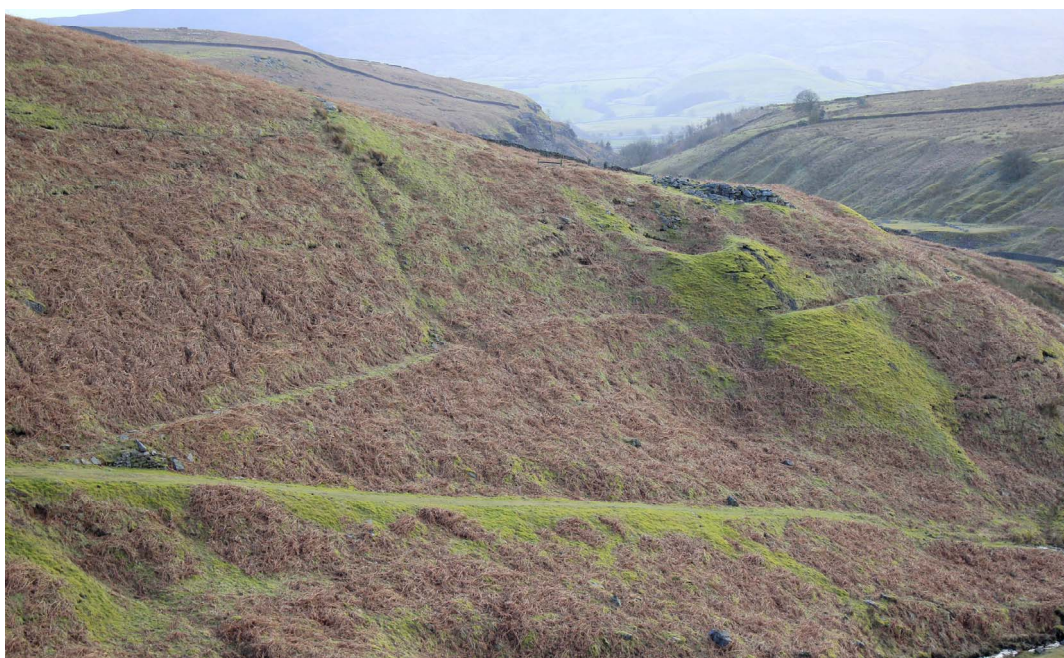
Plate 25: The line of the Bolton Haw Side leat (Site **3.2**) extending across the slope

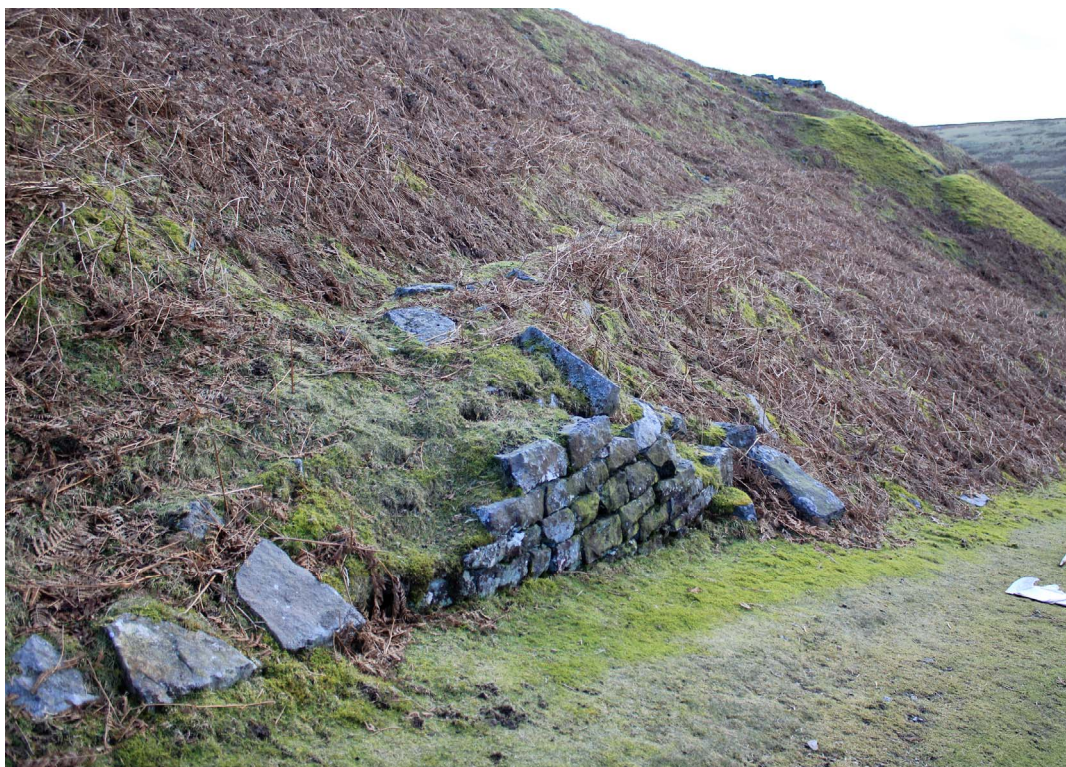
- 4.6.4 While it is evident that the leat was taking the waste drain water from the tail race (Site **18.1**), it is not obvious what the water was being used for. One possibility is that it was simply diverting the water into Bolton Gill from where it was, at a lower level, fed into the reservoir (Site **29**) by Bottle Level. In which case, structure **3.1** was simply the entrance to a culvert diverting the water underneath the track. The other alternative is that the water was being used to provide a power source on route to the lower reservoir (Site **29**), and would suggest that structure **3.1** was a mounting for a water wheel; however, there are no mining or dressing remains in the vicinity of the platform, and no apparent local need for any power generated.

Plate 26: The platform at the base of the leat (Site **3.2**)

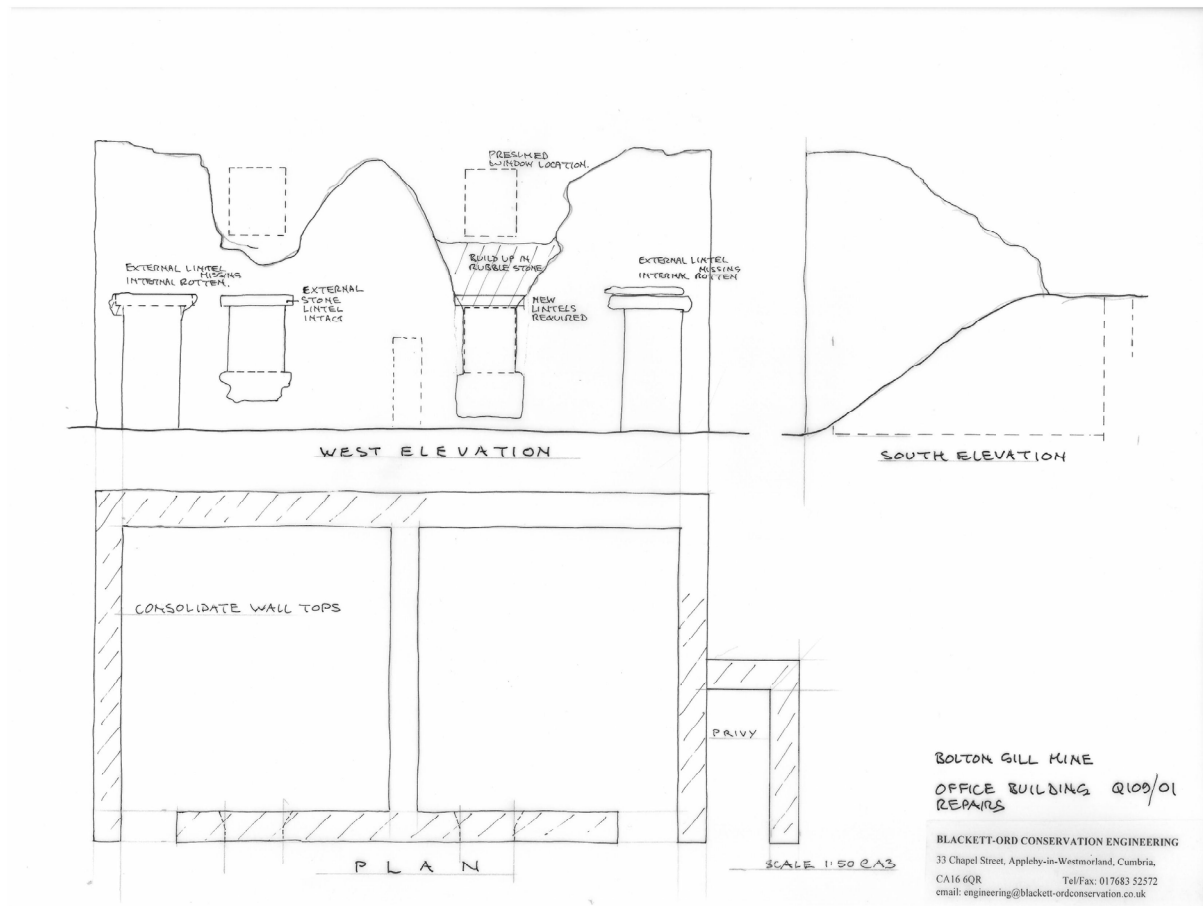
Plate 45: Sketch drawing of office building

- 6.3.1 *Site Office:* the Site Office was a two-storey, two-cell building located on the hillside above the water wheel. The external walls are still standing, but somewhat decayed, built of random rubble stone. Collapsed masonry covers the floor internally. There are no windows, doors or other fittings.

- 6.6.2 For stability, it is recommended that a section of wall that has collapsed down to ground-floor window cill level is rebuilt. It is proposed that the window lintel is reinstated and some masonry above this rebuilt to give some structural continuity in the front wall.
