Dairy Farm, Shepperdine South Gloucestershire

Historic Buildings Investigation and Recording

February 2018

Client: Horizon Nuclear Power

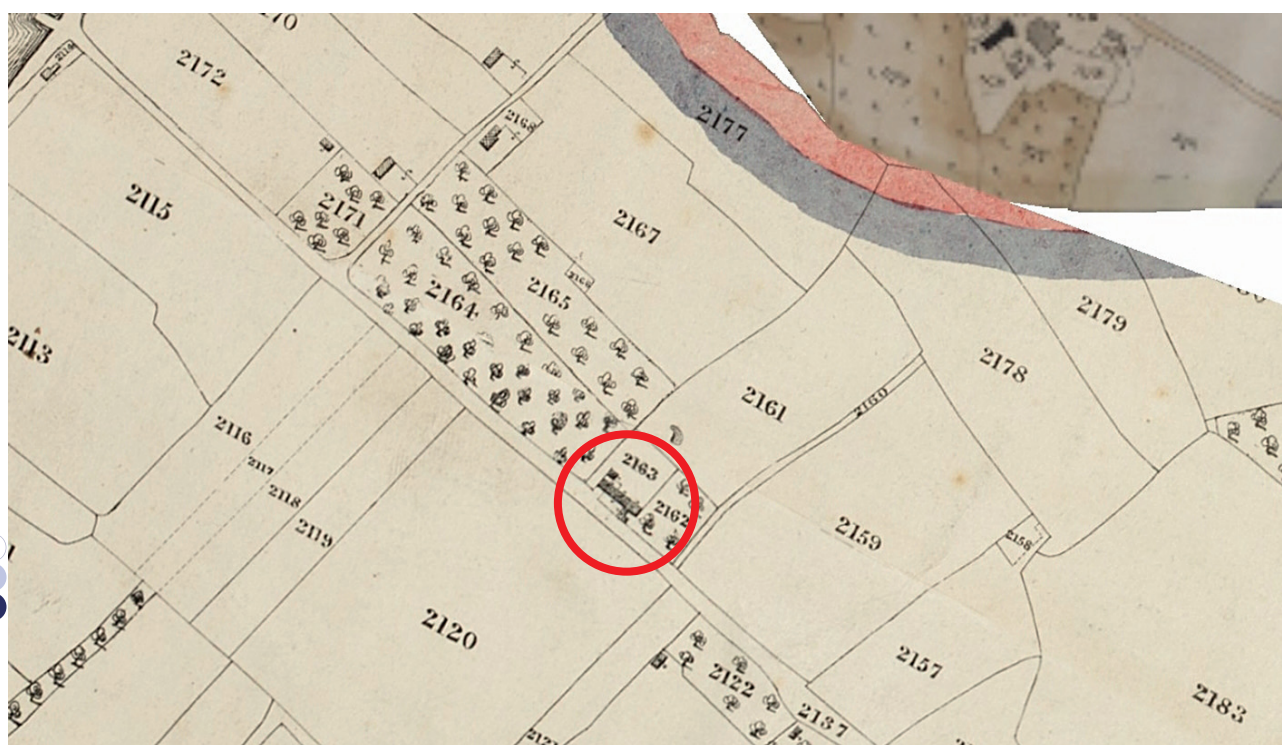
- 2.1.1 Dairy Farm appears on the Tithe map for Thornbury dating to 1840 as a linear range orientated roughly north-west to south-east, with a small detached building to the north of the north-west end, and a small adjoining building to the south of the south-east end, against the boundary of Shepperdine Road (Fig. 3). The range may be the existing south gabled range of the house, with the annexe and the barn abutting the north-west and south-east ends (described in Section 3). The adjoining building to the south is likely to be the existing shed, but the structure that joined it to the barn no longer exists. The small structure to the north of the north-west end of the range also no longer exists. The area of the existing farmyard to the south-east of the farmhouse is shown with no structures on it and has a different apportionment number.

Figure 3: 1840 Tithe map, showing Dairy Farm

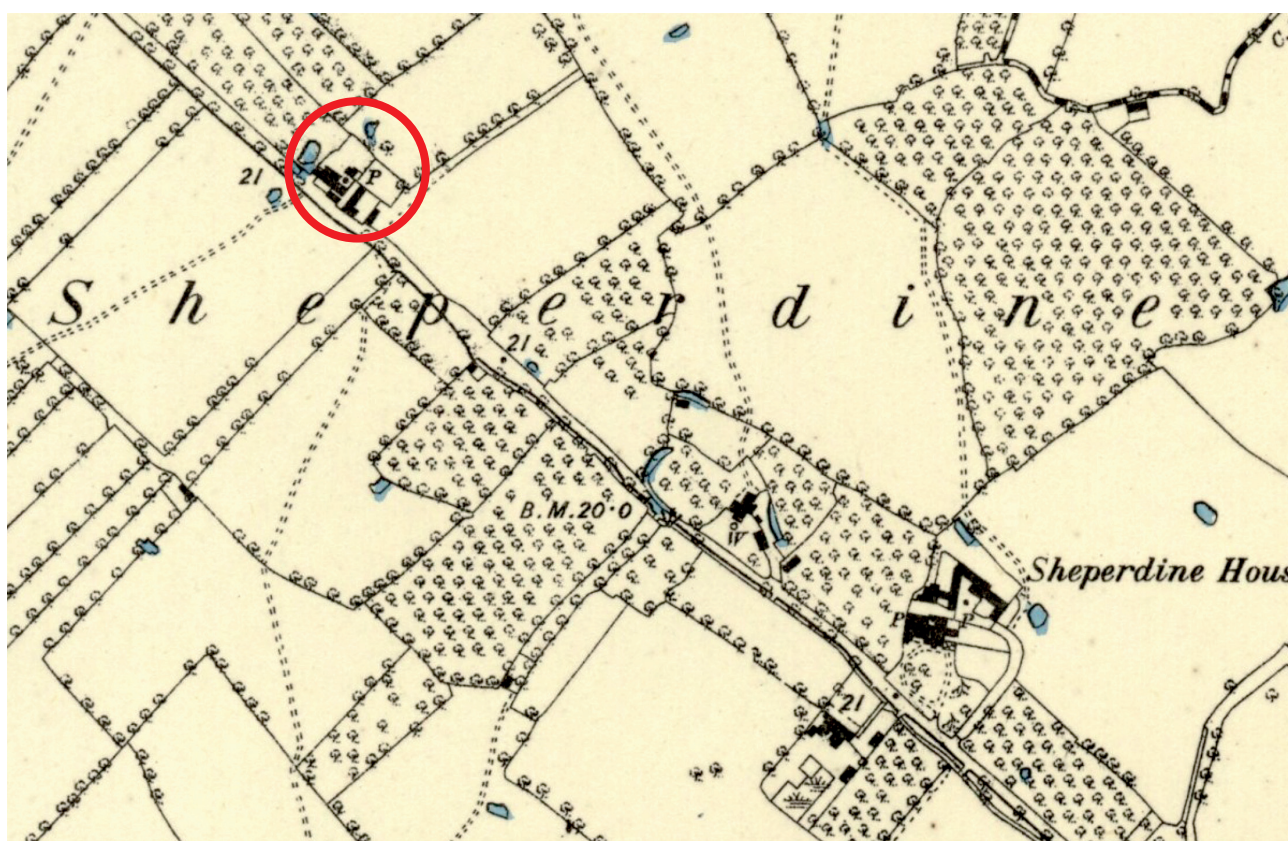
- 2.1.2 A plaque on the rear elevation of the farmhouse reads '1870', indicating that it was either rebuilt or enlarged at this time. The first edition 1881 OS map (Fig. 4) shows the footprint of the farmhouse as it exists now, with the annexe on the north-west side and the barn on the south-east side. The farmhouse itself has expanded north-eastwards to the rear. This is the northern gabled range, described in Section 3. The small shed to the south of the barn is now free standing and the small structure to the north of the north-east end has disappeared. The outhouse to the rear of the farmhouse has also been built with a small enclosure on its east side. To the south-east of the farmhouse, across a lane running north-east from Shepperdine Road, the farmyard has been developed. The map shows the footprint of the dovecote, the cowshed and the southern animal shelter as they exist today. The enclosure on the north-east side of the farmyard exists but the Dutch barn has not yet been built.

Figure 4: 1881 1st Edition OS map, showing Dairy Farm

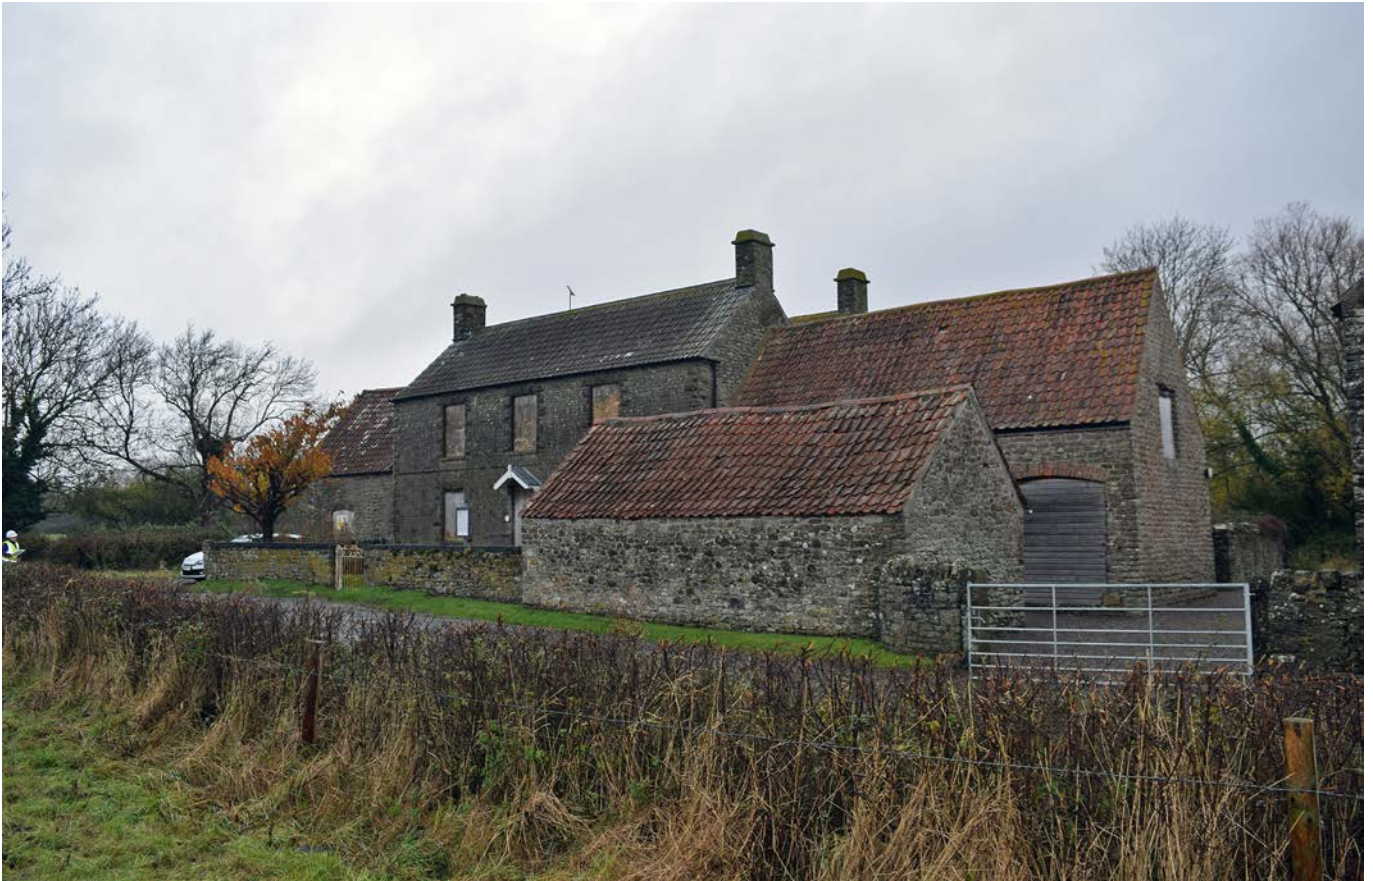
Plate1: Dairy Farm from Shepperdine Road, looking north-west

- 3.3.11 To the immediate south of the barn, across an open passage, is a linear outhouse structure comprising two adjoining spaces, built as one structure. The rear of this building forms the boundary of the site with Shepperdine Road (Fig. 7, Plate 1). It is built with irregularly-coursed cobbles, more squared at the corners, and a friable, sandy lime mortar. It is orientated east to west with gabled ends, the west of which abuts the east stretch of garden wall to the front of the farmhouse, and a pitched roof covered with pantiles. It has a plastic rain gutter along its eaves on the north side.

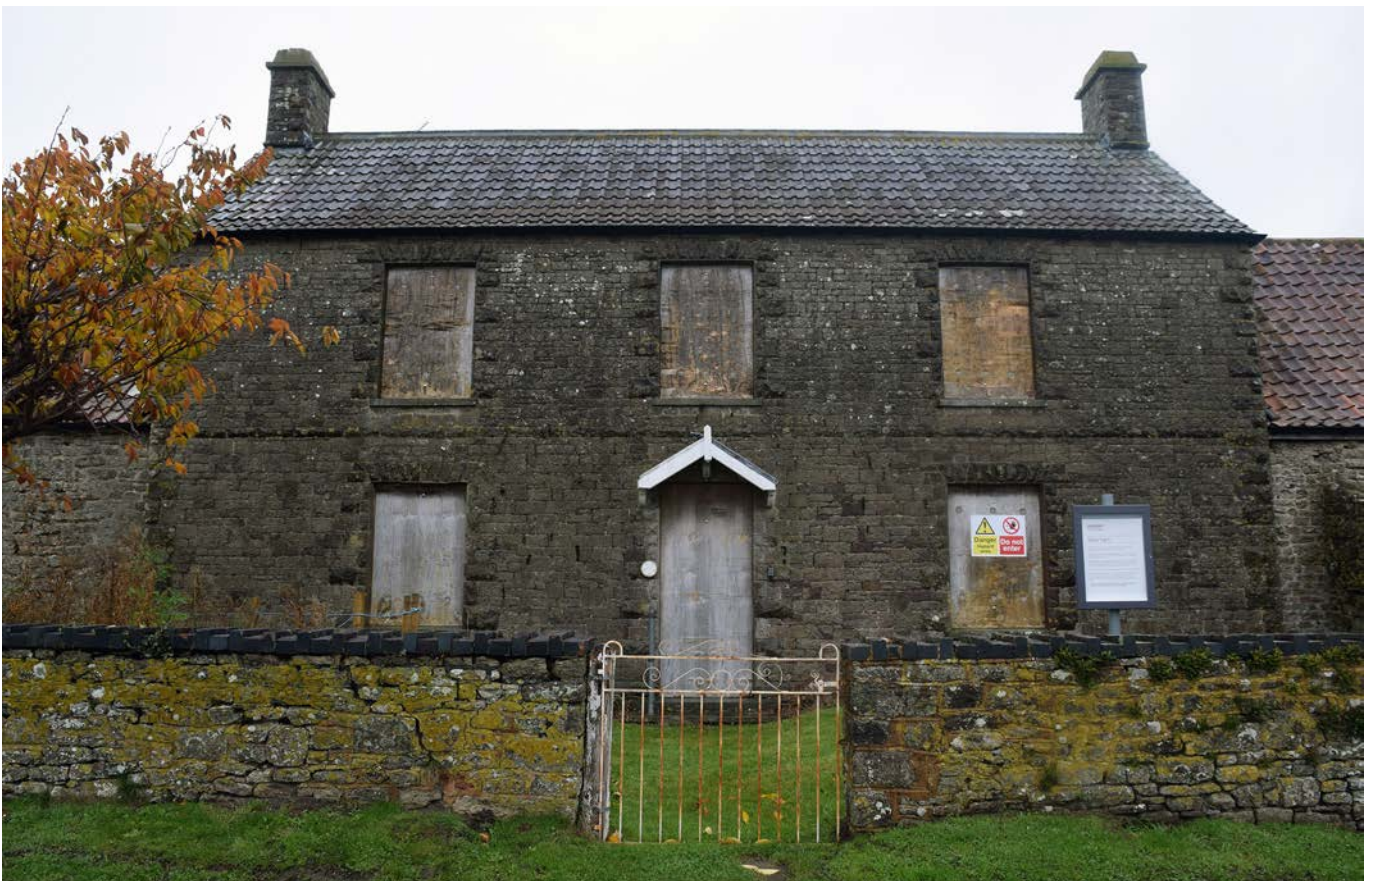
Plate 2: South elevation of Dairy Farmhouse, looking north

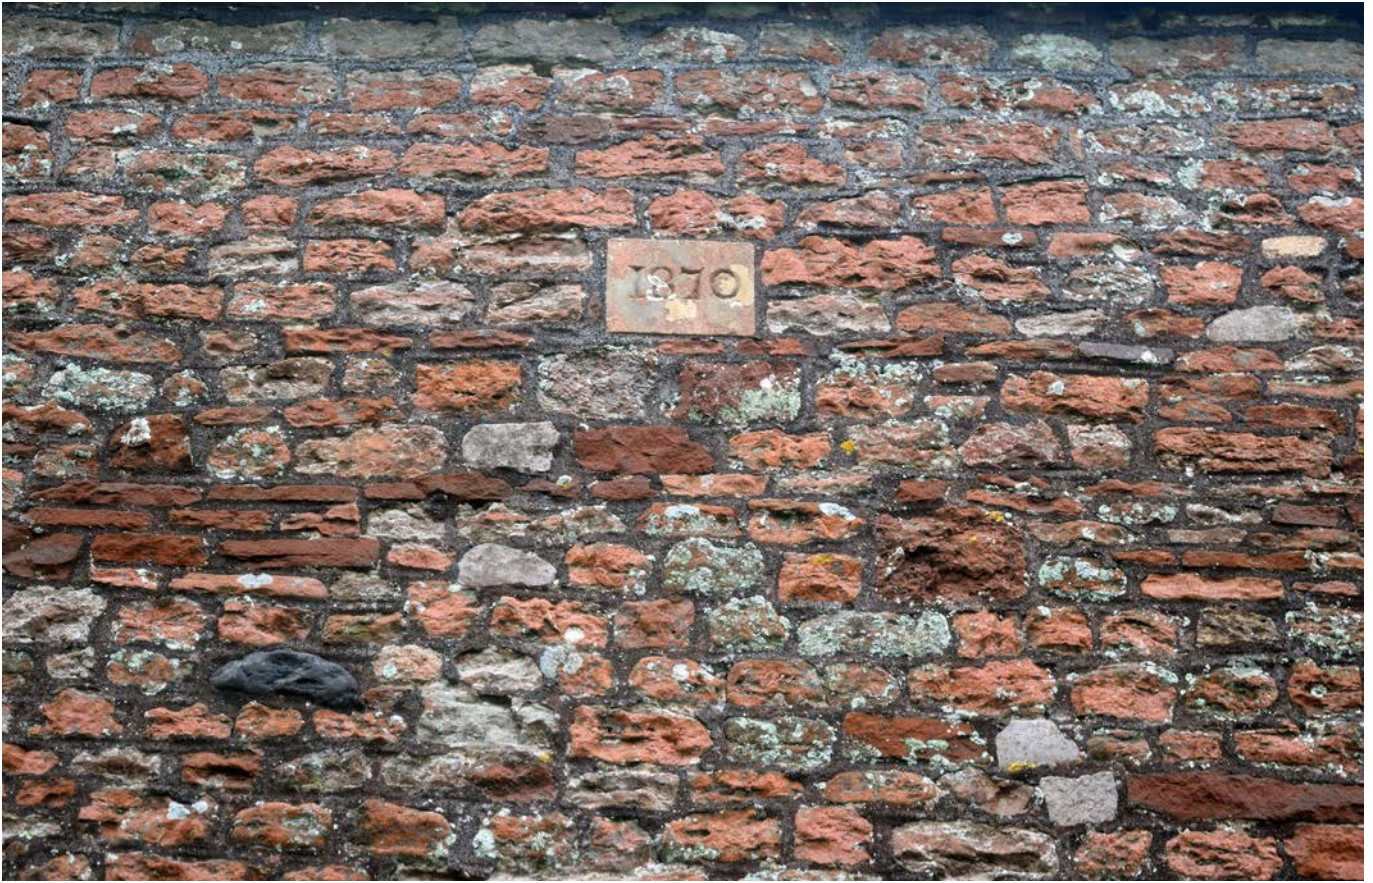
Plate 5: Plaque on north elevation of Dairy Farmhouse, looking south
