Moss House Farm, Cockerham, Lancashire

Archaeological Building Investigation

Oxford Archaeology North

September 2009

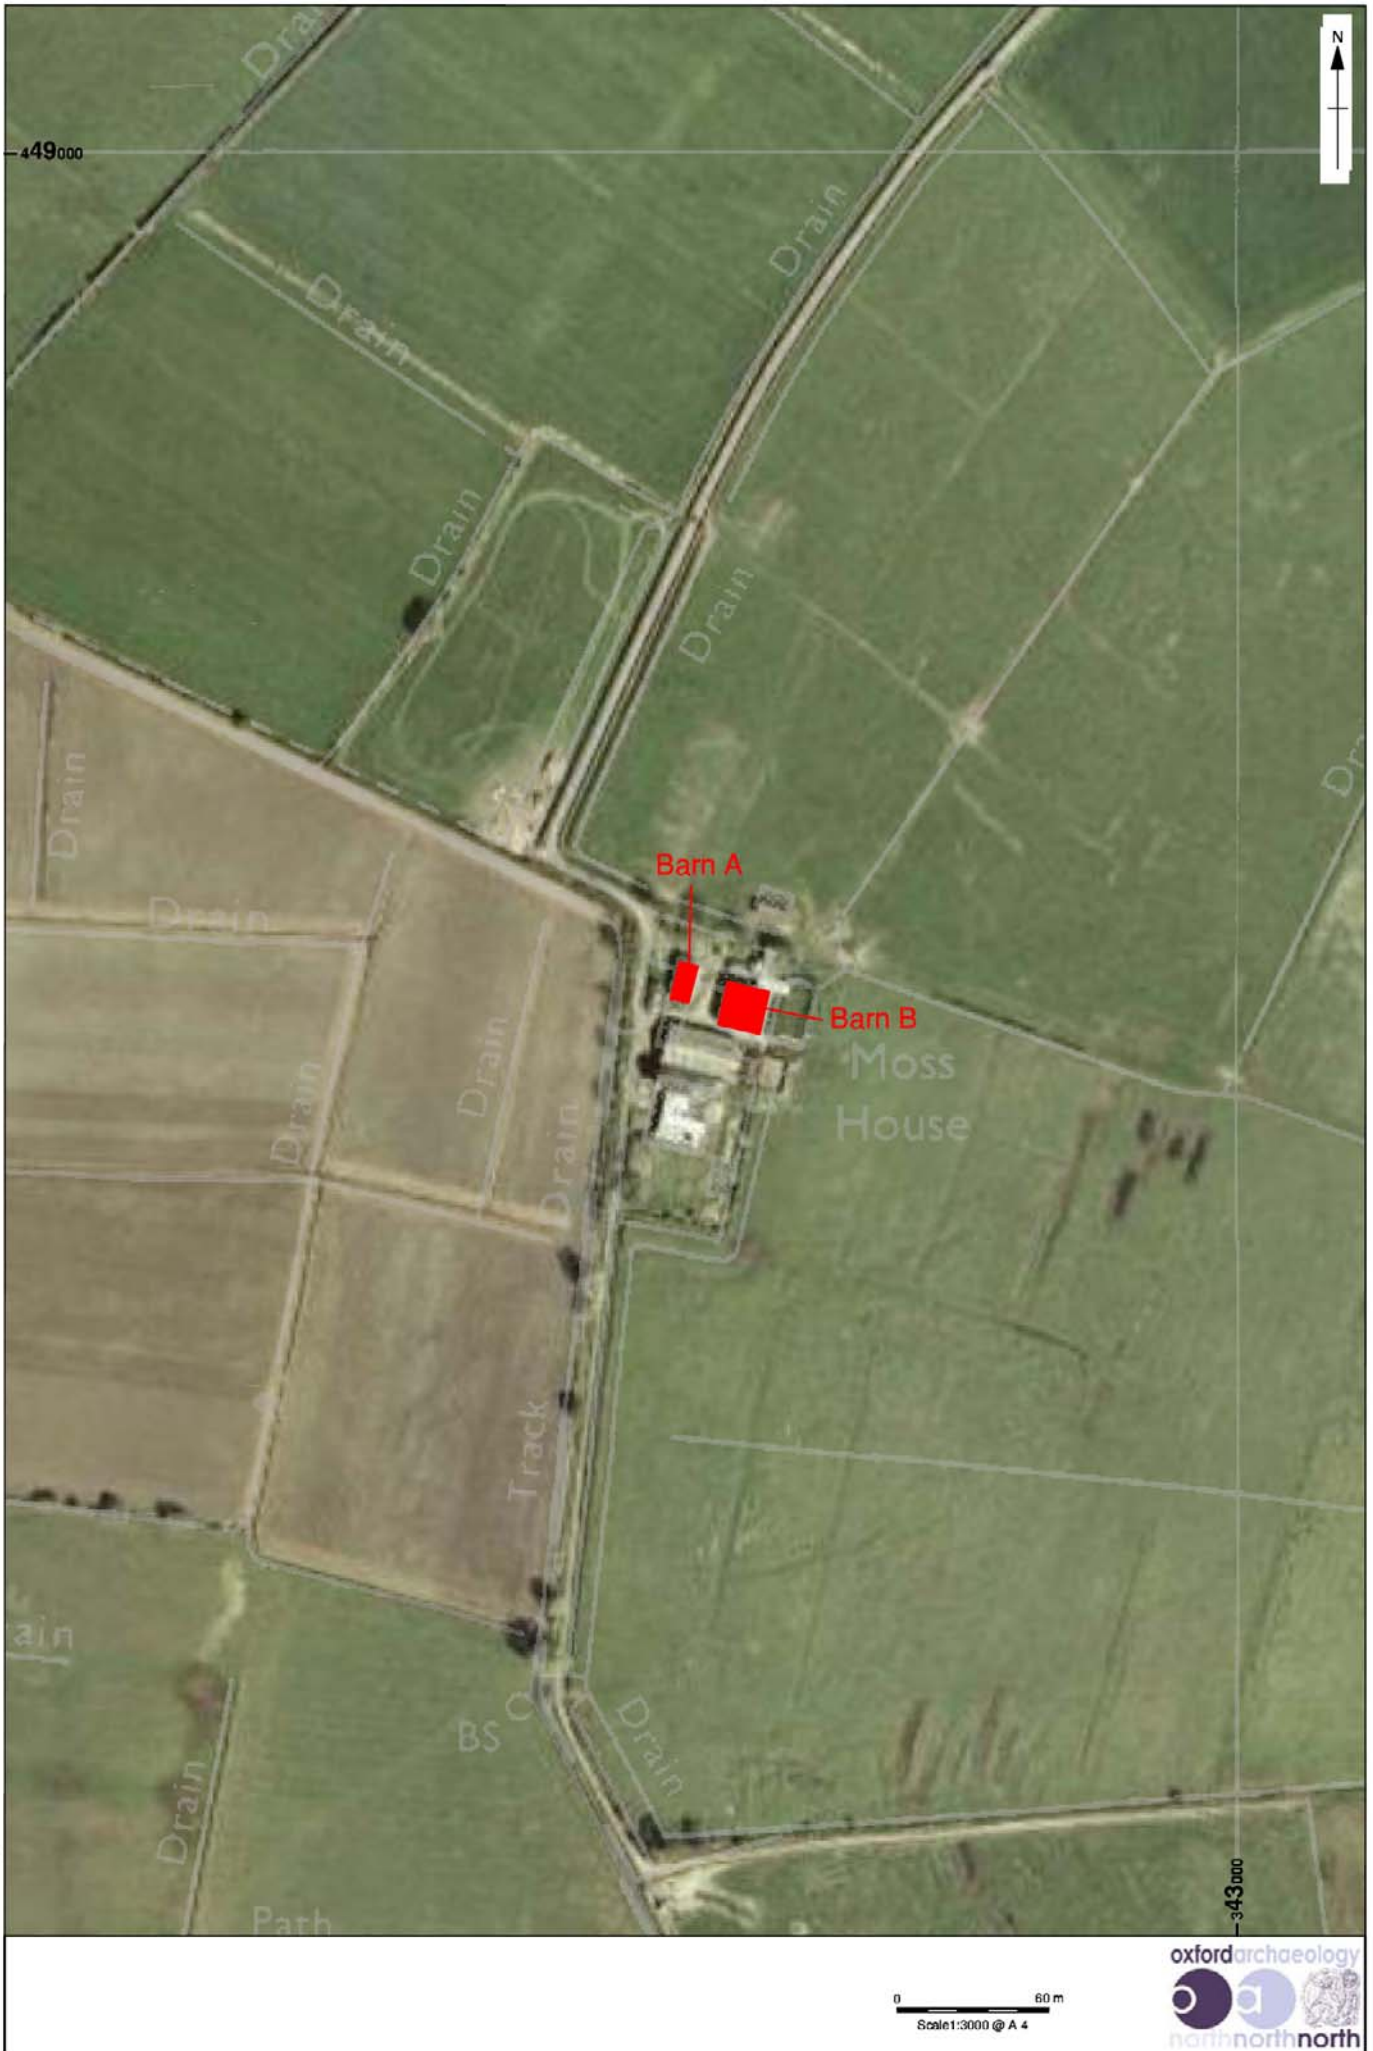
Figure 2: Plan of the farmstead, showing the position of the two barns

3.3.2 *Hennet's Map 1830*: there appear to be no structures situated on the site of the current buildings. The kink in the road close to the current Moss House (Fig 2) is present on Hennet's map but no buildings are located in this area. 'Moss Houses' are again labelled to the south-west.

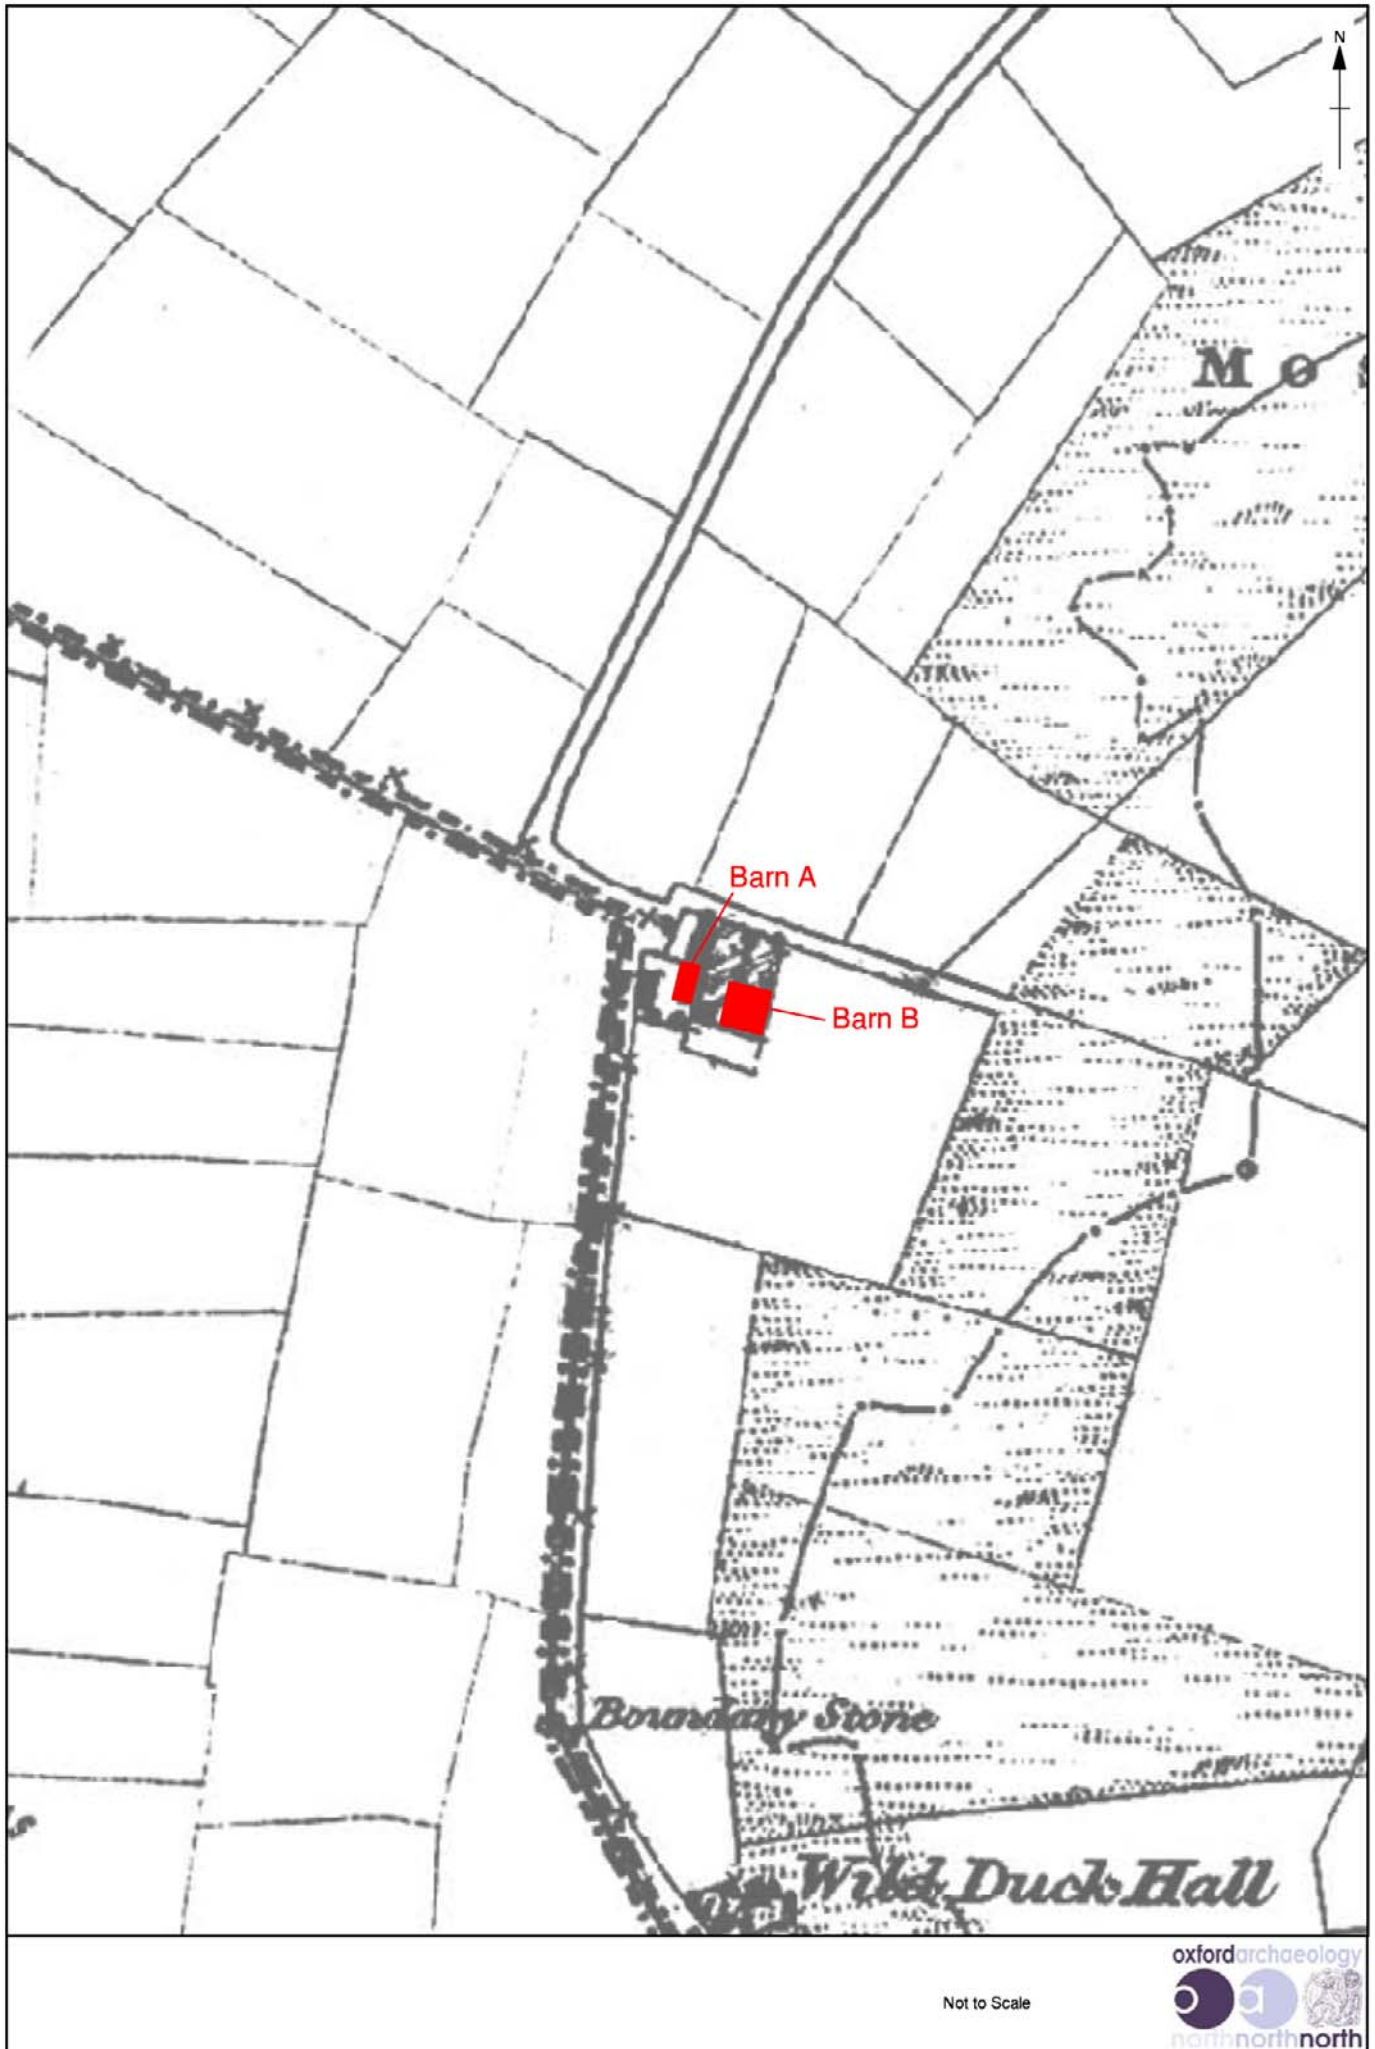
Figure 3: Extract from Ordnance Survey First Edition, 6 inch to 1 mile map, 1847

3.3.3 *Ordnance Survey, 6 inch to 1 Mile, 1847 (Fig 3)*: this is the earliest available detailed map of the area and clearly illustrates the road and field boundary pattern, which is very similar to the current appearance. To the right of the kink in the road first identified on Hennet's 1830 map, a collection of buildings is illustrated. One of these is a rectangular structure, which is of a similar footprint to the current Barn A (see *Section 4.1.1*). To the right of this, where the current barn B is situated, is a square wooded area. In common with both Yates' 1786 and Hennet's 1830 maps, there are other buildings labelled Moss House or Moss Houses located away to the south west.

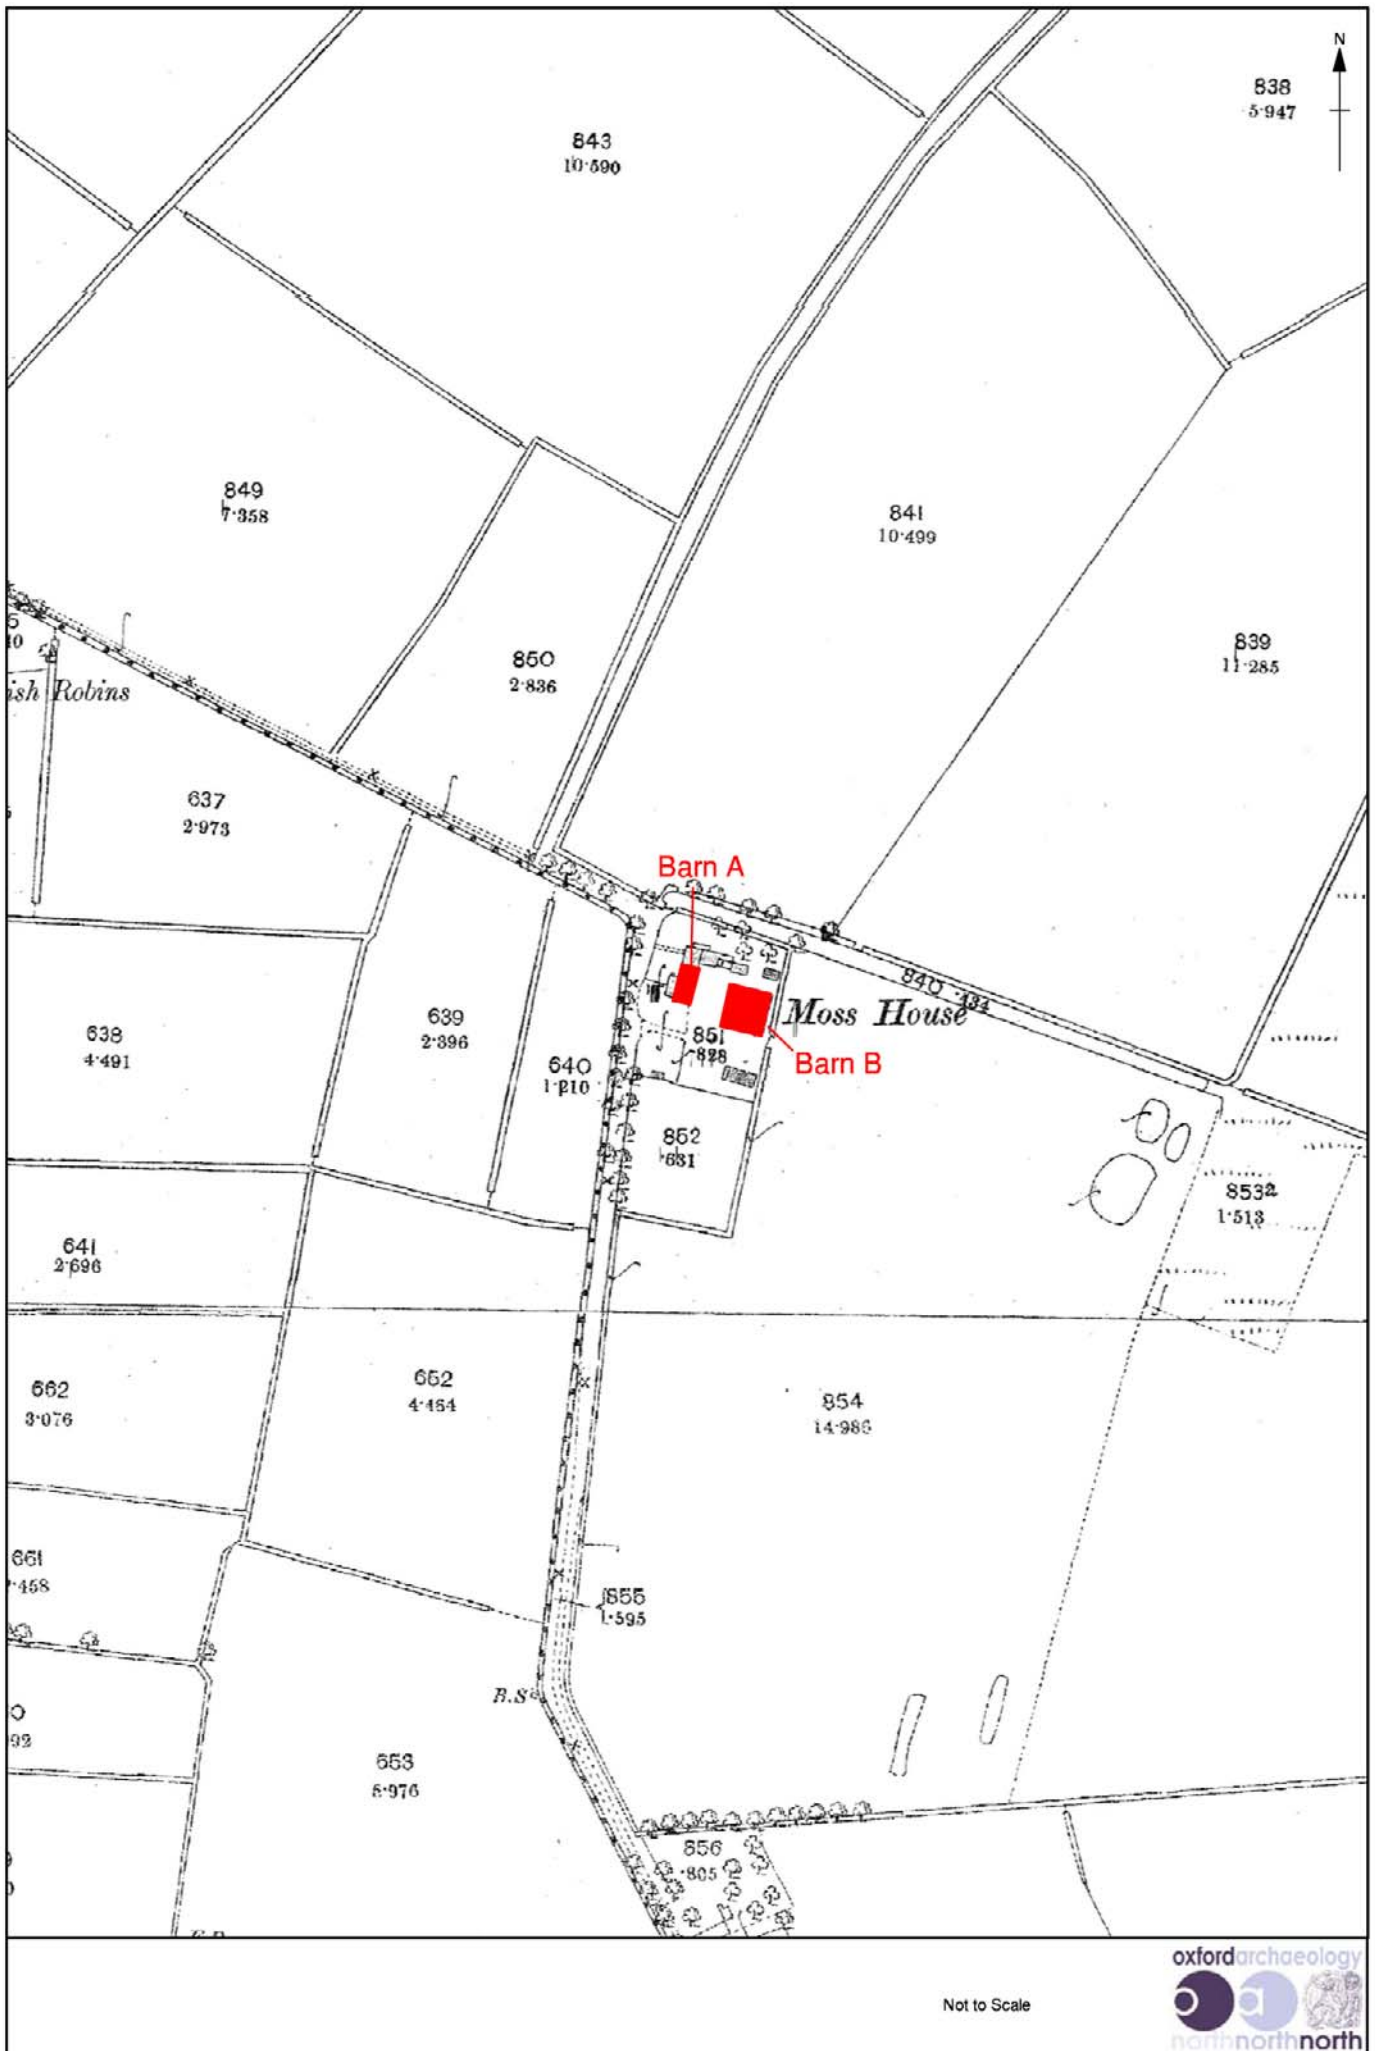
Figure 4: Extract from Ordnance Survey First Edition, 25 inch to 1 mile map, 1892

- 3.3.4 **Ordnance Survey, 25 inch to 1 Mile, 1892 (Fig 4):** this map is more detailed, and illustrates the nature of the layout of the buildings labelled Moss House. There are two ranges of buildings shown: one to the north and another to the west. The southern most of the buildings to the west is Barn A. On the opposite side of the farmyard are two detached buildings, the longer of these is (hard to see) Barn B. The remainder of the layout of the farmstead is clearly visible and paths are a dividing boundary are visible. The farmstead appears to be surrounded by a drainage ditch.

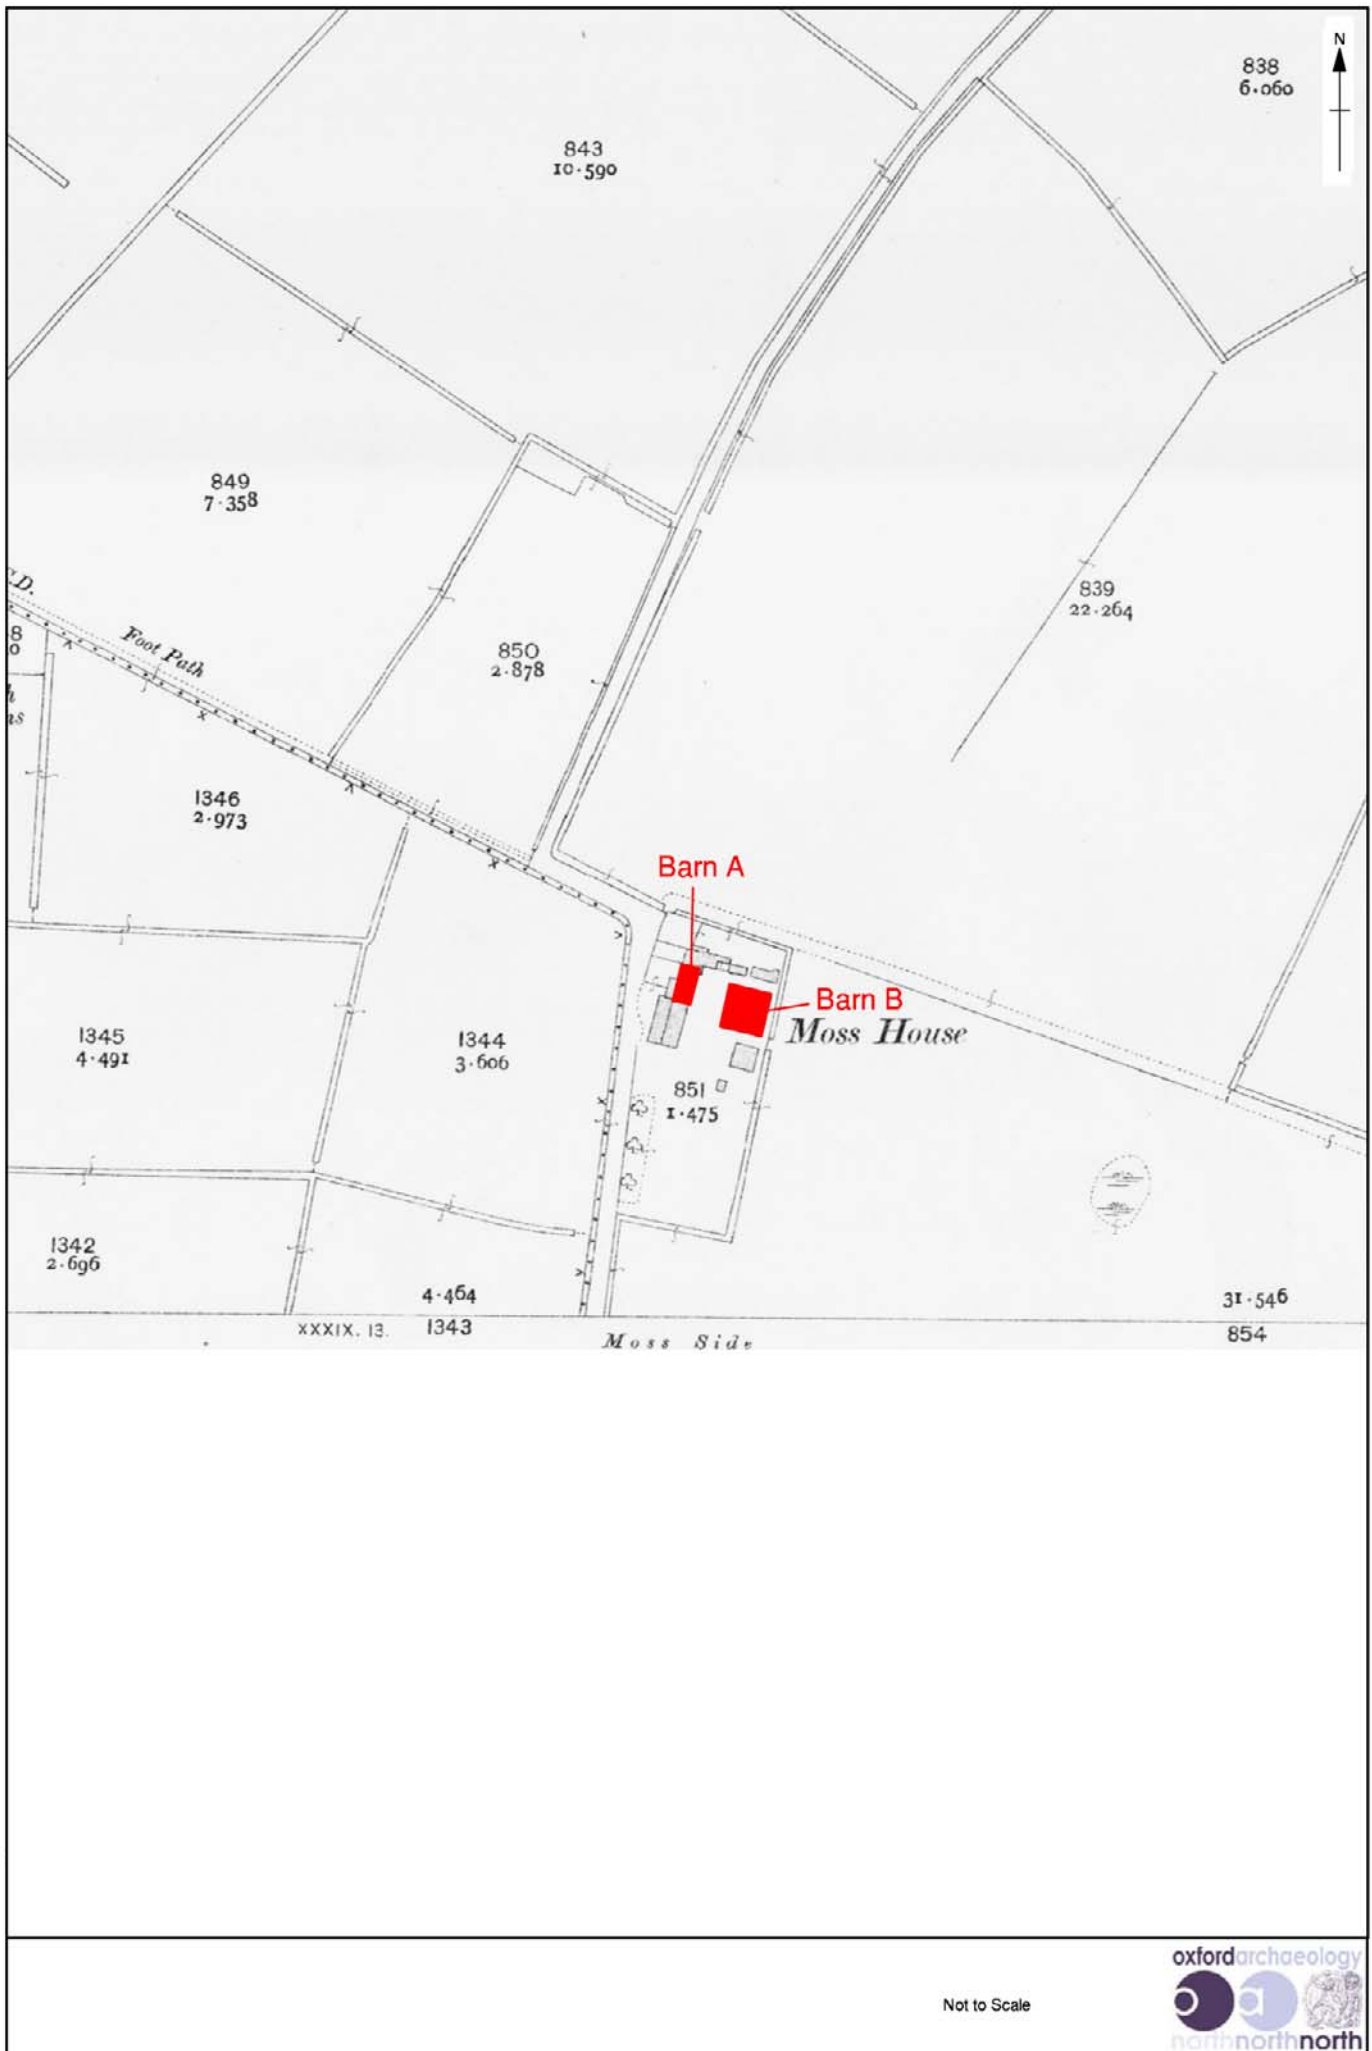
Figure 5: Extract from Ordnance Survey Second Edition, 25 inch to 1 mile map, 1912

- 3.3.5 **Ordnance Survey, 25 inch to 1 Mile, 1912 (Fig 5):** this map shows similar detail to the 1892 Ordnance Survey map, the most obvious difference being the addition of a large extension to the south end of the west building (Barn A). There are changes to the arrangement of the internal divisions within the layout of the farmstead and an additional structure located to the south of the current Barn B.

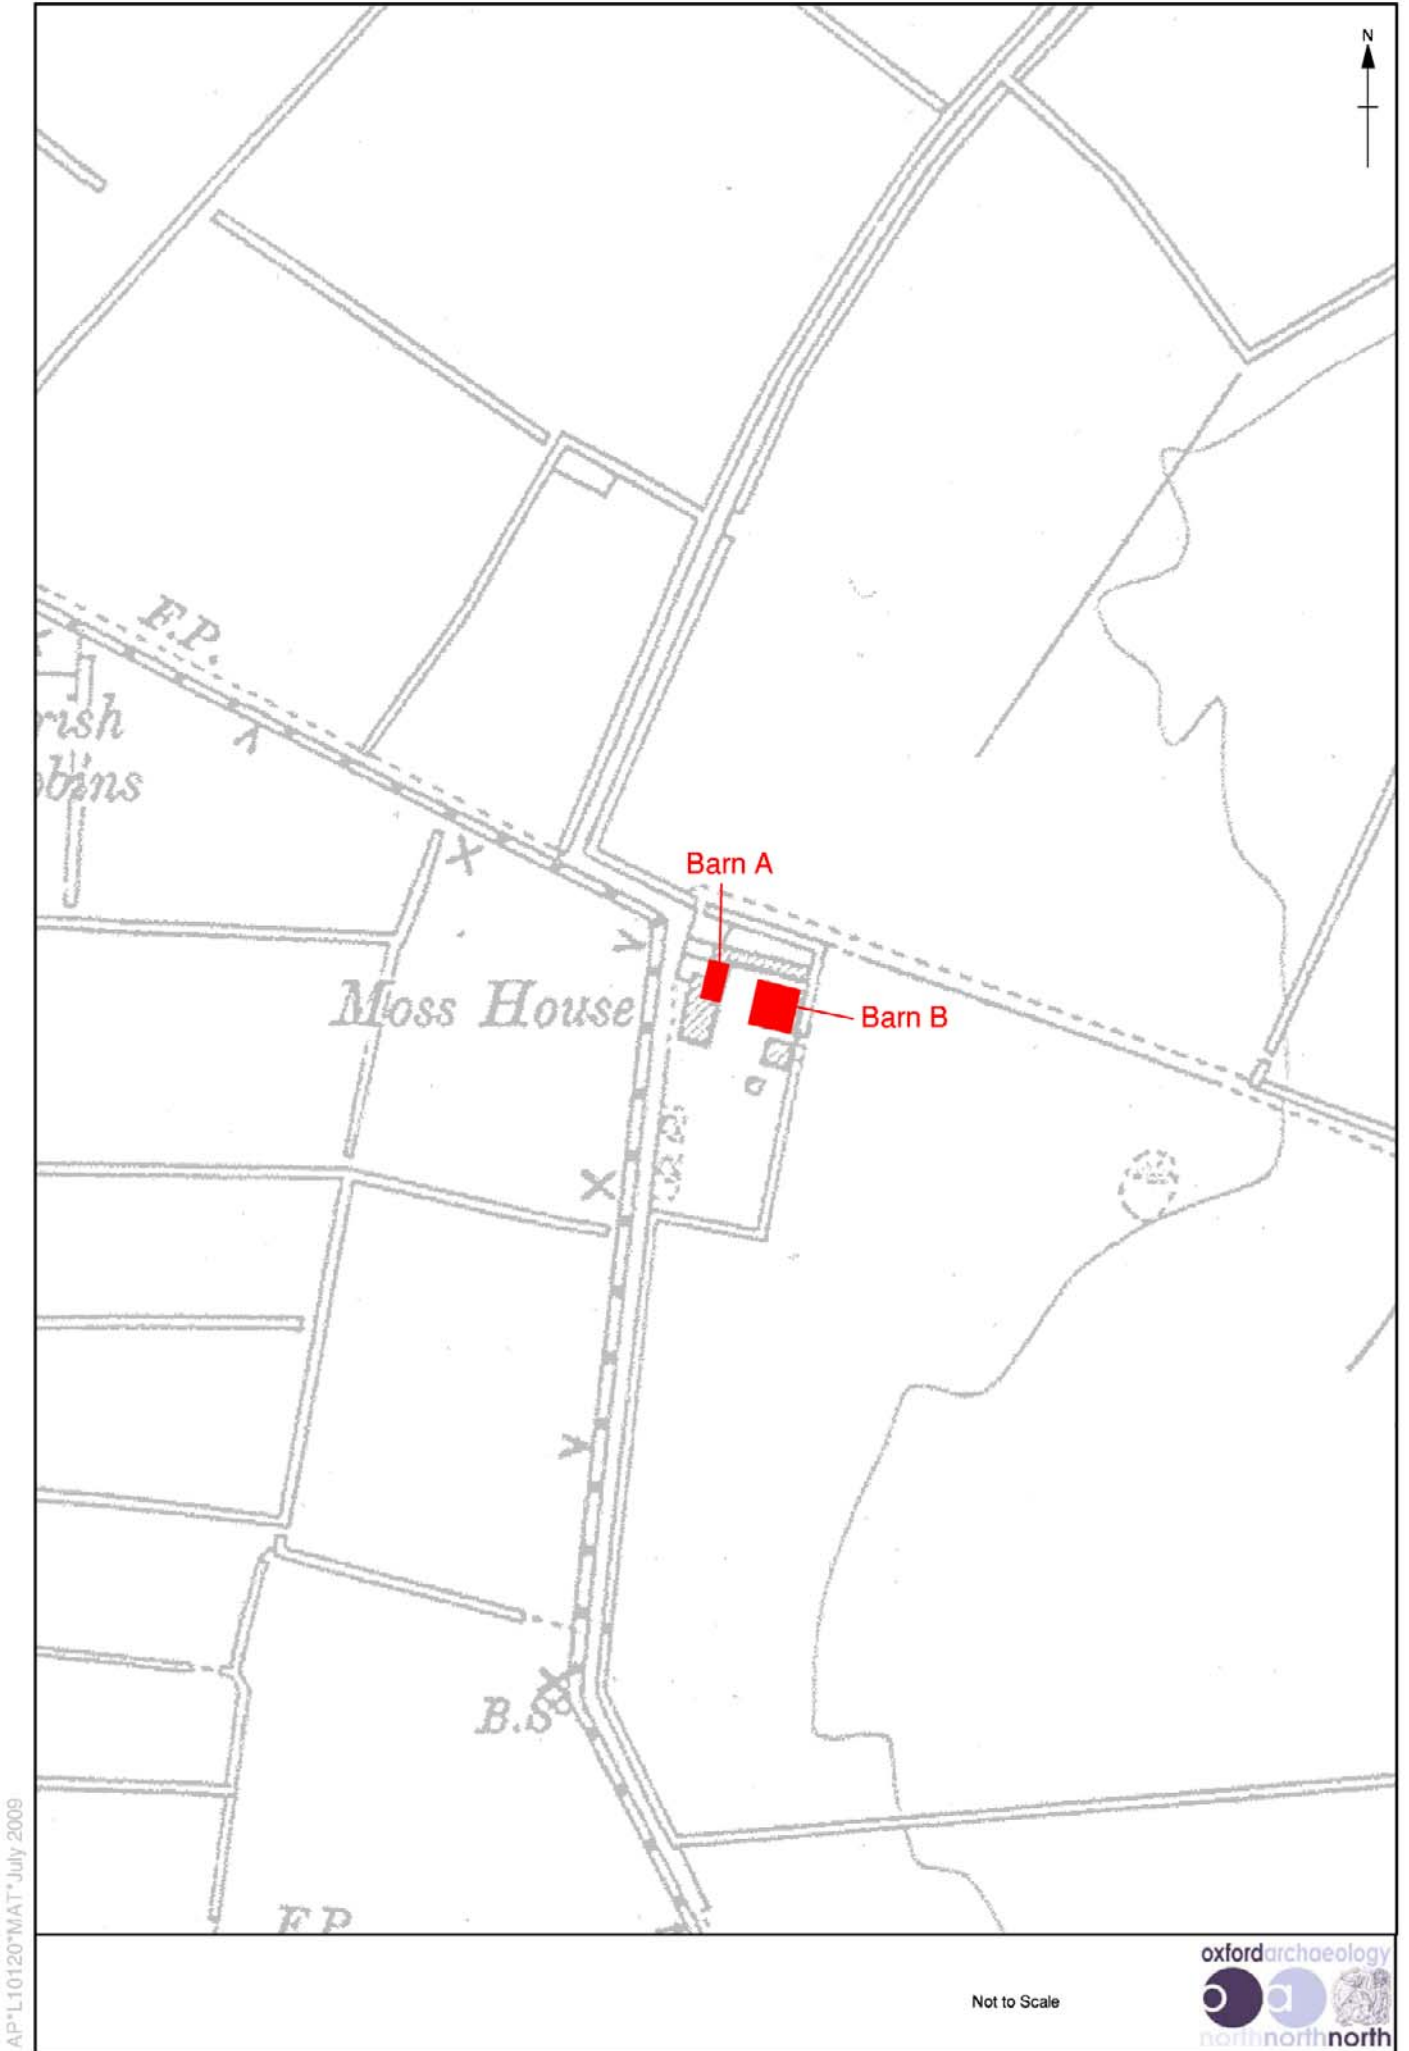
Figure 6: Extract from Ordnance Survey Third Edition, 6 inch to 1 mile map, 1914

- 3.3.6 **Ordnance Survey, 6 inch to 1 Mile, 1914 (Fig 6):** this map is not as detailed as the 1912 map but illustrates essentially the same layout. The north part western building has apparently been extended to the east.
