# Anstey Hall Farm

**Historic Building Survey**

September 2015

OA East Report No: 1802 OASIS No: oxfordar3-224708

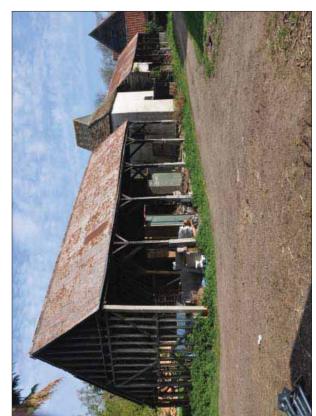
Plate 31: East Facing elevation of building 5

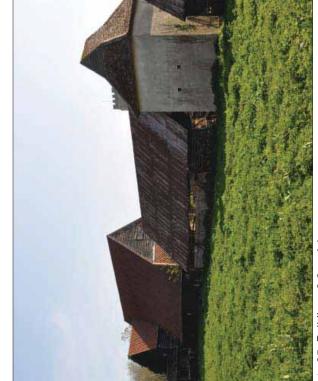
- 4.5.1 This is one of a pair of open fronted barns that occupy a site either side of the dovecote (Building 4). The building measures 17.20m by 6.99m and has a height of 6.09m. Although its construction suggests a nineteenth century date it probably replaced an earlier barn with a different ground plan as depicted on Baker's map of 1830 (Fig 4). The southern end of building 3 is located within 1.5m of the dovecote making it to close to have been an original location of any building on the site (Plate 35).

Plate 35: Buildings 2,3 and 4

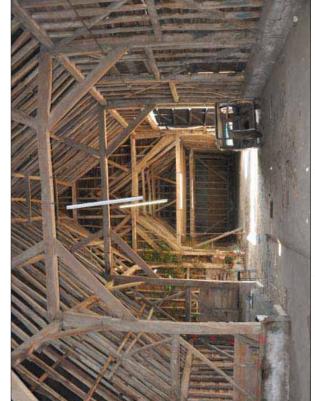
Plate 40: Two phases of roof structure at the northern end of barn 2
