The Old Rectory Letcombe Bassett

Historic Buildings Assessment and Heritage Impact Statement

Client Name: Mr Nicholas Ashe
Document Title: The Old Rectory, Letcombe Bassett
Document Type: Historic Building Assessment and Heritage Impact Statement
Issue Number: 2

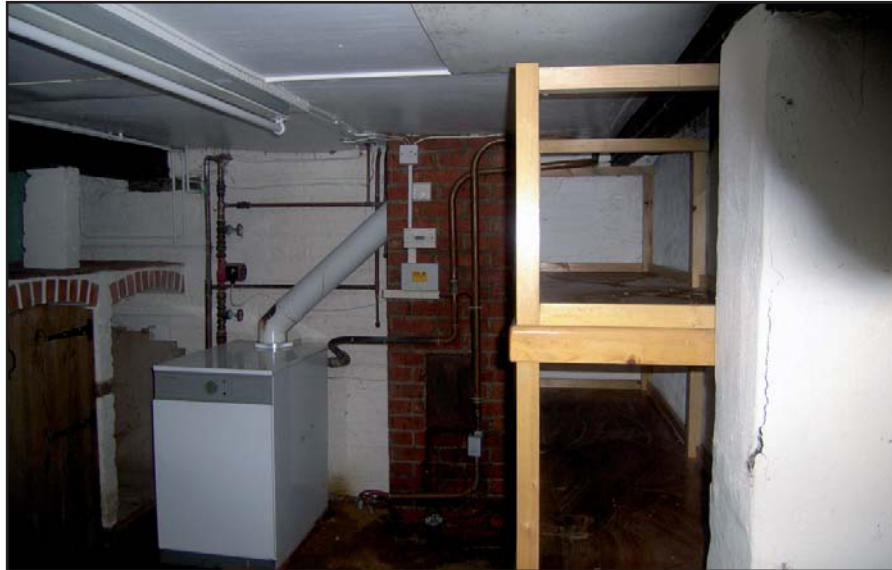
Plate 17 Cellar

- 3.1.24 A *Cellar* to the south-eastern end of the building is reached via a door under the main staircase (Pl. 17). This was not accessed due to recent flooding, but contains the modern boiler served by a brick flue dating to the second quarter of the twentieth century. Brick-built storage is to the south-west wall (Fig 5).
