# **Plantation Mill, Peel Park, Accrington Lancashire**

## **Archaeological Survey**

May 2010

**Jacobs Engineering (UK) Ltd**

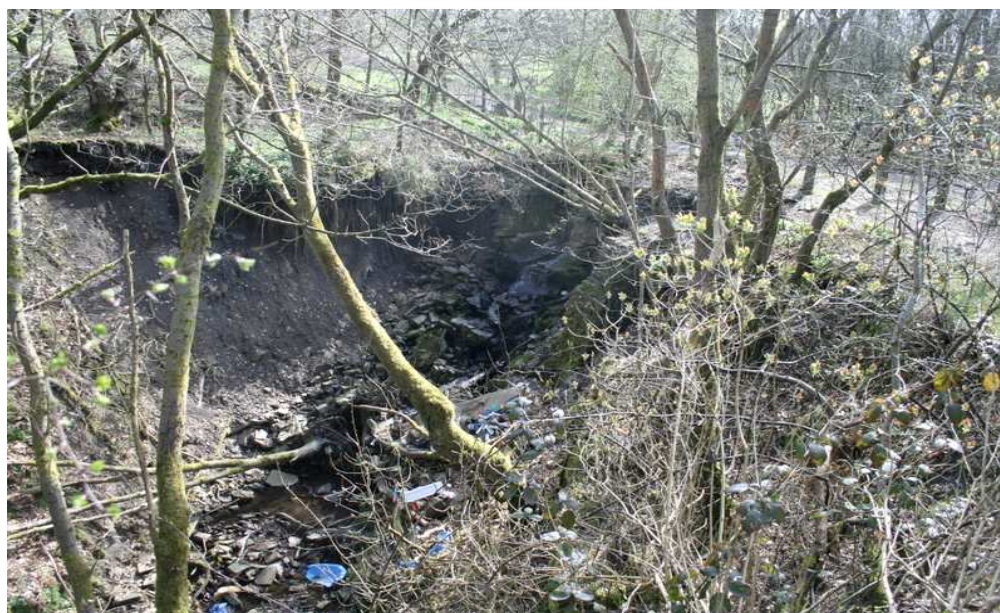
4.2.1 Area 1 comprised some 2200m<sup>2</sup>, and was dominated by the deep ravine for the Pleck Brook (Plate 10). This area incorporated the remains of three structural elements: a sluice from the former reservoir bordering the eastern boundary of the area; a bridge over the sluice; and the remnants of a retaining wall along the southern side of the ravine beyond the sluice (Fig 6). A raised area between the ravine and a trackway, marking the southern edge of Area 1, also had three visible features: a wall foundation; and culvert/tank; and a series of walls which appear to be associated with horticulture/gardening activity.

*Plate 10: Looking north-east across the ravine of Pleck Brook, beyond the reservoir*

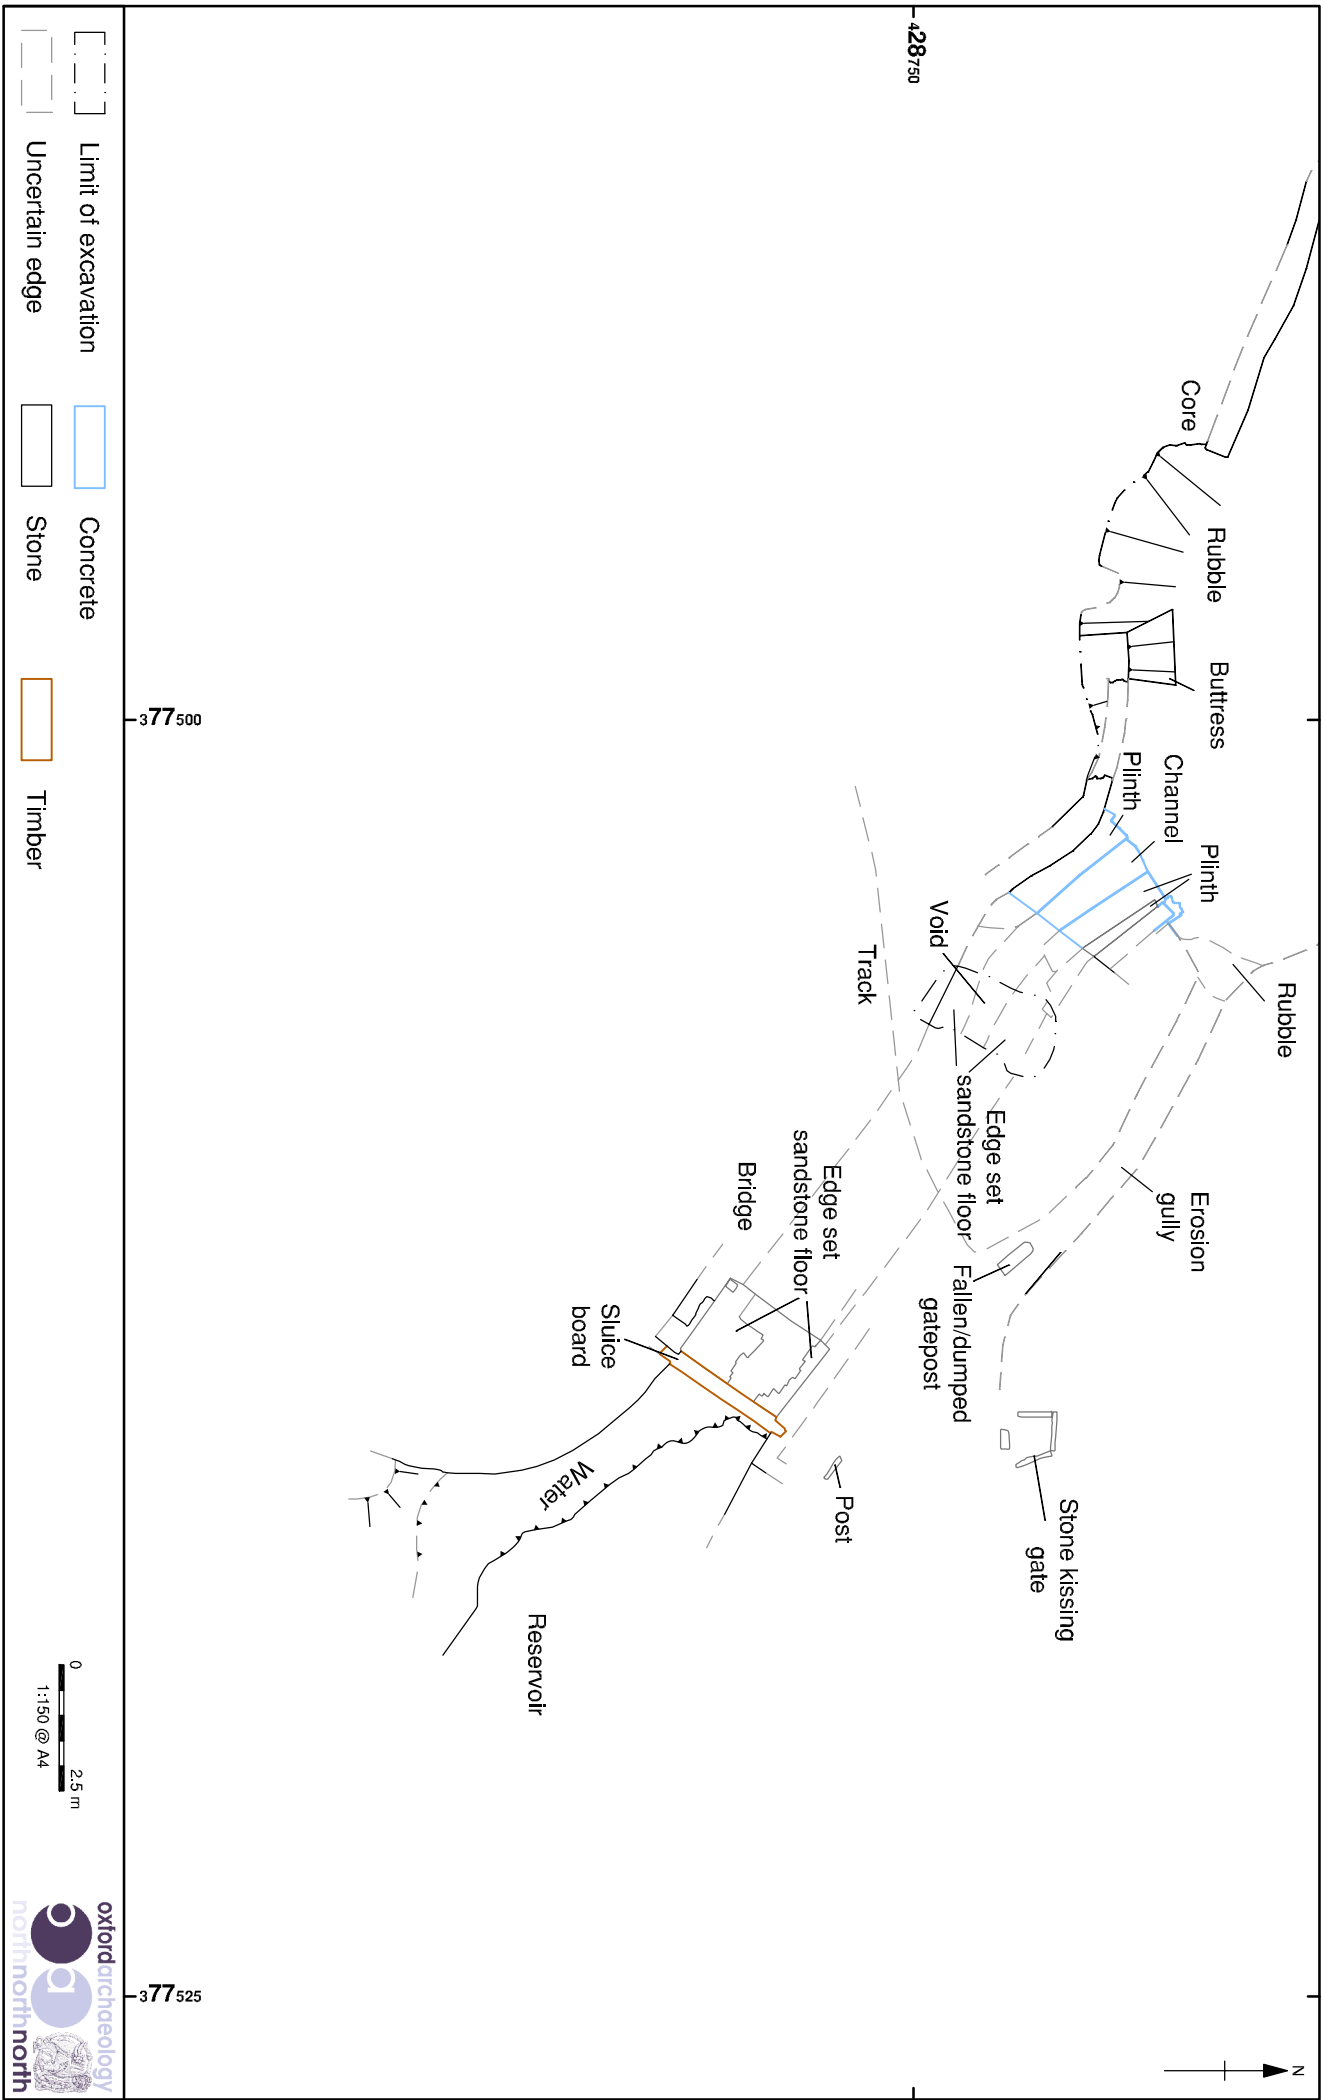
Figure 7: Detail of features in Area 1

- 4.2.6 The sluice widens into the ravine of Pleck Brook to the west of the bridge, and has been remodelled heavily (Fig 7). This mainly involved the insertion of a concrete channel into the base of the sluice, which overlies the original edge-set sandstone floor at its eastern extent. This has sloping outer edges, with a vertical drop into a 0.61m wide, flat-bottomed central channel. It was presumably constructed to repair the base of the sluice, which terminates at the end of the concrete flooring (Plate 14).

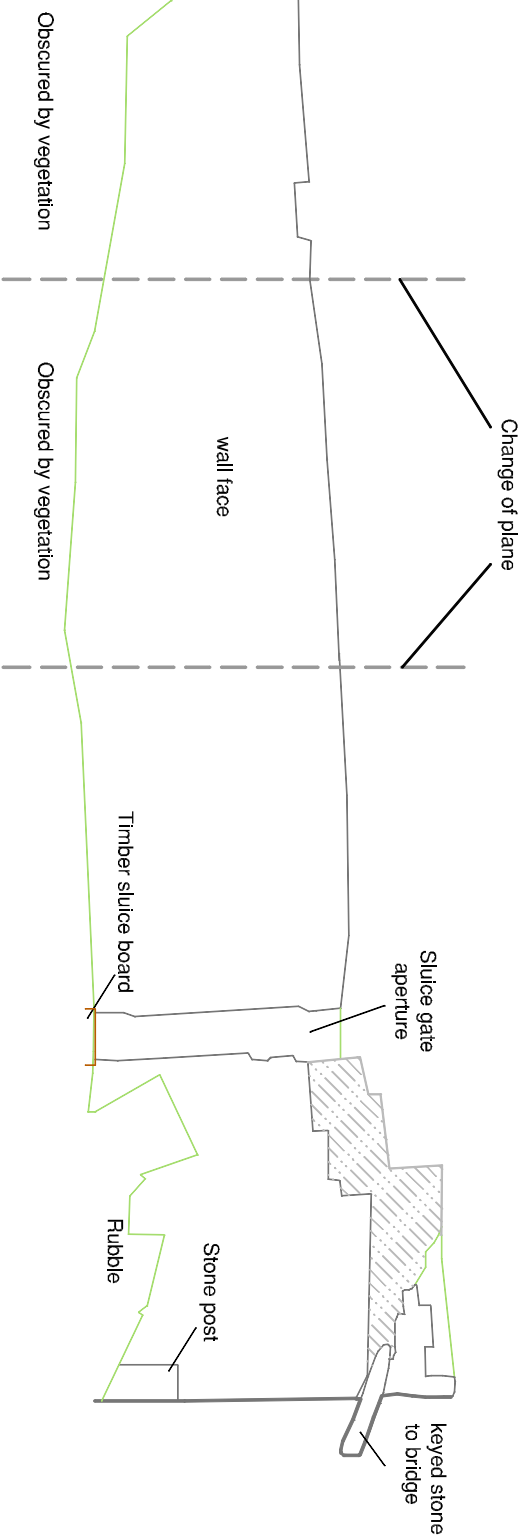
Figure 9: Area 1, Elevation A1\_3

- 4.2.4 The south wall (Wall A1\_3; Fig 9) survives for a length of 8.13m, and curves sharply to the south-east from the position of the sluice gate, and becomes an earthfast bank below a well-established tree. The wall is of similar construction to the north wall, but is keyed into the bridge at its western end, with one of the upper stones being keyed across the joint between the two elements at an angle of approximately 45° (Plate 13). The aperture for the sluice gate is of similar dimensions to that in the north wall, although it survives to a much lower height (Fig 9; Plate 13). Again, it appears integral to the initial construction of the wall, and incorporates the timber sluice board within its base. The wall curves sharply to the east, through an angle of approximately 90°, presumably forming the western boundary wall of the reservoir. The wall was constructed to a greater height to the west of the sluice aperture, extending up to the level of the bridge to the west.

- 4.2.5 At the base of the south wall, at its junction with the bridge, a square-section stone post, 0.48m high, projects 0.2m from the wall face (Fig 9). This corresponds with the position of a 0.30 x 0.23m rectangular aperture, set slightly higher in the north wall (Fig 8). This probably housed a timber beam, which would have been placed across the sluice, forming the top of a grate, to prevent larger items of debris becoming lodged under the bridge. The base of the sluice, to the east of the bridge, was largely covered by silts, demolition debris, and recent tipping, but two areas of partial survival of the original flooring were observed (Fig 7; Plate 12). These comprised edge-set sandstone blocks, aligned in rows, and sloping from the side-walls of the sluice towards the centre of the channel. These were well-preserved under the bridge to the west, where they had been protected from damage by the bridge above.

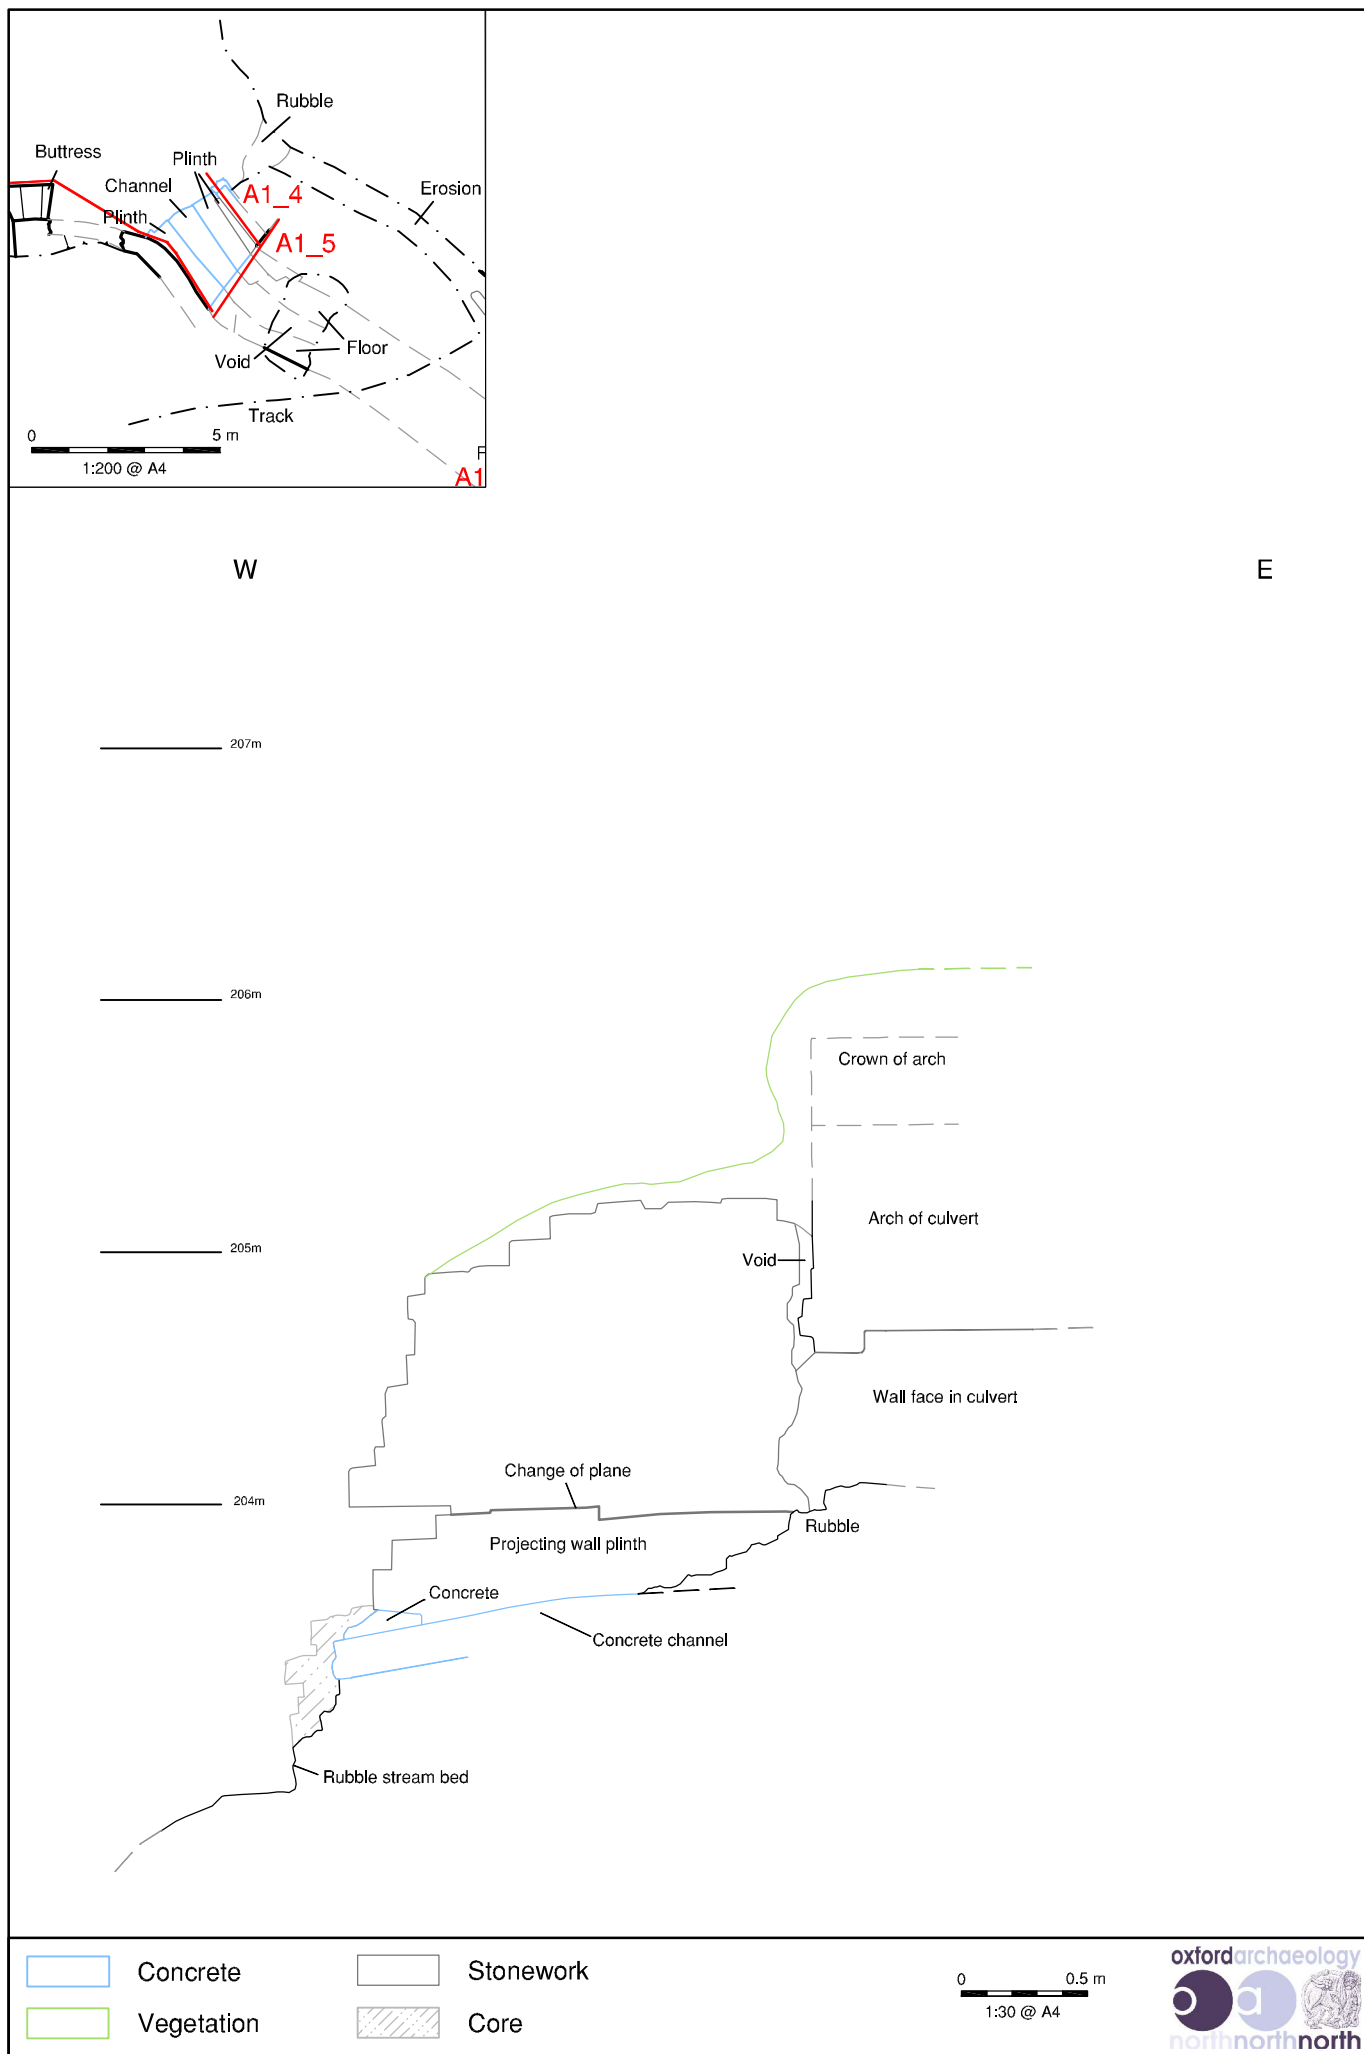
Figure 10: Area 1, Elevation A1\_4

4.2.7 The majority of the north wall (Wall A1\_4) survives along this part of the sluice, although it has collapsed at its western end, and has lost several of the capping stones along its length (Fig 10). It has an offset plinth, 0.42m above its base (Plate 14), presumably for structural stability, and also allowing a greater flow of water through the channel when required. The southern wall (Wall A1\_6) survives to a greater height (a maximum of 2.59m), and retains several of its coping stones, laid in buck and doe style, comprising alternating raised and lower coping stones (Plate 15; Fig 11). At its western end, level with the end of the concrete channel within the sluice, the wall has a sharp curve to the south-west into the ravine of the Pleck Brook. However, the wall has collapsed almost immediately beyond this change of direction, surviving only as a loose rubble core (Plate 15). Both walls of the sluice abut the bridge to the east.

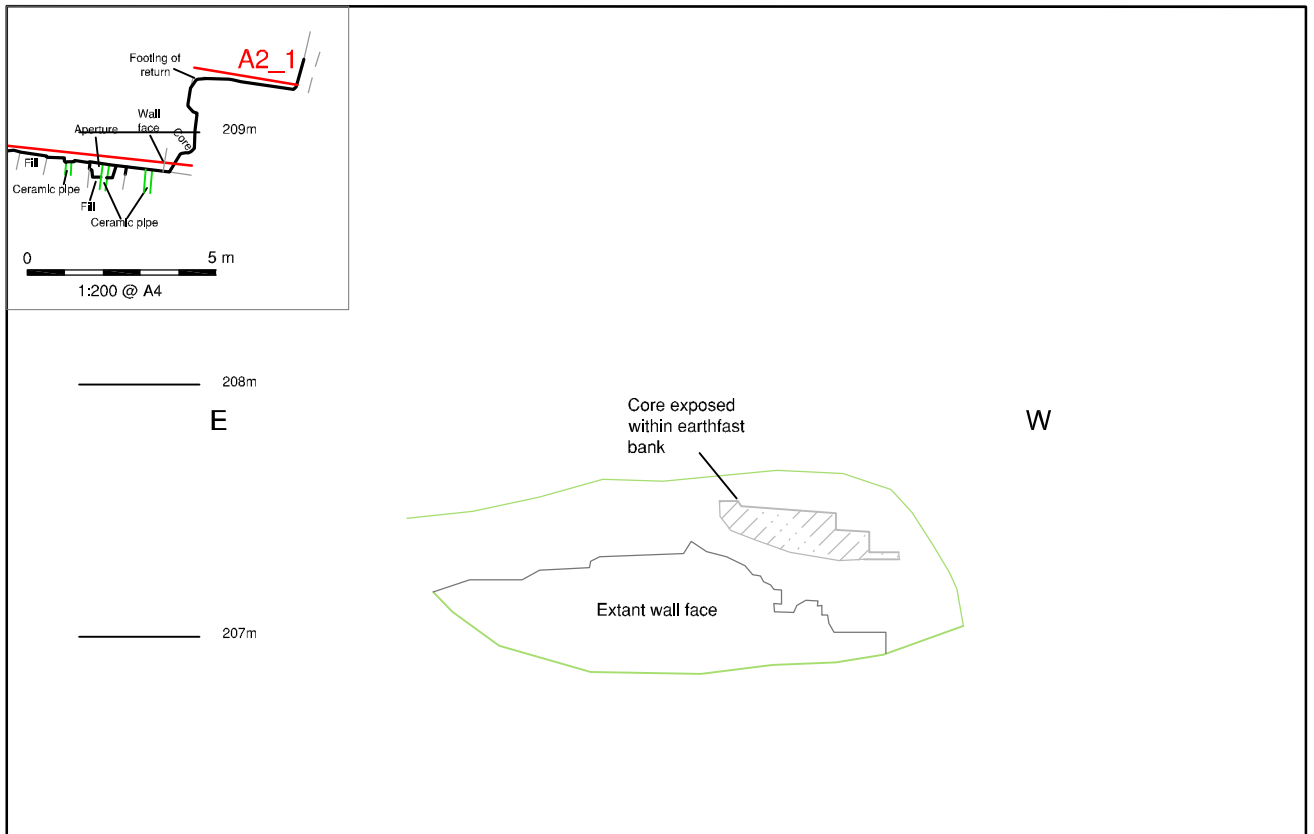
Figure 16: Area 2, Elevation A2\_1

- 4.3.3 At the eastern end of the study area, an east/west-aligned sandstone wall (Wall A2\_1) survived for a length of 1.76m, and to a maximum height of 0.47m (Figs 15 and 16). At ground level at its eastern end, the vestiges of a possible northward return survived, whilst a damaged return to the south survived at its western end. This survived for a length of 2.57m, where it had an unclear junction with a more substantial east/west-aligned wall (Wall A2\_2), which survived to a maximum height of 1.73m, and for a length of 13.85m (Fig 15). This contained elements of phasing, demonstrating the development of the printworks over time. The initial phase comprised a wall of roughly dressed and coursed sandstone rubble, bonded in a lime mortar, although the majority of the wall face comprised hungry joints (Plate 22).

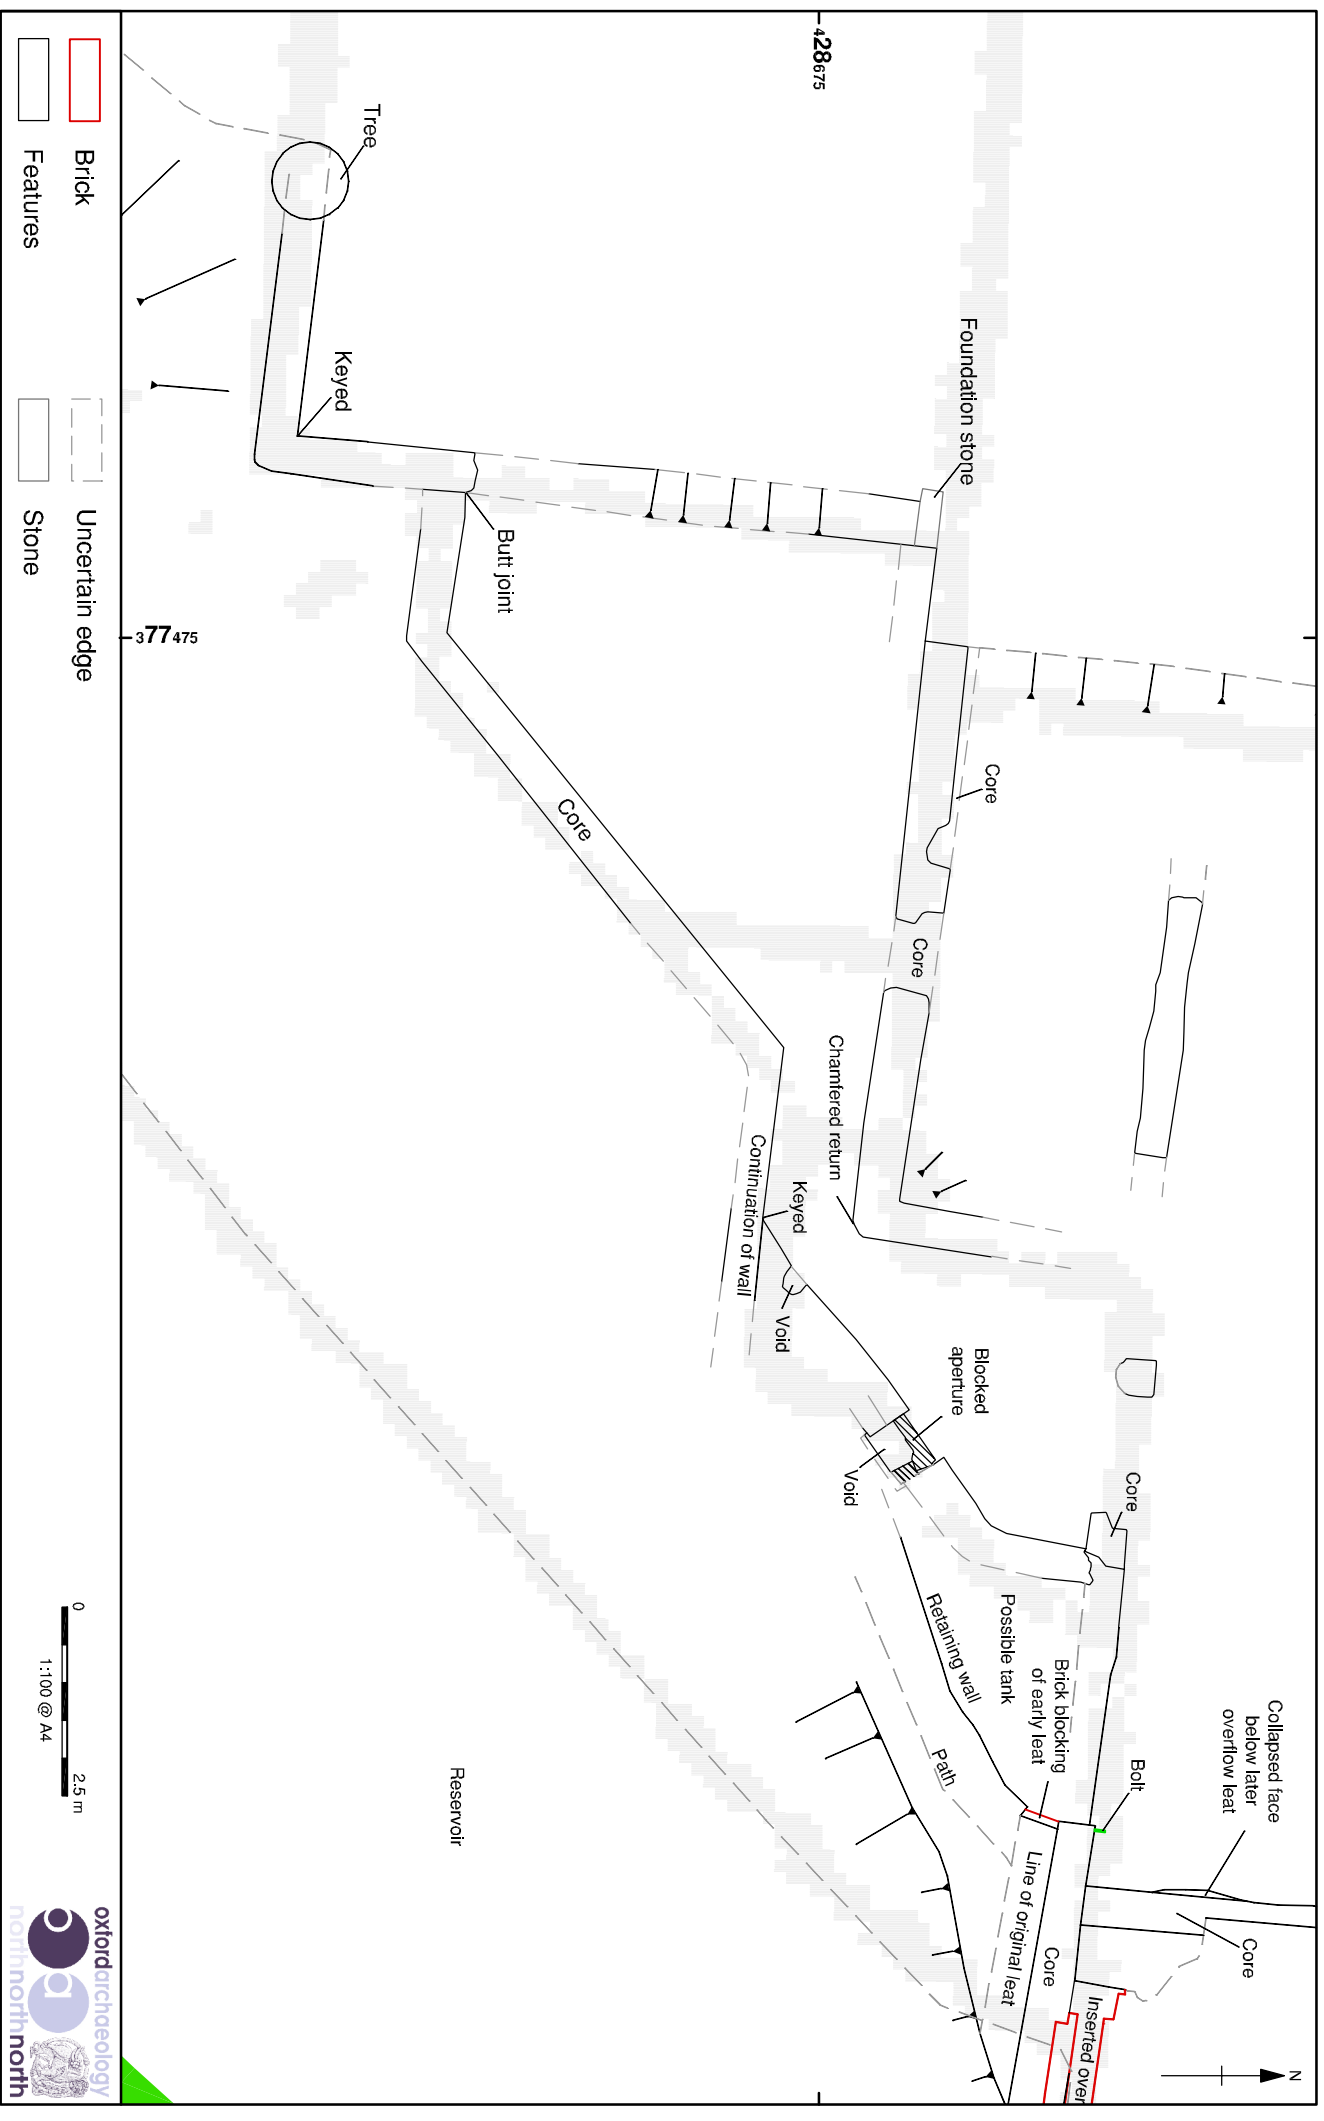
Figure 21: Detail of Walls A2\_6 to A2\_12, overlain onto the Ordnance Survey first edition 25": 1 mile map of 1893

- 4.3.10 The boundary wall has a further dog-leg at its western end (Wall A2\_8), parallel to the stub-walls to the north (Figs 21 and 23), and survives in a poor state of repair, before returning to the south-west (Wall A2\_9; Figs 21 and 24). This has a low return at its south-western end (Wall A2\_10; Figs 21 and 24), which butts the extant southern end of the earlier earthfast walls to the north (Wall A2\_11; Figs 21 and 25). This has a keyed, perpendicular return (Wall A2\_12), which terminates at a large tree trunk (Figs 21 and 26).

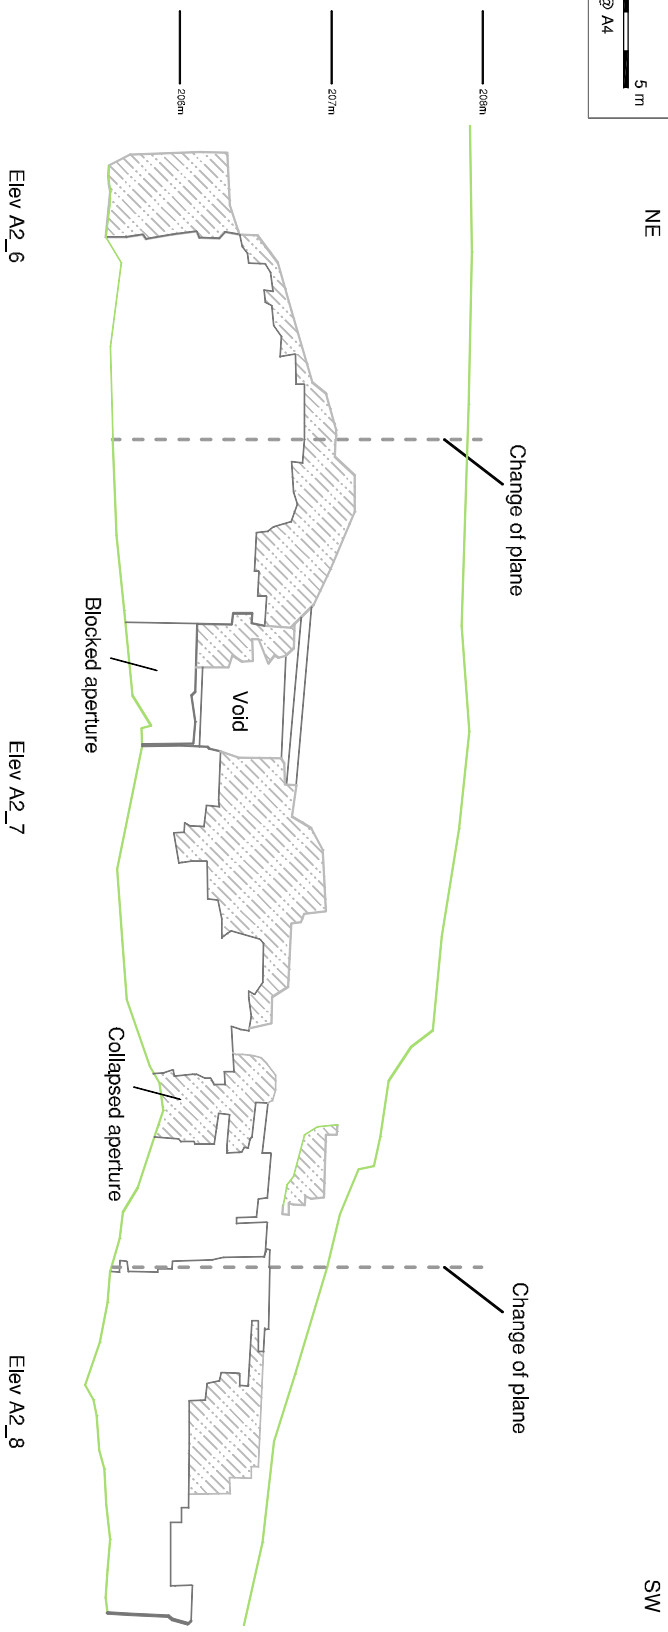
Figure 23: Area 2, Elevations A2\_6 to A2\_8

4.3.8 The western end of the surviving section of Wall A2\_5 was butted on its southern side by a wall of similar construction (Wall A2\_6), which survived to a similar height for a distance of 1.39m (Figs 21 and 23), before returning at an angle of approximately 45° (Figs 21 and 23; Plate 25). It seems likely that this infilled the available space to the reservoir wall, demonstrating the documented expansion of the complex during the second half of the nineteenth century. Two further foundational remains of similar width walls, on a similar orientation to that to the north, appeared to represent an earlier L-shaped extension to the southern side of the complex (Fig 21; Plate 26). A 0.93m wide gap in one of the walls also appeared to represent a doorway, although given the overgrown nature of these walls, it was not possible to determine whether this was an original feature, or inserted after the building was extended to the reservoir wall to the south (Figs 3 and 4).

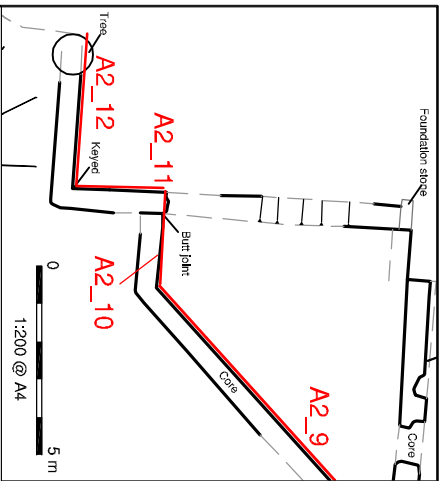
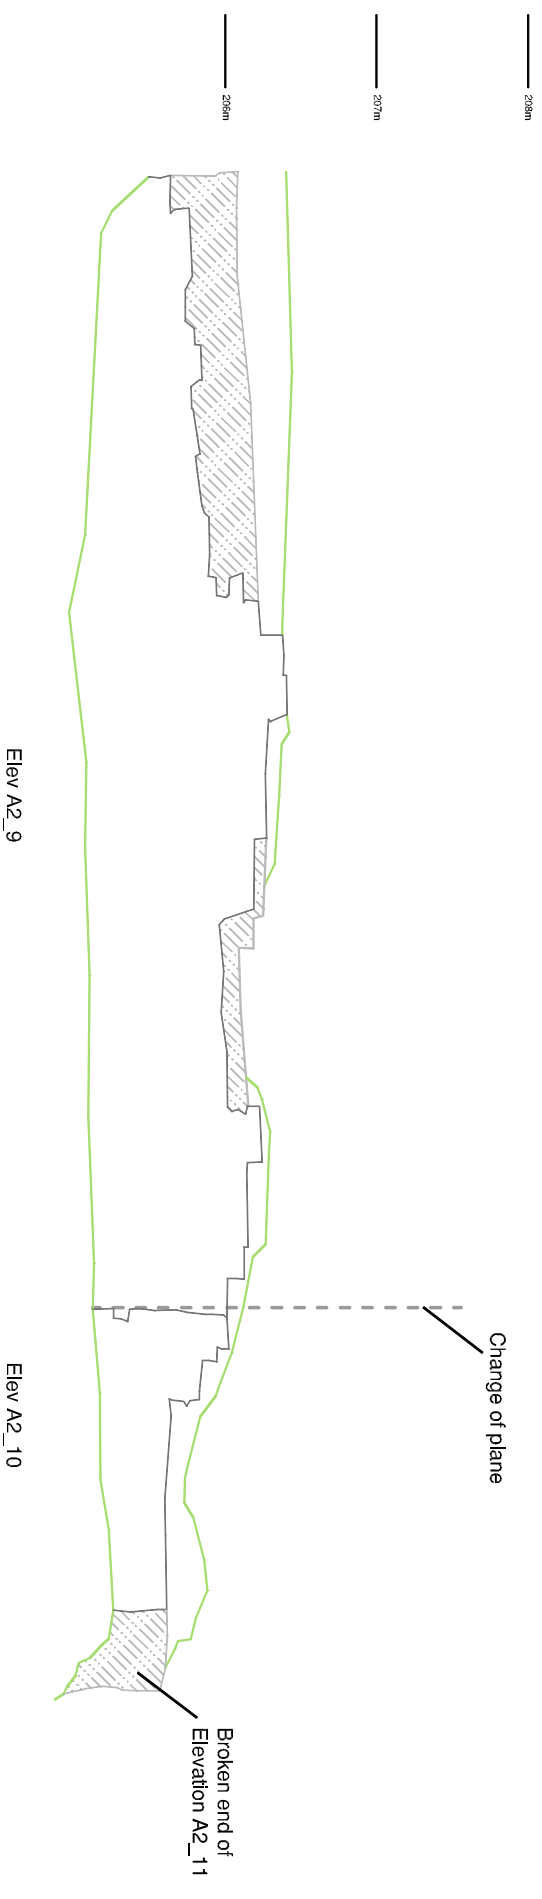
- 4.3.9 The angled extension along the reservoir wall (Wall A2\_7; Fig 23) contained a large recessed aperture, measuring 0.68m wide and 0.45m deep, which survived to the full height of the extant wall (Plate 25). Its rear wall comprised vertically set sandstone flags, the upper of which had been flattened into a horizontal position by a large tree growing out of the reservoir wall (Plate 25). The aperture, which had been stone blocked subsequently, probably represents a deep window light, affording daylight into what may have been a half-basement level; it could not be confirmed with confidence that this part of the mill complex incorporated a half basement, although this was implied from the level of the window light relative to the surrounding ground. Conversely, it is possible that the feature represented a vertical chute, perhaps leading into a culvert in this narrow part of the building, which appeared to be a passage into a larger room to the south-west (Fig 21). A less well-preserved and narrower aperture to the west, again partially infilled with stone (Fig 23), may have served a similar function.

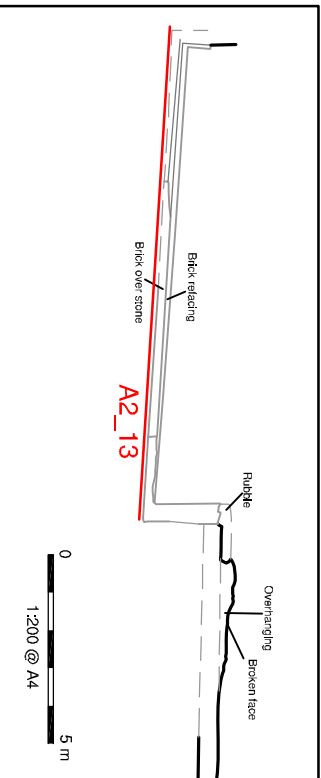
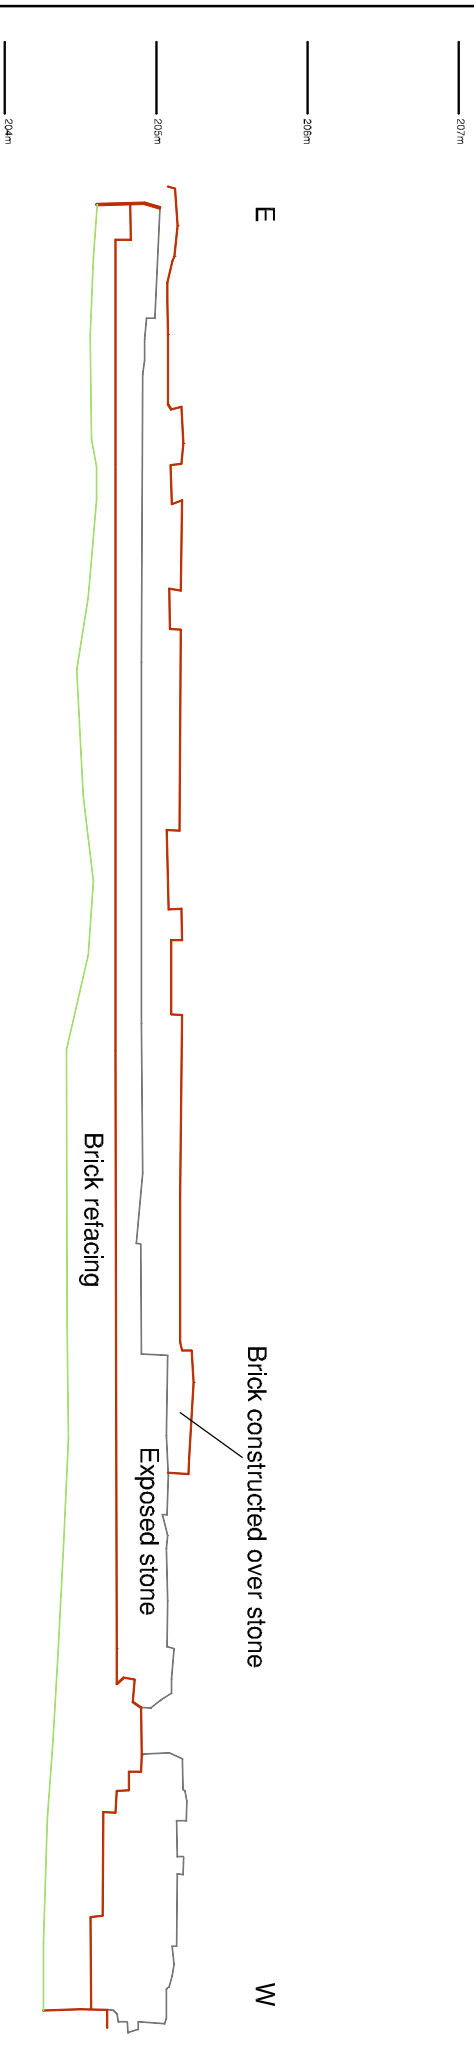
Figure 27: Detail of Wall A2\_13, overlain onto the Ordnance Survey first edition 25": 1 mile map of 1893

- 4.3.11 The wall is obscured completely to the west by vegetation for a distance of approximately 12m, reappearing as a stone wall lined with machine-made bricks (Wall A2\_13; Figs 27 and 28). This represents a remodelled or strengthening of the wall, and comprises locally-made 'Accrington' red bricks (Plate 27). At its western end, both the stone and brick elements of the wall return to the north, at a height of only 0.39m, before returning west as a shallow battered, stone retaining wall, for a distance of 13m (Fig 29; Plate 28). At the western end of the study area, this has a northward return as an earthfast wall, the vertical face of which is visible intermittently for approximately 12.7m. In the undergrowth between these two walls, the partial remains of a culvert are visible (Plate 29). This is of stone construction, measures 1.86m wide, and survives to a height of two courses on its northern side. It still retains water at its western end, and follows the alignment of the retaining walls. Its precise function remains, although it possibly represents a drain from the main processing areas from the structures adjacent to the reservoir to the east.
