Carr Mills, Meanwood Road, LEEDS, West Yorkshire

Archaeological Building Investigation

Oxford Archaeology North

May 2006

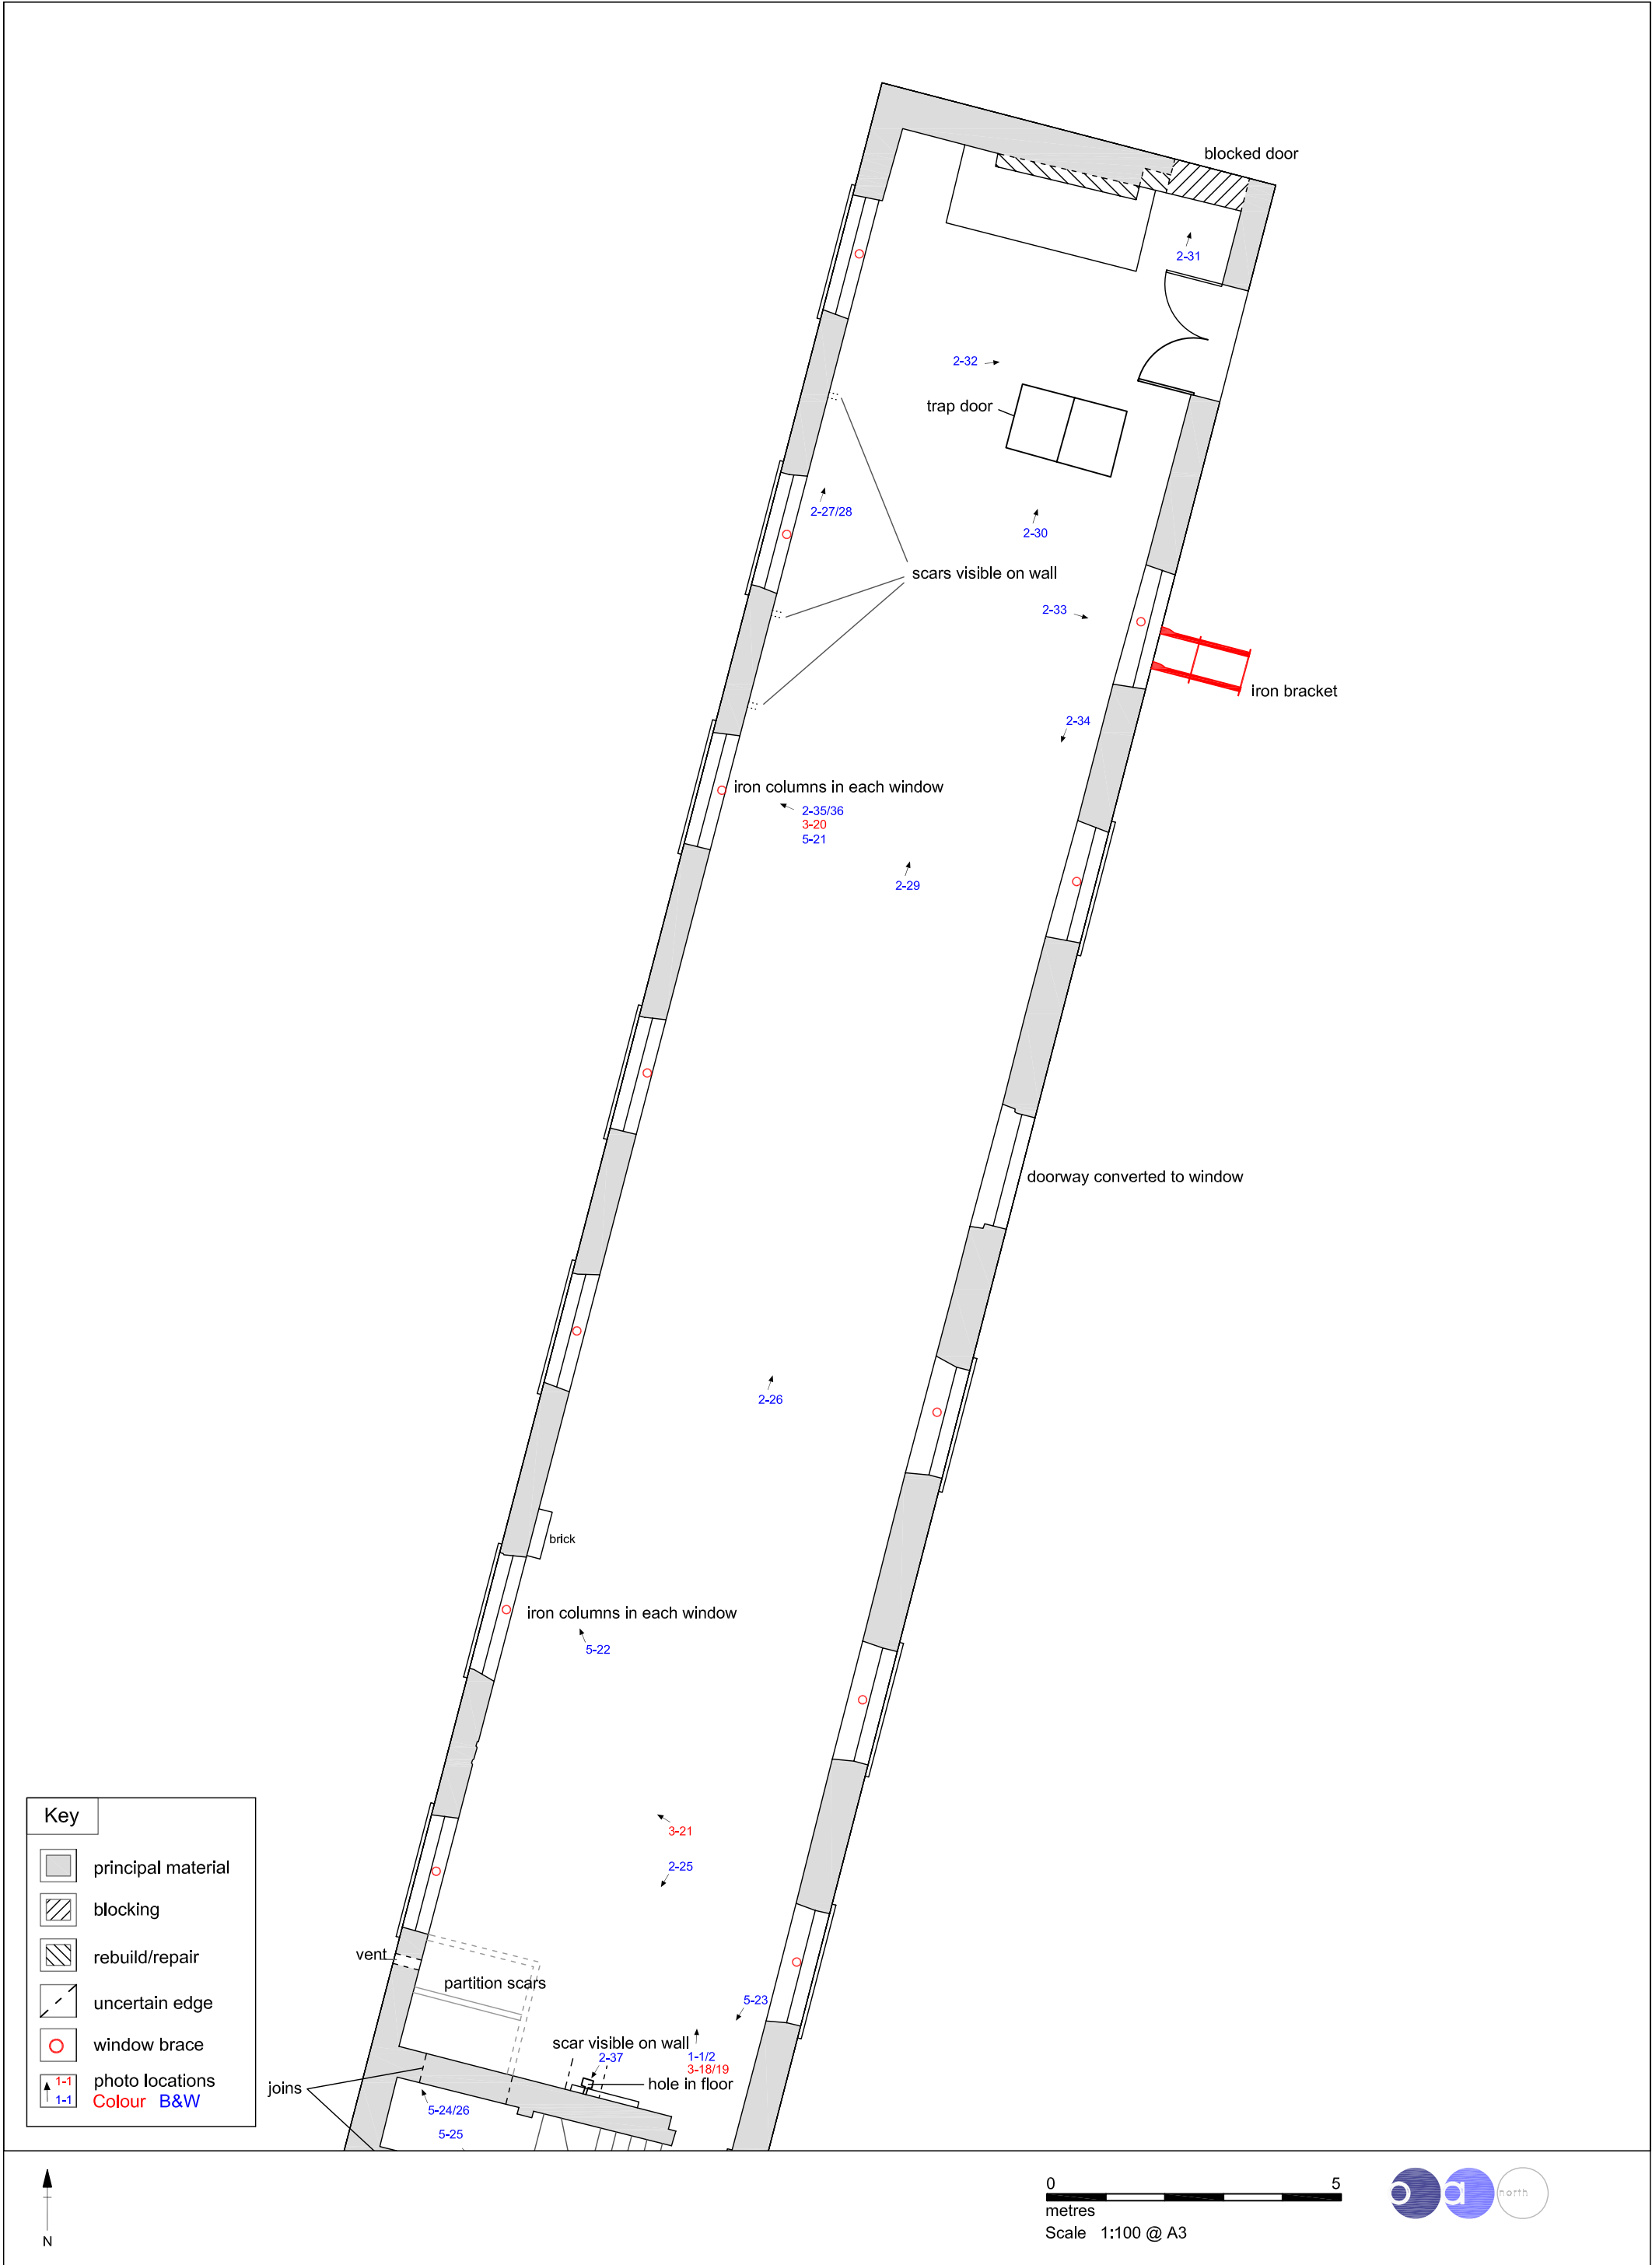
Figure 7: Second floor plan of Range B

- 3.5.46 At the north end of the east wall is a loading bay (Bay 7) which appears to have been created by modifying an existing window (Photo 2:32) via the insertion of steel RSJs and a timber lintel. This is directly below similar openings on the third and fourth floors (Fig 7, Bay 4). Inspection of both

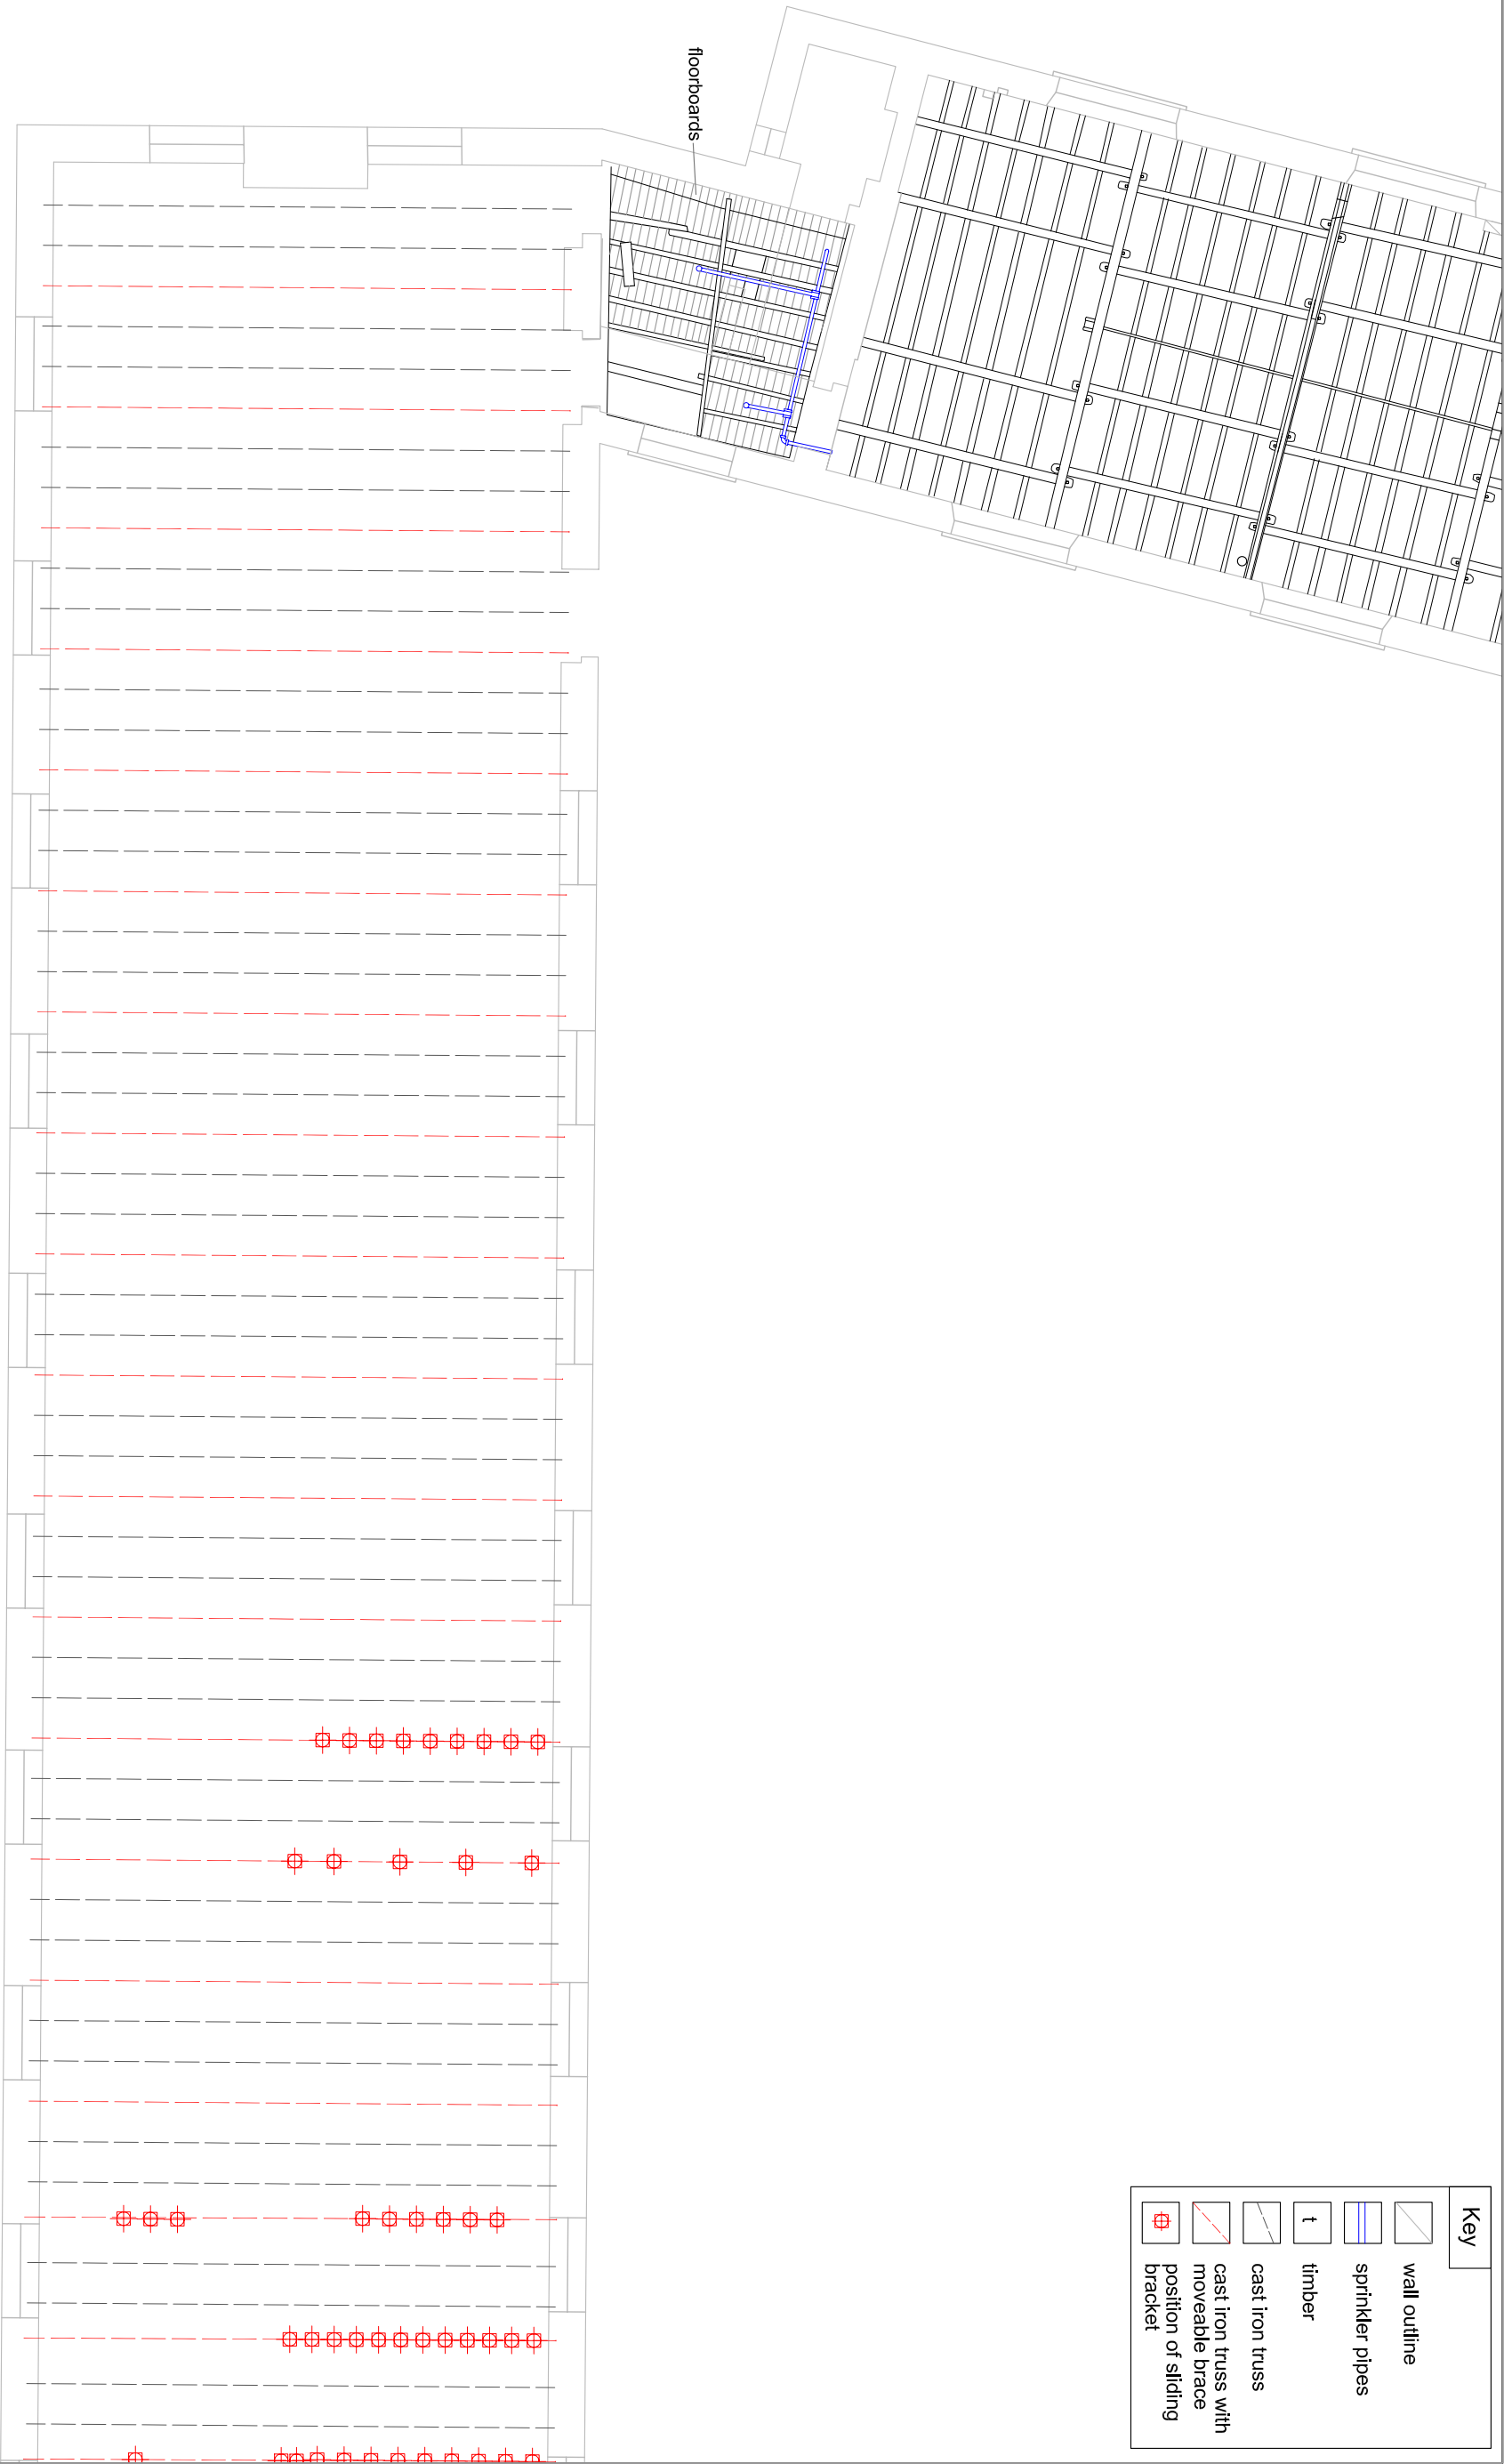
Figure 15: Fourth floor, reflected ceiling plan of Range A (west end)

- 3.5.27 There are 84 cast and wrought iron roof trusses, set two feet apart, which are of two types. These are based upon similar designs, the main difference being that every third truss has an additional tie beam and associated braces, sockets and tie rods (Figs 15, 16 and 22, Photos 11:15). Therefore, it follows that Trusses 3, 6, 9 and so on have rectangular wrought iron tie beams which are bolted to the base of the principals. They span the whole width of the building in a graceful arch not too dissimilar (although more plain in appearance) from the arched trusses at Old Mill Lane, Northowram, which was built in 1825-8 (Giles and Goodall 1995, Fig 124c), the main difference being the addition of tie beams and rods.

- 3.5.30 Most of those trusses with tie beams have various numbers of sliding brackets fitted to them (Photo 11:15, Fig 22). These are a single symmetrical casting with an integral rectangular slot through which the tie beam passes. On either side of each bracket is a flange with a single bolt hole. These brackets may have been designed to accommodate a length of timber which spanned three trusses and was connected to a corresponding bracket. At first this seemed a plausible explanation but more detailed inspection has revealed that there are not equal numbers of corresponding brackets on adjacent trusses (some may of course have been broken or removed) (see Figs 15 and 16).

common rafters with purlins that rest on the north and south walls. Initially, this was thought to be a continuation of the roof from Range B but closer inspection reveals it to be an independent construction (Fig 15). The roof above the toilet appears to be an extension of the roof from Range B. The roof of the stair/toilet has been constructed in such a way as to enable the slope of the roof from Range B to continue uninterrupted to the south wall of the stair tower.

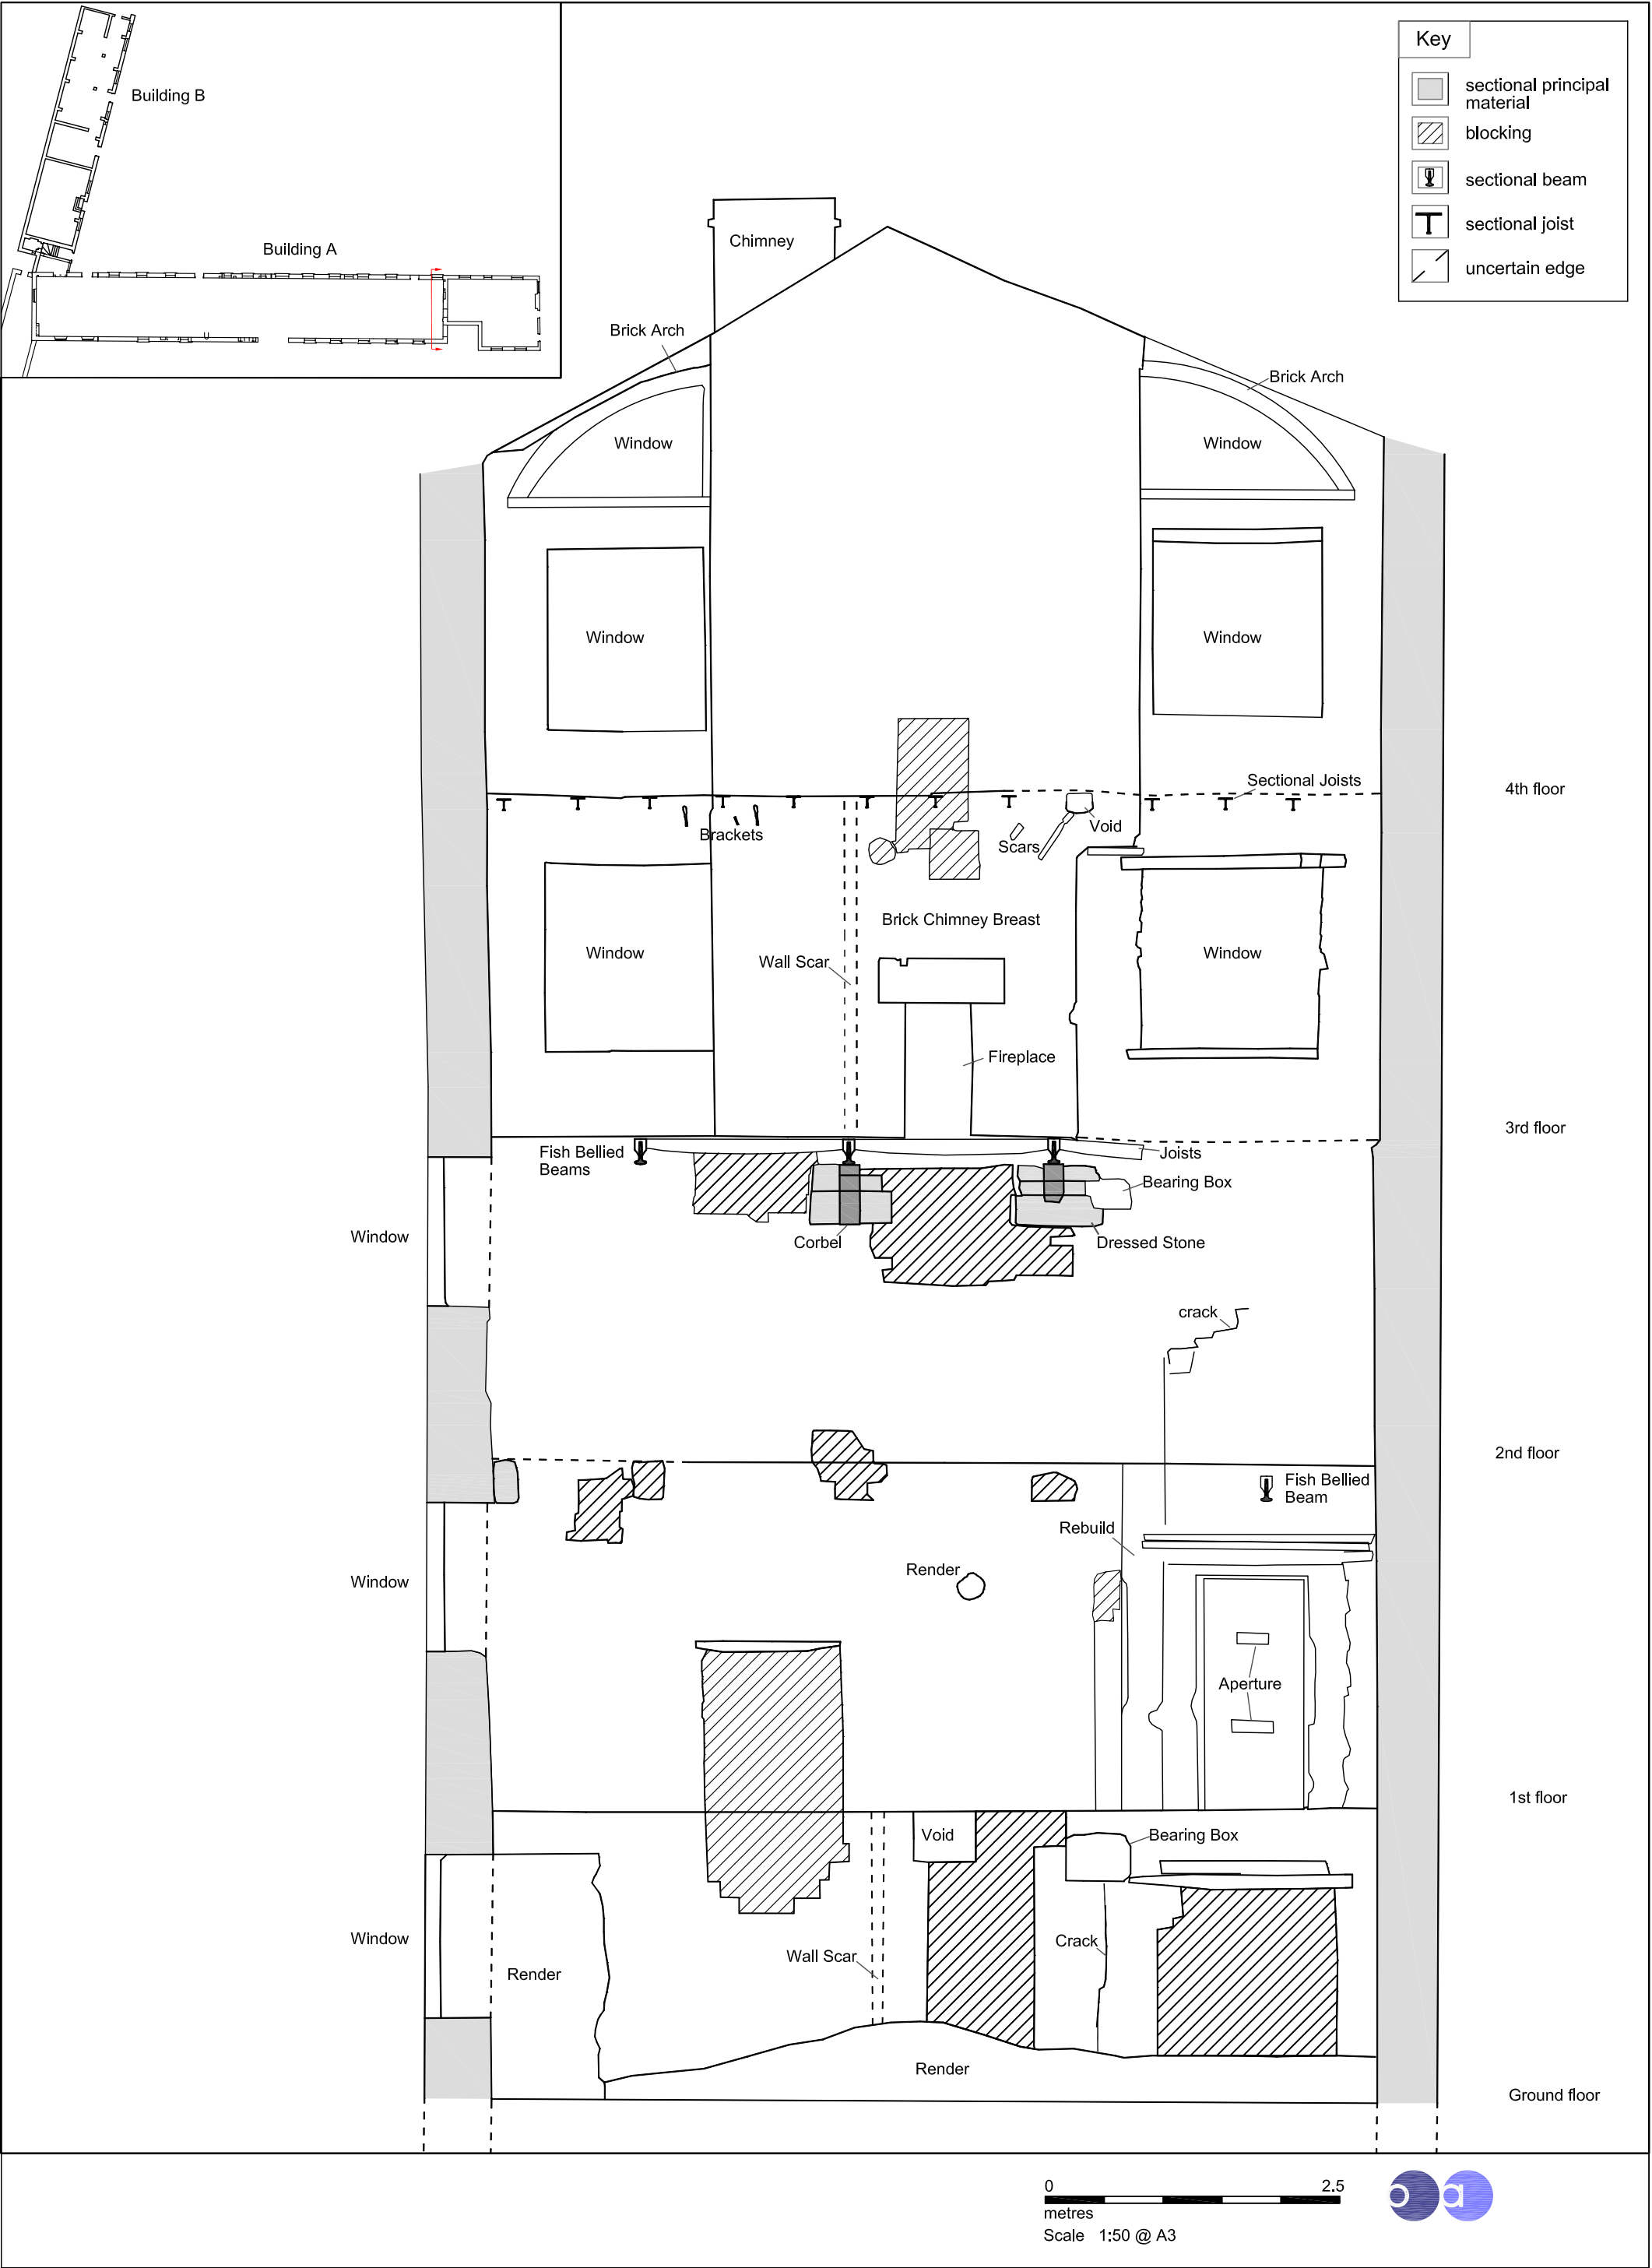
Figure 19: West-facing internal elevation of Range A

- 3.5.25 The east wall contains two windows either side of a projecting brick (stretcher bond with lime mortar) chimney breast, which contains a fireplace with a substantial sandstone lintel (Fig 19; Photo 6:19). To the left of the fireplace is a vertical wall scar, which attests to the presence of a studwall. A similar scar is present on the south wall (Photo 6:23). The east wall contains a similar projection (although deeper and of stone) with a window either side.
