MIDDLE HOUSE FARM BARN, CHIPPING Lancashire

Archaeological Building Investigation

Oxford Archaeology North
October 2003

Issue No: 2003-4/168
OA North Job No: L9257
NGR: SD 5868 4304

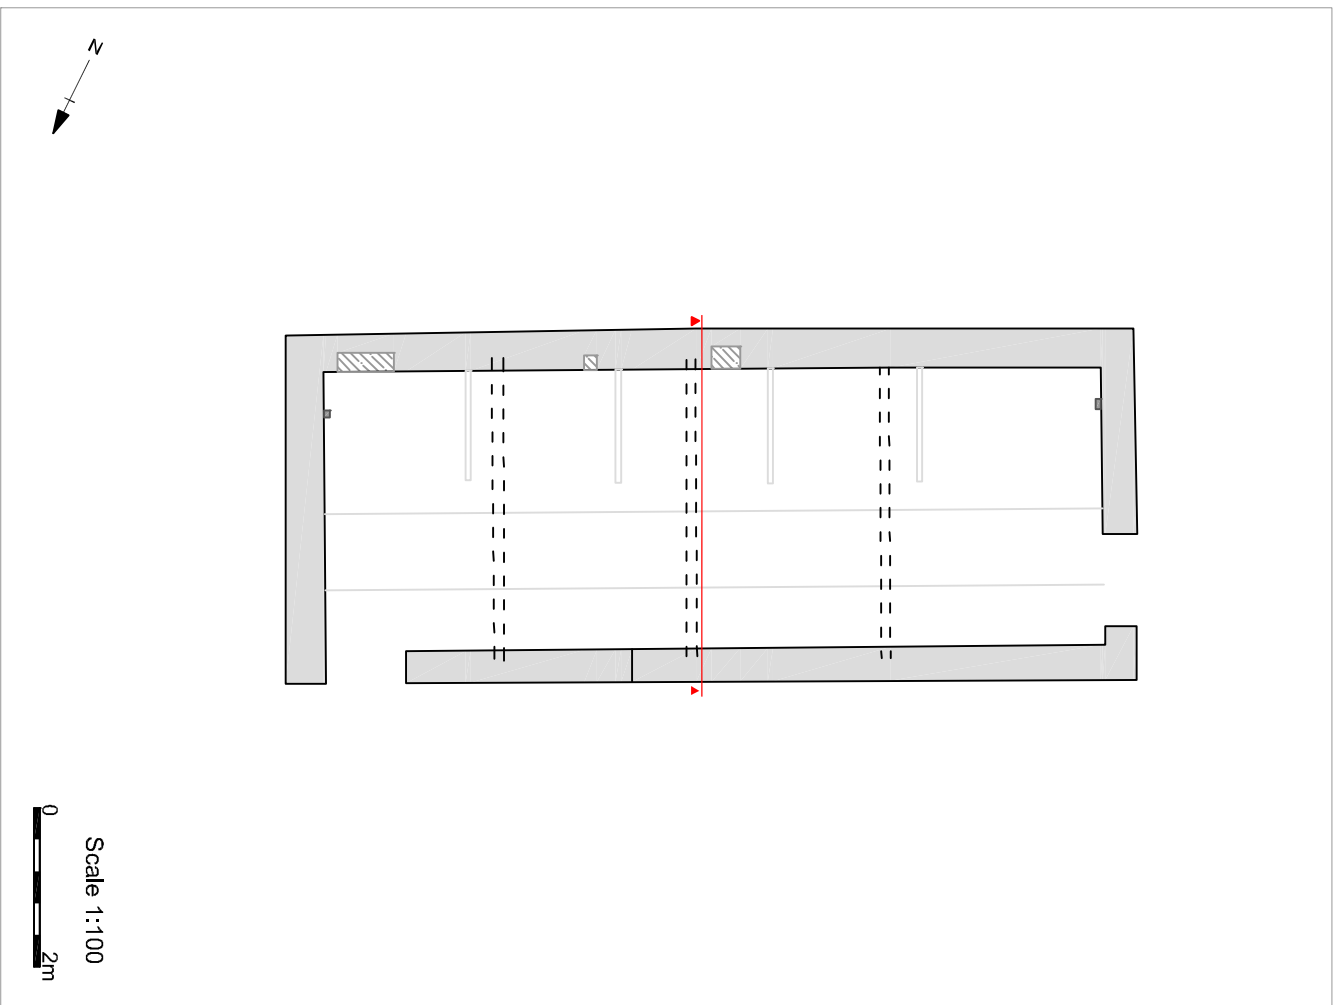
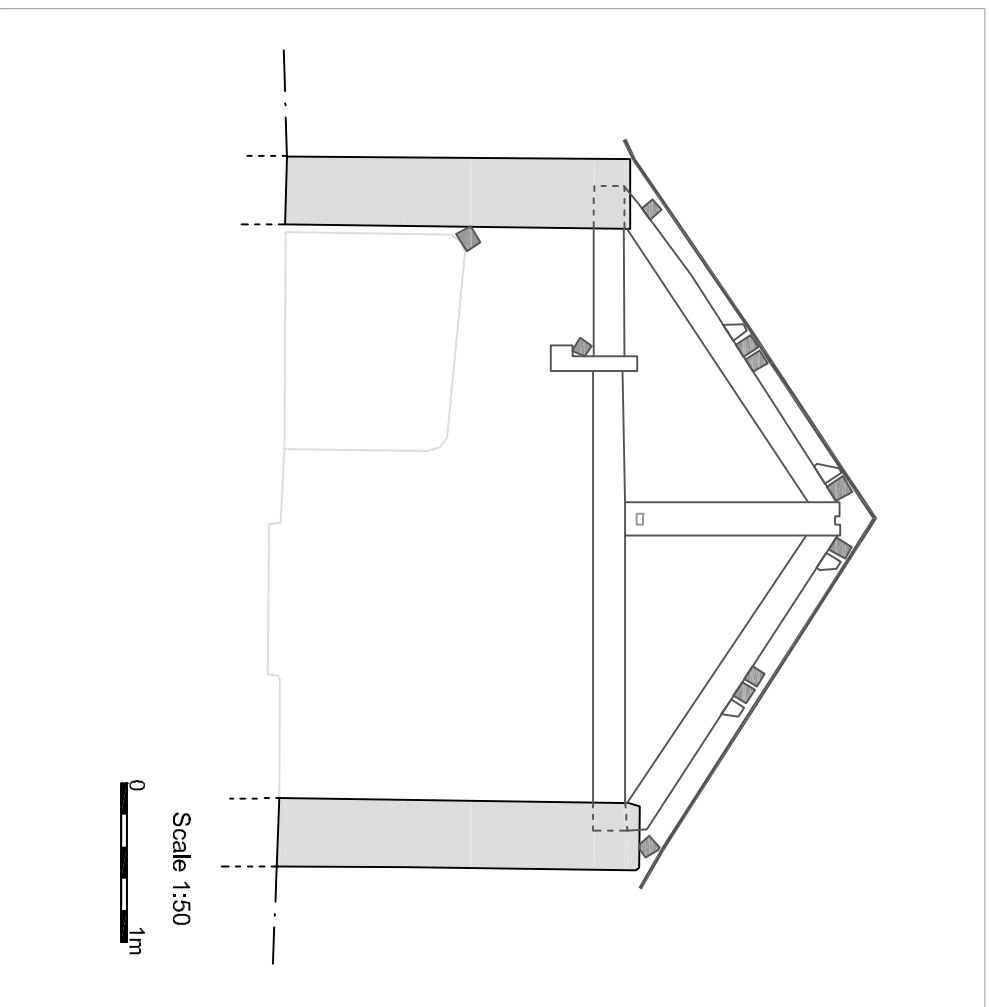
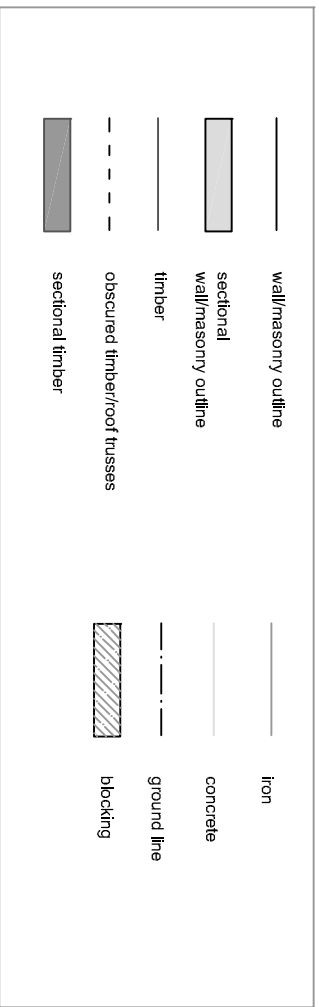
Figure 4 : Plan and east facing section of shippon

- 3.3.4 The roof consisted of three modern trusses of simple king post design. A hay rack along the south wall was held in position by notched lengths of timber fixed to the tie beams (Fig 4). A modern steel gate had been erected across the easternmost bay, presumably to control animal access.

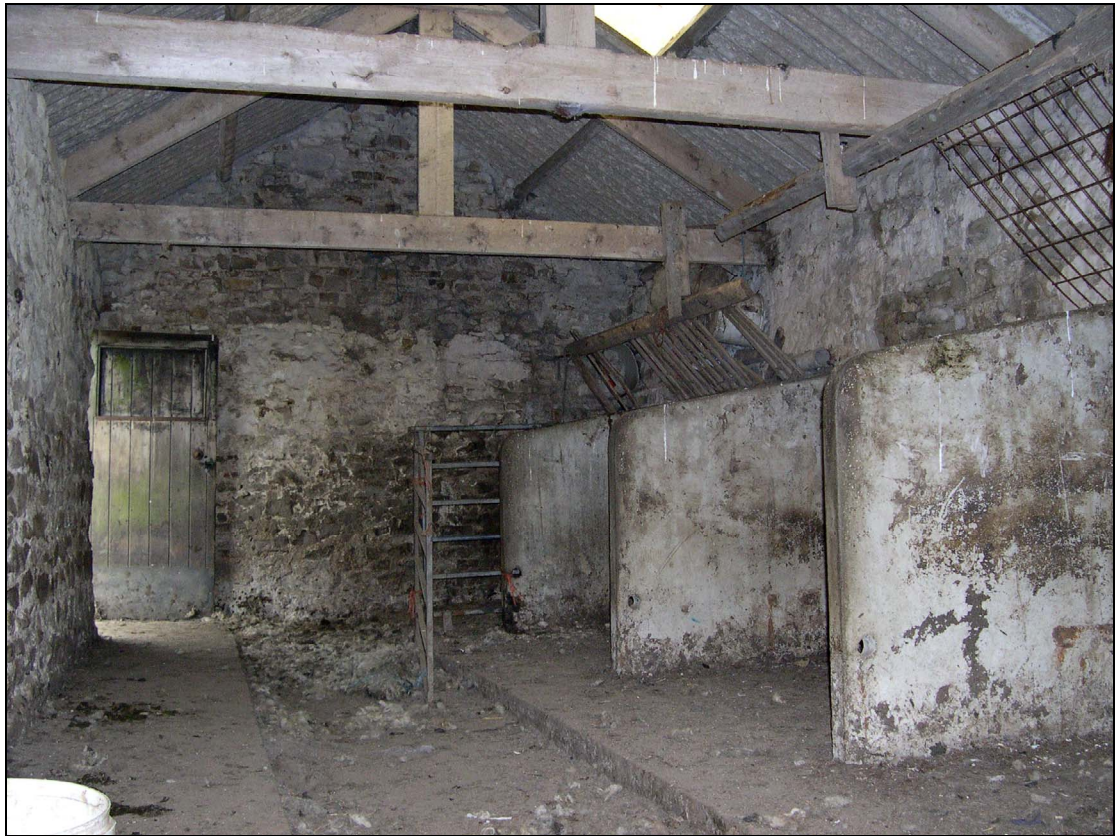
Plate 8: Interior of shippon, looking west

- 3.3.1 *External Detail:* this single storey building was located approximately 4m south-west of the barn (Plate 4). The only existing doorway was located at the eastern end of the north elevation (Plate 8). The building was seen to have a distinctly different build from the east side to the west. The eastern half of the north elevation was composed of roughly coursed, rectangular sandstone, whereas the western extent incorporated much more rounded cobblestones. The other elevations were predominantly of squared sandstone. Quoins were utilised on all corners except the south-west. Three ceramic land drains had been used as vents, and were evident along the uppermost course of the west elevation. Above this was a modern gutter.
