**TONDU IRONWORKS
BRIDGEND COUNTY BOROUGH**

ARCHAEOLOGICAL EVALUATION ON GROUND
TO SOUTH-EAST OF CALCINING KILNS

OXFORD ARCHAEOLOGICAL UNIT
SEPTEMBER 1998
GROUNDWORK BRIDGEND

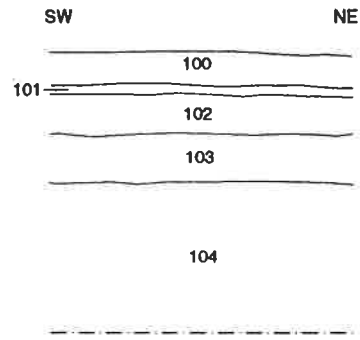
Test pit 1

- 3.1.2 The earliest deposit was a dark brown clay loam (104) with inclusions of slag, mortar and angular gravel. The deposit was excavated to a depth of 0.5 m but not bottomed. This was overlain by a compacted black shingle (103) 0.14 m thick, which formed an even surface across the excavated area. This surface was covered by a black clay loam (102), interpreted as topsoil. This was overlain by the geotextile (101) and compacted shingle (100) of the present road surface. No working surfaces demonstrably associated with iron-making were found, probably a result of the laying of the gas/water main (407). It is of note that at a depth of some 3 metres below the present ground surface, the geotechnical engineers penetrated a cavity (probably a flue) some three metres high at this point.
