The Black Barn, Warren Farm Horton-cum-Studley

Building record prior to repairs and alterations

NMR DATA	
Site Name	The Black Barn
Address	Warren Farm
Town	Horton-cum-Studley
Parish	Horton-cum-Studley
County	Oxon
NGR	SP 6055 1245
Listed Status	Grade II
Visit/Survey Date	May 1995
OAU Site Code	HOSWF 95

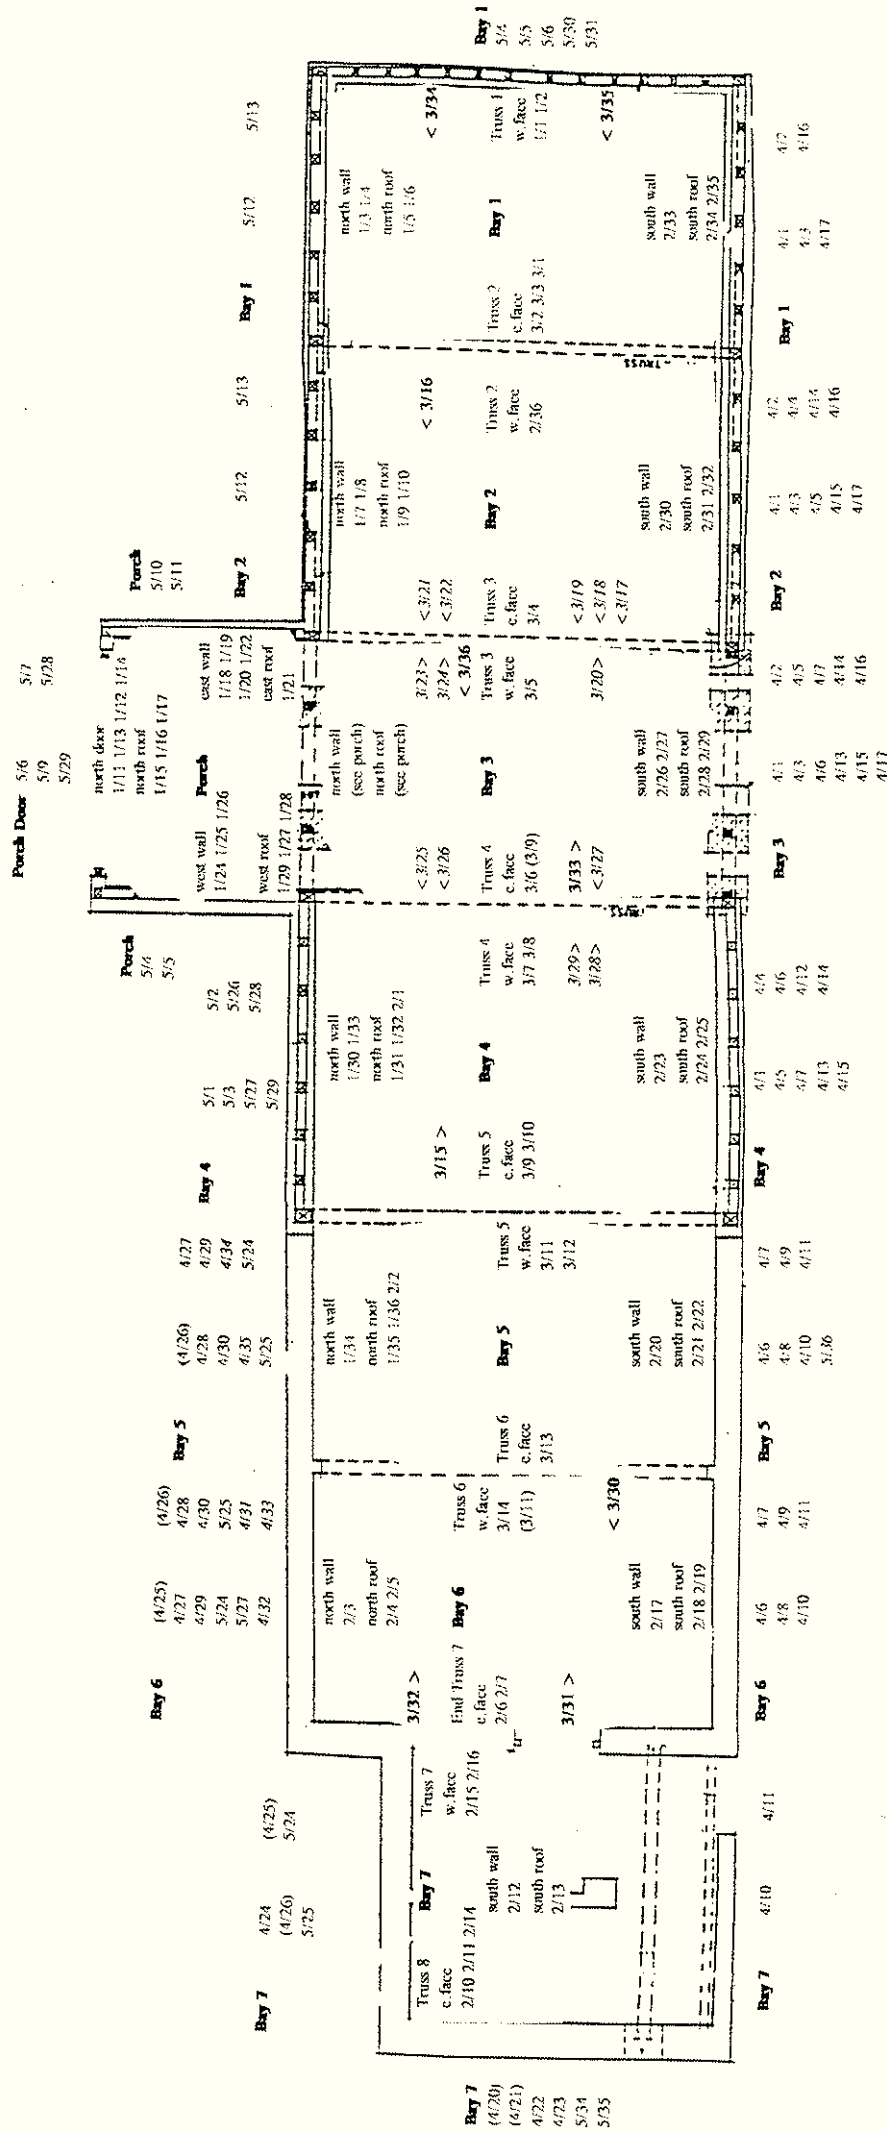
Photographic Key to The Black Barn, Warren Farm,
Horton-cum-Studley, Oxon

The first number refers to the film number and the second to the contact print number

Photographs showing general shots of the barn and the barn in its setting

4/18 4/19 4/20 4/21 4/25 4/26 5/8 5/17 5/18 5/19 5/20 5/21 5/22 5/23 5/32 5/33 5/35
