23-25 High Street Marlow Buckinghamshire

Historic Building Investigation and Recording

July 2008

Client: Comland Ringlead Ltd.

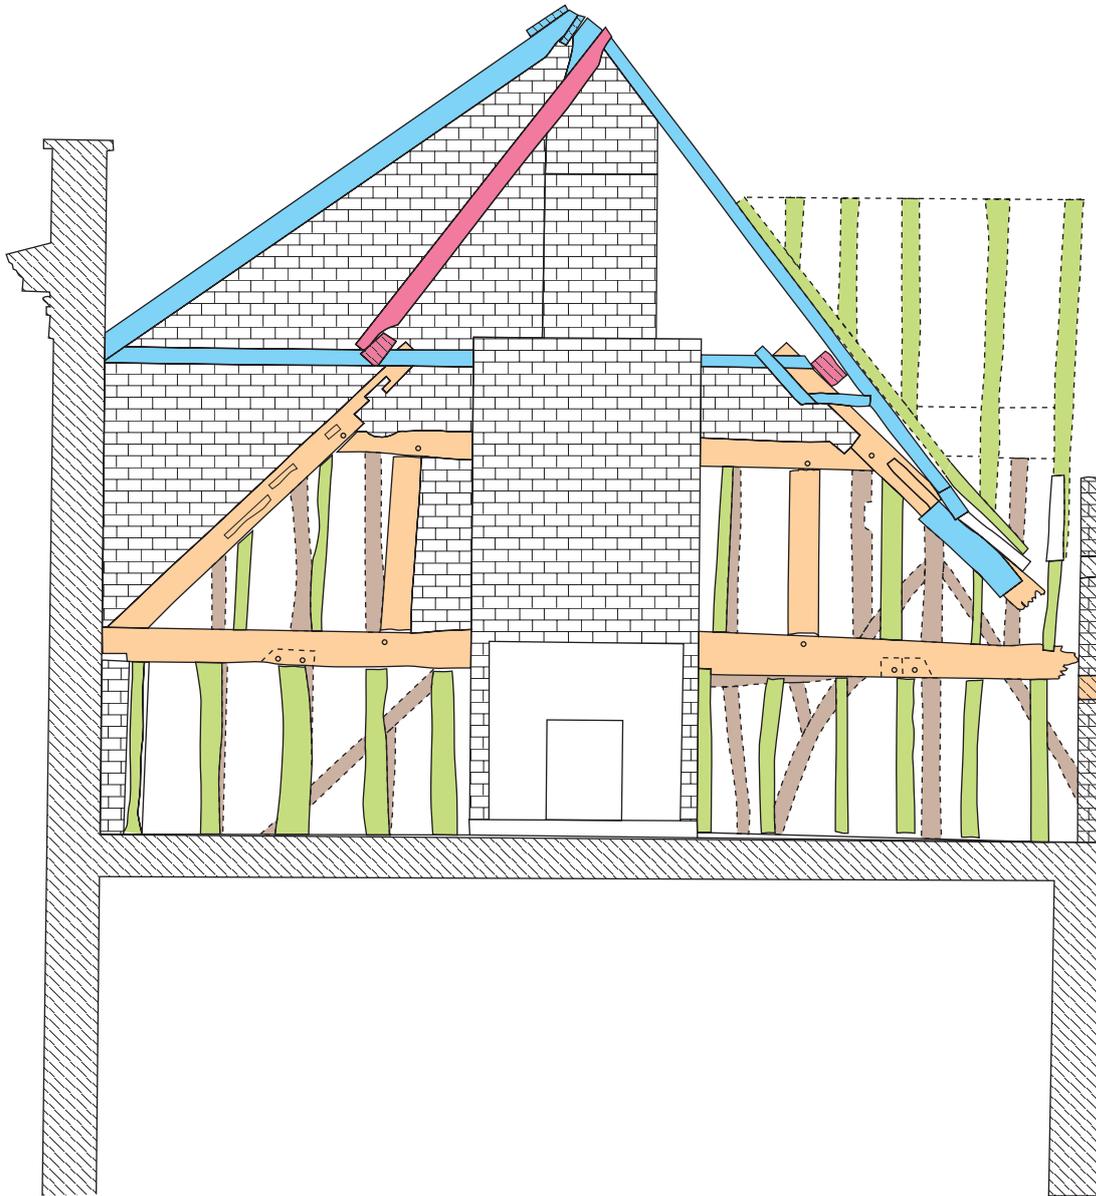
Figure 7: Truss 3: South elevation

3.6.5 Additional light stud framing was added to the main trusses to fill in the space above the principals which became part of the internal walls when the later roofs were added. In truss three brick infill was added above the western principal rafter. Ceilings were inserted after the roofs were altered by inserting central joists nailed to the underside of the primary purlins and outer joists between the primary purlins and later wallplates (Plate 18). The lower arrises of the primary purlins were flattened off to level up the ceiling, however the sagging east purlin at the north end meant that the joists from the purlin to the wall were set lower than the rest of the ceiling.
