Gate House

**Historic Building  
Recording**

**Gate House Farm, Culworth, Northamptonshire**

*Historic Building Survey*

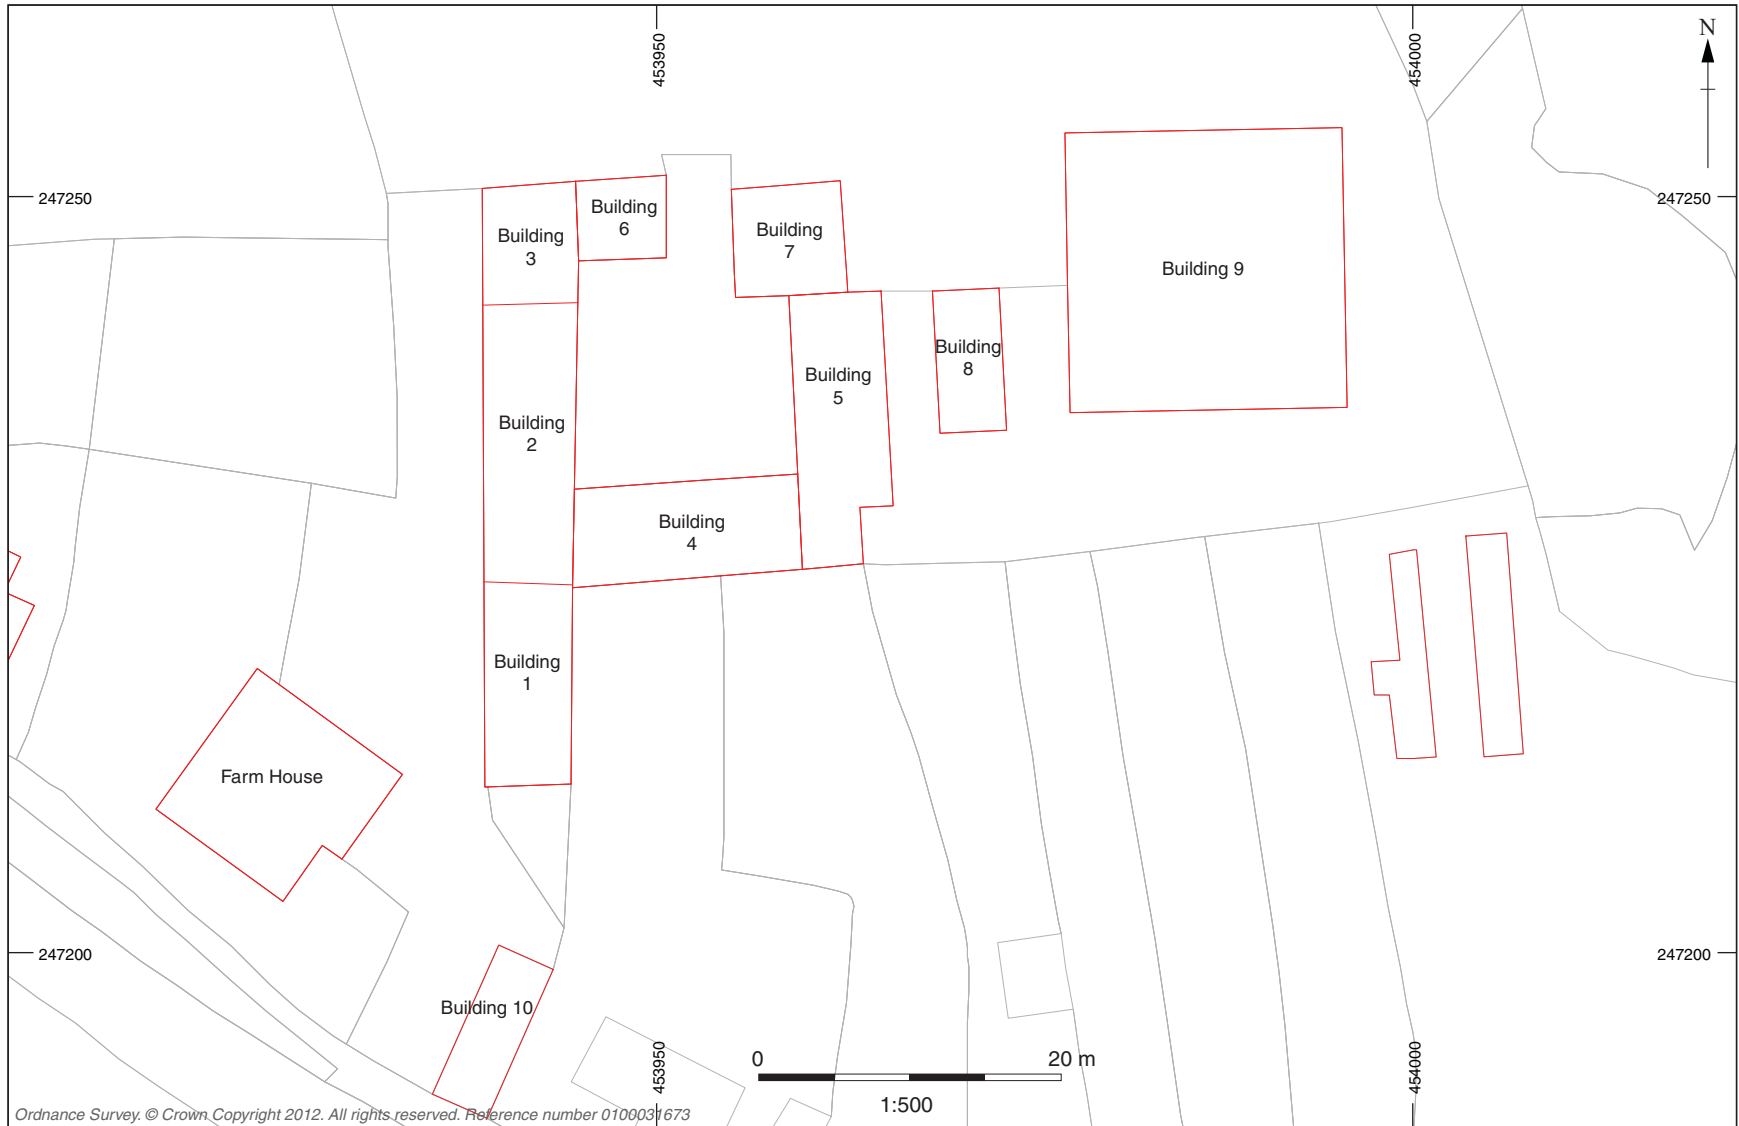
Figure 2: Plan of buildings surveyed at Gate House Farm, Culworth

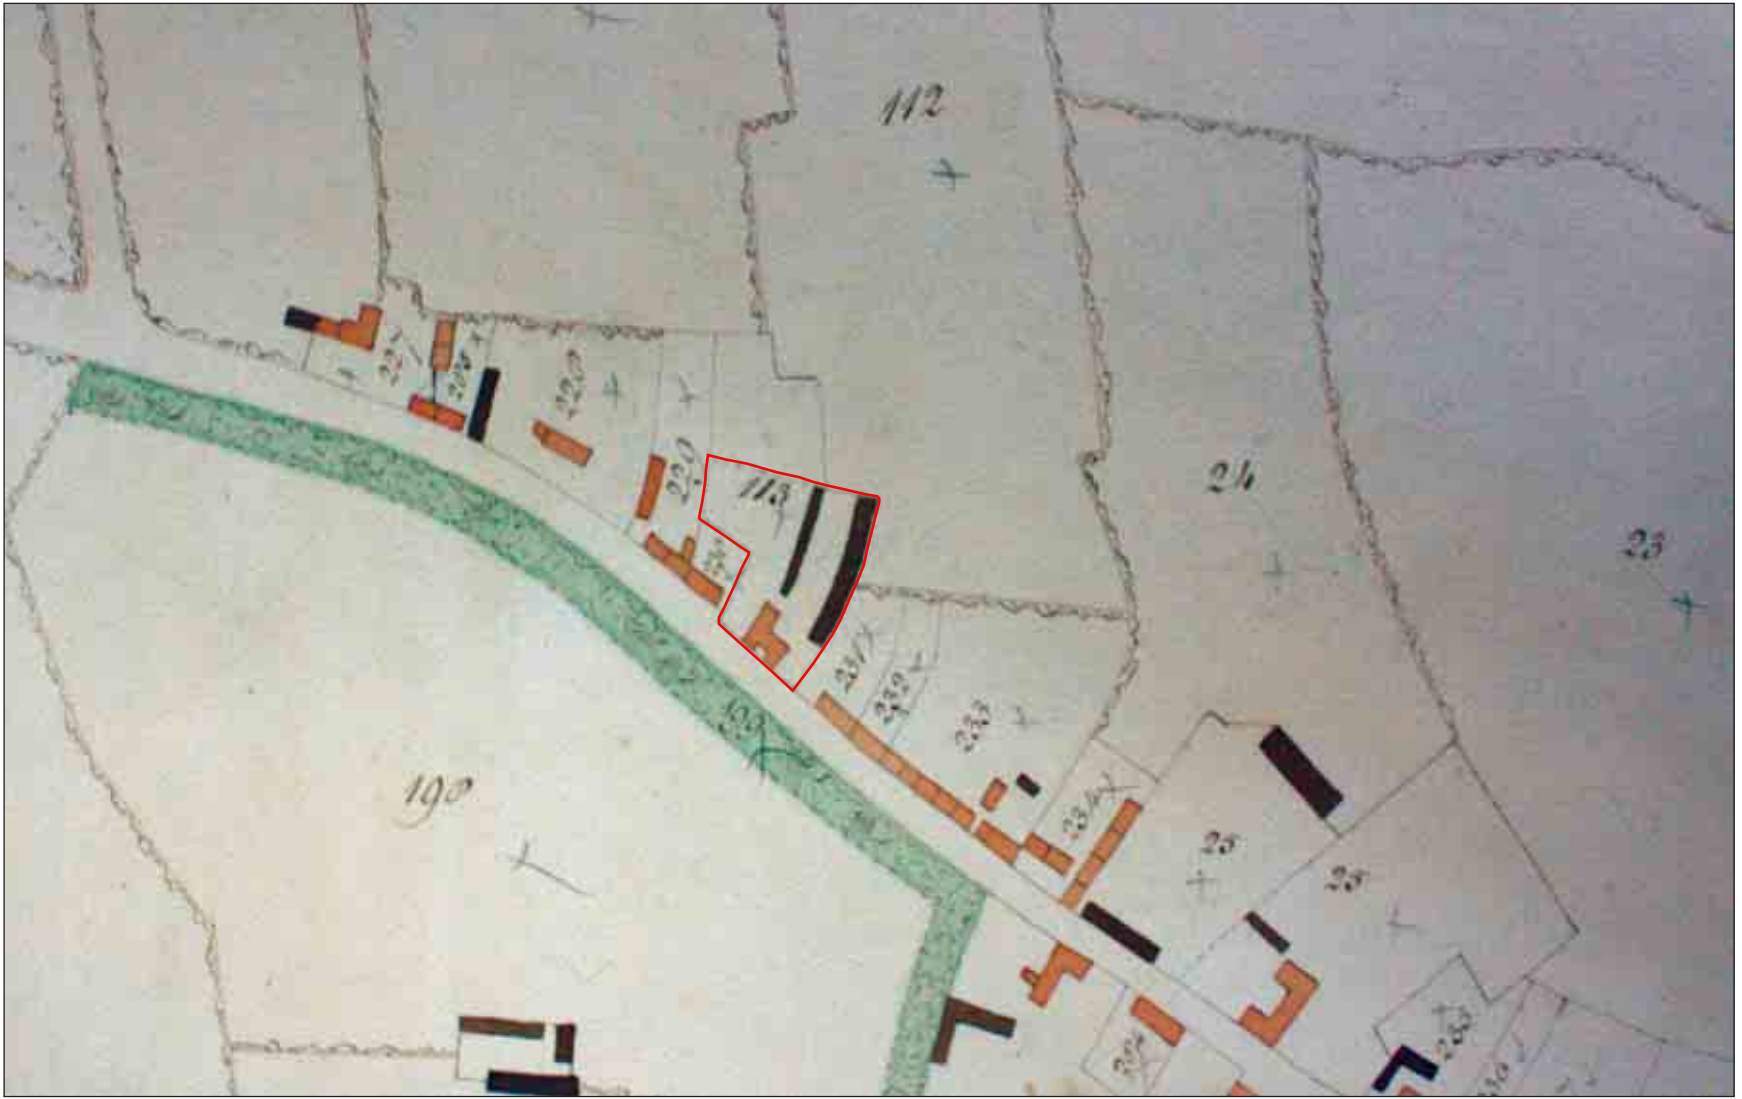
Figure 3 : Extract from Culworth Tithe Map, 1839, showing location of Gate House Farm (red)

*The earliest map consulted was the 1839 Tithe map (Figure 3), which depicts another parallel building range on the western side of the present range. Although there is no evidence to indicate when this was constructed, if it was contemporary with the earliest phases of buildings, the range may have included a threshing barn, hay barns, maltings, brew house or storage for other animals and/or a cart shed. This also suggests the original layout of the farm was directly to the north of the farmhouse as opposed to the shift to the east witnessed in the late 19th and early 20th century.*

**Culworth Tithe Map, 1839** (Figure 3)

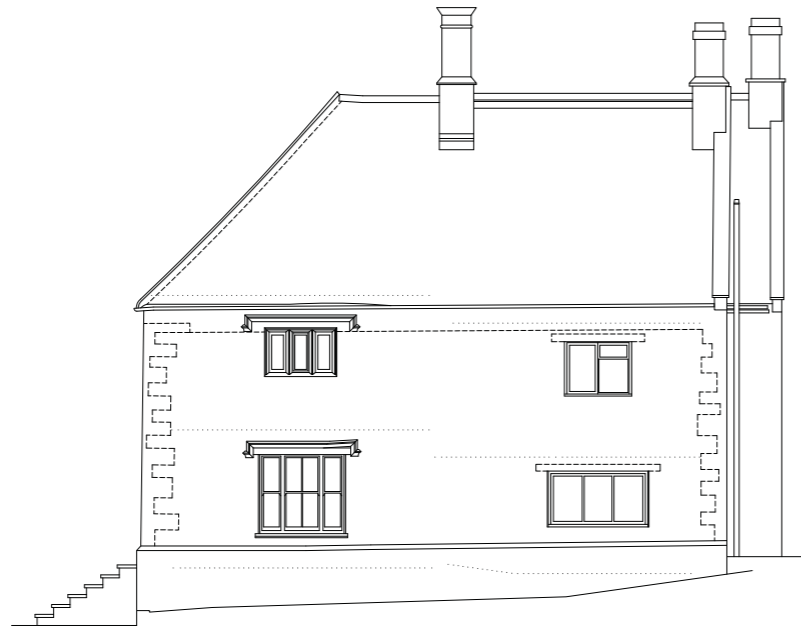
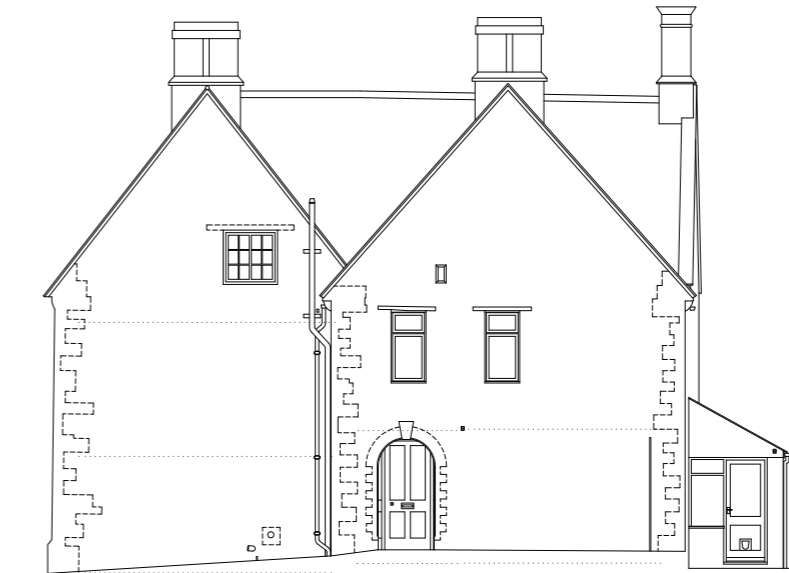
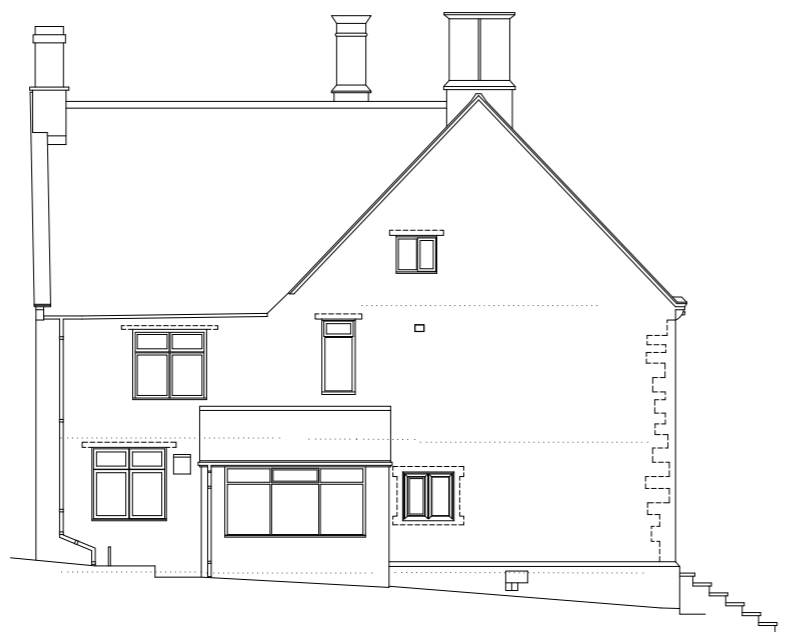
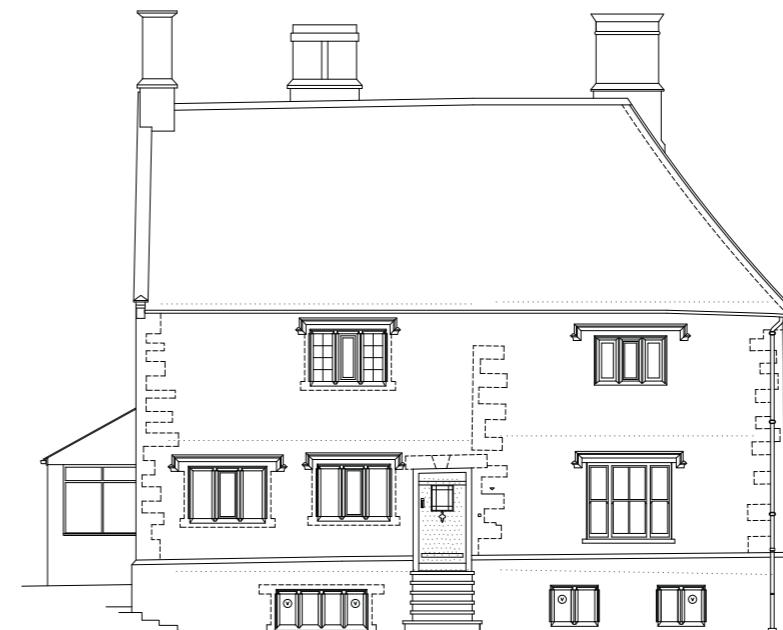
South West Elevation

South East Elevation

North East Elevation

North West Elevation

Figure 8: Farmhouse elevations (from data supplied by client)

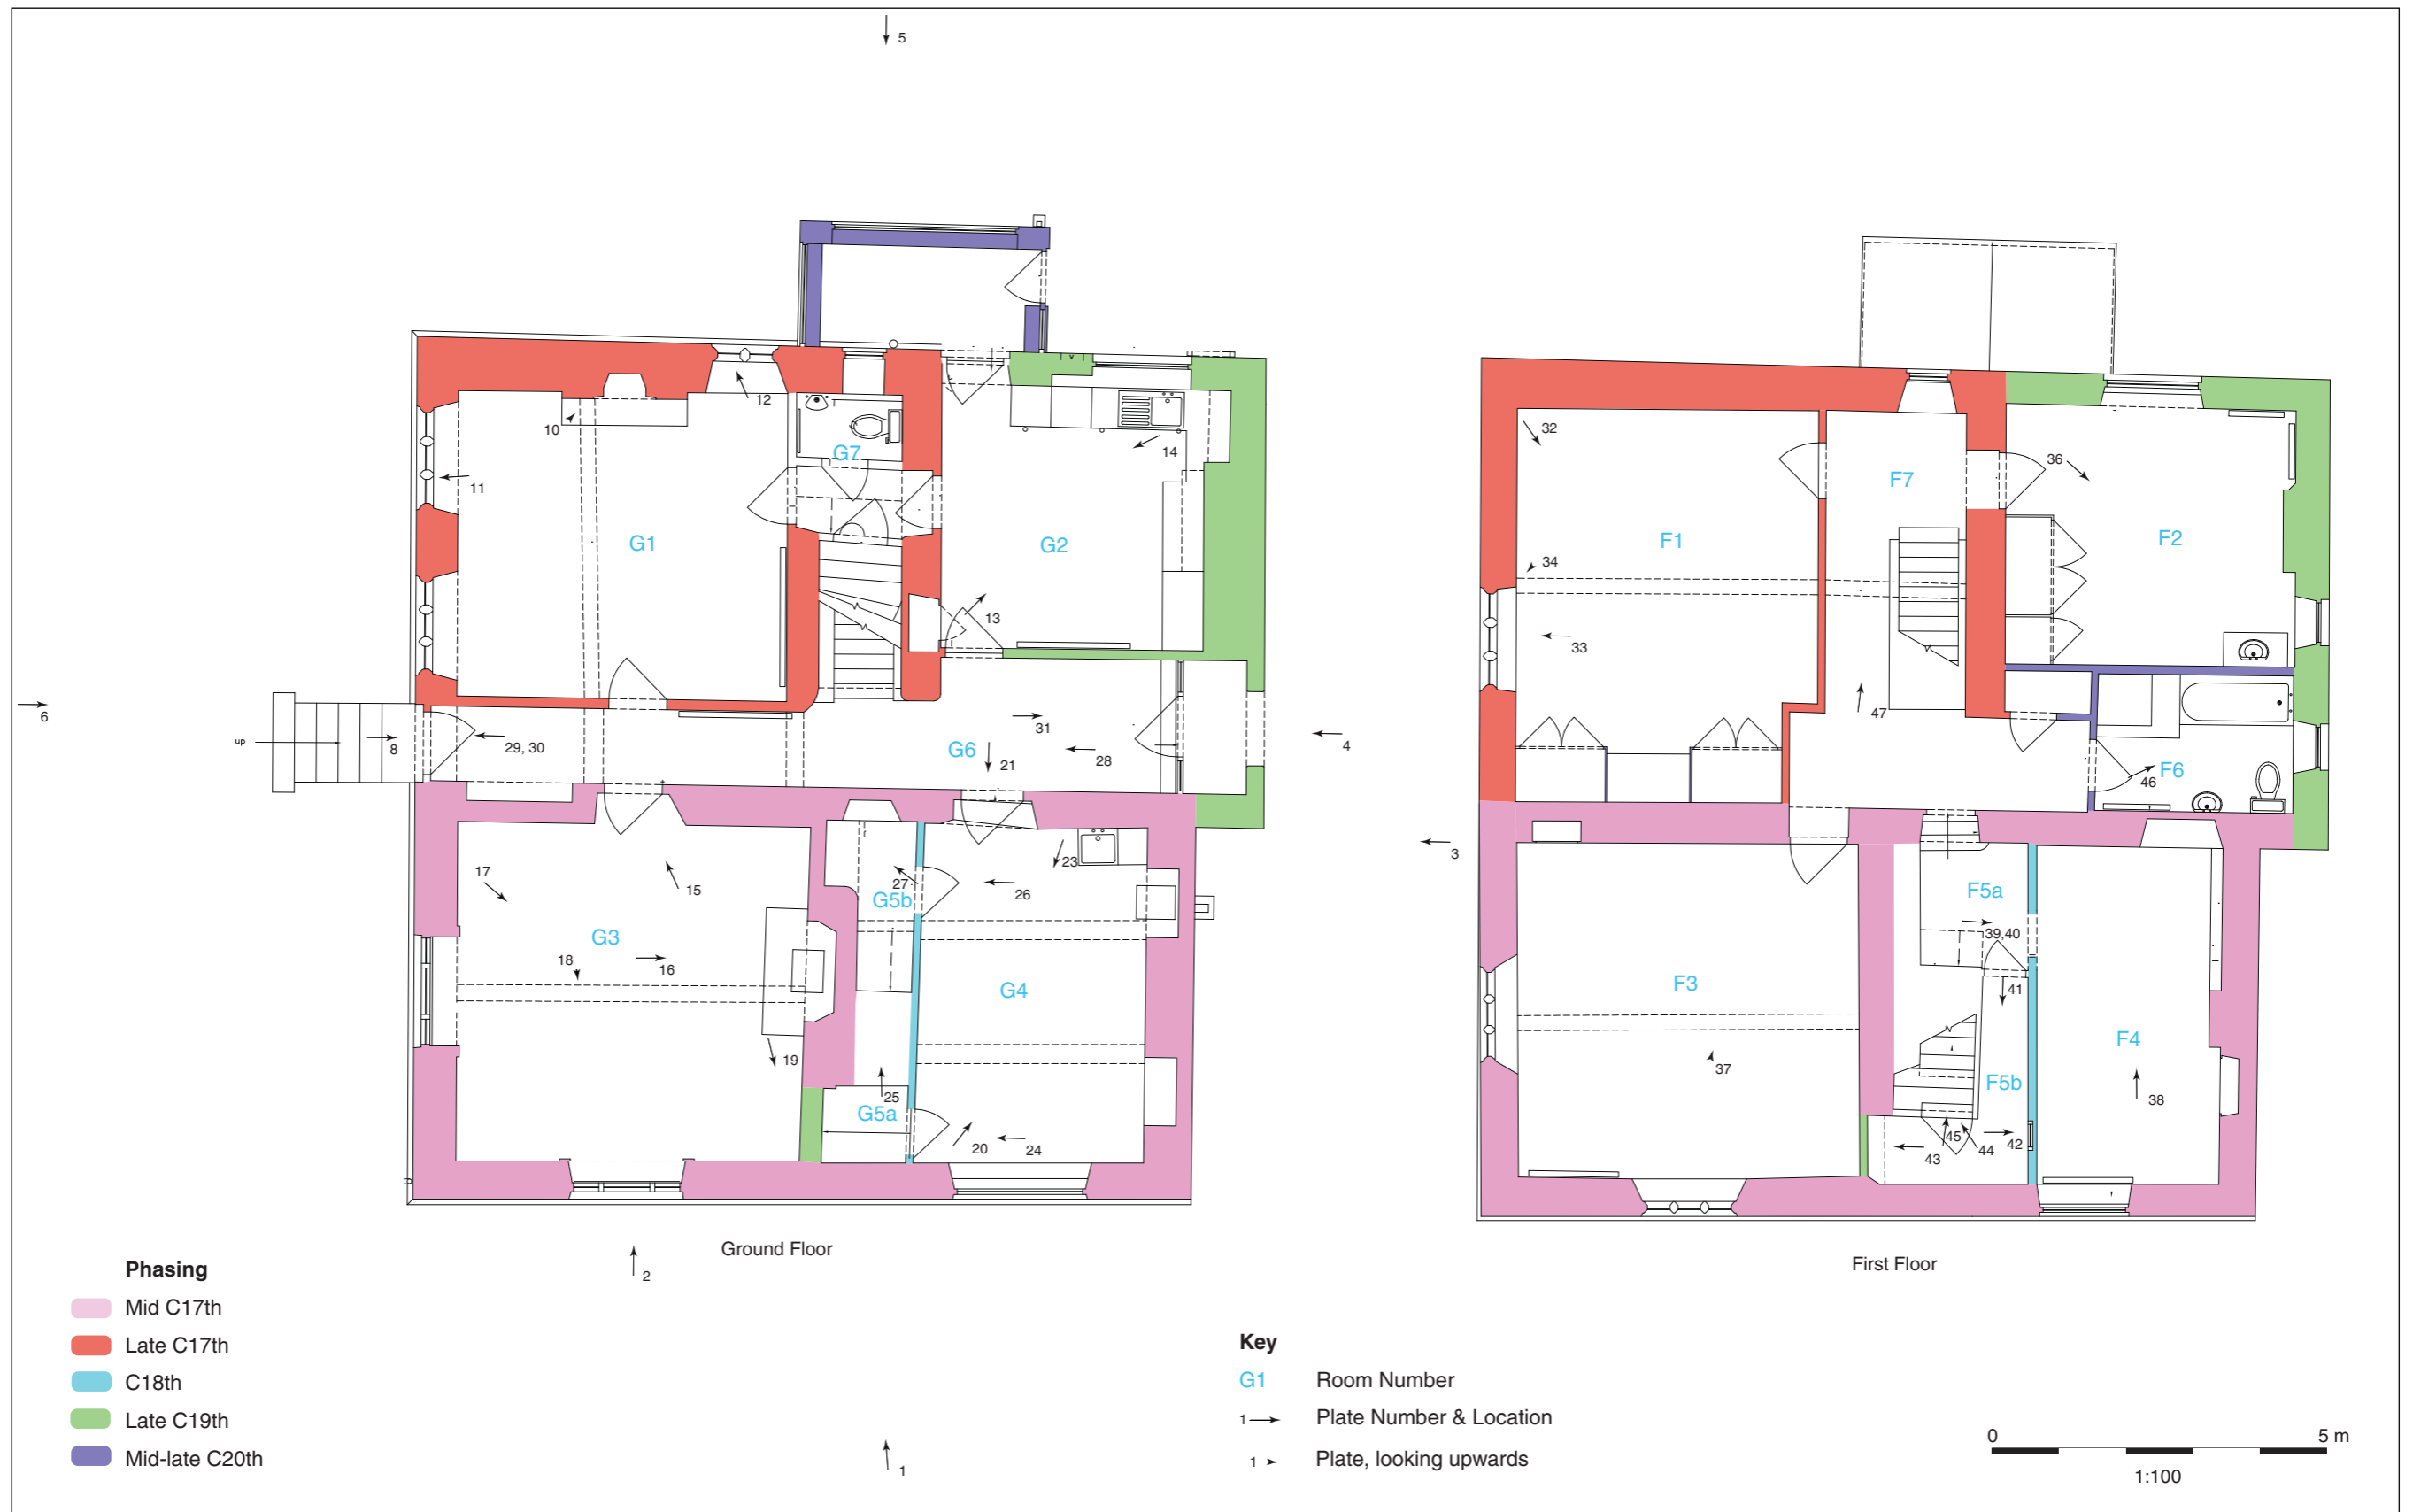
Figure 9: Ground and first floor plans of the farmhouse showing suggested phasing and location of plates referenced in report (from data supplied by client)

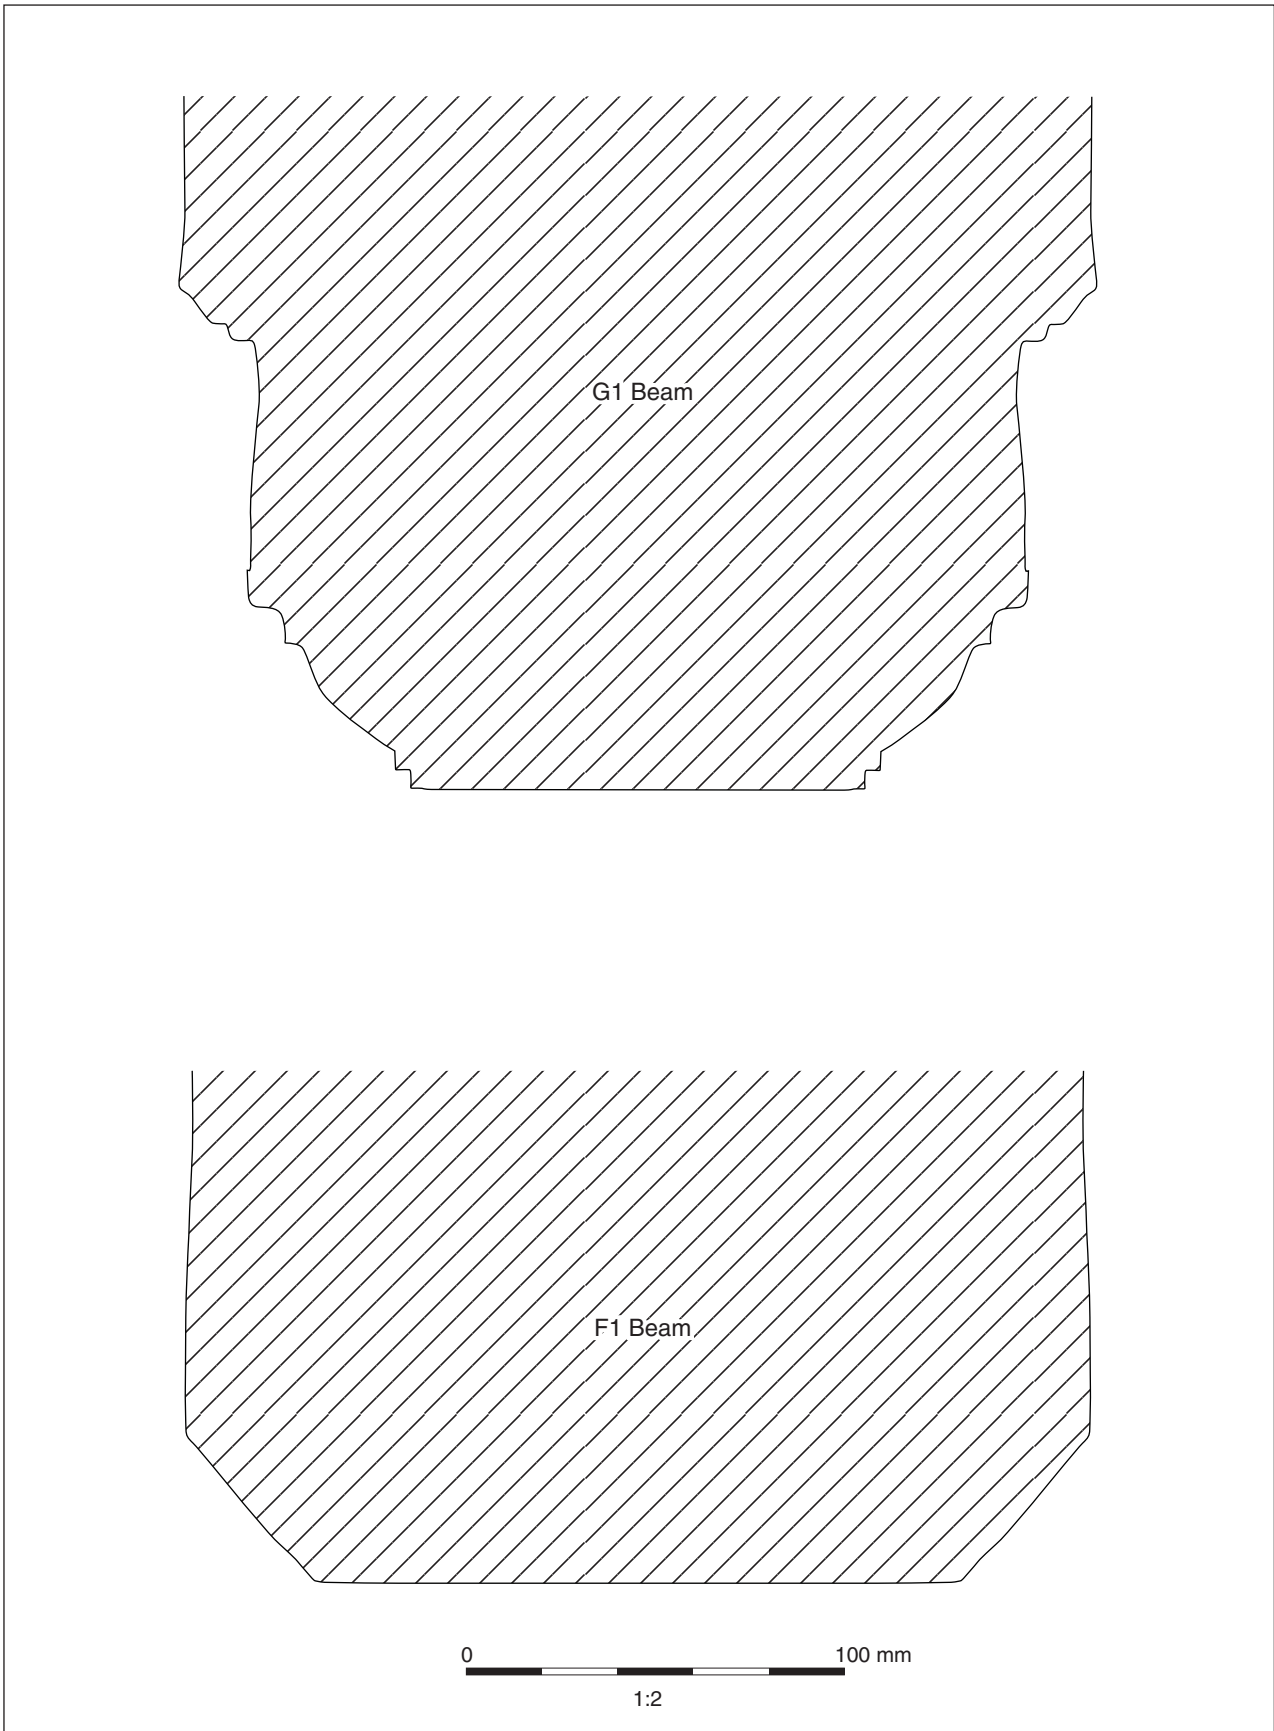
Figure 10: Profile of moulded ceiling beams in G1 and F1

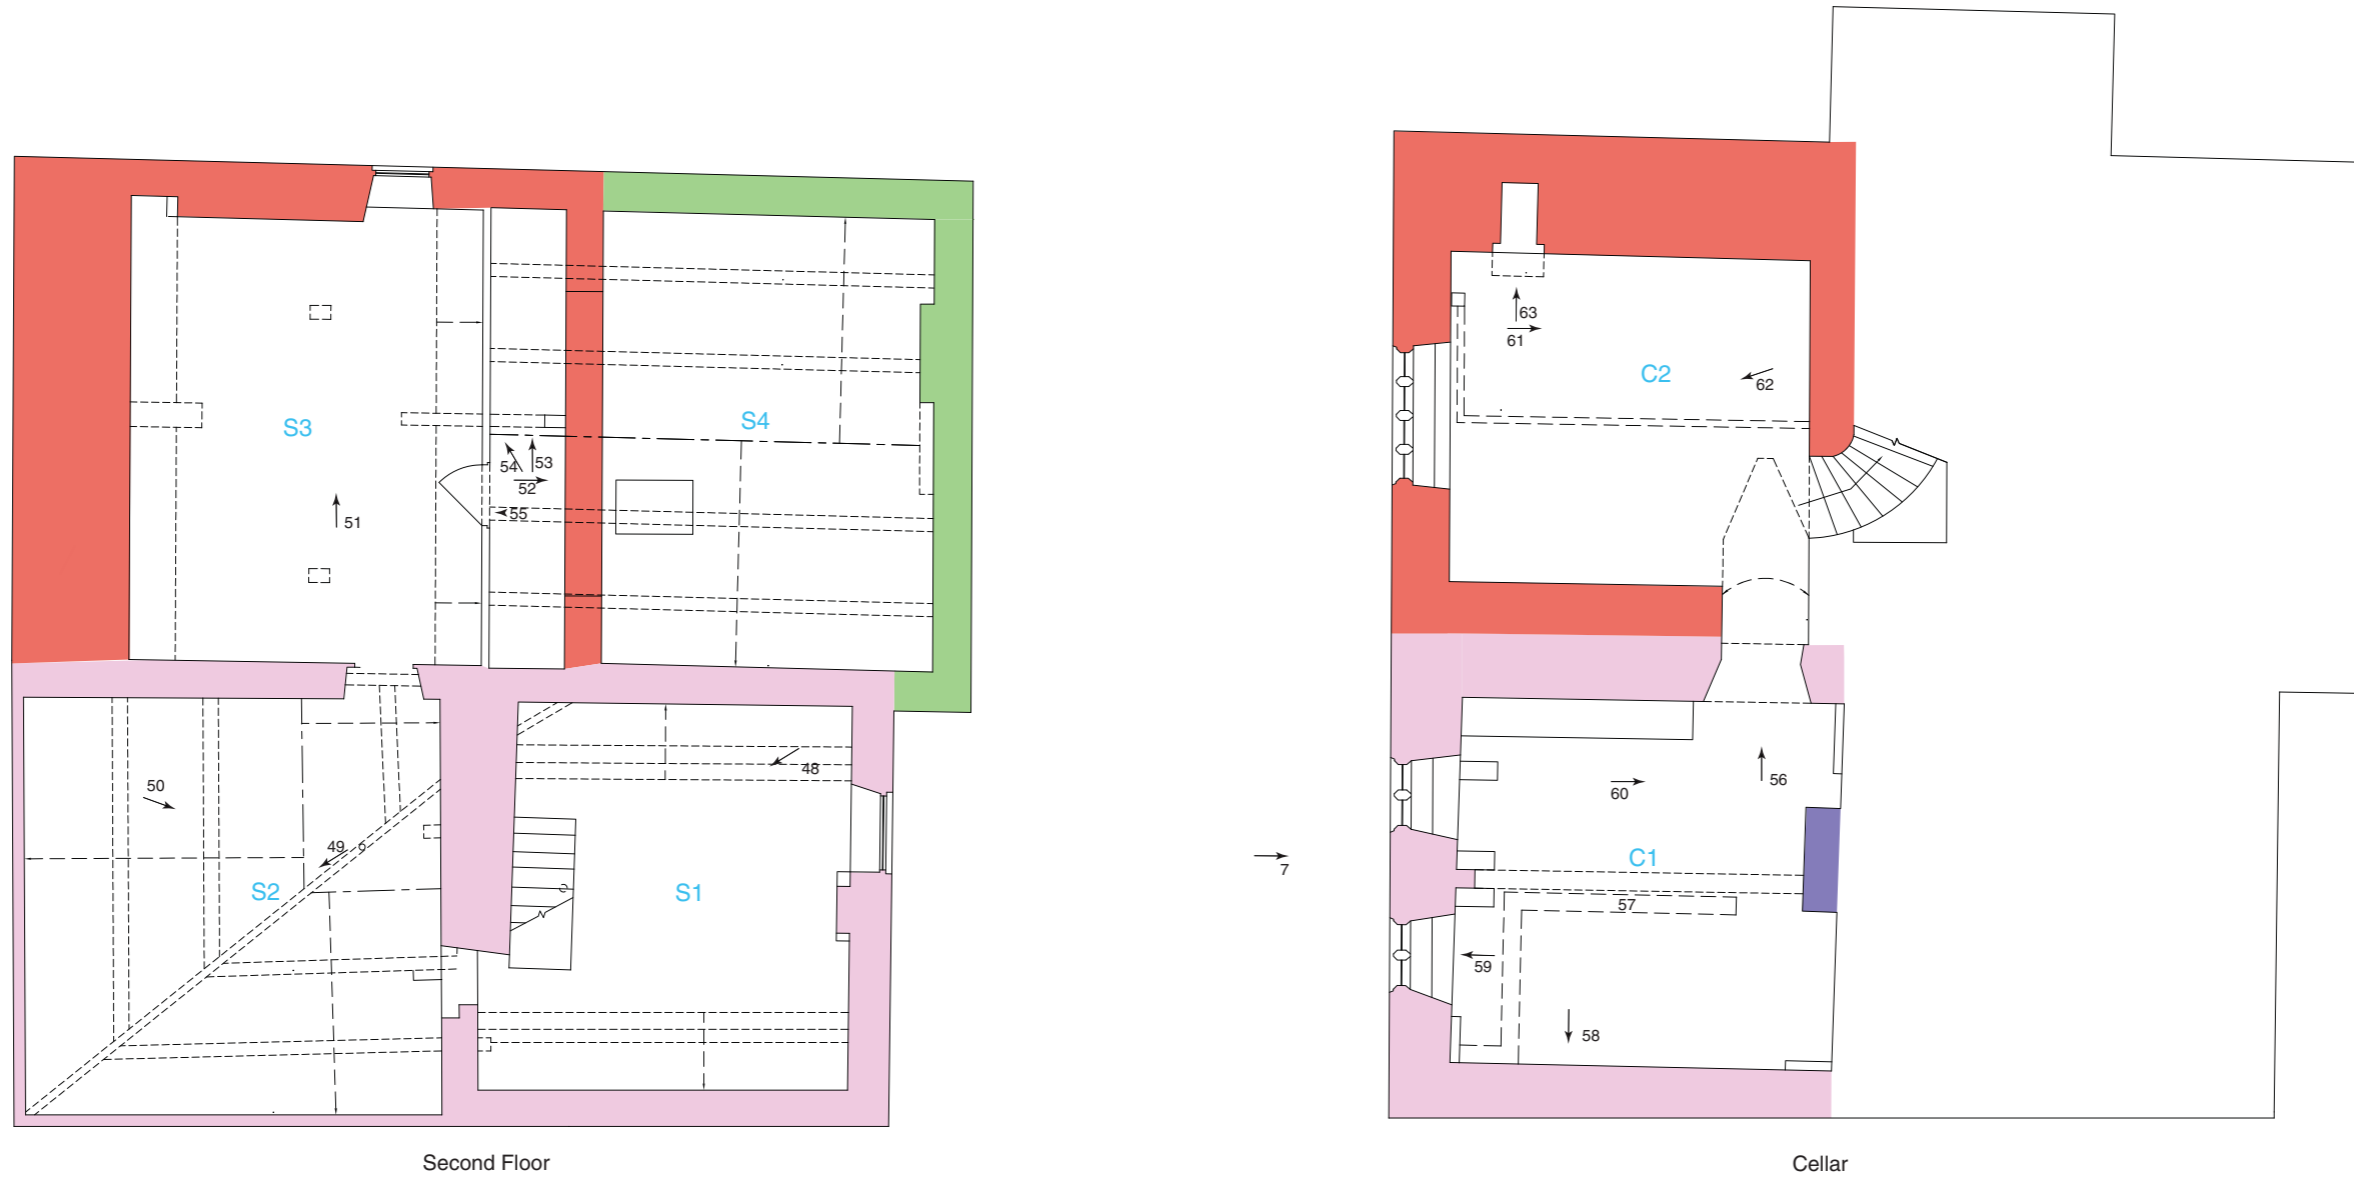
Figure 11: Second floor / attic and cellar plans of farmhouse, showing suggested phasing and location of plates referenced in report (from data supplied by client)

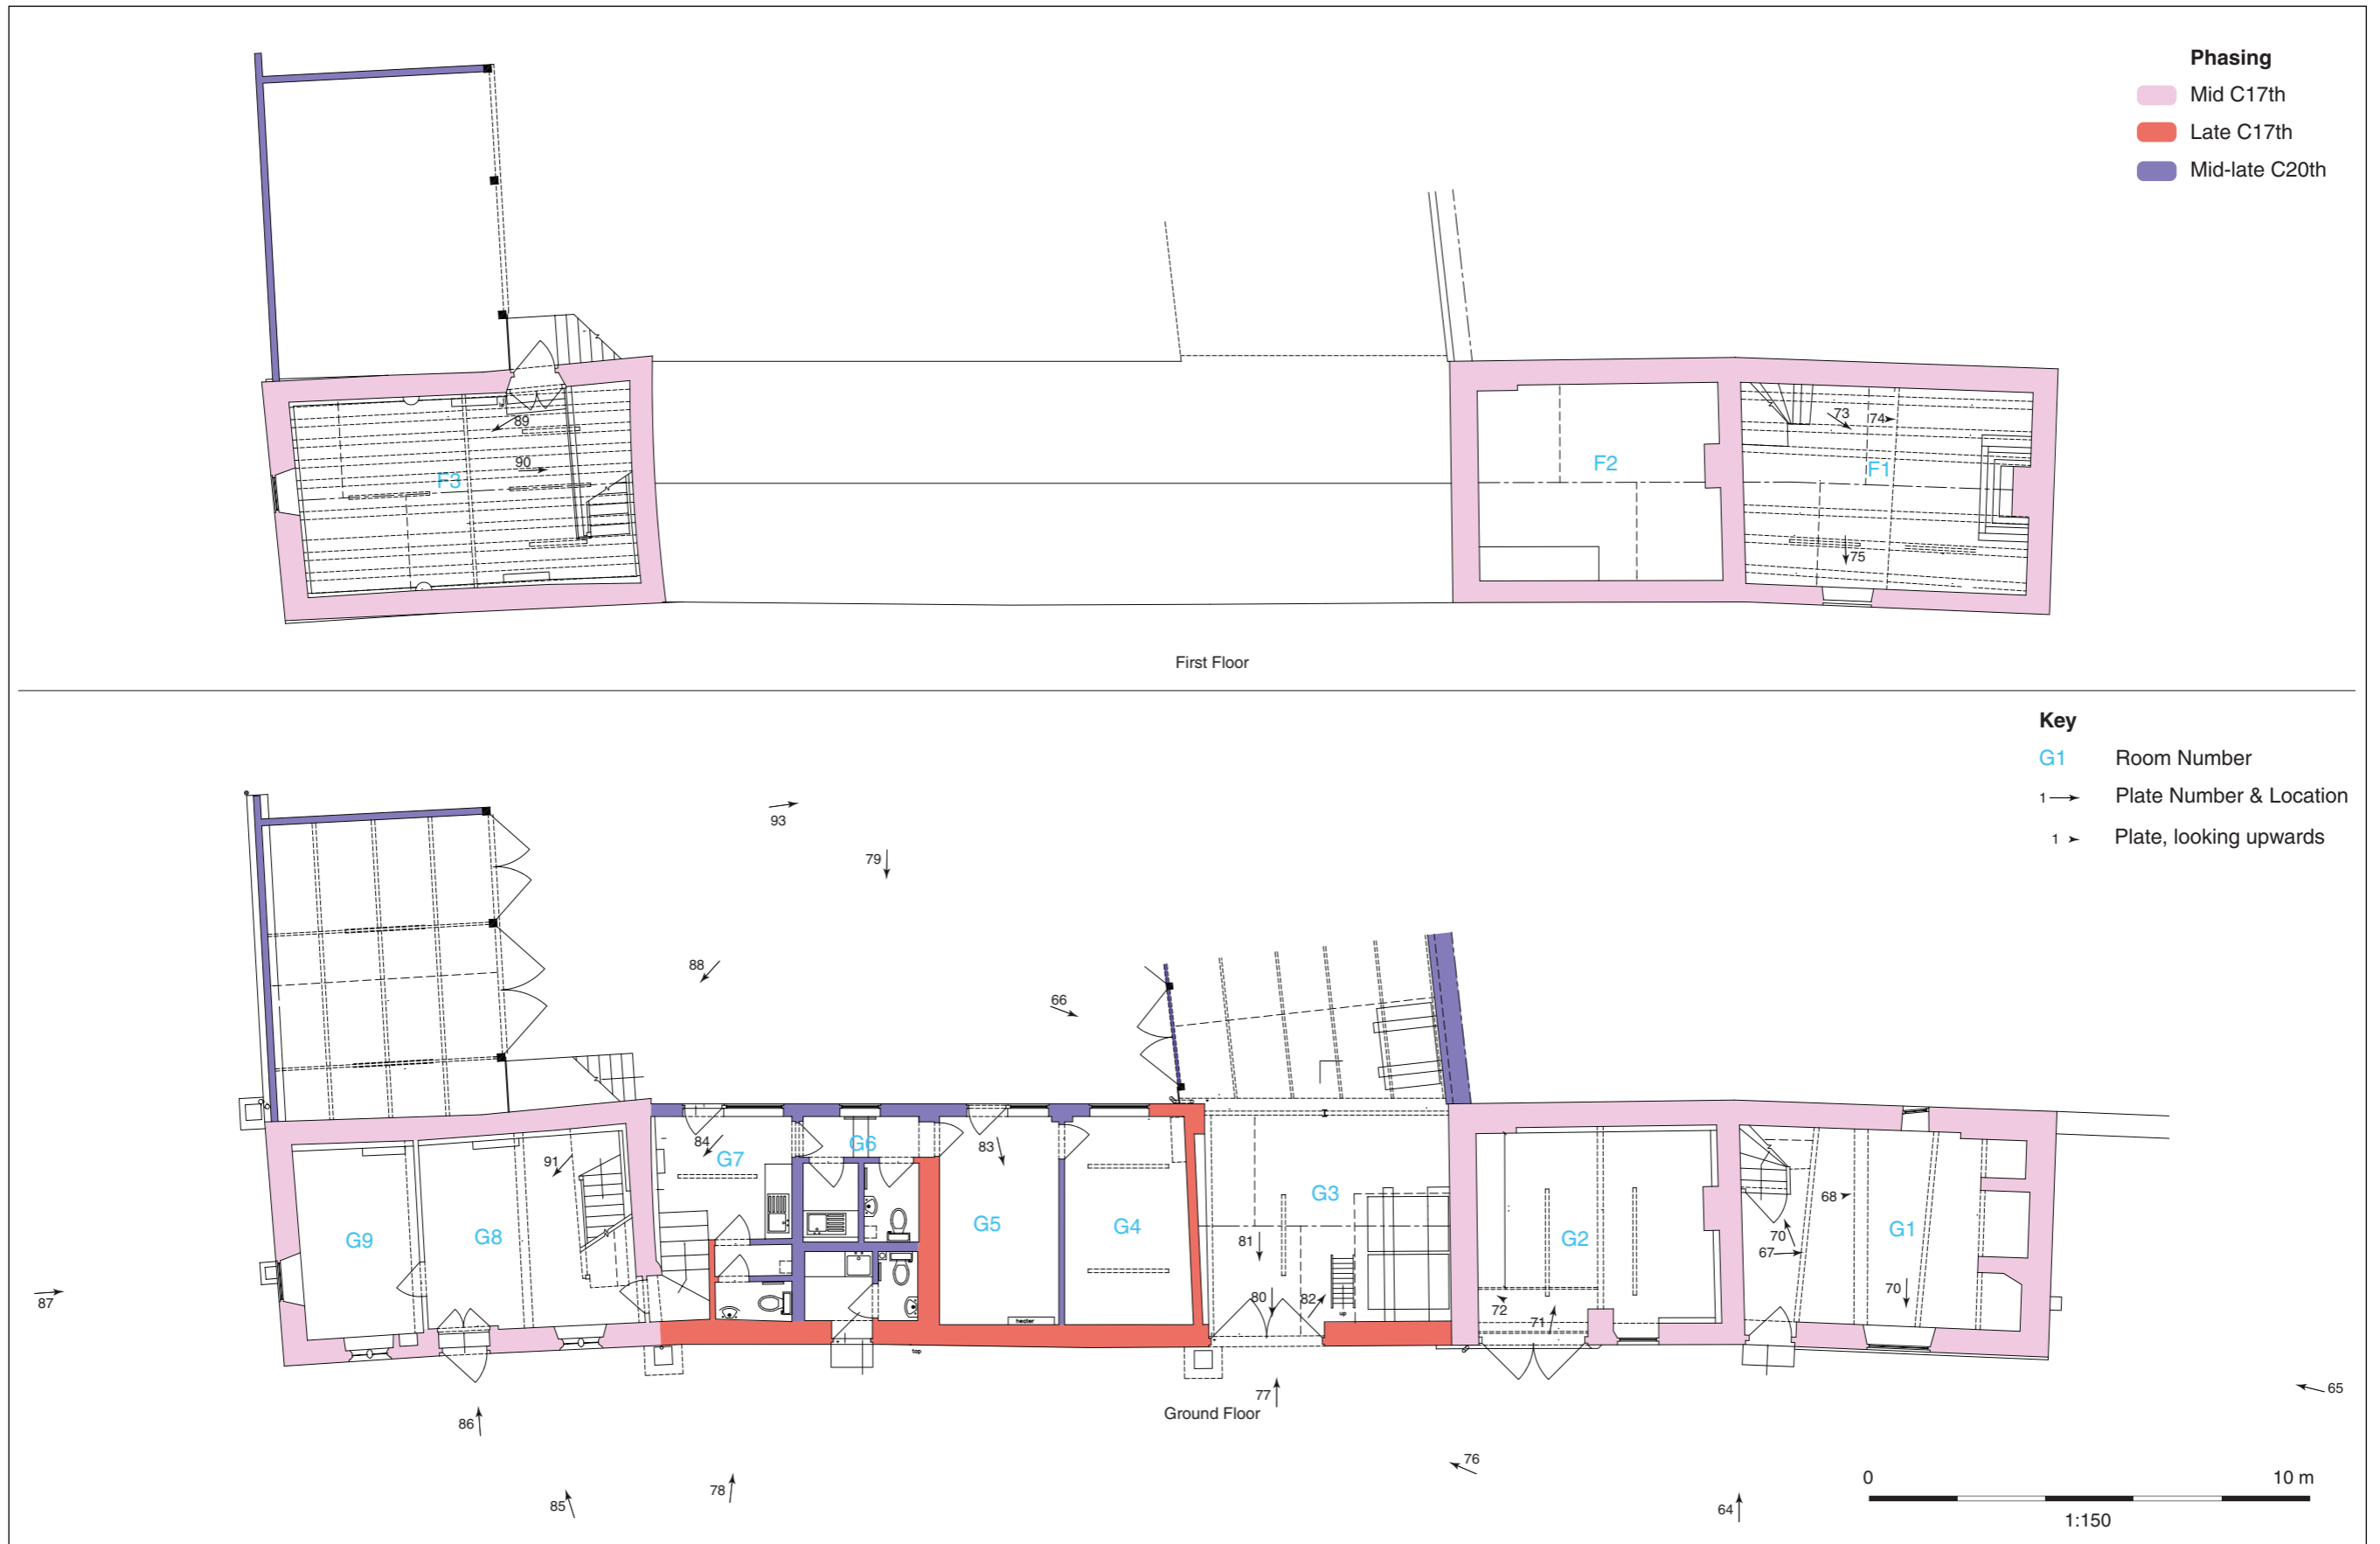
Figure 13: Ground and first floor plans of Buildings 1-3 showing suggested phasing and location of plates referenced in report (from data supplied by client)

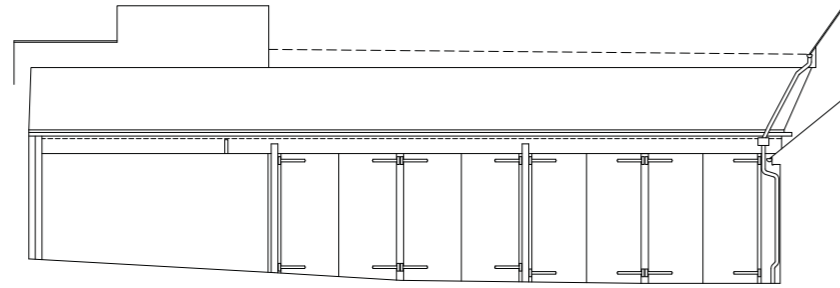
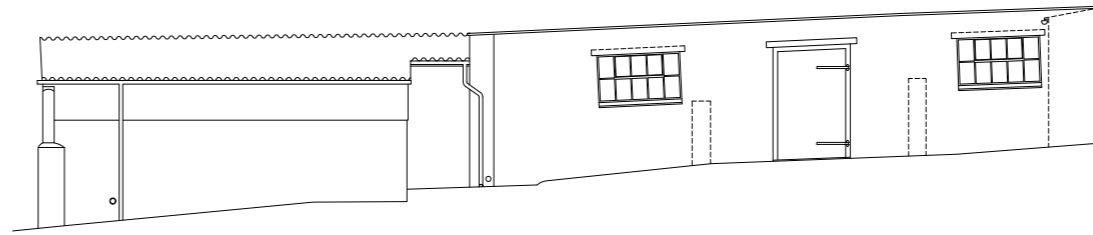
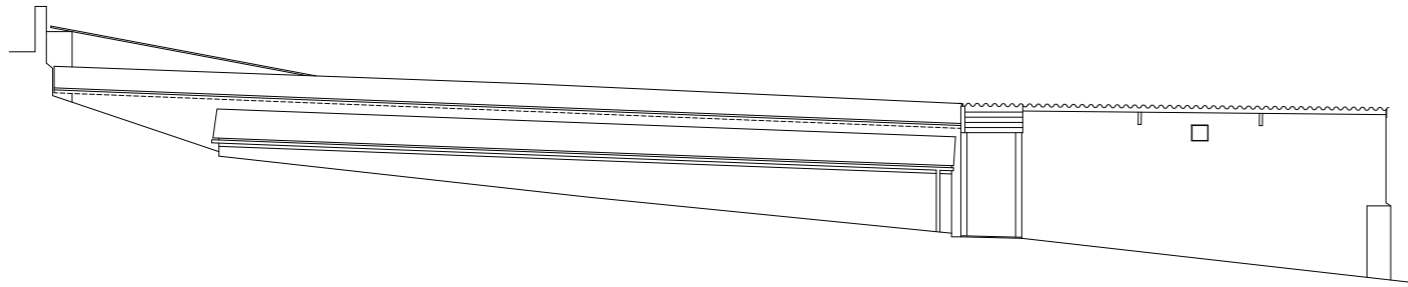
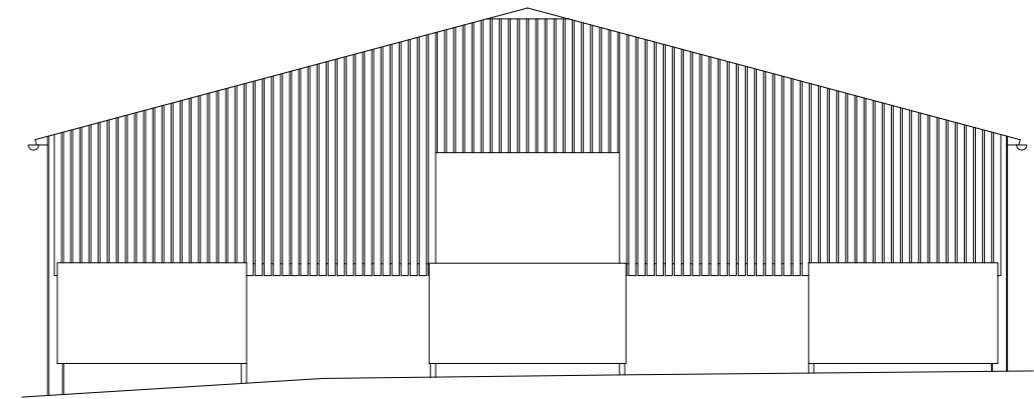
North Elevation  
Building 4

West Elevation  
Buildings 7 and 5

East Elevation  
Buildings 5 and 7

West Elevation  
Building 9

Figure 14: Elevations of Buildings 4, 5, 7 and 9 (from data supplied by client)

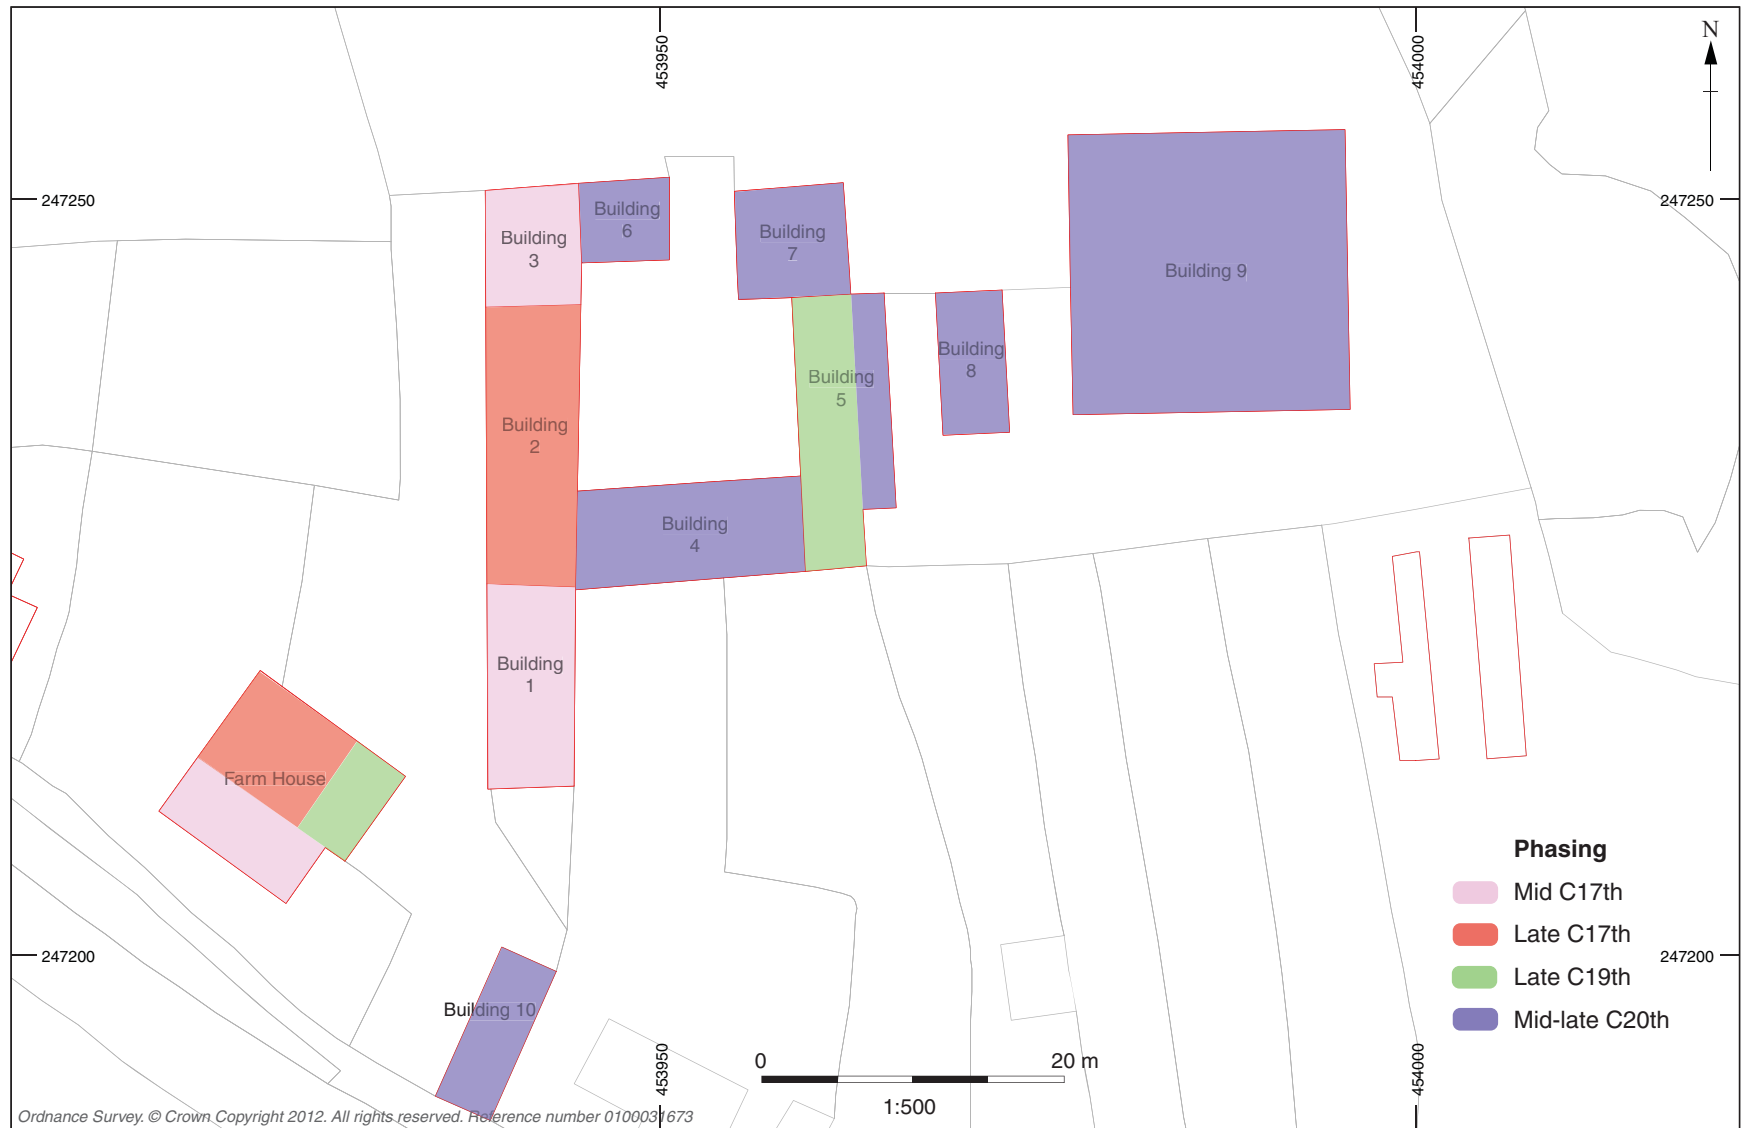
Figure 15: Plan of buildings surveyed with suggested phasing

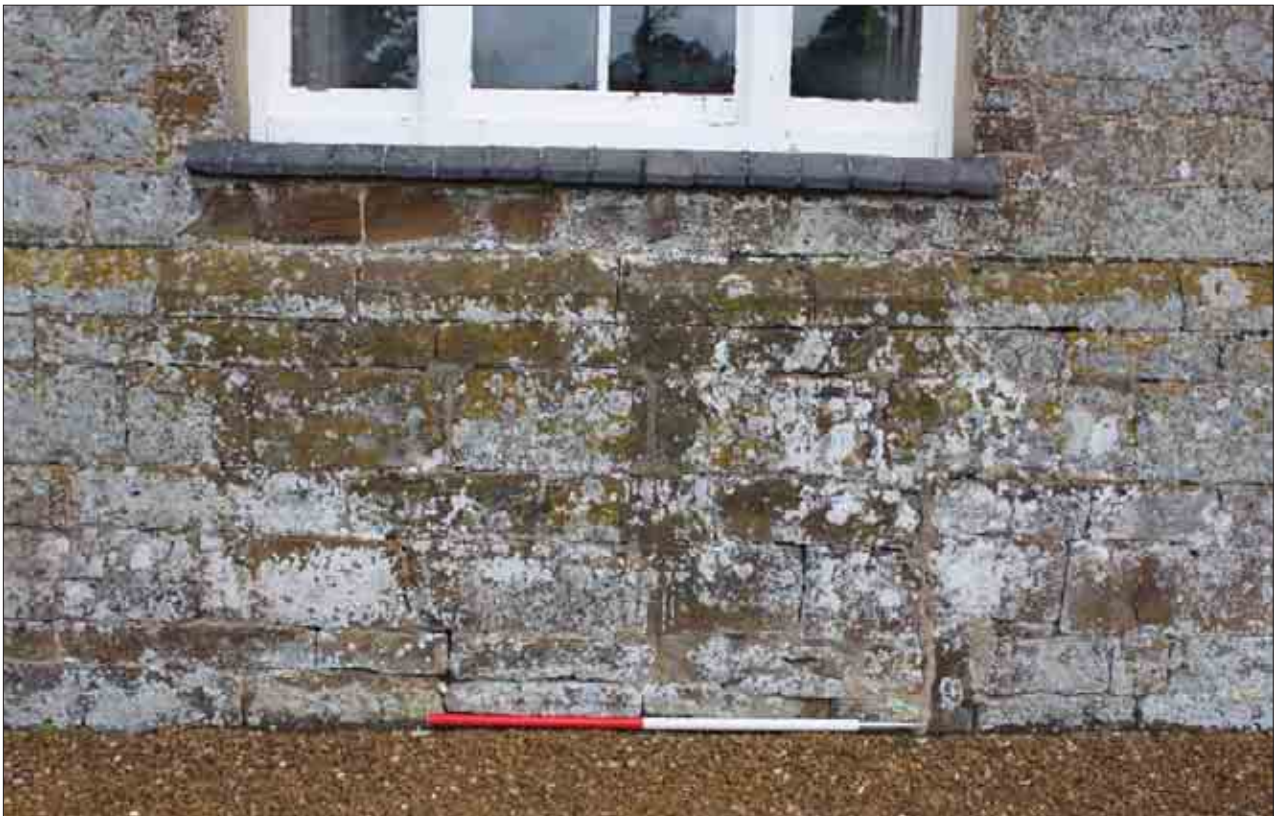
Plate 2: Blocked-up opening beneath window on south-west facing elevation of farmhouse
