Gate House

**Historic Building  
Recording**

**Gate House Farm, Culworth, Northamptonshire**

*Historic Building Survey*

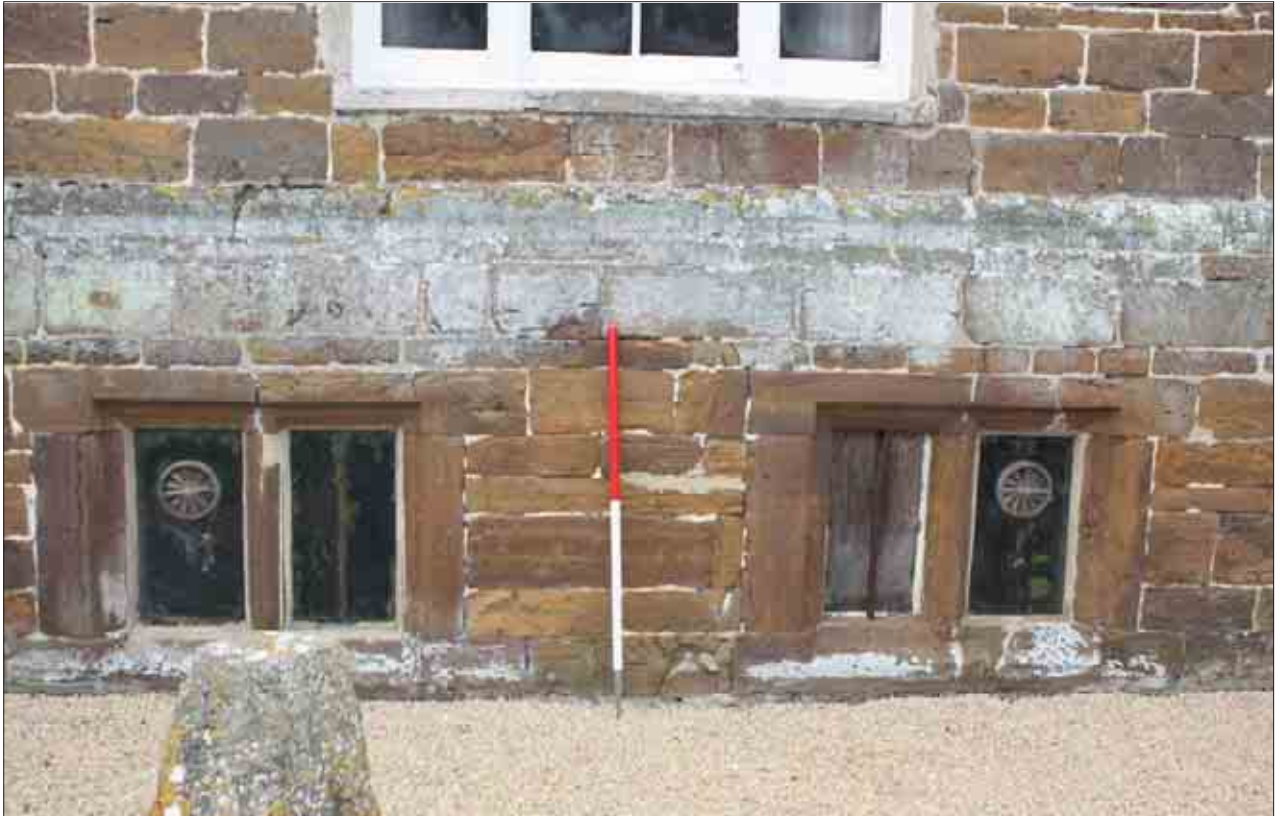
Plate 7: Detail of cellar windows on north-west facing elevation of farmhouse

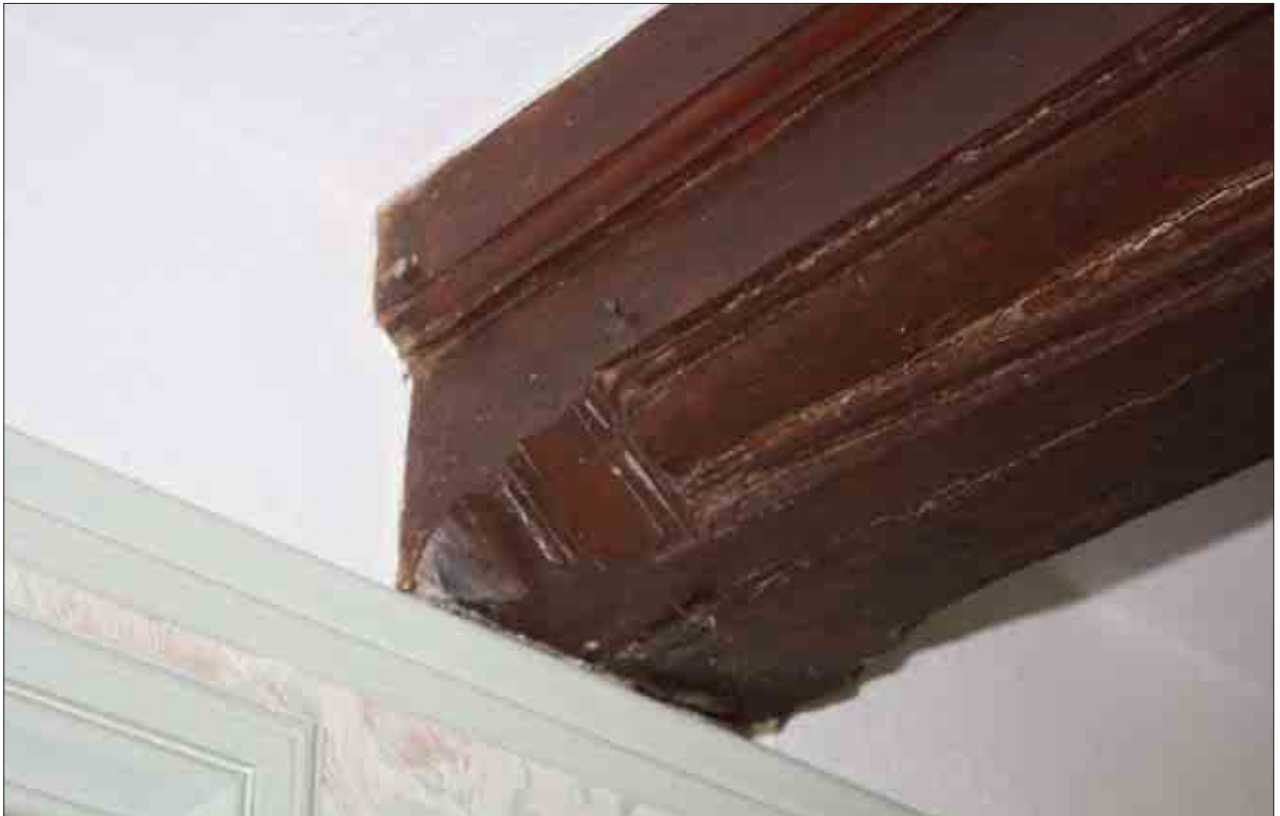
Plate 10: Detail of stop on ceiling beam, G1

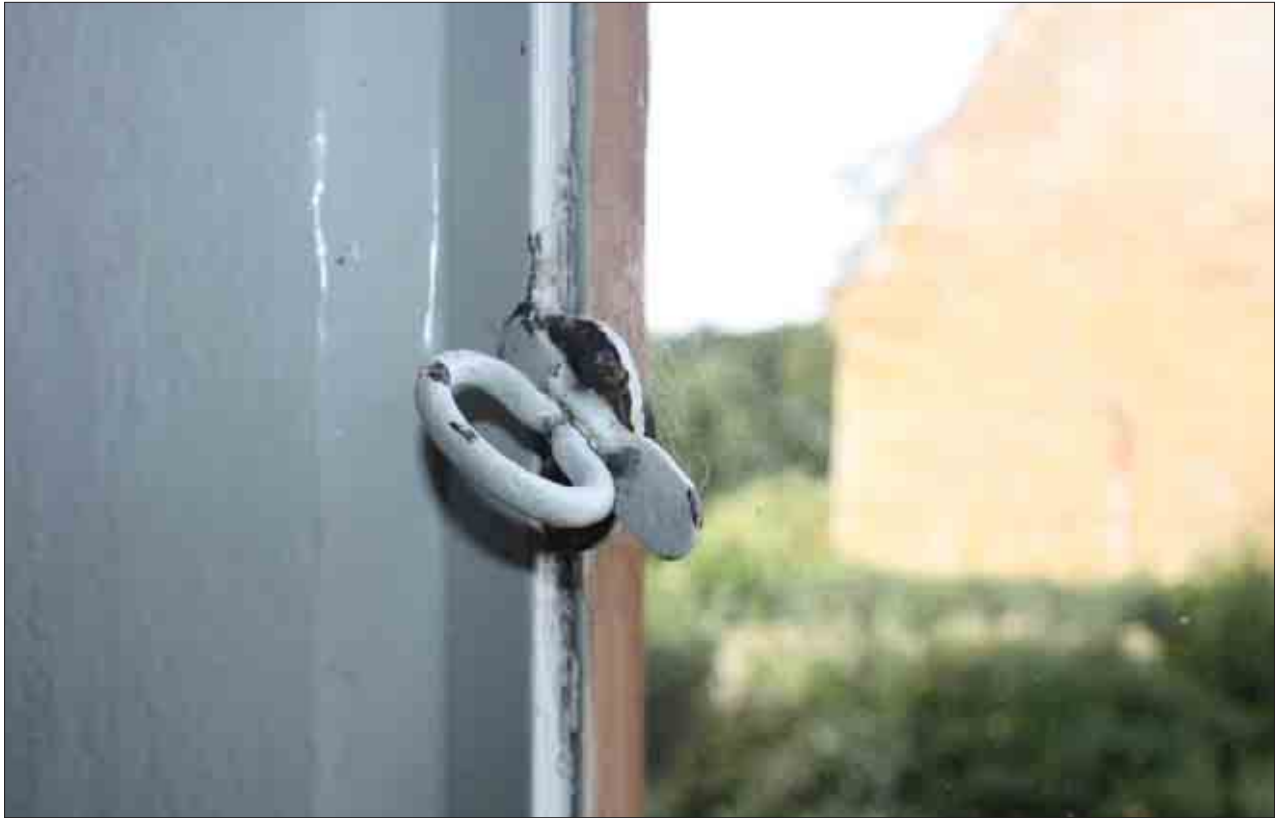
Plate 11: Late 17th century turnbuckle catch on window, G1

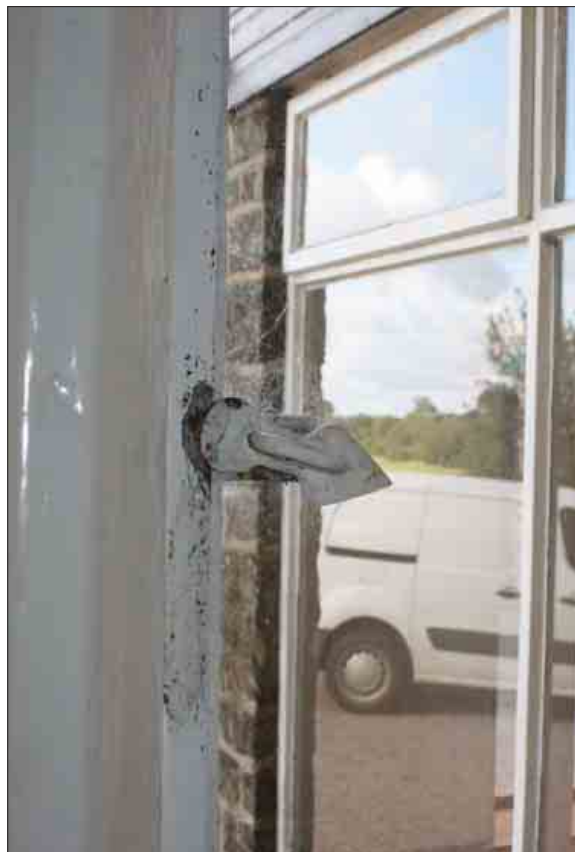
Plate 12: Late 17th century turnbuckle catch on window, G1

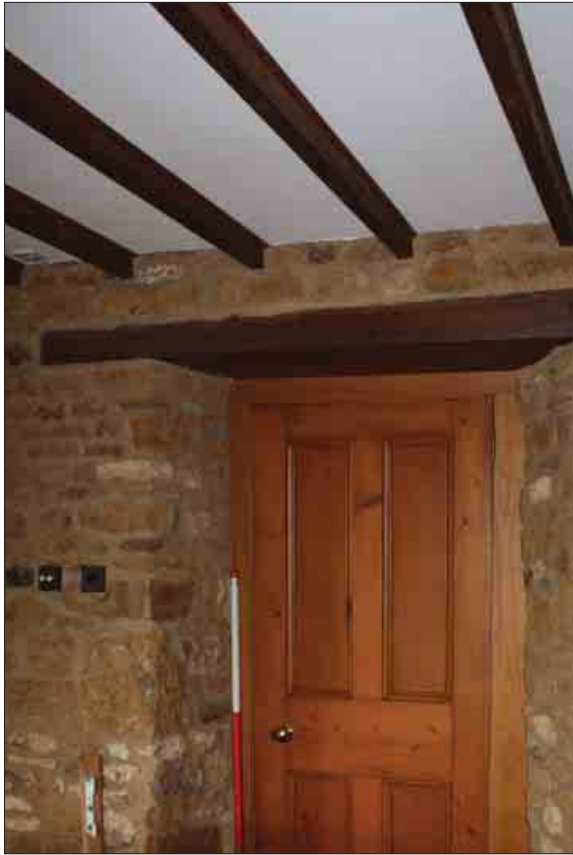
Plate 15: Internal doorway in splayed opening, G3

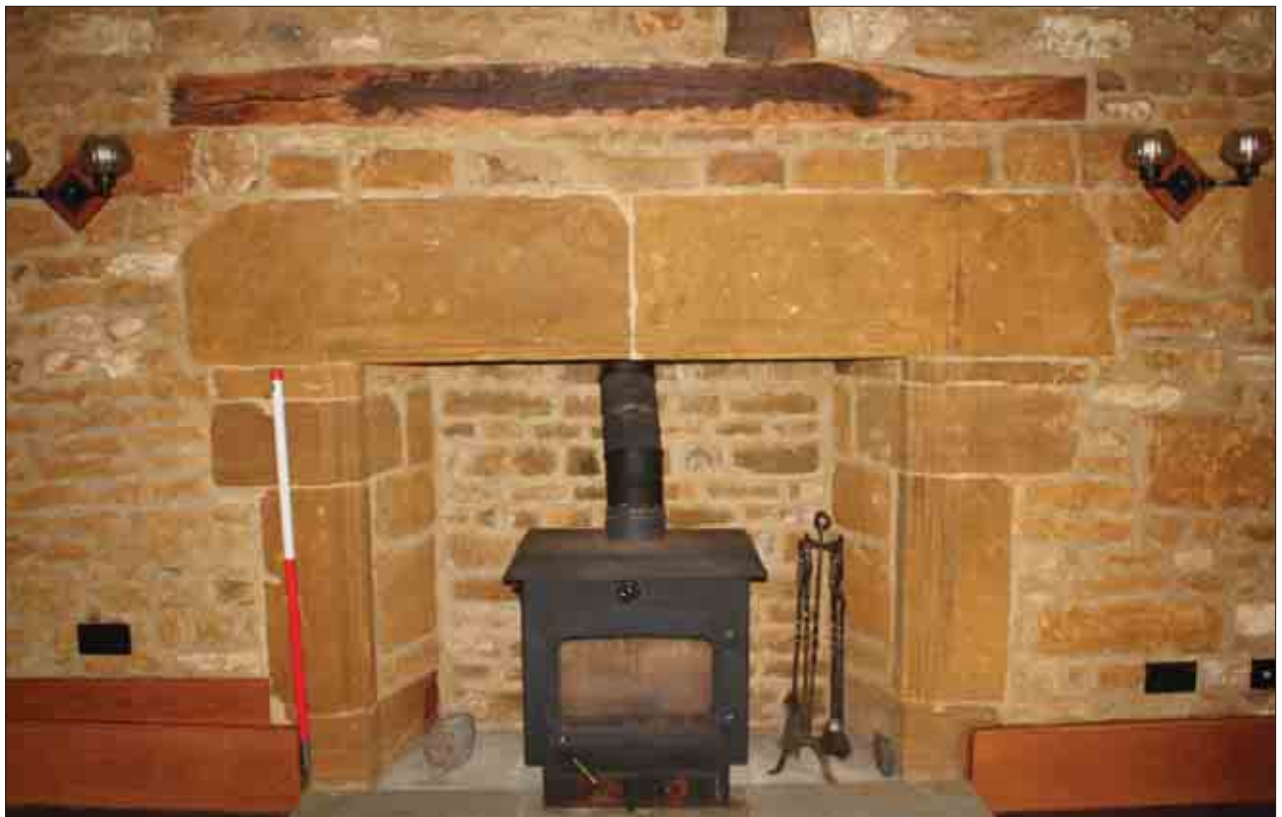
Plate 16: Fireplace, G3

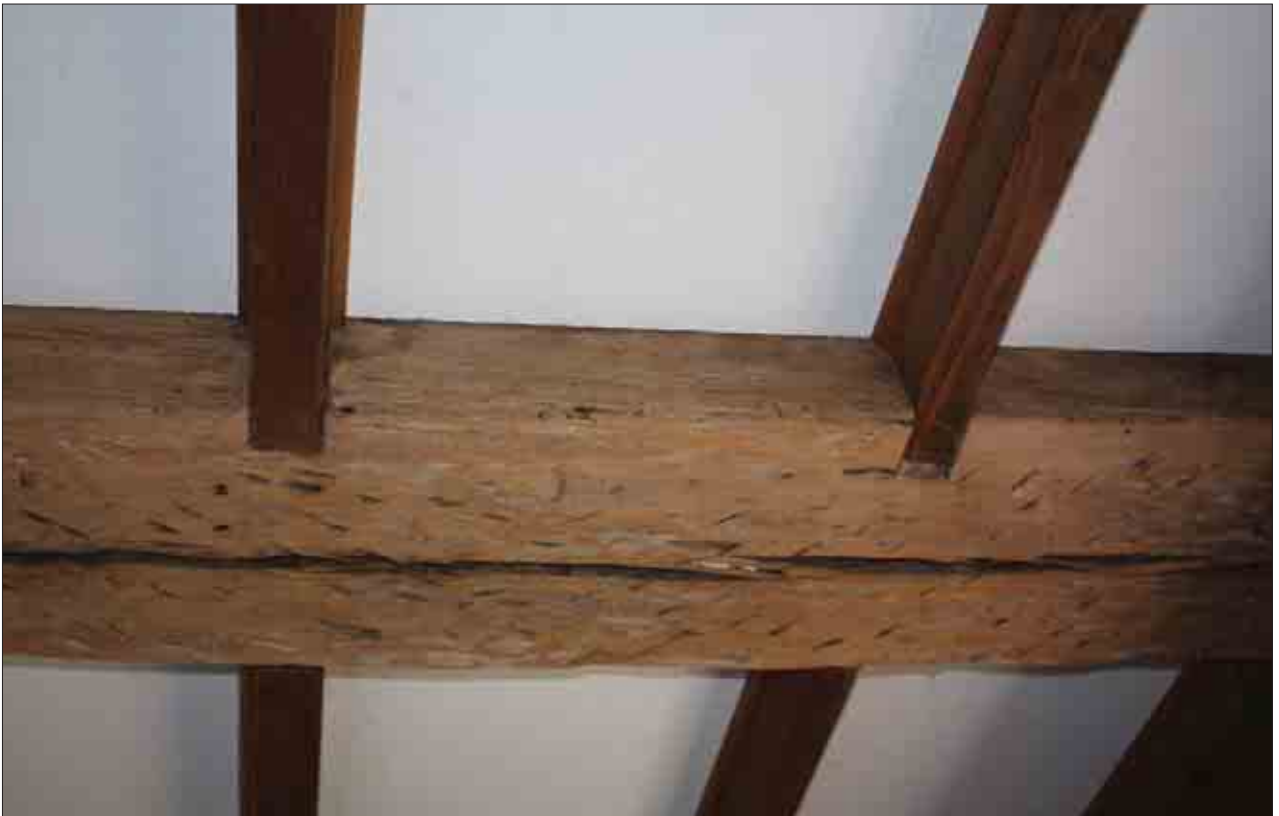
Plate 18: Detail of ceiling beam and replacement joists, G3

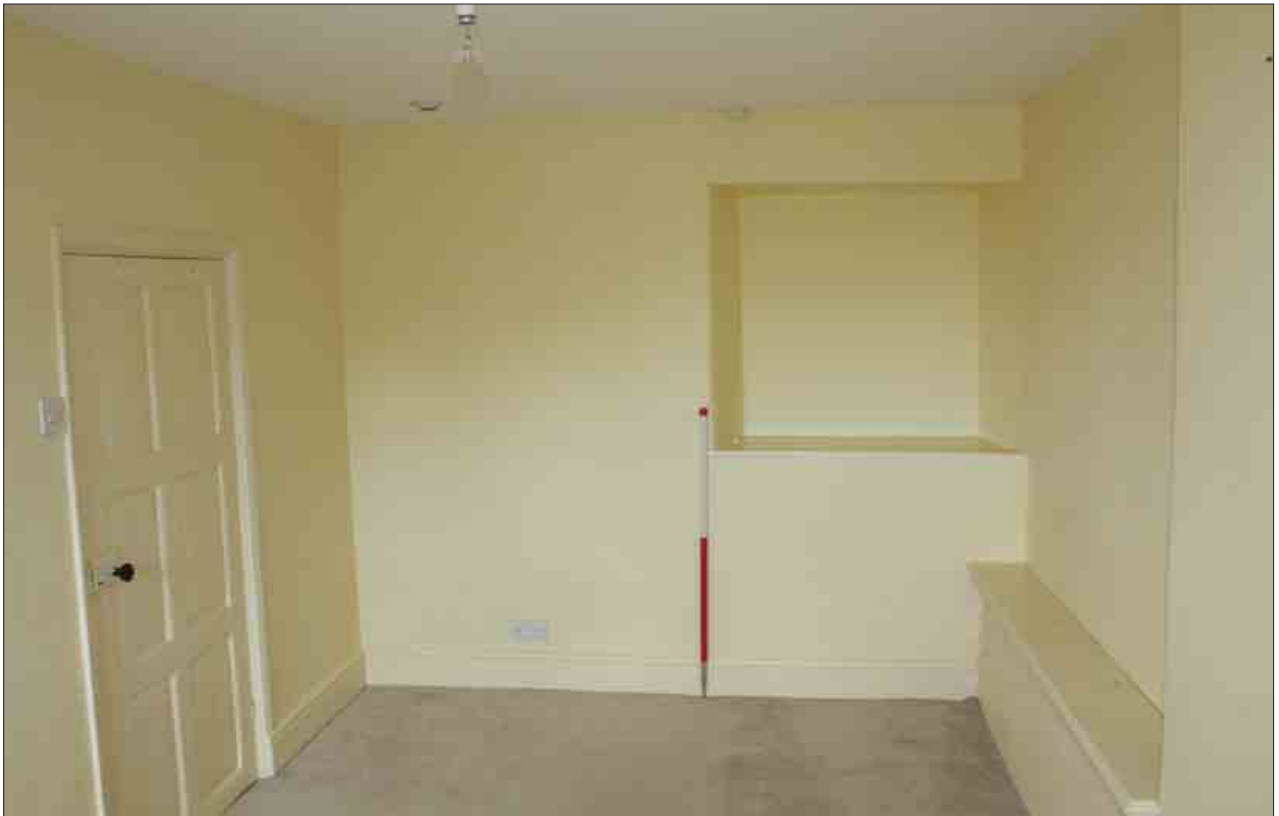
Plate 38: Blocked-up window, F4

4.1.59 F4 is accessed via a small area (F5a) which is a step down from the first floor landing (F7). This room measures 4.95m by 2.70m with carpeted floor and plastered and painted walls and ceiling (Plate 38).

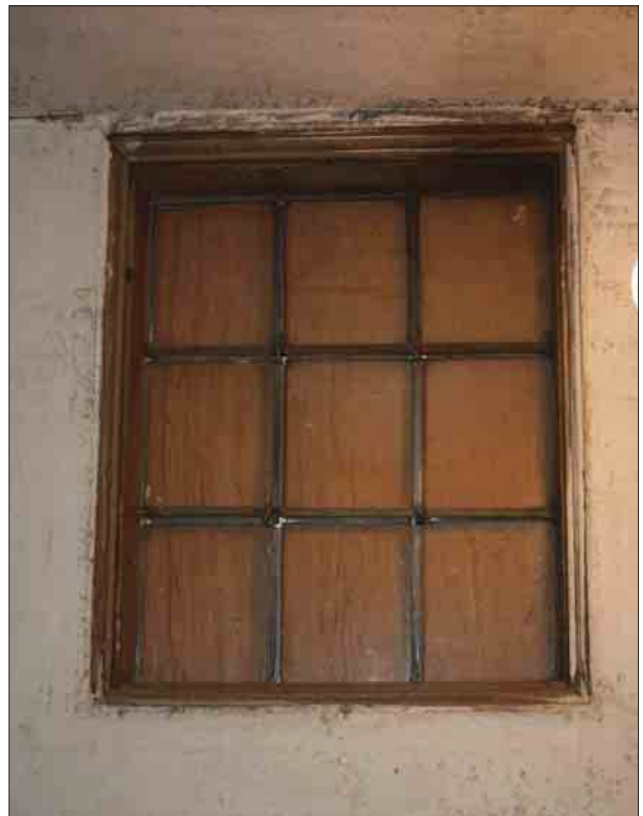
Plate 42: Interior "window" between F4 and F5b as viewed from F5b

4.1.66 On entering there is a small wooden-framed window on the left with lead glazing bars (Plate 42). Rather than an external window, it is likely to have been inserted to allow

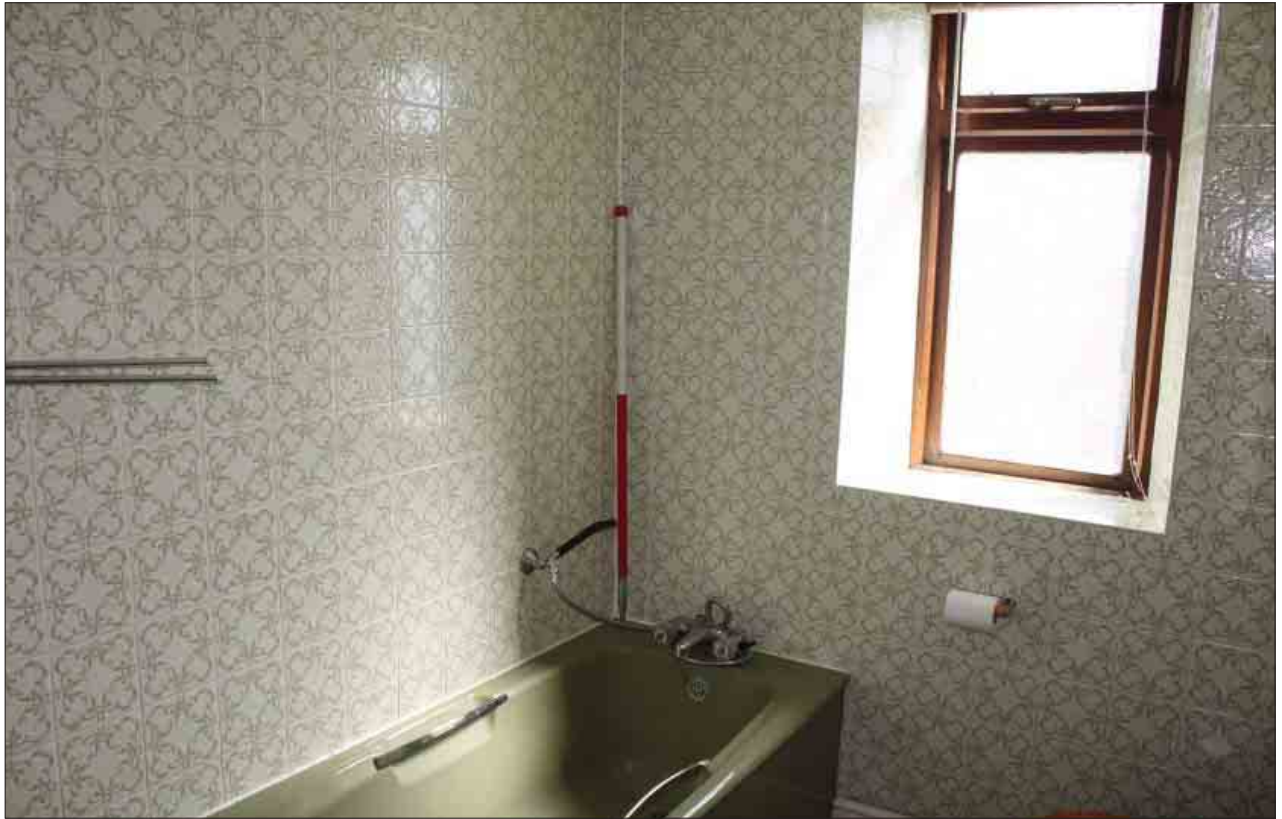
Plate 46: General room view, F6

4.1.69 F6 is the first floor bathroom in the farmhouse and is accessed from the first floor landing area (F7). It measures 2.87m by 2.0m and has a c.1970s avocado bathroom suite comprising bath, toilet and sink. There is a later shower unit in the corner and the walls are tiled (Plate 46).

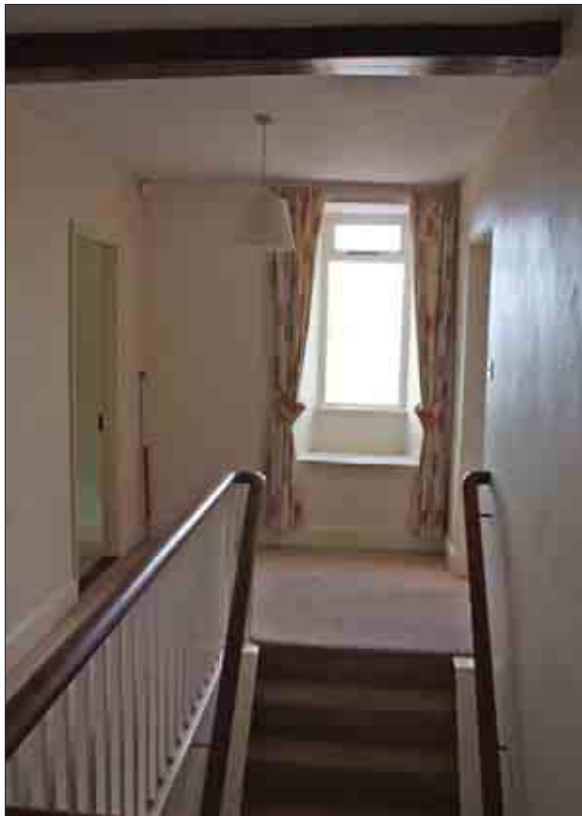
Plate 47: General room view, F7

4.1.71 The first floor landing area measures approximately 5.80m wide and is accessed via a 20th century staircase leading from G6 below. The walls are all plastered and painted and the floor carpeted. There is a mid-late 20th century window at the north-eastern end as recorded on the corresponding external elevation (Plate 47).

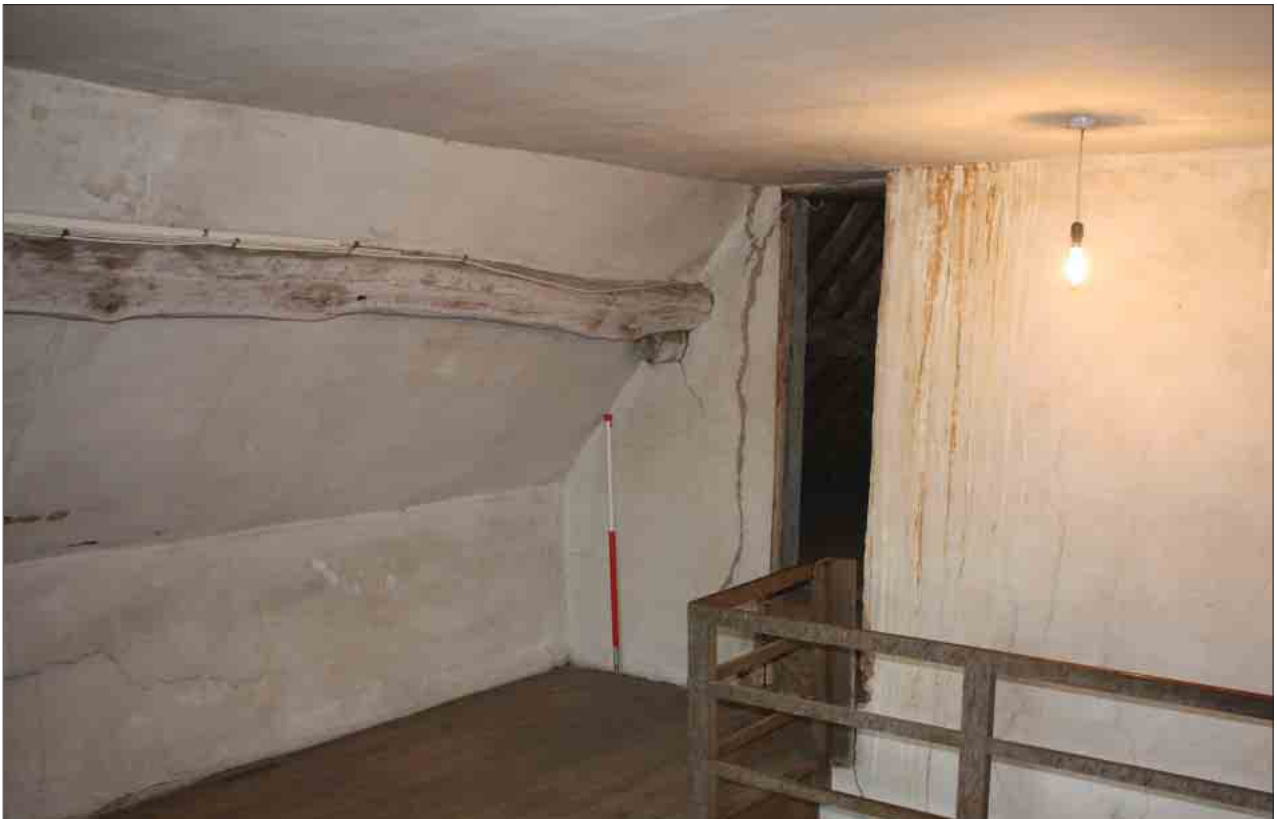
Plate 48: General room view, S1

4.1.73 This room is accessed via the staircase from F5b (Figure 11) and measures 5.05m by 4.79m. The walls and ceiling are all plastered and painted and there are exposed floorboards which measure approximately 22cm in width (Plate 48).

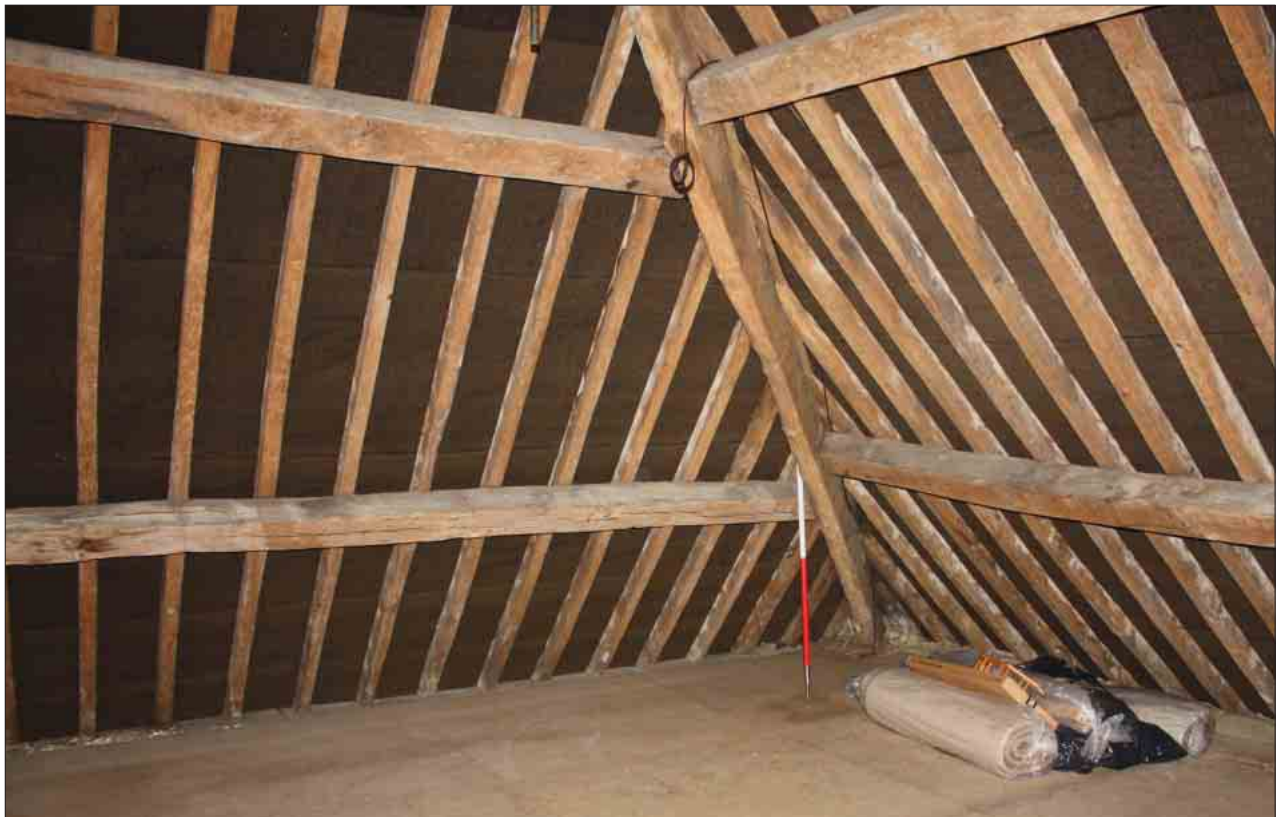
Plate 49: Purlins and common rafters, S2

(Figure 11; Plate 49). There is a felt covering which sits between the roof structure and the external covering. The floor is covered with modern ply-board.

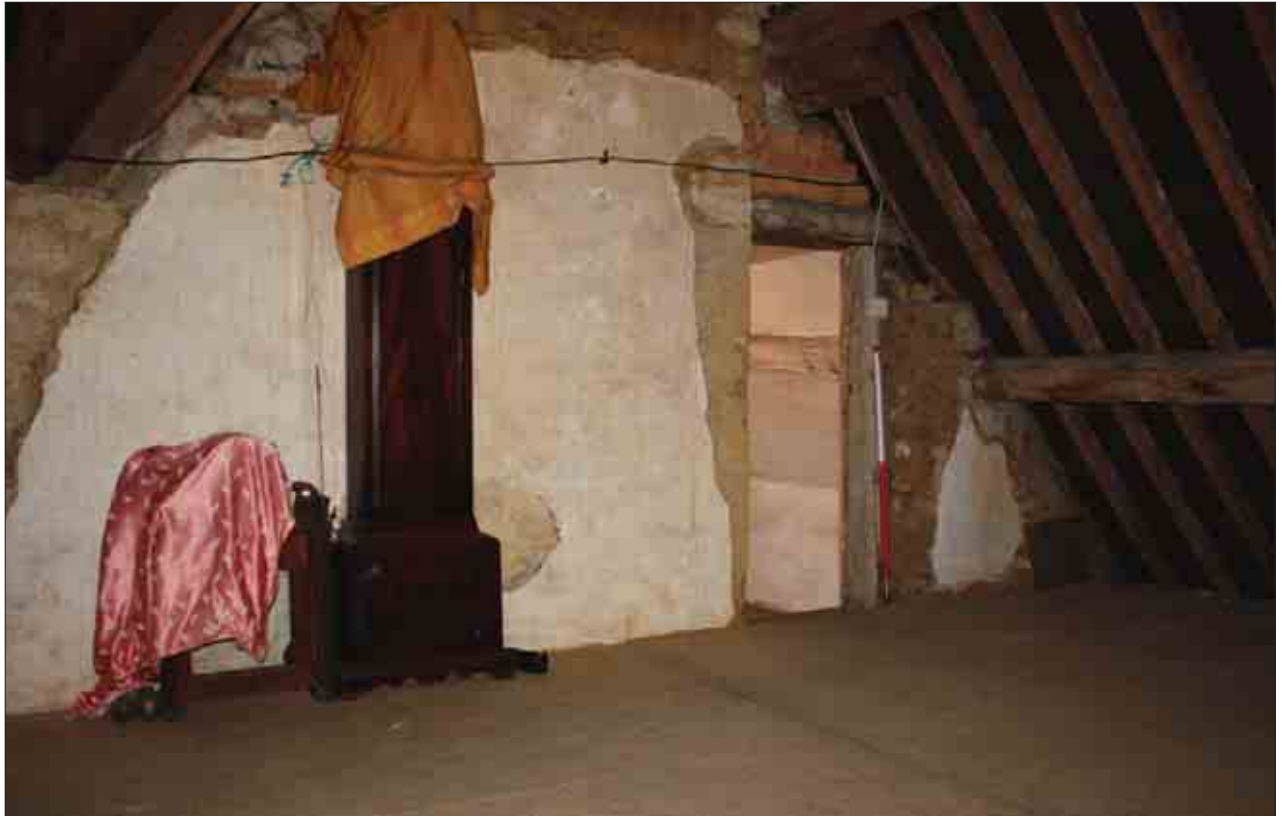
Plate 50: Rendered stone wall in S2

- 4.1.77 The walls on the south-east and north-east sides of the room have been rendered which has come away in places to reveal the original stonework, a wooden lintel above the door into S1 and modern brick repair above that (Plate 50).

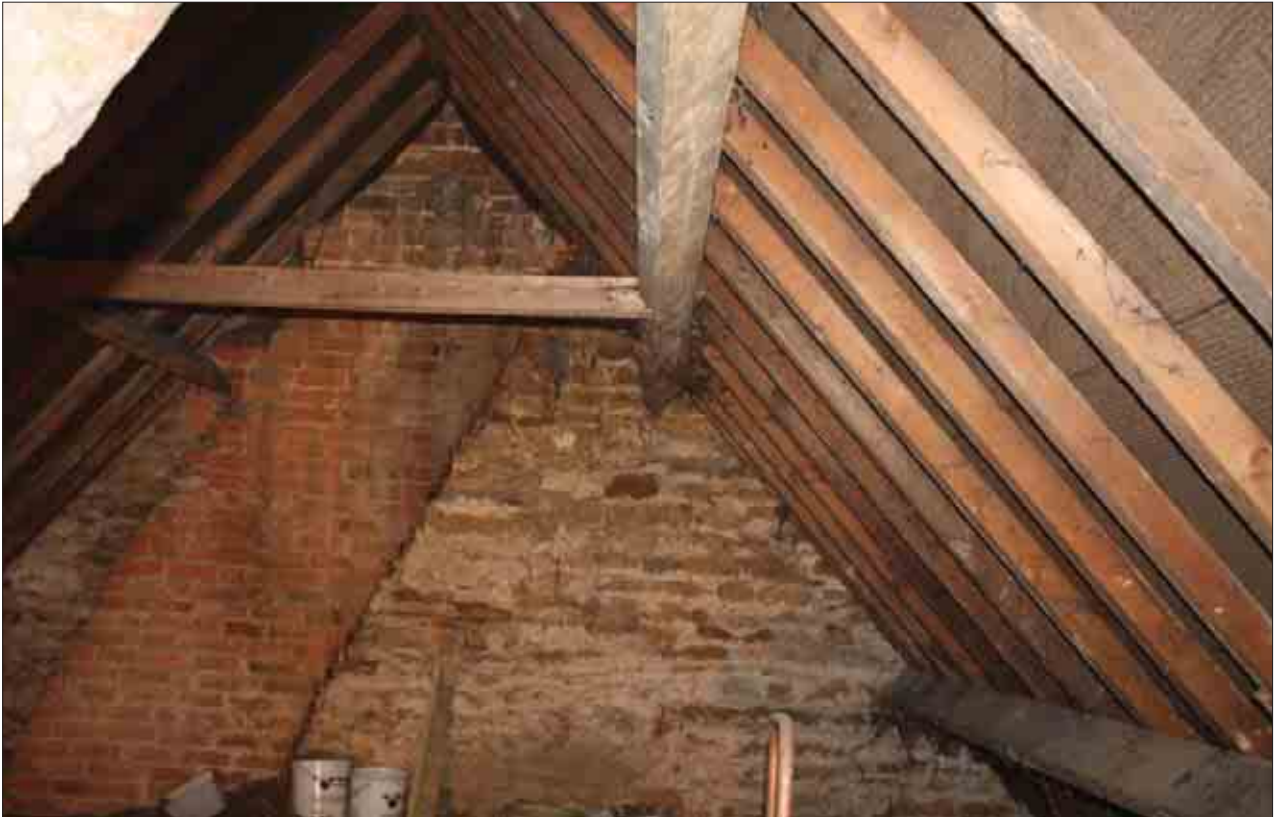
Plate 52: Detail of chimney within S4

- 4.1.82 On the opposite wall on entering is an angled brick chimney which must correspond with the possible bricked-up fireplace in F2 below (Plate 52). The common rafters and purlins used in the construction of this part of the roof are all machine cut and a layer of plyboard (?) sits between the roof and the external covering.

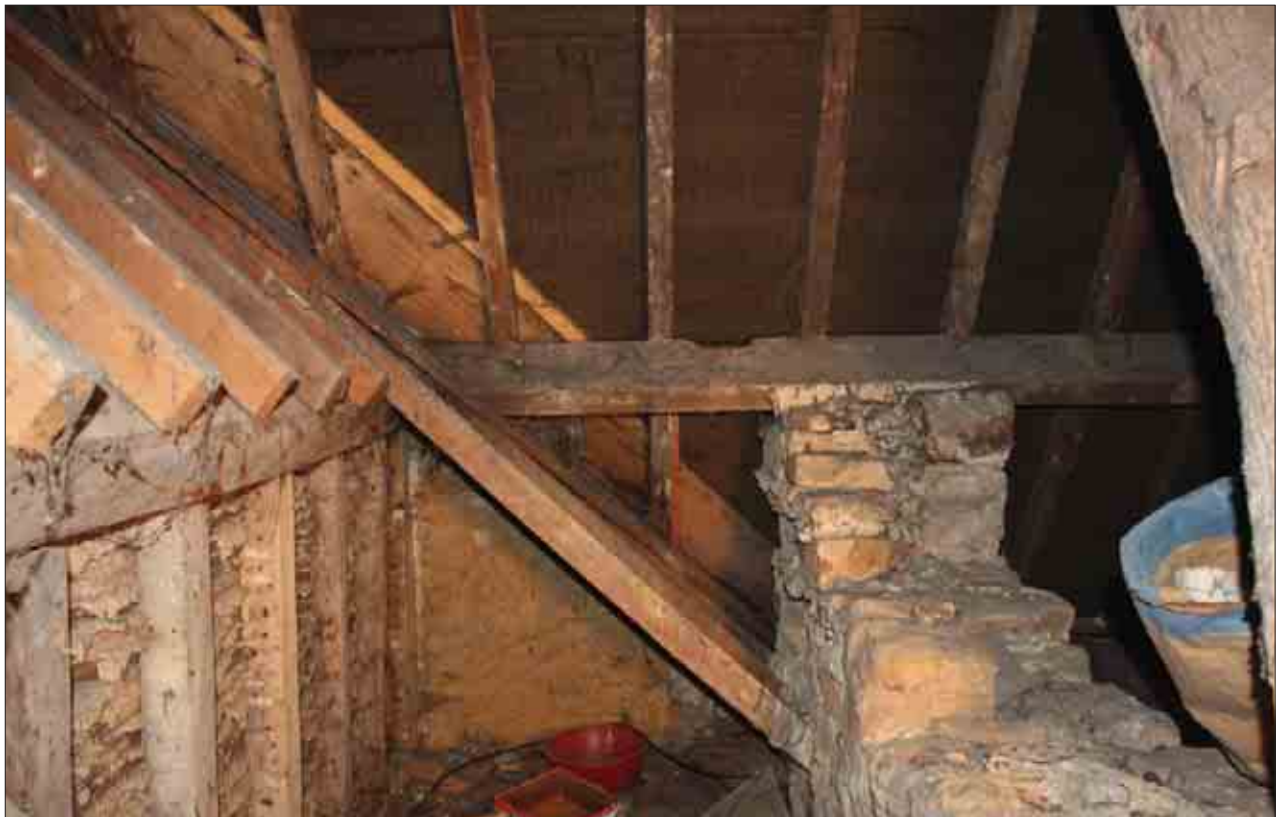
Plate 53: Original end wall as viewed from S4

- 4.1.83 Entering this area from S3, there is a narrow space in front of which part of a stone wall is exposed (Plate 53). This is considered to be the end wall of the house, prior to the addition of the corner in-fill as noted on the 1839 Tithe map (Figure 3). This wall has been raised slightly to support the purlins of the later roof. The common rafters of the roof which covers S3 have been cut (Plate 53) – these would have originally continued down to meet the top of this wall.

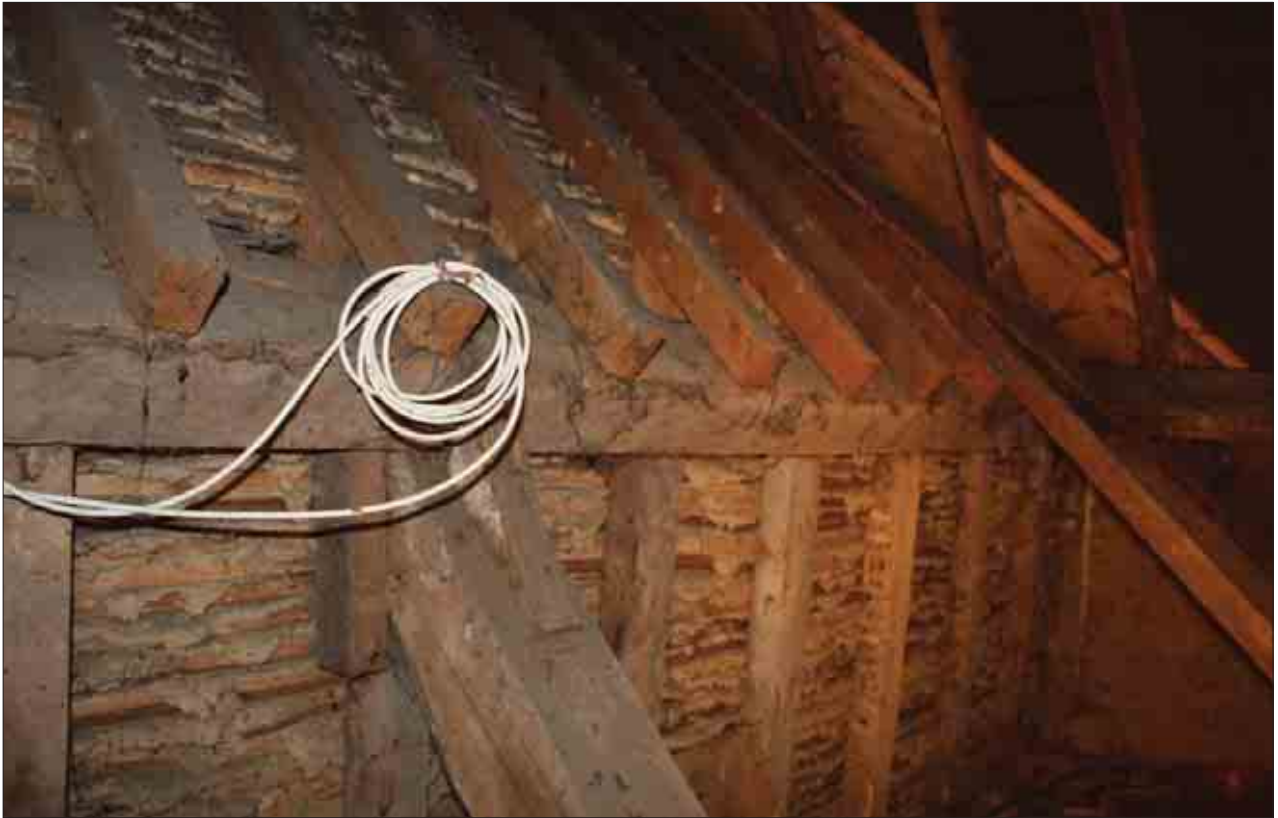
Plate 54: Detail of lath and plaster on outside of S3 as viewed from S4

- 4.1.84 From here, looking back towards the roof covering of S3, the rear of the lathe and plaster walls of S3 are exposed as well as the earlier roof covering of S3 (Plates 54 and 55), which it would appear has been incorporated into the later addition in the 19th century when a new roof was added to the whole building.

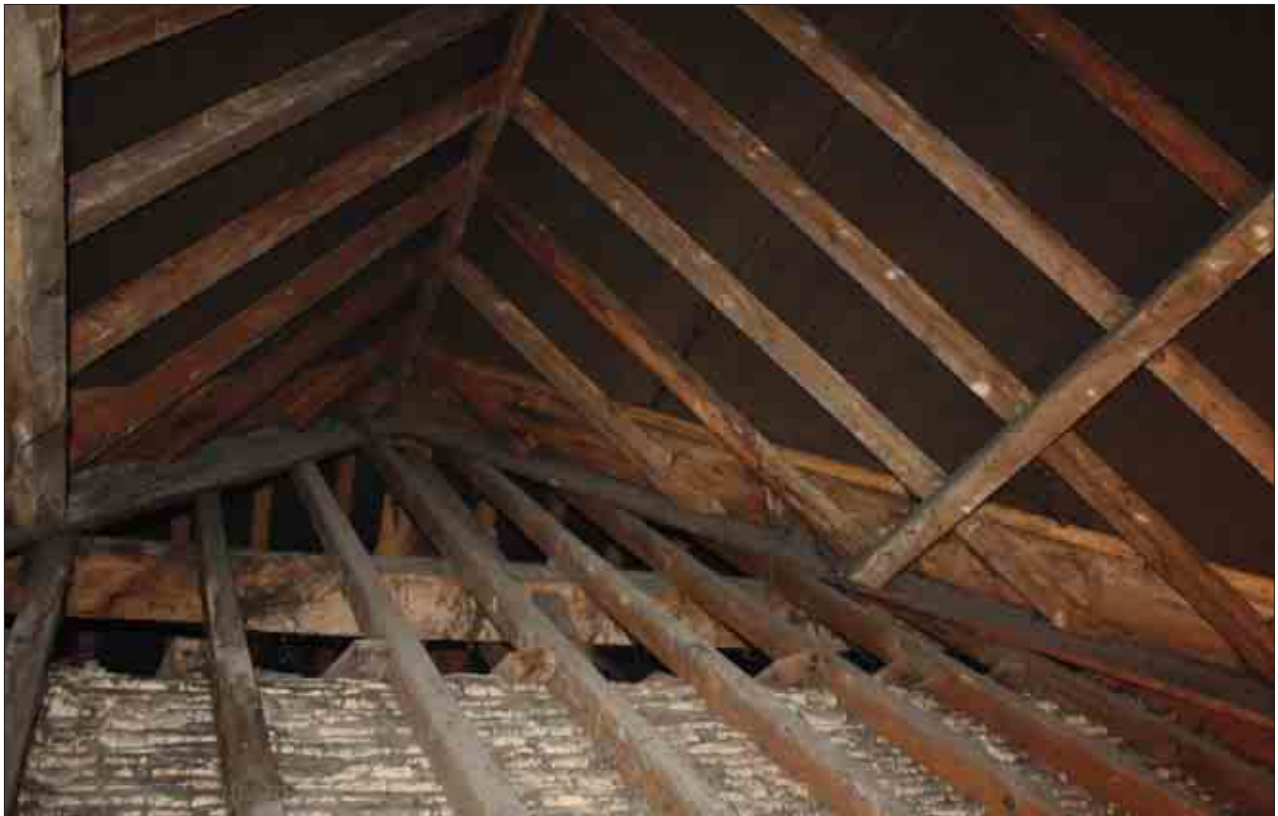
Plate 55: Remnants of original roof structure above S3 as viewed from S4

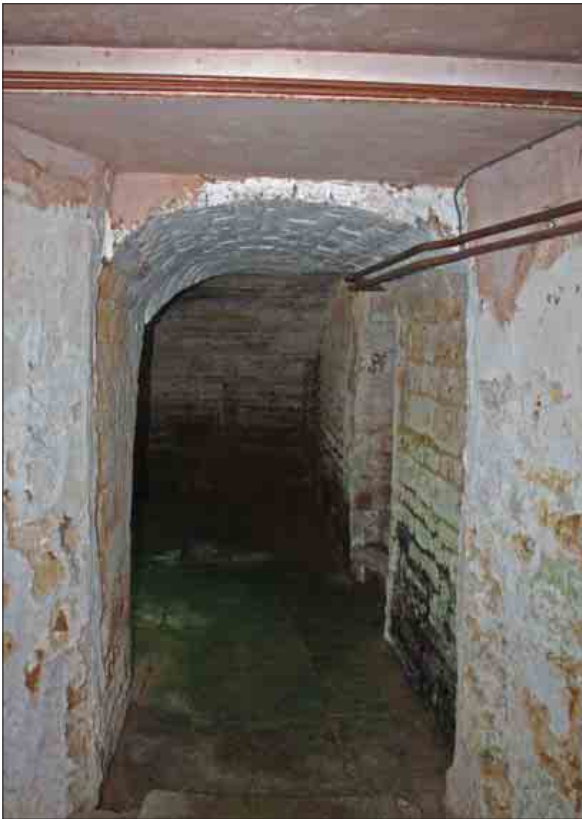
Plate 56: Archway between C1 and C2

- 4.1.85 This room is entered via a semi-circular brick arch from C2 (Plate 56). It measures 4.95m by 4.72m and has a painted plastered ceiling with unmoulded beam and an exposed stone floor. It is positioned directly below G3.
- 4.1.86 The floor has a central drainage channel which leads from the middle of the room towards the western corner (Figure 11). The drain is constructed from smaller stones

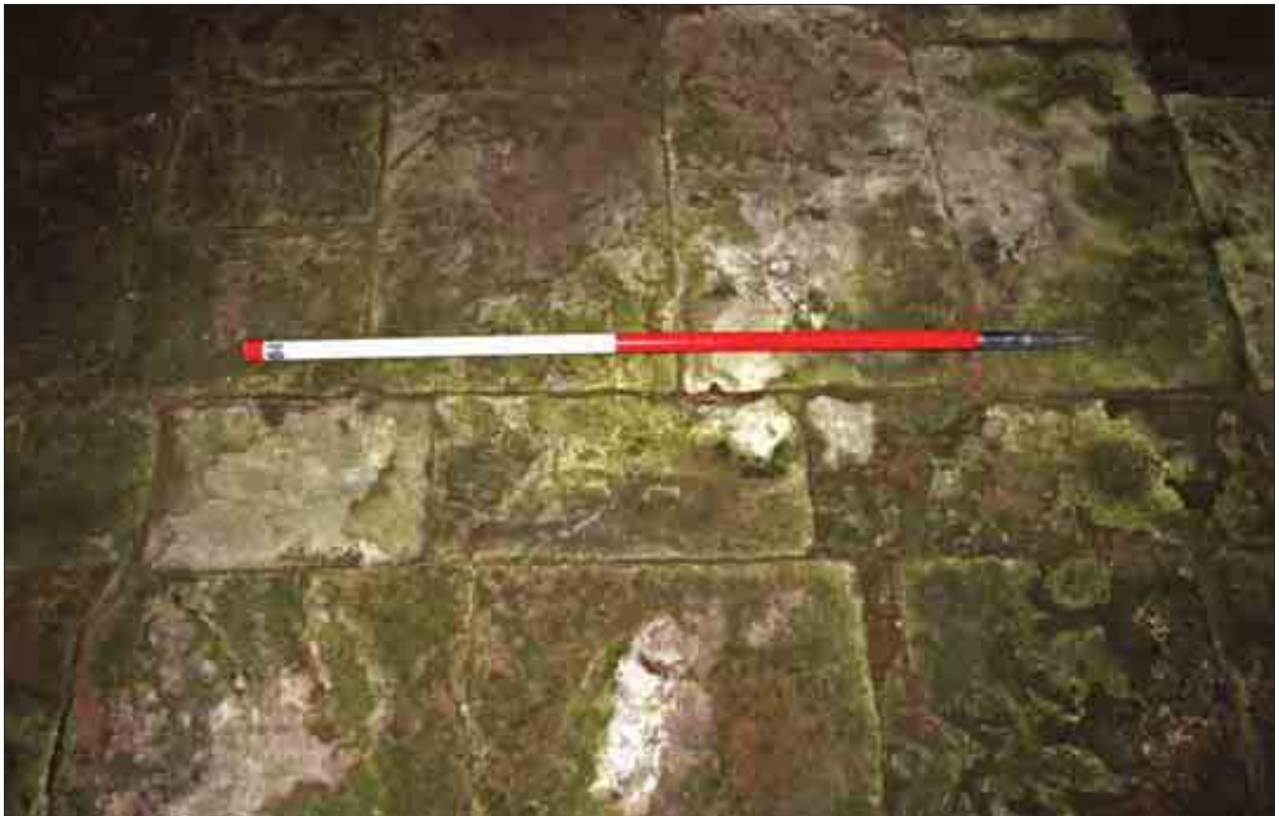
Plate 57: Detail of drainage gully in stone floor of C1

with a rounded base which are aligned on a slight downward slope towards the north-west side of the room (Plate 57).

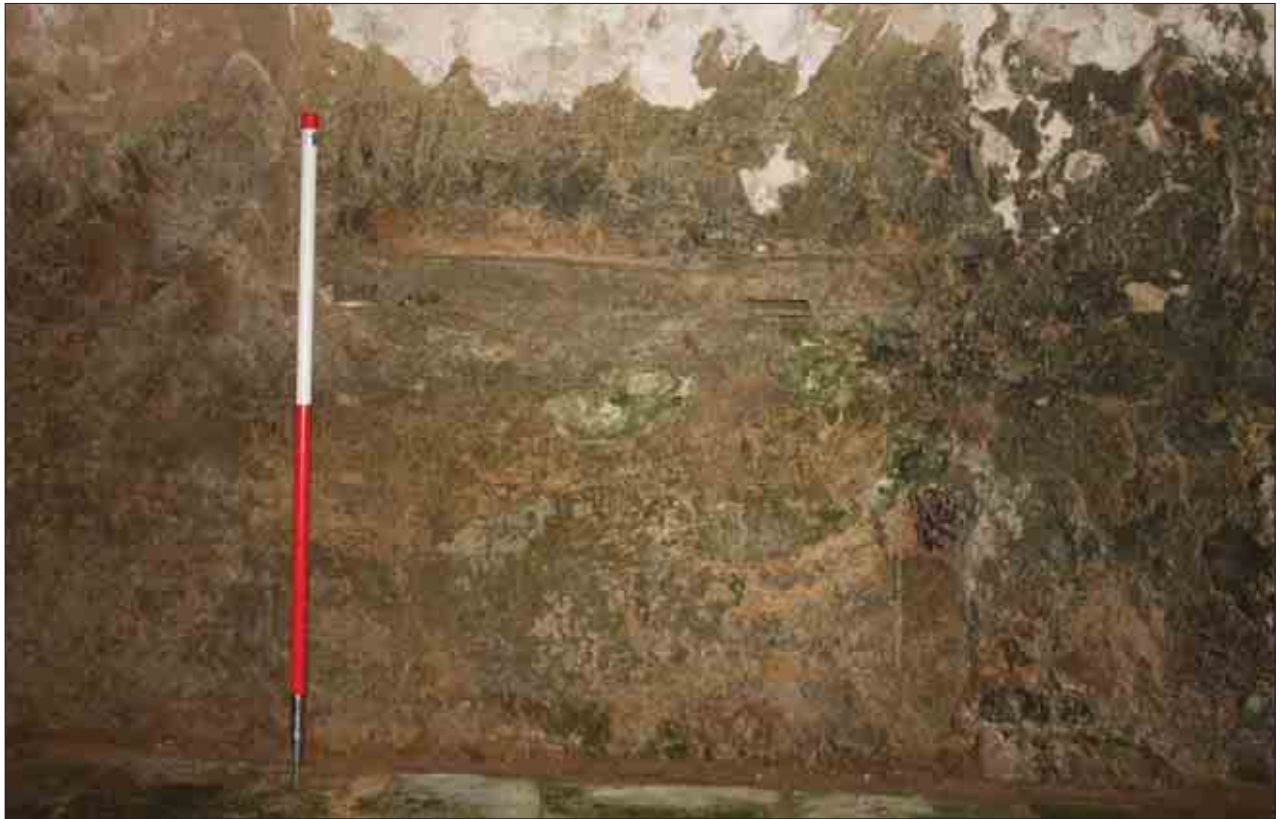
Plate 58: Blocked-up opening, C1

- 4.1.87 On the south-west wall is what appears to be the location of a blocked up opening with stone lintel and jambs (Plate 58). This measures approximately 0.75m in height and 0.90m wide. It corresponds to the possible blocked-up opening noted beneath the window on the street-fronting, south-west facing elevation. This is not considered to be an opening for a fireplace in this position and therefore is most likely a former doorway or chute to allow access directly into the cellar.

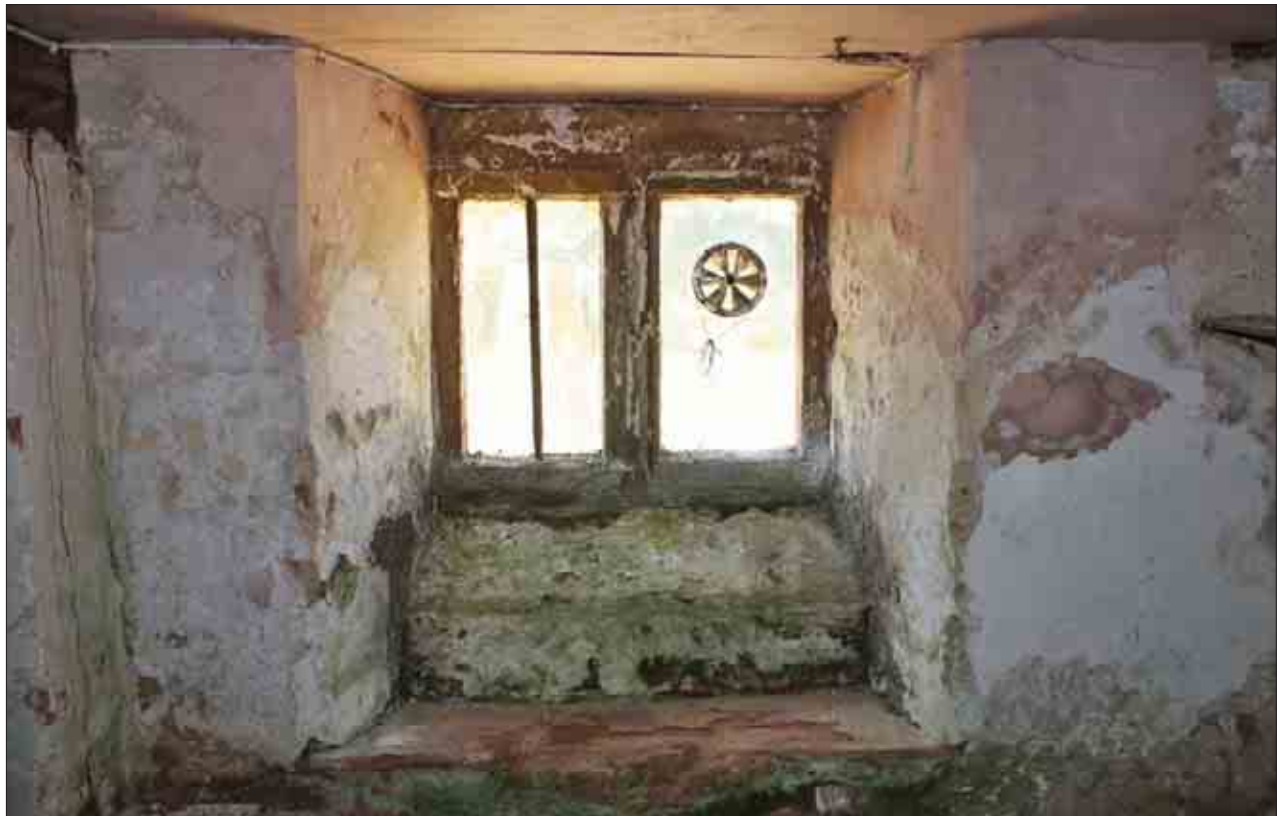
Plate 59: Splayed window on north-west wall, C1

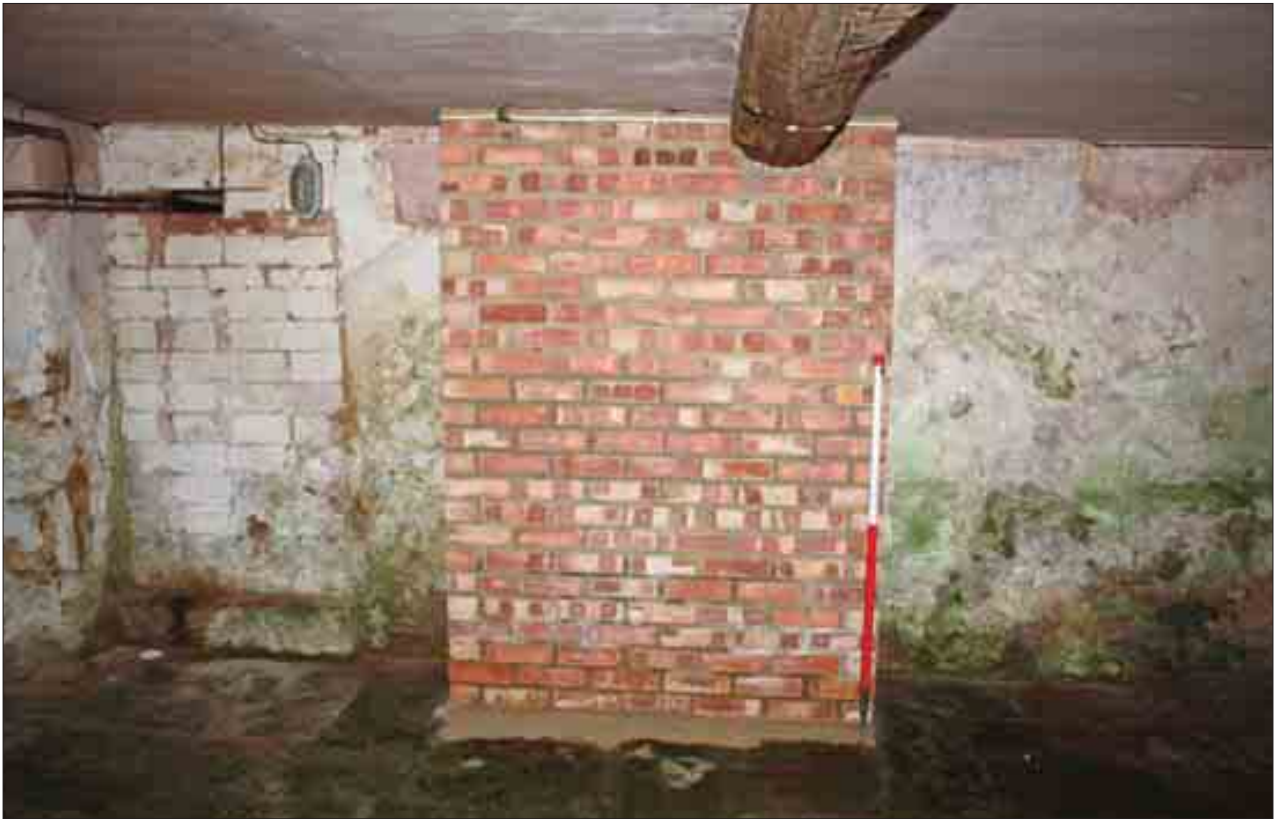
Plate 60: Blocked opening and 20th century structural support, C1
