Gate House

**Historic Building  
Recording**

**Gate House Farm, Culworth, Northamptonshire**

*Historic Building Survey*

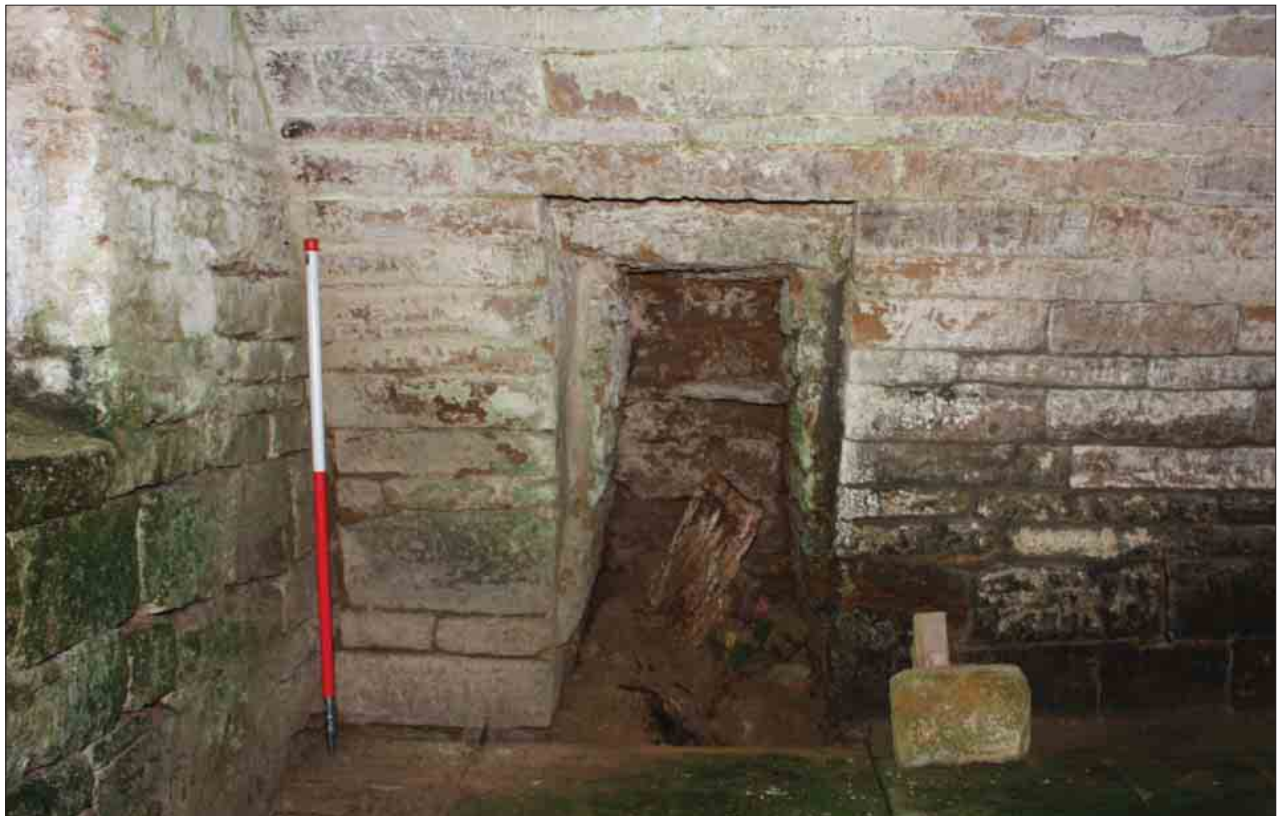
Plate 63: Small fireplace (?) C2

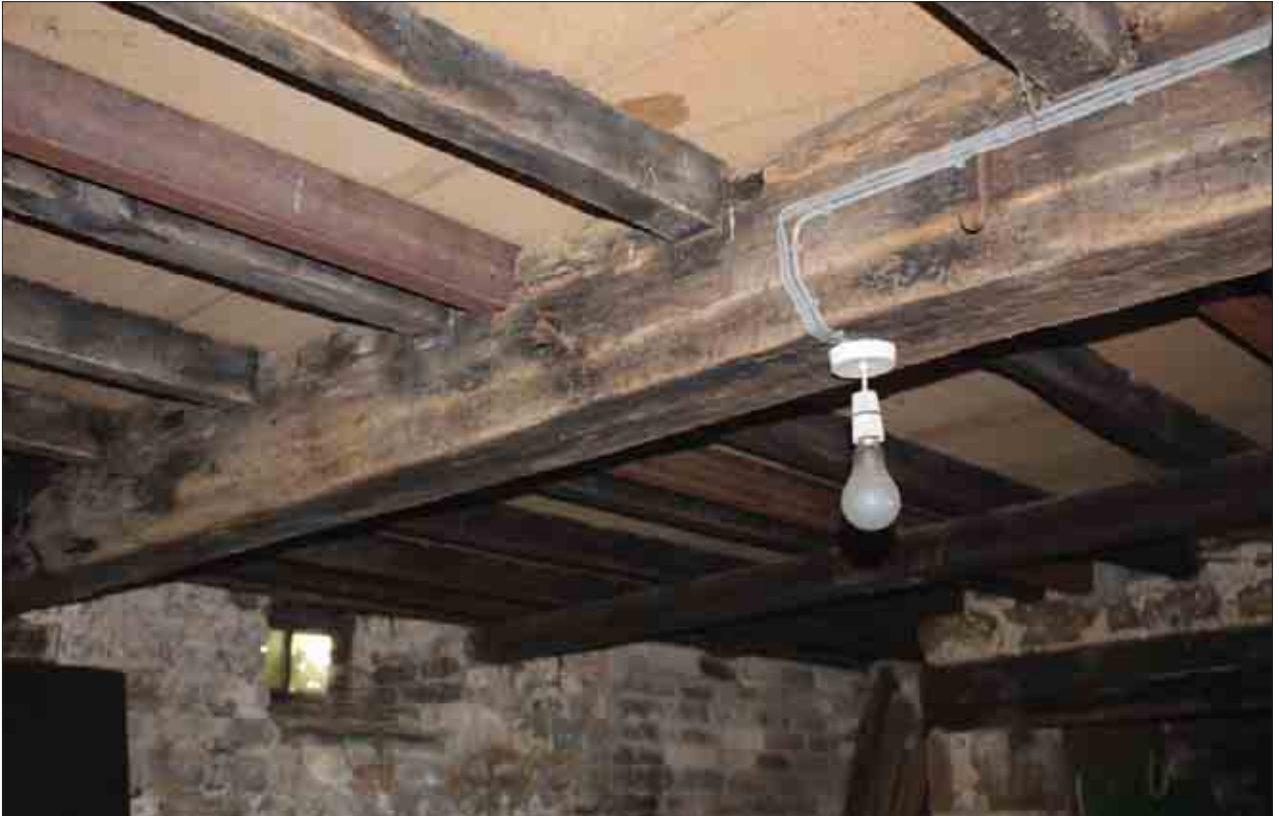
Plate 68: Ceiling beam and ceiling joists, G3, Building 1

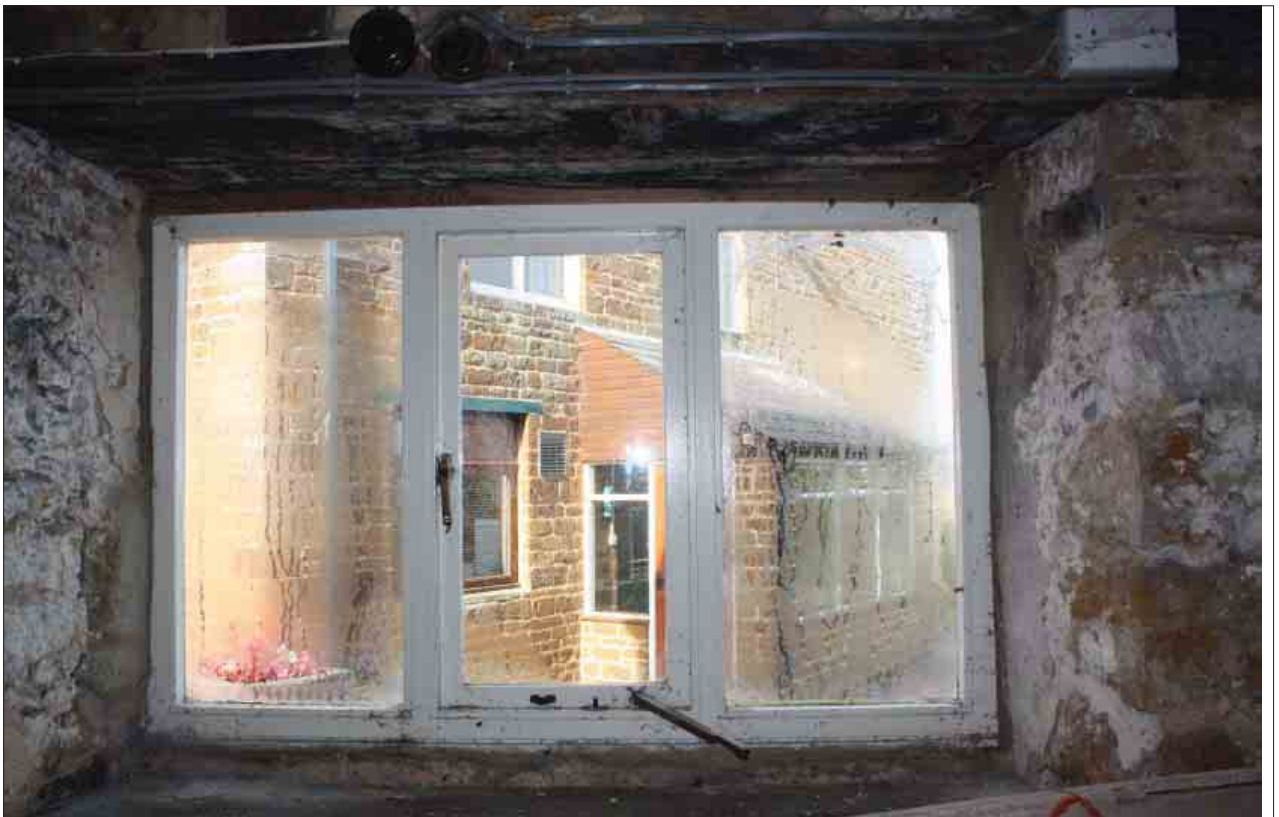
Plate 69: 20th century window, G3, Building 1

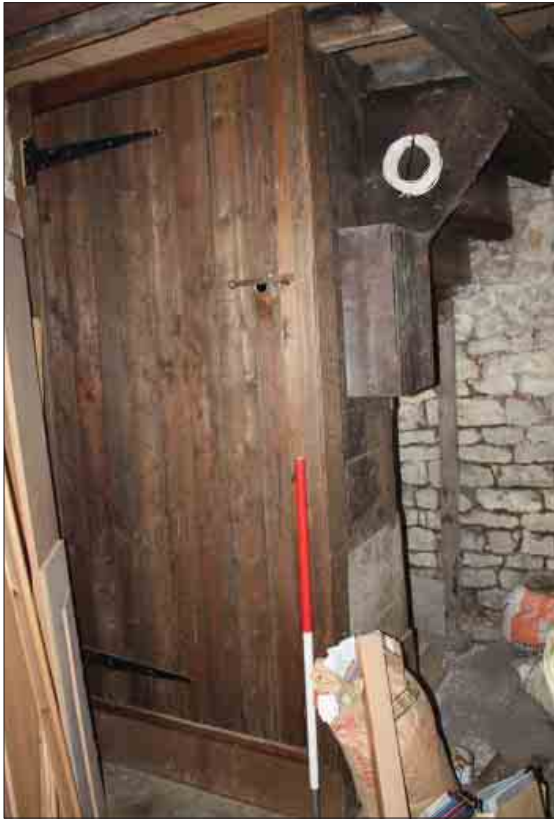
Plate 70: Access stairs to first floor, Building 1

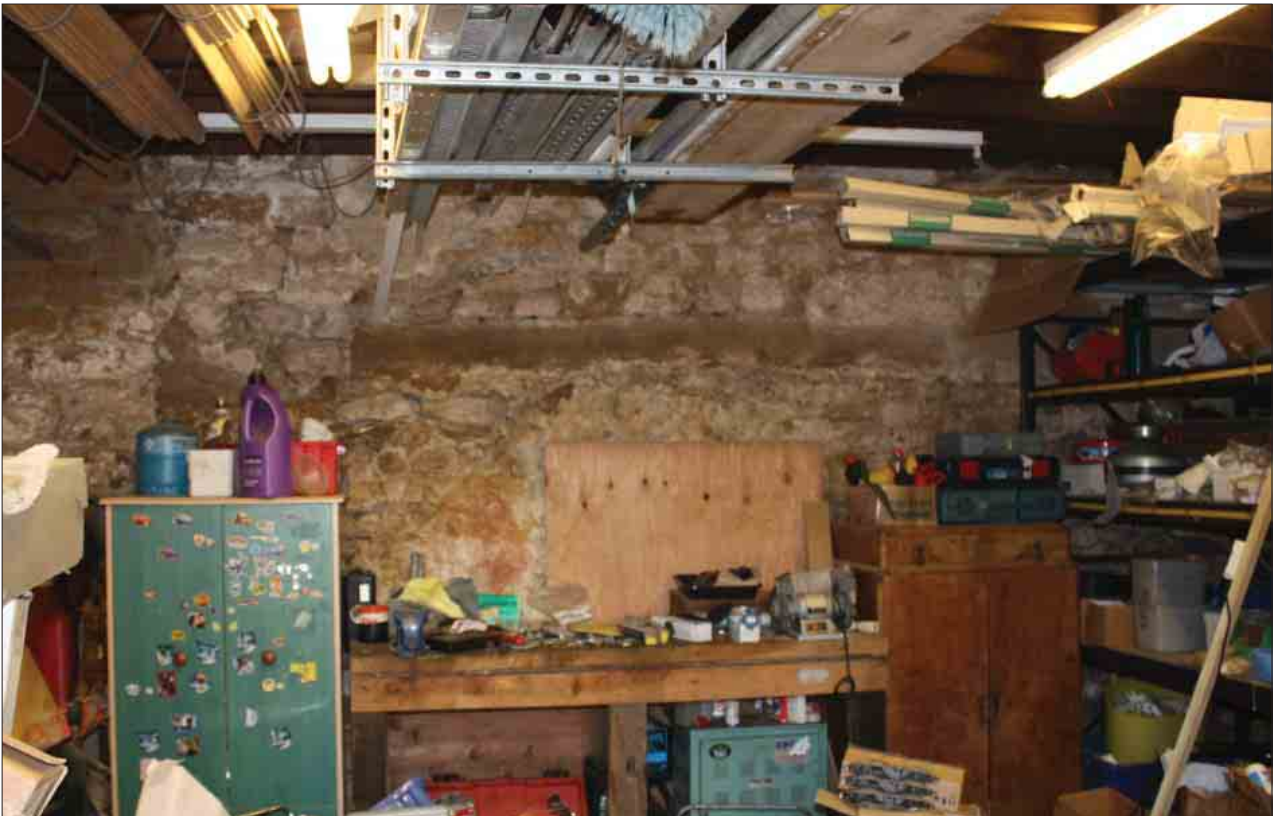
Plate 70: Lintel on rear wall, G4, Building 1

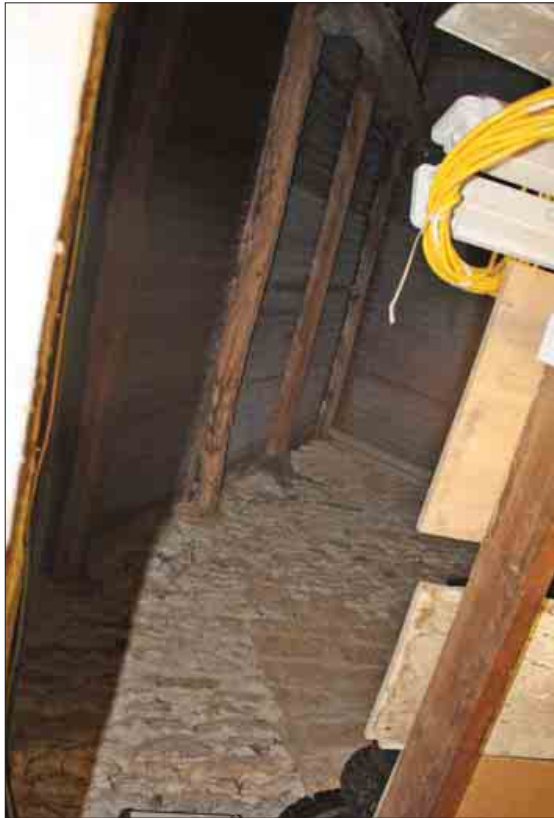
Plate 72: Blocked opening on southern wall at first floor level as viewed from G2, Building 1

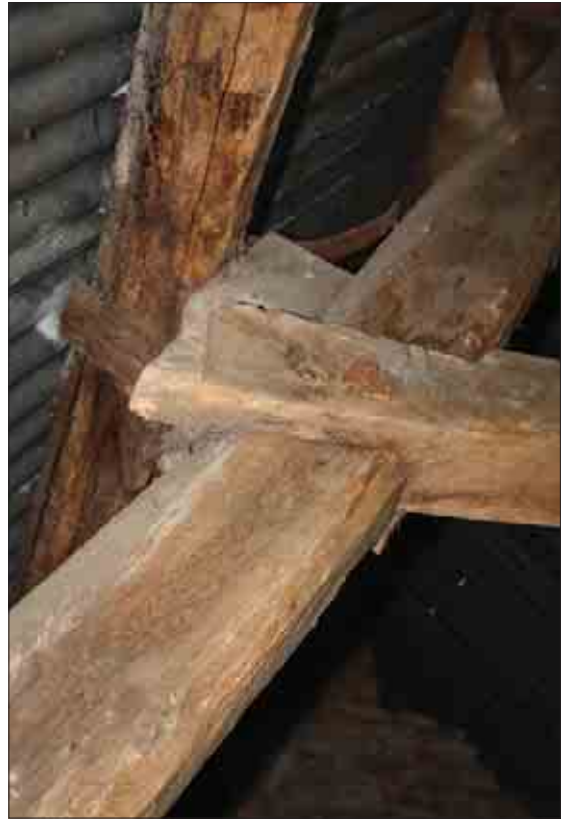
Plate 74: Carpenters mark on roof truss F2, Building 1

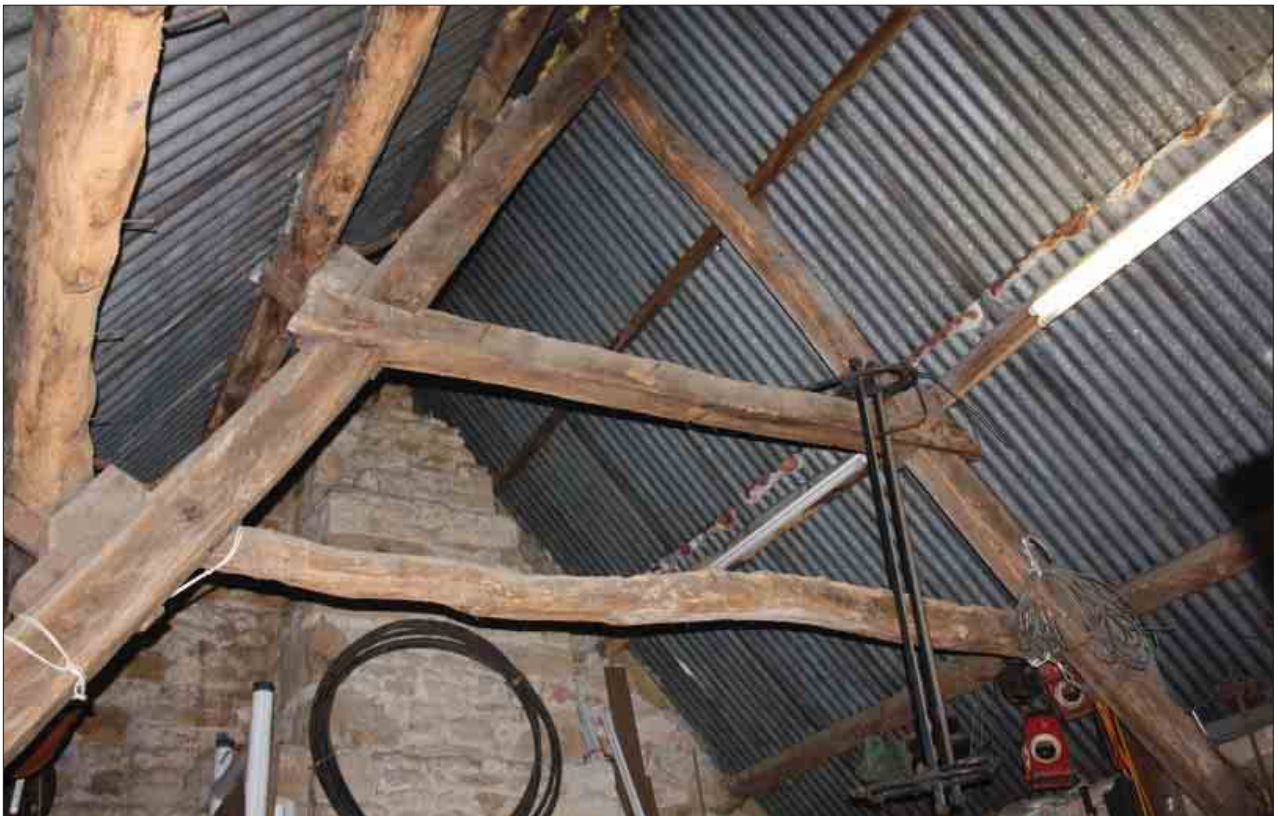
Plate 73: Roof structure and stone chimney, F1, Building 1

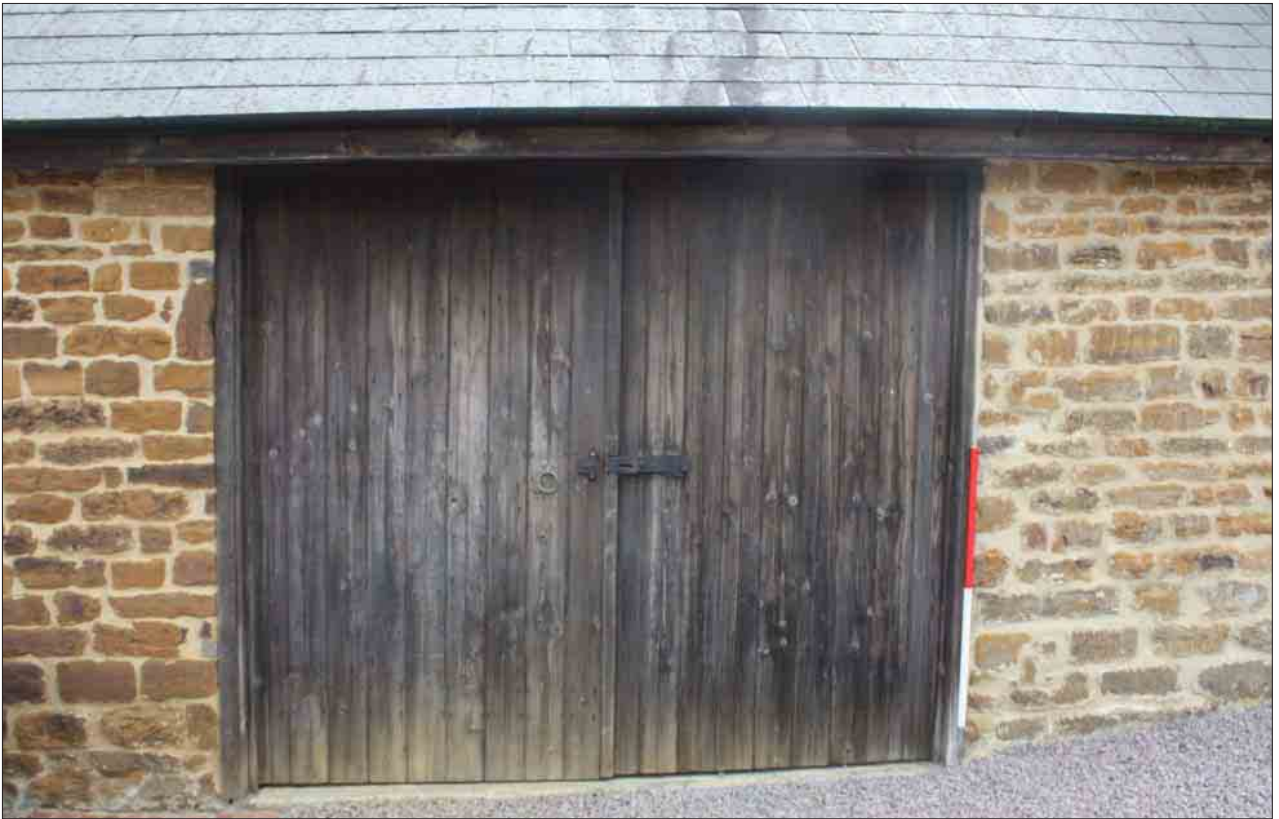
Plate 77: “Cart-door” entrance, west-facing elevation, Building 2

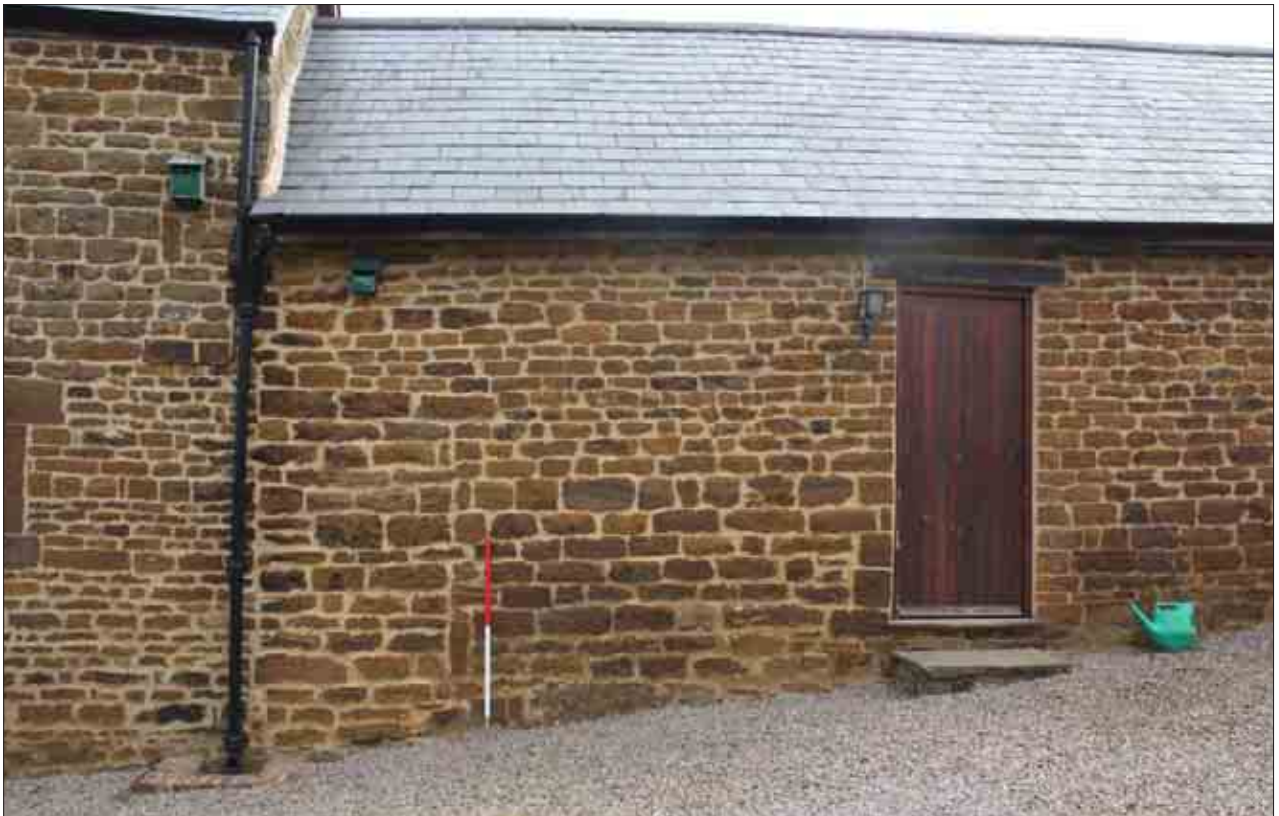
Plate 78: Blocked-up and modern doors, west-facing elevation, Building 2

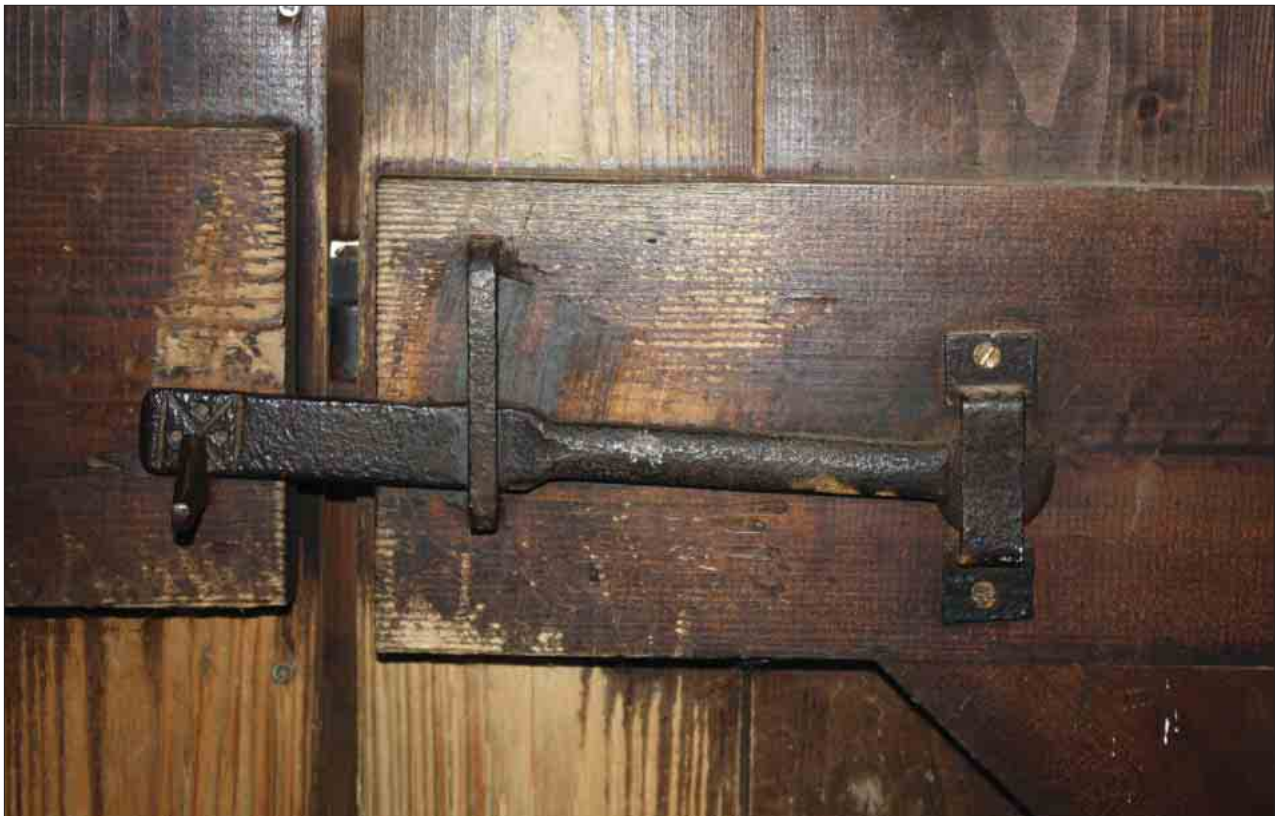
Plate 80: Detail of re-used latch, G3, Building 2

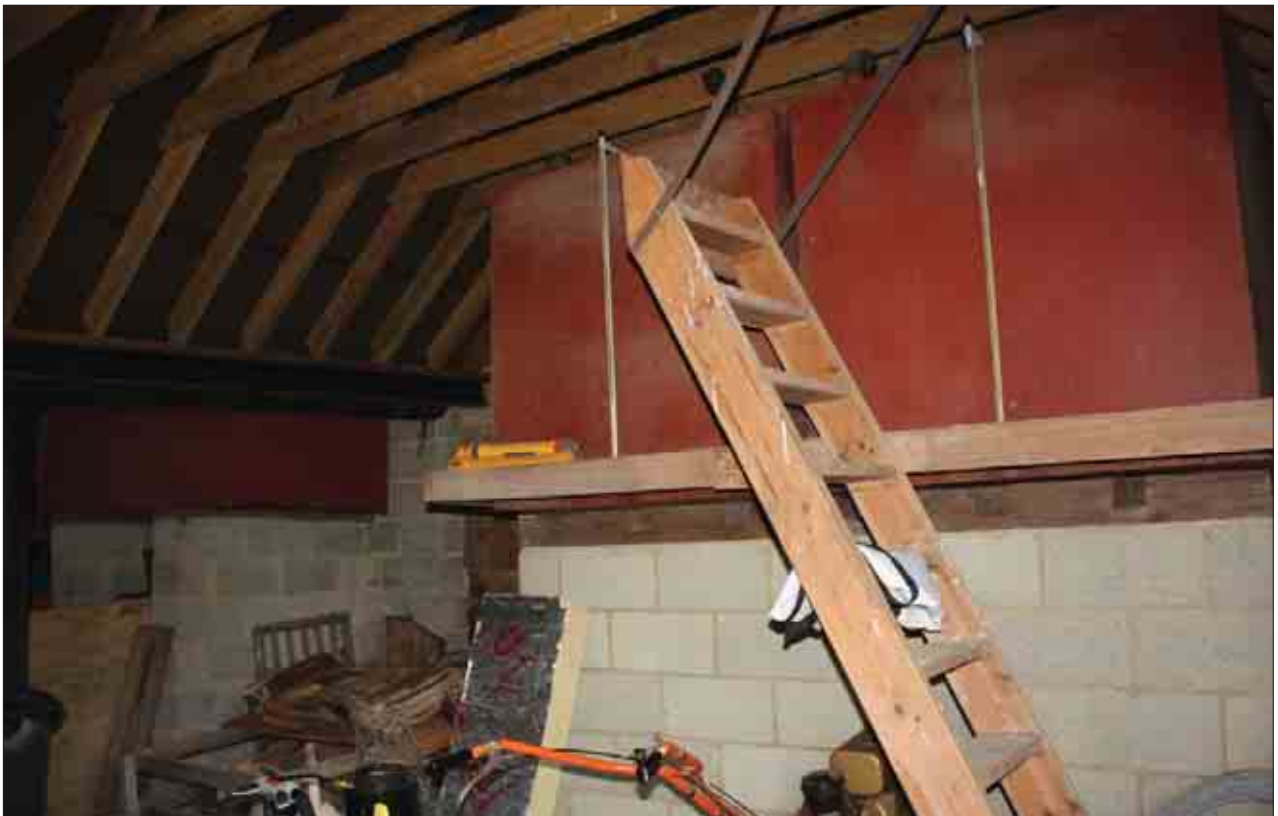
Plate 82: Modern breeze-block structure, walls and replacement roof, G3, Building 2

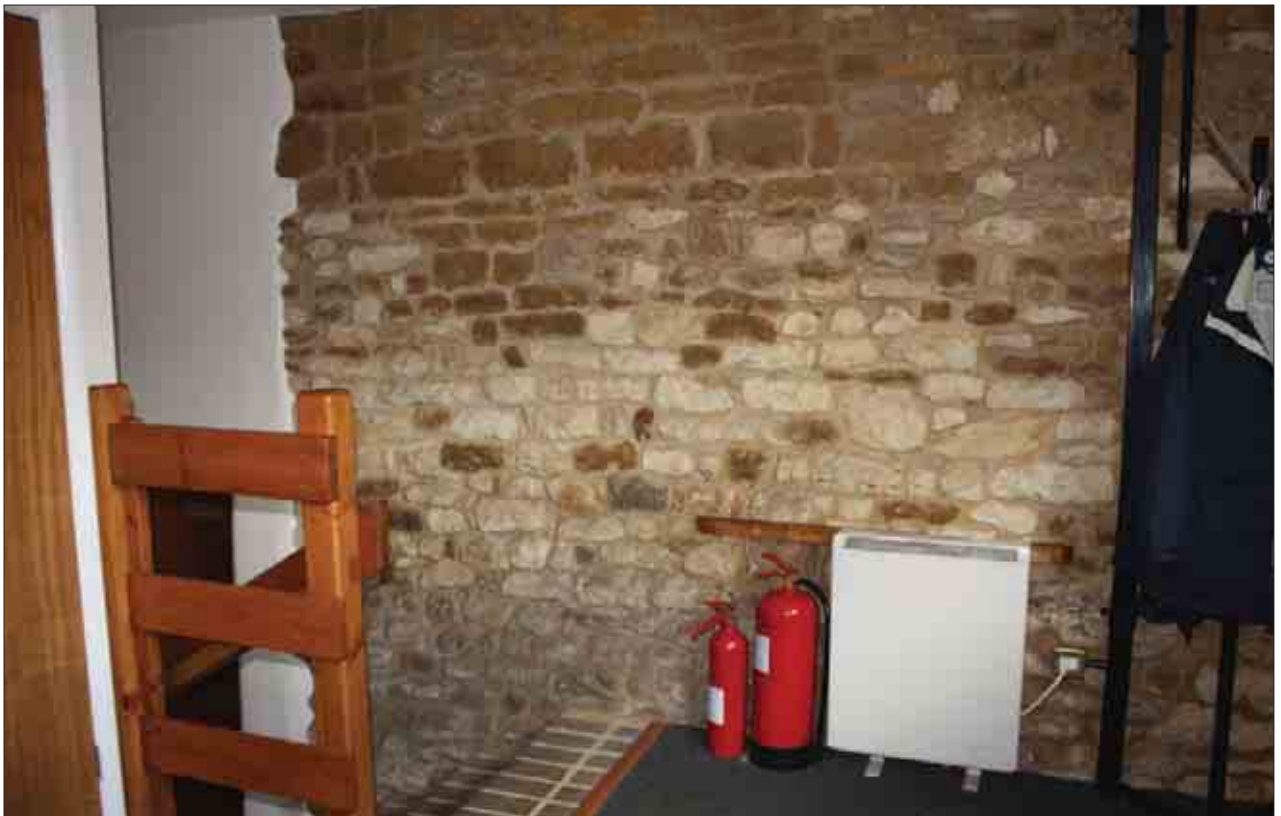
Plate 84: Exposed stone wall on northern wall, G7, Building 2

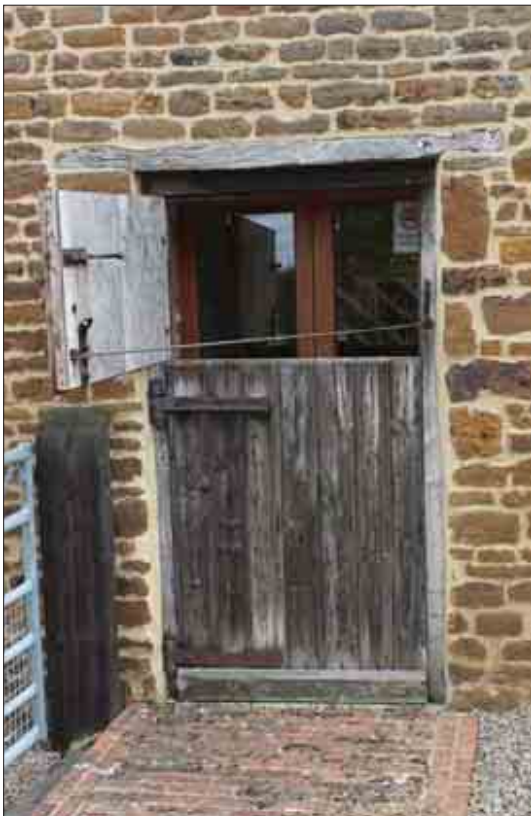
Plate 86: Two-part stable door on west-facing elevation, Building 3

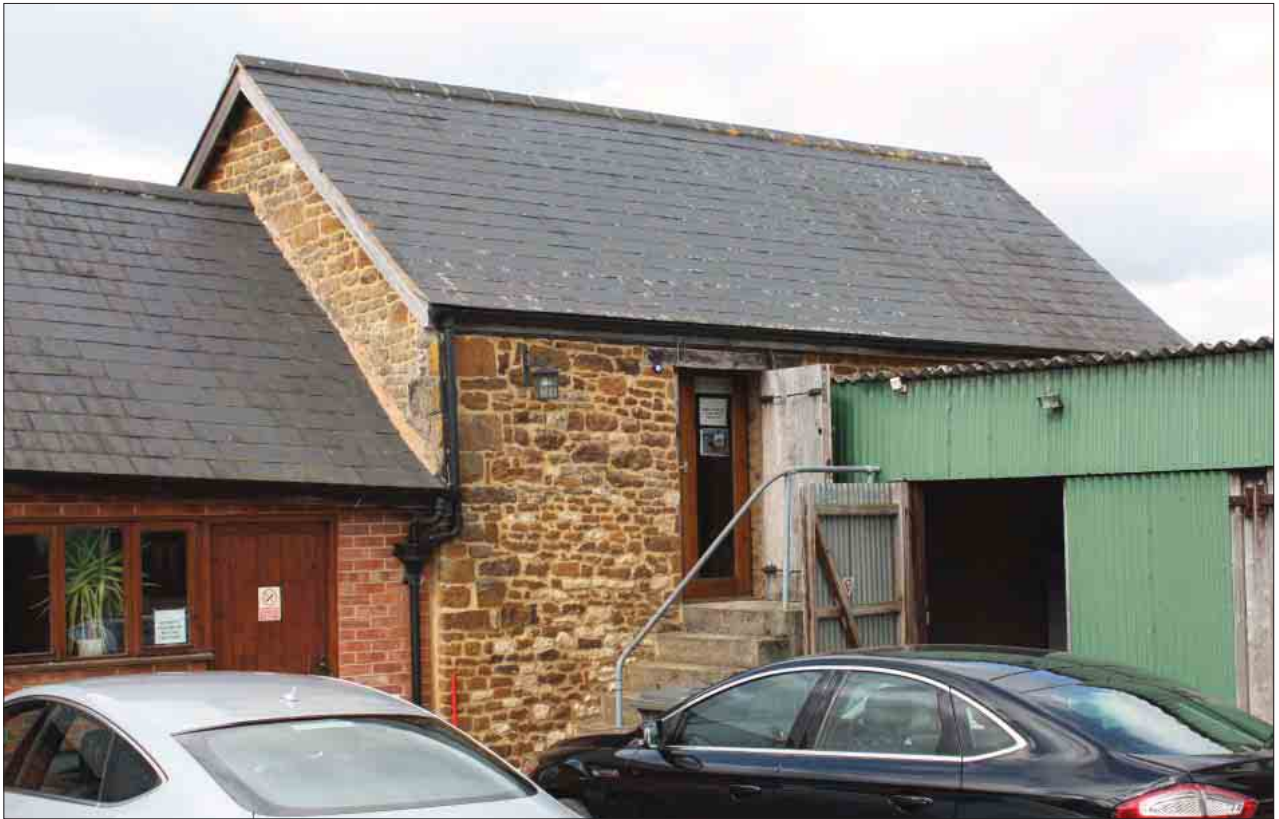
Plate 87: North-facing elevation, Building 3

buildings. It has a moderately steeply pitched roof and comprises two storeys (Plate 87). There are quoins on either side and a modern wooden barge-board.

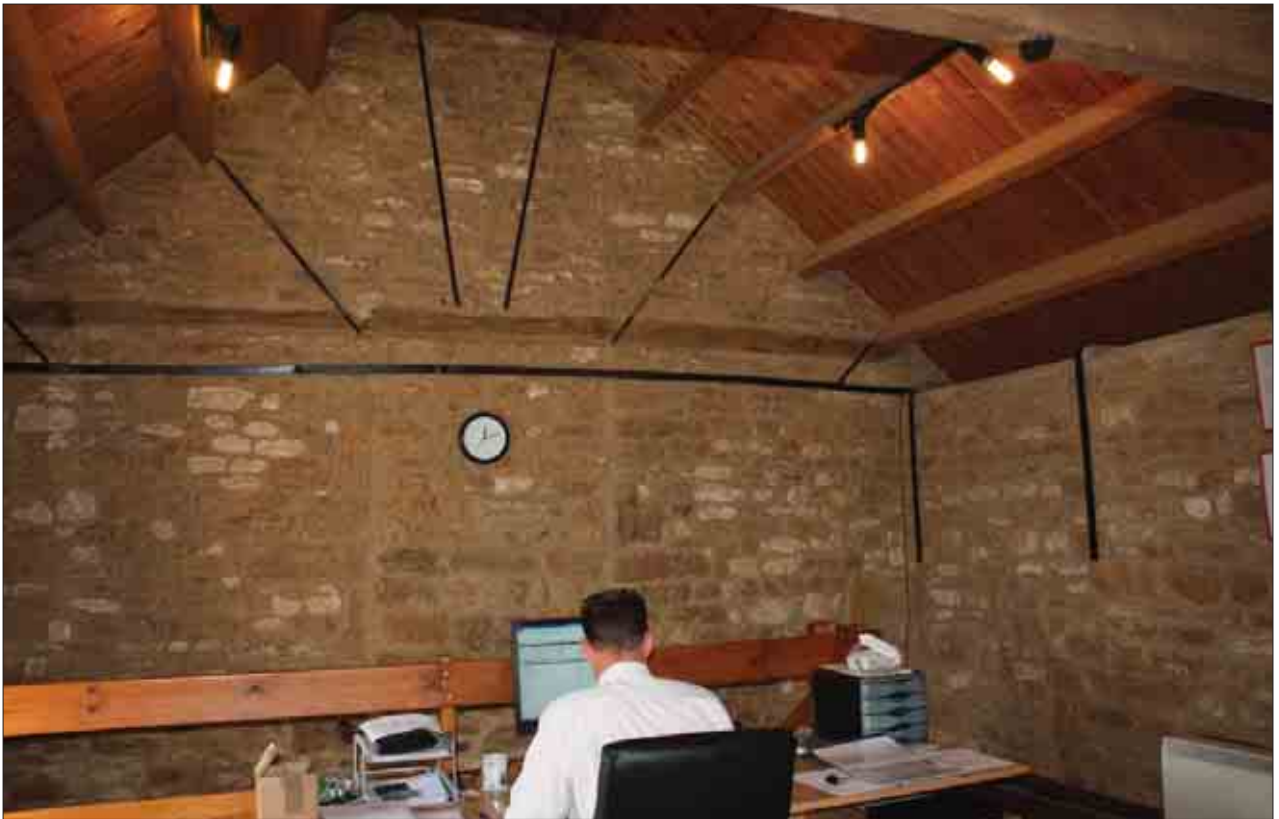
Plate 90: Blocked-up opening on northern wall, Building 3

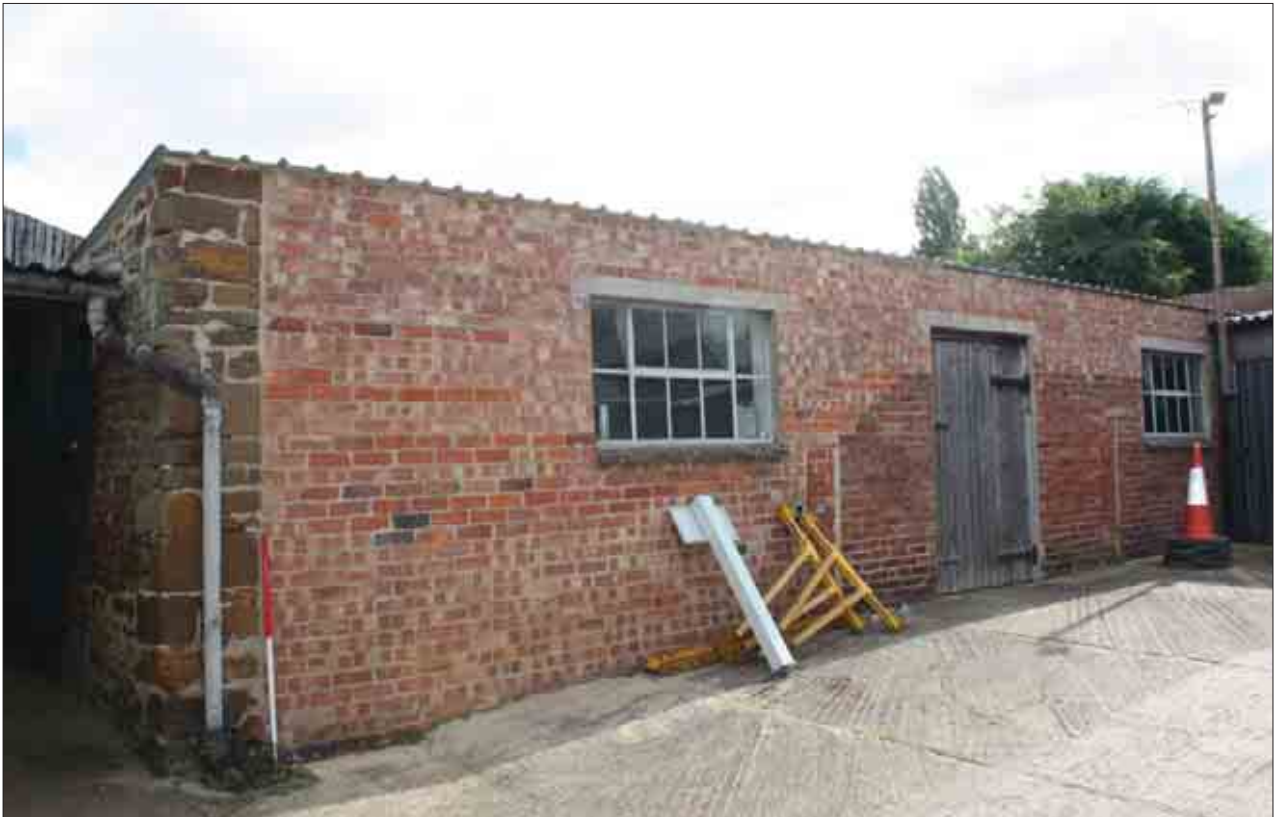
Plate 93: Internal view, Building 4

- 4.5.4 Building 4 is accessed via the double doors recorded on the northern elevation and from inside G3 of Building 2 (Figure 13). It has a concrete floor and machine-cut roof structure which is supported on a breeze-block rear wall and on the steel joist frame on the northern side (Plate 93). Breeze-blocks have been used to connect the building with Building 2 and also on the southern wall. The western end of the building utilised the former external wall of Building 5 (Plate 93). The former external wall of Building 5 is constructed in a dark red brick laid in a Flemish bond, which has later been raised using a pinkish coloured brick that looks to be 20th century in date.

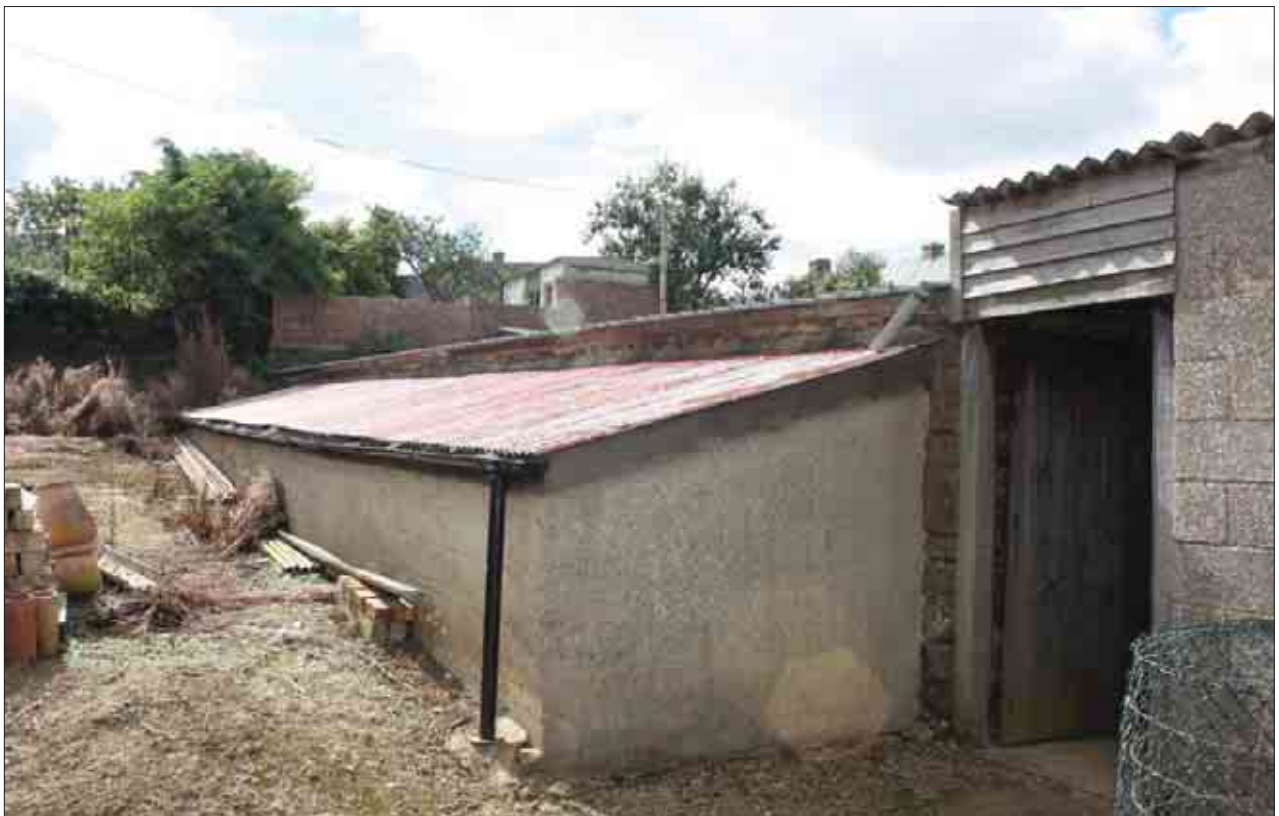
Plate 94: West-facing elevation, Building 5

Building 5 is north-south orientated and flanks the eastern boundary of the courtyard (Figure 2). It comprises a single storey brick and stone built structure with mono-pitched roof (Plate 94). It is accessed via a door on the west-facing elevation and cartographic evidence indicates a building was constructed in this location between 1884 (Figure 4) and 1900 (Figure 5). The most recent owners who have been at Gate House Farm for over 50 years used to house pigs in this building before it was given over to storage.

- 4.6.1 This elevation faces into the courtyard area and comprises the main access to the building via a large wooden plank and batten door with large iron hinges and a concrete lintel above (Plate 94).

- 4.6.2 The presence of ironstone and two different colours and types of brick visible on this elevation indicates there has been different phases of repair or re-build. The northern wall of the building is constructed entirely from ironstone blocks (Plate 94). This ironstone wall may be the only surviving part of an earlier stone-built structure or it may be an earlier wall which has been utilised. If it is an earlier wall, the orientation would line-up with the northern end of Building 2 (Figure 2). The brick used around the door and recorded within Building 4 where this elevation continues, is a dark red brick laid in a Flemish bond. This is likely to be part of the structure, dated by the historic maps to the late 19th century. The lighter pinkish coloured brick laid in a stretcher bond, used on the northern part of this elevation and also used to raise the roof line, is likely to be mid-late 20th century in date.

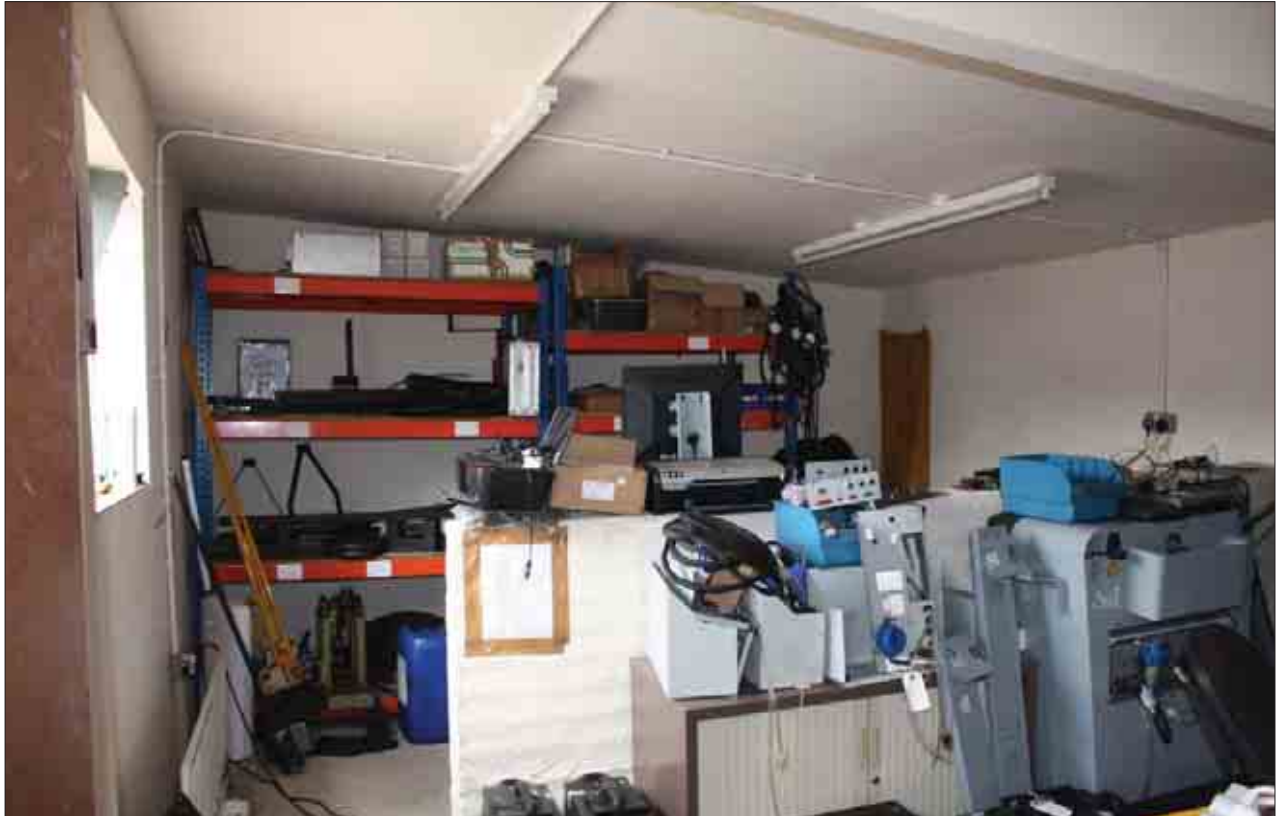
Plate 95: East-facing elevation, Building 5

- 4.6.5 The east facing elevation has been mostly obscured by a rendered breeze-block extension with mono-pitched roof covered with corrugated iron sheeting (Plate 95).
- 4.6.6 The earlier rear wall of Building 5 is partially visible and appears to be constructed from ironstone, however the blocks look to be significantly smaller than those used to construct the other buildings surveyed. There is a wooden plinth on top of the wall which supports the roof.

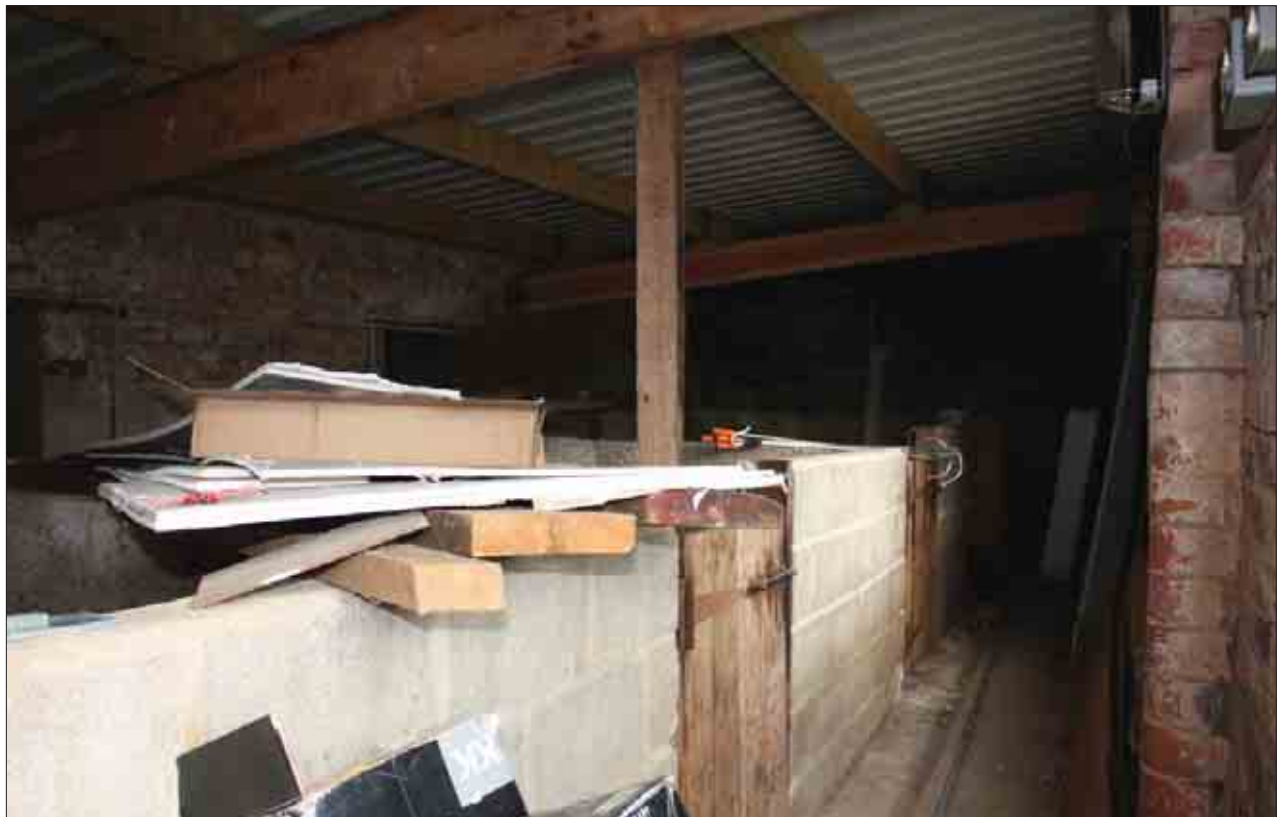
Plate 96: Internal room view, Building 5

- 4.6.7 Building 5 is accessed via the door recorded on the west-facing elevation. There is a room on the left on entering which has been converted for storage (Plate 96). The walls and ceiling are all plastered and painted, there are no exposed features, fixtures or fittings of historic or architectural value in this room.

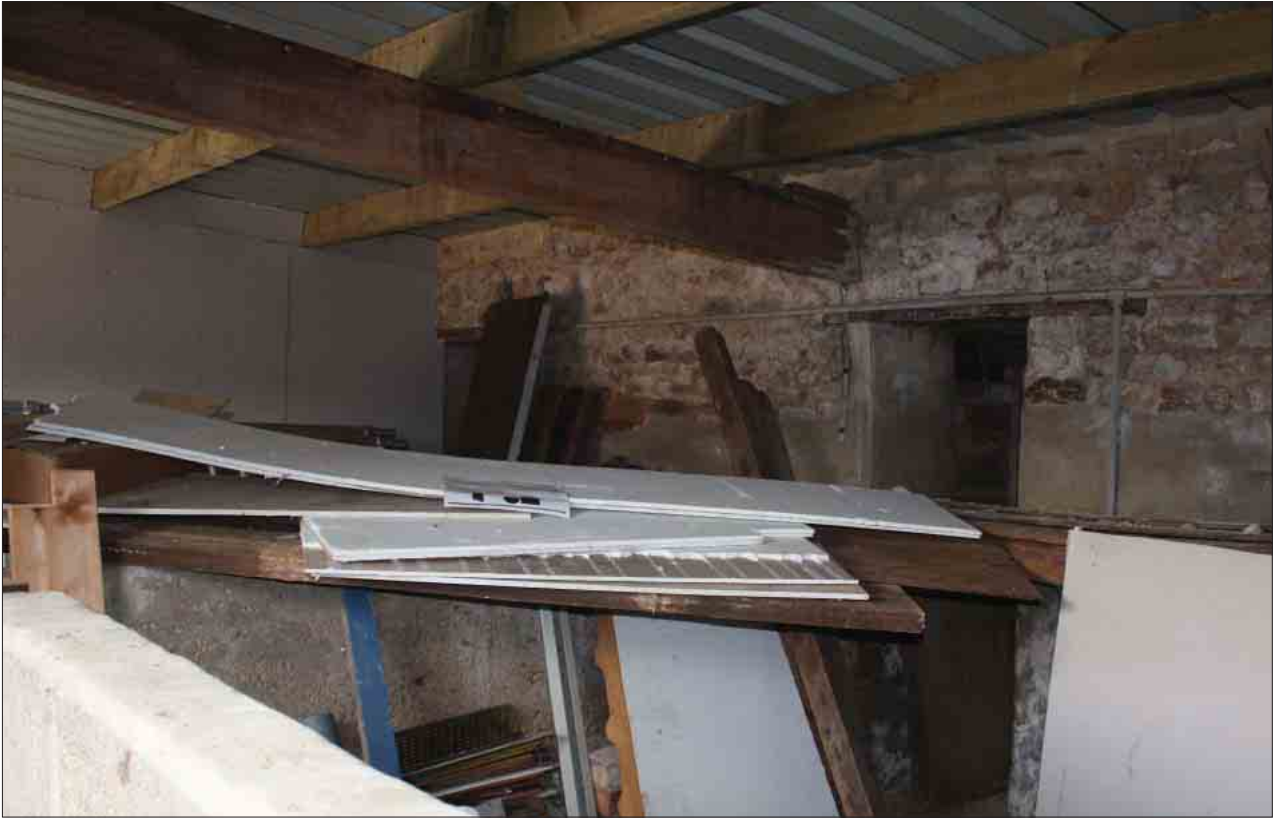
Plate 97: Internal view, Building 5

- 4.6.8 On the right on entering is the part of the building which has been largely unaltered since in use as a piggery (Plate 97). There are a series of small "pens" which have been created using breeze-block with small wooden access gates. There is an access walkway which spans the length of this area which has a concrete floor and drainage channel.

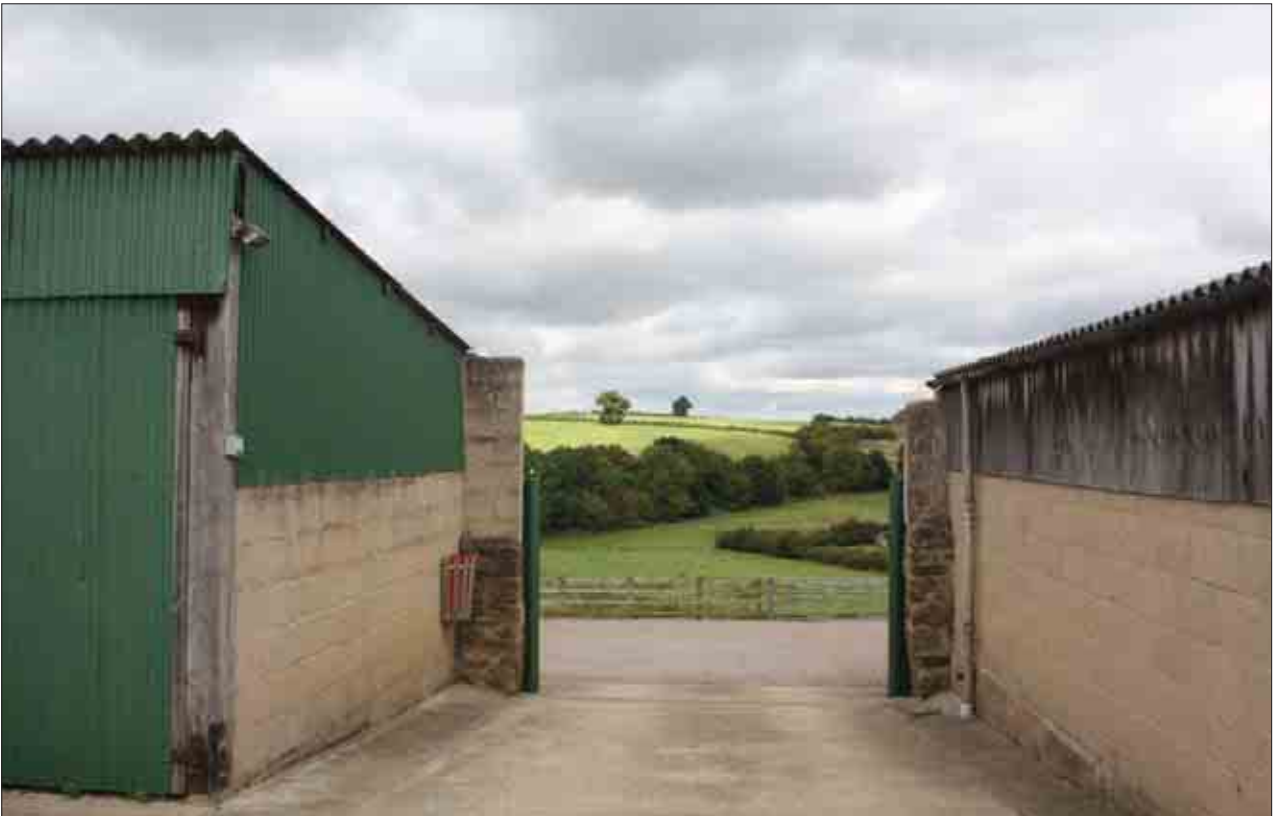
Plate 99: Entrance to courtyard looking northwards with Building 6 (left) and Building 7 (right)

Buildings 6 and 7 are located on the north side of the farm and together create the entrance into the courtyard (Figure 2) (Plate 99). Neither building was inspected internally. Cartographic evidence indicates that these structures were in place by the early 1980s (Figure 7).
