Gate House

**Historic Building  
Recording**

**Gate House Farm, Culworth, Northamptonshire**

*Historic Building Survey*

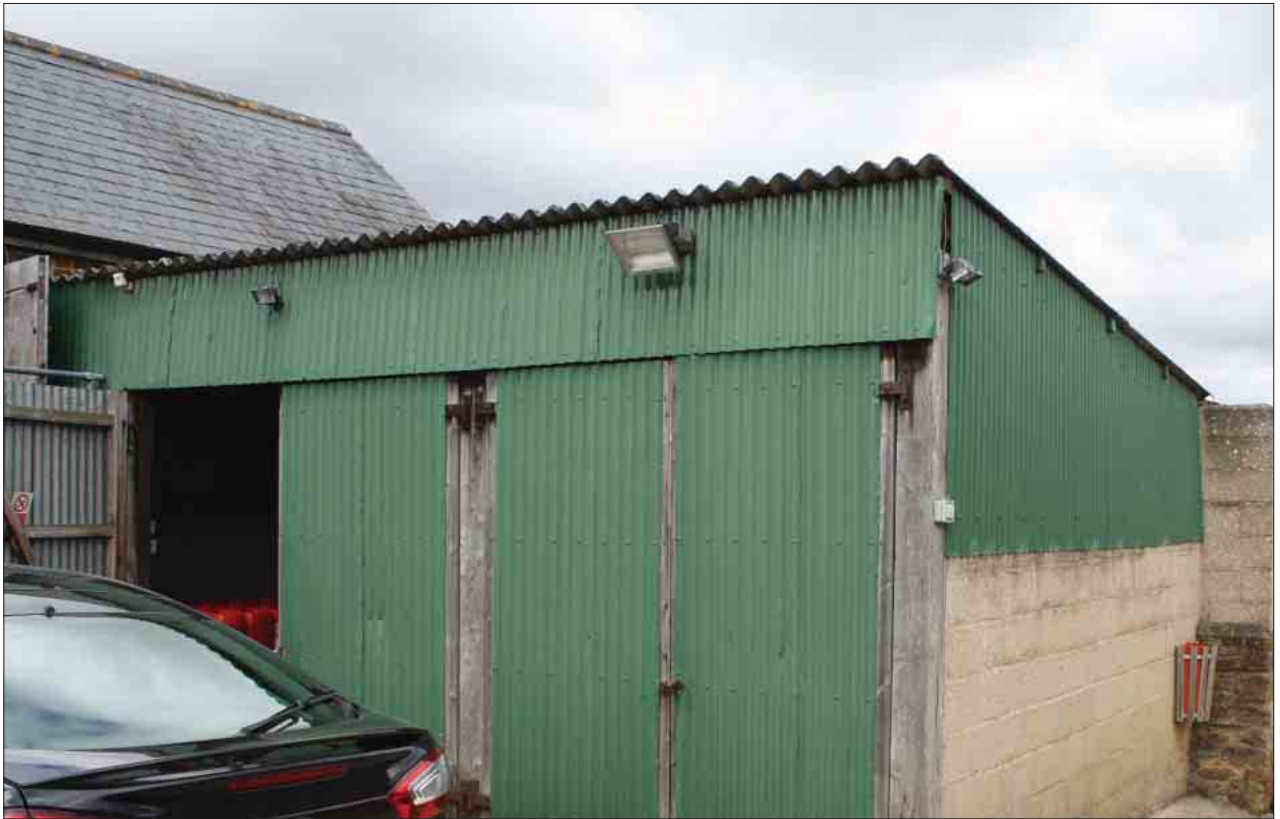
Plate 100: South-facing view, Building 6

- 4.7.1 Building 6 is constructed on the eastern side of Building 3 (Plate 100). It is constructed from a cream painted breeze-block and has a mono-pitched roof with corrugated iron sheet cover. On the northern side a former stone boundary wall has been utilised in its construction (Plate 101). The building is accessed via corrugated iron sheets on the south-facing elevation from the courtyard – this iron sheeting has also been used on the eastern side (Plate 100).
- 4.7.2 Building 7 is constructed to the immediate north of Building 5 (Figure 2) (Plate 102). A continuous corrugated iron roof cover from this building to Building 5 creates a covered walkway between the two. This building is constructed using the same breeze-block as Building 6 and is considered to be contemporary. Like Building 6, it also utilises the stone boundary wall on the north side in its construction.

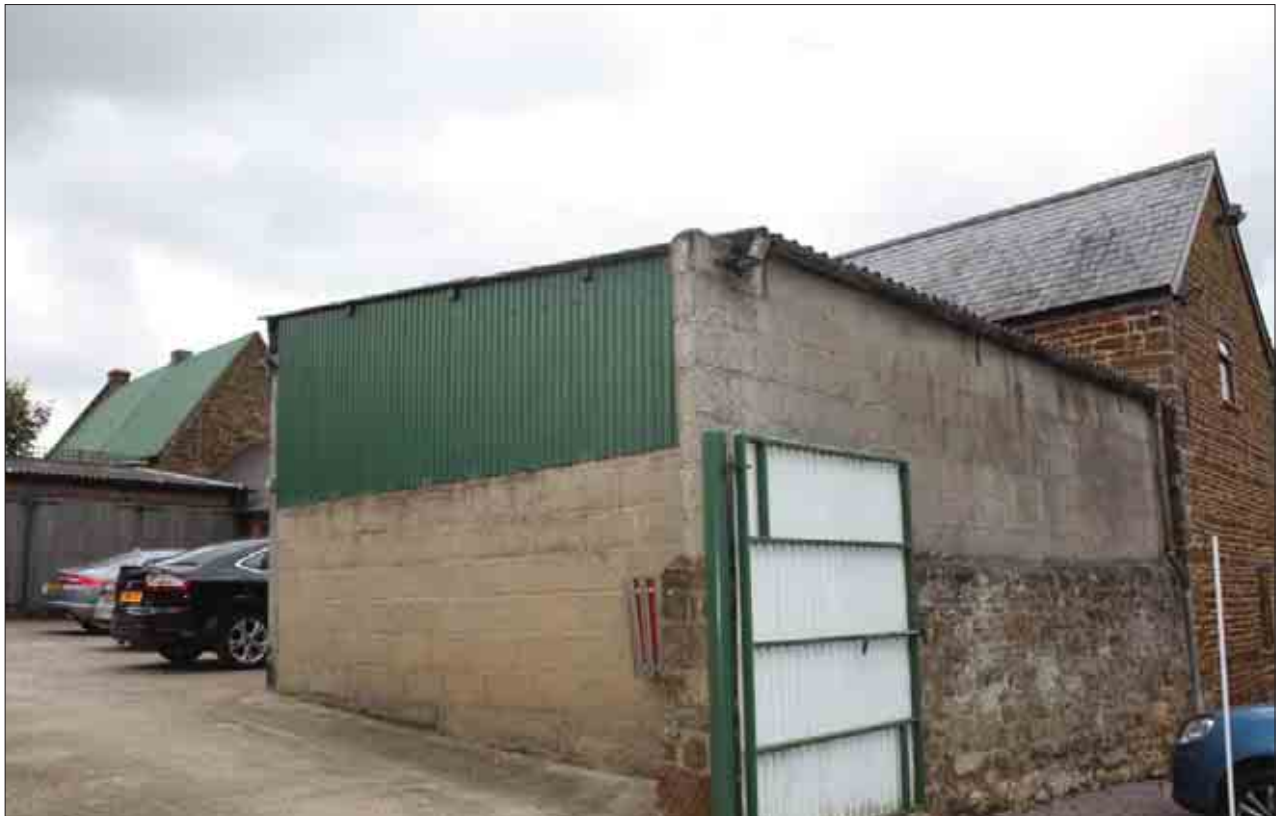
Plate 101: Building 6 as viewed from north-east

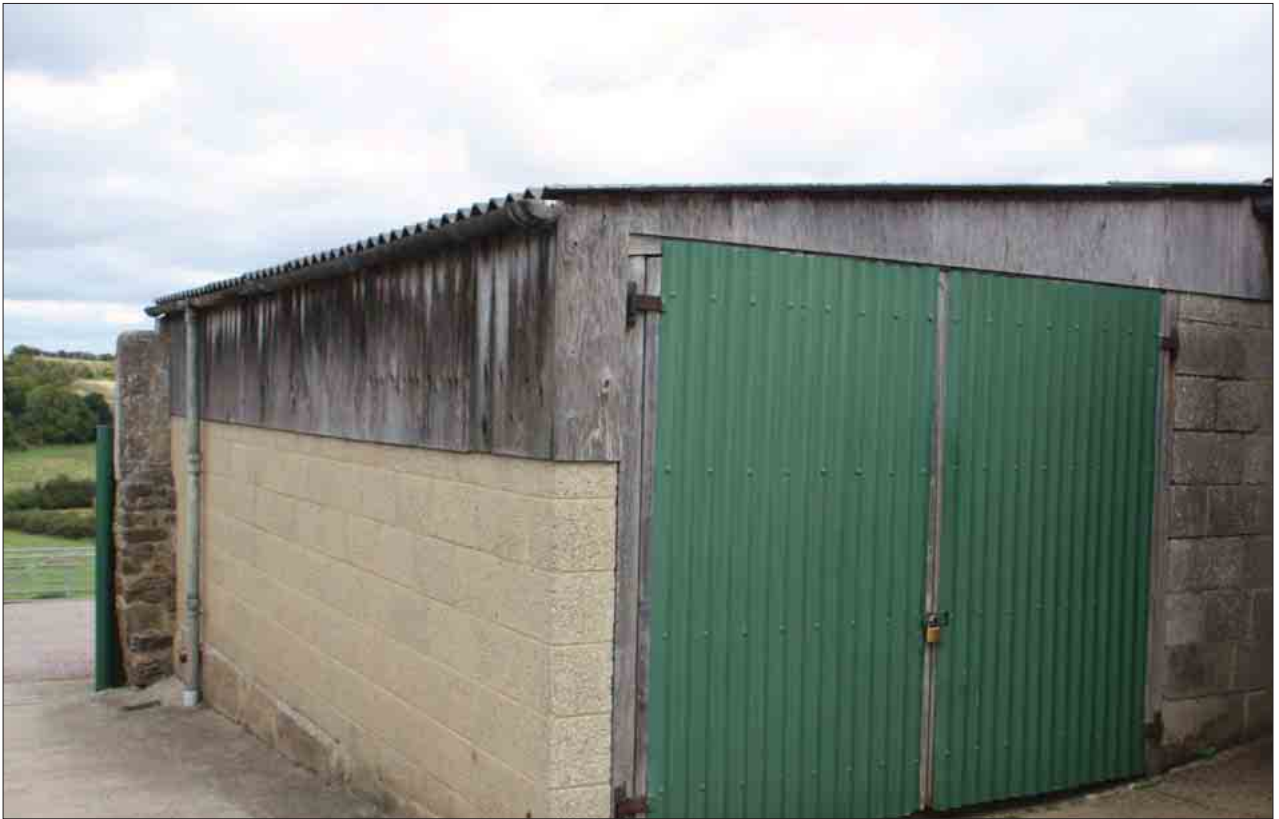
Plate 102: South-facing elevation, Building 7

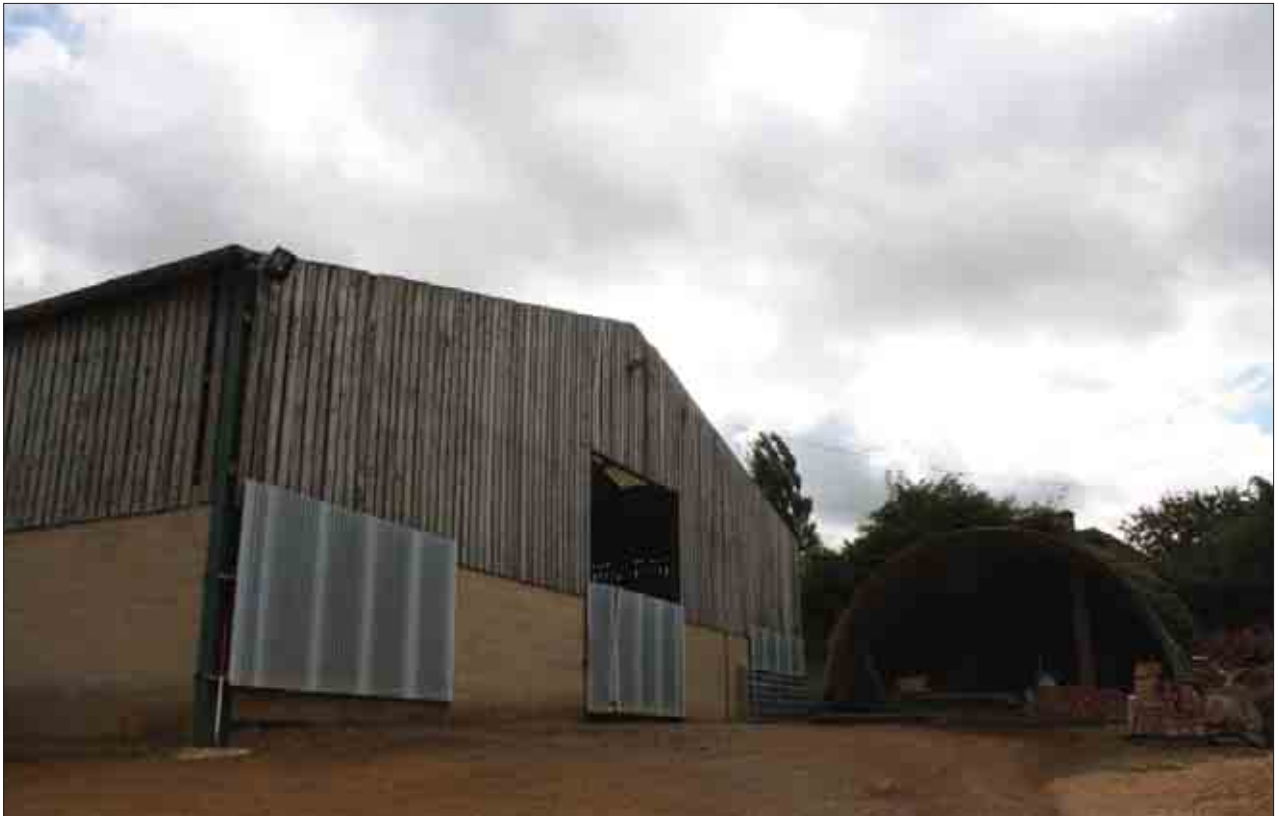
Plate 103: Buildings 8 and 9 as viewed from north

- 4.8.1 Building 8 is located on the east side of Building 5 (Figure 2). It is a large open-fronted shelter constructed from corrugated sheeting (Plate 103). There are no features, fixtures or fittings of historical or architectural interest within this building.
- 4.8.2 Cartographic evidence indicates that this building was constructed after 1979-1982 as it is absent from the Ordnance Survey map (Figure 7).

- 4.9.1 Building 9 is located on the eastern side of Building 8 (Figure 2). It is a large breeze-block and wooden-fronted building measuring approximately 18.5m by 18.5m. It has a gentle sloping corrugated iron-covered roof and a large opening on the west-facing elevation to allow access for farm machinery (Plate 103). There are no features, fixtures or fittings of historical or architectural interest within this building.

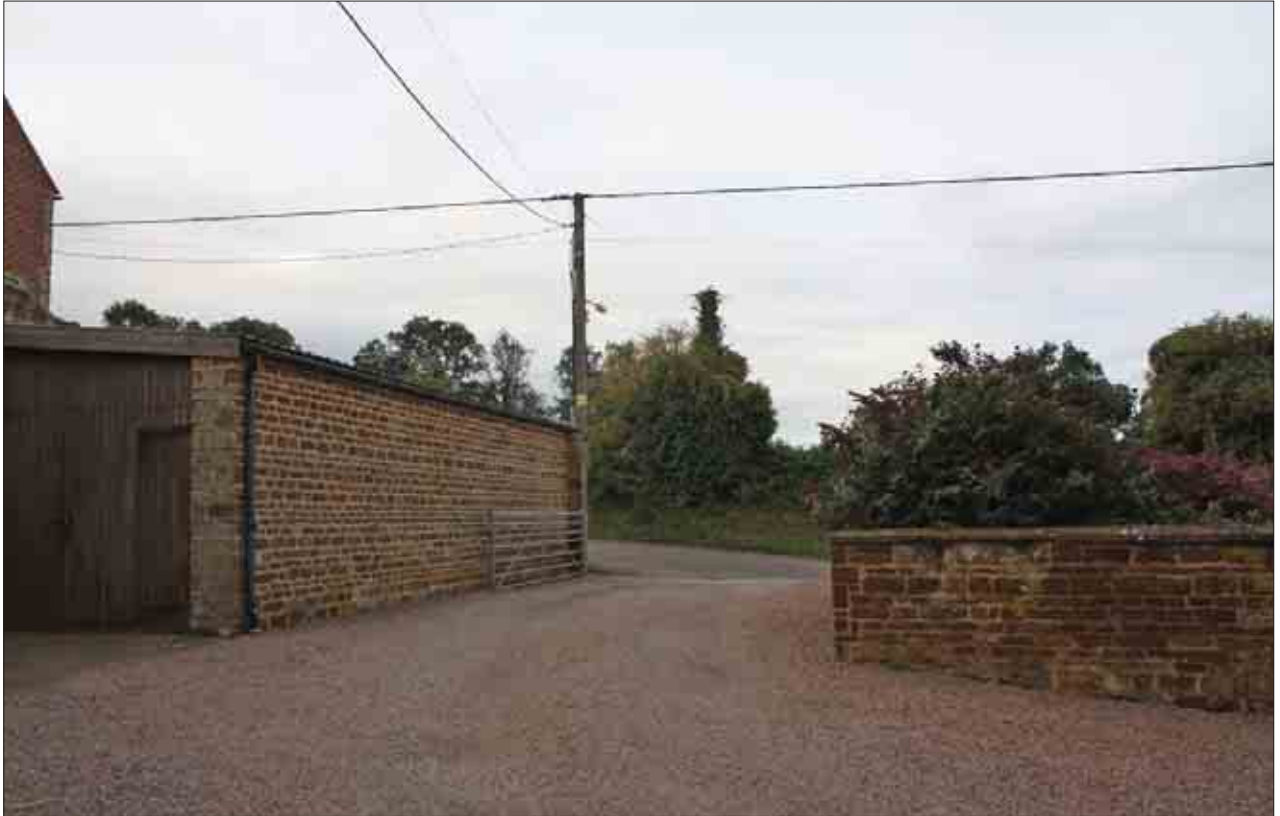
Plate 104: Building 10 and entrance to Gate House Farm as viewed from north

- 4.10.1 Building 10 is located on the eastern side of the entrance to Gate House Farm (Plate 104). It is constructed from ironstone and has a sloping mono-pitched roof. It has entrances on the north and south elevations and internal inspection was not possible at the time of the survey.
- 4.10.2 Cartographic evidence indicates that this building was constructed after 1979-1982 (Figure 7), however it was built in the footprint of another building which was on the site on the 1922 Ordnance Survey map (Figure 6). The street-facing elevation appears to

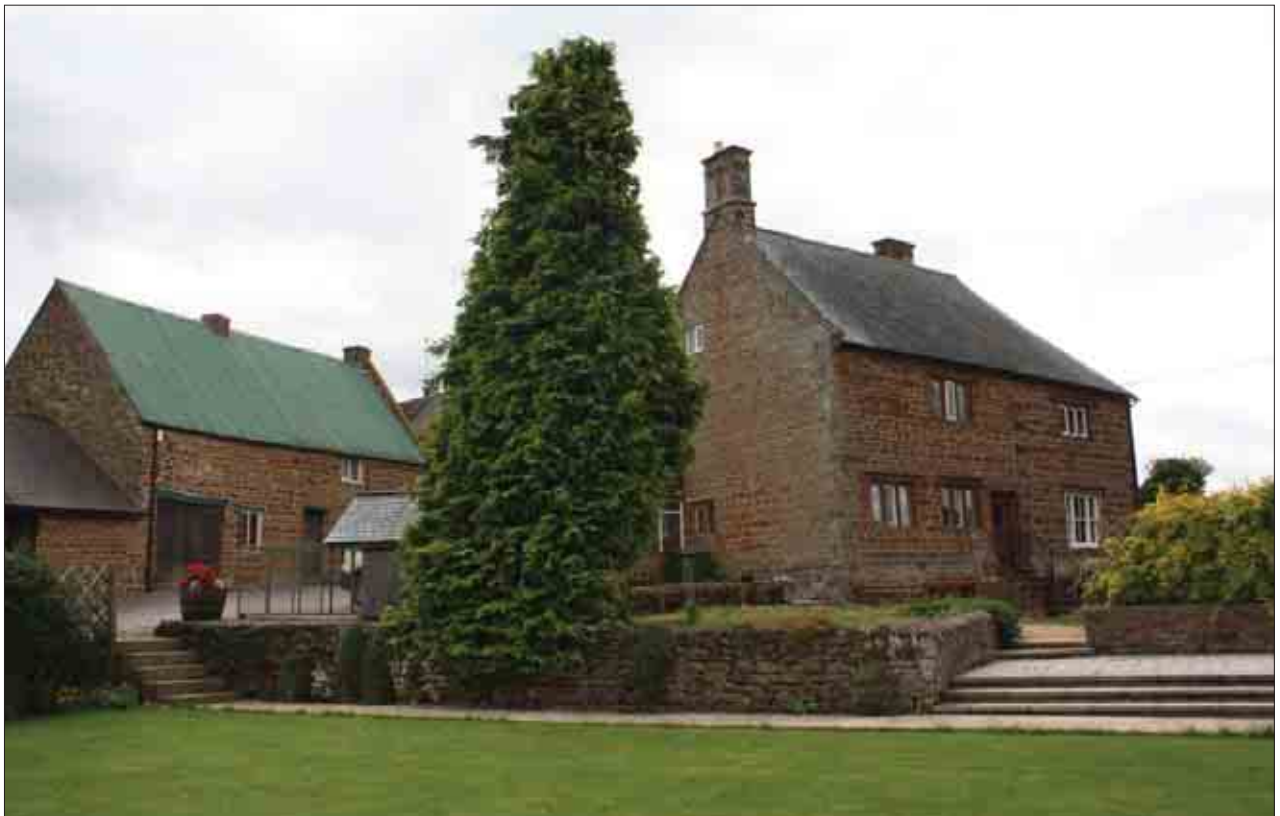
Plate 105: Gate House farmhouse and Building 1 (bakehouse), viewed from north

- 5.2.3 A new entrance door was added on the north-west facing elevation. This may have become the new entrance to the house, replacing one on the street-facing frontage. The new entrance has a grand and impressive door (possibly relocated from the previous entrance) as well as steps leading up to it. The new entrance shifts the focus of activity going on in the bakehouse to the rear of the house (Plate 105).

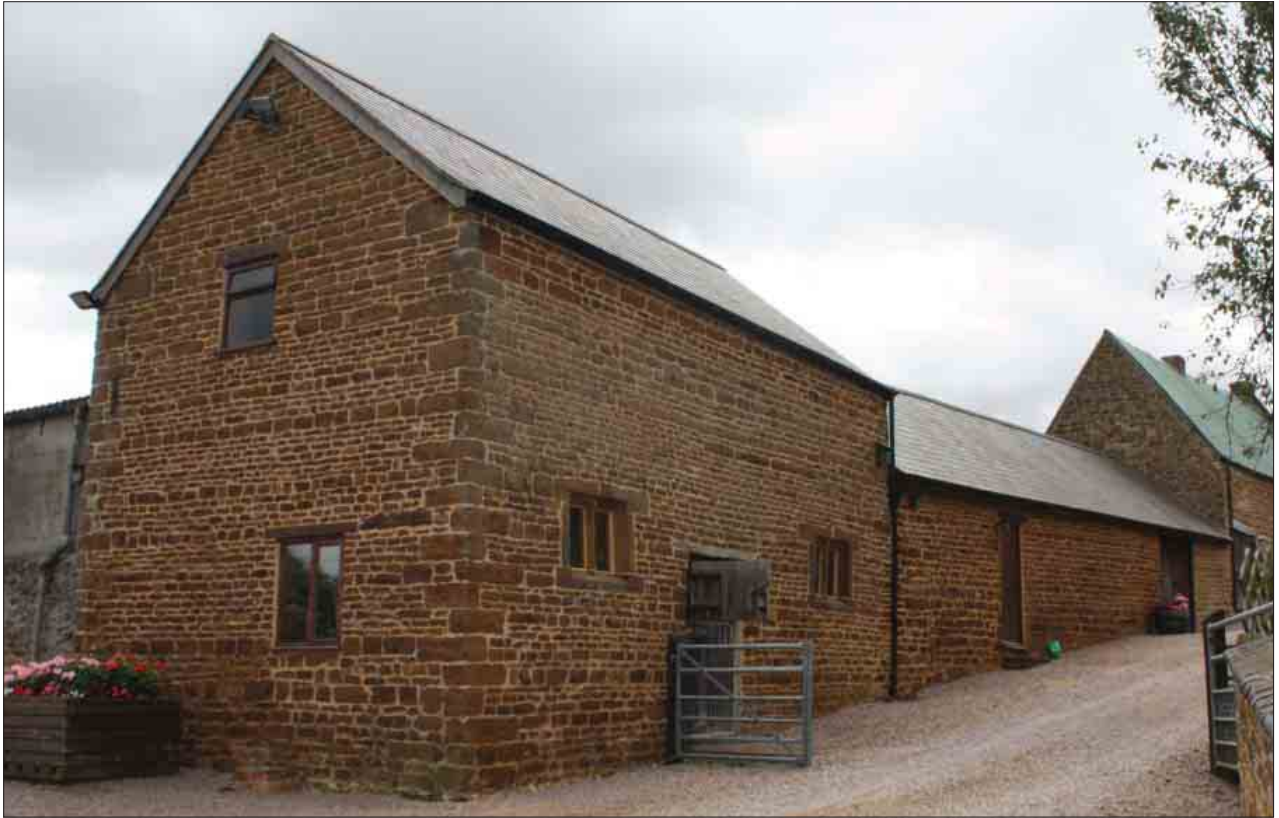
Plate 106: Buildings 3 (granary), 2 (barn) and 1 (bakehouse), viewed from north

- 5.2.5 It is possible that the storage barn/cart shed (Building 2) was constructed around this time. With a lack of physical dating evidence available such as original doors, windows, roof trusses etc however, it is difficult to say with any certainty. This building had at least one entrance door on the west-facing elevation (now blocked up) and possibly a wide cart-shed entrance. As the east-facing elevation was entirely re-built in the late 20th century, any evidence of entrances and windows has been lost.
- 5.2.6 This new building would have been positioned between the pre-existing granary and bakehouse, completing the range (Plate 106) as is first depicted on the 1839 map.
