# Newbury Parkway West Berkshire

## Gazetteer of Historic Buildings

**Client Name:** Standard Life Investment Funds Limited  
**Document Title:** Newbury Parkway: Archaeological Investigations  
**Document Type:** Gazetteer of Historic Buildings  
**Issue Number:** 2  
**Grid Reference:** SU471 674  
**OA Job Number:** 3904  
**Invoice code:** NEWPKBS  
**Site Code:** NEWPK08  
**Accession No:**

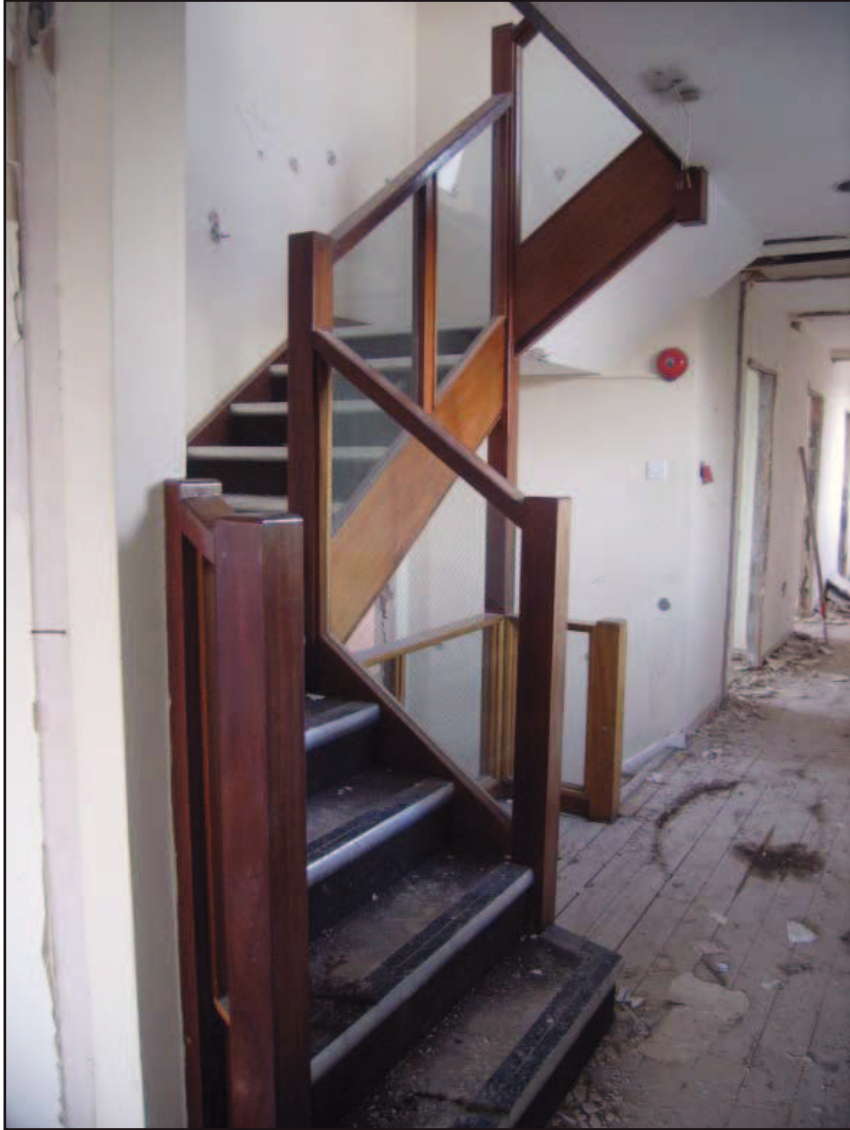
Building 1 Plate 5

Plate 5: Staircase at ground floor

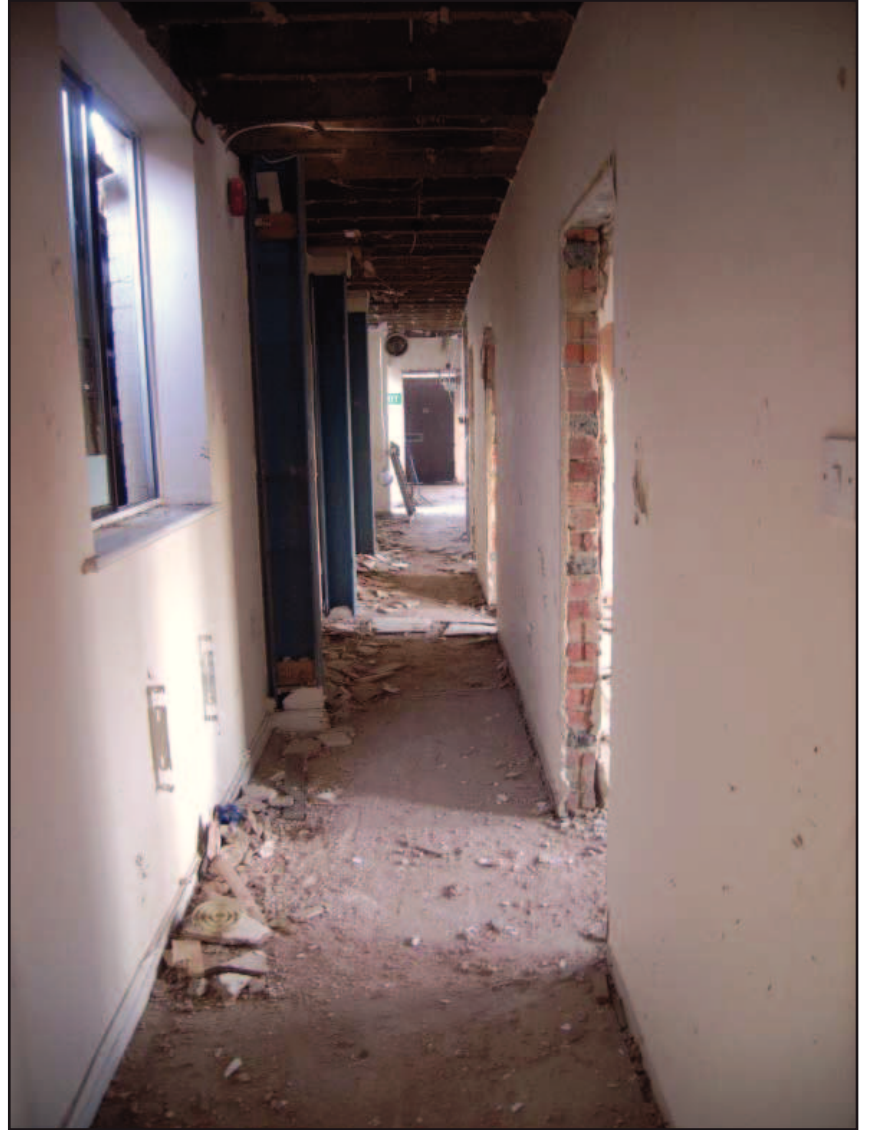
Building 1 Plate 6

Plate 6: Corridor at ground floor.

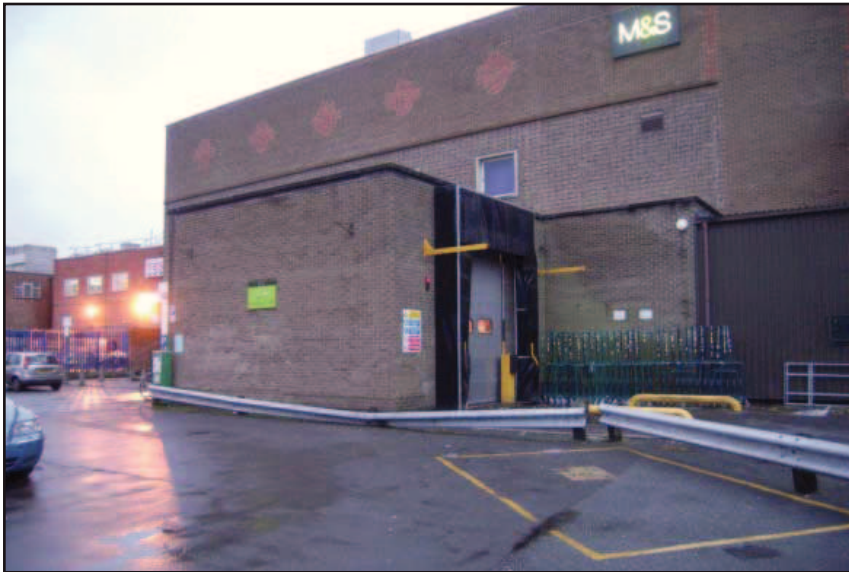
Building 2 Plate 3

Plate 3: View from north-east

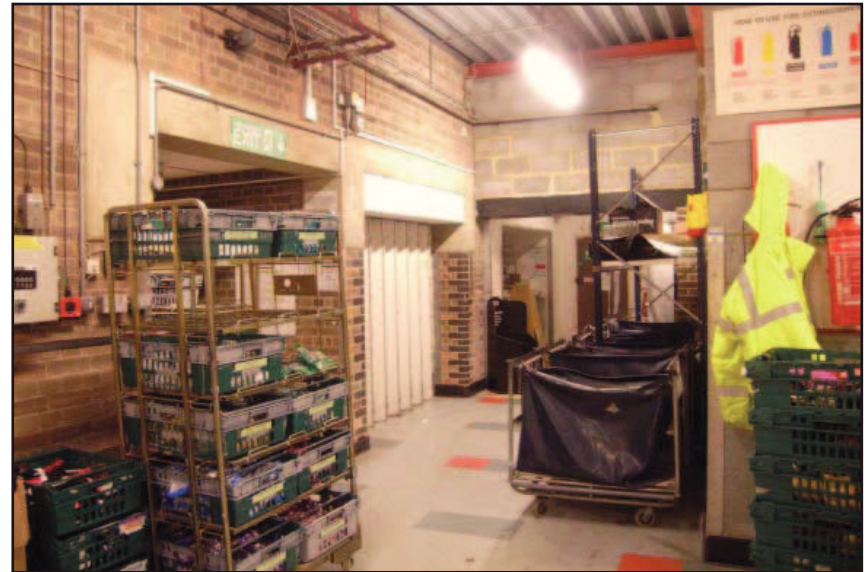
Building 2 Plate 4

Plate 4: Interior of loading bay

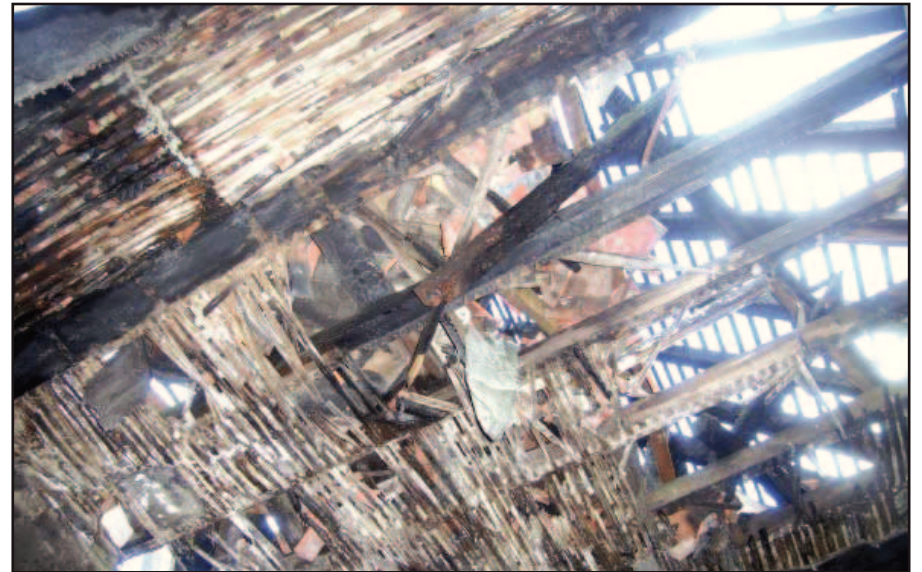
Building 3, Plate 8

- Plate 7: First floor main room, east wall
- Plate 8: First floor ceiling
- Plate 9: West wall at 1st floor adjacent to stairwell
- Plate 10: Roof detail

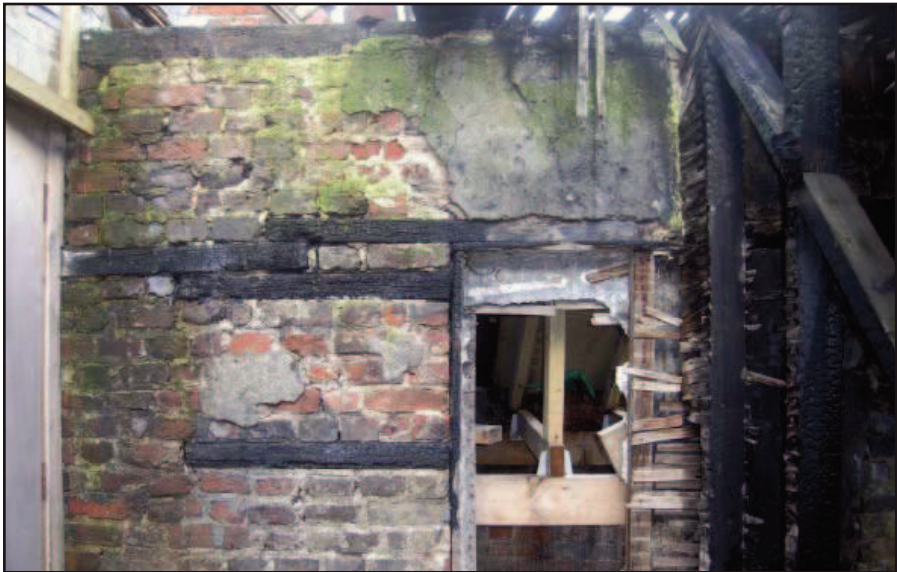
Building 3, Plate 11

- Plate 11: North wall 1st floor above stairwell with former window overlooking former external yard
- Plate 12: Looking down stairwell to ground floor
- Plate 13: View into Uncle Henry's at ground floor looking east

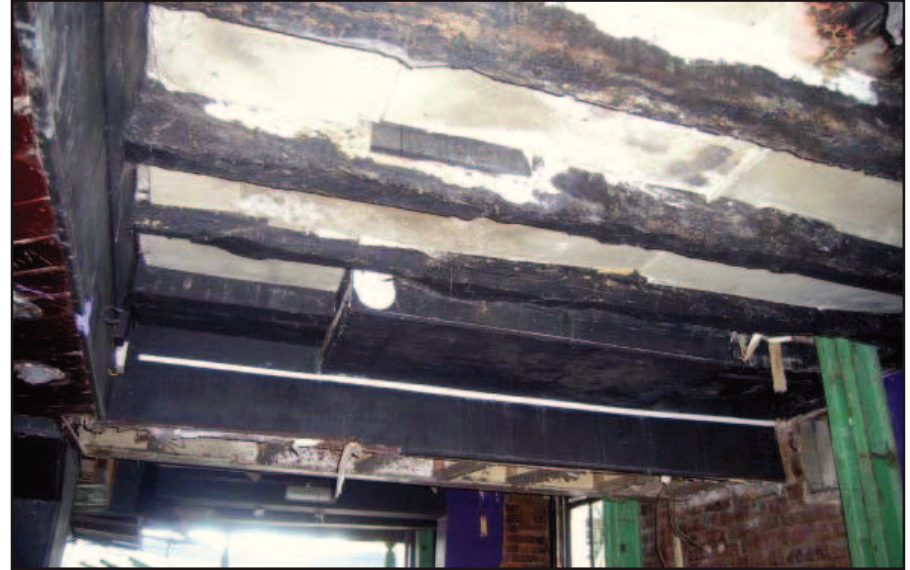
Building 3, Plate 14

- Plate 14: First floor ceiling joists in Uncle Henry's looking East
- Plate 15: Old 1st floor ceiling joists in main bar of Uncle Henry's
- Plate 16: North wall, at ground floor to north of stairs in area enclosing former external yard

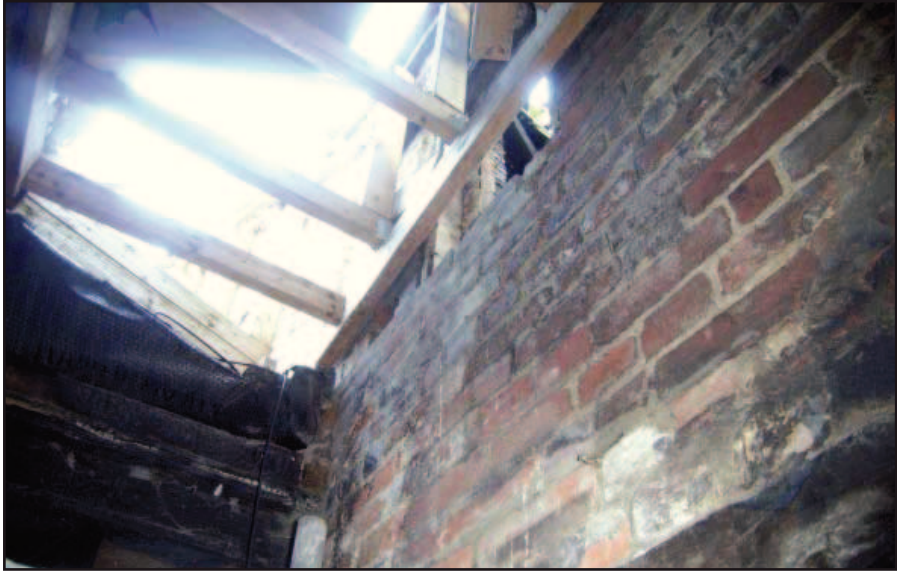
Building 3, Plate 17

- Plate 17: Secondary structure at ground floor enclosing former external passage (looking west)
- Plate 18: Secondary structure at ground floor enclosing former external passage (looking east)

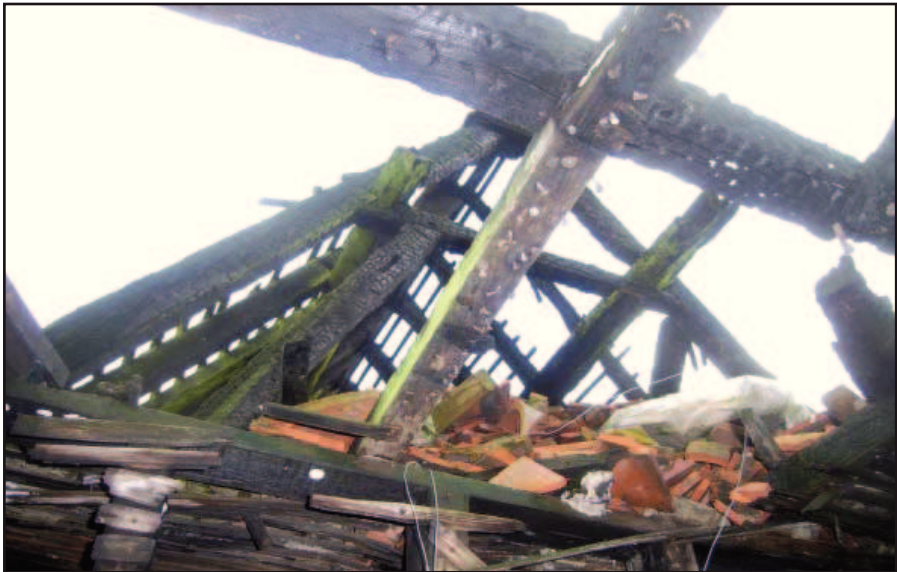
Building 3, Plate 19

- Plate 19: Roof detail
- Plate 20: First floor, south wall adjacent to top of stairs.

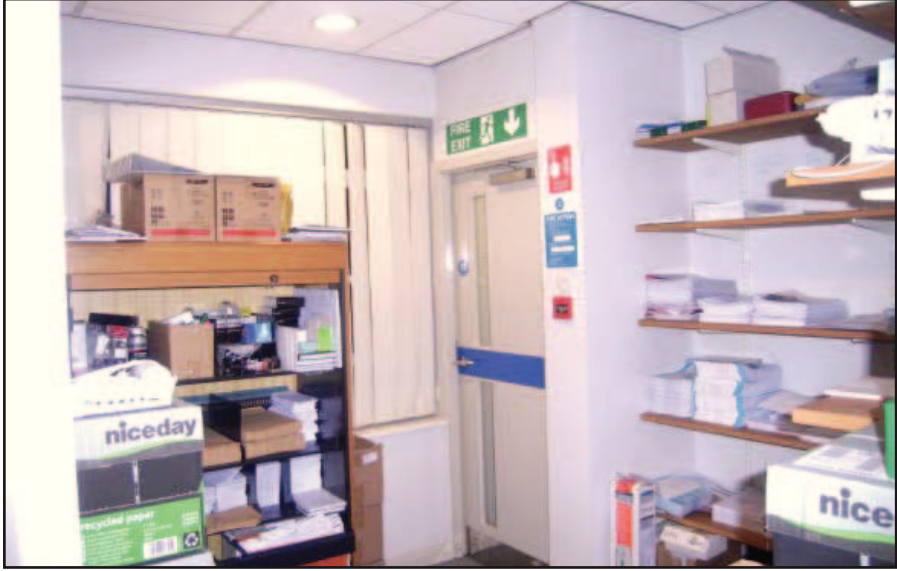
Building 6 Plate 5

Plate 5: Store room in OA6 towards north-east corner

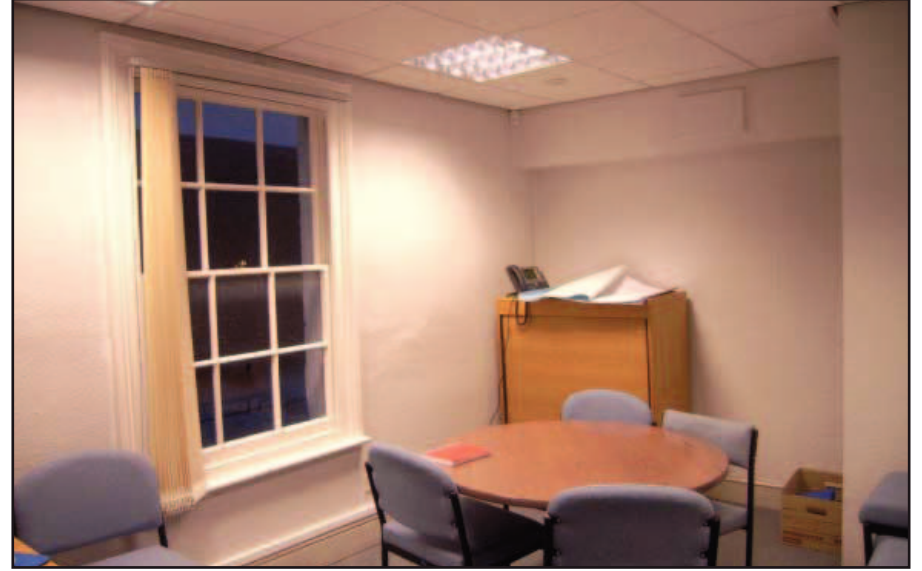
Building 6 Plate 6

Plate 6: First floor room of OA6

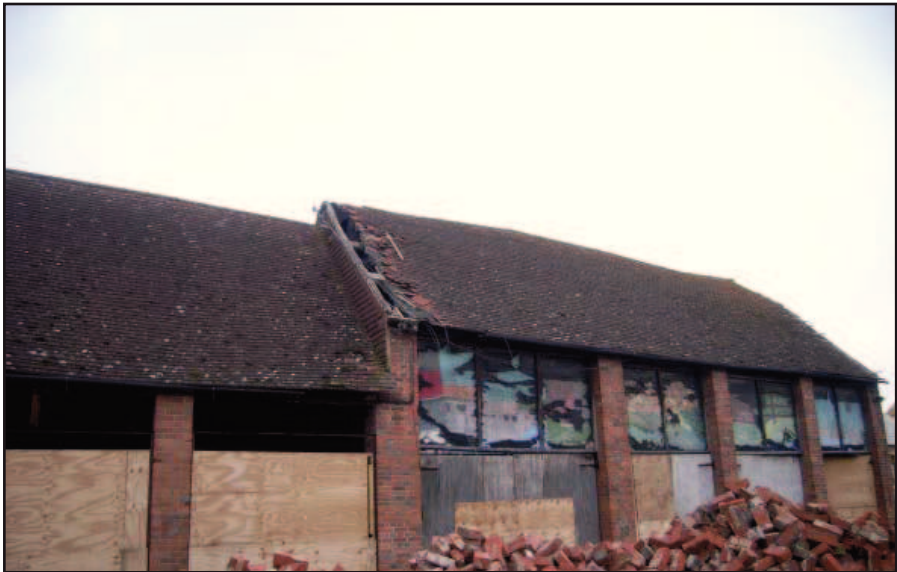
Buildings 7 and 8, Plate 7

Plate 7: South side of OA7& 8 during demolition.  
Plate 8: East end of OA8 during demolition  
Plate 9: South side of OA8 (Bays 2&3)  
Plate 10: South side of OA8 (Bays 1&2)  
Plate 11: South side of OA7 (Bay 6)  
Plate 12: East end of OA8 looking south  
Plate 13: North wall, OA7 to right, OA8 to left  
Plate 14: North wall of OA7  
Plate 15: General view in OA8 looking east  
Plate 16: Half hipped roof at east end of OA8  
Plate 17: General view in OA8 looking east (Truss 1)  
Plate 18 East end of OA8  
Plate 19: General view in OA8 looking east  
Plate 20: North wall in OA8  
Plate 21: View in OA8 looking west  
Plate 22: View in OA8 looking west  
Plate 23: Detail of tie-beam and wall plate in OA7 (Truss 6)  
Plate 24: Detail of roof in OA7 (wall plate to south side)  
Plate 25: Bay 7 in OA7 looking north  
Plate 26: Bay 7 in OA7 looking south  
Plate 27: Roof detail in OA8. North slope  
Plate 28: Trusses 4&5 between OA7 and OA8 looking east

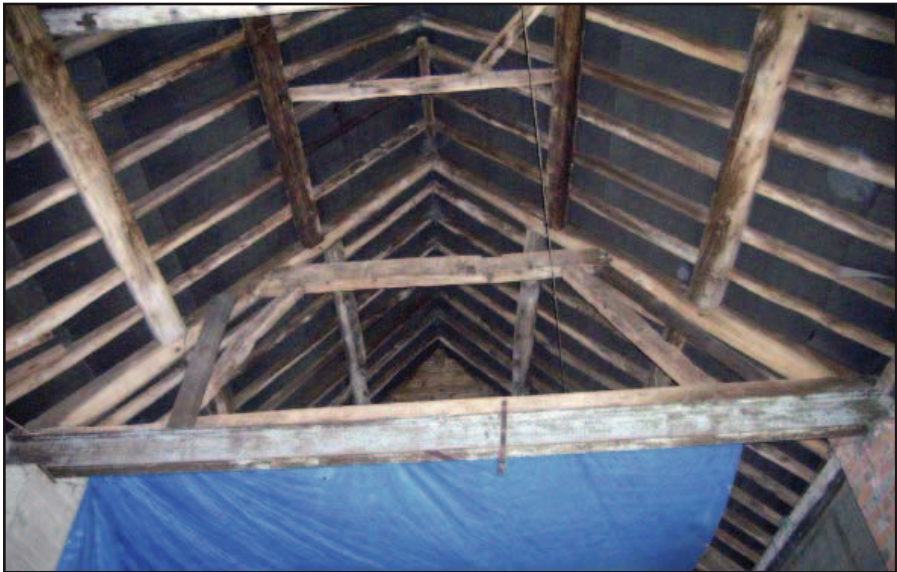
Buildings 7 and 8, Plate 30

Plate 29: Junction between OA7 and OA8 looking west  
Plate 30: North side of Truss 2  
Plate 31: Truss 3 looking east  
Plate 32: Truss 6 looking west  
Plate 33: Truss 2 looking west towards OA7  
Plate 34: South side of Truss 2 looking south-west  
Plate 35: Truss 2 looking west  
Plate 36: Bay 5 (OA7)looking north-east  
Plate 37: Truss 5 looking east  
Plate 38 Truss 2 looking west  
Plate 39: Partition between Bays 7 & 8  
Plate 40: Truss 7 looking west

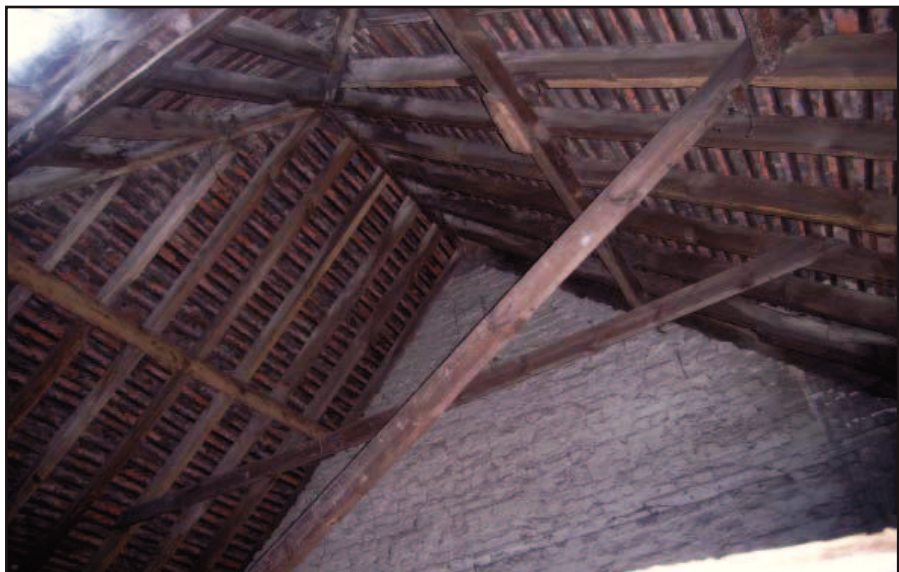
Building 11, Plate 23

Plate 5: General view from the west  
Plate 6: 20th century extension to west  
Plate 7: Western end of complex  
Plate 8: Buildings from the north-west  
Plate 9: Rear of primary part of building from north-west  
Plate 10: North elevation of primary part of OA11  
Plate 11: Main, easternmost room in northern property  
Plate 12: Main, easternmost room in northern property  
Plate 13: Room 2(A) looking east  
Plate 14: Room 2(A) looking north-west  
Plate 15: Room 1(B) north wall during demolition  
Plate 16: Room 2(B) looking north-east  
Plate 17: Room 3(B) looking south  
Plate 18 Room 3(B) looking north-east  
Plate 19: Room 4(B) looking west  
Plate 20: Room 4(B) looking east  
Plate 21: 1st floor room over Property B looking north-west  
Plate 22: First floor room in Property B  
Plate 23: Roofspace over Property A looking south  
Plate 24: Roofspace over Property A

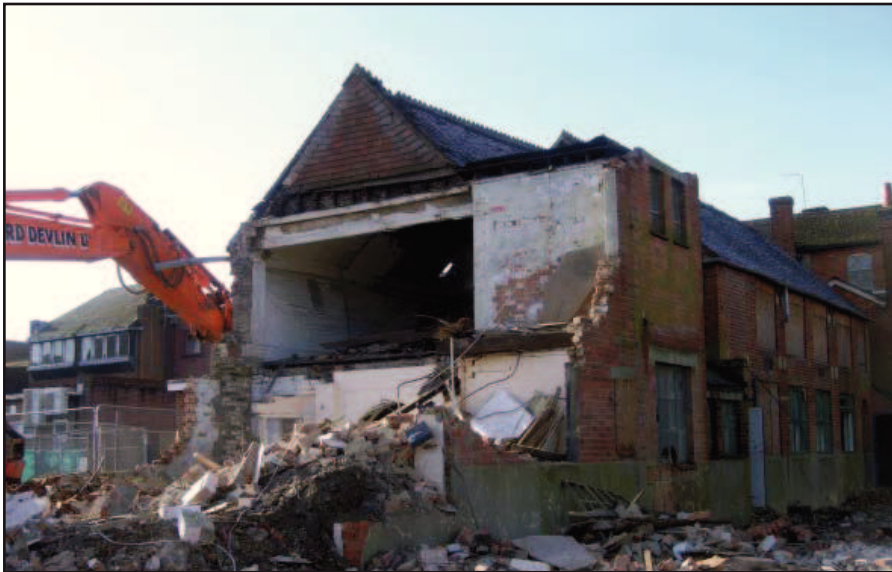
Buildings 12-15, Plate 7

Plate 7: Demolition of OA15

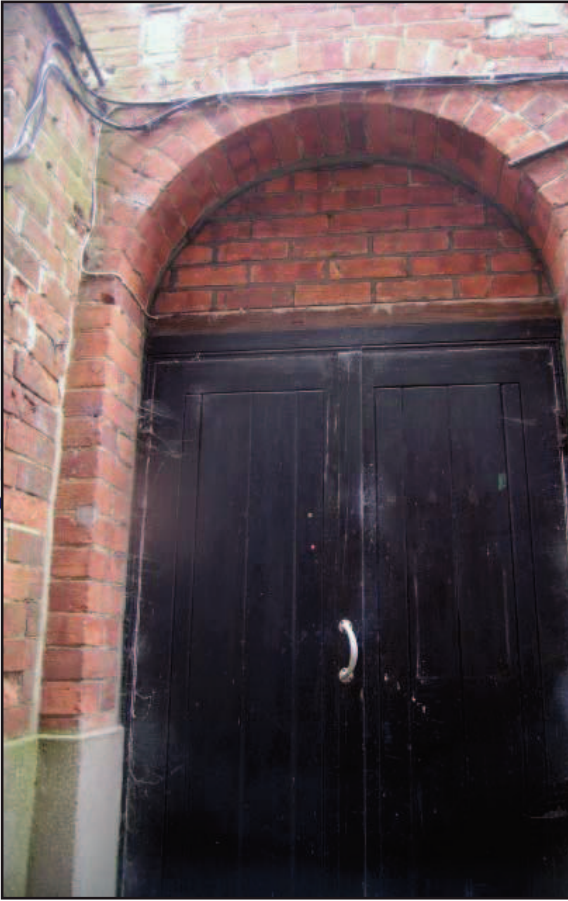
Buildings 12-15, Plate 9

Plate 9: Door in north wall of OA14

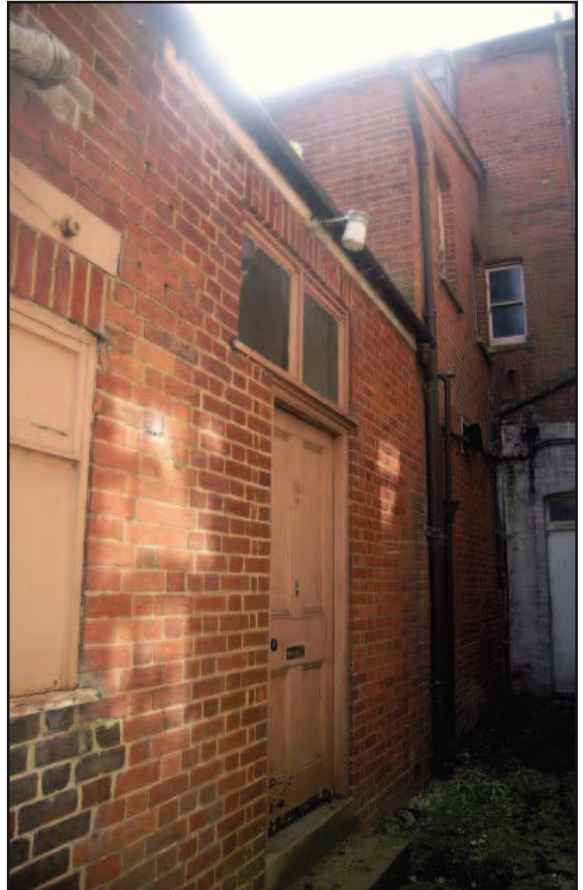
Buildings 12-15, Plate 12

Plate 12: Door in north wall of OA12

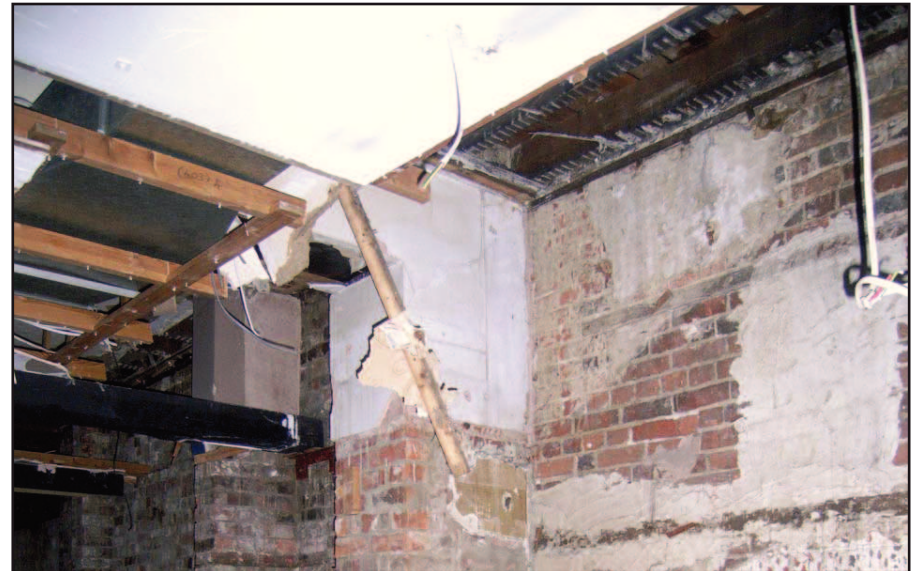
Buildings 12-15, Plate 16

Plate 16: Ground floor north wall of OA12 during strip out.

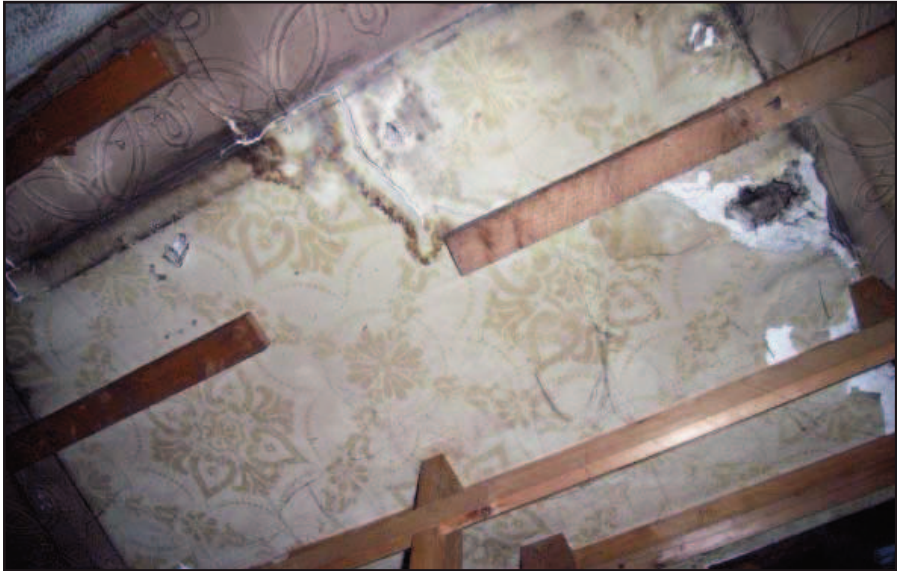
Buildings 12-15, Plate 17

Plate 17: Exposed ceiling paper in OA12 by entrance inside shop

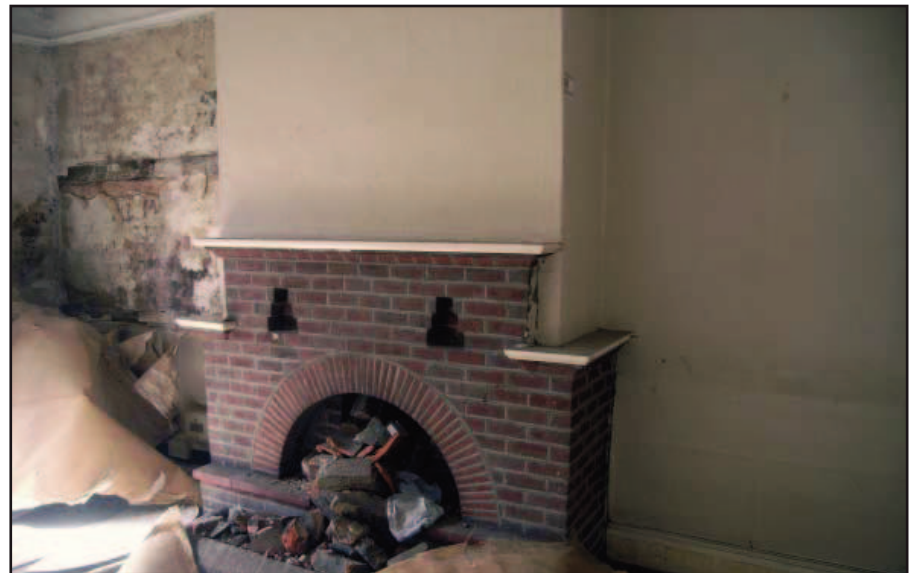
Buildings 12-15, Plate 20

Plate 20: Fireplace in main northern front room of OA12

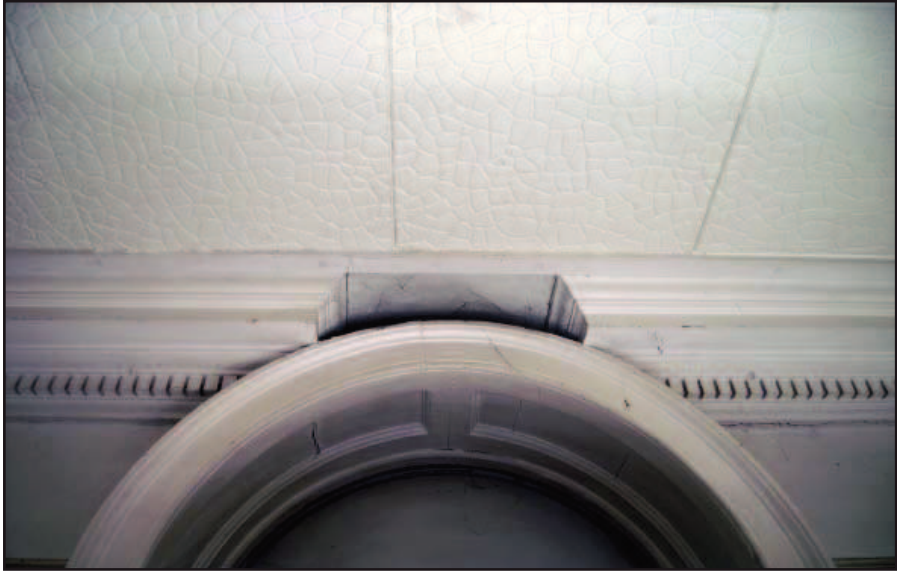
Buildings 12-15, Plate 21

Plate 21: Cornice/Venetian window detail in first floor front room of OA12

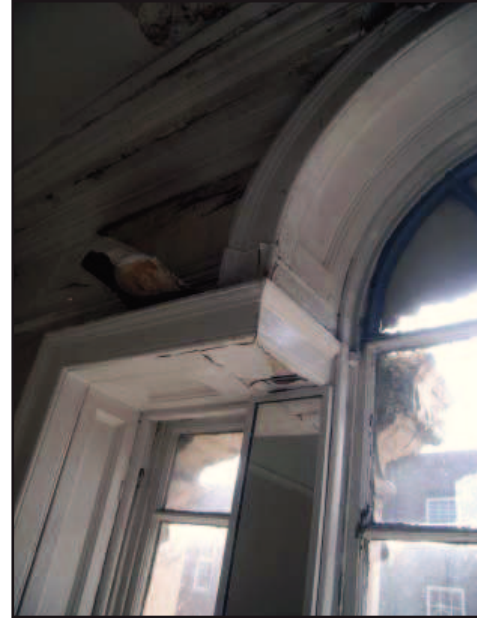
Buildings 12-15, Plate 22

Plate 22: Panelling details in front room of OA12

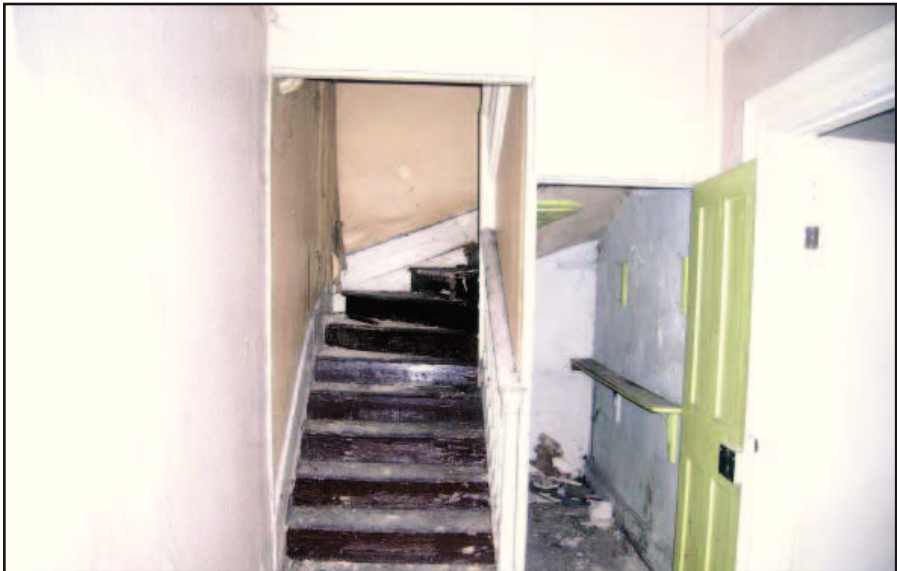
Buildings 12-15, Plate 23

Plate 23: Staircase up to 2nd floor of OA12

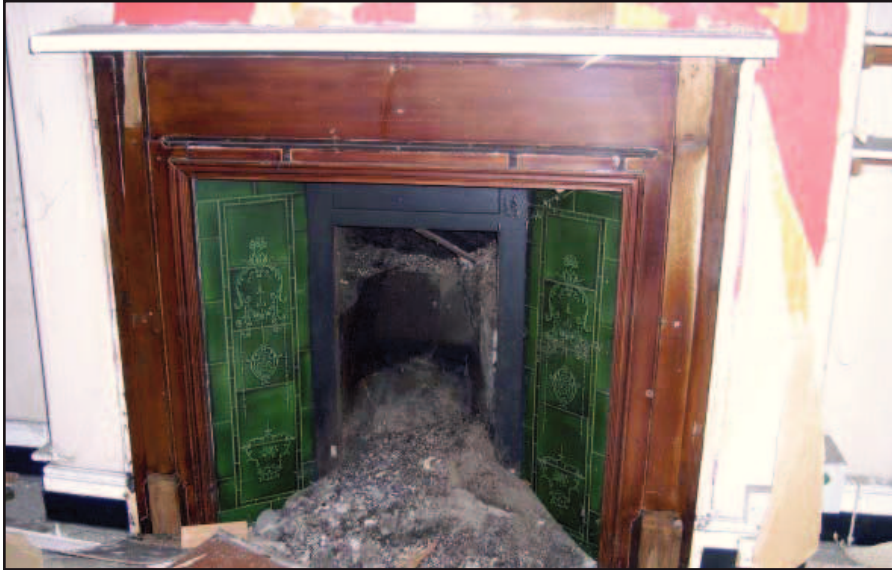
Buildings 12-15, Plate 25

Plate 25: Fireplace exposed by works (same fireplace as in Pl.24)

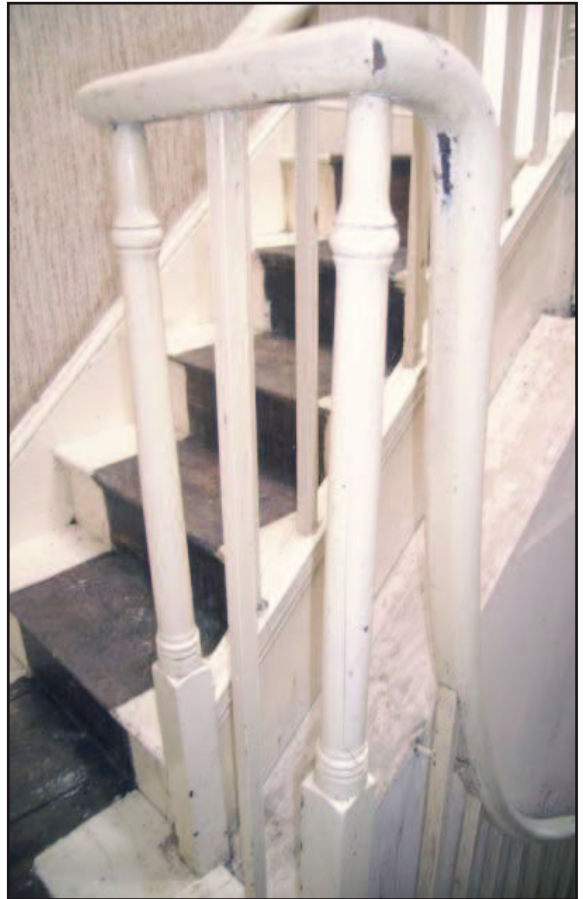
Buildings 17-18, Plate 22

Plate 21: First floor looking up stairs to 2nd floor in main street-front range  
Plate 22: Staircase detail at landing up to second floor  
Plate 23: View east into rear range from SW room of main primary building (2nd floor)  
Plate 24: View looking west at head of stairs into primary building (2nd floor)  
Plate 25: Door in NW room at 2nd floor level  
Plate 26: NE room in historic, street-front range (2nd floor)  
Plate 27: Western room in secondary rear extension looking east (2nd floor)  
Plate 28: SW room in historic building at 2nd floor level. Looking SE  
Plate 29: SW room of main street-front building at second floor level  
Plate 30: Easternmost 2nd floor room in secondary rear range looking NE  
Plate 31: Easternmost 2nd floor room in secondary rear range looking NW  
Plate 32: Easternmost 2nd floor room in secondary rear range looking east  
Plate 33: Underside of joists at 1st floor level in street-front building looking north

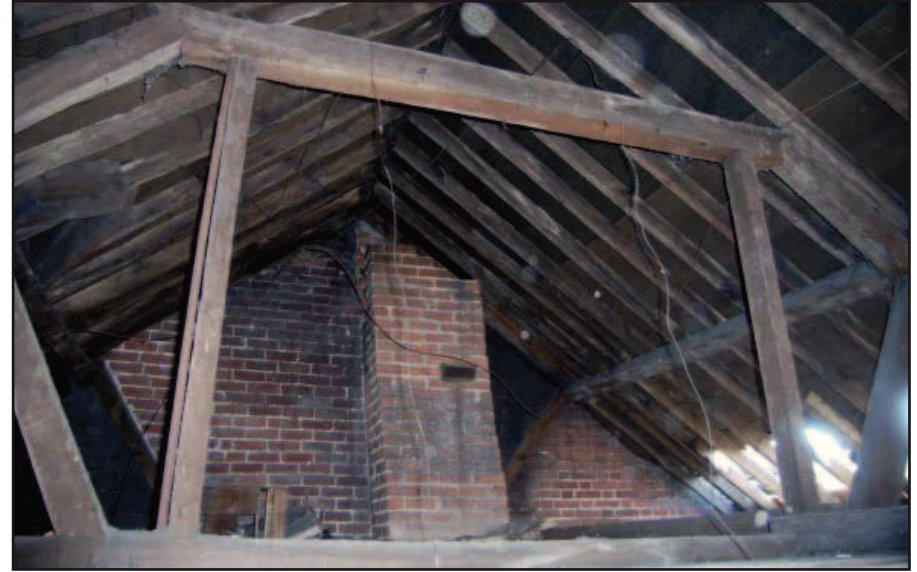
Buildings 17-18, Plate 34

Plate 34: Roof space looking south  
Plate 35: Roof space looking south-east  
Plate 36: Northern truss of OA17.
