# THE CALVERT A41 ACCESS, BUCKINGHAMSHIRE

# THE CALVERT A41 ACCESS, BUCKINGHAMSHIRE, AN ARCHAEOLOGICAL SURVEY

### Introduction

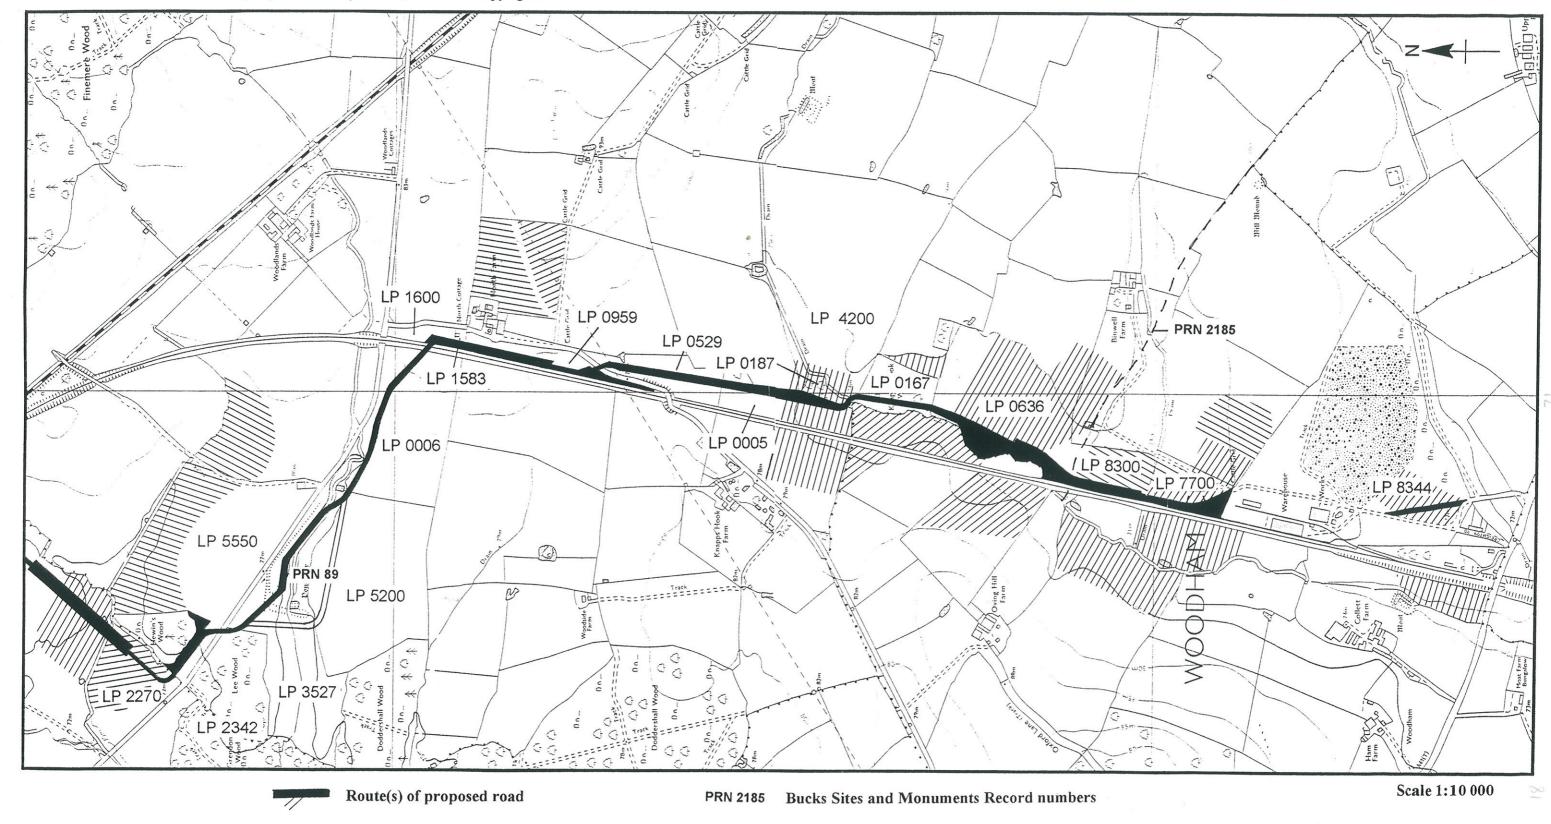
figure 1

Ridge and furrow plotted from aerial photographs

## Archaeological background (Fig. 1)

The southern and central parts of the route of the projected road run through a medieval and post-medieval landscape of considerable interest. The relatively high degree of survival of this landscape, at least until quite recently, means that there is very little evidence for the archaeology of earlier periods in the area as a whole, and no pre-medieval sites are known in the immediate vicinity of the new road.
