Hill House Farm Courtyard, Dullingham

Historic Building Recording

Client: Enterprise Property Group

OA East Report No 2011:
OASIS No: oxfordar3-289203
NGR: TL 6152 5867

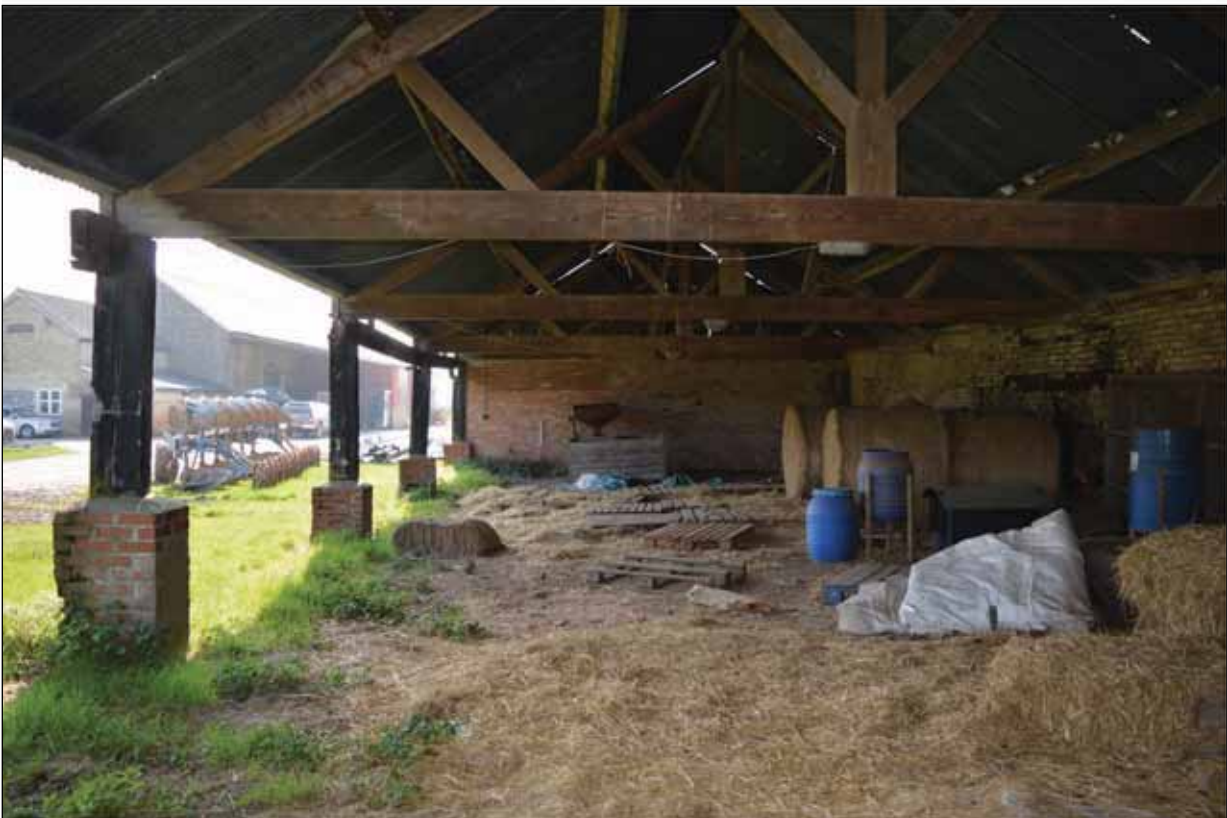
Plate 9: Building 1 - Internal view of the southern end of the building viewed from the north-east

- 4.2.4 The roof covering is supported on six trusses of a king post type. These had extra supports and displayed evidence of repair (Plate 10). All sit directly on the brick and concrete piers (Plate 9).

- 4.2.6 The floor of the building consists of pressed earth and chalk (Plate 9).

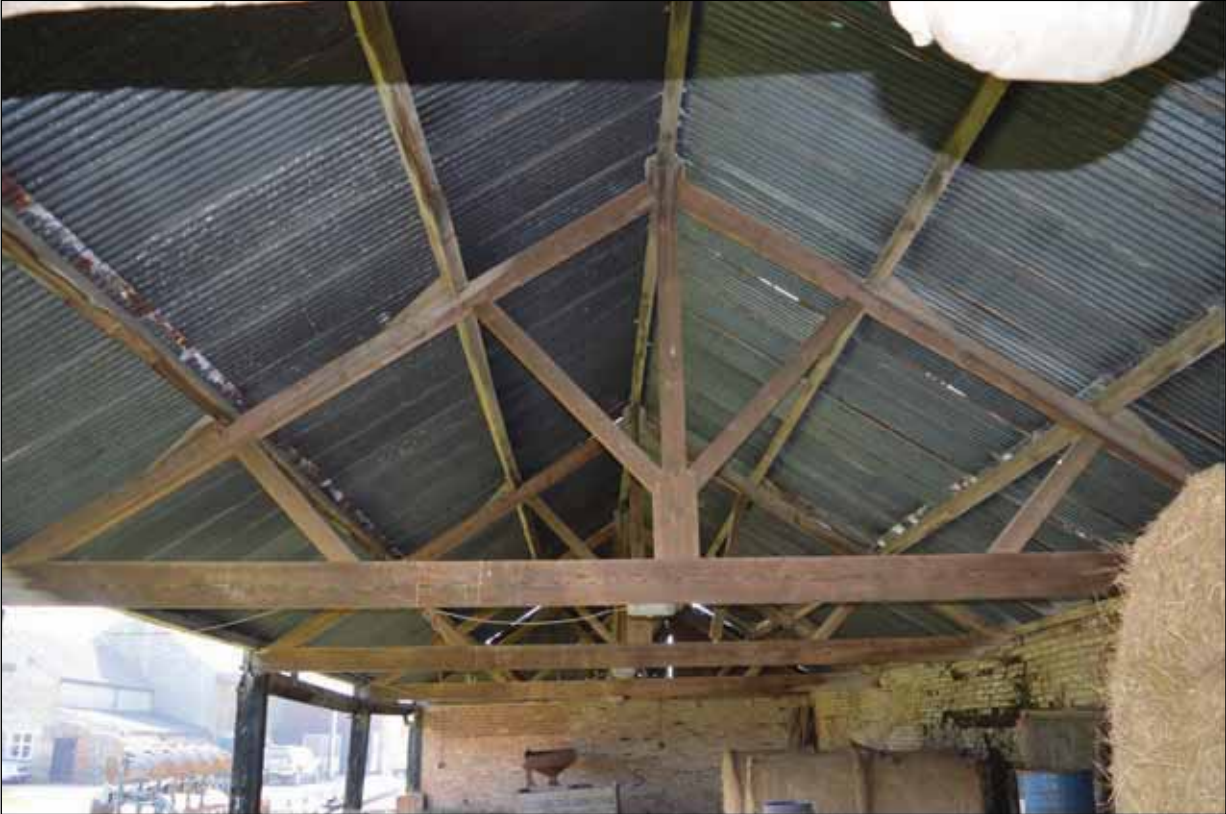
Plate 10: Building 1 - Detail of roof structure viewed from the north-east

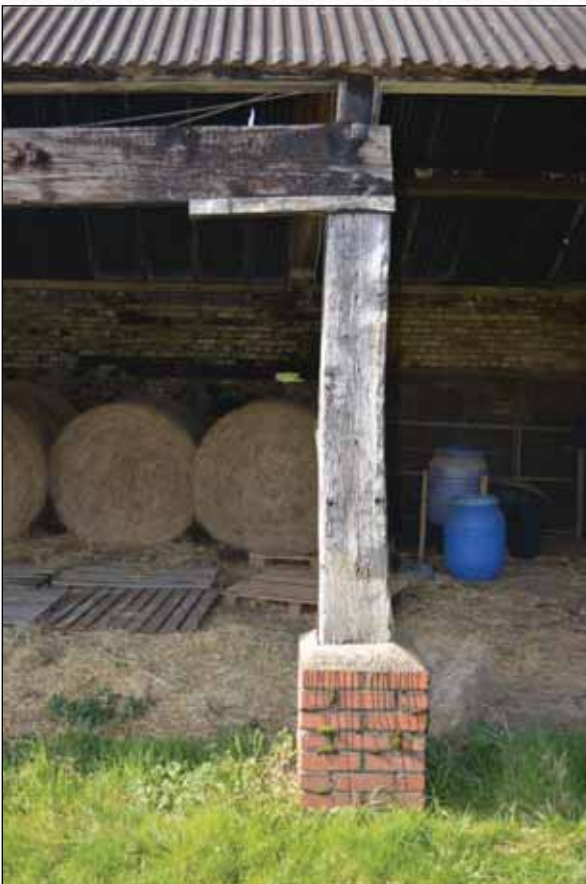
Plate 11: Building 1 - Brick pier with re-used upright viewed from the south-east

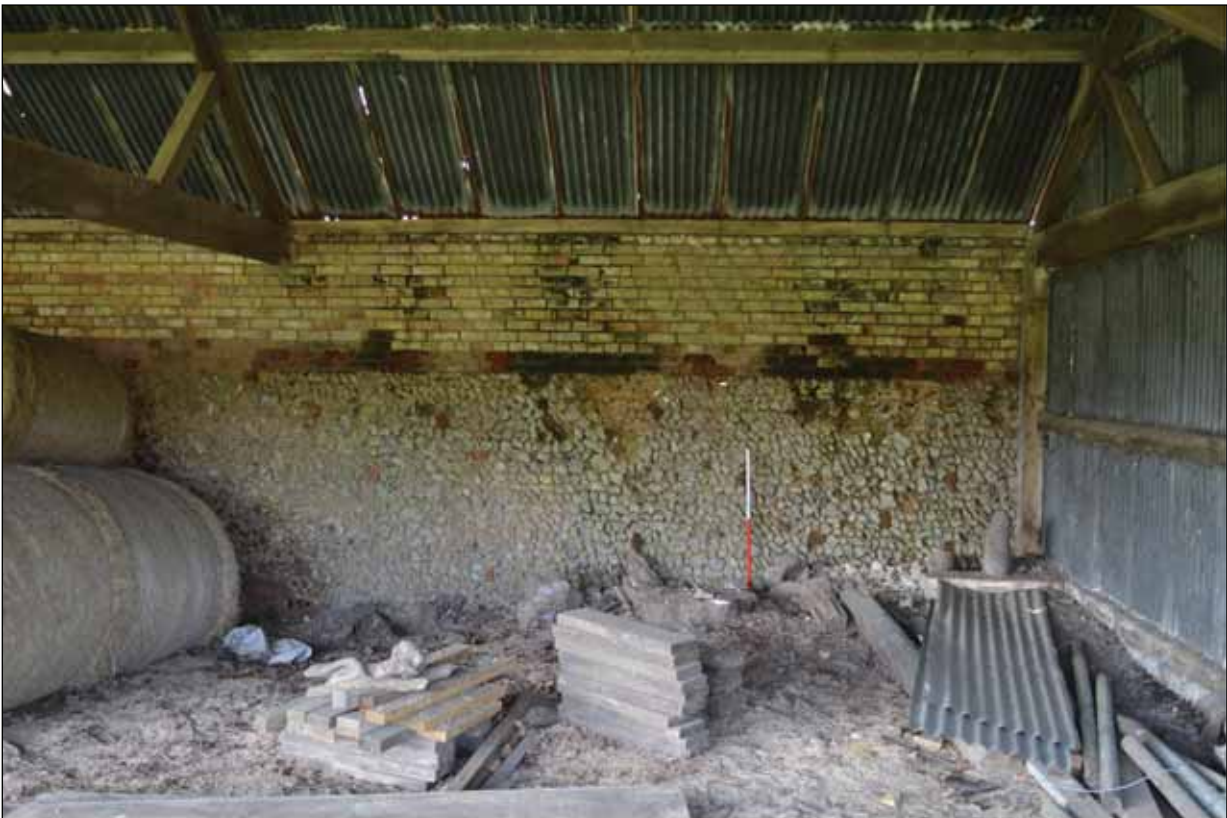
Plate 12: Building 1 - Rear wall viewed internally from the east

- 4.2.5 The rear of the building comprises elements of a pre-existing wall that was an original feature of the farm courtyard. This is constructed from dressed flint with brick courses added to increase the height and take the roof trusses (Plates 12 & 13). Both the bricks and the original flint wall show signs of extensive repair and alteration.

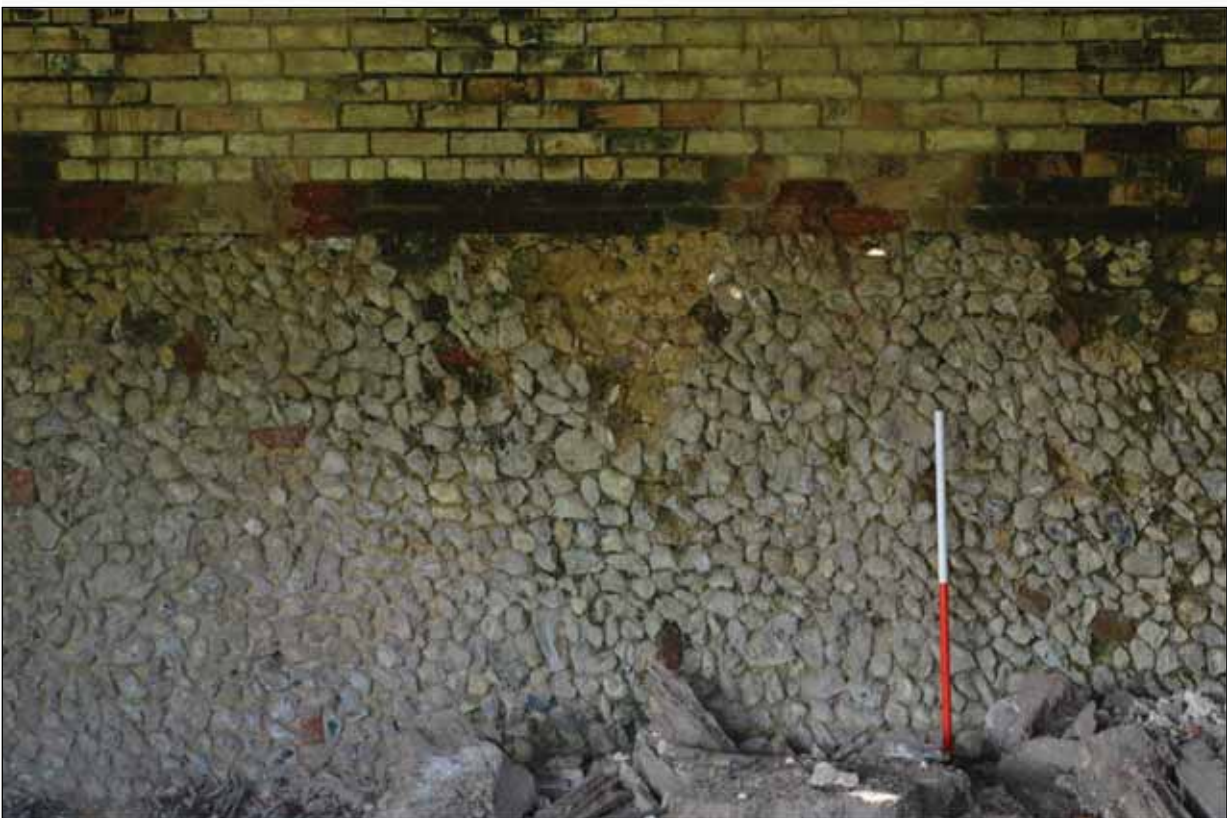
Plate 13: Building 1 - Detail of rear wall

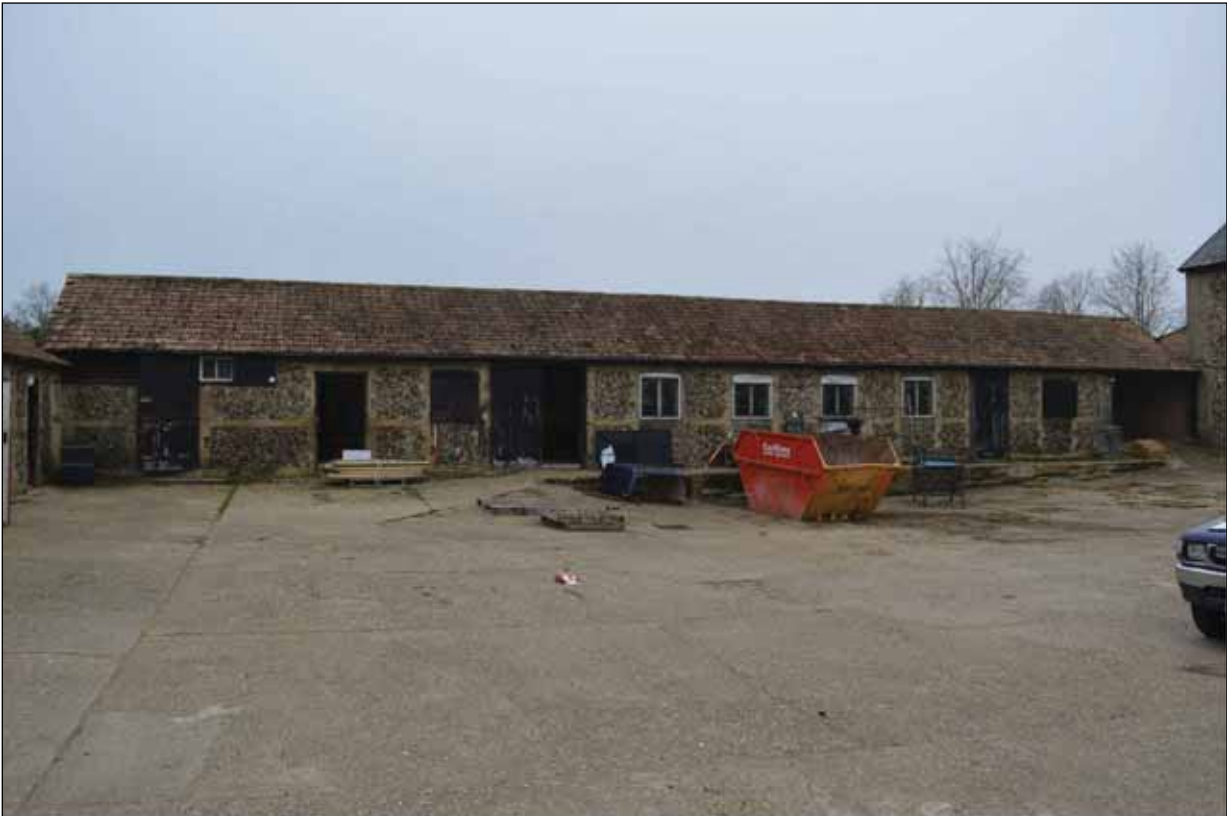
Plate 14: Courtyard aspect of Building 4 viewed from the north-east

- 4.3.3 There are doors and windows to the front and rear of the building (Plate 14). A single access door is located to the rear of the building (Plate 22) and this aspect also shows evidence of blocked windows.

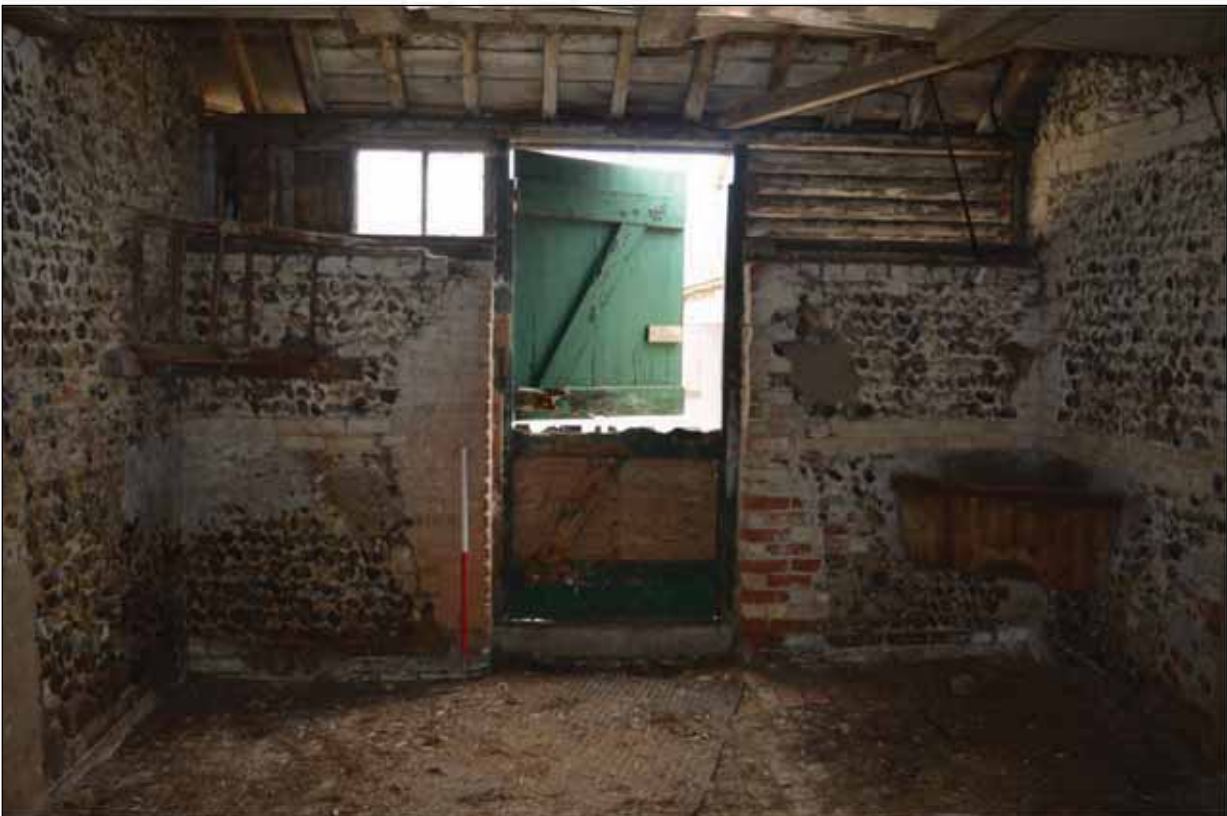
Plate 15: Building 4 - Internal view of stable door to the eastern end of the range

- 4.3.4 The surviving stable, located at the south-east end of the stable block, is 5.34m in length by 4.90m in width. A split stable door is set into the north-east wall, facing the courtyard. It is of wood construction with a height of 2.49m and a width of 1.09m (Plates 4 & 15). Strap hinges are attached to both the upper and lower doors.

- 4.3.6 Internal fittings are located either side of the stable door. To the right hand side of the door is a manger at a height of 0.35m, to the left is a hay rack, at a height of 1.34m. Both of these fittings date from the 19th century and are constructed of wood and iron (Plates 15, 20 & 21).

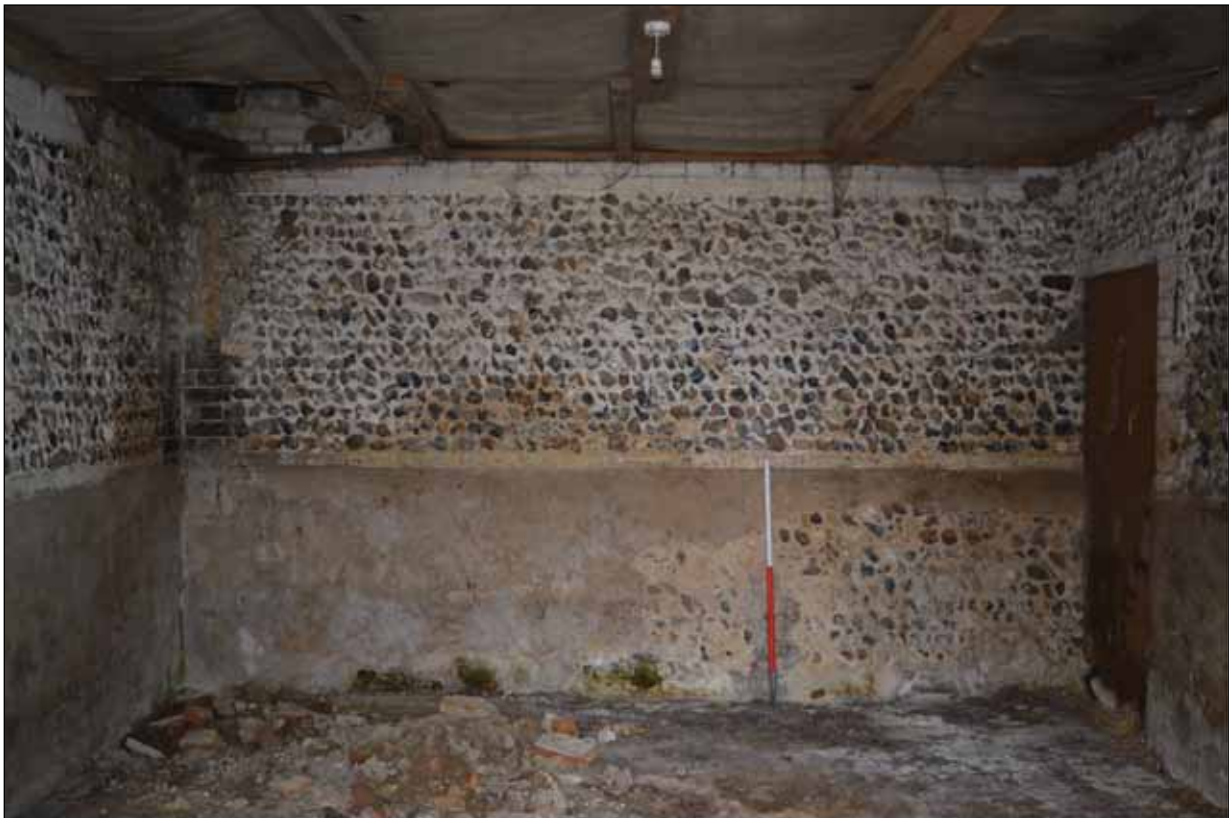
Plate 16: Building 4 - Internal view of the stable viewed from the north-east

- 4.3.8 A tack room housing saddles, bridles and other pieces of equine equipment would have been located close to the stable, most probably adjacent to it. The north-west wall of the stable shows evidence of a blocked door (Plates 16 & 18). There was no evidence of racks, harness or saddle brackets anywhere within Building 4.

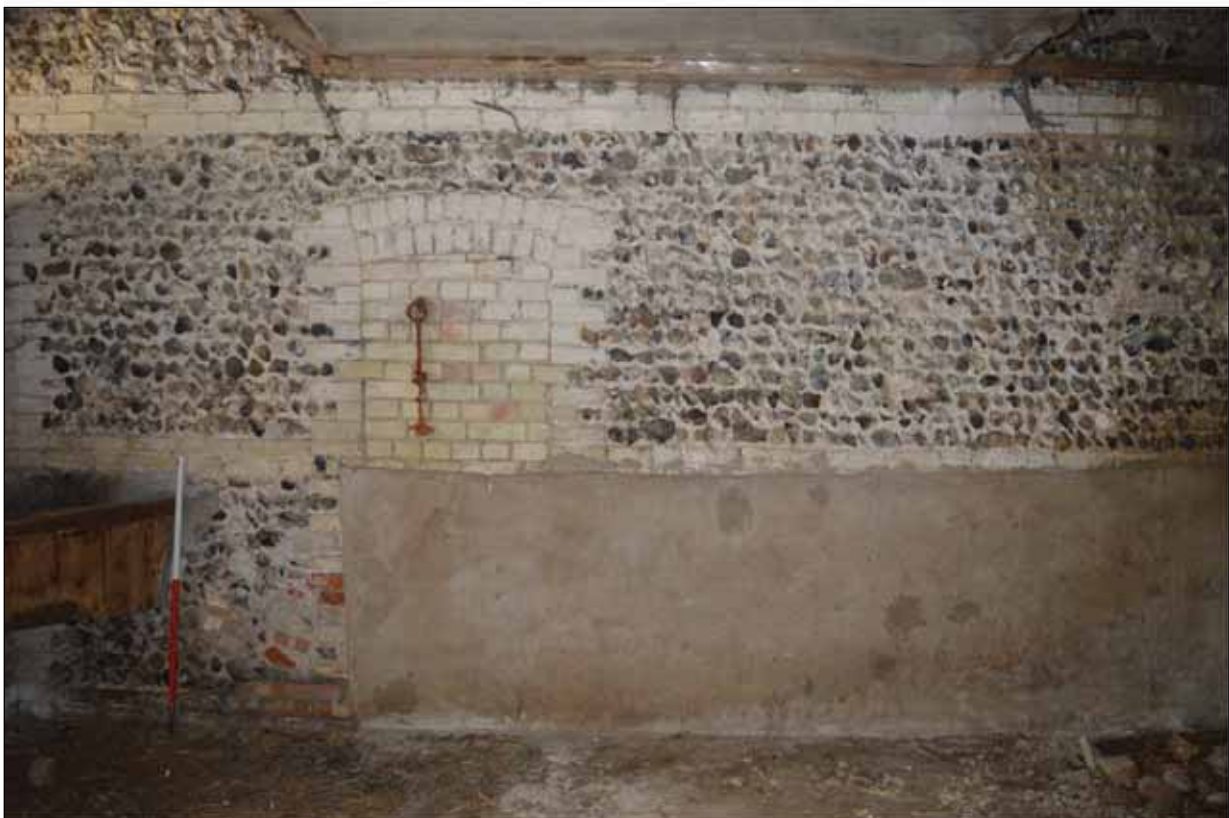
Plate 17: Building 4 - Internal view of the eastern wall

- 4.3.7 Another manger is set into the south-east corner of the room (Plate 17). The only other surviving fitting relating to the building's use as a stable is a small tie ring located on the rear wall (Plate 38). This had been set into a blocked up window, suggesting the tie ring was not an original feature.

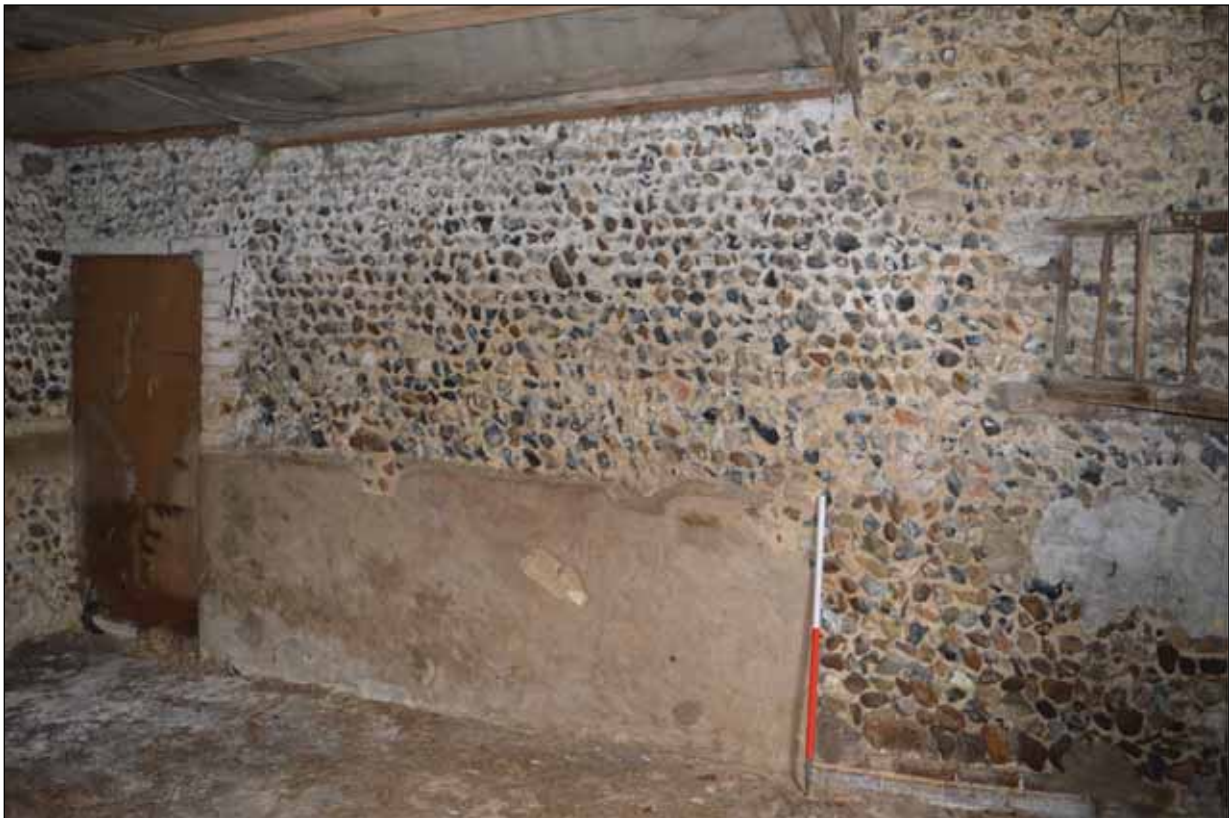
Plate 18: Building 4 - Internal view of the western wall

- 4.3.10 The floor consists of close set bricks laid edge on (Plate 19).
- 4.3.11 Adjoining the stable through a blocked up doorway (Plate 18) is the greater part of the building. Historically, this would have been used to house livestock but in more recent times it has been used as a workshop and for general storage.

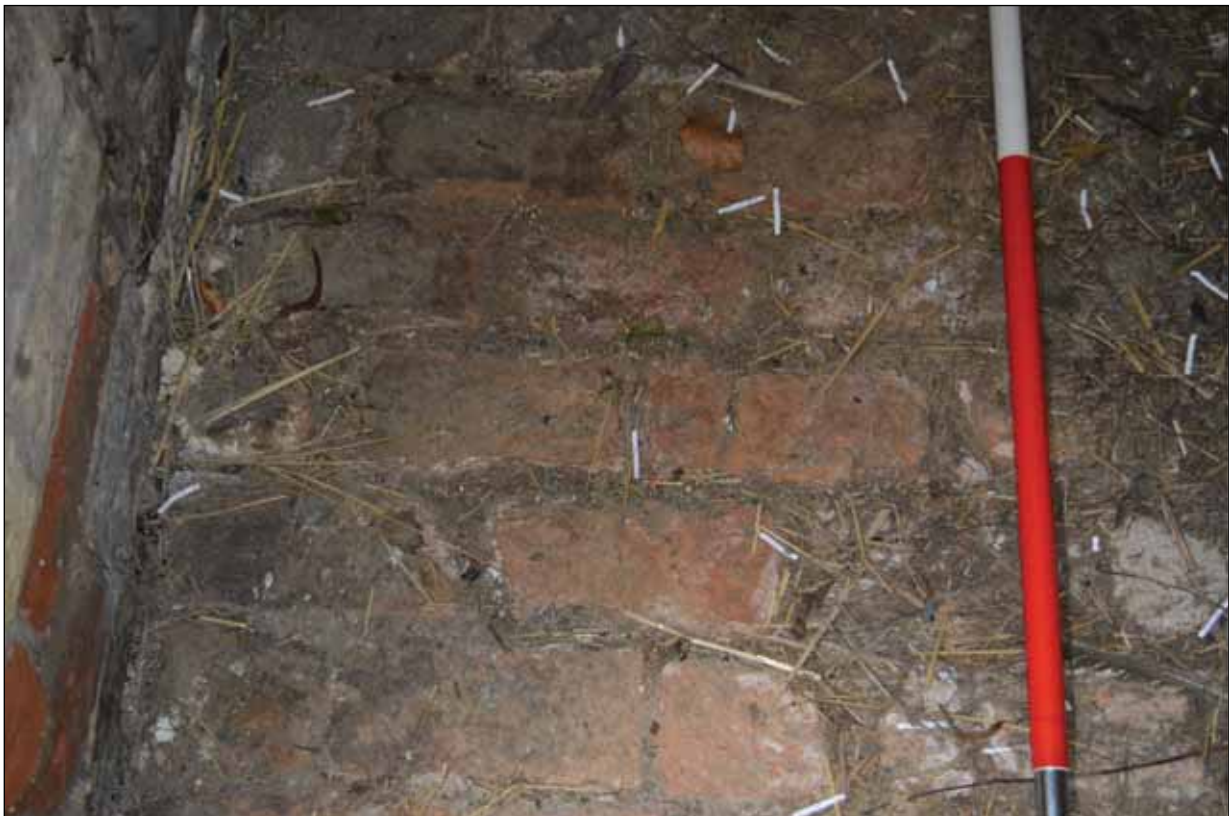
Plate 19: Building 4 - Detail of brick floor within the stable

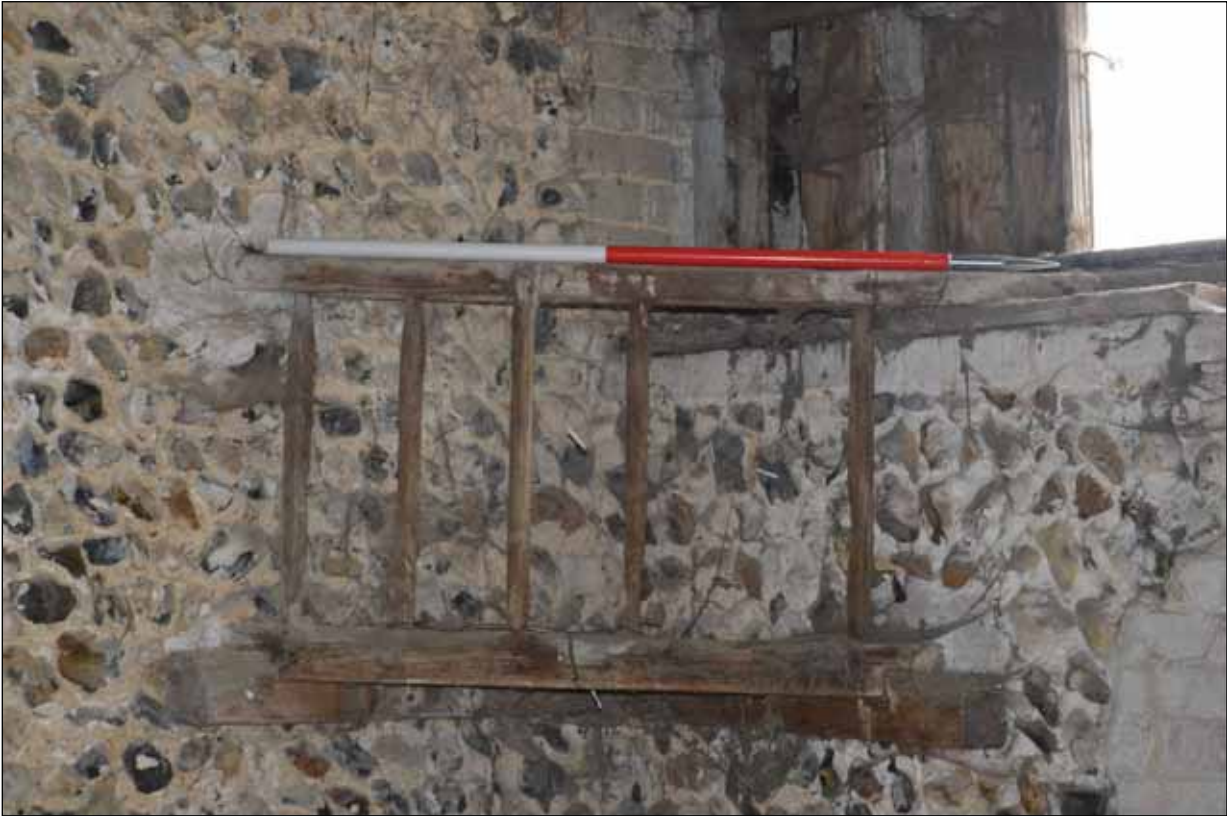
Plate 20: Building 4 - Detail of hay store on the eastern and northern wall

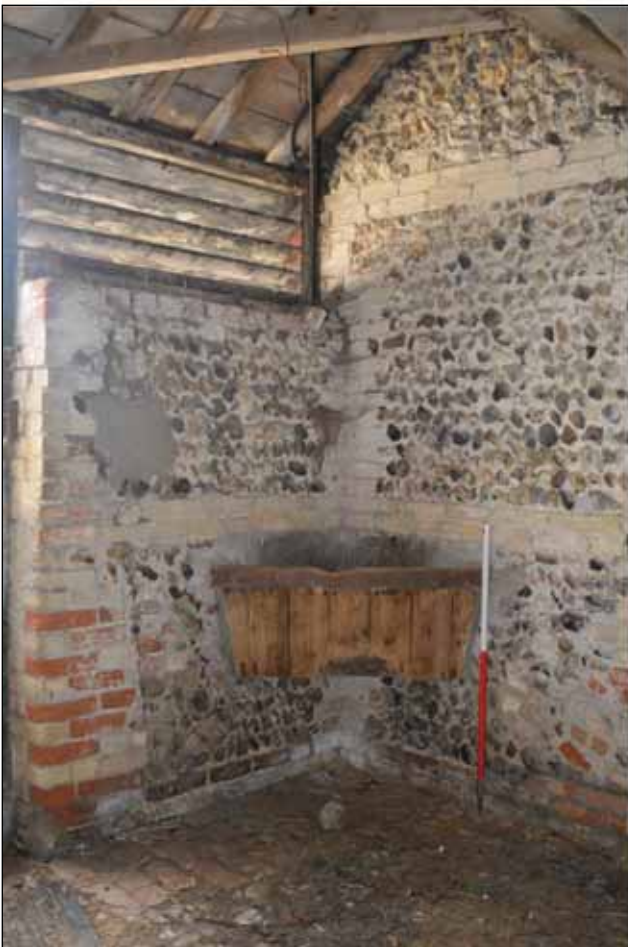
Plate 21: Building 4 - Detail of feeding trough on western and northern wall

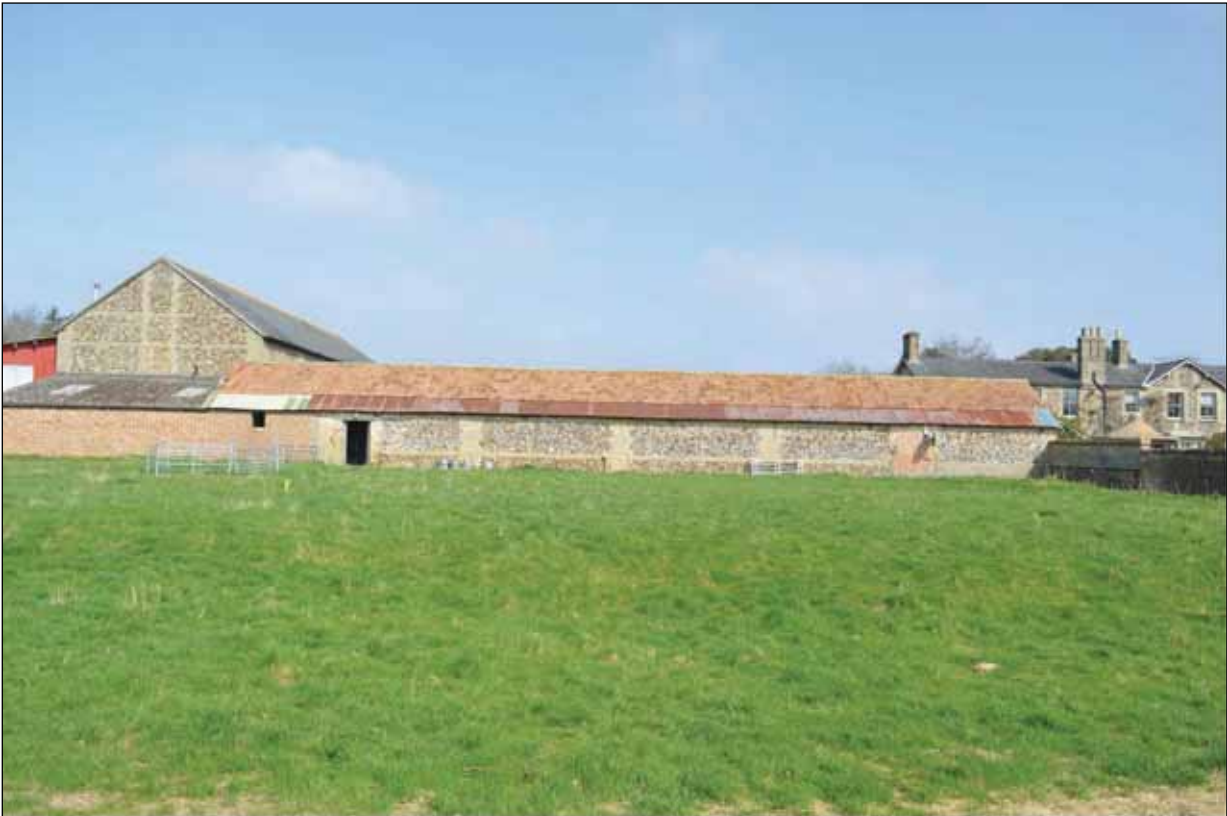
Plate 22: Rear of Building 4 viewed from south-west

- 4.3.1 Building 4 measures 23.78m x 5.43m with a height at its apex of 3.1m. It is located on the south-west side of the courtyard (Fig 2) and at the time of the building recording was used for storage. Historically, its primary use would have been housing for livestock and stabling. Only one stable, located at the south-east end of the range, survives in its near original state (Plates 19-21), although all the internal divisions, fixtures and fittings associated with the livestock pens have been removed.
- 4.3.2 The building is constructed from dressed flint walls with brick lacing to the height of the eaves (Plates 14, 22 & 23). Internally, parts of the flint wall had been rendered at a later date (Plate 17). The roof covering is mainly of pan tiles (Plate 14) but to the rear of the building there are a mixture of pan tiles and corrugated iron sheets (Plate 22).

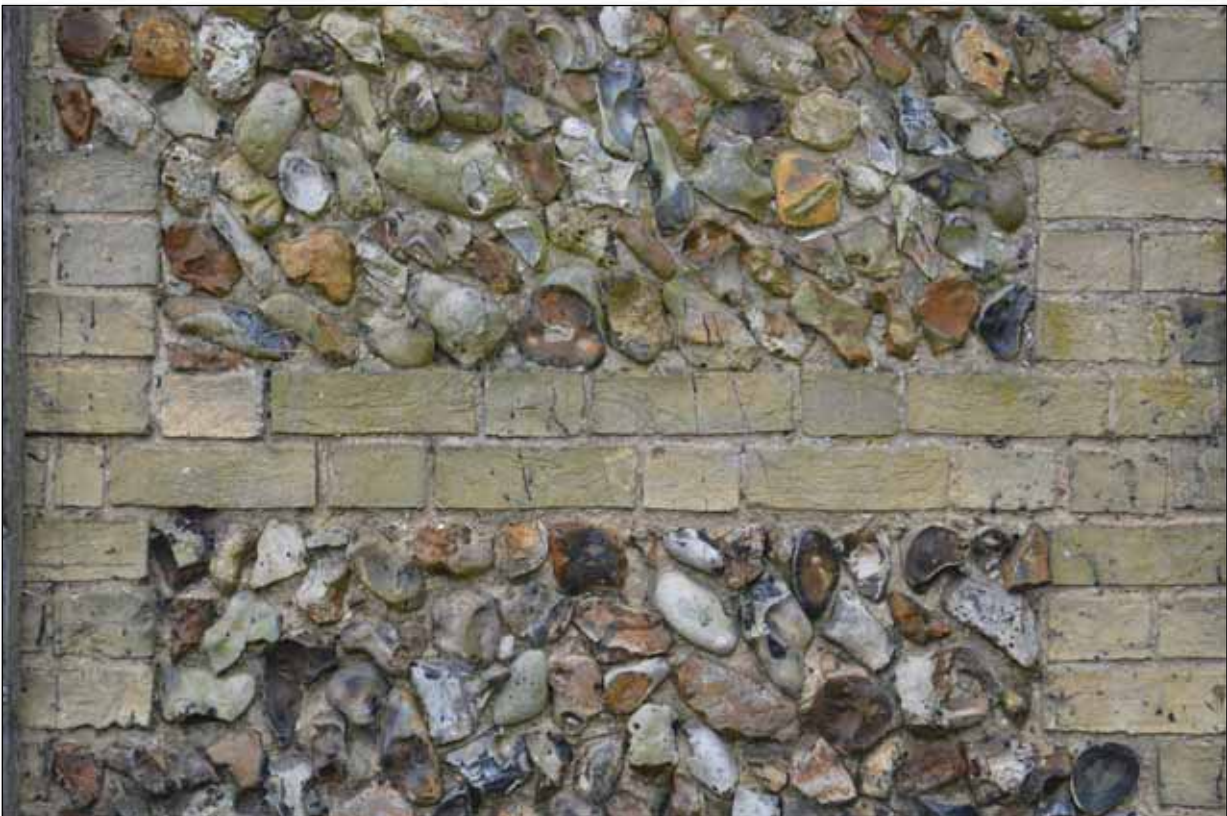
Plate 23: Building 4 - Detail of flint and brick lacing located on north-east elevation

- 4.3.12 Externally, the building is built in the same architectural style as the other structures within the courtyard. The two courses of brick lacing (Plate 23) on this fascia are set at 0.90m above ground level. A large, double sliding door is offset and would have provided access to the livestock stalls. The door opening itself is 2.2m high and 2.1m wide. A runner is still evident above the doors (Plate 24). No maker's marks can be seen. A small access hatch is located 3m above ground level and centrally to the livestock stalls (Plate 26). This was most probably used to access animal feeds.

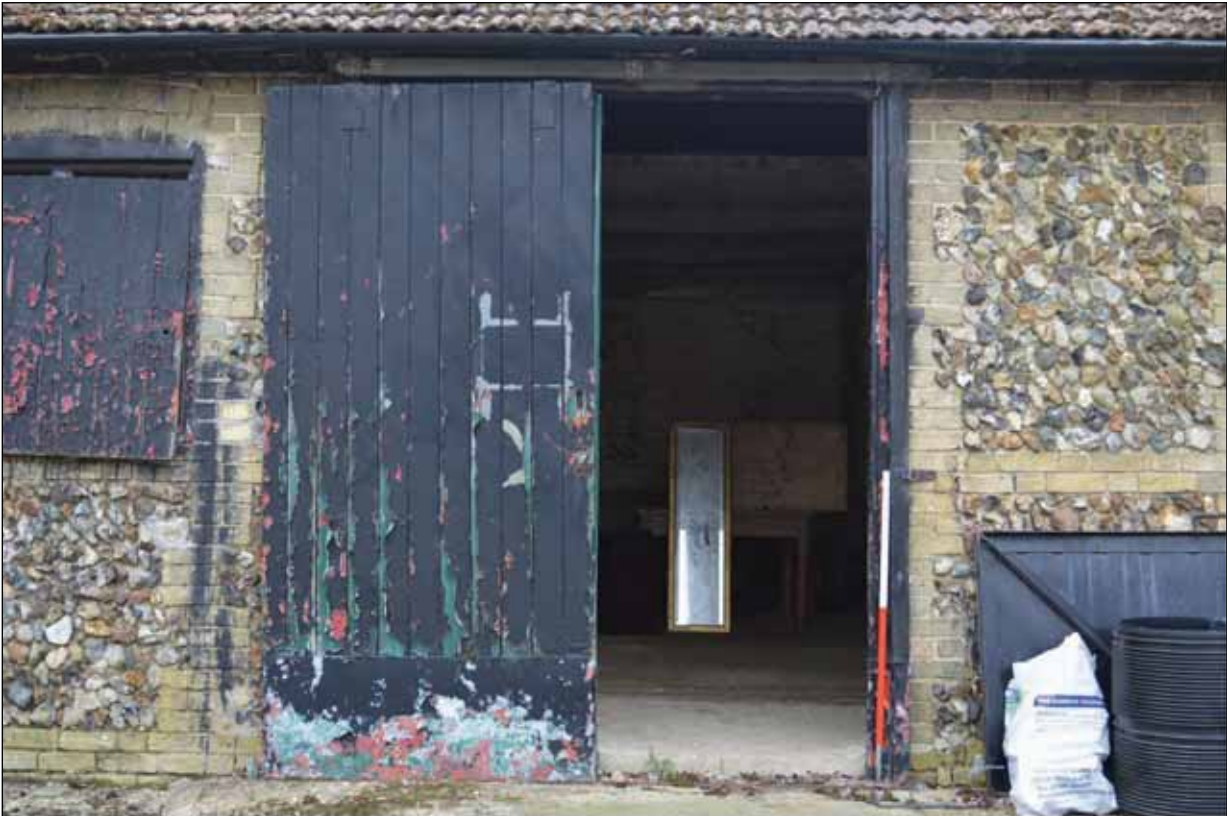
Plate 24: Building 4 - Double wooden doors located on the north-east elevation

- 4.3.13 One window is located to the left of the door and four are located to the right (Plate 24). The left hand window would have belonged to a stable or tack room and retained its original wooden shutter (Plate 25). The shutters have simple strap hinges located on the left hand side and a small aperture to the far right. The windows to the right of the door have been replaced with more modern, sealed casement windows measuring 1.10m x 1.10m; no evidence for wooden shutters can be seen.

- 4.3.14 To the far right hand side of Building 4 another stable once existed. Externally, a stable door and wooden shutter remain (Plate 24). Internally, there is no surviving evidence for a stable or tack room.

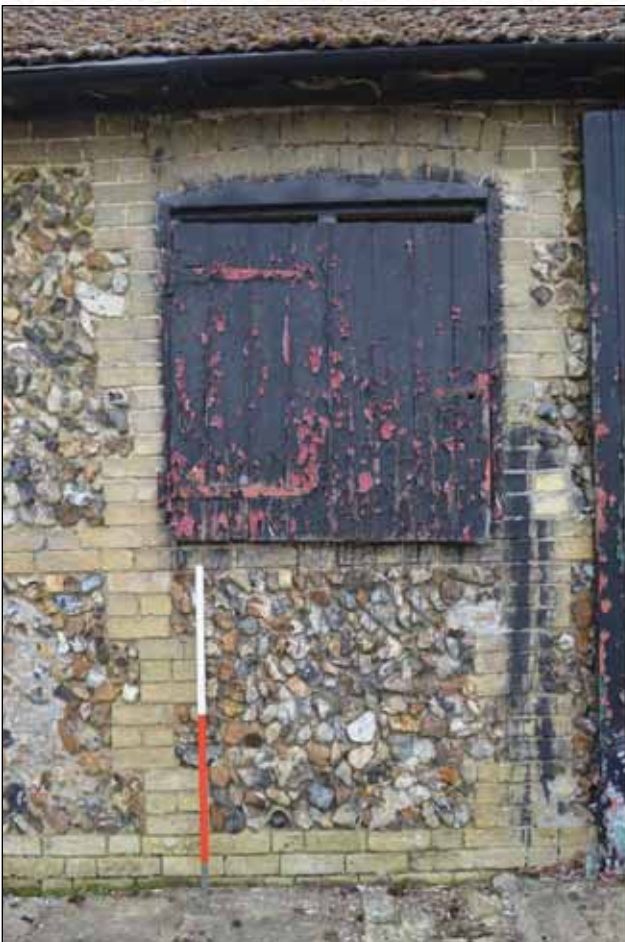
Plate 25: Building 4 - Detail of wooden shutter on the north-east elevation

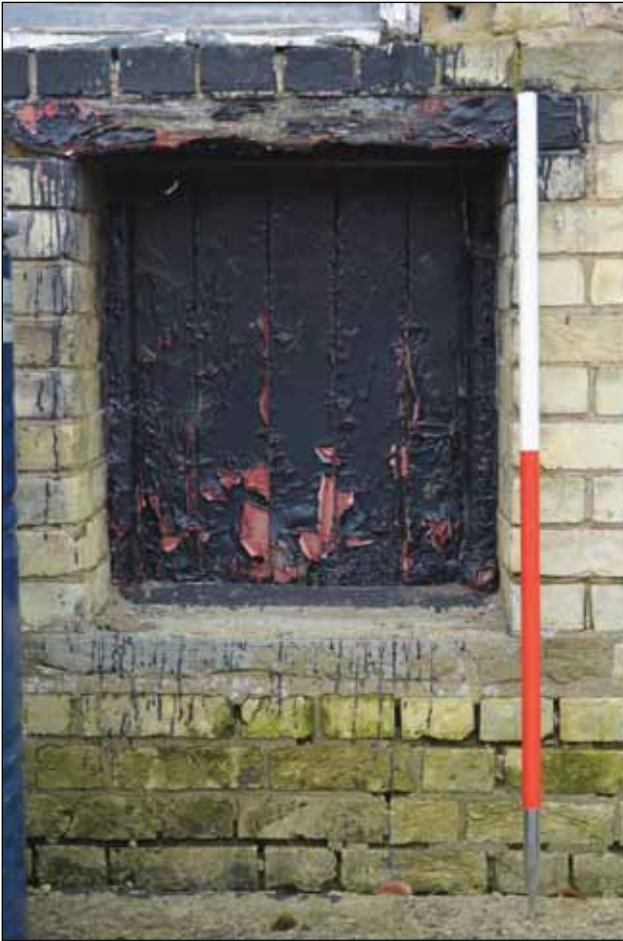
Plate 26: Building 4 - Detail of recessed window and wooden shutter on north-east elevation

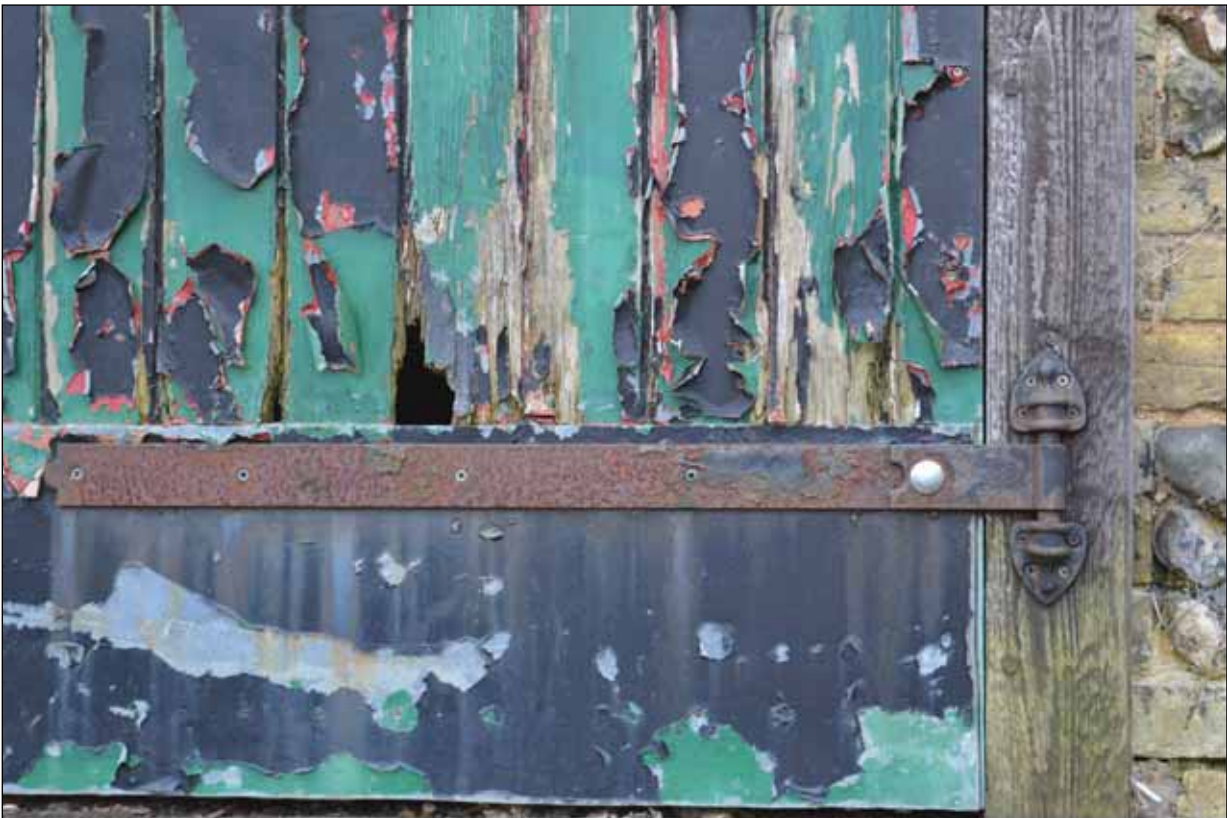
Plate 27: Building 4 - Window and door to the north-east elevation

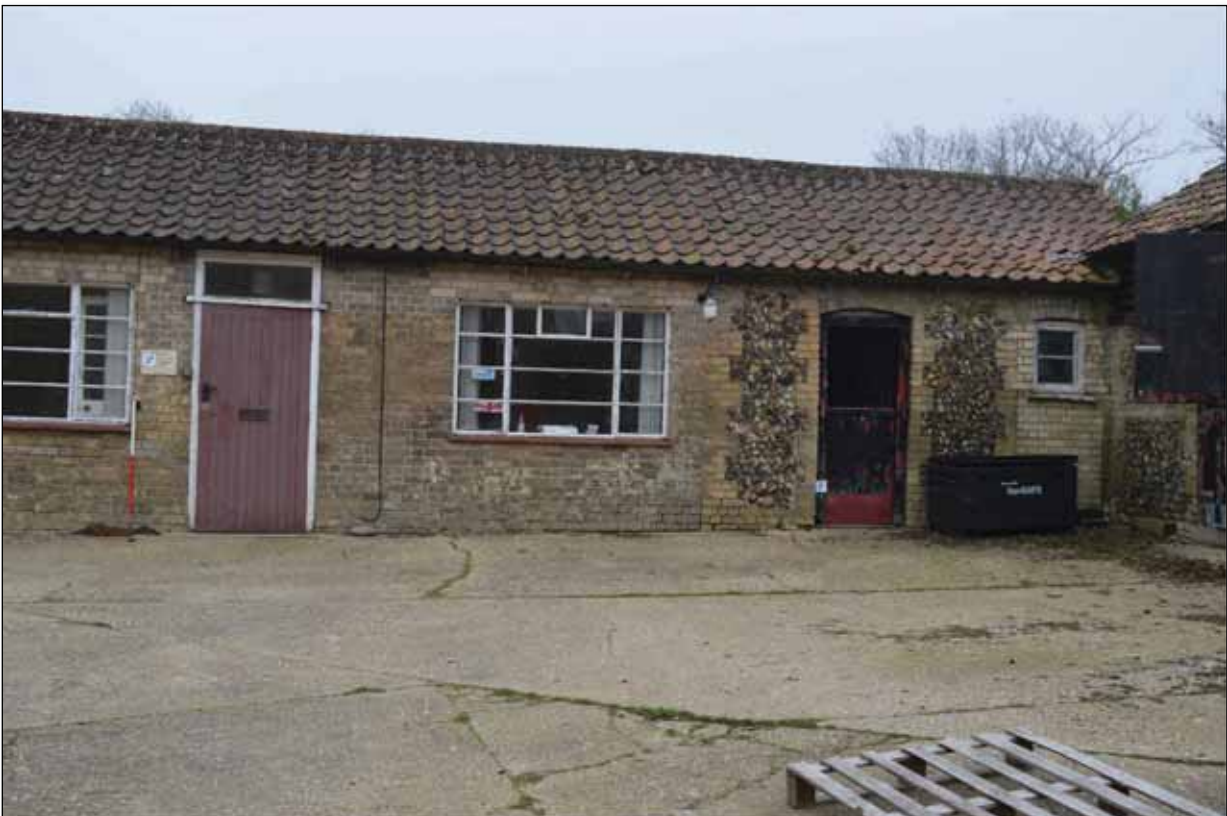
Plate 58: Building 5 - Detail of modern roof

- 4.4.11 Located at the south-west end of the building, Room 3 measures 4.64m x 3.76m with a ceiling height of 2.41m. It has been painted and fitted with a modern carpet.
- 4.4.12 A modern door located on the north-east wall leads to a small lobby (Plate 56) and to the central courtyard (Plate 54). The north-west wall is recessed with a small hatch located centrally (Plate 54). Shelving was located along the rear and south-west walls but had been removed at the time of recording (Plates 55 & 57). The only window is located on the north-west wall. This is of a metal Crittal type and measures 1.96m x 0.77m and has been described previously.
- 4.4.13 The roof structure could only be viewed through a small hatch located in the lobby. It showed that the timbers had recently been replaced (Plate 58).

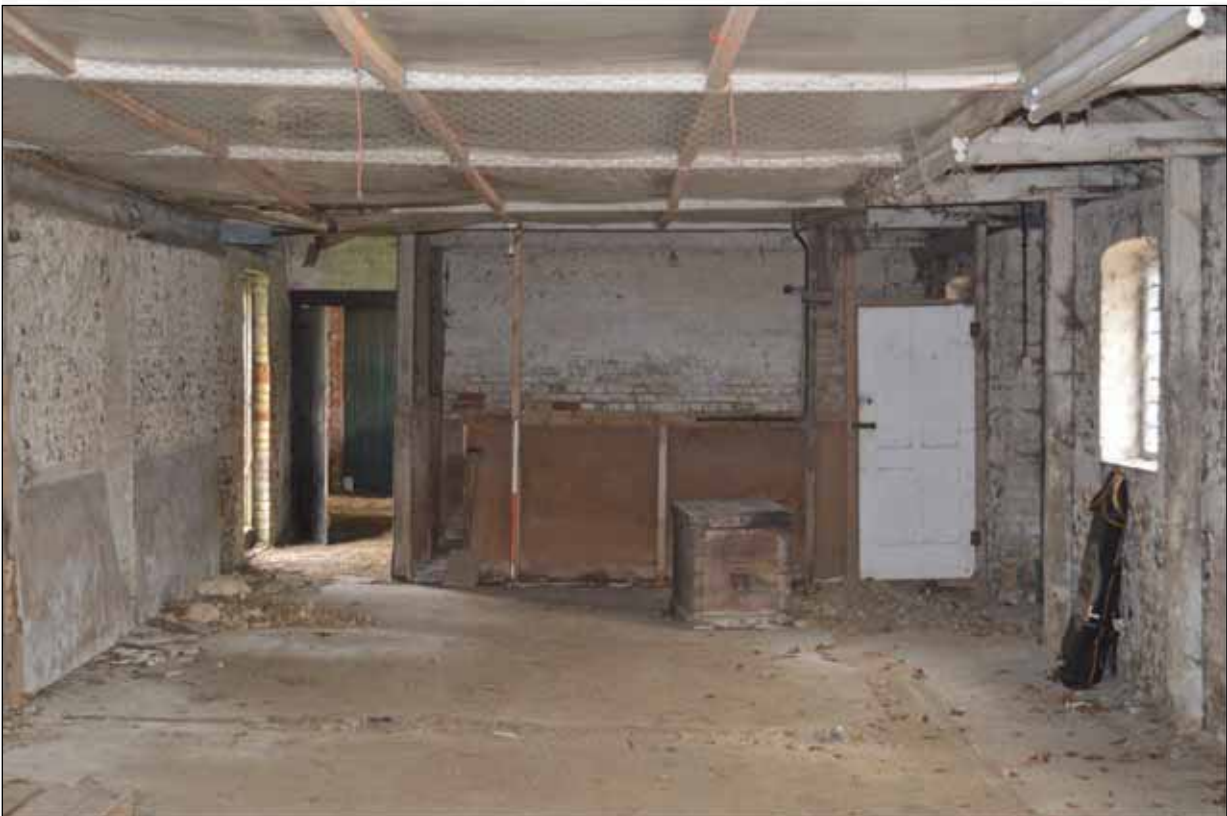
Plate 30: Building 4 - Internal view of the western end of the building

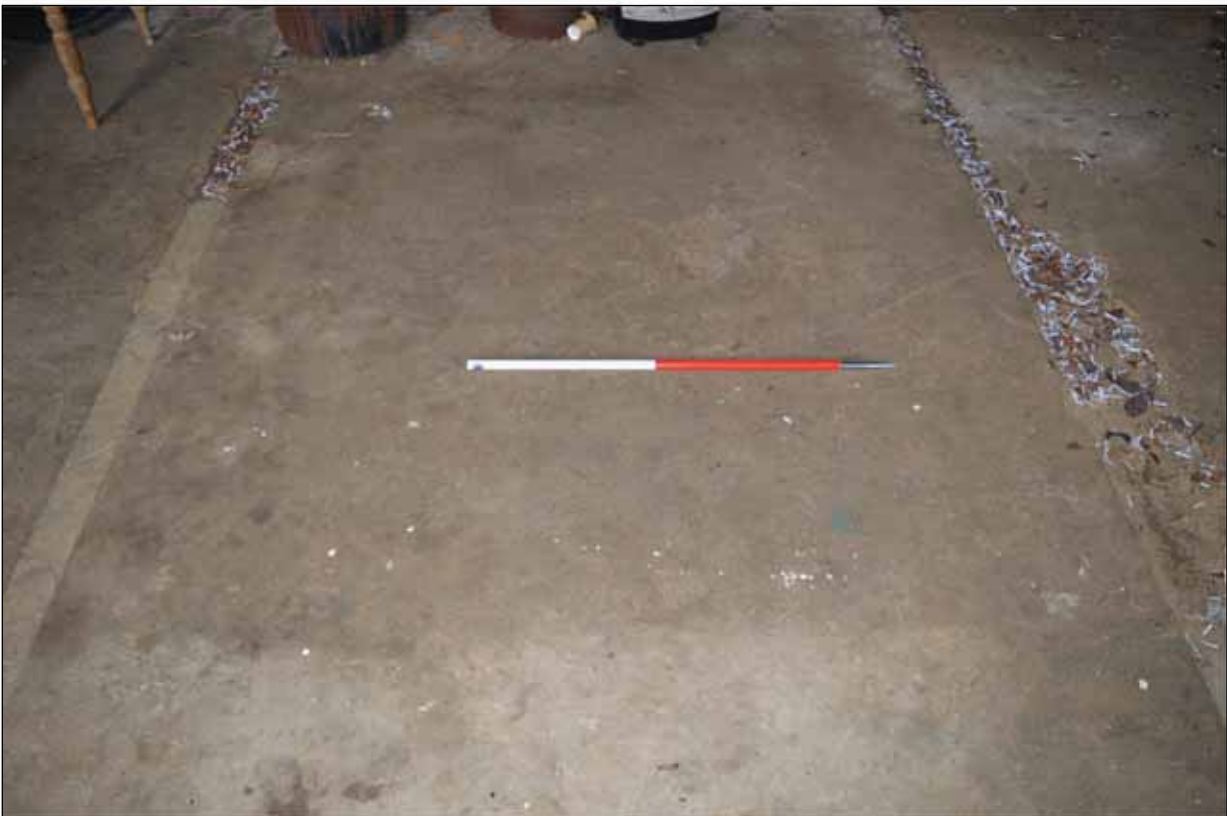
Plate 32: Building 4 - Internal view of the eastern end of the building

- 4.3.19 The floor consists of a modern concrete screed (Plate 32).
