Hill House Farm Courtyard, Dullingham

Historic Building Recording

Client: Enterprise Property Group

OA East Report No 2011:
OASIS No: oxfordar3-289203
NGR: TL 6152 5867

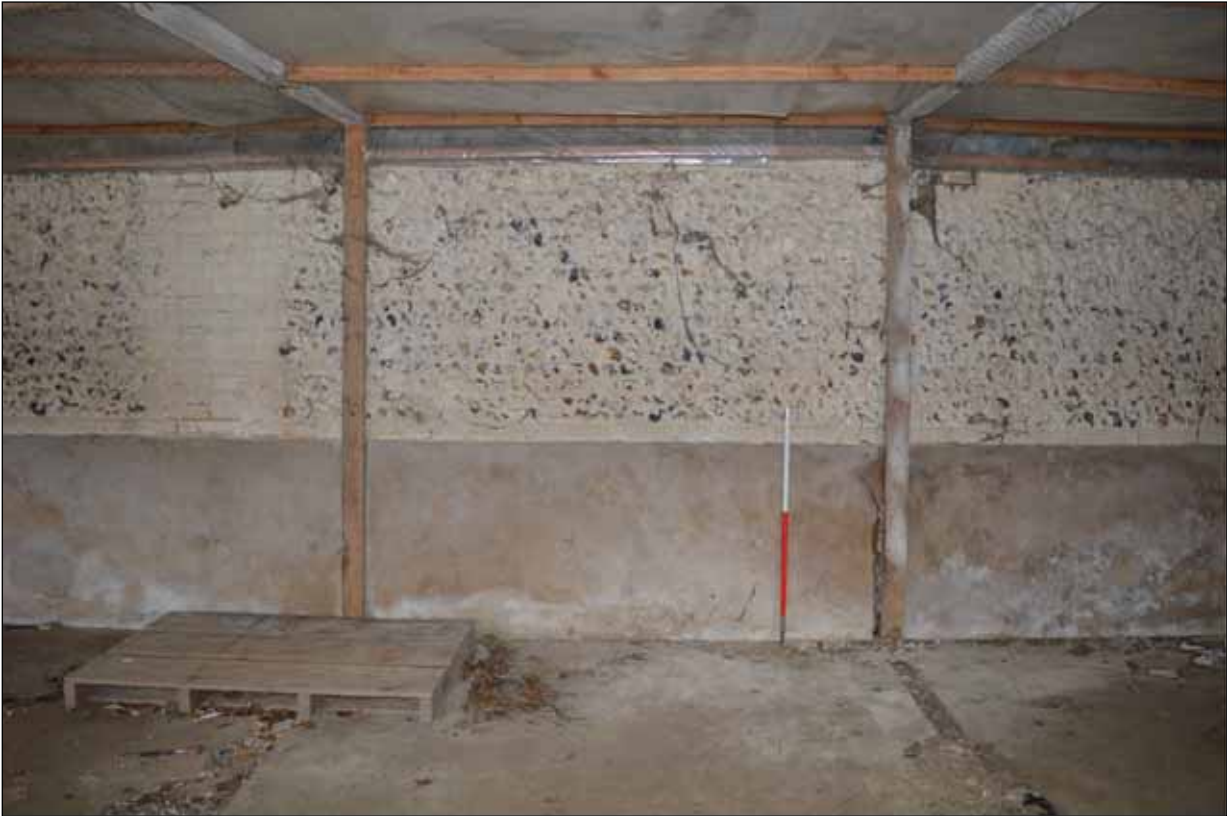
Plate 33: Building 4 - Floor surface showing stable wall divisions

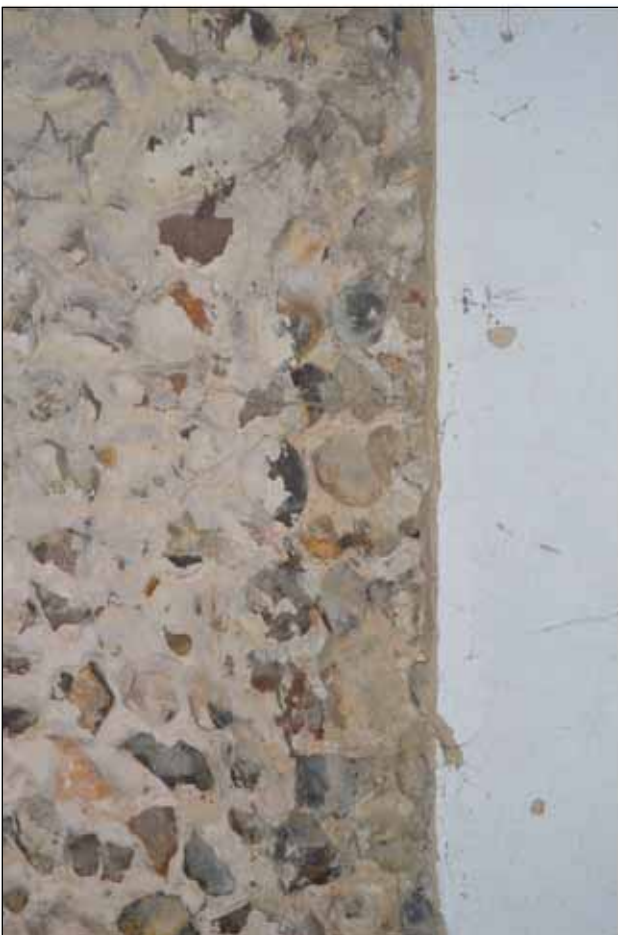
Plate 34: Building 4 - Internal view of wall to the rear of the building

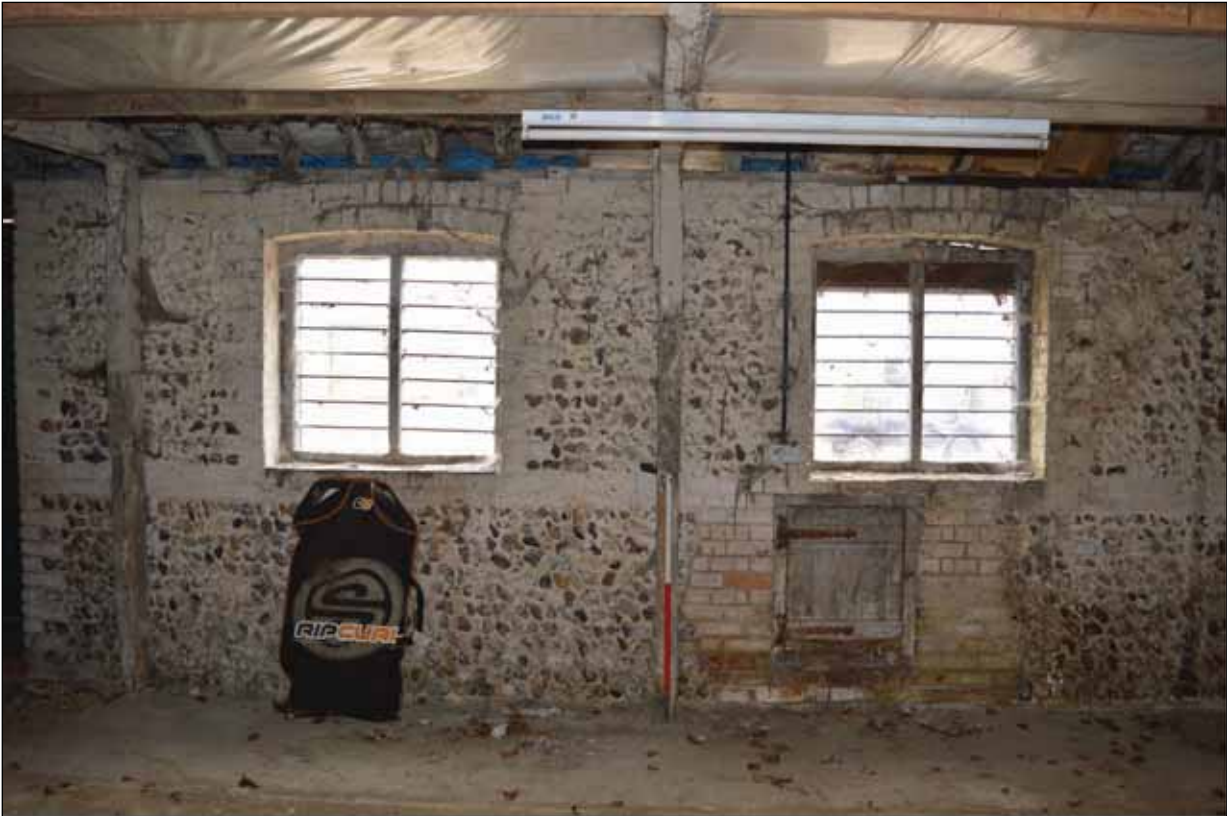
Plate 35: Building 4 - Detail of flint wall

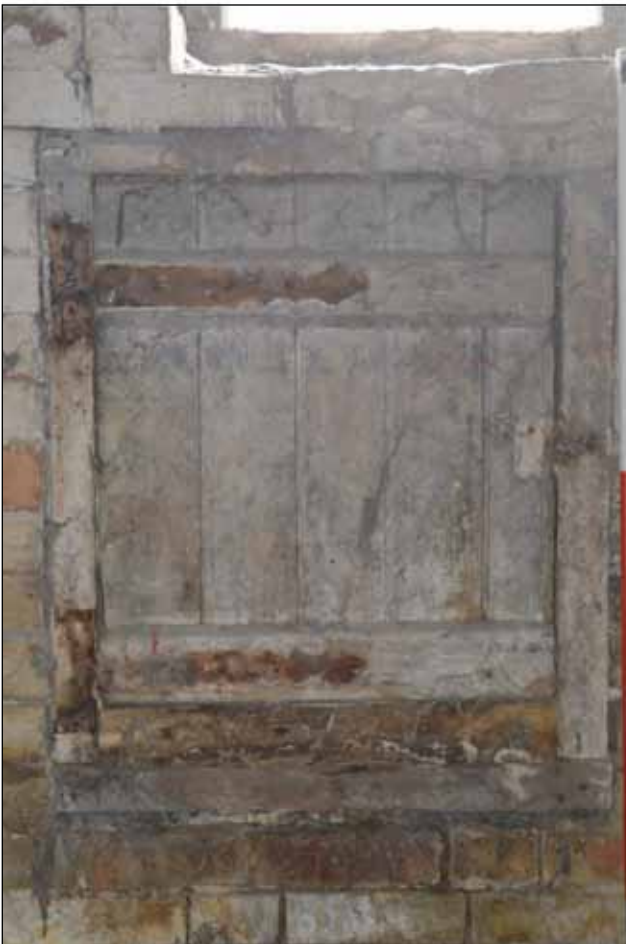
Plate 36: Building 4 - Internal view of windows located to the courtyard

- 4.3.17 Windows to the stalls look out into the courtyard. These retain the original horizontal bars but casements have been added in more recent times (Plate 36).

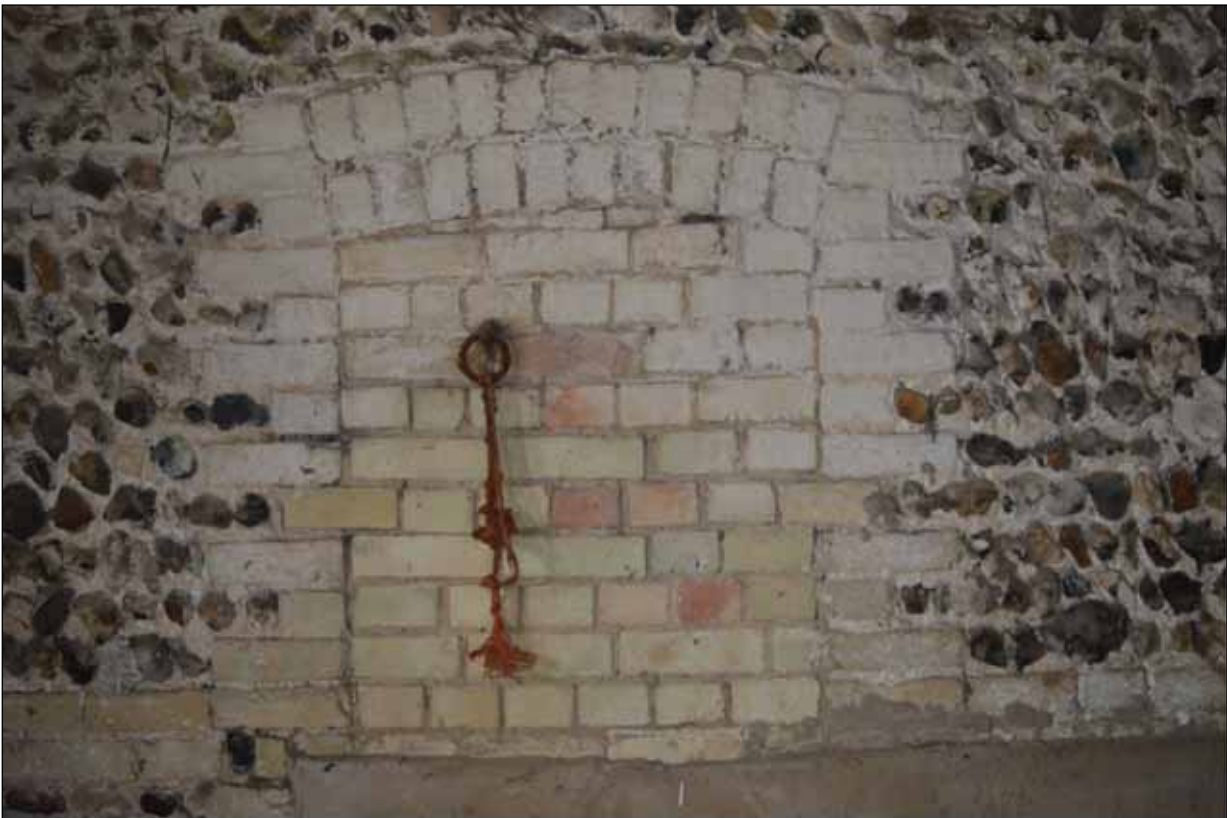
Plate 37: Building 4 - Detail of hatch door

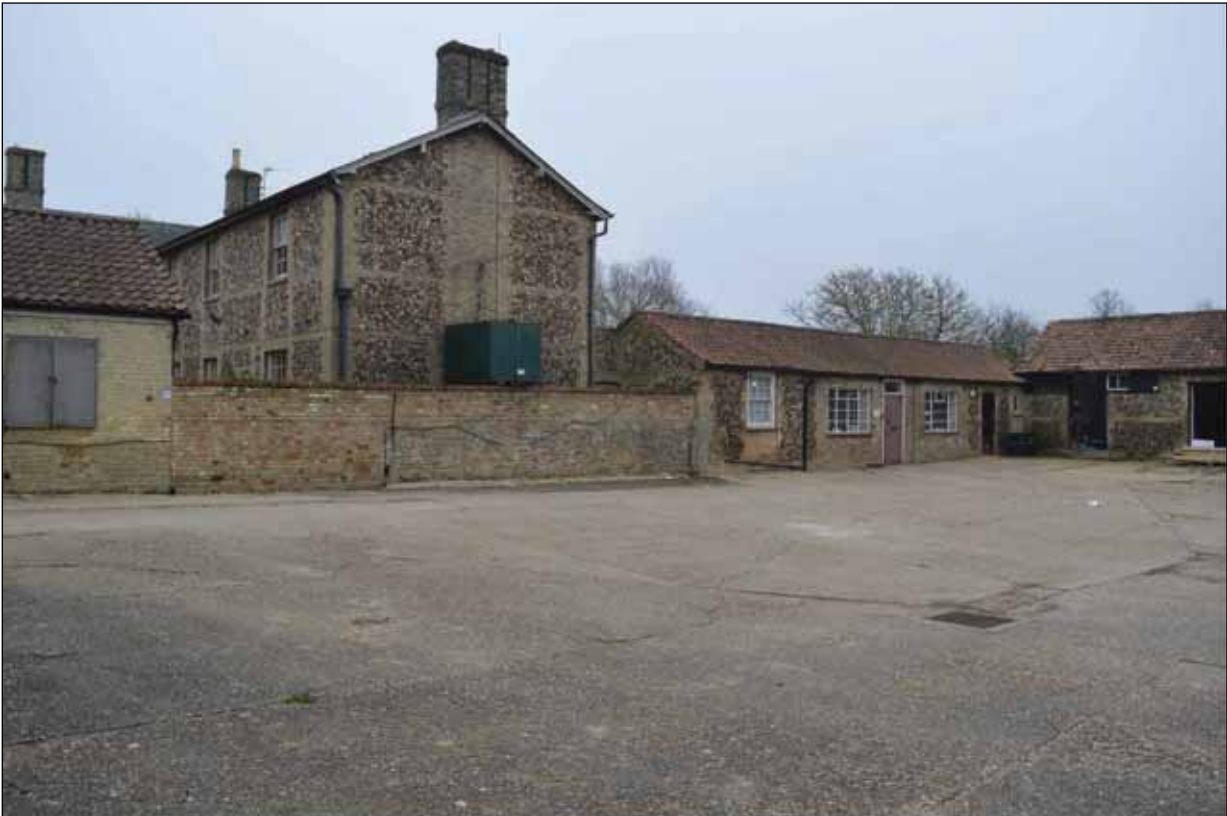
Plate 39: Courtyard view of Building 5 viewed from the north-west

- 4.4.1 Building 5 is located to the south-east of the courtyard (Plates 39 & 40). The building had previously acted as the farm office but at the time of survey had been vacated.

- 4.4.3 The building has a pitched roof which has been re-covered with pan tiles that may have been re-used from the previous roof. It is 15.3m long and has a depth of 5.4m. The north facing elevation is constructed from brick and dressed flint (Plate 39). The rear of the building was not accessible but aerial photographs taken in the 1951 suggest it was of similar construction (Fig 6). The dressed flint vertical bands exist either side of later in-fill brick work which is not tied in to the earlier brick work (Plate 42). The in-fill brick work created new rooms within the building.

- 4.4.4 Externally, two metal windows have been inserted either side of a modern wooden door (Plate 39). The windows comprise 12 glass panes encased in a metal frame and measured 2m x 1.23m (Plate 43). The openings are vertical on the sides and horizontal along on top. Windows of this type are often known as "Crittall Windows", after a prominent producer, but other manufacturers such as Hope also designed windows of similar appearance.

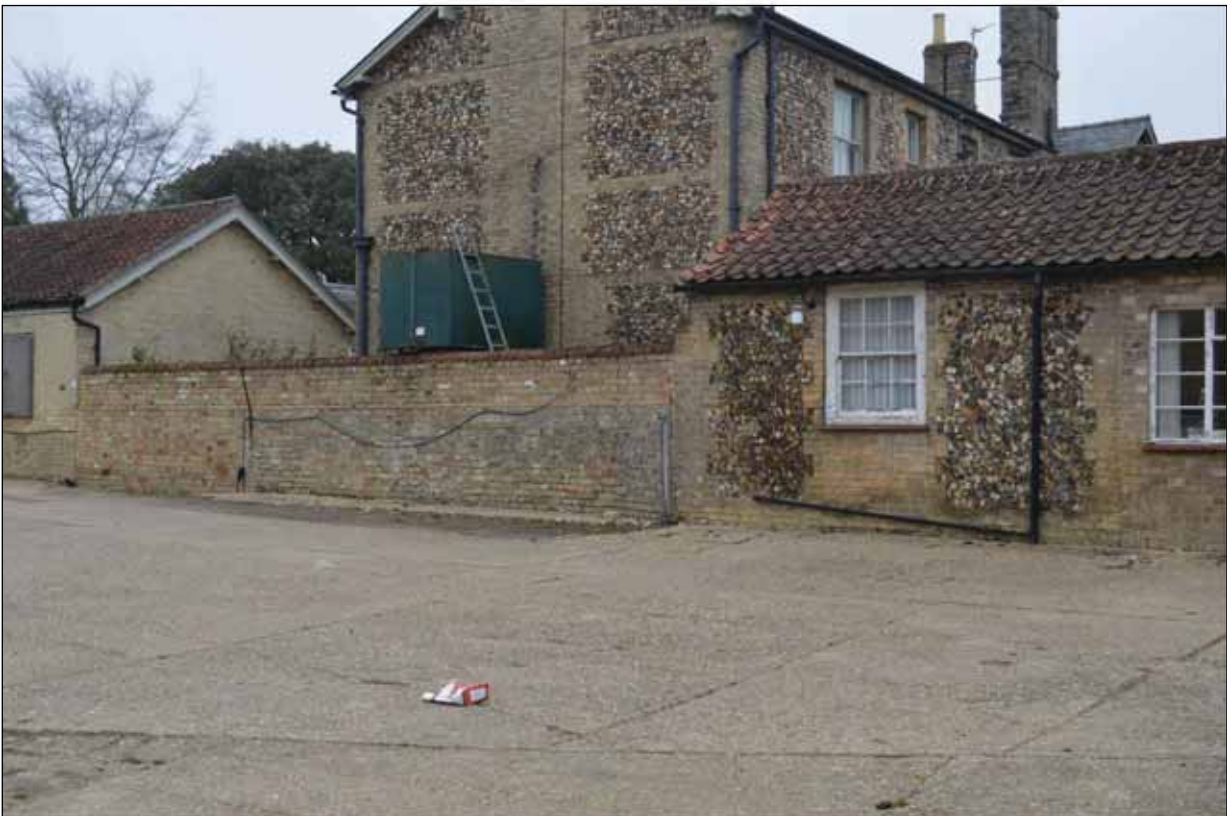
Plate 40: Building 5 - Building in relationship with the former farm house viewed from the courtyard

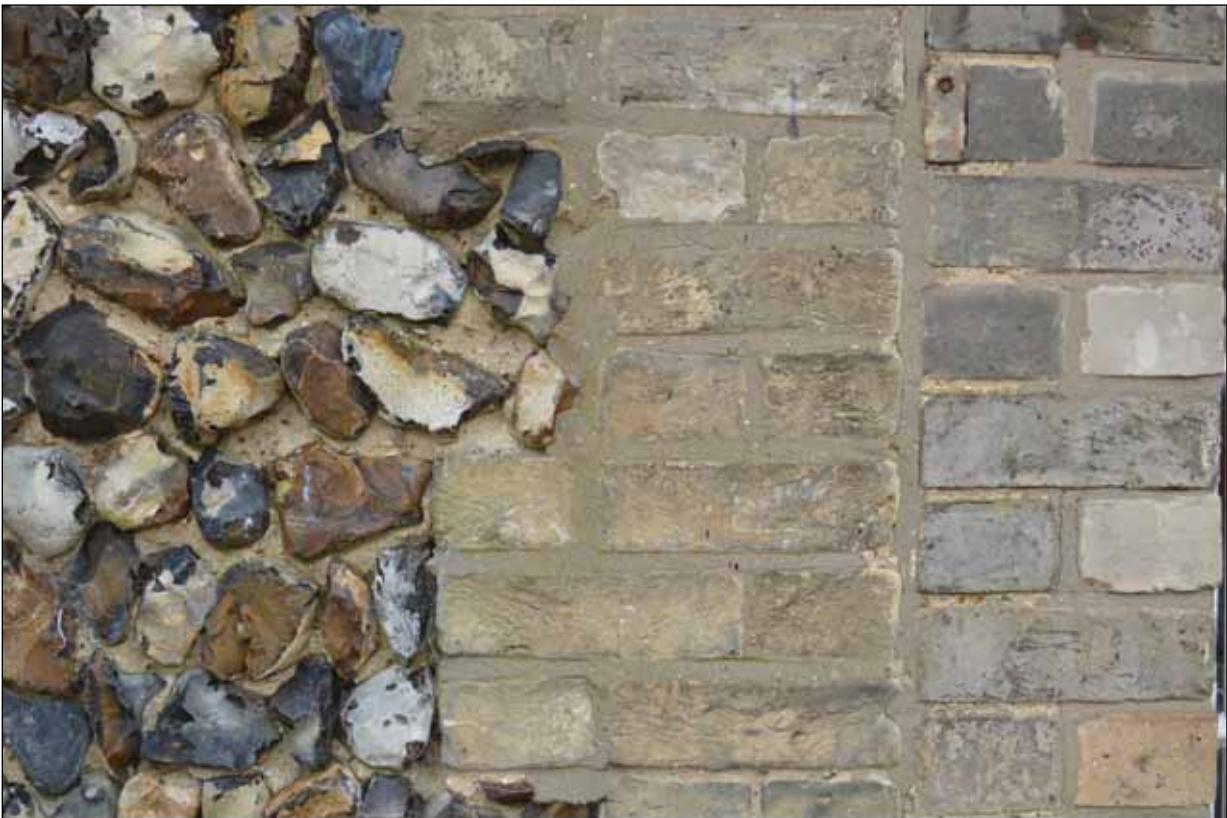
Plate 41: Building 5 - Detail of added wall to the northern end of the building

- 4.4.5 Another window at the north-east end of the barn may also have been a later addition. This differs in style from the metal frame windows, being of a vertical sliding sash type with six glass panes to the upper and six glass panes to the lower (Plate 41). The window has dimensions of 1.39m x 1.09m. Brick work below this window had also been added at a later date and this was not tied in to the original brick work. It is a distinct possibility that a door originally existed here.

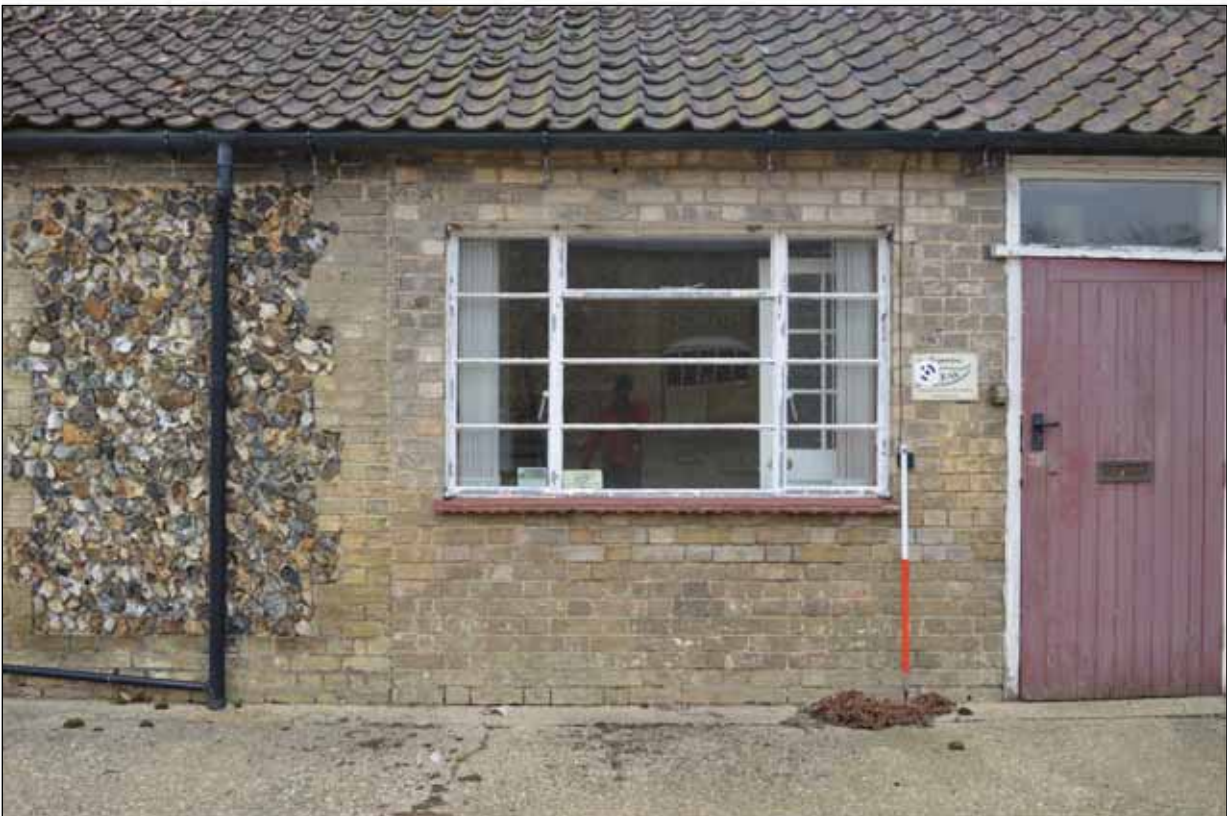
Plate 42: Building 5 - Detail of brick and flint work

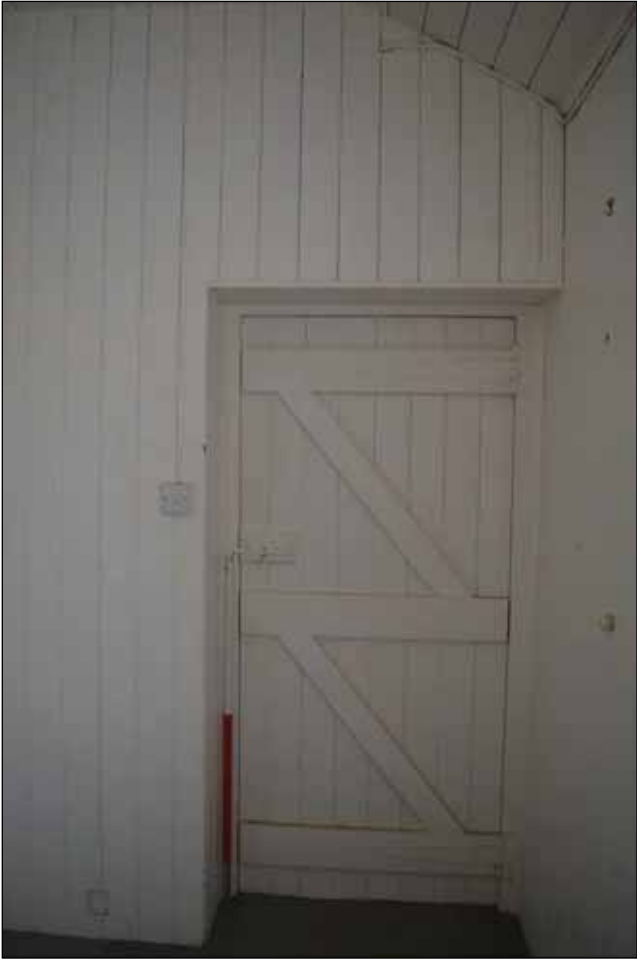
Plate 45: Building 5 - Internal wooden door located to the northern end of the building

is accessed from a small kitchen area through a simple vertical five bar door (measuring 1.99m x 0.74m) with vertical planks and strap hinges (Plates 45, 46 & 47). The walls and hipped ceiling are clad in tongue and groove panelling (Plates 46 & 48).

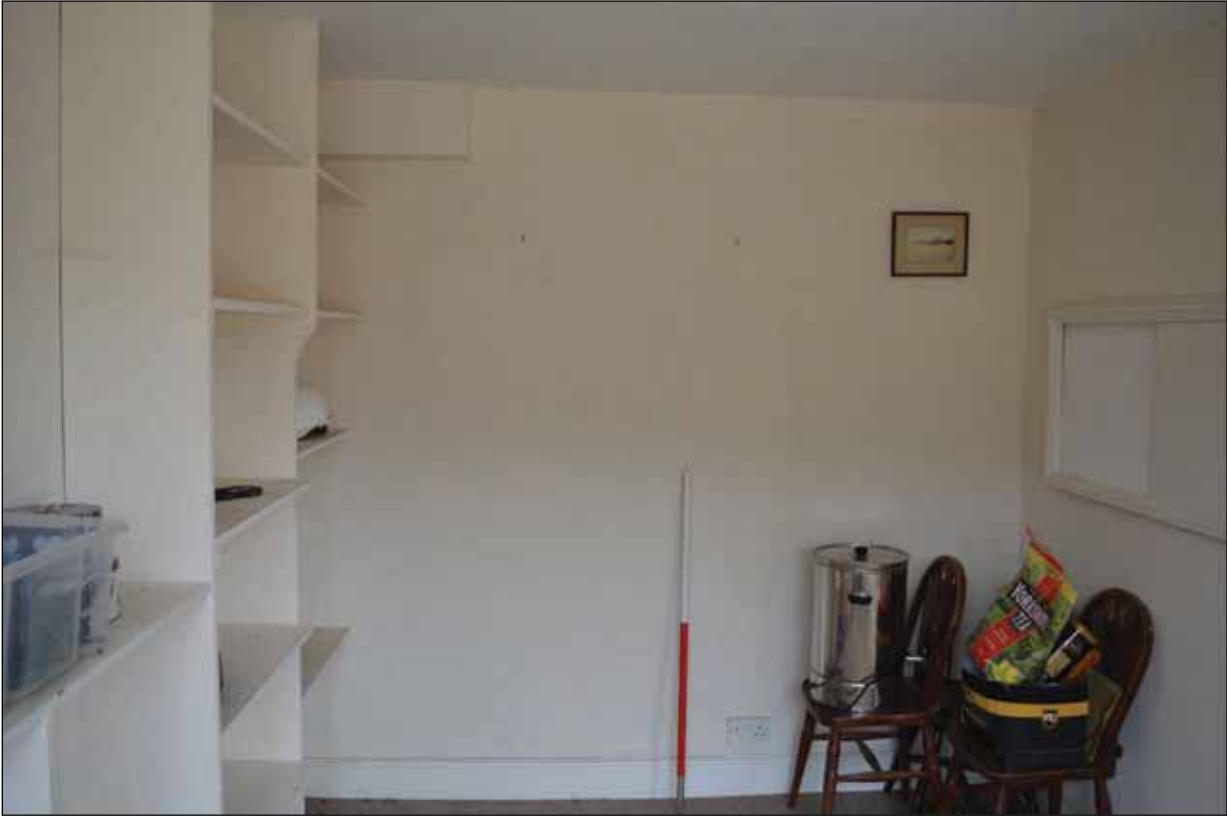
Plate 49: Building 5 - South-western stud wall of office showing door and hatch (room 2)

- 4.4.8 This room measures 2.99m x 3.77m and has a ceiling height of 2.39m. A window is located on the north-west wall and a door and hatch are located on the south-west wall (Plate 49); both hatch and doors are modern. The room is accessed from the courtyard by means of a small lobby measuring 1.22m x 1.22m.
- 4.4.9 Shelves have been constructed along the north-east wall of the room (Plate 50) and between these a strong box or safe has been inserted (Plates 51 -53). This was manufactured by Chubb of London, who began safe building in 1818. (<http://www.chubbarchive.co.uk>) The safe most probably dates to the second half of the 19th century.
- 4.4.10 Walls are of modern painted plasterboard construction with a skirting board to a height of 15cm. The ceiling is also constructed from plasterboard and the floor is carpeted.

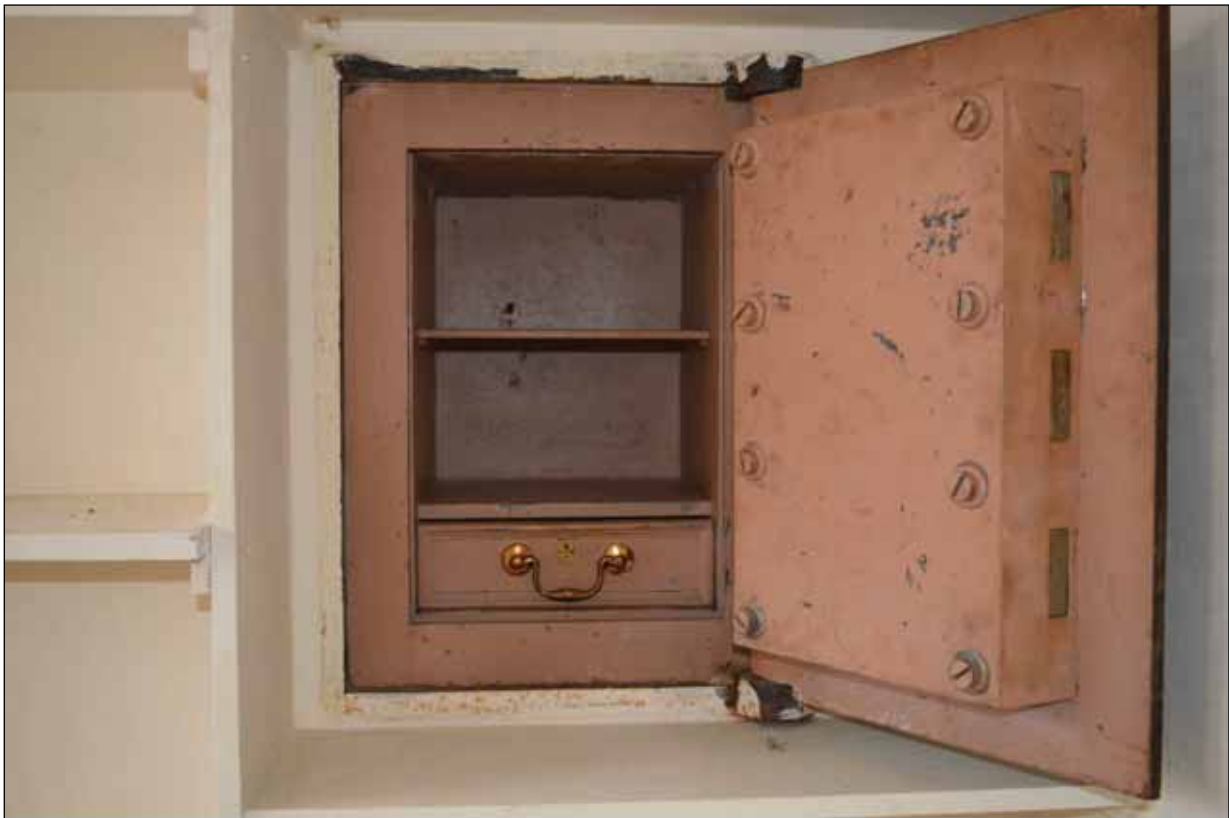
Plate 51: Building 5 - Chubb strong box / safe built into the wall of the office (room 2)

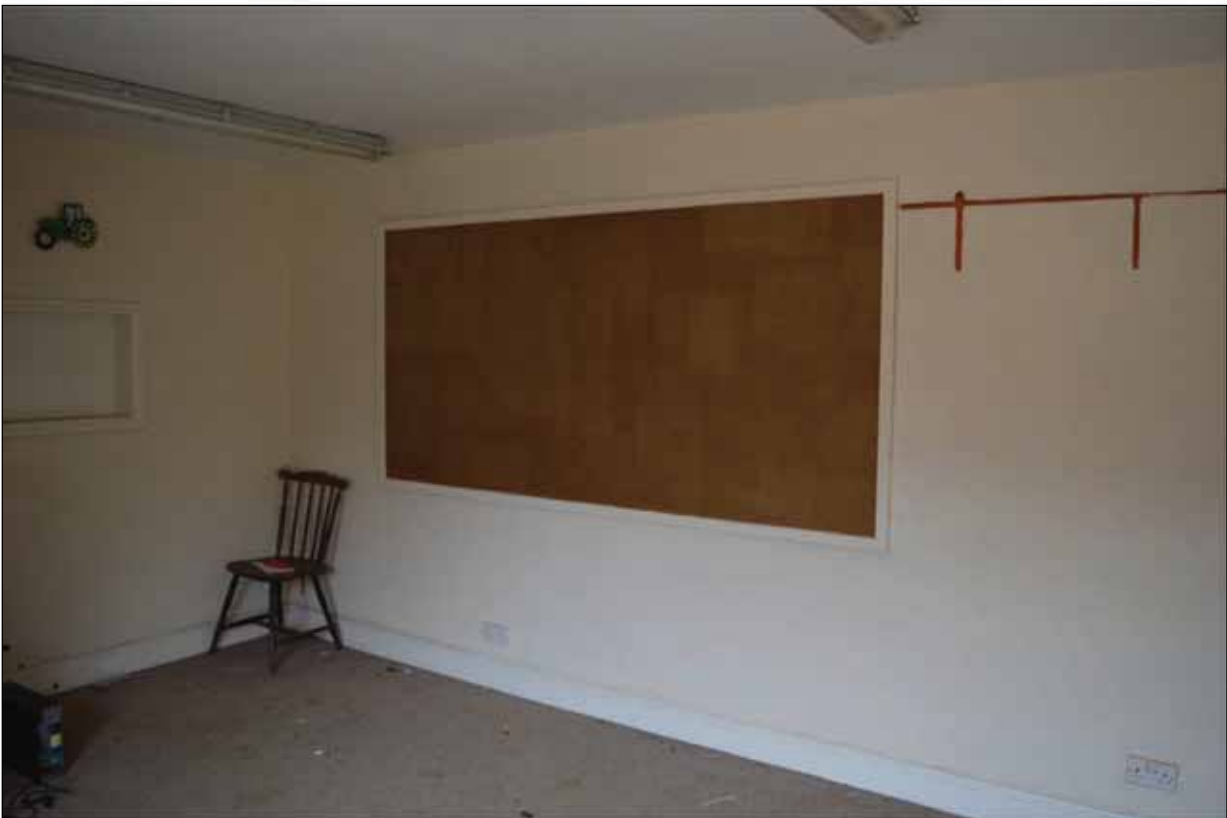
Plate 54: Building 5 - Foyer and wall of office

- 4.4.11 Located at the south-west end of the building, Room 3 measures 4.64m x 3.76m with a ceiling height of 2.41m. It has been painted and fitted with a modern carpet.
- 4.4.12 A modern door located on the north-east wall leads to a small lobby (Plate 56) and to the central courtyard (Plate 54). The north-west wall is recessed with a small hatch located centrally (Plate 54). Shelving was located along the rear and south-west walls but had been removed at the time of recording (Plates 55 & 57). The only window is located on the north-west wall. This is of a metal Crittal type and measures 1.96m x 0.77m and has been described previously.
- 4.4.13 The roof structure could only be viewed through a small hatch located in the lobby. It showed that the timbers had recently been replaced (Plate 58).

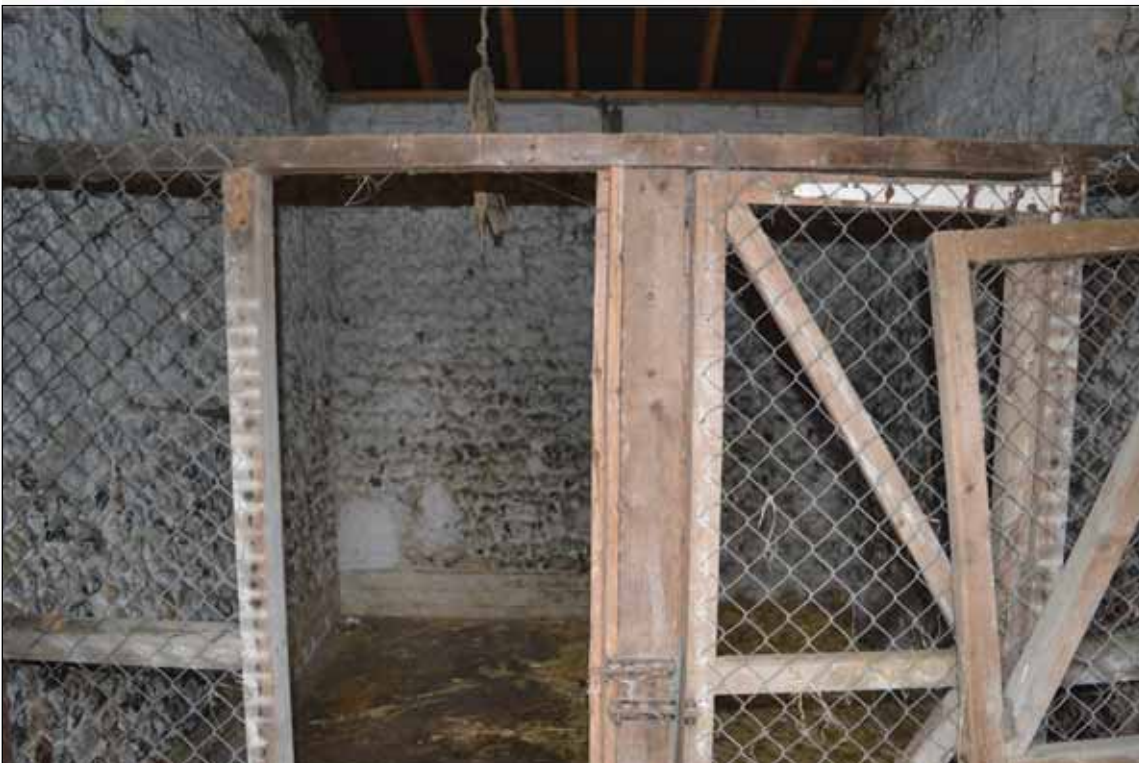
Plate 60: Building 5a - Detail of stable door viewed from the north-west

- 4.5.1 At the south-west end of the building, another stable (5a) was noted (Plate 59) but at the time of the survey it was not possible to gain access. The building had until recently been used as an animal pen (Plate 61). The two part stable door had been retained (Plate 60) and internally it is of flint and brick construction. As with the rest of Building 5 the roof had recently been replaced (Plate 62).

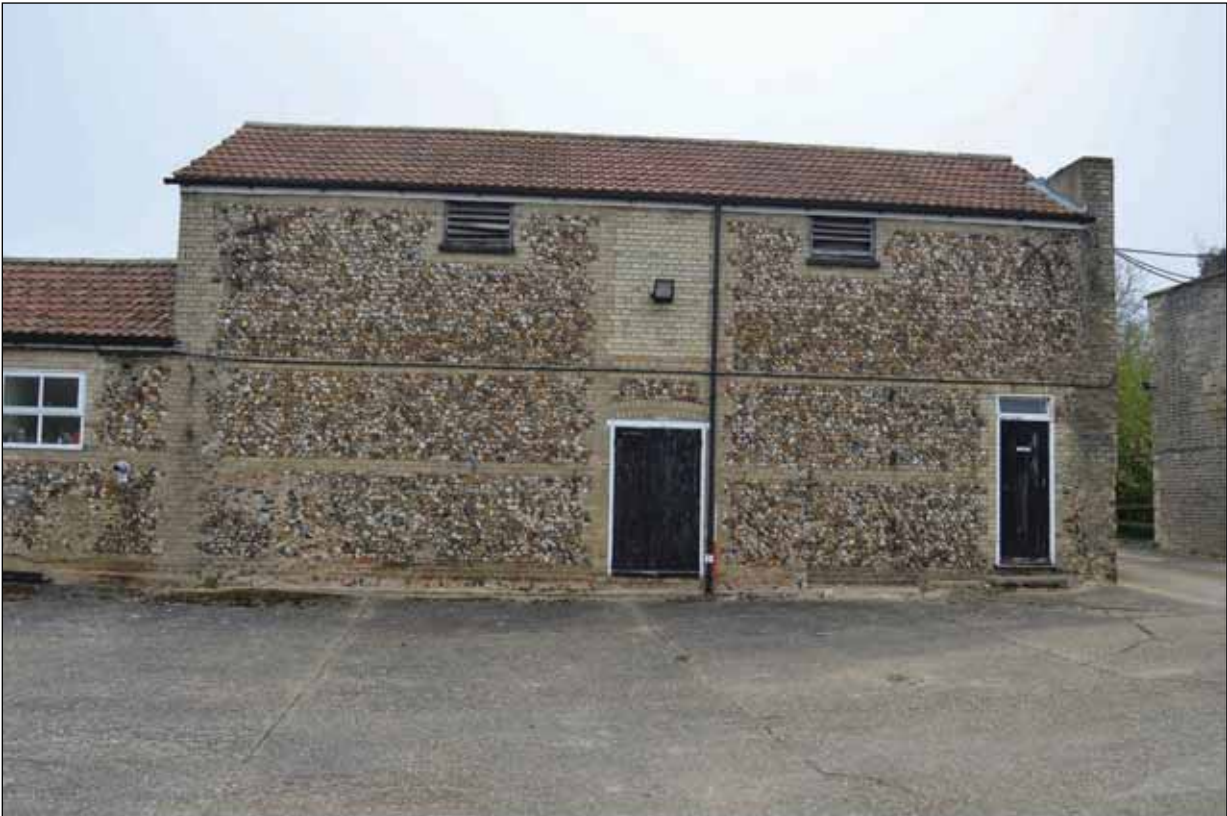
Plate 63: Building 6 - Courtyard view of building viewed from the south-west

- 4.6.2 A single storey extension is attached to the north-west end (Plate 63). This extension would originally have been an open fronted cart barn, as can be seen on aerial photographs dating to the early 1950s (Figs. 6-8).

- 4.6.6 Two small louvre ventilation windows are located at eave height (Plates 63 & 68).
- 4.6.7 Iron wall ties with cross bars are located at either end of the two storey building (Plates 64 & 74).

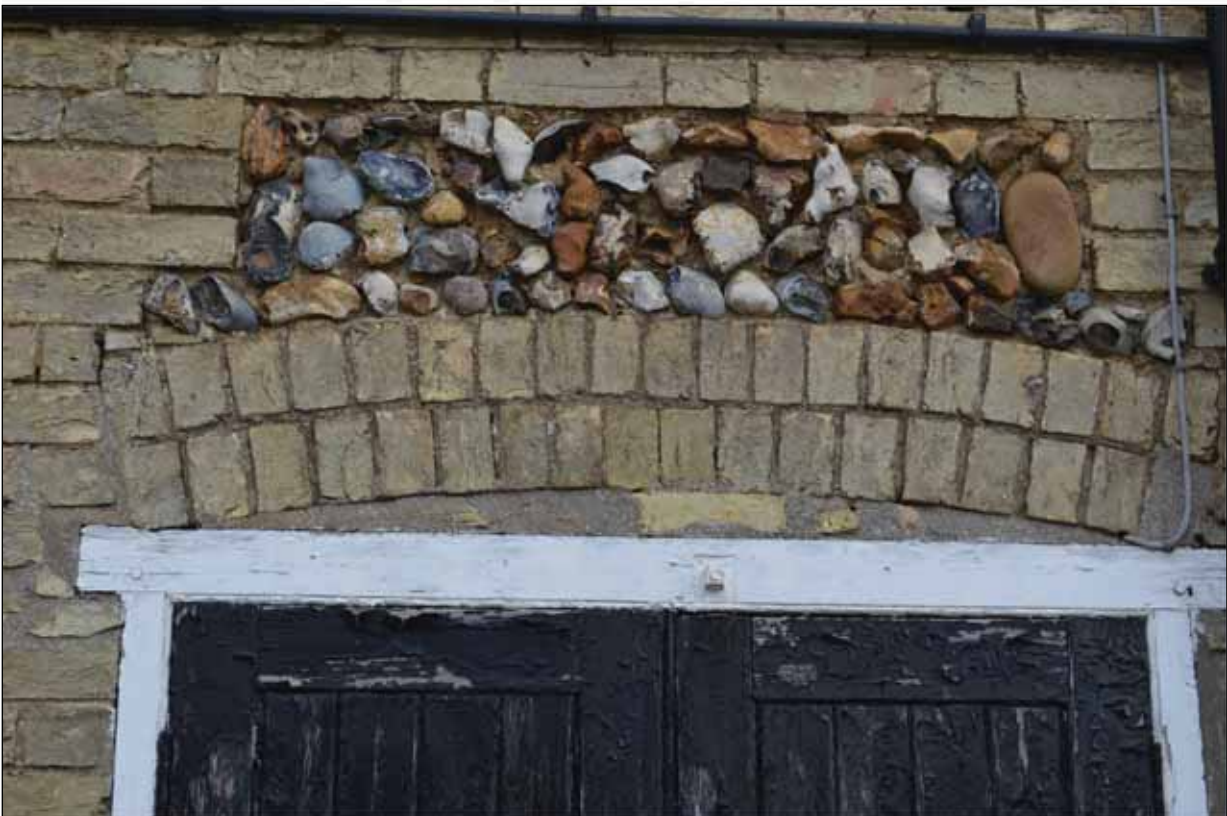
Plate 64: Courtyard view of the eastern end of Building 6 viewed from the south

- 4.6.1 Building 6 is constructed from brick and flint (Plate 64) and located to the north-east side of the courtyard (Fig 2). It comprises a two storey building that historically would have been used as a cart-lodge, with the north-east facing elevation predominantly open-fronted. Subsequently this aspect had been in-filled, between original timbers, with red brick (Plate 74). The gabled roof is covered in clay pantiles.

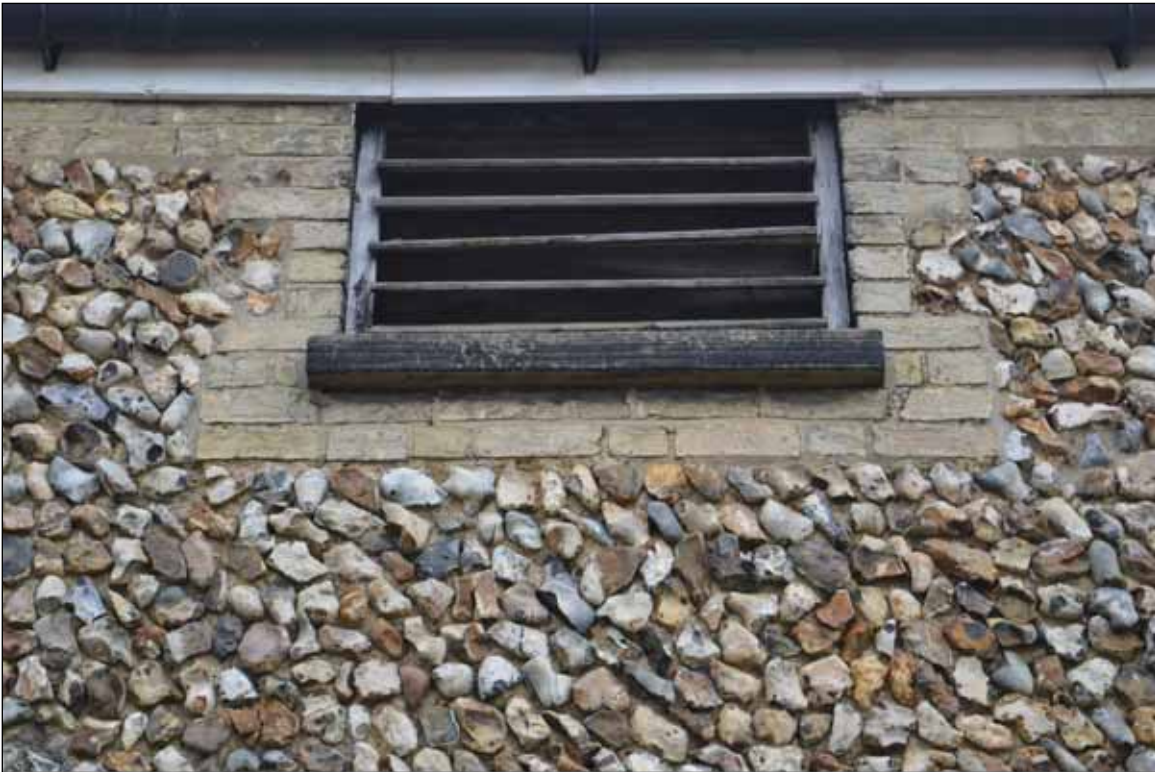
Plate 65: Building 6 - Detail of flint dressing

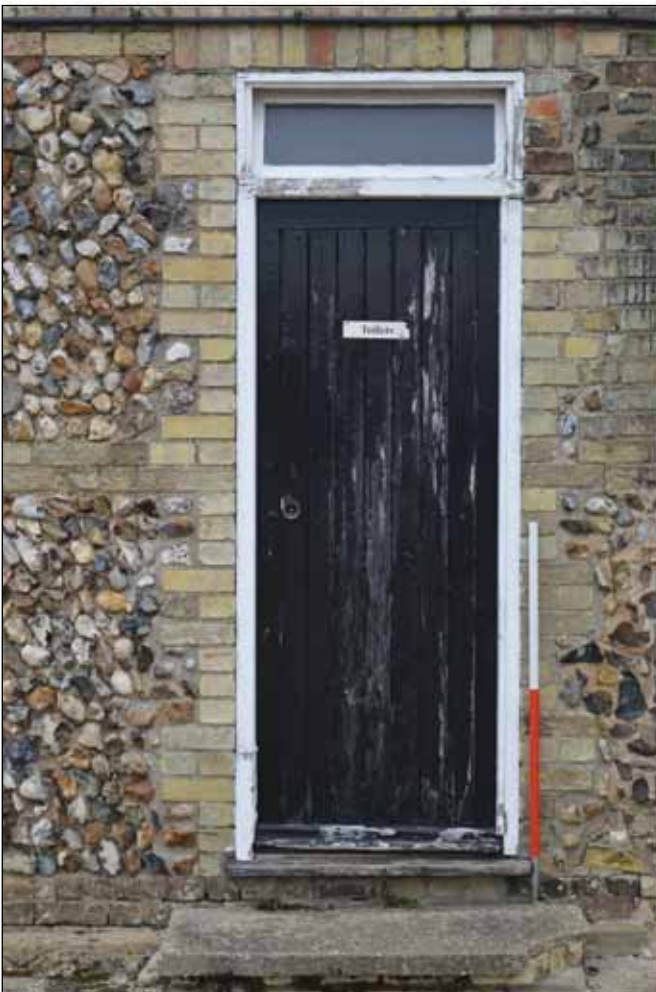
Plate 67: Building 6 - Detail of door to the east end of the building

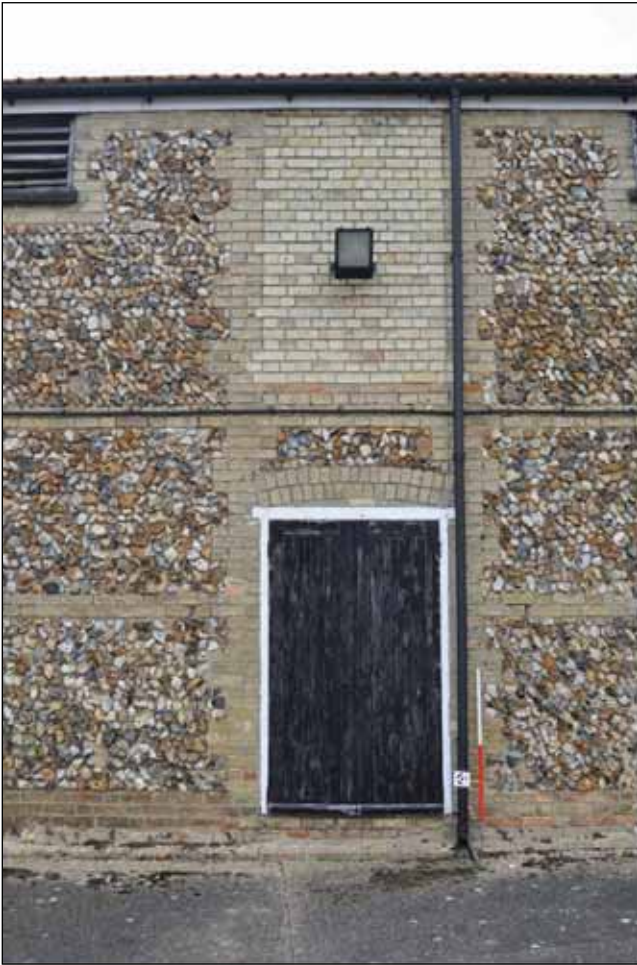
Plate 68: Building 6 - Detail of door viewed from the south-west

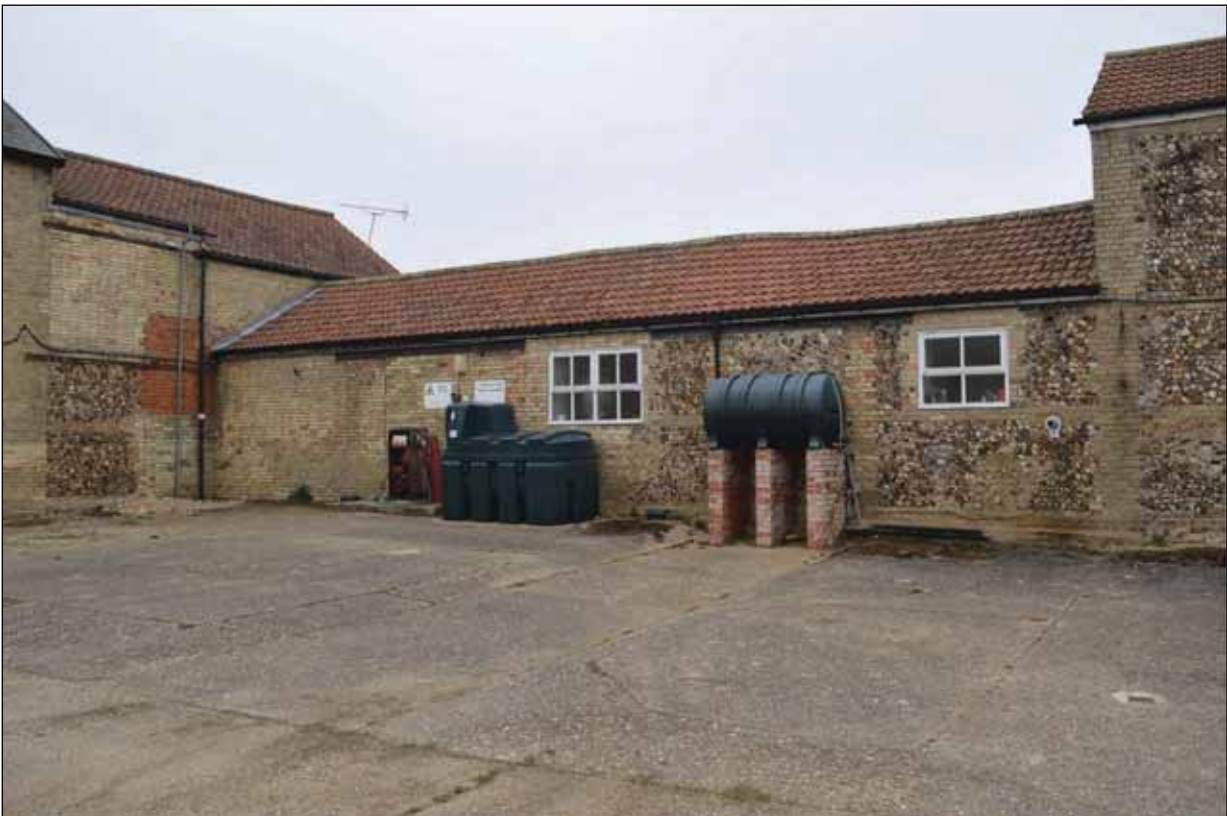
Plate 69: Building 6 - Western end of building showing in-filling viewed from the south

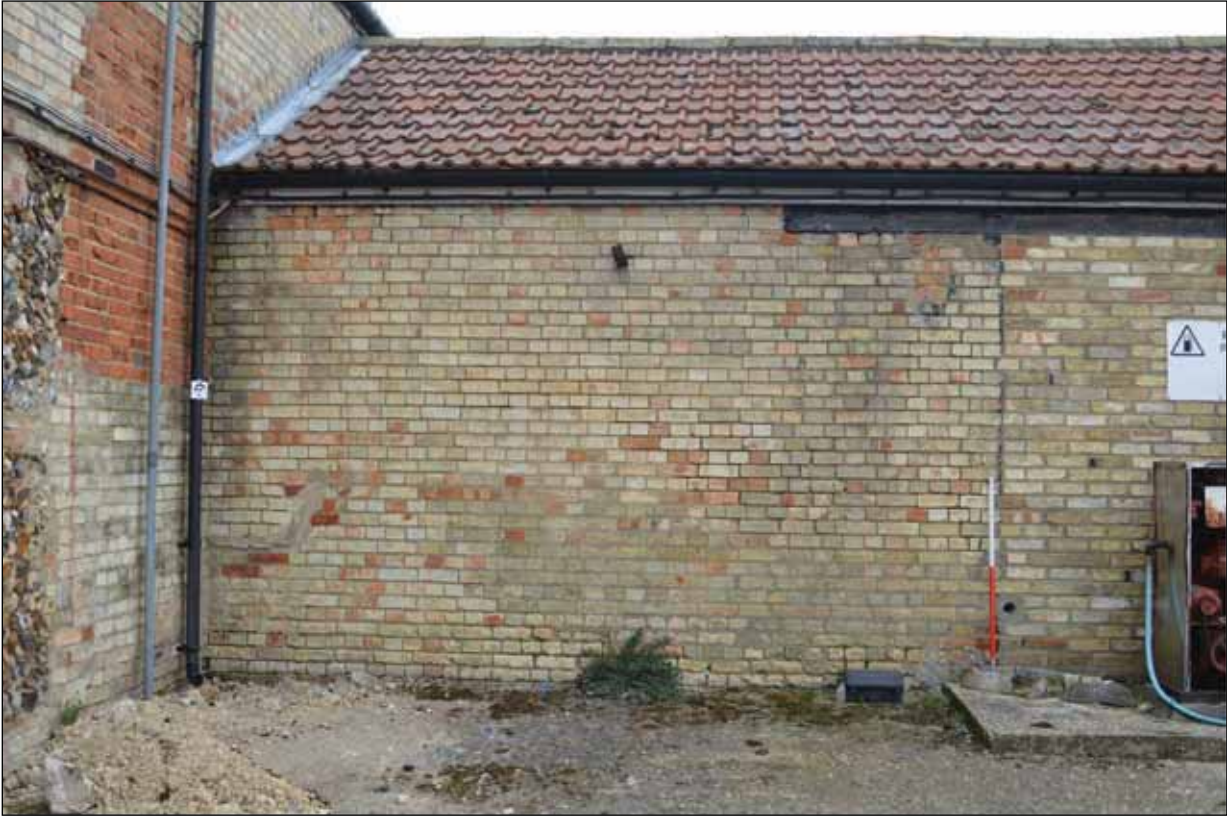
Plate 70: Building 6 - Detail of in-filling

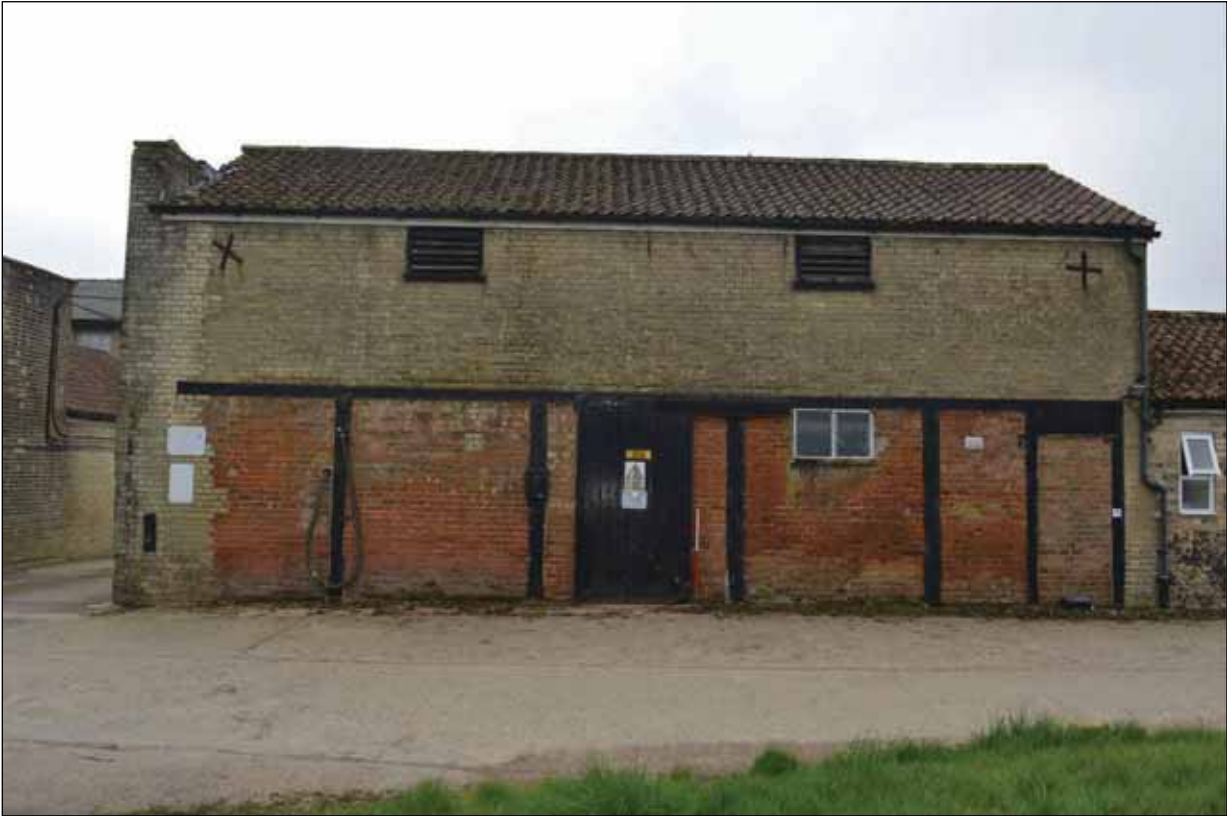
Plate 74: North-east facing elevation of Building 6

- 4.6.11 The floor throughout the building is laid with a modern concrete screed.
- 4.6.12 The roof structure had been replaced with modern rafters and purlins but the original King post roof trusses had been retained (Plate 79). Clay pantiles cover the exterior of the roof (Plate 74).

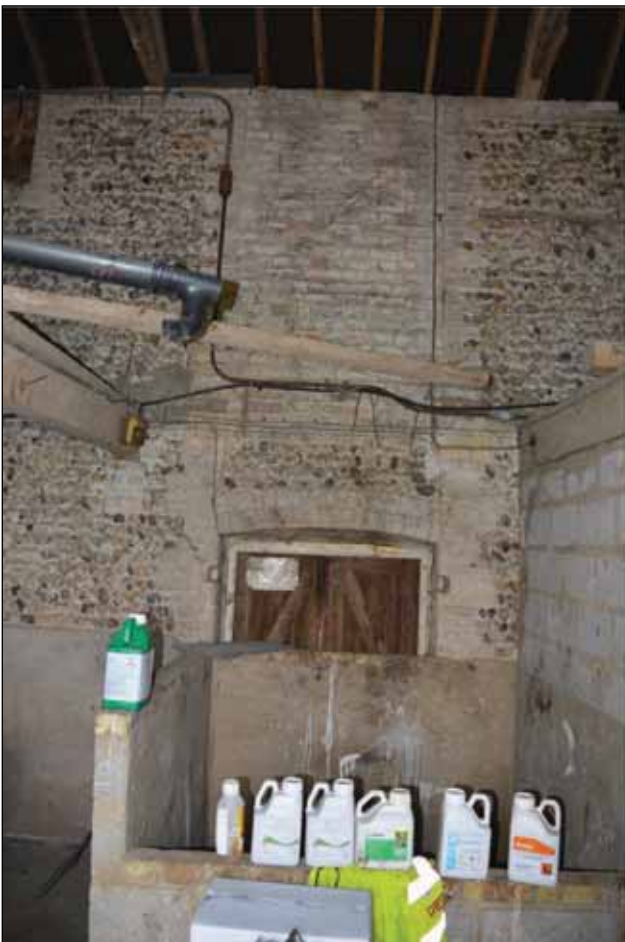
Plate 75: Building 6 - Internal view of the south-west elevation showing detail of blocked door (room a)

- 4.6.9 Internally, the two storey building has little remaining to suggest its former use as a cart-lodge. It does however retain the crossbeam that would have supported the upper floor (Plates 75, 77 & 78).
