Hill House Farm Courtyard, Dullingham

Historic Building Recording

Client: Enterprise Property Group

OA East Report No 2011:
OASIS No: oxfordar3-289203
NGR: TL 6152 5867

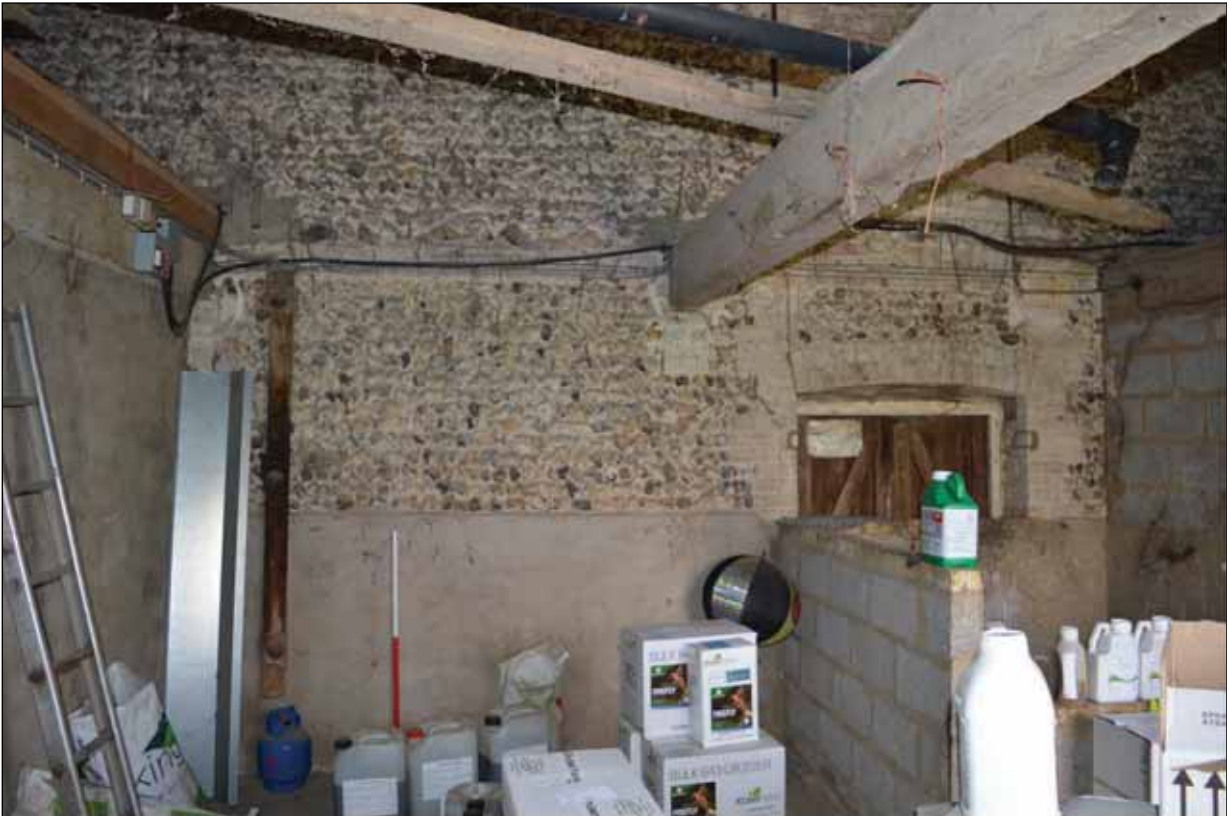
Plate 76: Building 6 - Detail of flint and rendered wall to the south-west elevation

- 4.6.10 The lower ground floor was, at the time of recording, being used for chemical storage and breeze block partitions had been constructed for this purpose. The rear wall has been rendered to a height of 1.35m and the south-east wall to first floor height (Plate 76). The western side of the room was also used for chemical storage and had been plasterboarded to ceiling height (Plates 80 & 81).

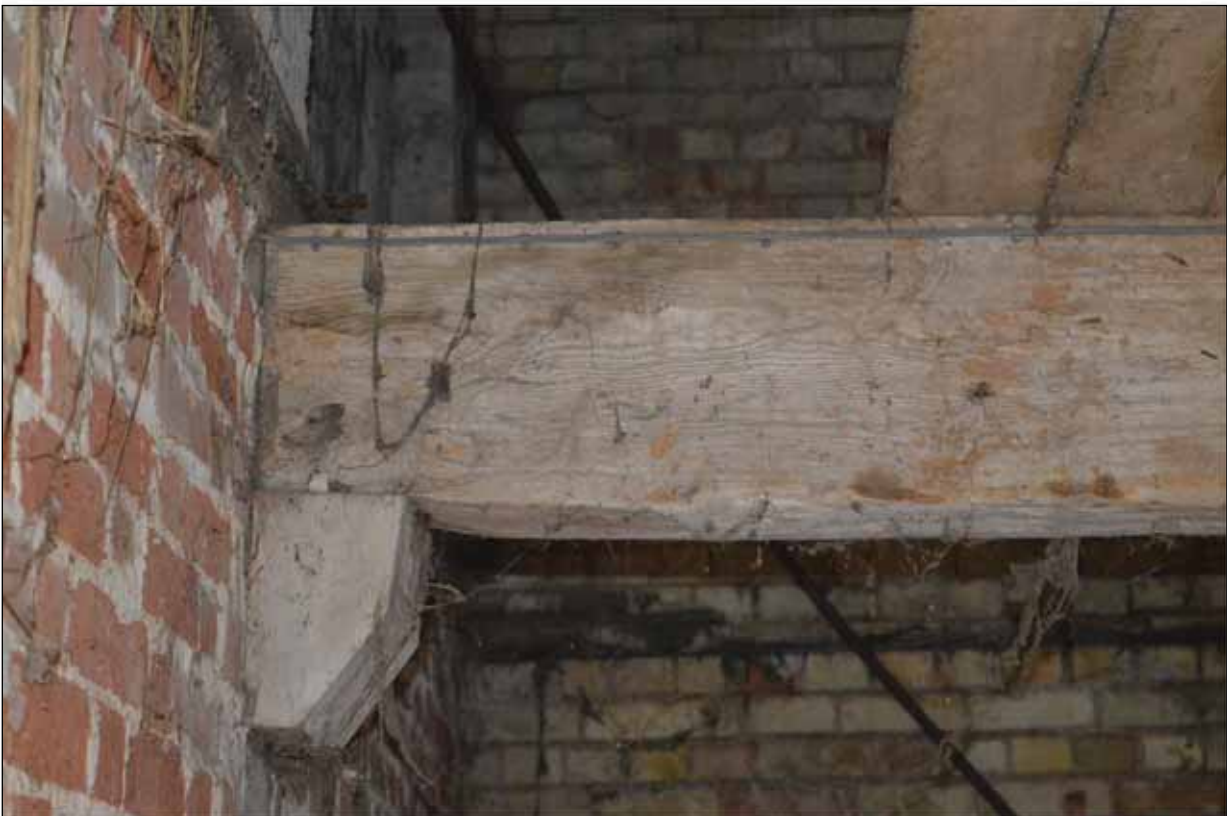
Plate 77: Building 6 - Detail of machine cut beam (room a)

- 4.6.9 Internally, the two storey building has little remaining to suggest its former use as a cart-lodge. It does however retain the crossbeam that would have supported the upper floor (Plates 75, 77 & 78).

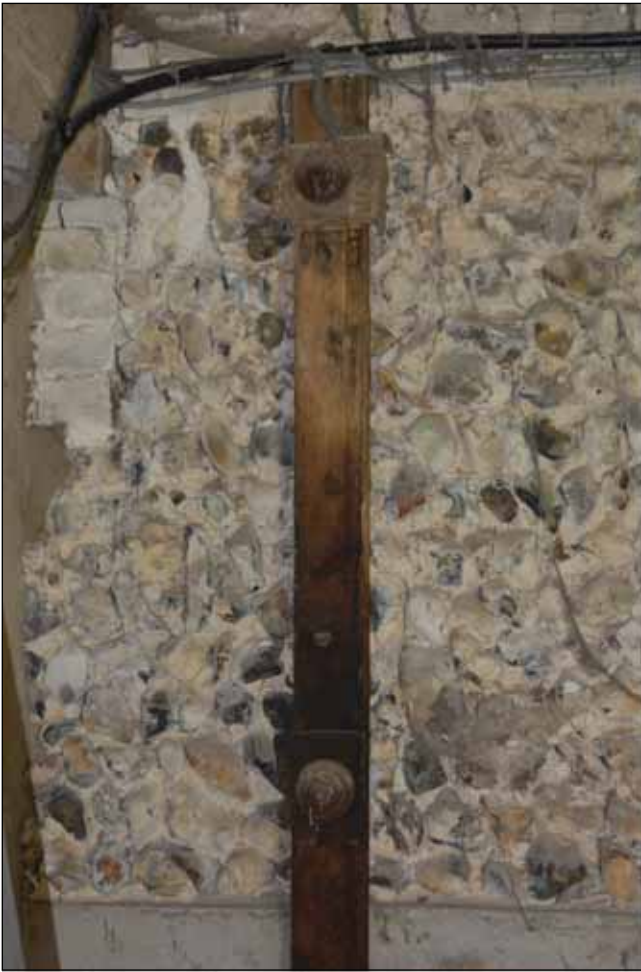
Plate 78: Building 6 - Detail of brace to rear wall (room a)

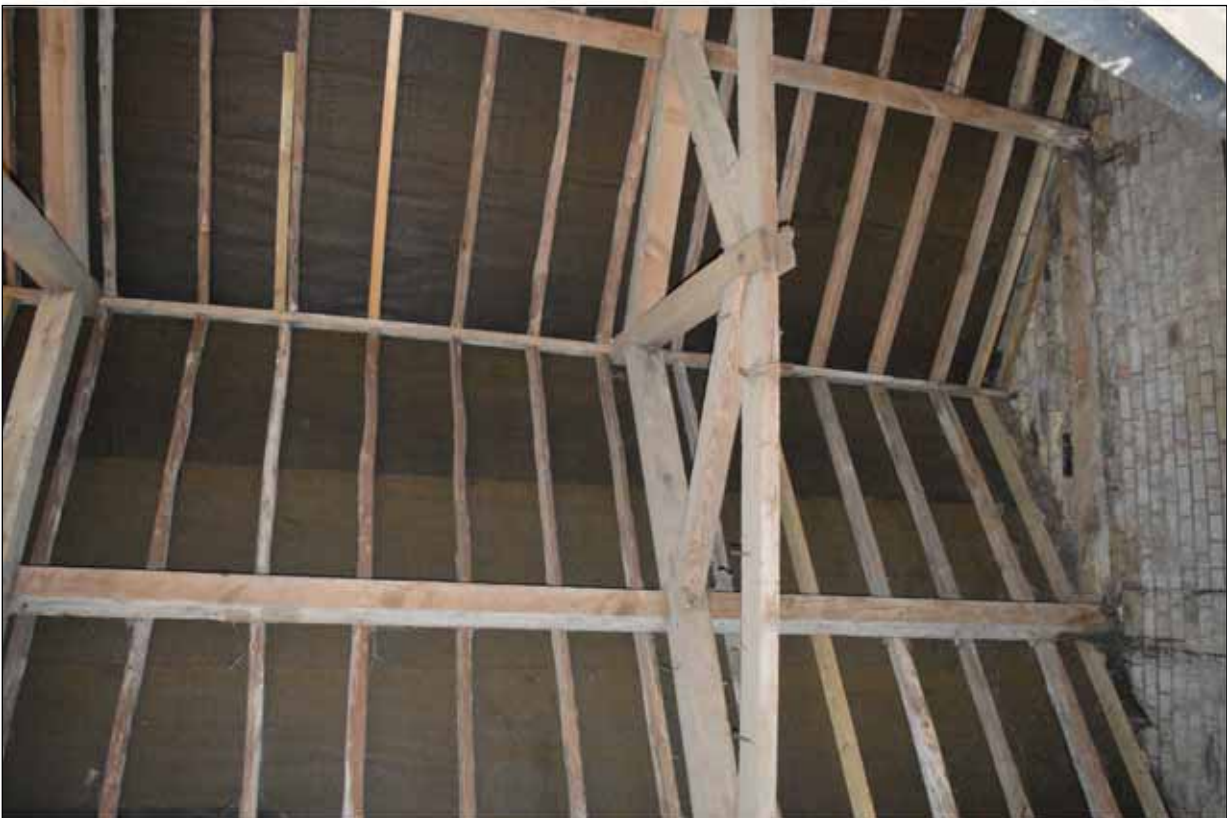
Plate 79: Modern re-roofing to Building 6

- 4.6.11 The floor throughout the building is laid with a modern concrete screed.
- 4.6.12 The roof structure had been replaced with modern rafters and purlins but the original King post roof trusses had been retained (Plate 79). Clay pantiles cover the exterior of the roof (Plate 74).

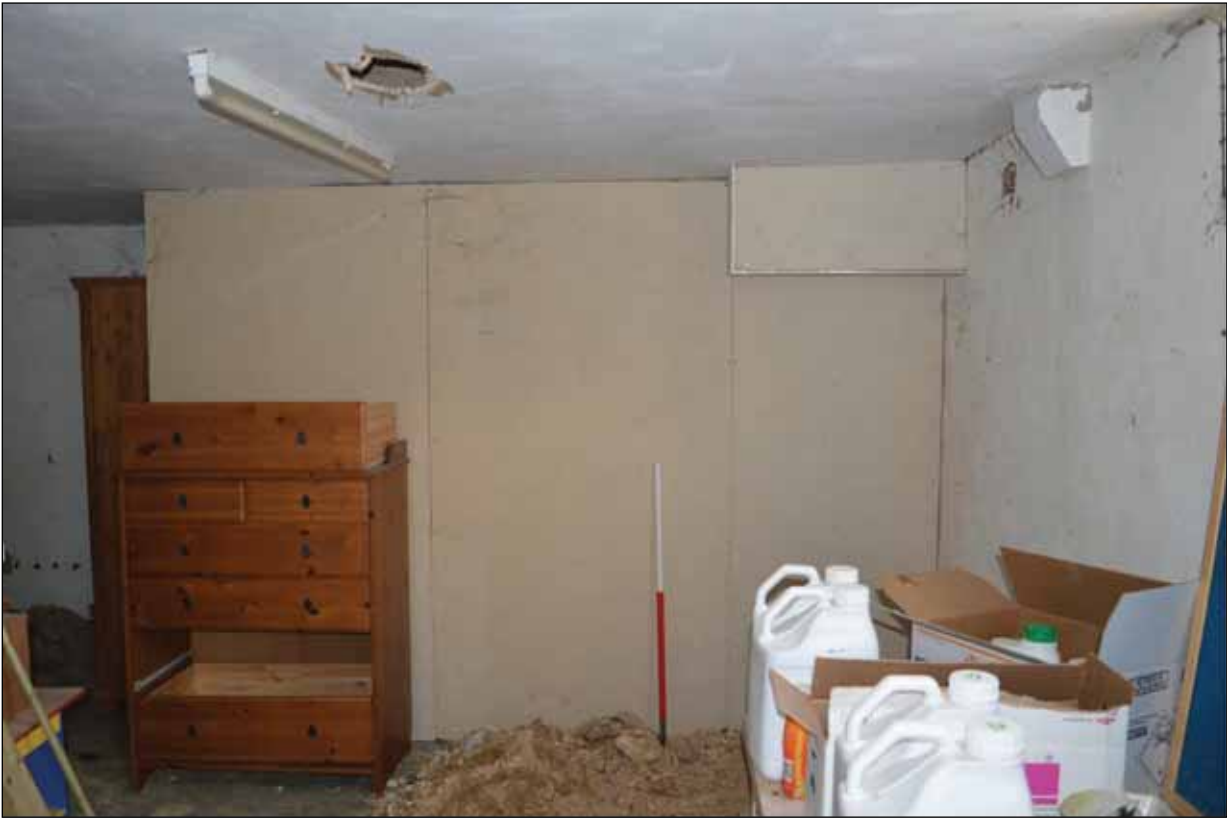
Plate 80: Internal modern stud wall and plaster boarding to Building 6 (room a)

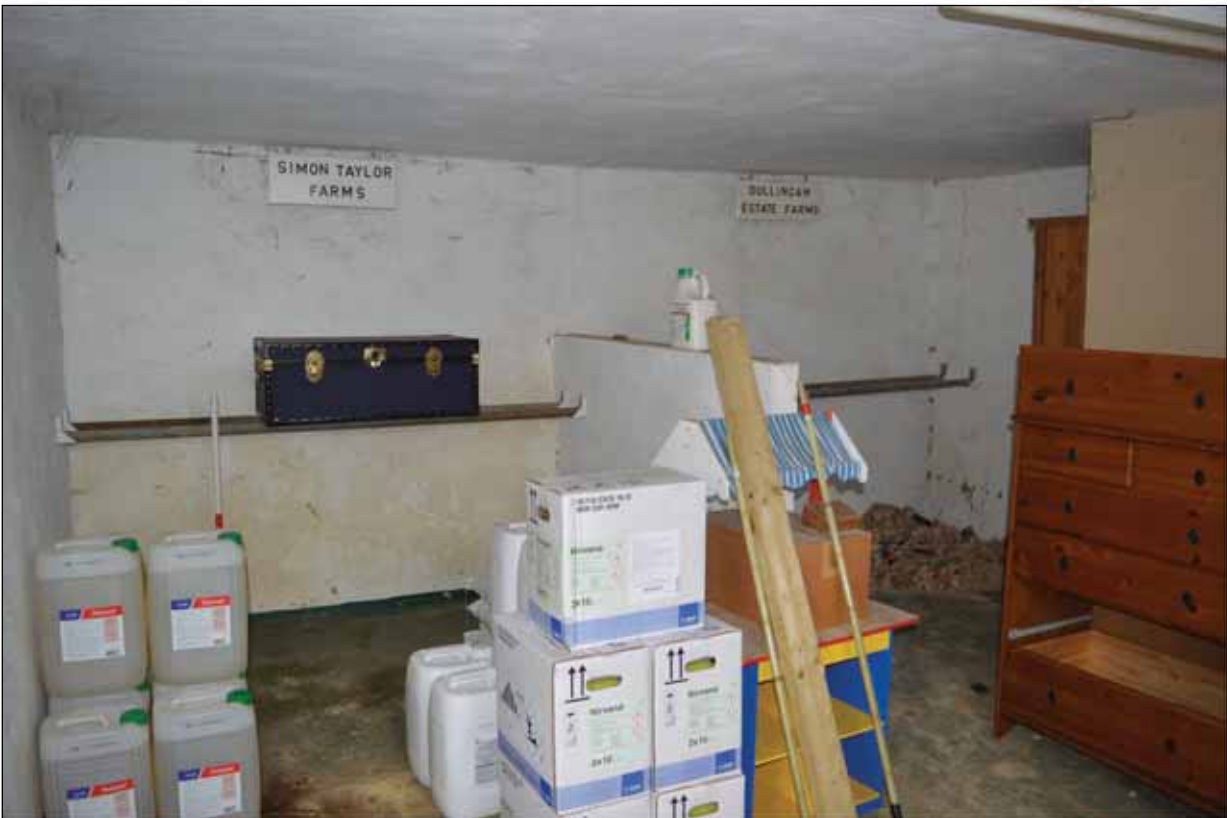
Plate 81: Internal modern stud wall and plaster boarding to Building 6 (rear wall)

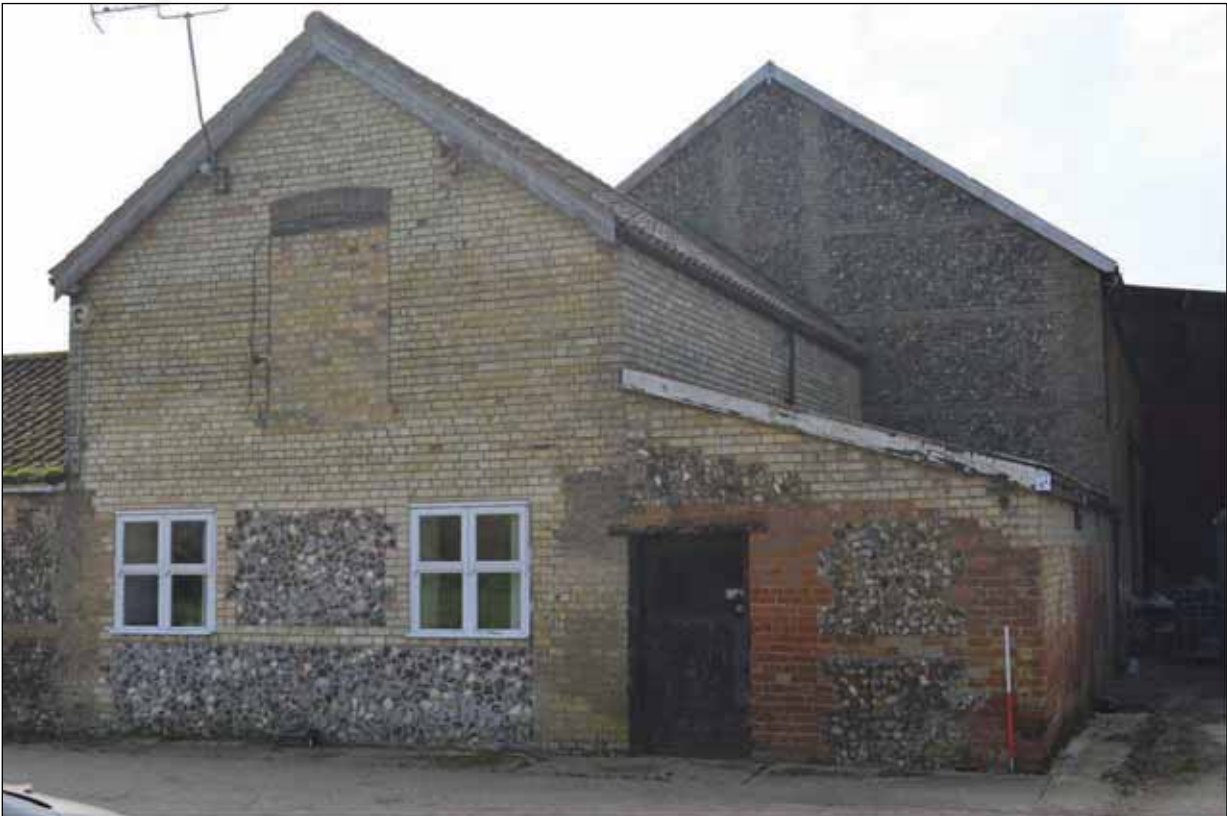
Plate 85: Building 6a viewed from the north-east

- 4.6.14 Externally, the gable roofed two storey building was constructed from brickwork laid in an English bond, and flint. It is 6.91m high at its apex (Plate 85). The roof is covered in clay pan tiles and from ground level looks to have been re-roofed relatively recently.

- 4.6.15 An upper floor doorway has been blocked and on the lower floor two modern casement windows have been inserted (Plate 85). The inside of the building was not accessible at the time of recording.

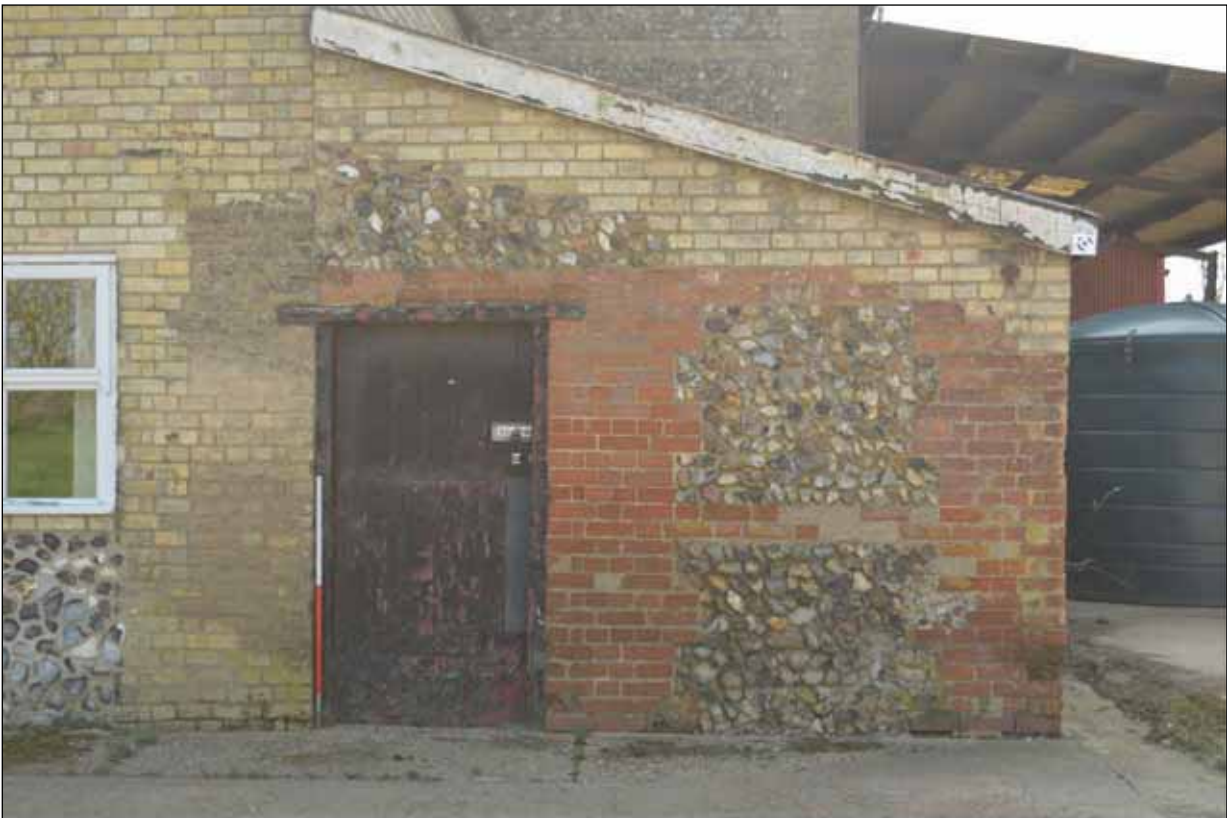
Plate 86: Extension to the north-west end of Building 6a

- 4.7.2 This building measures 10.82m x 3.25m and has a height of 3.54m. A single wooden door measuring 1.9m x 1m is located on the north-east elevation (Plates 86 & 90). A further door, located at the far end of the north-west elevation had been blocked with brick (Plates 88 & 89). This north-west elevation was constructed entirely from brick, that had undergone numerous phases of repair. Coursing consists of Flemish and English bond but the upper five courses consists entirely of common bond (Plate 87).

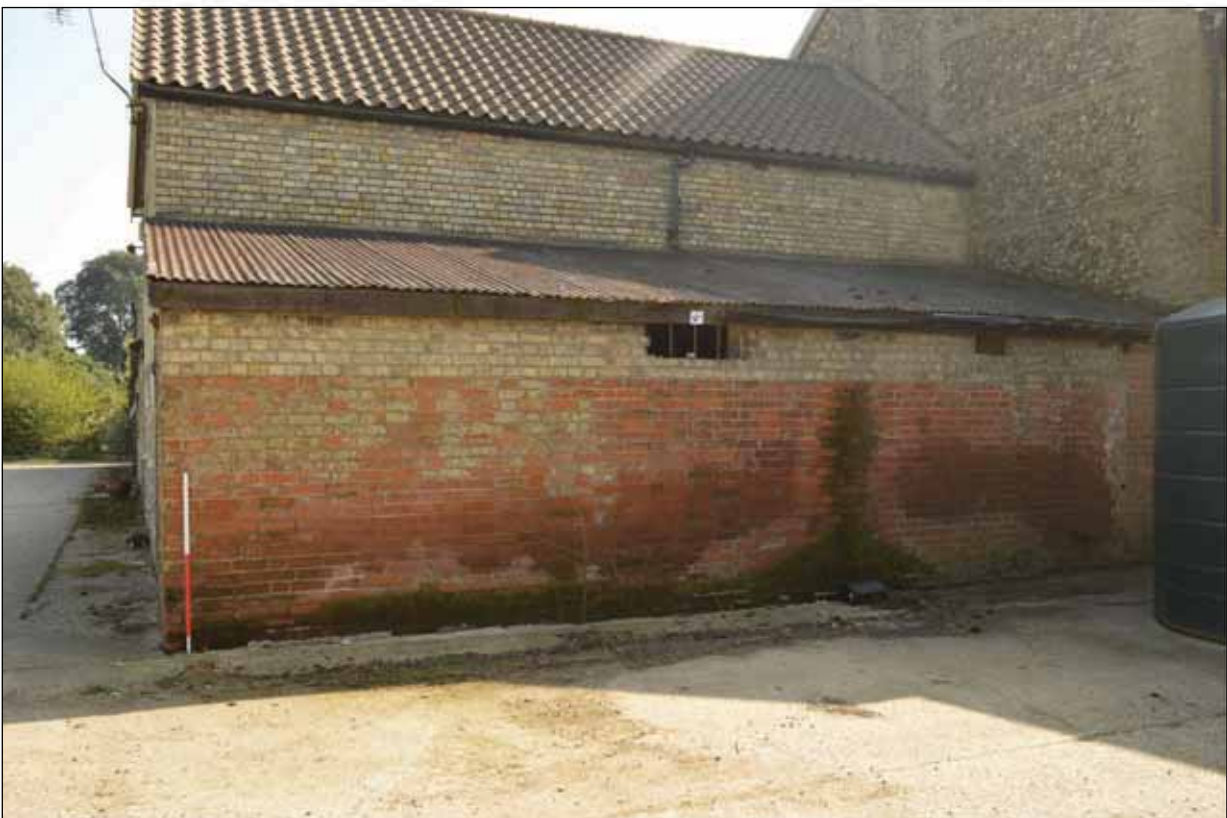
Plate 87: Extension to the north-west end of Building 6a viewed from the north-west

- 4.7.3 No attempt has been made to tie this structure into Building 8 (Plate 89) which indicates that the north-west elevation had been added after the initial phase of construction. The roof is covered by corrugated tin (Plate 87).

- 4.7.5 Two small, barred ventilation openings measuring 1.6m x 0.5m are located at eve height on the north-west wall (Plates 87 & 91).
- 4.7.6 The original external wall of the two storey building and the far north-west end of the range of buildings is now located within the lean-to. It is constructed from flint and brickwork with patches of repair visible along the length of the wall; these are likely to post-date the addition of the lean-to (Plates 92 & 93).

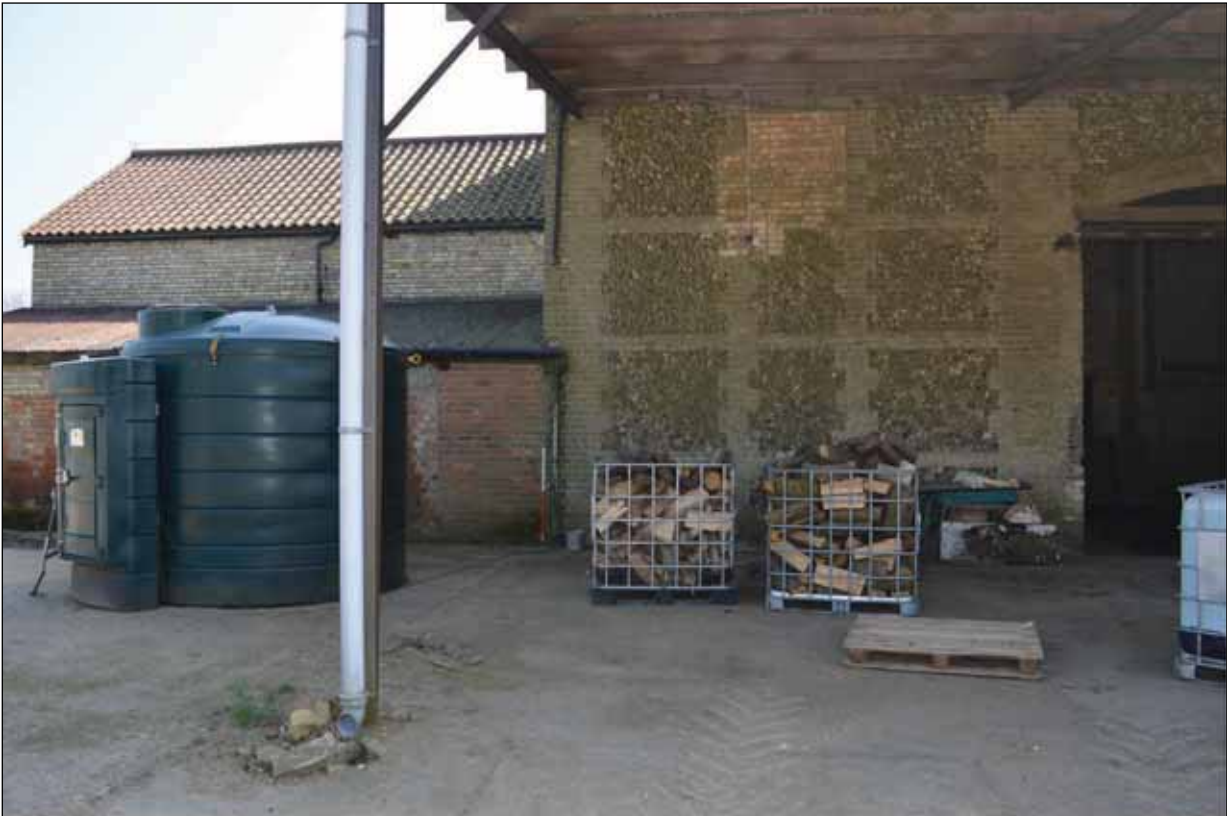
Plate 88: Building 6a - Blocked doorway to north west end of extension viewed from the north-west

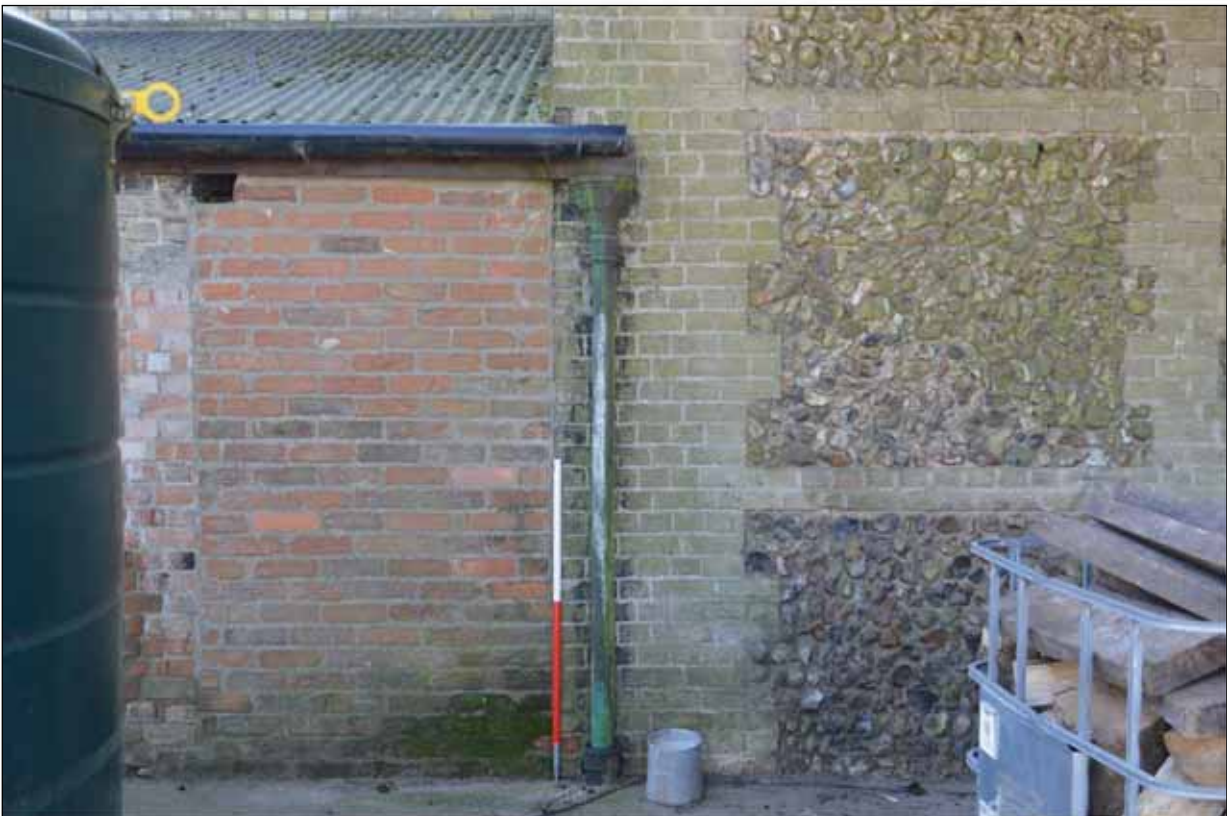
Plate 89: Building 6a - Detail of blocked door

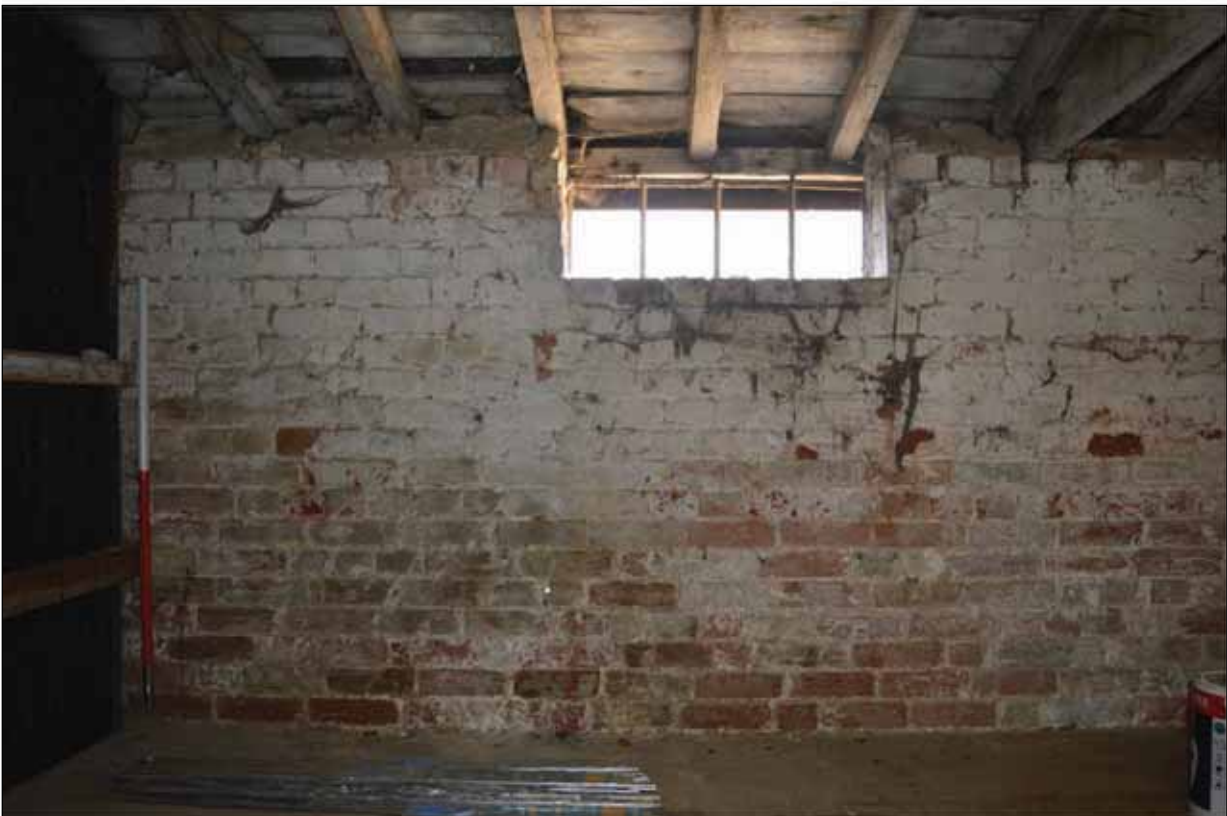
Plate 91: Building 6a - Internal view of window and brick wall to north-west elevation

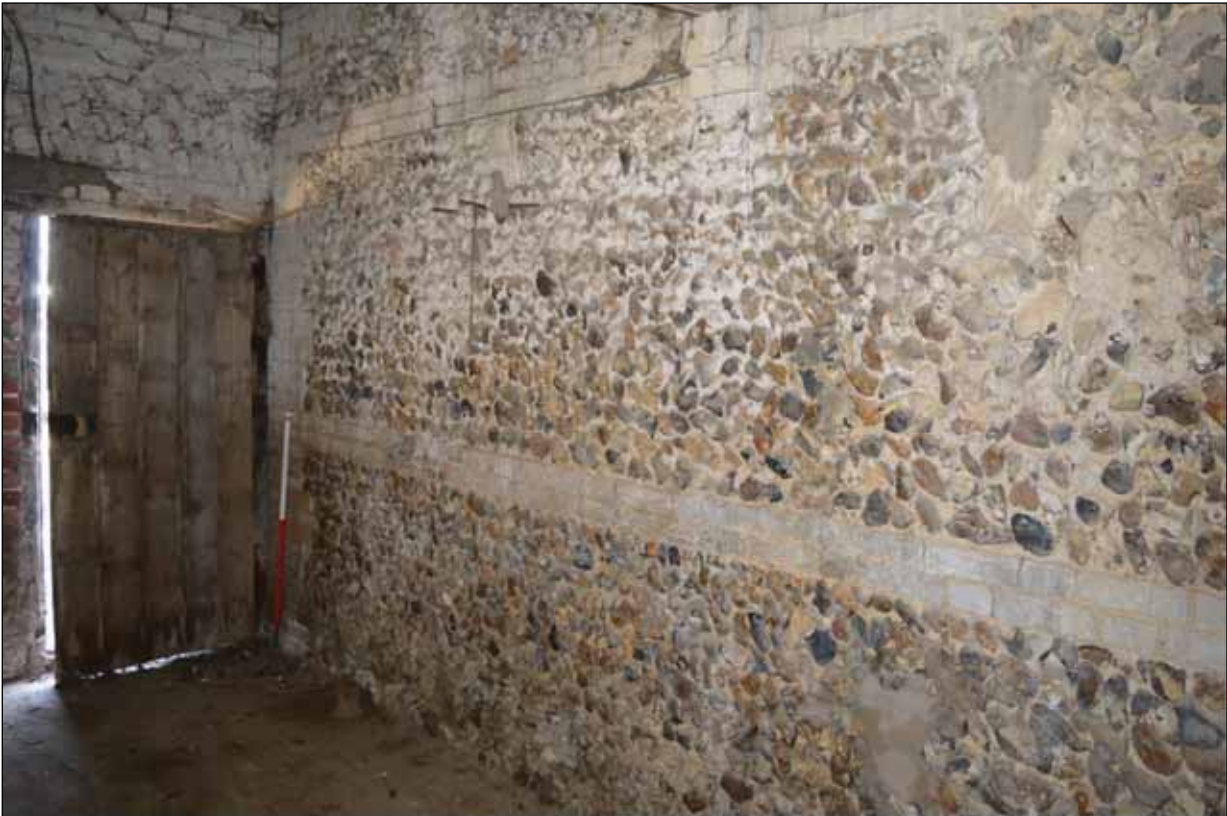
Plate 92: External wall of Building 6 viewed internally from Building 6a

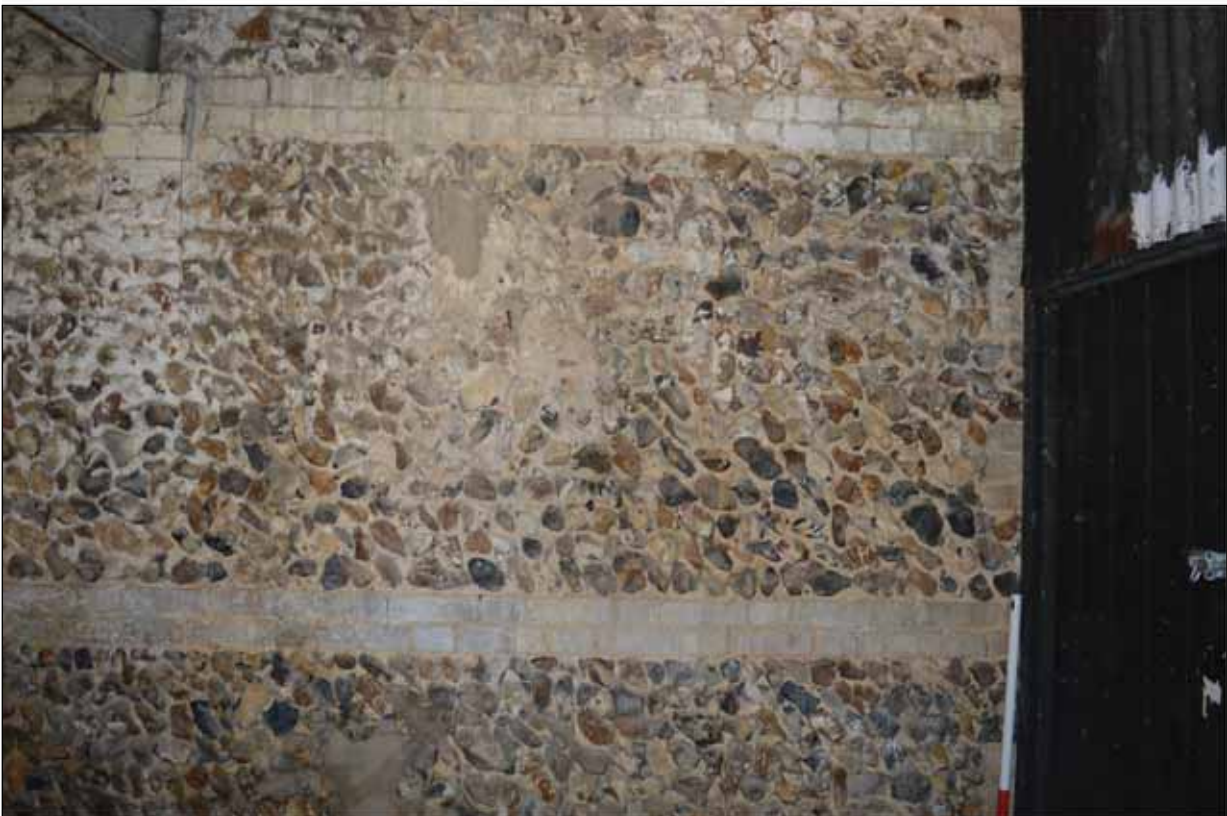
Plate 93: Detail of flint with brick lacing to the external wall of Building 6a

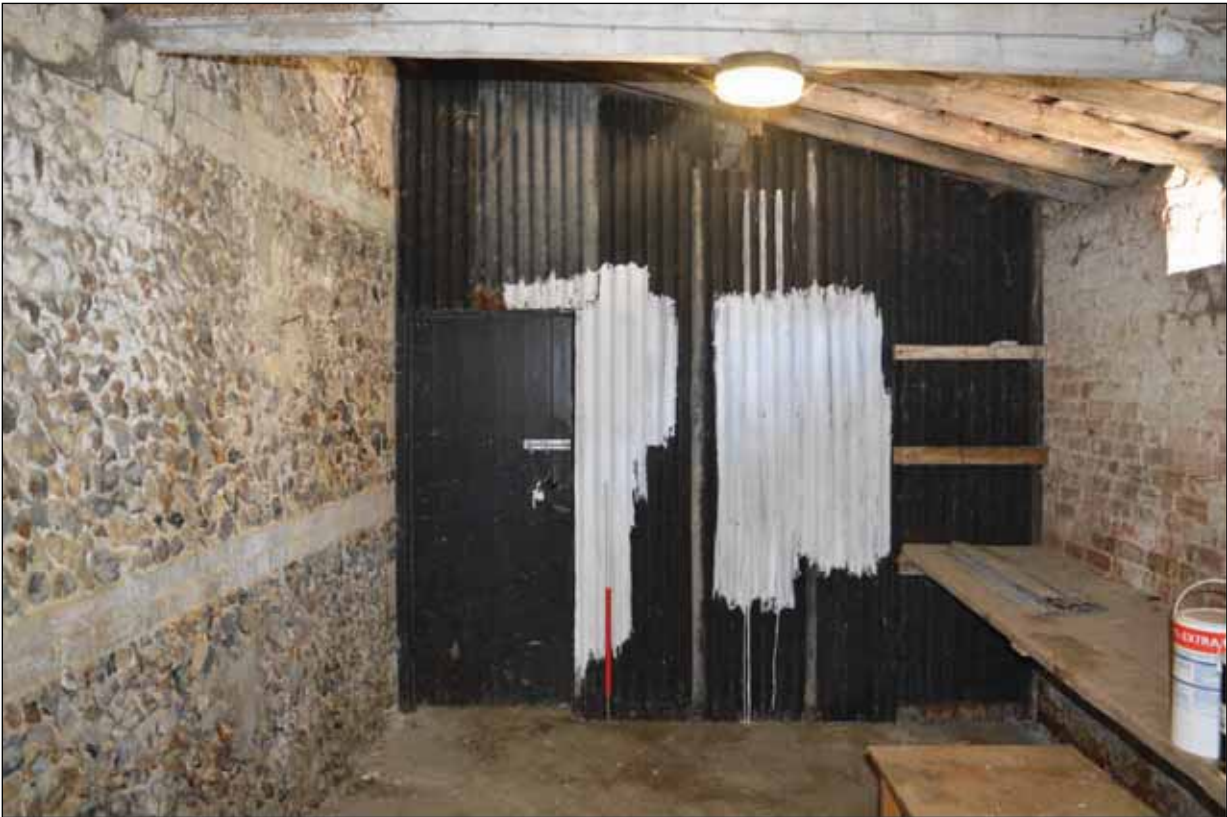
Plate 94: Corrugated wall and wooden door internally to Building 6a

- 4.7.4 Internally, the lean-to is divided into two rooms by a tin partition (Plate 94). Access is afforded by a wooden door situated on the left hand side of the lean-to (Plates 94 & 95).

- 4.7.7 Beyond the corrugated tin partition (Plate 94 & 96) the wall is constructed entirely from brick with rendering to a height of 1.2m and a blocked arch set into it (Plates 98-100). The arch is of brick construction and possibly led into the courtyard. Above this feature, floating brick piers have been added to take the load of the existing lean-to roof structure (Plates 98 & 99). A further pier has been built into the end wall of the structure (plate 97), which also formed the north-east elevation of Building 8.

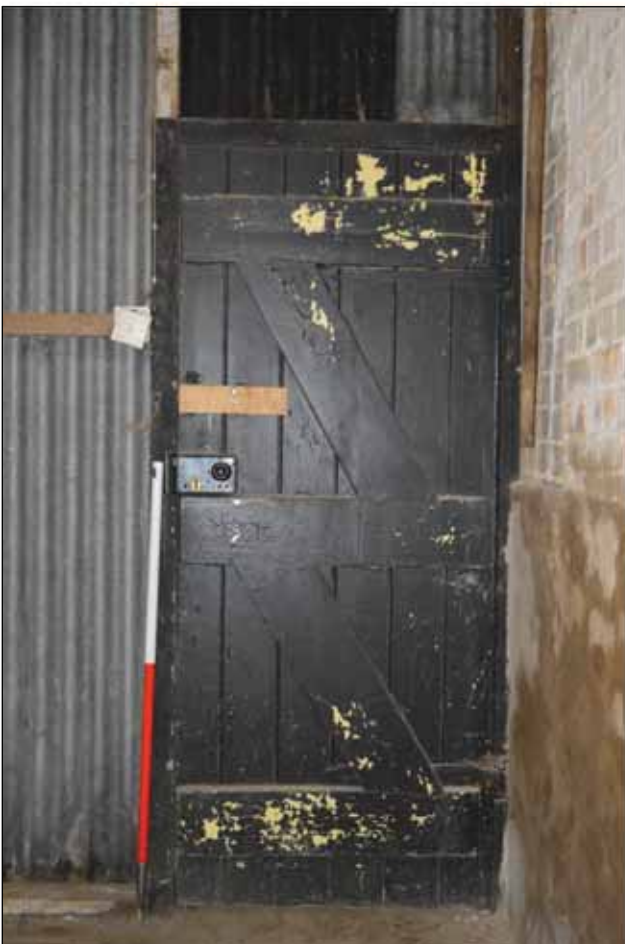
Plate 95: Building 6a - Detail of wooden door viewed from the south-west

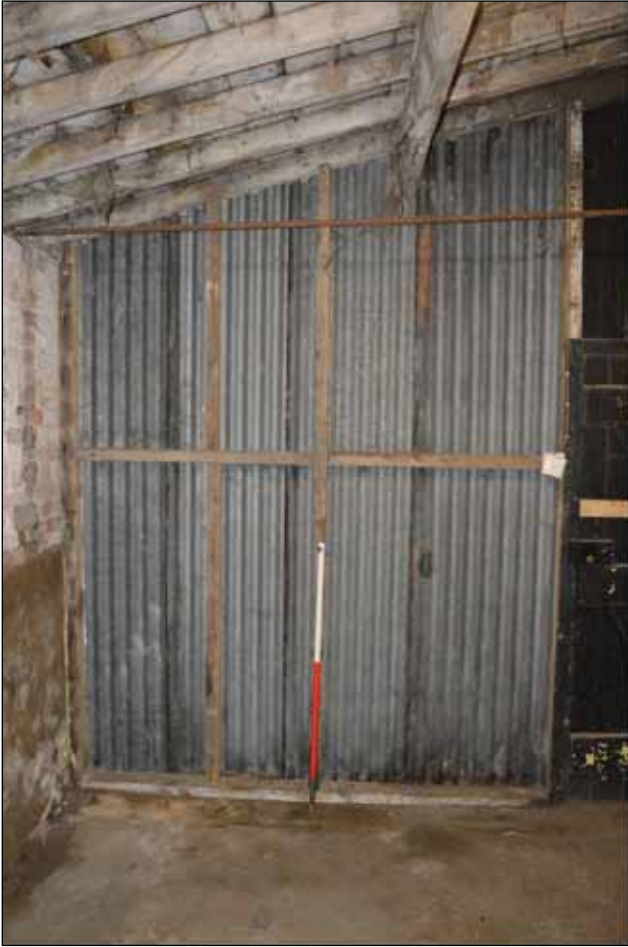
Plate 96: Detail of corrugated tin partition to Building 6a viewed from the south-west

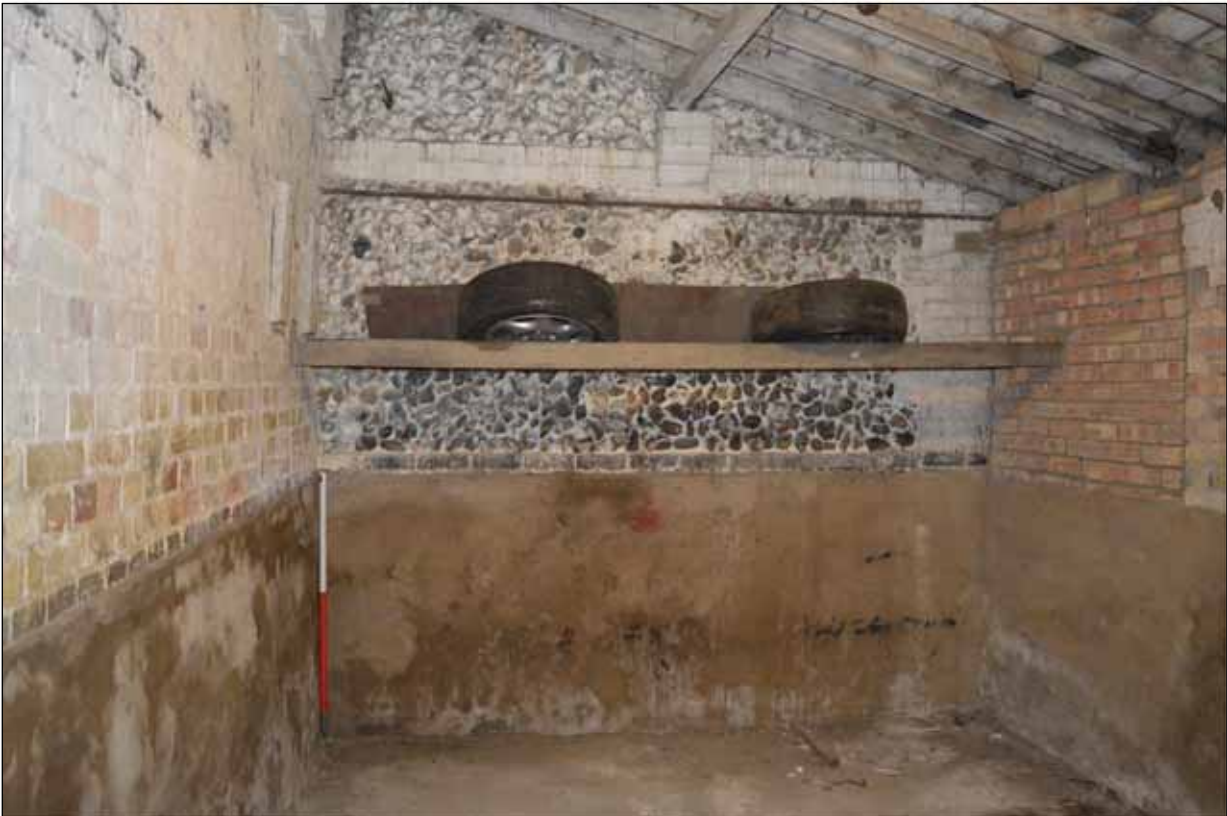
Plate 97: South-west wall of Building 6a

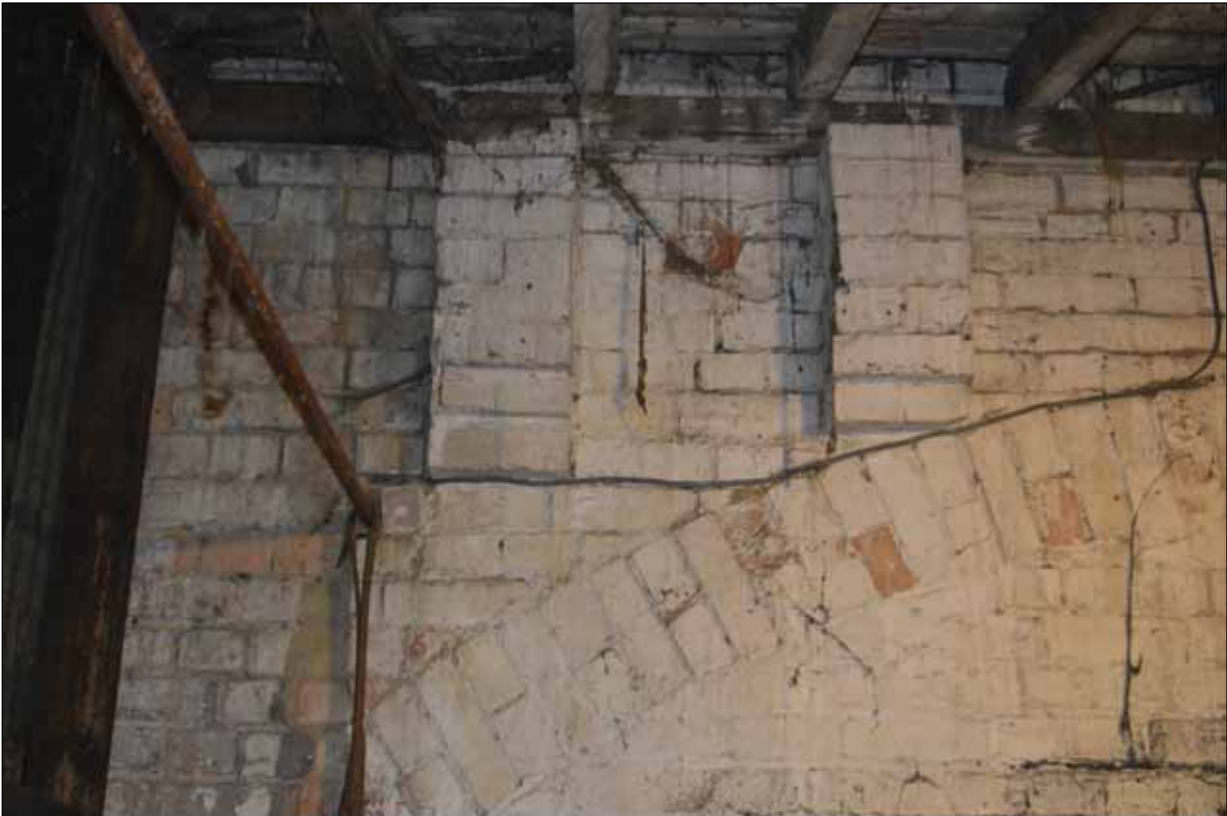
Plate 98: Detail of brick supports above blocked arch to the south-east wall of Building 6a

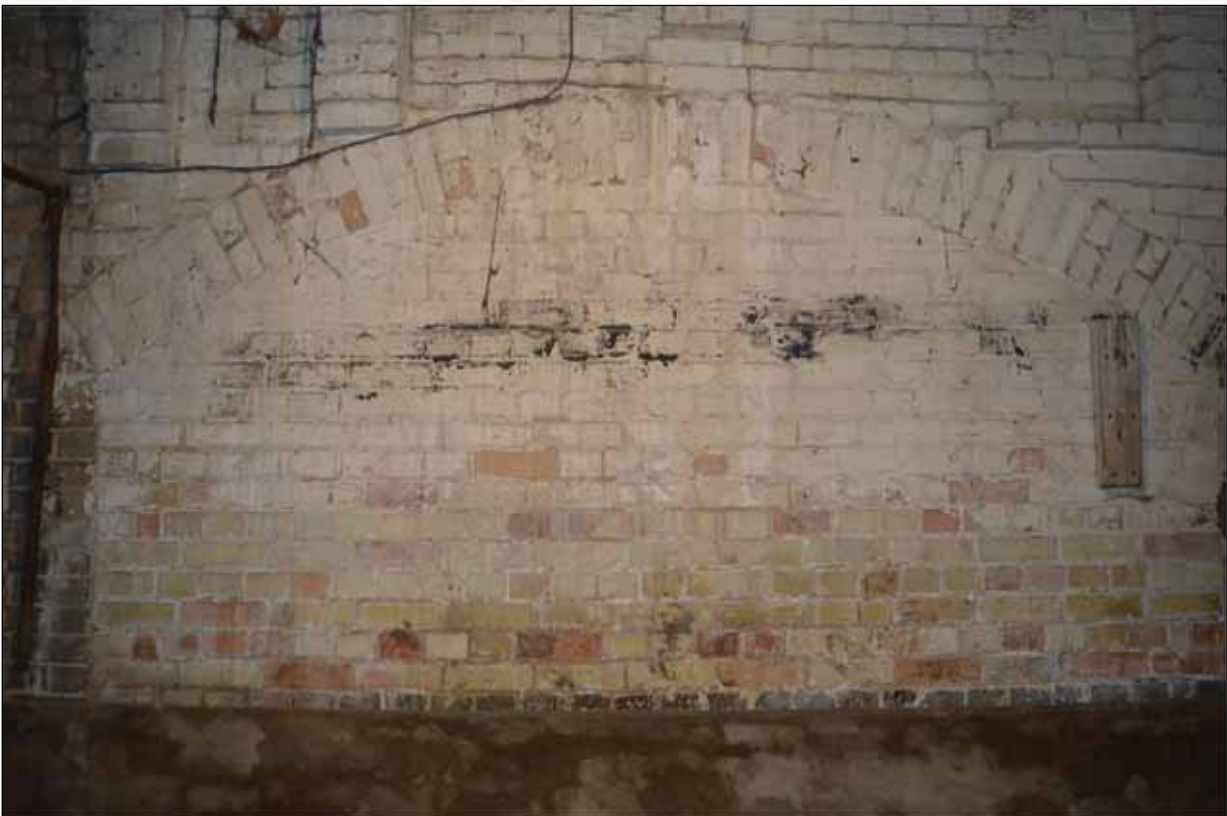
Plate 99: Blocked arch to the south-east wall of Building 6a

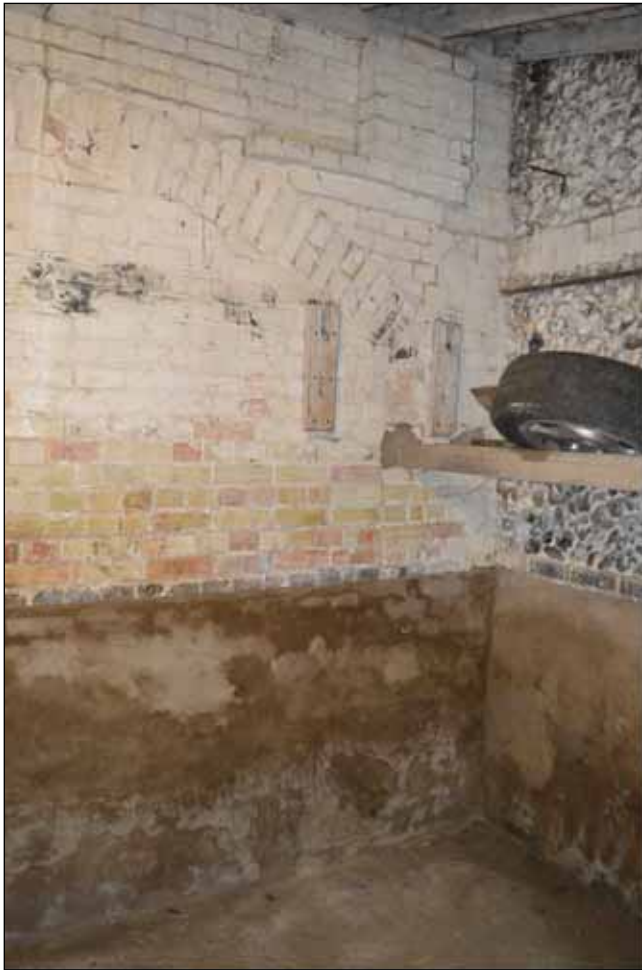
Plate 100: Rendering, brick and flintwork internally to Building 6a

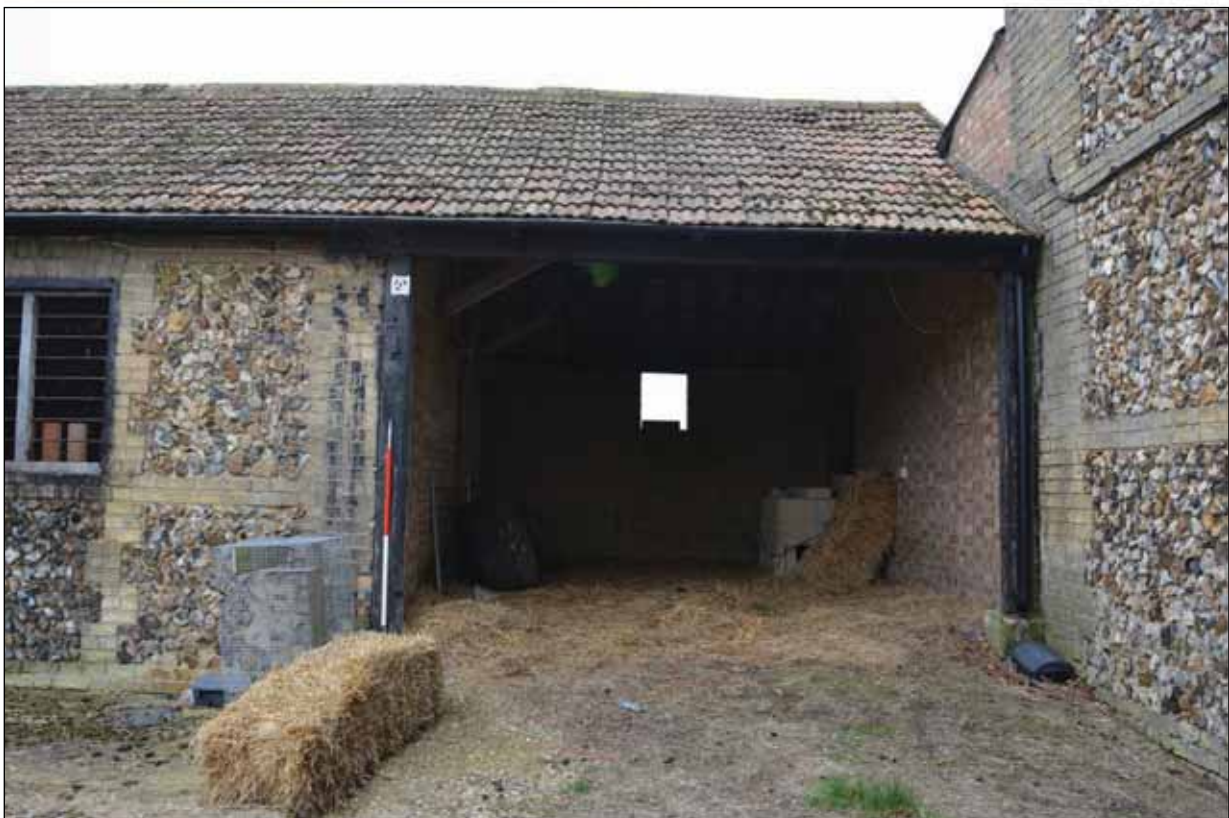
Plate 101: Courtyard view of Building 7 viewed from the north-east

- 4.8.1 Building 7, an open fronted shed (Plate 101) measuring 3m x 5.3 and with a ridge height of 3.1m, is located at the far south-west corner of the courtyard (Fig 2). It post-dated the buildings to either side and its location was most likely the historical access point to the livestock pens and to the south-western fields beyond. Evidence for this could be seen by the common roof structure (Plate 101) shared with Building 4 and the relatively recent addition of a rear brick wall, constructed from fletton type bricks that were obviously from a later phase (Plate 104).
- 4.8.2 Photographic sources show that the piggery to the rear of the buildings still existed until at least the mid 1950s (Fig. 6). It is assumed that the rear wall of the building would have been constructed after the piggery went out of use and access was no longer needed.

- 4.8.3 A wooden door, measuring 1.9m x 1.2m, on the south-east wall leads to Building 4 (Plate 103). A second door on this wall has been bricked up (Plate 106). A further doorway has been cut into the north-east wall of the building (Plate 104). This was installed after the blocking-in of the rear wall, which was a modern addition constructed to help form a lean-to workshop attached to the rear of Building 8 (Plate 132).
- 4.8.4 The floor consists of modern concrete and the roof structure, although pre-dating the formation of the building, is constructed from machine cut timbers (Plate 107). The roof is covered by clay pan tiles (Plate 101).
