Hill House Farm Courtyard, Dullingham

Historic Building Recording

Client: Enterprise Property Group

OA East Report No 2011:
OASIS No: oxfordar3-289203
NGR: TL 6152 5867

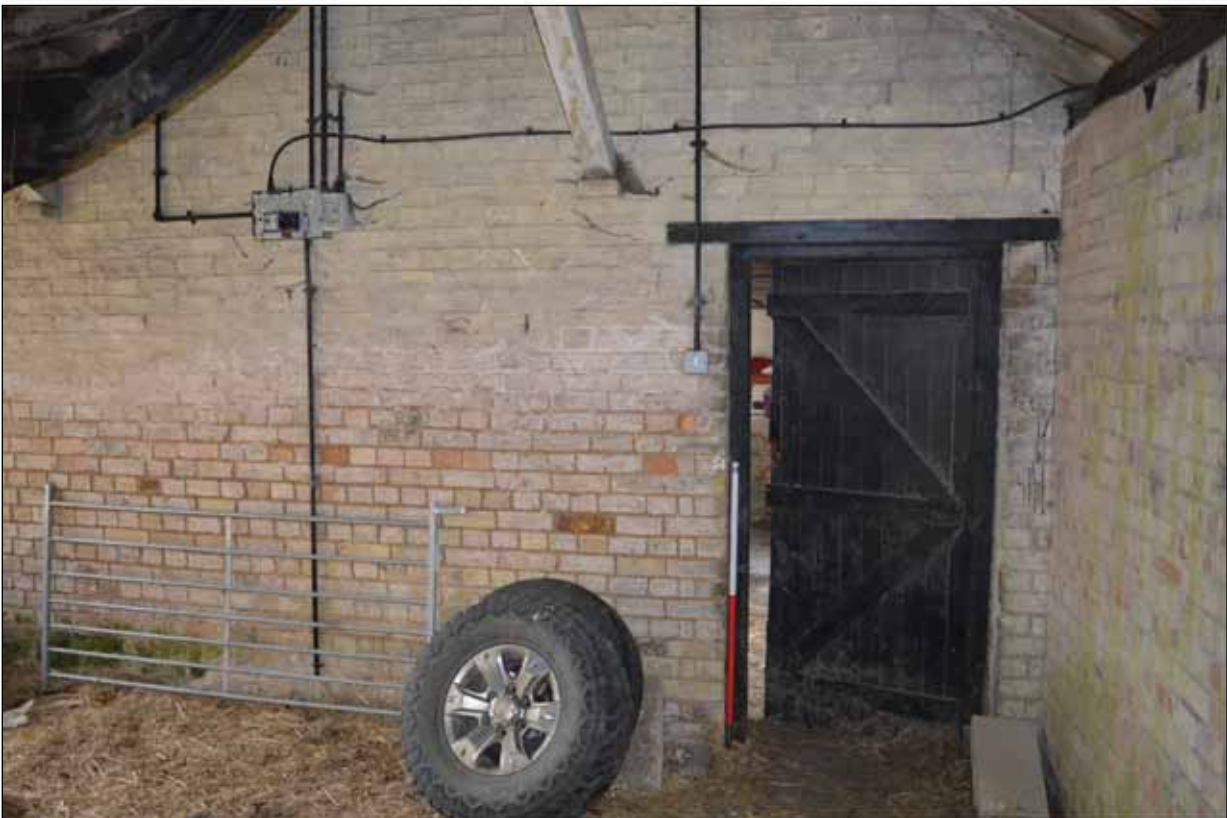
Plate 103: Door to Building 4 from Building 7 viewed from the north-west

- 4.8.3 A wooden door, measuring 1.9m x 1.2m, on the south-east wall leads to Building 4 (Plate 103). A second door on this wall has been bricked up (Plate 106). A further doorway has been cut into the north-east wall of the building (Plate 104). This was installed after the blocking-in of the rear wall, which was a modern addition constructed to help form a lean-to workshop attached to the rear of Building 8 (Plate 132).
- 4.8.4 The floor consists of modern concrete and the roof structure, although pre-dating the formation of the building, is constructed from machine cut timbers (Plate 107). The roof is covered by clay pan tiles (Plate 101).

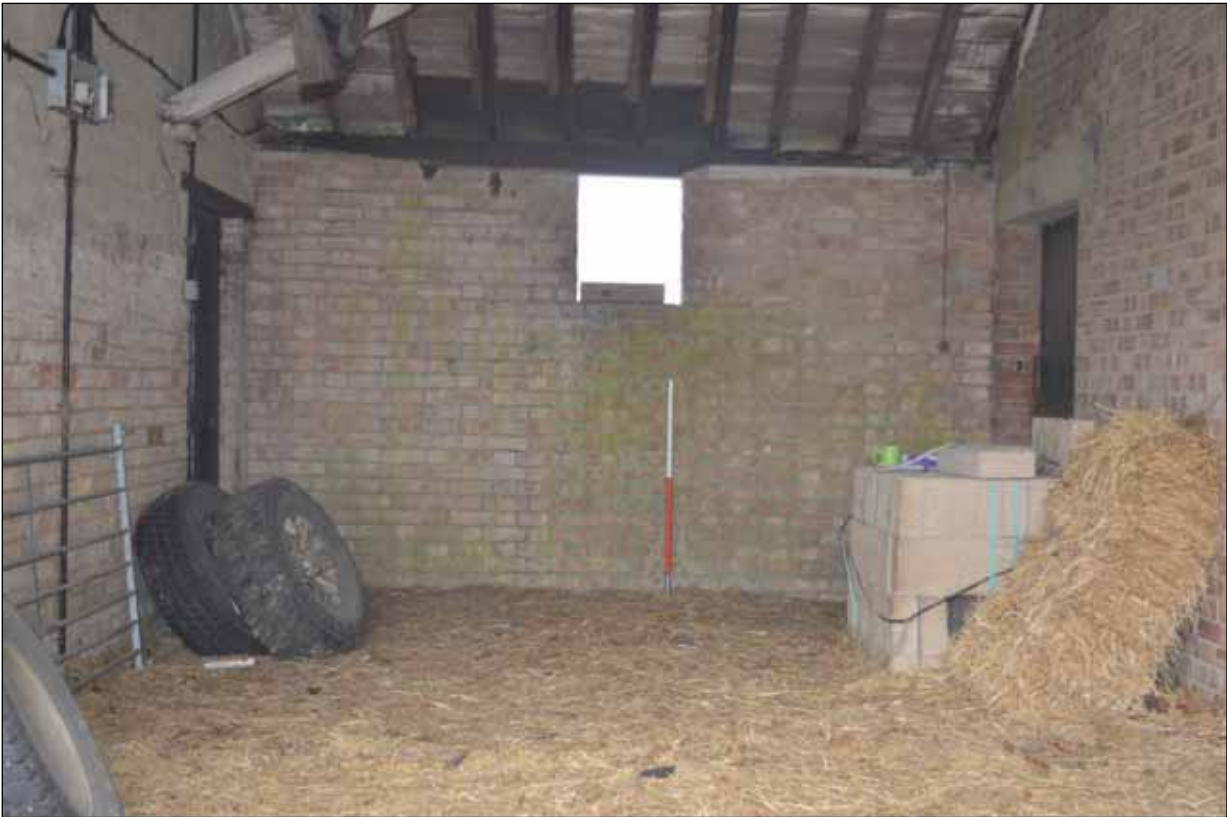
Plate 104: Rear wall of Building 7 viewed from the north-east

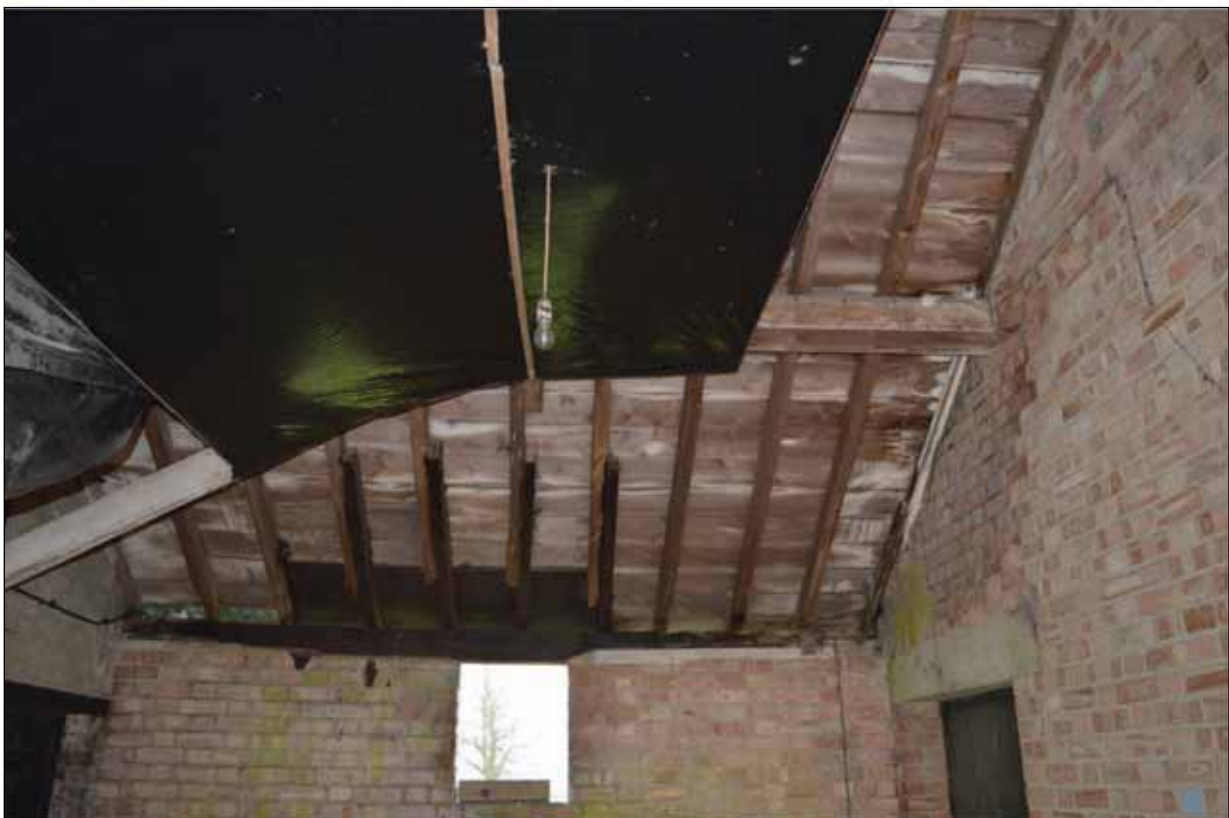
Plate 107: Detail of modern roof structure to Building 7

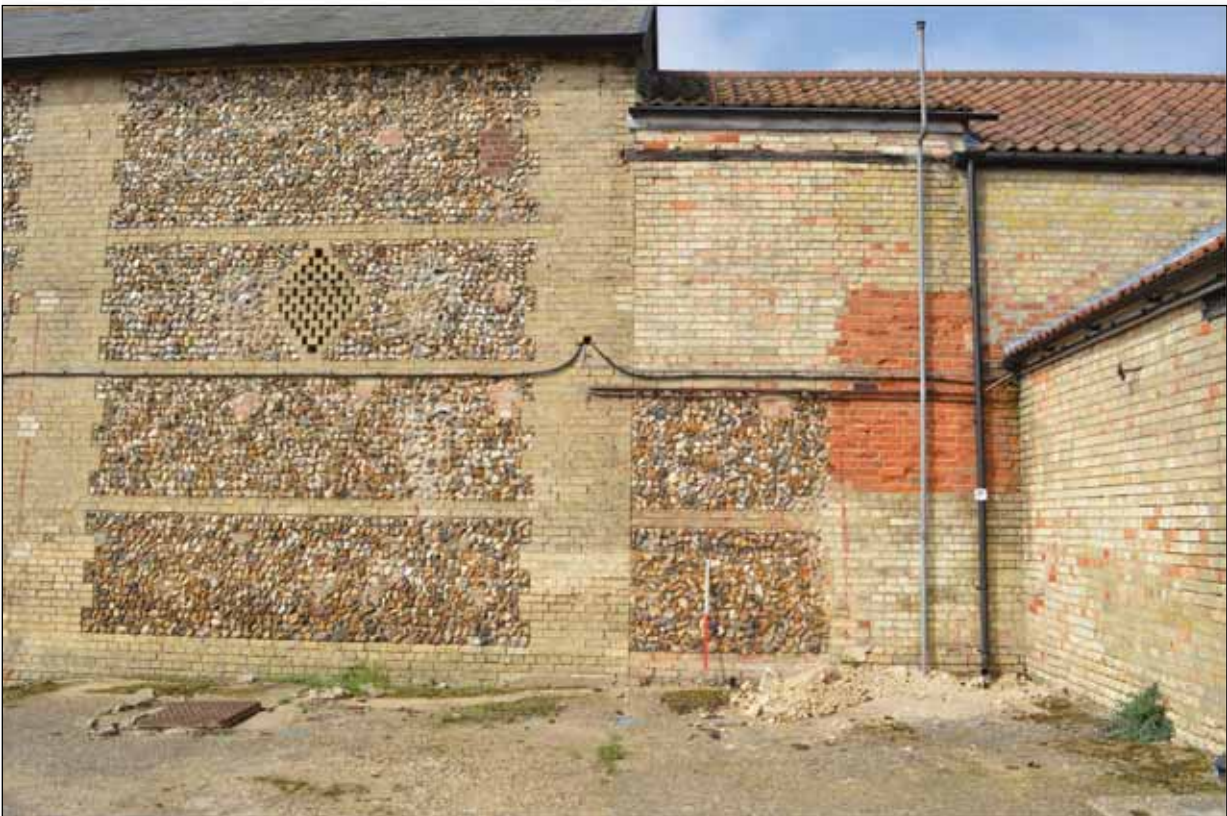
Plate 109: North-east end of Building 8 showing later brick in fill

- 4.9.5 Three diamond shaped ventilation openings are located on the south-east wall at 2.9m above ground level. These are constructed from brick and have been laid using only a header bond (Plate 109). A fourth, located to the south-west end of the building has been replaced by a modern metal window which incorporates six glass panes (Plate 108, 111 & 129).

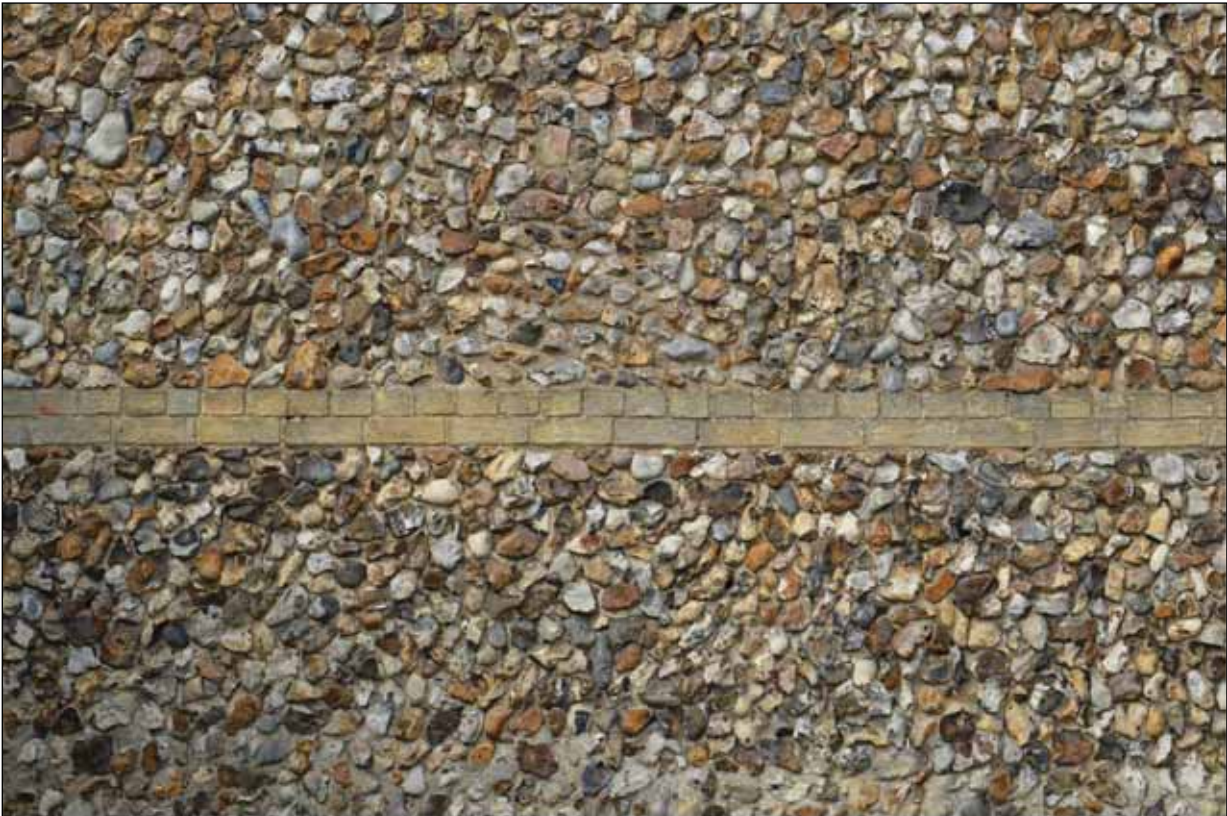
Plate 110: Detail of flint work and brick lacing bands to Building 8

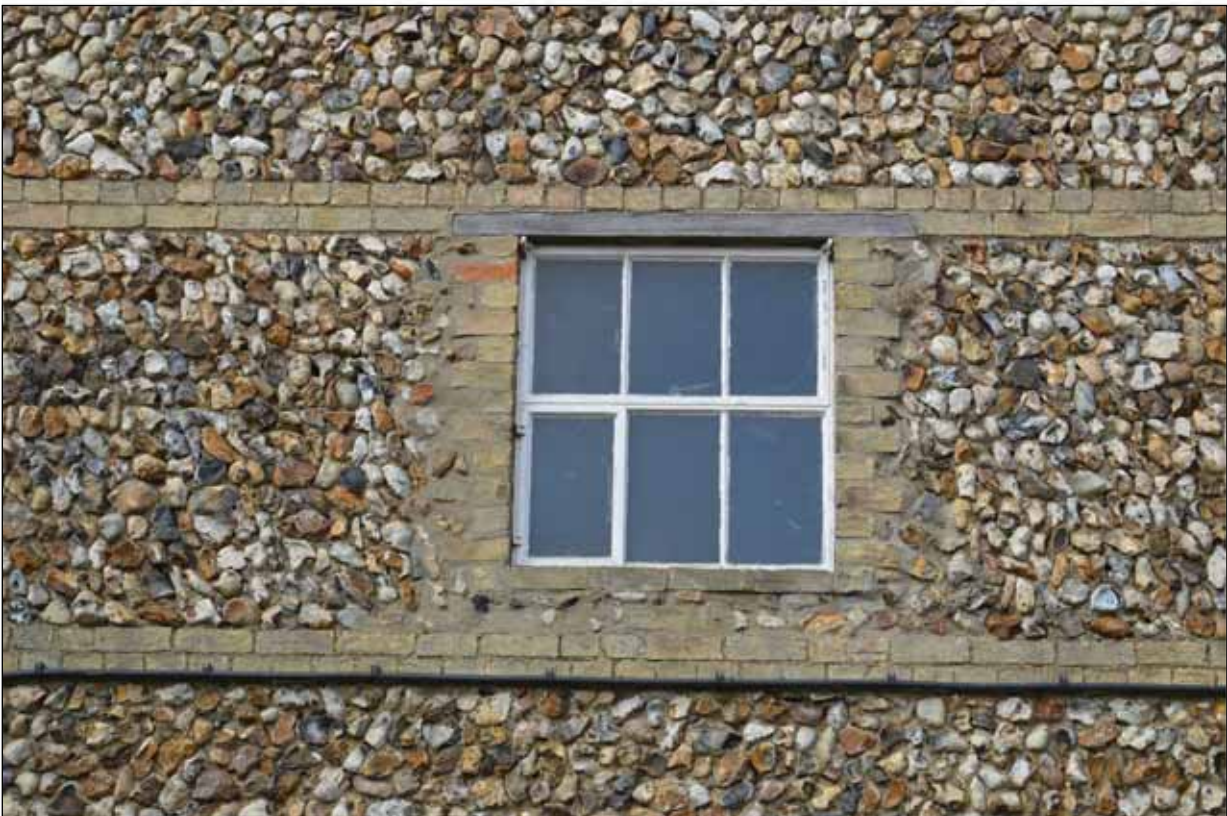
Plate 111: Building 8 - Detail of metal window to the south-east elevation

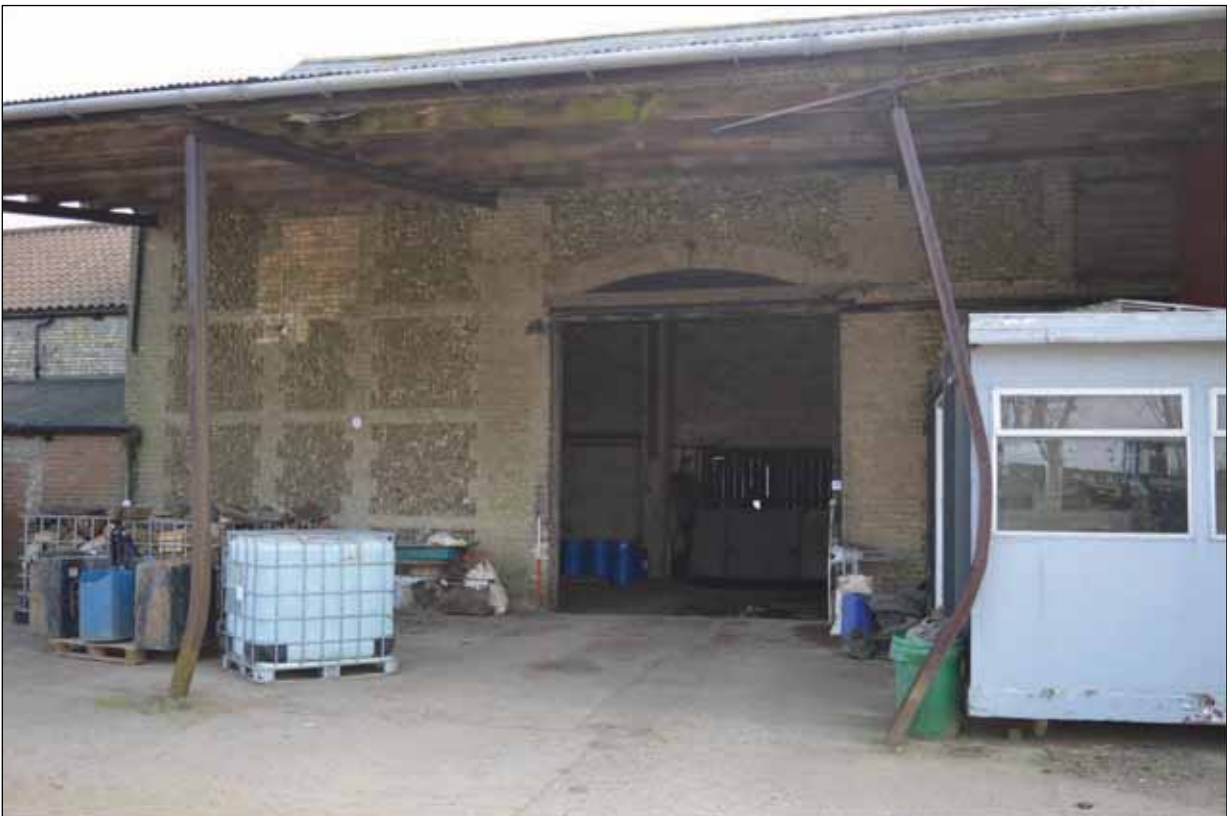
Plate 115: Building 8 - Double doorway to north-west elevation

- 4.9.6 Only one of the doors located on the north-west elevation is visible (Plates 115 & 116). These doors, which measure 3.44m x 5.96m, would have facilitated access by fully laden carts that, once unloaded, would have exited through the smaller doors opposite, into the courtyard. The bricked in arches (Plate 118) above the doors indicate that they are not original to the building.

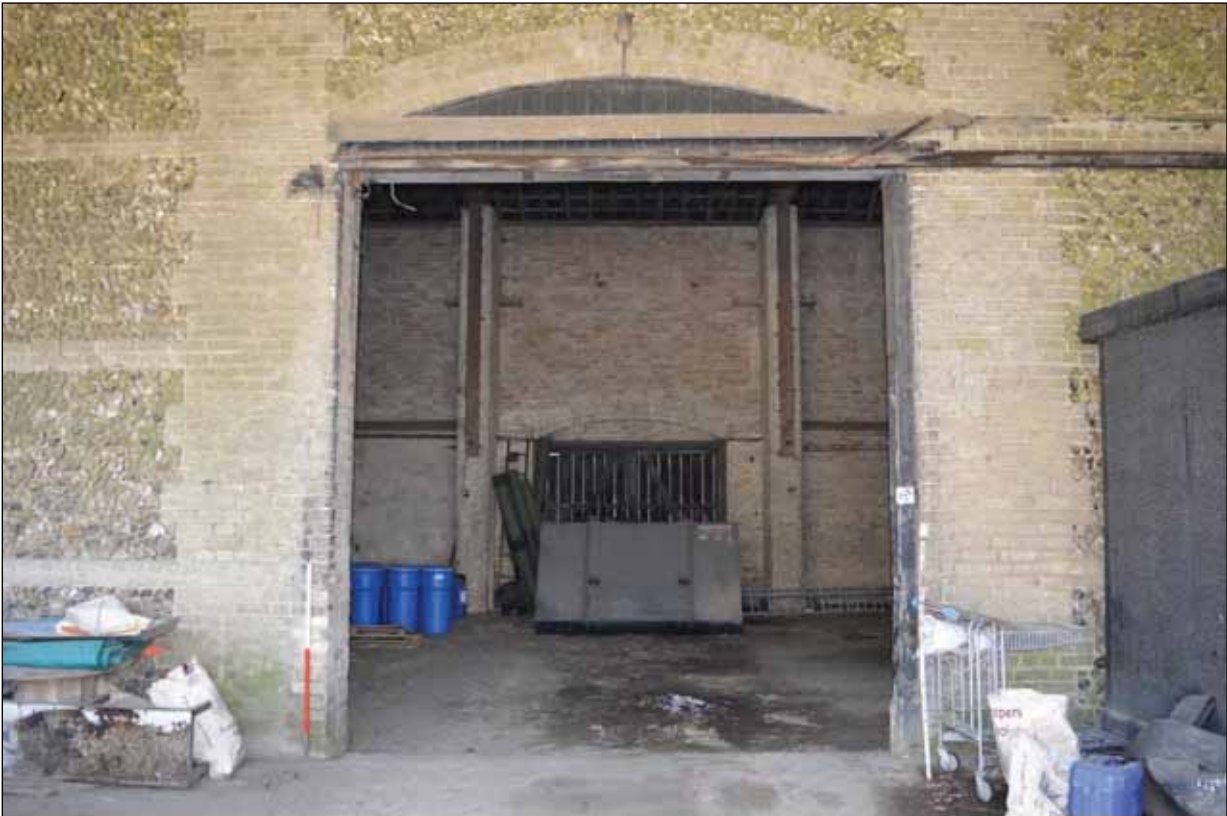
Plate 116: Building 8 - Detail of doorway

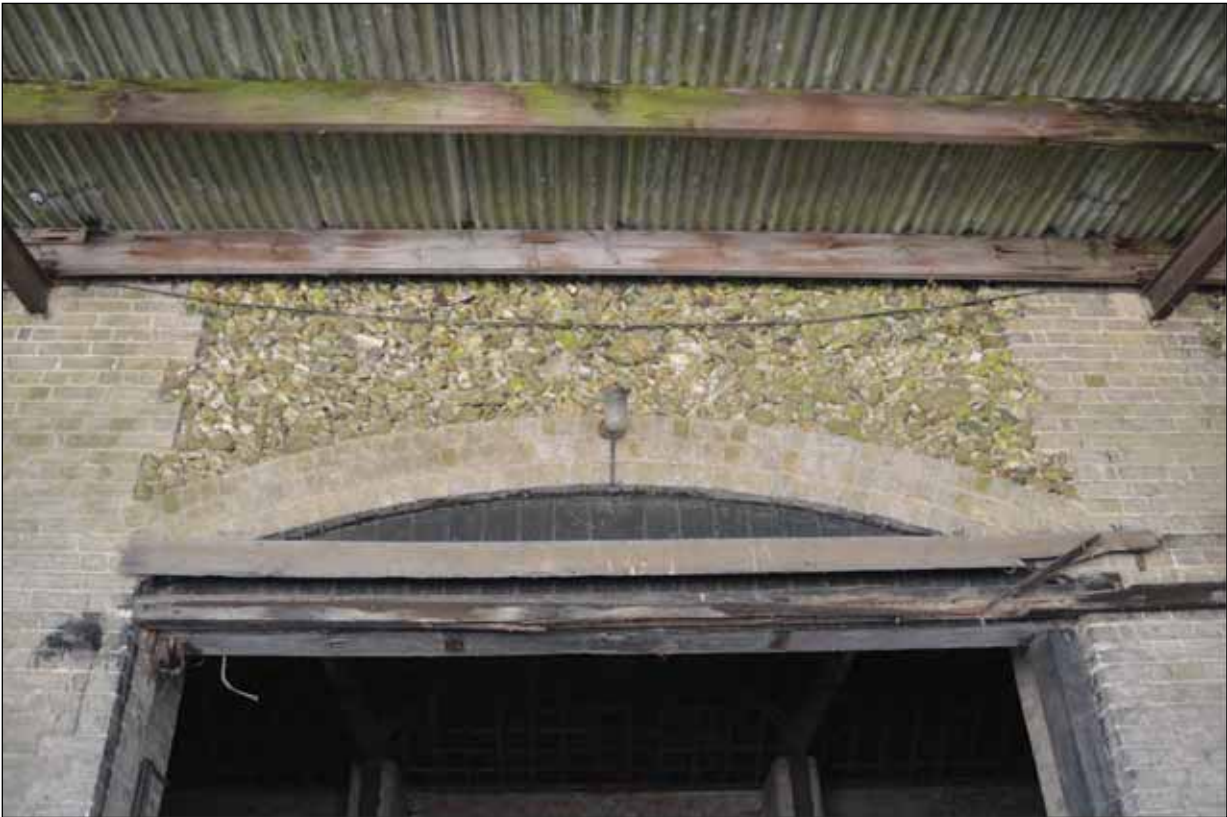
Plate 118: Building 8 - Brick arch and flint work above door to north-west elevation

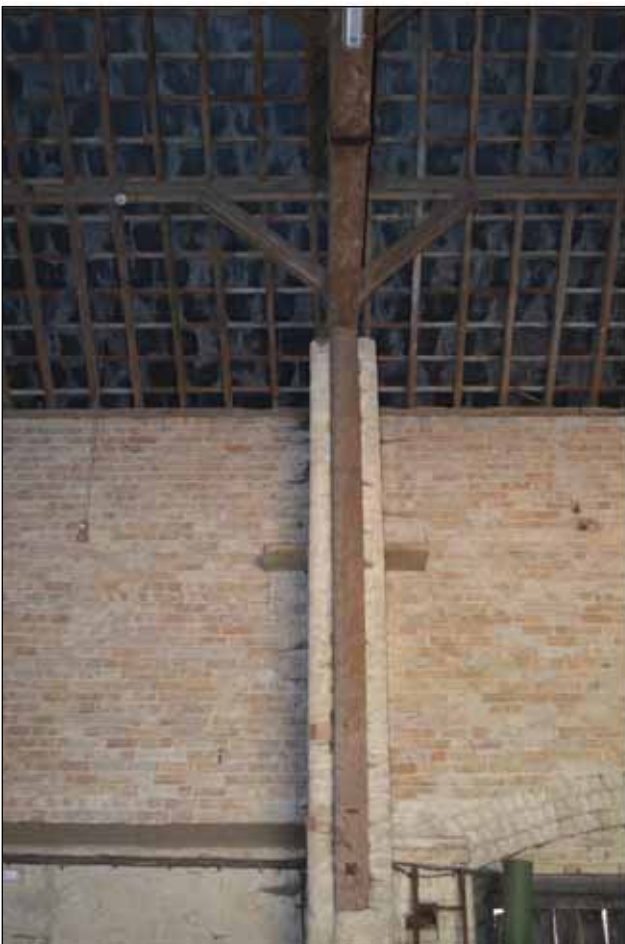
Plate 121: Building 8 - Detail of brick pier and roof structure to south-east elevation

- 4.9.11 The floor is entirely made of a cast concrete. No evidence of any original floor surface has survived.
- 4.9.12 The roof gable structure of the barn consists of queen post timber trusses (Plate 127) sitting on the brick piers (Plate 121). Iron strapping has been used to reinforce the common rafters, which are machine produced and bear no makers mark. Likewise, no carpenter's marks could be seen on any of the roof timbers. All the common rafters and purlins have also been replaced.

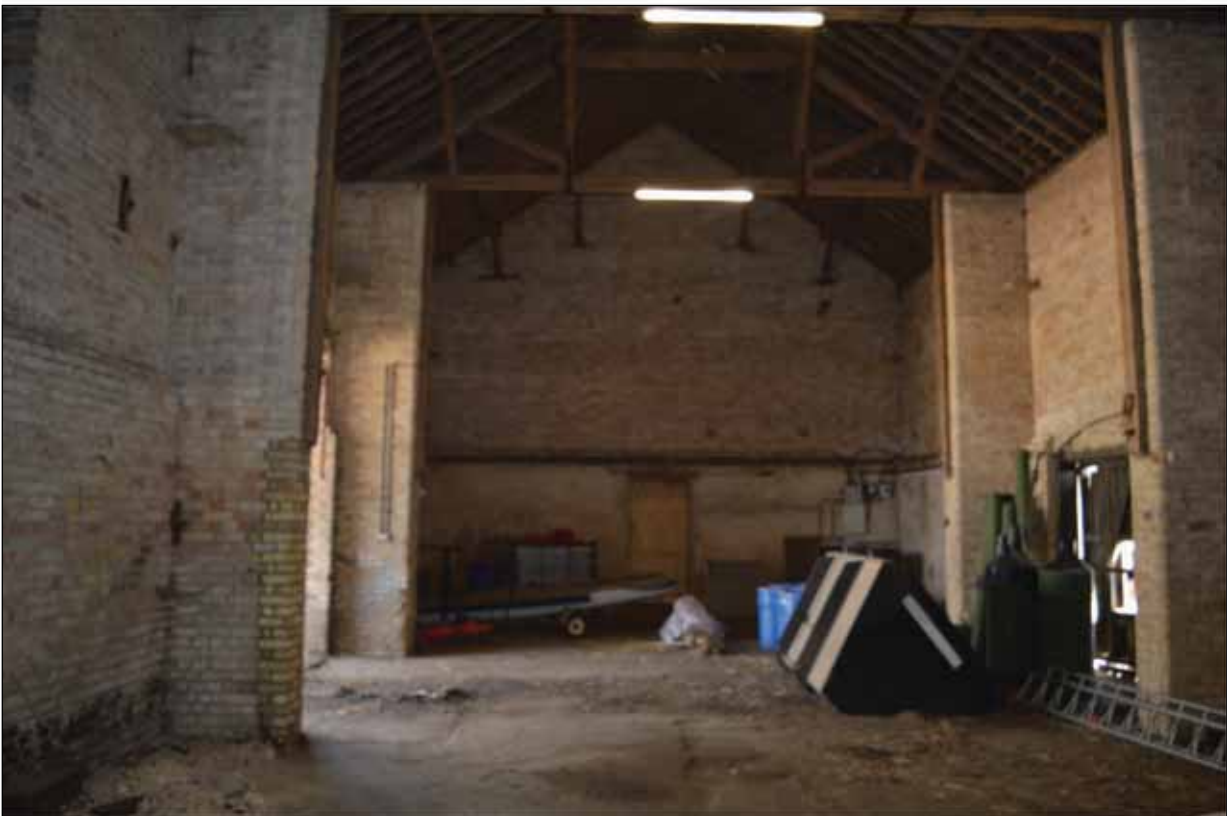
Plate 123: Internal view of the north-east elevation of Building 8

- 4.9.9 A single door is located at ground floor level within the north-east end of the building (Plate 123). Access to the room beyond was not possible at the time of recording but it would have led to the modern office space located in Building 6.

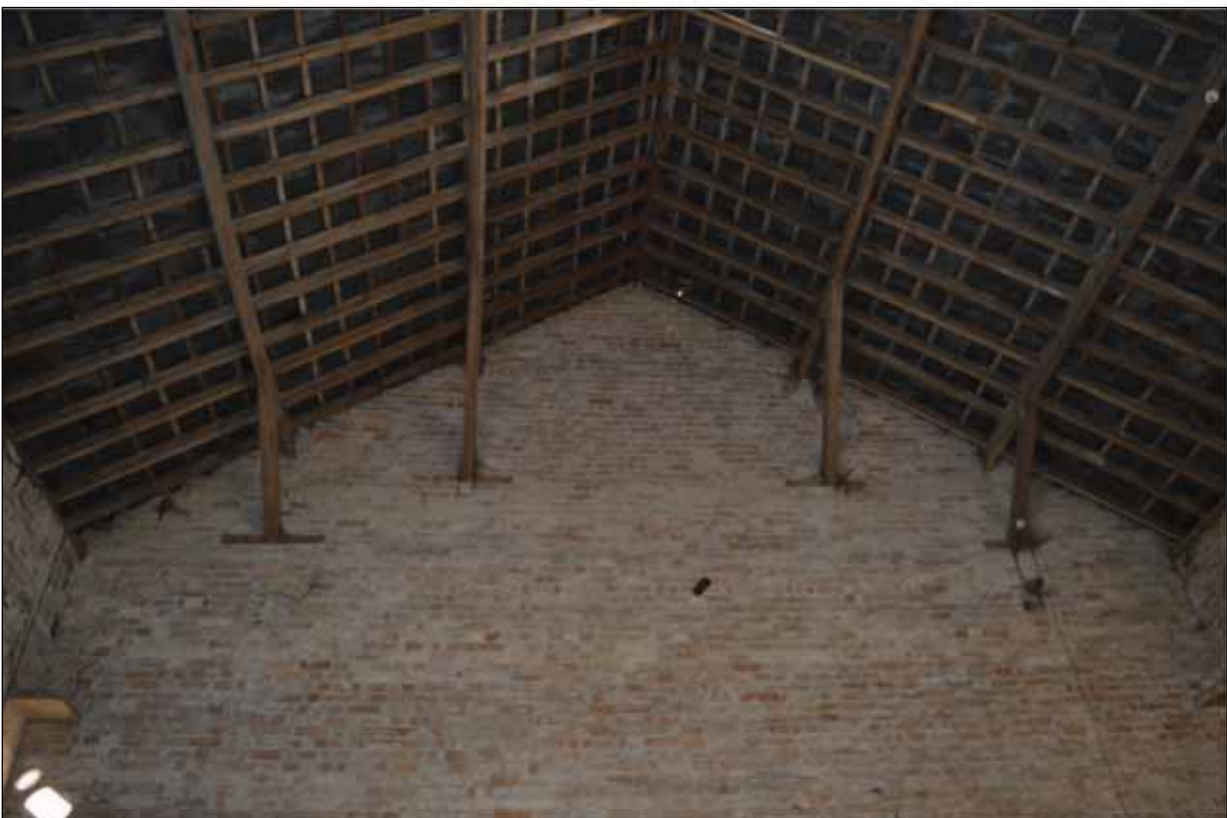
Plate 125: Building 8 - Detail of roof structure to the north eastern elevation viewed internally

- 4.9.13 The wooden roof structure has been tied in to the wall at either end of the building and strengthened with protruding angled struts (Plate 125). Externally, the roof is covered with grey slate.

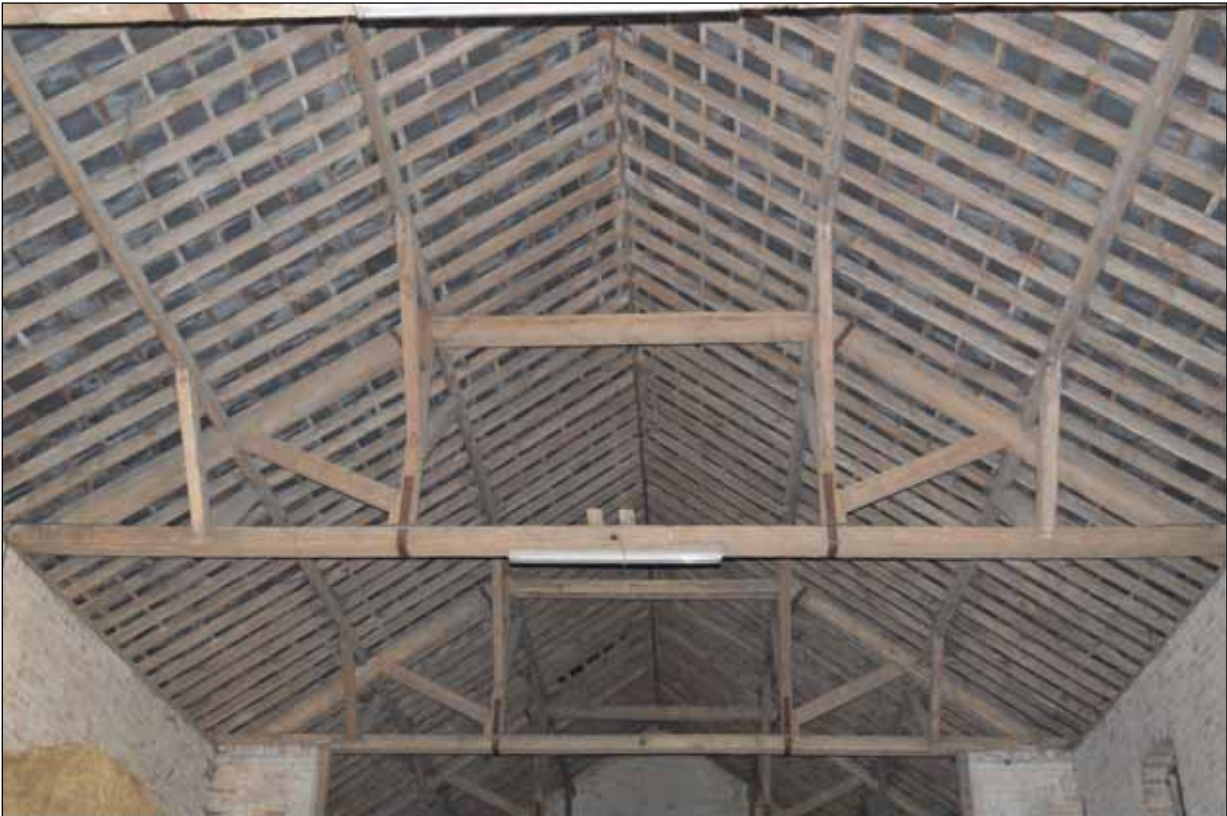
Plate 126: Detail of trusses and roof structure to Building 8 viewed internally

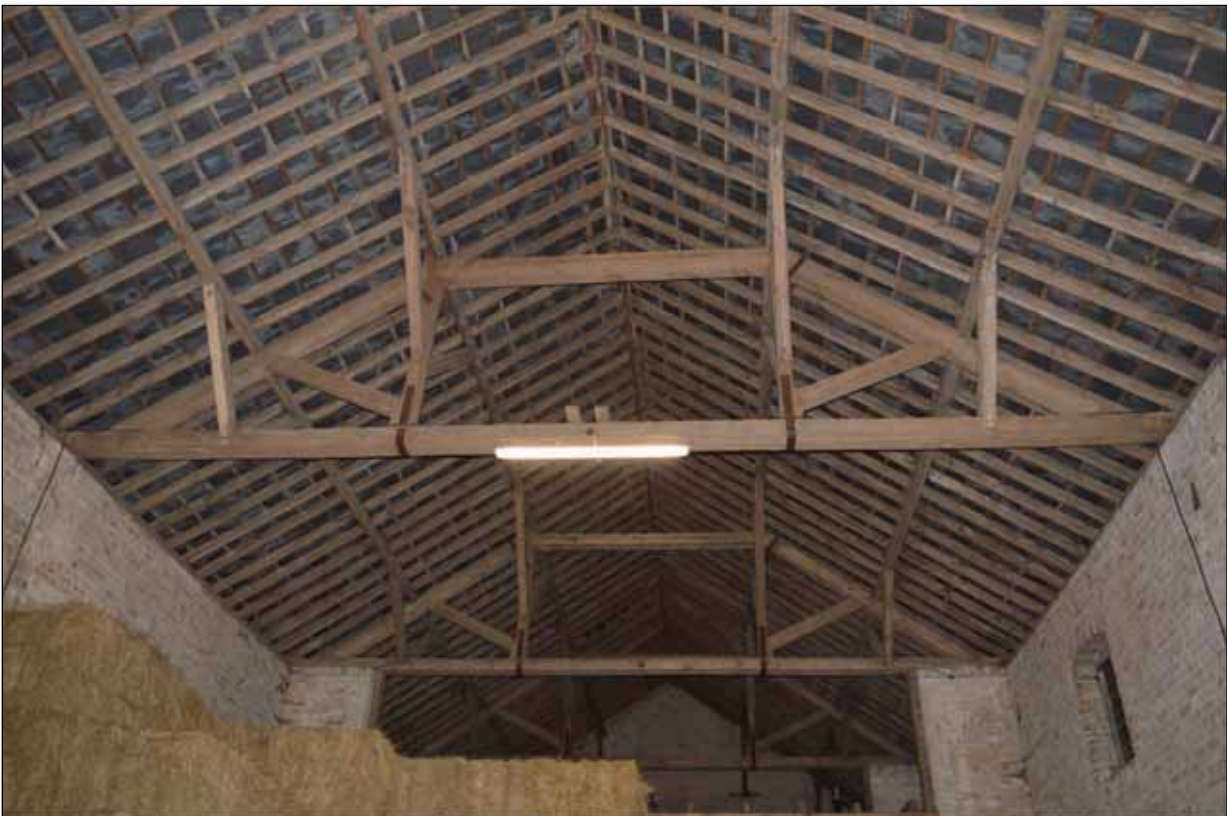
Plate 127: Building 8 - Detail of trusses resting on brick piers

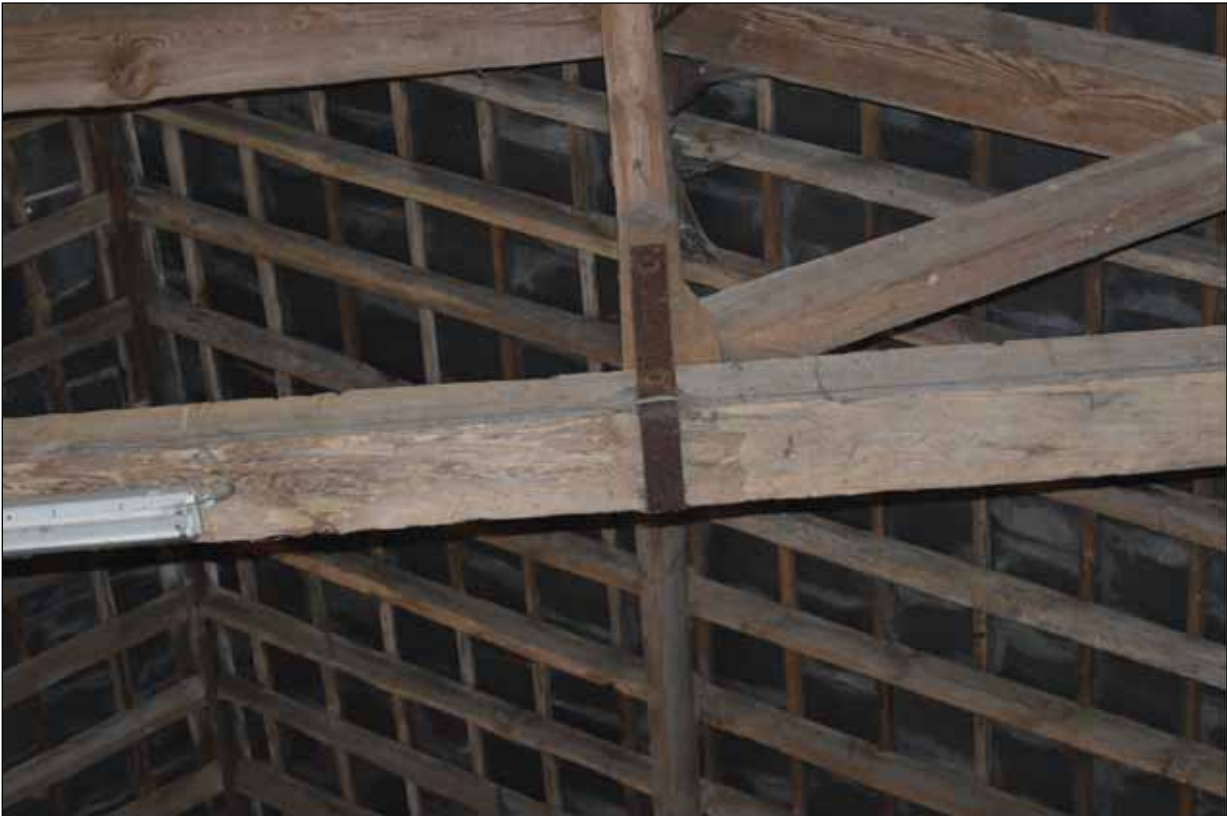
Plate 128: Detail of iron banding to trusses in Building 8

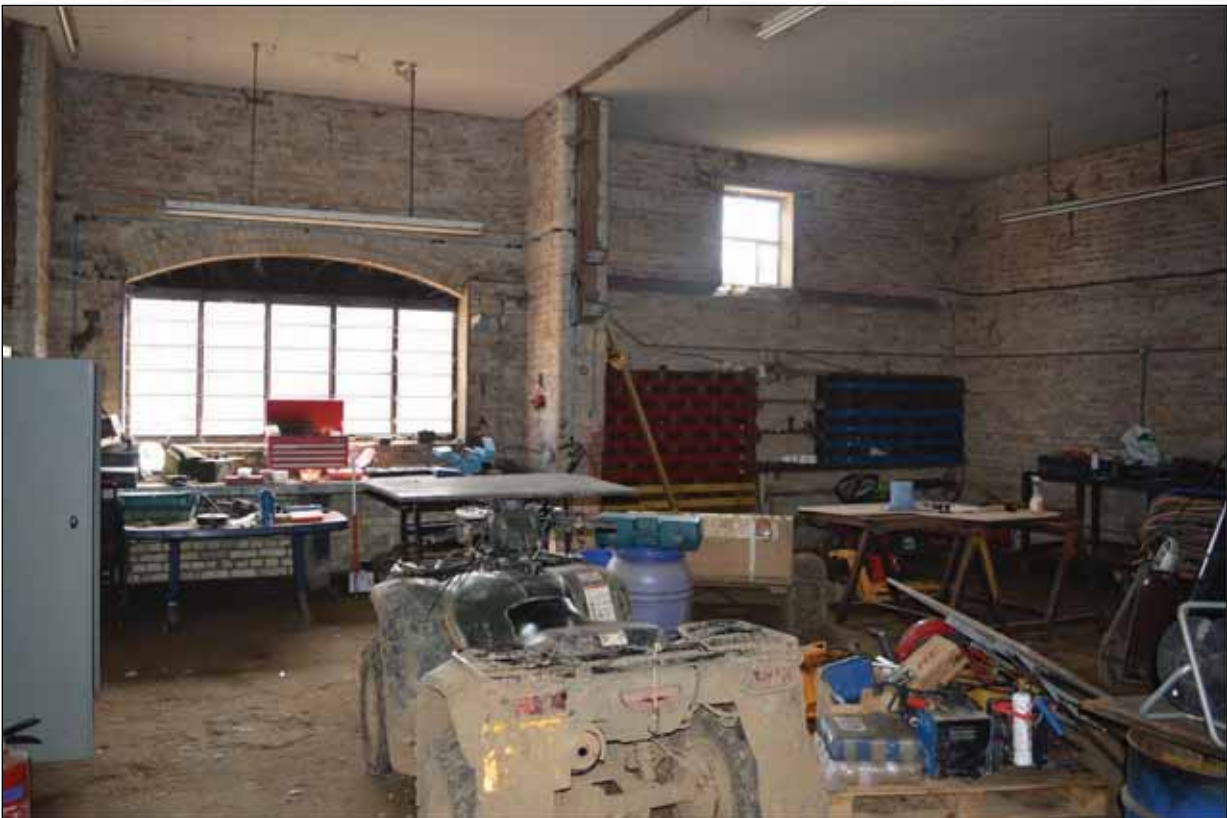
Plate 129: Modern workshop to the south-west end of Building 8

- 4.9.4 The door to the south-west end has been bricked up and a modern window inserted to the upper. This was done to help form a workshop at that end of the building. Plate 129 shows the former door from within the workshop. The door to the north-east end of the building retains its double wooden doors although these are no longer in use.

- 4.9.10 The south-west end of Building 8 has been blocked using modern concrete blocks to form a workshop (Plates 129 & 131), within which was the second of the larger doors (Plate 130). The doors themselves have been removed to access a modern steel structure attached to the exterior of Building 8. This structure (Building 10) is used as a secondary workshop.

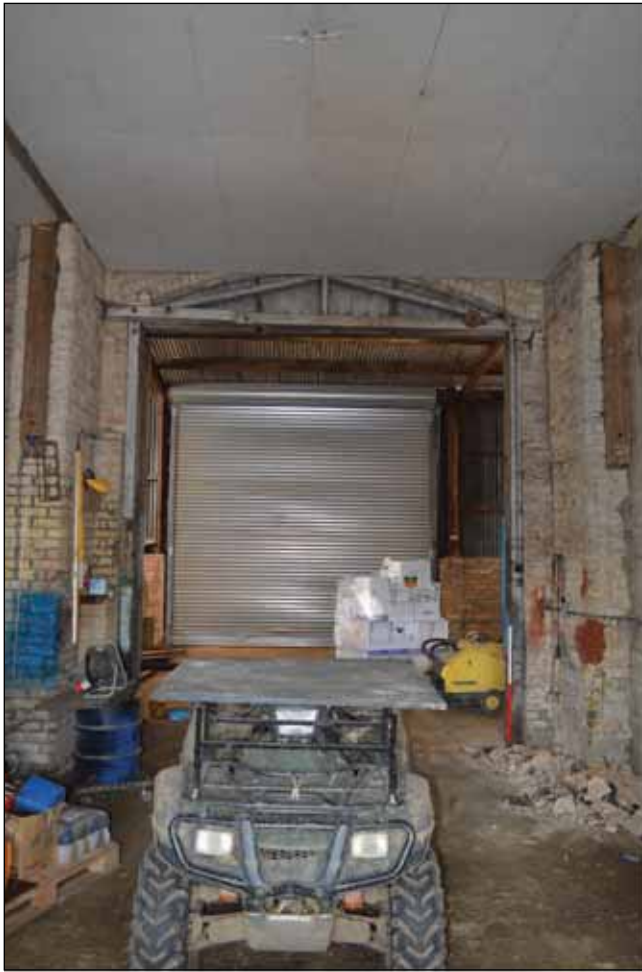
Plate 130: Modern metal shutter to the north-west elevation of Building 8

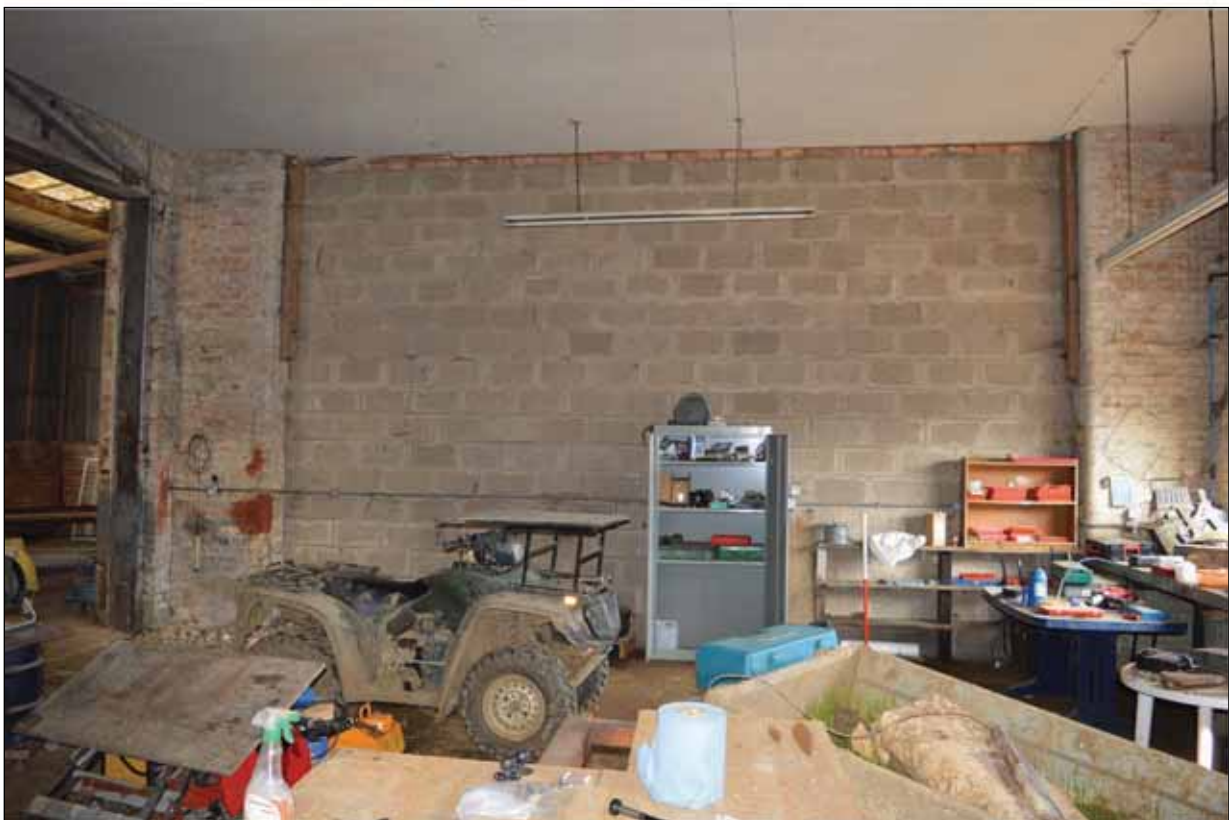
Plate 131: Modern block division at the south-west end of Building 8

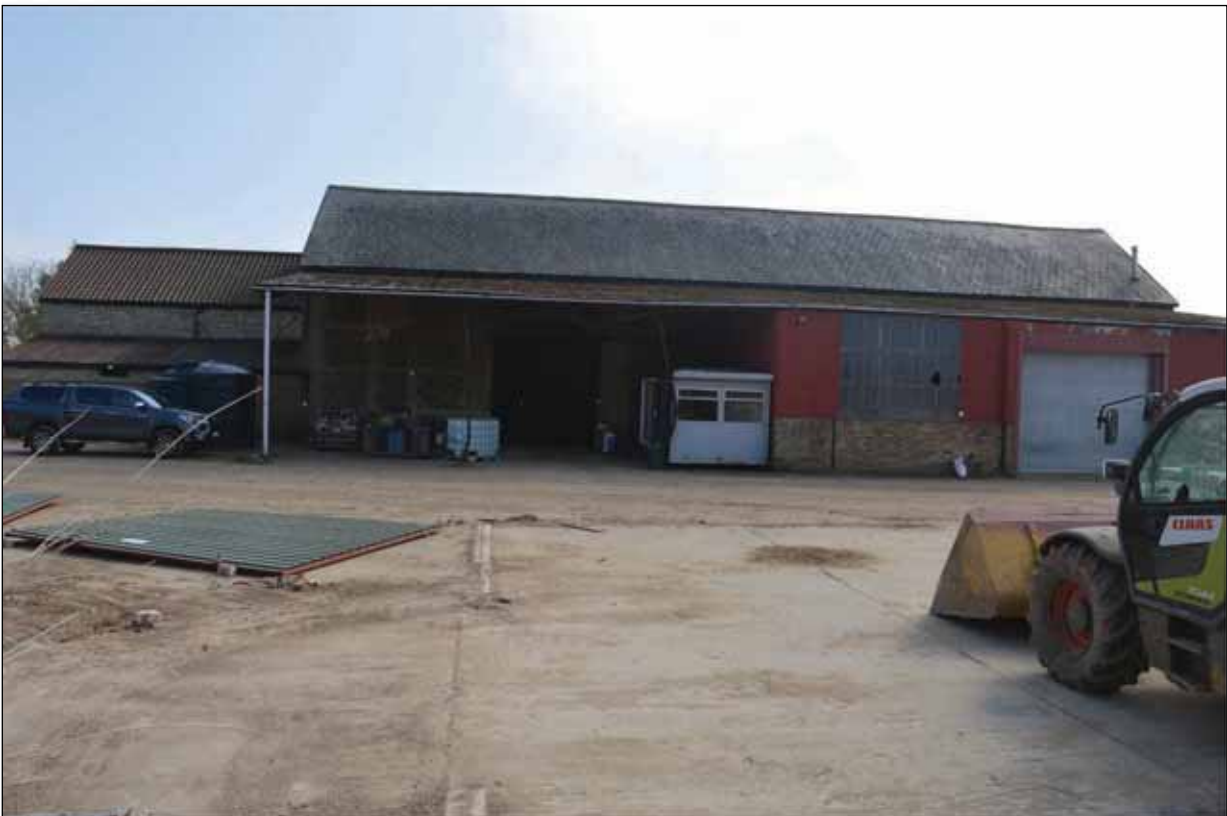
Plate 135: Building 10 - Modern lean to attached to the north-west elevation of Building 8

- 4.10.1 Building 10 is built on to the north-west elevation of Building 8 and measures 29.1m x 6.59m. It is divided into two parts with the north-east end open fronted and open sided. The south-west end is enclosed to form a workshop (Plate 135). The entire structure is manufactured from modern steel and asbestos sheeting.

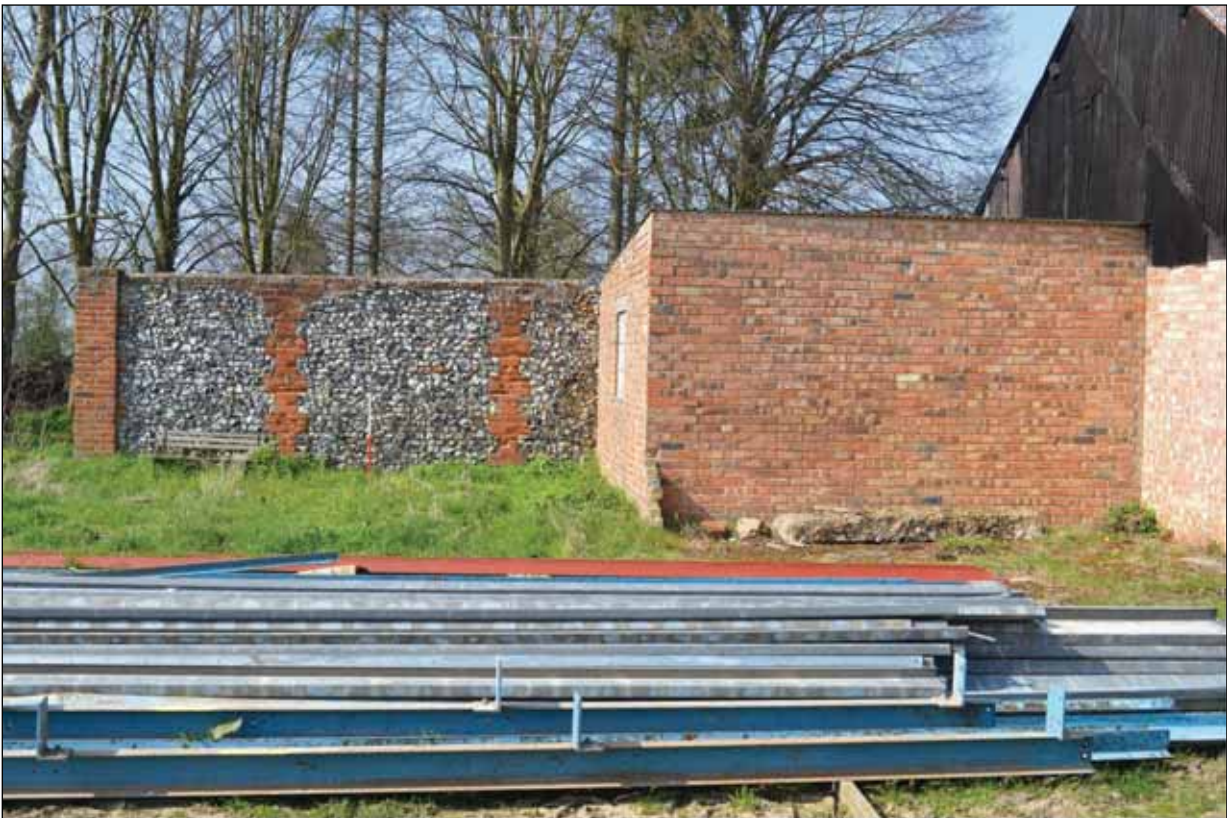
Plate 136: Building 11 and perimeter wall viewed from the south east

- 4.11.1 Building 11 is attached to the south-west end of Building 1 (Fig 2, Plates 136 & 137). It measures 5.35m x 4.56m with a roof height of 2.3m. It is built against the original perimeter wall of the farm yard and constructed entirely of fletton style bricks dating it to the 20th Century.

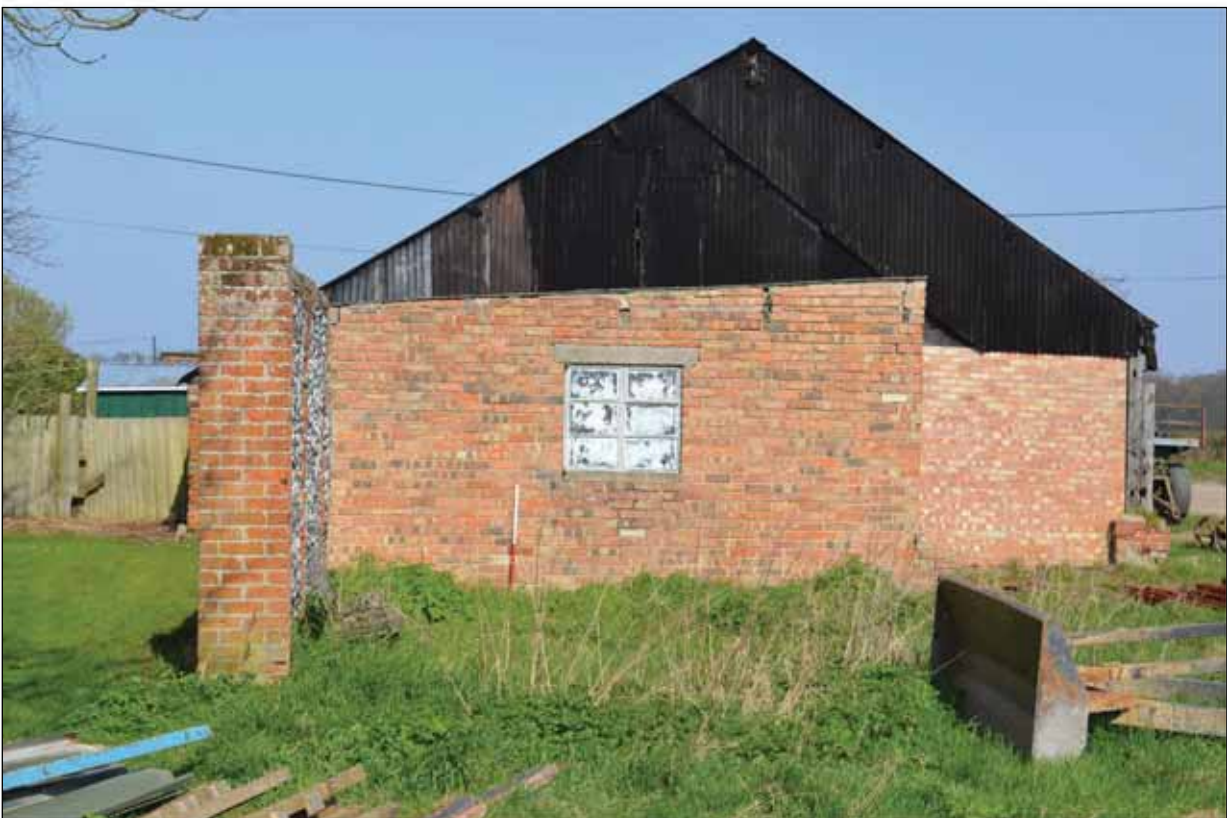
Plate 137: Building 11 and perimeter wall viewed from the south-west

- 4.11.2 A small metal framed window is located centrally on the south-west wall of the building (Plate 137). Building 11 is accessed through a single wooden door measuring 1.95m x 0.9m, located on the north-west wall (Plate 140).

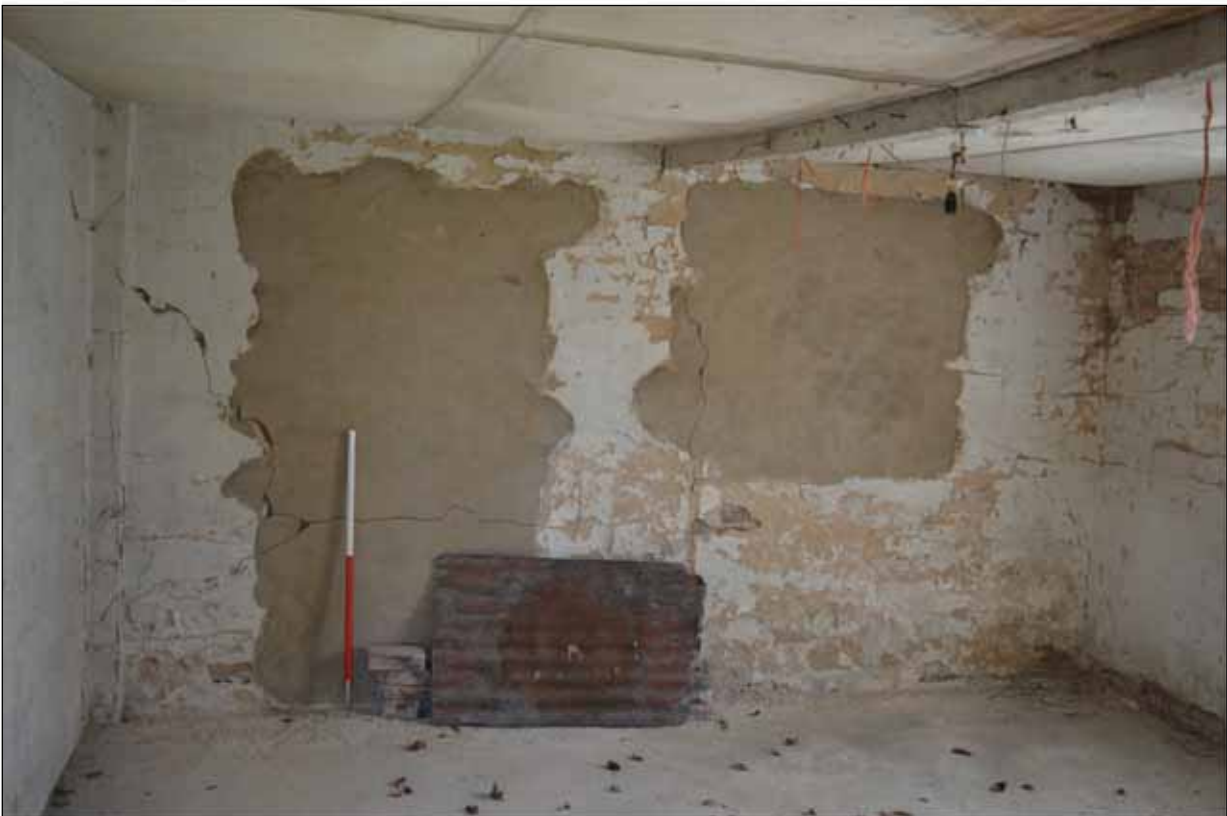
Plate 139: Building 11 - Blocked window and doorway on south-east wall viewed internally

- 4.11.3 A further door and window have been blocked up on the south-east wall (Plate 139). The walls and ceiling have been plastered and white washed (Plate 141). To the rear of the building graffiti was noted carved into a brick (Plate 138) but it was too worn to read.
