Hill House Farm Courtyard, Dullingham

Historic Building Recording

Client: Enterprise Property Group

OA East Report No 2011:
OASIS No: oxfordar3-289203
NGR: TL 6152 5867

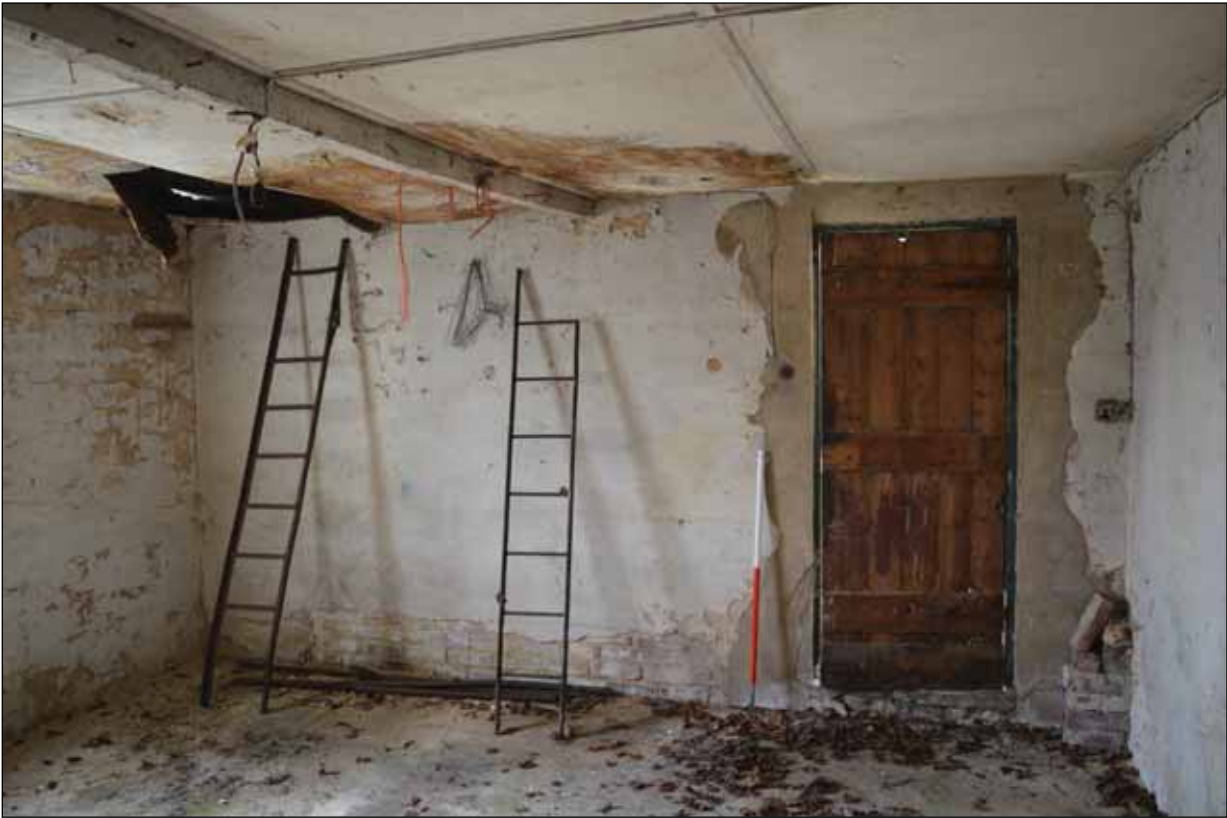
Plate 140: Door to the north west wall of Building 11 viewed internally

- 4.11.2 A small metal framed window is located centrally on the south-west wall of the building (Plate 137). Building 11 is accessed through a single wooden door measuring 1.95m x 0.9m, located on the north-west wall (Plate 140).

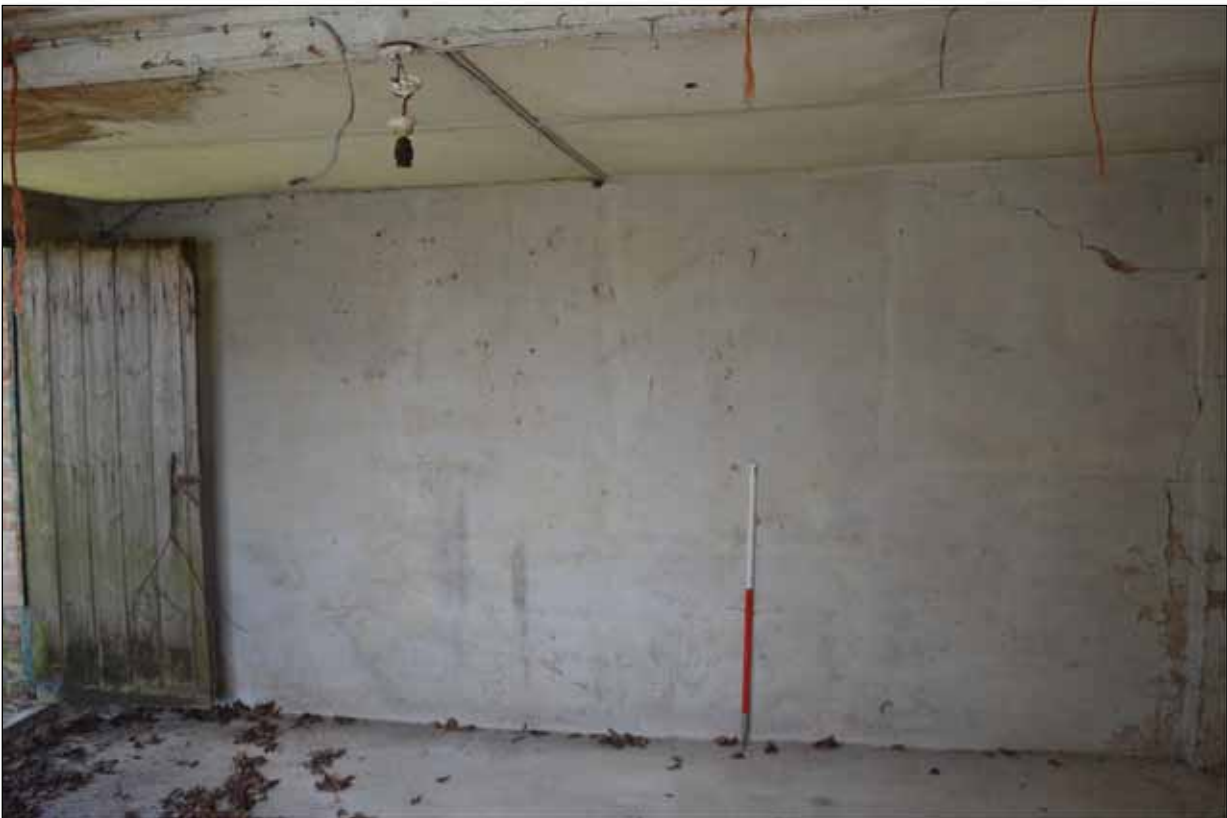
Plate 141: Wall to north-east wall of Building 11 viewed internally

- 4.11.3 A further door and window have been blocked up on the south-east wall (Plate 139). The walls and ceiling have been plastered and white washed (Plate 141). To the rear of the building graffiti was noted carved into a brick (Plate 138) but it was too worn to read.
