Redisher Works, Holcombe Brook, Bury, Greater Manchester Archaeological Investigation

December 2018

Client: CgMs Heritage

Archaeological Investigation

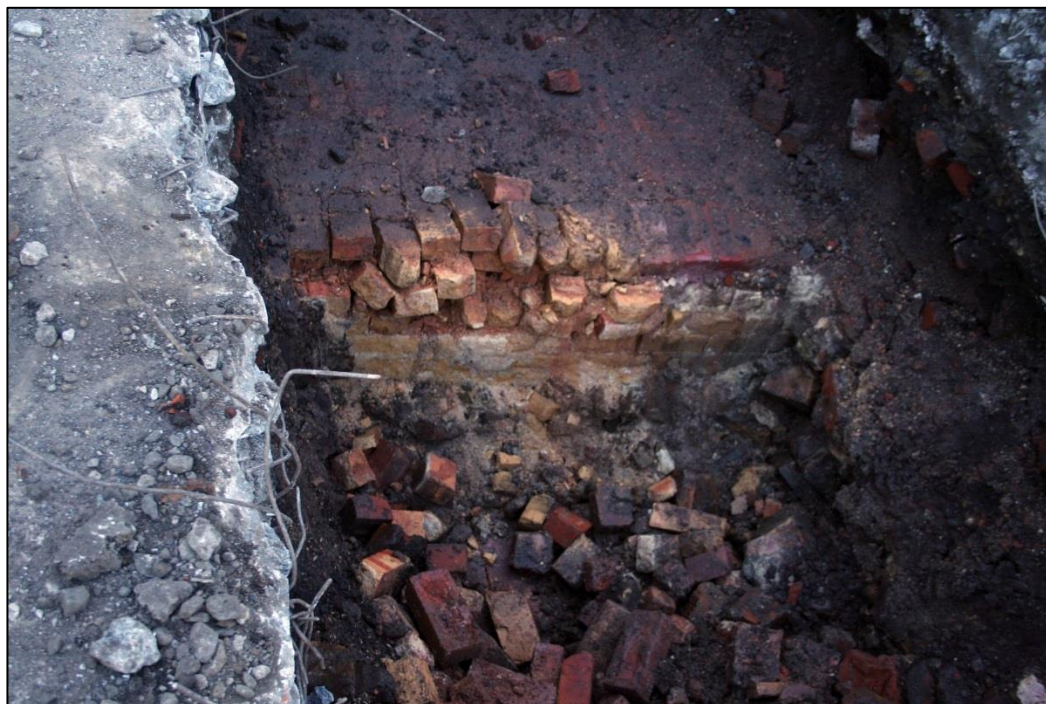
Plate 7: The heat-affected brick base and brick-lined channel (flue) in Trench 4

- 3.2.3 It is highly likely that these brick structures in Trench 4 represent the brick base and the flue of a boiler, that probably led to an adjacent chimney (Fig 4; see Section 3.2.4 below). Indeed, it is also probable that this was a Lancashire boiler, as these were in common usage throughout the latter part of the nineteenth century and into the early twentieth century in textile works across Greater Manchester and Lancashire (cf Phelps *et al* 2017, 29). The size of the boiler house, as depicted on historic mapping, suggests that it housed either two or three Lancashire boilers.

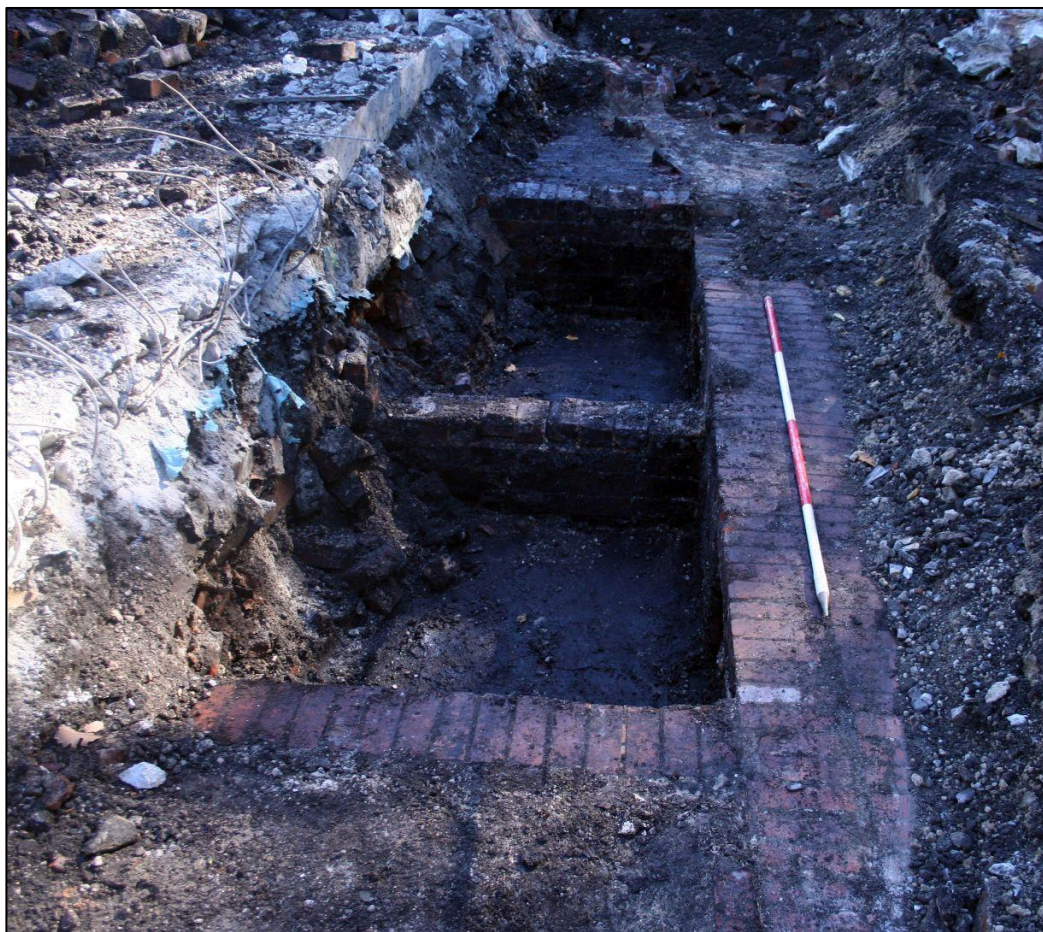
Plate 8: The brick-built tank in Trench 5

- 3.2.5 Although no remains of the chimney were present, evidence relating to the filter beds did survive (Figs 3 and 5). This evidence included a fairly large brick-built tank (504), which measured c 3.4m wide, and that contained a central dividing wall, which created two 1.6m-wide chambers (Plate 8). The southern wall of the tank was the more substantial, measuring four-bricks wide (c 0.44m across), whilst the side walls and central dividing wall were narrower being two-bricks wide (c 0.22m wide). The southern wall, side walls and base of the tank had been constructed using handmade brick, bonded with sandy mortar, whilst the central dividing wall was composed of both handmade and machine-made, frogged bricks. As handmade brick was commonly used up until the 1880s/90s, and frogged bricks date to the twentieth century, it is therefore possible that, in this instance, the handmade bricks represented reused building materials that were derived from an earlier structure at the site, that had been demolished prior to the construction of the filter beds. It is also possible that

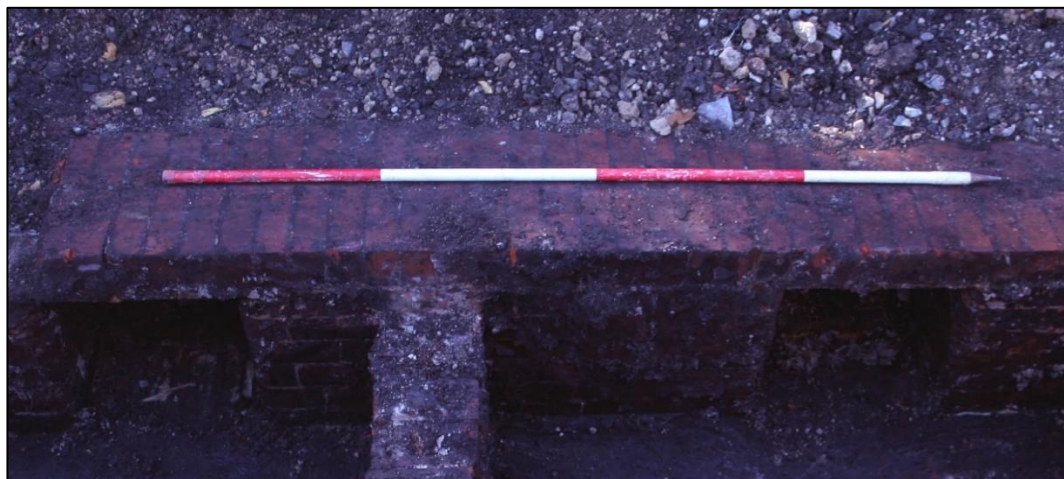
Plate 9: The openings on the southern elevation of the tank in Trench 5

- 3.2.6 The southern elevation of the tank had two c 0.5m-wide openings, which relate to the mouths of two culverts that channelled water into/out of the two separate chambers within the tank (Plate 9). Each of the culvert mouths were also provisioned with a metal sluice gate, of which the partial remains survived, allowing for the control of water into/out of the tank. The line of a brick-built culvert (**506**) was also visible running from the eastern end of the tank, outside of the evaluation trench, and this was almost certainly the culvert that served the tank. At this end of the trench a brick surface (**505**) was also present, whilst at the western end of the trench a short length of walling (**503**) was visible. This wall was composed of machine-made frogged bricks and ran parallel with the tank side walls.

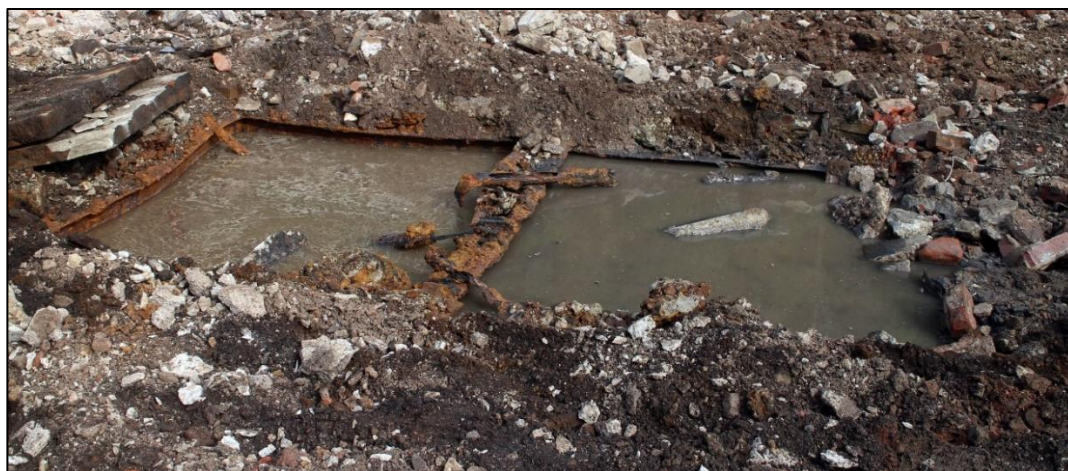
Plate 10: The tank exposed in Trench 6

3.2.7 **Trench 6:** this trench (Fig 2) was positioned across the site of a large rectangular building that formed an element of the late nineteenth-century brickworks (see Section 1.4.13 above). At the start of the excavation of this trench, a large open-topped metal tank was exposed, that was filled with potentially contaminated water (Plate 10). Given the Health and Safety implications, including the exposure to and the release of potentially harmful substances, excavations within this area were abandoned and no further investigation of the tank was undertaken

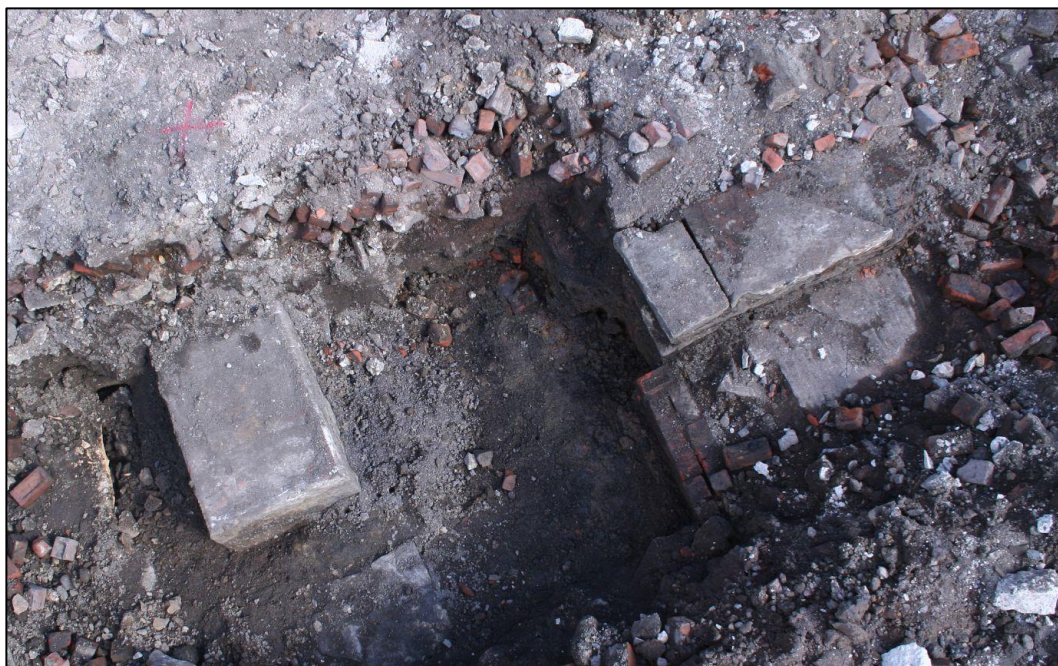
Plate 11: Wall **706** (left) and structure **708** (right), adjacent to wall **707** and surface **709**, in Trench 6

3.2.9 The trench was positioned across the south-western corner of the late nineteenth-century brick works' building, running parallel with its southern side wall and fragmentary remains of this building were present (Fig 3). These included a c 0.8m-wide sandstone wall (706), incorporating a large dressed sandstone block (705; Plate 11). This fairly substantial wall was aligned north-east/south-west and seemingly

3.2.10 Several later walls and structures were also present in the trench. These included a wall composed of machine-made bricks (**707**) and a concrete surface (**709**) that lay adjacent to structure **708** (see Section 3.2.9 above; Plate 11). It is possible that these were created when the late nineteenth-century building was incorporated into the design of the early twentieth-century bleach works' ancillary building. In the western half of the trench were also two machine-made brick walls (**703** and **704**) of twentieth-century date (Plate 12). The more westerly of these (**703**) was a two-skin thick wall, which seems to correspond with the outline of the works building as depicted on mapping dating to 1963/4 (see Section 1.4.19 above). The other wall, however, was much more substantial, measuring c 1.2m wide; although it is not clear precisely what this section of walling relates to, it too probably formed an element of the mid-twentieth-century works.

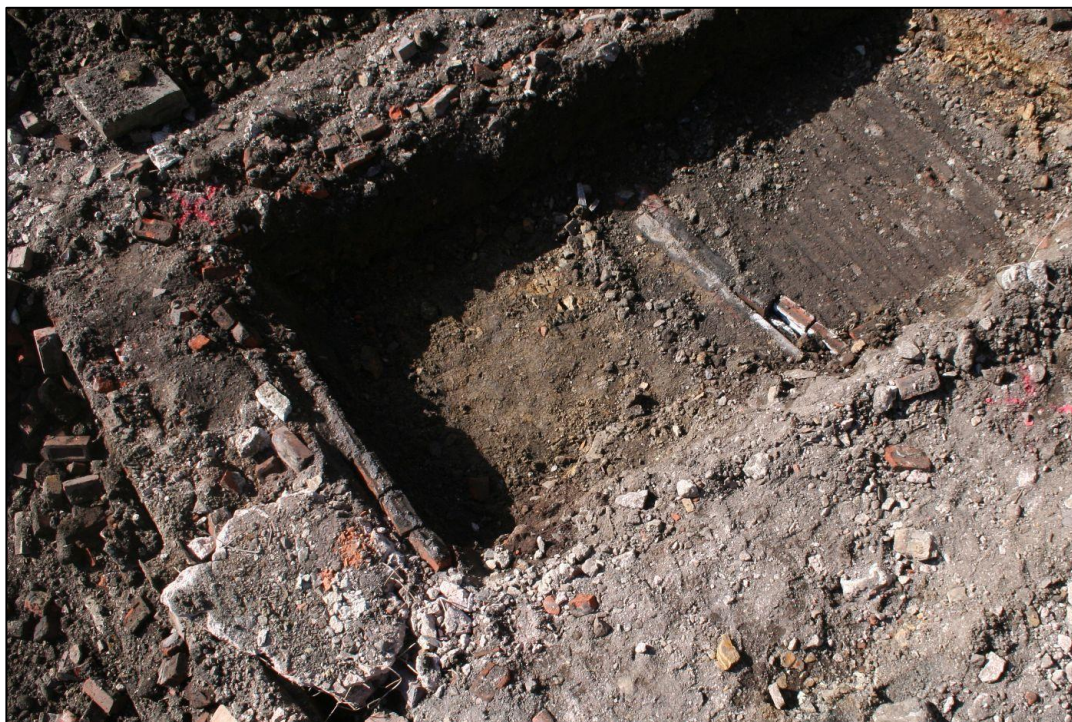
Plate 12: Walls 703 (right) and 704 (left), in Trench 6

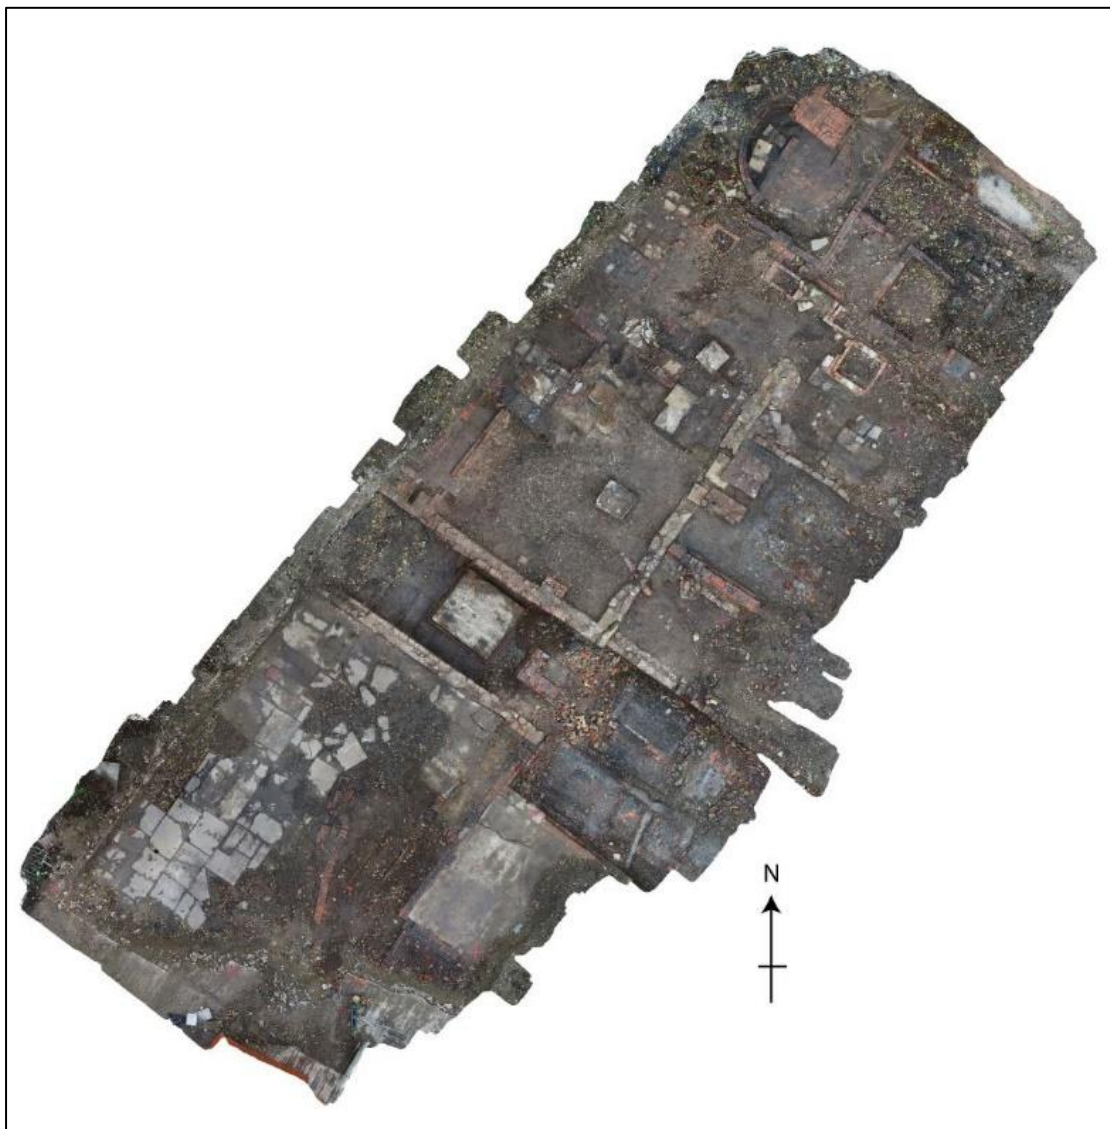
Plate 13: Overhead view showing the excavated structural remains in Area 1

3.3.1 Area 1 was located across the north-western extent of the site, encompassing evaluation Trenches 1-3 (Fig 2). The excavation area targeted archaeological remains associated with the original footprint of Redisher Wood Bleach Works and subsequent extensions observed on late nineteenth- and early twentieth-century OS mapping. A variety of structural remains were encountered across this area (Fig 7), including nineteenth-century stone walling, twentieth-century brick walling, stone and concrete floors, and the bases of machinery and vats/cisterns, most of which seem to date to the earlier part of the twentieth century when the site functioned as a bleach and dye works (Plate 13). Based on the character of these remains, and their stratigraphic relationships, four broad phases of building activity can be determined, dating to the early/mid-nineteenth century (Phase 1), mid-late nineteenth century (Phase 2), late nineteenth-early twentieth century (Phase 3), and early-mid-twentieth century (Phase 4; Fig 8).

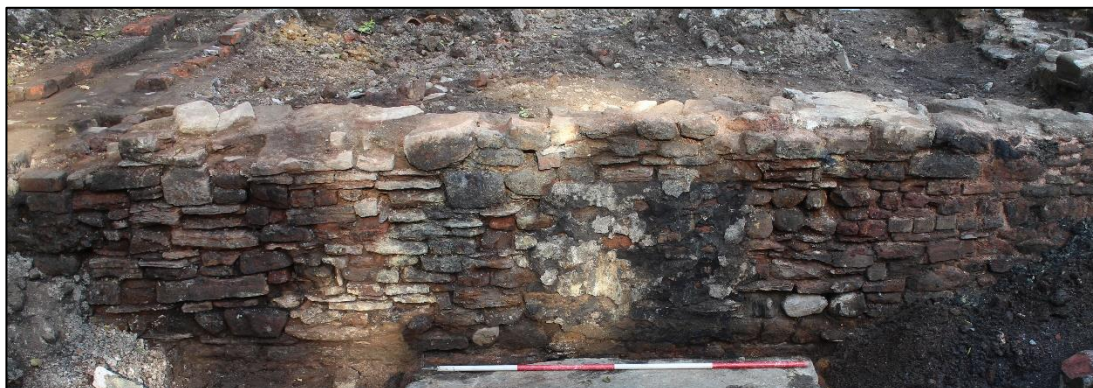
- 3.3.3 One of these walls formed a right-angled length of walling, which defined **Room 1017**. This was 0.5m thick and was constructed of squared rubble sandstone and mudstone masonry blocks, that were roughly coursed and bonded with lime-based mortar (Plate 14). The positioning of this wall indicates that it formed the south-eastern corner of the northern bay of the original mill/bleach works (*see Section 1.4.4 above*), and this right-angled wall was quoined at its south-eastern corner.

Plate 14: The south-western exterior elevation of the Phase 1 wall defining the northern bay (**Room 1017**) of the mill/bleach works

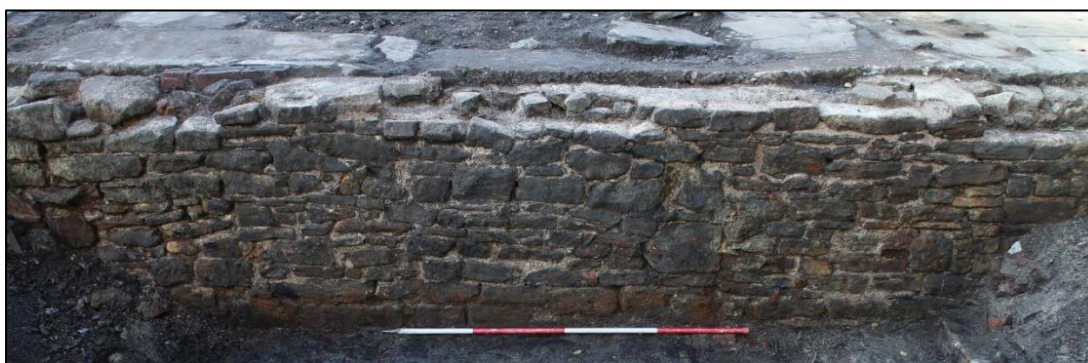
- 3.3.4 The other length of Phase 1 walling lay to the south-west and ran parallel with the south-western side of **Room 1017**, being set some 3m distant, with the area between the two walls being designated as **Room 1009**. This wall was also 0.5m thick, constructed of similar roughly square sandstone and mudstone blocks, bonded with lime-based mortar (Plate 15), and probably formed the northern side of the southern bay of the original mill/bleach works.

Plate 15: The north-eastern exterior elevation of the Phase 1 wall defining the southern bay of the mill/bleach works

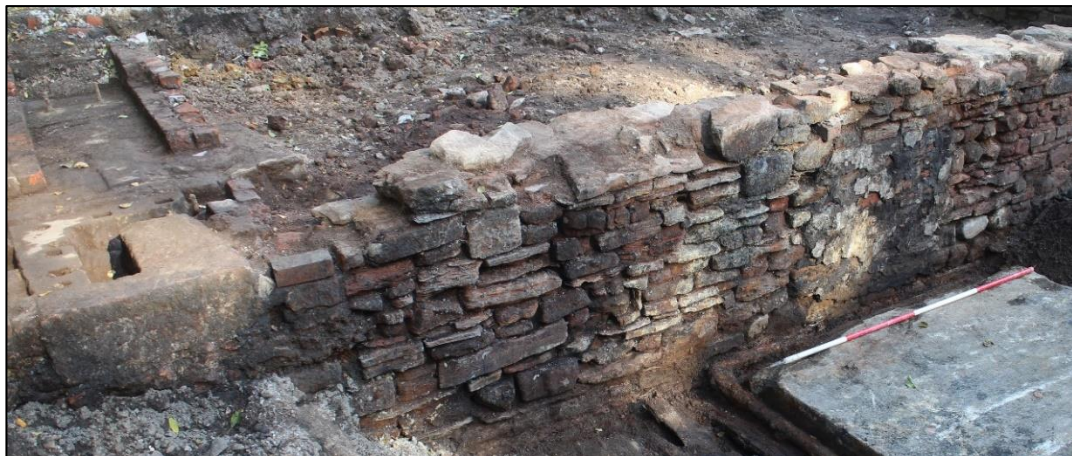
- 3.3.6 Significantly, there was evidence within the stone walls, defining **Room 1009**, for the position of this suspected waterwheel. On the northern side of this 'room' this comprised a large sandstone block, which was incorporated into the stone wall (Plate

16). This block measured 1.07 x 0.71m and contained an L-shaped slot, surrounded by six circular smaller rectangular and circular slots, marking the position of bolt holes. This block had also been encased in handmade brick on its eastern and western sides (Plate 17).

Plate 16: The large sandstone block (left) incorporated into the Phase 1 wall defining the northern bay of the mill/bleach works

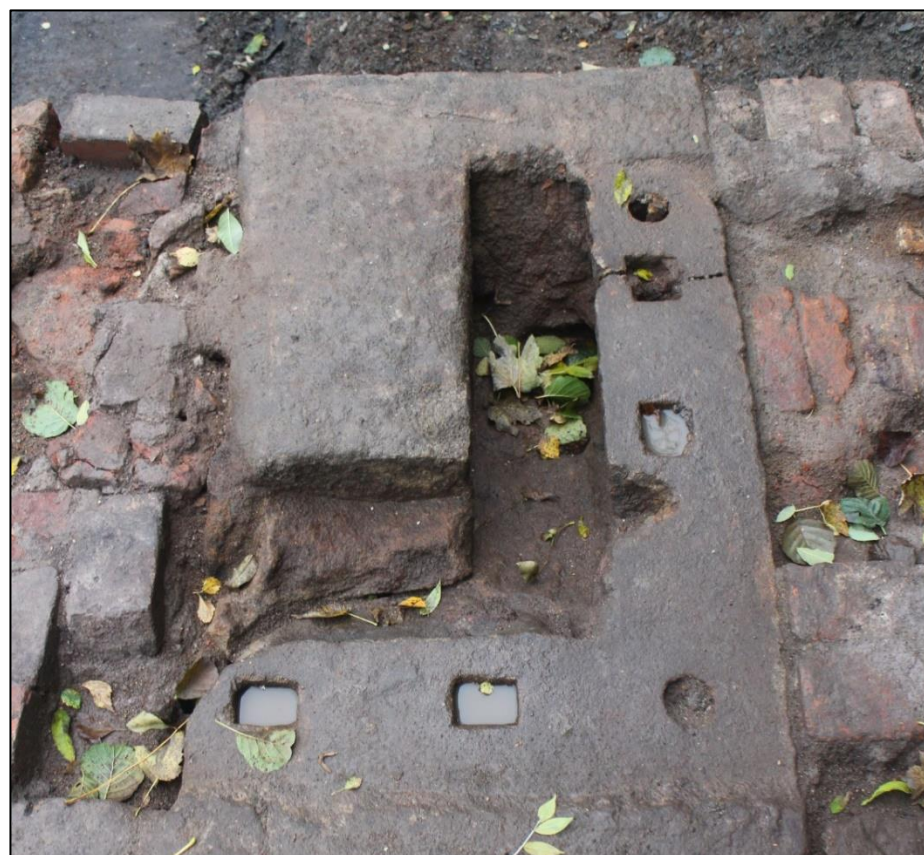
Plate 17: Detail of the large sandstone block incorporated into the Phase 1 walling

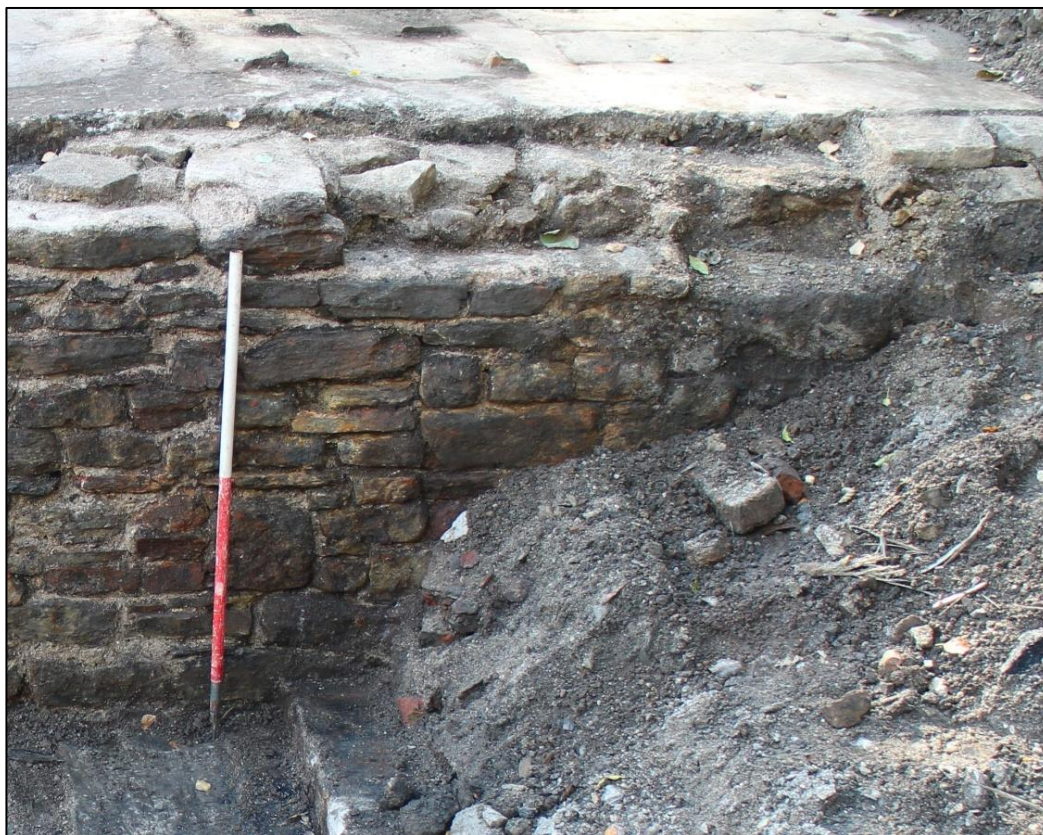
3.3.7 Directly opposite, on the opposing wall, an area of infilled masonry, measuring c 1.5m wide, was also present suggesting that an opening originally existed within this wall that was blocked at a later date (Plate 18). It is therefore possible that these two opposing features denote the position of the axle of the waterwheel, with the opening

Plate 18: Infilled masonry (right) in the Phase 1 wall defining the southern bay of the mill/bleach works

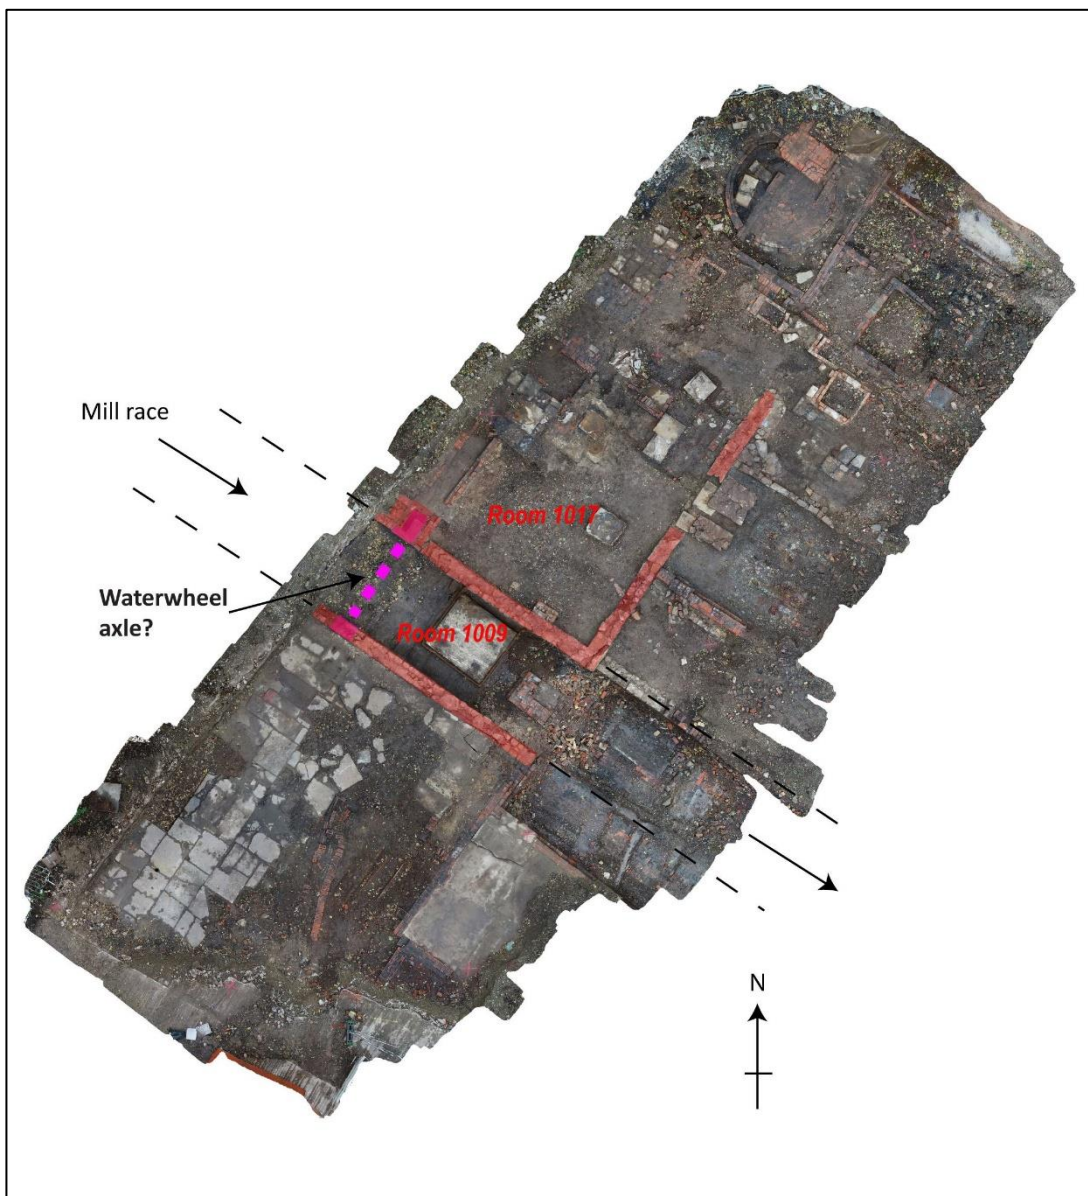
on the north-eastern wall of the southern bay marking the position of the gearing box for the waterwheel (Plate 19).

Plate 19: Overhead view of Area 1 with the Phase 1 remains highlighted

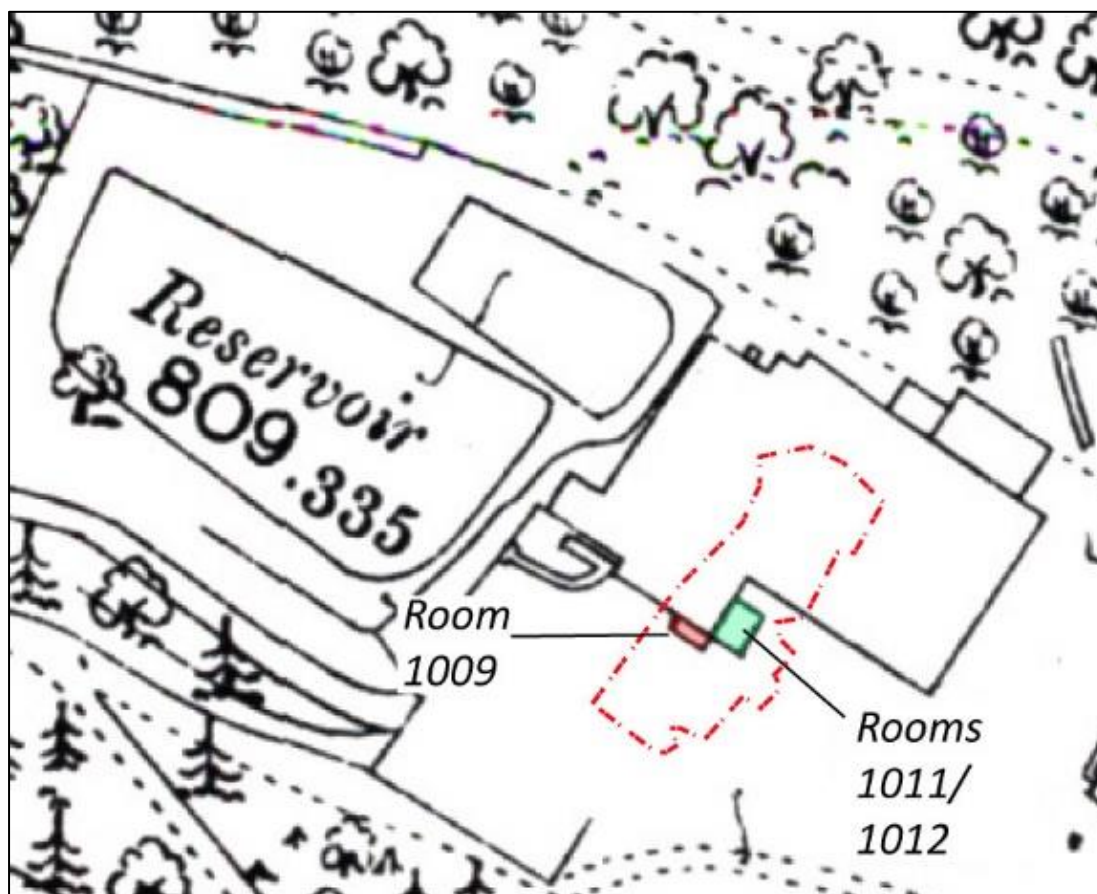
3.3.8 **Phase 2 (later nineteenth century):** the Phase 2 remains were very limited (Fig 8), but those that were present formed elements of the Redisher Wood Bleach Works that is depicted on the OS map of 1893 (see Section 1.4.10 above). It is evident from this map that by the time of its survey in 1891, the southern bay of the mill had been demolished, which in Area 1 would also have involved the removal of the Phase 1 waterwheel (see Section 3.3.7 above). The northern bay was, however, retained, though substantially extended on its eastern side. The map evidence and archaeological remains also indicate that, although the southern bay was demolished, one short section of walling that formed an element of its northern side was retained, which was used to create a small projecting room that interestingly broadly equates with the position of **Room 1009** in Area 1 (Fig 9; Plate 20).

Plate 20: An extract from the OS map of 1893, showing the late nineteenth-century bleach works in relations to Area 1, with the positions of **Room 1009** (Phase 1) and **Rooms 1011 and 1012** (Phase 2) highlighted

- 3.3.9 The map evidence also indicates that a small building was abutted onto the south-eastern corner of the northern bay (Plate 20) and part of this building was present in Area 1. Moreover, the remains indicate that it contained two rooms, designated **Rooms 1011** and **1012**, which measured 2.4m and 3.9m wide respectively (Plate 21; Fig 9). The southern exterior wall of this building abutted the eastern side of the Phase 1 wall defining **Room 1017** (see Section 3.3.3 above), and was built of squared rubble masonry, bonded with a light grey lime-based mortar; this wall was 0.5m thick (Figs 7 and 8). Similarly, the northern exterior wall of the building also butted the Phase 1 wall of **Room 1017**. However, this wall was composed of squared dry rubble masonry and was more substantial measuring 0.7m wide, though much of it had been ‘robbed’/removed at a later date. The partition wall defining the two rooms was also stone built, and mortared, c 0.5m wide, and butted the Phase 1 wall of **Room 1017**.

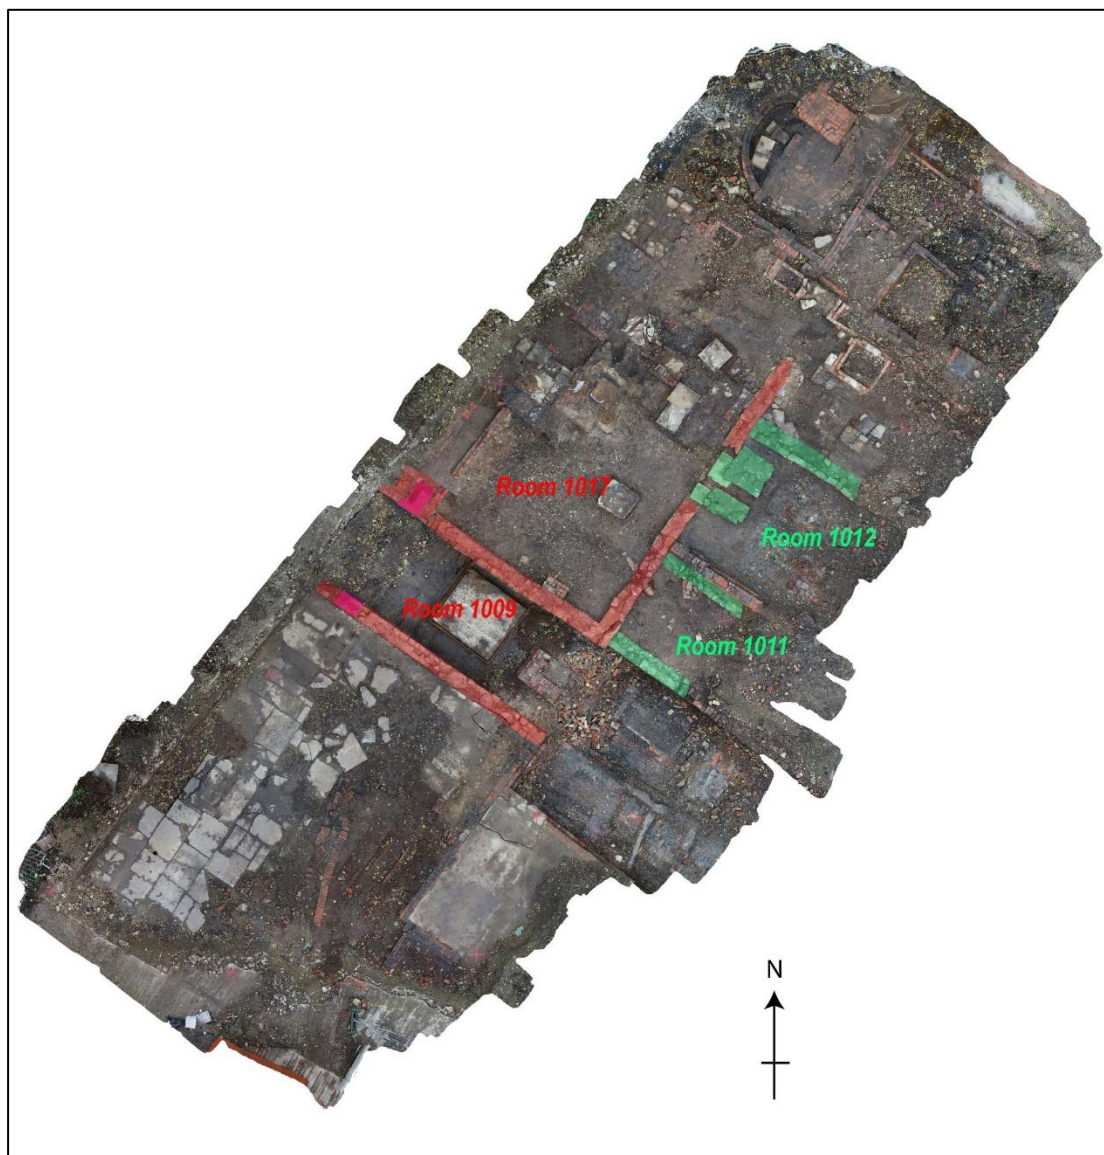
Plate 21: Overhead view of Area 1 with the Phase 2 remains highlighted in green

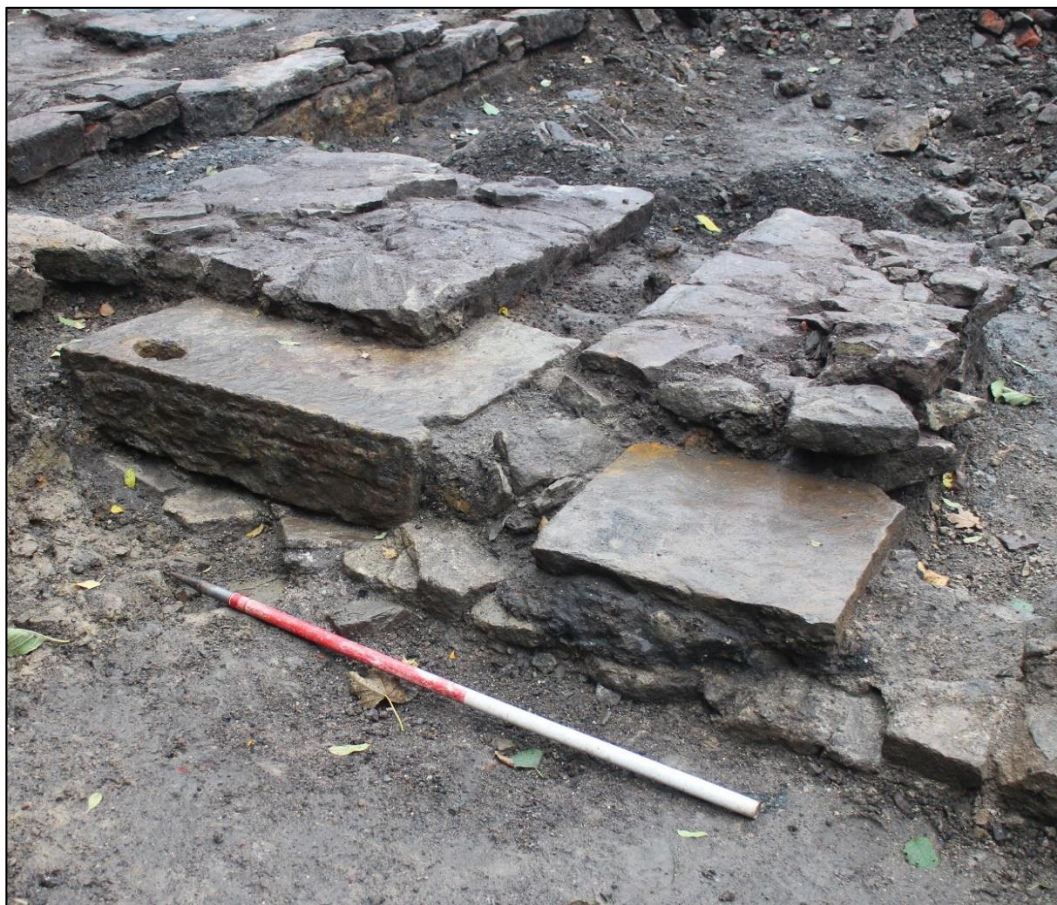
3.3.10 Although no floor surfaces survived in either of the rooms, **Room 1012** did contain two, late nineteenth-century structures, which truncated the Phase 1 wall defining **Room 1017** (Figs 7 and 8). Both structures were composed of stone rubble, bonded with mauve coloured lime-based mortar, and each was also partially set on a stone block and partially on a levelling deposit of shale (**1018**). The stone-rubble structures were set 0.36m apart and the more southerly measured 1.25 x 0.65m, whilst the northerly base measured 1.25 x 1.10m (Plate 22). Within the gap separating the bases three ‘holding down’ bolts were also present, whilst the stone slab that supported the northern structure also had a cut circular hole and arcing notch denoting the position of two additional bolts. This evidence clearly indicates that the structures and bolts represent a machine base, which secured a machine that lay within this part of the bleach works.

Plate 22: The Phase 2 stone machine base in Room 1013

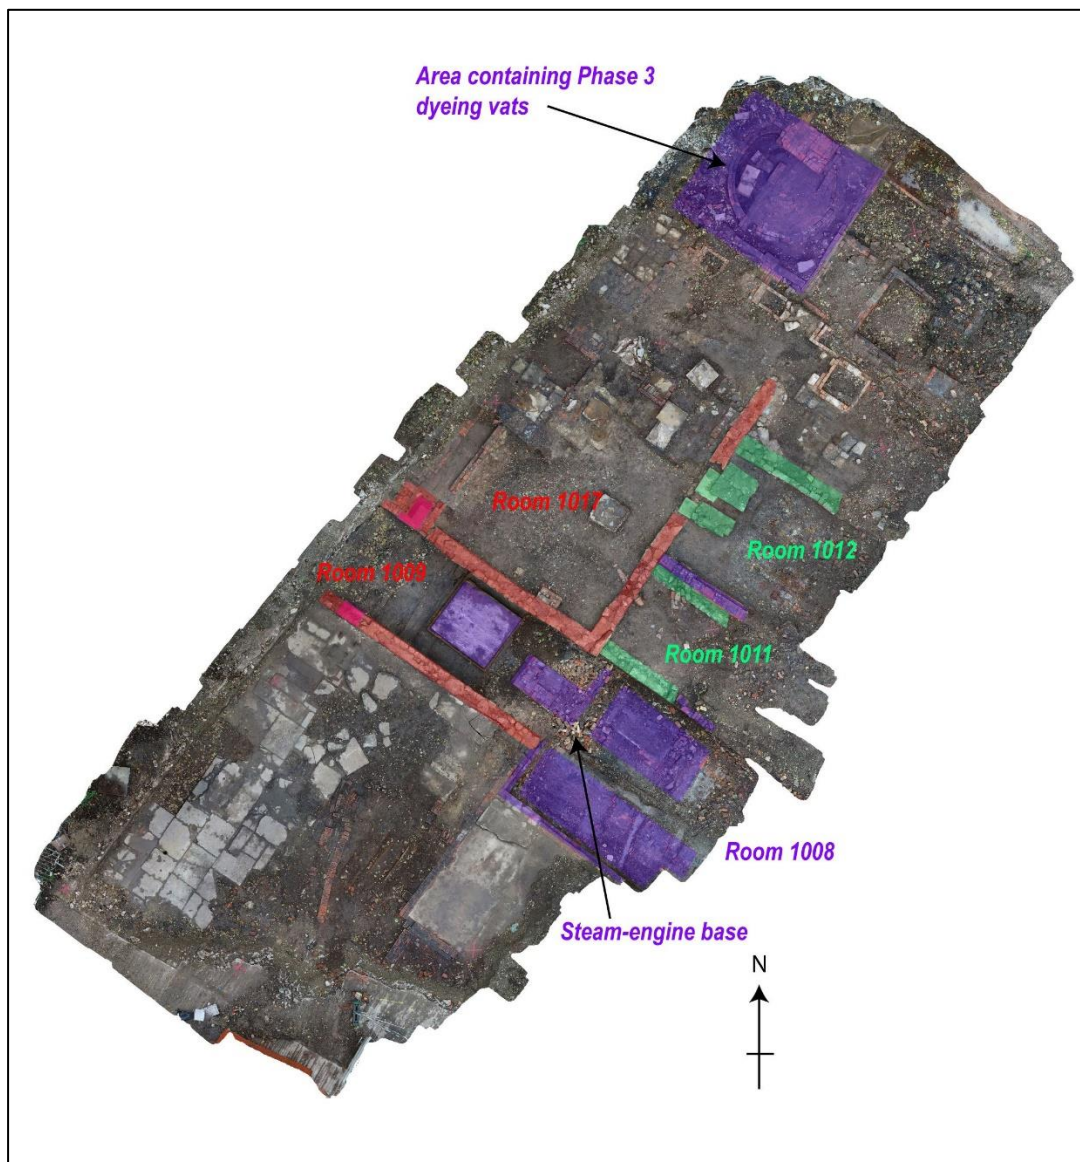
3.3.13 Within Area 1, remains relating to the south-western corner of **Room 1008** were present (Plate 24). Specifically, a right-angled length of double-skin walling was exposed, constructed of machine-made bricks. This butted onto the south-eastern stone wall of **Room 1009** and formed the exterior wall of the extended room. To the north-west, the wall of **Room 1008**, which now formed an interior partition wall, had also been partially replaced, as part of this expansion/modification, by a Phase 3 double-skin wall composed of machine-made bricks; in its lower courses, beneath the former floor levels, this wall also contained two ceramic drains. Similarly, the stone partition wall separating **Rooms 1008** and **1009** (see Section 3.3.9 above) was also completely replaced by a machine-made brick wall, beneath which lay a ceramic drain, that also cut through the earlier wall line (Plate 25). However, this latter wall was more substantial than the other Phase 3 walls, being three-bricks wide.

Plate 24: Overhead view of Area 1 with the Phase 3 remains highlighted in blue

3.3.18 Other Phase 3 remains were also encountered in the northern corner of Area 1 (Plate 24). In this part of the trench, a series of Phase 4 dyeing vats/cisterns were present (see Section 3.3.21 below), and excavation beneath one uncovered the remains of an earlier dyeing vat, which presumably dates to the earlier part of the twentieth century. Excavation of this structure was, however, hampered due to the ingress of contaminated liquids, and so its full extent could not be determined, but it was evident that the vat had a stone base and stone-slab sides (Plate 31).

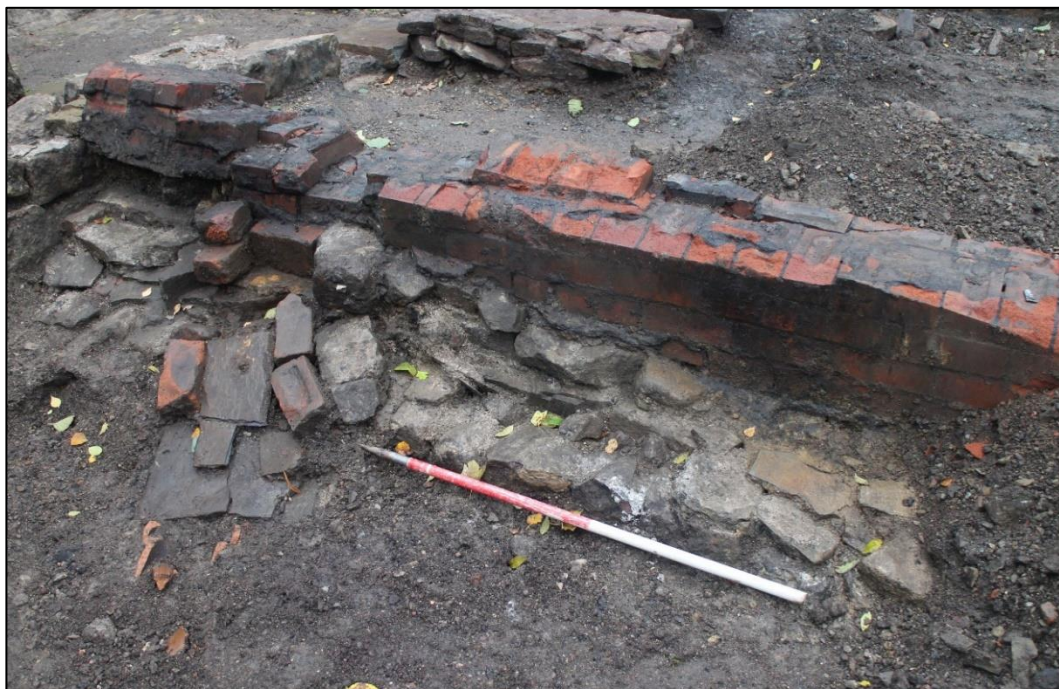
Plate 25: The Phase 3 brick wall positioned separating **Rooms 1008** and **1009** and the Phase 3 drain (left). These overlie a Phase 2 stone wall

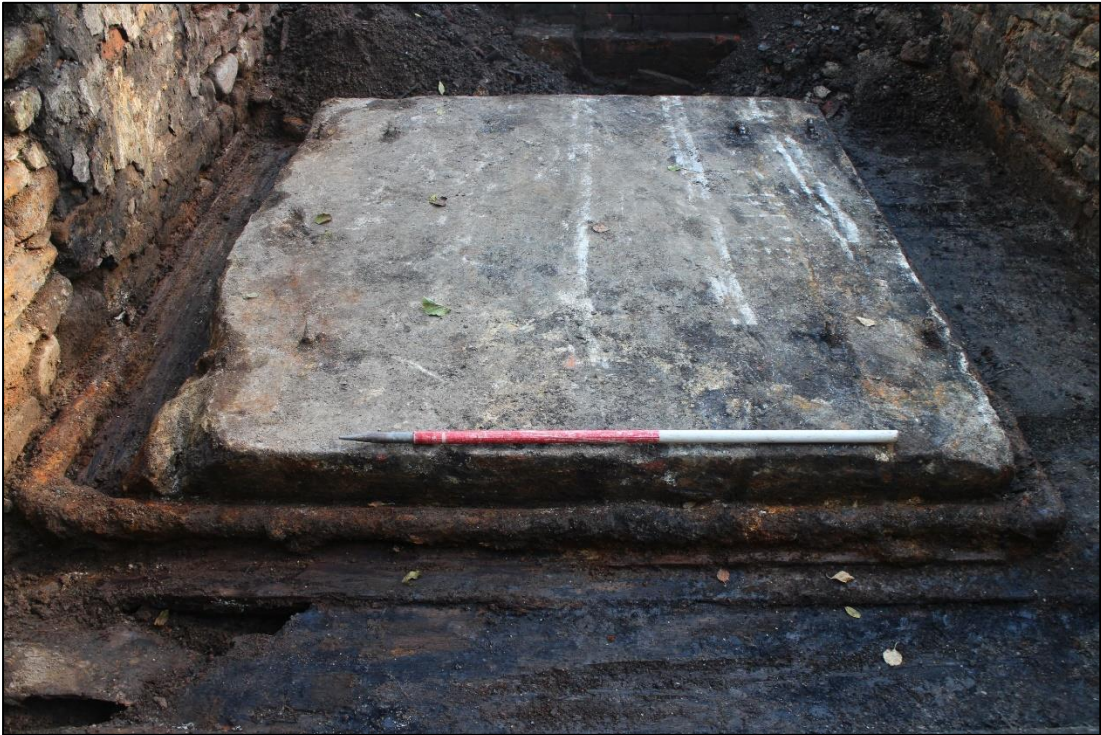
3.3.14 Significantly, within the confines of **Rooms 1008** and **1009**, which together formed one continuous room, were several structures which relate to the power system of the late nineteenth/early twentieth-century bleach and dye works (Fig 8). In **Room 1009** these included a large sandstone block, forming a base measuring c 2.2 x 1.95m, which contained eight iron ‘holding down’ bolts within the upper surface. These bolts were arranged in pairs and were positioned at the corners of the block. This block was also surrounded by a 2.5” diameter iron pipe (Plate 26). Set 0.91m south-east of this was another base. This was constructed of early twentieth-century frogged bricks, and slate, with cement mortars, and its upper surface, although truncated, contained a stone base with four iron fastening bolts (Plate 27). This base measured c 2.2 x 1.1m and a single-brick thick wall projected from its north-eastern side, which butted the Phase 2 stone wall defining **Room 1011**. Surrounding both of these bases was also an *in-situ* wooden floor, composed of floor boards measuring 3.10 x 0.27m that were aligned north-east/south-west (Plate 28).

Plate 26: The sandstone base in **Room 1009**

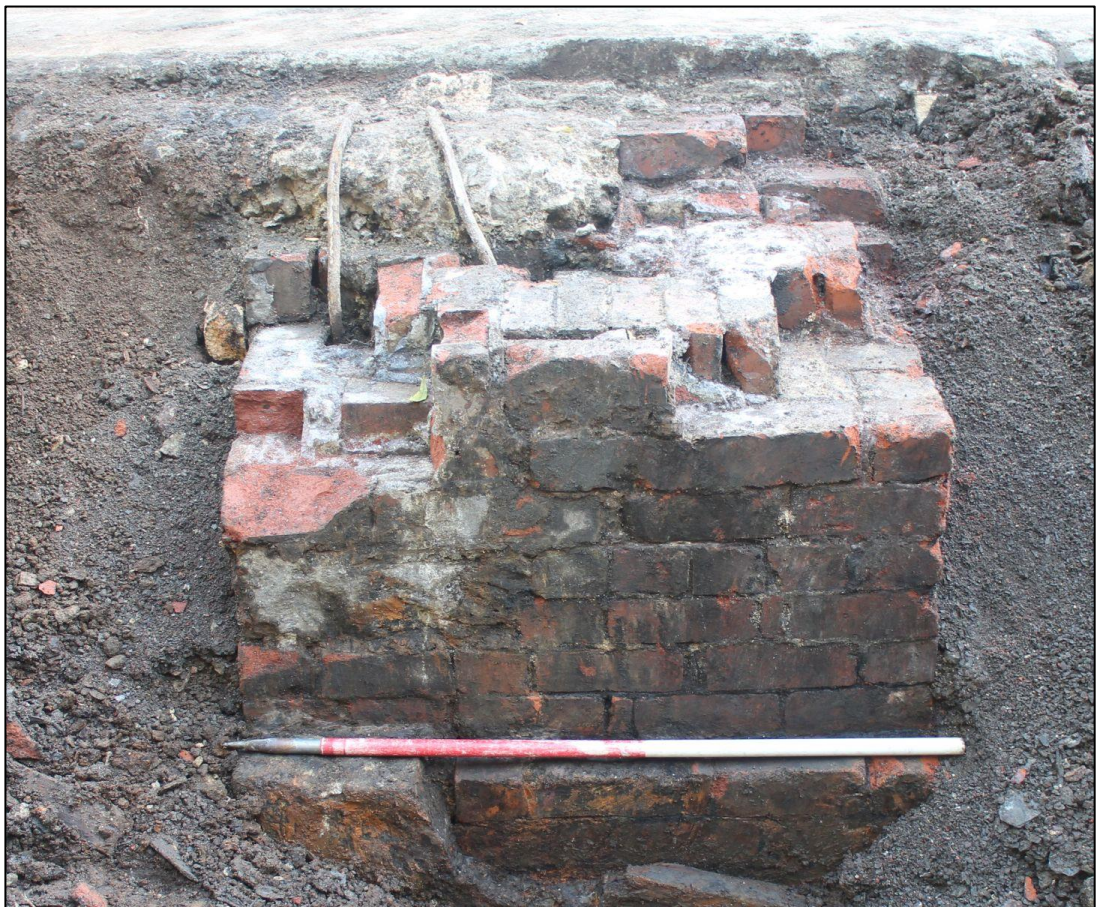
Plate 27: The brick and stone base in **Room 1009**

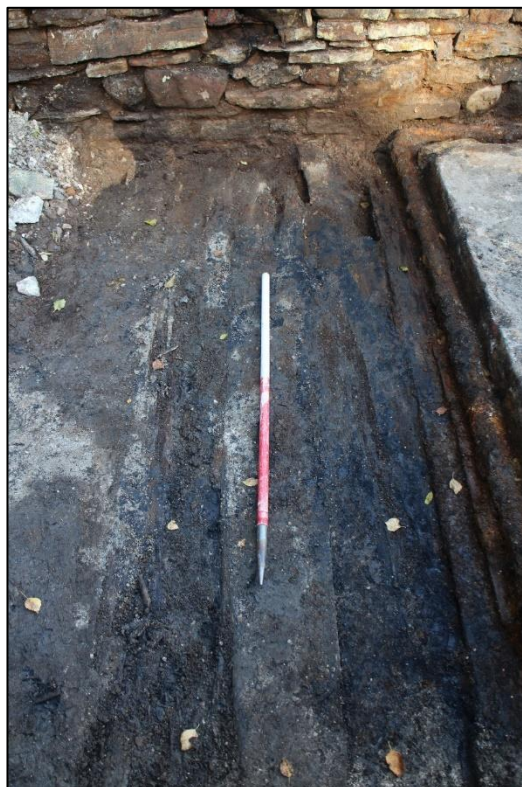
Plate 28: Detail of the wooden floor in Room 1009

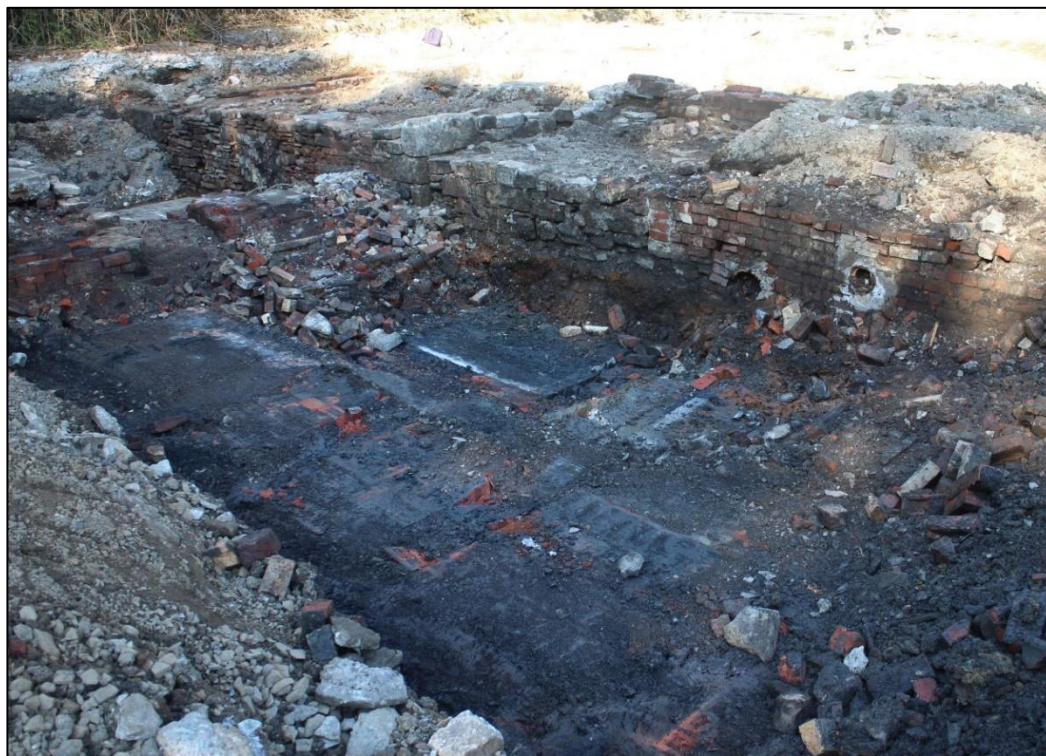
- 3.3.16 Excavation in **Room 1008**, to the south-east of the more easterly of the bases in **Room 1009** (see Section 3.3.14 above) also revealed several additional Phase 3 structures (Fig 8). Unfortunately, these had been heavily contaminated by hydrocarbons, which meant that the excavation was halted in this area, and their extent and form could not be fully determined (Plate 29). However, it was evident, following initial mechanical excavation, that these structures comprised an additional brick-built base, measuring c 1.95 wide, which extended for a least 3m and that contained a large sandstone slab. This base also lay adjacent to a c 1.9m-wide brick-built platform positioned in the southern part of **Room 1008**.

Plate 29: The structures in Room 1008 as seen following initial machine excavation
