Redisher Works, Holcombe Brook, Bury, Greater Manchester Archaeological Investigation

December 2018

Client: CgMs Heritage

Archaeological Investigation

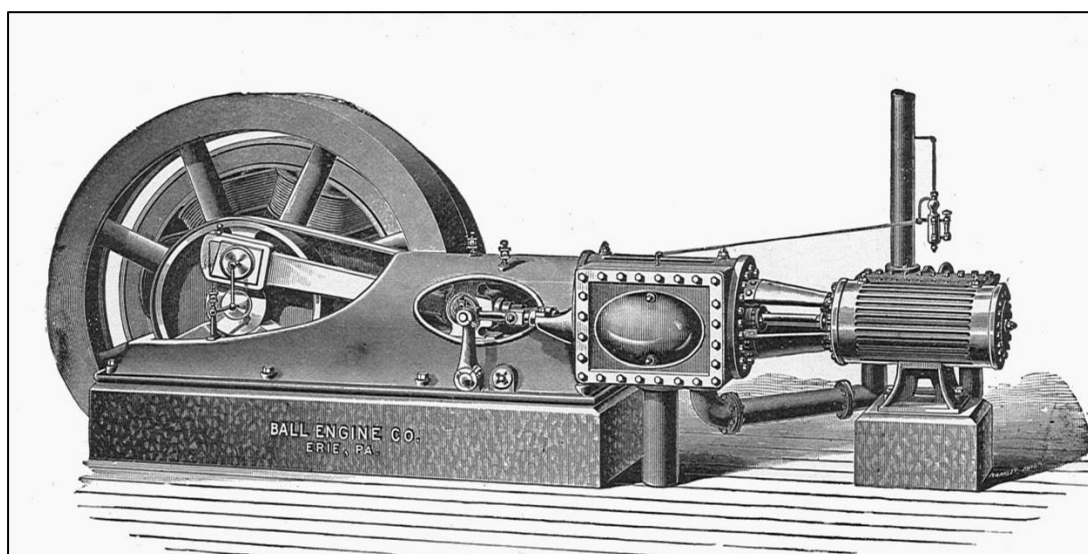
3.3.17 When the Phase 3 remains from **Rooms 1008** and **1009** are considered together, it is evident that these comprised two bases, with holding-down bolts, and a larger brick and stone base, adjacent to a brick platform. Significantly, based on their form and layout, it seems quite possible that these remains relate to a horizontal tandem-compound steam engine (Plate 30). If this was the case, the two bases in **Room 1009** would have secured the two cylinders of the engine, whilst the base and platform in **Room 1008** would have supported the piston and flywheel. This may also imply that the boiler(s) for the engine were positioned in the unexcavated portions of **Room 1008**.

Plate 30: An 1897 engraving of a tandem-compound engine, of a type that may have been installed in Rooms 1008 and 1009

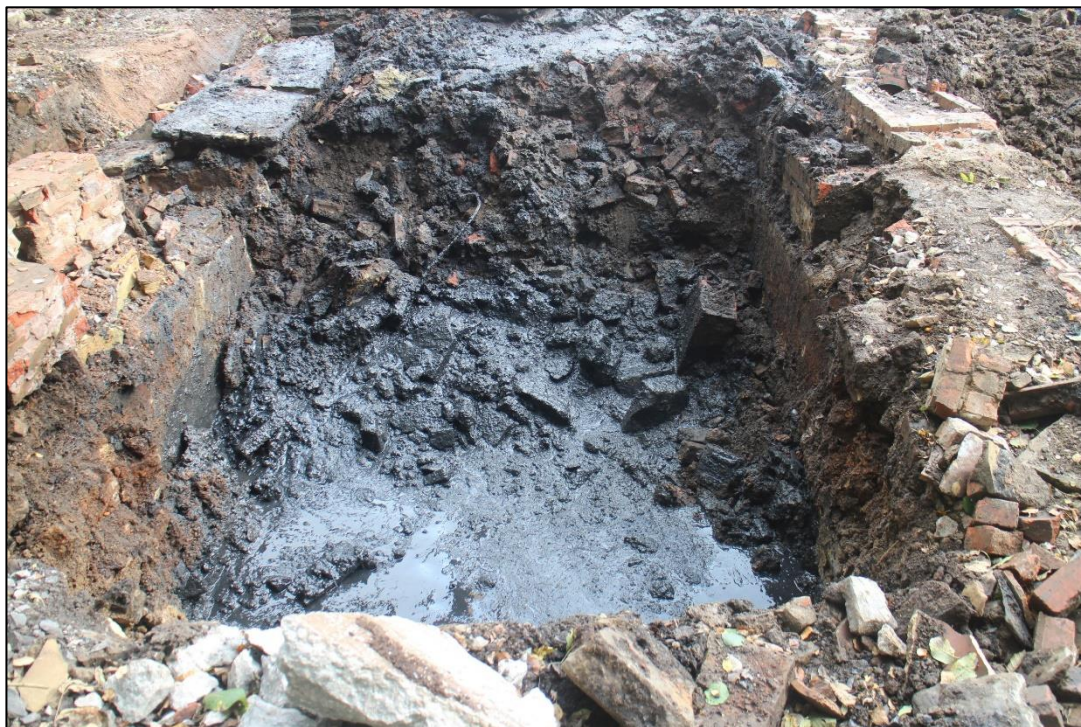
3.3.18 Other Phase 3 remains were also encountered in the northern corner of Area 1 (Plate 24). In this part of the trench, a series of Phase 4 dyeing vats/cisterns were present (see Section 3.3.21 below), and excavation beneath one uncovered the remains of an earlier dyeing vat, which presumably dates to the earlier part of the twentieth century. Excavation of this structure was, however, hampered due to the ingress of contaminated liquids, and so its full extent could not be determined, but it was evident that the vat had a stone base and stone-slab sides (Plate 31).

Plate 31: The partially exposed Phase 3 dyeing vat, heavily contaminated with hydrocarbons

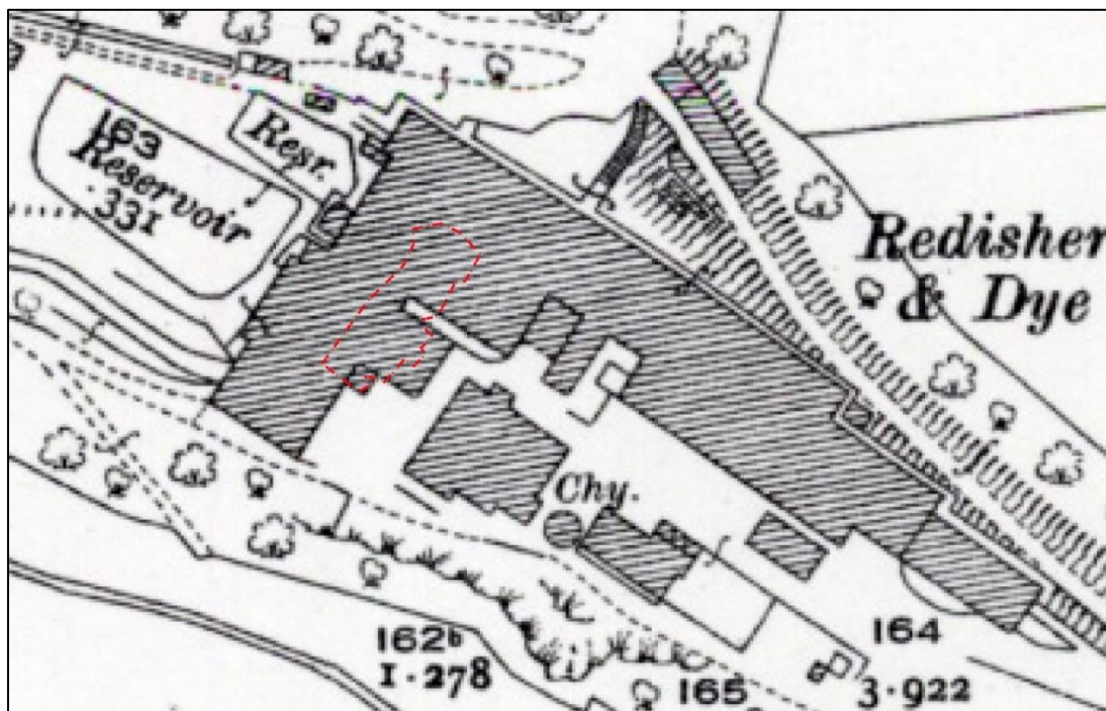
3.3.19 **Phase 4 (early-mid-twentieth century)**: the OS map of 1929 indicates that by time of its publication the bleach and dye works had been significantly expanded (Plate 32; see Section 1.4.17 above). Across Area 1 and its vicinity this entailed the construction of a large south-westerly extension, which covered the footprint of the southern bay of the original early nineteenth-century mill/works. **Room 1008** was also subsumed into a much larger building that lay on the eastern side of the south-westerly extension. It is evident from the remains in Area 1 that this phase of enlargement entailed the decommissioning of the engine in **Rooms 1009** and **1008** (see Section 3.3.17 above) with its structural remains in **Room 1008** being subsequently sealed by a Phase 4 concrete floor. In addition, the Phase 3 dyeing vat in the northern corner of Area 1 was also sealed and replaced by a series of Phase 4 structures that were also associated with the dyeing of textiles (see Section 3.3.22 below).

Plate 32: An extract from the OS map of 1929, showing the early-mid-twentieth-century bleach and dye works in relation to Area 1

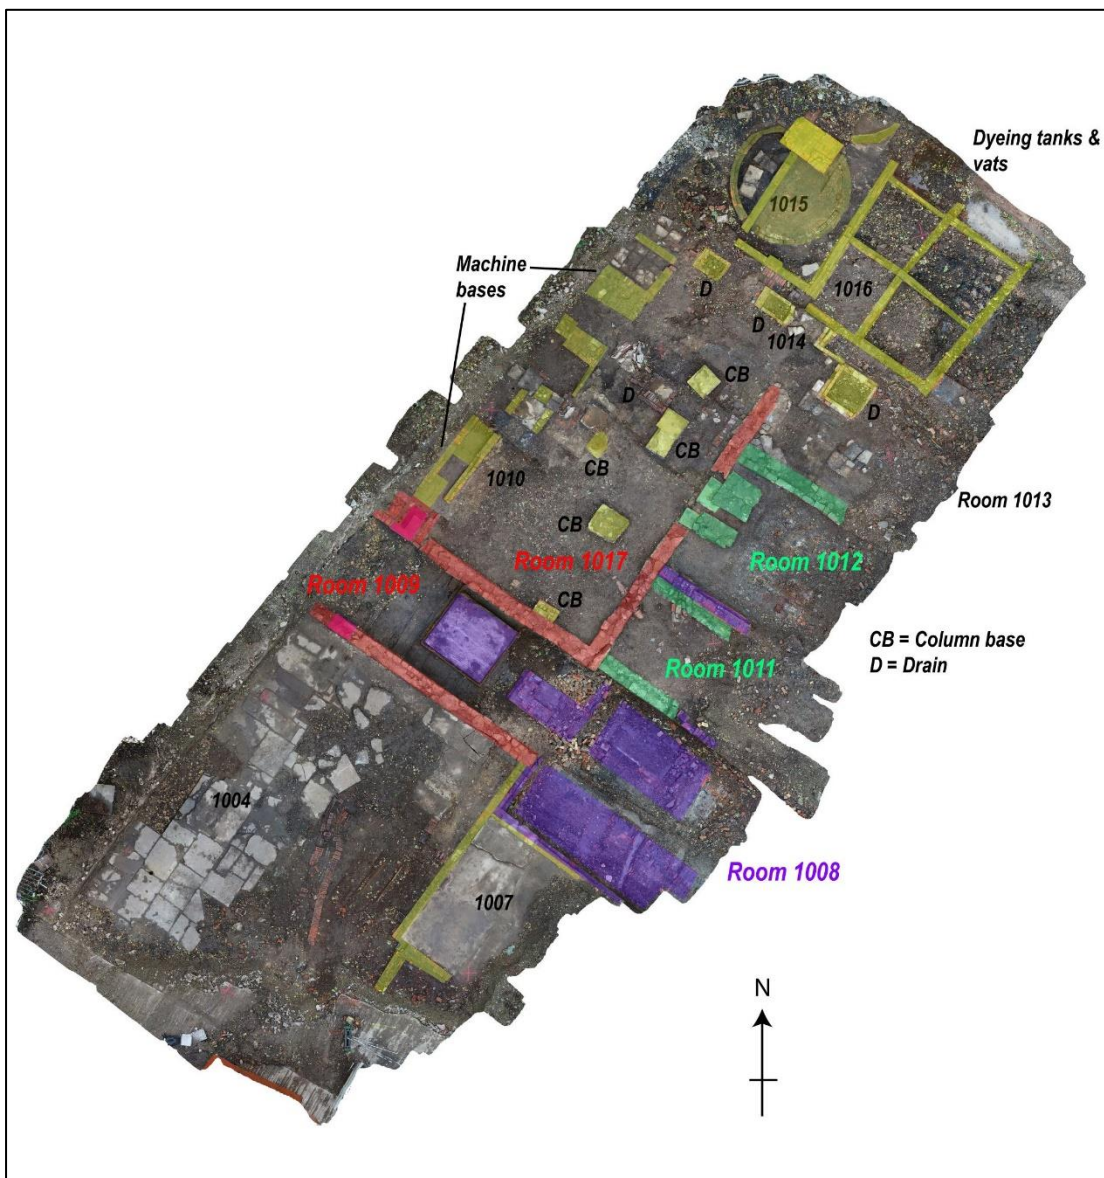
3.3.20 The Phase 4 remains to the south of **Rooms 1009** and **1008**, related to two rooms that lay within the south-westerly extension, which were separated by a machine-made brick partition wall, aligned north-east/south-west, that abutted the Phase 1 wall defining the southern side of **Room 1009** (Fig 8; Plate 33). The larger of these contained a floor surface (**1004**) that was composed of a mix of stone flags and concrete, beneath which was a brick-built drain (Plate 34). Although there were very occasional recesses or metal plates within the fabric of the floor, it seems that there was a general absence of machinery or structures associated with the bleaching or dyeing process within this area. The smaller of the Phase 4 rooms in the south-westerly extension lay to the east and this contained a concrete floor (**1007**) and, similarly, contained an absence of evidence for machinery or structures associated with the bleaching/dyeing process.

Plate 33: Overhead view of Area 1 with the Phase 4 remains highlighted in yellow

3.3.21 To the north of **Room 1009**, numerous Phase 4 structures were present in Phase 1 **Room 1017** (see Section 3.3.3 above) and also within an adjoining area, designated as **Room 1013** (Plate 33). Significantly, several of these structures at the far northern end of the **Rooms 1017** and **1013** were clearly associated with dyeing. Importantly, these structures were built above earlier (Phase 3) dyeing vats (see Section 3.3.18 above), indicating that this part of the works had been used for the same activities for a considerable period of time. In addition, it was also apparent that the Phase 4 structures had been constructed sequentially, with the earliest structure comprising the base of a circular dyeing vat (**1015**) with a 3.6m diameter. The base was constructed of machine-made frogged bricks, and comprised a two-course exterior wall bounding a brick floor that was stained in places with a blue-coloured dye (Plate 35). The brick base of the vat was set upon a stone slab, containing a circular recess for the seating of the tank walls above. This slab was composed of four stone flags that were set on redeposited clay. Another stone slab, with a similar arcing recess, lay to the north, continuing outside of Area 1, indicating that a second circular dyeing vat lay in this part of the site (Plate 36).

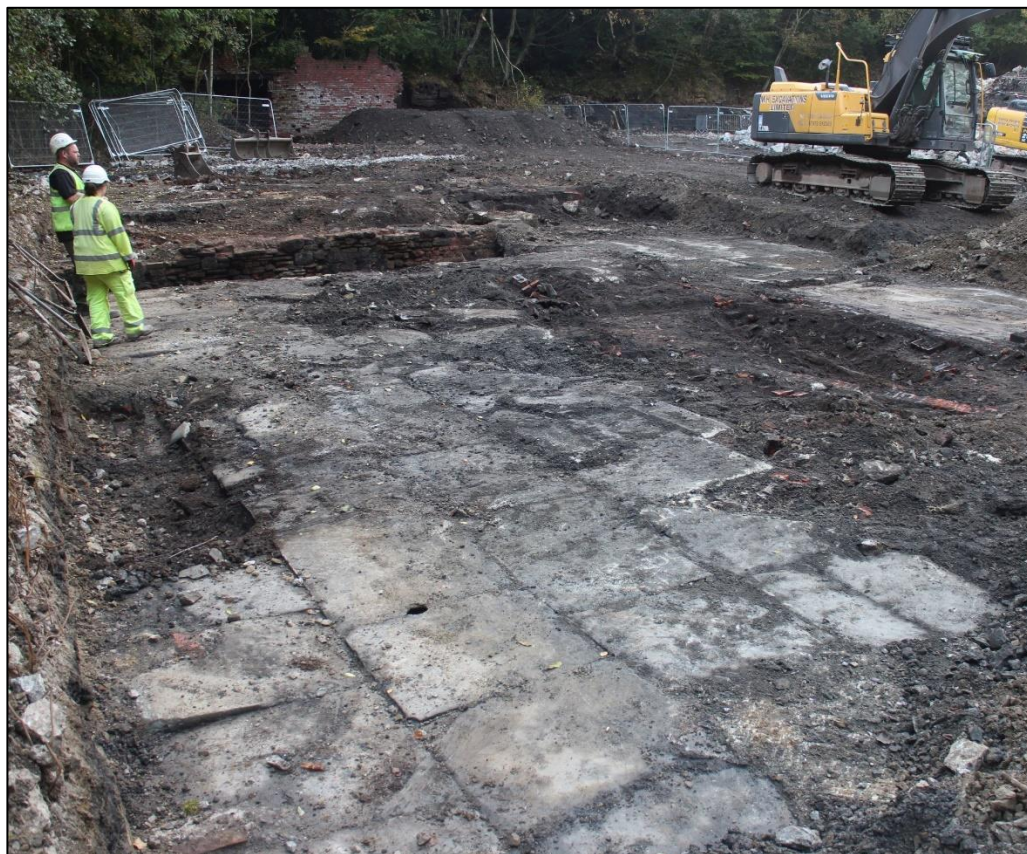
Plate 34: Floor surface 1004

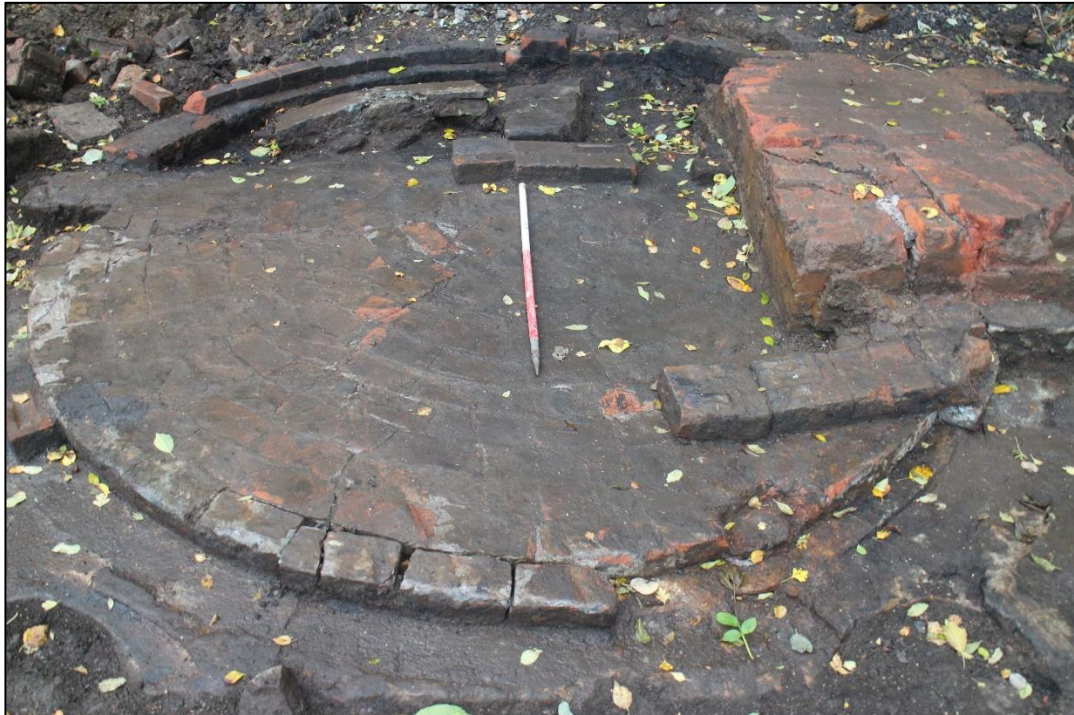
Plate 35: The base of the dyeing vat (1015)

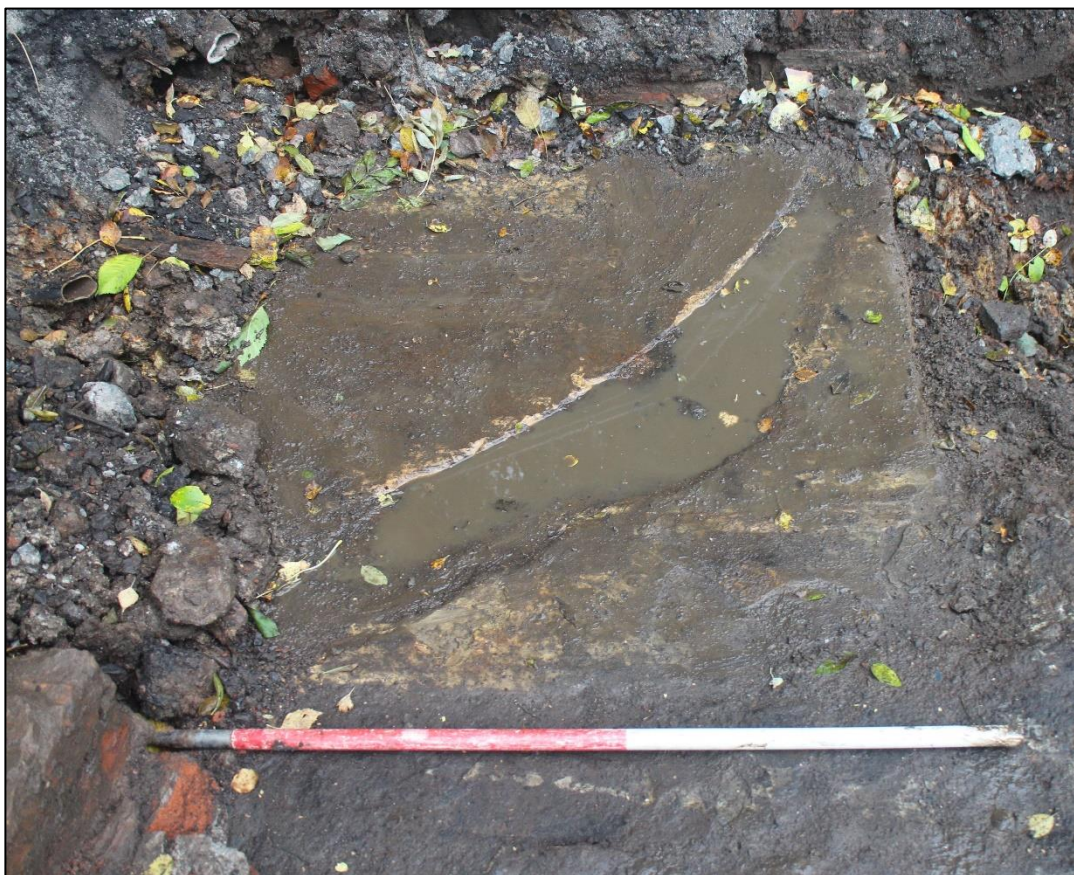
Plate 36: The circular recess defining the base of a circular dyeing vat

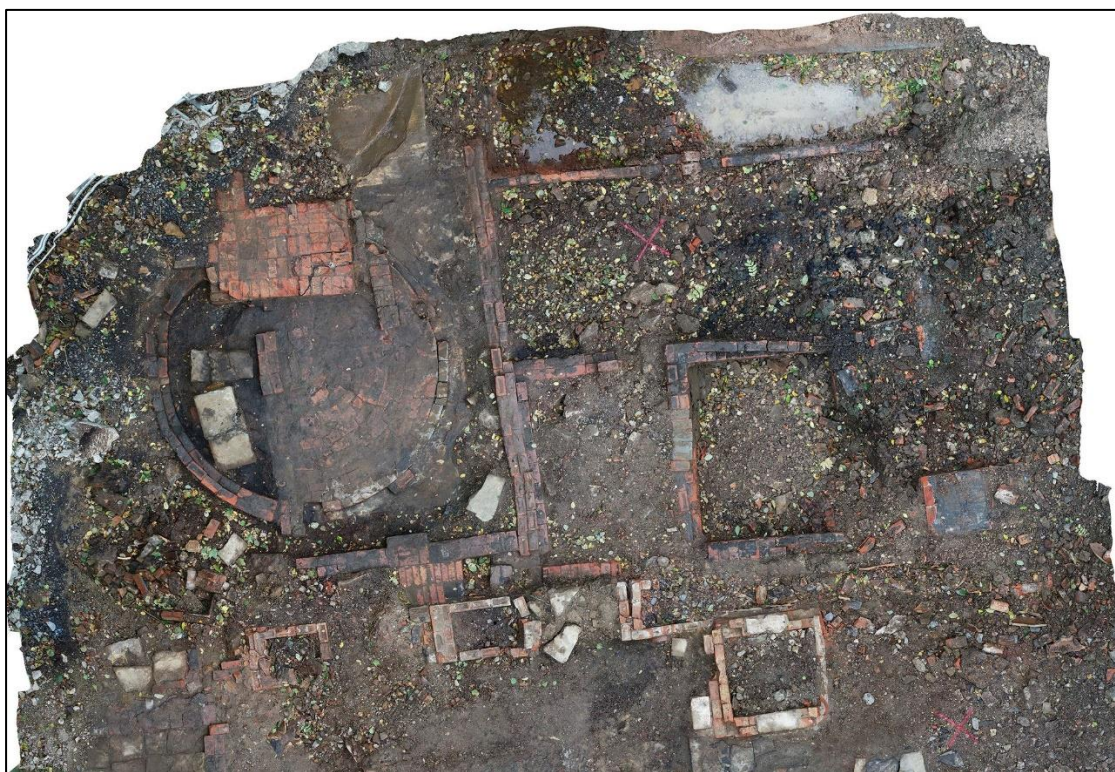
3.3.22 The life of these two circular vats seems, however, to have been short-lived, as they were subsequently replaced, in the mid-twentieth century, by a bank of rectangular/square dyeing tanks. The larger of these had been built directly over the circular dyeing vats (Plate 37), and although portions of this lay beyond Area 1, it was evident that it was defined by a double-skin brick wall and was 2.5m wide. Adjoining this tank, was a rectangular grid of twentieth-century brick walling that defining four additional square tanks (**1016**) covering c 3.50m², though an additional length of twentieth-century walling was observed to the immediate north east suggesting the presence of two more tanks that lay just outside Area 1. One of the tanks was excavated and this contained a thick, silty-clay deposit, which was heavily contaminated with a blue-coloured dye identical to that noted in the base of the circular dyeing vat (*see Section 3.3.21 above*). Its brick-built base was also encountered at a depth of 1m. At a later date, probably in the mid-twentieth century, the large rectangular tank was then replaced, by a brick plinth that was built over its western side, which measured c 1 x 1.7m (Plate 38).

Plate 37: The bank of rectangular dyeing vats and adjacent drains

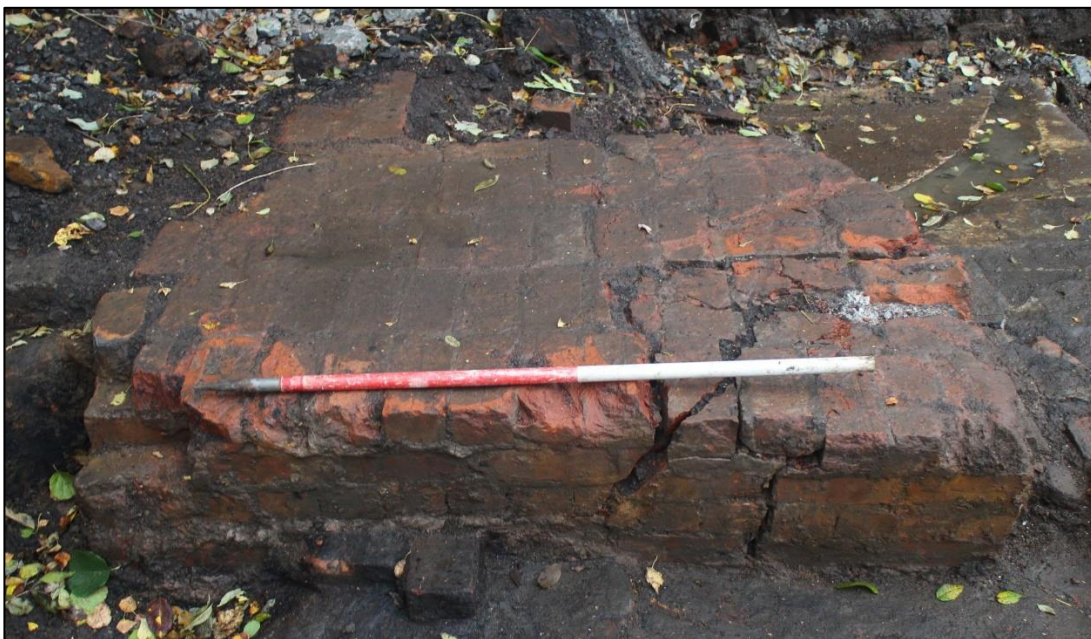
Plate 38: The brick-built plinth

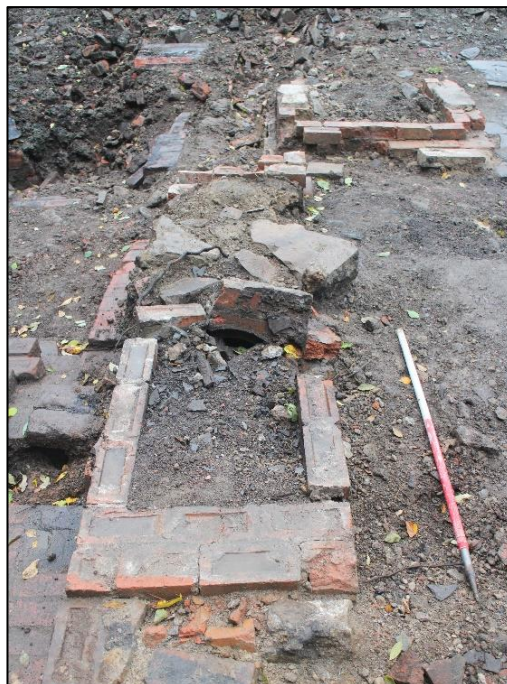
3.3.23 Several other features were also associated with the dyeing tanks and vats. These comprised three brick-built structures (collectively grouped as **1014**). Two of these, were small rectangular structures that lay immediately south of the area containing the circular dyeing vats (**1015**; see *Section 3.2.21 above*), whilst a larger square brick-built structure was positioned immediately south of the square dyeing tanks (**1016**; see *Section 3.2.22 above*; Plate 37). Significantly, a ceramic pipe linked all of these features indicating that they functioned as drains that were almost certainly used to empty the dyeing liquor from the vats and tanks to the north (Plate 39).

Plate 39: Drainage system 1014

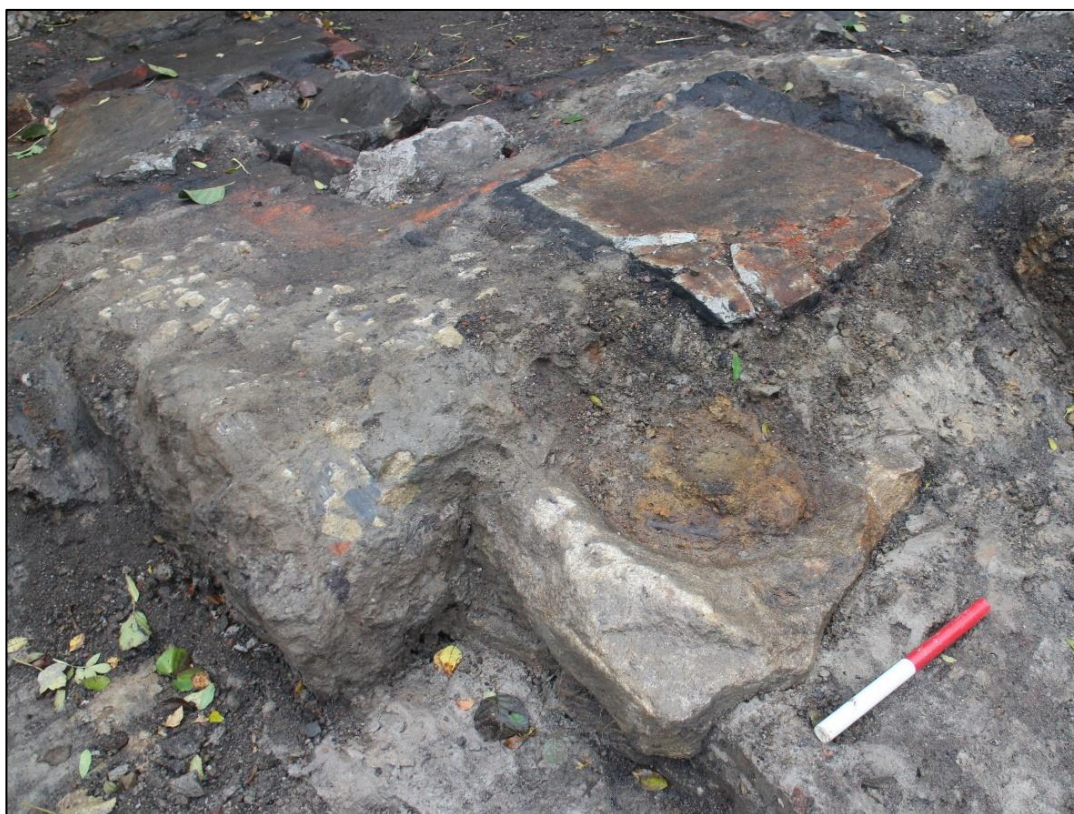
3.3.24 To the south of the vats and tanks, in **Room 1013**, the partial remains of a flagged-floor surface were present. The map evidence indicates, however, that this 'room' and floor surface actually lay outside of works in a passageway. More substantial Phase 4 remains were, however, evident, in **Room 1017**, to the south of the dyeing vats/tanks. These included five small brick/stone bases, set in concrete, which were designed to carry cast-iron columns that would have provided additional support for the room above. On average, these bases measured 0.8m square and in one the remains of a cast-iron column were present (Plate 40). Four of these bases were set in a north-east/south-west line, and one had been butted directly against the Phase 1 walling defining the southern side of **Room 1007** (Plate 33). The remaining column (that containing the cast-iron column base), lay to the west, it had been partially sealed by the only surviving portions of concrete flooring present in this area, which also contained an embedded brickwork floor (Plate 40). A square, brick-built drain, similar in form to those that lay adjacent to the dyeing vats/tanks (*see Section 3.3.24 above*) also lay immediately west of one of the column bases.

Plate 40: The column base with the remains of the in-situ cast-iron column

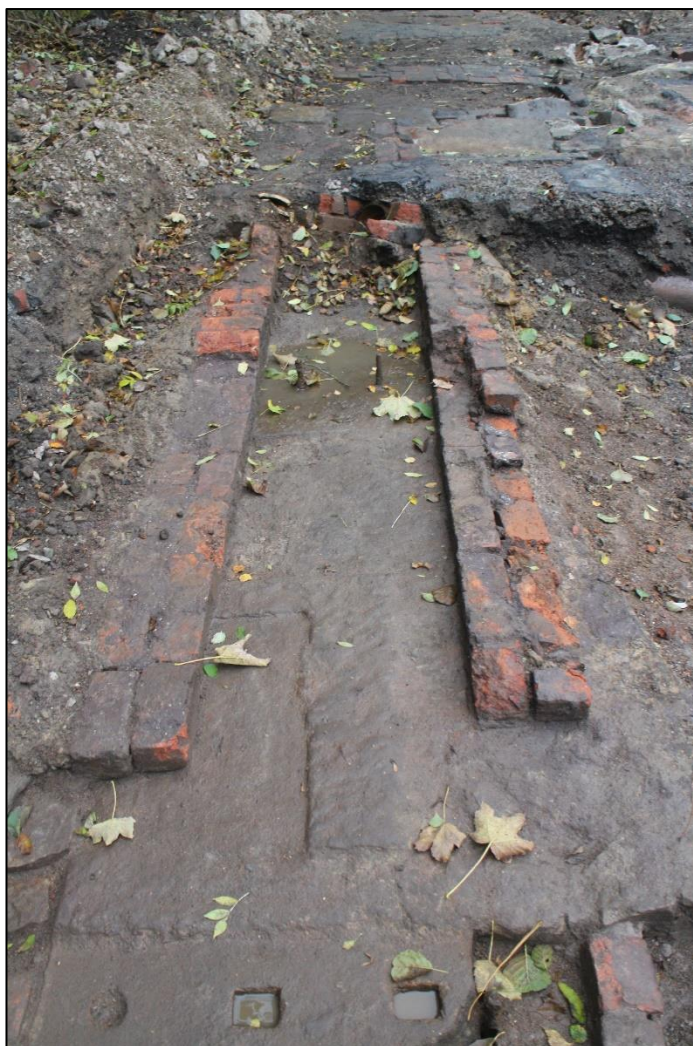
3.3.25 On the western side of **Room 1007** two brick-built pads were present that were associated with short lengths of brick walling that lay to their north-east and south-west, and a small circular ceramic drain that lay immediately north-east of the northern pad. The pads measured c 1.8 x 0.8m, and were spaced c 1m apart, and were constructed using frogged bricks, bonded with dark grey/black cement. To the south-west, the base for another piece of machinery was also present (**1010**), which measured c 0.8 x 2.6m. This was defined by two rectangular stone bases, set 0.74m apart, encased by two lengths of double-skin walling (Plate 41). The northern base also

contained several iron fastening bolts. The function of these features is difficult to ascertain, though they probably supported machinery associated with the dyeing process, given the presence of dyeing vats and tanks to the north.

Plate 41: Machine base 1010

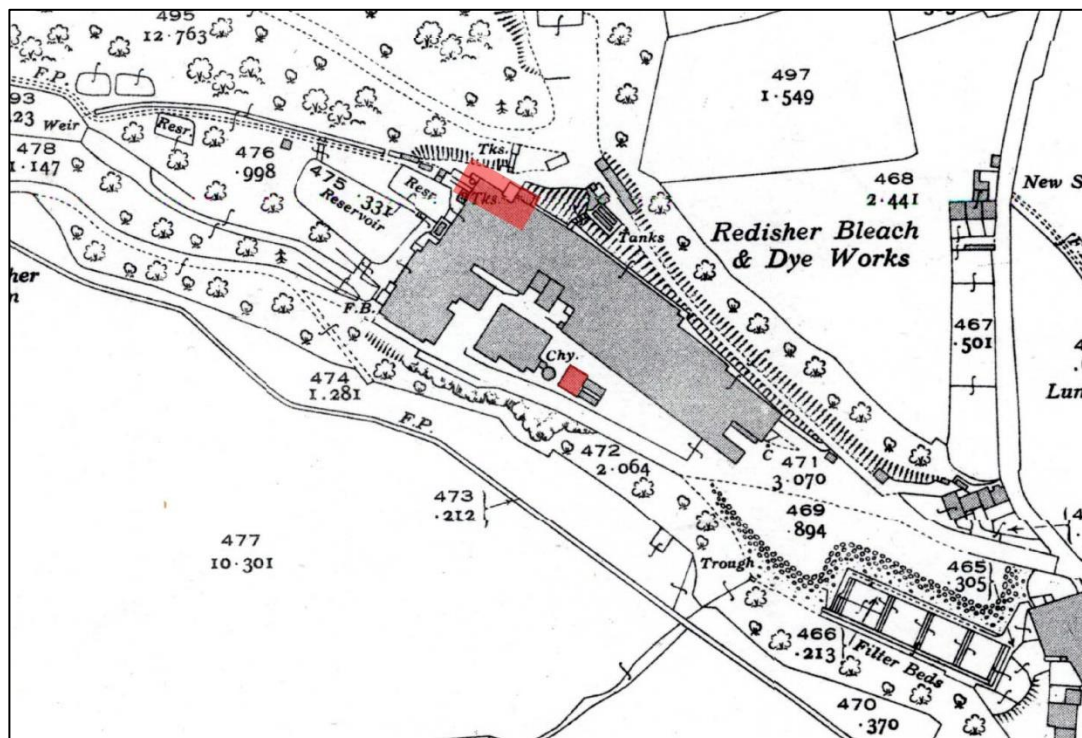
Plate 43: An extract from the OS map of 1939 with the building survey areas highlighted

4.1.1 The building survey targeted two parts of the site (Fig 2) that were deemed to contain historically significant extant structures. One of these areas contained an extant engine house, which is first depicted on the OS map of 1929 (Plate 42; see Section 1.4.17 above), indicating that it was constructed between 1908 and 1927, whilst the other area lay at the north-eastern corner of the site. This latter area was open and wooded at the time of the survey and lay adjacent to an extant reservoir, which formed the smaller of the western reservoirs that are initially depicted on the OS map of 1893 (see Section 1.4.11 above). It is, however, evident from OS mapping that originally it was covered and formed a north-eastern extension to the bleach and dye works that had been added at some stage between 1908 and 1927 (see Section 1.4.17 above), indicating that it was broadly contemporary with the surveyed engine house (Plate 42). It also contained a number of latter additions that are depicted on the OS map of 1939 (Plate 43).

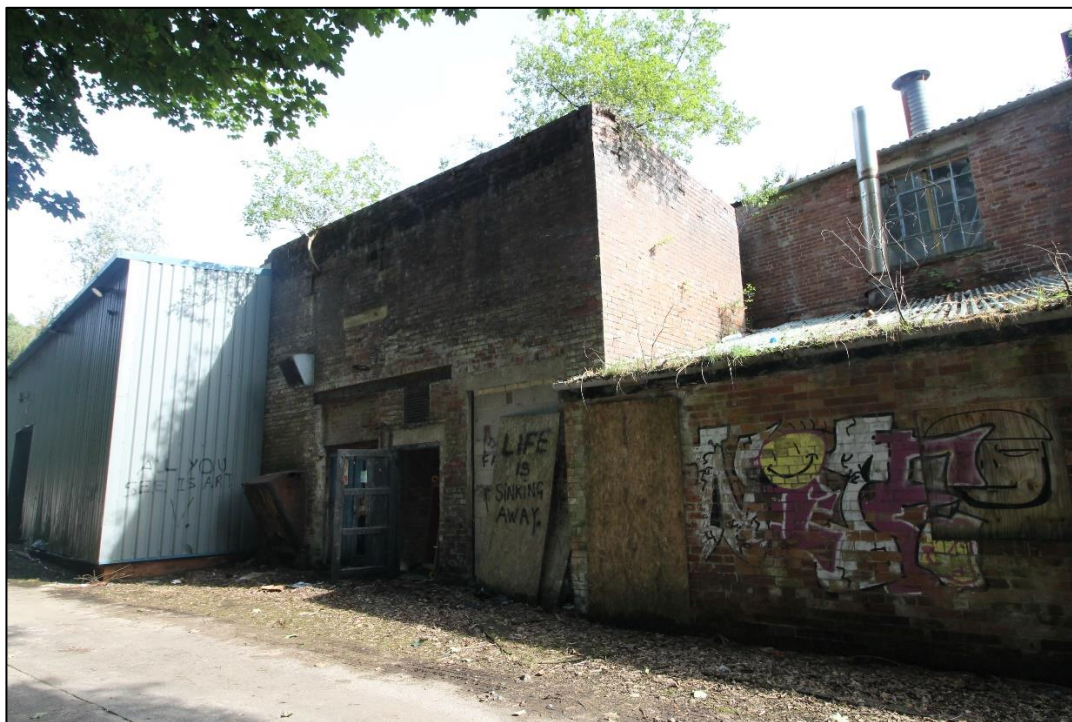
Plate 44: Engine house, facing north

- 4.2.2 **Exterior:** the structure was essentially square in plan, but incorporated a dog-leg at the southern end of the eastern wall that made it approximately a metre wider to the south (Fig 11). Although it only had a single-floor, it stood to nearly two-storeys in height and was constructed in hard-fired, twentieth-century red-brick (Plate 44). It had a flat roof of precast concrete beams set upon a framework of three steel I-section joists, which were hidden behind a low parapet wall. Its main entry point lay to the south.

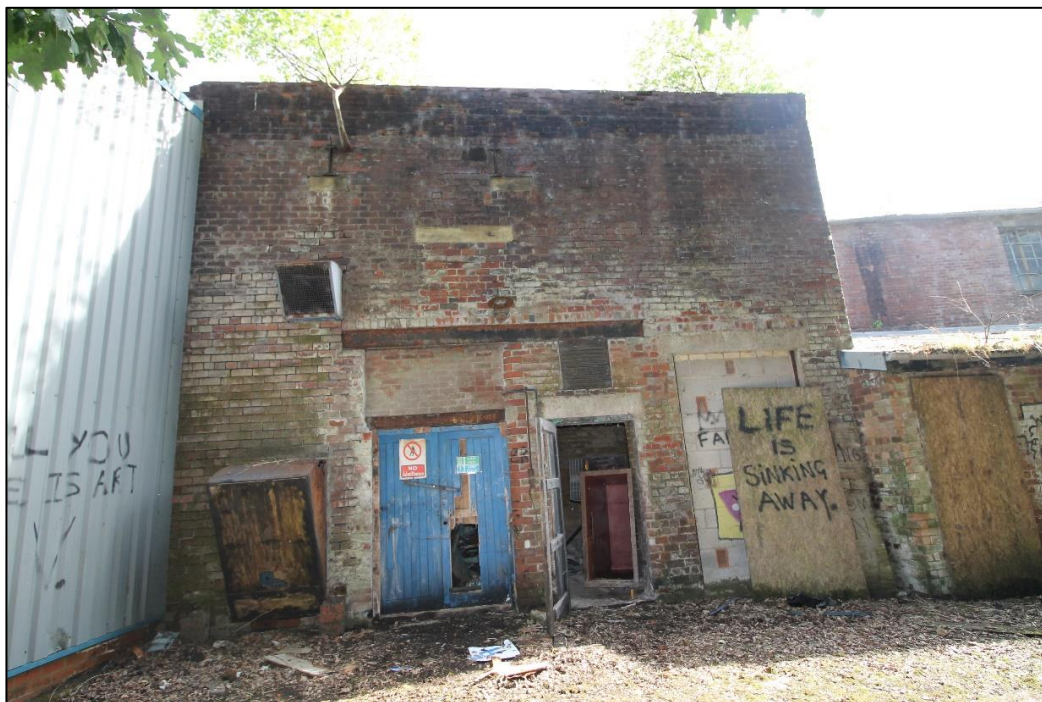
Plate 45: Southern elevation of the engine house

- 4.2.3 The southern elevation incorporated a set of blue double doors to the west of centre, set beneath a steel lintel (Plate 45; Fig 11). The brickwork on the eastern jamb of this door carried a radius, which was not identified on the doors opposing jamb, suggesting a degree of alteration. This opening may originally have been taller, for above the height of the lintel the wall was set back within a recessed rectangular panel that gave the appearance of infill. A second door, of pedestrian width, lay to the east of centre and employed a concrete lintel, above which a square metal vent had been set into the wall. Both the recessed panel and metal vent were topped by a large horizontal steel beam at approximately first-floor height, that spanned the width of both doors beneath. A third and larger door at the eastern end of the elevation had a concrete lintel, a chamfered sill at the base, and its jambs had been rendered in concrete in a manner that suggested the door had been inserted at a later date. This opening had been infilled with a mixture of concrete blocks and ceramic ventilator bricks.

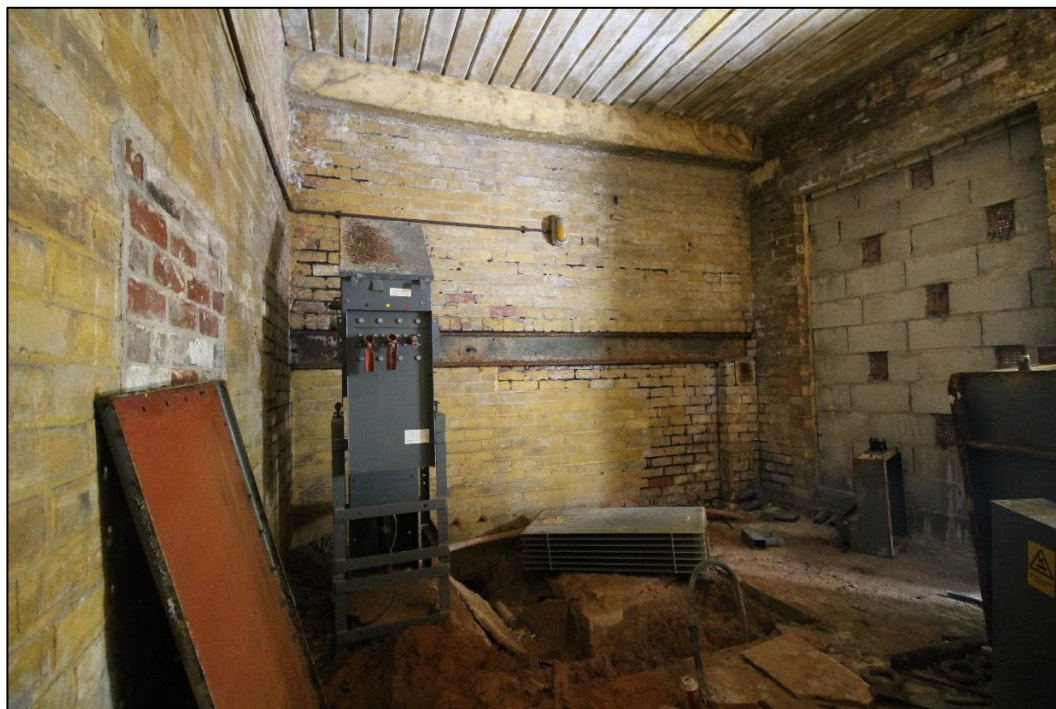
Plate 46: Interior of the smaller square cell, facing east

- 4.2.6 **Interior:** internally, the building had been divided into two cells, with a larger L-shaped cell to the north-west and a smaller square cell in the south-eastern corner (Fig 11). The brick walls of the smaller cell had been coated in white paint and its concrete floor was matched by its own independent internal pre-cast concrete ceiling (Plate 46). There had evidently been a square aperture near the centre of the northern wall, which had been infilled with brick and another above it which had not, retaining its steel louvre vent (Plate 47). A mid-height horizontal steel beam set across the length of the eastern wall may have provided a lintel for a low, wide opening beneath it, although this feature had been blocked in brick (Plate 46), and the room included several pieces of equipment that may have formed part of some kind of heat exchanger.

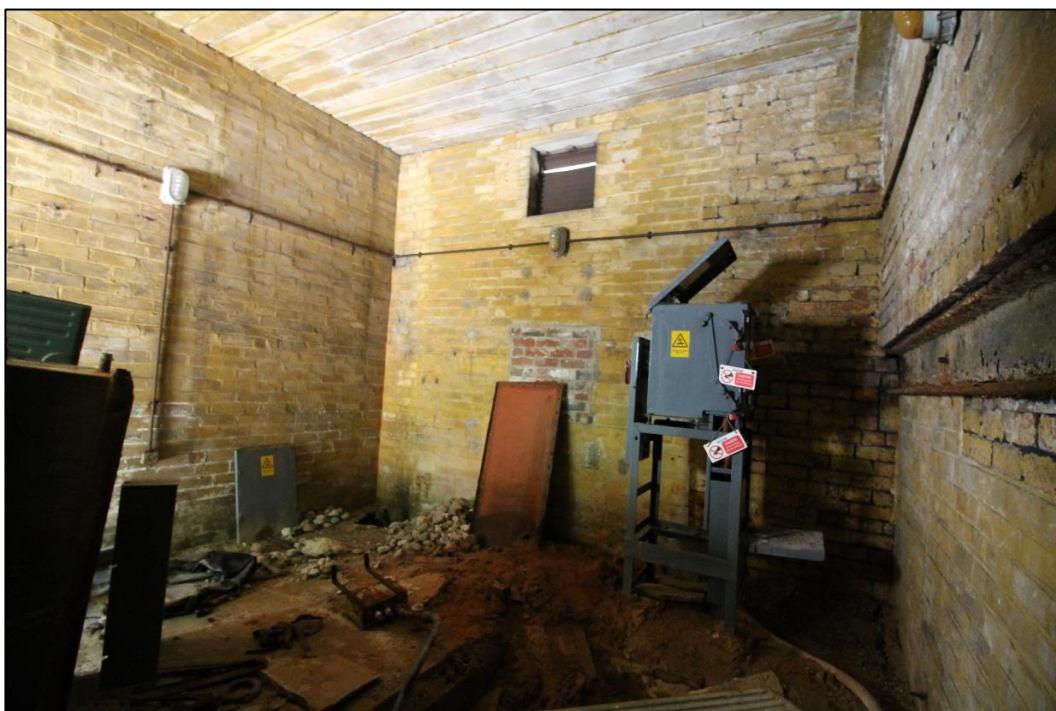
Plate 47: Interior of the smaller square cell, facing north

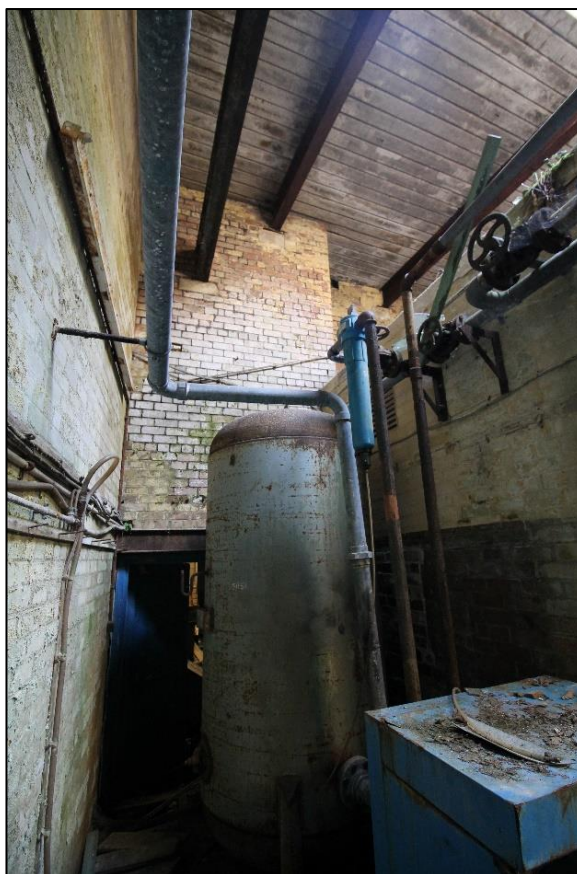
Plate 48: Circular tank in north-eastern corner of the larger cell

4.2.7 The larger cell was open to its pre-cast concrete roof, and its walls were painted in the same manner as the smaller room. A circular steel tank occupied a position in the north-eastern corner, which partially obscured a doorway at the northern end of the eastern wall that connected the building with the interior of the lean-to building (Plate 48). Evidently there had been a second door at the northern end of the western wall, which had been blocked in brick (Plate 49). To the south of the latter door a small low rectangular window fitted with horizontal steel bars had been blocked from the

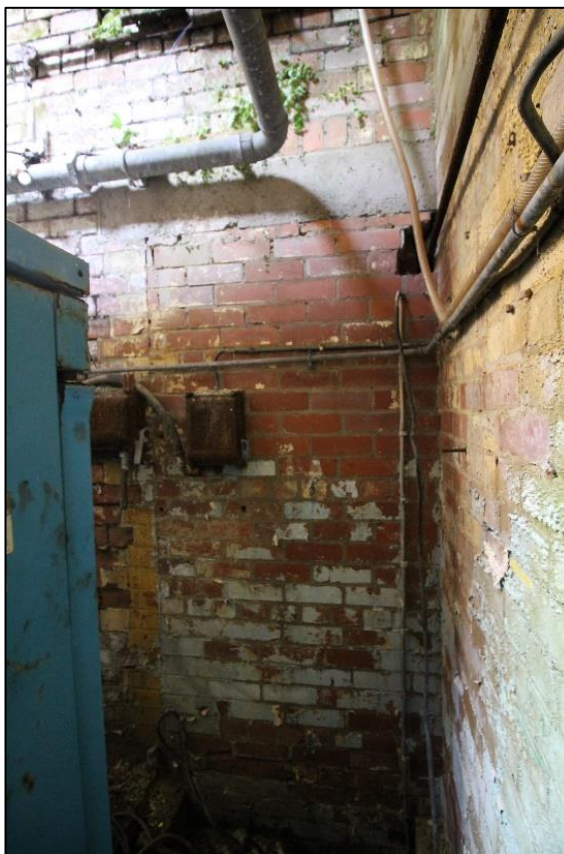
Plate 49: Blocked doorway on the western wall of the larger cell

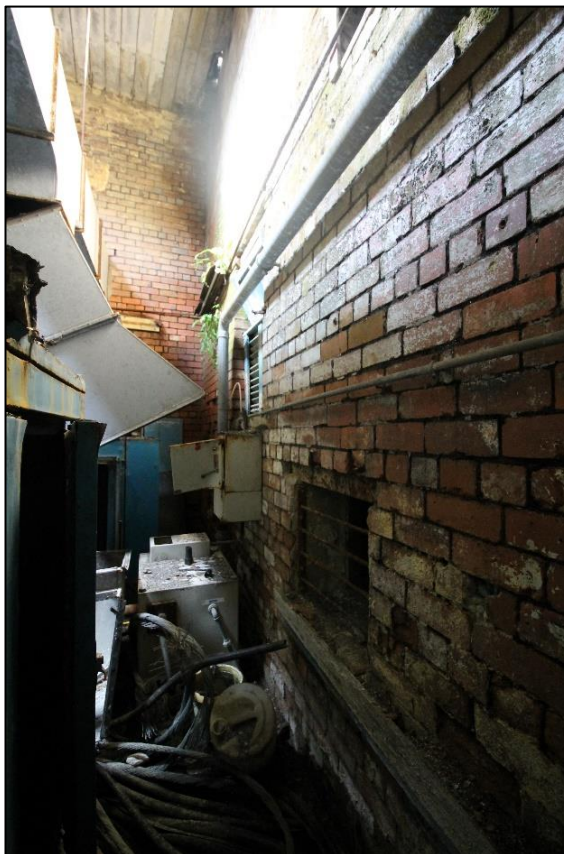
Plate 50: Western wall of the larger cell, showing blocked windows

western side with concrete blockwork. On the same wall, a second and slightly larger window to the south of the first, was fitted with a louvre vent below a two-light glazed hopper (Plate 50).

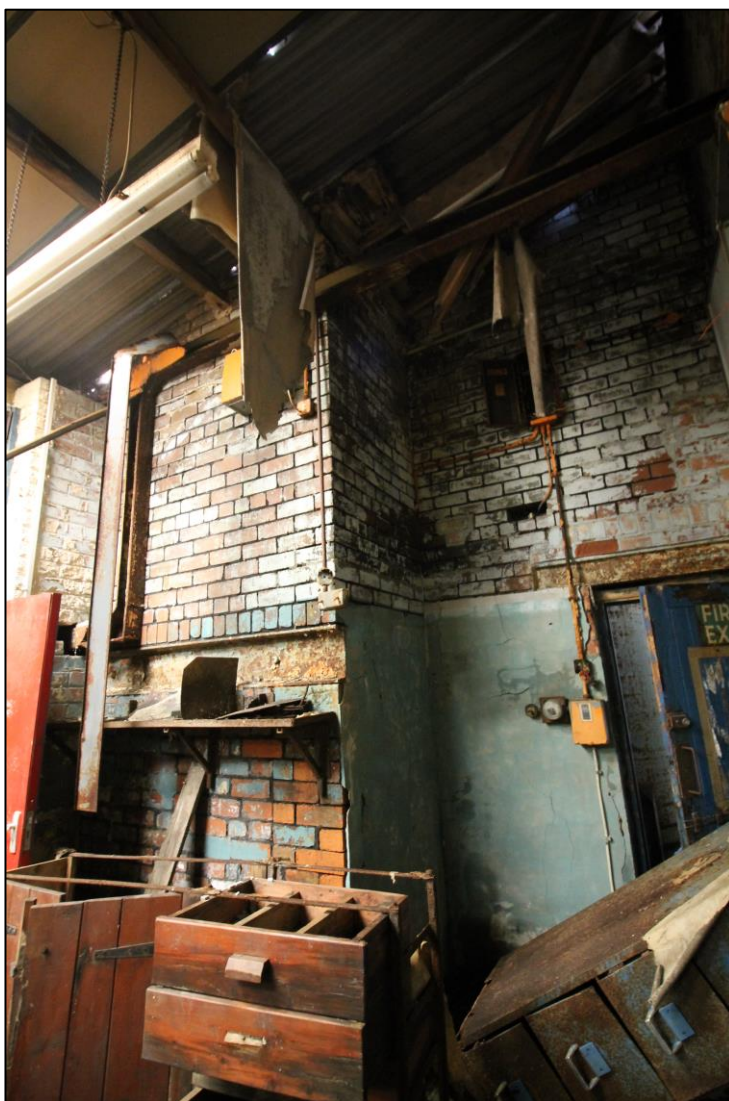
Plate 51: Lower half of the eastern wall of the larger cell, facing west

- 4.2.9 From the interior of the lean-to range to the east, it was possible to inspect the lower portions of the building's eastern wall. The horizontal steel lintel identified on the opposing face was again observed and traces of paint indicated that the lower half of the wall had been painted blue, with white above (Plate 51). Additionally, the internal angle formed by the dog-leg wall had been plastered to half-height and the southern end of the wall was obscured by a bank of steel cabinets associated with managing electricity generation (Plate 52).

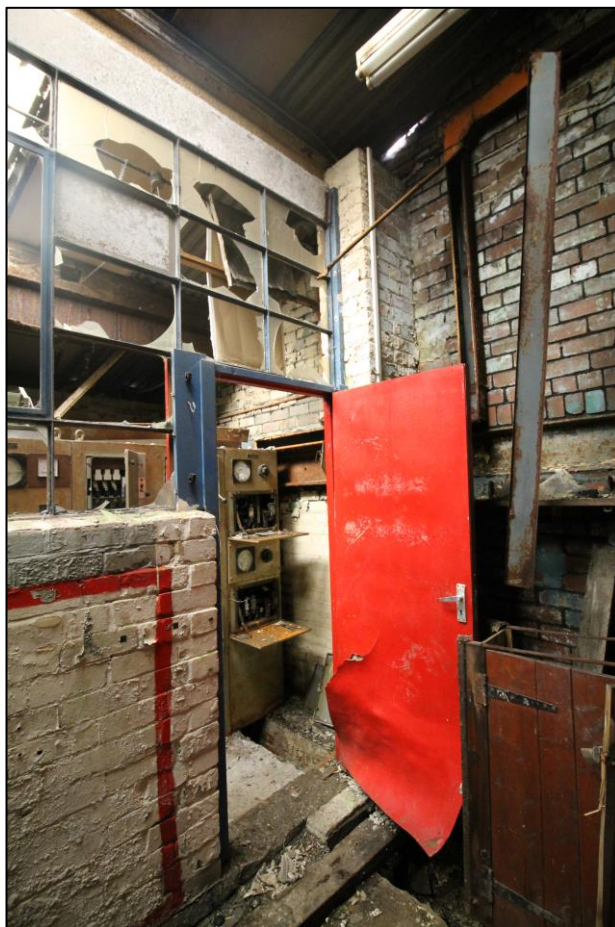
Plate 52: Electrical generation equipment at southern end of the eastern wall of the larger cell, facing south-west

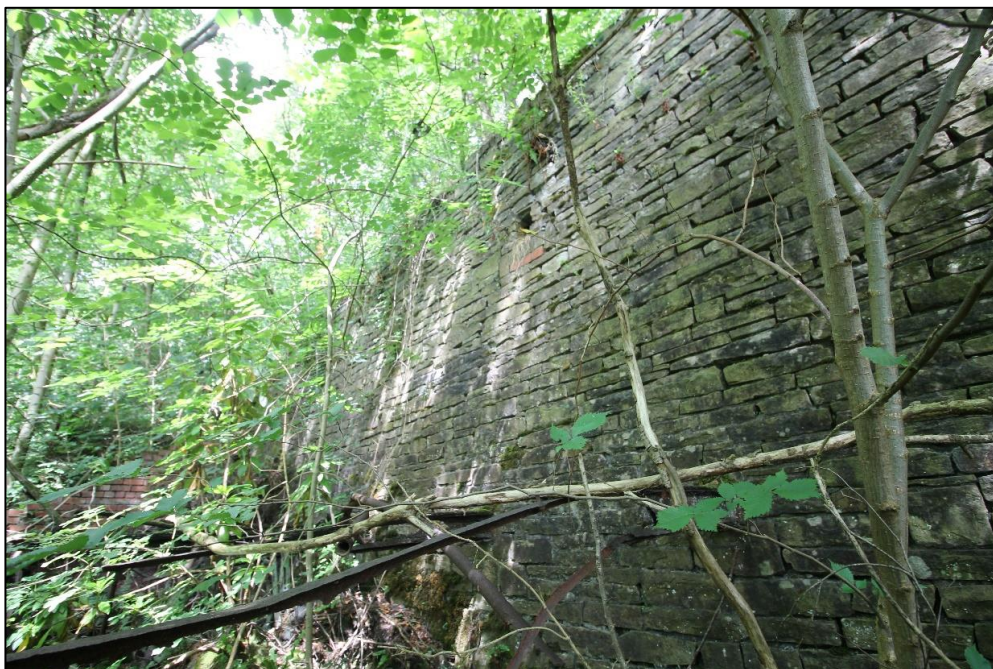
Plate 53: The early twentieth-century revetment wall

4.3.1 Several structures and buildings were identified and recorded in this part of the site which formed elements of the twentieth-century bleach and dye works (Fig 12). Specifically, these originally lay within an extension that had been made to the works during this period, at its north-eastern corner. One of these features was a tall rubble-built stone wall, which extending to a height of approximately 3.5m (Plate 53). The wall used coursed sandstone and was gently battered towards the top, and it had been built against a terraced slope; hence, it acted as a revetment wall, though it would also have formed the exterior wall of the extended section of the bleach and dye works. A series of smaller brick walls projected at a right angle from this wall, which formed several distinct bays. These walls varied in height and length but were all constructed of hard fired red brick of early twentieth century date. At the north-western end there was a brick-lined channel, 1.56m wide and filled with detritus, but surviving to a length of approximately 10m and aligned north-east/south-west. The brick foundations of a pair of small rectangular cells occupied the ground to the north.

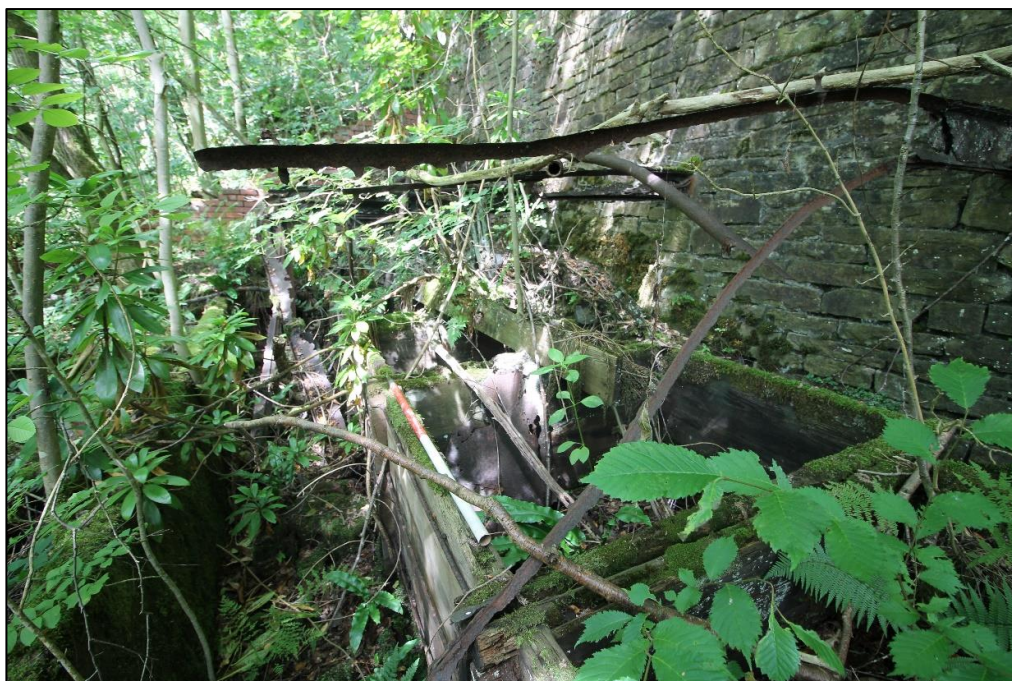
Plate 54: Timber tanks, facing north-west

- 4.3.2 To the south-east of the smaller bays (see Section 4.3.1 above), was a larger bay with an adjoining row of six small timber-lined tanks running parallel to the stone revetment wall (Plate 54). The perished remains of a rubber pipe were preserved within several of the tanks, indicating the transfer of water between them and a substantial steel frame, tied into the surrounding walls, was mounted above the tanks (Plate 55). A double row of concrete vats also lay to the south-west, and although these were much obscured by vegetation, six were visible (Plate 56).
