Redisher Works, Holcombe Brook, Bury, Greater Manchester Archaeological Investigation

December 2018

Client: CgMs Heritage

Archaeological Investigation

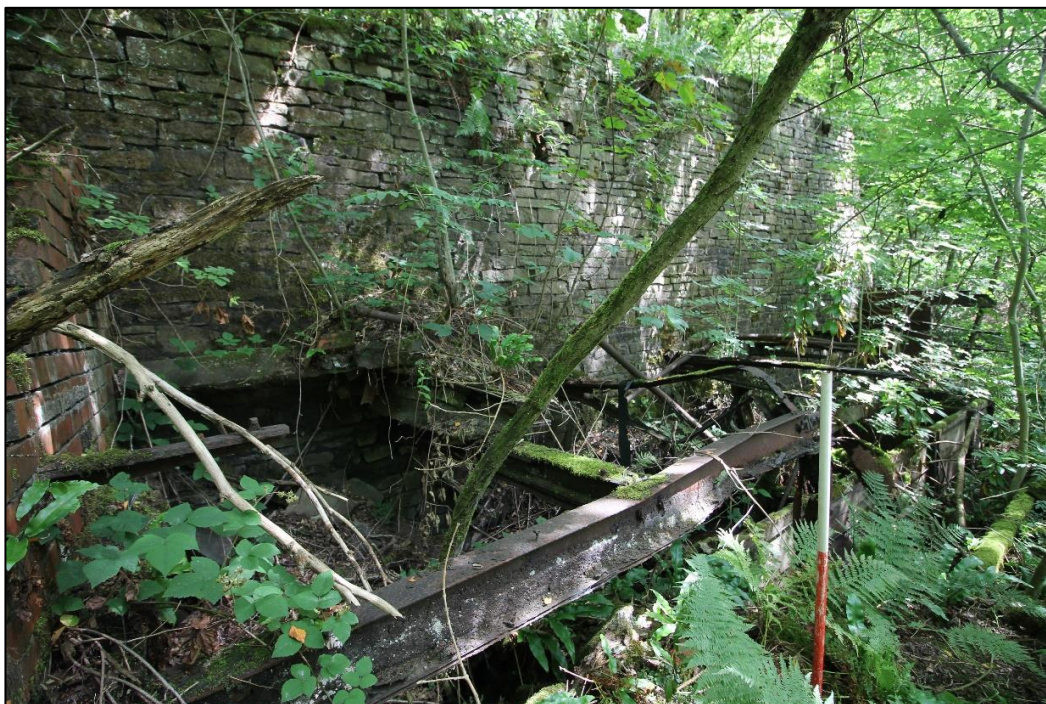
Plate 55: Steel frame above timber tanks, facing east

- 4.3.2 To the south-east of the smaller bays (see Section 4.3.1 above), was a larger bay with an adjoining row of six small timber-lined tanks running parallel to the stone revetment wall (Plate 54). The perished remains of a rubber pipe were preserved within several of the tanks, indicating the transfer of water between them and a substantial steel frame, tied into the surrounding walls, was mounted above the tanks (Plate 55). A double row of concrete vats also lay to the south-west, and although these were much obscured by vegetation, six were visible (Plate 56).

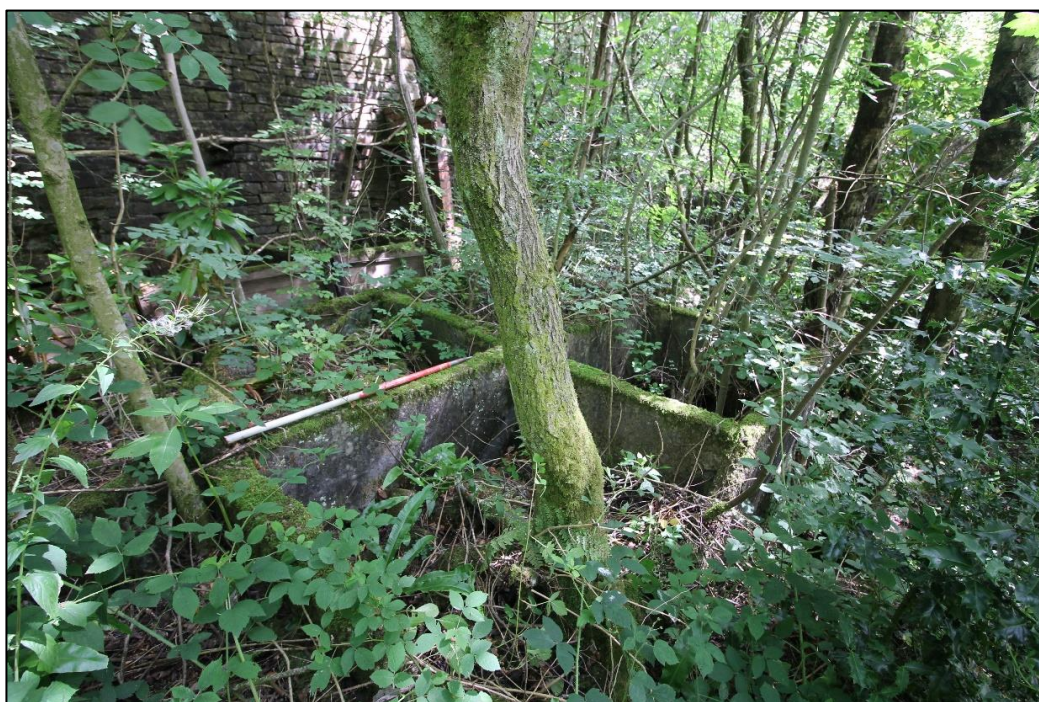
Plate 56: Concrete vats, facing east

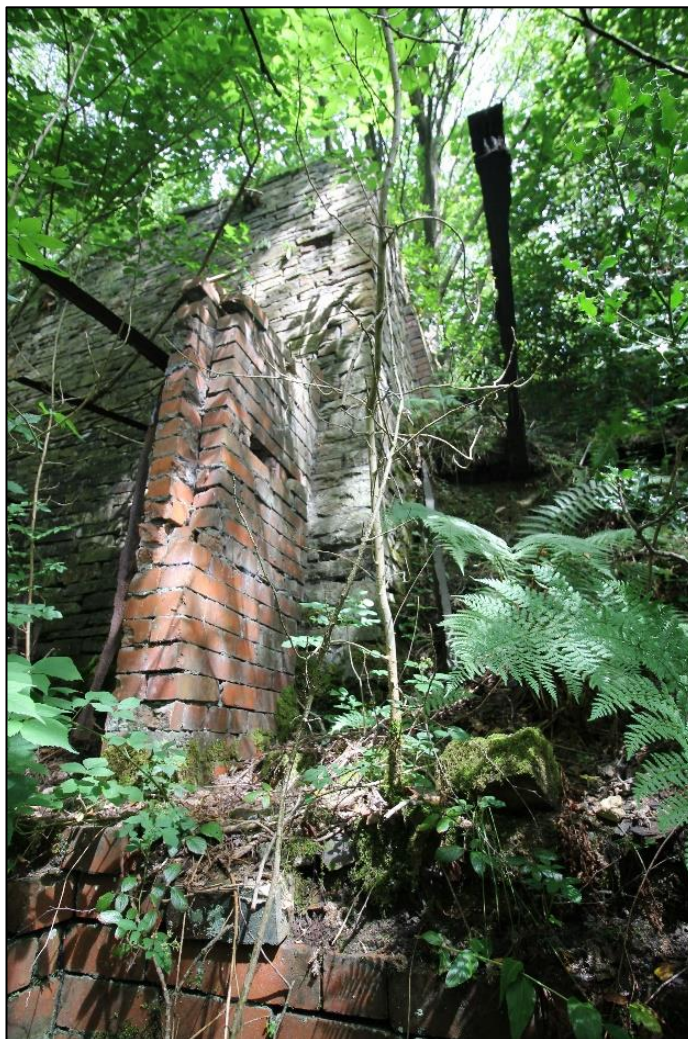
Plate 57: Corner of stone-built revetment wall, with redundant roof beam extend to right of centre

- 4.3.3 To the south-east of the vats, the revetment wall turned to the north-east, creating an additional square bay, set upon an area of slightly raised ground. A considerable quantity of tumble covered much of this bay, but a pair of steel beams projecting from the bank denoted the position of the roof in this part of the works (Plate 57). This bay is first depicted on the OS map of 1937 (Plate 43), and it was evident that it was bounded at the north-western end by a brick-built revetment wall rendered in cement and rising to a height of approximately 3m at its north-eastern end, while the

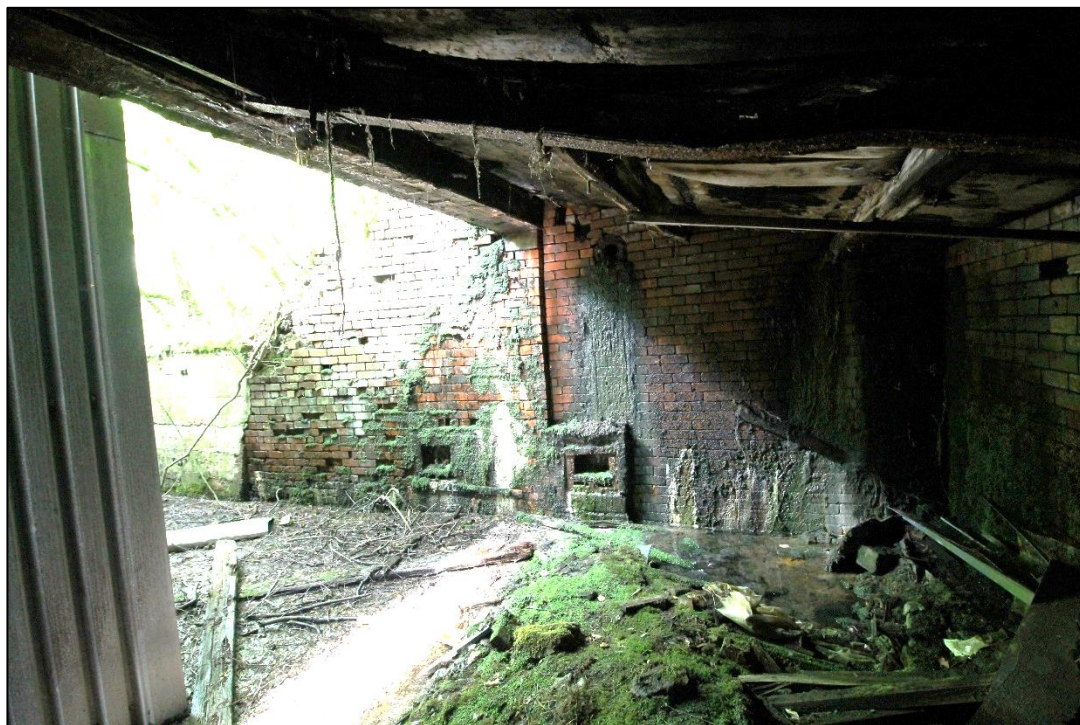
Plate 58: Open-sided brick-built structure, facing south-west

north-eastern side was defined by the exposed natural bedrock face for a distance in excess of 23m. In the north-western corner of the bay a rectangular brick structure had been erected, with a concrete single-pitch roof set upon steel and timber purlins, draining to the north-east. The building was open-sided to the south-west and had a cast iron pipe flange protruding from the face of its north-western wall (Plate 58). At the foot of this wall, directly beneath the pipe, lay what appeared to be a cast-iron end bearing box, with a second lying a short distance to the south-west (Plate 59).

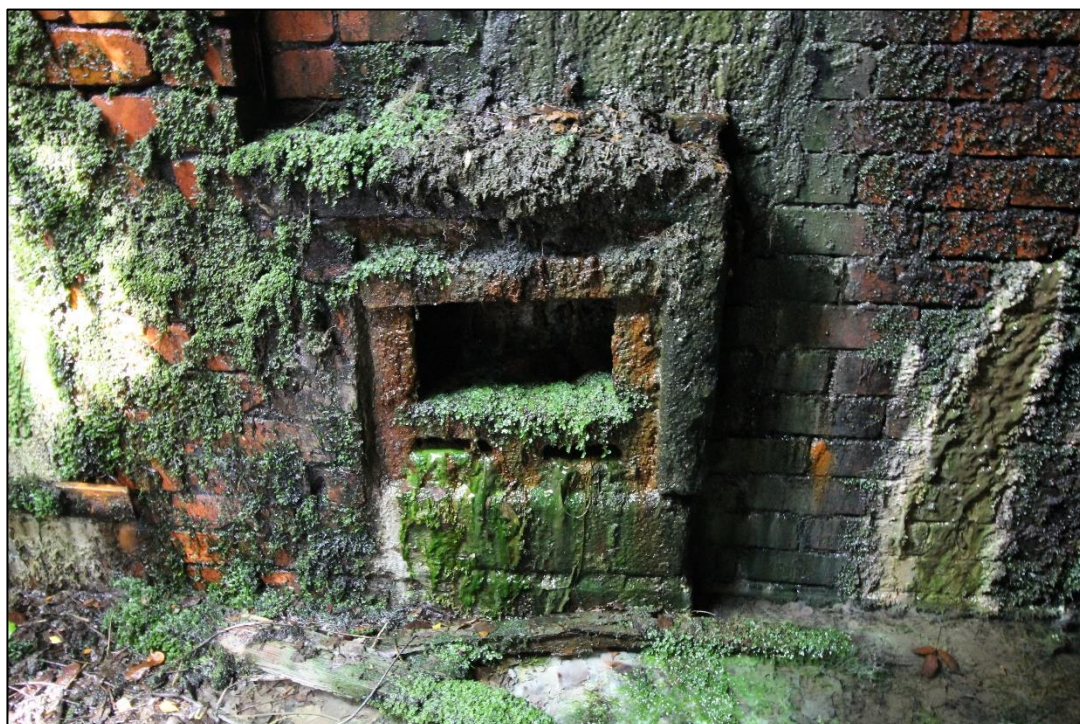
Plate 59: End bearing box on north-western wall of open-sided building

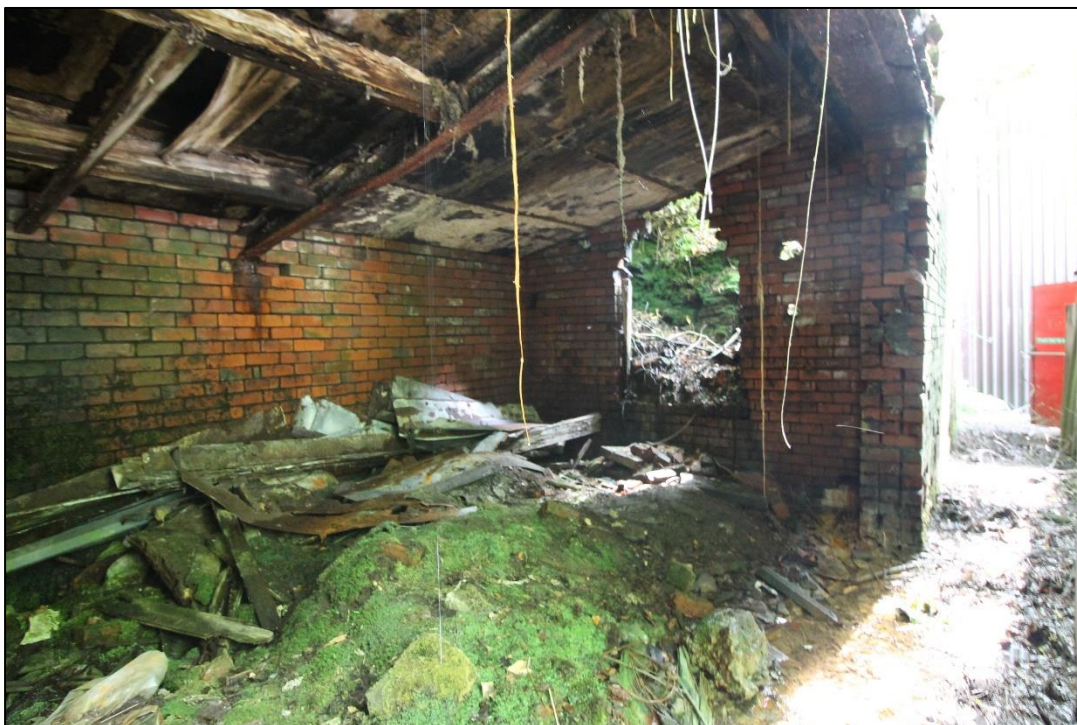
Plate 60: South-eastern end of open-sided building

- 4.3.4 The south-eastern wall of this building also had a large central aperture at its centre (Plate 60) and at its south-western end it turned though a right angle to continue to the north-east for a distance of 10m before abutting the corner of one of the modern industrial buildings. This created a narrow passage between this wall and the exposed bedrock, that could be accessed from an opening at the south-eastern end of the wall. The passage, which continued for a total length of over 17m, passed behind the

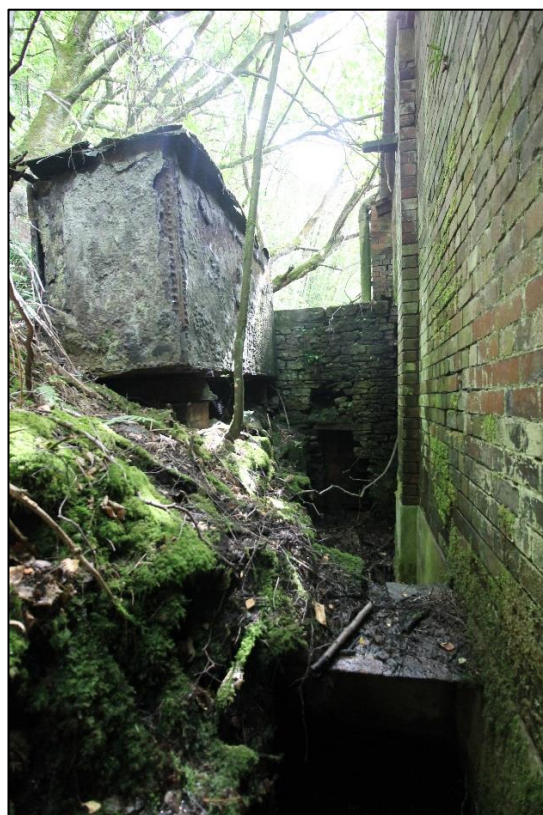
Plate 61: South-eastern end of narrow passage

adjacent industrial building, where it terminated in a stone cross-wall with what appeared to be a narrow aperture at its base and a metal tank above (Plate 61).
